FISHER HOUSE, RIVINGTON LANE, RIVINGTON, LANCASHIRE

Archaeological Building Recording

Planning ref: 22/00602/LBC

January 2023

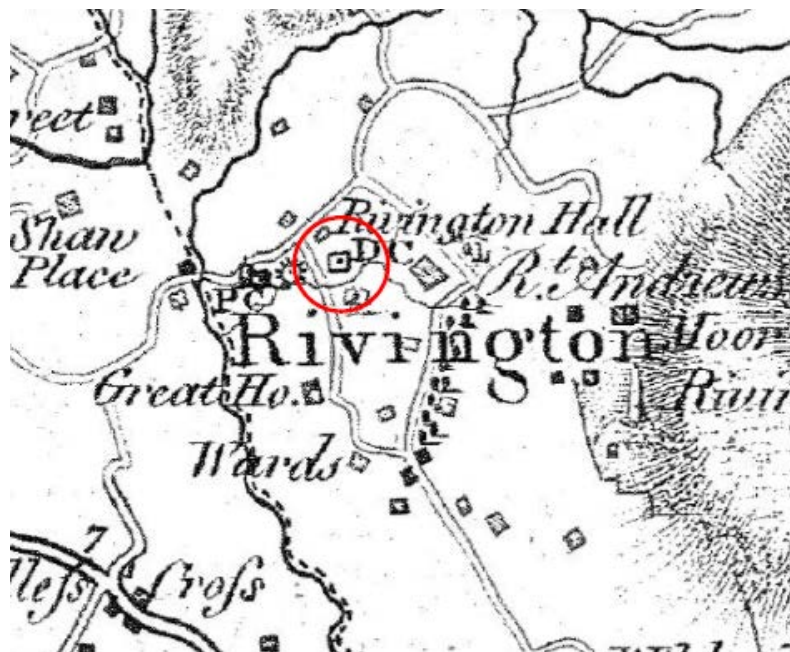
Plate 1: Extract from Yates's map of Lancashire showing the site (after Minerva Heritage 2021, 20)

3.1.2 **Yates, 1786:** this is one the earliest widely available and relatively detailed plans of the area, although the scale means that identifying individual buildings is difficult. It does appear to show a building on the site of Fisher Hall, although on a different alignment and depicted in an unusual way, closer to the manner in which industrial buildings and mills are shown (an open shape with a dot in the centre) rather than the manner in which houses are otherwise depicted.

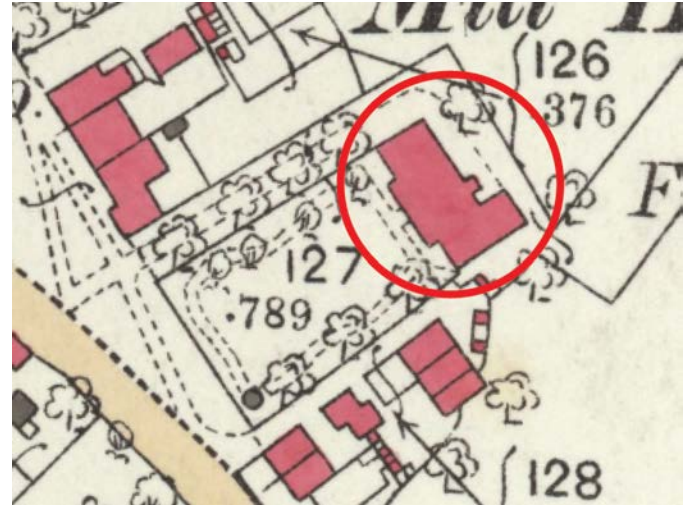
Plate 3 (right): Extract from the Ordnance Survey map of 1894

3.1.4 **Ordnance Survey, 1894:** this, the first edition 1:2,500 map, is more detailed than the previous edition of the Ordnance Survey maps (Plate 3; cf. Plate 2). The jutting sections to the front and rear of the property appear altered, although the extent to which this is due to the differences in scale at which the two maps were produced is unclear (Plate 3; cf. Plate 2). The block jutting out to the north-east at the south-east end of the rear (north-east) elevation has apparently been added by this time. The footprint of the building on the 1894 edition, surveyed in 1892, is much as it is today; however, there is a small jutting section approximately midway along the north-east elevation (possibly a porch), which is no longer present. The south-east end of the block, which has now mostly been demolished, was also still extant.

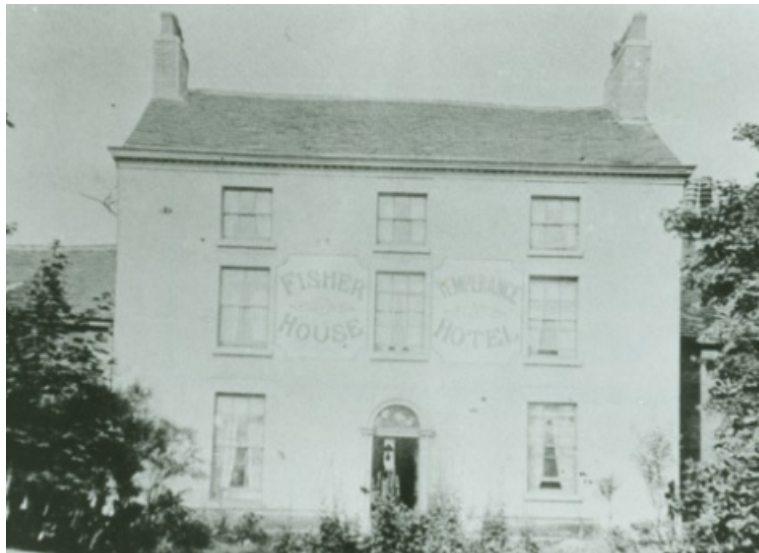
Plate 4: Fisher House Temperance Hotel, c1901

3.1.5 **Photograph, c1901:** a photograph of the front elevation of the building exists (Lancashire County Council nd). This is clearly from the period during which the building was used as a temperance hotel as it has a painted sign across the front reading 'Fisher House Temperance Hotel' (Plate 4), which dates it to approximately 1901 and no later than about 1904 (see Section 3.2.4).

3.2.4 **The building:** with the exception of the map evidence, historic evidence relating to the development of the building is relatively scarce. It was said to have been built on a plot of land '*which was once part of the goose hey field*' and in a list of properties in the village from 1817 it was named 'Goose Hey House'. The letting advertisement of 1837 describes it as comprising '*Dining, Drawing and breakfast rooms, very commodious kitchen, butler's pantry, stone [sic, presumably 'store'] room scullery, seven bedrooms and other suitable offices, laundry coach house, three stalled stable and shippon and moderately sized garden well arranged with fruit trees and other trees*' (Anon nd). It is also stated that the exterior was originally exposed brick and not rendered until the 1850s, although elsewhere it is stated that this was part of a programme of renovation undertaken after 1859 (*ibid*). It was used as a boys' school for a short time in the late 19th century, and between 1901 and about 1904 it was a temperance hotel (*ibid*). This is proved by a photograph of the exterior with the sign saying 'Fisher House Temperance Hotel' (Plate 4).

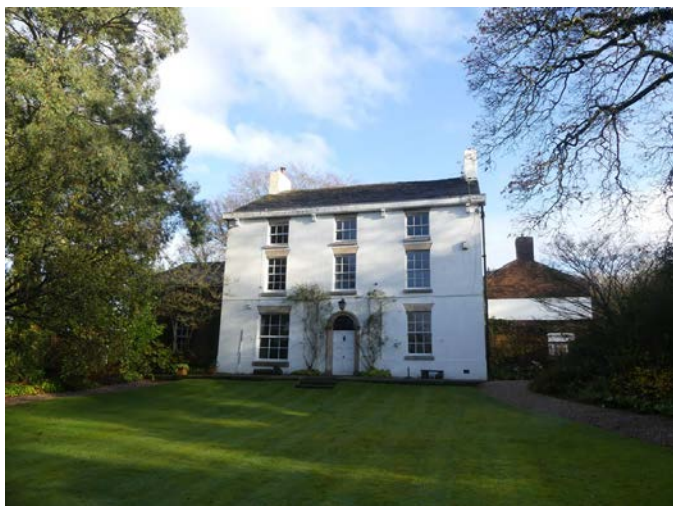
Plate 7 (left): General view of the front (south-west) elevation

4.1.2 **Fabric:** externally, the house is finished with smooth render, scored as ashlar blocks, and smoothly dressed, pale yellow sandstone is used for details (Plate 7 and Plate 8). The south-east extension comprises exposed stone of local buff gritstone and employs some small handmade brick. There is a modern conservatory to the south-west side. The south-west face of the north-west extension is also brick, matching the façade to south-east. The roof is thick stone flags to the front (south-west) and grey slate to the rear, with ceramic bonnet ridge tiles. There are two chimney stacks on the main house, with two modern pots, and a chimney on the north-east extension one with a cowl.

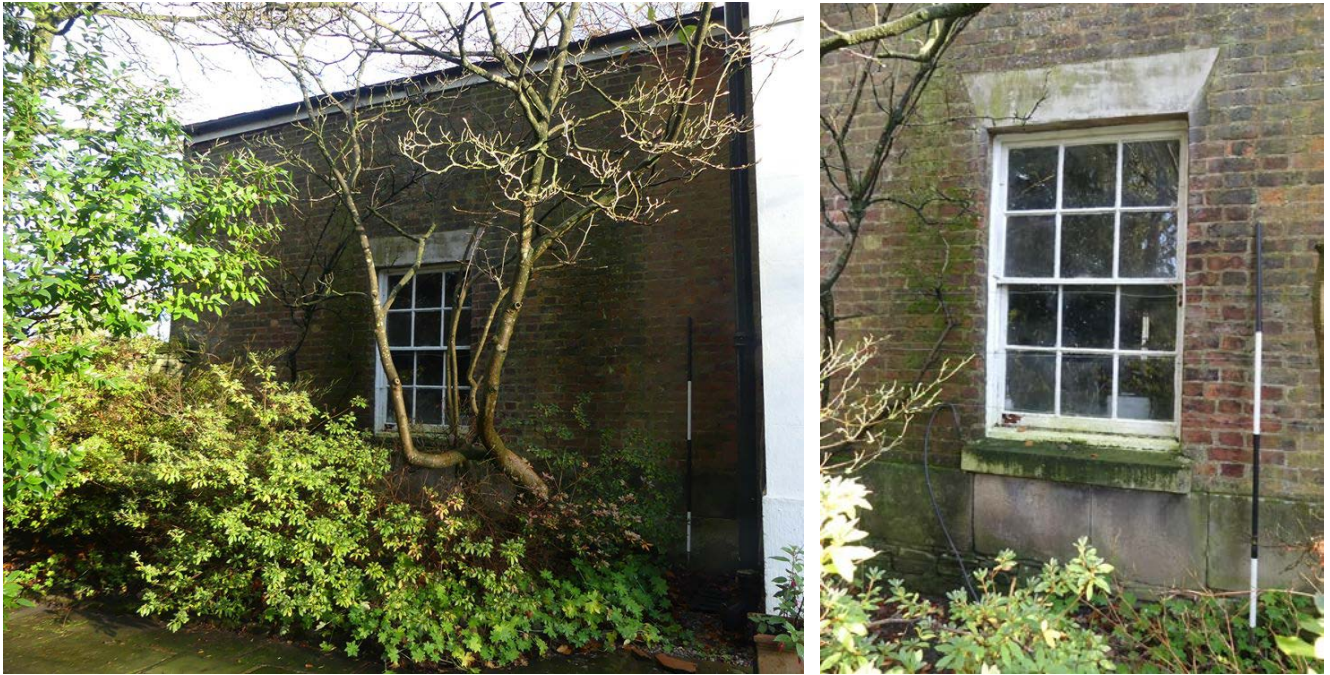
Plate 9 (left): Extension at the north-west end of the south-west external elevation
Plate 10 (right): Window at the north-west end of the south-west external elevation

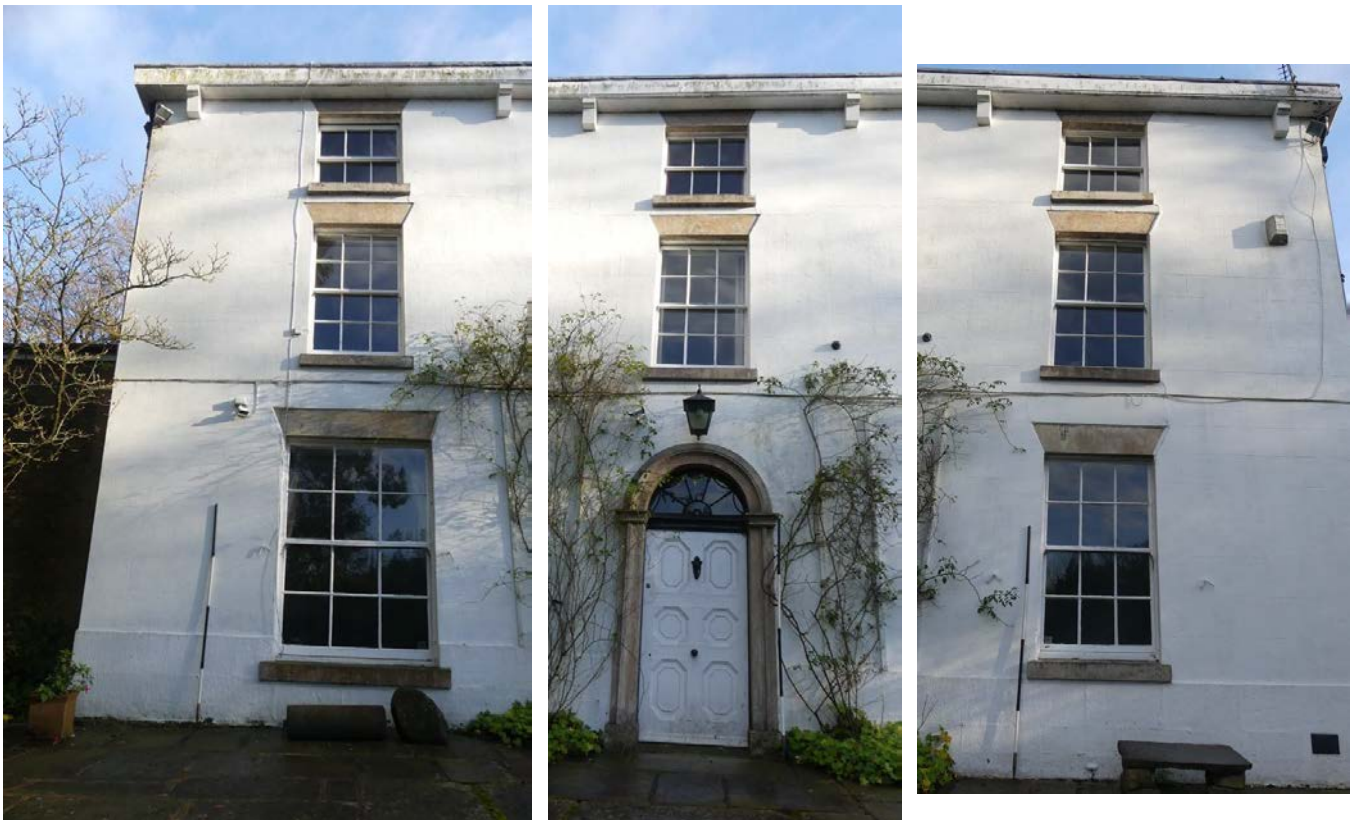
Plate 11 (left): North-west end of the south-west external elevation of the main house
Plate 12 (centre): Central part of the south-west external elevation of the main house
Plate 13 (right): South-east end of the south-west external elevation of the main house

4.2.2 The main elevation of the house is broadly symmetrical (Plate 11 to Plate 13) with a central doorway with a moulded dressed stone surround. The door is six octagonal panels, fielded, and with a glazed fan light over with relief decoration and astragals and swags and fleur-de-lys details. There are windows both sides on the ground floor, both six-over-six sash casements with dressed sills and splayed lintels but the one to the north-west is slightly larger and cutting through the projecting stone plinth at the base. There are three windows to first floor, all six-over-six sash windows with the same sill and lintel, and three on the second floor. Those on the second floor are three-over-three sash windows with the same sills and lintels. There is a projecting timber gutter at the top, supported on four angular brackets. There are L-shaped brackets either side of the ground floor windows.

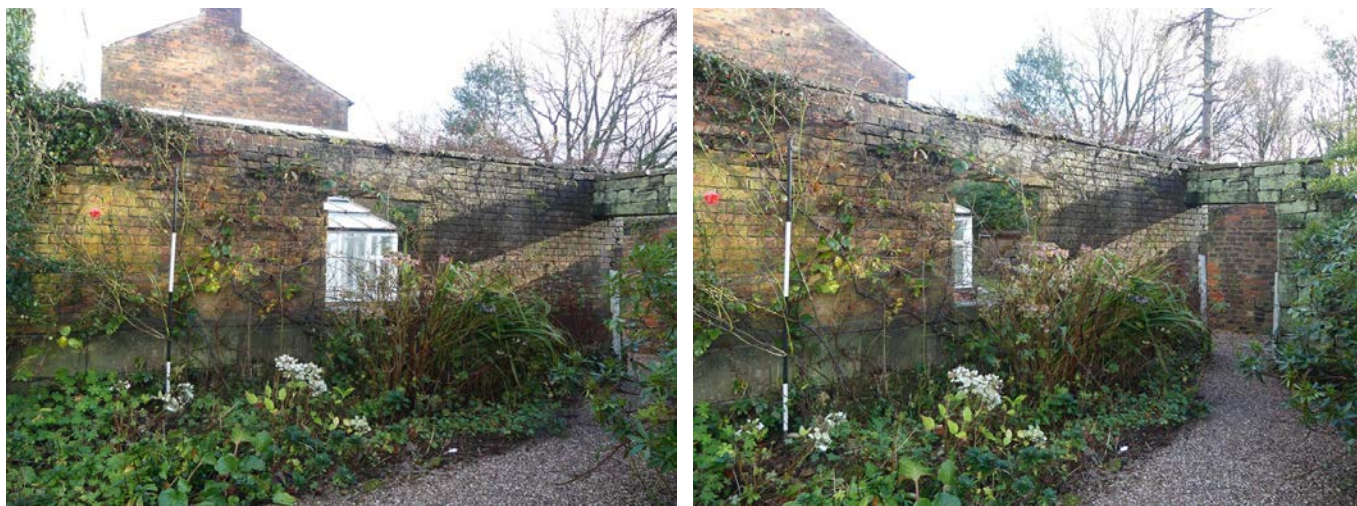
Plate 14 (left): Window in the brick wall to the south-east end of the south-west external elevation

Plate 15 (right): Brick wall and gate to the south-east end of the south-west external elevation

4.2.3 There is a slight return at the south-east side which is continued by a brick wall matching that to the north-west but capped with stone flags (Plate 14 and Plate 15). There is a hole for a window in the centre with a dressed sill with paint/plaster scar of a casement, but no lintel. The bricks are the same

size and type as those to the north-west and the plinth projecting at the base is butted by a stone garden wall with a gate on south-east side.

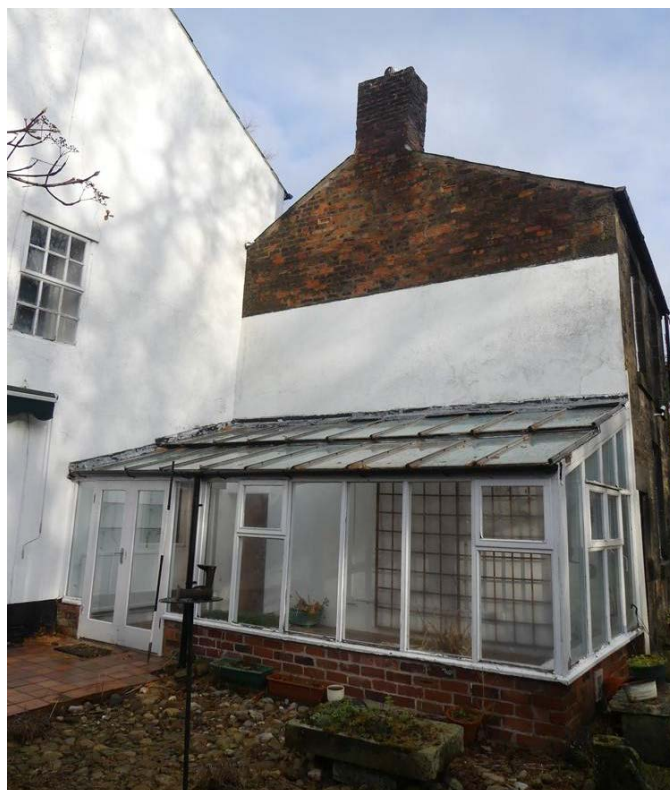
Plate 16: Conservatory and extension at the south-east end of the south-west external elevation

4.2.4 Behind this section of wall is the south-west elevation proper. The lower part is covered by a mono-pitch timber conservatory on 20th century brick base (Plate 16). The elevation is smooth rendered above and then brick gable. The bricks used are similar to those in the wall to the south-west but in English Garden Bond in a 5:1 ratio. The brick wall forming the boundary to the south-east also uses the same type of bricks.

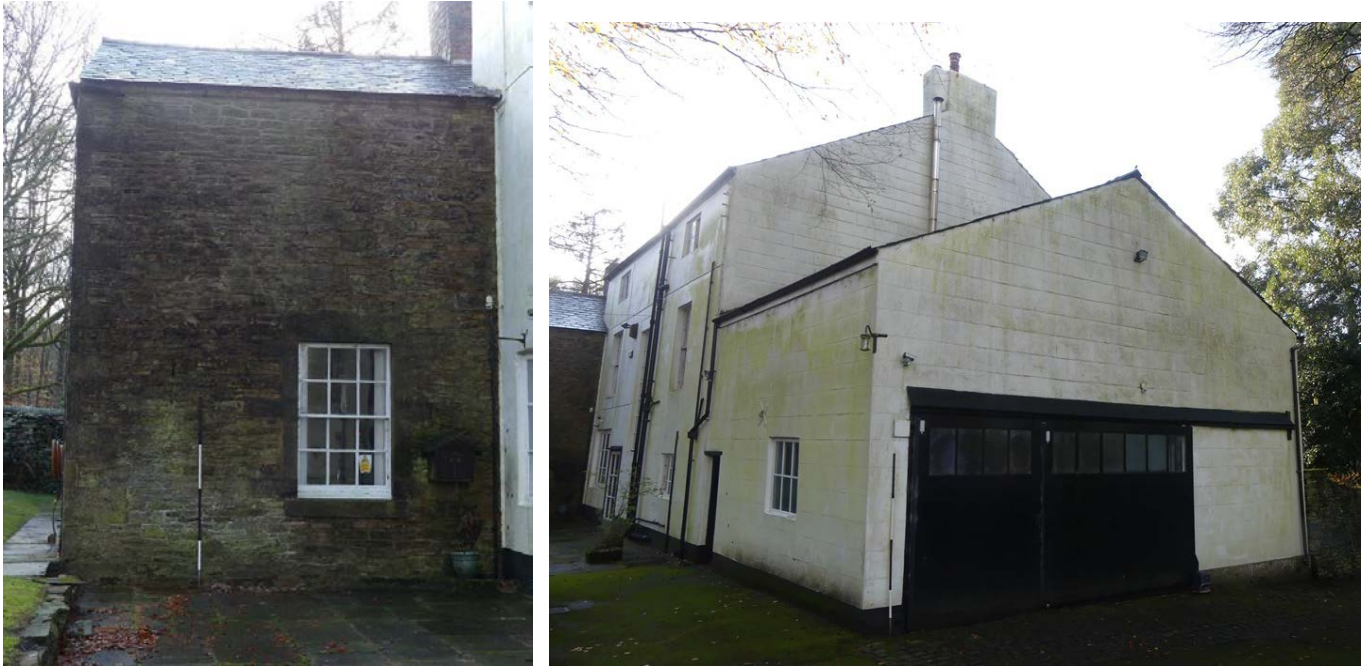
Plate 17 (left): North-west external elevation of the south-east extension

Plate 18 (right): North-west external elevation of the main house and garage

apparent above in the exposed stone. The stone is in rough courses. The north-west side of the main house is largely obscured by the lower gable of the extension (Plate 18), which has a massive garage door with sliding tongue and groove plank door in two parts (Plate 19). The north-east end has four lights in the top and south-west end has six (Plate 20). There is a projecting canopy over the runner marked "R Slinger & Son Preston" and "Coburn No. 11" on the mechanism (Plate 21 and Plate 22). There is a dressed stone plinth at the south-west end.

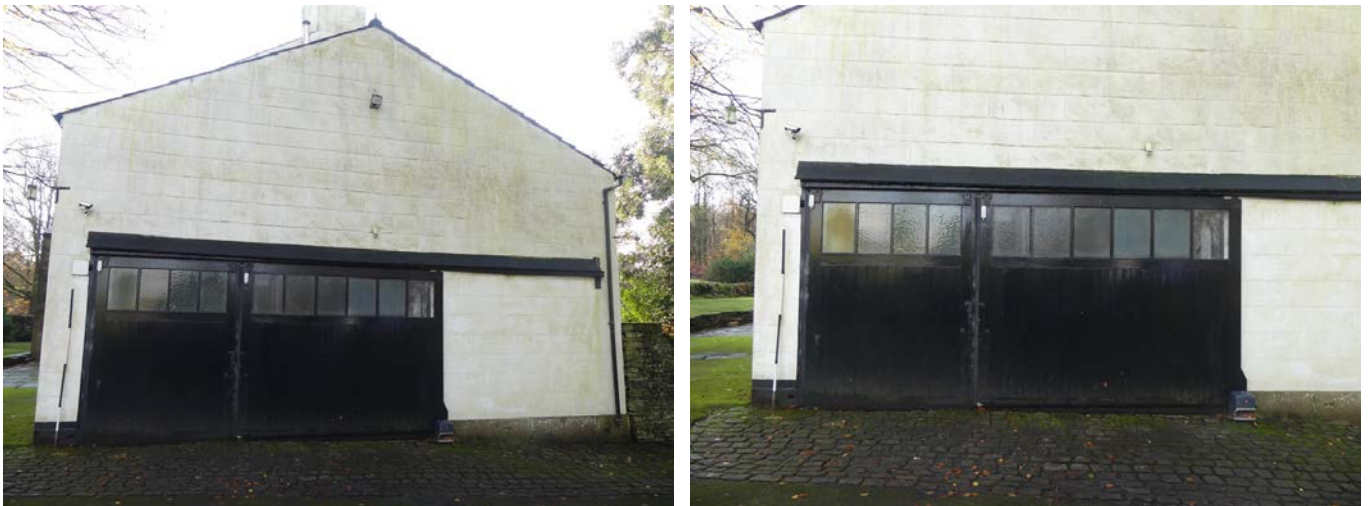
Plate 19 (left): North-west external elevation of the garage

Plate 20 (right): Sliding door to the garage

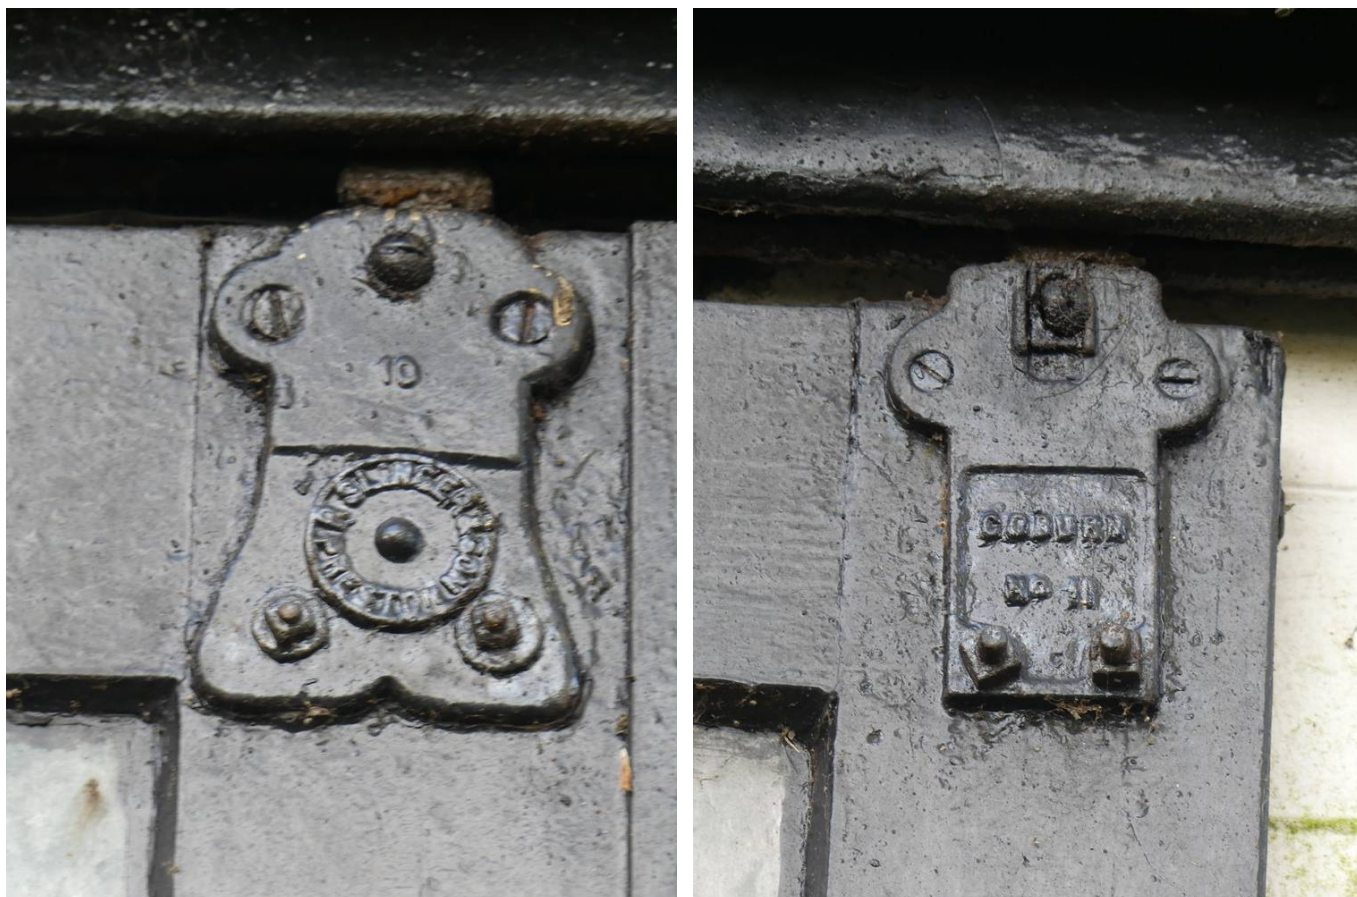
Plate 21 (left): Sliding door runner marked "R Slinger & Son Preston"

Plate 22 (right): "Coburn No. 11" on the sliding door mechanism

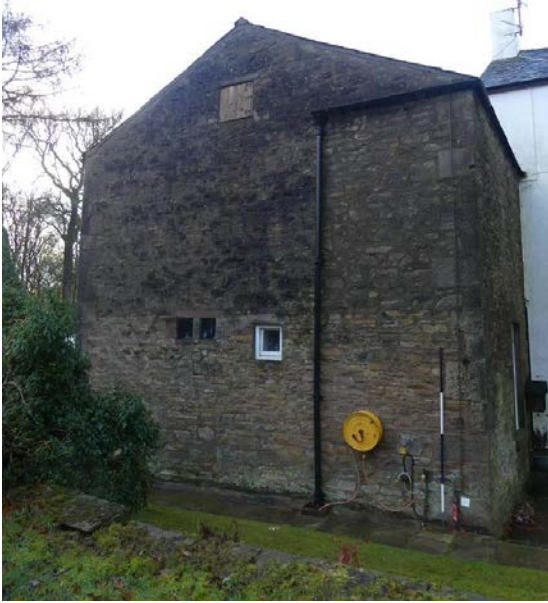
Plate 23 (left): North-east external elevation of the south-east extension

4.2.6 **North-east external elevation:** the south-east end of the north-east external elevation comprises the gable end of the south-east extension (Plate 23). There are two small openings at ground floor level, one of one light and one of two lights with square stone mullion between and dressed surround. There are quoins to both ends and the lower part is chamfered on the south-east side and the quoins are rounded below. There is a further small aperture below the apex with a modern overlapping plank door and stone sill and lintel. A change in the stone work is evident above the level of the windows and in the return to the south-west on the north-west elevation. The main part of the house has an irregular arrangement of doors and windows on the ground floor (Plate 24 to Plate 26). The large window to the south-east is 4x3-lights with a hinged opening in the centre. To the north-west is a doorway with a modern six-light glazed door with projecting surround and timber drip mould. The scar of a gable porch roof is apparent above and there is a vertical line in the render to the north-west. North-west of that is another smaller, 2x4-light Yorkshire sash window. In the centre is a 21-light stair window with a 2x8-light sash window to the south-east and a 2x6-light sash window to the north-west. At second floor level there is a 3x6-light Yorkshire sash to the south-east and 2x4-light Yorkshire sash to the north-west. The north-west extension is lower relative to the main part of the house (Plate 27). There is a doorway at the junction with the main house, with a timber lintel and plank door, and a fixed six-light window to the north-west. There is a cross-shaped tie rod in the centre.

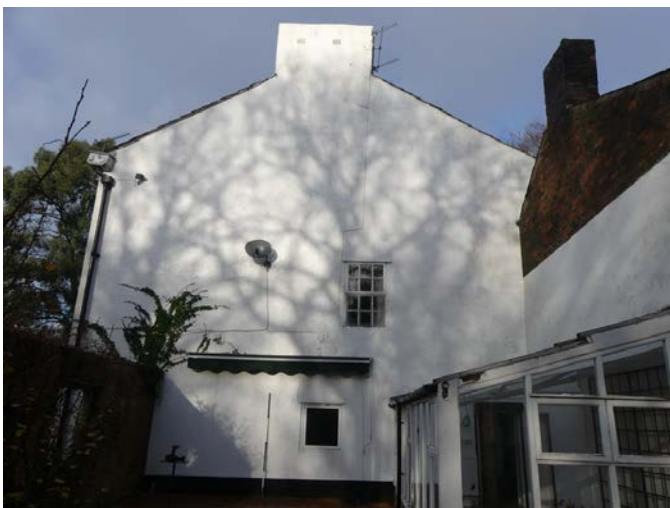
Plate 28 (left): South-east gable end of the main house

4.2.7 **South-east external elevation:** the south-west side of the south-east elevation comprises the gable of the main house and is finished with smooth plain render (Plate 28). It is topped with a chimney stack. There is a ground floor window in the centre with a modern single-light casement, which originally extended below for a taller window or possibly a door. The first-floor window to the north-east is a 12-light hinged timber casement. To the north-east side is the side of the timber conservatory attached to the south-east extension (Plate 29 and Plate 30). The extension mostly comprises exposed stone with a door on the south-west side with dressed quoins and lintel and tongue and groove plank door (Plate 31). The window to the north-east is a very tall 6-over-6 casement with dressed stone surrounds. There are two windows at first level the same as the one below. The change of stonework noted to the north-east elevation is not evident on this side. There is brick in the south-west side where the south-west elevation is also brick. The lower quoins are rounded to the north-east end of the elevation.

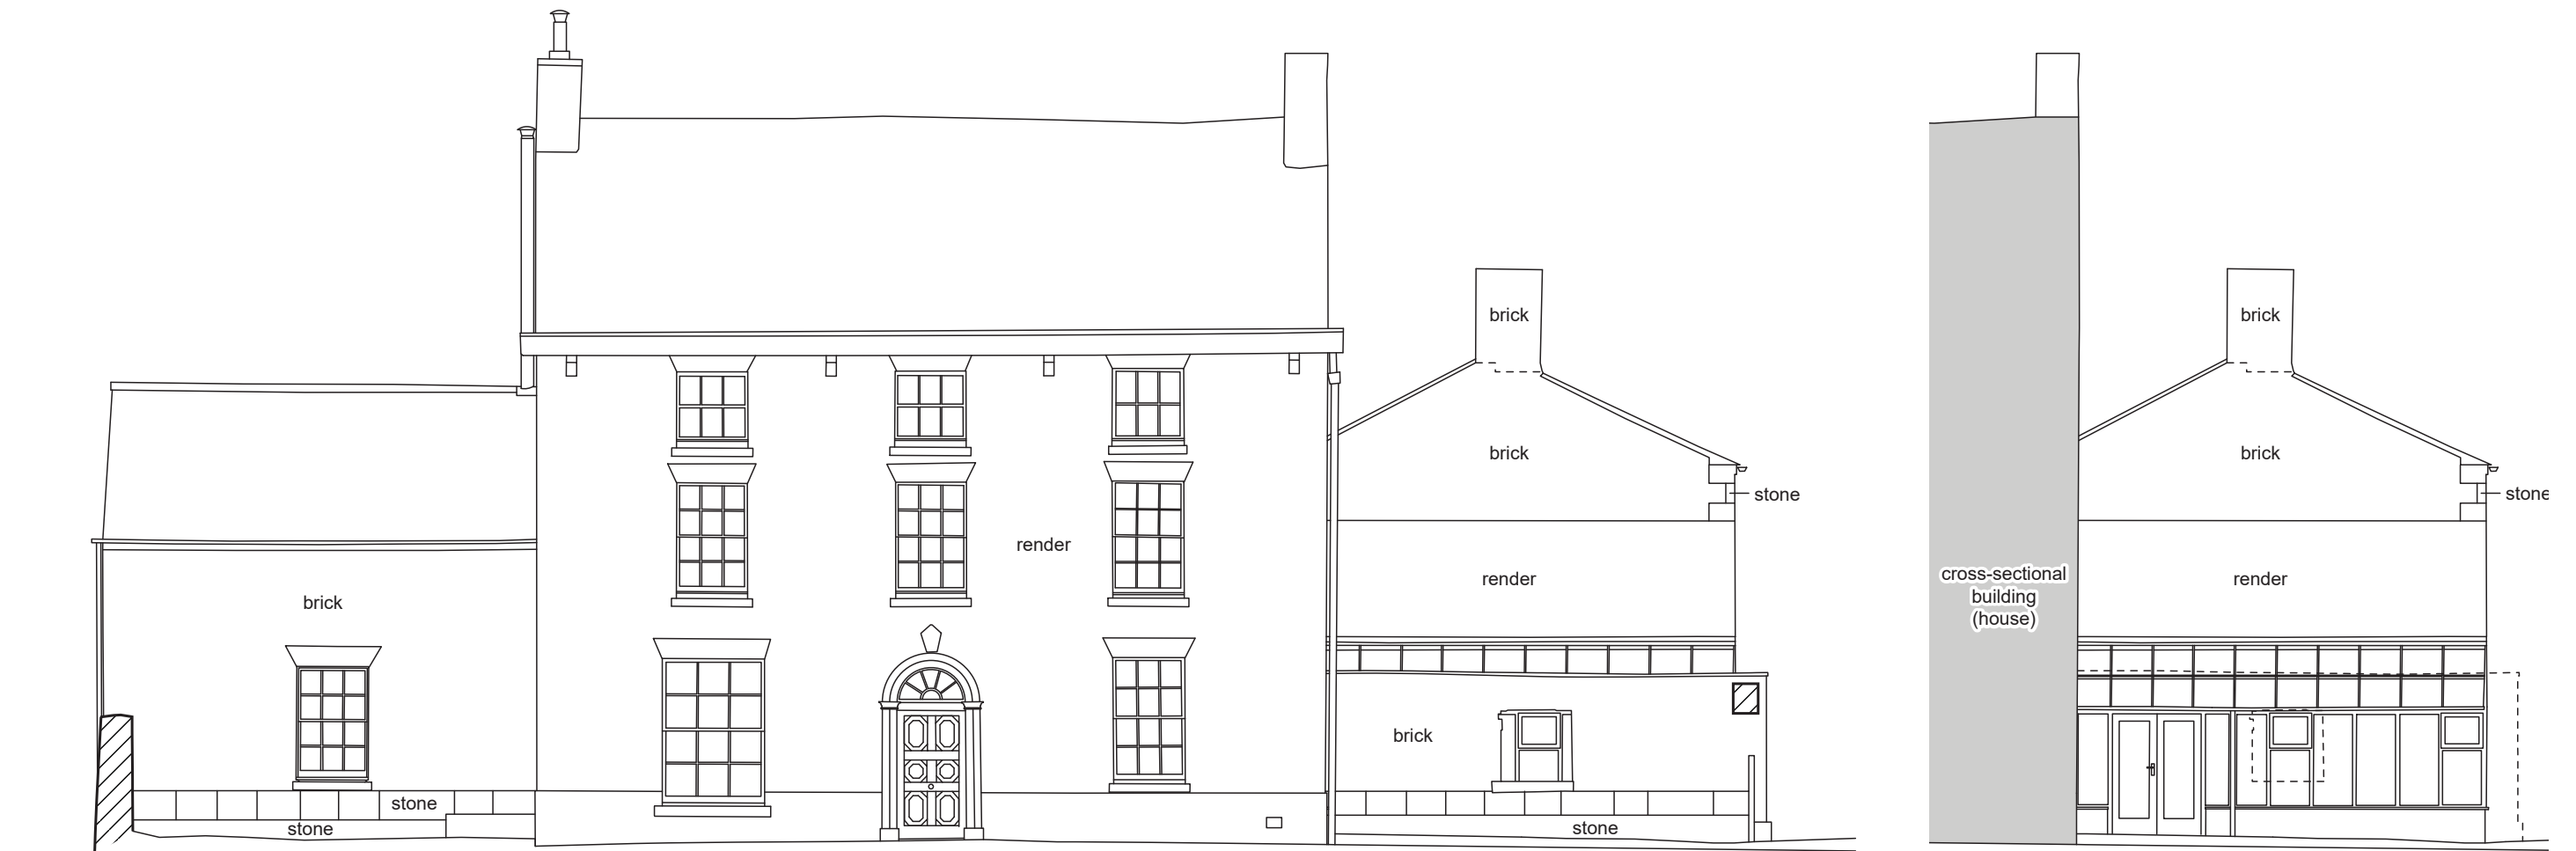
SOUTH-WEST EXTERNAL ELEVATION - MAIN HOUSE AND GARAGE

SOUTH-WEST EXTERNAL ELEVATION - CONSERVATORY

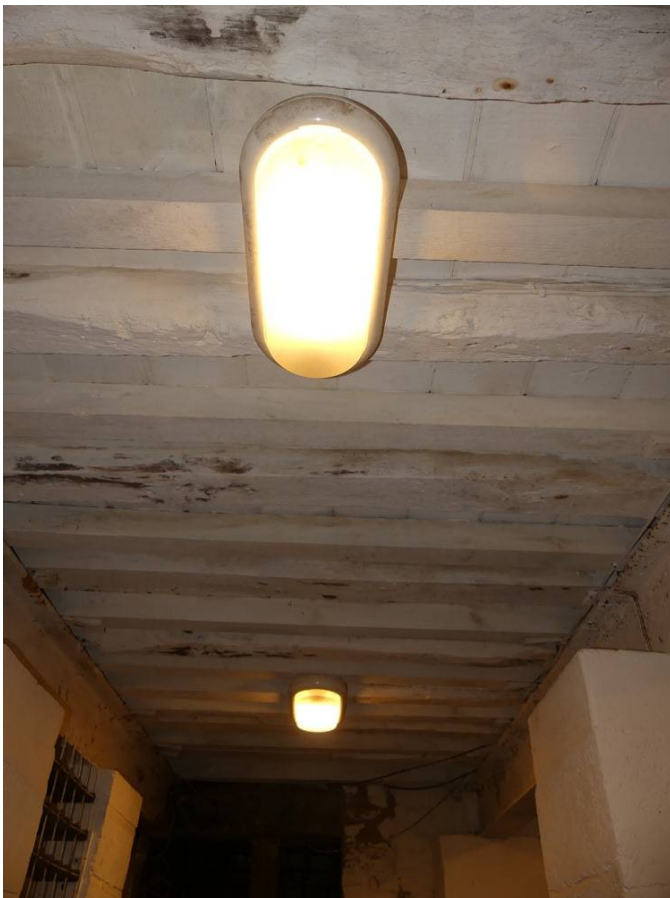
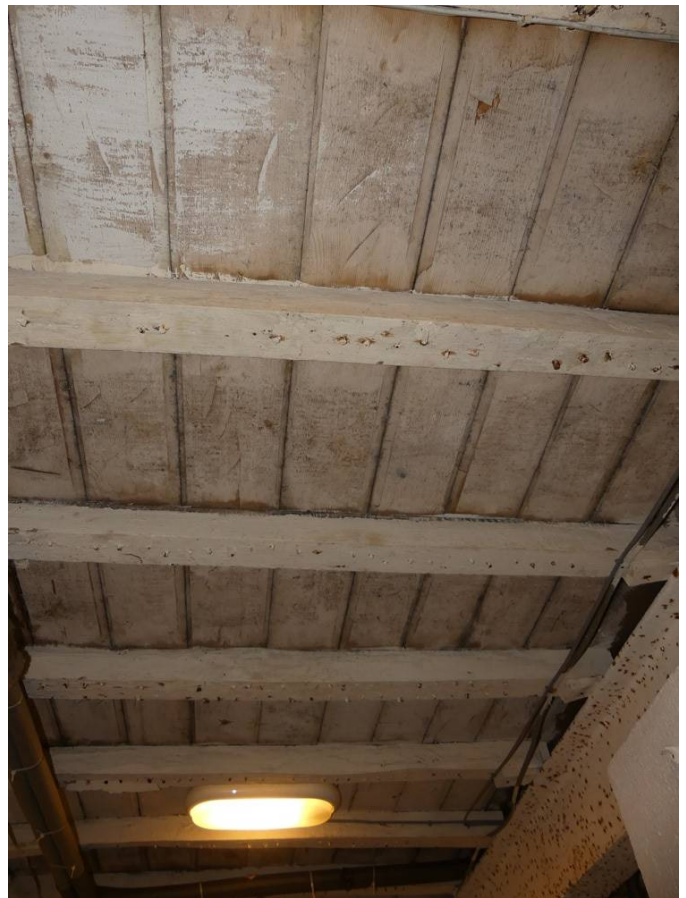
Plate 32 (left): Detail of the ceiling at the south-west end of the basement

Plate 33 (right): Detail of the joists in the basement ceiling

4.3.1 **Basement:** the cellar has a concrete floor and floorboards from the floor above visible on the joists in the ceiling (Plate 32). Some of the joists have nails for laths (Plate 33). The joists are supported by I-beams on concrete block 'columns' with timber shelves between (Plate 34 and Plate 35). The walls are painted white brick and stone. There are stone stairs up to the south-east on the north-east side of the room (Plate 36). These comprise dressed stones on brick. On the **north-east elevation** there is an alcove in the space next to the stairs on the north-west side (Plate 37) and the wall south-west of that is brick, with a round arch to the north-west side (Plate 38). The **south-east elevation** has a small alcove on the north-east side (Plate 39), a further opening to the south-west into a space under the building, and two more alcoves to the south-west (Plate 40). The **south-west elevation** is plain, with concrete columns with shelves between on the south-east side. The **north-west elevation** has an opening and external light at the south-west end (Plate 41). The opening has a heavy stone lintel and stone mullion with central band in relief and space for transoms. Iron rods are set in either side. The opening is brick. The centre of the elevation projects with brick columns and central block below the chimneybreast of the floor above (Plate 42), with two stone shelves, and there is a small alcove to the north-east (Plate 43).

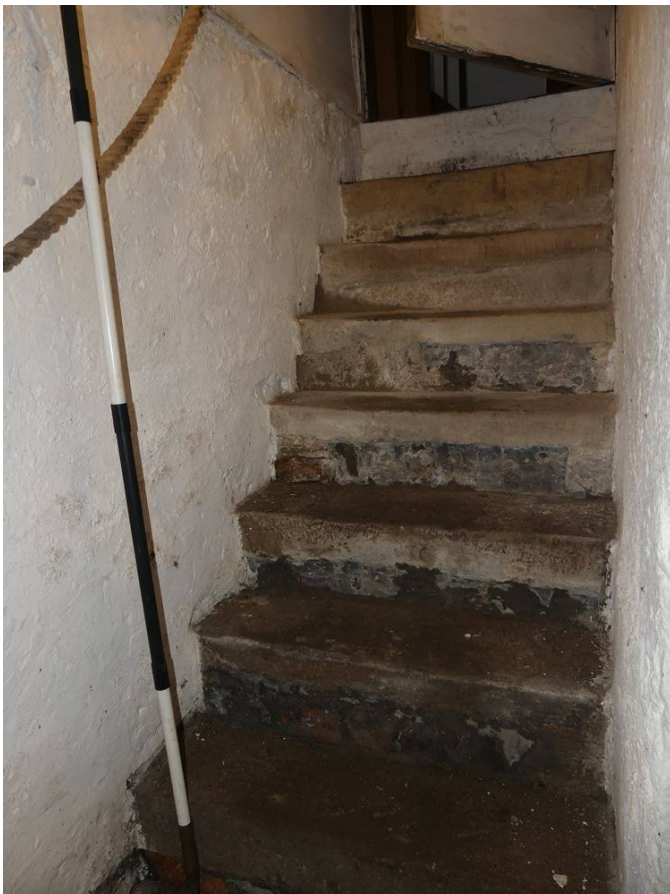
Plate 36 (left): Stairs at the north-east end of the basement

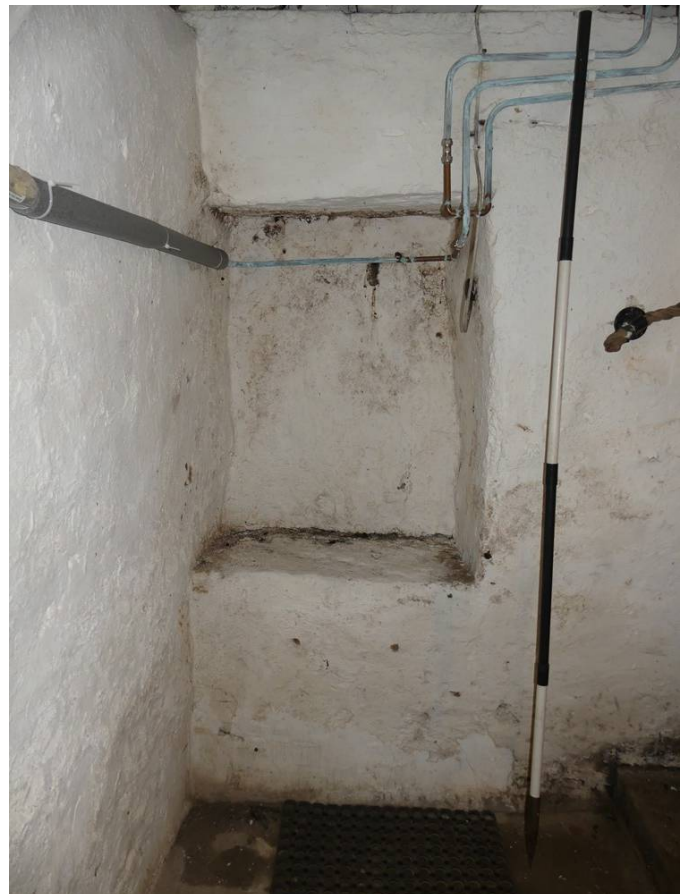
Plate 37 (right): Alcove in the north-east elevation of the basement

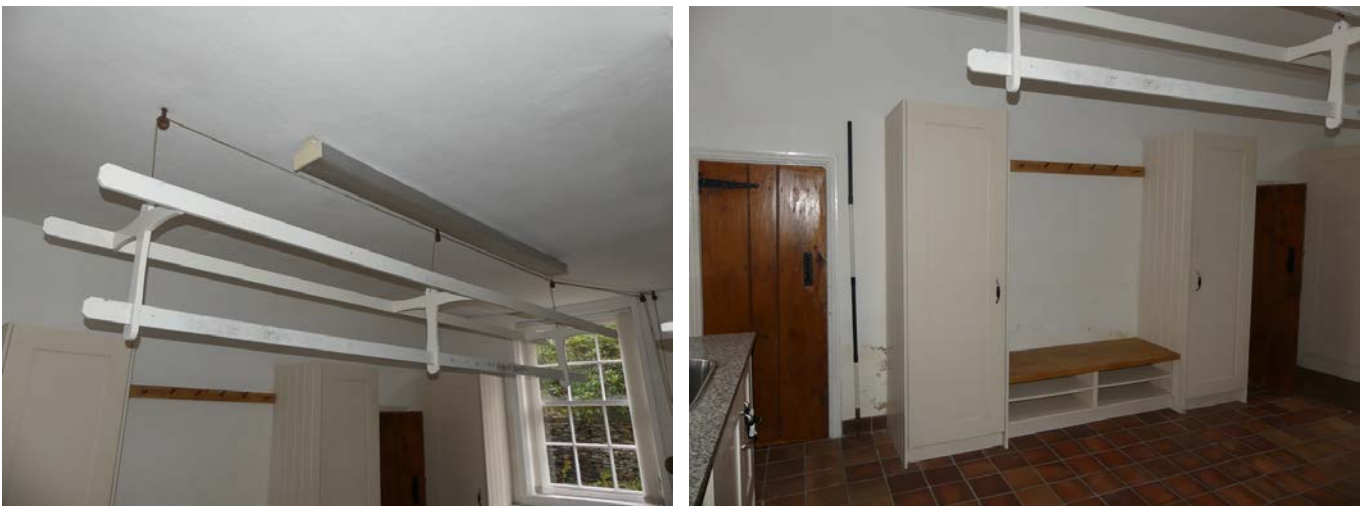
Plate 44 (left): Hanging timber drying rack in Room G1

Plate 45 (right): North-east elevation of Room G1

4.3.2 **Ground floor Room 1 (G1):** this room is main room in the extension to the south-east with two small rooms on the north-east side. It has a modern tiled floor and flat plaster ceiling with a hanging timber drying rack. The walls are painted plaster. The main **north-east elevation** has two doorways, one at each end, with beaded plank and batten doors with moulded surrounds and modern cupboards in between (Plate 45 to Plate 47). Inside the rooms to the north-east there is a sink and toilet in the room to the north-west (Plate 48 and Plate 49), with a high window in the north-east elevation and boxing behind the toilet and early cistern, and shelves in the room to the south-east (Plate 50), with a high window and sliding timber cover (Plate 51). The **south-east elevation** has modern units and a central six-over-six light window (Plate 52). The plank and batten door to the south-west has a stop-chamfered surround. The winder for the drying rack is attached to the wall to the side (Plate 53). The **south-west elevation** has a central fireplace with a dressed stone surround and projecting moulded mantle and wide opening (Plate 54). The doorway to the north-west houses a beaded plank and batten door on strap hinges (Plate 55). The **north-west elevation** has modern kitchen units and a six-over-six casement window (Plate 56).

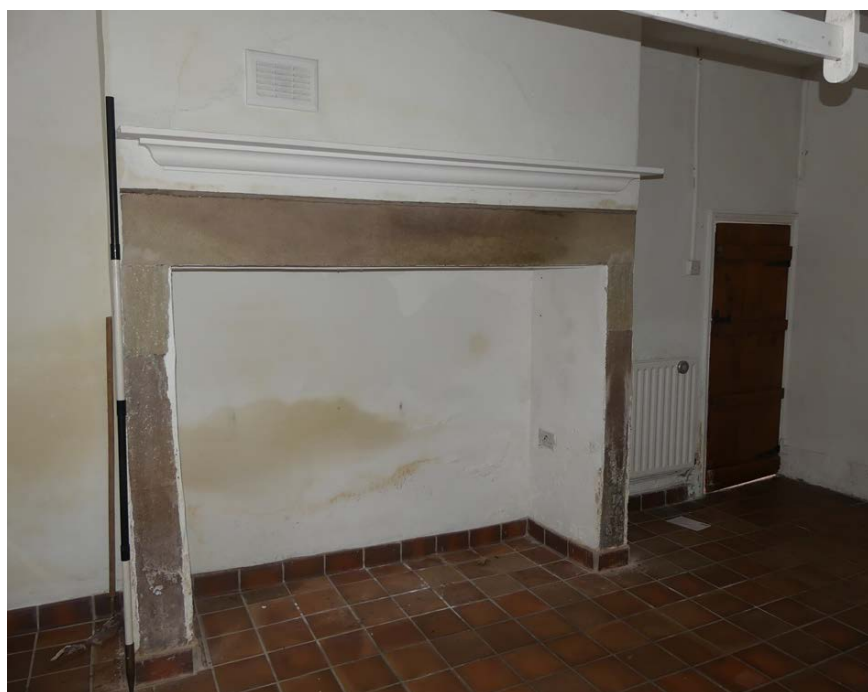
Plate 54 (left): Fireplace in Room G1

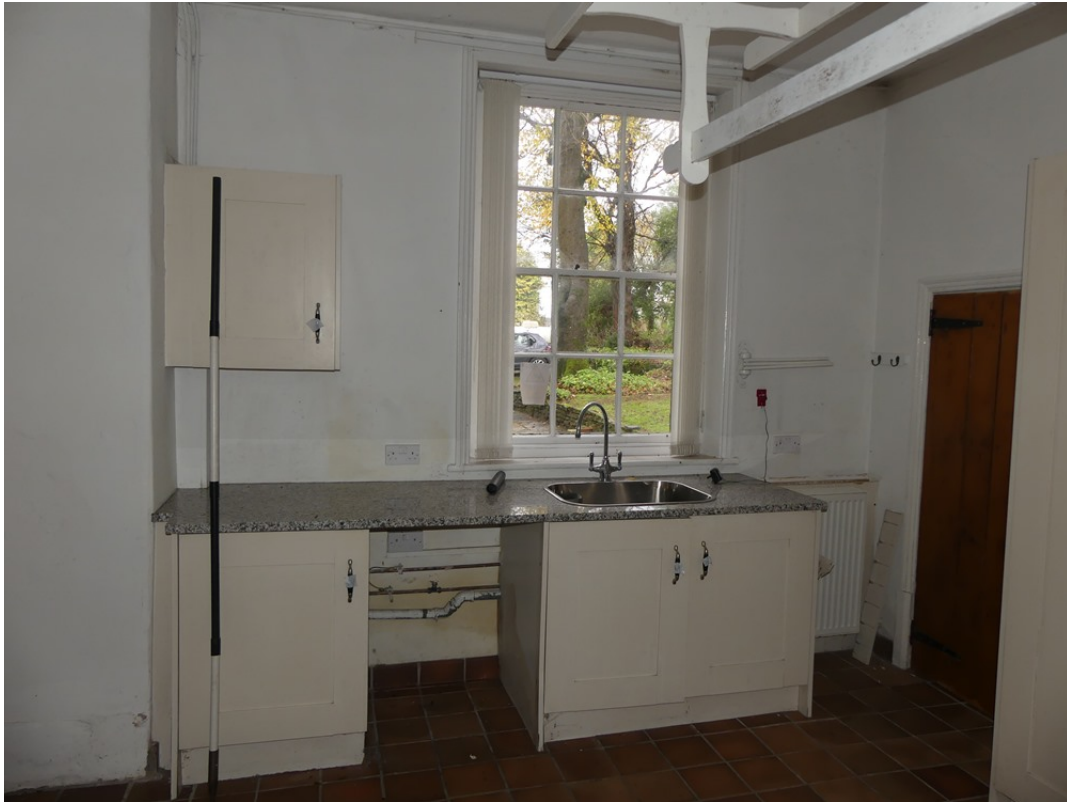
Plate 56: North-west elevation of Room G1

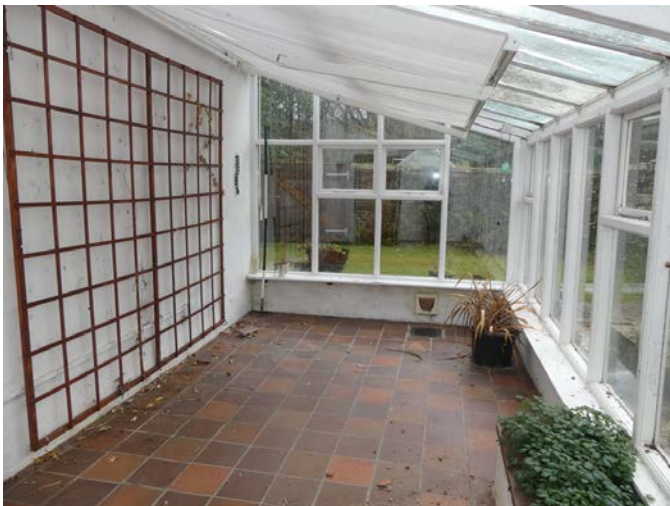
Plate 57 (left): General view of the south-east end of Room G2

4.3.3 **Ground floor Room 2 (G2):** the conservatory; this room has a tiled floor and glazed roof. The **south-east** and **south-west elevations** are glazed and timber construction on a low wall (Plate 57 and Plate 58). There is a double door to the south-west. There is a beaded plank and batten door in both the **north-east** and **north-west elevations**, which are otherwise plain plaster (Plate 59 and Plate 60). There is skirting board over the north-west side. There is an iron grate in the south-east end.

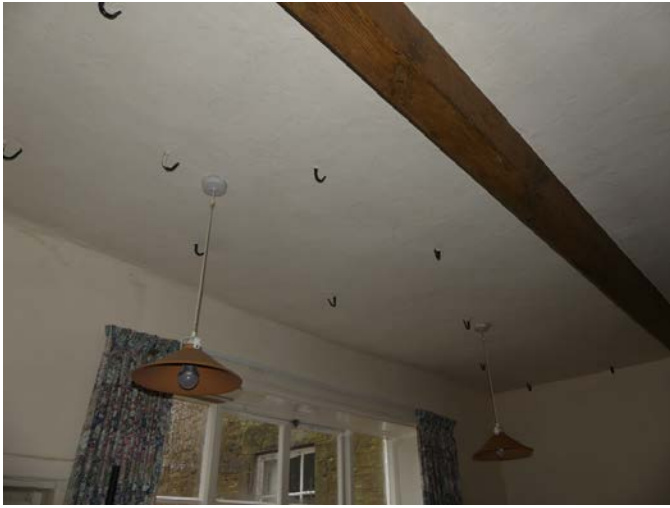
Plate 61 (left): Meat hooks in Room G3

4.3.4 **Ground floor Room 3 (G3)**: this room, the kitchen, has a large quarry tile floor and flat plaster ceiling with iron meat hooks on the north-east side (Plate 61). There are three south-east/north-west beams across the room, which are very neatly finished with a fine chamfer (Plate 62). The walls are painted plaster. There is a window and door to the **north-east** (Plate 63). The door is an early beaded plank and batten door on early strap hinges (Plate 64 and Plate 65) behind the outer glazed door. The window is of 12 lights with a central six. The **south-east elevation** has a beaded plank and batten door on the north-east side in moulded surround (Plate 66) and chimneybreast to the south-west with brick effect cladding inside and modern timber lintel and Aga (Plate 67). There is a small, single light UPVC window to the south-west. The wall is tiled between the rows of hinged cupboard units to the **south-west** (Plate 68) and there is a modern timber service hatch. There is a six-panel door in moulded surround to the **north-west** (Plate 69).

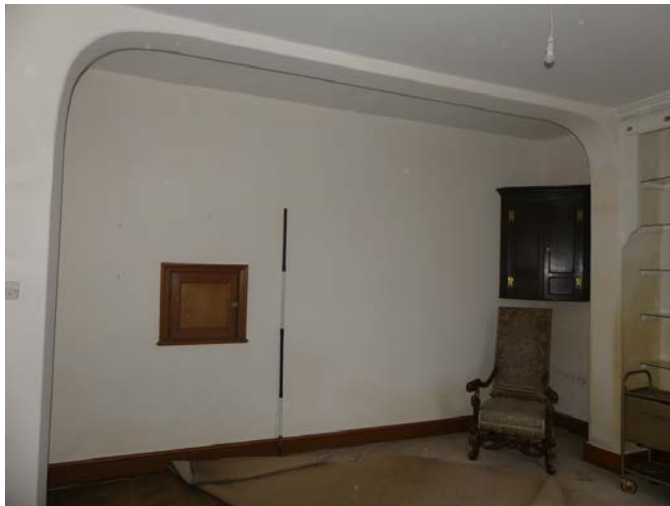
Plate 70 (left): North-east elevation of Room G4

4.3.5 **Ground floor Room 4 (G4):** this room has a narrow board floor below the carpet. The ceiling is flat plaster with a wide arch on the north-east side (Plate 70). The walls are plaster and flock wallpaper and moulded skirting. The **north-east elevation** is plain apart from the modern serving hatch and early corner cupboard to the east (Plate 70). The **south-east elevation** has an alcove with moulded timber surrounds each side of the central chimneybreast (Plate 71). The fireplace has a plain splayed opening clad with stone and a similarly finished hearth (Plate 72). The alcoves have original decorative entablature decorated with triglyphs and roundels and scrolled panels below (Plate 73). The **south-west elevation** has a single window with slightly splayed jambs and moulded surrounds and sill (Plate 74). The **north-west elevation** has a single six-panel door in moulded surround (Plate 75).

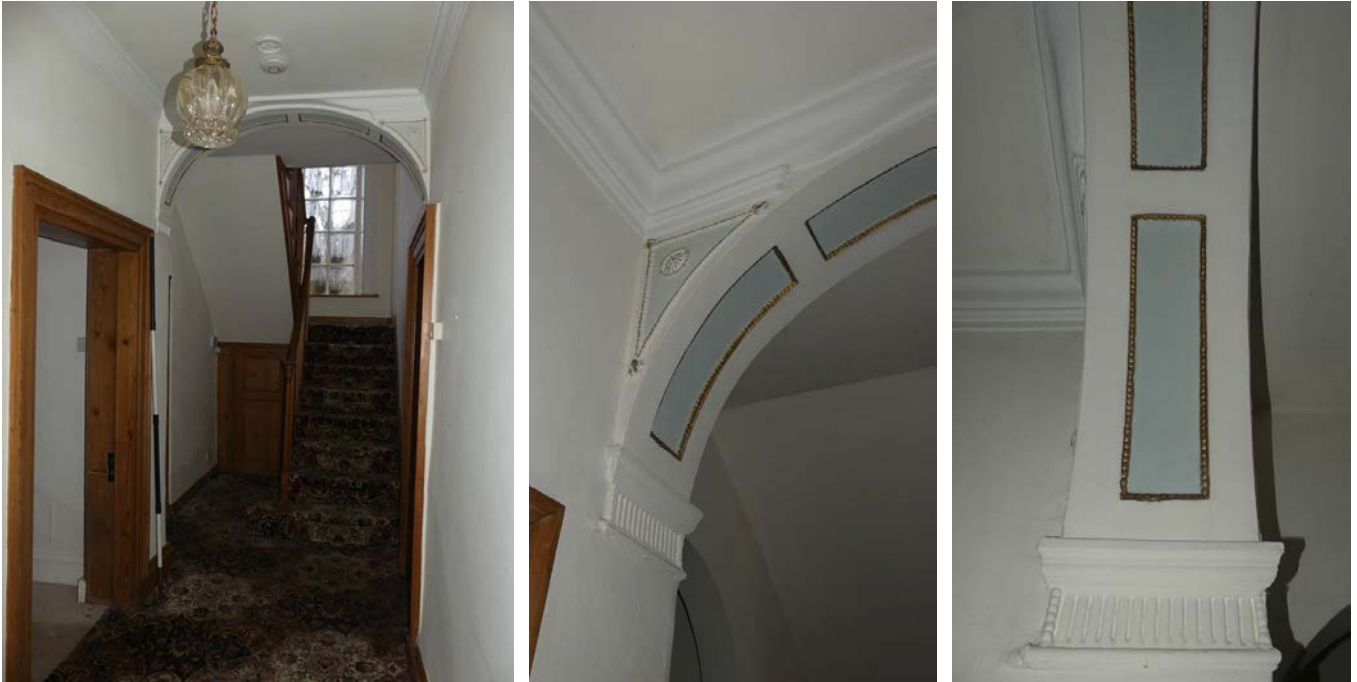
Plate 76 (left): Stairs at the north-east end of Room G5

(Plate 76 to Plate 78). The walls are plaster and paint and there is skirting board. The stairs are very plain. They have a simple turned newel with flat head and square balusters, two of which are iron rather than timber (Plate 79). There is a small two-panel door to the north-west (Plate 80) into the space under the stairs with a stone flag floor and board ceiling on joists and plastered walls. There is a further four-panel door to the south-west and an arch to the south-east, which is plain but with timber details. There are two further doors to the **south-east**, both with six-panel doors and moulded surrounds (Plate 81), one to the **north-west** in the same style, and one in return to cellar (Plate 82). The doorway to the **south-west** has a wide six-panel door with early door furniture and flanking engaged columns and fanlight over with plaster moulding (Plate 83).

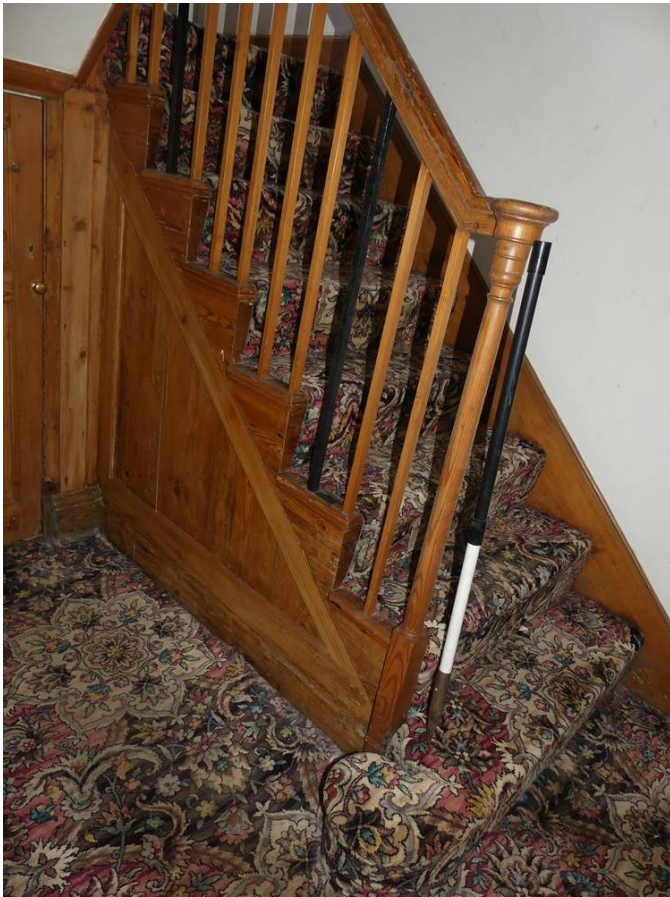
Plate 79 (left): Detail of the stairs in Room G5
