FISHER HOUSE, RIVINGTON LANE, RIVINGTON, LANCASHIRE

Archaeological Building Recording

Planning ref: 22/00602/LBC

January 2023

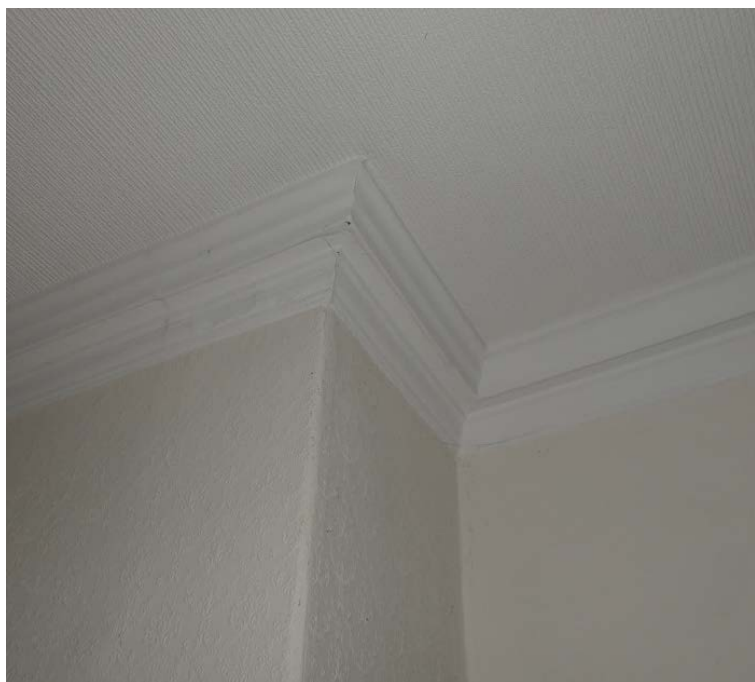
Plate 84 (left): Cornicing in Room G6

4.3.7 **Ground floor Room 6 (G6):** this room has carpet over narrow boards. There is newspaper dated 1st June 2001 below the carpet. The walls are plaster and textured wallpaper on the ceiling with moulded cornice and fairly plain ceiling rose (Plate 84 and Plate 85). There is tall skirting on the walls which are otherwise plaster and textured wallpaper. The **north-east elevation** is plain (Plate 86). The **south-east elevation** has a doorway on the north-east side, with a six-panel moulded door in moulded surround, decorated with triglyphs (Plate 87). The **south-west elevation** has a wide six-over-six light sash window with shallow splayed reveals, panelled with central roundel (Plate 88 to Plate 90). The **north-west elevation** is plain except for the central fireplace and raised hearth with modern tiles, modern iron and stone insert and copper and iron grate and hood (Plate 91). It has a timber surround and fairly plain scrolled brackets and moulded entablature.

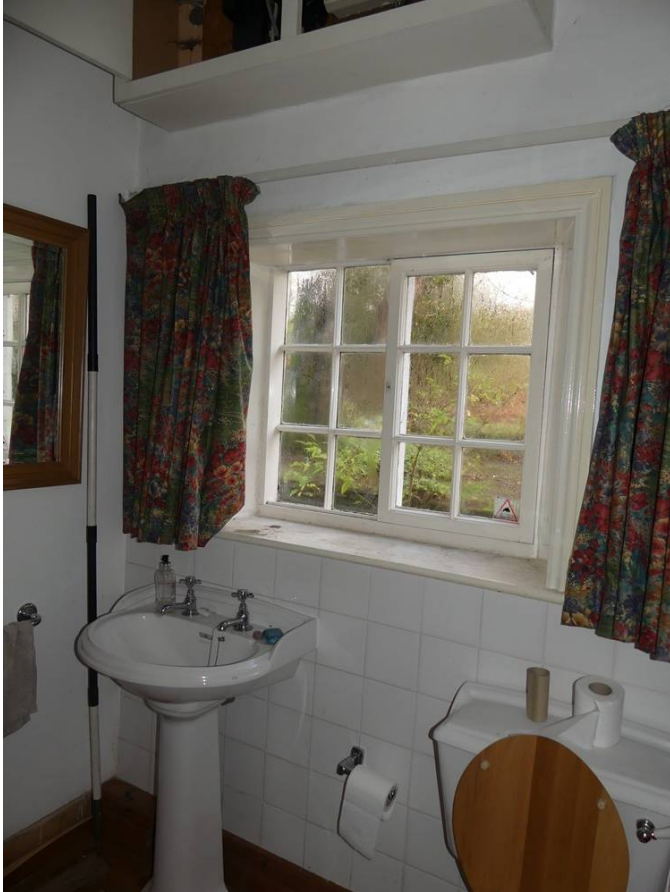
Plate 92 (left): North-east elevation of Room G7

4.3.8 **Ground floor Room 7 (G7)**: this room is now a bathroom but was originally the pantry. The floor is timber laminate and the ceiling is flat plaster. The walls are plaster and paint with modern skirting. There is a six-light Yorkshire sash window to the **north-east** (Plate 92). The **south-east elevation** is plain. The **south-west elevation** has a six-panel door at the south-east end (Plate 93) and steps back to the north-west with a boxed section over the stairs to the cellar and timber shelves on curved brackets (Plate 94 and Plate 95). There is an alcove in a former doorway in the **north-west elevation** (Plate 96), with coat hooks on a batten (Plate 97), and there is a shower built into the north corner.

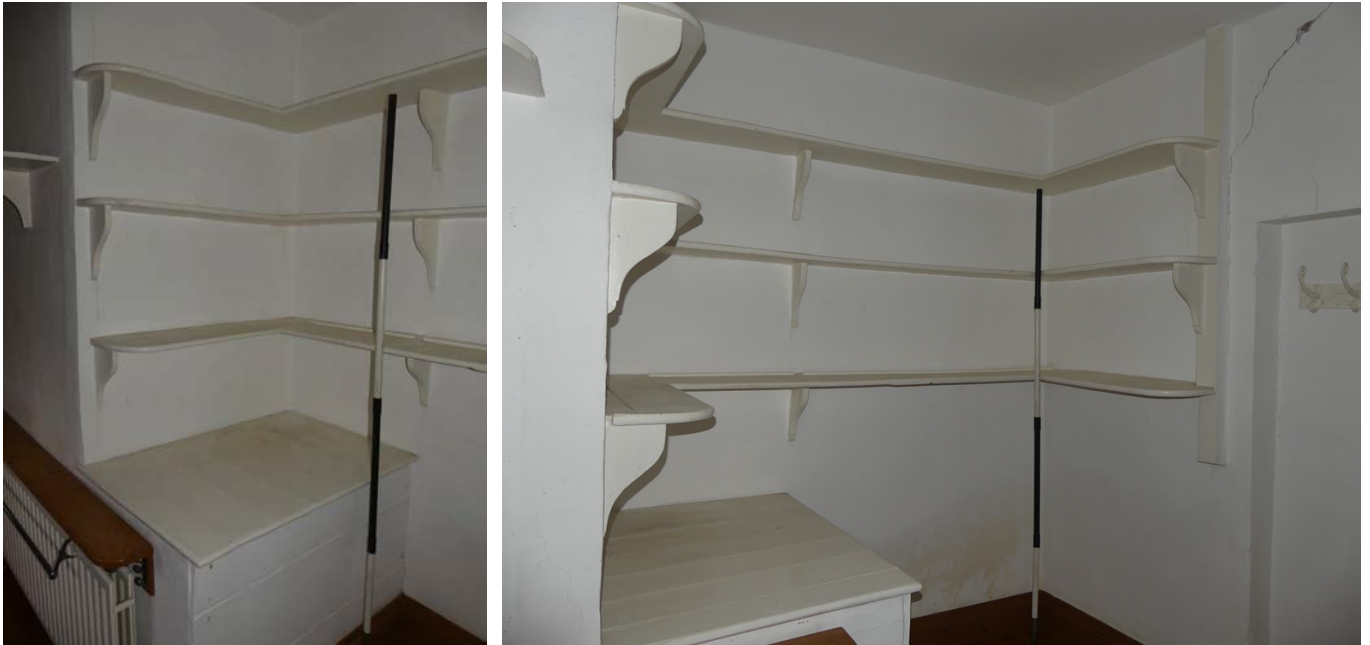
Plate 94 (left): Boxed section over the stairs in Room G7

Plate 95 (right): Shelving in Room G7

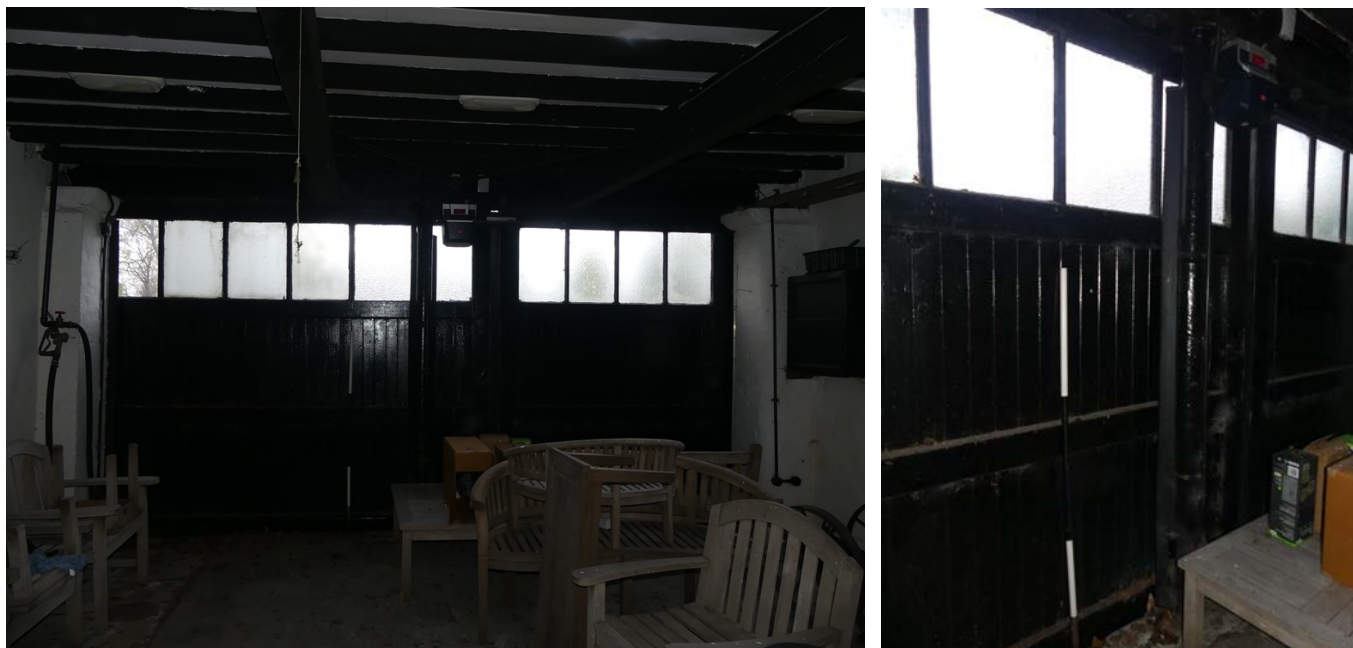
Plate 106 (left): North-west elevation of Room G8

4.3.9 **Ground floor Room 8 (G8)**: the main room of the garage has a concrete floor and painted walls. There are two north-west/south-east beams across the ceiling, supporting joists and modern boards of the floor above. There are tie rods running north-east/south-west. The **north-east elevation** has a central six-light fixed casement window with a column to the south-east of brick (Plate 98 to Plate 100) and the wall to the south-east is brick. The doorway to the south-east side houses a fairly late plank and batten door (Plate 101). The **south-east elevation** has timber stairs against it (Plate 102) behind a tongue and groove plank and batten stud wall to the north-west (Plate 103). There is a doorway, blocked with brick, behind the stairs (Plate 104). The **south-west elevation** is plain with a sliding door in the centre (Plate 105). The door is a four-panel, early 20th century door, on a metal rail, with early hooks on the wall to the south-east. The **north-west elevation** has a wide doorway, with columns each side with

stone corbels on top, and an iron column in the centre supporting a sawn timber beam (Plate 106 and Plate 107).

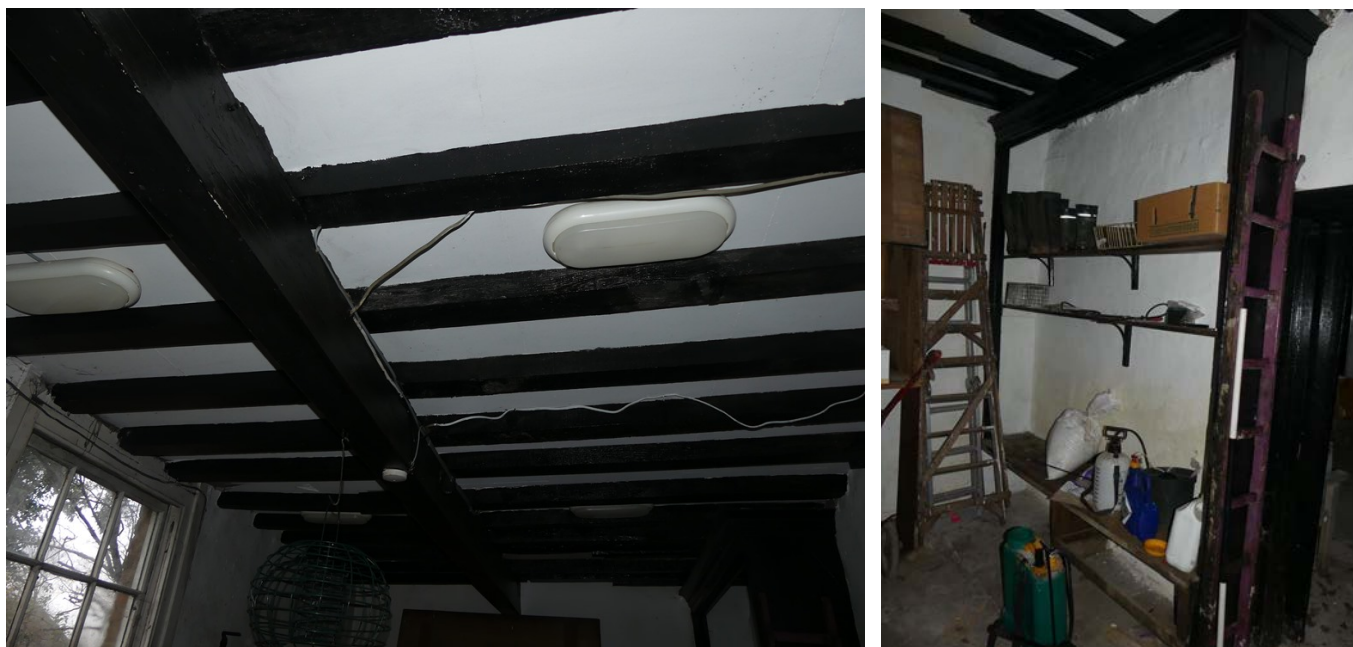
Plate 108 (left): Ceiling in Room G9

4.3.10 **Ground floor Room 9 (G9)**: the storeroom to the south-west side of the garage has a flag floor, limewashed walls, and a single north-west/south-east beam across it and joists supporting the ceiling (Plate 108). The **north-east elevation** is plain except for the remains of a tall built-in cupboard on the north-west side with moulded entablature and two later shelves on metal brackets and a shelf in the bottom (Plate 109). There is a sliding door to the south-east and modern shelves on long brackets with simple pegs (Plate 110). The **south-east elevation** has a central projecting flue (Plate 111). The **south-west elevation** has various benches and units and a central window in plain surround (Plate 112). The **north-west elevation** is plain apart from a large attached rough cupboard or bin (Plate 113).

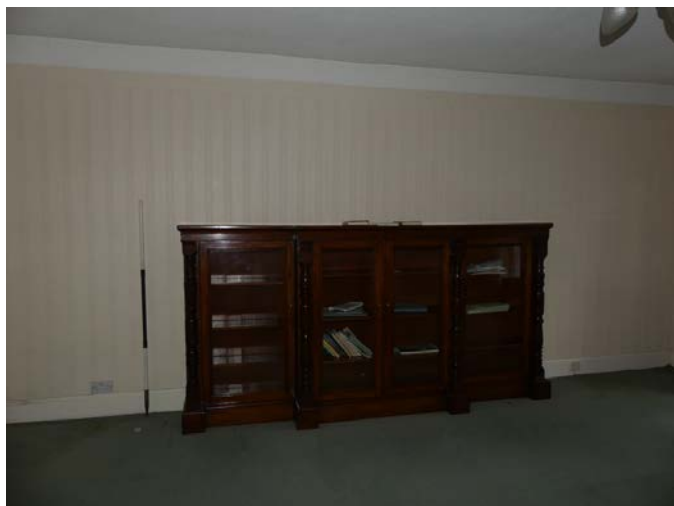
Plate 114 (left): North-east elevation of Room F1

4.3.11 **First floor Room 1 (F1)**: the first floor room of the extension to the south-east has carpet over narrow floorboards, a flat plaster ceiling, and the walls are textured wallpaper with moulded skirting. The **north-east** and **north-west elevations** are plain (Plate 114). There are two windows in the **south-east elevation** with splayed jambs and moulded surrounds (Plate 115). The **south-west elevation** has two, modern, built-in cupboards either side of the chimneybreast (Plate 116). The fireplace has a moulded stone surround and timber mantle on curved brackets with brick and stone inside (Plate 117). The decorative mirror over the fireplace is screwed on over the wallpaper classical scene. There is a door in the west corner with four moulded panels in a moulded surround (Plate 118).

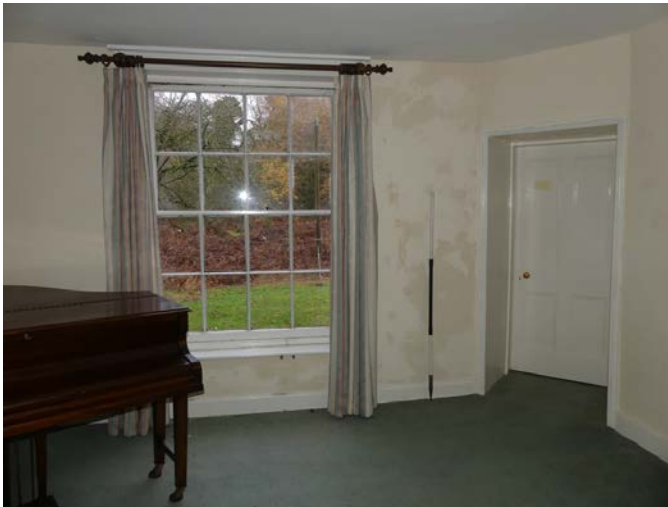
Plate 119 (left): North-east elevation of Room F2

4.3.12 **First floor Room 2 (F2)**: this room is carpeted and has a flat ceiling. There is a window to the **north-east** with a shallow window seat and moulding (Plate 119). There is a fireplace and chimneybreast to the **south-east** with a cupboard in the north-east side with one two-panel door and one one-panel door (Plate 120 and Plate 121). The fireplace has beaded modern surround and dentil moulding below the mantle and modern iron insert. The window to the south-west of the fireplace has splayed jambs and seat (Plate 120). The **south-west elevation** is plain (Plate 122). The door to the **north-west** is a six-panel door with moulded surround.

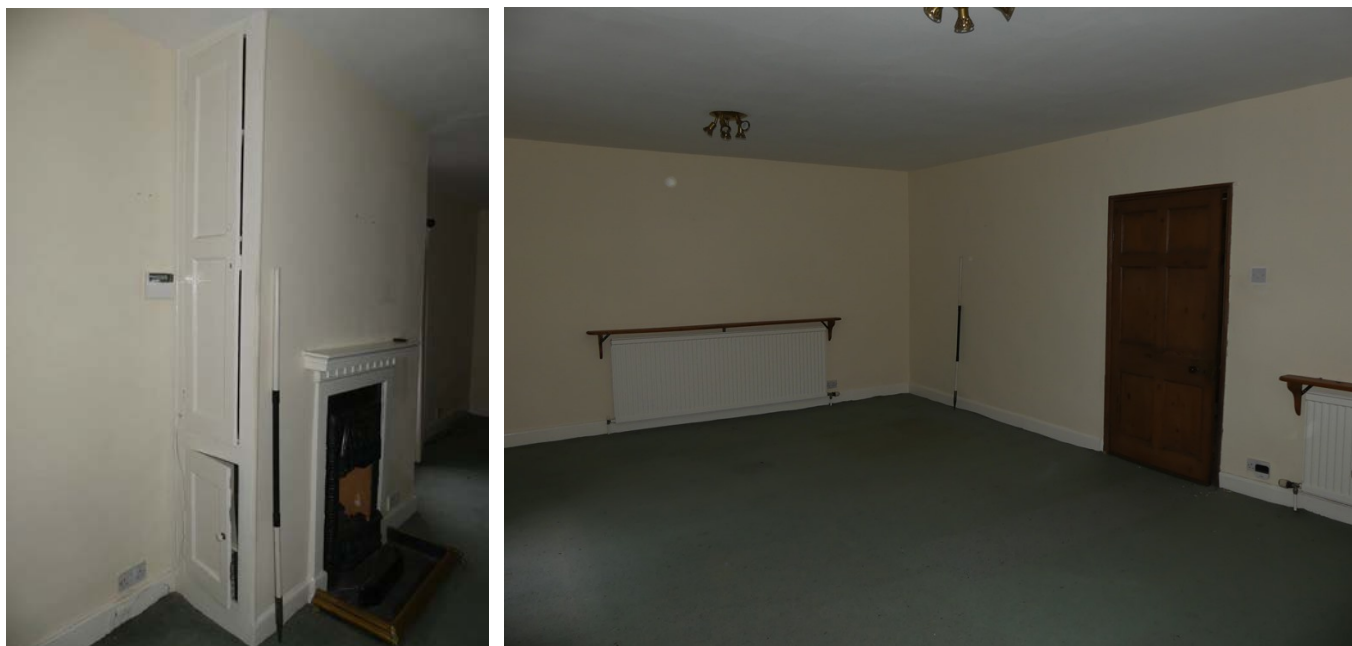
Plate 121 (left): Cupboard in the side of the fireplace in Room F2

Plate 122 (right): General view of the south-west and north-west elevations of Room F2

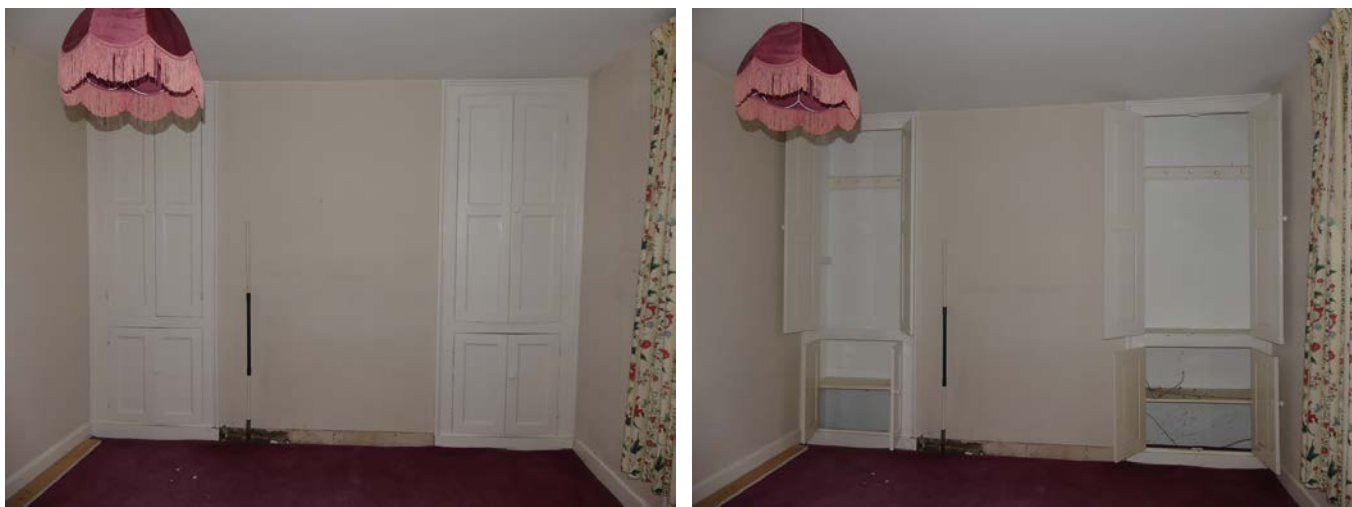
Plate 123 (left): Cupboards in the south-east elevation of Room F3 with the doors closed

Plate 124 (right): Cupboards in the south-east elevation of Room F3 with the doors open

4.3.13 **First floor Room 3 (F3)**: this room has carpet over narrow floorboards. The ceiling is flat and the walls are painted plaster with beaded skirting. There are two cupboards set into the **south-east** wall, each with a pair of two and one panel doors (Plate 123 and Plate 124). The window to the **south-west** has moulded surrounds. The doorway to the **north-west** houses a six-panel door in moulded surround.

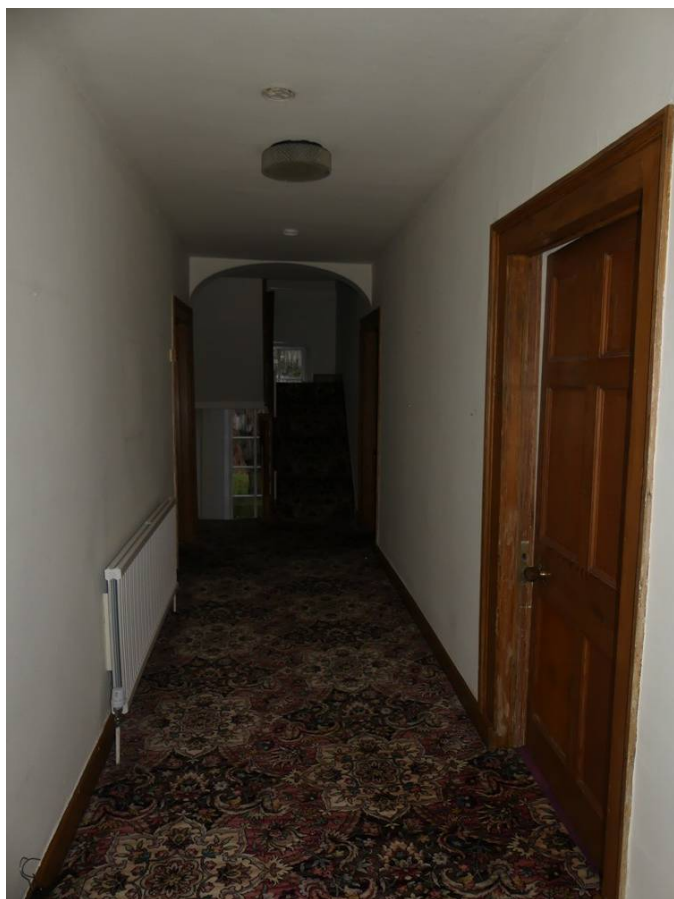
Plate 127 (left): Archway at the north-east end of Room F4

4.3.14 **First floor Room 4 (F4)**: this room forms a corridor from the stairs at first floor level. It is carpeted and has a flat ceiling with an arch at the **north-east** end to the stairs (Plate 127). The stairs have a fairly simple turned newel and square balusters, two of which are iron rather than timber (Plate 128). There is a tall stair window beyond, with splayed jambs, moulded surrounds and window seat. There are two doors to the **south-east** and two to the **north-west**. All are six-panel with moulded surrounds. There is a scar on the walls towards the **south-west** end of the corridor and the skirting changes, suggesting a partition was in place here previously, and a section of the wall sounds hollow at the south-west end on the south-east elevation (Plate 129). The window to the **south-west** has plain surrounds (Plate 130).

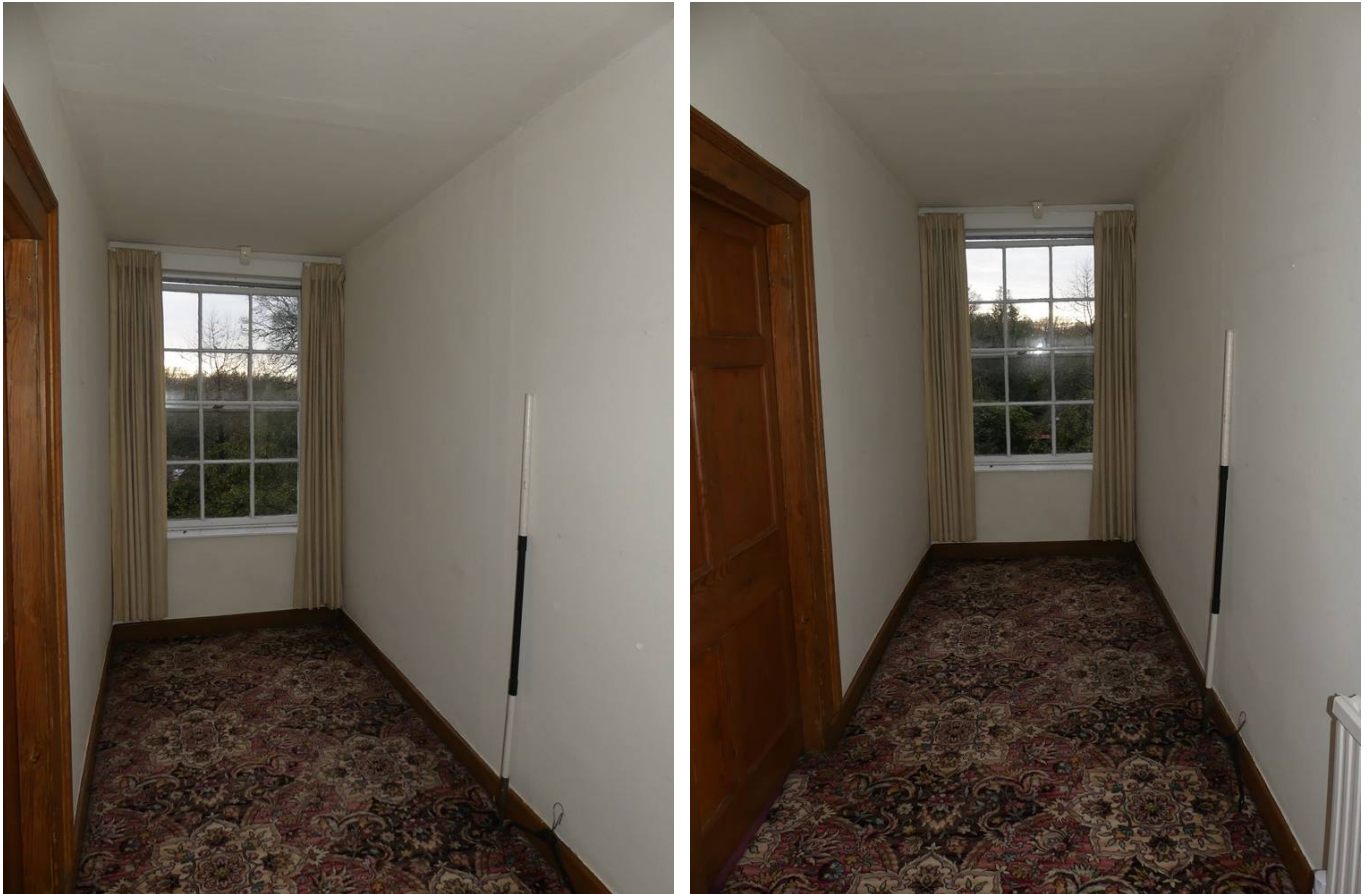
Plate 129 (left): Scar in the north-west elevation of Room F4

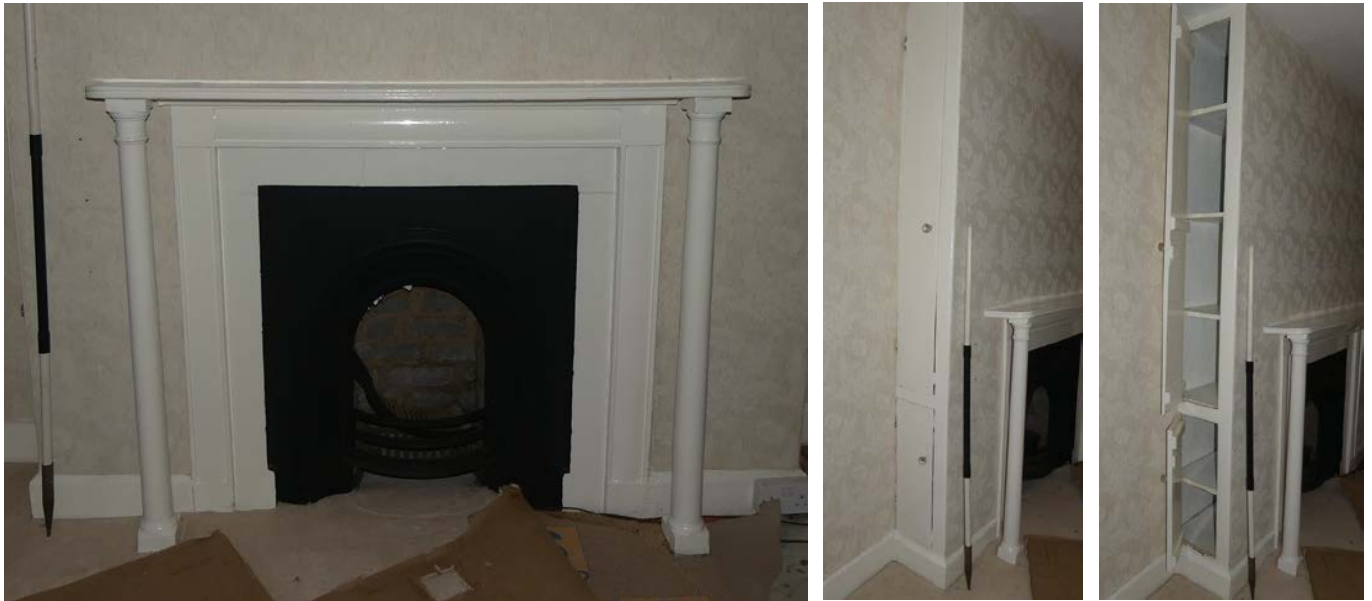
Plate 135 (left): Fireplace in Room F5

Plate 136 (centre): Cupboard to the side of the fireplace in Room F5 with the doors closed

Plate 137 (right): Cupboard to the side of the fireplace in Room F5 with the doors open

4.3.15 **First floor Room 5 (F5)**: this room has floral pattern flock wallpaper throughout, including the ceiling, and a mix of plain and moulded skirting. There is carpet above north-east/south-west aligned floorboards. The **north-east elevation** is plain with moulded skirting (Plate 131). The **south-east elevation** has a six-panel door in moulded timber surround with moulded skirting and is otherwise plain (Plate 132). The **south-west elevation** has a 12-light vertical sash (six-over-six) window, with horns, slightly splayed jambs, moulded timber surround and sill (Plate 133 and Plate 134). The **north-west elevation** has a central fireplace with fairly plain moulded surround, mantle piece supported by a single column at either end, and a cast-iron insert with brick behind (Plate 135). There is a cupboard to the south-west side with timber panel door and shelves inside (Plate 136 and Plate 137). The skirting is plain to the south-west side of the chimneybreast, which steps out and has vertical sides.

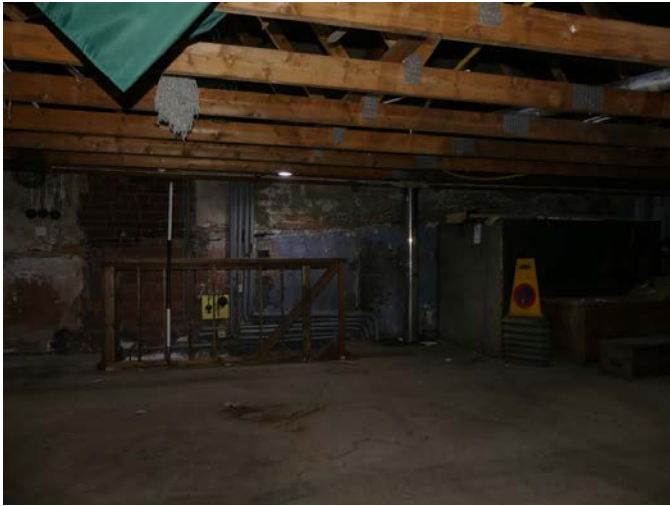
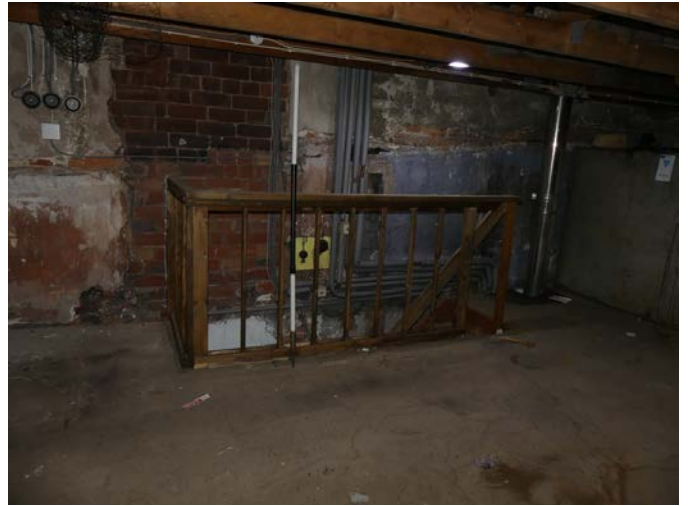
Plate 143 (left): General view of the south-east elevation of Room F7

Plate 144 (right): General view of the top of the stairs in Room G7

4.3.17 **First floor Room 7 (F7)**: the room over G8/G9 of the garage has a chipboard floor and is open to the ceiling with multiple modern trusses and roof felt. The walls are brick with some plaster on the south-east side. The **north-east** and **north-west elevations** have modern courses of brick in English Garden Bond in a 5:1 ratio on top of older brick (Plate 141). The **south-west elevation** is all old brick in Flemish Bond and some headers (Plate 142). The **south-east elevation** is mostly finished with plaster over brick (Plate 143 and Plate 144). There is a doorway on the north-east side blocked with brick (Plate 145).

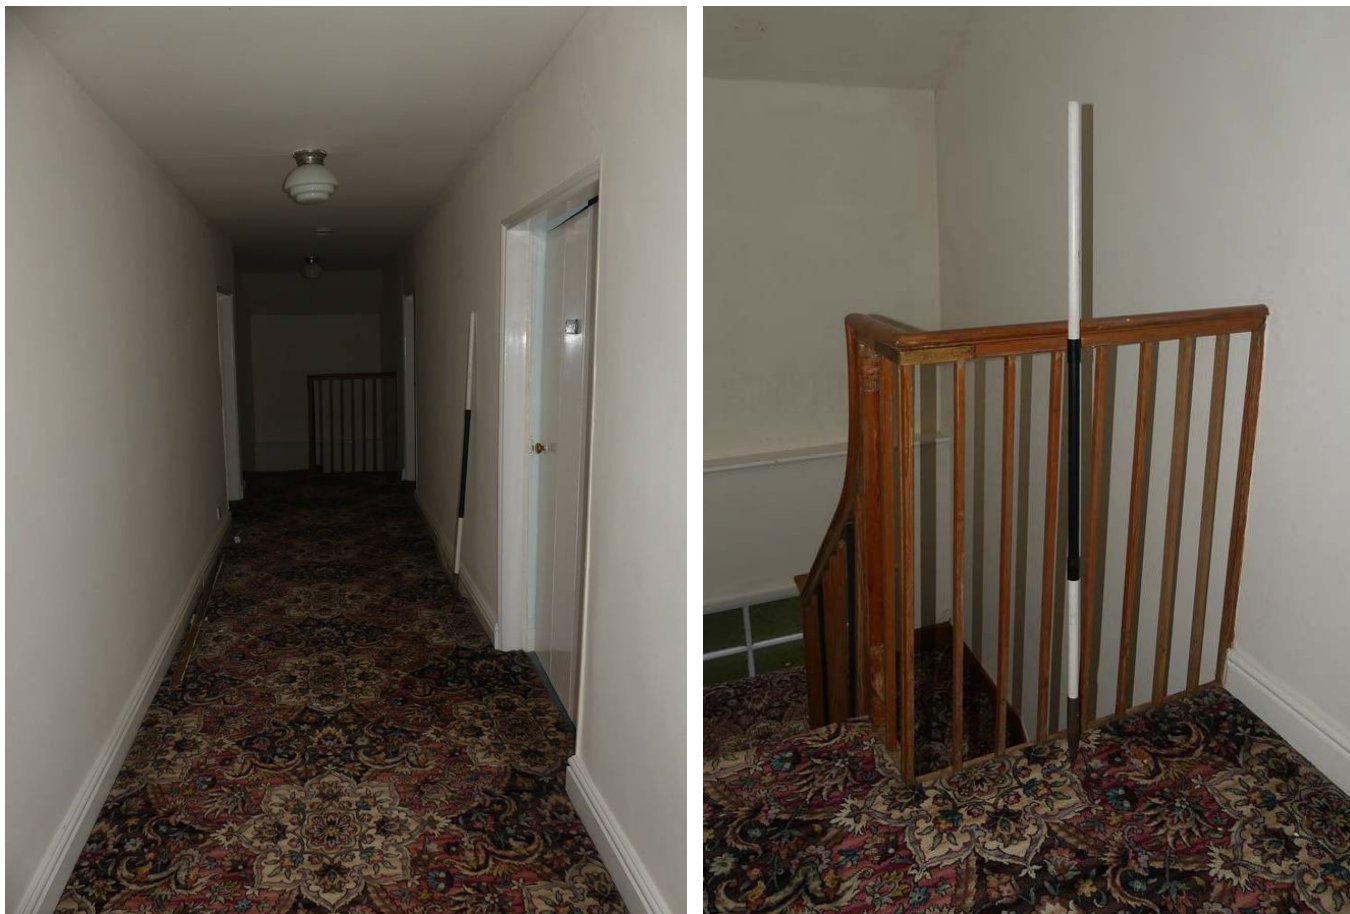
Plate 153 (left): North-east end of Room S3

Plate 154 (right): Stairs at the north-east end of Room S3

4.3.20 **Second floor Room 3 (S3)**: this room forms a central north-east/south-west corridor along the second floor. It has plastered ceiling and walls, all of which are painted and plain. It is open to the stairs at the **north-east** end (Plate 153). The stairs have square-cut timber balusters below a moulded timber handrail, the balusters possibly being modern replacements or repairs (Plate 154). The floor is carpeted which continues down the stairs. There is a small step above the window on the stairs, the top part of the window from the floor below visible above the small landing at the north-east end of the room. The **south-east elevation** has moulded skirting board and moulded timber door surrounds and original plank

and batten doors to Room S1 and S2. The **south-west elevation** has a six-light (three-over-three) vertical sliding sash window with no horns in a moulded timber surround (Plate 155). The skirting below is plain. The **north-west elevation** is plain with moulded skirting. There is a slight step to the north-west at the north-east end. Both doors have moulded timber surrounds. The door to Rom S4 is a moulded four-panel door and the one to Room S5 is a plank and batten door.

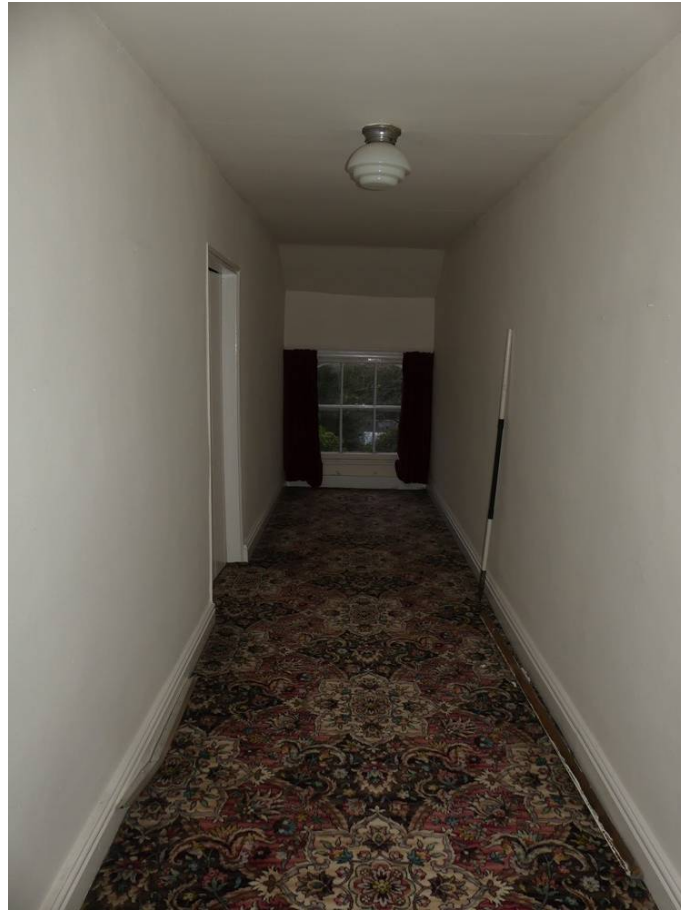
Plate 155: South-west end of Room S3

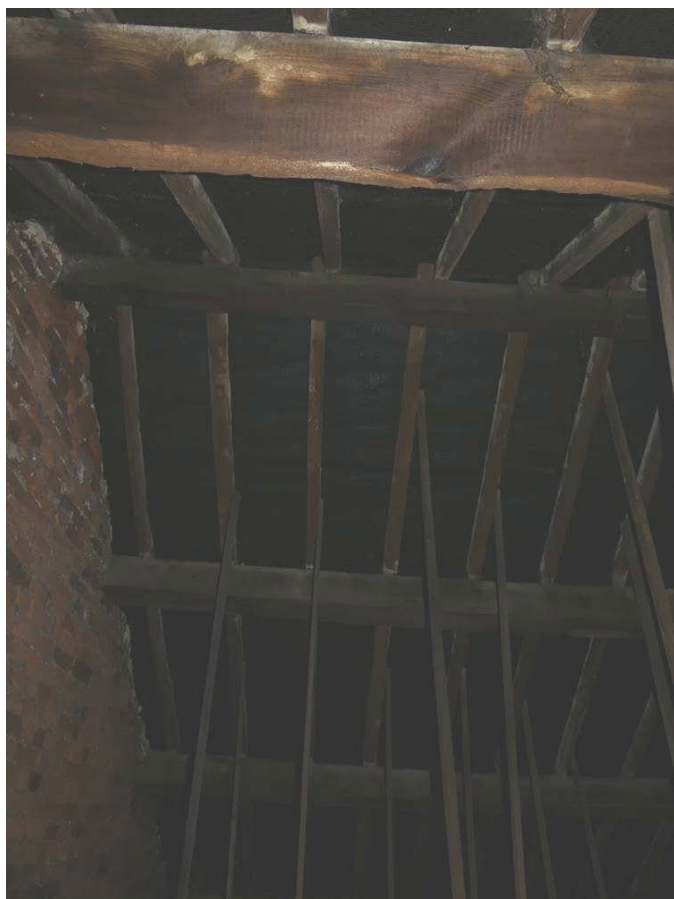
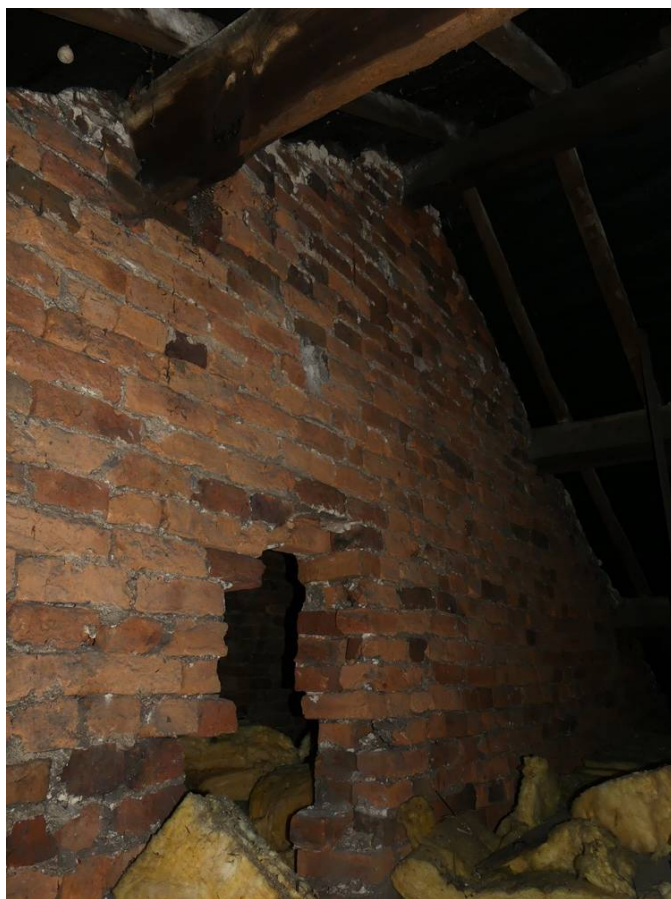
Plate 163 (left): Internal roof structure

4.3.23 **Attic:** the attic is accessible from Room S5 and it is not easy to gain access further south-east. The roof is supported by brick walls extending to the apex. There are two sawn purlins per pitch and a wide ridge plank (Plate 163). The wall is plastered to the north-west end. Holes have been broken through the dividing brick walls (Plate 164).
