THE SCULPTURE GALLERY, LOWTHER CASTLE, PENRITH, CUMBRIA

Archaeological Building Recording

Client: Lowther Castle and Gardens Trust

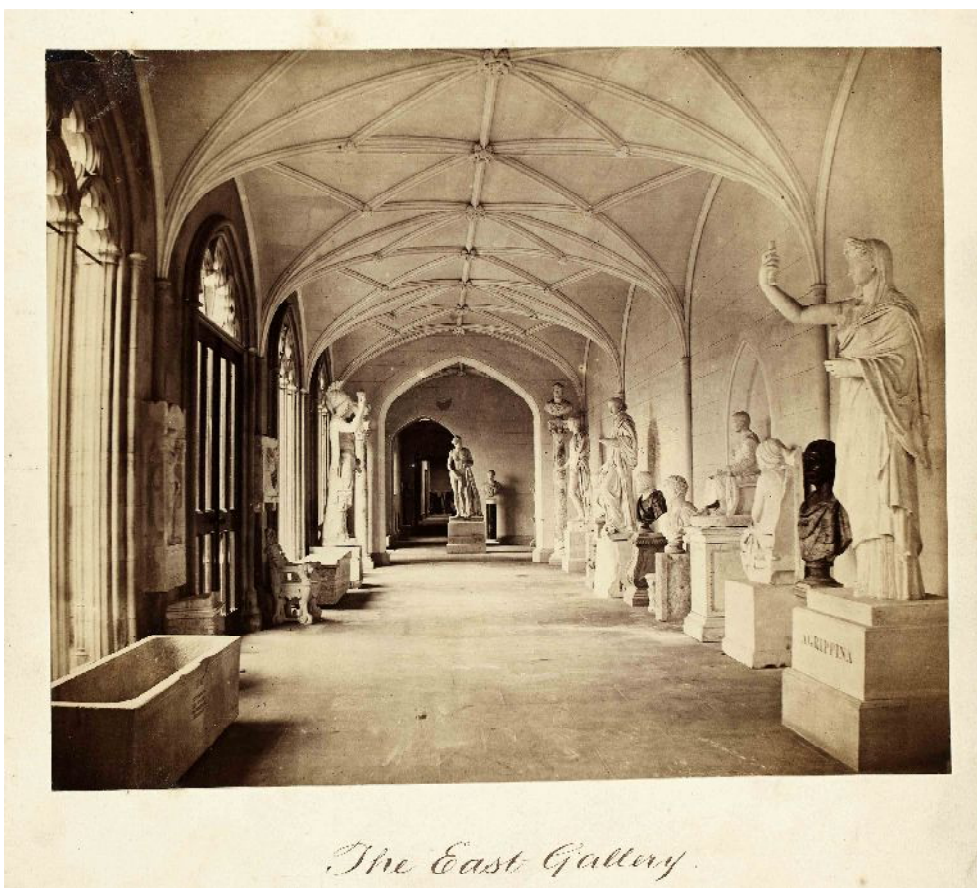
Plate 5: General view of the east gallery, 1865 (CRO(C) DLONS/L23/1/13 1865)

3.1.8 Original sources within the Lonsdale collection prove that the sculpture gallery certainly existed by at least 1865, as demonstrated by a series of essentially identical catalogues with photographs (CRO(C) DLONS/L23/1/12 1865; CRO(C) DLONS/L23/1/13 1865; CRO(C) DLONS/L23/1/14 1865; see Plate 5 to Plate 9). These are generally concerned with the large collection of Roman and Greek antiquities that had been acquired by the Lowthers and deposited at the castle in two galleries, the surviving 'sculpture gallery', originally known as the 'east gallery (see Plate 5) and the '*west or Caesar's gallery*', which now survives only as a roofless ruin, and as its name suggests held a collection principally made up of busts of Roman emperors (CRO(C) DLONS/L23/1/13 1865). The origins of many of the classical sculptures are not stated, while others are said to have been purchased from the Stowe or Bessborough collections (*ibid*). Subsequent catalogues of the contents of the galleries are considerably more detailed; a list from 1879 (CRO(C) DLONS/L23/1/20), entitled '*Catalogue of Pictures Statuary &c at Lowther Castle*', lists 91 Roman and Greek sculptures in the east gallery (most of these

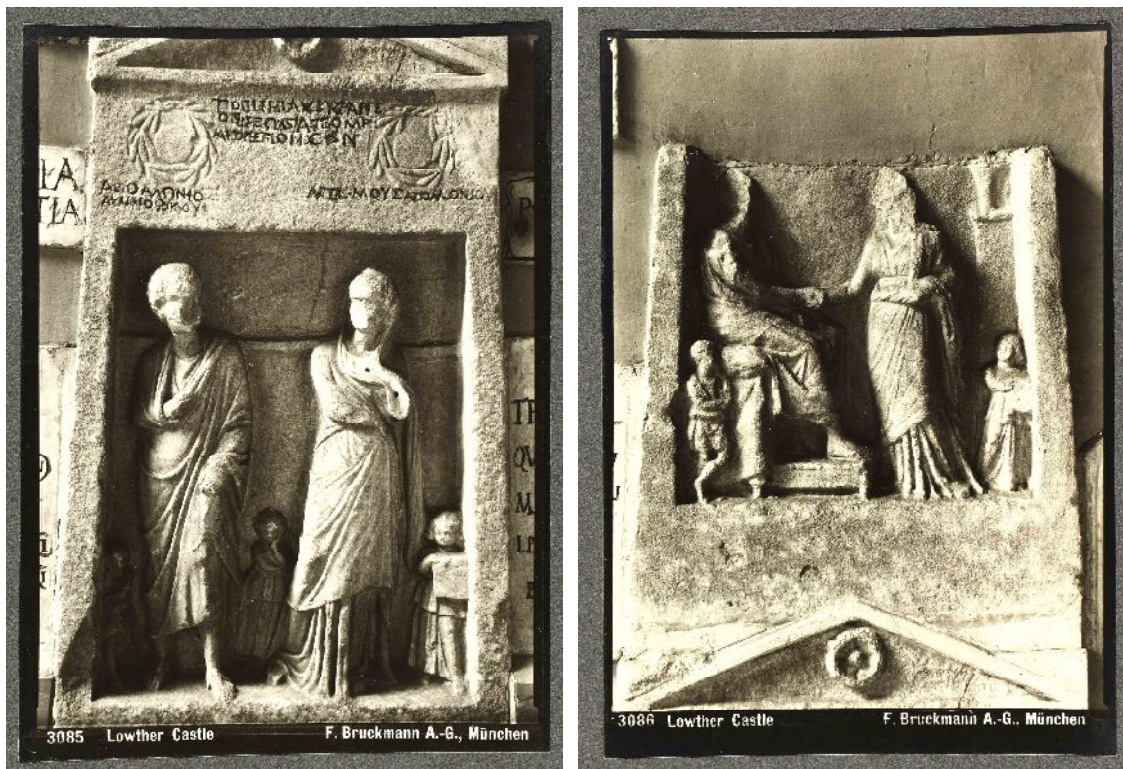
Plate 8 (left): Lower part of an altar and inscribed fragments set into the wall, presumably of the passage, c1900 (CRO(C) DLONS/L28/7 c1900)

Plate 9 (right): Upper part of the same altar and inscribed fragments set into the wall, presumably of the passage, c1900 (CRO(C) DLONS/L28/7 c1900)

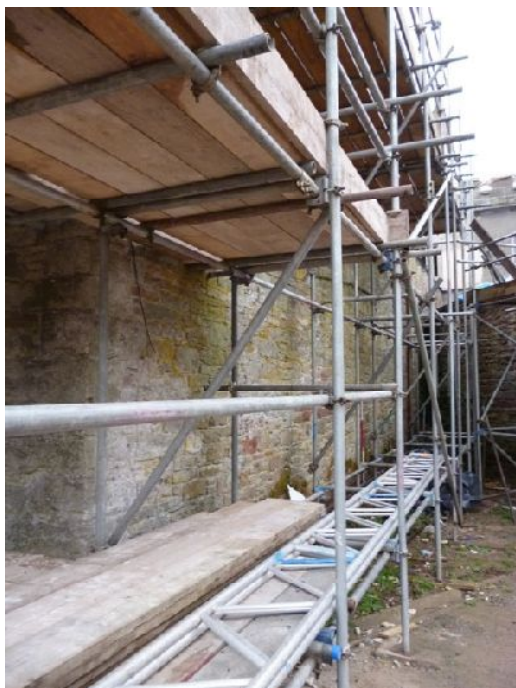
Plate 10 (left): The east external elevation

4.2.1 **East elevation:** the south end of the east elevation is a rough rubble build of dressed blocks (Plate 10) with a 0.05m deep plinth at its base, which has a flat top, and scrolled wrought iron brackets for the gutter remain. There is a doorway to the north-east, with a pointed arch, which is blocked with red brick in English-garden-bond in a ratio of four to one, and the remains of render survive which is scored to look like ashlar blocks (Plate 11).

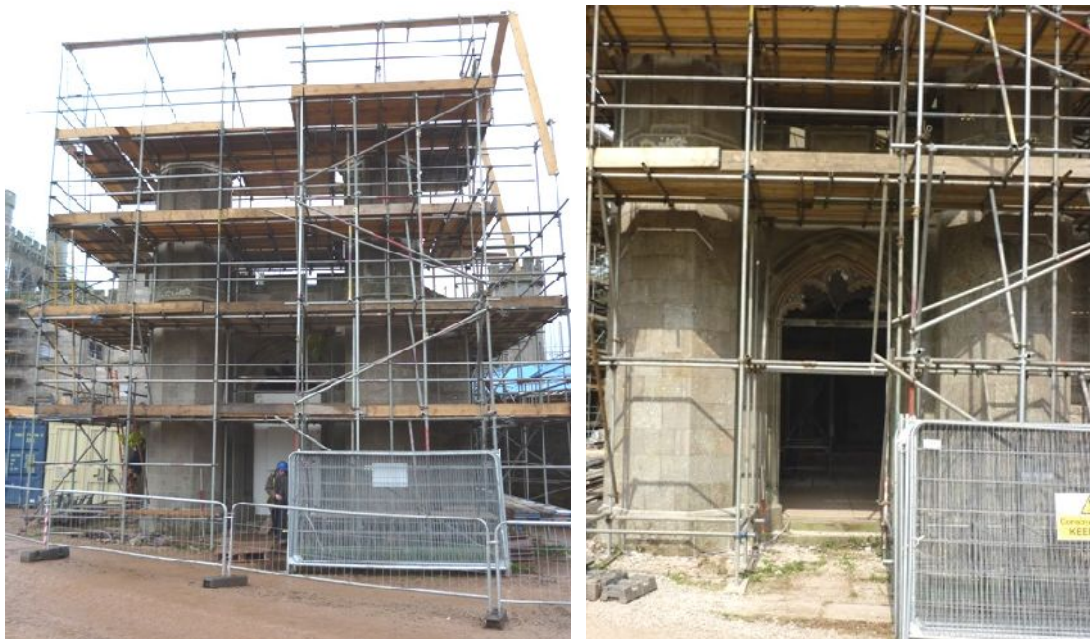
Plate 12 (left): The south external elevation

4.2.2 **South elevation:** the south elevation is largely ashlar block built, with two octagonal turrets with crenellated tops projecting either side of a doorway, which has moulded ribs with moulded trefoil-style arches above set within a larger four-centred (depressed) arch (see Plate 12 and Plate 13). The wall is crenellated above the doorway and at the top of the turrets (see Figure 3), which also have decorative panels with trefoil mouldings. The masonry on the north-east side is rougher, comprising dressed blocks in rough courses, and is more mixed, containing both limestone and sandstone blocks.

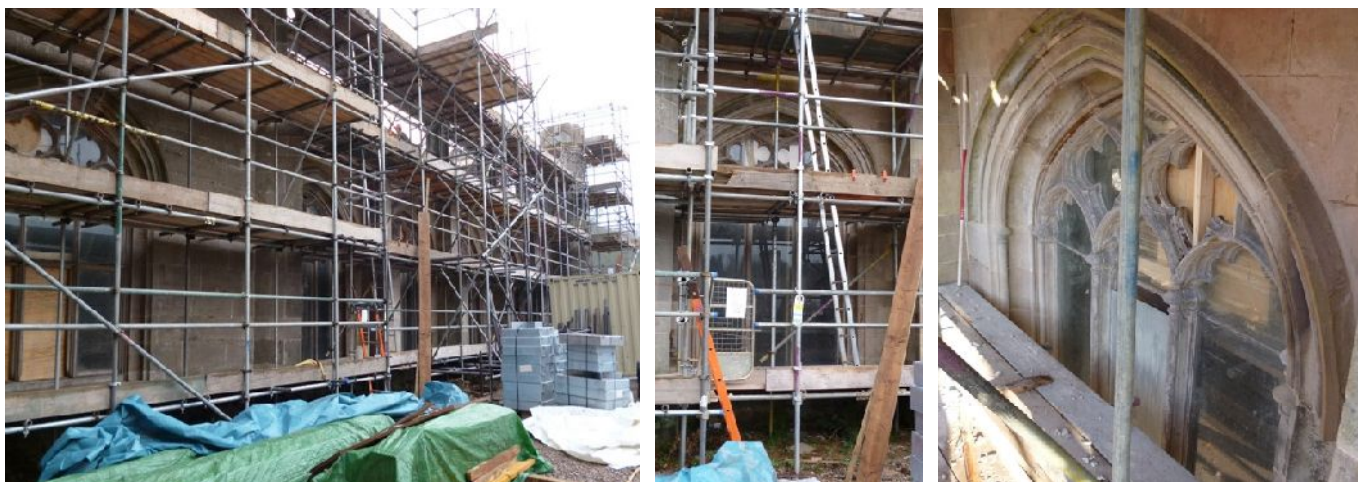
Plate 14 (left): The south end of the west external elevation

4.2.3 **West elevation:** there are five openings in a row at the south end of the west elevation (along the side of Room 5; Plate 14; Figure 3), four of which are windows with three divisions and trefoil heads (Plate 15 and Plate 16; Figure 3). The central opening is a doorway with a similar head to the one on the south elevation (see *Section 4.2.2* above).

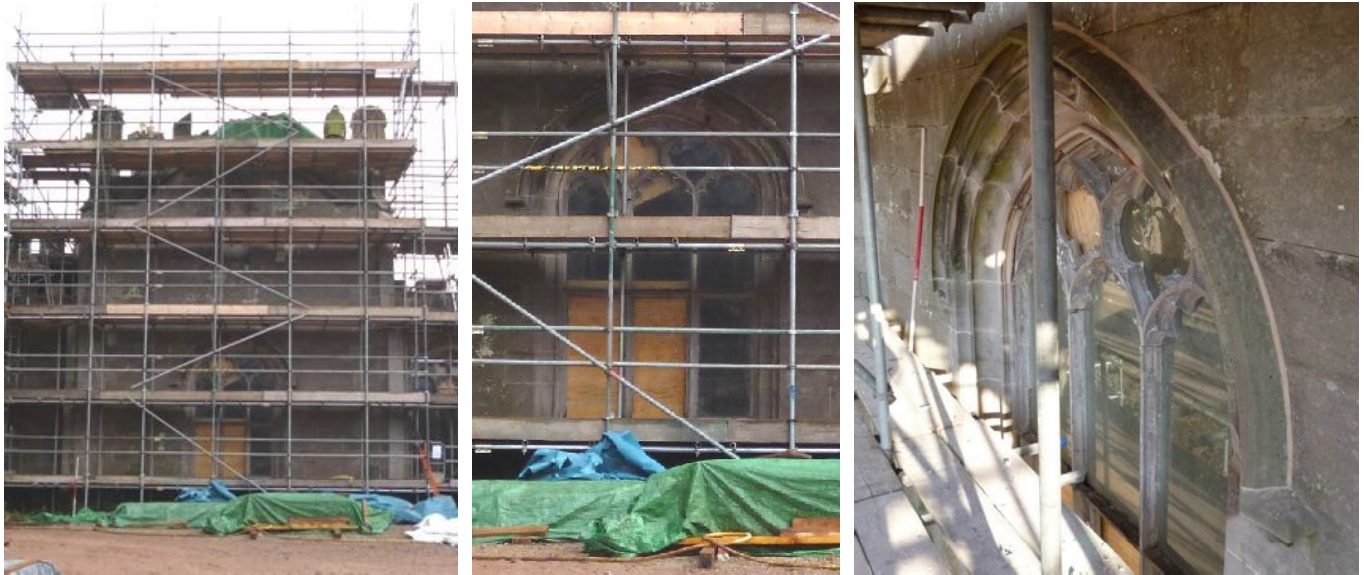
Plate 17 (left): The projecting section to the south end of the west external elevation

4.2.4 To the north of these five openings the elevation projects slightly with angled stepped buttresses, corresponding with the west side of Room 4, and there is a central window with transoms dividing it into six-lights (Plate 17 and Plate 18; Figure 2). The window top matches those to the south (Plate 19). This section is topped by two turrets, which are currently not in place, and the central detail (with a niche below) is missing. The crenellations along the top of the wall to the south had recently been restored and had a projecting moulded band along the top. To the north of this projecting section (corresponding with Room 3) there are two small ground floor windows with two rows of battlements above.

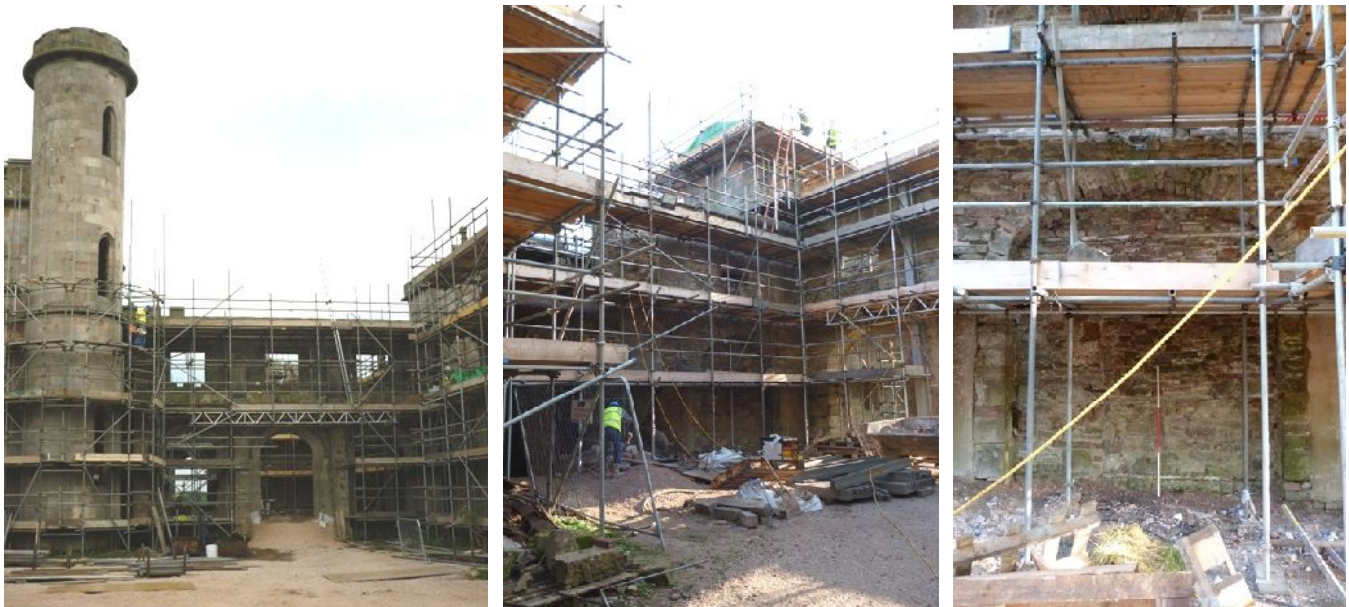
Plate 20 (left): The south façade of the west wing of the Castle (the sculpture gallery is to the right) (photograph taken 25th August 2011)

Plate 21 (centre): The west elevation of Room 1 and 2, butted by the south façade of the west wing

4.2.5 The west elevation of the gallery is butted by the southern façade of the west wing of the Castle at approximately the threshold between Rooms 2 and 3 (see Figure 3; Plate 20). The continuation of the gallery to the north (Rooms 1 and 2) would have formed an internal elevation of the west wing (see Plate 21). All of the stonework is very rough and has been patched. There is a large arched opening on the south side, which was presumably a doorway (or possibly a large fireplace), which is blocked with rough stone rubble (Plate 22). Within the larger archway there is a smaller doorway on the north side, but it has no obvious lintel. There are patches of concrete to the north and south and there is a large section filled in with concrete blocks to the north. The stub of a wall projects to the west below this concrete block section (see Figure 2 and Figure 3).

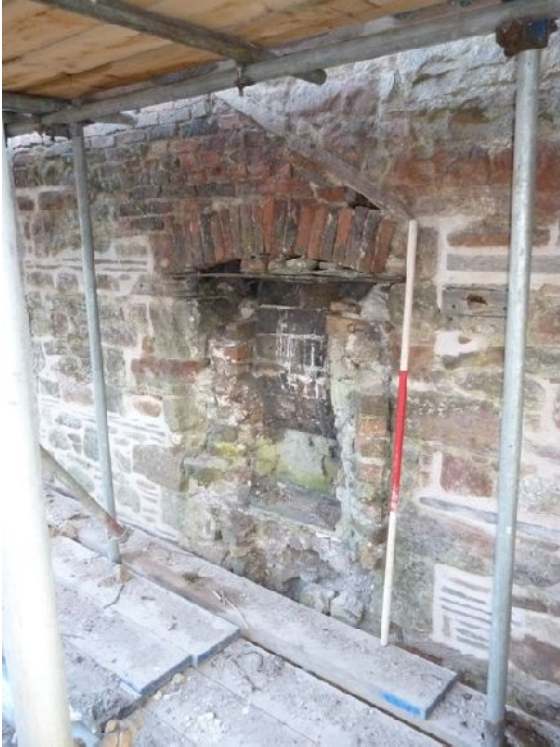
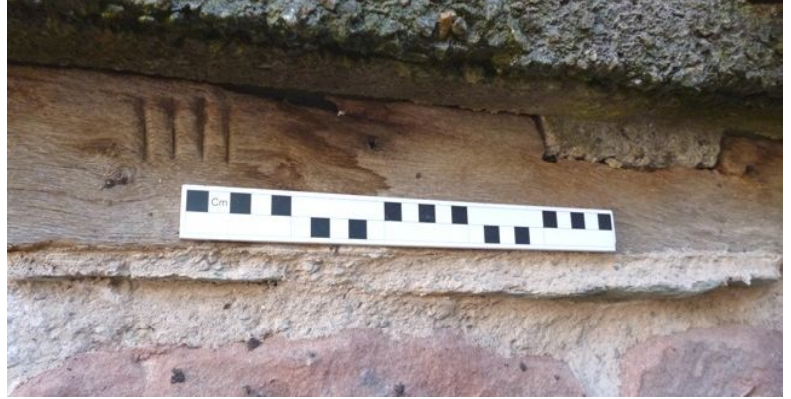
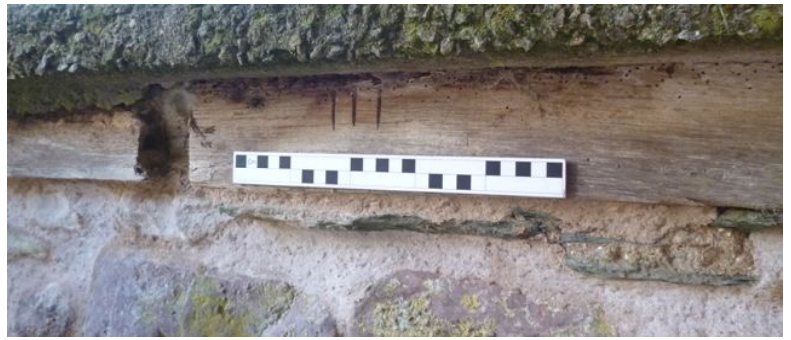
Plate 23 (left): Fireplace above the archway

4.2.6 Above the large arched doorway at the south end of Room 1 there is a fireplace at first floor level, with a brick backing and a low brick arch with an iron bar below (Plate 24). The iron bar support spans an earlier opening in stone. The backing is also in early brick, but later in-filling in hand-made and machine made brick has narrowed it and made it splayed. There is also an angled slab of sandstone above the arch, which forms a flue to the north, with an early brick filling. There is a patch of concrete render to its south side, possibly blocking a window, and another patch of concrete render to the north, possibly blocking another opening. This section of the wall is topped with concrete coping, with remnants of timber rails(?). These appear to have been reused as two pieces have carpenter's marks chiselled into them in the form 'IIII' on the one to the north (Plate 24) and 'III' on the one to the south (Plate 25).

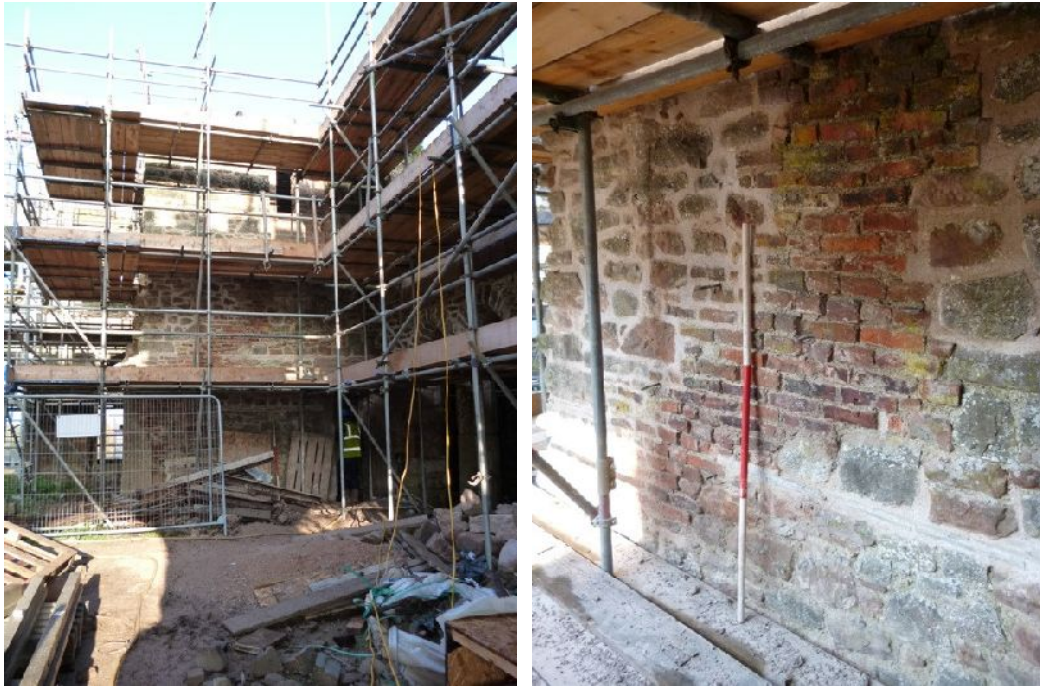
Plate 26 (left): The projecting section towards the north end of Room 1

4.2.7 To the north of the wall stub on the ground floor there are three pointed-arched doorways with dressed stone jambs above which the first floor level is open. The wall then returns to the west and becomes two stories again. (Note that this section of the west external elevation is to the west of what is considered to be part of the sculpture gallery; the north end of the sculpture gallery is to the east of a narrow corridor of which the west external elevation forms a part). The south elevation of this projecting section (towards the north end of Room 1; see Figure 2) has a ground floor doorway on the east side, with a concrete skim covering the jambs and an area above in-filled with concrete blocks. There is a lot of small, very early hand-made brick in this section (Plate 26 and Plate 27), some of which probably correspond to flues built into the wall. The upper floor has an opening on the east side, which is partly in-filled with concrete blocks, which extends to the west, where there is another possible window on upper floor, but the wall is broken away at ground floor level. The west end of the wall has been repaired with a skim of concrete on part of the ground floor where the core would otherwise be exposed.

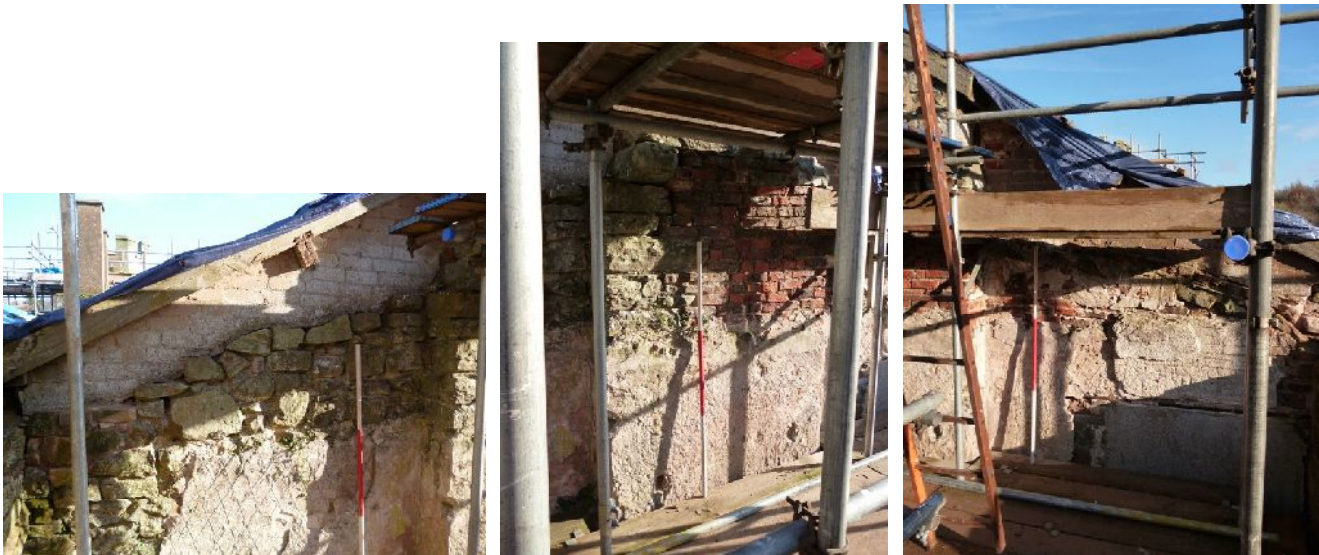
Plate 28 (left): North end of the gabled top

4.2.8 The north end of the west external elevation is two-stories with a gabled top which has been partly built up with concrete blocks (see Plate 28 to Plate 30). The ground floor level is fairly plain (Plate 31), with a blocked door on the north side with concrete render over and a modern timber lintel. There is another blocked doorway on the south side with stone blocking and a stone arched top. There is some brick included in the central section. The upper floor has remnants of plaster and a central projecting chimney breast with a fireplace with splayed sides and an iron bar supporting the top and brick backing (Plate 32). There is further brickwork above the fireplace to the level of the roof (Plate 29). The early bricks typically measure 23 x 6 x 13 cm.

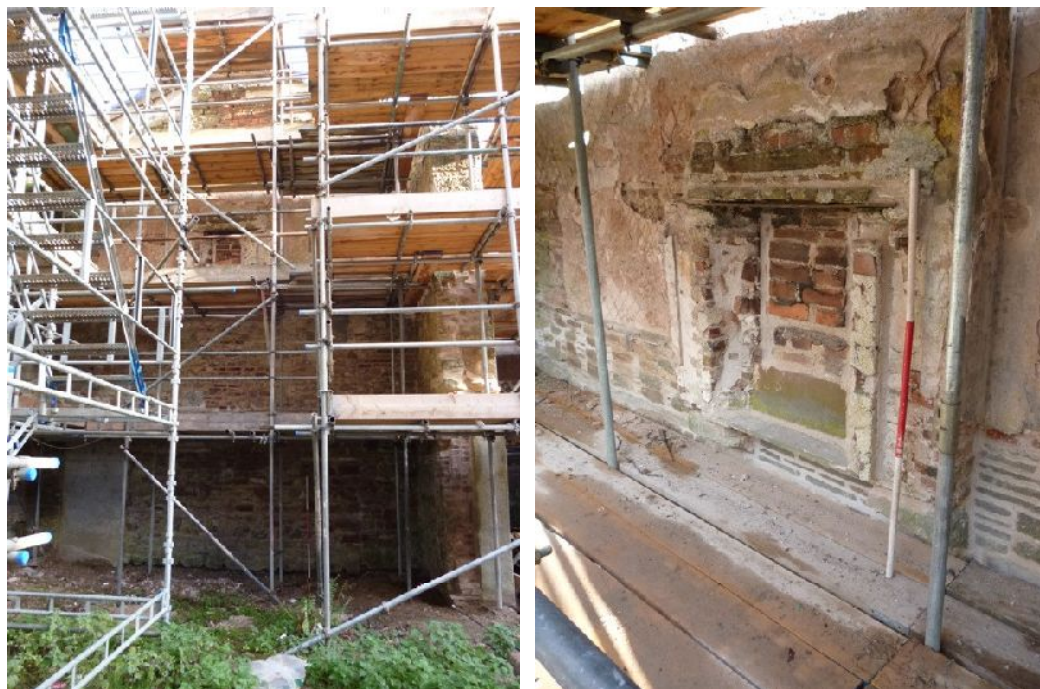
Plate 31 (left): West elevation of the projecting section at the north end of the west external elevation

Plate 32 (right): Fireplace on the first floor of the projecting section

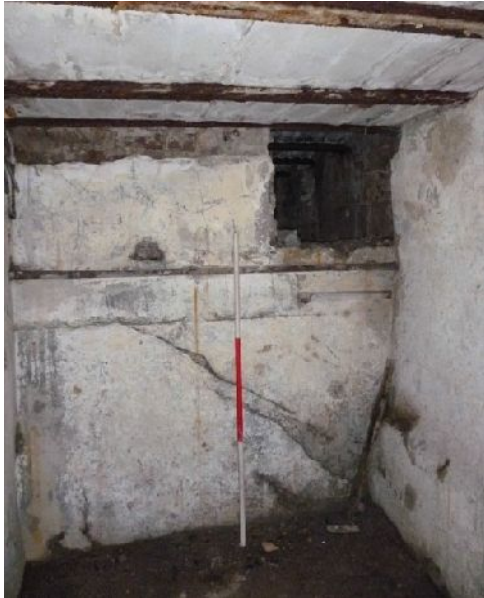
Plate 33 (left): North elevation of the basement

4.3.1 **Basement:** the ceiling in this room is constructed from corrugated concrete sheets and concrete tongue and groove planks supported by iron straps. The floor is concrete and there are remains of whitewash on each of the elevations (Plate 33). A hole has been broken through on the east side of the north elevation which gives access to a small crawl space to the north. The rest of the elevation is plain with pipes attached. The crawl space to the north could not be accessed safely, however, the rough masonry of the east elevation could be seen from the south; the jambs of one of the windows from Room 1 extend upwards from below the ceiling on the basement level (Plate 34).

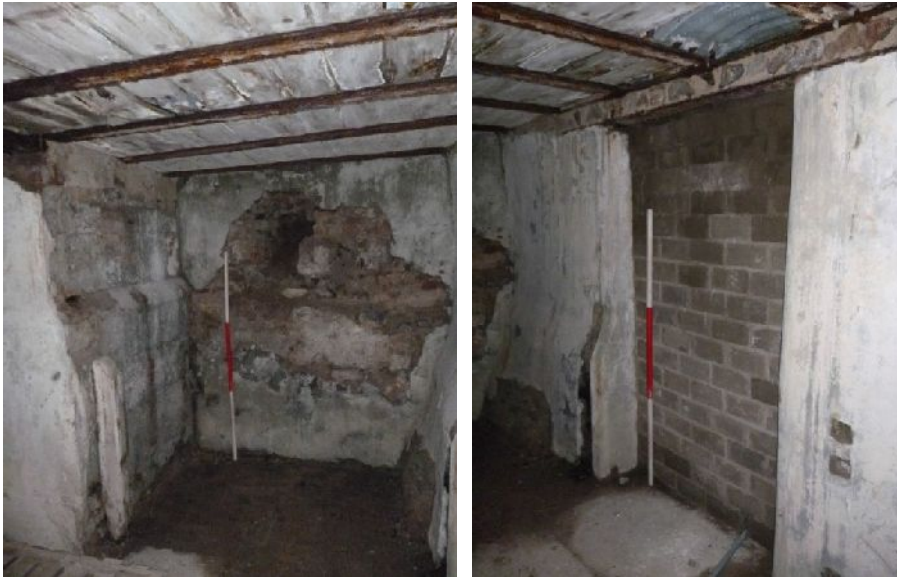
Plate 35 (left): The east and south elevations of the basement

4.3.2 The east elevation has a slight plinth on the north side of a central door with a dressed ashlar block surround exposed on the north side and an iron bar lintel. The stables are accessible to the east via steps from the central door. To the south of the doorway is a higher level chamfered, dressed stone plinth, below which are ashlar blocks. A wooden post is attached which has a groove down the west side (Plate 35). The south elevation is plain and has a slight step out towards the base. A hole has been punched through revealing the rough masonry build (Plate 35). The west elevation similarly has a slight bulge at the base on the south side and there is another smaller bulge in the wall below that (Plate 36). The central doorway on this side is blocked with concrete blocks and has an iron I-beam lintel. The elevation is fairly plain to the north.

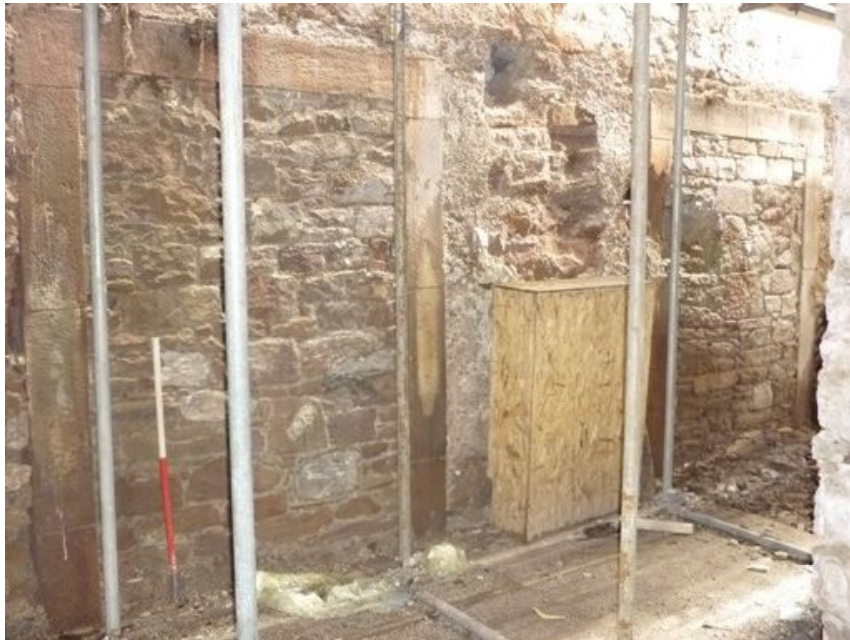
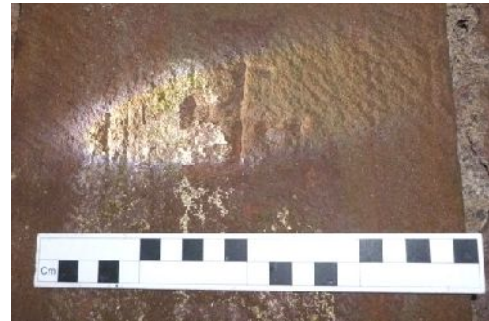
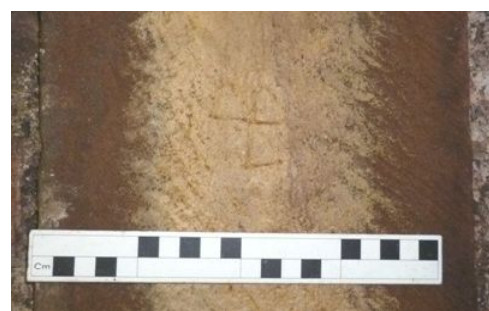
Plate 39 (left): The north end of the east elevation of Room 1 (photograph taken 25th August 2011)

Plate 40 (top right): Mason's Mark 1

Plate 42: Grave cover fragment

4.3.4 There is a blocked doorway to the south of this channel which has square-dressed sandstone surrounds with stone mason's marks on two of the stones (see Figure 2). The mason's mark to the north is in the form of a swastika (Plate 40; Figure 2, Mason's Mark 1); the one to the south resembles three upward pointing triangles in a row of two above one, touching at the centre (Plate 41; Figure 2, Mason's

Mark 2). To the south of this there is a piece of sculpted stone (a fragment of grave cover with heraldic device carved in relief, Plate 42) on a timber plinth, with iron clamps on top fixing it to the wall. To the south of this there is another 'doorway' in the same style as the one to the north. The lintels of both are in two parts. The one to the south has part of a moulded inner detail, so perhaps they were in fact both originally windows with a central mullion; this is actually more clear from the bases, which have beaded edges. There are further quoins to the south, one of which has an 'X' shaped mason's mark (Figure 2, Mason's Mark 3).

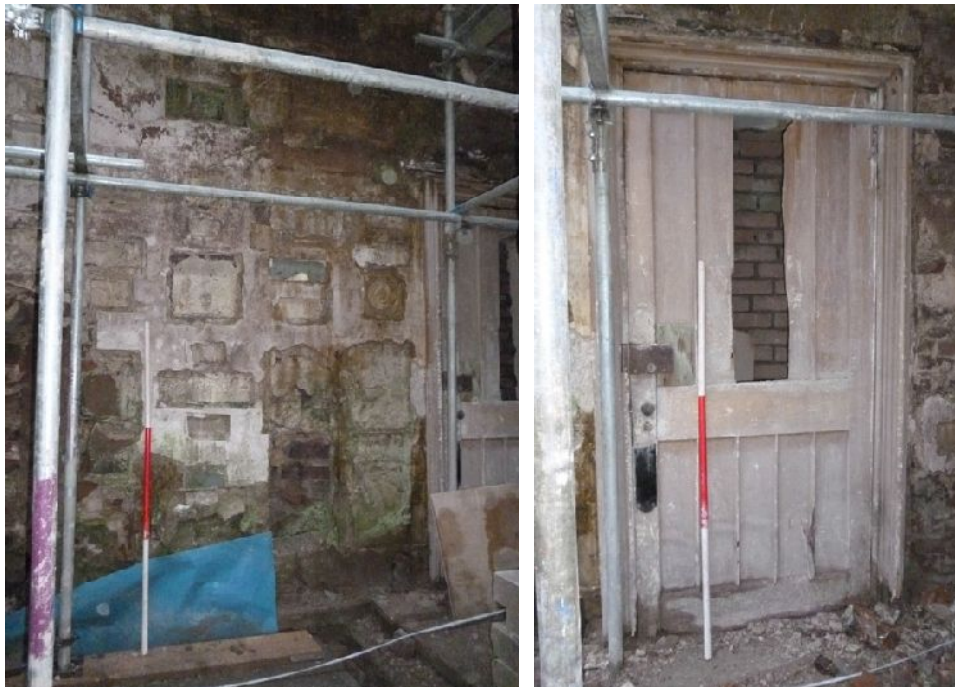
Plate 43 (left): North end of the jutting section of Room 1

Plate 44 (right): Deep moulded frame with heavy beading

4.3.5 The wall then steps out to the south with some plaster remnants and quoins at the turn (Plate 43). This section plastered in parts and very irregular; the plastered areas have square and rectangular holes in it, which sometimes record impressions of objects in the plaster at the back. A jamb with a

moulded edge was exposed behind some of this plasterwork at the north end of the section and although the south edge is less obvious it presumably is aligned with the window above on the first floor, which is the case with the other blocked 'doorways' to the north. The floor steps up to the south and there is a doorway a short distance to the south, with a ten-panel door in a deep moulded frame with heavy beading (Plate 44). This is blocked inside with bricks leaving an alcove, with a metal light switched on the north side.

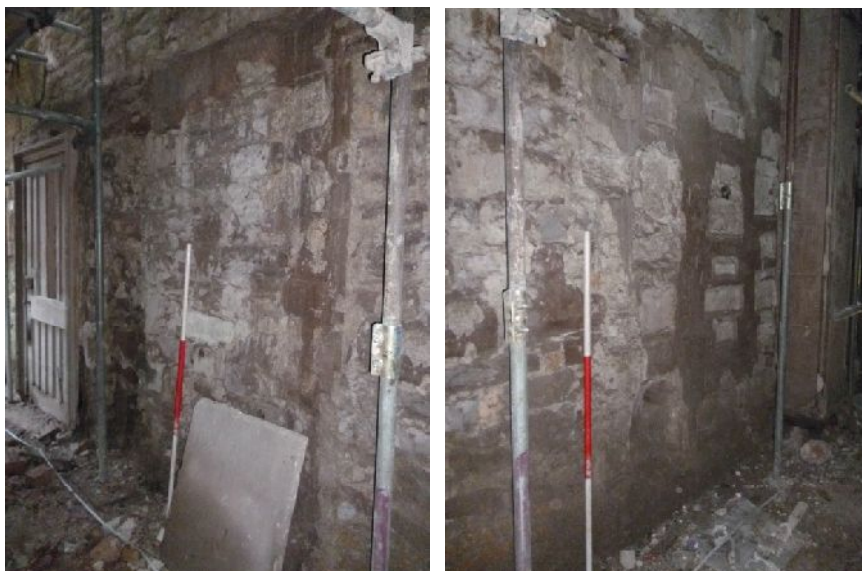
Plate 45 (left): Doorway with keystone

4.3.6 There is a further blocked doorway to the south, which is apparent from the remains of sandstone quoins with traces of a beaded edge, but it is badly damaged by having had panels cut out. The doorway has a heavy lintel, with a keystone (Plate 45), the north end of which forms the south jamb of the extant doorway with the deep moulded frame. There is a small area of blocking within the blocking of this door, approximately 0.5m wide by 1.4m tall, which is in-filled with stone rubble. There is a thin piece of timber, possibly forming a lintel, cut into the lintel of this door and the lintel of another possible doorway to the south. The jamb on the north is evident as a row of battered quoins, again with panels cut in and filled with plaster, one with the impression of a Roman inscription (see Plate 46 and Plate 47; Figure 4; see *Section 5.1.8*). The wall returns at the south end at the buttress, which is finished with scored plaster and has rolled corners, at the end of the room. The south elevation is open as a 'doorway' between the two buttresses, which have a heavy timber lintel (Plate 48).

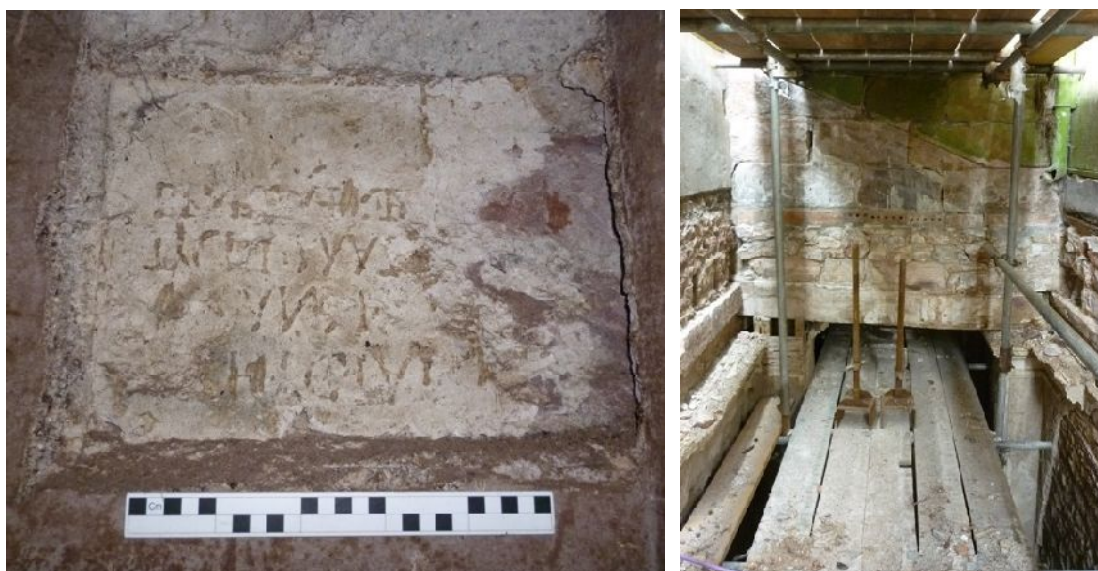
Plate 47 (left): Inscription preserved in the plaster, south end of Room 1 (note that the inscription is mirrored and inverted)

5.1.8 Of particular interest from this phase is the inscription preserved in plaster remaining in one of the niches. This has been exposed to the weather for some time and as a result is in a poor condition and an attempt to take a rubbing, while succeeding to some extent, removed part of the upper surface. A reading of the inscription is difficult. It has been suggested that it might be an impression of one identified as No. 770 in the Roman Inscriptions of Britain (RIB), found in Kirkby Thore in 1860 and known to have been housed in Lowther Castle (David Shotter pers comm). However, the size does not appear to be match for this; indeed, there are apparently no inscriptions in the RIB volumes that are an exact match. The first line would usually consist of the name of the deceased (only the letters H, I, and C can be clearly discerned, apparently then followed by 'IA', possibly with an N after); the second line would have the age at death; the third line the executor's name (possibly 'MAT[ER]', his mother); and the fourth line another name or funerary formula (Roger Tomlin pers comm). It is apparent that the inscription must have been on the rear side of another, perhaps more visually impressive, piece, which was re-used for a second inscription; this secondary inscription being less decorative, it was relegated to the back when the slab was displayed on the wall. The provenance of the inscription is uncertain. As described in *Section 3.1.8* the Lowther Castle collection contained many imports as well as locally derived items, and it is impossible without identifying the inscription, to know whether this is one of the former or one of the latter. The only remaining intact and presumably *in situ* piece of sculpture within the gallery is the grave cover attached to the east wall of Room 1. This was first recorded in 1882, at which time it was said to be at Lowther Castle, although more recently its location was considered to be 'unknown' (Ryder 2005, 36). Ryder describes the decoration as comprising '*a straight-armed cross with cusped arms and an elaborate fleur-de-lys terminals, with two roses above, and below what look like the upper sections of two shields, that on the left with a lion rampant and that on the right with five rings*' (*ibid*). The five rings are part of the Lowther family crest.

5.2.2 With regard to the Roman inscription preserved in the plaster of one of the niches, it would be a relatively lengthy task to ascertain whether it has ever been published and it is not expected that it will have been (Roger Tomlin pers comm). It is recommended that additional specialist photography be carried out with photographs taken at ninety degrees under better lighting conditions and in infra-red, which might improve the chances of reading the inscription (Roger Tomlin pers comm).

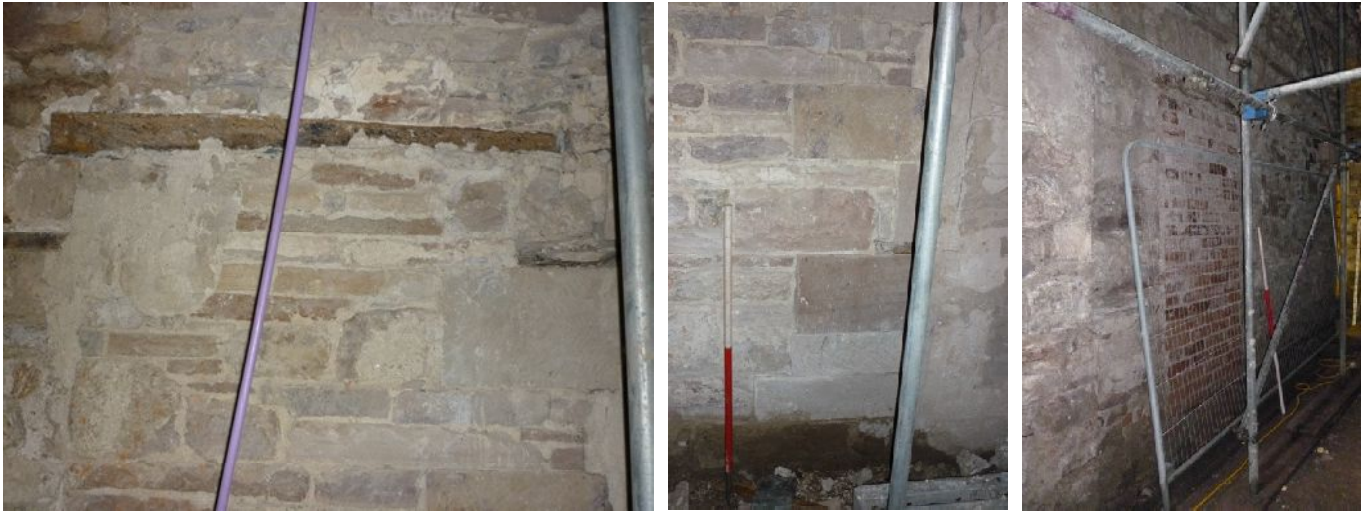
Plate 49 (left): Timber in the west elevation at the south end of Room 1 (photograph taken 25th August 2011)

4.3.7 The west elevation has two pieces of timber built in to the south end of the room up to the edge of a doorway to the north (Plate 49). The doorway is blocked but within the blocking is a row of dressed quoins (many of which are evidently reused and some finished with cross-broaching) for a smaller doorway (Plate 50). The main part is still covered with plaster, which has been scored presumably in order to fix the original skim. To the north of this is a rounded arch, which is built in hand-made brick and is stepped out in concrete blocks to the north (Plate 51). To the north of this there are three arches in roughly dressed stone (Plate 52 and Plate 53). The north side of the northernmost arch has some more finely dressed stone, but it is rather crudely cut back. The elevation steps back again north of the arches, to a doorway with a rounded stone arch, which is filled with machine-made brick comprising alternating rows of stretchers and headers. There is a large opening to the north of this, with a rounded stone arch and small quoins, which leads into the corridor beyond.

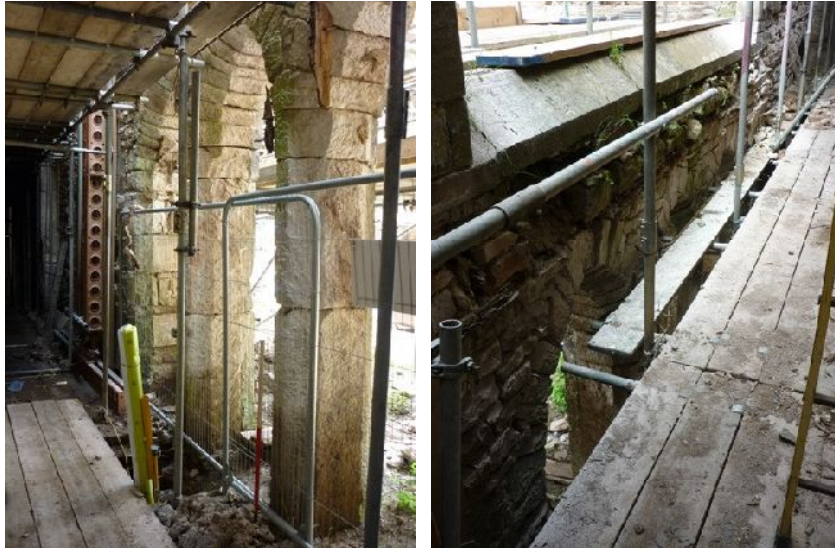
Plate 52 (left): Stone arches on the west elevation of Room 1 (photograph taken 25th August 2011)

Plate 53 (right): Detail of the top of the stone arches in Room 1 (photograph taken 25th August 2011)

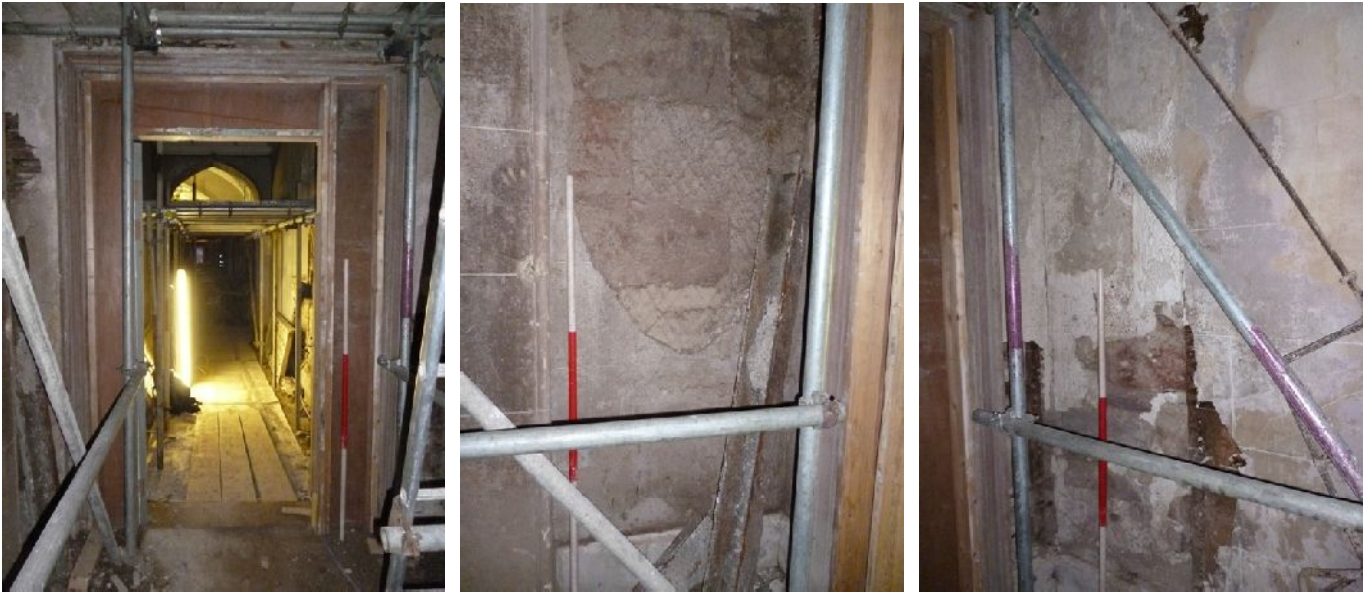
Plate 54 (left): South elevation of Room 2

4.3.8 **Ground Floor Room 2:** this room has the original sandstone flag floor and is actually raised relative to the floor to the north but continues into the south end of Room 1. It has no ceiling or roof. The ground floor walls are mostly finished with plaster scored as ashlar blocks and angled skirting. The north and south elevations comprise openings to the adjoining rooms. The opening to the north has no surround other than beaded cornices. The one to the south has a more complex beaded moulding for a wide door frame (Plate 54). The east elevation is mostly plain plaster and skirting with an alcove on the south side (Plate 55). The plaster has been removed within the alcove, revealing quoins on the north side. The west elevation comprises exposed stonework on the south side whereas the north side is filled in with lath and plaster, covered with a scored skim (Plate 56).

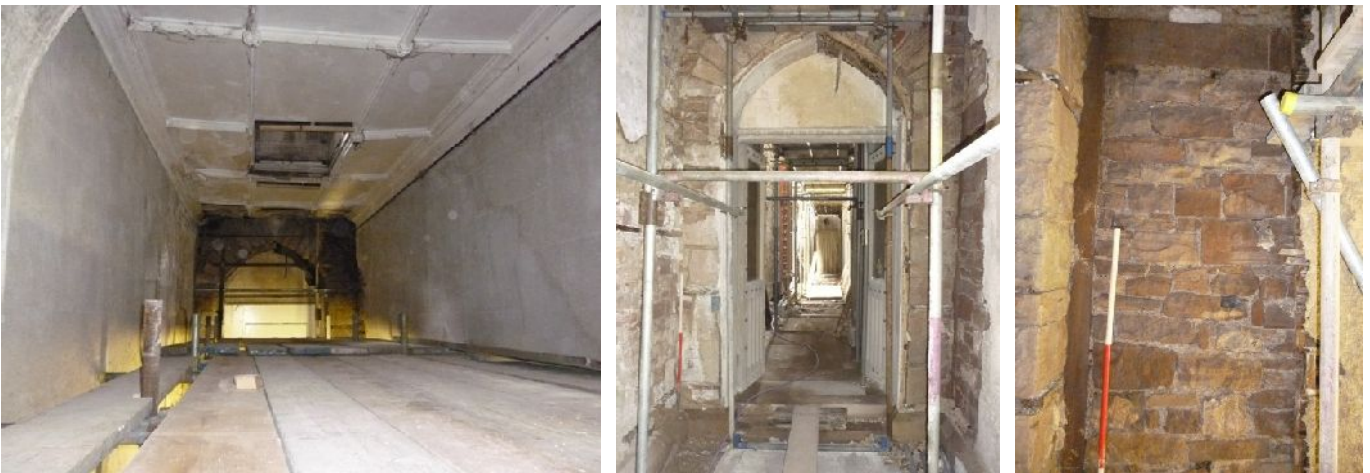
Plate 57 (left): Ceiling in Room 3

4.3.9 **Ground Floor Room 3:** this room also has a sandstone flag floor, which is slightly lower than Room 2, which is accessed by two stone steps to the north. It has a plaster ceiling with deep moulded cavetto and rolled cornice (Plate 57). The lath and plaster ceiling also has beaded ribs with spiralled bosses, although only four of these remain. There is also a central boxed skylight, which is lined with timber, although the glazing is now gone. The plaster remains in places on the walls, which are also finished with a chamfered stone plinth. The north elevation is essentially just a doorway with a pointed arch (Plate 58), which is lined with lath and plaster. The top part of the arch has been filled with more lath and plaster with an attached moulded batten. The stonework on the east side butts a pre-existing sandstone window frame at the north end of the east elevation (Plate 59), but the west side is contemporary with the west elevation. The lintel at the north end of the east elevation has square jambs, which are similar to those of the windows in Room 1 to the north. This window is filled with stone, a lot of which is dressed and re-used. One piece has moulding. The wall is largely covered with lath and plaster to the south, which is, in effect, forming 'dry-lining' and has been scored to give the appearance of ashlar blocks. Patches of the wall surface proper are visible behind, which is finished with roughcasting and lime wash.

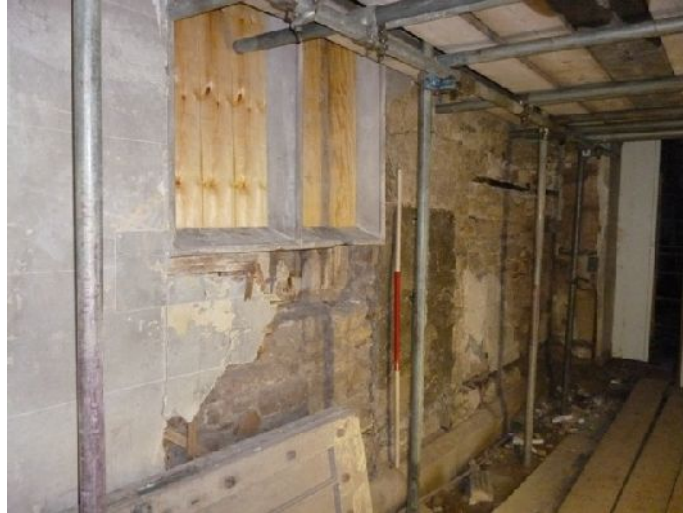
**Plate 60: The west elevation of Room 3**

4.3.10 The south elevation is essentially a large opening with a pointed arch. It is all plaster finished with ribbed corners. The east side is just timber stud attached to a solid wall whereas the west wall is solid. There is a central two-light, central mullion window on the west elevation, with splayed jambs and sill (Plate 60). The plaster has been removed below revealing the window frame extends further down to a heavy sandstone sill. The plaster finish is intact at the south end of the elevation, but to the north there is a patch of what looks to be a thick grey concrete render although some plaster is actually attached to the wall and survives higher up. There are levelling timbers built into the wall, or the scars for them, and there is some early brick included in the build.

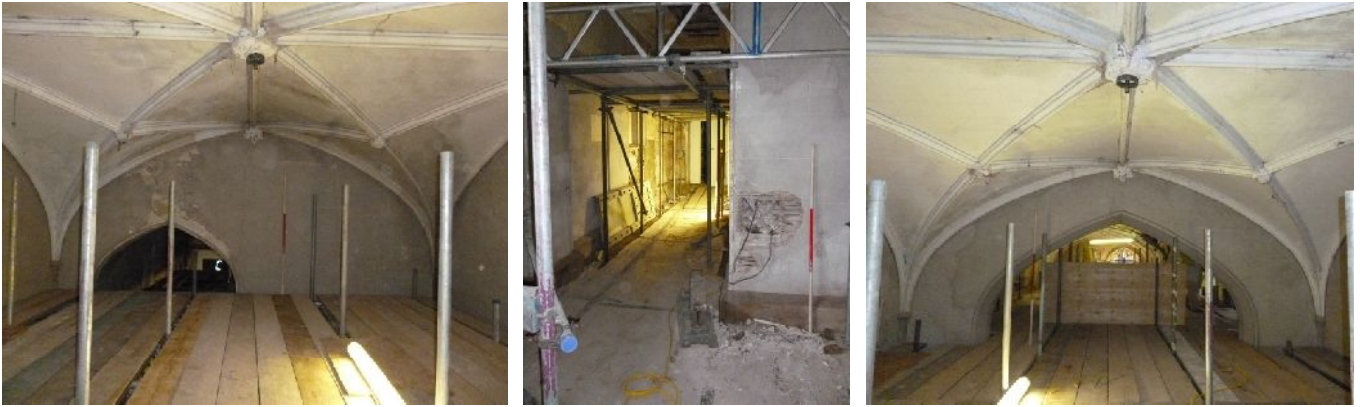
Plate 61 (left): Upper part of the north elevation of Room 5

Plate 62 (centre): Doorway on the west side of the north elevation of Room 5

4.3.11 **Ground Floor Room 4:** the floor is currently covered but is presumably also sandstone flags. The room has a ribbed vaulted plaster ceiling, with scored ashlar effect and spiral bosses (Plate 61) as per those in Room 5 (see Plate 68). The walls are all finished with plaster and scored with an ashlar block effect. The north elevation has a large opening on the west side (Plate 62) with an engaged column in the north-west corner on an octagonal base with scotia moulding extending into ribs, with a very simple moulded top. The east side of the opening at least is 'dry-lined' with lath and plaster over the stonework, with the line of a possibly quoin opening visible in an exposed section. There is a further engaged column in the north-east corner. The east elevation is mostly plain, with a plaster scar, perhaps from an attached statue near the centre, and the doorway on the south side is possibly a recent insertion or has recently been altered (Figure 2). There are concrete blocks on top of the doorjamb and it has a concrete lintel. The south elevation opens through a large arch (Plate 63), which has chamfered jambs all of which are finished with plaster and have ribbed corners. There are engaged columns in the south-east and south-west corners and the west elevation has the same finish. There is text stencilled on the south side of the west elevation, which reads 'FROM THE PALACE OF CÆSARS. ROME.' (Plate 64). This has been repainted, causing the text to look slightly embossed, and although the repainted text mostly lines up with the earlier text, the word 'Rome' has been moved slightly to the north, causing it to be better centred than it was before on the second line. There is a large six-light mullion and transom window with an arched top to the north of this text, with splayed jambs, which extend to the floor, and a dressed stone sill. There is an impressed mark in the plaster to the north which resembles a bull's head (Plate 65).
