THE SCULPTURE GALLERY, LOWTHER CASTLE, PENRITH, CUMBRIA

Archaeological Building Recording

Client: Lowther Castle and Gardens Trust

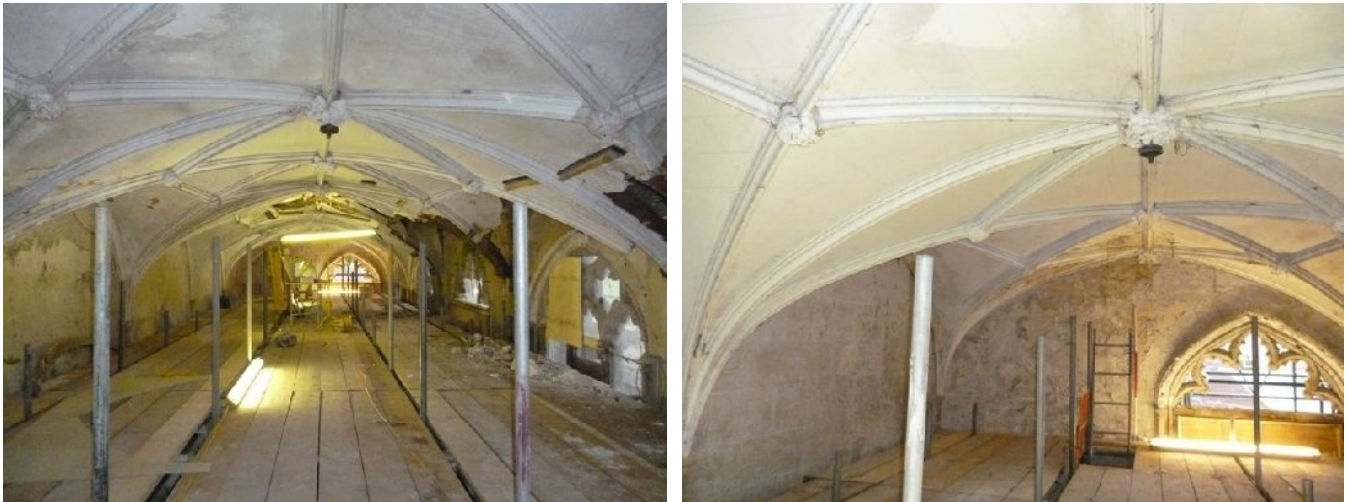
Plate 66 (left): View of the ceiling in Room 5, looking south

4.3.12 **Ground Floor Room 5:** the floor was covered to protect it during the restoration, but it is presumably sandstone flags underneath. The room has a ribbed vaulted ceiling like Room 4 (Plate 66 and Plate 67 and Plate 68), with additional 'leaf' bosses at its north and south end. The roof is formed of two hipped sections to the north and south, meeting at the central valley (Plate 66). The trusses are low king post type but much of this has been recently replaced. The tops of the windows have arches in stone with attached plaster mouldings. The walls mostly have surviving plaster, which is scored as ashlar blocks, although some elevations are actual ashlar stonework. All of the elevations have a chamfered stone plinth. The north elevation has a large opening with ribbed corners and arch and is otherwise plain (Plate 69). The plaster has been partially removed at the north end of the east elevation, with lath and plaster filling a gap in the stonework, which may have been an opening (Plate 70). Much of the stonework, which is in fairly irregular courses, is reused (Plate 71). The east elevation is broken into five sections by four engaged columns and another one at each corner of the room (Plate 72). A central alcove is formed in a doorway which is blocked externally with modern machine made perforated bricks loosely set in lime mortar (Plate 73). The doorway is arched and the surround is plastered and ribbed on the south side where the plaster survives. The remainder of the wall is plain plaster. The south elevation has a plain scored plaster finish on the east side of a central doorway, which has a stone roll-moulded surround and engaged columns on octagonal bases with trefoil head (Plate 74 and Plate 75). West of the doorway the wall comprises ashlar stone. The west elevation is all stone block work and mirrors the five divisions along the east elevation, with four large three-light windows and one doorway, all of which

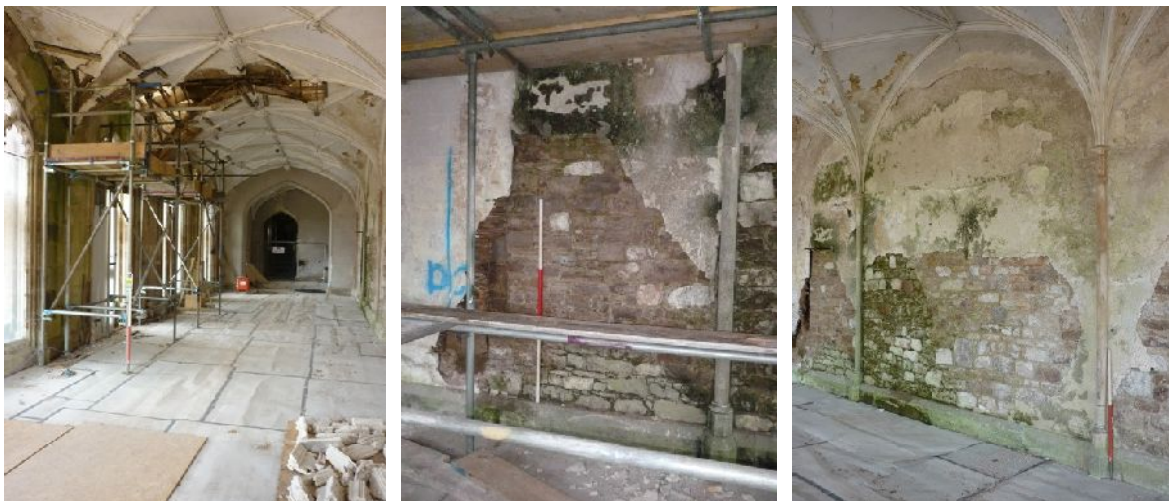
Plate 69 (left): General view of Room 5 from the south (photograph taken 25th August 2011)

Plate 70 (centre): Edge of lath and plaster and exposed stonework

Plate 71 (right): Stonework exposed in the east elevation of Room 5 (photograph taken 25th August 2011)

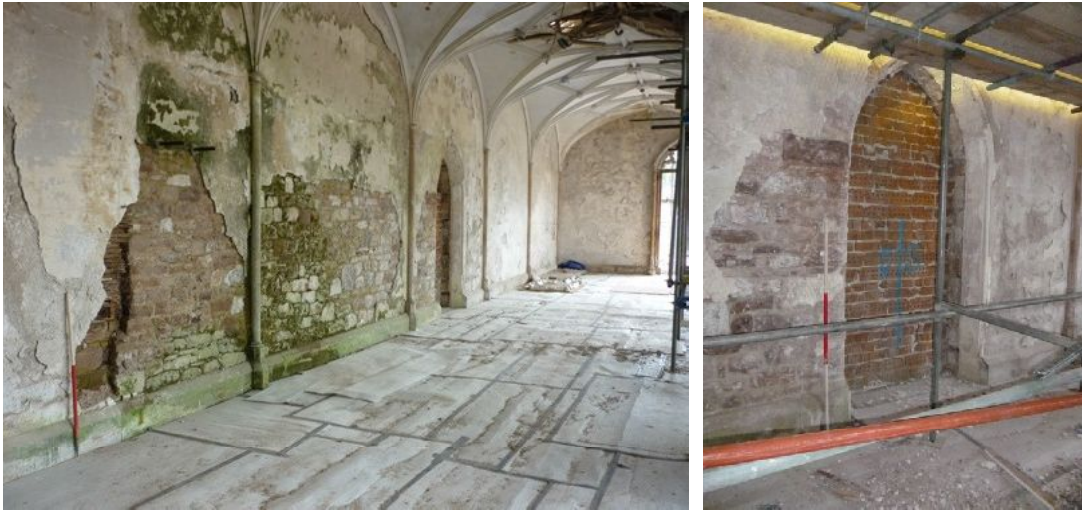
Plate 72 (left): East elevation of Room 5 (photograph taken 25th August 2011)

Plate 73 (right): Blocked door on the east elevation of Room 5

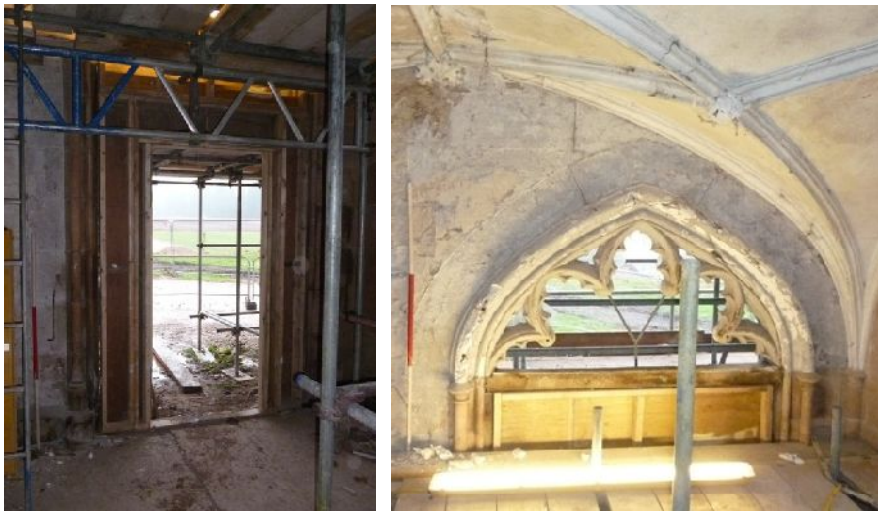
Plate 74 (left): Doorway in the south elevation of Room 5

Plate 75 (right): Detail of the door head in the south elevation of Room 5

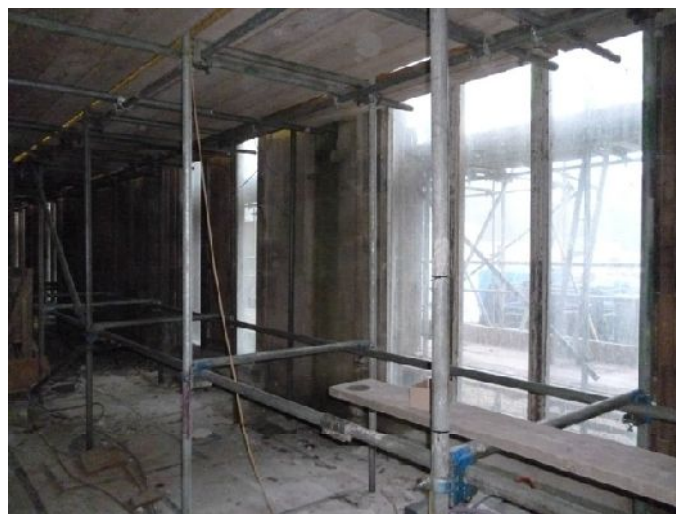
Plate 76: East elevation of Room 5

have engaged columns on octagonal bases and further columns between (Plate 76). All of the columns are stone.

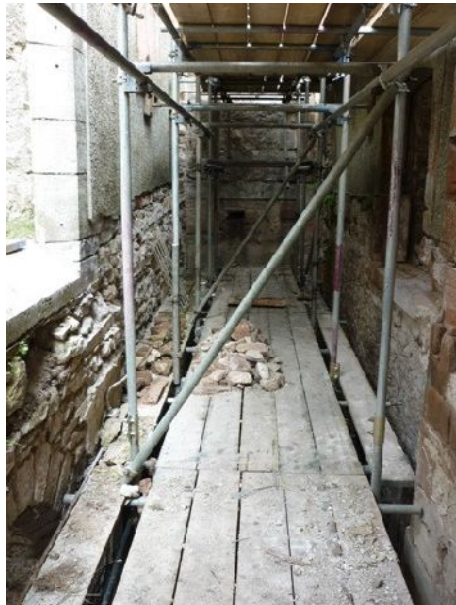
Plate 77 (right): North end of Room 1 (photograph taken 25th August 2011)

4.3.13 **First Floor Room 1:** none of the first floor was properly accessible at the time of the survey. The masonry of the wall is exposed above the doorway in the north elevation, with rows of quoins on the east side and a band of red sandstone on the west running horizontally then vertically, apparently extending to the full height of the wall, as well as is a band of slate running horizontally across the elevation. The east elevation is largely covered with cement and roughcast render. There is a row of windows with sandstone surrounds in line with those on the ground floor below. The window at the north end is blocked and rendered over, but it is still visible and the quoins are also exposed. The window south of the centre has joist holes cut through the sill and blocking and the south jamb has been moved slightly to the north. There is a smaller window to the south in the same general style and a further very broken aperture to the south and there are the remains of cornice with beading at this end (Figure 3).

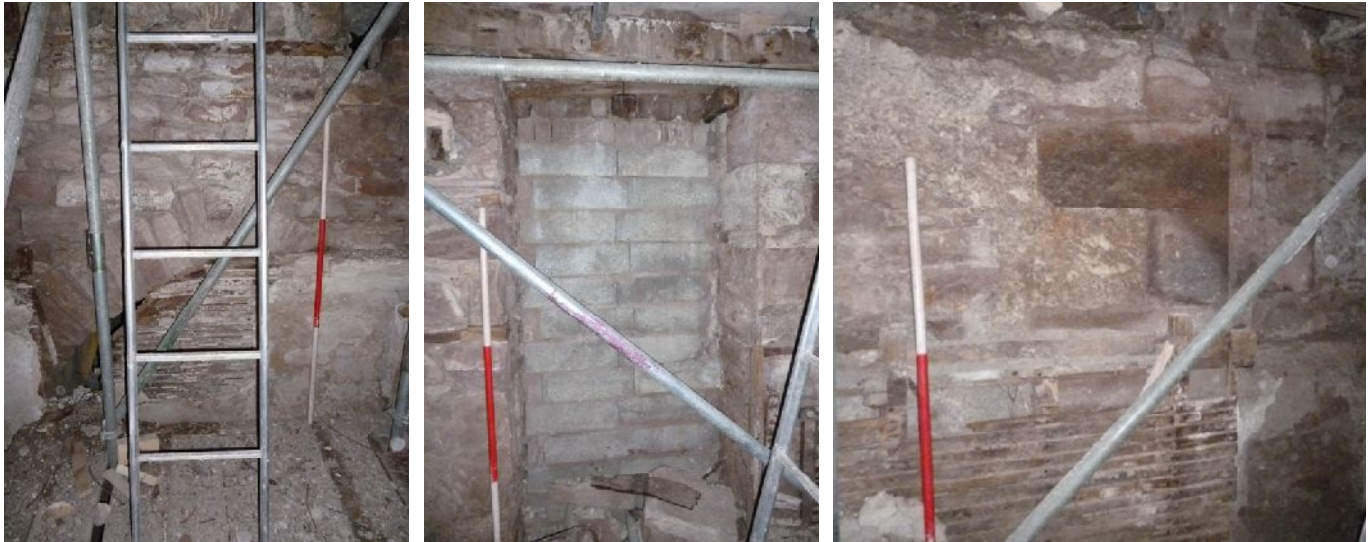
Plate 78 (left): Arch in the north elevation at first floor level in Room 2

Plate 79 (centre): Alcove on the first floor level of Room 2

4.3.15 **First Floor Room 2:** there are remains of a cornice on the west side, which is cavetto moulded and beaded. There is a pointed arch to the south, which is mostly covered by lath and plaster (Plate 78), of which the cornice forms part. The alcove on the south side of the east elevation at ground floor level (see *Section 4.3.9*; Plate 55) continues to the first floor, and has quoins in its jambs (Plate 79). Quoins are also present on the south side of a projecting section to the north, but this is partially covered by lath and plaster (Plate 80), which presumably held the cornice and does not continue beyond first floor level. The north elevation contains the top of the doorway, with a heavy hand-sawn timber lintel.
