# PRIORY GARDENS, PRIEST LANE, CARTMEL, CUMBRIA

## Archaeological Desk-Based Assessment

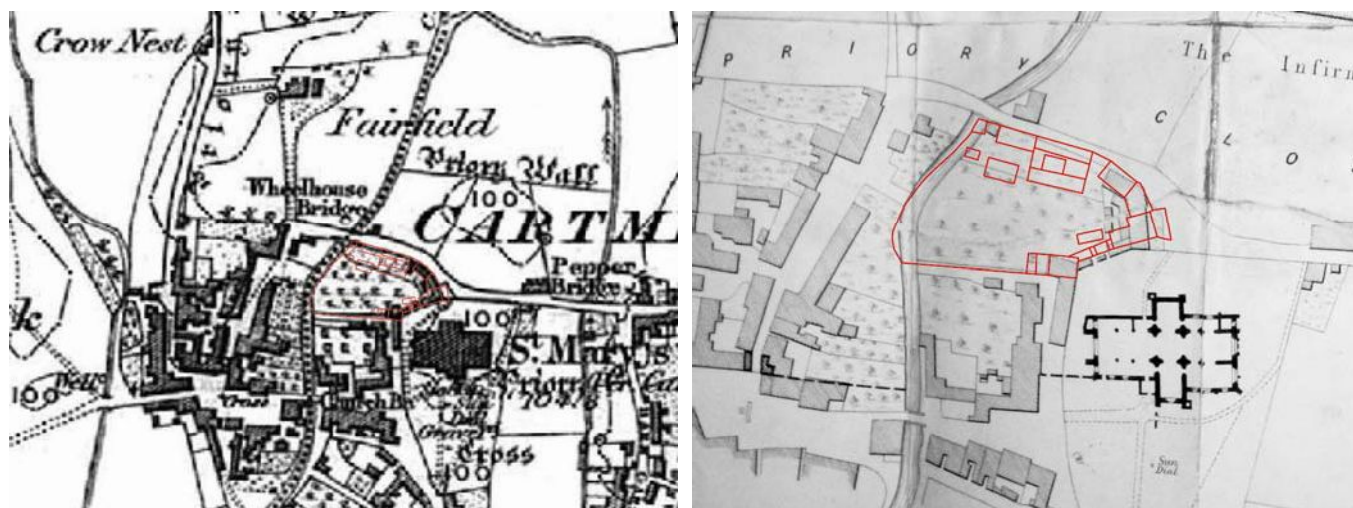
Plate 1 (left): Extract from the Ordnance Survey map of 1851

Plate 2 (right): Extract from Ffoliot's plan of 1854

3.2.2 **Ordnance Survey, 1851:** the site is located to the north-west of the priory church and east of the River Eea, which runs north-east/south-west through the centre of the village. The open area to the north side of the site (along Priest Lane) is divided from the south side, which is mostly covered in trees. The site has been built over along the south-east side as well as along the east side of Priest Lane (to the north), but the rest of the site is undeveloped.

3.2.3 **Ffoliot's map, 1854:** this map shows the divisions between the buildings along the east side of the site in a similar arrangement to the earlier Ordnance Survey mapping. A small square building is shown in the north-west corner of the site adjacent to the River and other small structures might have been added. The boundary which separates the northern strip of land along Priest Lane from the more wooded area to the south is still apparent. The fields to the north-east of the site are marked as the 'The Infirmary'.

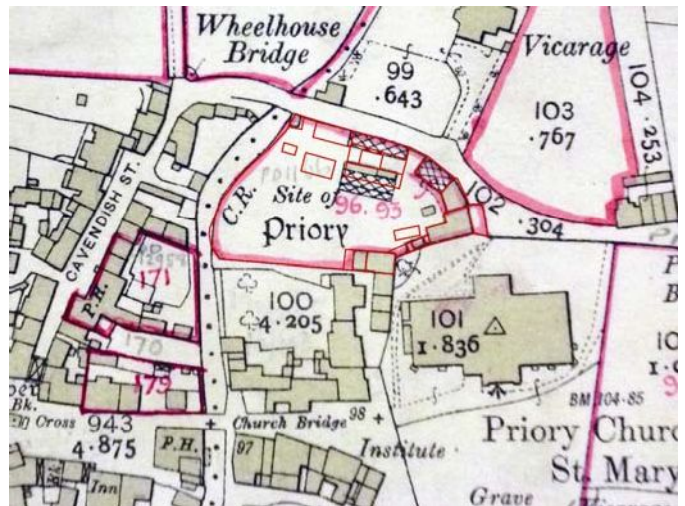
Plate 5 (right): Extract from the Ordnance Survey map of 1933

3.2.6 **Ordnance Survey, 1933:** the arrangement of buildings on the site remains largely the same, although some of the smaller structures have been removed, but the boundaries are no longer shown and the area is not shown as covered in trees. Two of the previously existing structures are now filled with a crosshatched pattern, which indicates they were glass structures (i.e. greenhouses), and part of the rectangular block towards the centre of the site is also shown as being made from glass. This edition shows the boundaries and assessment numbers allocated by the c1910 land valuation made by the commissioners of the Inland Revenue. From the valuation records it is apparent that this area counted as part of the parish of Upper Holker, although it had been labelled Lower Allithwaite on earlier editions of the Ordnance Survey mapping. This map has been marked with reference numbers corresponding to the 1910 rating valuation (CRO(B) BT/IR/1/2 1910), in this case 96 and 93. The reference book states

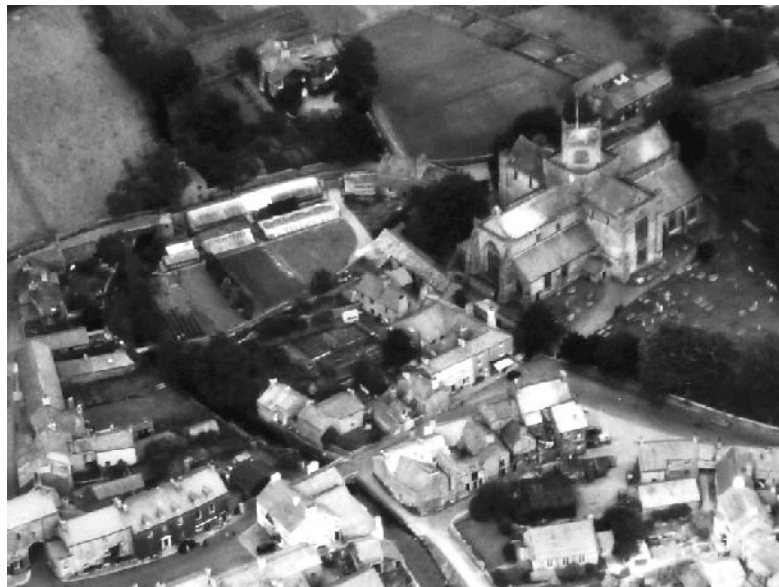
Plate 6: Aerial photograph, 1970 (north is to the top left)

**3.2.7 Aerial photograph, 1970:** this photograph, apparently taken in 1970 (Cambridge University 1970), shows the arrangement of buildings along the east side of the site (to the north of the Priory) and two rows of greenhouses to the south side of Priest Lane (Plate 6). At this time the greenhouses appear to be glazed along their length and the greenhouse or houses to the north extend almost the full length of Priest Lane along this side of the site. The footings of these greenhouses correspond well with the most recent survey of the site wherein they appear as low standing garden walls (Figure 3). The same photograph is reproduced by Dickinson (1991, 8), who states, presumably on the basis of this photograph, that 'a large hall with twin aisles and an open area at one end' that was part of the monastic infirmary together with a broad boundary ditch is visible in 'Farmery Field' (*op cit*, 109). This is presumably a reference to what appear to be a group of pale and dark crop marks in the open field to the north of the priory church, although it is difficult to distinguish the level of detail that Dickinson describes.

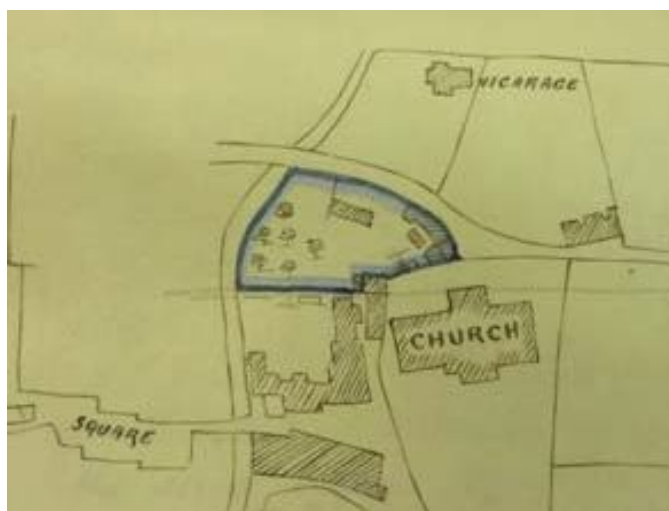
**Plate 9: Plan from the conveyance of 1897 (CRO(B) BDHJ/290/49 1897)**

3.3.17 **Priory Gardens:** some history specific to the site can be ascertained, in part though information contained in the deeds provided by the client, but also through its connection to Priory House (immediately to the east), for which it originally formed the garden. Priory House is considered to be of 18<sup>th</sup> century origin (English Heritage 2007), although it is thought likely to have originally related to the medieval priory, perhaps serving as the prior's lodgings (Stephen Roe pers comm.) and its name and proximity to the priory church do suggest that this is possible. The available history of Priory Gardens only begins in the late 19<sup>th</sup> century, when it was conveyed, in 1897, from Thomas Orr and others to James Peddar (CRO(B) BDHJ/290/49 1897), following its sale at auction on May 4<sup>th</sup> of that year (CRO(B) BDHJ/290/48 1897). At this time Priory Gardens still formed the gardens for Priory House; the same document describes it as comprising '*Freehold messuage or dwelling house known as Priory House with the stable coach house yard and outbuildings... and the gardens and orchards behind*' (CRO(B) BDHJ/290/49 1897), and the auction sales particular marks the site (Plate 9). An undated document of late 19<sup>th</sup> or early 20<sup>th</sup> century date (CRO(B) BDHJ/290/51 n.d.) relates to attempts to sell or let the property, which is described as comprising '*Priory House, Cartmel, Grange over Sands. Containing Dining, Drawing and Morning Rooms, 4 Bedrooms, Dressing Room, good attics, Bathroom H & C., W.C., good kitchen, Scullery, Larder and the usual out offices, stable, Loose Boxes, Coach House, Garage, Orchard and Garden (3/4 of an acre).*'

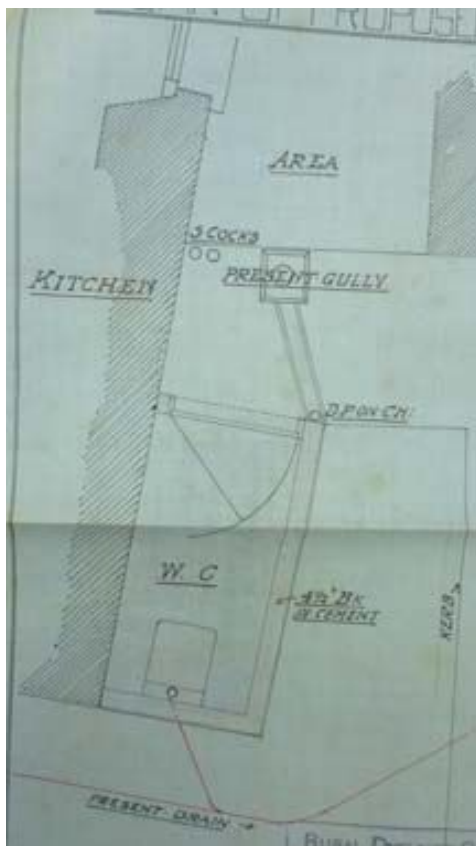
**Plate 10 (left): Proposed outside toilet (CRO(B) BSRDNL/3/899 1932)**

**Plate 11 (right): Proposed location of the petrol pump showing the neighbouring buildings (CRO(B) BSRDNL/3/1569)**

3.3.18 A list of later owners is given in Table 1, below, and information regarding owners and occupiers contained in the 1910 valuation is given in *Section 3.2.6* above. This appears to demonstrate that the Priory Gardens was retained with Priory House into the early 20<sup>th</sup> century. Some details of the later history of the site are also available in various documents. Three proposed alterations to the site were made in the 1930s, an outside toilet to the west of Priory House in 1932 (CRO(B) BSRDNL/3/899 1932; Plate 10), and two separate proposals for a petrol pump in 1938, immediately to the east of the greenhouses (CRO(B) BSRDNL/3/1529 1938; CRO(B) BSRDNL/3/1569 1938; Plate 11). It is not clear if the toilet still exists or was ever built, but the petrol pump remains on the site. Further proposed modifications were also made to the house at this time, including the addition of an oriel window

(CRO(B) Z/889 1933) and the conversion of a former barn into a shop and work room (CRO(B) Z/888 1932). It is evident that by this time the former garden was being used as a market garden, Priory House is described as a house, office and shop on the plans of 1938, and the range of greenhouses and a potting shed are shown. This coincides with the conveyance in 1929 to Arther Futer, a nurseryman or market gardener.

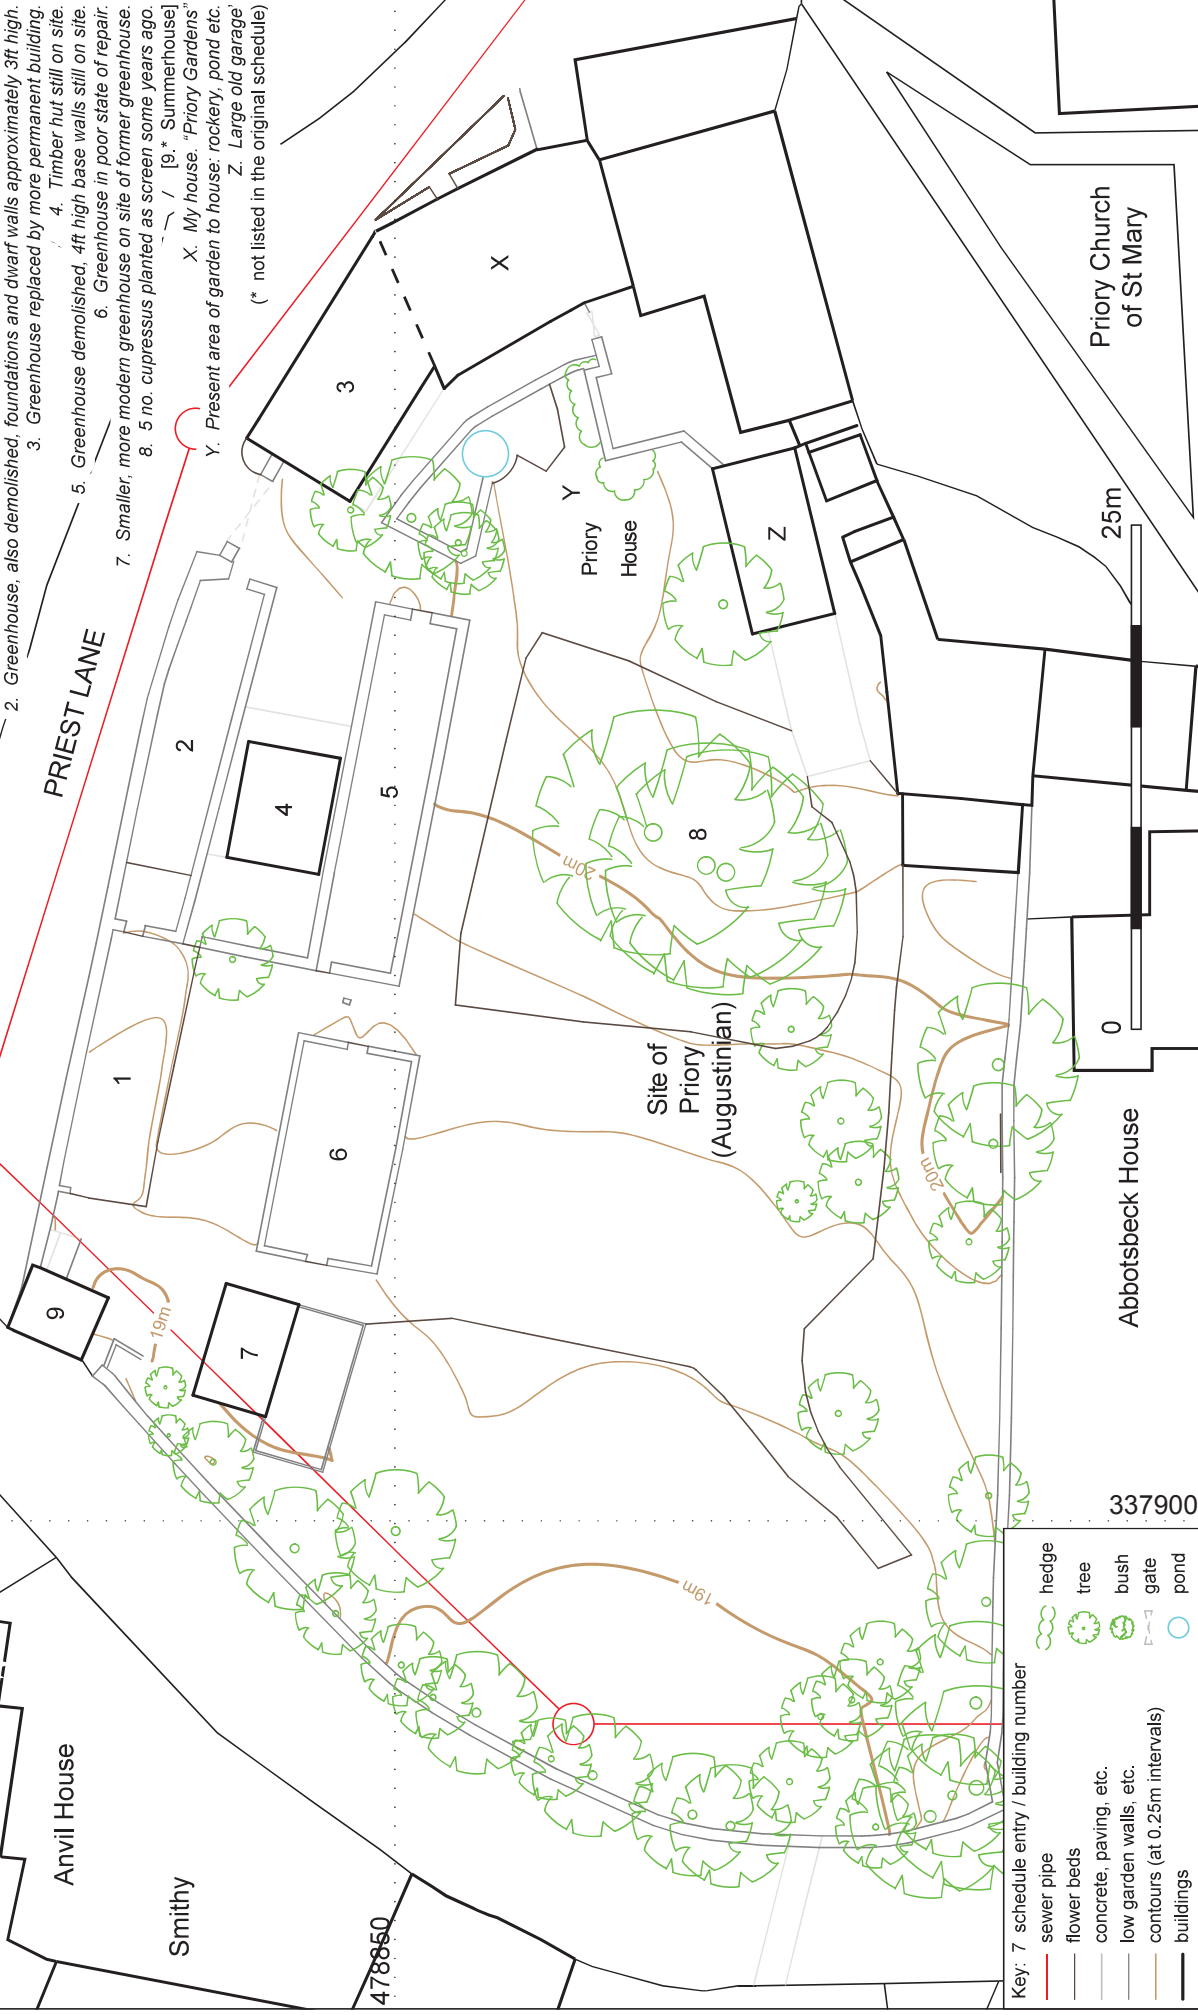
1. Greenhouse, now demolished, only low foundations visible.
2. Greenhouse, also demolished, foundations and dwarf walls approximately 3ft high.
3. Greenhouse replaced by more permanent building.
4. Timber hut still on site.
5. Greenhouse demolished, 4ft high base walls still on site.
6. Greenhouse in poor state of repair.
7. Smaller, more modern greenhouse on site of former greenhouse.
8. 5 no. cupressus planted as screen some years ago.

- X. My house. "Priory Gardens"  
 Y. Present area of garden to house: rocky, pond etc.  
 Z. Large old garage  
 (\* not listed in the original schedule)

3.5.1 The position of one below-ground service, a sewer pipe, is recorded, on a plan provided by United Utilities to the client, as running along the west side of the site parallel to the River Eea (see Figure 3) and there are two manhole covers serving this. Its impact on any archaeological remains is uncertain, but its installation is likely to have caused considerable damage. In addition, an electrical cable and water pipe are known to be present in the area adjacent to the gate from Priest Lane, approximately in the area between buildings 3 and 4 (Figure 3) (Stephen Roe pers comm.).

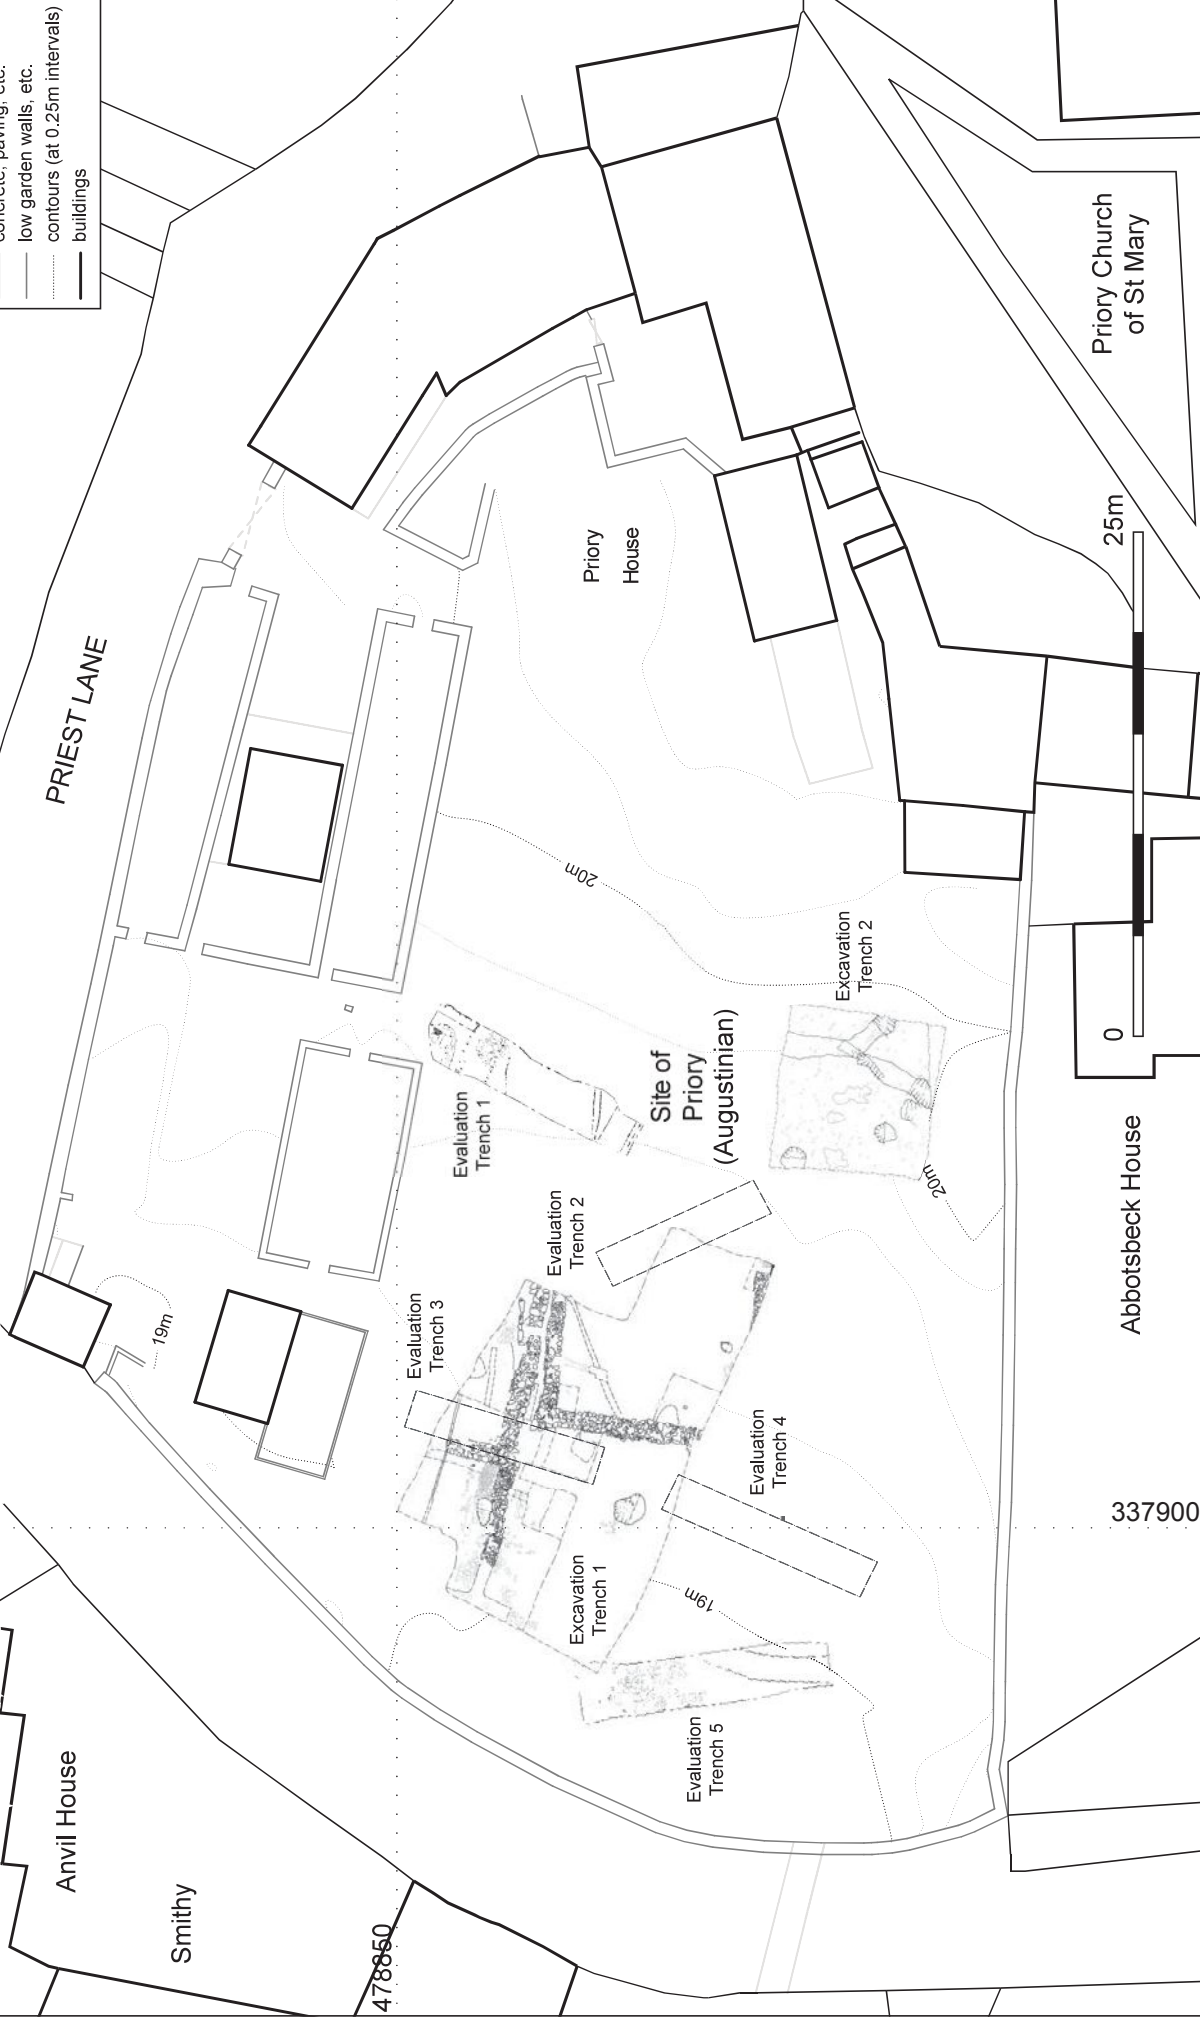
After a 2011 survey by Spatial Data Limited on behalf of John Coward Architects; trench plans overlaid from LUAU (1998a) and Wild and Howard-Davis (2000; figs 1 to 3), using the Ordnance Survey data as a base map. © Crown Copyright 2011. All rights reserved. Licence number 100045169.

Figure 4: Previous archaeological work at the Priory Gardens site

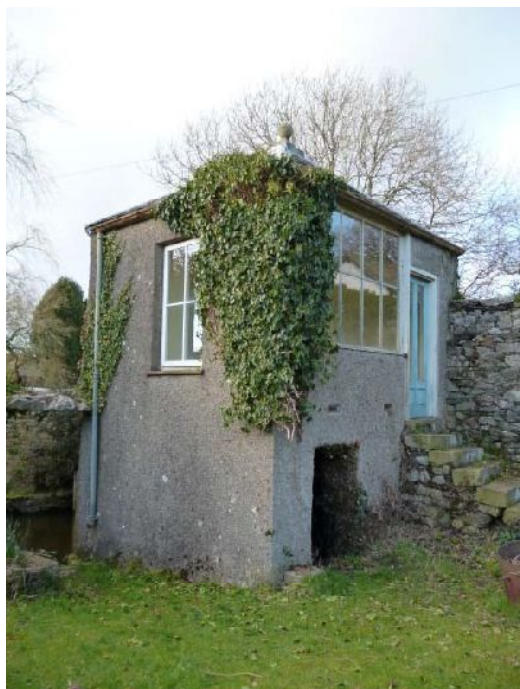
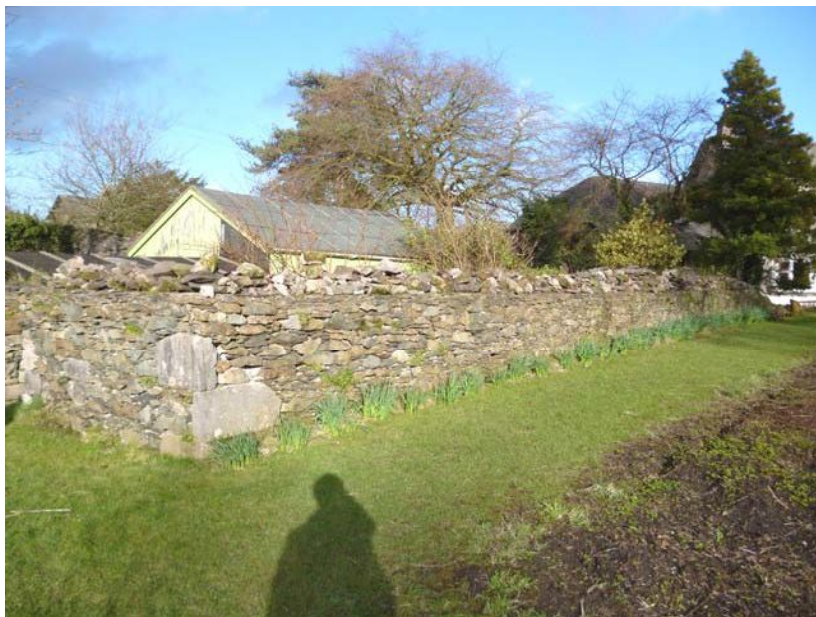
**Plate 12 (left): Summerhouse (Building 9) in the north corner of the site**

**Plate 13 (right): Dwarf stone walls, remains of Building 5**

3.6.3 **Impact:** it is evident that the southern part of the site, which is undeveloped, is likely to have relatively well-preserved below-ground archaeological remains – as demonstrated by the previous excavation. Only the trees are likely to have had a significant impact; the five *cupressus* trees do not appear to still be present, although three trees, at least one of which appears to be willow, are in approximately the same location. The effect of the buildings on the north side is more varying. Two of them are clearly of 19<sup>th</sup> century origin: the summerhouse (Building 9) in the north corner, next to the river and adjoining the tall northern boundary wall, is clearly shown on Ffoliot's plan of 1854 (Plate 2). The larger rectangular building (Building 5) to the south-east is shown on the Ordnance Survey map of 1890 (Plate 3). Both are stone built, although only the summerhouse now stands to what is presumably its full height (it is two storeys, with a small room below and steps up to the upper floor; Plate 12), while the other has been truncated (Plate 13). It was clearly latterly used as the base for a greenhouse. The remaining buildings all appear to be 20<sup>th</sup> century in date, as shown by the mapping, with many only consisting of low walls or bases that originally supported greenhouses, although there is one timber building amongst these (marked 'Z' on Figure 3). While the latter, which is presumably a more light-weight structure, is perhaps unlikely to have had a significant impact on any below-ground remains, the earlier buildings will probably have more substantial footings and so are more likely to have. It is worth noting, however, the observation that was made during the work carried out in 1998 that '*medieval drains may have been exposed during excavations under the greenhouses... during the 1930s*' (Wild and Howard-Davies 2000, 179). Buried remains in that area may, therefore, be shallower than elsewhere, although the depth of excavation carried out at the time is not known, and the possibility of pipes having been excavated for heating systems must also be taken into consideration.
