NATLAND HALL, NATLAND, KENDAL, CUMBRIA

Archaeological Building Recording

Client: Dale Rennard

September 2012

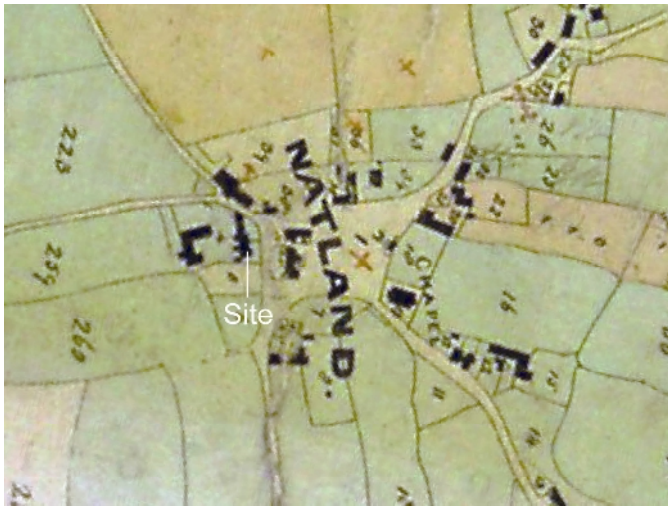
Plate 1 (left): Extract from the corn rent map of c1836 (CAC(K) WQ/R/C/12 c1836)

3.2.1 *Corn rent map c1836*: this is the earliest map found depicting Natland Hall in reasonable detail. It shows the basic shape of the structure, essentially a long linear block orientated north/south, including the attached stable block although there are apparently as many as three outshuts on the east side (Plate 1).

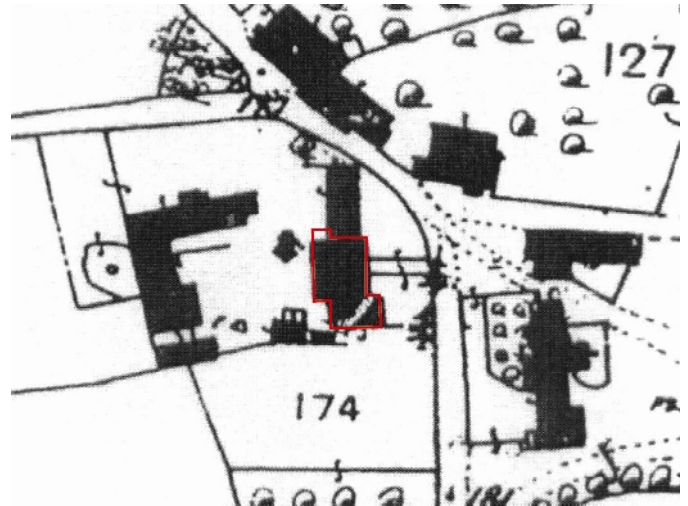
Plate 2 (right): Extract from the Ordnance Survey map of 1863

3.2.2 *Ordnance Survey 1863*: this is the first particularly detailed map of the site and it shows that the present arrangement of the building had developed by this date, with its characteristic L-shape visible, with a row of extensions along the west side and the stables to the north (Plate 2).

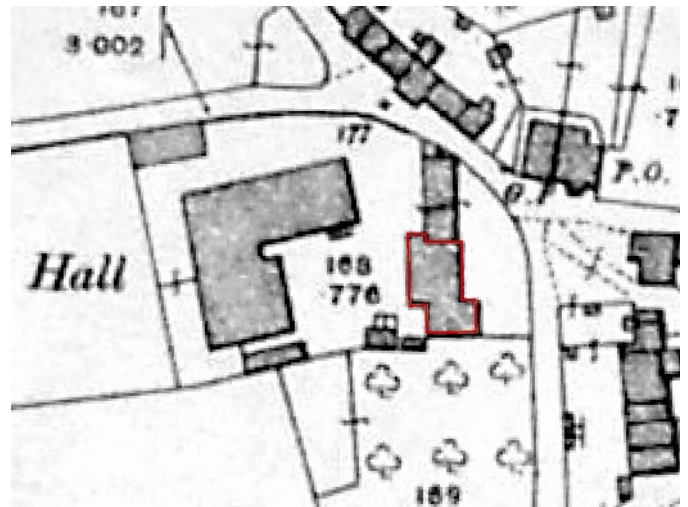
Plate 4 (right): Extract from the Ordnance Survey map of 1912

3.2.4 **Ordnance Survey 1912:** this map shows the same layout as the earlier edition of the Ordnance Survey (Plate 4; cf. Plate 3). The Hall and stables appear unchanged.

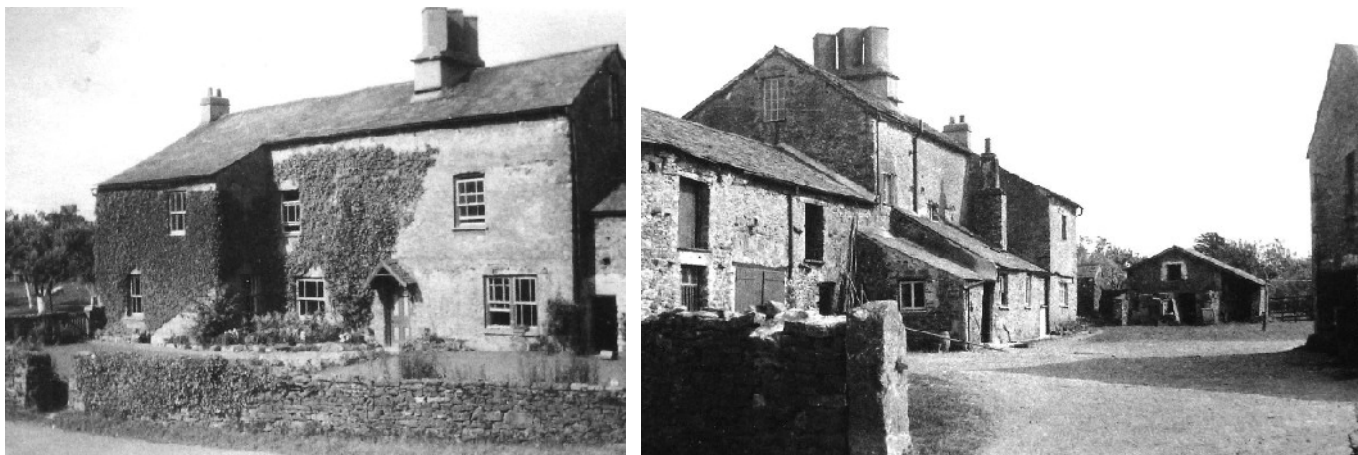
3.2.5 **Early 20th century photographs:** an early 20th century photograph of the east elevation shows that there used to be only three six-light sash casement windows on the first floor (Plate 5). What is more there is only one sash casement on the jutting section at the south end and there are no lines of slate above the windows which have since been added. An early 20th century photograph taken of the Hall from the north-west shows the lower level additions to the west side of the Hall, which step up in height from north to south. In addition, a tall chimney extends from the middle of the second outshut, which is no longer present (Plate 6). Two early 20th century photographs detail the inside of the Hall, one shows the fixed table (Plate 7), which has since been removed, and the other shows the stairs (Plate 8), which are largely unchanged.

Plate 5 (left): Early 20th century photograph of the east elevation (after Inglesfield 2006, 44)

Plate 6 (right): Early 20th century photograph of the north and west elevation (after Inglesfield 2006, 44)

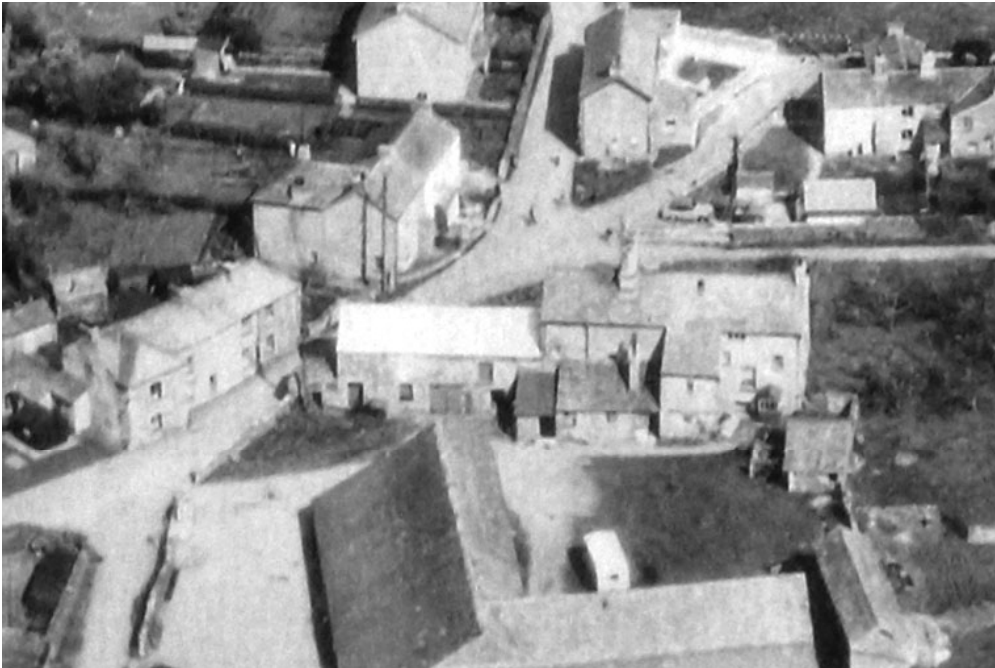
Plate 9: Aerial photograph c1960 (after Inglesfield 2006, 82)

3.2.6 **Aerial photograph c1960**: this aerial photograph of Natland shows the west elevation of the Hall (Plate 9). The lower level chimney to the west side is still present and there is also a small porch at the south end of the elevation.

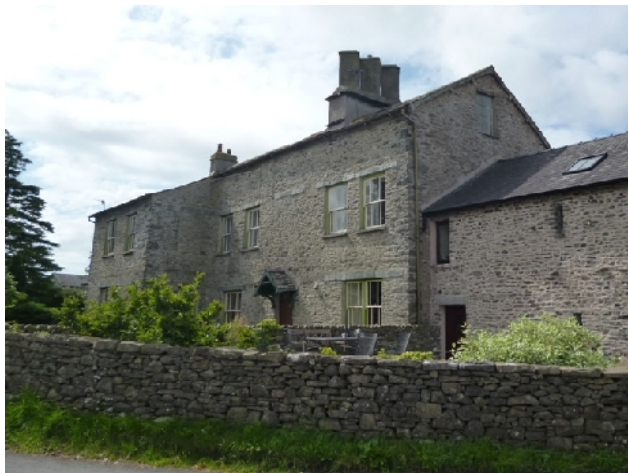
Plate 10 (left): View of the Hall from the north-east

4.1.1 The Hall is built over two floors with an attic and cellar and is arranged approximately north/south (see Figure 1 and Figure 4 to Figure 7; Plate 10). Two single-storey extensions have been added to the west side at the north end (Plate 11) and the east/west aligned section at the south end of the Hall now comprises separate accommodation. The separate cottage accommodation comprises Ground Floor Room 11 to 14 and First Floor Rooms 7 to 10 and has no access to the cellar or attic.

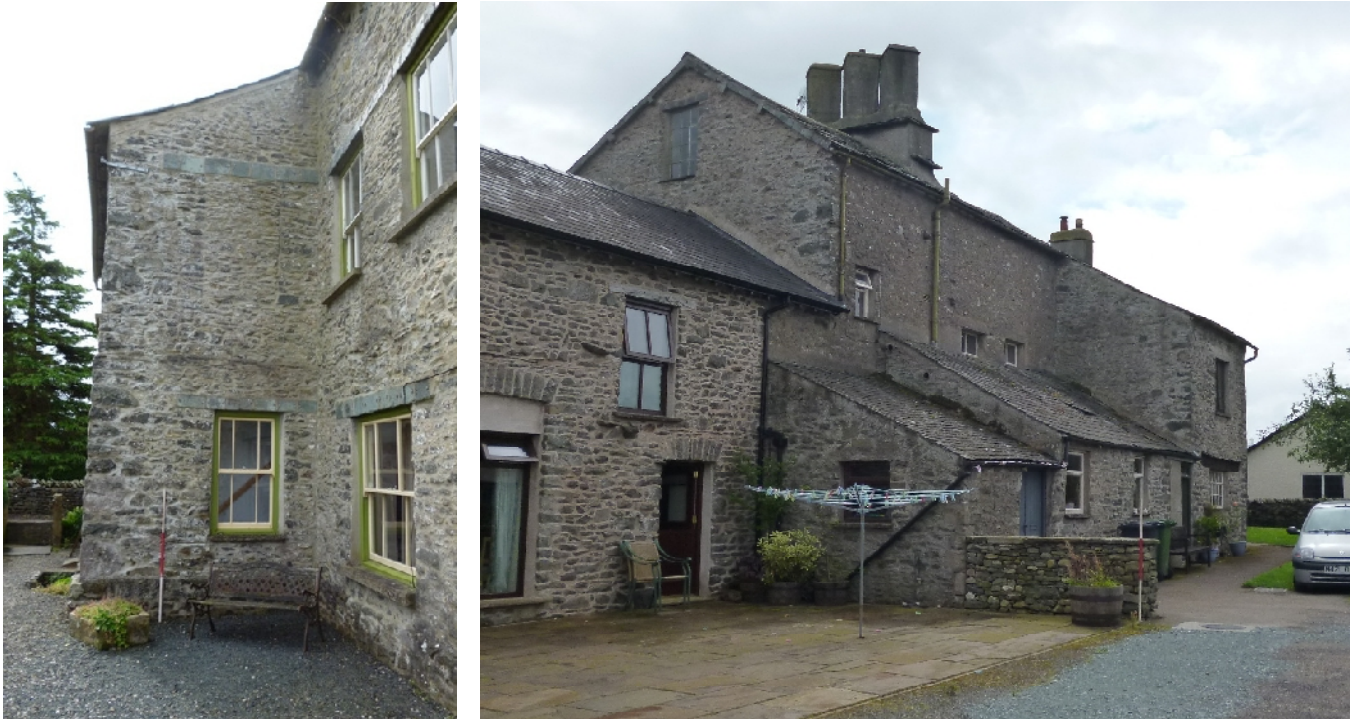
Plate 12 (left): East end of the north external elevation

There is a top opening two-light, plain, timber framed window with a stone sill at ground floor level and quoins to the western edge on the ground floor and on the two storey section, but the rest of this section is plain.

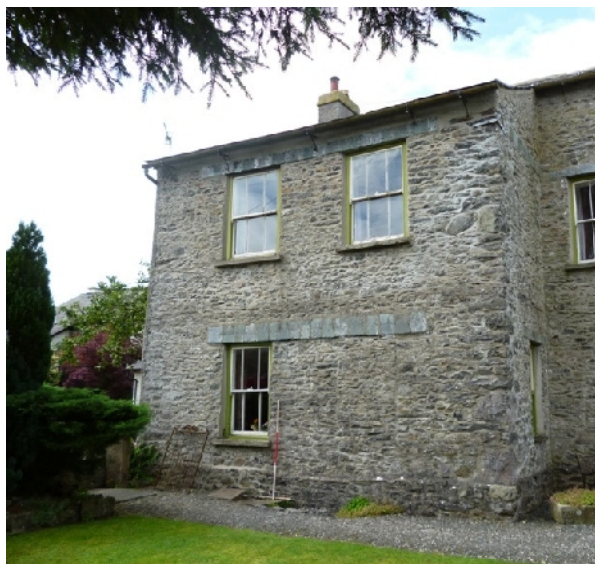
Plate 14 (left): South end of the east external elevation

4.2.2 East elevation: there is a step down from the allotment to the south side of the Hall to the garden on the east side. There is a continuous low level plinth along the east side of the Hall apart from a gap across the door and a short distance to its north side. All the windows on this side of the Hall are six-light sliding sash windows with timber frames (see Plate 14 and Plate 15; Figure 2). On the ground floor the sills look to be stone with concrete render over the lintels; on the first floor the sills appear to be a mix of concrete and stone, the concrete sills presumably relating to later insertions. Although the windows are superficially the same, there are some slight differences: the casements with stone lintels have a beaded edge; the ones with concrete sills do not. All of the windows have hung slate over the, presumably, timber lintels above, which, as is clear from the early photograph of this side of the hall (Plate 5), are relatively late additions. The whole of this elevation is set over two storeys, in addition to the basement at the south end. The elevation juts out at the south end, comprising separate accommodation. The south section has a sash window on the ground floor with a continuous band of slates above a blocked aperture to the north. There are two more sash windows at first floor level with a continuous band of slate above. There is a two-light mullion window to the cellar, which is covered by a sheet of plastic, and the plinth continues above it. The section to the north has a central door with a small gabled porch roof above it made from slate with timber supports. The ornate door has a single fixed light above and a chamfered decorated surround. There are windows with sash casements, double to the north, either side of the door, with vertical lines alongside each denoting that they were formerly wider. The doorway two has an evident line to the south, which is also present in the plinth, suggesting that it too was originally wider. There are four sash windows on the first floor, two either side of the central door below bands of slate. A band of slate above the central door suggests there is possibly a fifth blocked window. This elevation is heavily re-pointed, masking later insertions and alterations.

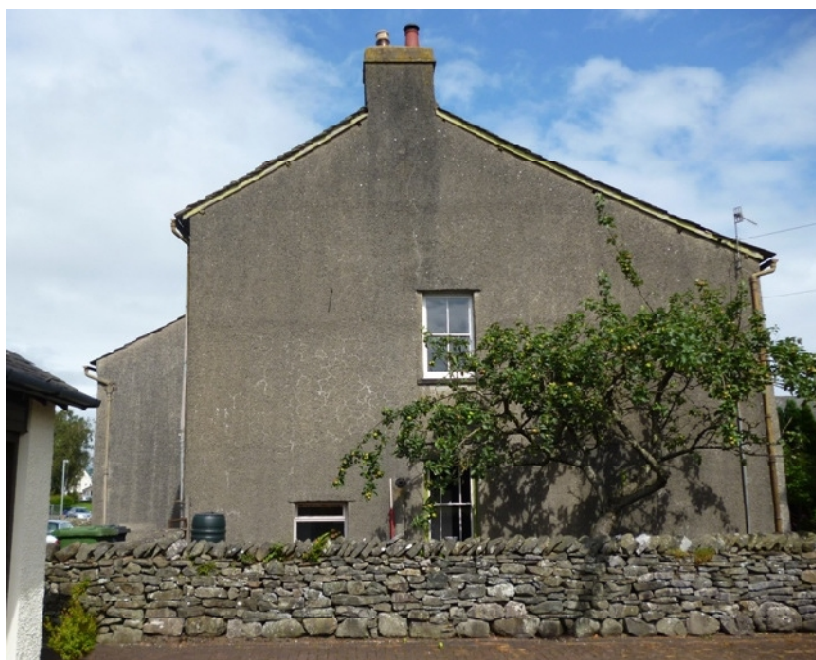
Plate 16 (left): South external elevation

4.2.3 **South elevation:** where the Hall juts out to the west side the stonework is covered with concrete pebble dash and it has a cast iron downpipe (Plate 16). The elevation steps to the south and continues as the gable end of the main section of the Hall (Figure 3), which is also pebble dashed. At ground floor level on the west side is a low level, top-opening two-light hinged casement timber frame window with slate set in concrete over the sill (Plate 17). To the east of this is a central six-light sliding sash timber-framed window, similar to those on the east elevation, with a stone sill and concrete lintel and a short slate drip course above. Above this is a four-light sliding sash timber framed window with plain stone sill and concrete lintel. The rest of the elevation is plain, with the purlins exposed below the roofline.

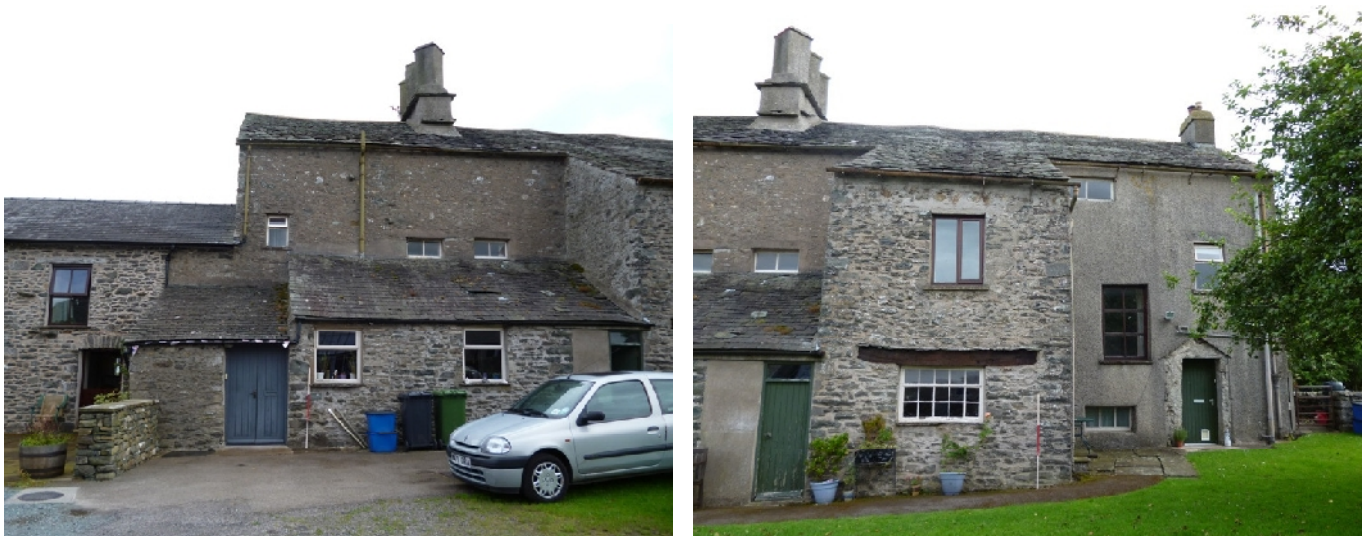
Plate 18 (left): North end of the west external elevation

4.2.4 **West elevation:** the north end of the west elevation is partially covered by two later additions to the Hall. The extension at the far north end comprises a small low lean-to with a slate roof and plastic guttering which partially overlaps the neighbouring property and is butted by a low stone wall at the north end (Plate 18; Figure 3). There is a plain plank and batten double door with a plain chamfered timber

surround at the south end, the elevation comprising concrete render over stone with quoins visible at the north end. The extension to the south of this has a slate roof blocking two windows on the main section of the Hall to the rear (see Plate 18). The roof level steps up from the extension to the north and again to the south where the Hall juts out over two storeys. The stonework here is exposed with quoins to the north end and with some larger stones to the north side of the doorway. There are two two-light top-opening hinged-casement plain timber-framed windows on the ground floor of this extension and there is a double door to the south, the north side of which is blocked and rendered over with concrete (Plate 19). The lintel and surround of the north window has been rendered over and probably has a slate sill; the south one has a timber lintel. The door is plank and batten with a plain timber surround and a fixed single light above. At the far north end of the Hall, behind the two ground floor extensions, there is a two-light top-opening hinged casement window with a plain timber frame. It might have a timber lintel and stone sill but the surround has been rendered over with concrete, so it is unclear. The stone of the main section of the Hall at this end is rendered over, with some throughstones protruding, and cast iron rainwater goods. There is a single modern vent to the south and two two-light fixed casement windows with timber frames to the south, the lower parts of which are covered by the later extensions as noted above and the surrounds are rendered over with concrete. The chimney stack is rough concrete-rendered with slate courses and throughstones exposed. To the south of the two extensions the Hall juts out over two storeys with cast iron guttering along the top (Plate 19). The grey slate roof is continuous across this section and the main Hall. At ground floor level there is a central 15-light top-opening hinged casement window with a plain timber frame, with a slate sill and a large, heavy timber lintel with a slate drip course above. There is a slight plinth along the base of this section of the elevation, which has quoins at the north and south ends where it projects from the main part of the building. At first floor level there is a single two-light hinged, side-opening modern window with a plain timber frame, which from the outside appears to be slightly south of centre. This window appears to have a concrete sill and lintel and the surround has been patched with concrete, so it may be a later insertion but this is more likely to be a result of rebuilding. The south end of the elevation is stepped back to the main section of the Hall and pebble-dashed (Plate 19 and Plate 20). The stonework is exposed around the door at the south end where there is a scar for the gable of a small porch. The north end of this section has a low-level, fixed, three-light, plain timber-framed window. The door to the south is modern plank and batten with a plain timber frame and thin slate lintel and slightly splayed jamb to the north side. To the north of this (above the stairs internally) is a large six-light fixed casement window, with a plain timber frame and a stone sill. At first floor level there are two-light top-opening hinged casement windows with plain timber surrounds and stone sills and there is a two-light fixed casement timber-framed window at a higher level to the north side. This end has cast iron guttering and downpipe and later plastic water pipes. The chimney stack at the south end is rendered over with a stone course exposed near the top (probably slate) and two pots. The allotment to the south side of the Hall is gated and raised relative to the south end of the west elevation (see Plate 17).

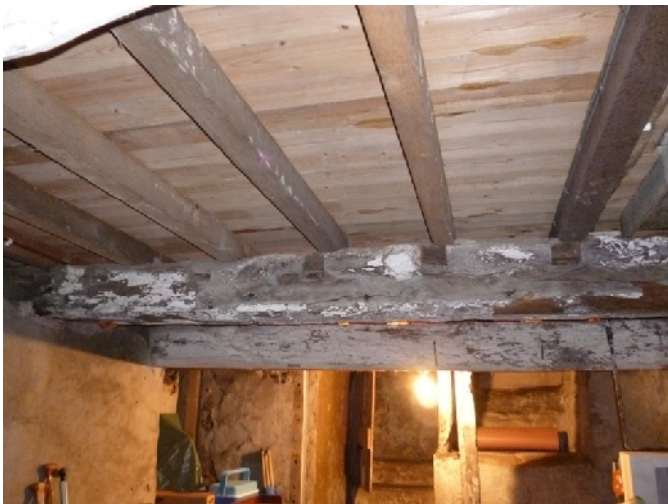
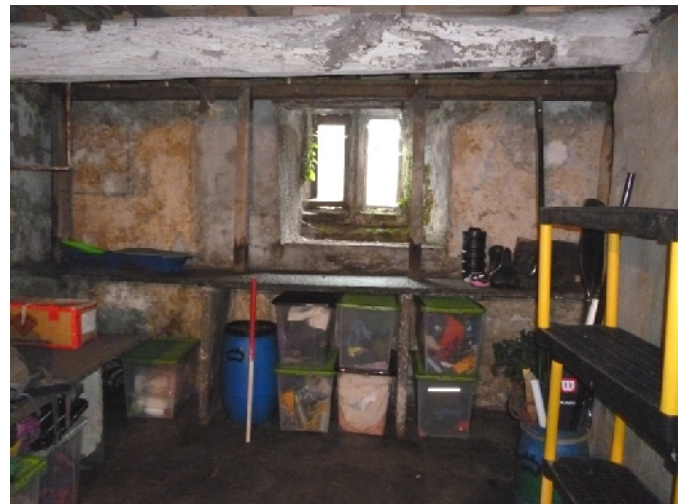
4.3.1 **Cellar:** the cellar has a stone flag floor and slate benches supported on flag uprights against all the walls. The ceiling comprises tongue and groove boards supported by two main north/south hand-finished beams, either side of the centre, with an additional one in the centre with slots for the original joists evident. There are iron meat hooks in the beam to the west of this (Plate 21). There is a further machine cut beam against the east elevation with three posts supporting it, which sit atop a slate bench (Plate 22). There is a further beam at the west end, which is machine-cut, with three posts immediately to the west of it supporting part of a timber framed wall of the floor above (Plate 23). The walls are finished with plaster and limewash. The north and south elevations project inwards in the centre and are recessed either side, with benches in the recesses on the west side of the room, and across the centre on the north side (Plate 24) and the east side, with an additional timber 'partition' of three rough planks and two upright posts between the benches on the west side. The east elevation has a stone mullion window, made from yellow sandstone, with angled stone mullion jambs and chamfered central mullion in splayed jambs with a timber lintel and there are two single-light timber casements crudely fitted; the one to the north is just a wire mesh (Plate 25). The west elevation has a staircase near the centre with a lower wall on the north side, forming a ledge, with a post sat on top supporting a beam. Both are very rough and 'VD 1957' is carved into the top of the beam (Plate 26). The elevation is stepped to the north of the doorway, perhaps indicating a staircase, with rough wall on top made from random bits of timber. The doorway to the south has a rough plank and batten door, with modern hinges and a plain surround. The stone steps continue into the L-shaped corridor to the west and north. The landing at the top of the stairs has a stud wall to the south (Plate 27) and a window to the west and an early plank and batten door with moulded panels to the north.

Plate 21 (left): Detail of the ceiling in the cellar

Plate 22 (right): East end of the cellar

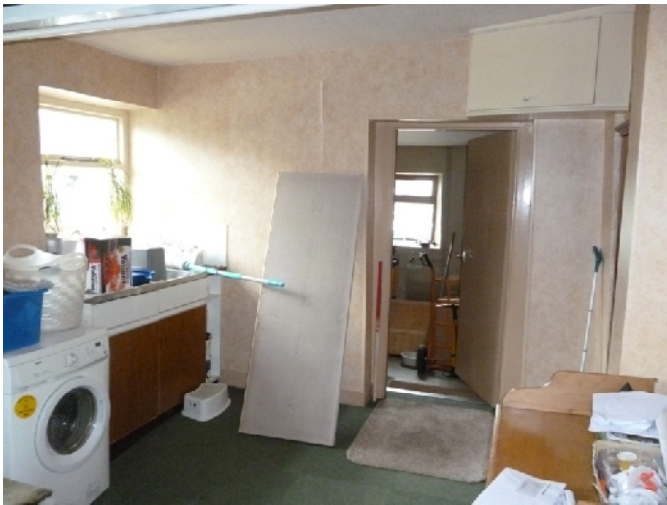
Plate 28 (left): North end of Ground Floor Room 2

4.3.3 Ground Floor Room 2: the utility room comprises the southernmost of the two extensions to the west side of the Hall. The ceiling and walls are wallpapered (Plate 28), with a central square cut east/west beam across the ceiling, actually the end of a half-truss as the end of the principal rafter is also visible (Plate 29). There is a small step up from the extension to the north (Ground Floor Room 1) and the floor is carpeted. There is plain timber skirting from the east side of the door around an alcove at the north end of the east elevation but elsewhere there is a low stone plinth at a similar height which is painted to match the skirting board. There is a sink in the north-west corner in front of the window, cupboards along the south elevation, and a fuse cupboard in the north-east corner above the door (Plate 29). The north elevation is plain apart from the door and splash tiles above the sink. The alcove at the north end of the east elevation narrows towards the south (the north jamb splays inwards to the back) and now houses a wardrobe. There is modern door with a plain wood frame and timber surround to the south end, where the wall is very thick. The south elevation is plain. The west elevation has two two-light windows with timber sills and splayed jambs.

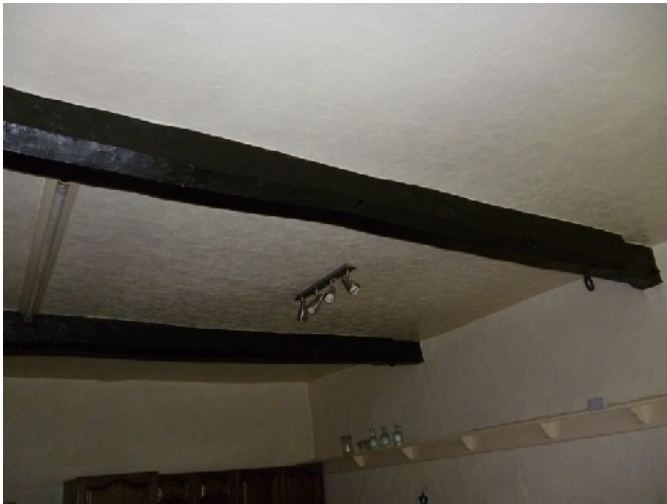
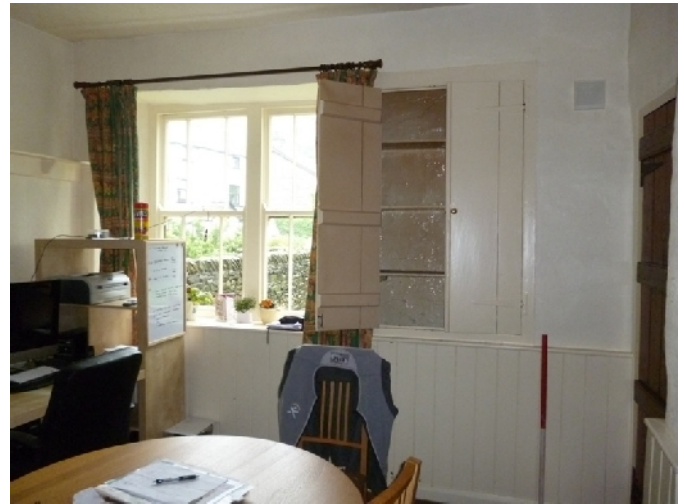
vertical timbers, which are no longer present (Plate 30), perhaps suggesting that these timbers are re-used. Kitchen units occupy the north-west corner. There is tongue and groove timber panelling along the north, west, and east elevation and around the east side of the fireplace on the south elevation and a timber skirting throughout. The west elevation is otherwise plain. The north elevation has a shelf on a low wall at door level and an alcove with a heavy timber lintel set in the wall above the sink. The east elevation has a large double window (two six-light sash casement) with timber frames and a timber sill at the north end (Plate 31). There is a shallow cupboard to the south with timber panel doors and early hinges. The south elevation steps back slightly at the east end above the plank and batten door, which has early latches and hinges. Central to the south elevation is a very large former fireplace below a very heavy timber lintel with tool marks and a chamfered edge (Plate 32) and hanging hooks on the inside to the east end. The fireplace now houses an oil-fuelled Aga.

Plate 30 (left): North/south beams in Ground Floor Room 4

Plate 31 (right): East elevation of Ground Floor Room 4

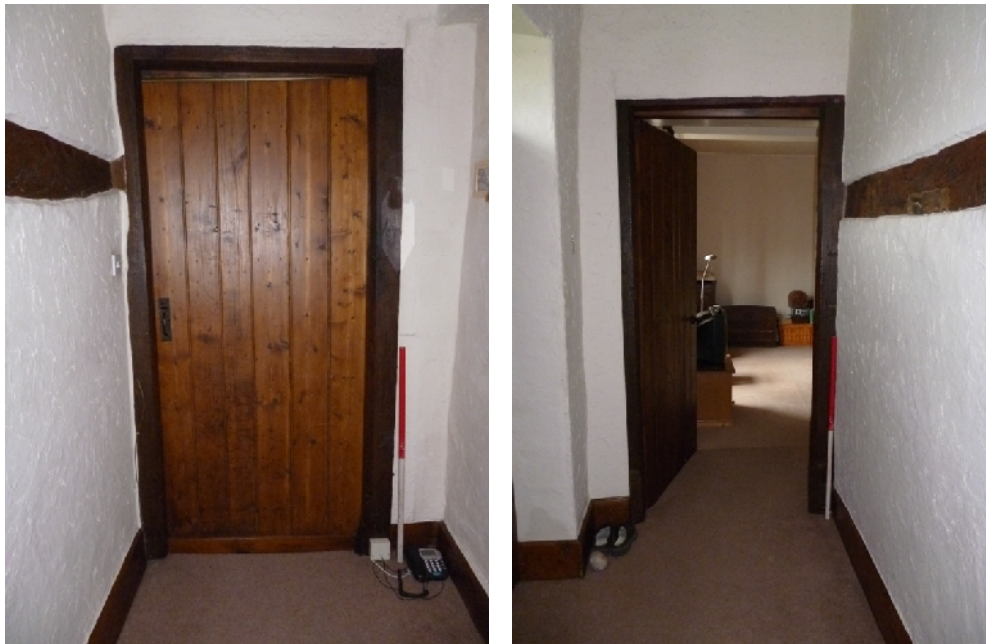
Plate 33 (left): North elevation of Ground Floor Room 5

4.3.6 **Ground Floor Room 5:** this room comprises a corridor to the east side of the Hall and is carpeted. The ceiling and walls are all plastered with a rough finish and painted, with plain timber skirting throughout. The north elevation has a tongue and groove plank and batten door with an old latch and a heavy stop-chamfered timber surround (Plate 33). The east elevation is stepped in slightly at the north end (on the north elevation also) and to the north side of the door. The door in the east elevation is south

of centre and is ornately finished with stop-chamfering with a single fixed light above. The wall returns slightly to the west to the south of the door. The south elevation has a similar door to the one to the north, with early hinges but a later latch. It has a stop-chamfered timber frame and there are pegs in the west jamb, which suggest it may be re-used (Plate 34). The west elevation has a north/south beam set at about head height into the wall, which is marked with notches and has an in-filled cut section (possibly an empty joist slot) near its centre.

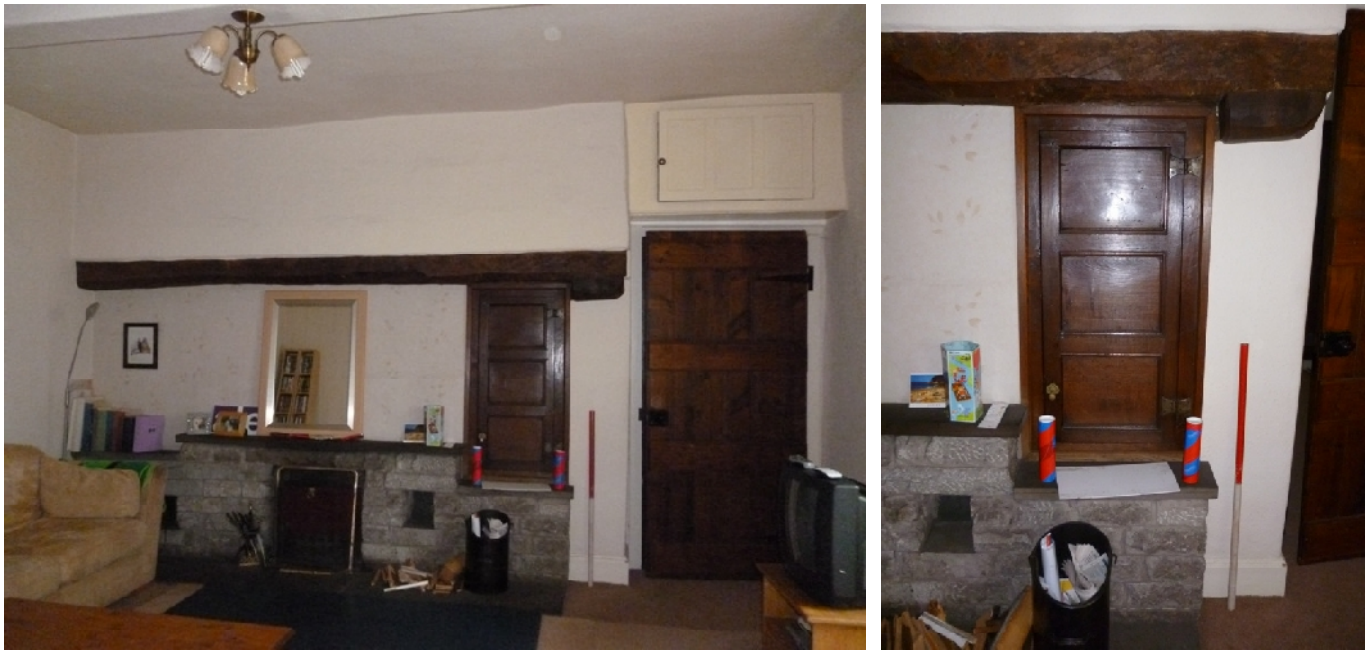
4.3.7 Ground Floor Room 6: this room is the lounge. The ceilings and walls are wallpapered, the floor is carpeted, and there is a moulded skirting throughout. There is an east/west chamfered beam across the centre of the room and another against the south elevation, both of which are covered by the wallpapering. The south-west corner is partitioned off to the stairs by thin partition walls. The door to corridor to the north (Ground Floor Room 5) is set back at the east side of the north elevation (Plate 35). A wooden shelf unit fills the space above the door, covering another east/west beam. The rest of the elevation forms the 'back' of the fireplace. The wall is stepped out above the large east/west beam in the fireplace and continues the remainder of the elevation to the west. The beam sits on top of the end of the north/south beam in the west elevation of the corridor (Ground Floor Room 5) which pokes through to the side of the door in the north elevation of the lounge (see Plate 36 and also Plate 34). To the west of this is a small cupboard with shelves with an early three-panel door and chamfered timber surround with old hinges (Plate 36). The lower part of the wall is set back slightly below the beam and there is a low slate-topped stone wall in front of it with a small fireplace and slate hearth with two small alcoves either side. The east elevation has a large central sliding sash window with splayed jambs and a large timber window seat but is otherwise plain (Plate 37). The south elevation is plain. There is a door at the south end of the west elevation through to the corridor with the stairs. The door is a tongue and groove plank and batten type with stop-chamfered surround. The north end of the elevation is plain.

Plate 35 (left): North elevation of Ground Floor Room 6

Plate 36 (right): Cupboard in the north elevation of Ground Floor Room 6

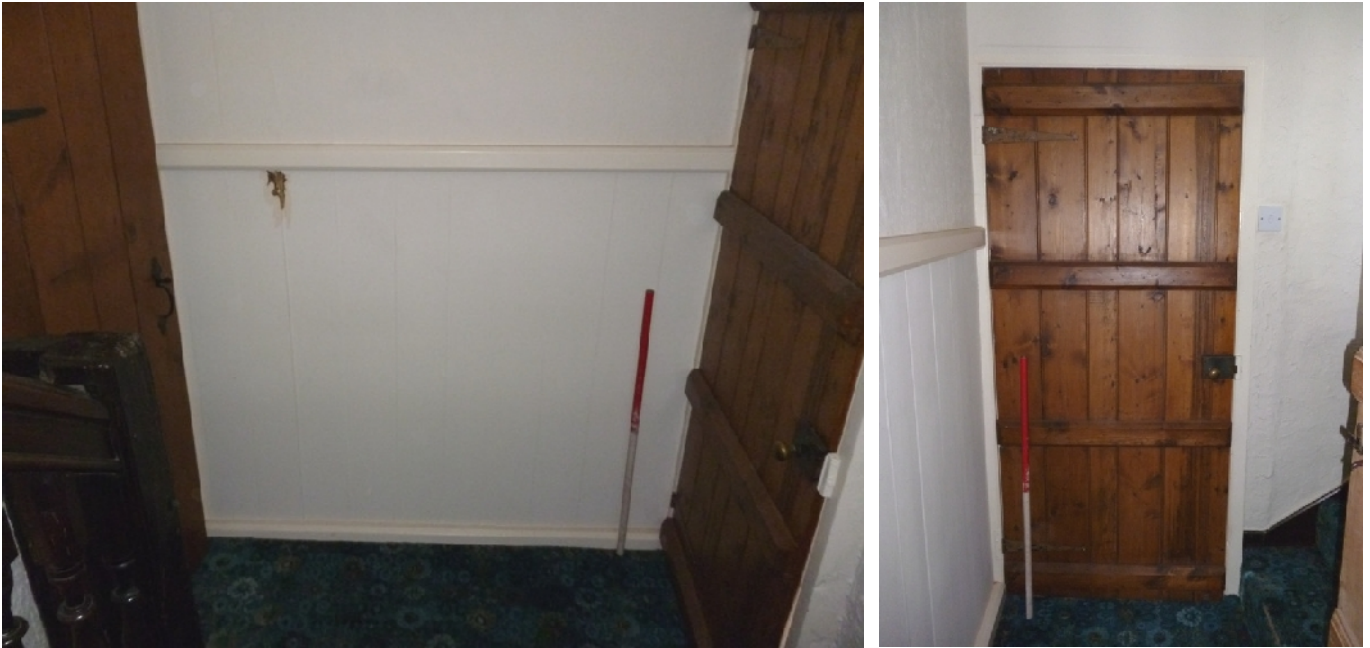
4.3.8 **Ground Floor Room 7:** this corridor forms the lower part of the stairwell between the ground floor and first floor. The north elevation forms a thin partition wall to the lounge (Ground Floor Room 6). The top half is plain and wallpapered whereas the lower part is timber panelling with a dado rail (Plate 38) and there is a thin chamfered beam along the top and west side of the wall. The east elevation is wallpapered above the door in the partition through to the lounge (Ground Floor Room 6) (Plate 39). The walls are roughly finished in plaster up the stairs and painted. An east/west beam cuts across the room above the east and west doors in line with the partition. The ceiling is wallpapered, covering the beam. The south elevation is open to the stairs, which are carpeted. There is a broad moulded handrail to the inside, with square newels and turned balusters (Plate 40; see also Plate 80). The doorway in the west elevation leads to the corridor along the west side of the Hall (Ground Floor Room 8) and has a plank and batten door with early latches and hinges and moulded timber surround (Plate 40).

Plate 38 (left): North elevation of Ground Floor Room 7

Plate 39 (right): East elevation of Ground Floor Room 7

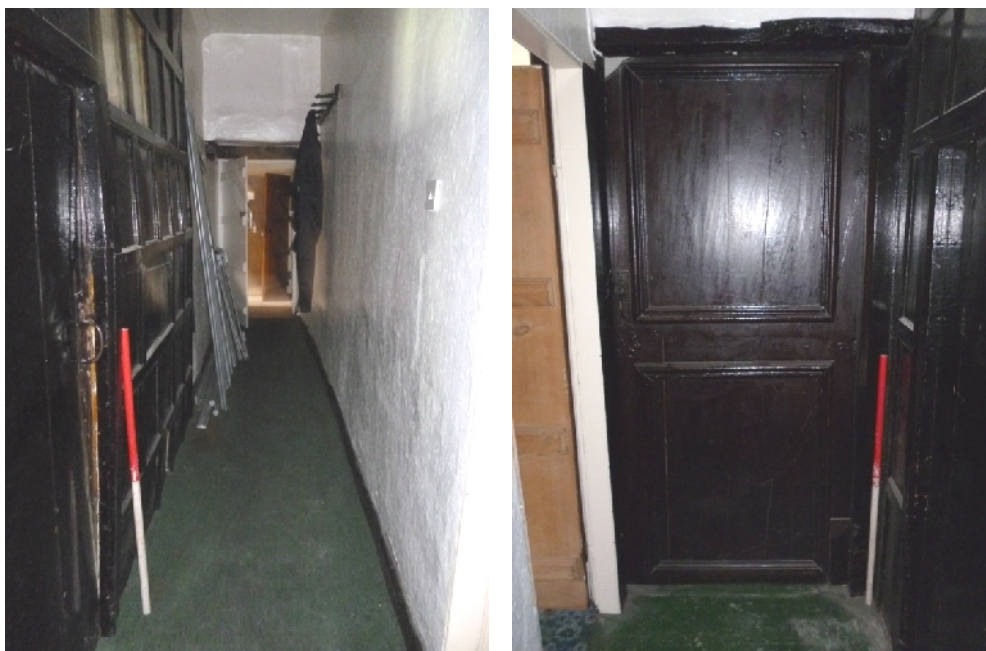
Plate 41 (left): General view of Ground Floor Room 8 from the south

4.3.9 **Ground Floor Room 8:** this is the long corridor at the west side of the Hall. The ceiling and walls are mostly wallpapered with a low concrete plinth or skirting throughout and the floor is carpeted. The doorway at the north end is formed by an exposed overhead beam, with a slight chamfer, which is inset from the door (Plate 41). To the south of this the corridor narrows slightly where another east/west beam with chamfered edges has been cut through, with the cut ends projecting slightly into the room. The east elevation is plain. A similar distance again to the south is another east/west beam. The door to the stairwell (Ground Floor Room 7) is at the far south end on the east elevation and the south elevation comprises the door to the cellar. The door to the cellar is an early plank and batten door, with moulded strips attached forming two panels, with a stop-chamfered surround (Plate 42). From the south beam to the south end of the corridor, the west elevation comprises a severely bowed wood panel wall (Plate 43),

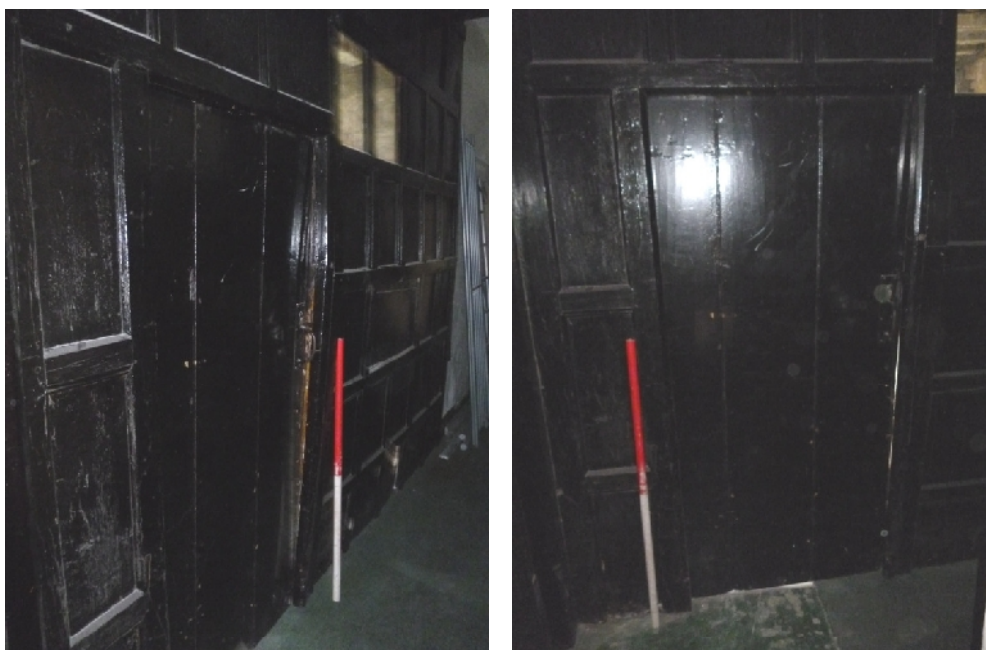
Plate 43 (left): The panel wall in Ground Floor Room 8

with two centre lights and a low plank and batten door with old latched and hinges to the south side (Plate 44).

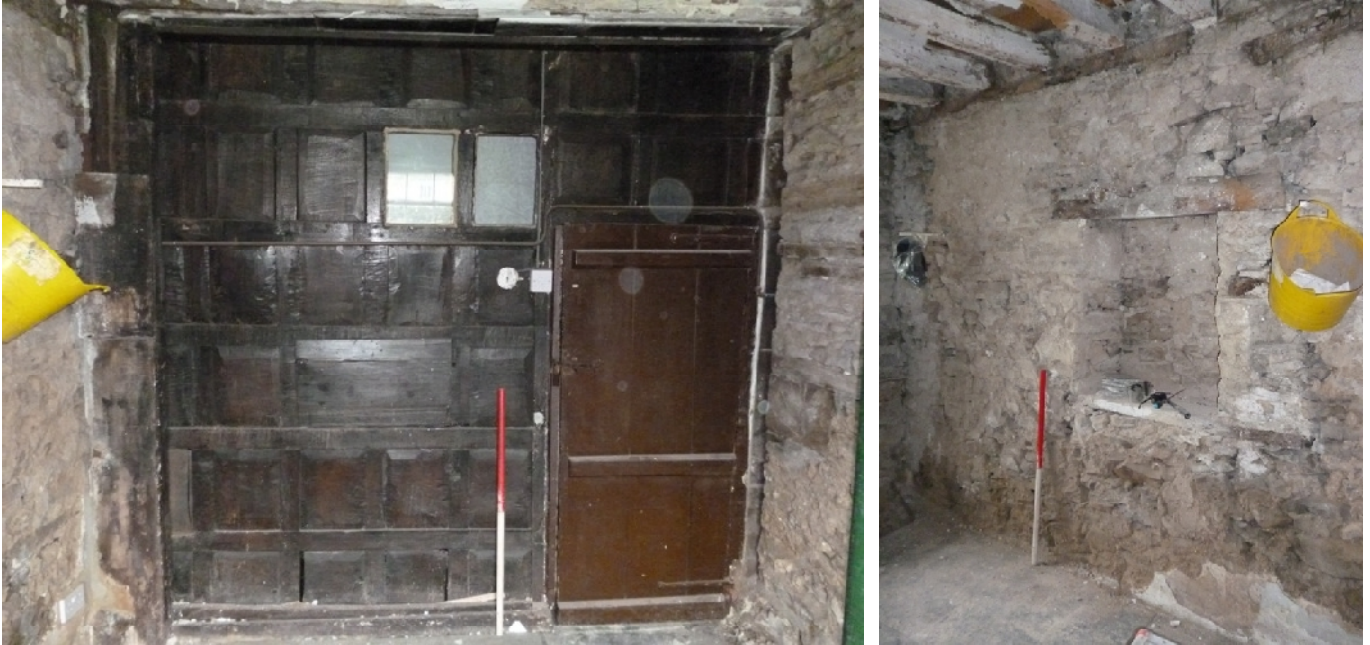
Plate 45 (left): East elevation of Ground Floor Room 9

4.3.10 **Ground Floor Room 9:** this room is on the west side of the Hall at the south end of the corridor (Ground Floor Room 8) and has been stripped leaving the north/south joists in the ceiling exposed through to the board floor above and the stonework exposed in the north, south, and west elevations. The room has wood panelling along the east elevation (Plate 45) and there is a heavy timber beam set vertically in the north-east corner and modern supports to the south side of the room. The north elevation has a central alcove with a timber lintel and sill and three further pieces of timber built into the wall, some of which are clearly plates for the joists above (Plate 46). The south elevation is relatively plain with

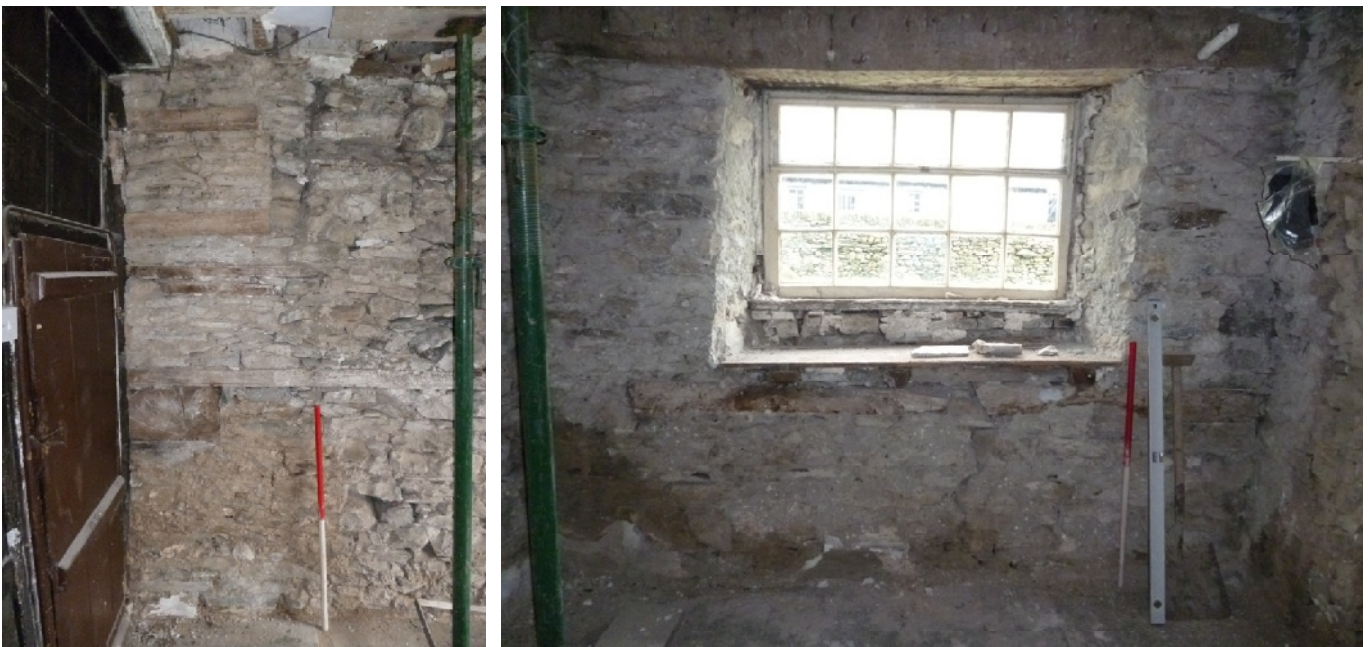
Plate 47 (left): The south-east corner of Ground Floor Room 9

some timbers set east/west into the wall; the main part of the wall apparently butts the east end, although not all the way to the floor, and there is a large piece of timber built into the wall at this point (Plate 47). The west elevation has a central 15-light window below a heavy timber lintel which is covered in notches and has four pegs protruding from it (Plate 48). The window has splayed jambs and a timber sill above three timber 'supports'; the window frame is set on top of further stonework, which is above the timber sill.

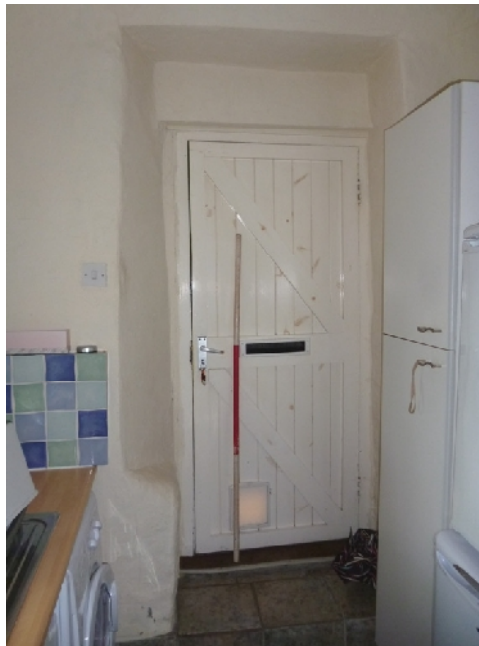
Plate 49: Doorway in the west elevation of Ground Floor Room 11

4.3.12 Ground Floor Room 11: this room is the only entrance to the separate accommodation at the south end of the Hall and is currently used as a kitchen and utility room. The walls and ceiling are woodchip wallpapered and painted. The lower section has kitchen units and three rows of tiles above. The floor is tiled. The north elevation is plain with no obvious features present. The east elevation houses a modern door with a plain surround to the lounge (Ground Floor Room 12). The south elevation has a central two-light top-hinged timber-framed window with a timber lintel. The west elevation has a plank and batten door with diagonally set battens with a cat flap and letterbox (Plate 49). The room is accessed by a step down from outside. The jamb is splayed on the south side, the lower section of which is right-angled, suggesting it was formerly a window. The aperture for the door is markedly high, matching the height of the windows in the lounge (Ground Floor Room 12).

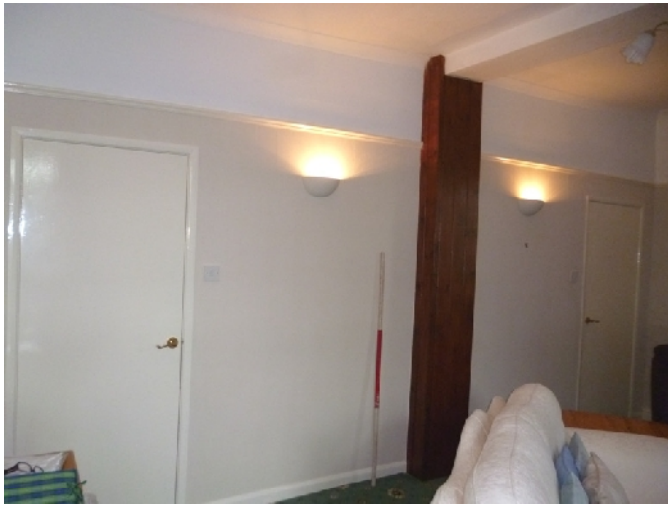
Plate 50 (left): North elevation of Ground Floor Room 12

4.3.13 Ground Floor Room 12: this is the living room in the separate accommodation. The floor is carpeted and there is woodchip wallpaper on the ceiling and north/south beam. The beam is very wide and it is either boxed in or modern. The walls are finished with textured wallpaper and painted over. There is a modern timber picture rail and modern cavetto-moulded cornice/coving throughout and plain skirting. The north elevation is a modern stud wall with modern doors with plain surrounds at the east and west ends (Plate 50). Modern tongue and groove boxing projects in the centre, which is either housing pipes or a column supporting the crossbeam. The east elevation has a six-light sash casement window on the south side, with splayed jambs and a timber sill (Plate 51). The picture rail continues into the jambs. There is a blocked window evident to the north of this which corresponds to a blocking externally. The chimneybreast is central to the south elevation, with a modern gas fire and stone surround (Plate 52). There is an alcove to the east of the fireplace and a window to the west. The window is a six-light sash casement with a timber sill (Plate 53). The west elevation is a stud wall to the south, with a modern door, and an earlier build to the north.

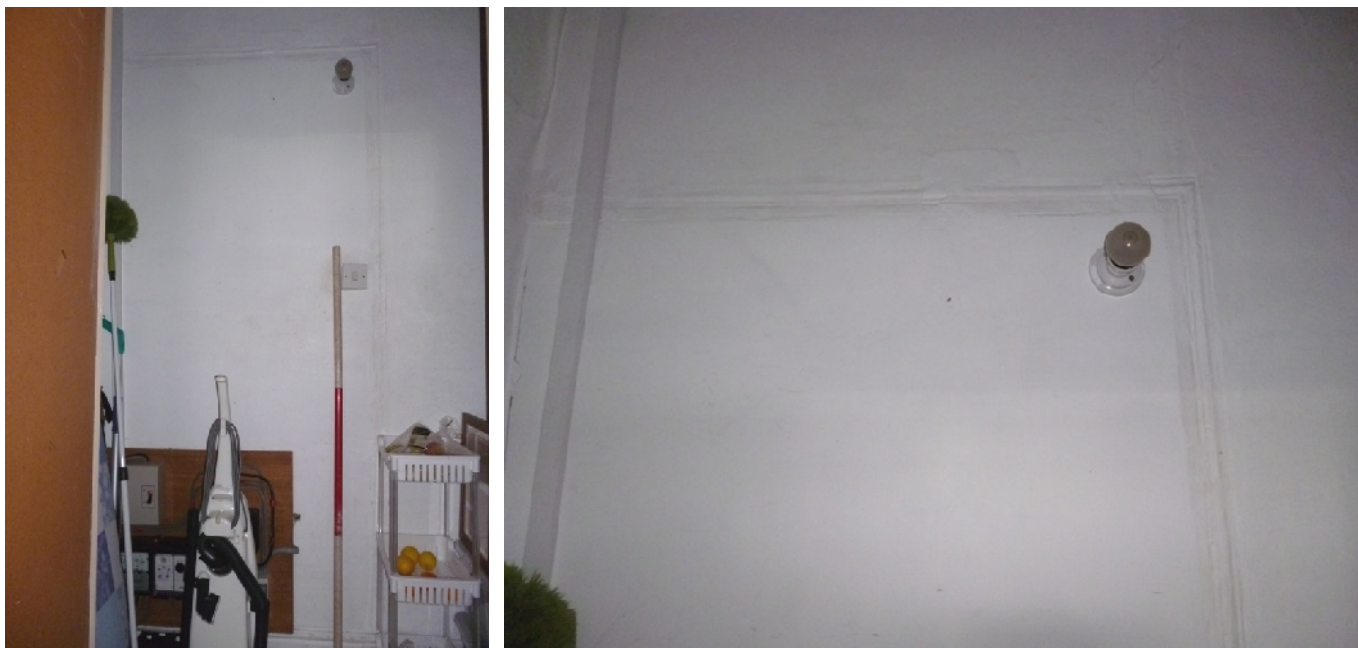
Plate 54 (left): North elevation of Ground Floor Room 13

4.3.14 **Ground Floor Room 13:** the cupboard below the stairs has tongue and groove floorboards. The stairs to the east side of the room are modern and there is textured wallpaper over the rest of the room to the north, south and west. The north and west elevations are part of an earlier build, but the south elevation is a later partition with a plain modern door. The north wall has a blocked doorway with remnants of a plaster moulded surround (Plate 54 and Plate 55).

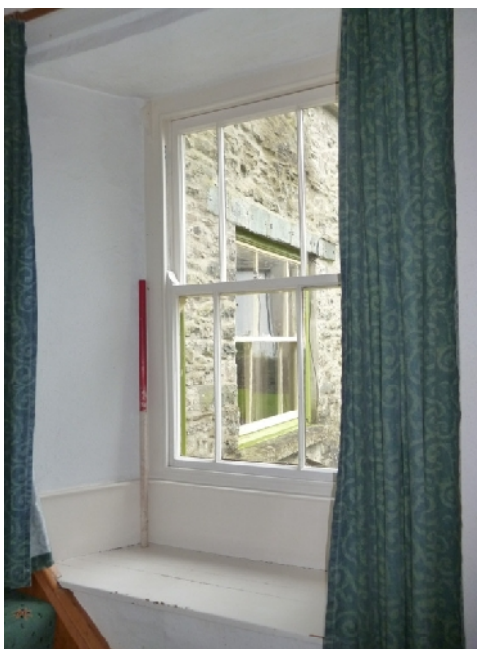
Plate 56: Window in the north elevation of Ground Floor Room 14

4.3.15 **Ground Floor Room 14:** the stairs lead up to the first floor to the west and are finished with carpet. The lathe and plaster ceiling is finished with paint and the walls are finished with woodchip wallpaper. The north elevation has a six-light sash casement window with splayed jambs and a timber seat with panelled sides (Plate 56). The east elevation is plain apart from the traces of a blocked window, which continues into Ground Floor Room 12 to the south. The south elevation is a modern stud wall with a modern door to the east and the handrail for the stairs.

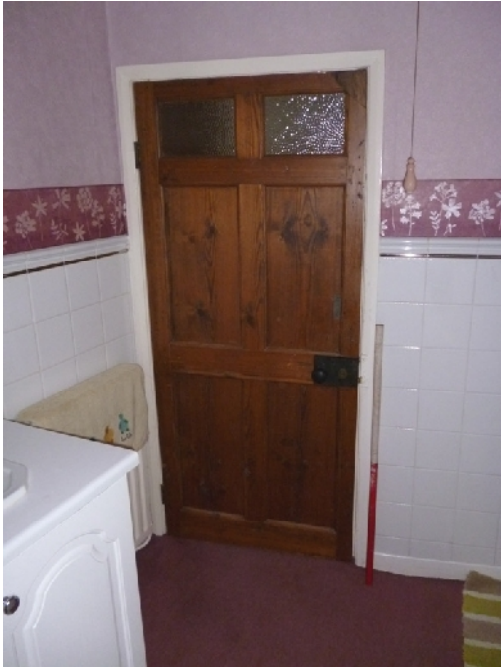
Plate 57 (left): The south-east corner of First Floor Room 1

4.3.16 **First Floor Room 1:** the bathroom on the first floor has tiles along the lower section and is wallpapered above and over the ceiling (Plate 57). There is an east/west beam across the room, which is chamfered on both sides and covered over (Plate 58). The bath and toilet are to the west side of the room; the sink is to the east. There is a small two-light window, with slightly splayed jambs and a plain timber frame, above the bath at the north end of the west elevation. To the east side of the south elevation there is a six-panel door leading to the corridor with fixed lights replacing the upper two panels (First Floor Room 3).
