NATLAND HALL, NATLAND, KENDAL, CUMBRIA

Archaeological Building Recording

Client: Dale Rennard

September 2012

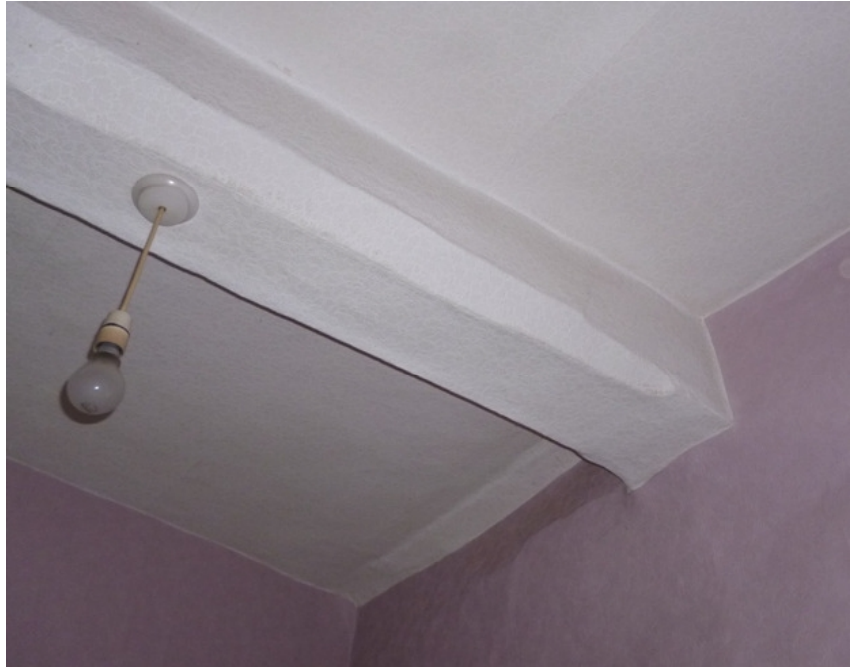
Plate 58 (right): West end of the beam in First Floor Room 1

4.3.16 **First Floor Room 1:** the bathroom on the first floor has tiles along the lower section and is wallpapered above and over the ceiling (Plate 57). There is an east/west beam across the room, which is chamfered on both sides and covered over (Plate 58). The bath and toilet are to the west side of the room; the sink is to the east. There is a small two-light window, with slightly splayed jambs and a plain timber frame, above the bath at the north end of the west elevation. To the east side of the south elevation there is a six-panel door leading to the corridor with fixed lights replacing the upper two panels (First Floor Room 3).

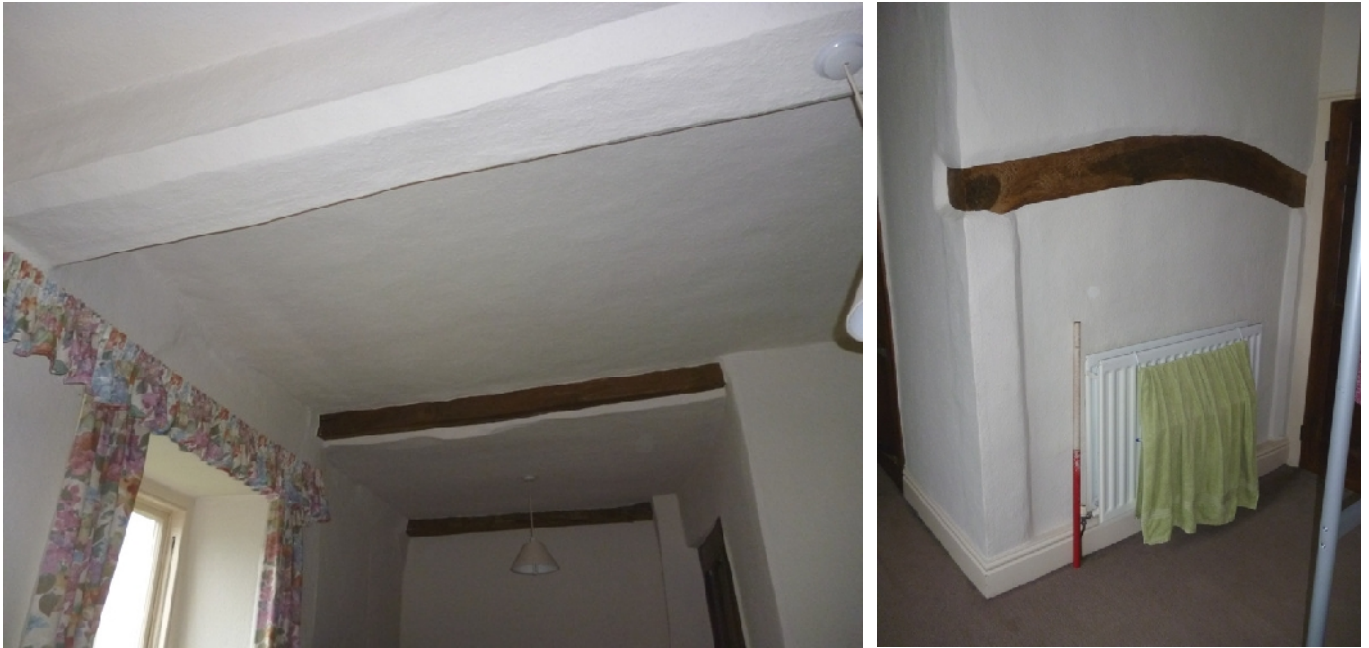
Plate 59 (left): Beams in First Floor Room 2

4.3.17 **First Floor Room 2:** this is the bedroom at the north end of the corridor on the east side of the Hall. The room is stepped in the in the south-west corner, woodchip wallpapered from floor to ceiling and all over the ceiling, and carpeted and has moulded skirting throughout. Three east/west beams visible in the ceiling: one across the middle of the north end of the room, one partially visible where the room steps in, and another along the top of the south elevation (Plate 59). The one to the north is chamfered and the two to the south are square cut and are comparatively thinner. The main feature is the blocked fireplace in the south elevation (Plate 60). The south elevation is recessed at the east end and plain until stepping out to the north. The west end has a large curved timber lintel set into the wall above a slightly recessed blocked fireplace. The north elevation is plain. The east elevation has two six-light sliding sash windows with timber frames (Plate 61). The one to the south has a window seat, which is probably a later alteration. The south end of the east elevation is slightly recessed into the wall between the beams and continuing into the bedroom to the south (First Floor Room 4). The south end of the west elevation is stepped into the room (around the fireplace) and the east elevation of the stepped in area has three cupboards set into it at the south end (Plate 62), with two two-panel doors (Plate 63) and one four-panel door above (Plate 64) and old hinges (which have replaced earlier ones on the bottom cupboard door). The back, which is common to all the shelves in the cupboards, is sloping, causing the lowest cupboard to be very shallow from front to back (Plate 65). The beam above the blocked fireplace is visible to the north. The remainder of the west elevation of the room is set back to the west, housing the old six-panel door with timber frame through to the corridor (First Floor Room 3) (Plate 66).

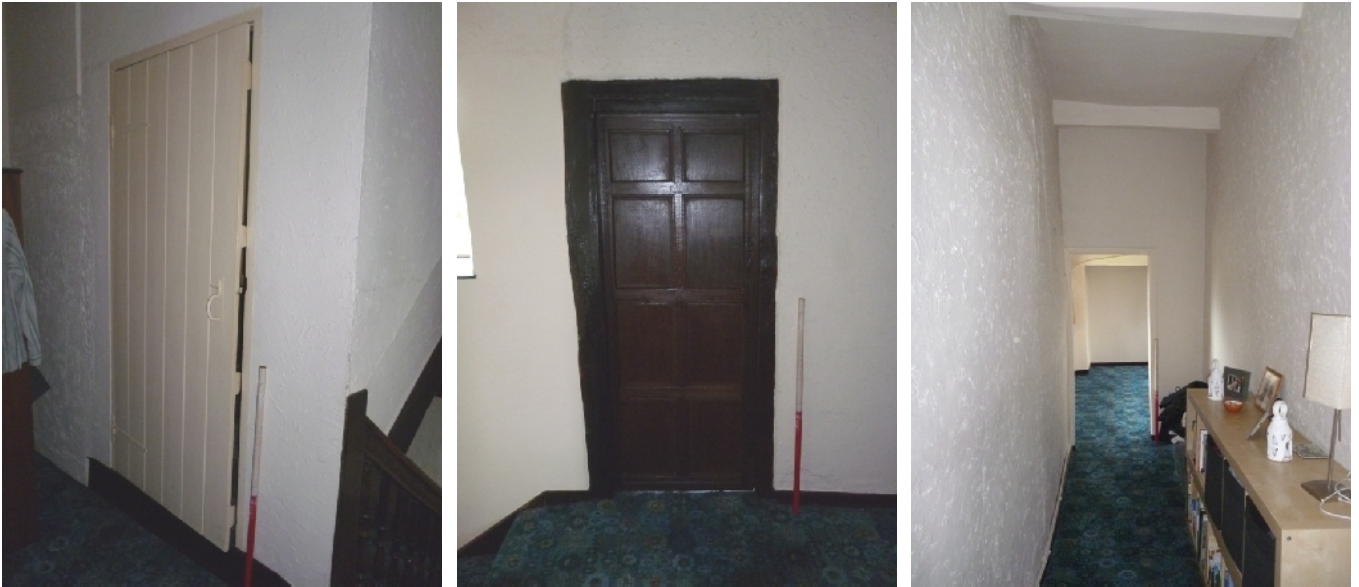
Plate 67 (left): Doorway to the attic at the south end of First Floor Room 3

4.3.18 **First Floor Room 3:** this room forms a large L-shaped corridor along the west side of the Hall and is open to the stairs to the ground floor on the west side at the south end (First Floor Room 6). The walls of the corridor are all plastered with a rough finish and painted with a low plain timber skirting. The east side of the south elevation has a plank and batten door to the attic with a plain surround and early latch and hinges (Plate 67). There is possibly a beam above this, covered by wallpaper and the ceiling is painted north of this. Features in the stairwell to the south of this beam are described separately (First Floor Room 6). There is a door north of this beam to the west bedroom (First Floor Room 5). The frame is plain but possibly original with an eight-panelled door with moulded panels (Plate 68). There is a large chamfered east/west beam to the north of this and another smaller beam north of that before the thin diagonally set partition wall (Plate 69). The partition has a plain timber door frame but no door and is otherwise plain. Beyond the first partition there are two two-light fixed casement windows with splayed jambs and timber sills and original timber lintels (Plate 70). There is a possibly a large east/west beam above, between the two windows. The north elevation is plain, forming a thin partition to the bathroom (First Floor Room 1) at the far north end of the corridor. The door to the east side has four moulded

panels with two fixed lights inserted above and a plain surround. The door to the bedroom at the south end of the corridor (First Floor Room 4) is a six-panel moulded door with a moulded surround (Plate 71). The side of the bedroom is plain to the east of this. The door to the bedroom at the north end of the east elevation (to First Floor Room 2) is the same as the one to the bathroom (First Floor Room 1) but has two small panels above the other four (where the other has windows inserted). It too has a fairly plain surround. To the south of this door is another diagonally set wall which returns part of the way across the room forming the L-shape of the corridor and immediately south of this are set three cupboards, with shelves and early hinges. The bottom two cupboards have early tongue and groove plank and batten doors and are side opening (Plate 72). The remainder of the east elevation is plain apart from a small window through to First Floor Room 4.

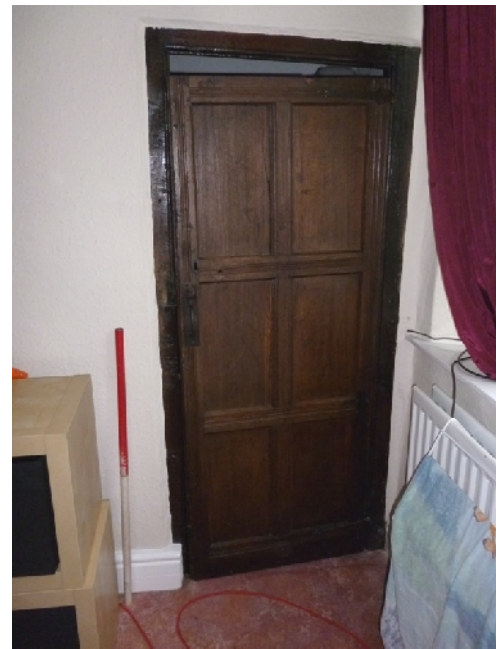
Plate 74 (right): Doorway at the east end of the north elevation of First Floor Room 4

moulded skirting board. The east/west beam is covered by papering. The north elevation kinks to the west end and shows signs of blocking near the centre, presumably relating to the fireplace (Plate 73). There is an early six-panel door at the east end of the elevation through to a small room and cupboard with moulded panels, an old latch and hinges and original carved surround (Plate 74). The east elevation has two large six-light sash windows with timber sills (Plate 75). Neither has been modified to form a window seat, unlike in First Floor Room 2. There is a beam against the south side of the room where it recedes at the east end. The south-west corner of the room is partitioned to the corridor (First Floor Room 3) by thin walls. The door to the west side has six-moulded panels with a rough timber frame. The north end of the west elevation has a single high-level fixed window to the south side of the beam but is otherwise plain. The small square room to the north side of the room has an east/west beam along the north side recesses on the east and west sides. The timber shelf against the south elevation does not rest on the timber bracket below, which looks early, but continues into the wall to the west. The cupboard to the north end of the west elevation has an old moulded three-panel door with early hinges but the upper part is boarded shut with hardboard (Plate 76). The initials 'WB' are crudely scratched into the timber below (Plate 77).

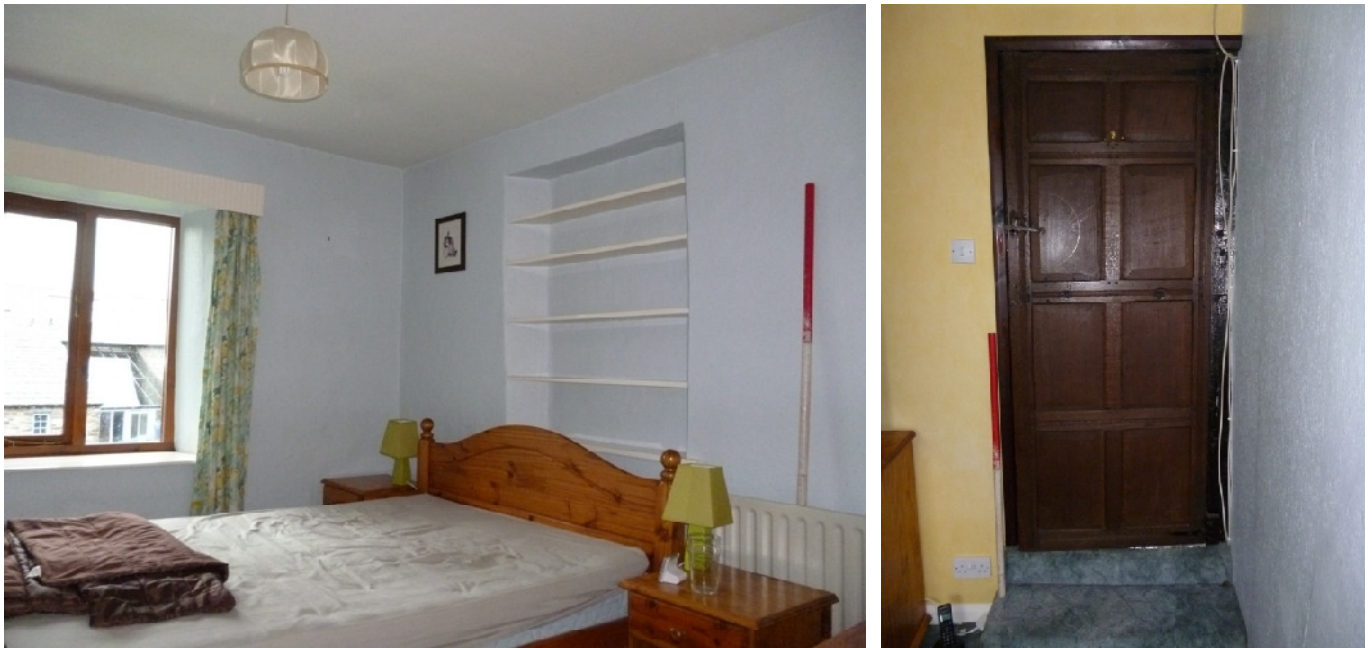
Plate 78 (left): North and west elevations of First Floor Room 5

4.3.20 **First Floor Room 5:** the walls of the bedroom to the west side of the house are wallpapered and plain, with plain wood skirting throughout. The ceiling is plastered and painted. The north elevation is plain with shelves set into an alcove with splayed jambs in the centre (Plate 78). The east elevation is plain with two steps up to the eight-panel door at the south end. The door has moulded panels and a chamfered timber frame (Plate 79). The south elevation is plain but slightly curved along its length. The west elevation has a fairly central two-light side-opening hinged-casement timber-framed window, with a timber sill (Plate 78).

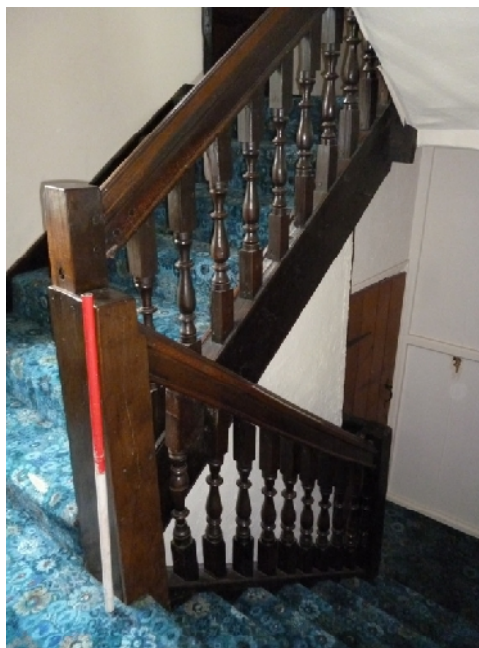
Plate 80: Stairs from First Floor Room 6 to Ground Floor Room 7

4.3.21 **First Floor Room 6:** the stairwell at the south end of the main section of the Hall is effectively a continuation of Ground Floor Room 7 and is open to First Floor Room 3 at the top (Plate 80). The ceiling is wallpapered and the stairs are carpeted. The broad handrail continues along the inside of the stairs, which has square newels and turned balusters. The west elevation has a large window above the stairs in the stairwell and a smaller higher level two-light window above the stairs, with splayed jambs and a wooden sill, to the north of that. The larger window in the stairwell above the small landing on the stairs has a six-light fixed casement window with splayed jambs and a timber frame and a sill made from wide timber panels.

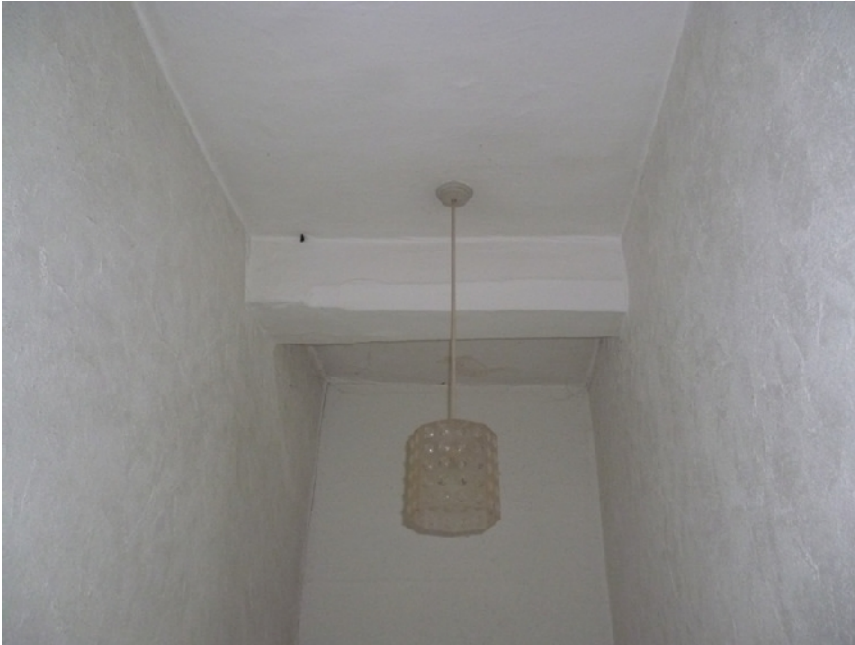
Plate 81 (left): Stop chamfered beam in First Floor Room 7

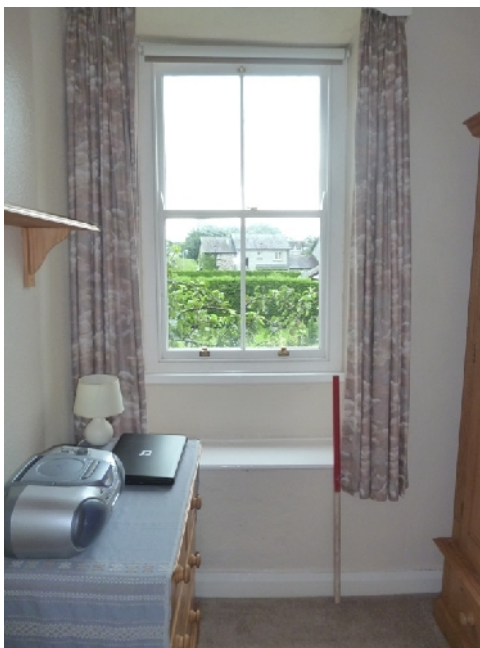
Plate 83: Window in the south elevation of First Floor Room 9

4.3.24 **First Floor Room 9:** the vestibule between the bedroom to the east (First Floor Room 10) and the bathroom to the west (First Floor Room 8) has carpet over the floor and the ceiling is finished with flock wallpaper and has a single north/south beam across it. The beam might be boxed in as it appears very square. The walls are finished with flock wallpaper and paint and have plain skirting. There is a slight step in the centre of the stud walls in the north elevation. The doorway on the east side has a three-panel door, like the room to the east (First Floor Room 10), with a plain surround. The top panel is fixed with plywood and possibly glazed. The east elevation is plain. There is a modern four-light sash casement window with splayed jambs and timber window seat on the east side of the south elevation (Plate 83). The west elevation is plain and has a very modern door with a plain surround on the north side.

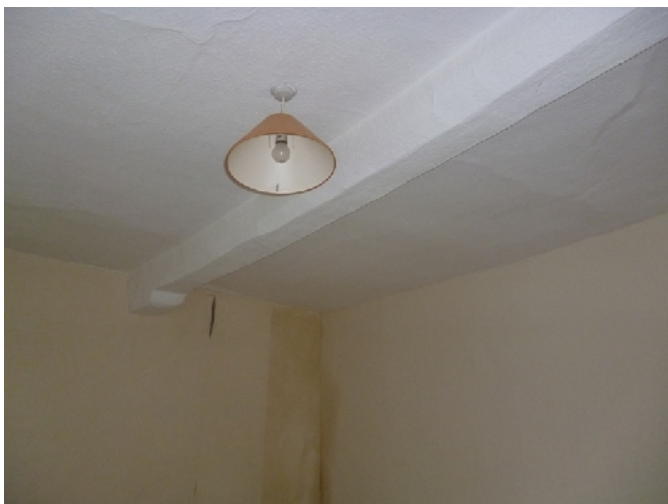
Plate 84 (left): South end of the beam in First Floor Room 10

4.3.25 **First Floor Room 10:** this carpeted room is on the first floor to the east of the Hall in the separate cottage accommodation. There is a single north/south beam across the lathe and plaster ceiling. The ceiling is finished with woodchip wallpaper. The beam has a thickened corbel at the south end and it is chamfered, carrying through into the stairs to the north (Room F7) (Plate 84). The walls are finished with woodchip wallpaper and a plain angled skirting. The north elevation returns on the east side with a modern stud wall around the staircase (Room F7). The east elevation has two large windows with splayed jambs and six-light sash casements, timber south-west (Plate 85). The north window has a section below which now forms shelving but it was perhaps originally a window seat. The south elevation is relatively plain with a grill vent in position of a former fireplace. The west elevation is a stud wall. The doorway on the north side houses a possibly early 20th century four-panel door, with ovolo-moulding and plain surround (Plate 86).
