14 MILL BROW, KIRKBY LONSDALE, CUMBRIA

Heritage Statement

Client: John Gordon
Associates Ltd

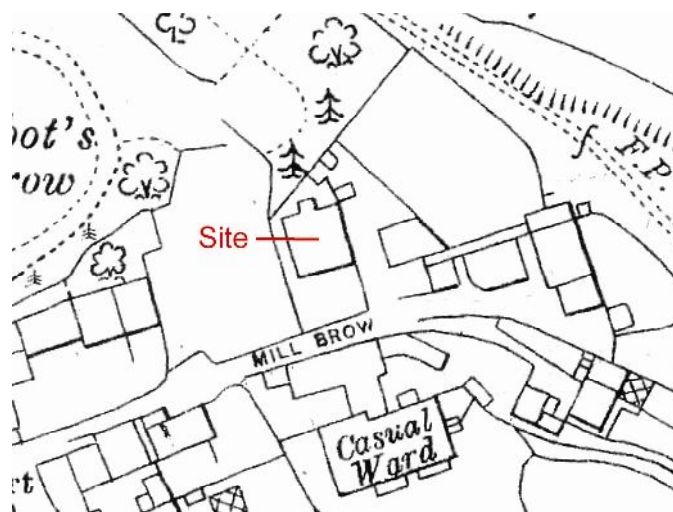
Plate 5: Extract from the Ordnance Survey map of 1914

3.3.6 **Ordnance Survey, 1914:** this is essentially identical to the previous two maps (Plate 5).

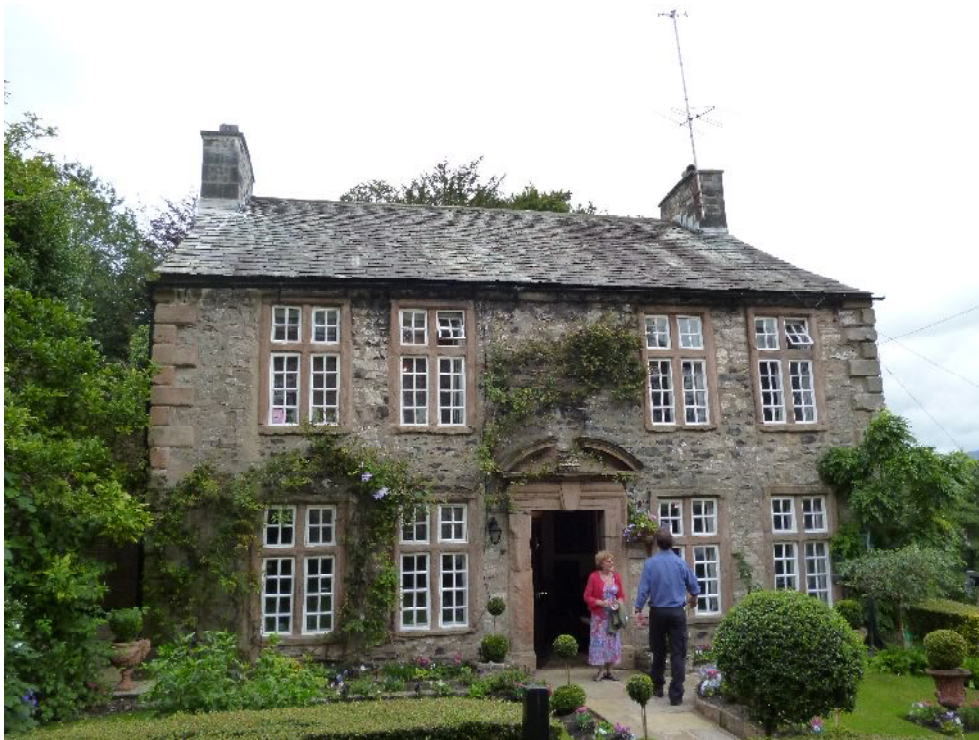
3.4.1 Externally the entire building is shown to be constructed from rough, largely limestone, rubble, with relatively modern concrete pointing, with windows comprising large mullion or mullion and transome type, in neatly dressed yellow gritstone (although augmented with applied concrete on the front elevation, presumably where the stone has eroded). Within these windows are timber casements, to the front these are of four and eight lights, the top four opening on a central hinge. To the rear they are more irregular, typically single-light hinged casements. Both the front and rear elevations incorporate re-used pieces of an antique stained glass, including fragments said to be from Kendal parish church and Furness Abbey, via the workshops of Shringley and Hunt of Lancaster (Mrs Leech pers comm.). The front elevation is broadly symmetrical in arrangement with paired windows on both floors either side of a central doorway with a moulded lugged surround incorporating a key stone and topped by a broken semi-circular pediment ornamented with a crown finial, above which is a slight alcove in the wall above (Plate 6). The south-west and south-east corners are finished with dressed v-jointed quoins, the roof is finished with local grey slate and there is a chimney stack at either end constructed from ashlar blocks of yellow gritstone.

Plate 6: General view of the front (south) external elevation

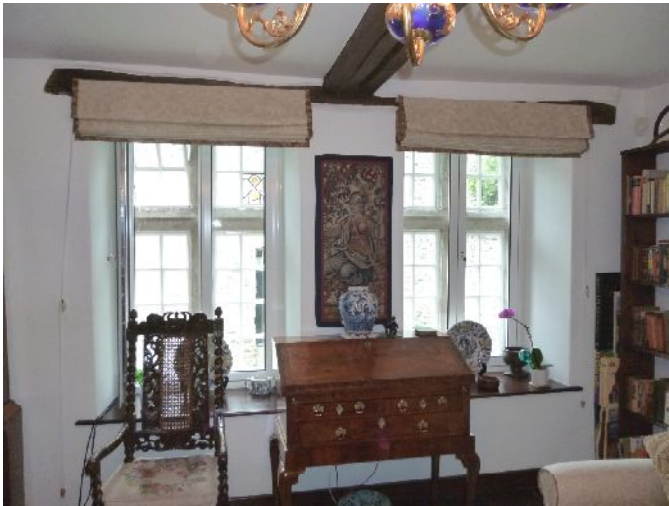
3.4.3 Of particular interest are the windows. Those to the front (south) and one to the east now have two-light UPVC casement hinged opening secondary glazing, attached to the wall within the window reveals (Plate 7 to Plate 9). Those to the rear (north) have single-light panes attached directly to the stone of the mullions and transoms within each opening sealed with rubber seals, liquid sealant, and cement (Plate 10 and Plate 11).

Plate 7 (left): Typical two-light secondary glazing in the southern windows, first floor

4.5.1 The proposed alterations, some of which have already been carried out, are likely to have an essentially neutral or even potentially beneficial impact on the historic fabric of the building. The secondary glazing to the south, although not a good historic match to the building being UPVC, is attached to the wall rather than the more fragile stonework of the windows themselves. It also cannot be seen externally as the division between the two lights is hidden by the central stone mullion and so, in general, is considered to have a neutral impact. As this secondary glazing can also be opened (unlike that to the north, see *Section 4.5.2* below) this enables the space between the secondary glazing and the window proper to be ventilated.

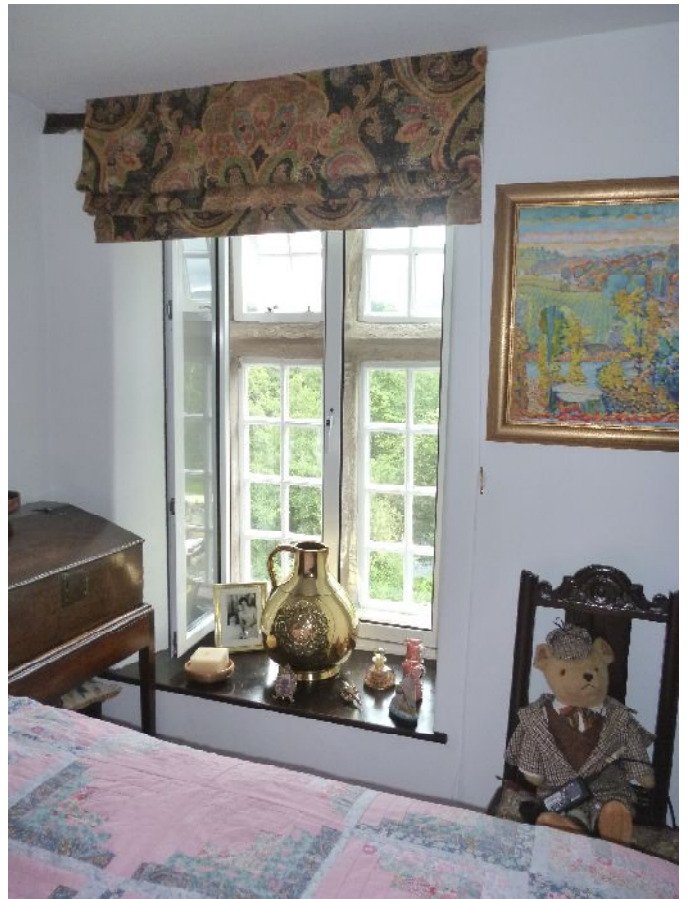
Plate 8 (right): Two-light secondary glazing in the east window, first floor

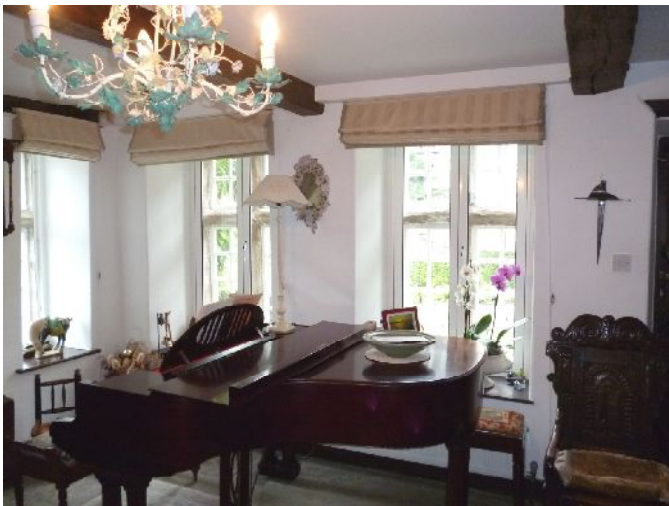
Plate 9 (left): Typical secondary glazing in the southern windows, ground floor

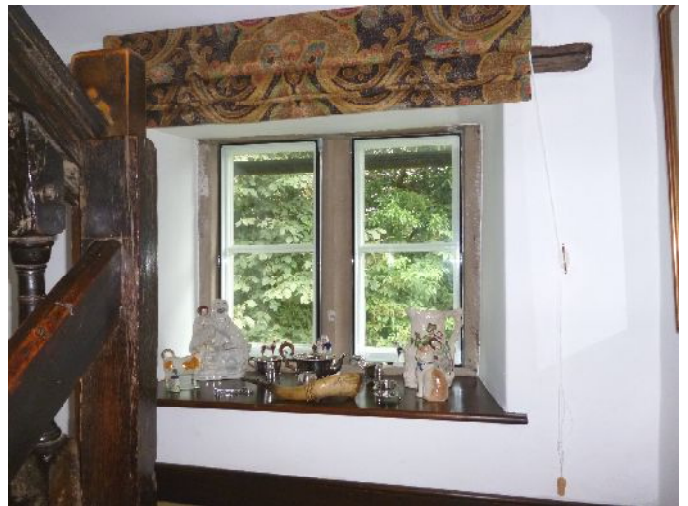
Plate 10 (right): Single-light secondary glazing in the north window looking into the stairs

4.5.2 The secondary glazing to the north, although only attached with sealant and concrete, is likely in the long-term to have a negative effect on the historic fabric of the building, both because of the immediate effect on the stonework but also the more lasting affect of trapped moisture in the space

between the external glass and the internal secondary glazing. Its removal will ultimately be a positive improvement to the building in removing this problem.

4.6.1 Removing the secondary glazing from the windows to the north is highly recommended in order to prevent later damage to the stonework, timber, or both. The proposal to use only the shutters (although those currently in place are in themselves not a particularly good historical match, but they are relatively unobtrusive when open) in lieu of secondary glazing is also to be recommended.

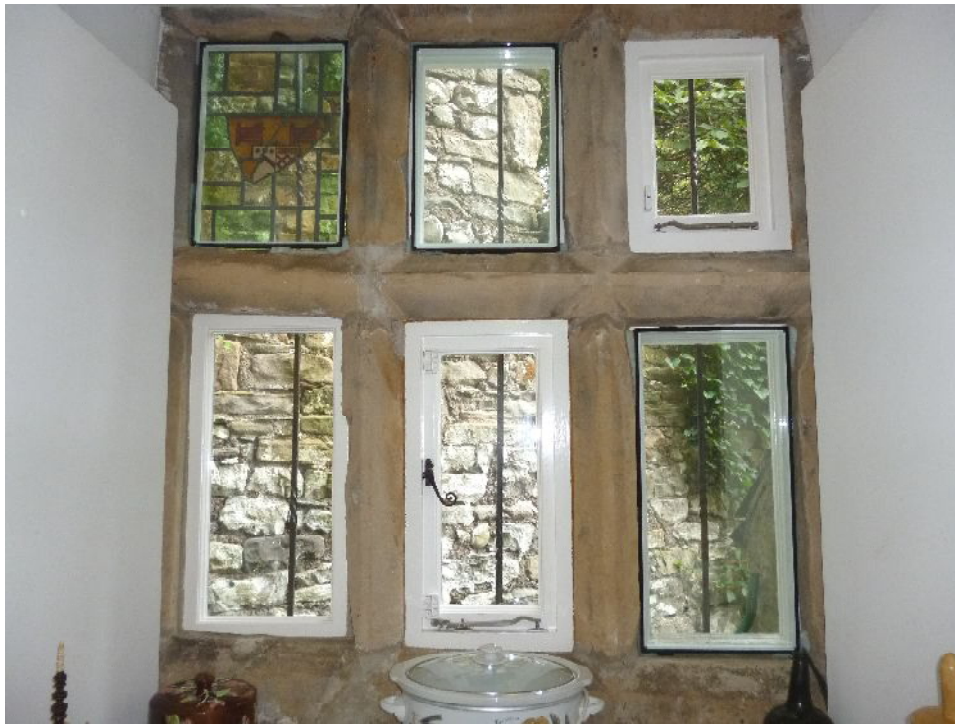
Plate 11: Multiple single-light glazing in the north elevation
