OLD FREEZER CENTRE, STOCKBRIDGE LANE, ULVERSTON, CUMBRIA

Archaeological Building Recording

June 2013

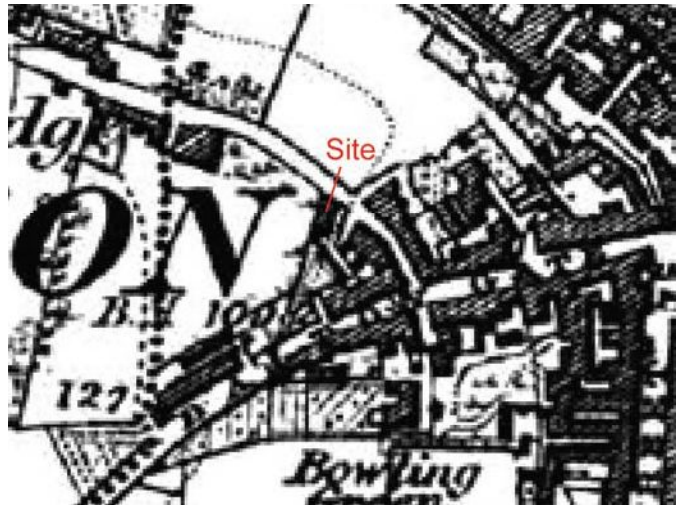
Plate 2 (right): Extract from the Ordnance Survey map of 1850

3.1.2 **Ordnance Survey (1850):** this is the earliest Ordnance Survey map available, although its scale means that it shows a similar level of detail to the previous plan (Plate 2). It shows the footprint as essentially unchanged at this time.

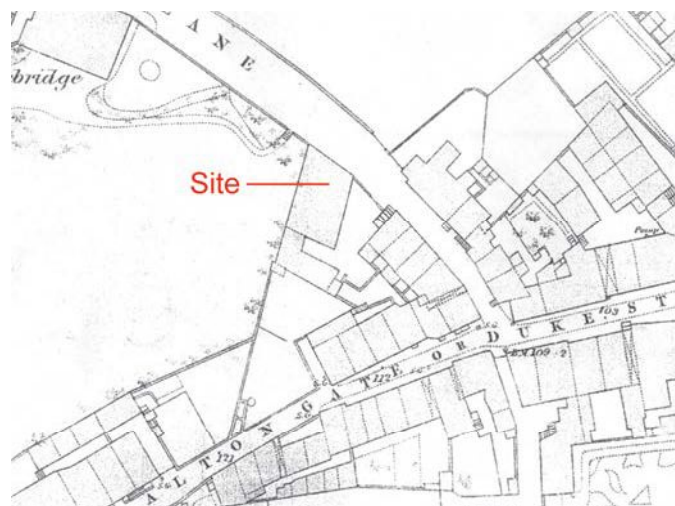
Plate 3 (left): Extract from the Ordnance Survey map of 1852

3.1.3 **Ordnance Survey, 1852:** this is an especially detailed map of the town showing the divisions between individual buildings (Plate 3). The divisions between the main block of the building and the extension to the south is clearly shown, although once again there is no information given about its use.

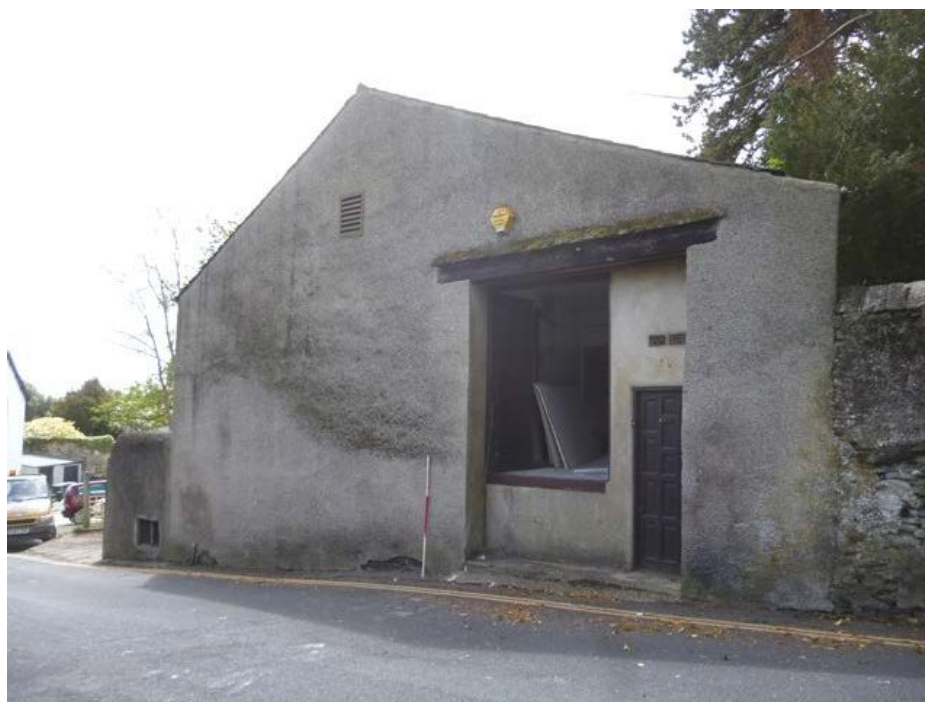
Plate 5: The north-east external elevation

4.2.2 **North-east elevation:** this comprises the gable end, and is finished with roughcast concrete render, with a slight bulge mid way up on the south-east side. It is extended to the north-west by the boundary wall for the adjoining property and south-east by a shorter boundary wall ending at a large stone gatepost and with a low opening with metal framing for a window or grill or two lights. The elevation proper has a large doorway on the north-west side. This has a large sawn timber lintel with a projecting drip course over. The doorway has been partially blocked, leaving an extant doorway at low level on the north-west side, with a modern timber multi-panel door. Above it are two ceramic grill vents. To the south-east is a larger doorway at a higher level, with a double plank and batten door and an iron plate over the step. The elevation is otherwise plain, although there is a modern grilled vent near the top in the centre.

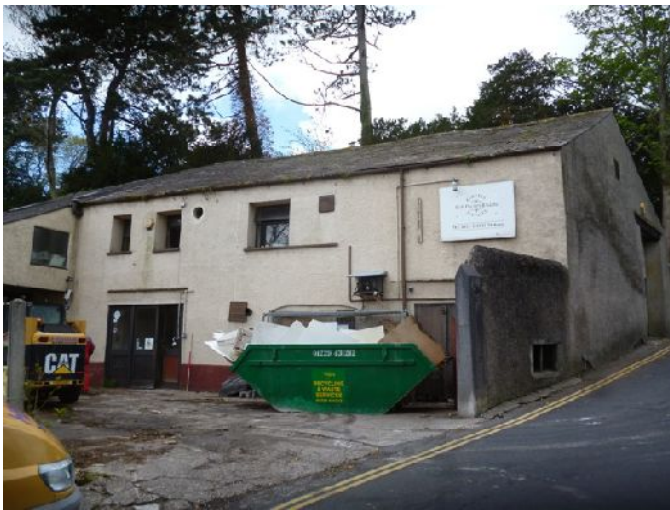
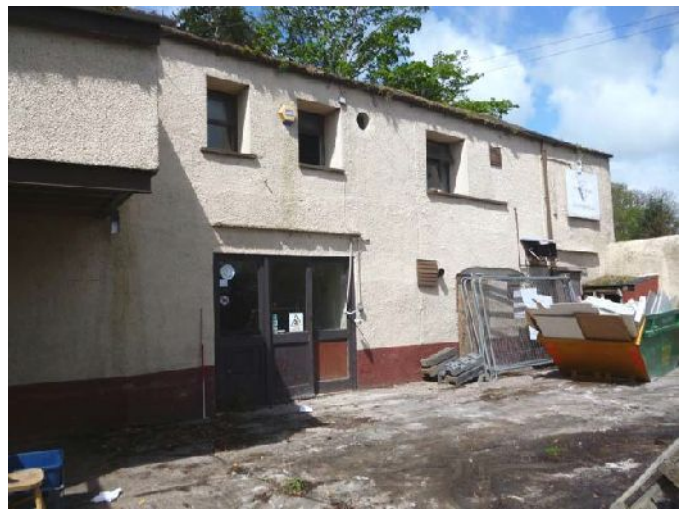
Plate 6 (left): South-east external elevation

4.2.3 South-east elevation: this elevation is also finished with rough cast render, mostly painted a cream colour, but the lower strip is a dark red. At ground floor level there is a wide doorway on the south-west side with a slate drip course over and a modern timber double door with a single glazed panel in each. To the south-west of this is a further glazed timber section. There is a plastic slatted vent to the north-east then a further wide doorway with a flattened arch over, which has been partially infilled leaving a pedestrian doorway on the south-west side (now board up) and a vent on the north-east side. At the north-east end there is a further doorway with a double plank and batten door with a slate drip course over with an engine attached on iron brackets attached to the wall between this and the top of the doorway on the south-west side. Immediately to the north-east of this is an aperture filled with timber slats, which is almost entirely covered by a monopitch lean-to attached to the short boundary wall. This also has a slate roof and a wide double doorway covered by mesh and houses an engine, apparently for an extractor fan. At first floor level the elevation has a row of windows; the two on the south-west side are slightly smaller and have two-light hinged timber casements and thin concrete sills, while a larger window to the north-east has a similar style casement and sill, but the sill extends to the north-east. This and an evident line in the render shows that this window was originally much larger; the blocked section also incorporates a slatted plastic vent. At the north-east end on the first floor there is a large sign attached reading 'FURNESS Fish Poultry & Game TEL: 0229 585037 24 hours'.

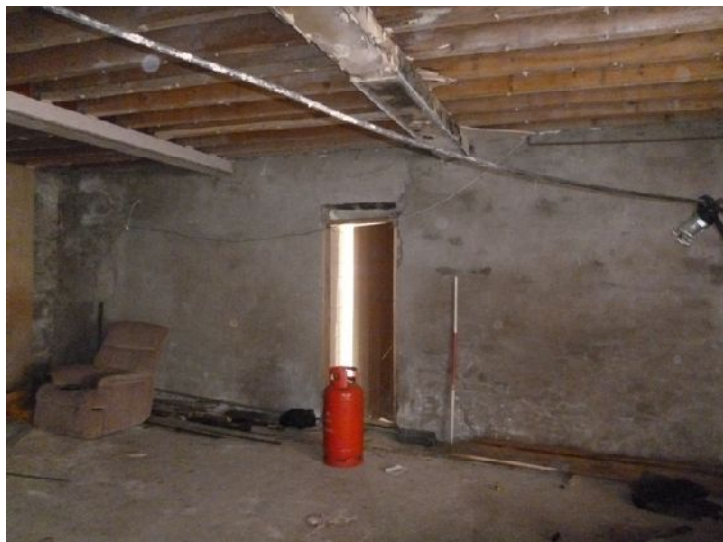
Plate 8 (left): Ground floor doorway in the south-west elevation

4.2.4 South-west elevation: there is no external elevation as such on the south-west side, it being contained within the later extension. However, some features of interest relating to what would have been the external elevation are evident. At ground floor level the wall is entirely finished with a concrete skim and there is a single doorway in the centre. This is a possibly early timber lintel but a modern frame and panel door below. The first floor is finished with plaster and has a number of stud walls butting against it. There is a doorway on the north-west side, the opening for which was originally wider but has been partially filled on the south-west side to incorporate the modern door. A through stone projecting through the wall is exposed above. There is also a small window with a modern hinged timber casement looking into the building from a store room.

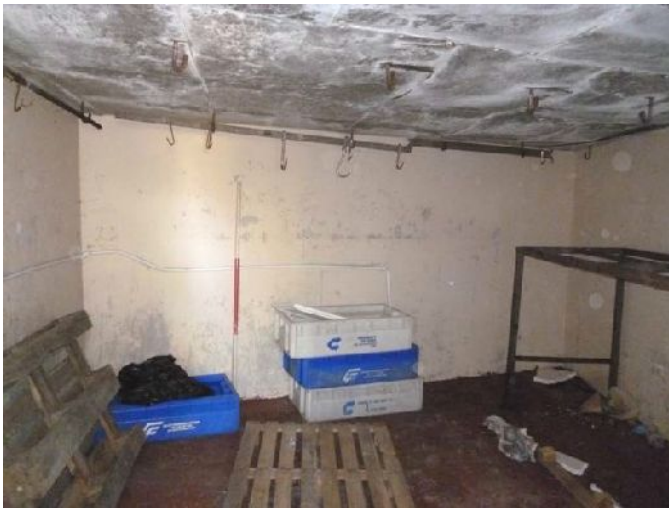
Plate 15 (left): General view of Room G5

4.3.5 **Ground floor Room 5:** this is essentially a single room, although accessed separately via the doorway at the north-east end of the south-east elevation, with a small lobby to the south-east (Room 6). It has a concrete floor and insulated sheet metal covering the ceiling with attached iron bars supporting meat hooks (Plate 14). All of the walls are finished with concrete skim and paint and all are plain although there is a doorway to the south-east with a plastic curtain over and thick insulated door and graffiti on the south-west wall (Plate 15).

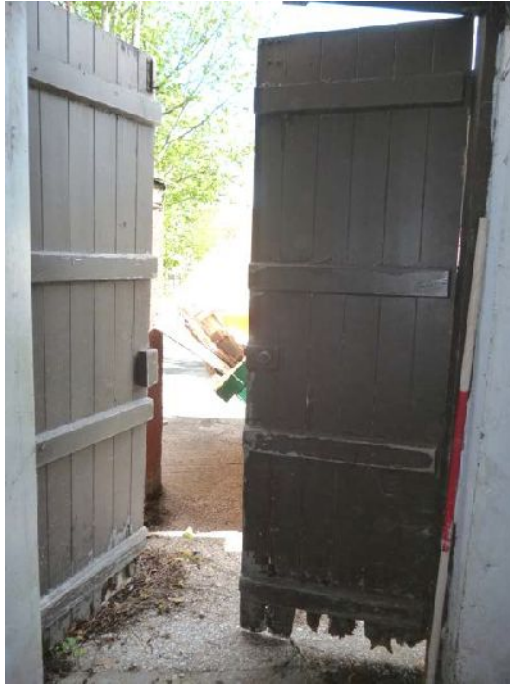
Plate 17: Double door in the south-east elevation of Room G6

4.3.6 **Ground floor Room 6:** this comprises a small lobby to the south-east of Room G5. It has a concrete floor and a stud wall on the north-east side with a doorway forming a cupboard for the meters and fuse box. There is further stud walling to the south-west forming another cupboard. The ceiling is flat and plastered. The north-east elevation proper has concrete blocks in the east corner, representing the actual thickness of the wall, while the south-east has a timber slatted aperture on the north-west side and a wide doorway with a double plank and batten door to the south-west (Plate 16). The south-west elevation also has concrete blocks forming the thickness of the wall, possibly indicating that the doorway

to the south-east is inserted. The north-west elevation is plain, apart from the doorway to Room G5, which has a heavy fridge door.

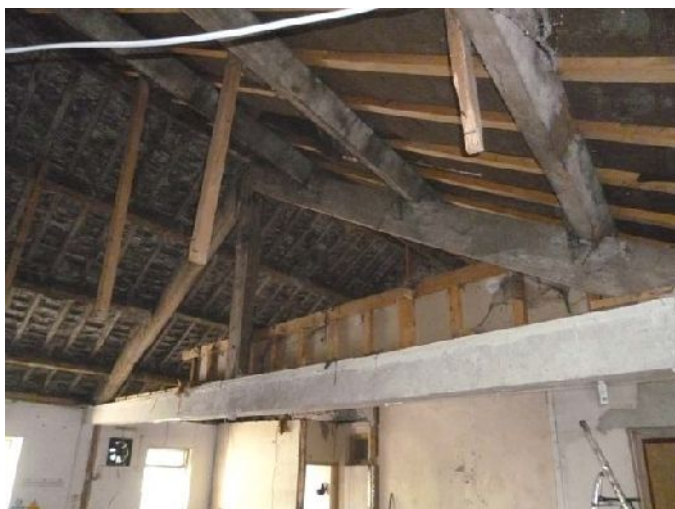
Plate 18 (left): Truss, Room F1

4.3.7 First floor Room 1: this comprises the majority of the floor, filling two thirds of the south-western end and spanning the full width. It has a concrete floor, which is mostly finished with tiles, although there are scars of timber stud partitions and a raised timber area on the north-west side, presumably a former fridge base. Extant stud walling in the south corner forms a small toilet cubicle. The whole room is open to the roof, their having previously been a suspended ceiling. There is a single king post truss supporting this section of the roof, the king post bolted to the tie beam and notched to meet the principal rafters (Plate 17). All of the timber is sawn and there are Baltic marks on the south-west face of the north-west principal rafter (Plate 18). The roof is in turn supported by three purlins in each pitch and what are probably the original slates backed with lime plaster remain on the south-east side while the north-west side has been re-roofed with new rafters and felt backing. The walls are generally finished with a concrete skim and painted. The majority of the north-east elevation comprises a solid wall with another king post truss sat on top of it in the same style as that to the south-west (Plate 19). This wall returns to the north-east north-west of the centre of the room, and the resulting gap is filled with fairly modern stud walling incorporating a large doorway. The south-east elevation has two windows with hinged timber two-light casements, the north-east larger than the other and there is a fan vent between the two (Plate 20). The elevation continues into the toilet formed by the stud walling in the south corner, where there is another window in the same style as the others. The lower part of the south-west elevation is finished with plaster and paint, with the scars of stud walling evident. The upper part is exposed stone with thick lime mortar (Plate 21). There is a small window with a hinged timber casement on the south-east side and a doorway on the north-west with a wide opening and modern plank door and concrete step. The north-west elevation is essentially plain, with a hole knocked in on the south-west side housing an electric fan (Plate 22).

5.1.2 **Phase 1 (late 18th – early 19th century):** the style of the present structure and certain elements of its fabric, essentially just the truss form and presence of Baltic marks, suggests that it was constructed in the late 18th or more likely early 19th century (Greene 1995; 1996; Brunskill 2002, 152-153), and the cartographic sources indicate that it was standing by 1832. The purpose of the building is uncertain; it has the arrangement of a bank barn, with high-level access at a raised ground level (Brunskill 2002, 105-111), but it has none of the other features that might be associated with this and the arrangement of three large doorways at lower floor level would be unusual for this type of building. It is also wider than barns of this type tend to be. The documentary sources do suggest that it may have been used as a theatre and if it was the 'New Theatre' referred to it 1808 this could be taken to indicate that it was built at around that time (which would fit with the likely date of the building). Its form is not unlike other early theatres, which were often little more than a single open space, and examples from the local area are not dissimilar (Eddershaw 1989, 4-12). In some cases at least these also had space below the main floor level that '*could have provided space for stage-machinery, traps, dressing-rooms and even a sunken pit*' (*op cit*, 10). In addition, the dimensions are arguably closer to those of contemporary theatres, the purpose-built theatre in the Woolpack Yard, Kendal being 23m long, 10.75m wide, and 9 high (*ibid*). The major divisions present within the lower floor do appear to be to be original, each accessed by a separate doorway, so such a use is not inconceivable. In the absence of additional evidence it is difficult to be certain of this, however.

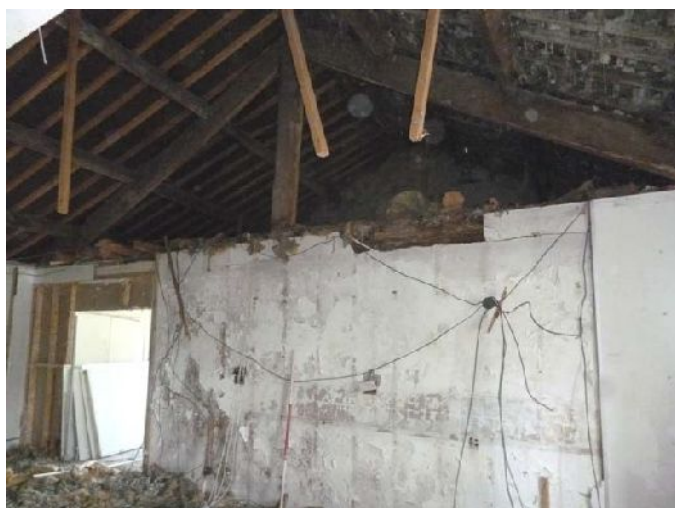
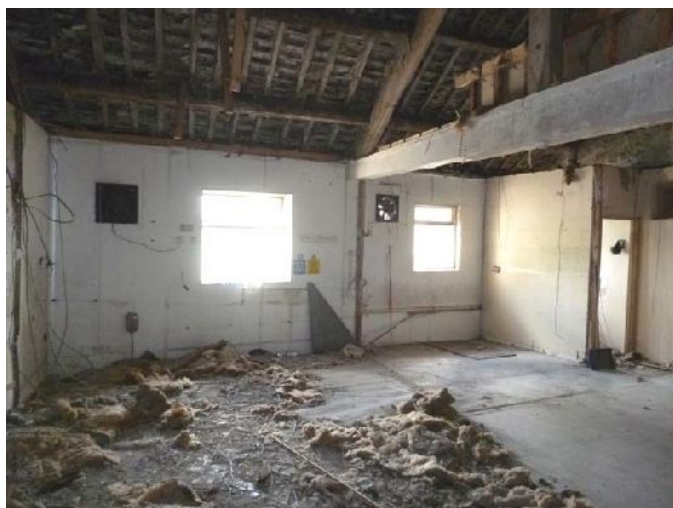
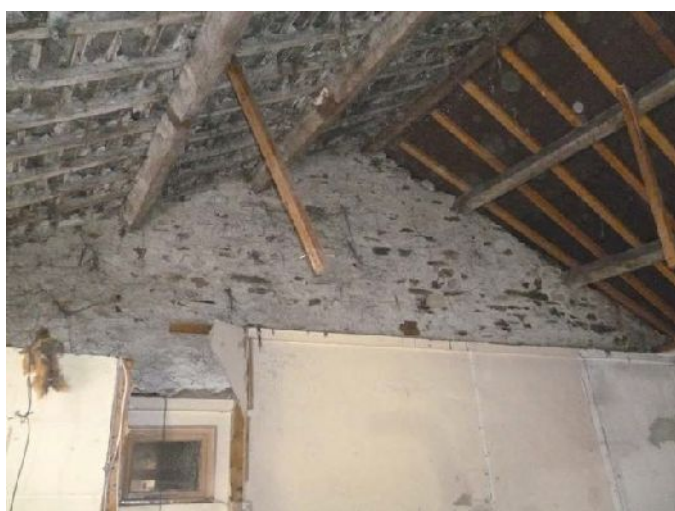
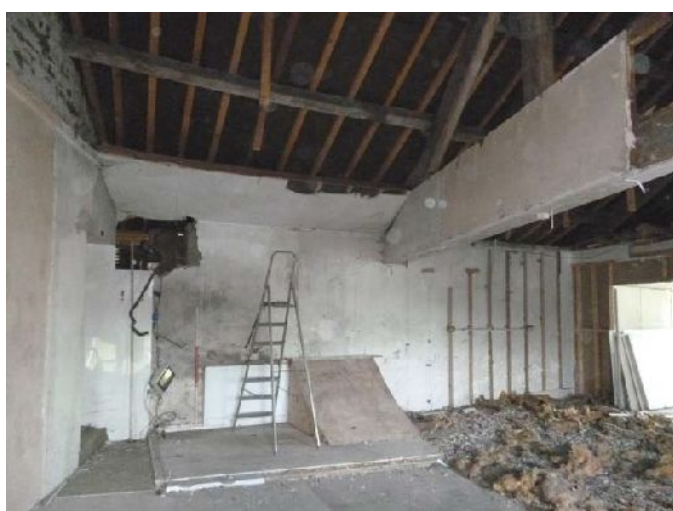
Plate 20 (left): North-east elevation and second truss, Room F1

Plate 21 (right): South-east elevation, Room F1

Plate 22 (left): Upper part of south-west elevation, Room F1

Plate 23 (right): North-west elevation, Room F1

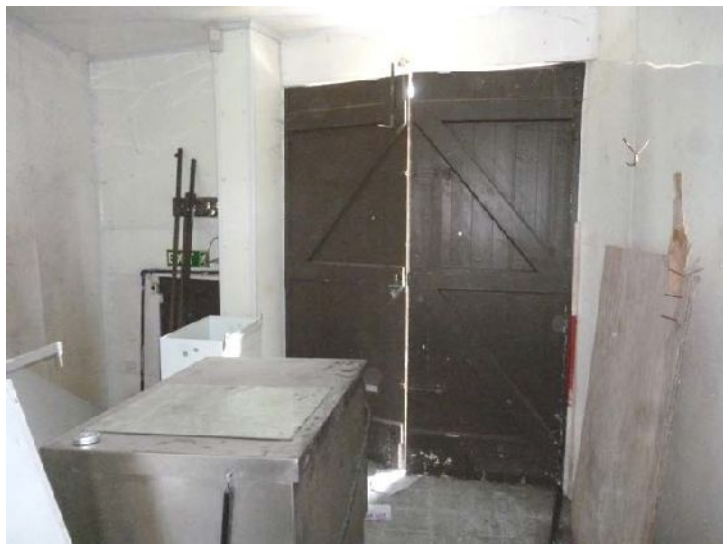
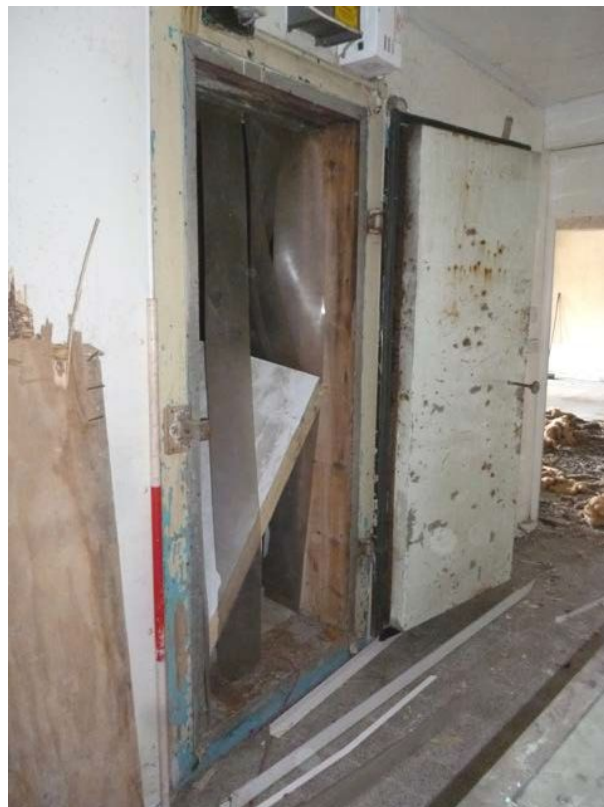
4.3.8 **First floor Room 2:** this is situated in the north corner of the first floor. It too has a concrete floor finished with tiles as per room F1, and there is a short flight of concrete steps running down to the smaller doorway in the north corner. The ceiling is suspended plaster construction at the level of the underside of the trusses. The walls are finished with insulated sheeting held on with clips or bolts. The north-east elevation has a doorway with a double plank and batten door at floor level on the south-east side (Plate 23), and a smaller doorway with a modern multi-panel door on the north-west side at the bottom of the stairs. The south-east elevation is essentially plain, apart from a single doorway with a heavy fridge door (Plate 24). The south-west elevation is a stud wall with a large doorway but with no door, which projects on the north-west side to form a large cupboard. This continues onto the north-west elevation, which is otherwise plain.

Plate 24 (left): Double door in the north-east elevation, Room F2

Plate 25 (right): Fridge door in the south-east elevation, Room F2
