FORMER POLICE STATION AND MAGISTRATES' COURT, MILLOM, CUMBRIA

Archaeological Building Recording

Client: John and Ruth Cullen

July 2013

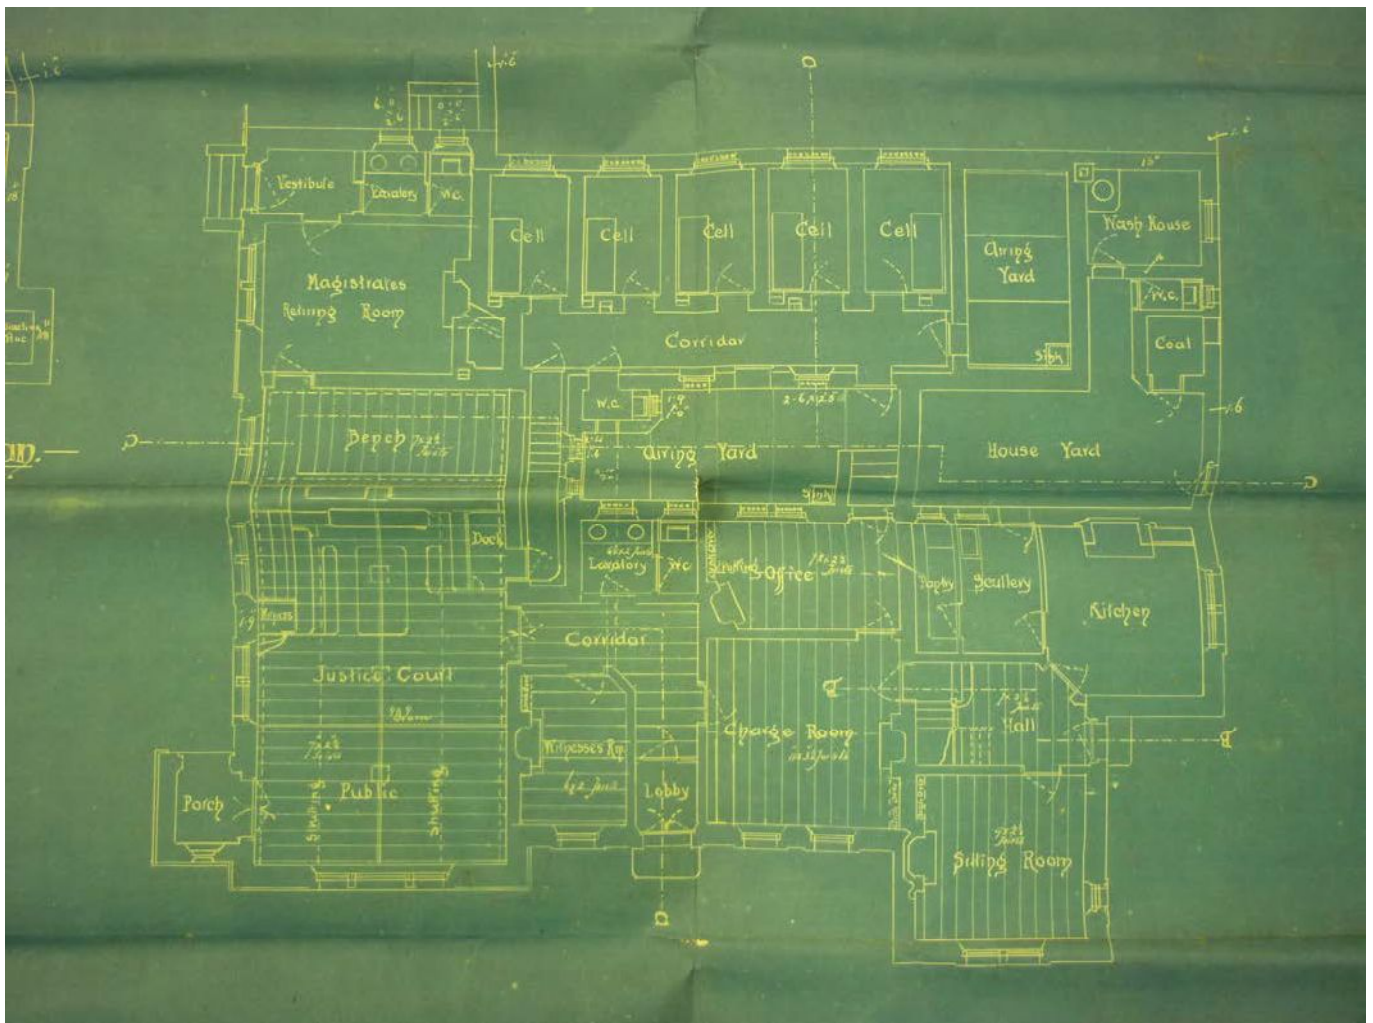
Plate 1: Ground floor plan, 1892 (CAC(W) SRDMB/3/4/485a 1892)

3.1.2 **Building Plans, 1892:** the original plans of the police station (CAC(W) SRDMB/3/4/485a 1892) are dated November 1892 and signed by George Dale Oliver, County Architect, who is listed in a contemporary directory as a FRIBA (Fellow of the Royal Institute of British Architects) based at Bank Chambers, Bank Street, Carlisle (Kelly and Co Ltd 1894a). The plans show the building as intended although the plan corresponds closely with the building as it now remains and the later Ordnance Survey maps so was presumably constructed according to the plans (Plate 1-Plate 10). The plans also give details of the use of the rooms and show features that have not survived including smaller outbuildings at the north end and two further open spaces, a second 'Airing Yard' and the 'House Yard'.

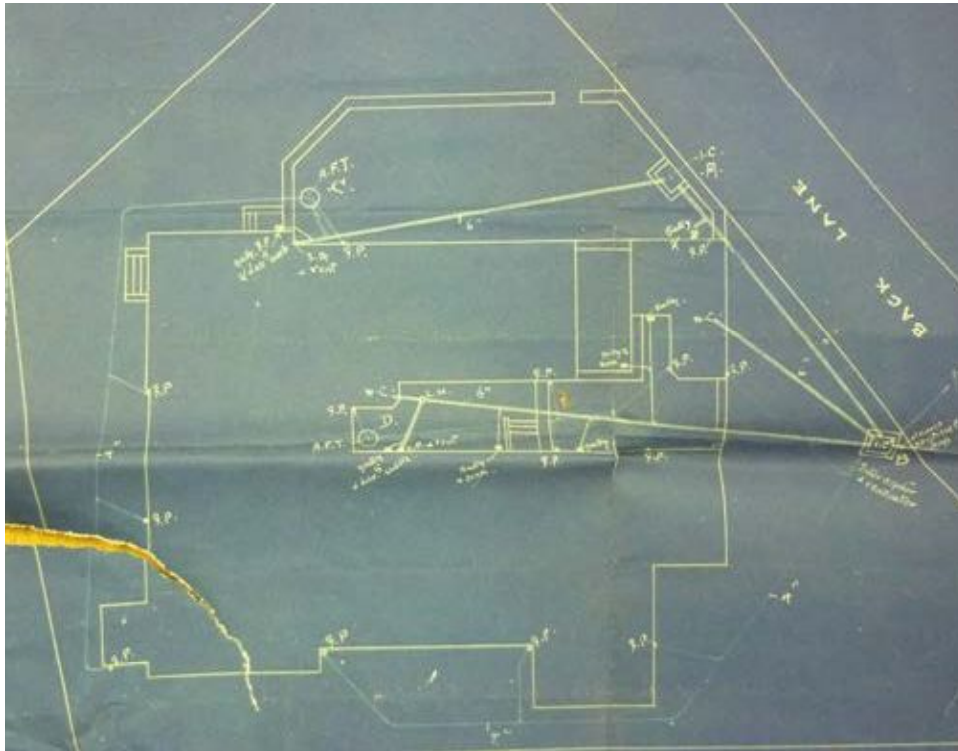
Plate 11: Drainage plan, 1893 (SRDMB/3/5/46 1893)

3.1.3 **Drainage Plan, 1893:** this was also produced by George Dale Oliver but in 1893 (CAC(W) SRDMB/3/5/46 1893). It only shows the building in outline, but this at least corresponds to the original plans, but it shows the arrangement of the original drainage, which was focussed around the central airing yard and the enclosing wall to the rear (north-west) (Plate 11).

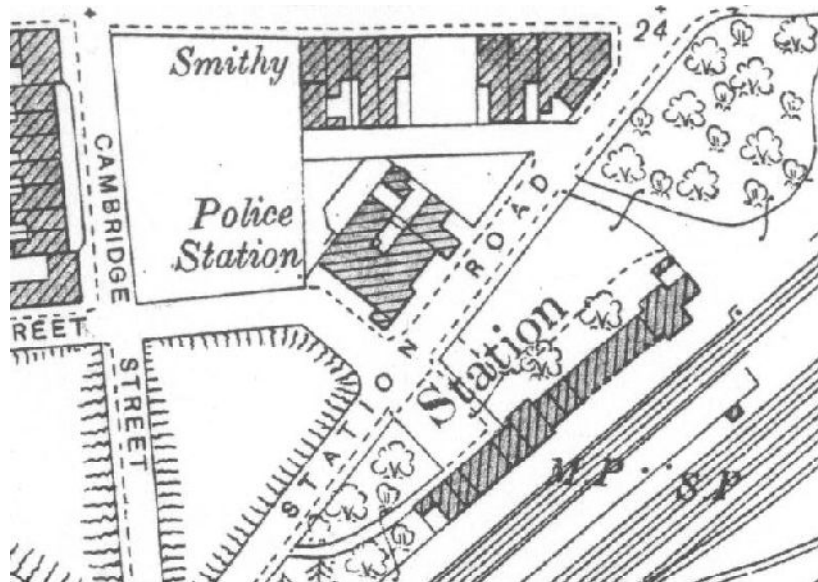
Plate 12: Extract from the Ordnance Survey map of 1899 showing the police station

3.1.4 **Ordnance Survey, 1899:** this is the earliest map to show the building and was surveyed shortly after its construction (Plate 12). It demonstrates that the basic plan was entirely present by this time, although the north corner was detached from the rest of the building with what appears to be an enclosed yard at this end. The central yard was also not entirely surrounded by the rest of the building, as it is now, but was clearly enclosed on the north-east side by at least one wall and there is a small outshut or similar shown in the west corner of the yard. Some internal divisions are shown within the building, although it is unclear how accurate these are as it is evident that not all of the divisions are depicted.

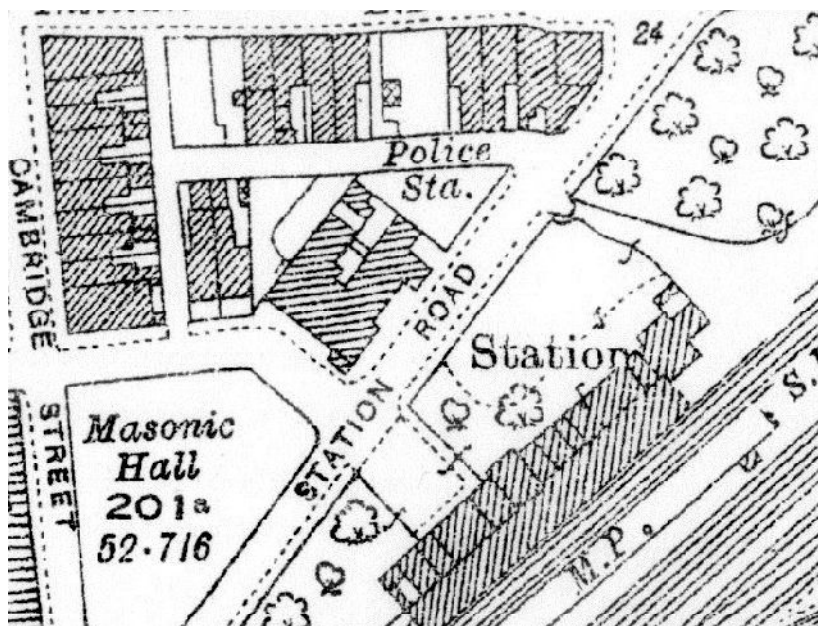
Plate 13: Extract from the Ordnance Survey map of 1924 showing the police station

3.1.6 **Ordnance Survey, 1924:** this is at a similar scale to the map of 1899 and essentially shows that the building was little changed from that date (Plate 13). It does not show the internal divisions but as already mentioned, it is not clear how reliable these are.

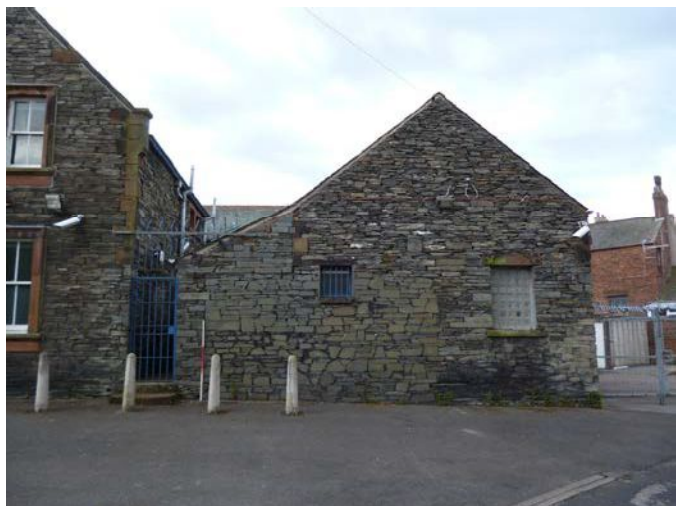
Plate 14 (left): North-east external elevation, north-west side

4.2.1 **North-east elevation:** the north-west end of this comprises a gable with a ground floor window with a multi-light concrete casement with a sandstone sill and lintel and there are two quoins high on the north-west side (Figure 2). To the south-east it has been extensively rebuilt, also in slate but not quite matching the rest as the sawn faces are outwards (Plate 14). There is a small (original) window in the original built above the rebuilt with a single-light casement with iron bars over and a sandstone sill and lintel. There are quoins to the south-east of this above the rebuilt section, which extends to the south-east to form a monopitch extension. This returns to the south-west to form a small passageway, the north-east side of which is constructed from concrete blocks. The passage ends at a doorway with a modern panel door and the south-east side is the original build. Beyond this the main elevation proper comprises a two-storey gable with a double window on each floor with dressed moulded sandstone surrounds and a pair of four-light sash casements with horns and the gable has sandstone quoins at either side extending to scrolled kneelers and coping although there are no quoins in the lower part of the north-west side, which has presumably been rebuilt (Plate 15). The south-east end of the elevation has a low monopitch porch extension covering the lower part, with a small two-light window above with sandstone surrounds, sill and lintel. There is a further ground floor window to the south-east with a two-light casement with horns in a dressed sandstone surround and there is a notice board attached to the south-east of this. At the base of the south-east section is a chamfered sandstone plinth.

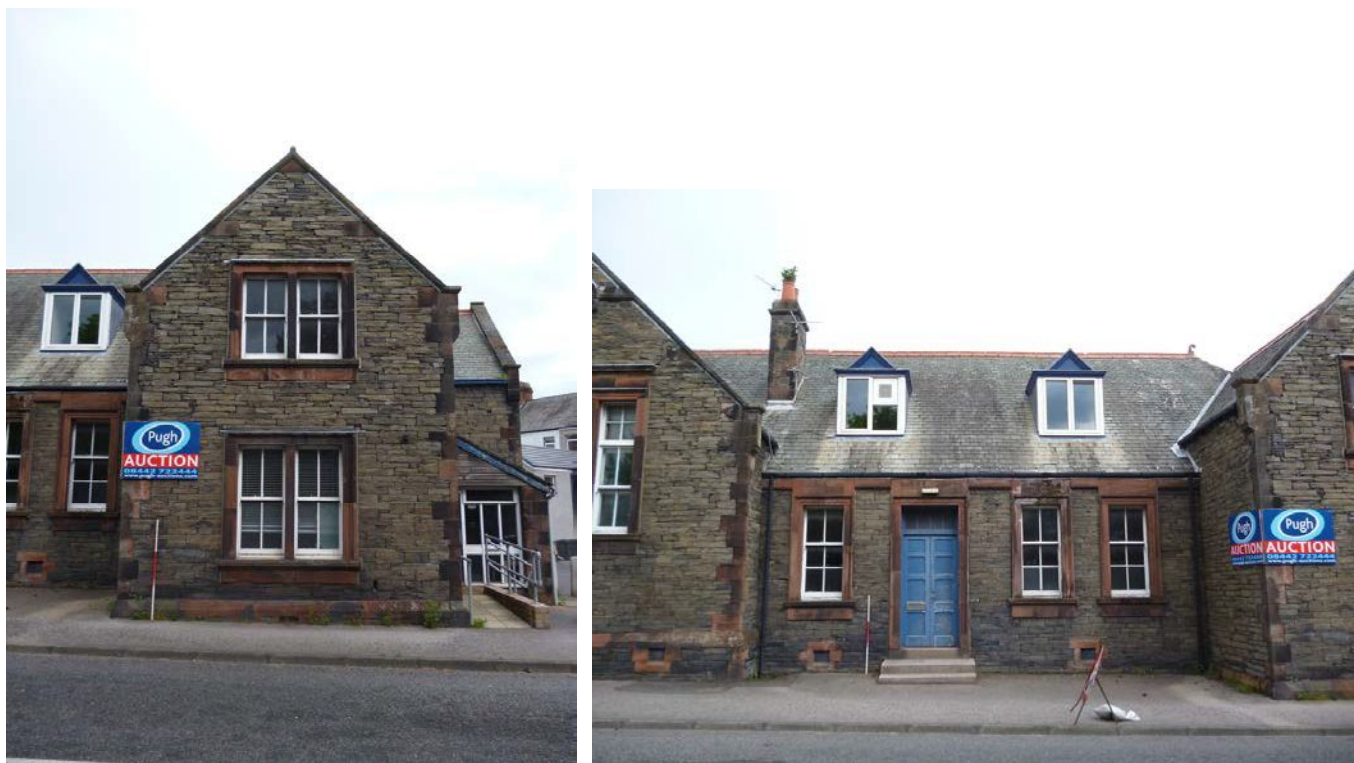
4.2.2 South-east elevation: the north-east end is extended by the low porch, which is accessed by a concrete ramp (Figure 2). The north-east side of this is stone and finished with quoins but the rest is timber infill with a seven-light window and glazed modern door with tongue and groove planks filling the area above and the side of the gable above that (Plate 16). The north-east end proper comprises a projecting gable with two windows each with a pair of four-light sash casements with dressed sandstone surrounds. There is a dressed sandstone plinth at the base of the wall with a vent hole with an iron grill built in at the centre and there are quoins at either side extending to scrolled kneelers and a stone coping (Plate 16). The main central section is lower than the ends but is topped by two gabled dormers with moulded eaves and modern UPVC two-light casements, although the south-west also incorporates a vent. There is a chimney above on the south-west side finished with sandstone quoins and a moulded band and with two ceramic pots (Plate 17). The elevation in the centre has a row of three windows, similar to those to the north-east and south-west but slightly smaller and with four-light sash casements in dressed sandstone surrounds extending above to meet a rounded band or rail below the eaves. There are two vents with iron grills and sandstone surrounds at the base of the wall and a flight of three concrete steps leading up to a doorway south-west of the centre. The doorway has a moulded sandstone surround extended by a flat panel above to the rounded band and a double door with four stop-chamfer panels in each and a four-light overlight above (Plate 17). The south-east end of the elevation comprises another projecting gable with a chamfered plinth at the base incorporating two vents with iron grills and stone quoins, lintels and sills. There are quoins at either side of the gable extending to kneelers a coping with incorporates two moulded sandstone bands connecting to a semi-circular sandstone plaque with the date '1894' carved in relief. Below this is a large window filling the central part of the gable, which comprises three parts, the outer two having four-light sash windows with a further four-light fixed casement above, while the central part has a six-light sash casement and nine fixed lights over. The whole window is set within a moulded stone surround with an entablature above (Plate 18). The elevation is extended at the south-west end by a low porch with a flat roof with a moulded rail along the top and a projecting rail below. The end is finished with quoins, which extend to the chamfered plinth and there is a small window slightly north-east of the centre with a multi-light leaded casement (Plate 18).

Plate 16 (left): North-east end of the south-east elevation

Plate 17 (right): Centre of the south-east elevation

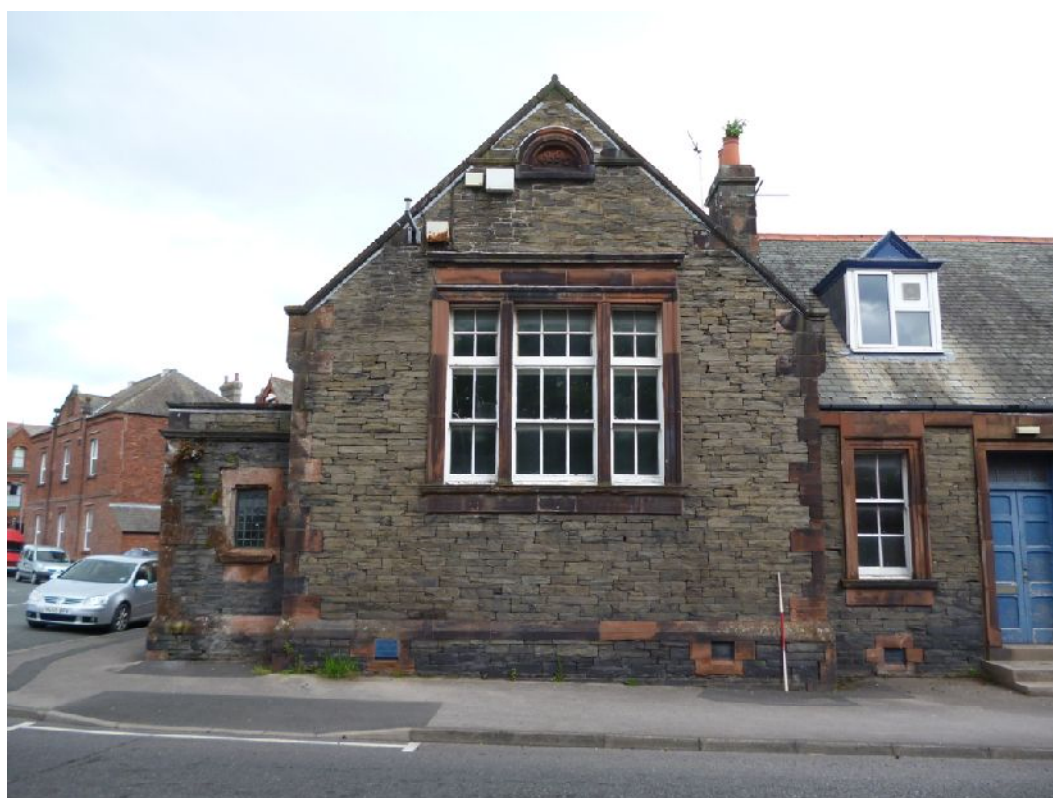
Plate 18: South-west end of the south-east elevation

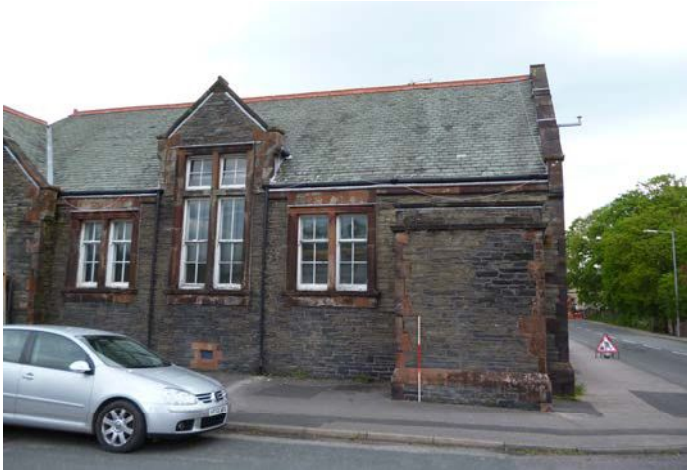
Plate 19 (left): South-east end of the south-west external elevation

part of the elevation is recessed relative to the north-west end and has a central dormer gable with sandstone coping on scrolled kneelers extending into an area of quoins or ashlar blocks either side of a tall window (Plate 19). This has moulded stone surrounds as per the rest of the windows and a sandstone sill with a moulded band and houses two tilting four-light windows in the top and two four-light sash casements below. This window is flanked by a pair of lower windows each with a six-light sash casement, again in moulded surrounds and with a moulded band incorporated into the sill. The lintels are extended by a row of ashlar blocks to meet a rounded band at the eaves. Below the central window there is a square vent with an iron grill and stone surrounds. The north-west end is a projecting gable with dressed quoins at both ends and a plinth at the base. The quoins extend to the kneelers and coping, which extends in turn into a sandstone plaque with the words 'POLICE STATION' carved in relief (Plate 20). Within the quoins, at the base of the south-east side, is a brass plate with bench mark and the text 'OS BM S7104'. There is a window comprising a pair of six-light sash casements in a moulded stone surround with a wide lintel with a projecting entablature and sill with a moulded band and on the north-west side a flight of five yellow sandstone steps, topped with a low flanking wall with stone copings, lead up to a doorway. This is also set within a moulded surround with an entablature over and houses a large door with eight stop-chamfered panels with four lights over (Plate 20). Below the windows, to the south-east of the doorway, is a pair of low two-light windows set within the chamfered plinth and looking into the basement. Attached to the north-west side of the stairs to the doorway, and running to the west, is a short section of cast iron fence with a small gate; the fence comprising simple spikes but the gate posts having a more decorative finial. One of the gateposts has the maker's mark 'BAYLISS & CO [??????]' (Plate 21).

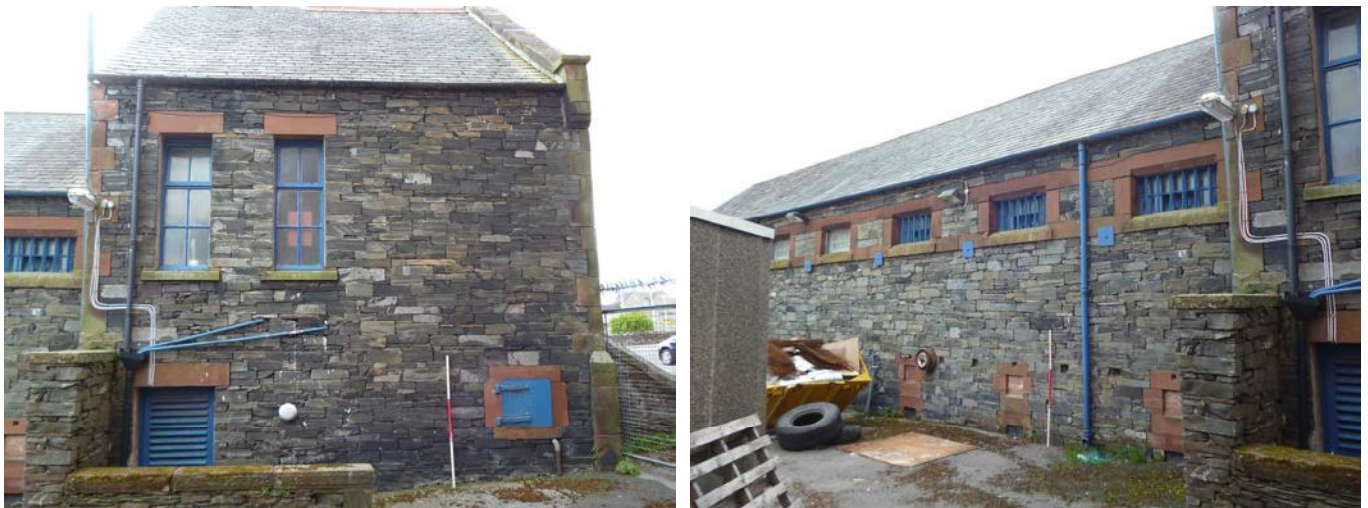
4.2.4 **North-west elevation:** the south-west end has a low-level hatch with stone surrounds and an iron door with long strap hinges (Plate 22; Figure 3). The corner is finished with quoins extending to a kneeler although they are sat on top of a projecting ashlar column or buttress at the base. There is a flight of yellow sandstone steps running against the wall down to a doorway into the basement, with a low flanking wall finished with sandstone coping. The doorway into the basement is timber and slatted, with a sandstone lintel. There are two windows above this, both relatively tall and narrow and with very plain sandstone lintels and sills and no surround, and housing six-light casements, the top two lights hinged (Plate 22). There are quoins at the north-east end of the south-west section, before a return to the main part of the elevation, which is slightly lower. This has a row of five high-level windows, the three to the south-west with bars fixed over them and fixed 14-light casements arranged as two rows of seven, with the two lights in the bottom of the centre row hinged. The other two have 10-light concrete casements (Plate 23). All of the windows have plain ashlar sawn sandstone surrounds, the sills and lintels with a chamfered finish and there are five iron tie rod plates between the windows. At low level, below each window, there is a row of five openings with sandstone surrounds apparently filled with a single sandstone block leaving a slight alcove. Below each is a vent with an iron grill and there is a row of further small holes (for pipes?) across the elevation at the lintel height of the alcoves (Plate 23). The north-east element of the elevation is of a different build, suggesting it has been rebuilt, but is essentially plain, although with some evidence for holes (again for pipes?) projecting through the wall (Plate 24).

Plate 22 (left): South-west end of the north-west external elevation

Plate 23 (right): Centre of the north-west external elevation

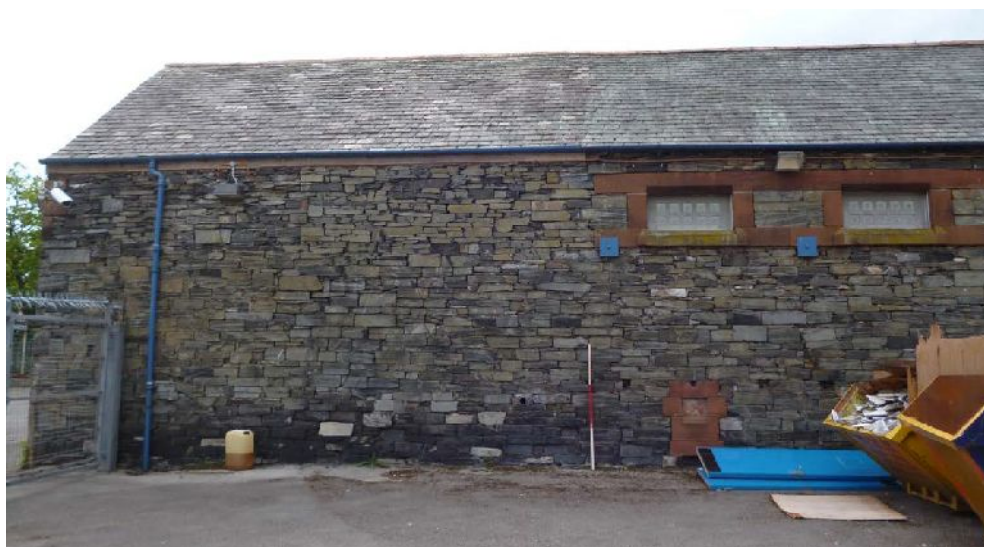
Plate 24: North-east end of the north-west external elevation

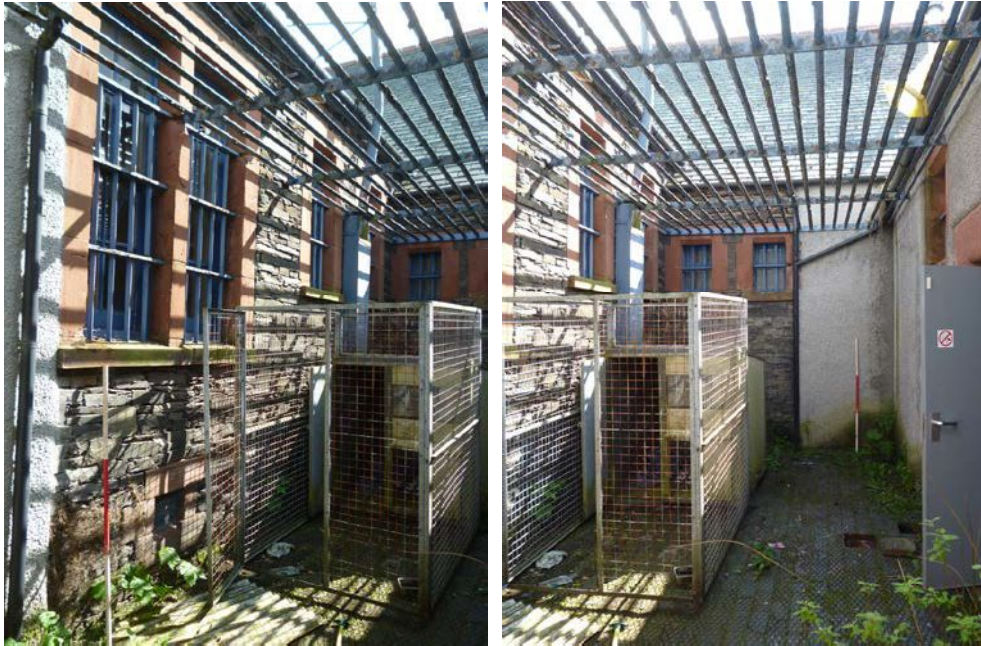
4.2.5 **Yard:** within the centre of the building there is an open area comprising the former exercise yard. The floor of is a mixture of gridded ceramic blocks and concrete at the north-east end and there are a number of drain covers. There is no roof, but it is enclosed by steel bars. The walls are mostly finished with rough cast render but exposed stone otherwise. The north-east elevation is plain just plain and rendered, with an attached extractor fan or air conditioning unit. The south-east elevation has a two-part window on the north-east side with two fixed eight-light windows with bars over and a sandstone surround, sill, and lintel. There are two smaller windows to the south-west with a boxed pipe between and fixed six-light casements with bars over and sandstone surrounds and two vents with iron grills and stone surrounds (Plate 25). The south-west elevation has two small windows on the south-east side with two-lights, bars and stone surrounds (Plate 26). The wall is rendered to the north-west of these. The north-west elevation is entirely rough cast and has two small windows with four-lights, bars, and stone surrounds (Plate 27). There are two vents with iron grills and stone surrounds and there are corresponding grills in the floor. Between these is a doorway with stone surrounds and a modern panel door.

Plate 25 (left): South-east elevation of the yard

Plate 26 (right): South-west elevation of the yard

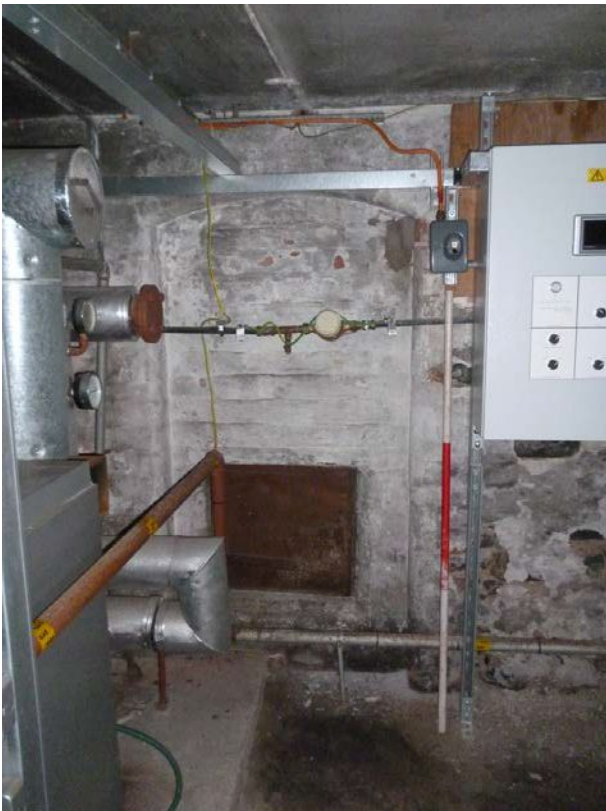
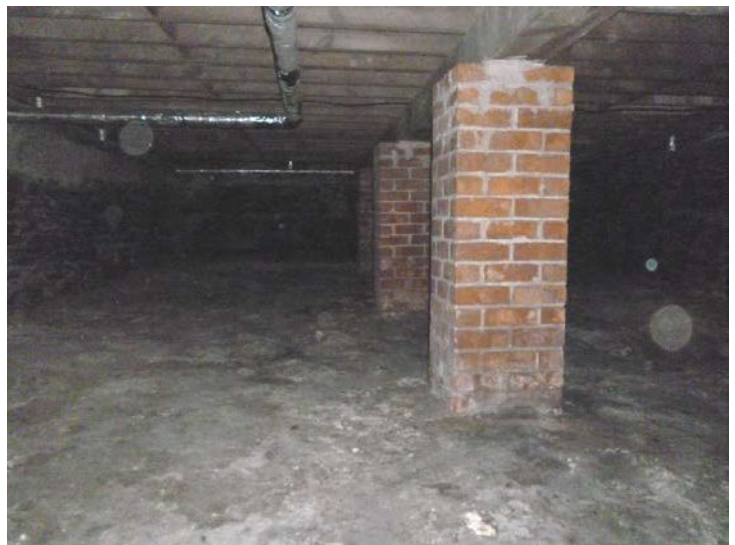
4.3.1 **Basement:** this essentially comprises a single room below the west corner of the building, but it extends to the east and south-east as a lower crawl-space, extending below a large part of the building, and to the north-east as a small room of uncertain function (Figure 4). Within the main room there floors is concrete and it has a plaster ceiling. All of the walls are roughly finished with limewash and there is a modern boiler sat in the centre of the room. The north-east elevation is essentially plain, with a step in the wall line and a small doorway to the south-east of this. This leads into a small room that was difficult to access but was angled on the south-east side and appeared to form part of a large flue running through the entire building to the roof. The south-east elevation has an alcove in the centre with a rounded top and a small iron door in the middle (Plate 28), which leads into the crawl space beyond. This was difficult to access but essentially corresponded to the Rooms G18-27 above with internal walls with small access hatches between and some apparent blocked apertures to the north-east and north-west. The space below Room G22 is supported by a row of three brick columns (Plate 29). The south-west elevation of the main room has two small windows extending to the ceiling, with two-light casements and splayed jambs (Plate 30). The north-west elevation has a series of internal brick walls forming two smaller spaces against this wall (Plate 31) and a small opening blocked with brick on the south-west side corresponding to the hatch externally. At the north-east end of the north-west elevation there is a doorway with a slatted door and plain surround.

Plate 28 (left): Alcove in the south-east elevation, basement main room

Plate 29 (right): Brick columns supporting the floor of Room G22

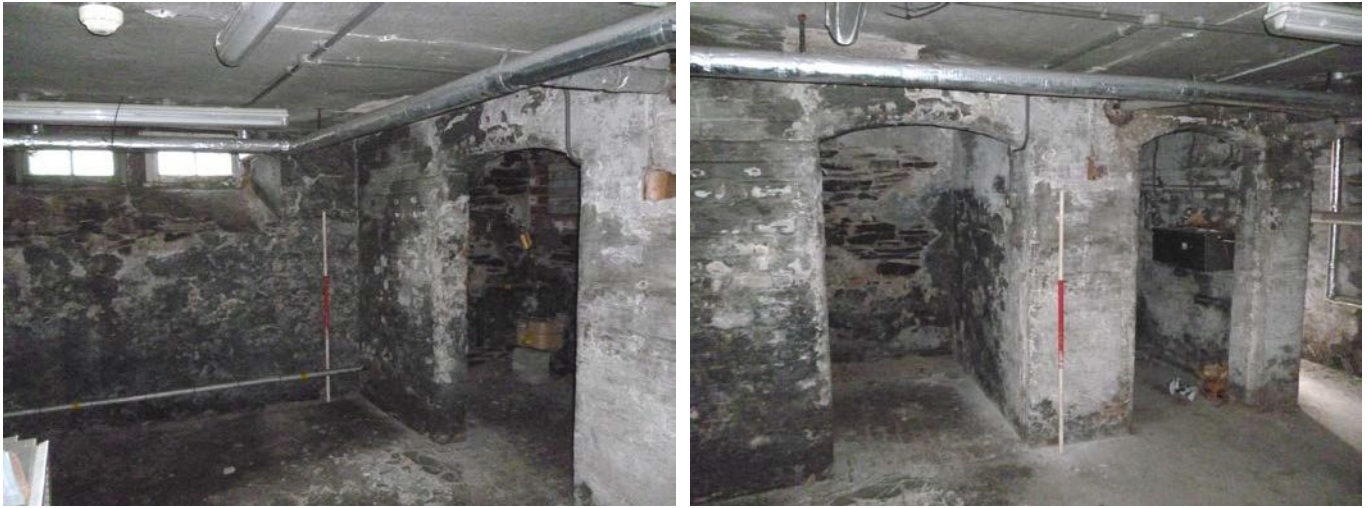
Plate 30 (left): Windows in the south-west elevation, basement main room

Plate 31 (right): Internal walls against the north-west elevation, basement main room

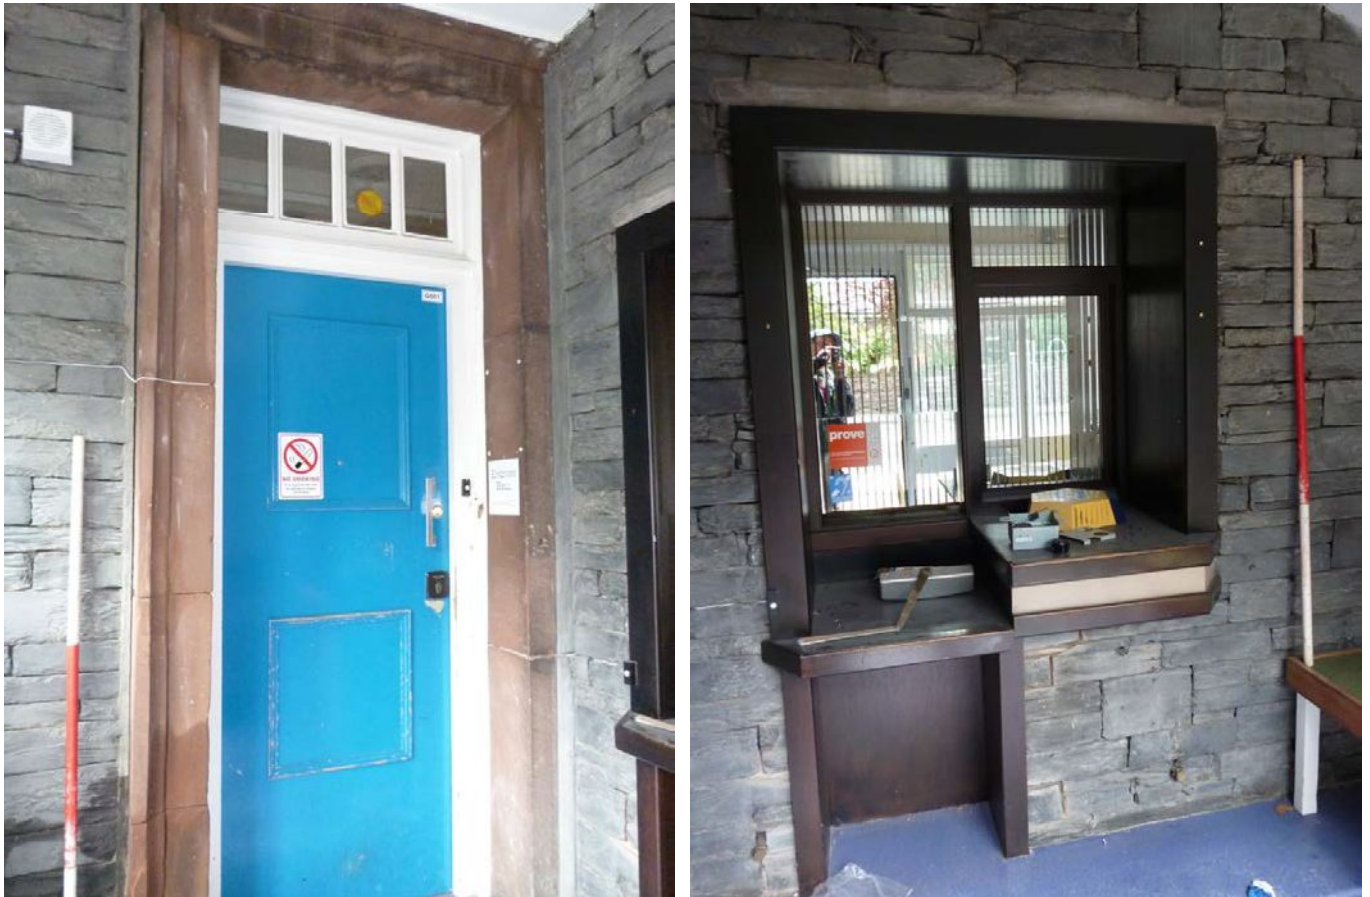
4.3.2 **Ground floor Room 1:** this comprises a lobby, within the porch on the south-east side of the building. The floor is finished with vinyl and the ceiling is plastered and sloping down on the north-east side. The north-east elevation has a modern bench set against it and a timber batten fixed to the wall forming its back. The wall is of concrete brick construction and seems to be butting the north-west elevation. The south-east elevation is of concrete brick construction on the north-east side but mostly stud wall, incorporating a glazed section and door with a single light. The south-west elevation is exposed stone with mortarless joints. There is a chamfered sandstone plinth at the base, continuing the line of that visible externally, and a doorway on the north-west side with a cavetto-moulded stone surround and a door with two moulded panels and four lights over. The north-west elevation is also exposed stone with mortarless joints, with a presumably inserted reception desk in the centre with modern timber surrounds, a counter with a blocked opening below, and a three-light window with a sliding hatch.

Plate 32 (left): Doorway in the south-west elevation, Room G1

Plate 33 (right): Reception in the north-west elevation, Room G1

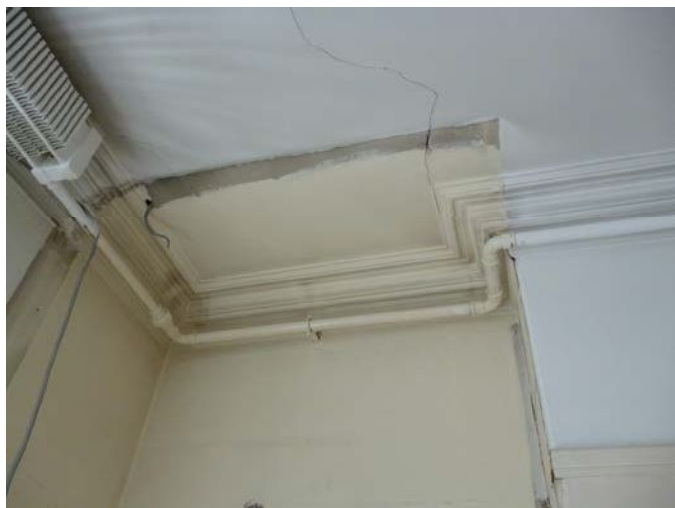
Plate 34 (left): Cornice detail, Room G2

4.3.3 **Ground floor Room 2:** this has timber tongue and groove floorboards orientated north-east/south-west with a tiled hearth on the south-west side. It has a plaster ceiling with a moulded cornice, the walls are finished with plaster and paint, and there is a high moulded skirting board and picture rail. The north-east elevation has a window on the south-east side with splayed jambs, a moulded timber surround, and a timber sill with a moulded band below. The south-east elevation has a large central window divided into two by a central timber mullion and with moulded surrounds and a moulded band below the timber sill. The south-west elevation has a projecting central chimney breast, the alcove to the north-west with a rounded arch top. The hearth has been blocked and the skirting board is continuous across it with no obvious gap. A vent has been attached and there is a scar for a second but the vent just comprises holes drilled through the blocking into the flue. The north-west elevation has a doorway on the north-east side with a moulded surround.

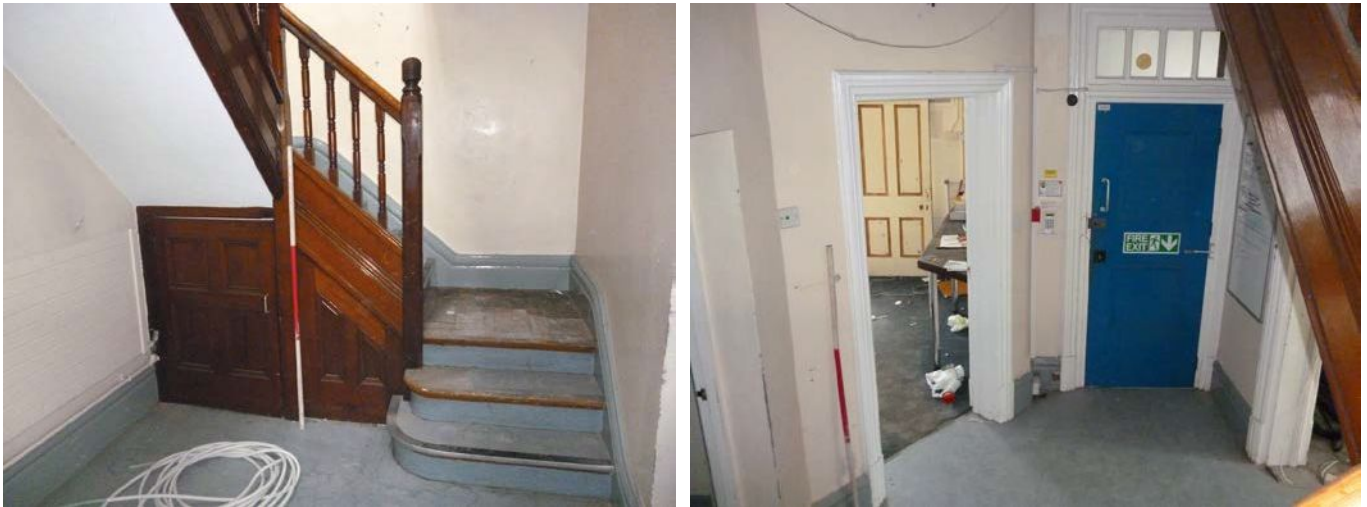
4.3.4 **Ground floor Room 3:** this forms the ground floor hall linking to the stairs to the first floor. The floor is finished with vinyl and there is a flat plaster ceiling with a moulded cornice, although the staircase extends through this on the south-west side. The stairs have square newel posts with stop-chamfer decoration and round finials, the balustrades are turned, and there is a moulded hand rail and moulded rails along the side panel. There is a small cupboard below the stairs on the south-east side with a six-panel door (Plate 37). The walls of the room are finished with plaster and paint and a moulded skirting board. The north-east elevation is angled on the north-west side where there is a doorway with a moulded surround including a plinth. This wall is rounded at the junction with the north-east elevation proper where there is another doorway with a relatively plain door with two moulded panels, four lights over and a moulded surround (Plate 38). The south-east elevation has a doorway on the north-east side with a moulded surround but no door. The lower part of the south-west elevation is covered by the stairs but otherwise plain. The north-west elevation has a doorway on the south-east side, which is very plain

Plate 37 (left): Stairs on the south-west side of Room G3

Plate 38 (right): Doors in the north-east elevation, Room G3

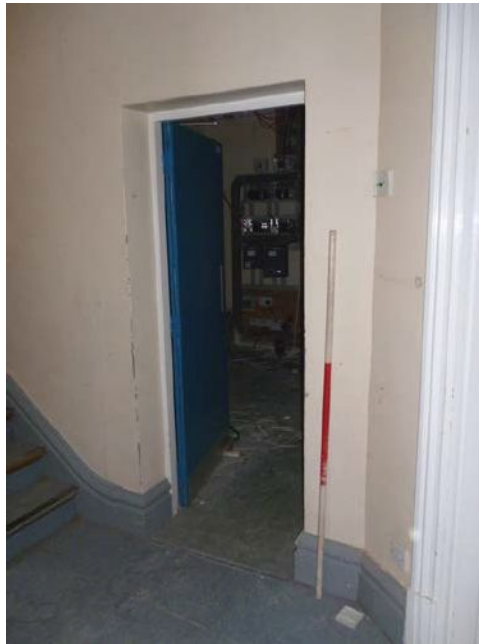
Plate 39: Door in the north-west elevation of Room G3

and probably inserted although the skirting board continues round it. It has a plain door surround and a modern plain door (Plate 39).

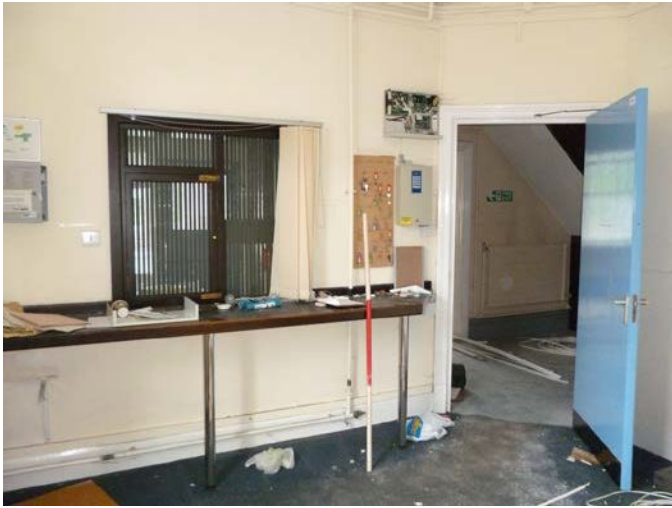
Plate 40 (left): Desk and door, south-east elevation, Room G4

4.3.5 Ground floor Room 4: the floor is finished with carpet, presumably over floor boards and the ceiling is plain plaster. The walls are finished with plaster and paint and there is a plain skirting board throughout. The north-east elevation has a wide window in the centre with splayed jambs and a moulded surround and moulded band below the sill. There is a metal vent in the wall to the south-east. The south-east elevation has a long counter fixed against it supported by three steel legs and there is a glazed window incorporating a hatch above (Plate 40). To the south-west boxes, presumably relating to the alarms, are attached. At the junction with the south-west elevation the walls is an angled and contains a doorway with a cyma moulded surround and modern plain door (Plate 40). The south-west elevation is essentially plain although there is a at the north-west end with a plain surround, which is blocked with timber stud and plasterboard. The north-west elevation has a central chimney breast, the hearth of which is blocked. There is an alcove to the north-east with two sets of double panelled doors, one above the other, and modern shelves internally. The top doors are taller and have four panels while the smaller lower doors have two (Plate 41).

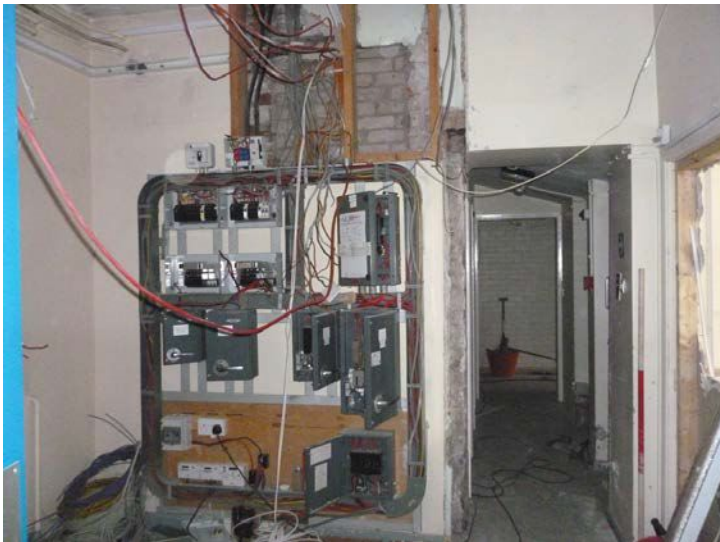
Plate 42 (left): North-west elevation, Room G5

4.3.6 **Ground floor Room 5:** this has a vinyl floor covering with the scar of a north-west/south-east stud wall on the north-west side and a plain plaster ceiling. The walls are finished with plaster and paint and a plain skirting board but it is apparent that they are of brick construction in areas where the plaster has been removed. All of the walls are essentially plain. There is a large board with electrical fittings attached to the north-west elevation, behind which is a high-level aperture or hole that is filled with concrete bricks (Plate 42). There is a doorway to the north-east of this with no surround, which is perhaps inserted. The north-east elevation also has a doorway on the north-west side, which appears to have been inserted as it is evidently cut through the brick wall but has been blocked with stud work and plasterboard (Plate 43). The doorway to the south-east is plain and has a plain modern door and surround.

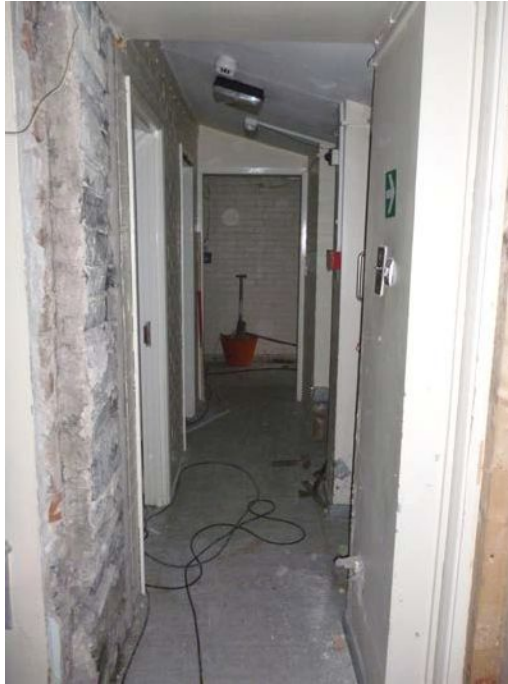
Plate 44: General view along Room G6 from the south-east

4.3.7 Ground floor Room 6: this comprises a short corridor linking the reception area to south-east to the larger corridor connecting to the cells to the north-west (Plate 44). The floor is finished with vinyl and the ceiling is plaster, sloping down to the north-east (Plate 44). The walls are all painted concrete brick. There are doorways to the north-west and south-east, both of which are plain and have no surround and are probably inserted. There are two doorways to the south-west both with plain modern surrounds and doors, labelled 'SHOWER' (to Room G7) and 'DRYING ROOM' (to Room G8). There are two further doorways to the north-east, again with plain surrounds and doors, the south-east of which leads to the outside passage and the north-west to Room G9. The latter is labelled 'INTERVIEW ROOM'. The walls are otherwise plain, although the south-west elevation butts the stone wall at the south-east end.

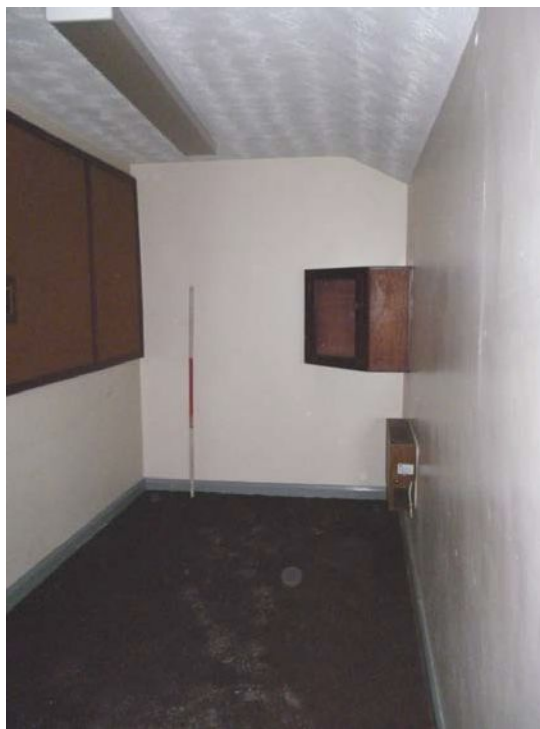
Plate 45: General view of Room G9

4.3.10 Ground floor Room 9: the floor is finished with carpet and the ceiling is plaster finished with Artex or similar and slopes down to the south-east. The walls are finished with plaster and paint and there is a plain skirting board throughout. All of the walls are plain, with the exception of some modern fittings and a doorway to the south-west with a plain modern surround and door.

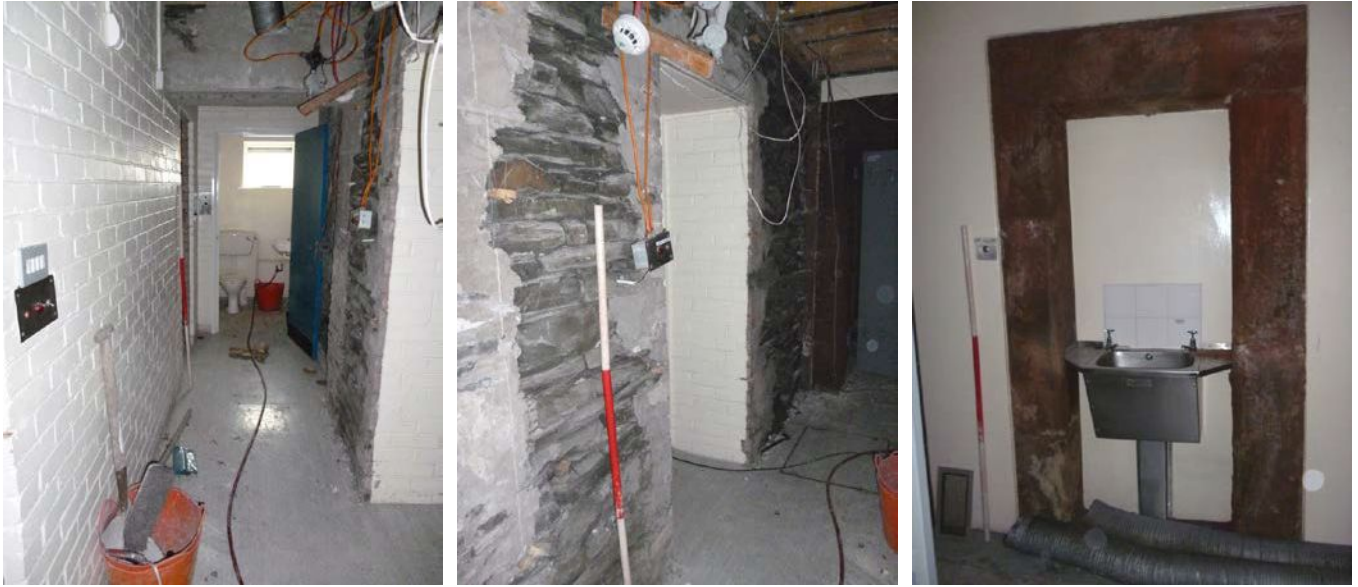
4.3.11 **Ground floor Room 10:** this comprises a long corridor orientated north-east/south-west linking the cells and other rooms along the north-west side of the building. The floor is finished with vinyl at the north-east end and exposed concrete at the south-west, with a channel covered by an iron grill along the south-east side. It has a flat plaster ceiling, although this has been removed at the north-east end revealing the roof structure above, which is entirely modern. The ceiling at the south-west end is slightly higher than the north-east. There is a stud wall at the north-east end separating the end of the corridor from the rest and forming a toilet (Plate 46). This has a modern plain door and surround and there is a small single-light window with a hinged casement in the north-east elevation proper within the toilet cubicle. The north-east end of the south-east elevation is painted brick within the toilet cubicle but beyond this the plaster has been removed revealing the stonework below, which is covered by remnants of earlier plaster. There is a small blocked aperture with brick-built jambs, perhaps a vent(?), within this and the upper part of the wall has also been raised with concrete blocks. There is a slight return after which the stonework is entirely unfinished and un-mortared. A doorway across the corridor at this point is clearly inserted as it has a concrete lintel. The wall also continues this, although not to the height of the roof, and there is a piece of disused lead flashing protruding from the wall. Beyond this, within the south-east elevation proper, there is a wide doorway that is clearly inserted as it has a concrete lintel and the jambs are built up with concrete blocks (Plate 47). South-west of this is a further doorway across the corridor with heavy dressed sandstone surrounds; the south-east elevation appears to butt the south-east of these. Beyond this, to the south-west, is another doorway of similar type set within the south-east elevation. This has been blocked, leaving an alcove that is filled by a small steel sink (Plate 48). To the south-east is a high-level window with chamfered quoins, lintel and sill and a four-light casement, the top two lights hinged.

Plate 46 (left): North-east end of Room G10

Plate 47 (centre): Inserted doorway, north-east end of south-east elevation, Room G10

Plate 48 (right): Blocked doorway, south-east elevation, Room G10

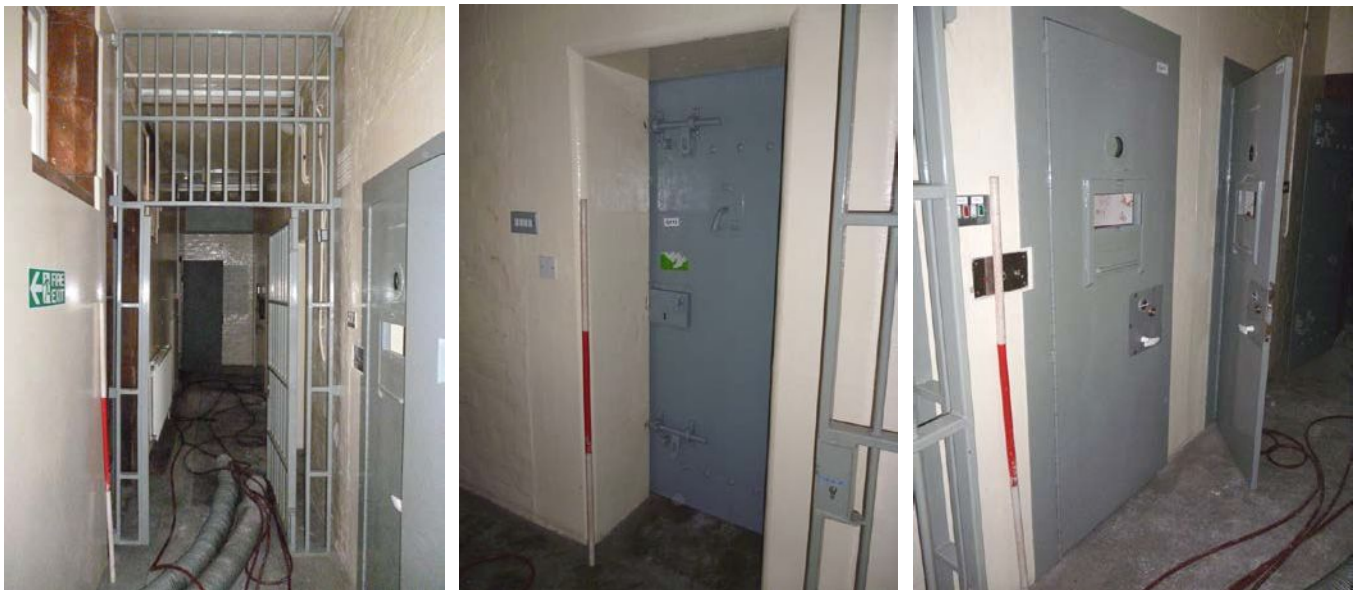
4.3.12 A further doorway, this time comprising steel bars and a gate, divides the corridor to the south-west of this (Plate 49) and beyond it is another doorway in the south-east elevation again with heavy sandstone surrounds, rebated and fitting a modern door. Another high-level window is situated to the south-west of this. At the far south-west end there is another door with rebated sandstone surrounds housing a heavy iron door with a hinged hatch. The south-west elevation is plain and painted brick. The north-west elevation is also painted brick and has a row of five doorways leading into the cells at the south-west end. All of these have dressed stone surrounds that are painted and there are two original iron vents set within dressed stone blocks as well as other vents exiting into metal flue pipes. The three doors at the south-west end have their original heavy iron doors (Plate 50), while the two at the north-

east end have later iron doors (Plate 51), and all five have a small hatch. The north-east end of the wall, beyond these doorways, is of painted concrete block construction with door doorways with concrete lintels.

Plate 49 (left): Steel bar gate across Room G10

Plate 50 (centre): Original iron door, north-west elevation, Room G10

Plate 51 (right): Modern iron doors, north-west elevation, Room G10
