FORMER POLICE STATION AND MAGISTRATES' COURT, MILLOM, CUMBRIA

Archaeological Building Recording

Client: John and Ruth Cullen

July 2013

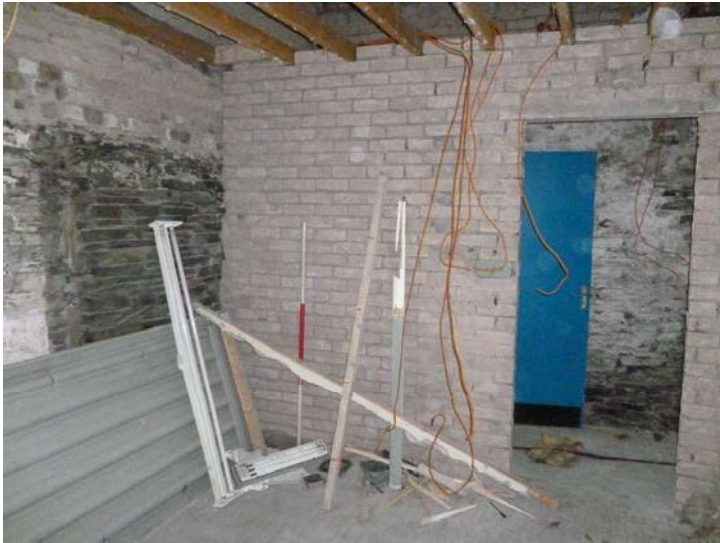
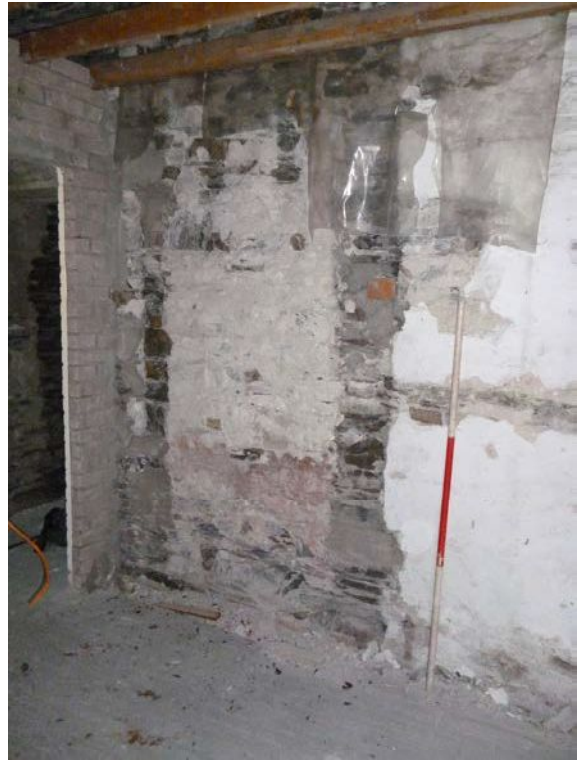
on the south-east (Plate 53). The wall continues above the line of the suspended ceiling but not to the roof and there is disused lead flashing protruding from it. Concrete block pillars have been added to support the purlins. The north-west elevation is of stone construction with remnants of plaster and has also been raised with concrete blocks to the height of the present roof. There is a row of three vents or flues at ground level with ceramic grills (Plate 54). These are clearly inserted as two have concrete blocks in the surrounds. There is also an iron tie-rod plate on the south-west side.

Plate 52 (left): South-east side of north-east elevation and south-east elevation, Room G11

Plate 53 (right): Scar on south-east side of south-west elevation, Room G11

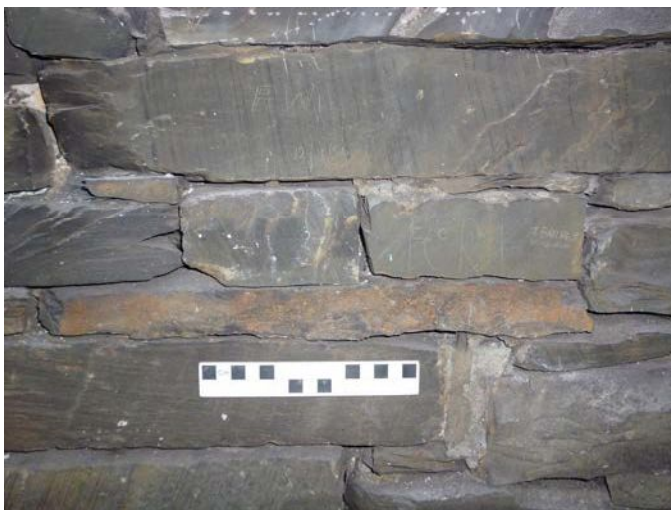
Plate 55 (left): Graffiti on the south-west elevation, Room G12

4.3.14 Ground floor Room 12: this has a vinyl floor covering and there are pipes running along the north-west side, which were presumably originally enclosed in boxing. The suspending ceiling has been removed leaving only the timber super-structure and revealing the modern roof above. The walls are all exposed un-mortared stone and so were presumably originally external, apart from the south-east, which is concrete block. The north-east elevation has concrete block columns on top extending it to support the roof although the stonework is higher than the wall to the north-west and it extends to the south-east over G10. The south-east elevation is plain, with a doorway on the south-west side with a concrete lintel. The south-west elevation is generally plain, although there is scratched graffiti across the centre and south-east side the legible sections of which include various names and initials (Plate 55) including 'A MURNING' (Plate 56), 'C WILSON' (Plate 57), 'T THOMPSON', 'P WILSON 12/7/56' and 'J BARNES WHITEHAVEN'. At the north-west end there is a low concrete scar on the wall, which extends onto the north-west elevation (where there was even moss still present) (Plate 58), presumably relating to a former small external outshut. Above the suspended ceiling line the wall extends to the full height of the gable and there is a small aperture leading into the roof space beyond. This could not be accessed but the roof structure appeared to be original. The north-west elevation has three vents at floor level with concrete rebuild around them demonstrating that they are inserted and there is an iron tie rod plate. Above the ceiling level this elevation was also raised with concrete blocks.

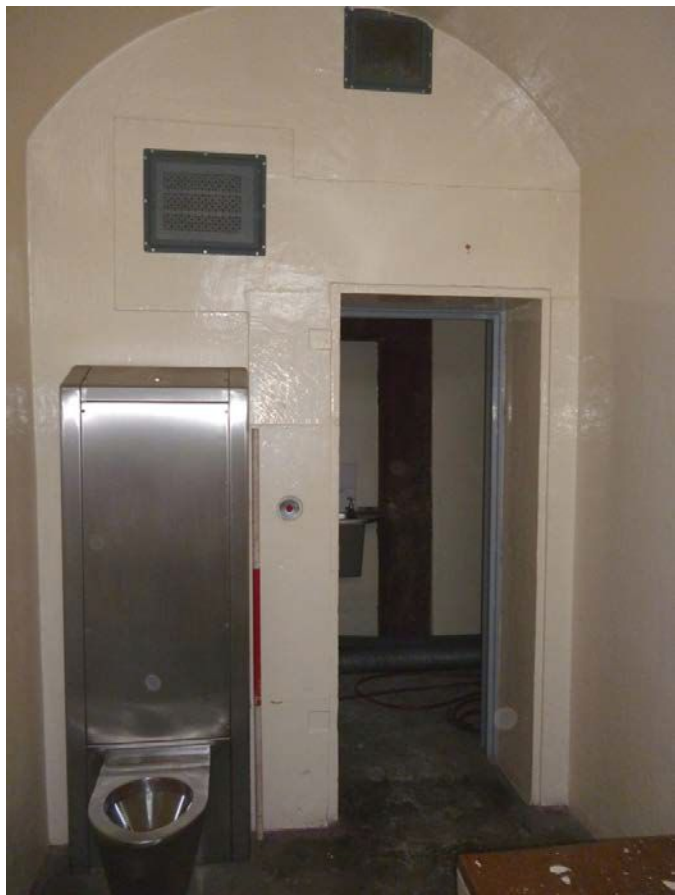
4.3.15 **Ground floor Room 13**: this is the most north-easterly of a row of cells along the north-west side of the building. It has a concrete floor and barrel-vaulted ceiling finished with plaster and paint. The walls are similarly finished. The north-east elevation is essentially plain although there is a bulge in the masonry on the north-west side and an attached projecting steel plate running almost the full length of the wall at ground level. The south-east elevation has a toilet attached on the north-east side, which is steel with an associated steel casing presumably housing the pipes (Plate 59). The doorway is in the centre of the elevation and has a dressed stone surround with a rebate but has a modern iron door attached on the outside. There is a modern metal grill vent above the toilet, set in an area of ashlar blocks, and another above the door (Plate 60). The south-west elevation is plain but has a timber bed set on a block of masonry against it. The north-west elevation has a stone block, presumably a lintel, at low level with the space below covered by a panel. Above is a window with a multi-light concrete casement set in a splayed dressed stone surround (Plate 60).

Plate 59 (left): South-east elevation, Room G13

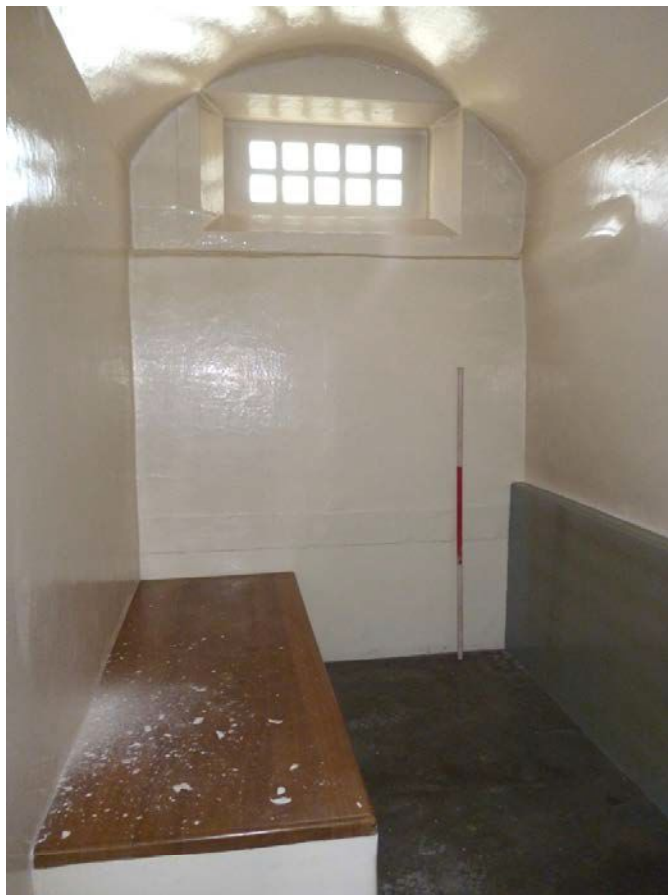
Plate 60 (right): North-west elevation, Room G13

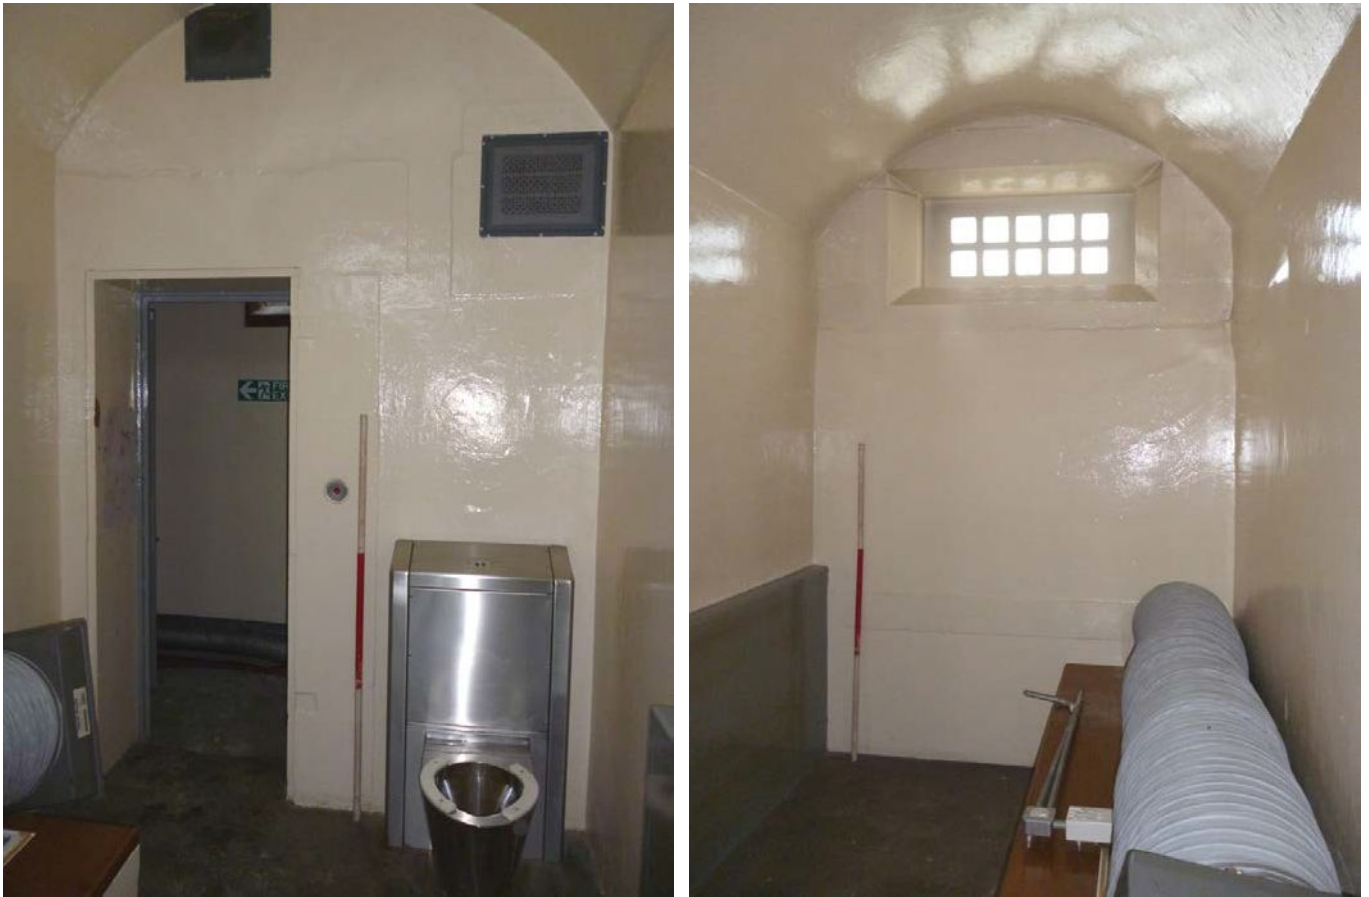
4.3.16 **Ground floor Room 14**: this is essentially identical to Room G13, but with the bed on the north-east side, the toilet to the south-west of the doorway, and the steel sheet attached to the south-west wall (Plate 61 and Plate 62). The name 'KRAY' and letters 'R' and 'W' have been scratched into the stonework of the doorway.

Plate 61 (left): South-east elevation, Room G14

Plate 62 (right): North-west elevation, Room G14

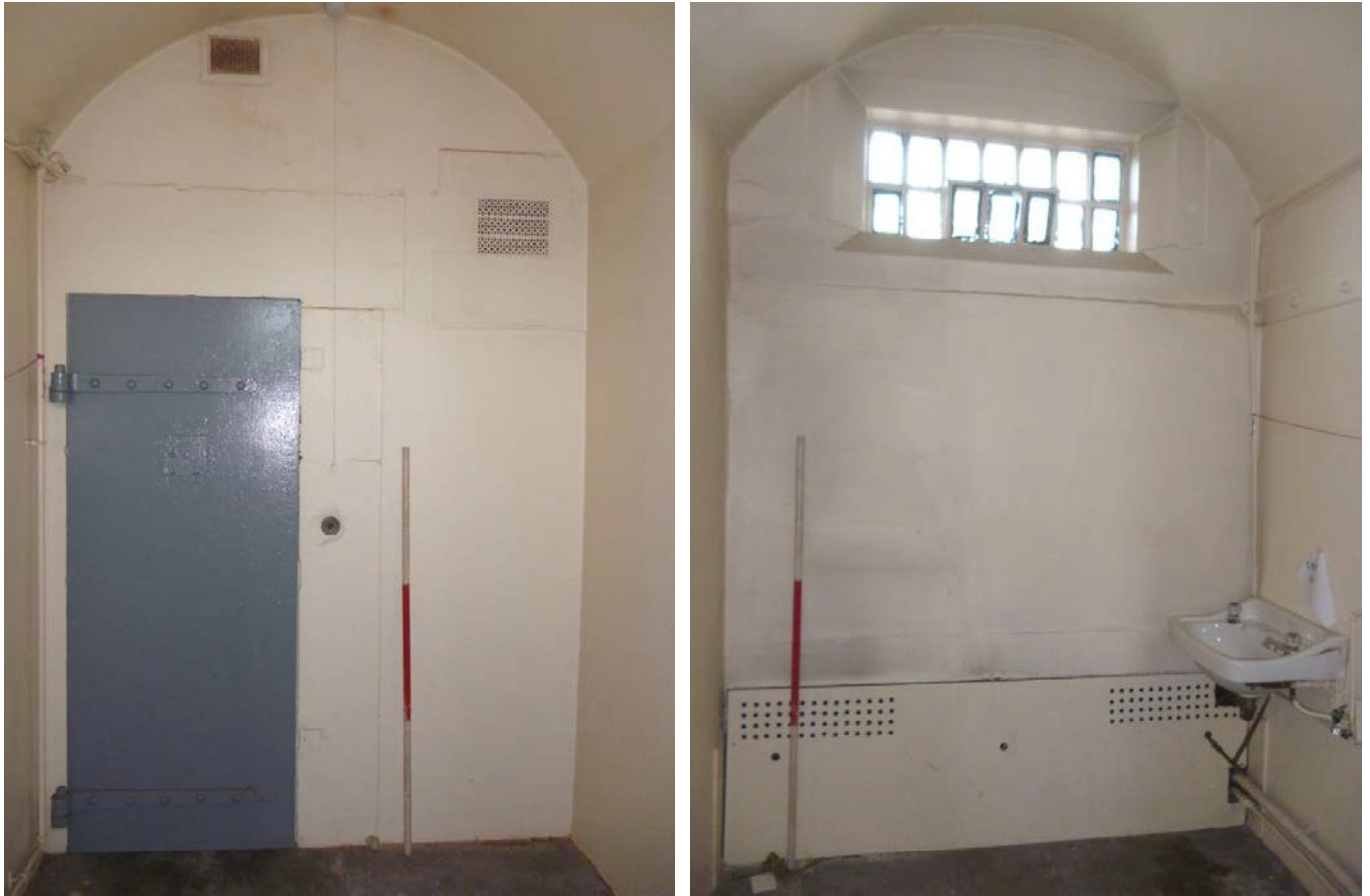
4.3.17 **Ground floor Room 15:** this also has a concrete floor and barrel-vaulted ceiling finished with plaster and paint as are the walls. It is generally quite plain, with a sink and two taps attached on the north-east side (Plate 64), with the scar for a further sink. The south-east elevation has its original heavy iron door on long strap hinges fitting the rebate in the stone surround and there is a small iron vent over the door and a larger original one to the south-west (Plate 63). The north-west elevation has a timber 14-light casement, of which three lights in the bottom row are hinged (Plate 64). There is a stone lintel at low level below which is a large iron plate with vents covering what appears to be an open space (Plate 64).

Plate 63 (left): South-east elevation, Room G15

Plate 64 (right): North-west elevation, Room G15

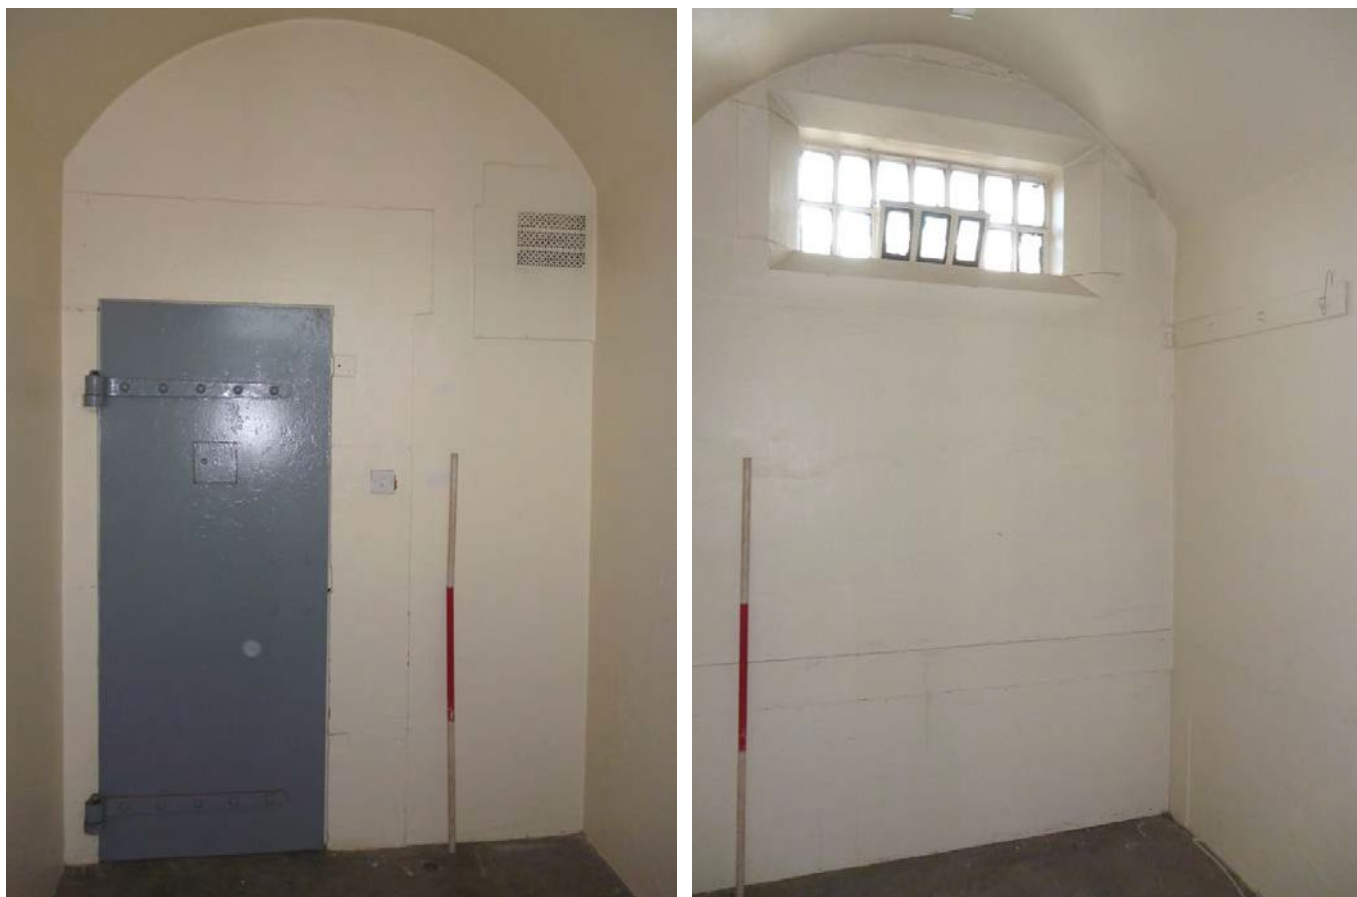
4.3.18 **Ground floor Room 16:** this is broadly the same as Room G15 although there is no sink or similar attached to the wall. The doorway and door to the south-east are the same as in G15 although there is only the large vent to the south-west (Plate 65) and the north-east elevation has a large iron support bracket attached on the north-west side (Plate 66).

Plate 65 (left): South-east elevation, Room G16

Plate 66 (right): North-west elevation, Room G16

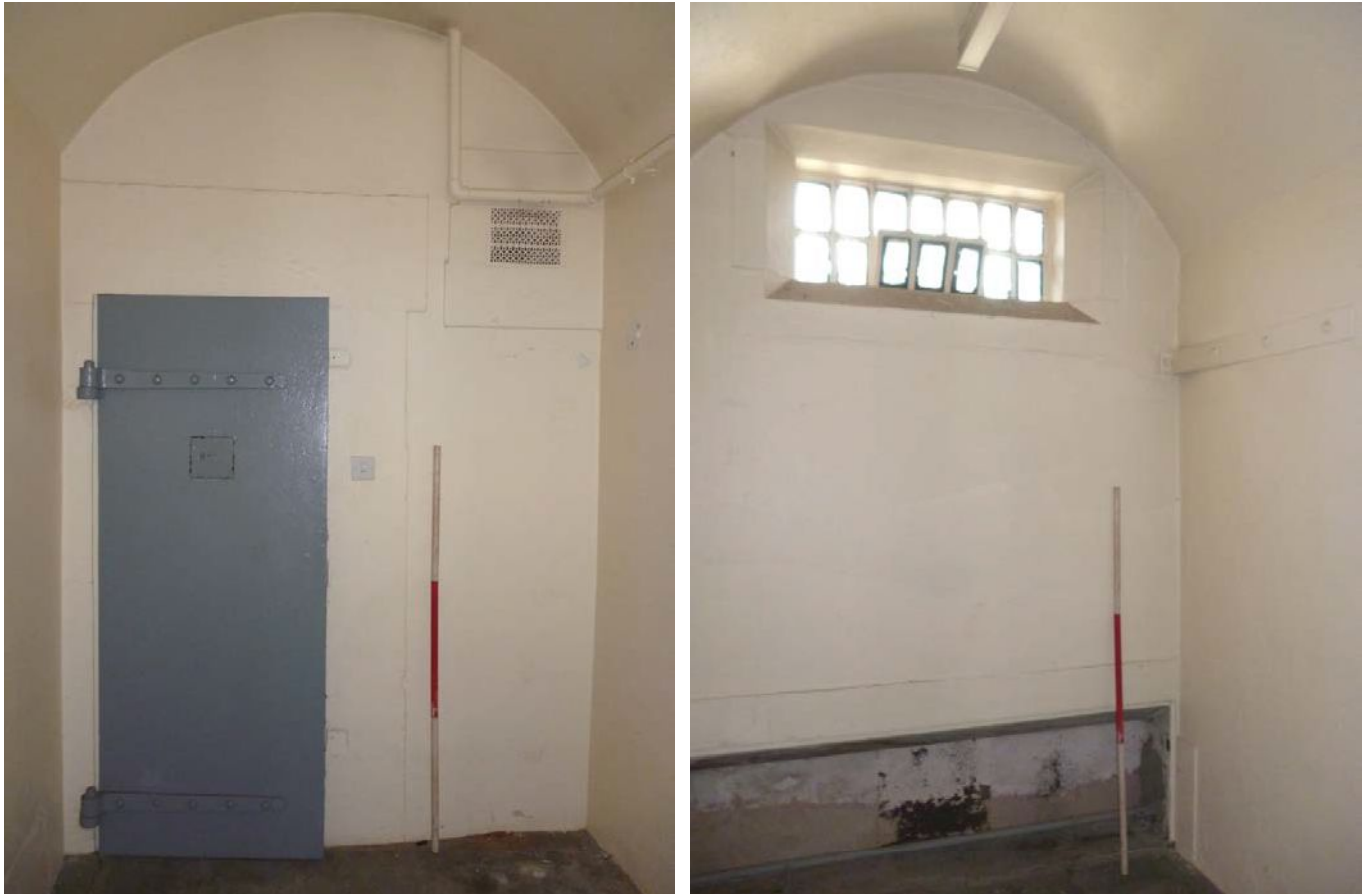
Plate 67 (left): South-east elevation, Room G17

4.3.19 **Ground floor Room 17:** this is the south-westerly of the five cells and is essentially the same as Room G16, including the supporting bracket on the north-east elevation and the vent to the south-west of the doorway in the south-east elevation. The panel at the base of the north-west elevation, below the stone lintel, has been removed revealing a chamfered lintel and a blocked central aperture filled with an iron sheet.

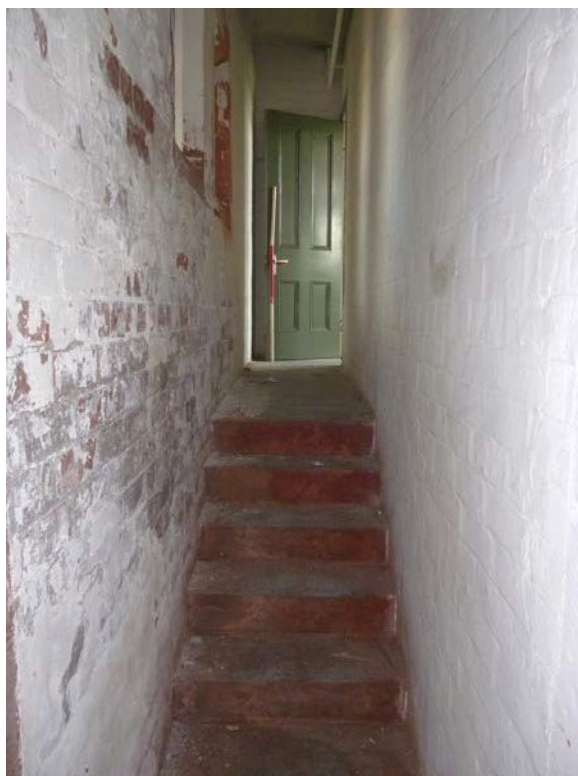
Plate 69: General view of Room G18 from the north-west end, showing the steps and door to the south-west

4.3.20 Ground floor Room 18: this comprises a short corridor linking the cells (Rooms G13-G17) and associated corridor (Room G10) to the court room (Room G22). It has a concrete floor with a flight of steps up from the north-west end (Plate 69) and a plaster ceiling. The walls are painted brick laid in stretcher bond and there is a heavy iron door at the north-west end. There are two small windows in the north-east elevation with chamfered stone surrounds and relatively late two-light hinged casements. There is a doorway at the south-east end of the south-west elevation, with four moulded panels (Plate 69).

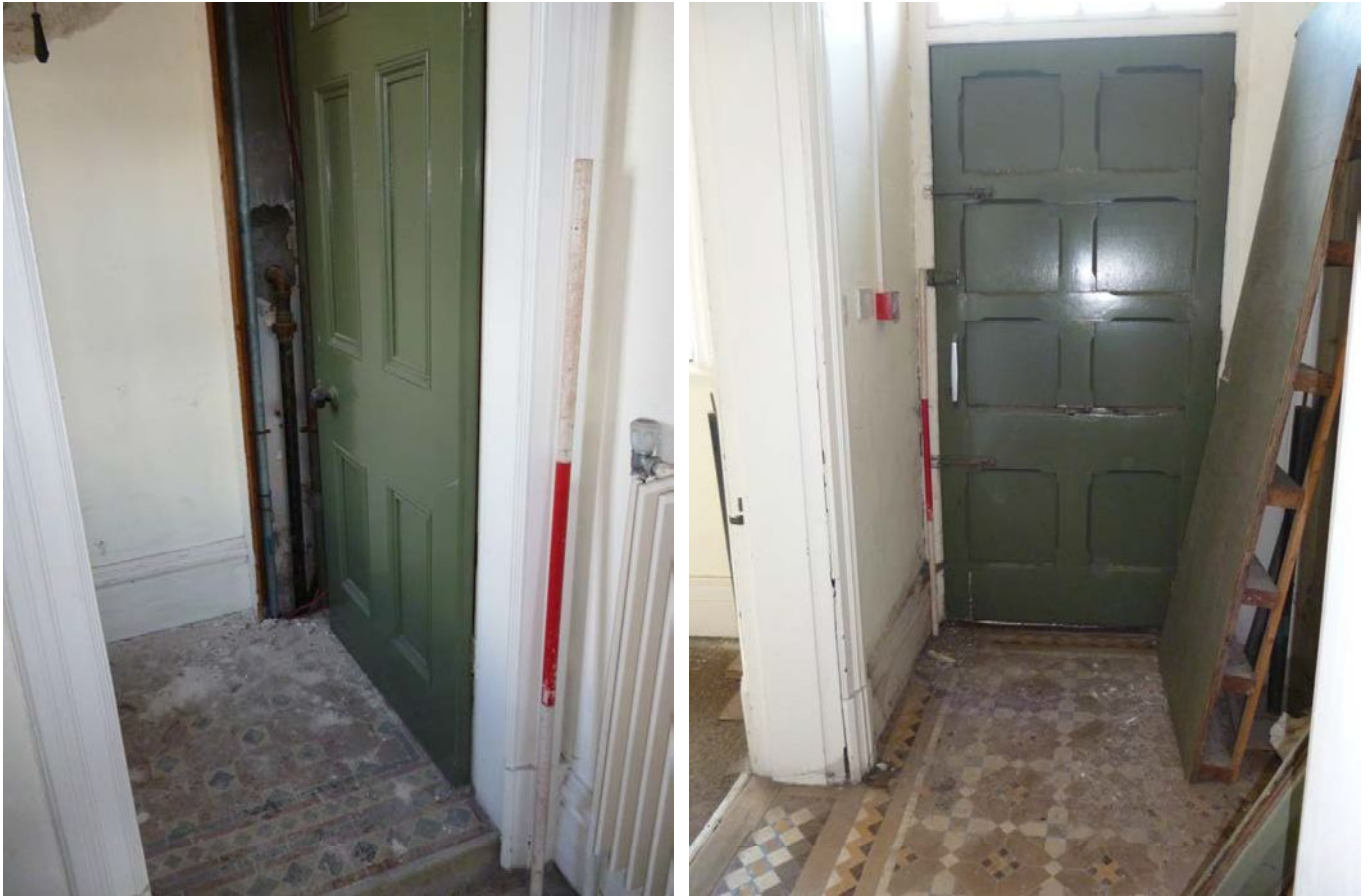
Plate 70 (left): Tiled floor and dividing doorway, Room G19

4.3.21 **Ground floor Room 19:** this comprises a small toilet with a separate sink separated by a brick partition wall with a doorway with a moulded surround and six-panel door (Plate 70). The floor is finished with tiles laid in a geometric pattern, and steps up on the north-east side (Plate 70). The ceiling is plaster with a moulded cornice and an access hatch to the roof space above. The walls are finished with plaster and paint over brick and there is a moulded skirting board throughout. The north-east elevation is plain with boxed and exposed pipes attached and the south-east elevation is also plain. The south-west elevation has a doorway into Room G20 with a moulded surround and six panels. The north-west elevation has two windows, one either side of the dividing wall, with moulded surrounds and a rail below the sill and housing six-light casements, the top two hinged. Two sinks and a toilet are also attached.

4.3.22 **Ground floor Room 20:** this comprises a large entrance hall or lobby leading to a main entrance on the south-west side of the building. This too has a tiled floor with a geometric pattern (Plate 71) and a plaster ceiling with a moulded cornice. The walls are finished with plaster and paint and there is a moulded skirting board throughout. There are doorways to the north-east, south-east and south-west, all of which have moulded surrounds. The doors to the north-east and south-east have six moulded panels, while the door to the south-west has eight stop-chamfered panels and four over lights (Plate 71). The door to the south-east is labelled 'COURT OFFICE'.

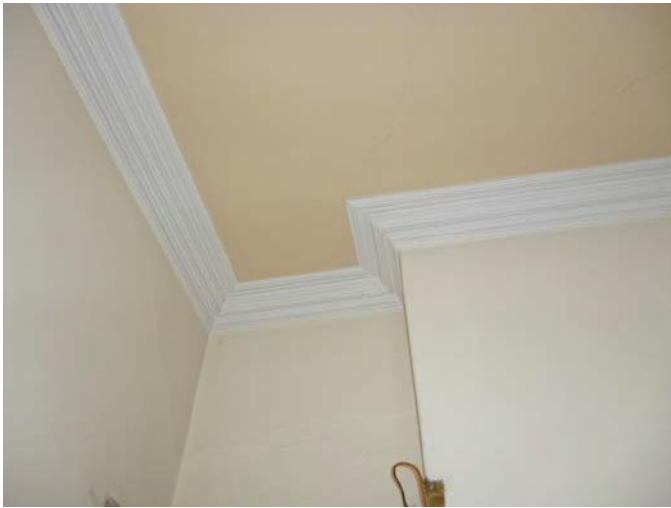
Plate 72 (left): Cornice detail in Room G21

4.3.23 **Ground floor Room 21:** this has a parquet floor underneath a carpet, with a stone or concrete hearthstone on the north-east side. The walls are finished with plaster and paint and there are the remnants of wallpaper in the north corner where a cupboard has been removed (Plate 73). There is a tall moulded skirting board throughout and the ceiling is plaster and has a moulded cornice (Plate 72). The north-east elevation has an alcove on the north-west side and in the centre there is a low rounded block projecting from the centre of what was originally the fireplace, perhaps to support a later fireplace or stove (Plate 73). There is a doorway in the south-west elevation with a moulded surround and plain door. The south-west elevation has a large window with splayed jambs and moulded surrounds and secondary glazing has been added. The north-west elevation has a doorway on the south-west side with a moulded surround and six-panel door (Plate 74).

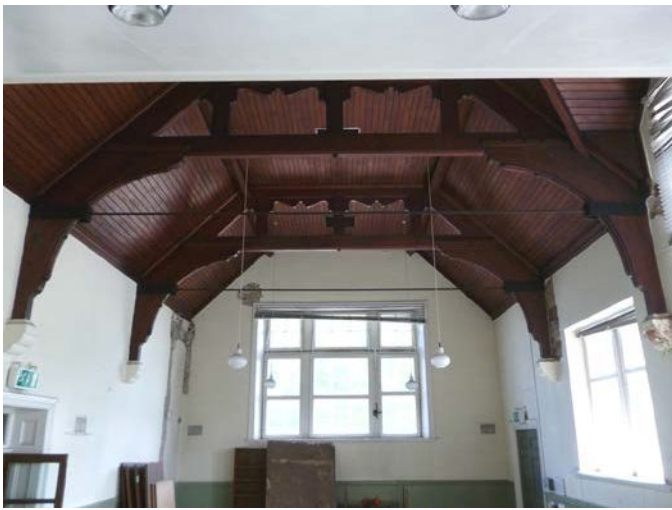
Plate 75 (left): Roof trusses in Room G22

4.3.24 Ground floor Room 22: this was originally the main courtroom and comprises a large room extending across much of the south-west side of the building. It has a timber floor comprising tongue and groove boards orientated south-east/north-west, which is raised at the north-west end by a masonry wall to create a stage area, which is covered by vinyl sheeting and accessed by a flight of steps on the south-west side. There is also a raised section of floor on the north-west side adjacent to one of the doorways, which leads from Room G18 onto it and presumably served as the dock for the court (Plate 76). The whole room is open to the roof, which is clad with tongue and groove planks attached to the rafters and supported by three trusses (Plate 75). These are of a complex design with posts supported by scrolled stone corbels set into the wall supporting the principal rafters, which have attached angled braces supporting a collar (Figure 7). This in turn supports three posts between it and an upper collar, which is decorated with scrolled timber and the whole truss is held with iron straps and an iron tie rod running between the principal rafters. There are three gridded vents set into the flat section of the ceiling and an access hatch. The walls are finished with plaster and paint although the lower part is finished with tongue

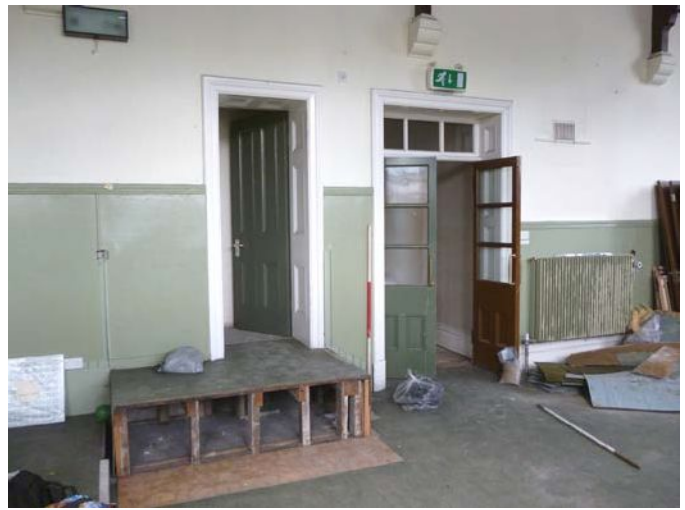
Plate 76 (right): Doorways and raised floor on north-east side of Room G22

and groove planks below a moulded rail although these have been covered with hardboard. The north-east elevation has a doorway on the north-west side with panelled reveals and a moulded six-panel door connecting G18 to the raised floor (Plate 76). There are a set of double-doors to the south-east each with two moulded panels and three lights as well as three over lights and panelled reveals. There are also two vents covered with iron grills in this wall. The south-east elevation has a large window of three parts, as per the exterior, with a moulded surround (Plate 77). The south-west elevation has a double-door on the south-east side, each door with four panels (Plate 78). There are three windows to the north-west, comprising two pairs of six-light casements and a taller window between, as per the external description, with moulded surrounds. The north-west elevation has a doorway on the south-west side with a six-panel door and moulded surround but is otherwise plain, although a large panel containing four lights hangs from the ceiling over the stage area (Plate 79). The double doors on the south-east side of the south-west elevation lead into a small porch (Room G22a). This has a rubber mat over the floor and flat tongue and groove planks covering the ceiling and a moulded cornice. The walls are all dressed ashlar sandstone blocks. There is a double-door to the north-east with ovolo-moulded quoins, and a window to the south-east with splayed jambs and leaded window. The south-west elevation is plain and the north-west has a doorway with a large plank and batten door with long strap hinges and elaborate latch (Plate 80).

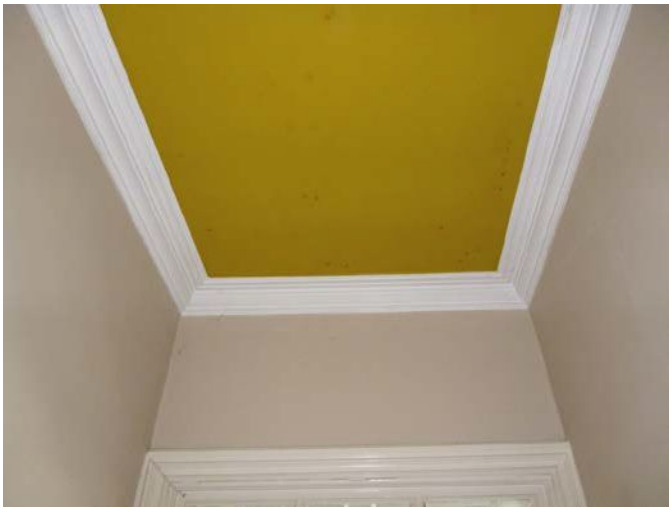
Plate 81 (left): Cornice detail, Room G24

4.3.26 Ground floor Room 24: this comprises an L-shaped corridor linking the various rooms in this part of the building. It has a timber board floor, the boards orientated north-west/south-east and a plaster ceiling with a moulded cornice (Plate 81). The walls are finished with plaster and paint. There are doorways to the north-west, south-east and north-east, all with moulded surrounds and six panel doors, apart from the modern door to the north-west (Plate 82). There is also a double doorway with three lights over and a double door with two panels and three lights in each door to the south-west (Plate 83). There is an internal dividing door to the south-east with three glazed panels on the north-east side and leaded glass over as well as six-lights in the door itself (Plate 84). This forms a porch to the main door, which has four panels in each door plus four over lights and a moulded surround (Plate 84).

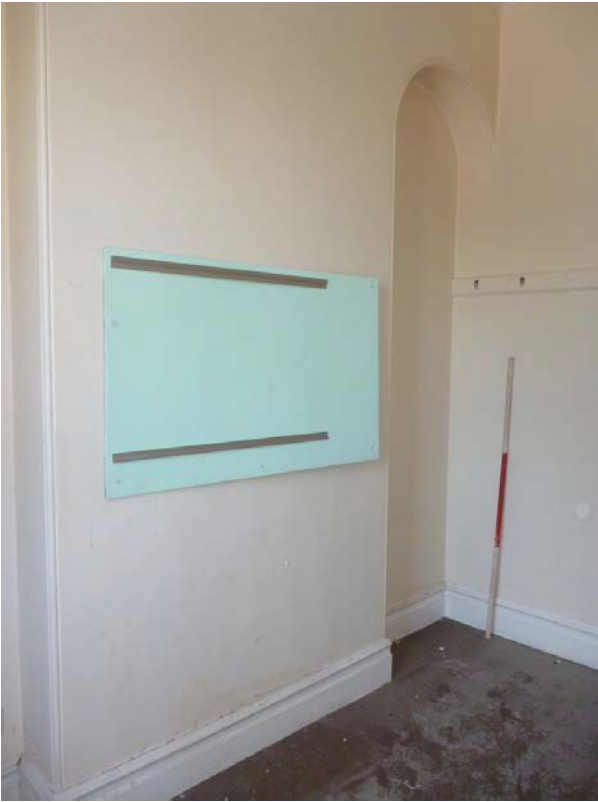
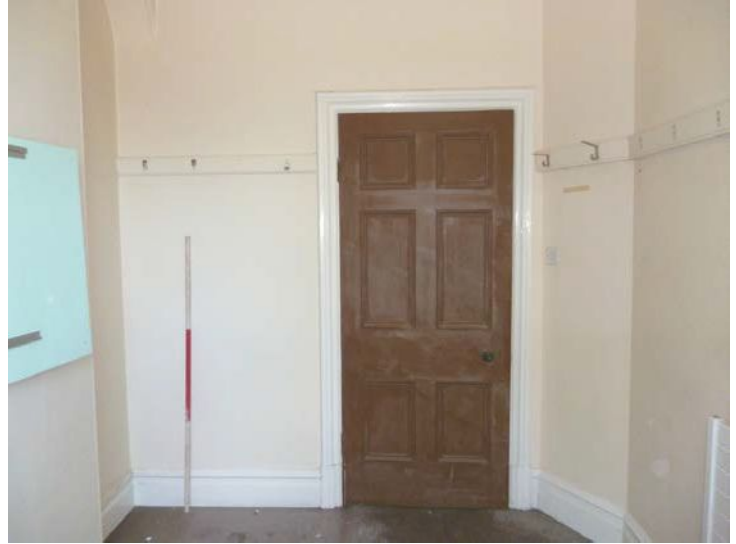
Plate 85 (left): Chimney breast and alcove, south-west elevation, Room G25

4.3.27 **Ground floor Room 25:** this has a vinyl floor covering and plaster ceiling with moulded cornice. The walls are finished with plaster and paint and there is a moulded skirting board. The north-east elevation is plain apart from an attached beaded batten with coat hooks and the south-east elevation has a window with a moulded surround. The south-west elevation has a projecting chimney breast, the fireplace for which is blocked and covered by the skirting board. There is a round-headed alcove in the resulting recess on the north-west side. The north-west elevation has a doorway with a moulded surround and six-panel door and another batten for coat hooks, which continues to the south-west side. The north corner is angled.

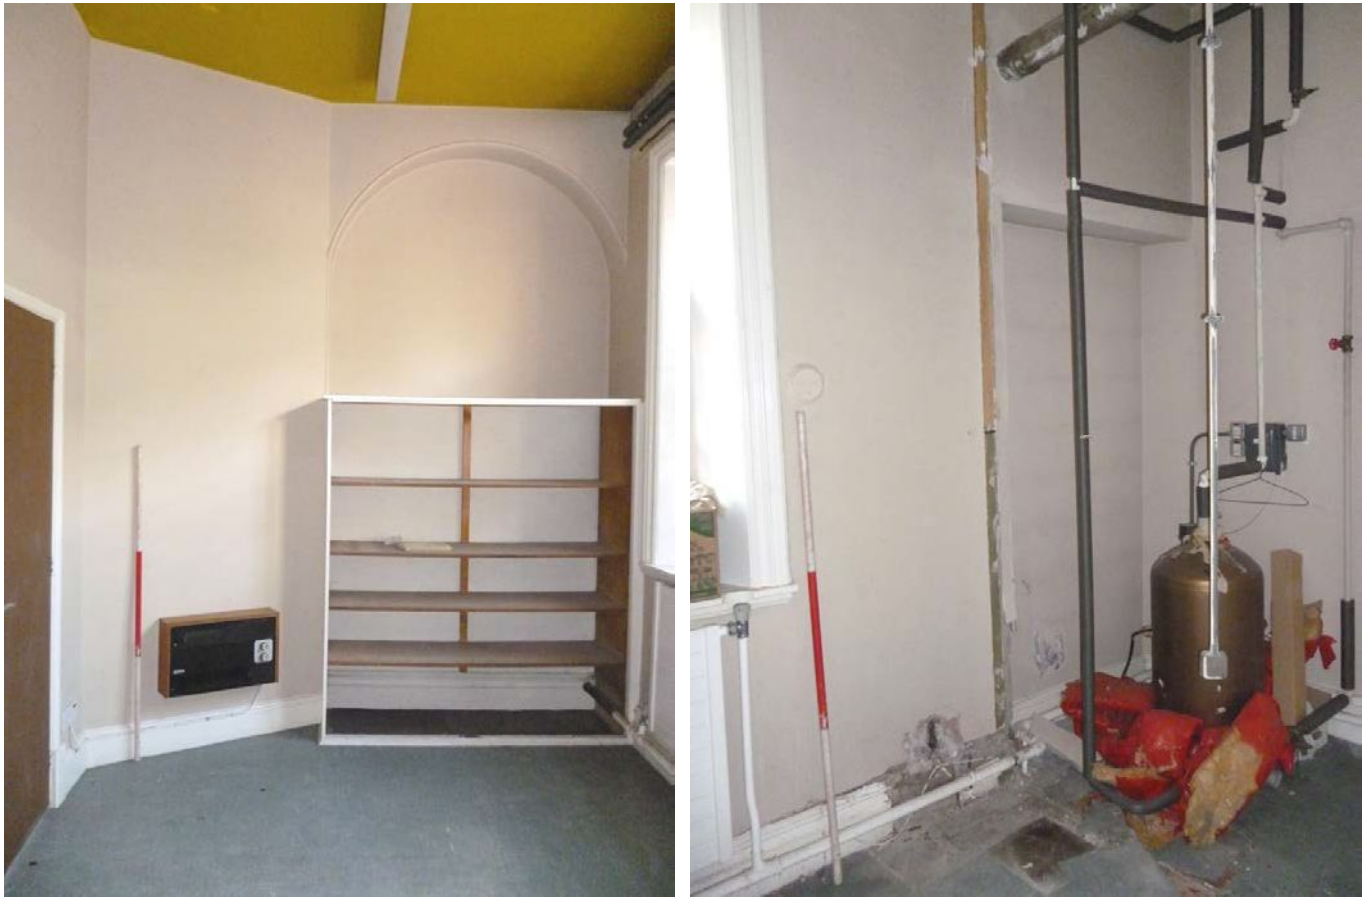
Plate 87 (left): Alcove and angled wall to the south-west, Room G26

4.3.28 **Ground floor Room 26:** this has a vinyl floor covering over floorboards orientated north-east/south-west and the ceiling is finished with plaster with the scar of a stud wall running across the north-east side, clearly originally forming the side of a cupboard housing a hot water tank, which is still present (Plate 88). The walls are finished with plaster and paint and there is a moulded skirting board throughout. The north-east elevation is plain, the south-east has a doorway on the south-west side with a plain surround and door. The south-west is angled with an alcove on the north-west side with a round head (now covered by a book case) (Plate 87), suggesting there was a fireplace in this corner. The north-west elevation has a double window with splayed jambs and a moulded surround. There is another alcove at the north-east end with slightly splayed jambs extending the full length, which presumably was originally a doorway or another window (Plate 88).

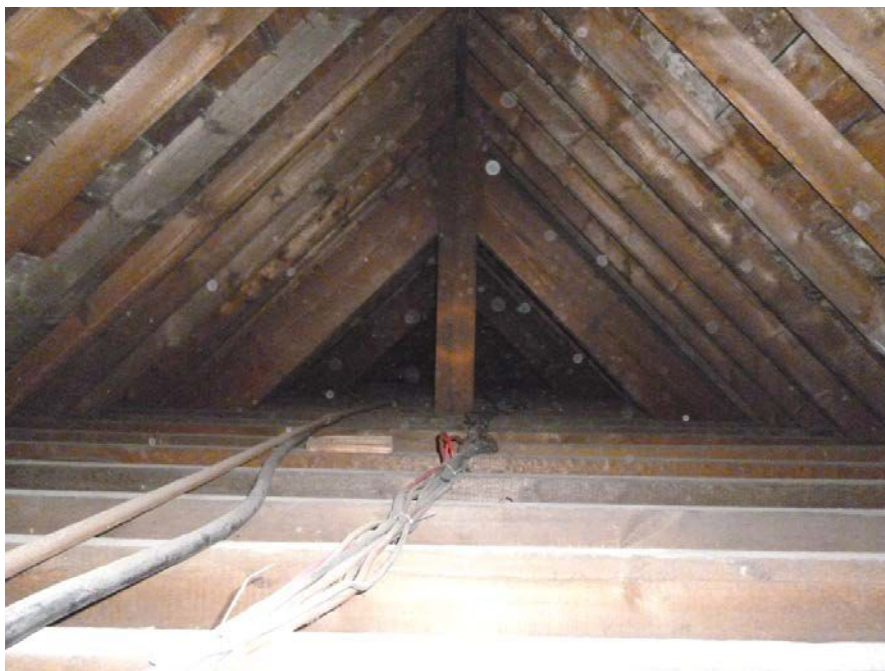
4.3.30 **Roof space:** the area over Rooms G19-G21 is a single space with a complex arrangement of angled struts and purlins forming the roof structure. The walls to the north-east and south-west are stone, while the south-east is brick laid in English garden bond at a ratio of five rows of stretchers to one row of headers. There is a vent in the north-east elevation. The roof space over Room G22 could not be safely accessed but reveals the tops of the trusses in Room G22, which comprise a series of king posts (Plate 89). There is also timber sarking backing the rafters.

Plate 89: Roof structure above Room G22

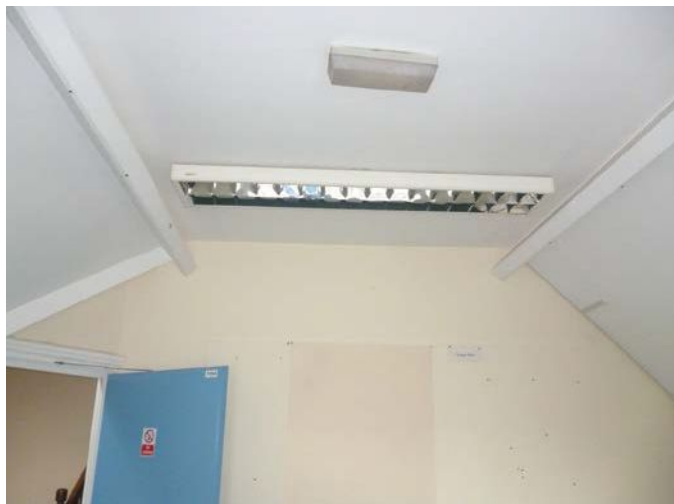
Plate 90 (left): Ceiling and purlins, Room F1

4.3.31 **First floor Room 1:** this has a carpet floor presumably over timber boards and a plaster ceiling sloping down to the north-west and south-east. There are two purlins exposed, one per pitch, and they are chamfered (Plate 90). The walls are finished with plaster and paint and there is a tall moulded skirting board throughout. The north-east elevation has a wide window with splayed jambs and moulded surrounds. The south-east elevation is plain and angled at the south-west end where there is a doorway with a moulded surround but modern door. The south-west elevation is plain, the north-west elevation has a chimney breast in the centre, with a blocked hearth with the skirting board across it although a possible line of the opening is visible as a scar in the plaster. There is a cupboard set in the alcove on the north-east side with a double door with two moulded panels and a entablature and four original shelves inside and a beaded batten at the top (Plate 91).

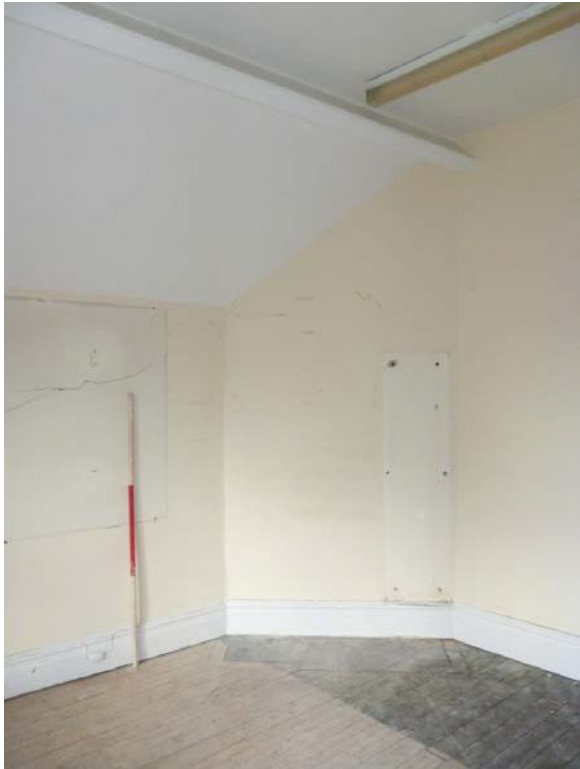
Plate 92 (left): Angled wall in the west corner, Room F2

The north-east and south-west elevations are plain. The north-west elevation has an angled section on the south-west side where there was evidently a fireplace, which is blocked and covered with the skirting board (Plate 92). The south-east elevation has a large window with splayed jambs and a moulded surround (Plate 93).

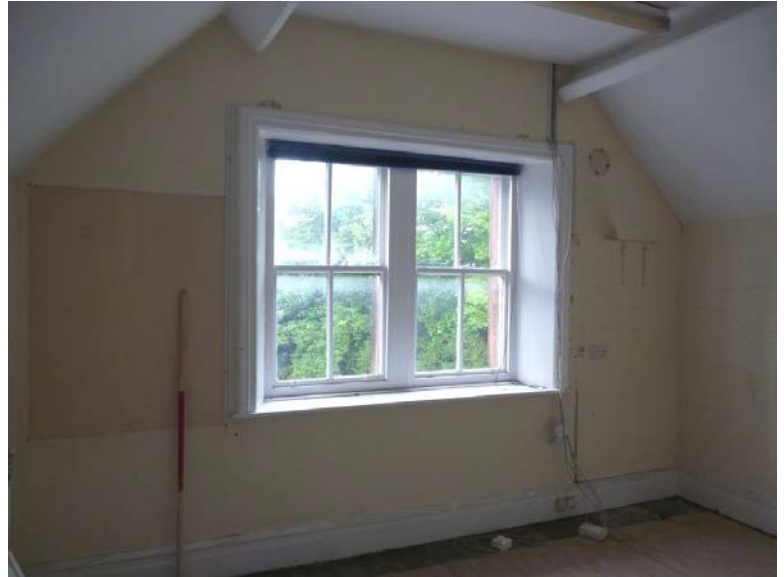
Plate 93 (right): Window in the south-east elevation and purlins, Room F2

4.3.32 **First floor Room 2:** this has a board floor, the boards orientated north-west/south-east and stained around the edges and there is a concrete hearth stone in the west corner. It has a plaster ceiling, sloping down to the north-east and south-west and there are two purlins exposed with chamfered edges (Plate 93). The walls are finished with plaster and paint and there is a moulded skirting board throughout.

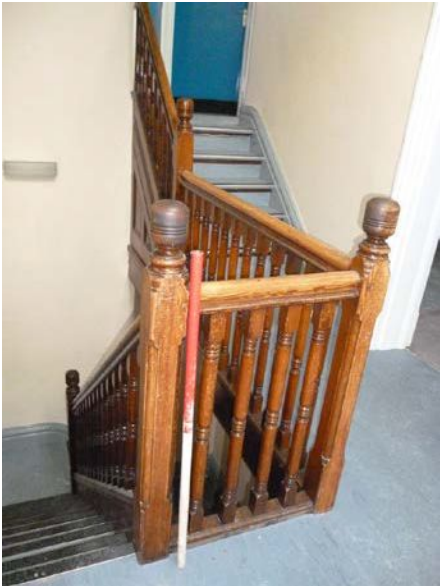
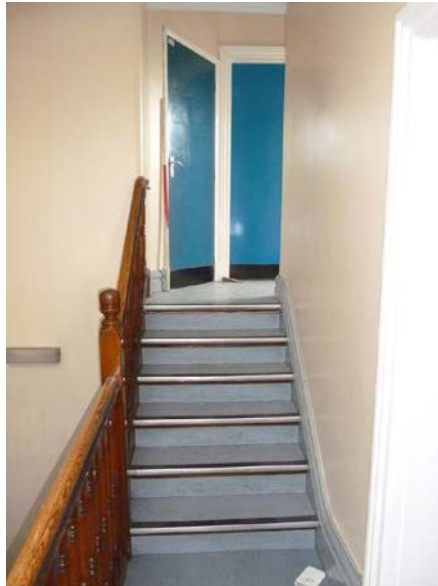
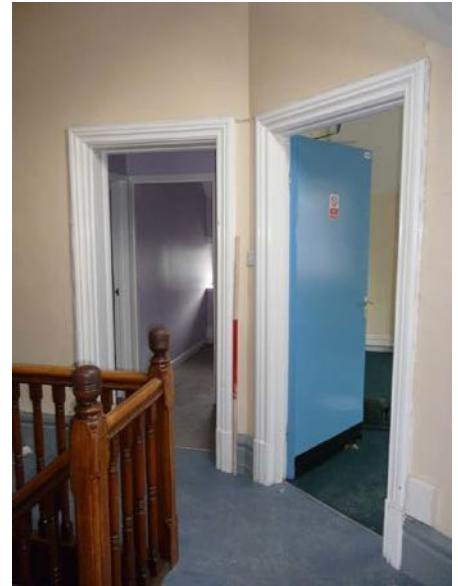
Plate 94 (left): Top of staircase, Room F3

4.3.33 First floor Room 3: this comprises the top of the stairs and a hall linking the rooms on the north-east side of the first floor. The stairs turn to the south-west (Plate 94) and a further straight flight then goes up to the rooms beyond and are in the same style as the floor below (Plate 95). The floor is timber boards finished with vinyl and the ceiling is plaster with two north-west/south-east orientated purlins, which are chamfered. The walls are finished with plaster and paint and there is a moulded skirting board throughout. Most of the walls are plain although there are doorways to the south-east, south-west and north-west most of which have moulded surrounds and modern plain doors (Plate 96). One door to the south-west has a modern surround and door and leads into a cupboard (essentially part of Room F5). The north-east elevation has a low window with splayed jambs, moulded surround and two lights (Plate 97). The corridor extending to the south-west runs along the north-west side of the building within the slope of the roof where there are two skylights (one of two lights and a Velux window) and there are two north-east/south-west orientated purlins (Plate 98). There is a door at the south-west end in Room F6 with a vent in the wall to the north-west.

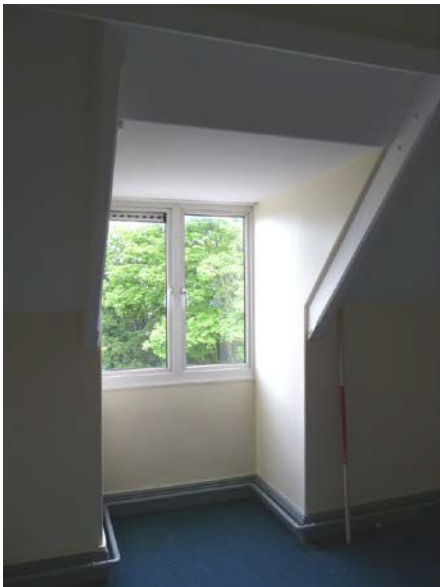
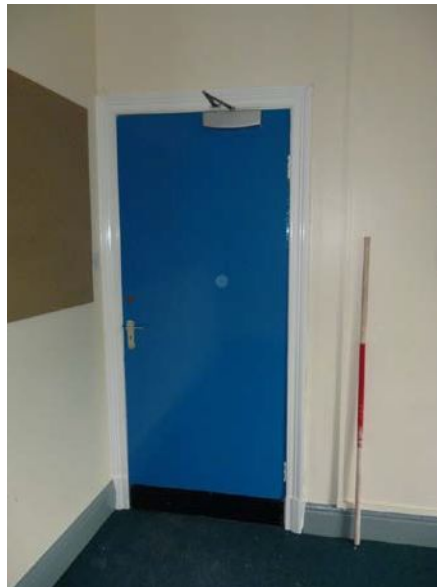
Plate 100 (left): Dormer window, south-east side, Room F5

4.3.35 **First floor Room 5:** this has a carpet floor and a plaster ceiling sloping down to the south-east, with a chamfered purlin orientated north-east/south-west and raking supports leading to a dormer window to the south-east (Plate 100) and there is an access hatch to the roof space on the north-west side. The walls are finished with plaster and paint and a moulded skirting board and are mostly plain. There is a two-light UPVC window in the dormer to the south-east and a doorway to the north-east with a moulded surround, in a different form to others in the building, and a modern door (Plate 101).
