# PRIORY CLOSE, CARTMEL, CUMBRIA

## Archaeological Building Recording

Client: Lisa Clarke

November 2013

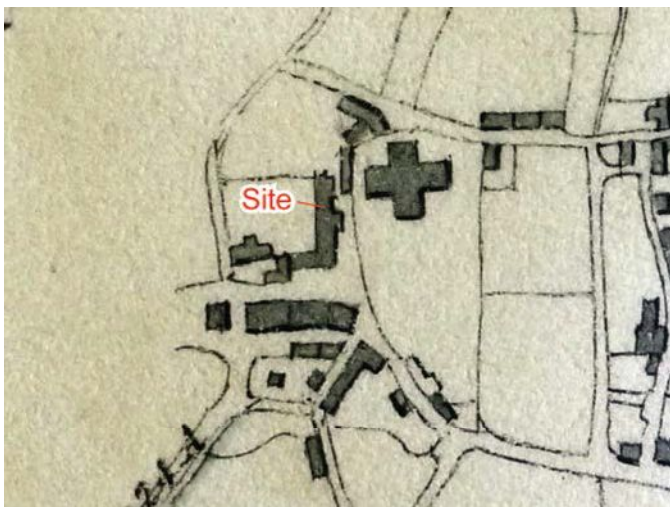
Plate 1 (left): Extract from the Enclosure map of 1807 (CAC(K) WPR 89 Z3)

3.1.2 **Enclosure map, 1807:** (CAC(K) WPR 89 Z3 1807): this map clearly shows the row of buildings to the west of the Priory albeit in a simplified way (Plate 1). The segment set back to the west near the north end of the block is apparent.

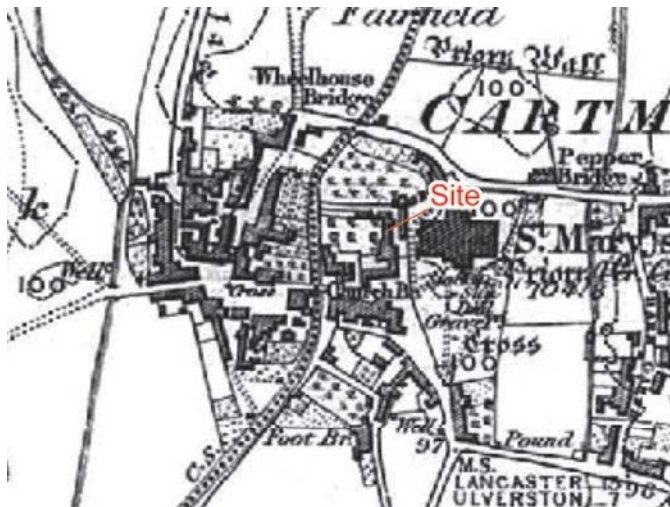
Plate 2 (right): Extract from the Ordnance Survey map of 1851

3.1.3 **Ordnance Survey, 1851:** this plan is also detailed enough to show the general arrangement of buildings forming the block including Priory Close (Plate 2).

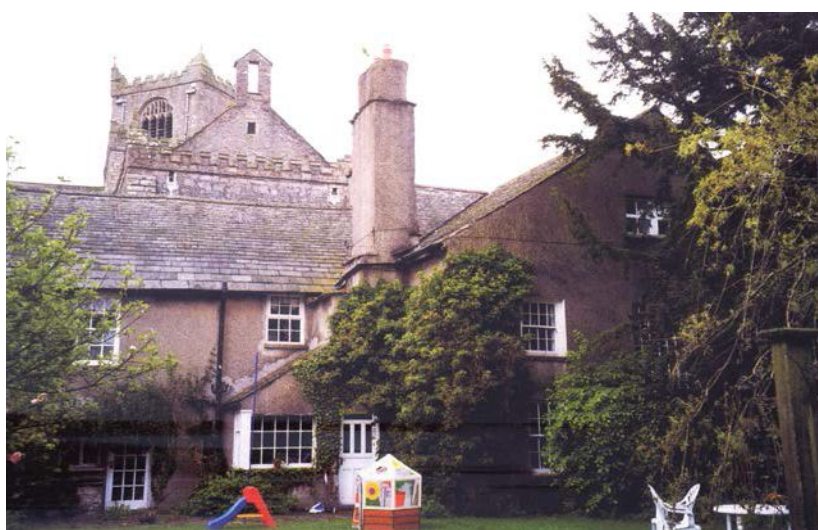
**Plate 7 (left): The rear (west) elevation of the house in 1999 (CVS and RBPT 1999, 11)**

3.1.8 **Photographs and plans, 1999:** the investigation of the building in 1999 included two photographs of the rear (west) of the building (Plate 7 and Plate 8) and plans of the ground and first floors (Plate 9). These essentially show that this side of the building is little changed since then, although it has been re-rendered.

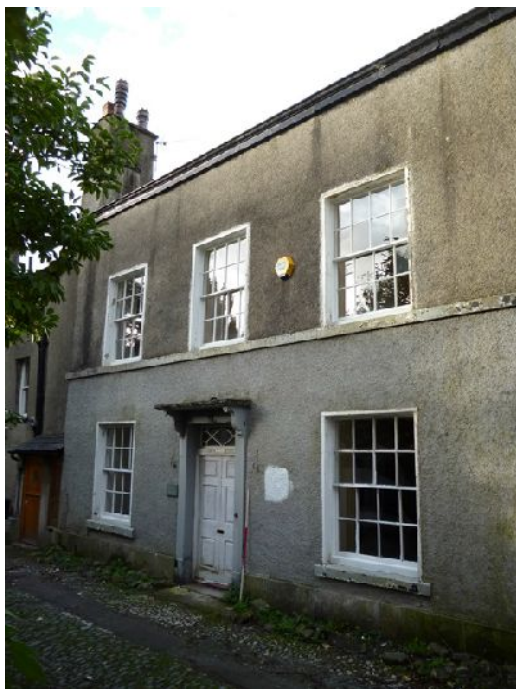
Plate 10 (left): South end of the east external elevation

4.2.1 **East elevation:** the south end of the elevation, corresponding to the main part of the house, has an ashlar plinth which continues either side of the central ground floor doorway (Plate 10 and Plate 11). The doorway has a square stone surround on projecting bases and supports a canopy with an ovolo-moulded edge on scrolled brackets. It houses a modern six-panel bevel raised and fielded door with a geometric overlight with fluted band below. There is a 16-light, sash window, with no horns and a stone sill forming a narrow band, either side of the door at this level and three windows in the same style on the first floor, centred over the door. The first floor windows use the string course as a sill, which returns to the west, along the north elevation (see below). The north end of this elevation is plain, with a raised block at the junction, which is roughcast and topped with slate (Plate 12). The doorway north of the junction has a chamfered and rebated stone surround and heavy corbels support the stone canopy above, which is in poor condition but roughly moulded (Plate 13). The six-panel door is again bevel raised and fielded. The top two panels are glazed and the two at the bottom are truncated by a horizontal batten suggesting it has been reused. The window above this and to the north on first floor level has a four-light hinged casement and there is another small single-light hinged casement window to the north of this on ground floor level with a concrete sill. There are a further two ground floor windows to the north, one a tall, eight-light window with a slate sill, the other a four-light window with a stone sill located beyond a slight step in the wall and actually part of the adjoining property.

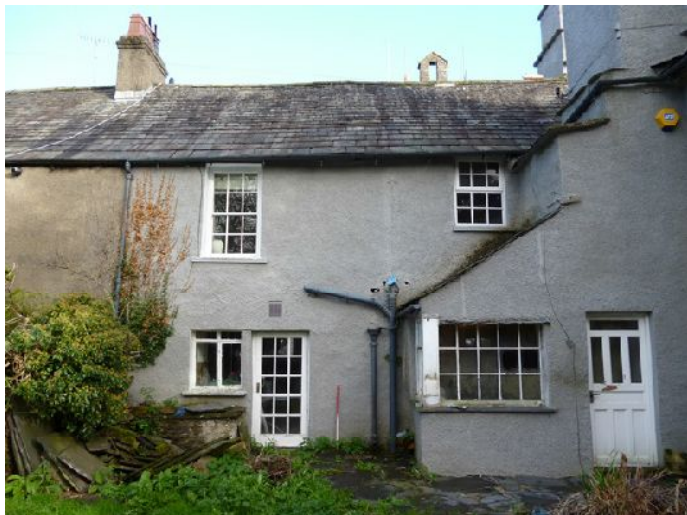
**Plate 14 (left): North end of the west external elevation**

4.2.2 **West elevation:** the west external elevation has been recently re-rendered in roughcast concrete. Starting at the north end, this elevation has two 12-light windows on the first floor, the north one is sash and the south one is hinged, both with stone sills (Plate 14). The ground floor has a four-light window with a large projecting block of masonry of unknown purpose below and a 15-light door to the south. To the south of this the elevation projects to the west to form the base of a large fireplace to which a mono-pitch outshut has been added, extending it to the north. This has two multi-light windows and a timber column at the corner and a door to the south with four panels and four glazed sections. The elevation returns again to the west to the south of the door and there are sash windows on the ground and first floor at the north end of this section (Plate 15 and Plate 16). The window at first floor level is a 16-light sash with horns, whereas the one on the ground floor is a 12-light casement. There is a split plank and batten door to the south of this on the ground floor with plain surrounds below a massive stair window. All the

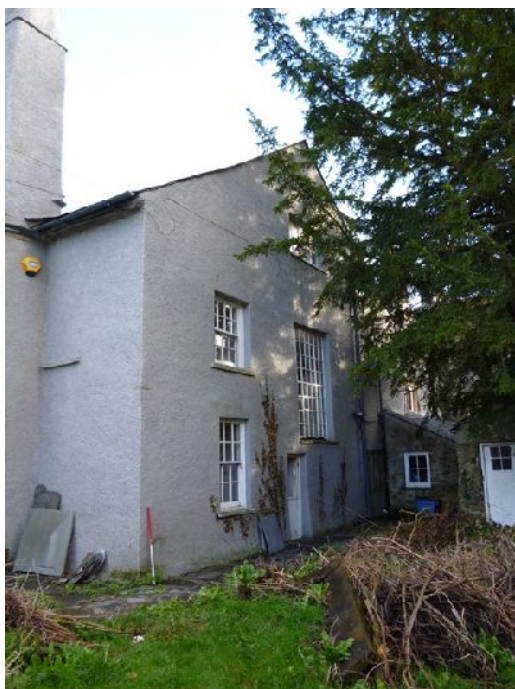
**Plate 16 (left): South end of the west external elevation**

windows have stone sills. At the top of the gable is a small eight-light window, formed by two four-lights. At the south end of the elevation on the ground floor is a three-light stone mullion, each section of which is split in three with timber casements (Plate 17). Above this is another 12-light sash window with no horns and there is a further three-light mullion with a drip mould over the neighbouring outshut to the south (Plate 18). The neighbouring property to the south has at least four mullions, most with rough stone slate drip moulds.

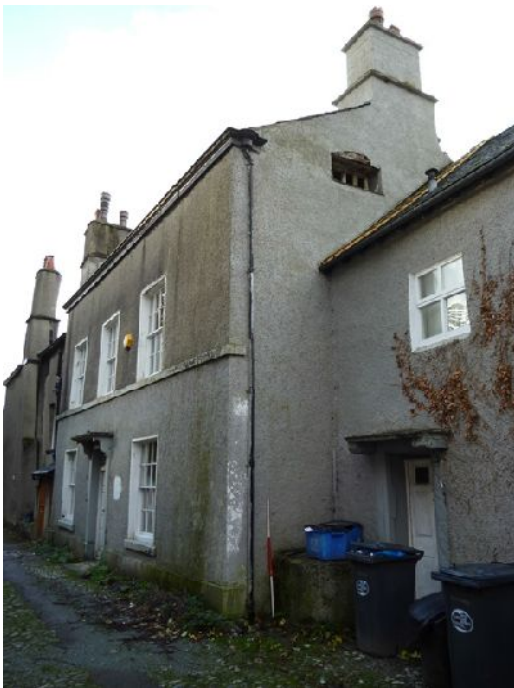
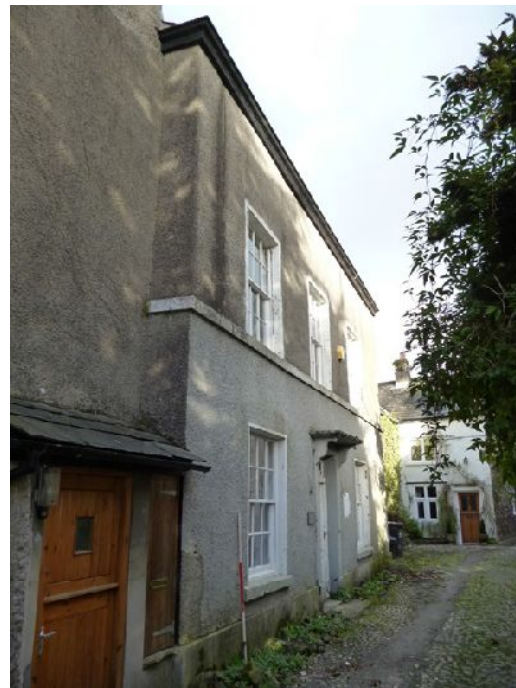
4.2.4 **South elevation:** the east side of the south elevation is visible with the chimney from the adjoining property abutting. The south elevation is rendered apart from the string course, which continues from the east elevation (Plate 20).

**Plate 19 (left): North external elevation**

**Plate 20 (right): South external elevation**

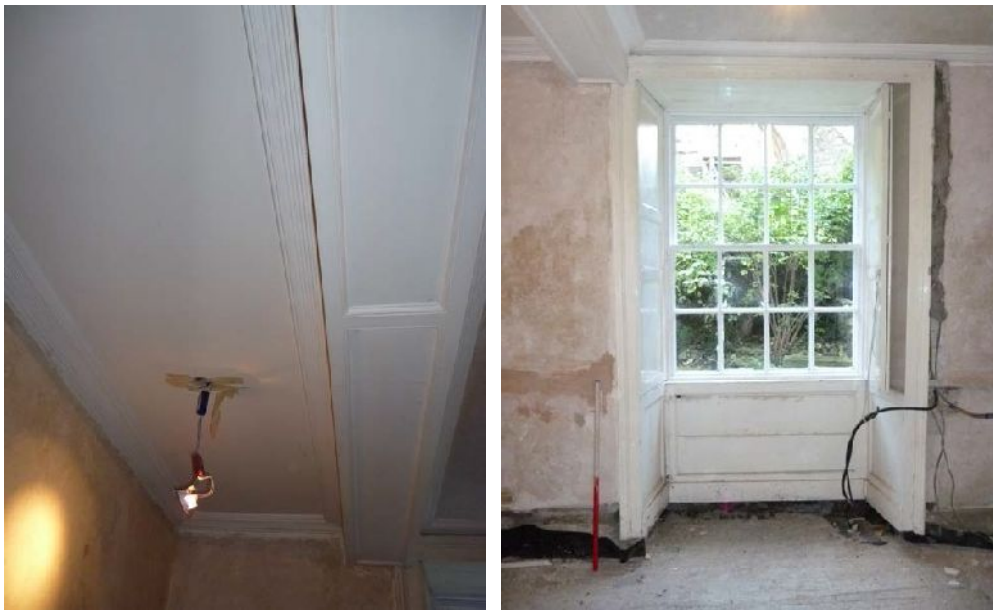
4.3.1 **Ground Floor, Room 1:** this room has had a modern concrete floor put in and as a result the skirting and such has been lost. Any wallpaper has been removed and the walls are plastered. The plaster ceiling has a moulded cornice and a single east/west beam with moulded edges (Plate 21). The north elevation is a stud partition with a central doorway with an ovolo-moulded surround. There is a central window on the east elevation with splayed jambs to the floor and moulded panels and shutters (Plate 22). The south elevation has a central fireplace with a square marble surround but it is plain internally (Plate 23). It has a slate hearth which is possibly modern as it has sawn edges. A stud wall sits proud of the masonry wall along the west elevation which has remnants of plaster on the north side of the main wall behind. There is a central round-headed alcove in the stud walling which has scars for two shelves and a decorative strip below with a shelf with scrolled side pieces and moulded edge *in situ* and a later cupboard with two doors below and ducting for pipes contained within (Plate 24).

Plate 21 (left): Beam and cornice in ground floor Room 1

Plate 22 (right): Window in the east elevation of ground floor Room 1

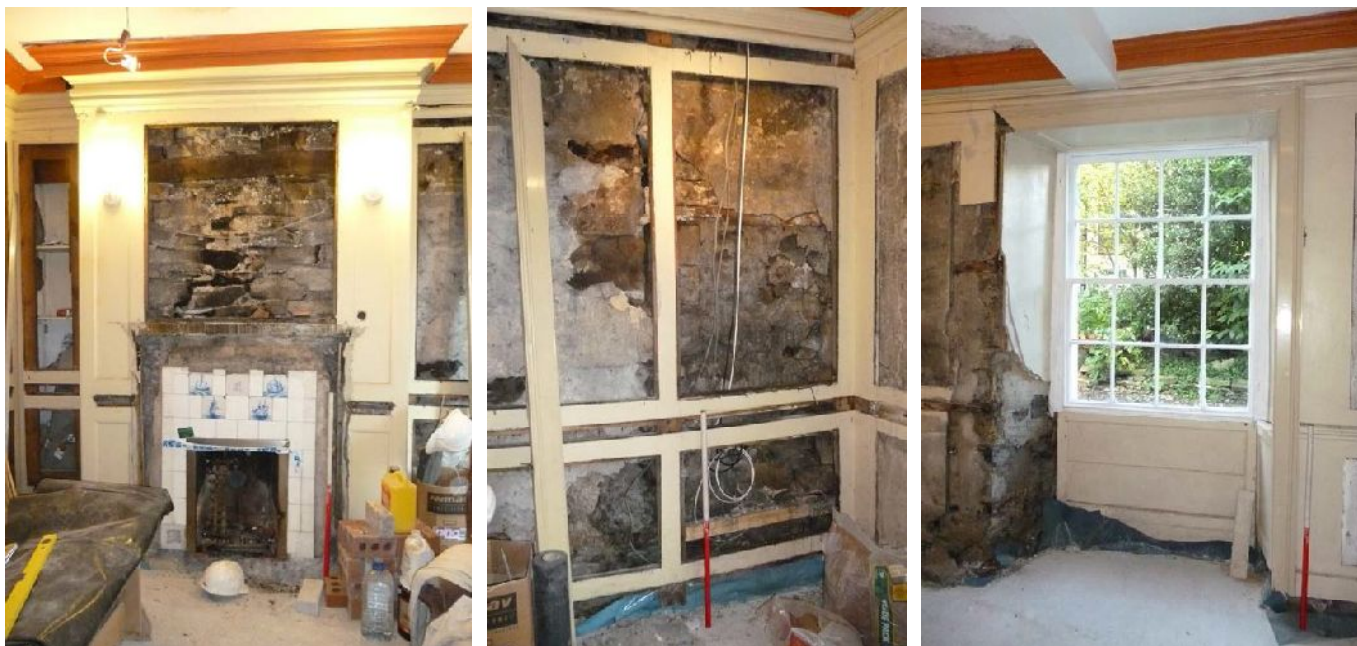
**Plate 29 (left): Fireplace in the north elevation in ground floor Room 3**

4.3.3 **Ground Floor, Room 3:** this room has a modern concrete floor and plaster ceiling with cornice and a very plain east/west beam. The walls have remnants of panels with a moulded top rail extended into entablature over the fireplace on the west side of the north elevation (Plate 29). It is panelled but the surround has been removed leaving the Delft tiles and metal hearth surround. The associated white tiles are clearly late (possibly 20<sup>th</sup> century) and set in concrete on machine-made red brick. The quoined end of the building to the north is visible in the elevation to the east of the fireplace and there is a blocked aperture (possibly a window) to the east of this with a timber lintel and quoined jambs (Plate 30). There is a central window on the east elevation with splayed jambs to the floor and some panelling left and a recess for shuttering (Plate 31). The south elevation is plain apart from the central doorway with moulded surround and a panel over and a six-panel door with brass fingerplate and lock and there are two moulded rails attached on the on south side. The west elevation is plain, with lath and plaster behind the panels, and the central part possibly has a door with the latch still *in situ*, although this was obscured by a stack of timber.

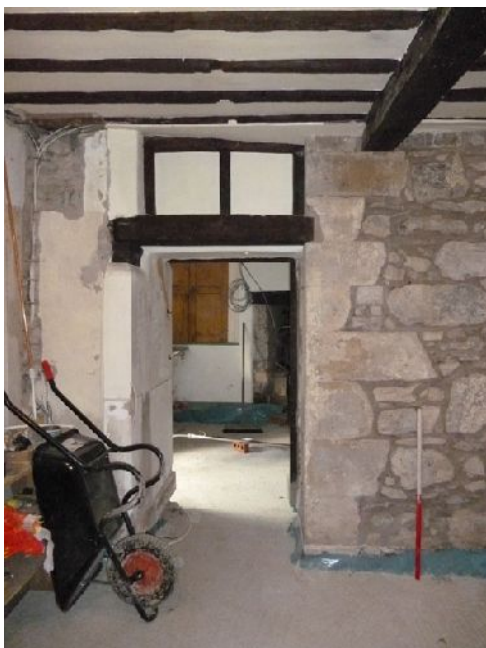
**Plate 32 (left): Door and quoins in the north elevation of ground floor Room 4**

**4.3.4 Ground Floor, Room 4:** this room has a concrete floor and plasterboard ceiling with exposed east/west beam and joists, all of which are hand-finished. The walls are mostly plastered except on the east side of the north elevation. The north elevation has a doorway on the west side, extending to the ceiling, although the upper part has been infilled with timber over the timber lintel, which is probably reused (Plate 32). There are quins exposed on the east side, all of which are ashlar dressed stone and probably medieval. The east elevation has a small window on the north side with a modern casement and shutters in a larger opening (possibly a doorway) with very heavy timber lintels and infilled above with timber (Plate 33). There is a doorway to the south of this with a panelled door and moulded surround. The door is six-panel, ovolo-moulded, the top two of which are glazed, and it has very long hinges. The south elevation has a concrete block stub wall below the beam (Plate 34). The wall to the east slopes in at the top and there is a very plain two-panel door to the west with a plain surround and moulded rail. The west elevation is open to Room 5 below a large arch (Plate 35; see *Section 4.3.5*).

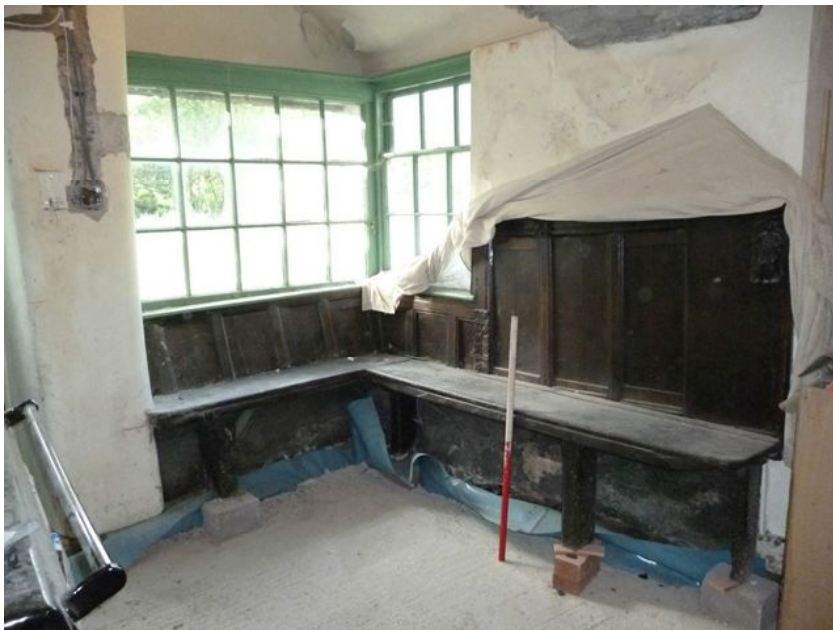
Plate 36: North-west corner of ground floor Room 5

a modern four-panel door below four lights with square surrounds (Plate 35). To the north of this is a masonry pillar and north of this is a 15-light fixed casement window with a shelf over (extending to the north) and the bench set below the sill (Plate 36).

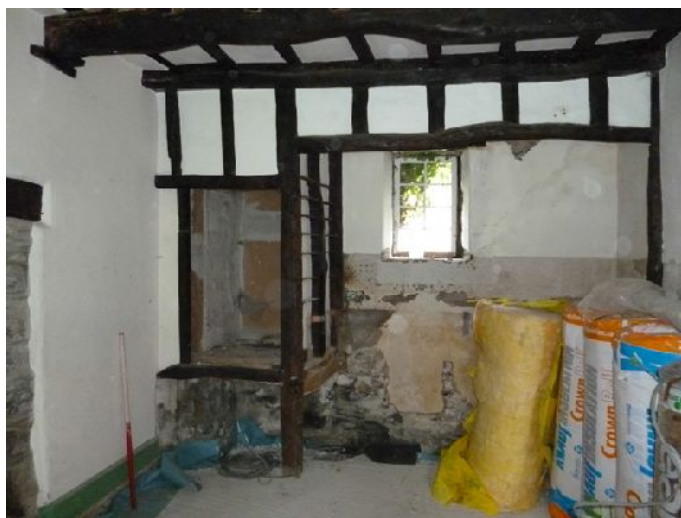
**Plate 40: East elevation and cupboard in Room 6 on the ground floor**

4.3.6 **Ground Floor, Room 6:** this room has a concrete floor and a plasterboard ceiling with three north/south beams and east/west joists from the room above exposed. The two beams to the west are stop-chamfered and the one to the east is reused. This one also has a short section of stud walling added below and incorporates a chipboard/timber stud construction in the north-east corner with plasterboard sides to the south and east (Plate 40). There is possibly an infilled opening inside this on the north side, where there is a timber lintel. Elsewhere the walls all have a modern plaster finish and concrete skirting. The north elevation has a built in cupboard in a large recess on the west side with three shelves inside, two-panel doors, and moulded surround (Plate 41 and Plate 42). The central fireplace on

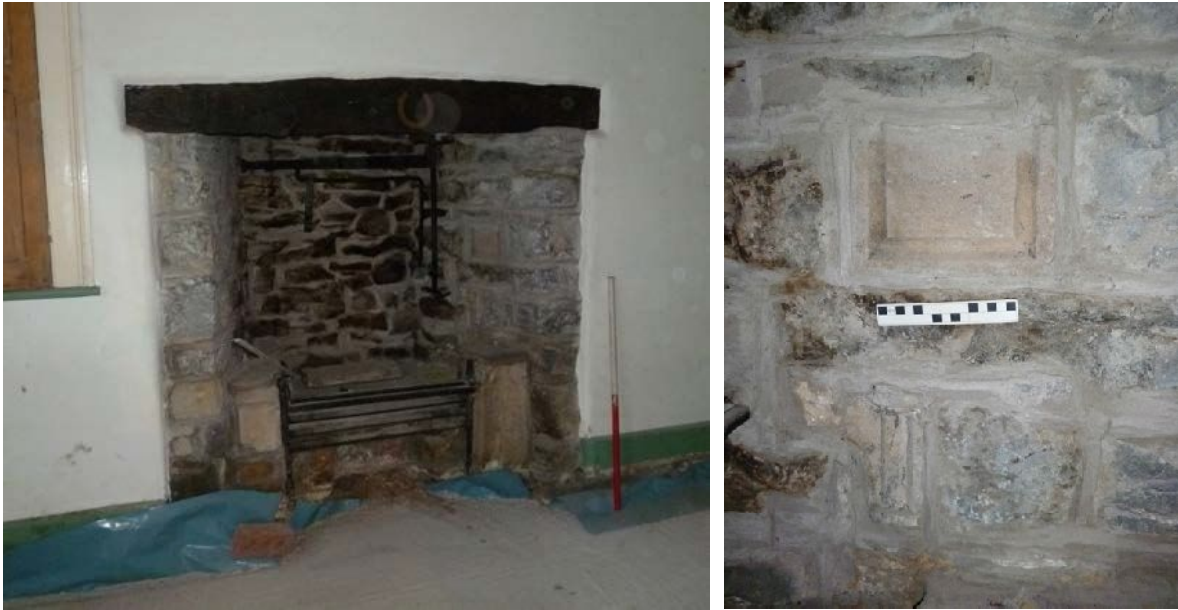
the north elevation has a hand-finished beam and angled inside and includes two pieces of reused dressed masonry in the sides (Plate 43 and Plate 44). The base of the fireplace is concrete, the front grill is iron, and the side columns are stone, some of which is dressed, and the iron crane survives. The east elevation has a central window, with a modern eight-light casement, the lintel for which extends to the north, suggesting it may originally have been larger (Plate 40). The south elevation is mostly plain, although a piece of stud walling extends down the wall on the east side. The door to the west has a timber lintel. Most of the west elevation is taken up by a large opening incorporating the doorway on the south side, with a modern 15-light door, and the window to the north (Plate 45). The window to the north has a hand-finished timber lintel over and is supported by an upright post. It has two main lights (one of which is divided into two by a vertical iron bar), below two sets of three-lights. The central pane of the three to the right has 'W Newe' or 'W Newb' and '1854' scored into it (Plate 46). There is a modern aluminium sink below and chipboard side unit sat on modern bricks to the south side and a concrete sill below the window.

**Plate 43 (left): Fireplace on the north elevation of Room 6 on the ground floor**

**Plate 44 (right): Reused stone inserted in the east side of the fireplace in Room 6**

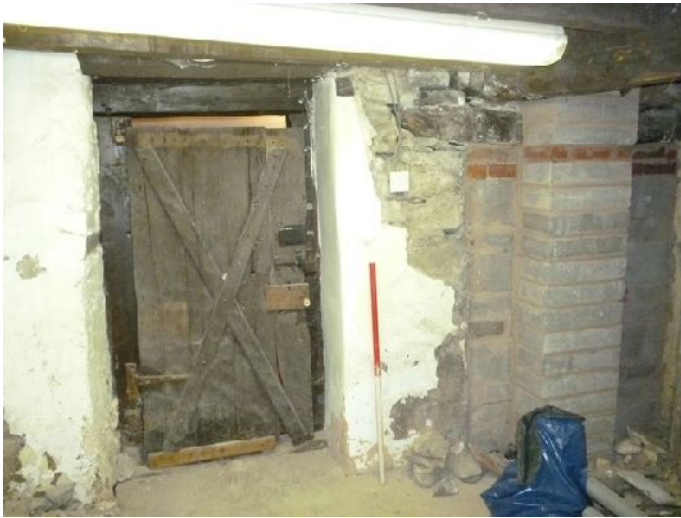
**Plate 47 (left): North elevation of Room 7 on the ground floor**

4.3.7 **Ground Floor, Room 7:** this room has a raised plywood floor and the ceiling is very low. There is a massive chamfered north/south beam on the east side and sawn joists supporting the floorboards above. The walls are rough and finished with plaster and paint. On the west side of the north elevation in a chamfered surround is a very early plank door with crossed battens on hung strap hinges, although the east plank is now detached (Plate 47). To the east is a blocked opening with a chamfered timber lintel. The opening is blocked with concrete blocks and there is a projecting block stub wall. The east elevation is stud walling, angled to the north-east to meet the north side of the opening, and there is plasterboard boxing at the south end. The south elevation is plain. The west elevation has a hole gouged out on the south side below the ceiling, presumably forming a flue for a modern boiler or stove and connecting to the chimney above, and there is a small alcove fireplace in the centre, presumably an earlier fireplace, which has been partially blocked with stone and plastered over (Plate 48).

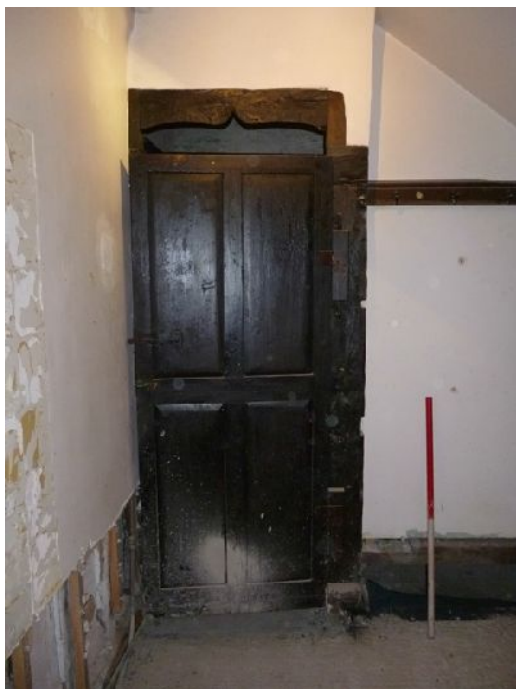
Plate 49 (left): Door at the north end of the east elevation of ground floor Room 8

4.3.8 **Ground Floor, Room 8:** the floor is concrete and there is no skirting. It has a plasterboard ceiling with a north/south beam on the east side, finished with plaster and running into the structure supporting stairs in the south-east corner. The cupboard below the stairs reveals that while the steps are a modern structure, the superstructure below is constructed from hand-finished timber and much earlier. The walls are modern plaster and plasterboard although the north elevation is a modern covering of an earlier stud wall and the east elevation is again a mix of old and new stud walling. The door on the north side of the east elevation has an ogee-moulded head and square surround and an early, four-panel, raised and fielded door with later hinges, but the iron pintels for earlier hinges are present (Plate 49). The doorway in the south side below the stairs has a plain square surround and iron pintels (Plate 50). The early plank and batten door, presumably for this doorway, was loose in the cupboard. The south elevation is plain apart from the central door, which has a plain hand-finished square surround and a plank door on strap hinges (Plate 51). The hole knocked in the west side suggests the south wall is butting the west. The west elevation is plain apart from the three-light stone mullion window, each section divided into three, with plain rhomboid mullions (Plate 52).

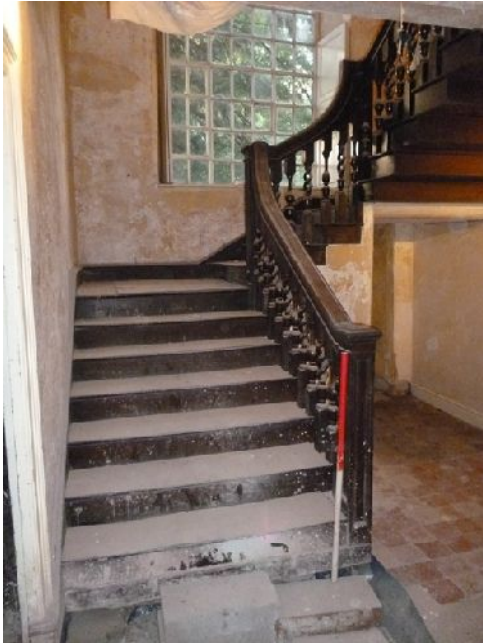
**Plate 53 (left): Main stairs viewed from the ground floor**

4.3.9 **Ground Floor, Room 9:** this room contains the main stair (ascending to the west) and back stair (to the south). It has a concrete floor and red quarry tiles on the north side (visible in Plate 53) and flags in the north-west corner and a flat plaster ceiling and plastered walls. The back stairs are modern timber whereas the main stairs are original (currently covered with hardboard). The main stairs have a moulded handrail, the newels are square with flat tops, and the balusters are turned and twisted with urn bases and square tops (Plate 53 and Plate 54). The north elevation is plain. The east elevation has a wide window on the north side with a rough timber lintel as in Room 2 (see *Section 4.3.2* above; Plate 55) and the door to the south of this has a round head. The doorway to the stairs in the south elevation has a

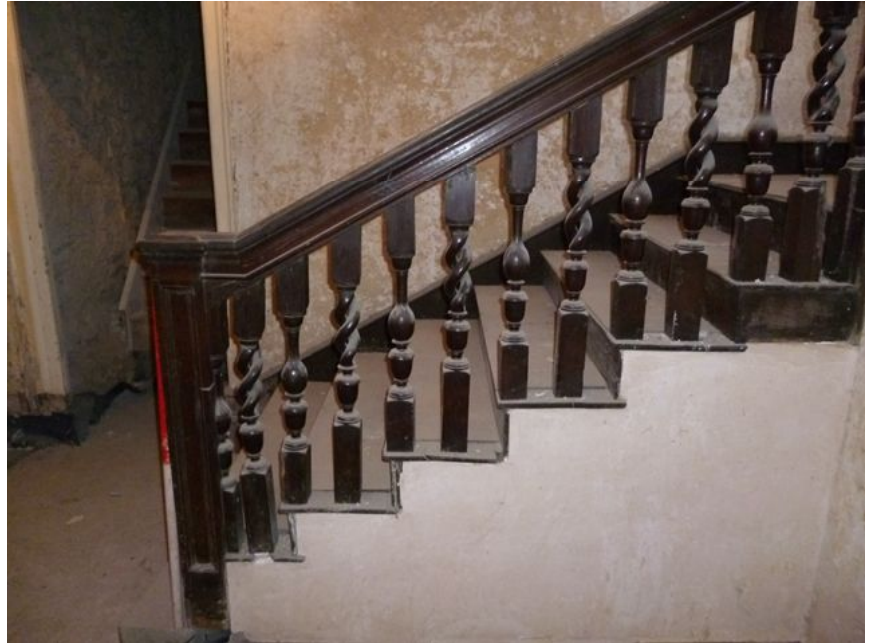
**Plate 54 (right): Detail of the main stairs**

moulded surround but the elevation is otherwise plain. The west elevation is dominated by the stairs and a massive 56-light window above the landing to the first floor (see *Section 4.3.18* below). The four at the bottom right are tilting and there are shutters for the lower part. There is a small cupboard below the stairs on the west side with a beaded plank and batten door and the door to outside at the north end of the west elevation is a split beaded plank and batten door.

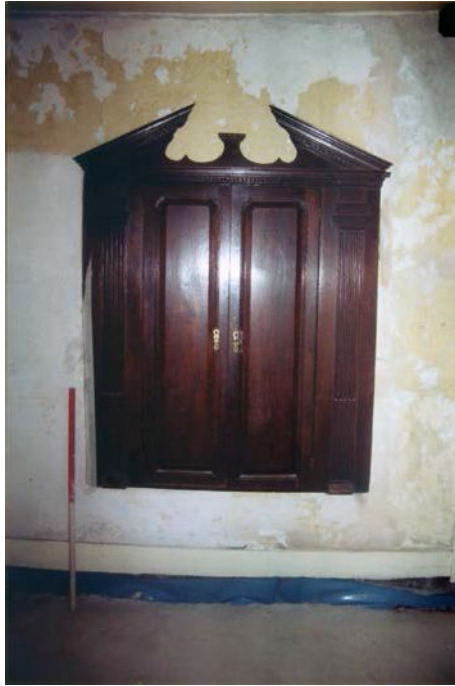
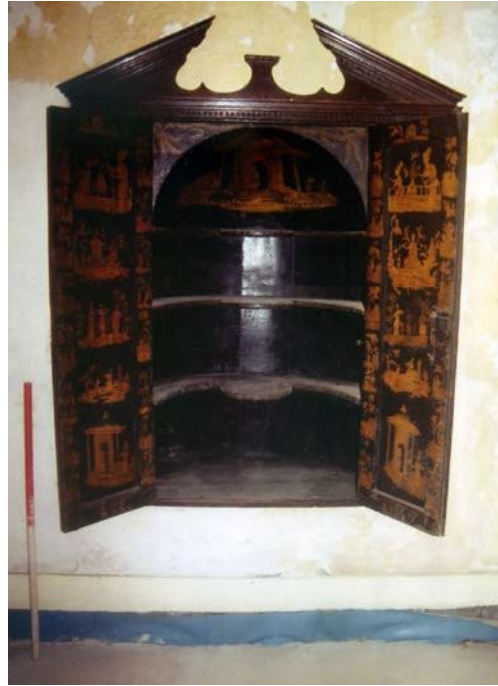
**Plate 56 (left): Cupboard in the north elevation of ground floor Room 10**

**4.3.10 Ground Floor, Room 10:** this room has a concrete floor and plastered ceiling. There is a north/south beam and joists exposed, which are hand-finished, and the walls are plastered. The north elevation has an alcove in the wall, which is rounded in plan and has a rounded top, into which is set a cupboard, painted internally with oriental scenes (Plate 56 and Plate 57). The cupboard has two doors with moulding and surrounding fluted columns and broken pediment entablature with denticular

decoration. The pediment is clearly not original and the fluting is probably not either. To the east the wall turns slightly and there is a fireplace with a timber moulded outer surround around a beaded stone inner surround and with an iron hob grate decorated with urns of flowers (Plate 58). The east elevation is plain apart from a two-panel door, now glazed, in a moulded surround, and a large boulder in the footing (Plate 59). The south elevation is a stud wall with lath and plaster over earlier beaded studs visible where the skirting has been removed (Plate 60). The west elevation is plain apart from a central 12-light sash window with horns and splayed jambs to the floor with recesses for shutters and panelling and a moulded surround (Plate 61). 'Margaret Lewthwaite 1967' is scratched into one pane.

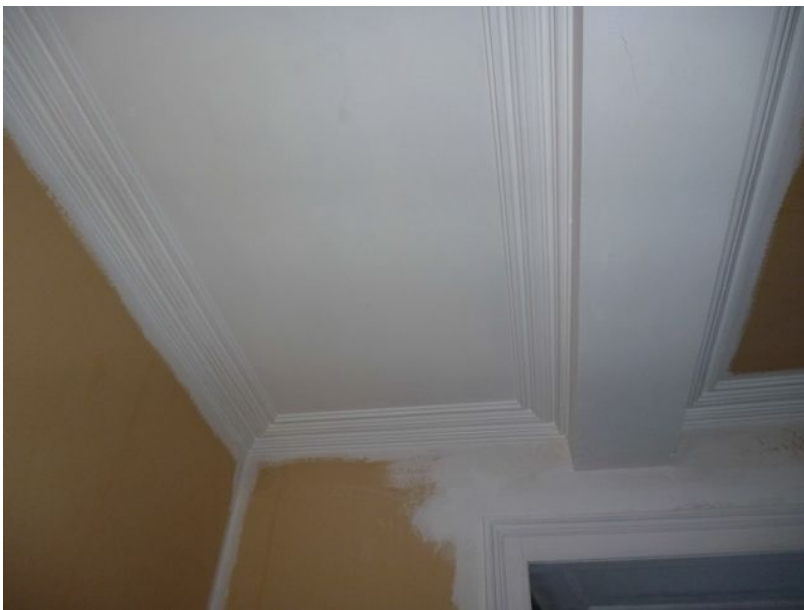
**Plate 62 (left): Beam and cornice in first floor Room 1**

4.3.11 **First Floor, Room 1:** this room is finished with plaster and has modern spotlights in the ceiling. The floor comprises fairly broad east/west timber floorboards and there is skirting throughout. There is an east/west beam across the north side of the room with painted cornicing around the beam and along the top of the walls (Plate 62). The walls appear recently plastered and are plain. The north elevation has a door to the west side with moulded panels and a moulded surround (Plate 63). The east elevation has a central 12-light sliding sash window with a deep timber sill and moulded surround (Plate 64). The south elevation has a central cast iron fireplace with a decorative marble surround and a stone hearth (Plate 65). The west elevation is plain.

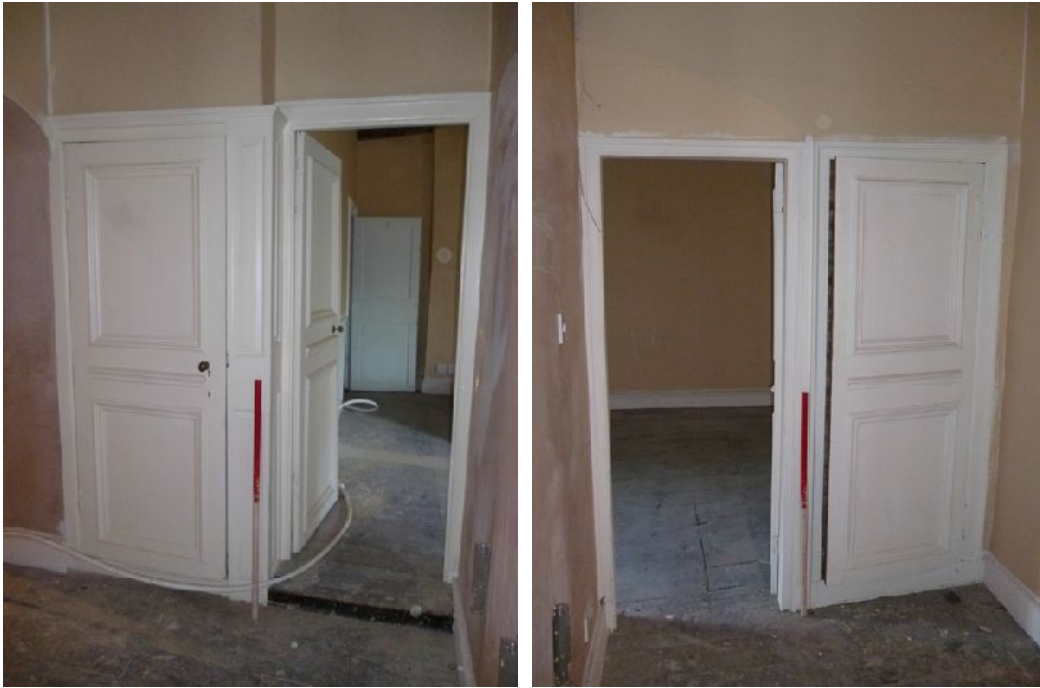
**Plate 66 (left): North elevation of first floor Room 2**

4.3.12 **First Floor, Room 2:** this approximately square room has been recently plastered. It has east/west timber floorboards and an east/west beam across the ceiling, which has presumably been reused as it is notched on the north side. The ceiling is otherwise plastered and plain with modern spotlights inserted. There is a locked door on the west side of the north elevation to a small cupboard which was inaccessible (Plate 66). The door to the cupboard matches those to Room 1 to the south and Room 3, immediately to the east. There is some decorative panelling between the cupboard door and the door to Room 3, with moulded panels and a plain timber surround and a moulded top edge. There is a step into Room 3 to the north. The east elevation is plain. The south elevation has a door to Room 1 to the east side and another door the same to the west, although the one to the west is blocked with lath and plaster on the inside of Room 1 and is not visible from Room 1 (Plate 67). The west elevation is plain with skirting and has a large opening with a rounded top through to the stairway and landing. There are two steps down to the landing from in Room 2.

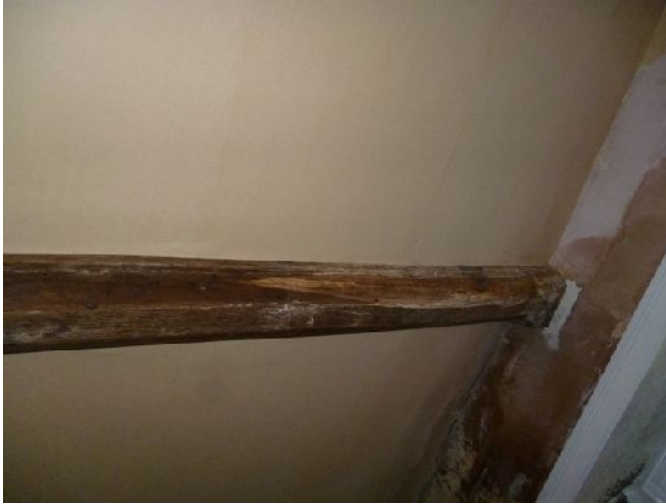
Plate 68 (left): Central beam in first floor Room 3

4.3.13 **First Floor, Room 3:** there are three east/west beams across this room with the north beam only visible to the west side of the fireplace. The central beam is ovolo-moulded along both sides, although the moulding stops short of the east elevation (Plate 68). The south beam is probably reused as it has seven trapezoid notches in the north face and the chamfered edge ends ahead of the east elevation. The ceiling has a modern plastered finish with spotlights and the walls are plastered. The north elevation has a central cast iron fireplace with marble surround and is stepped out to the south round the fireplace (Plate 69). There are east/west floorboards to the north side of the room and modern panels to the south. The east elevation has two large 12-light timber sliding sash windows with timber casements and timber sills which are set back slightly and moulded surrounds (Plate 70). The south elevation is plain with skirting and there is a door to Room 2 to the west side where the elevation steps out (Figure 3). The west elevation is stepped to the east at the south end around Room 2. There are two doors with panelling to the north end, one to a cupboard and one to Room 4. Panelling with decorative moulding surrounds both doors from the floor to waist height and the moulding suggests there was a third door at some point at the south end (Plate 71). The cupboard on the west side of the room was plain inside, although the east/west beam from inside the room extends across it and it extends above the locked cupboard to the south (which would otherwise have been accessible from Room 2) and above the archway to Room 4 to the north.

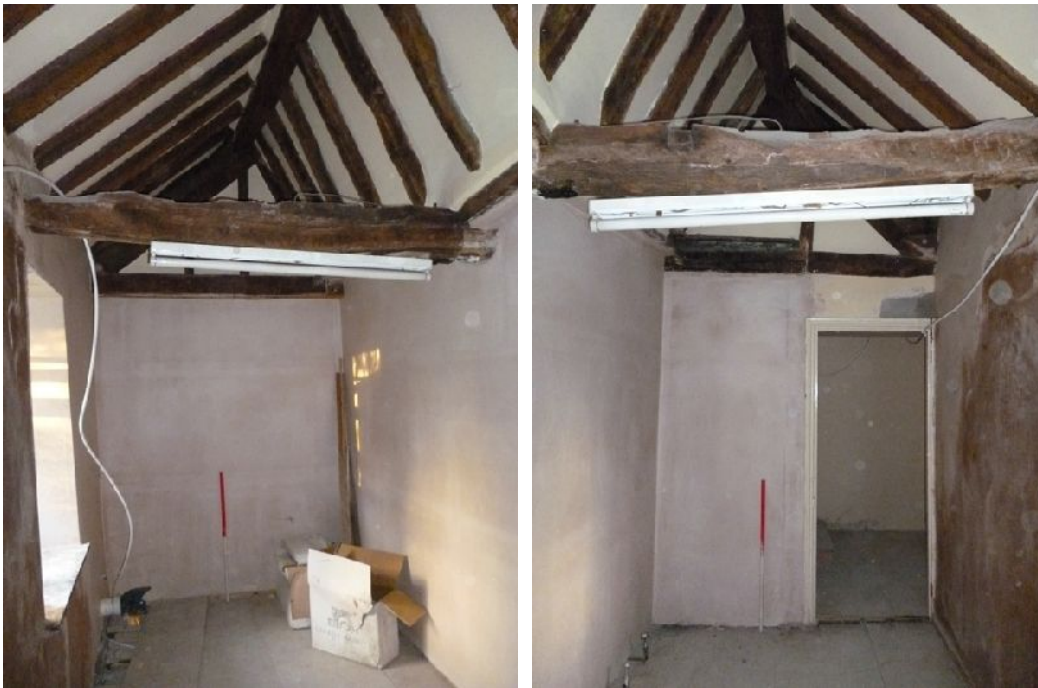
**Plate 72 (left): North elevation of first floor Room 5**

4.3.15 **First Floor, Room 5:** parts of the trusses are visible to the north and south with post/struts and purlins visible and the elevations are painted and plastered between the timber structure. The cross beams overhang slightly into the room and there is a central east/west beam across the room with a metal bracket below the south end and notches along the top edge that has also been scored repeatedly on the underside. The ceiling is pitched and slopes down to the east and west. The walls are plastered and plain and the room has a modern finish throughout and is plumbed at the south end on the east elevation (Plate 72 and Plate 73). There is no skirting. The south elevation opens to Room 4 on the west side. The west elevation has a top-opening hinged six-over-six light timber casement window with wide splayed jambs and two broad timbers for a sill. The lintel is plastered over internally.

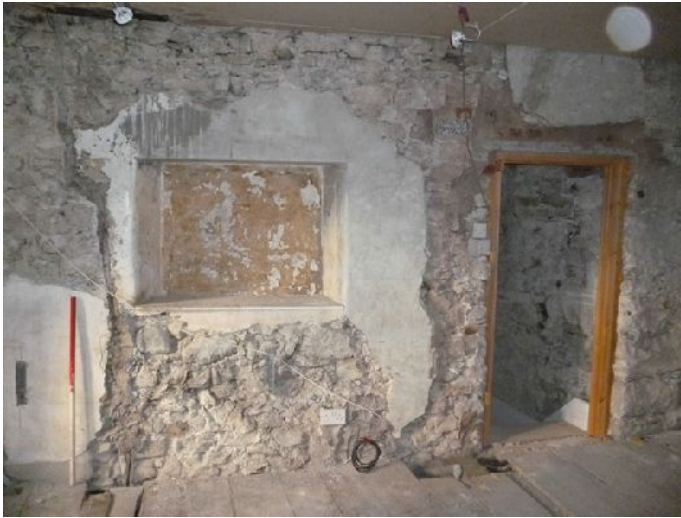
Plate 74 (left): North elevation of first floor Room 6

4.3.16 **First Floor, Room 6:** Room 6 sits lower than the rest of the first floor between two levels at the south end of the property. The ceiling is modern plasterboard with spotlights fitted and the floor has north/south aligned timber floorboards. There is some exposed stonework in the north elevation although there is also some modern brick and concrete above the doorway (Plate 74). There is a large alcove to the west side with splayed jambs and concrete over the surrounds and lintel with a plain timber sill. The modern timber door frame to the east has a concrete lintel and brick rebuild and concrete above. To the east side of this there are largely neatly dressed ashlar stone quoins, which suggest this was the end of an external wall at some point. This wall, which extends into the stairway to the north, has had moss or lichen growing on it which was still present in the corridor (see *Section 4.3.18* below). The stonework of the east elevation appears to butt this wall to the north, but the rest of the east elevation is plastered to the south. To the north side the east elevation steps up to an old plank and batten door with old hinges and handle and a timber lintel and there is another step into this oddly shaped cupboard which has four plain timber shelves in the north side and a curling south wall (Plate 75; Figure 3). The south elevation is stepped and angled slightly but plain and plastered. The west elevation has a large painted decorative stone fireplace to the south side with raised daggers carved into it (one either side of the splayed opening) and a chamfered surround and pointed arch top (Plate 76). To the north of the fireplace is a large stone mullion window with window seat and splayed jambs the glass for which has been replaced with two single-glazed six-light fixed timber casements either side of a single-light side-opening hinged timber casement, all of which appear fairly modern (Plate 77).

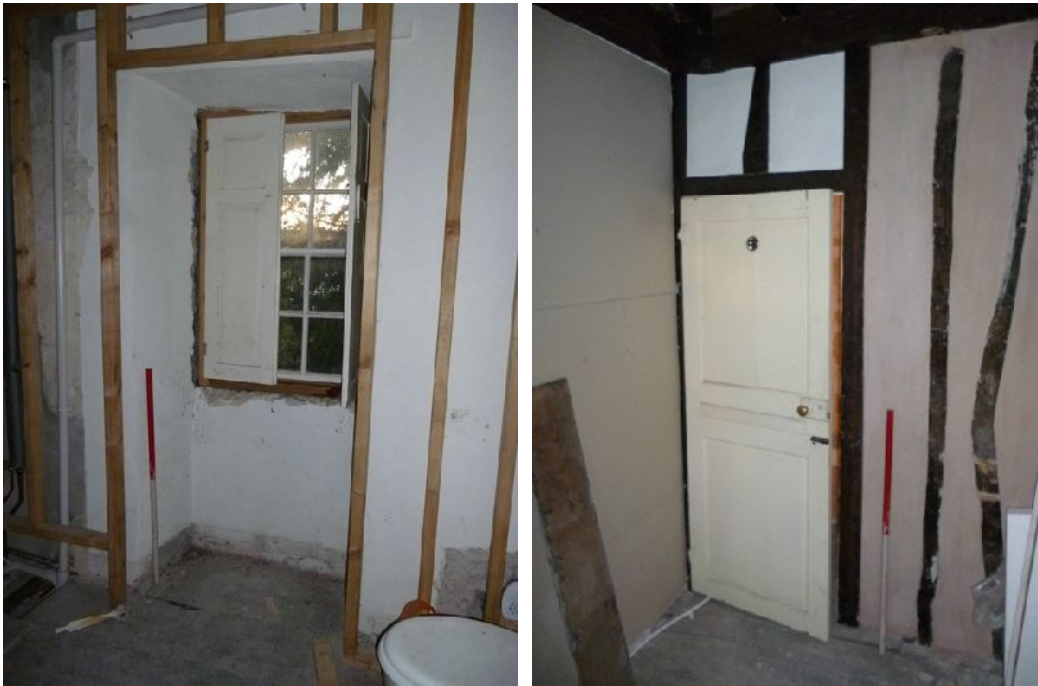
**Plate 78 (left): Window in the west elevation of first floor Room 7**

4.3.17 **First Floor, Room 7:** this room has a north/south beam along the east side and joists to the room above left exposed in the ceiling. The gaps are plastered and painted with spotlights inserted in between. The south elevation has exposed stonework, but there are no obvious blocked features. The west elevation has stud partitioning partially completed across the elevation and there is a 12-light timber casement sliding sash window with splayed jambs and a very modern timber surround above a stone sill (visible from the outside) to which older moulded panel doors have been reattached (Plate 78). An east/west beam is visible along the top of the north elevation although the rest of the elevation is hidden by modern boarding screwed to the stud partition wall and a toilet is fitted to the west side. Within the timber uprights of the partition wall to the east here is a two-panel door with a vent, the handle for which

is on the outside (Plate 79). The wall is lath and plaster between the timber uprights to the north/south beam above.

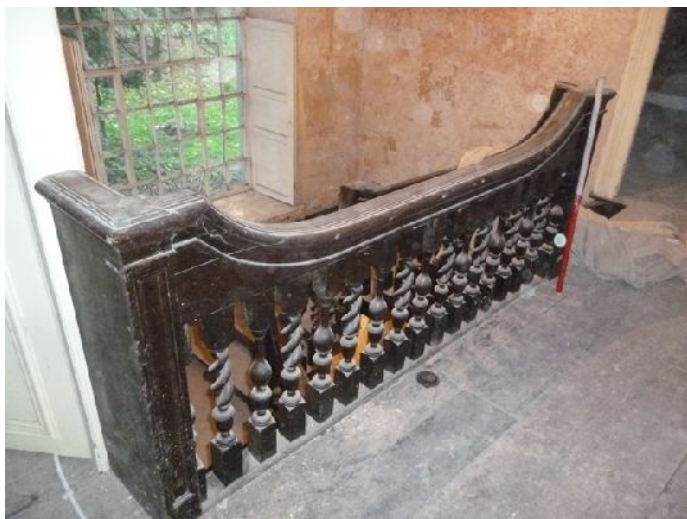
Plate 80 (left): Stairs viewed from the landing on the first floor (Room 8)

4.3.18 **First Floor, Room 8:** this forms the corridor and landing on the first floor. It has north/south timber floorboards and is plastered and painted throughout and has a plain skirting board. The elevations are plain. The north elevation looks to have had two doors to the north at the top of the stairs originally within a single moulded surround, but the one to the east is now blocked and modern skirting runs across its base. The remaining door to the west has a moulded panel door with possibly the original handle. The east elevation is plain and steps up to Room 2 through a thick archway with a rounded top. There are two plain timber door frames to the back stairs to the south end of this room but no doors. The ceiling is lower at the south end of the room in line with the north wall of room 7 on this floor. The main stairs are to the west. The stairs have a curved moulded top rail and decorative twisted-effect and turned balusters (Plate 80). The west elevation is dominated by a large 56-light (seven columns of eight) metal casement window with a broad and deep timber sill and covered lintel, which has been plastered (Plate 81). There are panelled shutters for the bottom five rows of windows. Beyond the doors to the south the back stairs lead to Room 6 through the door to the west and then to the ground floor and to the second floor through the door to the east. The stairs are modern, with older square newels, and the balusters are hidden (Plate 82). The walls are mostly plastered and painted and have a plain skirting although the stonework is exposed in the east side, where the quoins are visible at the south end. Moss or lichen remains on this elevation, suggesting it was originally an external wall (Plate 83).

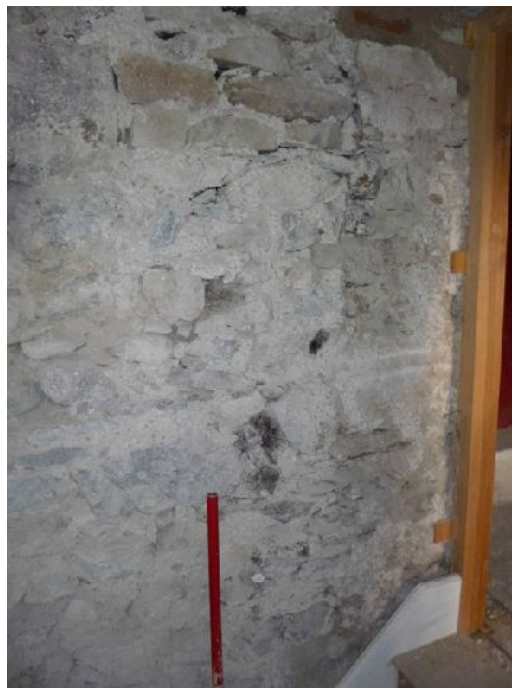
Plate 83 (right): Quoins in the stonework and moss or lichen at the south end of the back stair outside first floor Room 6

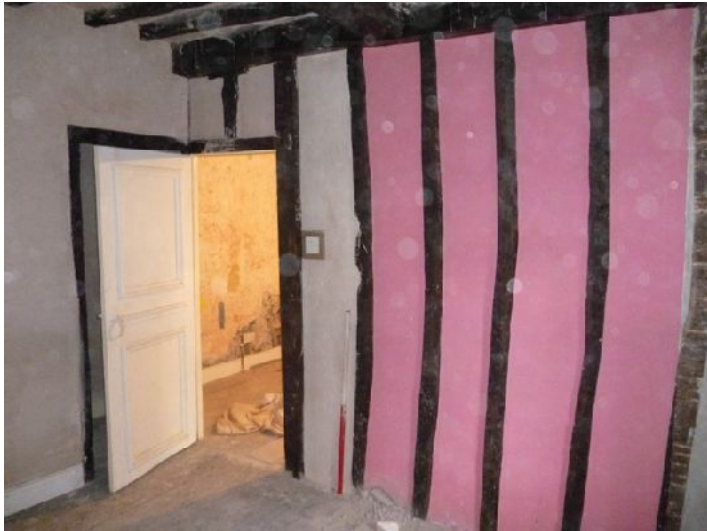
Plate 84 (left): South-east corner of first floor Room 9

across the blocking apparent in the south side (this was originally a door visible from Room 8). The south elevation has an east/west beam above the timber uprights which are painted and plastered in between and there is no skirting along this side (Plate 84). The door to Room 8 to the east side is a moulded panel door with a plain surround. The west elevation has a 16-light sliding sash window with plain surround (Plate 85).

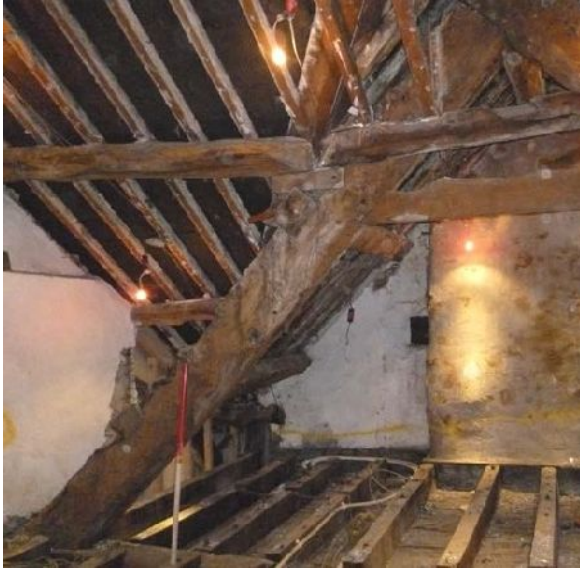
**Plate 86 (left): West end of the north truss in second floor Room 1**

4.3.20 **Second Floor, Room 1:** remnants of timber floor boarding remain but elsewhere this is replaced by chipboard. The room is open to the roof with three east/west trusses across it, each a tie beam type (Plate 86 to Plate 92). All of them clearly originally had wind braces and angled braces between the beam and principals and probably a king post fixed between the collar and junction of principals. Only the central truss retains the latter features whereas the others retain the wind braces. The purlins and wind braces are cut through on the central truss to allow access to the two doorways to the west, and there is a stud wall built onto the truss dividing the room into two with extra timbers attached to the truss suggesting this perhaps originally extended across the whole room (Plate 93 and Plate 94). The east side has been raised in height and extra timbers have been added to raise the roof line (Plate 95). Timbers in the east wall are perhaps the original wall plate. The trusses are stop chamfered at the joints and have carpenter's marks I to III scored at the collar junction. The walls have remnants of plaster in most places, although the north is finished with lime wash. Apart from the timbers built into the wall forming the old wall plate the east elevation is plain. The north elevation has a central chimney stack, evidently part of the wall (Plate 96), and a four-light timber mullion window to the east with octagonal mullions and a rough timber lintel and sill plank (Plate 97). The south elevation is fairly plain with the letters 'DB' scratched into the plaster on the east side and a very large scar to the west of a fitting in the plaster with worked timber *in situ* (Plate 98 and Plate 99). The alcove to the west side has a timber lintel and a sill below the floorboards hidden by rubble (Plate 100). The back is lath and plaster with one rough shelf attached with very neatly dressed quoins on the west side. The west elevation has a piece of dressed sandstone on the south side with an angled piece coming from it, possibly part of an arch or window. To the north of this the double doorway either side of the central truss has a heavy timber lintel and there are two steps down to Room 3 to the west. The wall from this point to the north has a step at the top (Plate 101). The north door has neat quoins in the north jamb and both have remnants of very square plain surrounds and formerly hung doors evident from the pintels. The north end has a large opening filled with a modern timber stud wall and with a beam across it with 'principal' running between the spine wall and main wall to the north; the beam is heavily worn.

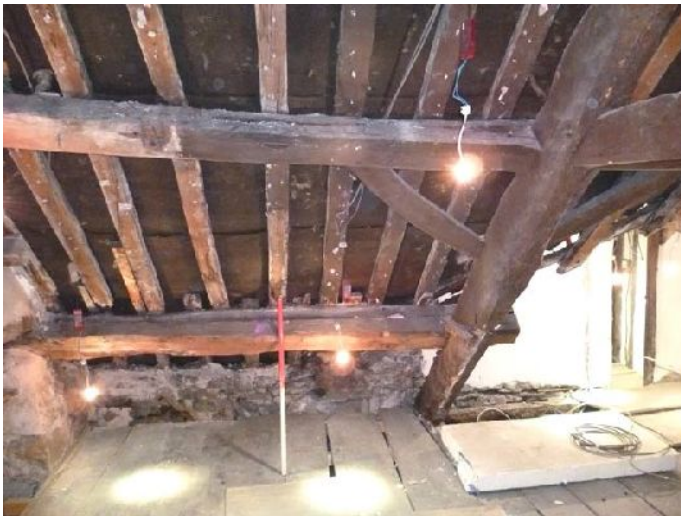
**Plate 93 (left): Wind braces cut through to the west, second floor Room 1**
