# PRIORY CLOSE, CARTMEL, CUMBRIA

## Archaeological Building Recording

Client: Lisa Clarke

November 2013

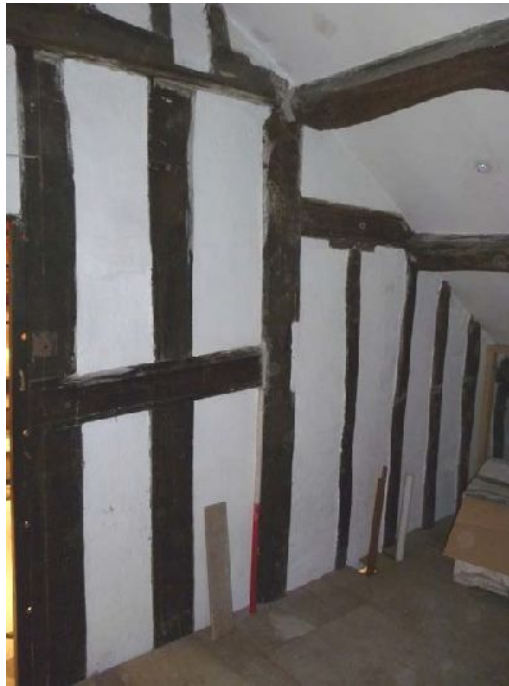
**Plate 102: East elevation of second floor Room 2**

4.3.21 **Second Floor, Room 2:** the east/west purlins are visible and the roof slopes towards the north and south as shown on the plan. The walls are plastered and painted between the exposed timber uprights (Plate 102). There is a doorway at the north end of the east elevation and a four-light top-opening hinged timber casement window with splayed jambs at the north end of the west elevation, possibly with a stone sill, although this is painted over and the sill is covered also. There is pipework along the west elevation and timber stud is part finished along the east and south side of the room.

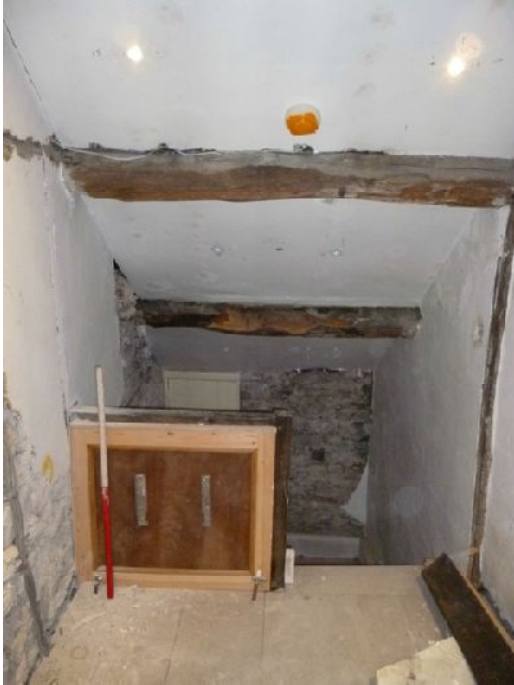
**Plate 103 (left): South end of second floor Room 3**

4.3.22 **Second Floor, Room 3:** this is the second floor landing. The walls are painted and plastered between various elements of the timber structure which are exposed. The south elevation, above the stairs, and the south end of the east elevation is exposed stonework apart from the brick rebuild around the door in the south elevation (Plate 103 and Plate 104). This plank and batten door has a modern timber frame and opens to a void with a modern finish. The walls inside are plastered with boxing on the north side and skirting board throughout. The floors inside are modern plywood floorboards and the truss is exposed but clad with timber. At the north end of Room 3 is a doorway with a slightly mismatched

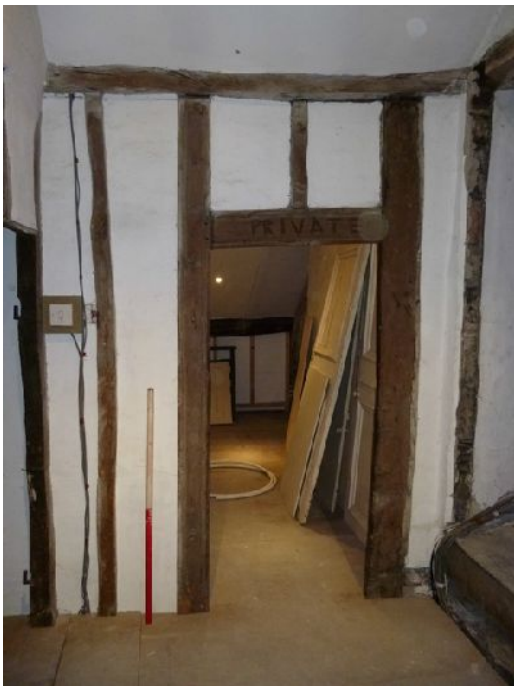
**Plate 105 (left): North end of second floor Room 3**

moulded frame, with 'private' daubed in paint on the top part, but there is no door (Plate 105). In the east elevation there are steps either side of the central truss which partitions Room 1 to the east, leaving two doorways below a heavy curled timber lintel with cuts for uprights to each side and a larger central post. The roof slopes down to the north and south away from this central post but the doors and post to the north side are missing. The south elevation is open to the stairs. The west elevation is plain and has a low door on the north side and there are modern plywood floor panels throughout (Plate 106).

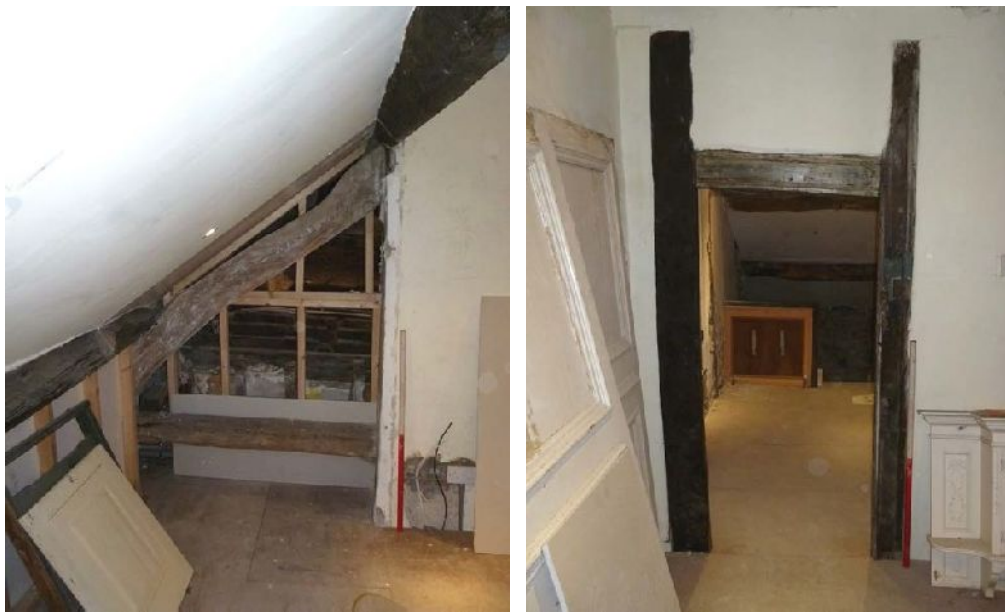
**Plate 107 (left): North end of the east elevation of second floor Room 4**

4.3.23 **Second Floor, Room 4:** the roof slopes as shown on the plan, there is a modern two-light metal hinged casement skylight to the north side, and the ceiling is painted and plastered between the roof purlins (Figure 3). There are modern plywood floorboards throughout. There is a void behind a modern partition to the north side of the room with pipework along the back wall. There is a large opening at the north end of the east elevation with part of a truss visible but the south end is plain (Plate 107). There is a doorway to the landing at the east side of the south elevation, with pintels attached but no door (Plate 108). The rest of the elevation is plastered and plain. The pipework and modern partition continues unfinished along the west elevation from the north elevation and there is a top-opening four-light hinged timber casement window to the south-end with splayed jambs (Plate 109). The rest of the elevation is again plain.
