GARAGE/STORE ADJACENT TO OWL MEWS, BACK LANE, ULVERSTON, CUMBRIA

Archaeological Building Recording

Client:
Jonny Briggs Joinery Ltd

February 2014

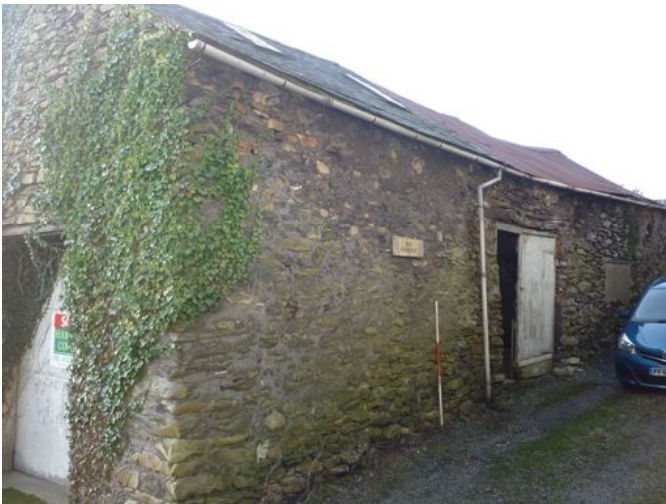
Plate 7 (left): North external elevation

4.2.1 **North elevation:** this forms one of the side elevations (Figure 2) and noticeably bends to the north at the east end. The east end is plain apart from a timber board with a plastic “NO PARKING” sign attached (Plate 7). The central wagon doorway has a rough timber lintel, formed from two scarf-jointed pieces, with another thinner piece of timber placed above that (Plate 7). The door is a double tongue and groove plank and batten door, the door to the east side being slightly smaller than the one to the west. To the west of this is what may have been a small window, with a rough timber lintel, although it is now blocked and covered with concrete (Plate 7). The north-west corner of the building is quite rounded and there is a gate to the garden to the west attached.

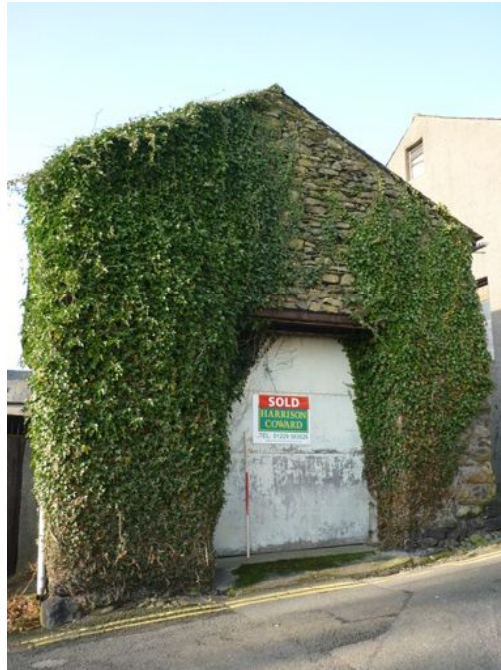
Plate 9: East external elevation

4.2.2 **East elevation:** the east external elevation is largely covered by ivy (Plate 9). It forms the gable end of the building (Figure 2) and some larger stones have been used at the corners and for footings. The large central doorway with a timber sheet folding/rolling door and iron I-beam lintel is probably inserted.

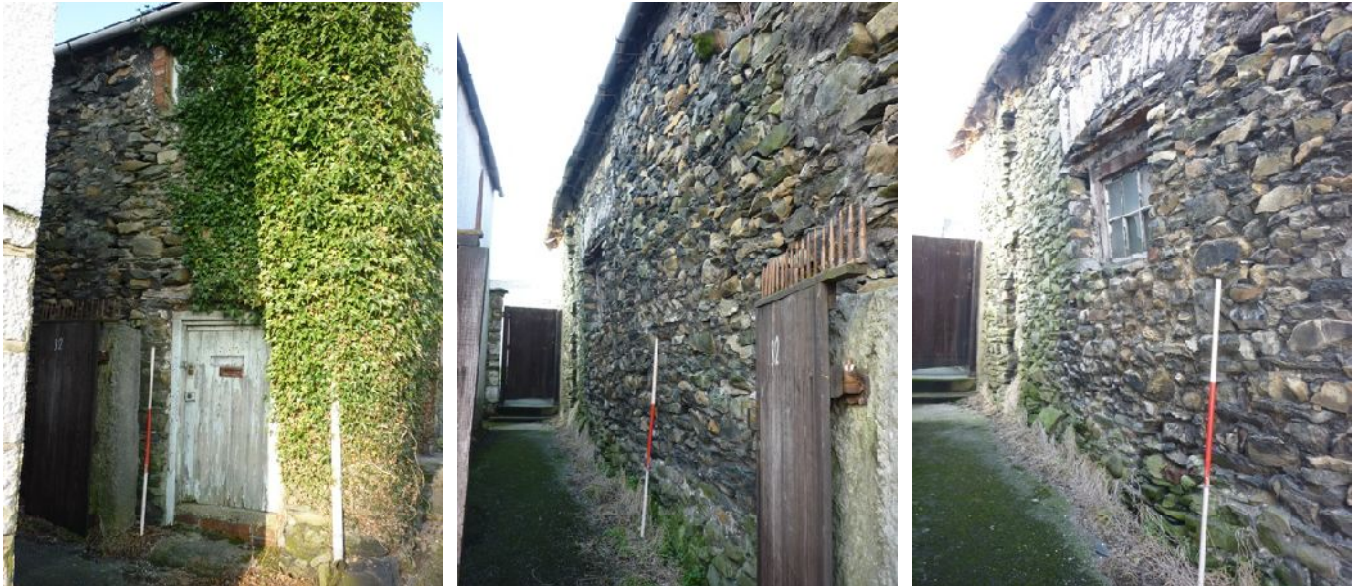
4.2.3 **South elevation:** there is a doorway to the lower level at the east end with a rough timber lintel and a concrete step on top of machine made bricks (Plate 10). The doorway houses a beaded tongue and groove door with a chamfered surround but this does not quite fit the space as there are bricks in the space between the frame and the lintel. Above the doorway a window has been inserted and machine made bricks have been used in the west jamb. The east side is obscured by ivy but part of the stone sill and at least two lights are visible to the west. There is a smaller opening to the west of this, with a stone lintel and filled with timber slats but the lower part is blocked with stone. There is a doorway near the centre of the elevation opposite the one on the north side with a voussoir limestone arch but this has been partially blocked with stone, leaving a window with eight lights in a fixed timber casement in a very basic machine sawn timber frame (Plate 11 and Plate 12). The timber casement has probably been reused from a sash window. The west end of the elevation has a line of rebuild extending the full height (Figure 3).

Plate 10 (left): East end of the south external elevation

Plate 11 (centre): General view of the south external elevation

Plate 12 (right): Doorway at the west end of the south external elevation

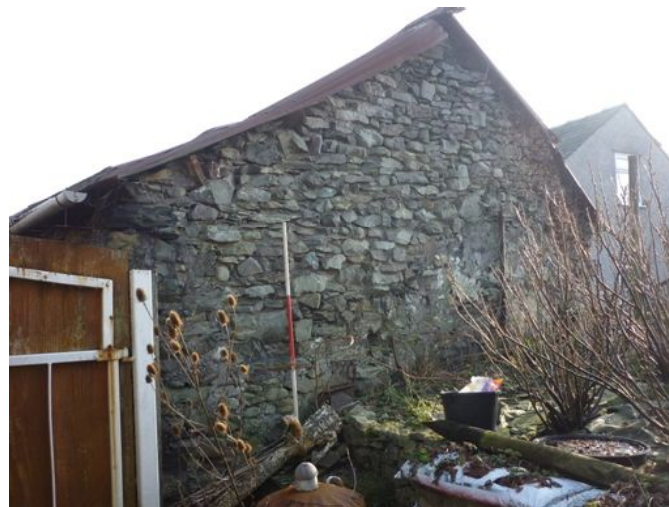
Plate 13: West external elevation

4.2.4 **West elevation:** this elevation is essentially plain although the upper part has been rebuilt and there are patches of plaster on the south side suggesting a lean-to was attached here once. The ground of the garden is built up against it on the south side (Plate 13; Figure 3).

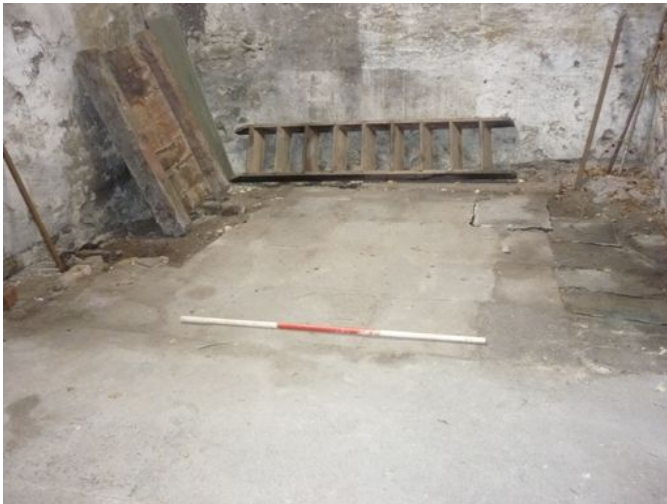
Plate 14 (left): Floor at the west end of Room 1

4.3.1 Ground floor Room 1: Room 1 occupies the west end of the building (Figure 4). All the walls are stone, finished with rough plaster and lime wash, apart from the dividing wall to the east, which is brick. The floor is mostly poured concrete with some concrete slabs and stone flags on the west side and open patches on the north and south sides and an area of bricks on the south (Plate 14). The north patch is covered by green roof slates and there is thick concrete in the north-west corner. The room is open to the roof. There are two basic tie beam type trusses and a skylight on the south side (Plate 15 and Plate 16). The western truss comprises reused cruck fragments and the beam is supported on additional iron I-beam corbels set in the wall (Figure 5; Plate 16). There are two purlins per pitch between the trusses, but only one to the west, and a diagonally set ridge purlin. All of the timber is hand finished. There is a corrugated metal roof on top of the adze finished rafters, which are possibly Baltic timber. At the east end of the building there is a half loft constructed entirely from machine-cut timber, with a random selection of planks forming the floor including one piece of packing crate with a stamped label: 'FOR EXPORT PACKED IN BORAX EST. 2 B'. The north elevation has a chamfered timber board attached on the west side with a plate, perhaps for a gas light, to the east and mortar lines marking the position of a formerly attached structure corresponding with the concrete base in the north-west corner. There is a blocked window to the east with a sawn timber lintel and a wagon door to the east of that with a plank and batten door and hand finished chamfered lintel (Plate 17). Attached to the door is a piece of timber with the letters 'RSTON' stamped or printed on, presumably originally part of a label saying 'ULVERSTON'. The east elevation comprises the dividing brick wall and butts the outer stone build to the north and south (Plate 18). There is a recess in the lower part with a timber lintel, which appears to be round in section, and the resulting gap is covered by planks attached on the east side to short timber posts. The south elevation is plain apart from the eight-light timber casement window on the east side with a timber sill and a rough reused timber lintel, with a slot on its east side (Plate 19). The west elevation is plain apart from two slot vents, which are blocked externally; the one to the south has a rough timber lintel and both have later plank sills (Plate 20). The upper north side of the elevation has been rebuilt.

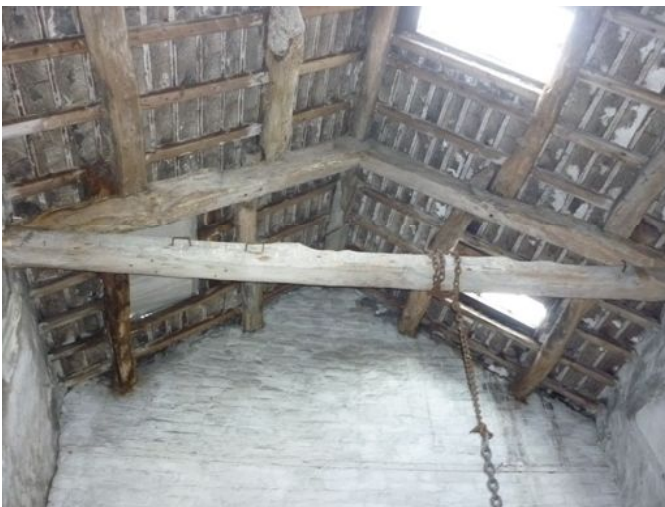
Plate 21 (left): Truss in Room 2

4.3.2 **Ground floor Room 2:** this room has a concrete floor and is lower than Room 1 to the west. Again it is open to the roof. It has a single truss with two purlins per pitch and a diagonal ridge purlin like

those in Room 1 (Plate 21). The backs of the slates used in the roof are finished with plaster and there are three skylights in the north side in various arrangements and one in the south. The rafters are machine cut and the walls are finished with plaster and lime wash. A half loft has been added on the west side using machine cut timber and sheets (visible in Plate 24 and Plate 25). The north elevation is plain. The east elevation is dominated by a large folding doorway constructed from timber panels and battens (Plate 22). An additional section of an earlier plank door is attached on the south side. Machine made brick is visible in the north jamb, so the doorway is evidently inserted. There is a doorway on the east side of the south elevation with a tongue and groove plank and batten door with an enamelled letter box, electrical fuse box, and four meters above (Plate 23). Above is a six-light fixed casement window with splayed jambs and a timber lintel. To the west is a small alcove with a timber sill and possibly a timber frame (Plate 24). This was perhaps a blocked aperture although if it was then it was not visible externally. The west elevation is built from brick laid in a stretcher bond with planks fixed over the lower part and a large opening in the base which cuts under the floor of Room 1 (Plate 25). This area is supported with corrugated metal sheets and rough battens made from reused beaded pieces and modern veneered pieces.
