ELM HOW AND BRAESTEADS, PATTERDALE, CUMBRIA

Archaeological Desk-Based Assessment

Client: Madeleine Scott

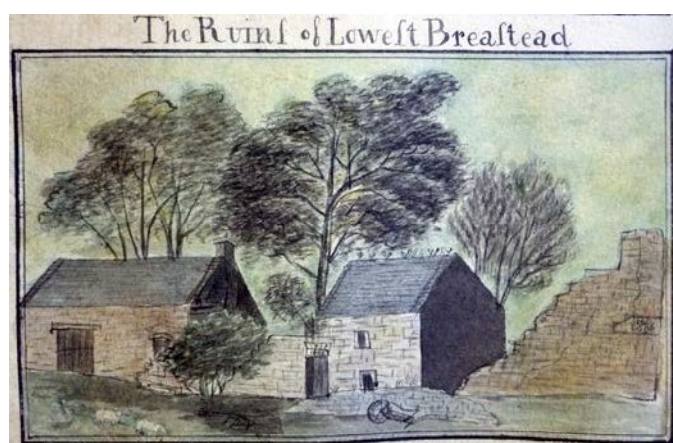
Plate 4 (right): Floor plans, presumed to correspond to the new house of 1801

3.3.2 Various illustrations are also shown along the bottom of the estate map of c1810 (CAC(K) WDBS/987 c1810; Plate 3 to Plate 6). These are remarkably detailed, showing a new house, described as built in 1801 (Plate 3) with floor plans, presumably of the same building (Plate 4), ruined buildings at 'Lowest Braesteads' (Plate 5) and the buildings at 'Pye Thorns' (Plate 6). These drawings are extremely detailed and provide a considerable amount of information about the buildings (see Section 4.6.5 below).

4.6.6 Arguably the most useful is the estate plan of c1810 (CAC(K) WD BS/987 c1810), which is remarkable in its detail. It shows not only that Braysteads comprised three separate elements 'High Breastead', 'Low Breastead', and 'Lowest Breastead', with a total of four buildings between them (see *Section 3.3.1*; Plate 5). In addition, a further farm, probably the group of three buildings marked to the east and called 'Pye Thorns' also existed. This plan is even more remarkable because it not only shows the buildings and fields in plan, it also has watercolour sketches of the 'Ruins of Lowest Breastead', 'The New House Built Anno Domini 1801', a ground and first floor plan, presumably of this new building, and buildings at 'Pye Thorns' (Plate 3, Plate 4 and Plate 6). Even more remarkable still is the detail in the first of these drawings, which shows a datestone over the door in the central section of 1800 and another in the ruined section to the right marked 'IBA[?] 1696'. This in turn provides additional information about the occupiers as the letters are the initials of someone connected to the property, and perhaps corresponds to another member of the Bewsher family (see *Section 4.6.5* above). The 1841 census shows that Piethorns was still standing at this time, although the earliest Ordnance Survey map shows it, and the other elements of Braesteads, had been demolished by 1863 (see *Section 3.3.4* above).

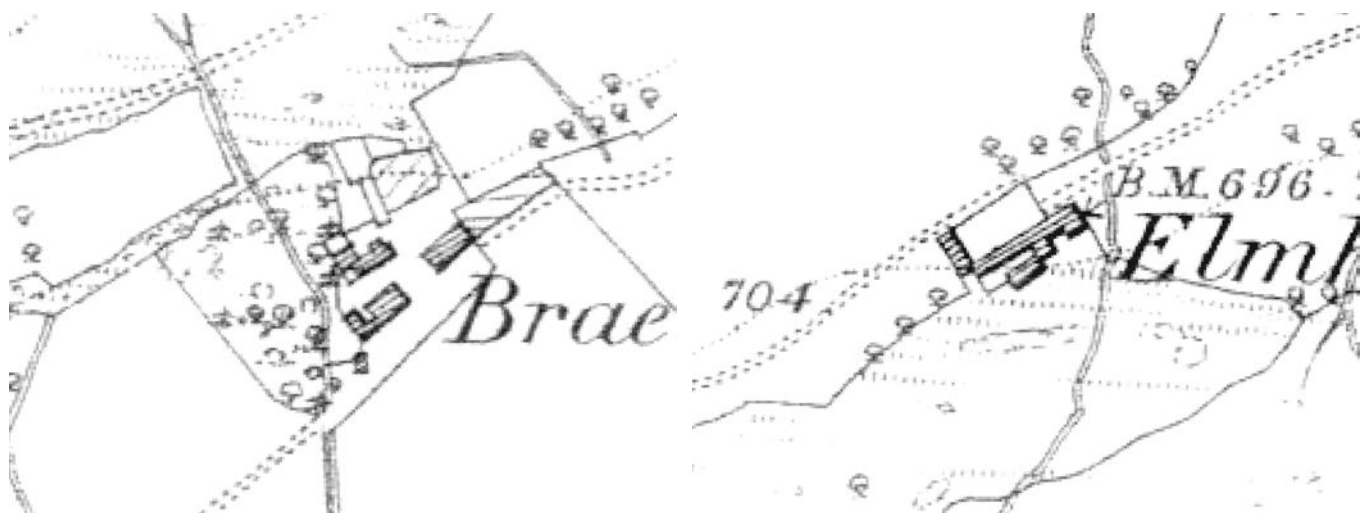
3.3.4 **Ordnance Survey 1863:** this map shows the entire area at good level of detail (Plate 9; Braesteads and Elmhow Plate 10 and Plate 11). The buildings previously shown to the north-east of Braesteads are no longer extant.

Plate 10 (left): Braesteads - Ordnance Survey, 1863

Plate 11 (right): Elmhow - Ordnance Survey, 1863

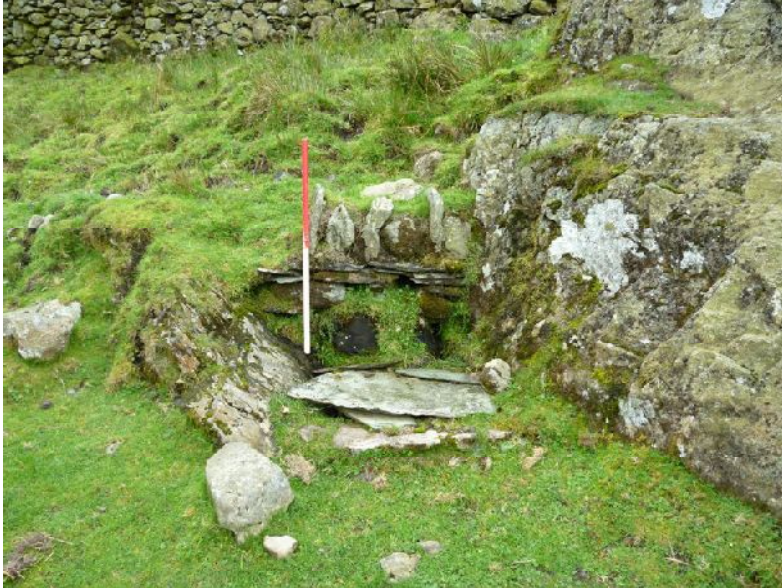
Plate 16: Spring head, viewed from the north-east (Site 1)

Description: Spring head, with dry stone wall edging east side against the outcropping bedrock and opening covered by stone slabs, including pieces of roof slate, and an iron grill.

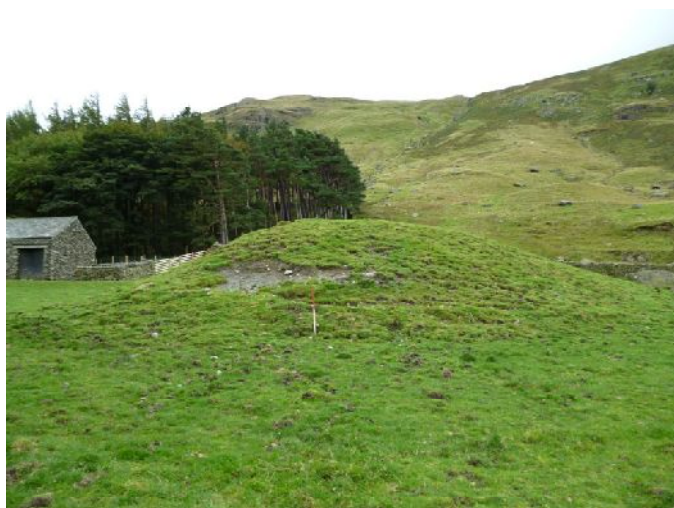
Plate 17 (left): Mound, viewed from the north (Site 2)

Description: Mound, c15m long by 10m wide and up to 3m tall, orientated approximately north-east/south-west. Very gravelly structure, probably a drumlin and others are spread along the valley in this area.

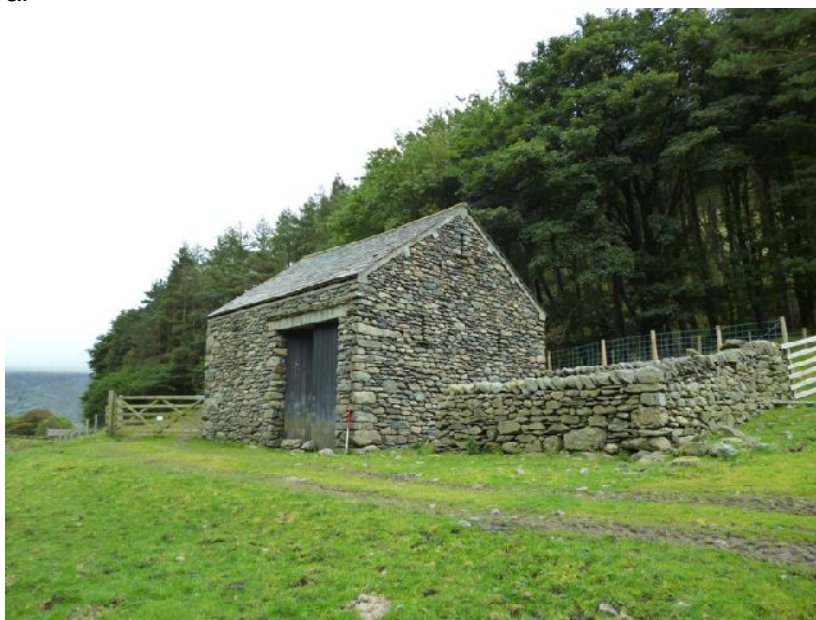
Plate 19: Barn, viewed from the north-west (Site 3)

Description: Field barn or perhaps a building associated with the nearby lead mines, clearly extensively rebuilt. Stone built with quoined corners, c8m square, with a slate roof and double door on the north side. There is an attached pound on the west side and ventilation slots in the remaining elevations. Internally the roof is supported by a single tie beam truss.

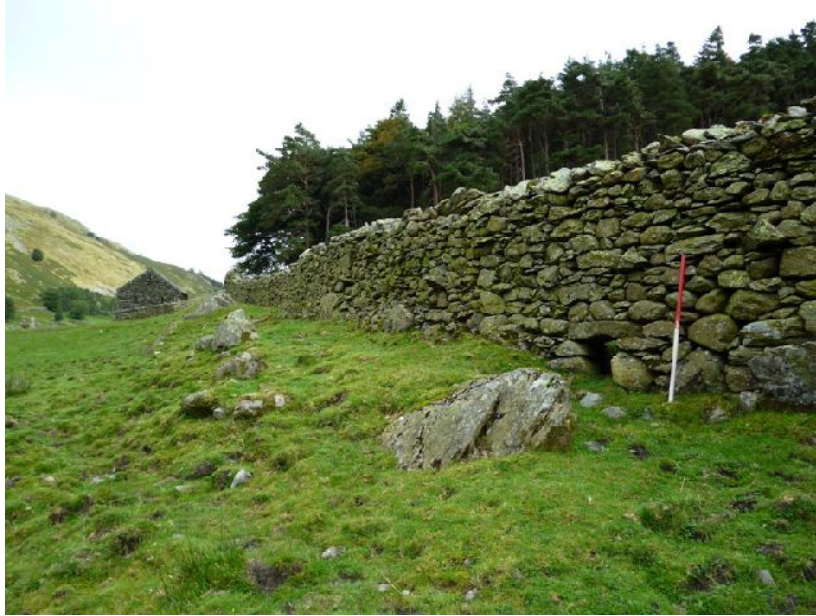
Plate 20: Smoot- or hogg-hole and adjacent earthwork, viewed from the north-west

Description: Small hole in wall, hogg-hole or possibly smoot-hole. Immediately to the east is an earthwork forming a possible platform against the field boundary, which extends c2m from the wall and is edged on the north side with stones.

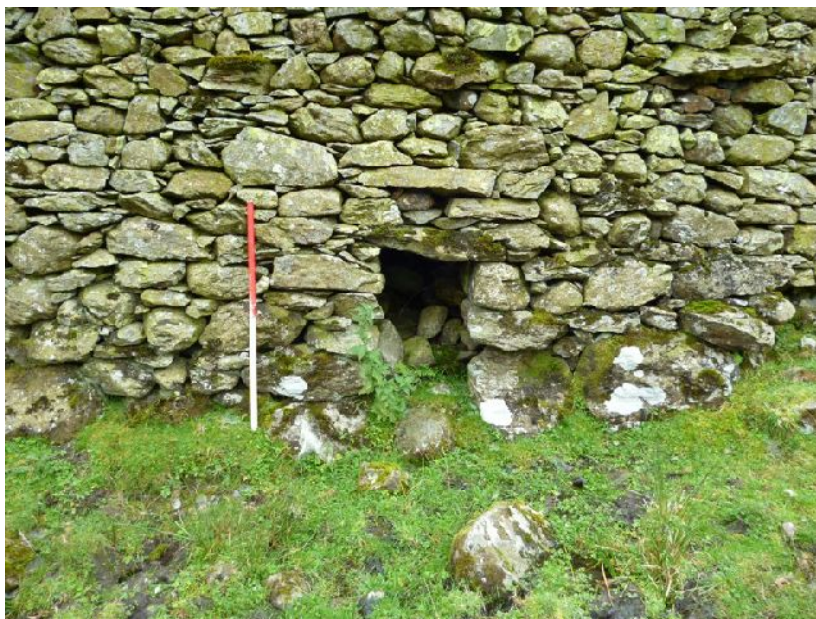
Plate 21: Hogg-hole, viewed from the north (Site 5)

Description: Hogg-hole in wall, c0.6m wide by 0.8m tall.

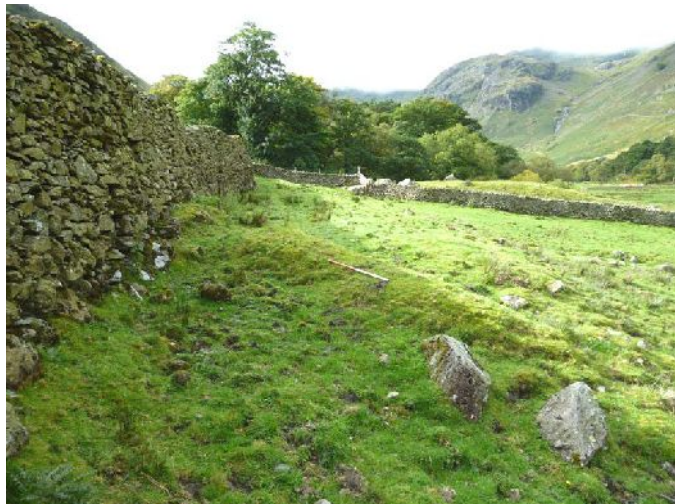
Plate 22 (left): Platform, viewed from the east (Site 6)

Description: Platform set against boundary wall comprising a curving bank with stones set along it, c0.8m tall and 20m long. There is a larger bank on the east side, c1m wide and constructed from earth, adjacent to **Site 5**. The main bank appears to pre-date the boundary wall, although there are some large stones protruding from the base of this that may relate to the platform. There is also a low bank curving round the platform, 0.6m wide and 0.3m tall.

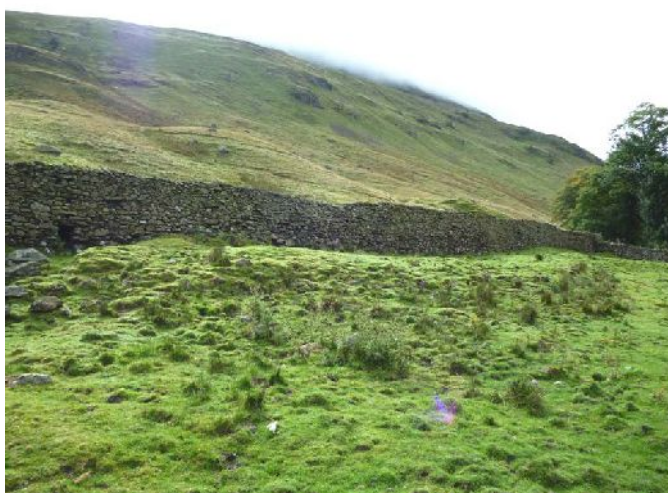
Plate 23 (right): Platform, viewed from the north-east (Site 6)

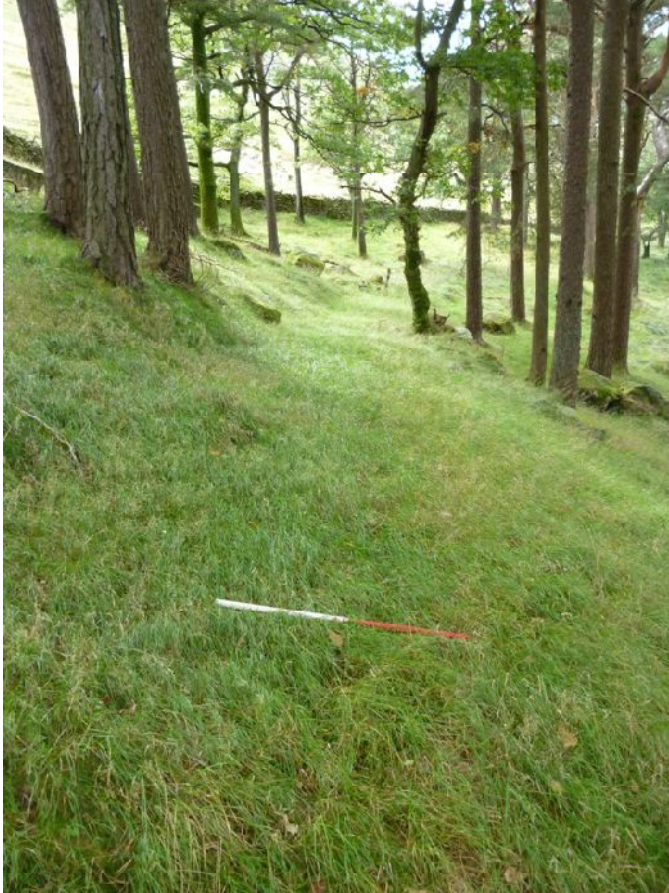
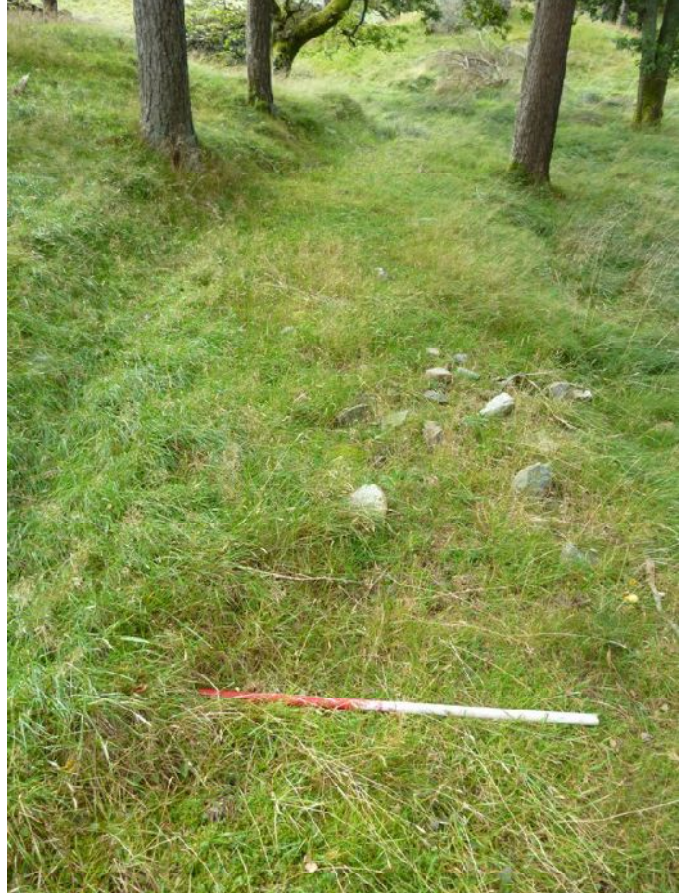
Site Number: 7**NGR:** 336713 514635 (point)**HER No:** -**Sources:** Site visit**Designation:** None**Description:** Track winding east/west through woodland, cut into slope, seemingly connecting Elmhow with the lead mines further up the valley. Typically 2-3m wide and cobble sized stones exposed in one area. Ends not obvious, especially east, but lines up with gate (**Site 8**) at west end and evidently continues beyond this.**Period:** Post-medieval?

**Plate 24 (left):** Track, viewed from the east (**Site 7**)**Plate 25 (right):** Track, showing stones, viewed from the east (**Site 7**)**Site Number: 8****NGR:** 336592 514559**HER No:** -**Sources:** Site visit**Designation:** None**Description:** Gate in boundary wall, now blocked with stone. Corresponding to line of track (**Site 7**). It has quoined jambs and is c3m wide.**Period:** Post-medieval

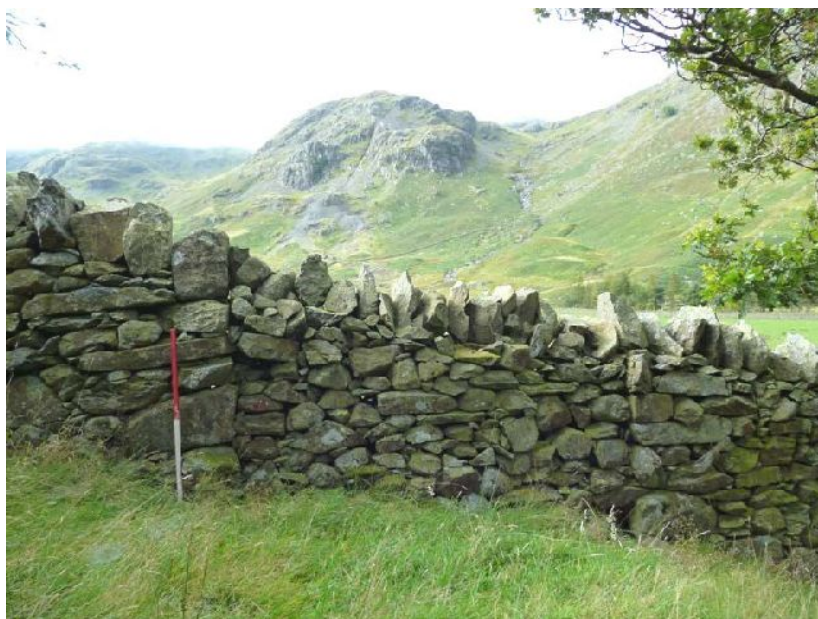
Plate 26: Gate, viewed from east (Site 8)

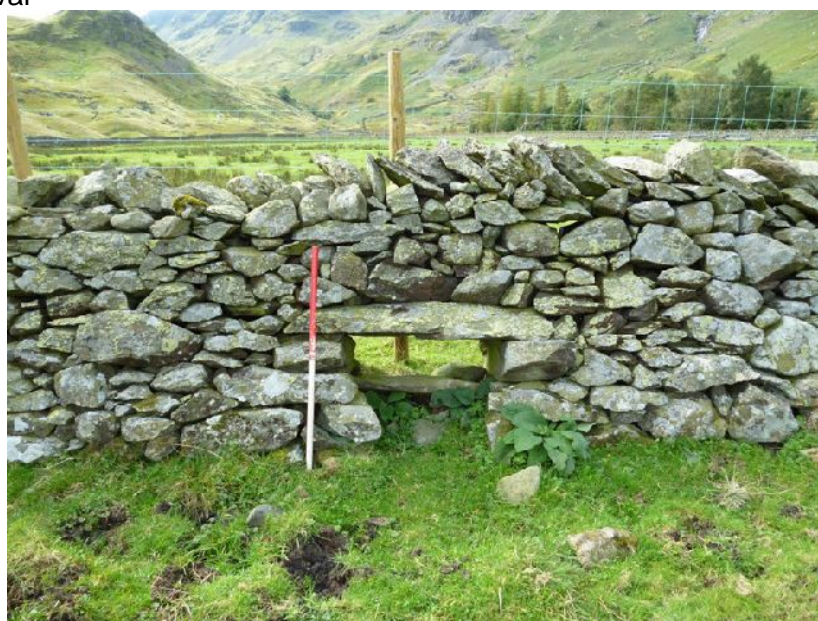
Plate 27: Hogg-hole, viewed from east (Site 9)

Description: Hogg-hole in boundary wall. Drystone construction with horizontal dividing slab inside. 0.7m wide and 0.7m tall.

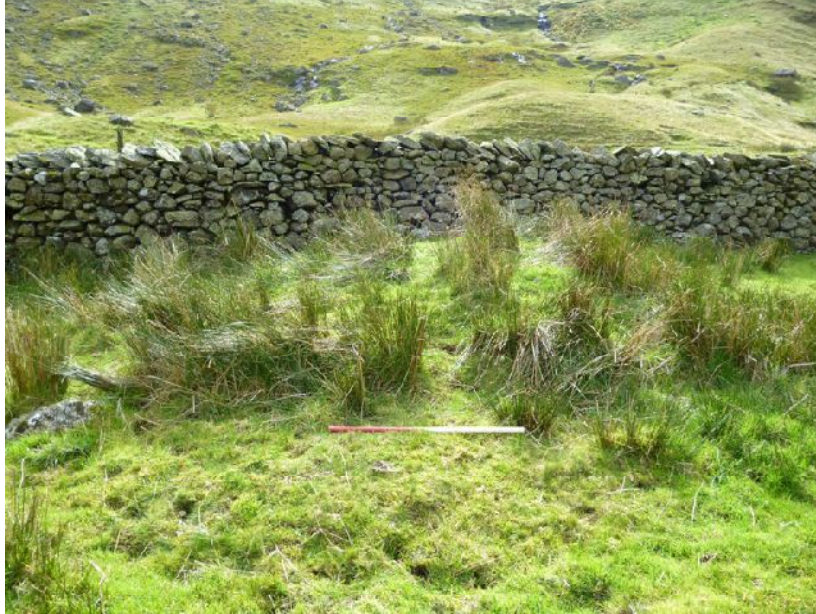
Plate 28: Possible cairn, viewed from the north-east (Site 10)

Description: Possible cairn situated against the field boundary. C5m by 4m north-east/south-west and 1m at tallest point. It mostly seems to consist of soil but some stones are visible.

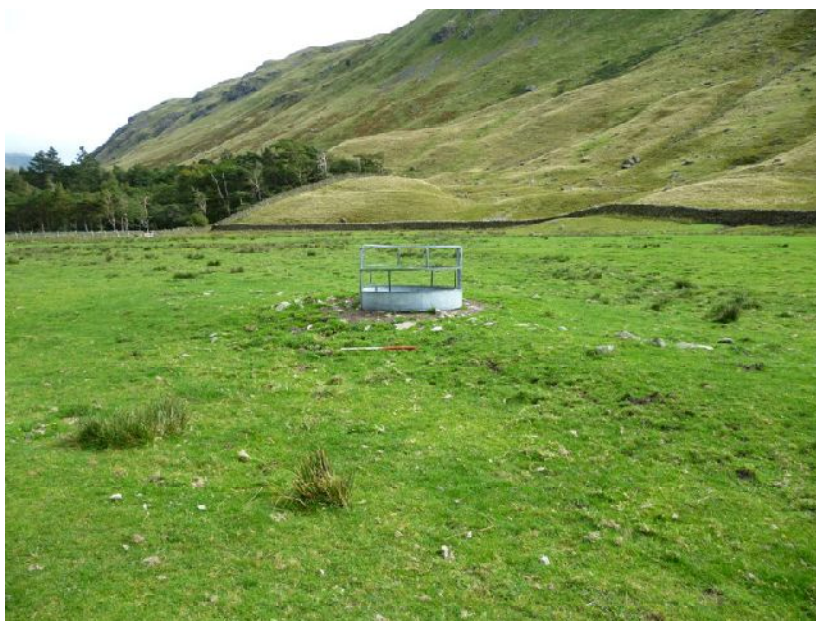
Description: Possible clearance cairn (a pile of stones removed from a field to improve the land). Irregular spread of material with some stone exposed where it has been eroded by having an animal feeder placed on top. Roughly orientated north-east/south-west and c5m at its widest and perhaps 10m long.

Plate 29: Possible cairn, viewed from the north-west (Site 11)

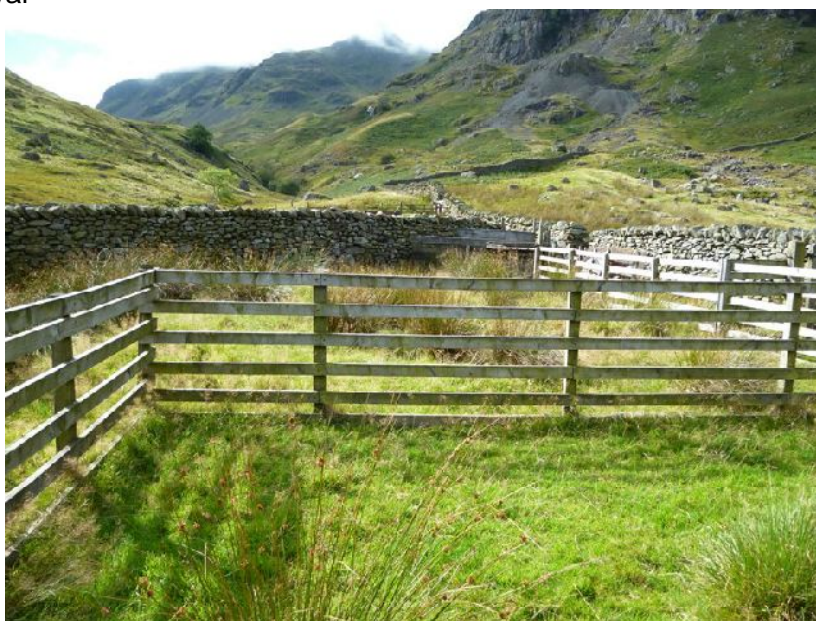
Description: Sheepfold set against field boundary. Drystone built and rectangular in plan with timber internal divisions and added sections in post and wire to the east and west. There are entrances to the main part on the east and west sides.

Plate 30: Sheepfold, viewed from the east (Site 12)

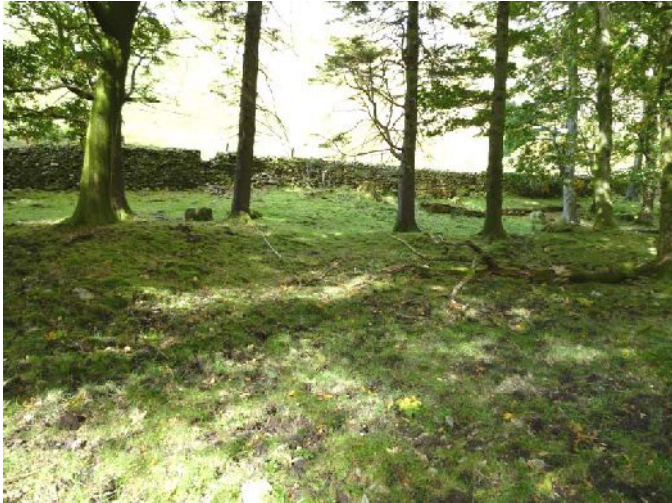
Description: Remains of a settlement site now difficult to identify in detail although an outer bank demarking an oval area with a small 'hut circle' off the north-east corner and a bank running off from the south-west corner of the main enclosure to the south are visible. The banks are set against the slope on the north side and so up to 1.2m high, and there is stone exposed in several places. The whole site covers an area of perhaps 20m square.

Plate 31 (left): Bank forming part of enclosure, viewed from south (Site 13)

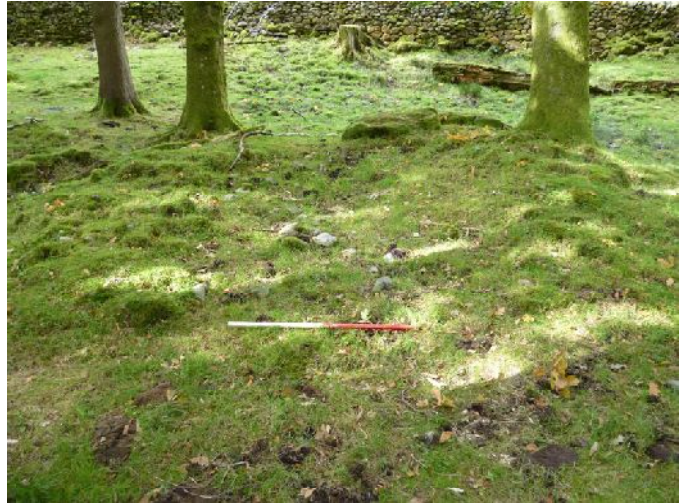
Plate 32 (right): Hut circle on north-east side of enclosure, viewed from south (Site 13)

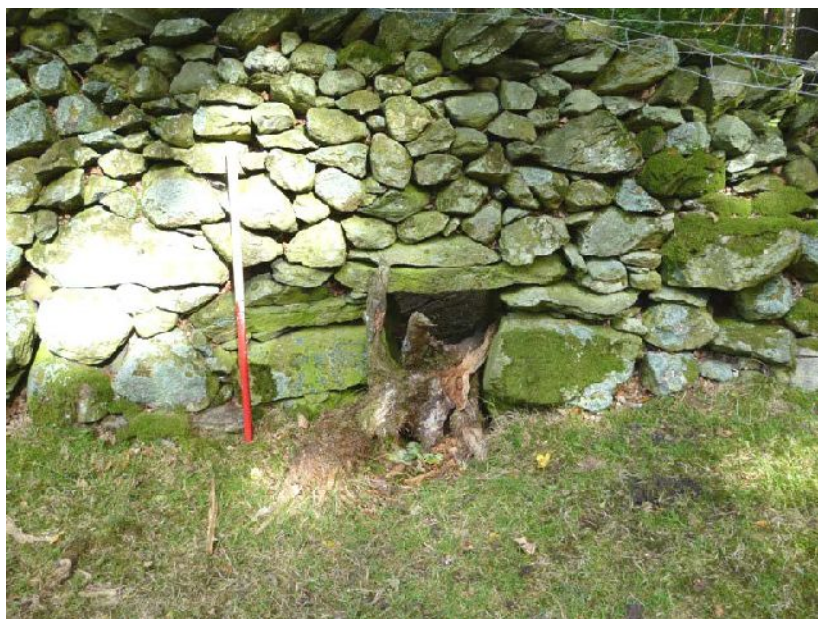
Description: Hogg-hole in boundary wall. 0.5m wide and 0.6m tall.

Plate 33: Hogg-hole, viewed from west (Site 15)

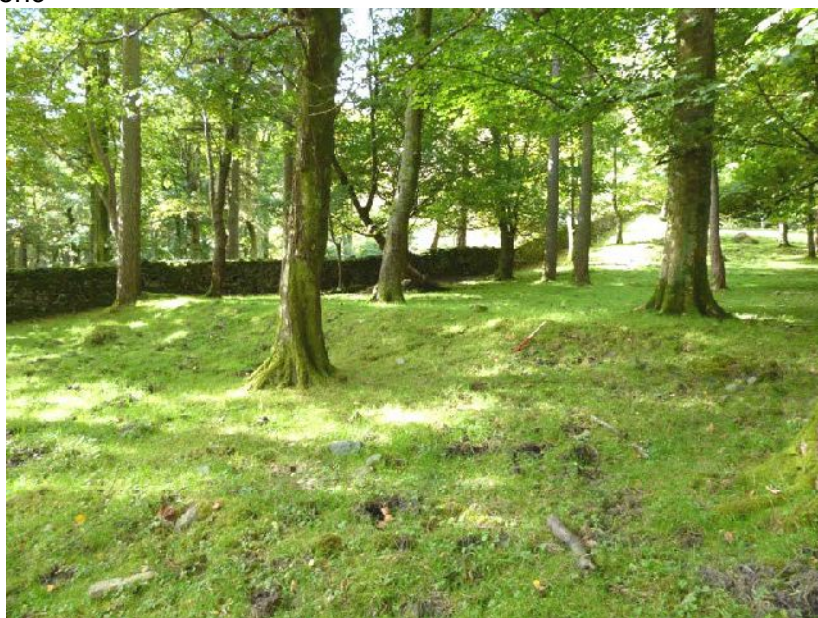
Description: Bank running east/west, up to (and below?) the boundary wall to the west and until the beck running north/south down slope and apparently continuing beyond this. C1m tall and 20m long.

Plate 34: Bank, viewed from the south (Site 16)

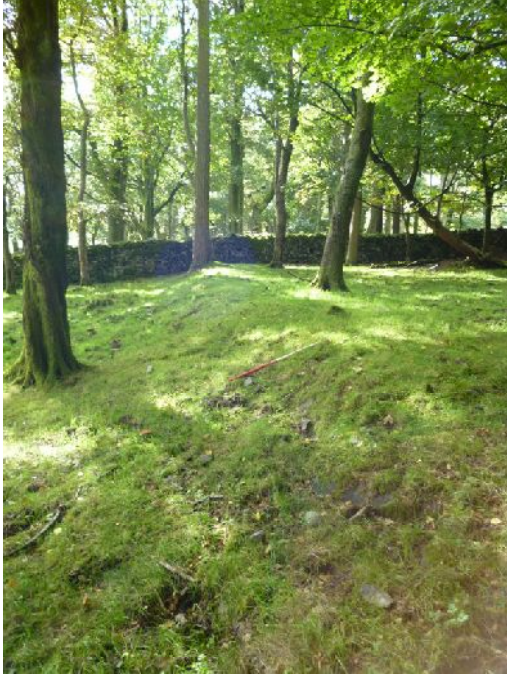
Description: Bank, similar in dimension to **Site 16**, but with orthostats at east end. Possibly connected to **Site 16** by a lower bank running along the west side of the beck.

Plate 35 (left): West end of the bank, viewed from the south-east (Site 17)

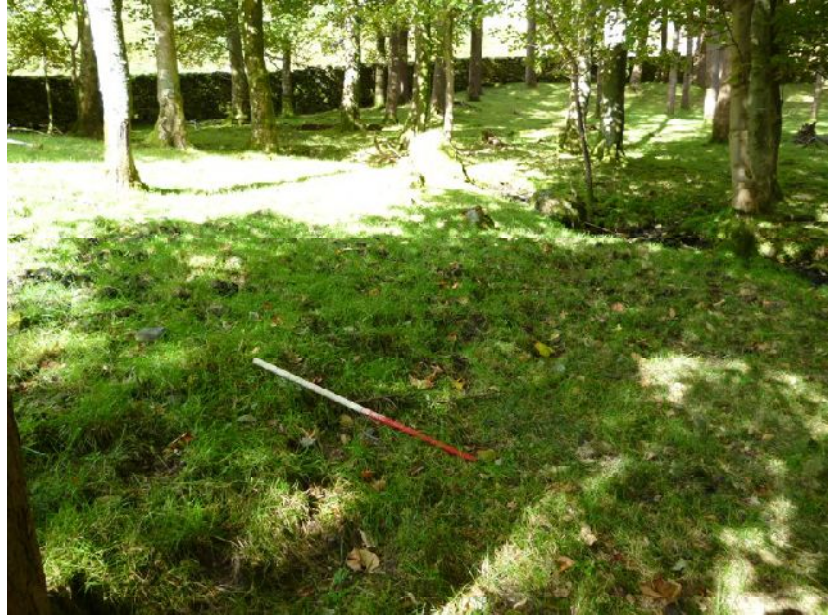
Plate 36 (right): East end of the bank, viewed from the south-west (Site 17)

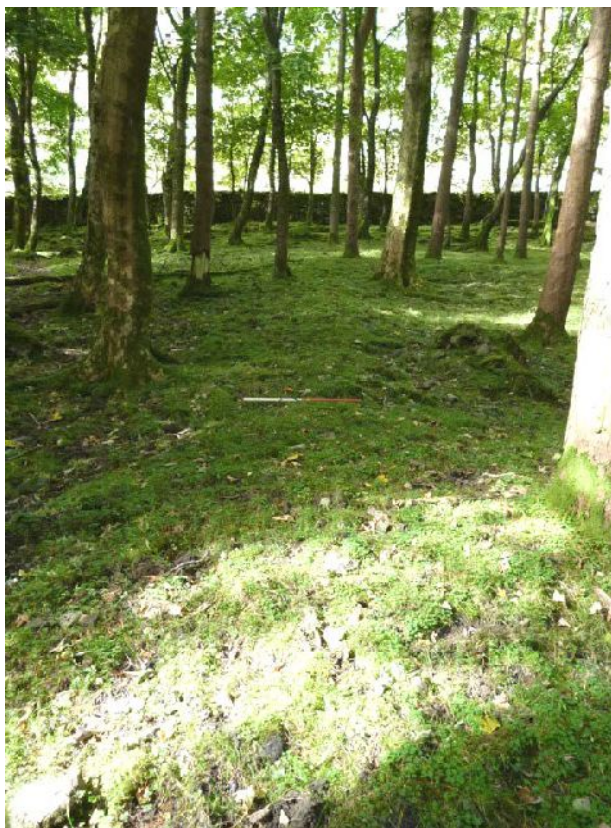
Description: Low bank, c0.6m tall and 2m wide running north/south, some stones exposed. Presumably forming part of a field system with **Site 16** and **Site 17**.

Plate 37: Bank, viewed from south (Site 18)

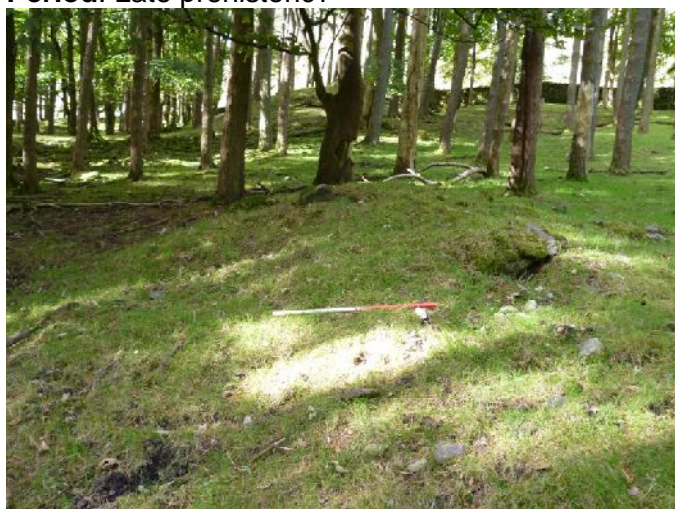
Description: Low cairn c4m by 5m, and up to 1m tall, orientated north-east/south-west. Lots of stones visible in its fabric.

Plate 38 (left): Cairn, viewed from the south (Site 19)

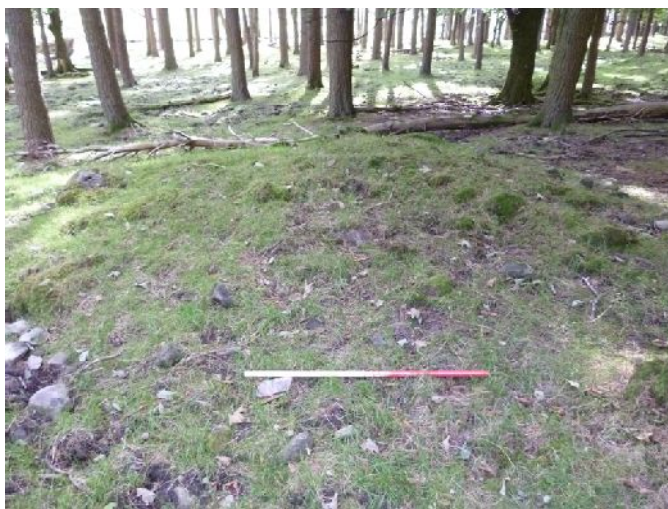
Plate 39 (right): Cairn, viewed from the north (Site 19)

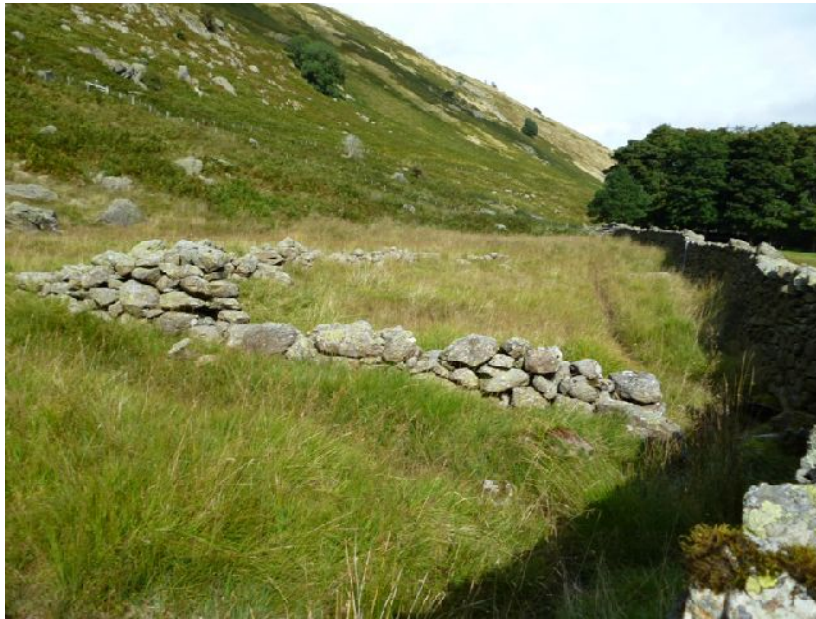
Description: Ruined stone structure, probably former sheepfold. Rectangular in plan, orientated east/west c20m long by c10m wide. Five to six courses surviving and built against the extant field boundary.

Plate 40: Probable sheepfold, viewed from west (Site 20)

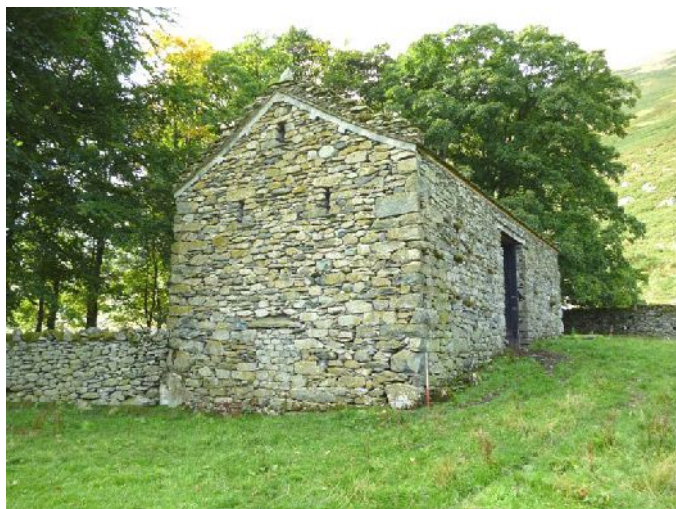
Description: Barn, stone built with slate roof and crow-stepped gables. There is a wagon doorway in the east side and vents throughout. The trusses are of simple tie-beam type.

Plate 41 (left): Barn, viewed from the south (Site 21)

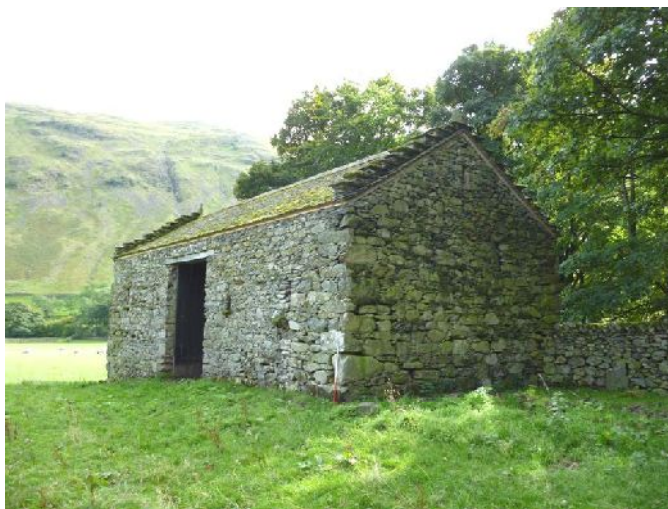
Plate 42 (right): Barn, viewed from the north (Site 21)

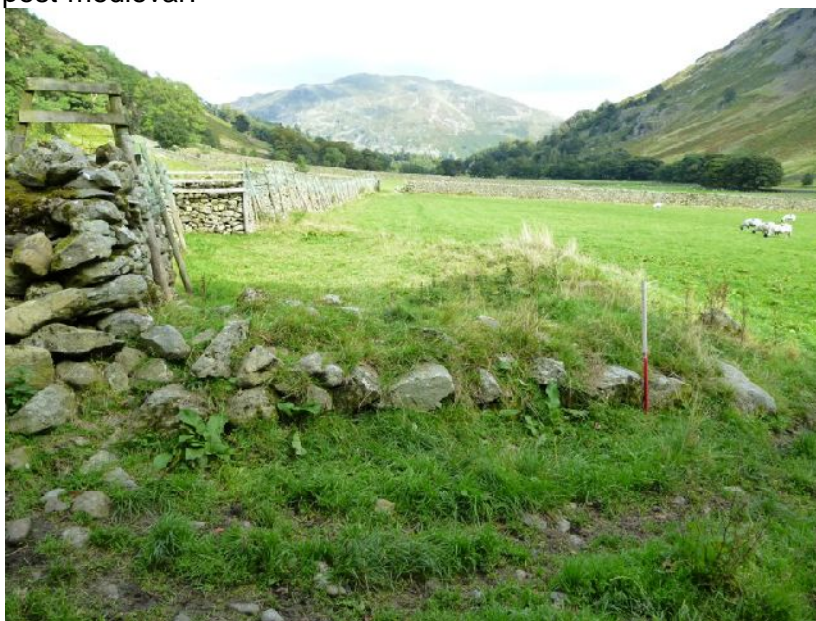
Description: Rectangular footings of ruined structure, built against existing field walls with up to three courses remaining. Walls remarkably thick, perhaps as much as 1m.

Plate 43: Building footing, viewed from the west (Site 22)

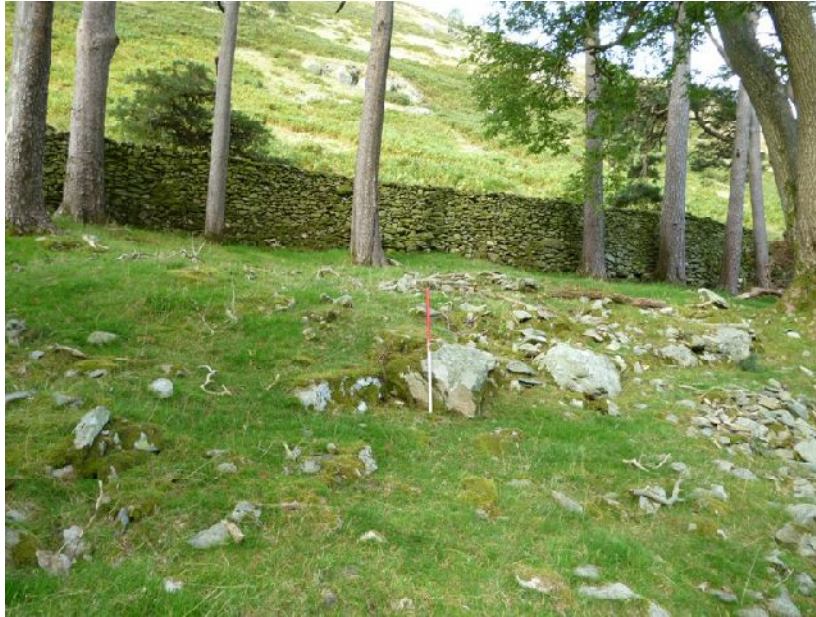
Plate 44: Possible platform, viewed from south-west (Site 23)

Description: Possible platform comprising a four-sided area set against the field boundary although irregular in plan. It is formed by large angular boulders along the south side, with a single course possibly remaining on top and lots of loose stone on top of the platform in general.

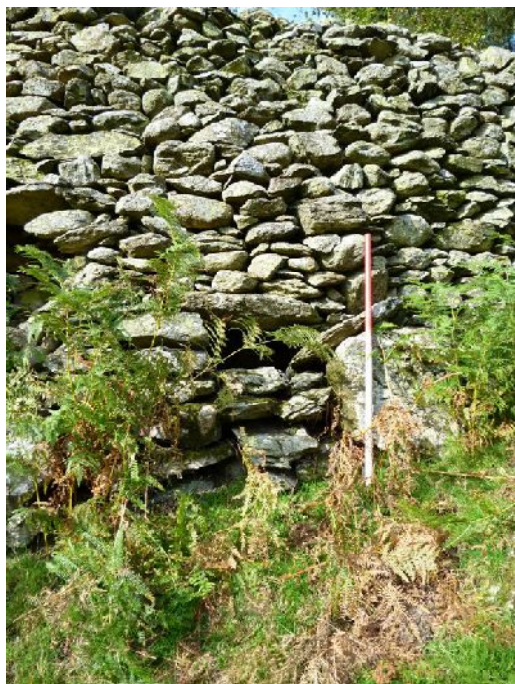
Description: Hogg-hole built into the boundary wall, c0.5m wide and 0.7m tall, to the west of the possible remains of a structure incorporated into the same field boundary. This has quoins evident at the west corner and to the east, where they are butted by the continuation of the wall. The wall is very thick and there is a possible blocked ventilation slot and other feature in the wall between the two sets of quoins.

Plate 45 (left): Hogg-hole, viewed from the south (Site 25)

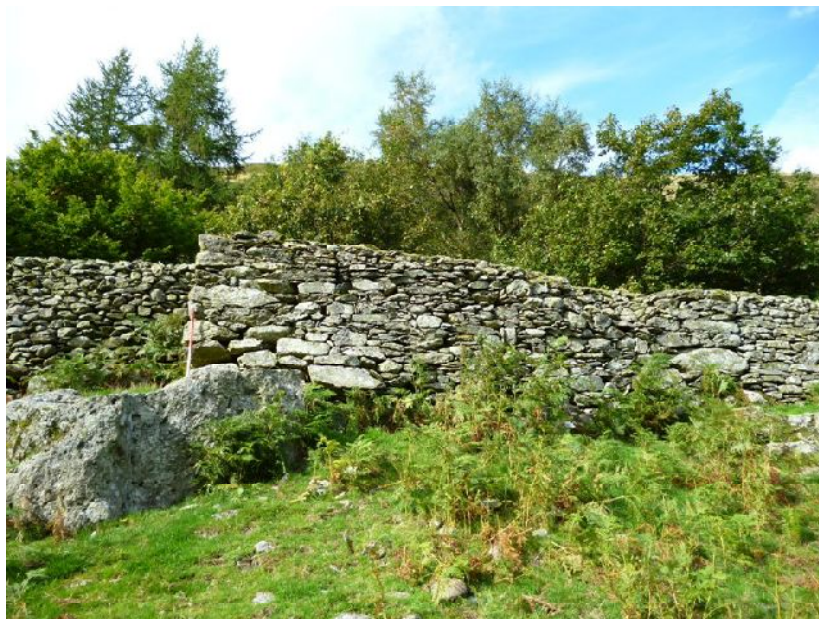
Plate 46 (right): Remains of building incorporated into field boundary, viewed from the south (Site 25)

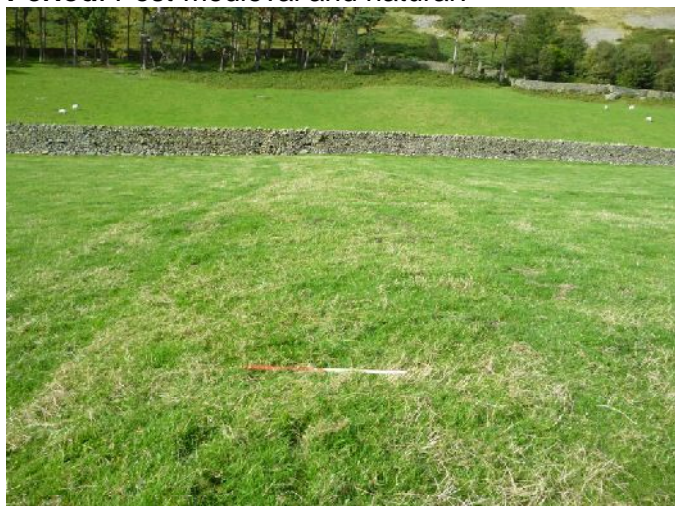
Description: Bank 2m wide and up to 0.7m tall, presumably a former field boundary, running north/south, that turns to the east at the south end into a much larger and perhaps natural bank. This is smaller to the west and has a possible track running across it (towards the bridge, **Site 43**) to the south-west) but much larger to the east where it is at least 2m tall.

Plate 47 (left): Bank, viewed from the south

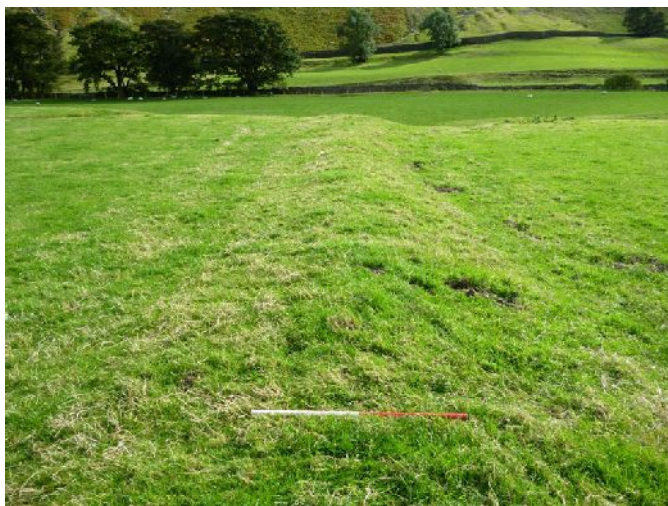
Plate 48 (right): Bank, viewed from the north

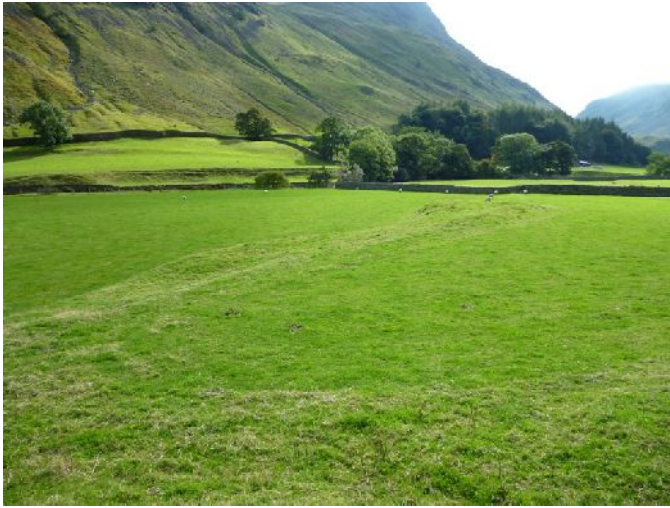
Plate 49 (left): Bank extending to the west, viewed from the north-east (Site 26)

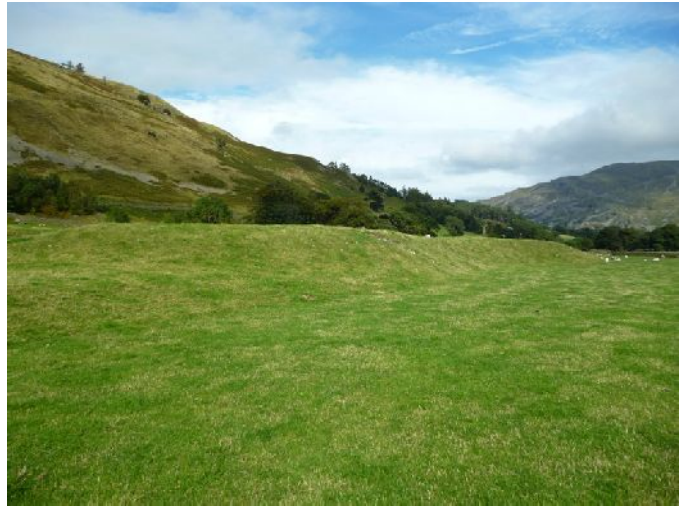
Plate 50 (right): Bank extending to the east, viewed from the south-west (Site 26)

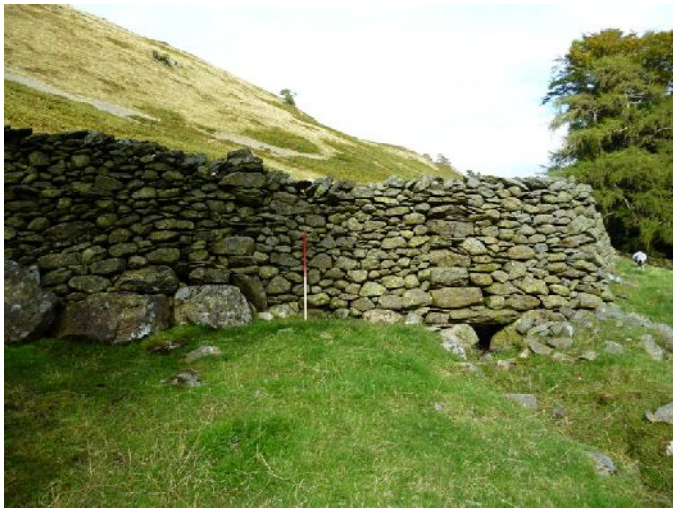
Description: Gateway in field boundary wall, blocked with stone, with a section of orthostatic walling adjacent to it. A ditch carrying water runs up to the wall and through it via a low stone-built opening.

Plate 51 (left): Blocked gate, viewed from the south-west (Site 29)

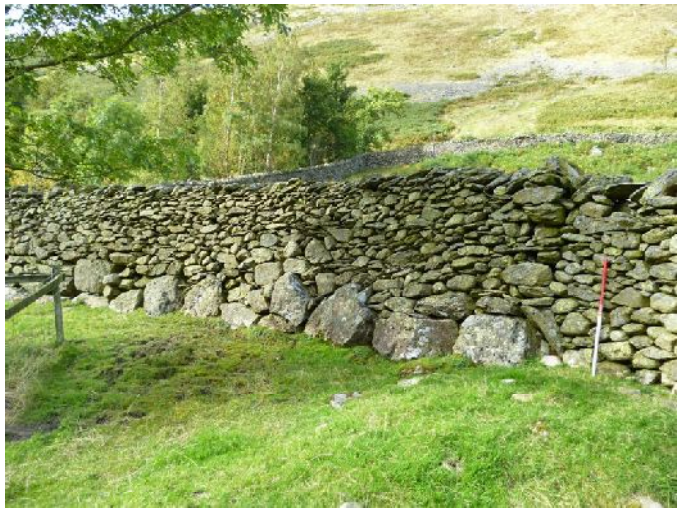
Plate 52 (right): Orthostatic wall to the west of the blocked gate, viewed from the south-east (Site 29)

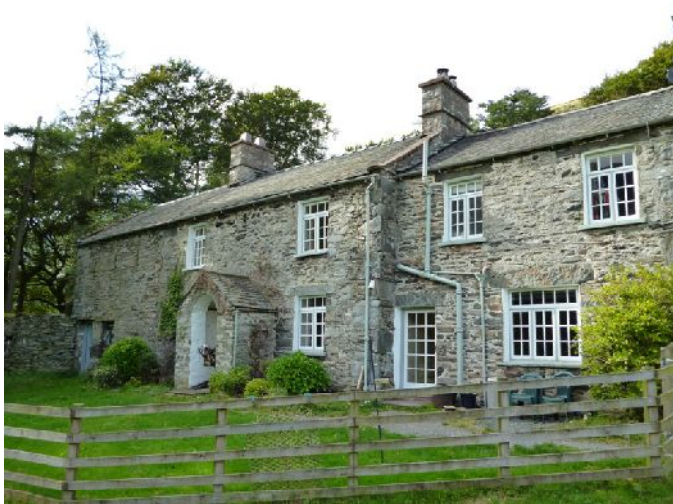
Description: Braesteads Farm. The main farmhouse comprises a rectangular range of buildings with the central section probably representing a single double-pile house with a symmetrical front (south) elevation with a gabled porch and chimney at either end. The west end is clearly a later extension, apparently to form an animal house, and incorporates a re-used date stone of 1683. The east end is set back from the line of the rest. There is a two-bay cart shed to south-west, connected by a boundary wall, and early barns to the east and north.

Plate 53 (left): The front elevation of Braesteads Farm, viewed from the south-east (Site 30)

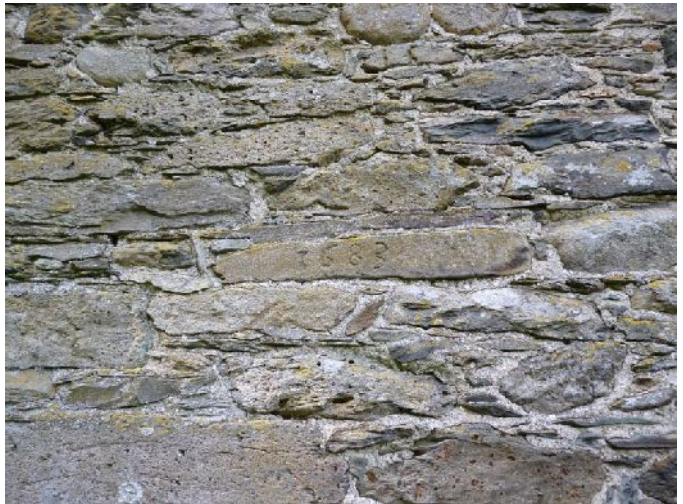
Plate 54 (right): The re-used date stone at Braesteads Farm, viewed from the south (Site 30)

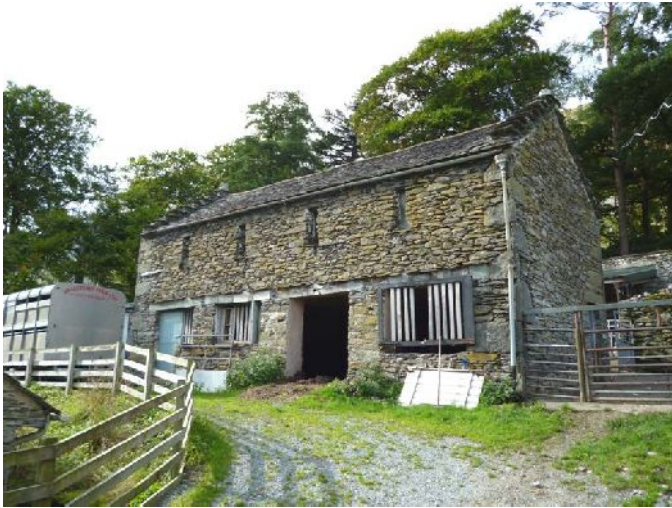
Plate 55 (left): Barn to the north of Braesteads Farm, viewed from the south-east (Site 30)

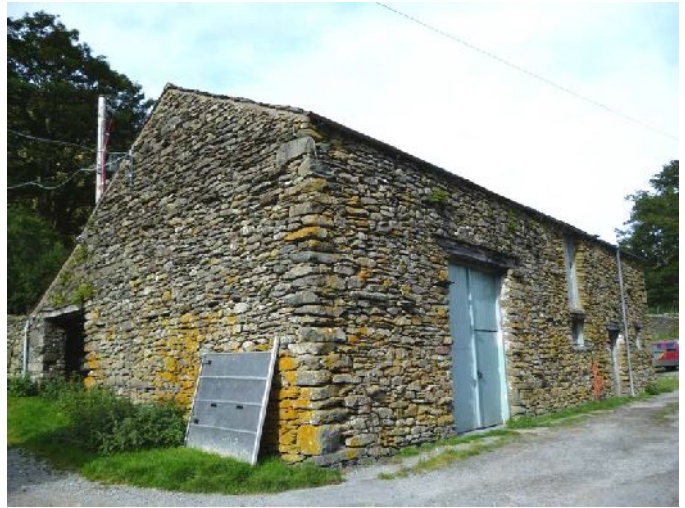
Plate 56 (right): Barn to the east of Braesteads Farm, viewed from the south-west (Site 30)

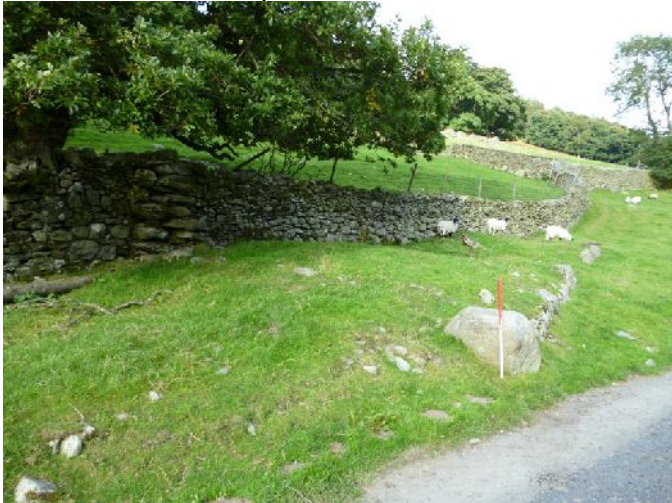
Description: Remains of a building comprising just the boulders of the footings, with especially large boulders at the corners and part of the walling still standing in the field wall against which it is set. It is approximately 10m long by 5m wide and has a possible entrance on the east side of the south elevation. It possibly extends to the west as the field wall has a pedestrian doorway surviving to full height, albeit blocked with stone.

Plate 57 (left): Ruined building, viewed from the west (Site 31)

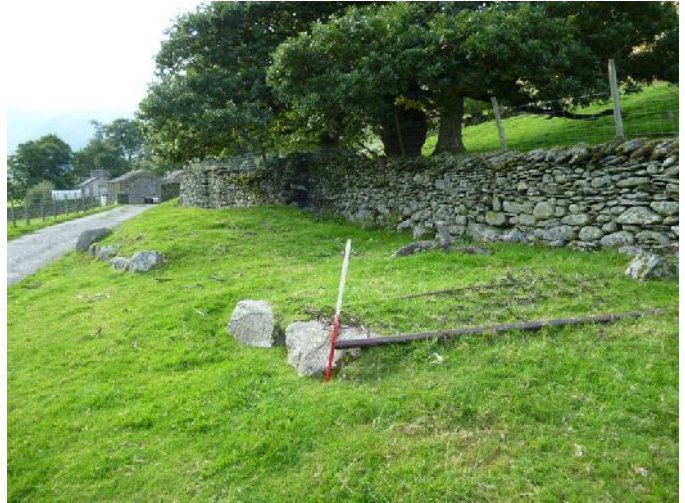
Plate 58 (right): Ruined building, viewed from the east (Site 31)

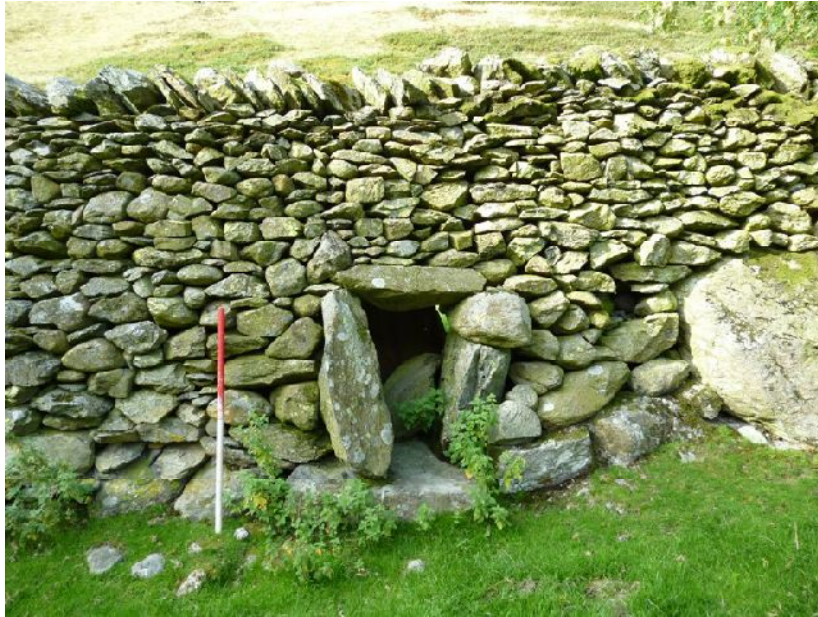
Description: Hogg-hole built into boundary wall. Drystone construction, with jambs constructed from single large pieces of stone. Approximately 0.5m wide and 0.8m tall.
