ELM HOW AND BRAESTEADS, PATTERDALE, CUMBRIA

Archaeological Desk-Based Assessment

Client: Madeleine Scott

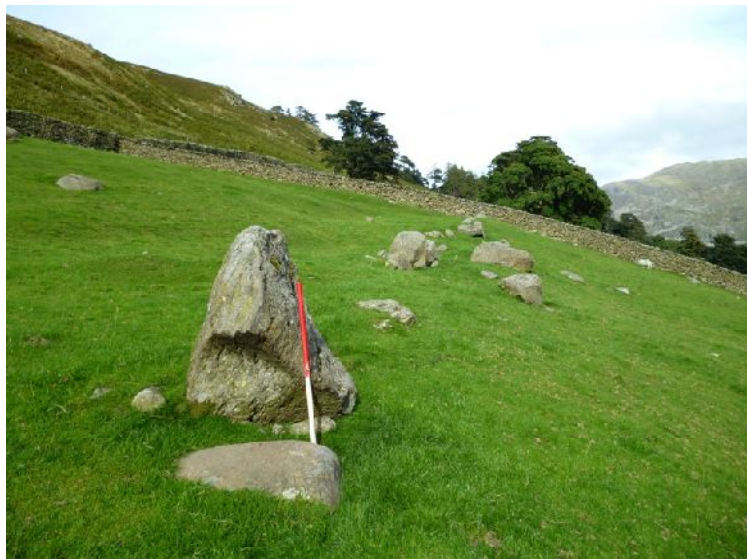
Description: Section of orthostatic wall running east/west, with only the orthostats remaining, some of which have clearly moved from their original positions down slope. It continues to the extant field boundary to the east and is possibly continued by a ruined field wall on the other side of this. There are also amorphous but essentially linear earthworks orientated north/south running from the east end of it. The line of the wall is probably continued by a ruinous but better preserved section on the east side of the field boundary.

Plate 59 (left): Orthostatic wall, viewed from the west (Site 33)

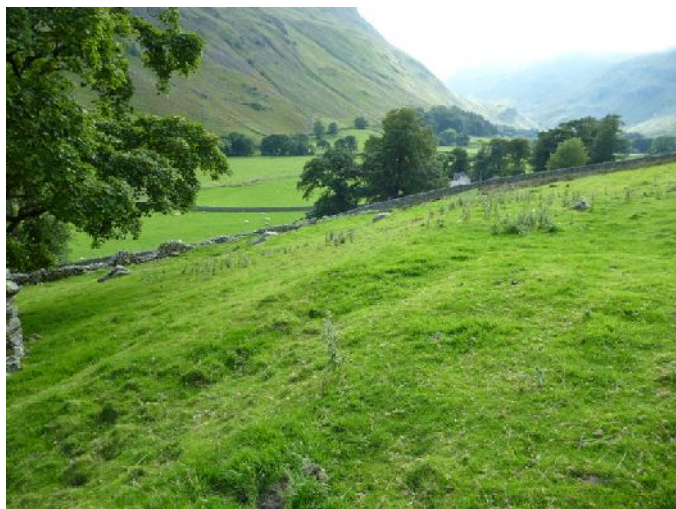
Description: Area of terraces and ruined structures. There are at least three terraces, all orientated east/west and typically 1.5m tall. To the west of these are the remains of a ruined building, still standing quite high but covered with vast amounts of rubble and with further ruined walls to east. East of this is a much larger ruined enclosure.

Plate 61 (left): Terraces, viewed from the north-east, part of Site 34

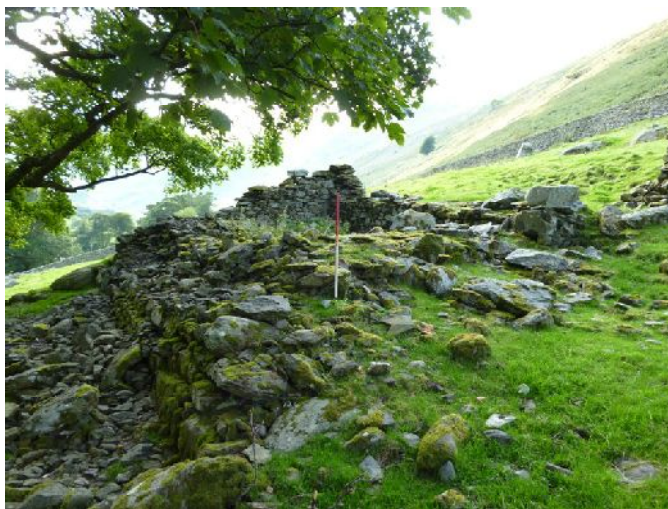
Plate 62 (right): Ruined building, viewed from the east, part of Site 34

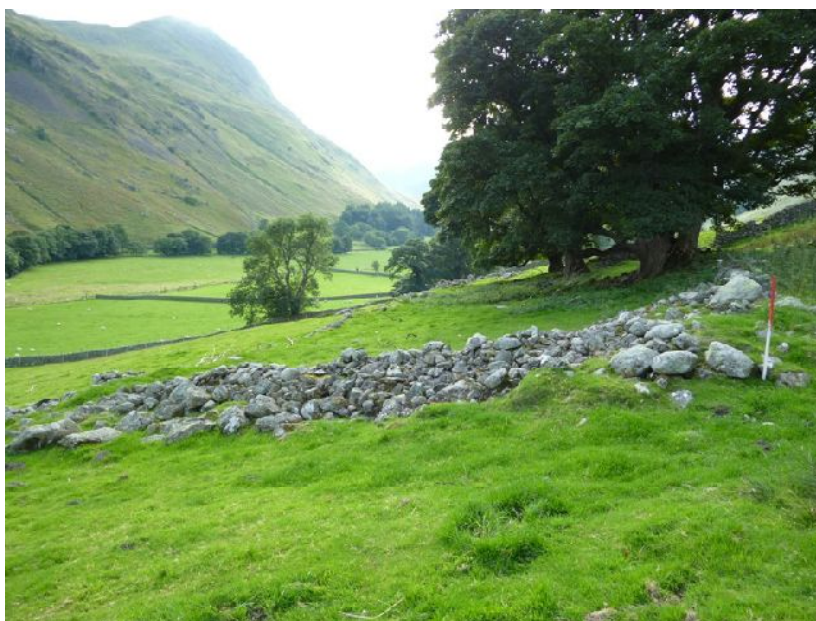
Plate 63: Ruined structure, viewed from the east, part of Site 34

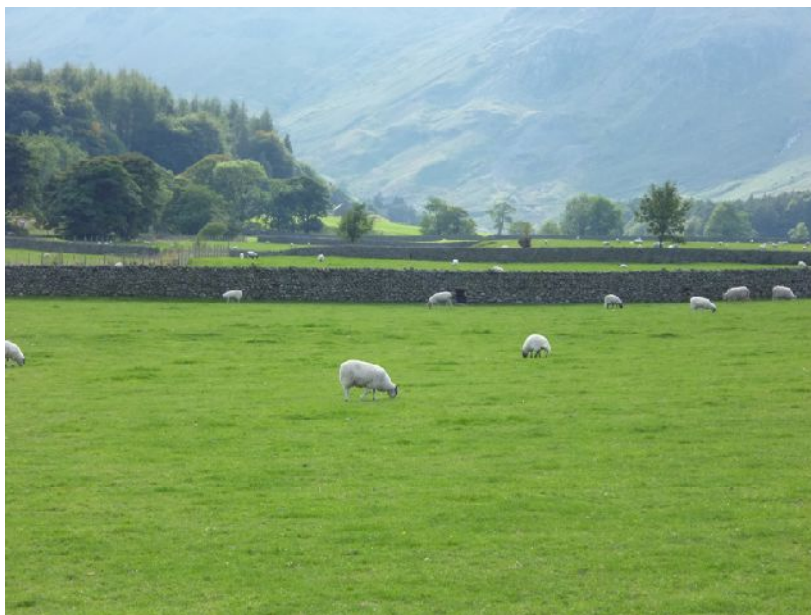
Description: Hogg-hole in boundary wall. Approximately 0.6m wide by 0.8m tall.

Plate 64: Hogg-hole, viewed across the field from the east, Site 35

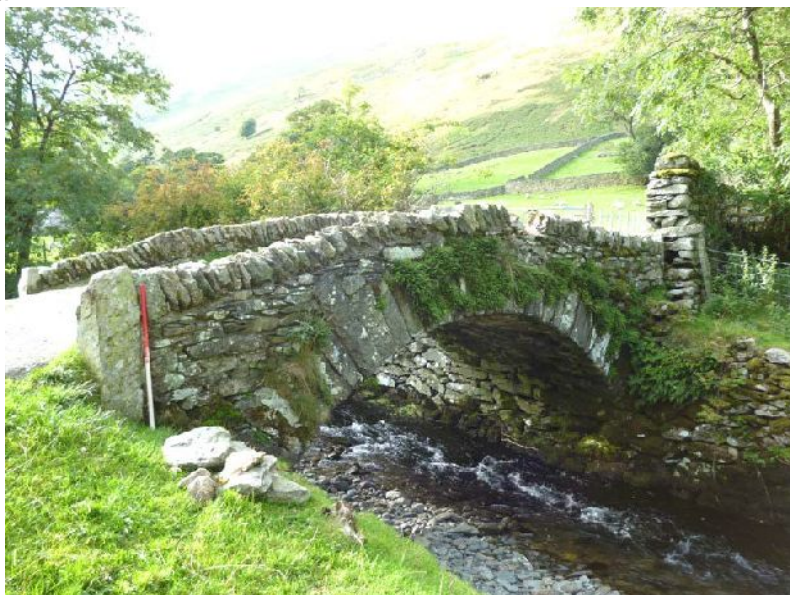
Description: Stone bridge, single voussoir arch in essentially packhorse bridge style but topped with walls finished with cams and end posts.

Plate 65: Bridge, viewed from the south, Site 36

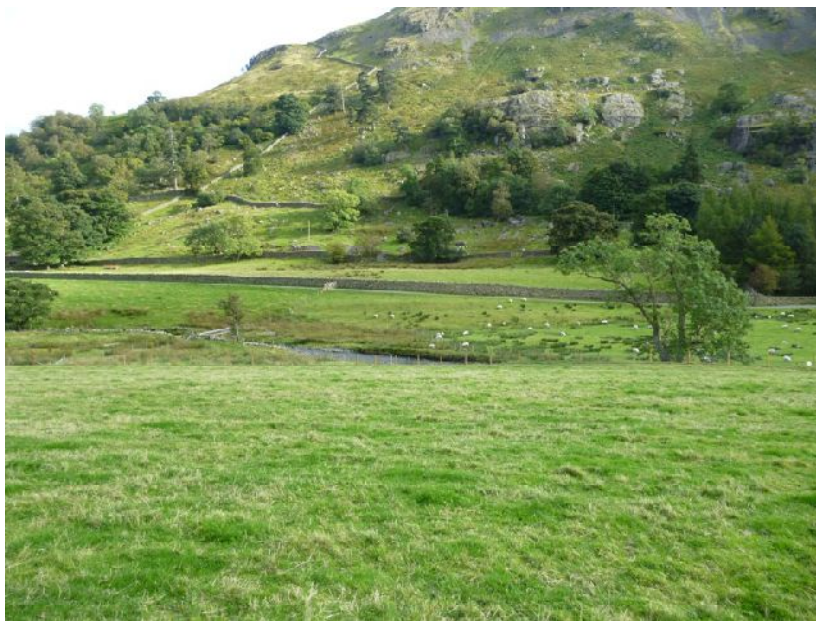
Description: Bank, possibly former river terrace but angled to line of river. C1m tall.

Plate 66: Bank, viewed from the north across the beck, Site 37

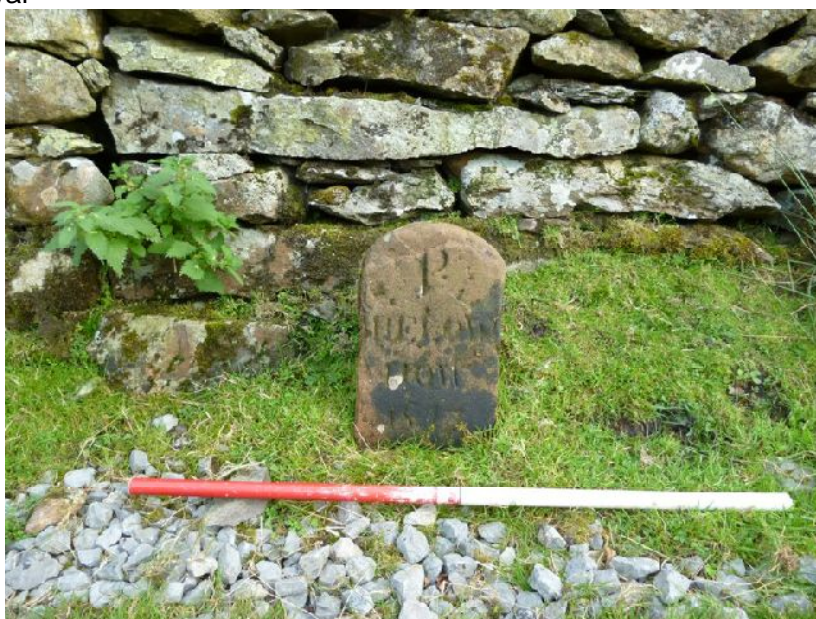
Description: Marker stone, low piece of dressed sandstone with round head, c0.2m wide and 0.4m tall. Inscribed "P BELOW HOW 15[?]17".

Plate 67: Stone, viewed from the north, Site 38

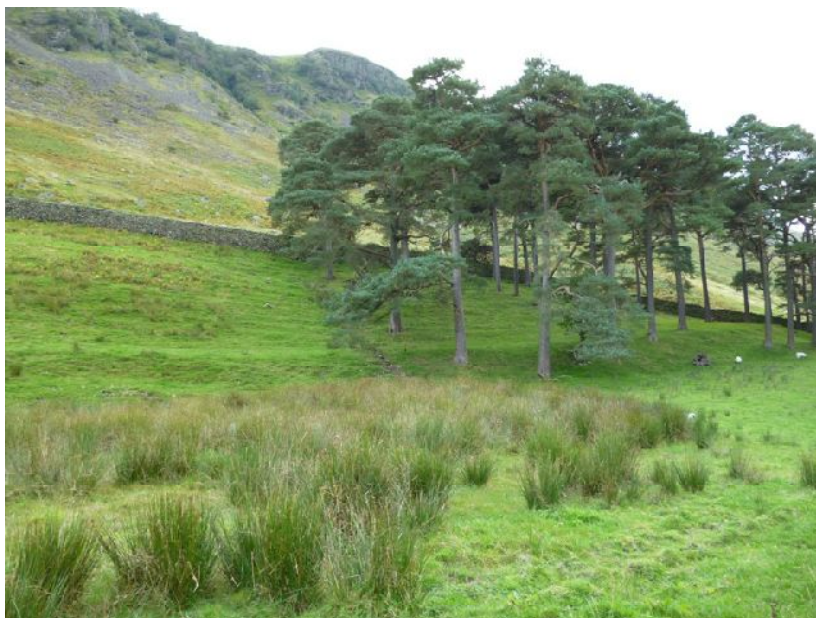
Description: Lynchet running approximately east/west along the slope, 1-2m tall.

Plate 68: Lynchet, viewed from the north-east, Site 39

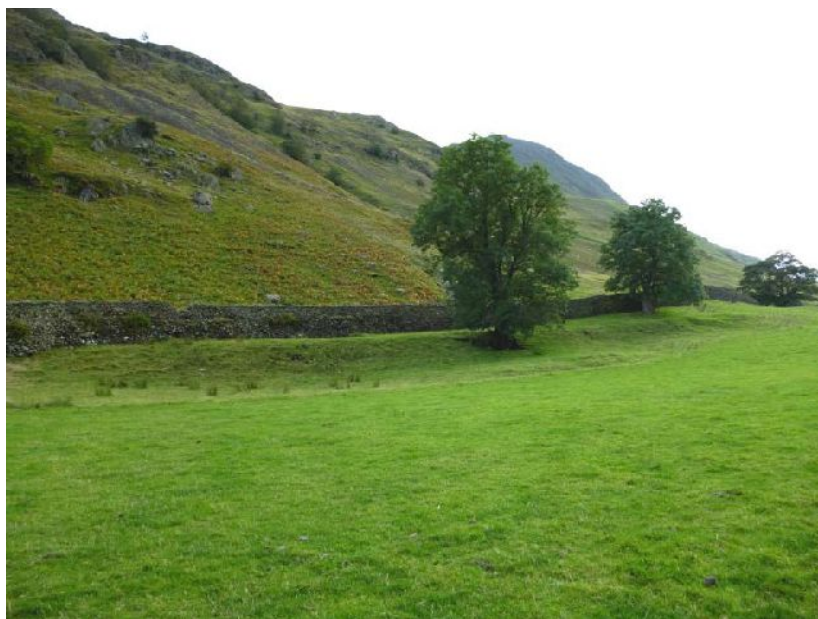
Description: Lynchet running approximately east/west along the slope, 1-2m tall.

Plate 69: Lynchet, viewed from the north-east (Site 40)

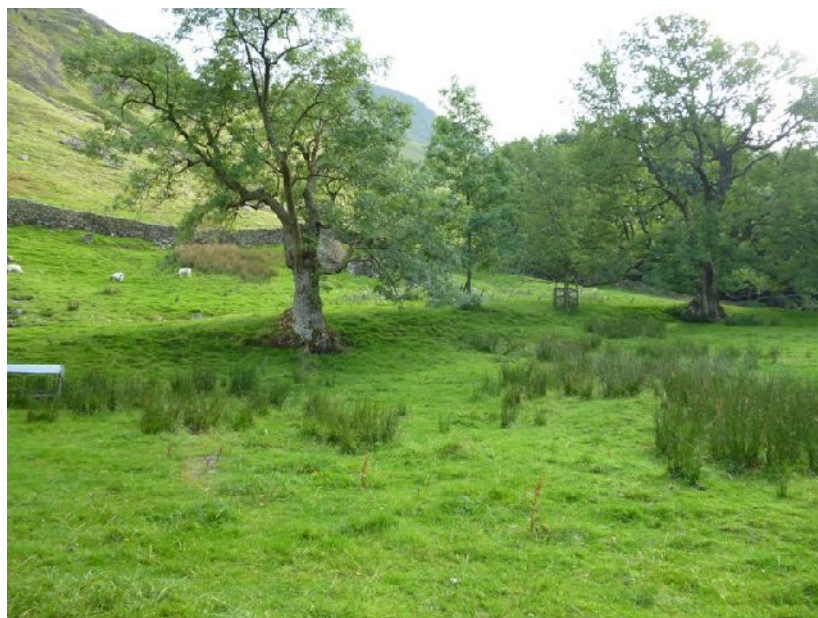
Description: Lynchet running approximately east/west along the slope, 1-2m tall.

Plate 70: Lynchet, viewed from the north-east (Site 41)

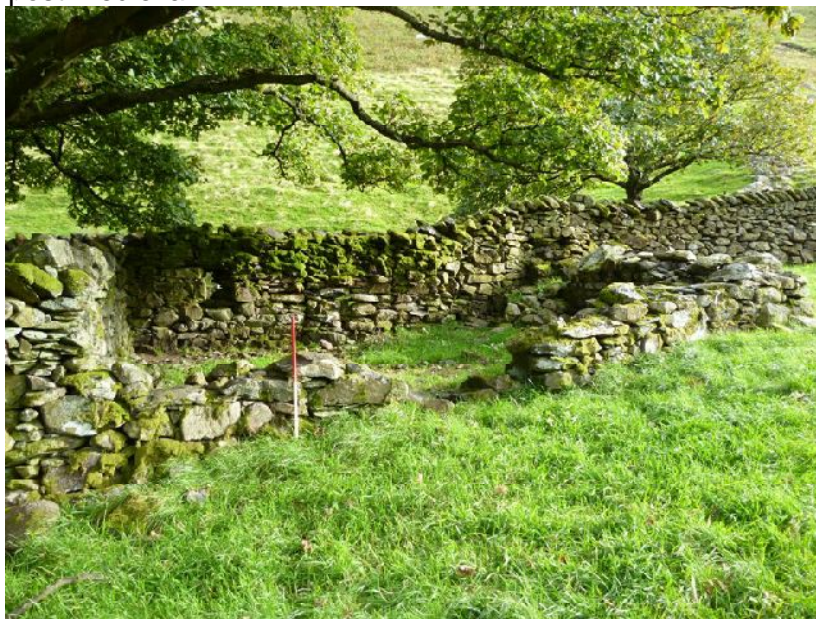
Description: Ruined rectangular building, c10m by 5m, up to six courses still standing, with possible doorway on north side and apertures in south side. Apparently pre-dating the field boundary, which butts against it.

Plate 71: Ruined structure, viewed from the north (Site 42)

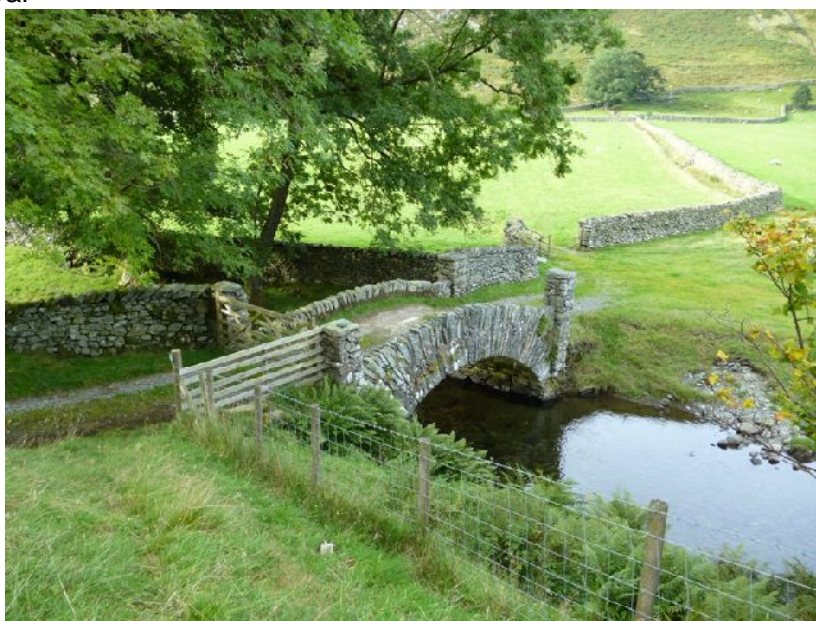
Description: Stone bridge, almost semi-circular arch topped with low stone walls with square-section pillars at each end.

Plate 72: Bridge, viewed from the south (Site 43)**Site Number: 44****NGR:** 337262 515055**HER No:** None**Sources:** Site visit**Designation:** Listed Grade II (see *Appendix 3*)

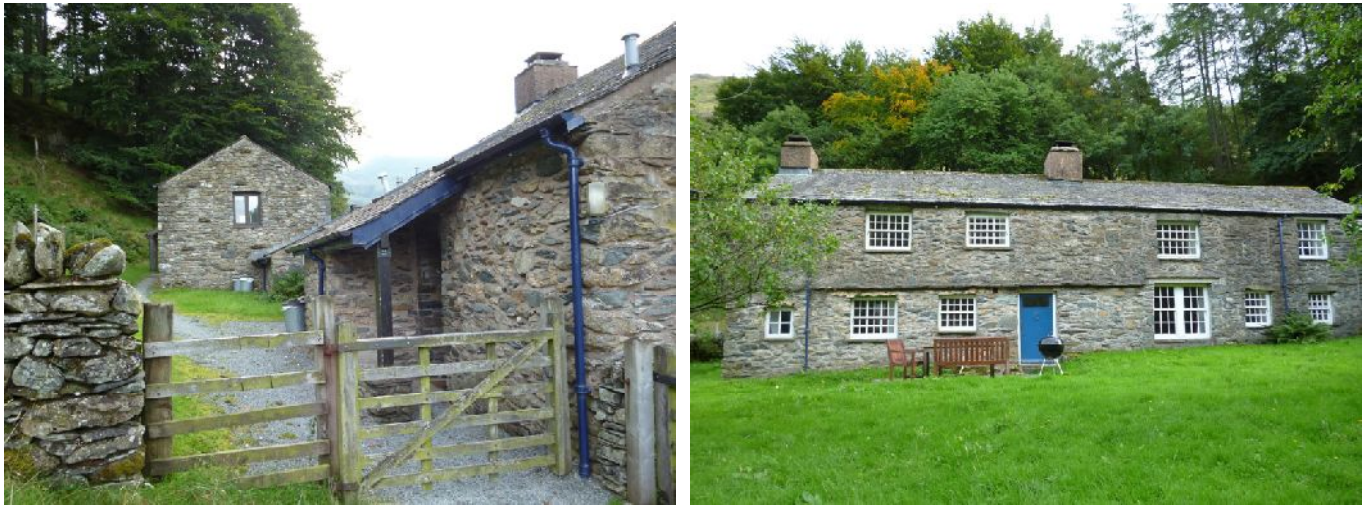
Description: Buildings at Elmhow. The main farmhouse has a cross passage connecting to a stone spiral staircase on the south side, although the rooms either side of the passage both have fireplaces with square (probably 18th century?) surrounds. The barn to the south-west of the house is cruck framed, while the barn to the west has crow-stepped gables and a date stone of 1677 re-used upside down as a lintel. Between the house and the west barn is a row of four cart sheds.

**Plate 73 (left):** The cruck barn at Elmhow, viewed from the east (part of Site 44)**Plate 74 (right):** The house at Elmhow, viewed from the north (part of Site 44)

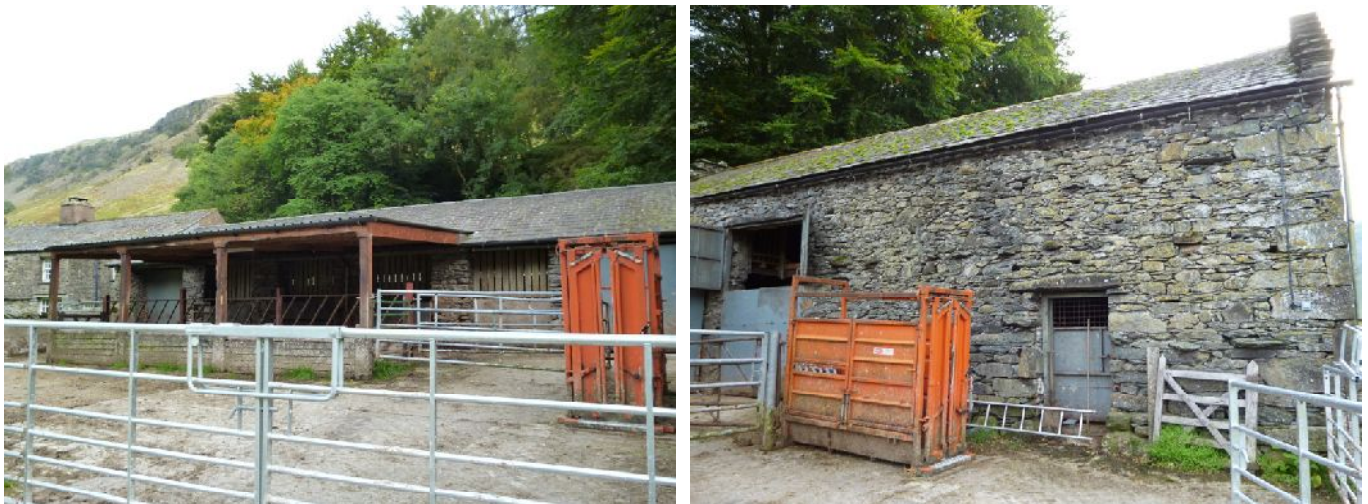
**Plate 75 (left):** Cart sheds at Elmhow, viewed from the north (part of Site 44)**Plate 76 (right):** The west barn at Elmhow, Viewed from the east (part of Site 44)

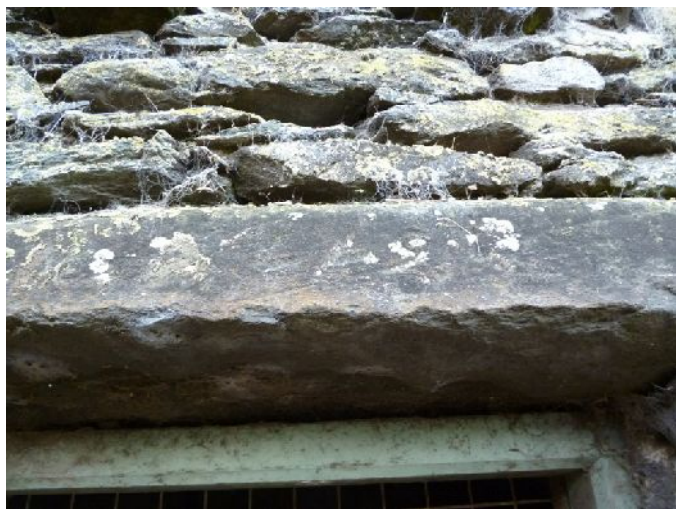
Plate 77 (left): Re-used date stone in the west barn at Elmhow, viewed from the east (part of Site 44)

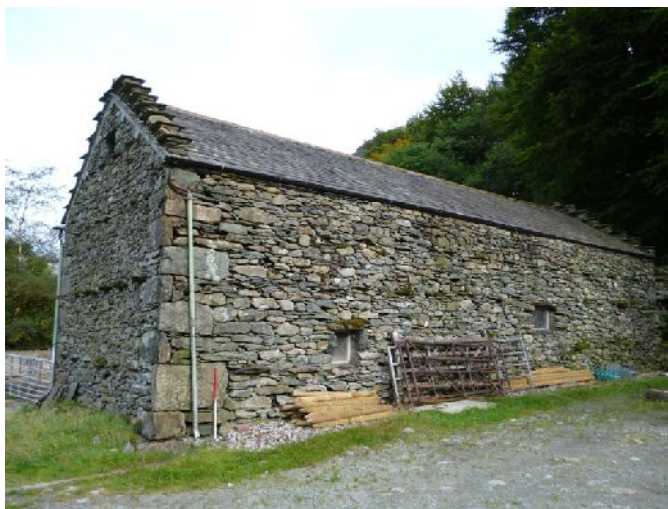
Plate 78 (right): West barn at Elmhow, viewed from the north-west (part of Site 44)
