# PRIORY GARDENS, PRIEST LANE, CARTMEL, CUMBRIA

## Archaeological Watching Brief

Client:  
Stephen Roe

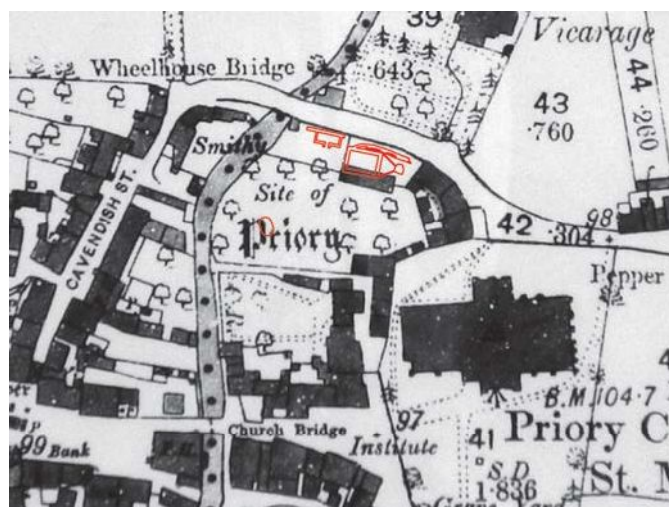
Plate 3: Extract from the Ordnance Survey map of 1890

3.1.4 **Ordnance Survey, 1890:** the open area along the north side of the site has been subdivided laterally and a large rectangular structure has been built on the south side of the eastern block (Plate 3). The arrangement of the rest of the site is largely unchanged.

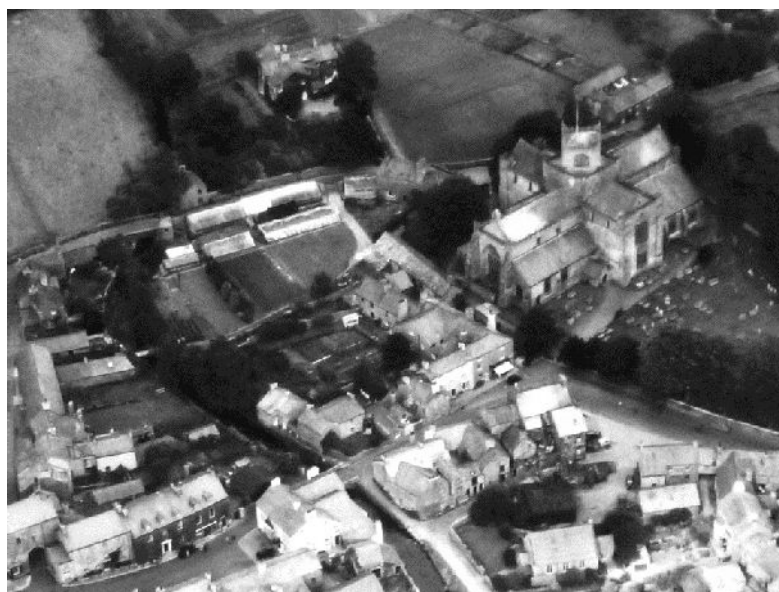
Plate 6: Aerial photograph, 1970 (north is to the top left)

3.1.7 **Aerial photograph, 1970:** this photograph, apparently taken in 1970 (Cambridge University 1970), shows the arrangement of buildings along the east side of the site (to the north of the Priory) and two rows of greenhouses to the south side of Priest Lane (Plate 6). At this time the greenhouses appear to be glazed along their length and the greenhouse or houses to the north extend almost the full length of Priest Lane along this side of the site. The footings of these greenhouses correspond with low standing garden walls at the site.

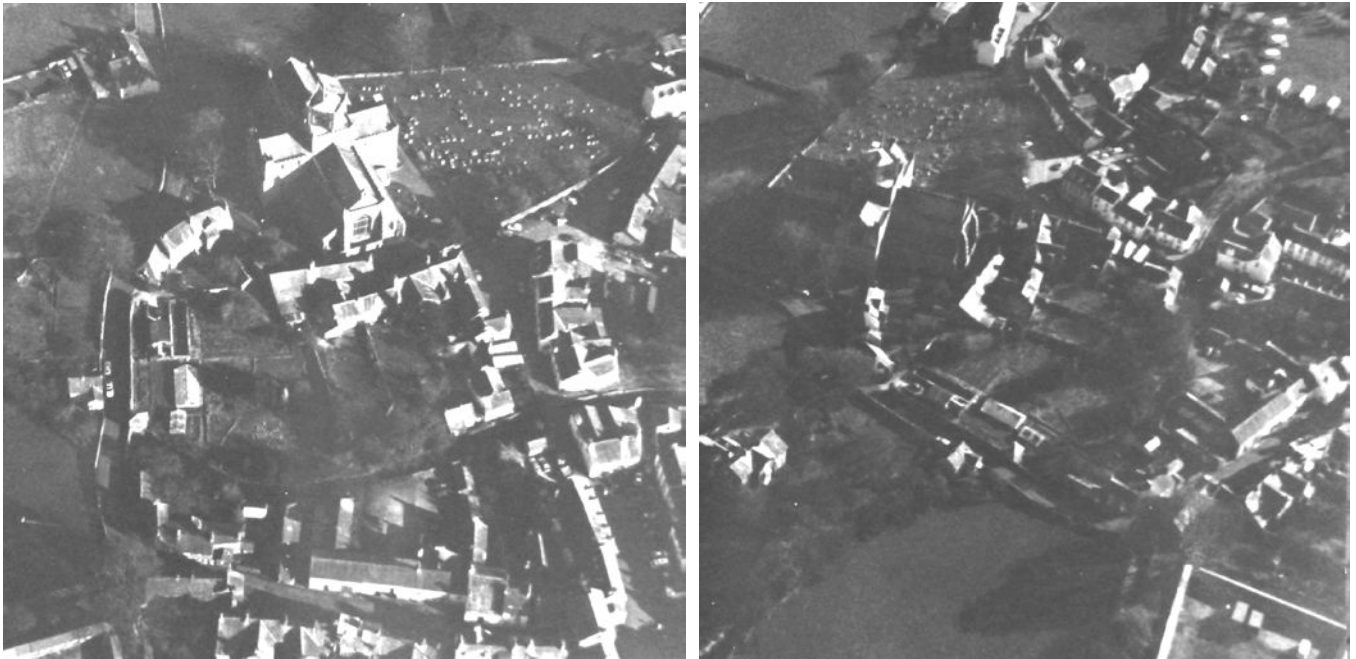
Plate 7 (left): Aerial photograph, 1989 (north is to the left)

3.1.8 **Aerial photographs, 1989:** there are two aerial photographs taken 1989 (Plate 7 and Plate 8; CCC 1989). They are very dark but some detail is discernable: the northern row of greenhouses has at least been partially removed and the glazing has been removed on the eastern one on the southern row leaving the footings.

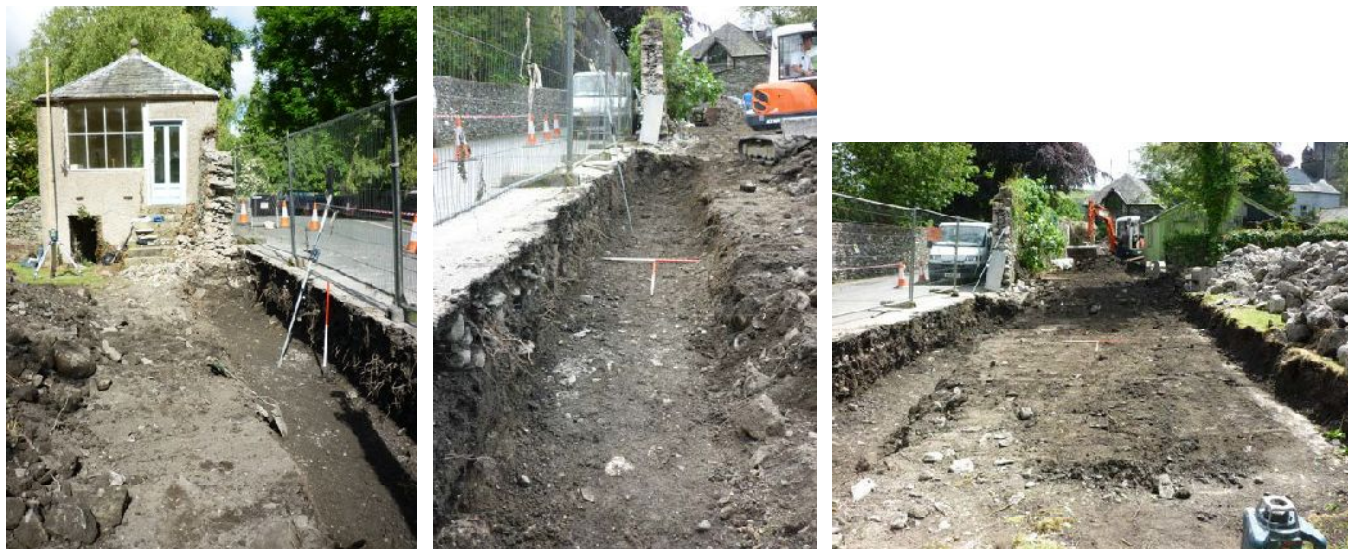
4.1.1 **Excavation within the area of the greenhouse and along the south side of Priest Lane:** excavation below the property boundary wall along the south side of Priest Lane exposed a concrete drain to the west end of the trench and revealed that the footings of the wall continued approximately 0.7m below the height of the road surface (Plate 9 and Plate 10). The area to the south of this had been stripped to reveal the footings of the low garden walls (formerly the base for a greenhouse) and the outline of the greenhouse walls was still apparent (each wall being c. 0.3m thick) (Plate 11; Figure 2). Roughly 0.4m depth of a dark, friable topsoil / garden soil (context **100**) was apparent to the south side (external to the former greenhouse).

**Plate 9 (left): Excavation below the boundary wall along Priest Lane, looking west**

**Plate 10 (centre): Excavation below the boundary wall along Priest Lane, looking east**

**Plate 11 (right): Foundations of the former greenhouse exposed along Priest Lane**

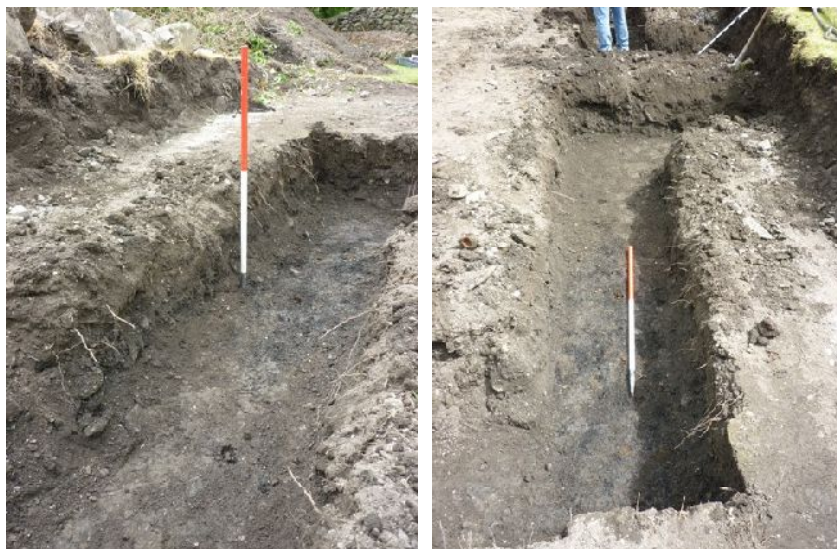
4.1.2 Footings for the new greenhouse were cut into similar mid-to-dark brown silt (**101**) within the footprint of the former greenhouse (Plate 12 to Plate 17). This deposit was c.0.5m thick and contained fragments of frogged (marked 'Furness') red brick and post-medieval pottery. A soft black silty deposit (**102**), several centimetres thick at least, with abundant iron slag and charcoal (ash) inclusions, was exposed below this (at the base of the trench) towards the south-west corner of the area of the new greenhouse (Plate 12 and Plate 13; Figure 2). Medieval pottery was recovered from this apparently burnt deposit. It appeared to continue to the east, below context **101**, but it was not further excavated as it was only exposed at the level required for the foundations of the new glasshouse.

**Plate 12 (left): Black deposit 102 to the west side of the new glasshouse, viewed from the east**

**Plate 13 (right): Black deposit 102 to the west side of the new glasshouse, viewed from the west**

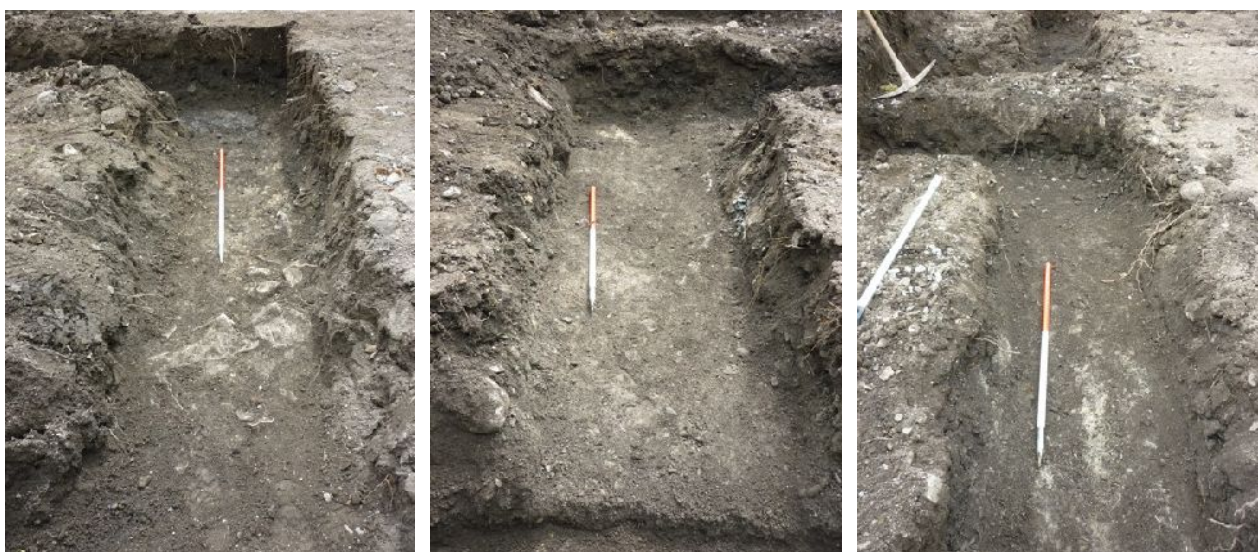
4.1.3 A stony area was observed at the base of the trench to the west side of the footings for the new glasshouse (Plate 14) and patches of pale/light grey clay (103) were exposed in places at the base of the trench to the east (Plate 15 and Plate 16). This clay layer may have been the underlying geological 'natural' layer, but it was not investigated further as it was only exposed at the limit of excavation and its thickness was not determined.

**Plate 14 (left): Stony area exposed (in the foreground) to the west side of the new glasshouse**

**Plate 15 (centre): Patches of light grey clay exposed to the east side of the new glasshouse**

**Plate 16 (right): Patches of light grey clay exposed to the south side of the new glasshouse**

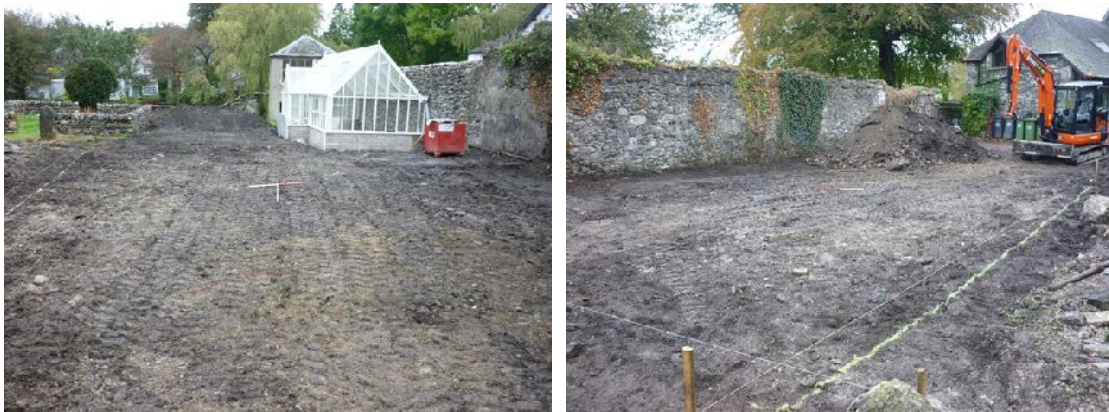
**Plate 18 (left): Area of the new garage/workshop prior to excavation, viewed from east**

4.1.4 **Excavation within the area of the garage/workshop:** the area to the east of the new greenhouse was cleared of any above ground standing structures prior to excavation of the foundations of the proposed garage/workshop (Plate 18 and Plate 19).

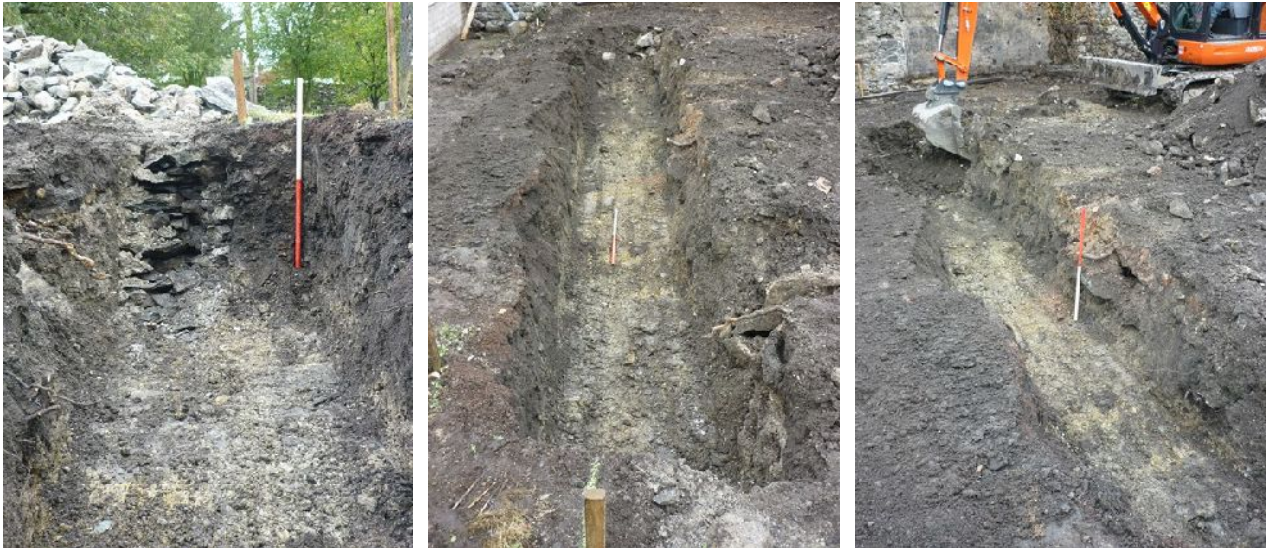
4.1.5 Excavation of the footings began at the south-west corner and a wall (part of structure **106**; see below) was immediately exposed at the south end of the west trench, apparently cut into the underlying natural (**105**) (Plate 20; Figure 2). The topsoil (**104**) had apparently either been cut through or built up against its west side. To the west of the wall the topsoil was up to 0.7m thick and was noted to be silty towards the surface and a silty-clay towards the base of the trench. No distinct edge could be determined. Below this layer was the underlying natural (Plate 21 and Plate 22), which was similar to that encountered below the new greenhouse. The natural was overcut by approximately 0.15m. The wall continued along the edge of the trench and was approximately 0.6m thick.

**Plate 20 (left):** Cross-section of wall exposed at the west end of the south side of the trench

**Plate 21 (centre):** The west side of the trenched area

**Plate 22 (right):** Trench section viewed from the west side of the area

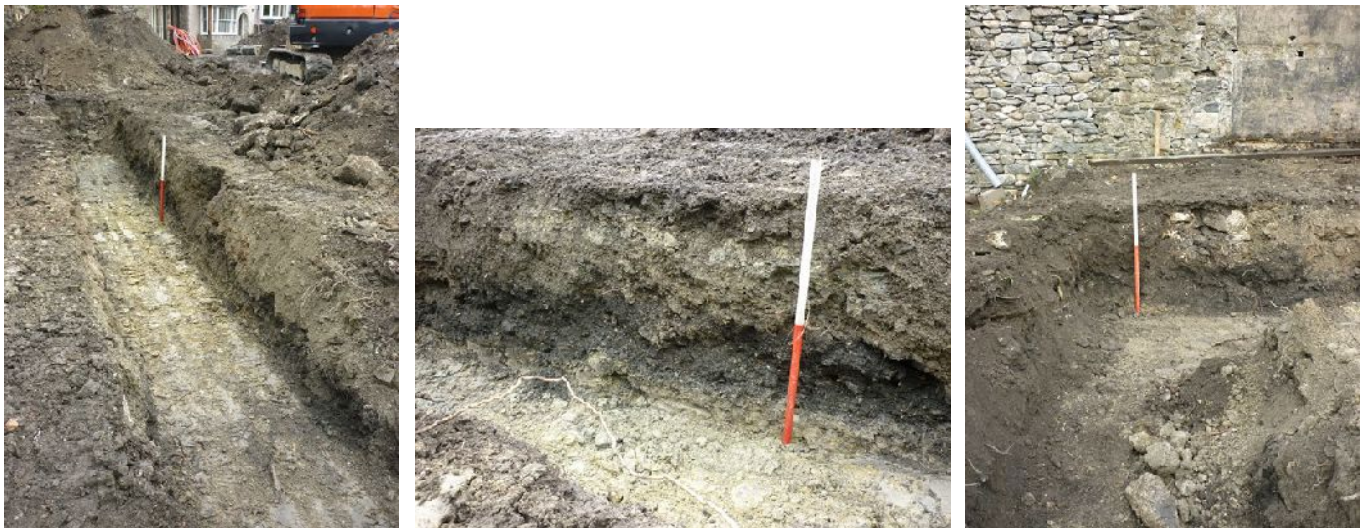
4.1.6 The area inside the new garage/workshop was also reduced. This area mostly comprised a modern make-up layer of fine grey gravel and sand (**107**), with concrete and brick features and modern disturbance such as ceramic drains relating to the former buildings on site which were demolished ahead of the current phase of work. This layer was approximately 0.5m deep. Below that, certainly to the north side of the area, was a very dark grey-blackish silt layer (**108**) c.0.3m thick (Plate 23 and Plate 24), which contained a lot of animal bone and some small fragments of medieval pottery. This probably related to medieval activity at the site, perhaps relict topsoil or a large midden. In the north section this appeared to form a continuous layer and was overlain by the shallow foundations of another wall at the west end of the area (Plate 25).

**Plate 23 (left):** Trench section viewed from the north-west corner of the area

**Plate 24 (centre):** Section showing the dark midden deposit (**108**)

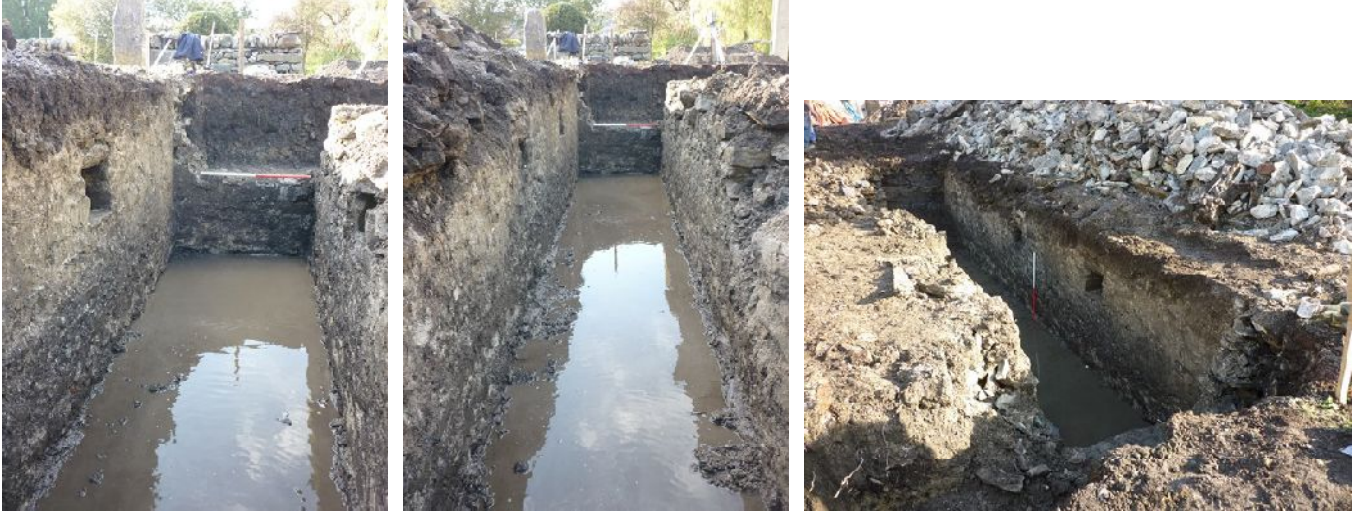
slightly crumbly off-white mortar. The more angular stones exposed in cross-section perhaps formed a rubble core. There were three small alcoves in the south elevation (Plate 28; Plate 32 to Plate 34) and one of a similar size in the north side (Plate 29 (unfortunately in shadow); Plate 35), which did not appear to be facing one on the other side, and there were two or perhaps three steep steps at the east end (Plate 30 and Plate 31) (Figure 3). The sawpit may have had an earth floor or possibly a timber floor which had either rotted or been removed; no slate or cobble floor was apparent, but the base filled very rapidly with water.

**Plate 26 (left): West elevation of the sawpit**

**Plate 27 (centre): View of the sawpit from the west end**

**Plate 28 (right): View of the south elevation of the sawpit**

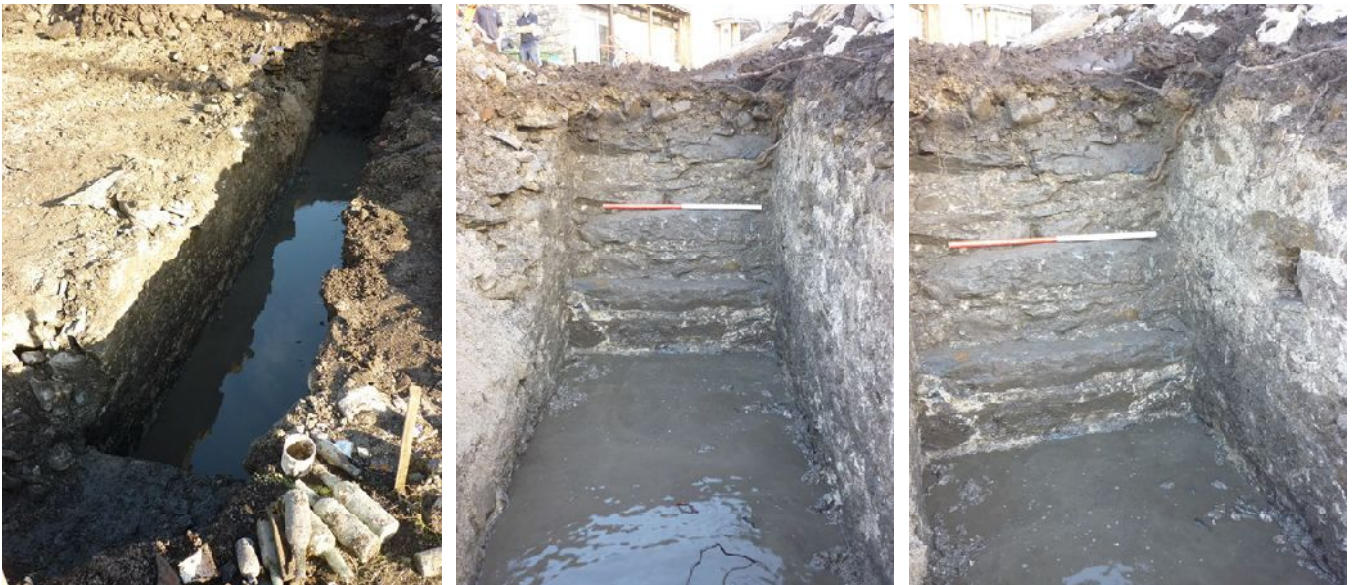
**Plate 29 (left): North elevation of the sawpit**

**Plate 30 (centre): Steps at the east end of the sawpit**

**Plate 31 (right): Steps and alcove at the east end**

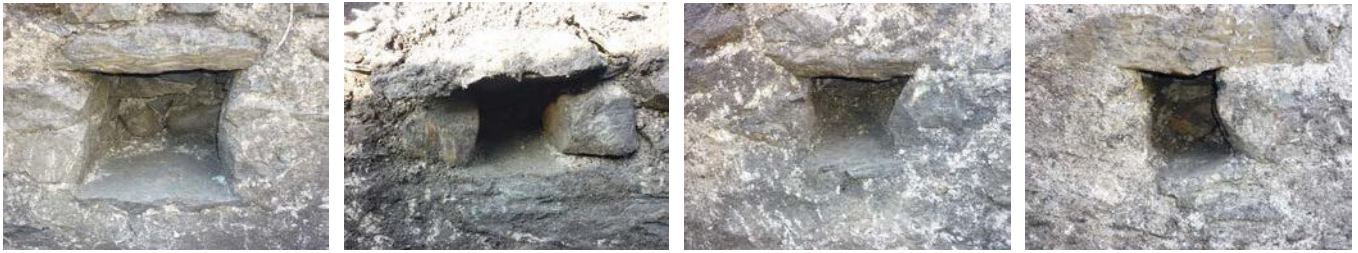
**Plate 32 (far left): Alcove at the west end of the south elevation of the sawpit**

**Plate 33 (centre left): Alcove at the centre of the south elevation of the sawpit**

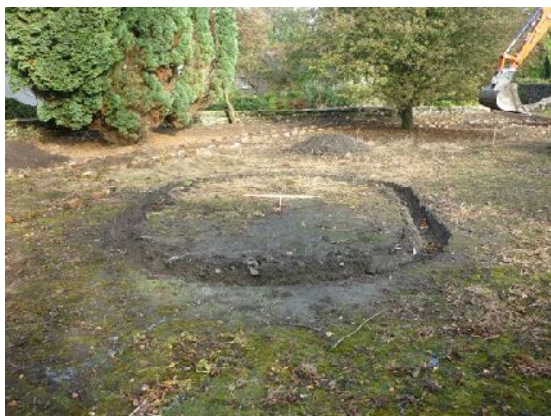
**Plate 38 (left): Area of the new pond**

4.1.9 **Excavation within the area of the new pond:** the new pond is a long oval in shape and stepped in approximately 0.15m around its edge (Plate 38; Figure 4). From there it sloped down approximately 0.6m to the base (Plate 39). The topsoil (**113**) was similar to that at the north end of the garden (**103** and **105**), c.0.2m thick above the subsoil (**114**), which was noticeably lighter, perhaps 0.3-0.4m thick. A small, oval-shaped pit with a shallow concave base (**115**) was cut into the natural (**117**) at the north end of the pond (Plate 40). It was filled with a dark reddish-brown clayey-silt (**116**) and its base comprised large fragments of iron slag (Plate 41). A small rusted nail was also recovered from its fill.

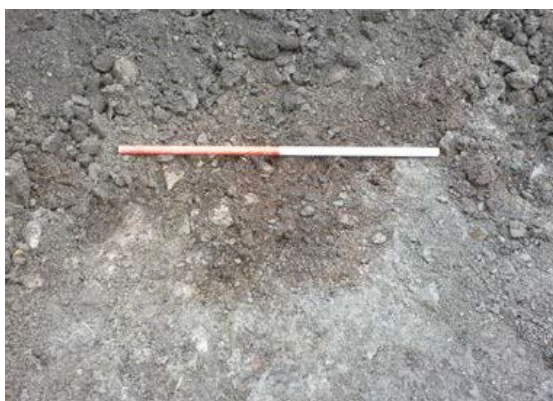
**Plate 40 (left): Pit 116 pre-excitation**

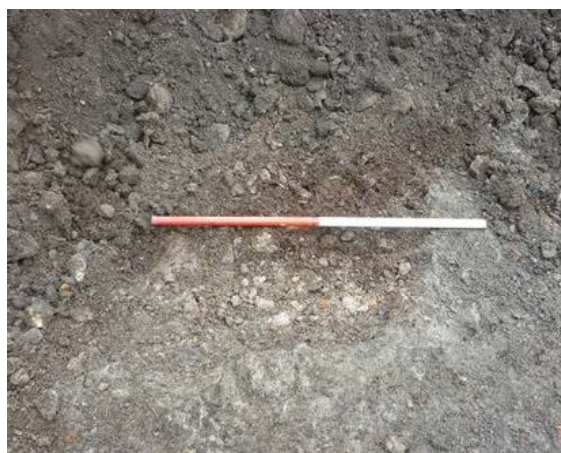
**Plate 41 (right): Pit 116 half-sectioned**

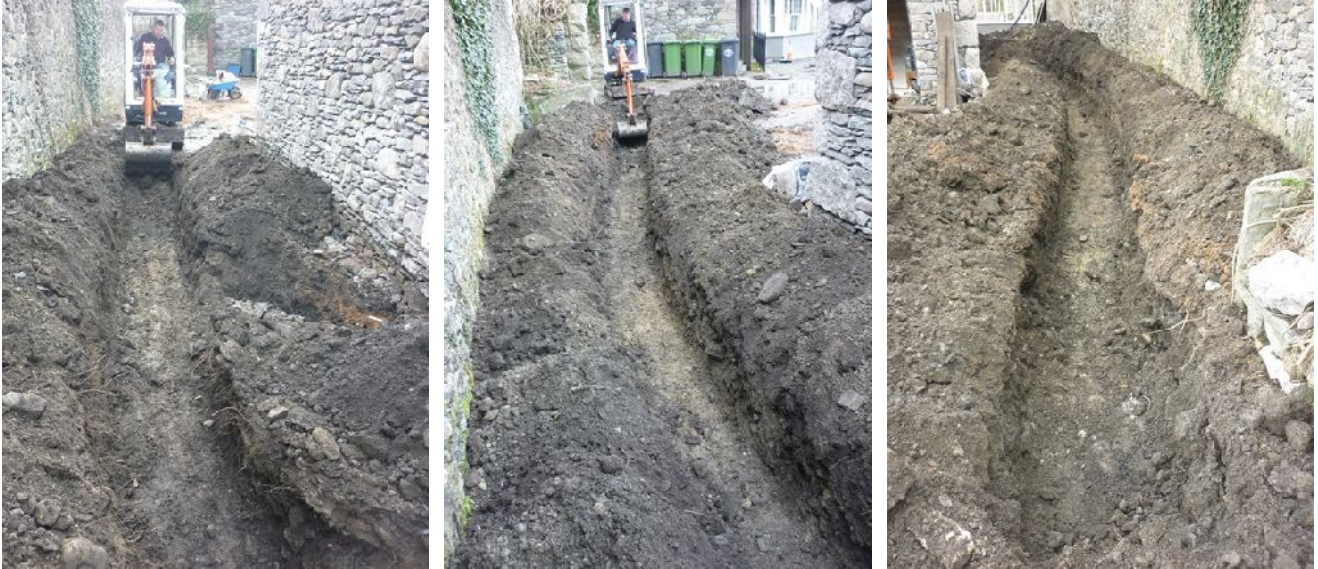
**Plate 42 (left):** Excavation of service trench to the north of the new garage

4.1.10 **Excavation to the north and east of the new garage:** a wide service trench was excavated along the north side of the new garage against the boundary wall along Priest Lane (Plate 42 to Plate 44; Figure 5). The upper deposit was a mix of rounded cobbles and gravel (**118**), typically c.0.1-0.2m thick. Below that was a buried topsoil (**119**), 0.2-0.3m thick, and patches of pale brown sandy-clay subsoil (**120**), less than 0.1m thick. The natural in this area was a firm, pale brownish-yellow, gravelly clay (**121**). The trench was typically 0.7-0.8m wide and 0.45-0.50m deep.

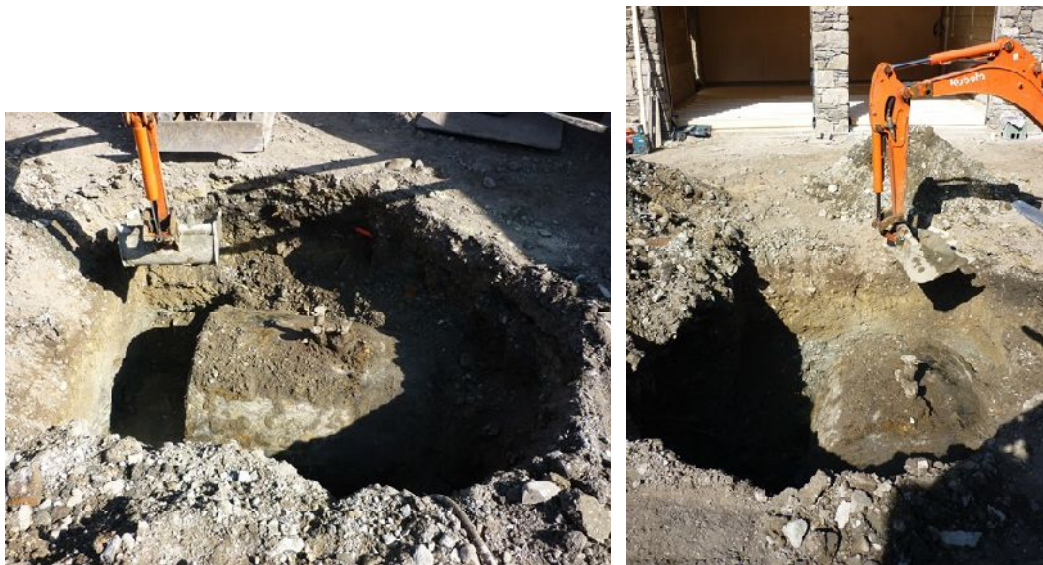
4.1.11 A disused fuel tank (Plate 45) was removed approximately 6m to the east side of the new garage (Figure 6). The tank aligned approximately with the central pillar of the new garage, between the two garage doors, and was buried c.0.3m deep beneath a compacted layer of overburden (context **122**) (Plate 46). The tank was c.1.65m long, east/west, and c.1.2m diameter. Above it were a few red bricks, possibly boxed round the main valve in a wall, one brick thick. The tank itself was set within a looser grey gravel (context **123**), the original cut for which (**124**) extended approximately 0.2-0.3m around the edges of the tank on all sides.

**Plate 45 (left):** Disused fuel tank

**Plate 46 (right):** Fuel tank in relation to the front of the new garage

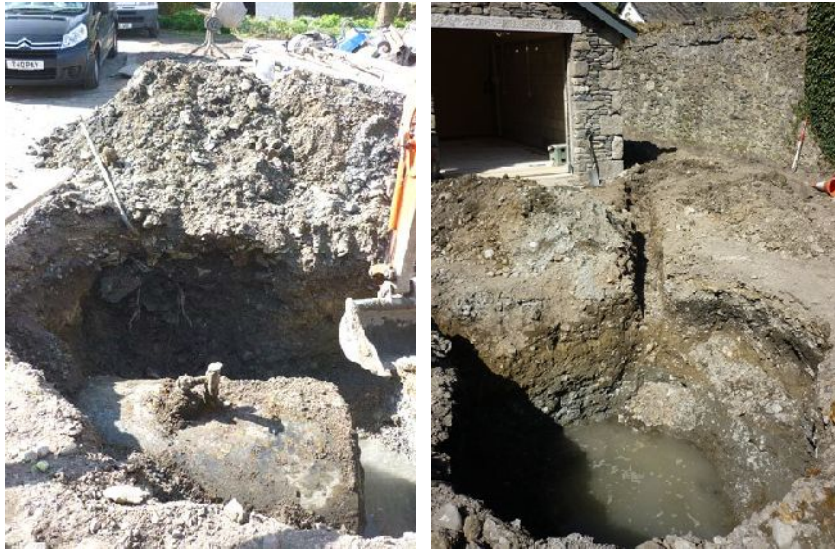
4.1.12 The hole excavated to remove the tank, which will subsequently be used as a soak-away, was roughly 3m by 3m. It was dug to a maximum depth of c.1.5m, which is close to the level of the water table at this point (Plate 48). A modern duct was observed in the north side, apparently cut into the overburden (**122**). The overburden generally overlay a possible subsoil or buried soil (**125**), which was about 0.3m thick above the natural (**128**). The natural in this area varied from a yellowy clay to a grey clay at about 1m deep.

4.1.13 A stony deposit (**126**) was observed in section in the south side of the hole dug to remove the tank (Plate 47; Figure 6). It was overlain by the overburden (**122**) and was possibly within a vertical cut (context **127**), which may have cut the underlying subsoil layer (**125**) and was certainly cut into the natural (**128**). It was probably truncated by the later cut for the fuel tank (**124**). The nature of this stony deposit was undetermined, it may have been a soak-away or possibly foundation for an earlier structure, although it does not appear to be aligned with any known features. The stony deposit (**126**) was c.1.6m wide from the south-east corner and continued to a depth of c.1.2m. Its uppermost extent merged with the gravel of the overburden and was obscured.

**Plate 47 (left): Stony deposit (126) visible in section (to the left hand side) near the disused fuel tank**

**Plate 48 (right): Area excavated to remove the disused fuel tank**

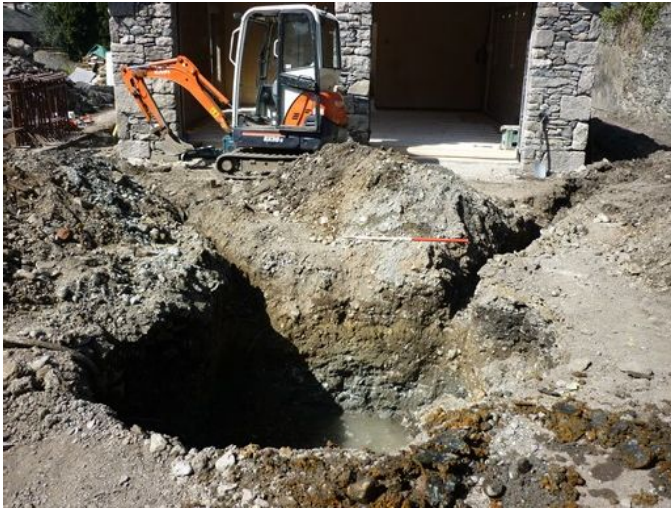
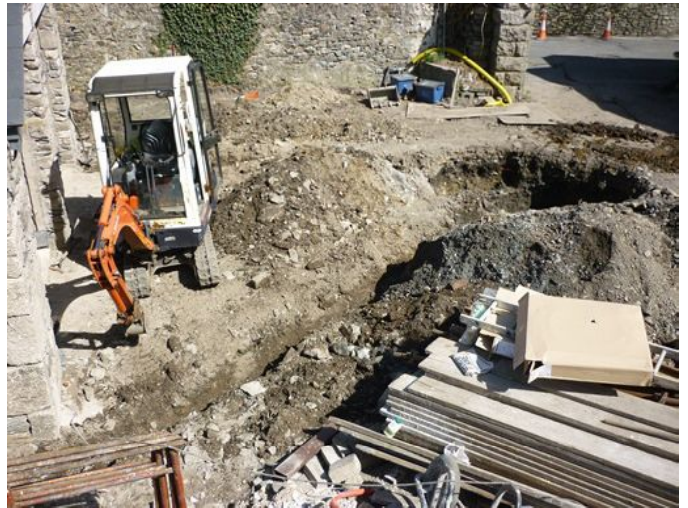
4.1.14 Two narrow drainage ditches were excavated from the west side of the area of the fuel tank to the corners of the new garage (Plate 49 and Plate 50; Figure 6). They were separated by roughly 1.5m where they met the edge of the area excavated to remove the disused fuel tank. Both ditches were of similar lengths and depths to each other. Each ditch was c0.3m to 0.4m wide at most and was c0.55m-0.60m deep where it met the soak-away and rose closer to the surface at the west end, near the corners of the garage (Plate 51 to Plate 53). This depth of excavation remained within the layer of overburden (**122**) towards the garage (to the north and east) and cut into the underlying buried topsoil or subsoil layer (**125**) to the south and east.

Plate 49 (left): Narrow drainage ditches feeding into the area excavated to remove the fuel tank

Plate 50 (right): Drainage ditches and area of fuel tank in relation to main entrance

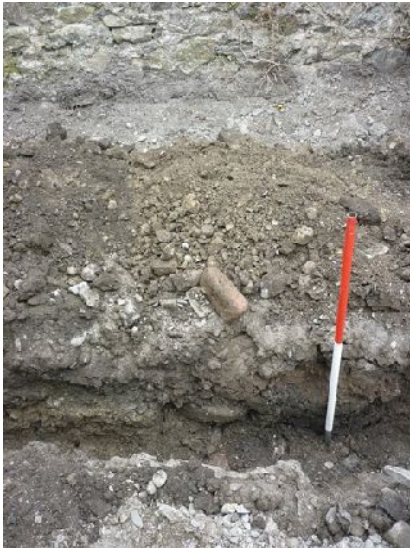
**Plate 54 (left): Possible wall in the narrow service trench north of the new garage/workshop**

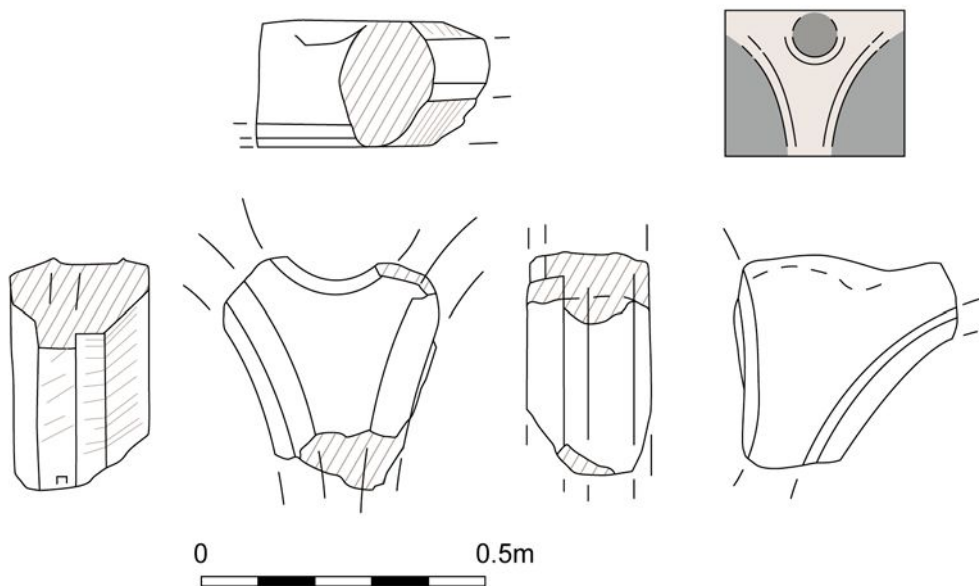
4.2.2 **Stone artefacts:** the boundary wall along Priest Lane incorporated various worked pieces of stone, which were presumably reused from the Priory. An example of one of the more finely worked pieces of plate tracery is shown in Plate 59. This neatly dressed *vousoir* from a Gothic window arch perhaps dates from the 12<sup>th</sup> to 14<sup>th</sup> century, based on similarities in appearance between this piece of stonework and a fragment recovered from a site in Lancaster (Greenlane Archaeology 2010) and what is known historically about the site.

**Plate 59: Measured sketch of fragment of stonework recovered from the boundary wall along Priest Lane**

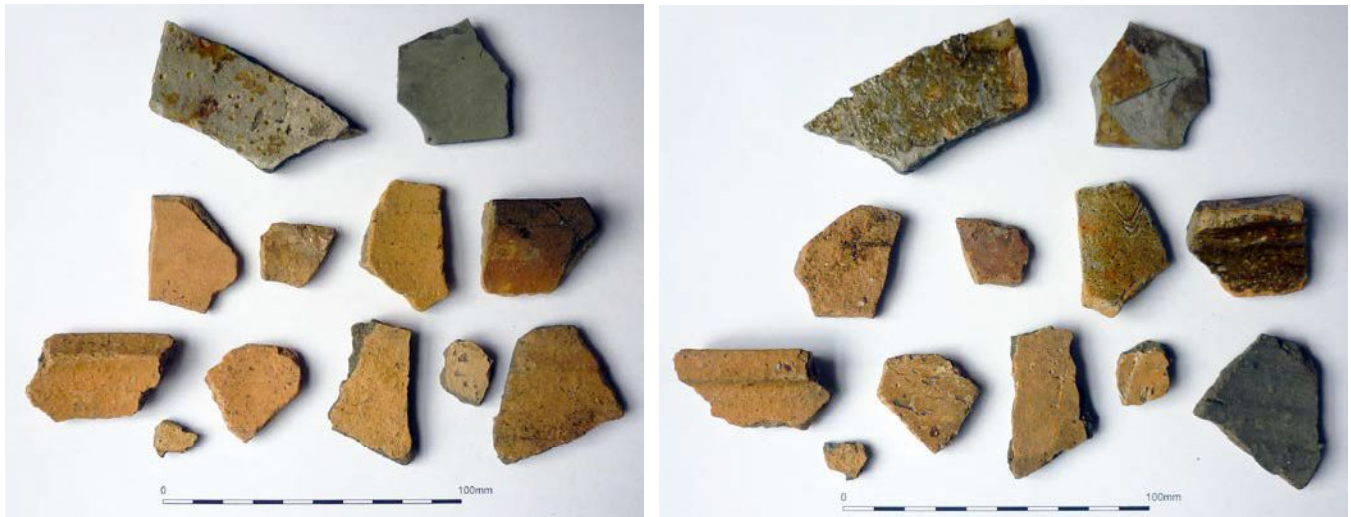
**Plate 60 (left): Internal surfaces of the medieval pottery fragments**

**Plate 61 (right): External surfaces of the medieval pottery fragments**

4.2.5 The material was fairly equally split between hard and soft firing, usually under oxidising conditions, although several fragments were noted to have a reduced, grey core, and some fabrics were noted to be more fully-reduced. Glazes were only applied externally to some, but not all, of the sandy wares and more fully-reduced fragments (the centre and top rows of Plate 60 and Plate 61), and varied from light green, to olive green to brown. Decoration was uncommon: only one fragment of sandy ware had a combed wave pattern incised externally (second from right on the second row down on Plate 61).

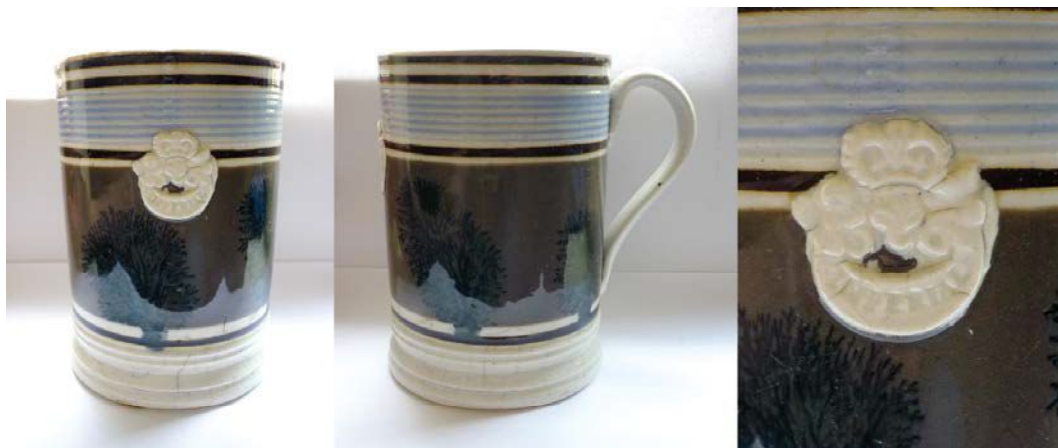
**Plate 62: Complete but chipped white earthenware factory-produced slipware banded mocha mug with sprig applied to the side from context 112**

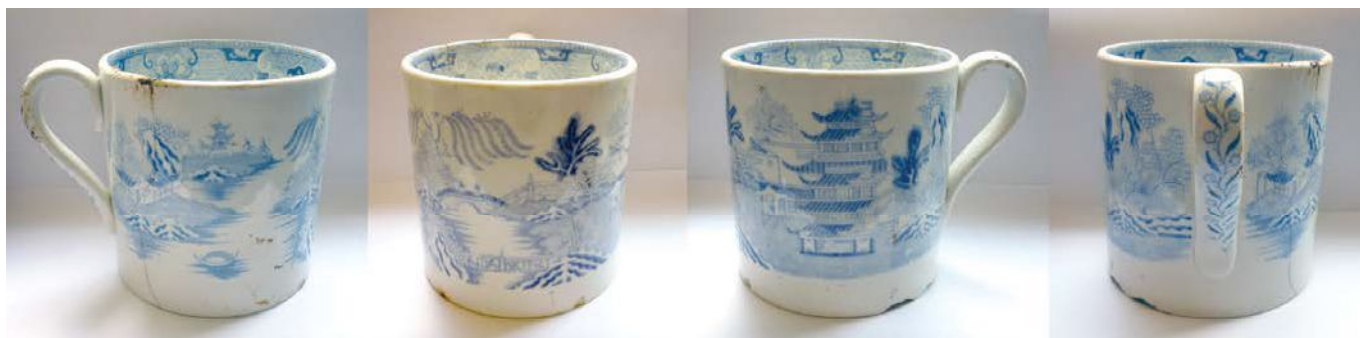
**Plate 63: Complete but cracked white earthenware Broseley transfer-printed mug from context 112**
