# FORD BYRE, THE SQUARE, CARTMEL, CUMBRIA

## Archaeological Building Recording

Planning application ref.:  
SL/2015/0354

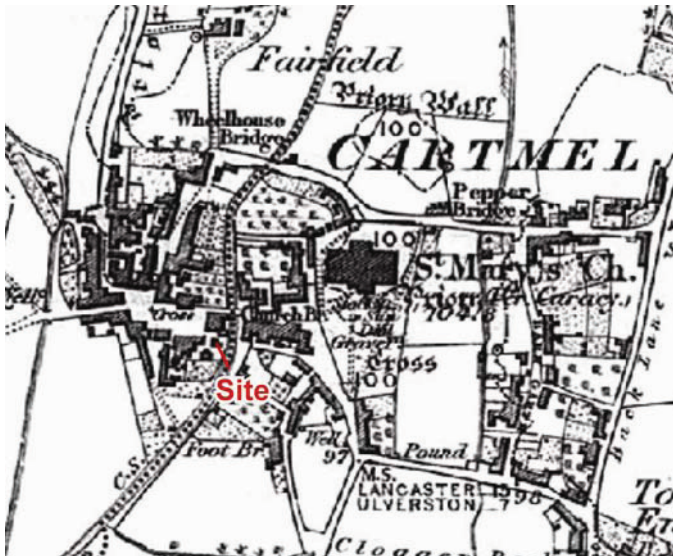
Plate 1 (left): Extract from the Ordnance Survey map of 1851

3.1.2 **Ordnance Survey, 1851:** the centre of Cartmel is already well-established (Plate 1). A structure is shown approximately in the location of the site on the Ordnance Survey map of 1851, but it is a little unclear how or if this relates to the current buildings on site because of the scale at which this map was produced. The shape and orientation of the building marked at this location (a blocky L-shape) does not match the footprint of the current buildings.

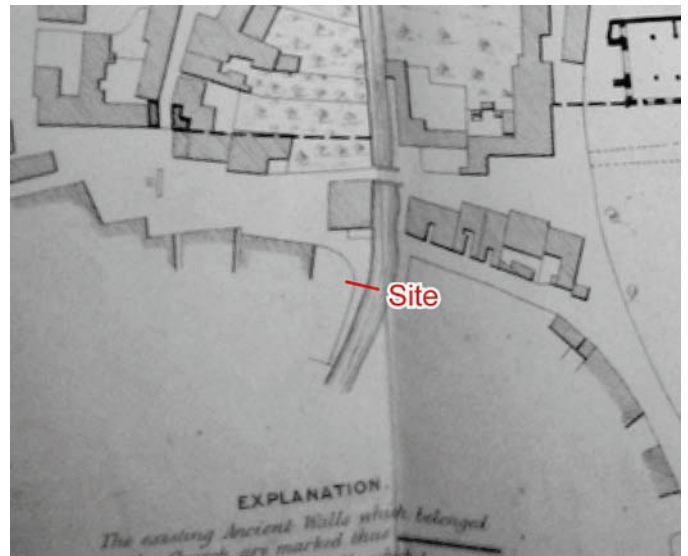
3.1.3 **Ffoliott 1854:** nothing is shown at this location on Ffoliott's map of 1854 (Plate 2).

Plate 2 (right): Extract from Ffoliott's map of Cartmel from 1854

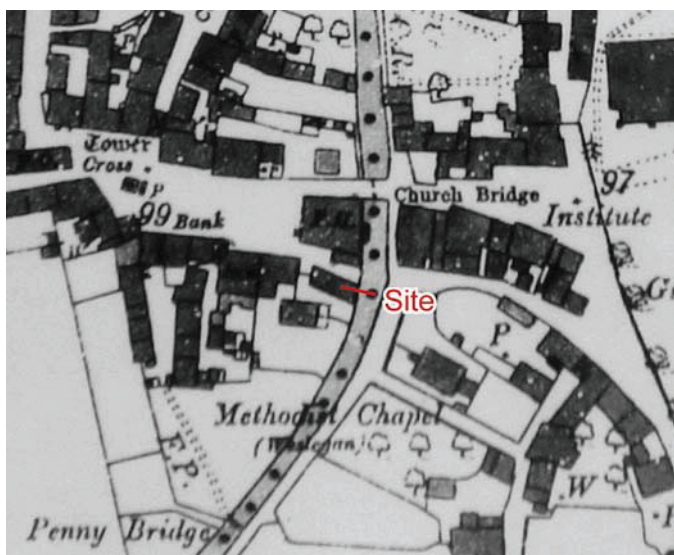
Plate 3 (left): Extract from the Ordnance Survey map of 1890

3.1.4 **Ordnance Survey, 1890:** a long building is clearly marked in the location of the site by 1890 (Plate 3). The building is aligned west-north-west/east-south-east, the east end of which relates to the current building on site. The west end is no longer standing, apart from the north wall.

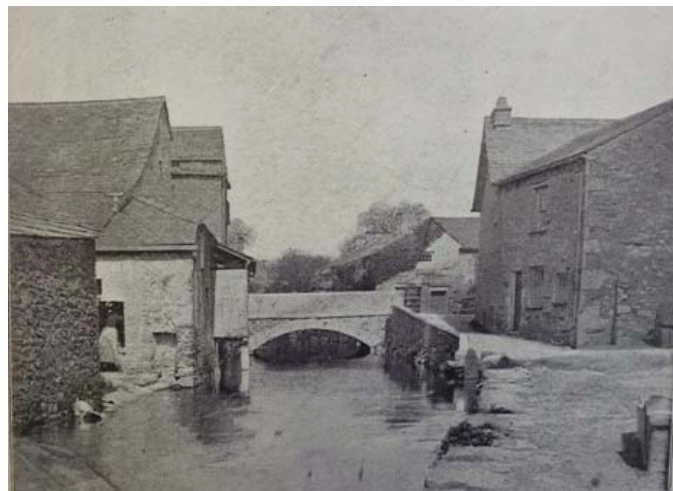
Plate 4 (right): A view of the building from 1900 (from Richardson (ed) 1900)

3.1.5 **Photograph of 1900:** a photograph from the *Cartmel and Lower Holker Almanack of 1900* shows the very east end of the building (Richardson (ed) 1900; Plate 4). Although it does not show any particular detail of note, it is of interest in showing how high the water level of the adjacent beck was at the time!

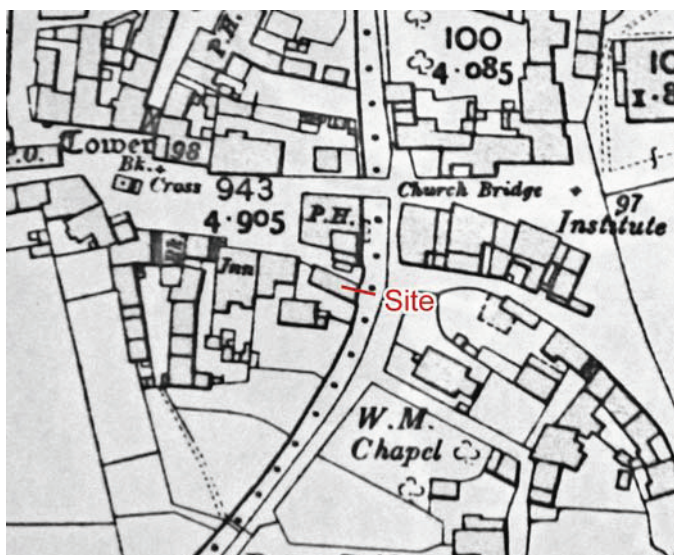
Plate 5 (left): Extract from the Ordnance Survey map of 1913

3.1.6 **Ordnance Survey, 1913:** the footprint of the building on site is unchanged between 1890 and 1913 (Plate 5; cf. Plate 3).

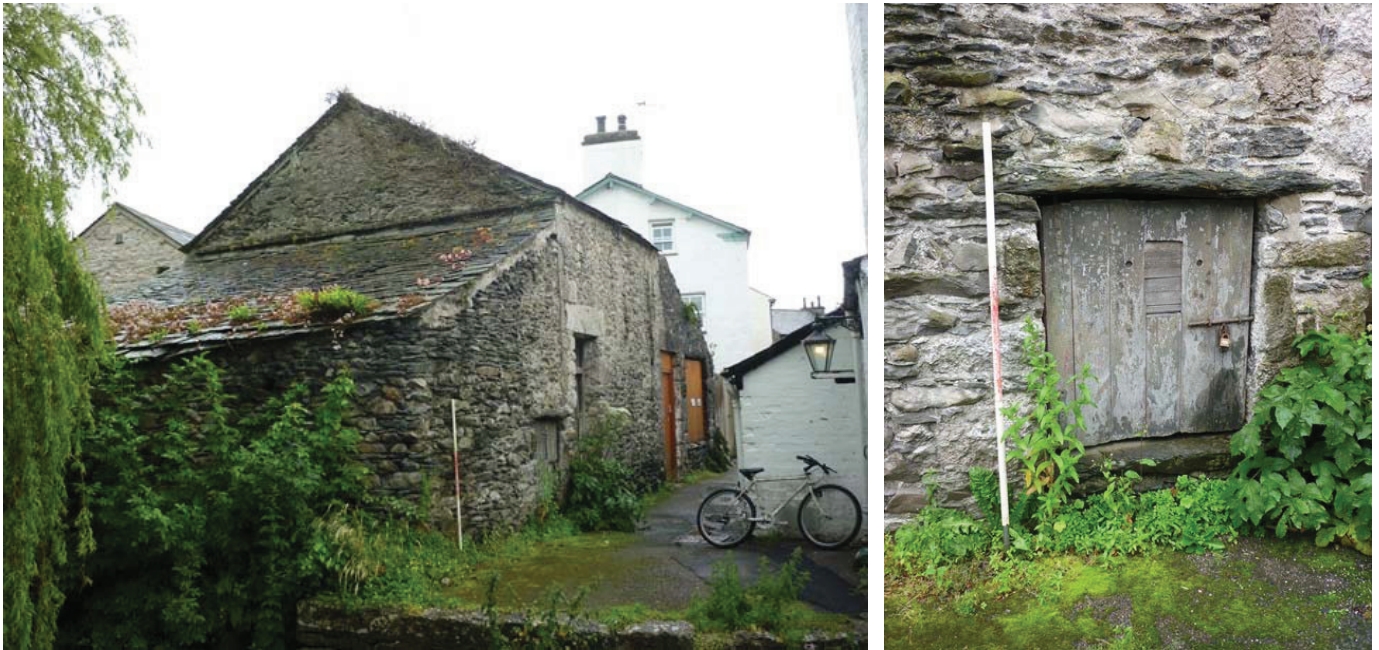
4.2.1 **North elevation:** the east end has been extended to form a monopitch outshut with a small doorway on the west side (Figure 2; Plate 7). The doorway had a stone lintel and step and a plank door with a hole cut in the middle, which was covered from inside (Plate 8). The end of the main building was finished with roughly dressed limestone quoins. There was a doorway immediately against these with a panel door. The door had raised fields and ovolo-mouldings in beaded surround with a slatted opening over (Plate 9). The door was raised on a step of overgrown material but the opening continued to the ground. There were quoins on the west jamb and it had a dressed limestone lintel. There was a further doorway to the west, which similarly had a quoined surround and a dressed lintel, with a modern timber door (Plate 10). There was a large opening to the west of the second door with a (drilled) limestone lintel and quoined jambs. There were quoins at the west end of what was presumably the north-west corner. The top of the wall at this point was irregular but finished with concrete. The line of the original wall evidently continued in this direction (Figure 4).

Plate 7 (left): North and east external elevations

Plate 8 (right): Small doorway at the east end of the north external elevation

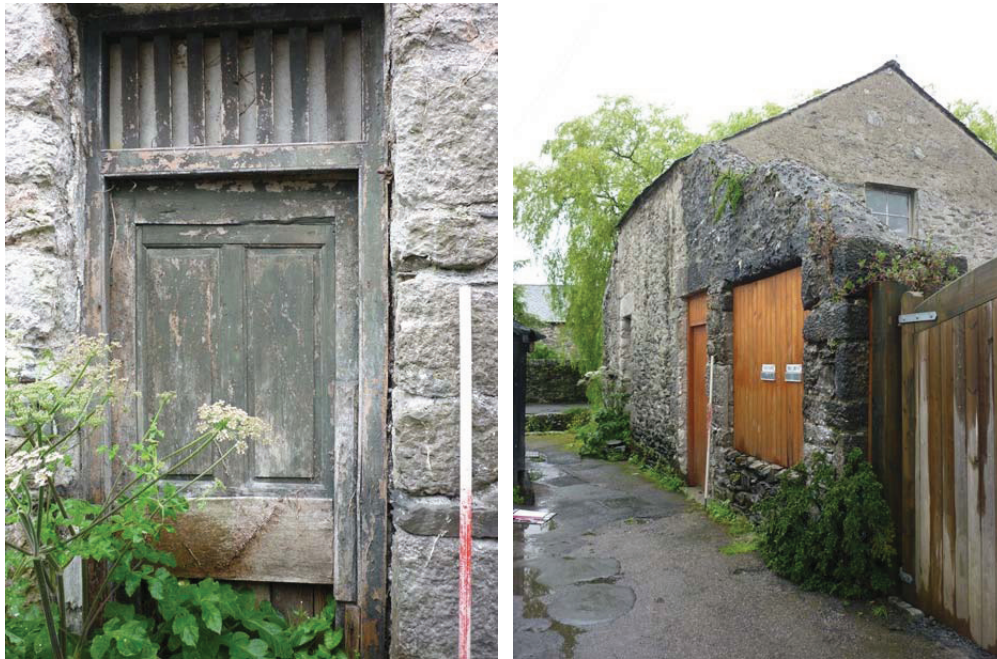
**Plate 9 (left): Panel door on the north external elevation**

**Plate 10 (right): West end of the north external elevation**

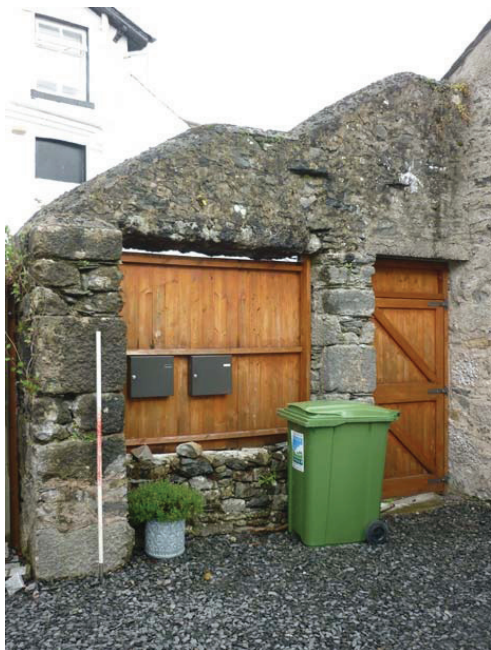
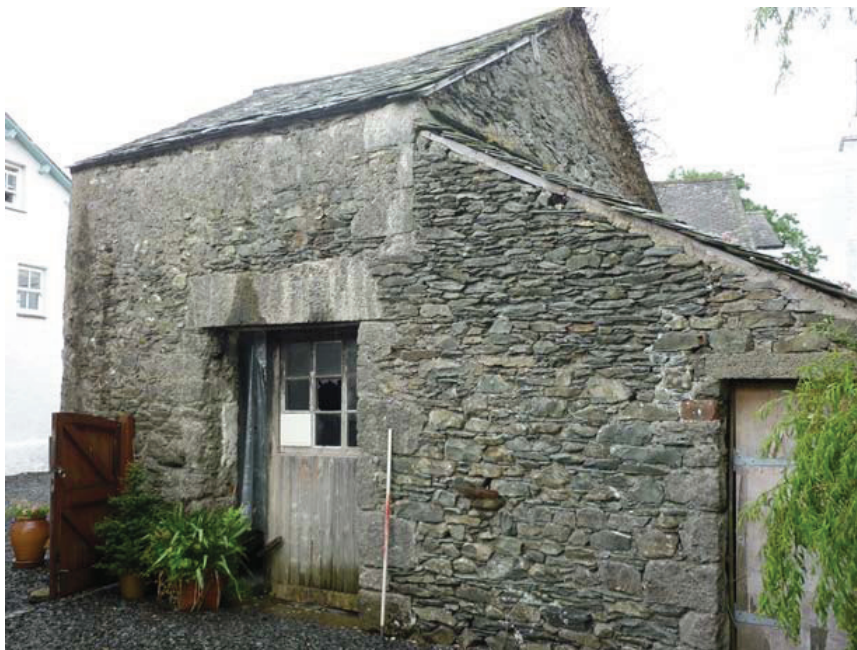
4.2.3 **South elevation:** the west side had remnants of the section extending to the west, so presumably this was internal originally (Figure 4). All of the material was exposed stone. The west end comprised the quoined jambs of a doorway and there was a large opening to the east of this, with a long limestone lintel, filled with a modern timber panel (Figure 3; Plate 11). There were quoins in the east jamb, shared with jamb of a smaller doorway to the east. The doorway had a concrete lintel and housed a modern plank and batten door (Plate 11). There were some thin through stones in the wall above, which was irregular and topped with concrete at this point. The main part had a wide doorway in the centre with a heavy limestone lintel and dressed quoins (Plate 12 and Plate 13). The door was a sliding plank door with fixed nine-lights. The outshut to the east was an obvious addition but the jamb of the doorway continued into it, so this must have been a rebuilt, although quoins showing the original line of the wall are evident above. The doorway at the east end had quoined jambs, a concrete lintel and a modern timber sheet door (Plate 14).

Plate 11 (left): West end of the south external elevation

Plate 12 (right): Central section and east end of the south external elevation

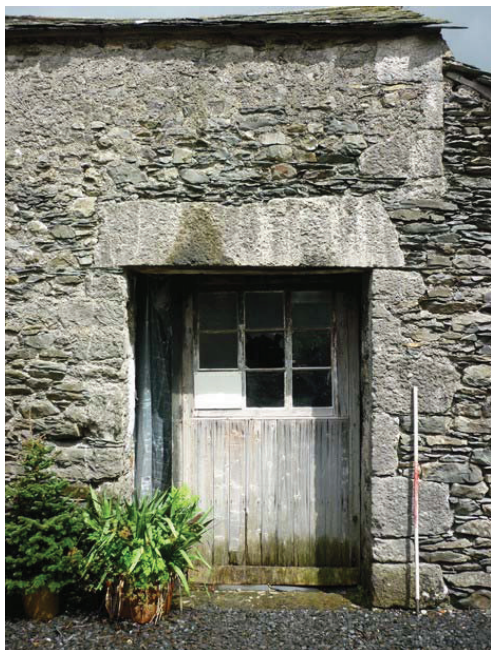
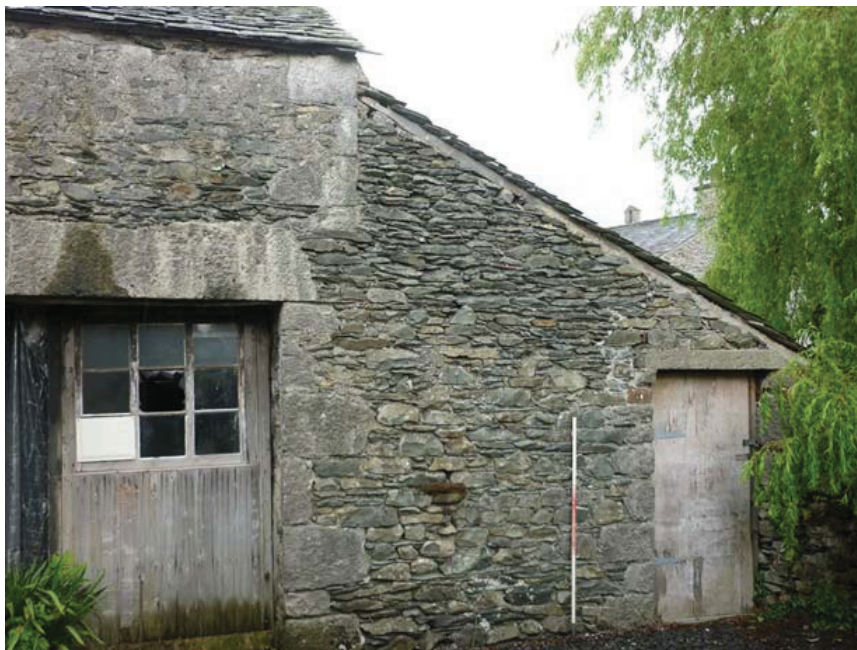
Plate 13 (left): Wide doorway in the centre of the south external elevation

Plate 14 (right): The east end of the south external elevation

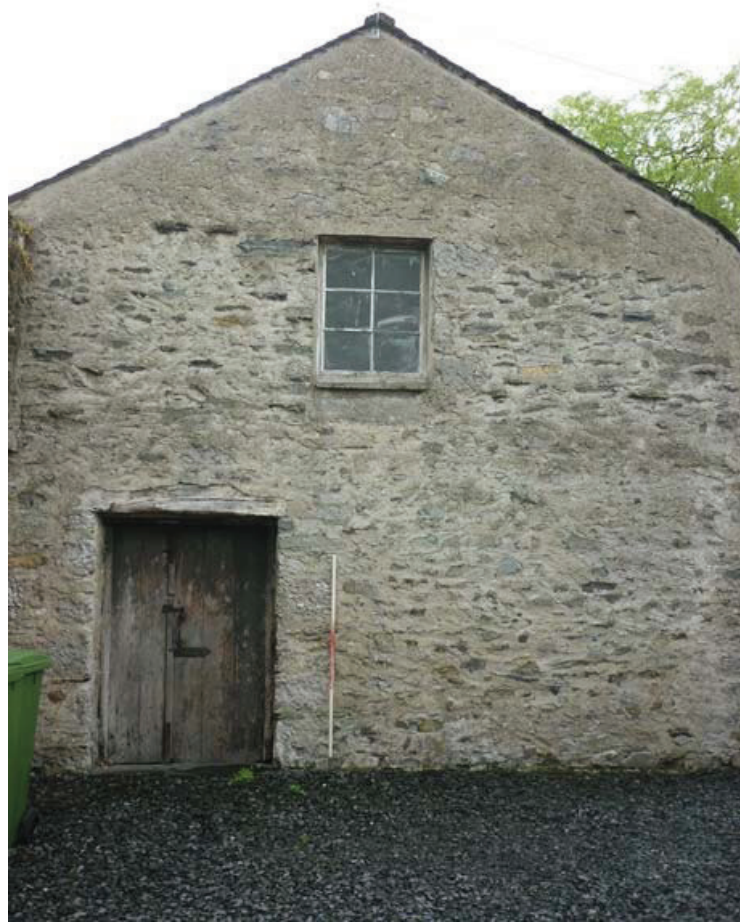
**Plate 15: West external elevation**

4.2.4 **West elevation:** this formed the gable end, which was relatively plain, with a rough mortar finish (Figure 3; Plate 15). The south corner was rounded. It had a central window at the upper level, which possibly had a filled in section below. The window had a thin slate sill and a fixed six-light casement. There was a doorway to the north, at ground floor level, with a timber double plank and batten door and surround with a run-out stop chamfer. The doorway also had a slate stone threshold and a rough timber lintel. Above this there were some thin through stones.

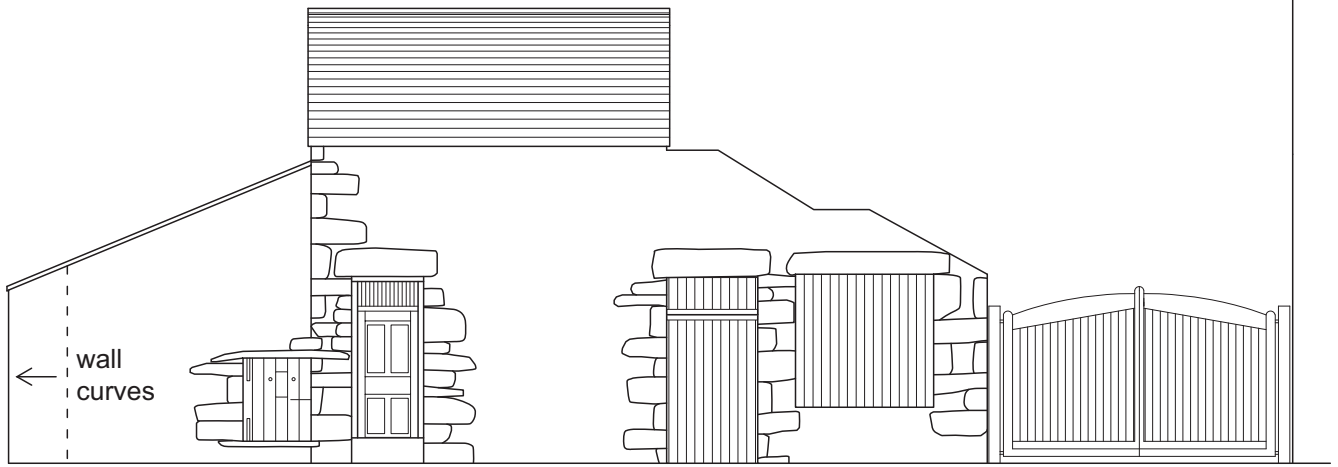
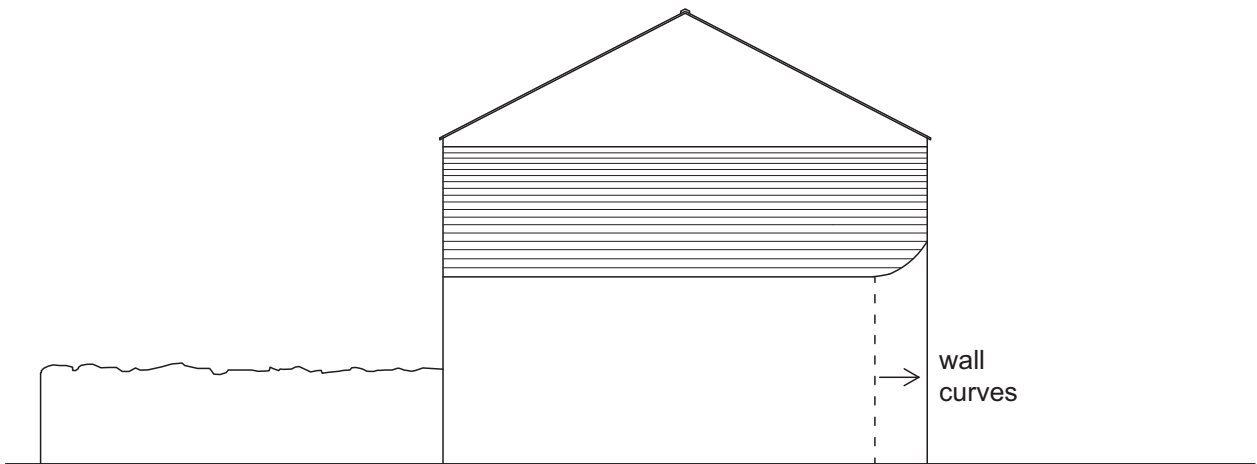
Figure 2: North and east external elevations

4.2.2 **East elevation:** the east elevation was difficult to access as it was against the beck (Figure 4). The lower part was covered by an outshut with a monopitch slate roof (Figure 2). It curved at the north corner but was otherwise plain (Plate 7). Above the roof of the outshut was the gable end of the building, which was also plain, with slate hung over the ends of the purlins.

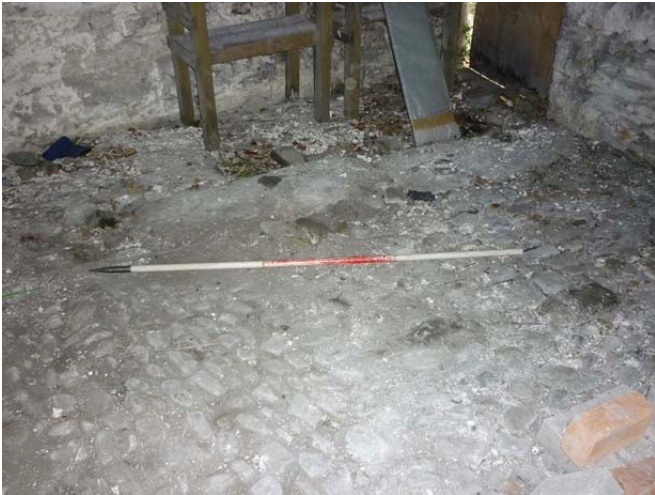
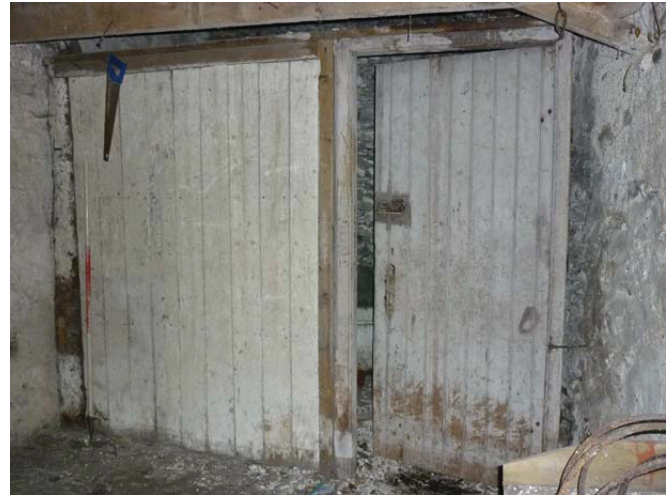
4.3.1 **East room (Room 1)**: the east room had a cobbled floor, with a lowered channel in the south-east corner, edged with large limestone blocks (Plate 16). The space was subdivided into two unequal rooms (Figure 4) by a timber plank wall, mostly machine-cut, with a tongue and groove plank and batten door on the east side with ovolo-moulded surround (Plate 17). The floor to the north side of the partition was covered in rubbish. The walls were mostly finished with lime wash on to stone on the east, north and south sides, but finished on a layer of plaster on the west. The room was open to the roof, supported by a single machine-cut, half truss, with overlapping timbers bolted together, two proper purlins and a small one against the west elevation (Plate 18). All the timber was machine-cut except one purlin, which was round and had some bark remaining. The north elevation had a low doorway on the west side, with a stone lintel and plank and batten door, originally with an opening in the top, which was now covered by boards (Plate 19). The east corner was rounded into the east elevation, which was otherwise plain. The south elevation had a doorway on the east side with a heavy timber lintel, a modern timber sheet door, and plain surrounds (Plate 20). There was a tether post to the west, with an iron ring. The lime wash was only up to the height of the lower east elevation. The west elevation had a door on the south side of centre, with a heavy hand-finished timber lintel, which may have been reused. It had a machine-finished door surround with a run-out stop chamfer. The north elevation was plain.

Plate 16 (left): Floor in Room 1

Plate 17 (right): Timber plank wall in Room 1

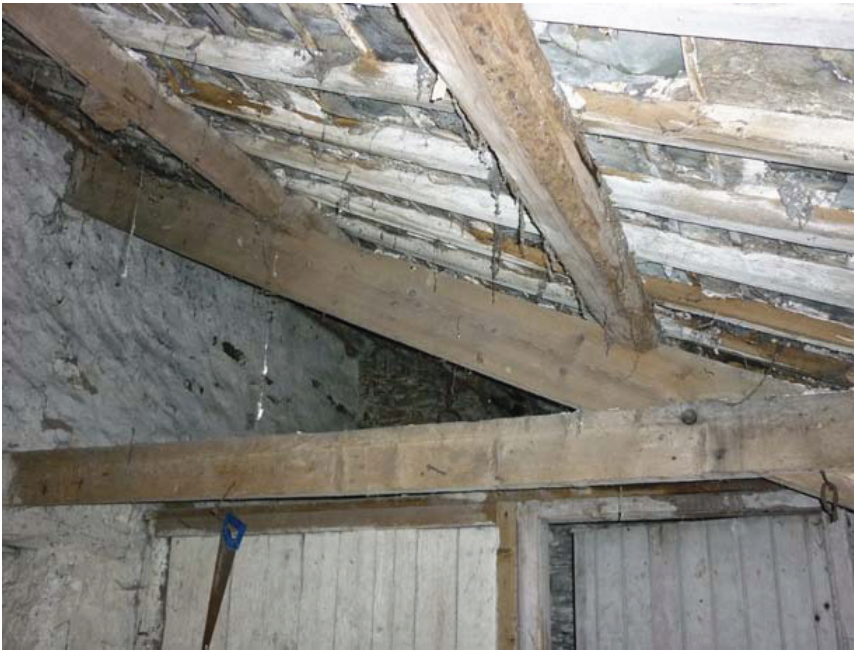
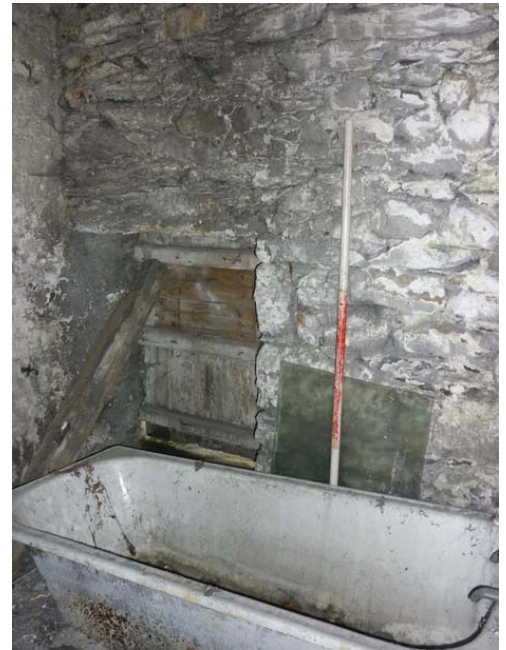
Plate 18 (left): Half truss in Room 1

Plate 19 (right): North internal elevation of Room 1

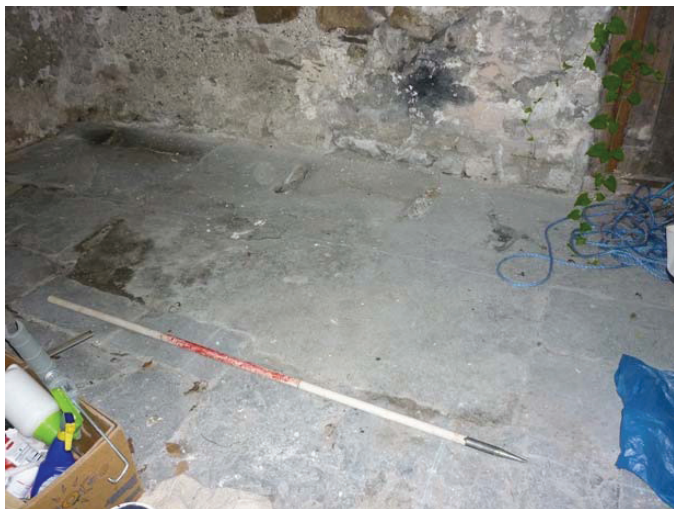
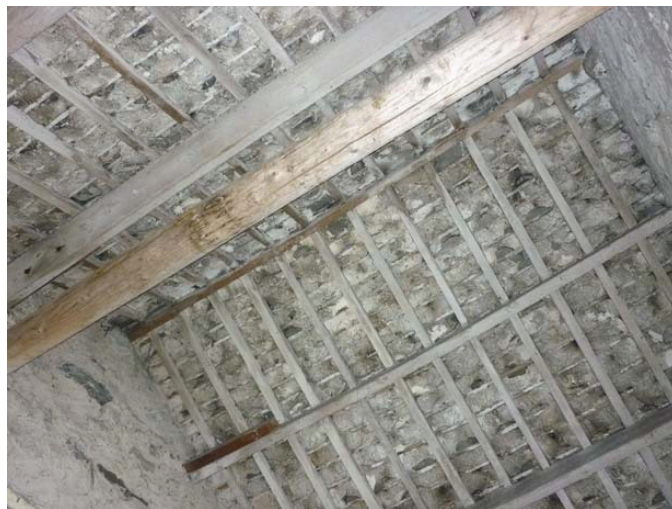
4.3.1 **West room (Room 2):** this room mostly had a flag floor but had a patch of concrete on the north side against the wall, with two scars for legs of a table/sink/bench, and another area of concrete in the centre (Figure 4; Plate 21). The room was open to the roof and had just two purlins per pitch and a ridge plank (Figure 5) and a lower east/west timber between the walls, possibly an old telegraph pole (Plate 22). The walls all had remnants of lime wash. The north elevation had a doorway on the east side with an overlong rough timber lintel, which was continued by machine-cut batten built into the wall, all of which had iron hooks attached (Plate 23). The door had plain panels, with long hinges (of early 18<sup>th</sup> century date; Alcock and Hall 2002, 25), and an over-light (Plate 24 and Plate 25). It was now covered with modern board and the lower part of the door was also covered by thick lengths of wood. Above the battens are two patches of repair. The east elevation had a rough timber batten built into the wall on the north side with two iron hooks (Plate 26). South of centre was a doorway with a rough timber batten door

**Plate 21 (left): Floor of Room 2**

**Plate 22 (right): Roof of Room 2**

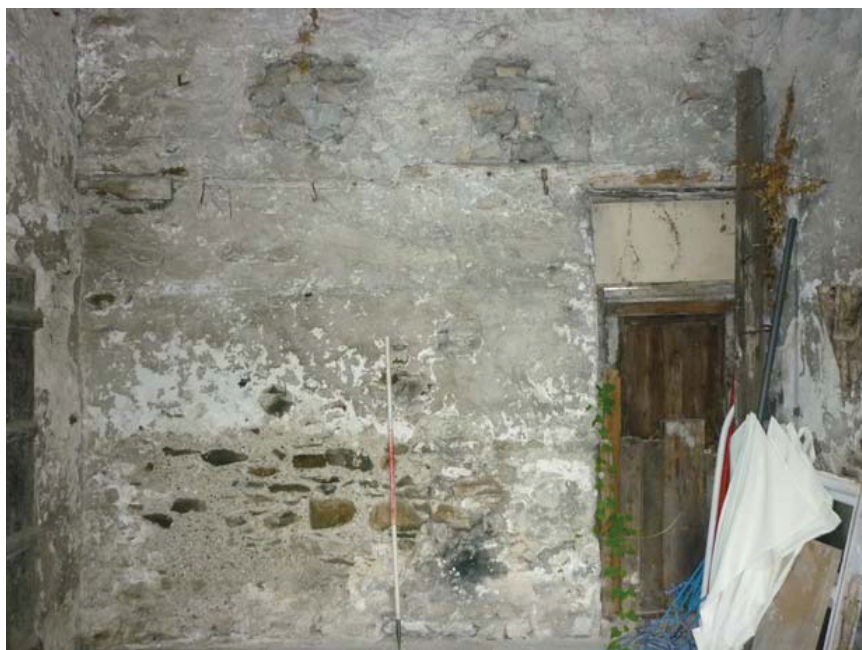
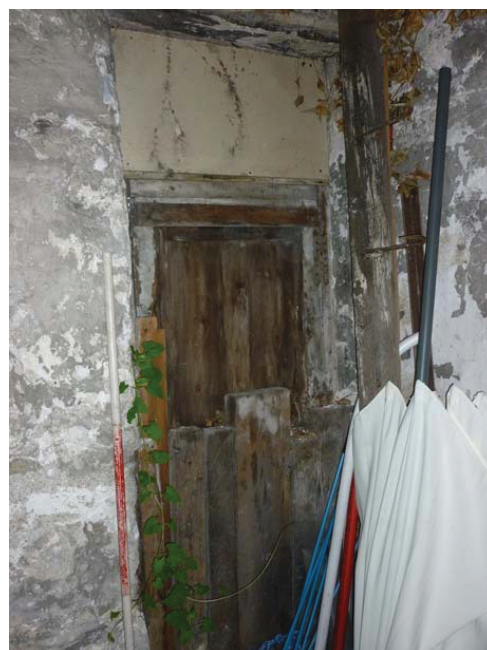
**Plate 23 (left): North internal elevation of Room 2**

**Plate 24 (right): Door to the east side of the north internal elevation of Room 2**

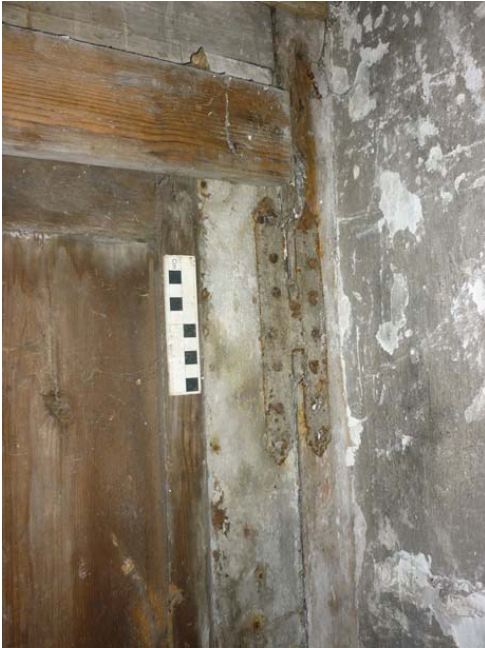
and square surround (from this side) (Figure 5; Plate 27). The door was hung from pintles on long hinges. There was a further chamfered batten to the south and a hole at high level (possibly an alcove). The south elevation had a large doorway on the east side, with a rough timber lintel, covered by a sliding door on a metal rail (Plate 28). The door was a 20<sup>th</sup> century plank and batten with nine-lights and a further batten to the west in the wall. The west elevation had a double plank and batten door on the north side on pintels and strap hinges, with an irregular hand-finished timber lintel (possibly a former cruck blade) (Plate 29). There was a long batten in the wall to the south of that, with iron hooks attached and the end of a sawn-off timber below (Plate 30), and a window at high level in the centre, with a six-light fixed casement and concrete lintel (Plate 31).

**Plate 25 (left): Hinge detail on the door to the east side of the north internal elevation of Room 2**

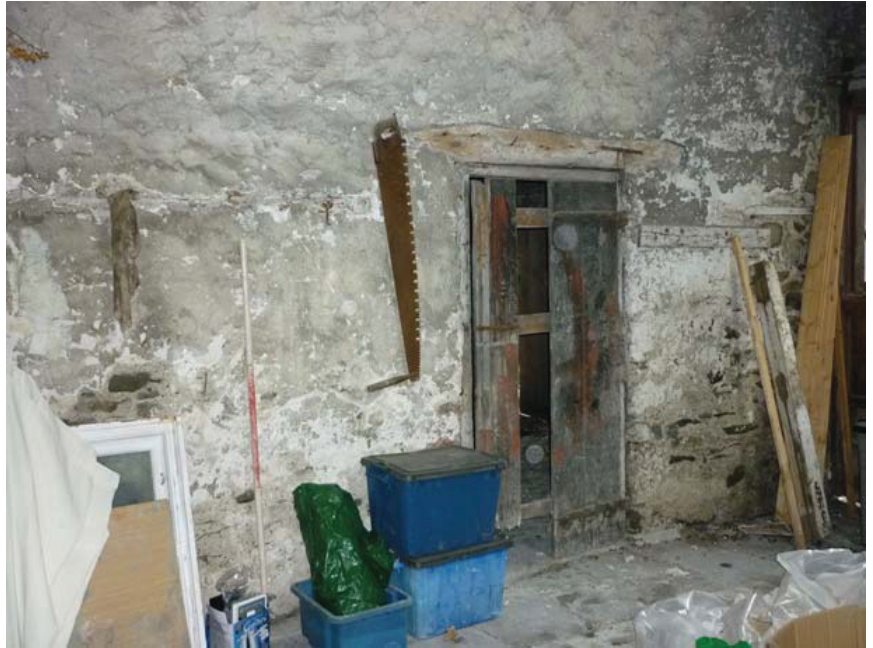
**Plate 26 (right): East internal elevation of Room 2**

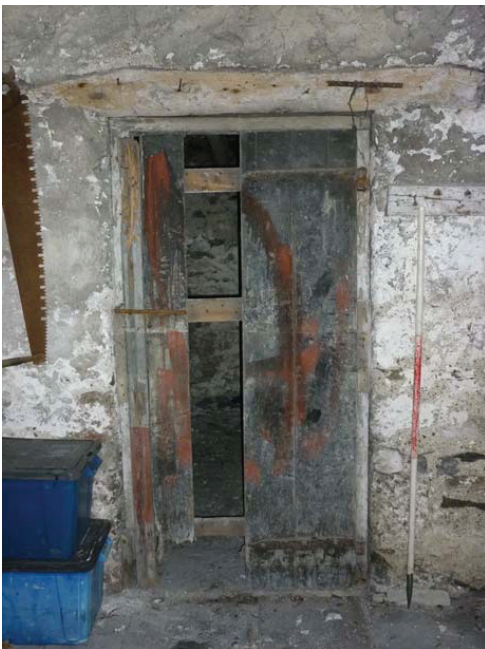
**Plate 27 (left): Detail of the door in the east internal elevation of Room 2**

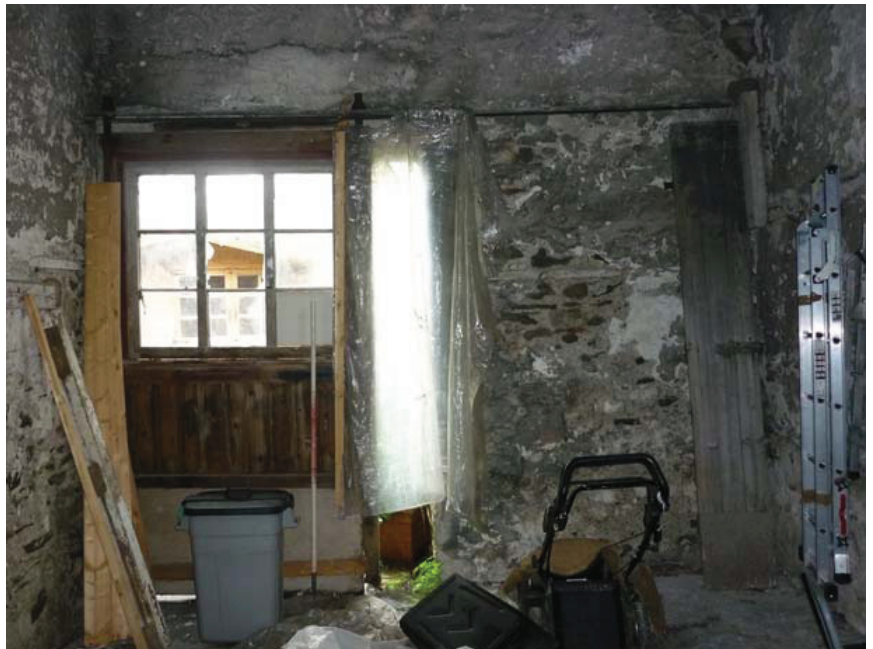
**Plate 28 (right): South internal elevation of Room 2**

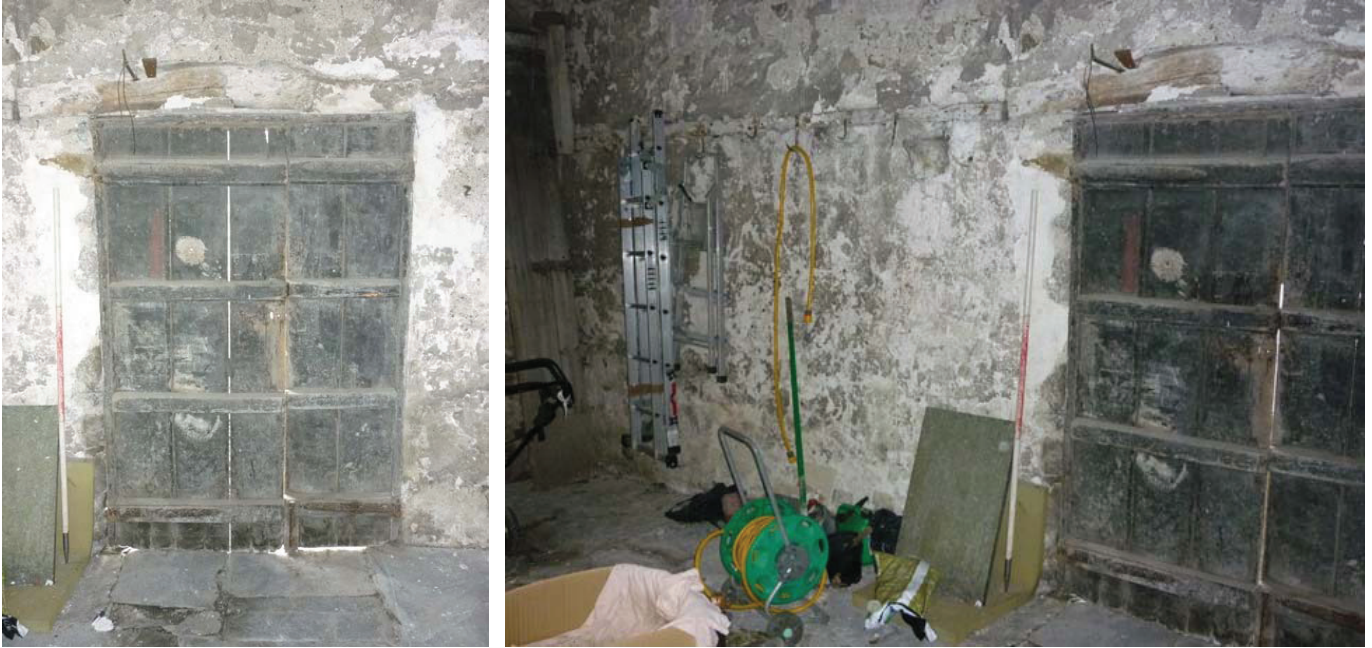
**Plate 29 (left): Double plank and batten door on the north side of the west internal elevation of Room 2**

**Plate 30 (right): West internal elevation of Room 2**

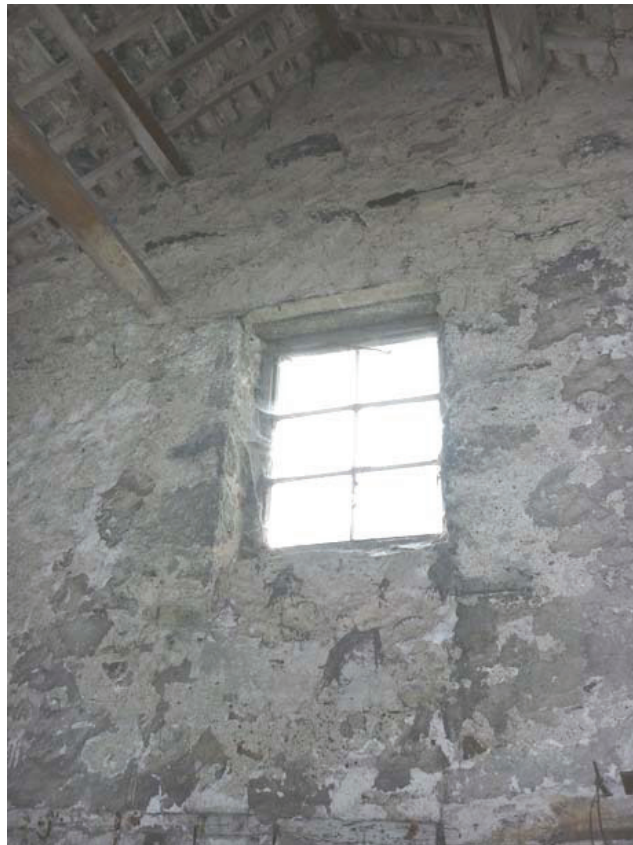
**Plate 31: Window at high level in the centre of the west internal elevation of Room 2**
