# OAKHEAD FARM, MEWITH LANE, TATHAM, LANCASTER, LANCASHIRE

## Archaeological Building Recording

Planning Application Reference:  
1/15/00255/CU

September 2015

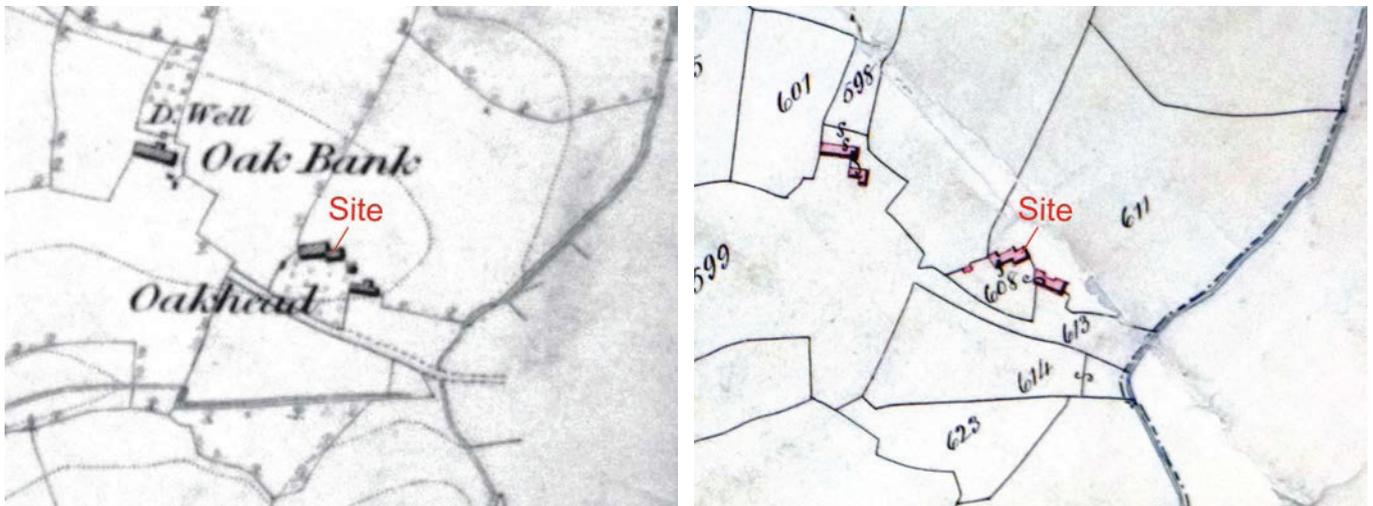
Plate 1 (left): Extract from the Ordnance Survey map of 1847

Plate 2 (right): Extract from the Tithe Map of 1848

3.1.2 **Ordnance Survey 1847:** the first edition Ordnance Survey map, which was surveyed in 1844-1845, is at a scale of 1:10,560 and as such lacks specific detail (Plate 1). Oakhead Farm is clearly marked and the current farmhouse and barn appear to be shown, albeit in a simplified way.

3.1.3 **Tithe Map 1848:** this map (LRO DRB 1/183 1848a; Plate 2) shows the same basic plan of the farm as the earlier Ordnance Survey map (cf. Plate 1). The west end of the current farmhouse now shows the dog leg in the north elevation. The east end, where the current farmhouse butts the barn, seems to be not in line on the south side but this could just be because of the scale at which the map was produced.

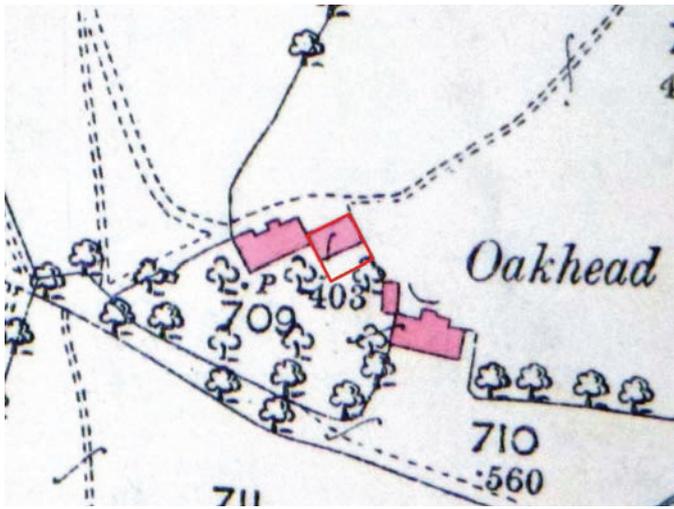
Plate 3 (left): Extract from the Ordnance Survey map of 1894

3.1.4 **Ordnance Survey 1894:** this is the first 1:2,500 scale plan (surveyed in 1890) to depict the site, and is therefore considerably more detailed than its predecessors. The current farmhouse and barn are more clearly shown (Plate 3). The shippon to the south-east side of the barn had yet to be built.

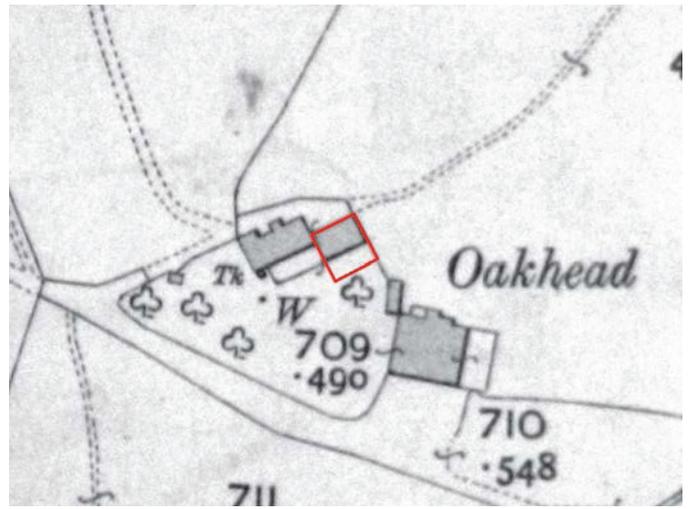
Plate 4 (right): Extract from the Ordnance Survey map of 1913

3.1.5 **Ordnance Survey 1913:** this shows essentially the same information as the previous map (Plate 4; cf. Plate 3). The shippon to the south-east of the barn had yet to be built.

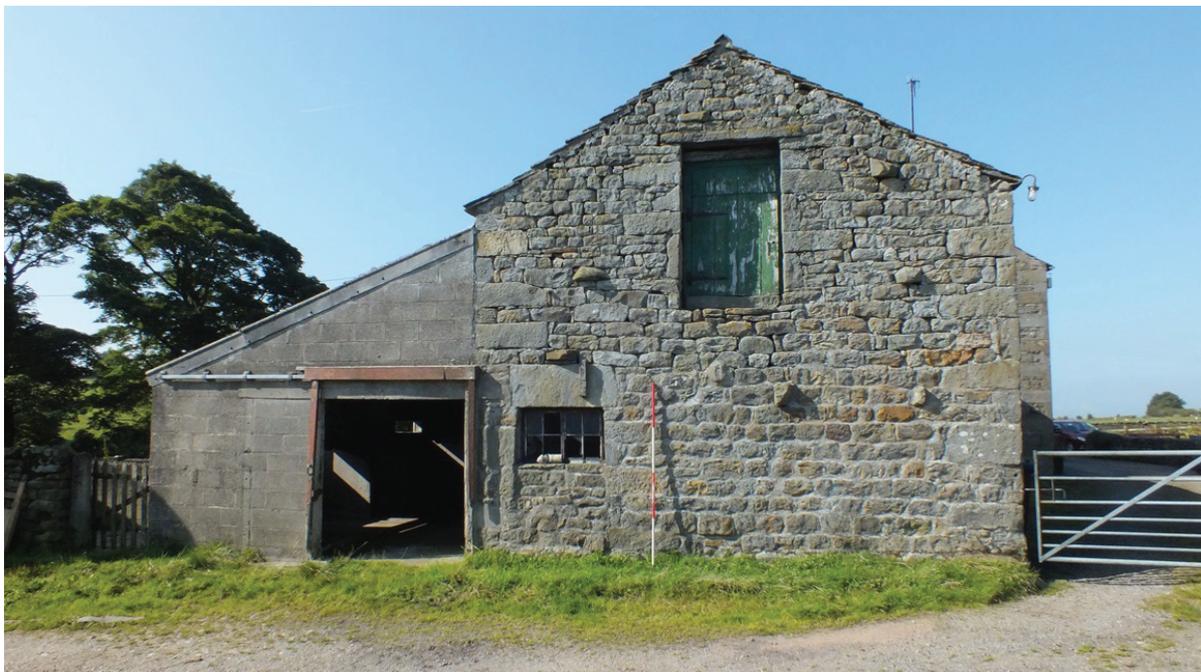
Plate 5: North-east external elevation

4.2.1 **North-east elevation:** the block work extension to the south-east had fittings for a sliding door but the door itself was absent (Plate 5). The doorway had been in-filled with concrete blocks to the south-east side and the long concrete lintel above extended beyond that. The barn had quoins at the ends (Figure 2) and the lower part had been re-pointed. On the ground floor there was a doorway which had been partially blocked to leave a window in the top. The gap housed an eight-light window, comprising two blocks of four, in a rusted, hinged metal casement (Plate 6). The doorway, as was, had quoins and a heavy stone lintel. To the first floor was another doorway with quoins and a heavy stone lintel, housing a plank door, with a plain timber surround, on long hinges (Plate 7).

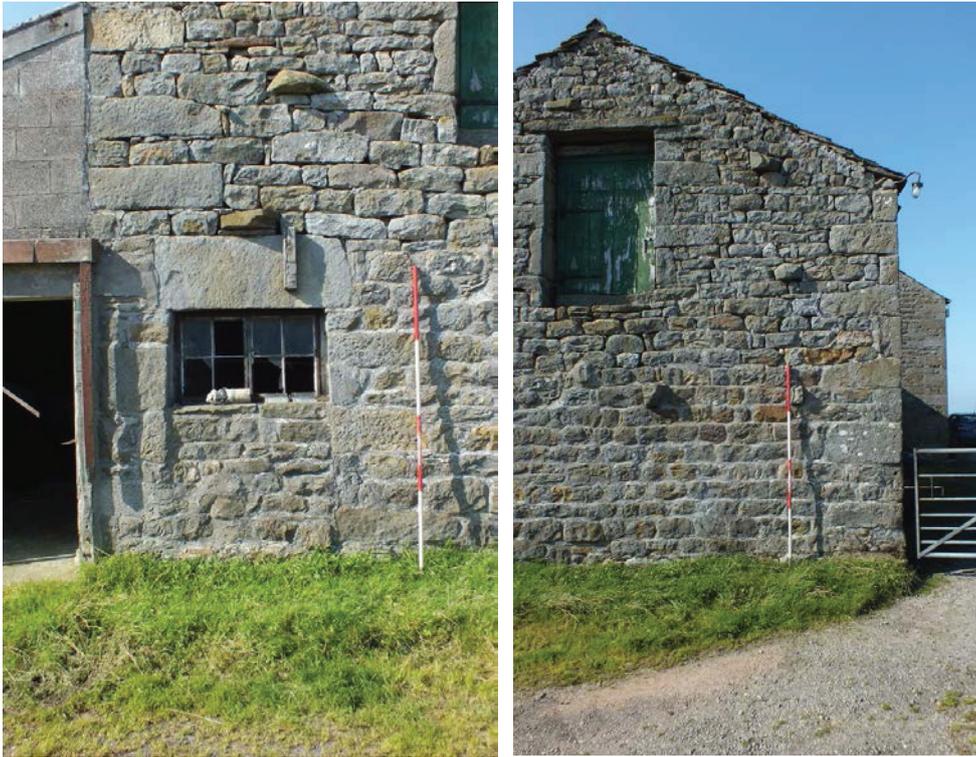
**Plate 6 (left): Blocked doorway to the barn on the ground floor of the north-east external elevation**

**Plate 7 (right): North-west end of the north-east external elevation**

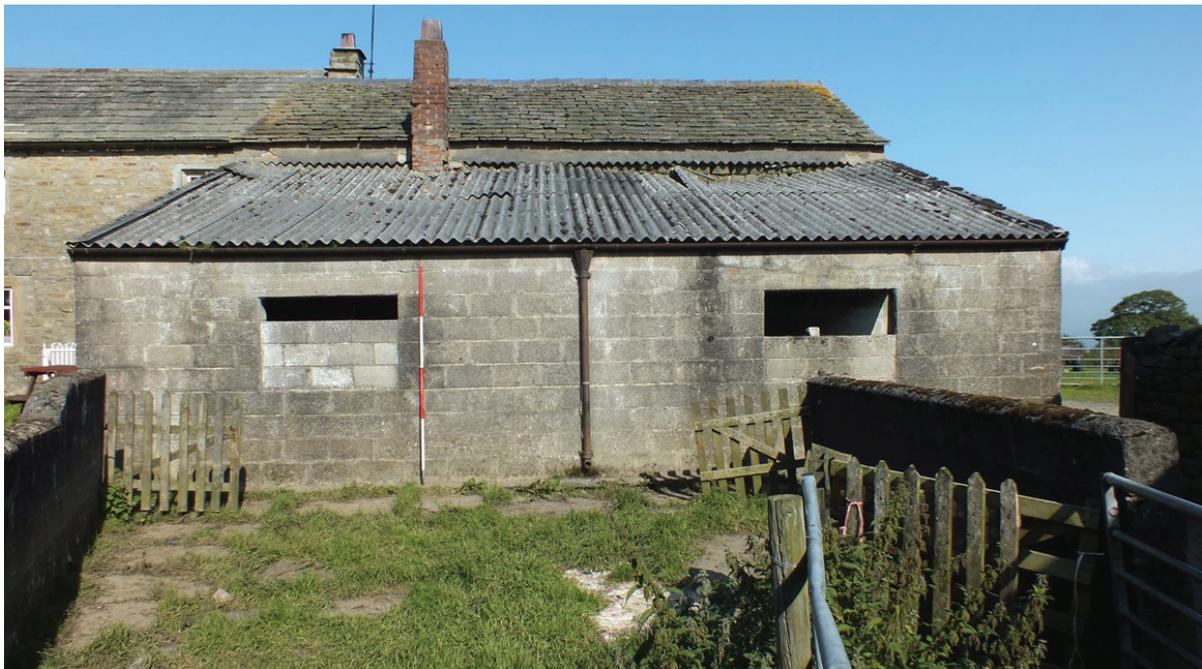
**Plate 8: South-east external elevation**

4.2.2 **South-east elevation:** the modern shippon obscured the lower level of the barn (Plate 8; Figure 3). Above the modern extension, the elevation of the barn appeared to be rendered with concrete. There were two (window) openings in the block work of the shippon, both of which had been partially blocked leaving a gap at the top. The one to the south-west was blocked further up (another course of bricks higher) than the one to the north-east. The corrugated sheet roof was visible above that and the slates of the barn were visible behind. The square red brick flue from the shippon was also visible above the roof of the shippon.

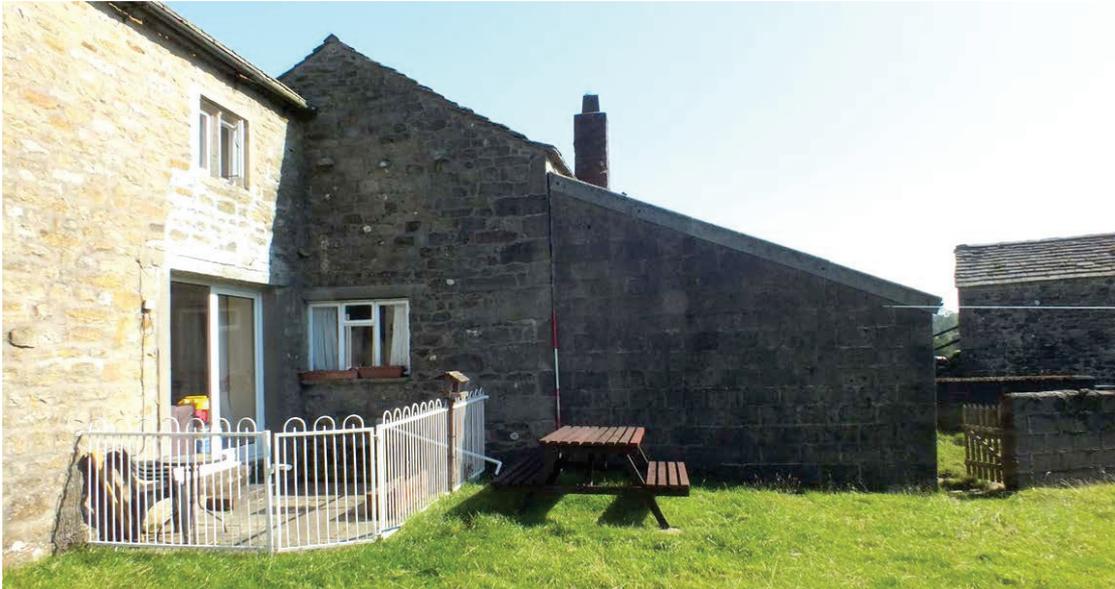
**Plate 9: South-west external elevation**

4.2.3 **South-west elevation:** the exposed stonework of the barn had quoins at the south-east end and was plain above the window of the kitchen (Plate 9; Figure 3). The kitchen window was modern below a concrete lintel. The modern block work of the shippon extended the line of the building to the south-east. Again, the red brick flue from the shippon was visible above the line of the corrugated roof.

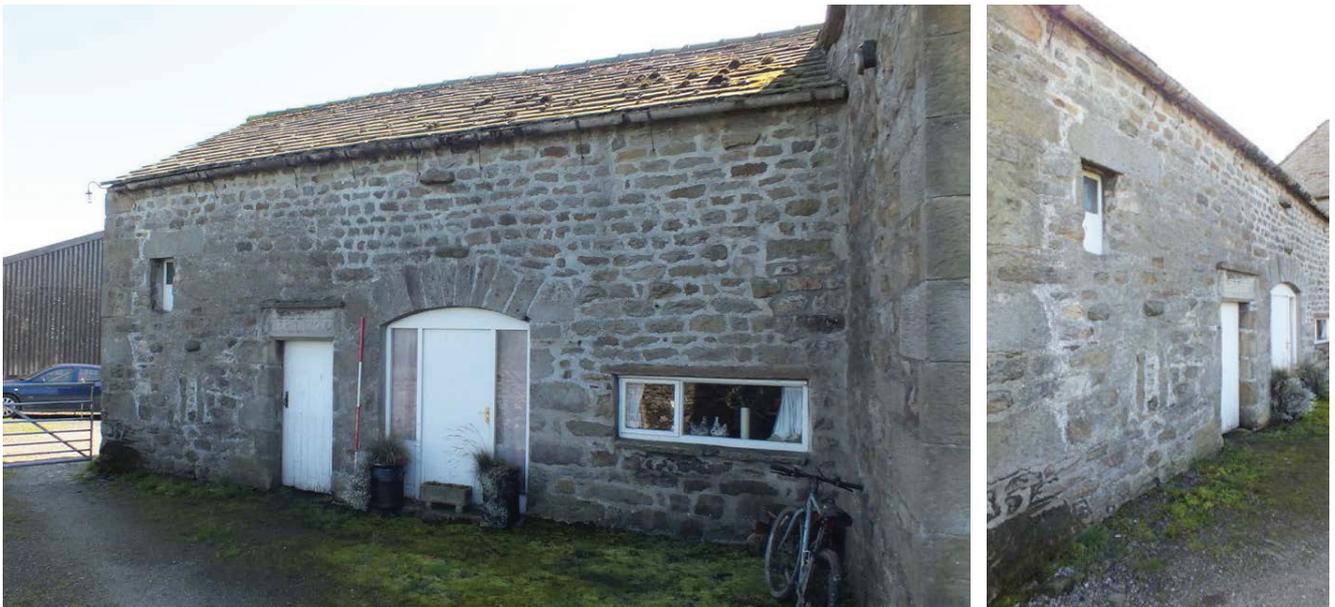
**Plate 10 (left): North-west external elevation**

**Plate 11 (right): North-east end of the north-west external elevation**

4.2.4 **North-west elevation:** the stonework was exposed and some throughstones were apparent. The barn had quoins at the north-east end, but had no quoins where it met the current farmhouse at the south-west end (Plate 10; Figure 3). On the ground floor there was a blocked narrow window with a stone surround at the north-east end (Plate 11). To the south-west of that was a plank door, with quoins and datestone above (Plate 12). The datestone read 'IEE | 1720' and there was a possible drip course above that (Plate 13). To the south-west of that was the arched doorway to the kitchen, with quoins in the jambs and modern door and full length windows either side. South-west of that was a low, modern window fitting with a stone sill and long stone lintel. As noted above, the barn did not have quoins to the main house and presumably butted it. On the upper level of the barn, to the north-east end, there was a window, which had been partially blocked with stone, below a heavy stone lintel (Plate 10 and Plate 11). The lower part of the remaining gap had been boarded and there was a single-light above with a timber surround.

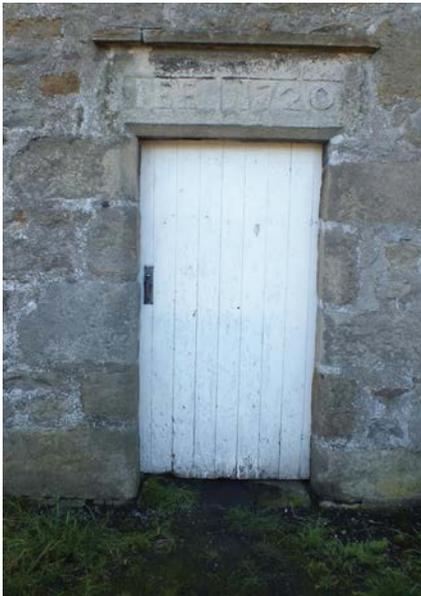
**Plate 12 (left): Door to the barn at the north-east end of the north-west external elevation**

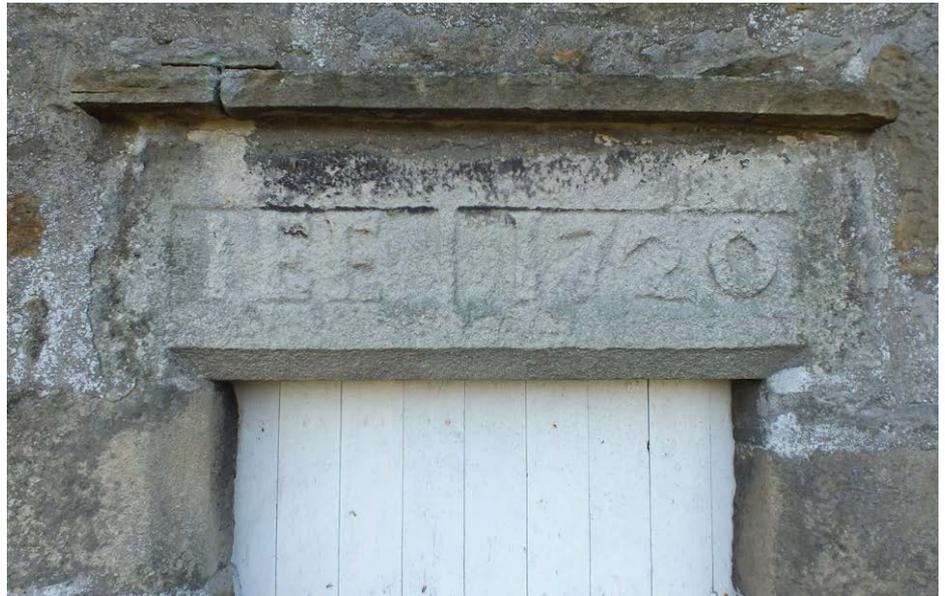
**Plate 13 (right): Datestone above the door to the barn at the north-east end of the north-west external elevation**

3.2.1 **Oakhead Farm:** there is a datestone above the door of the barn, which reads 'IEE | 1720'. The initials perhaps belong to John Ellershaw (1681-?1759), whose family continued here until at least 1835 (Garnett 2008, 208). Ellershaw is a common name in Tatham/Bentham (*ibid*) and the apportionment accompanying the tithe map of 1848 records that plot 608, which includes Oakhead Farm, was owned and occupied by Henry Ellershaw (LRO DRB 1/183 1848b). It was recorded as 'house, yard, orchard and garden' at that time (*ibid*). Another barn on the site also contains a datestone with the same initials and the year 1713, which presumably therefore relate to the same person (John Ellershaw), but this building has no physical relationship to the building subject to recording and is still in use as part of the farm (Peter Longton per comm.).

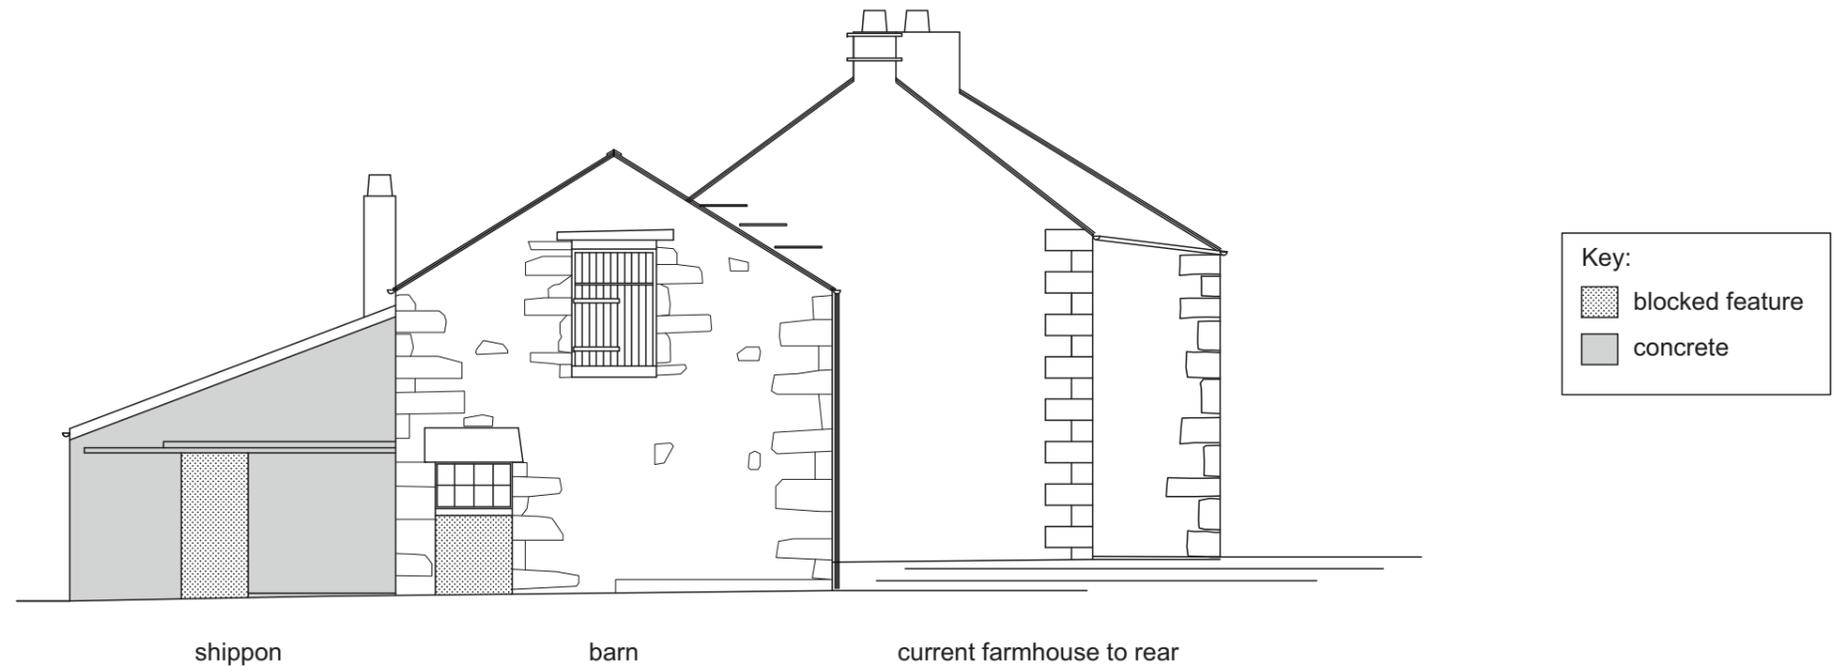
Figure 2: North-east and south-east external elevations

NORTH-EAST EXTERNAL ELEVATION

SOUTH-EAST EXTERNAL ELEVATION

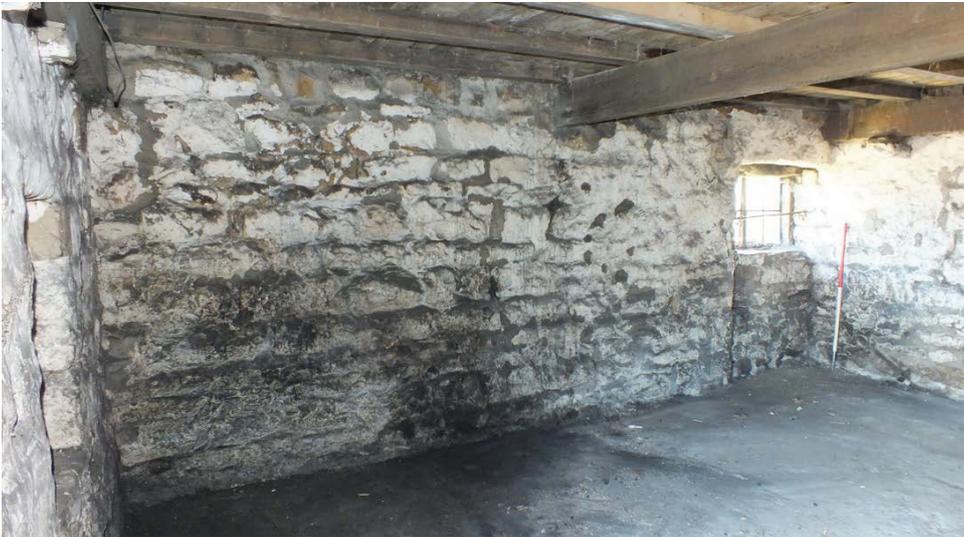
Plate 14 (left): North-east elevation of G1

4.3.1 **Ground floor room 1 (G1):** this room was located at the north-east end of the barn (Figure 4). The ceiling was open to the sawn timber beams and floorboards of the room above. There was a dung channel along the south-west side of the room. The floor was concrete on the north-east side and was flagged to the south-west (along the dung channel) apart from a small area of setts at the south-east end of the dung channel. The walls were all exposed stone with a thin lime wash throughout. The north-east elevation was plain apart from a partially blocked doorway at the south-east end (Plate 14), which housed a rusted eight-light metal casement window (two four-light hinged casements) within a timber surround and with a timber lintel (Plate 15). The south-east elevation was plain apart from a possible blocked opening towards the centre and blocked opening (doorway?) within the dung channel (Plate 16). The opening to the south-west end left a small alcove beneath a stone lintel. The south-west elevation was again plain apart from a small square alcove with a stone lintel and sill at the north-west end (Plate 17). The doorway on the north-west elevation to the south-west side had splayed jambs and stone quoins (Plate 18). There were additional 'arched' timber lintels behind the datestone to the exterior. The door was a plank and batten door on long hinges (Plate 19). To the north-east of that was a blocked slot window with a stone lintel and sill and splayed jambs (Plate 18).

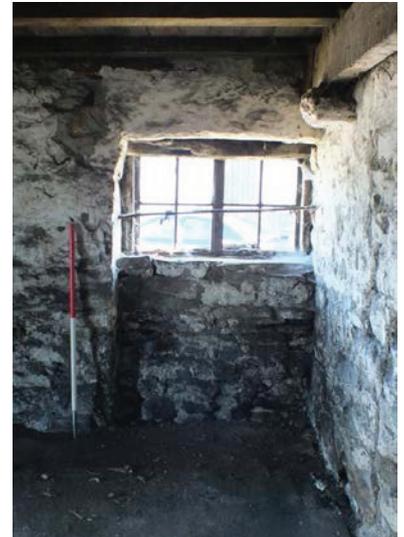
Plate 15 (right): Blocked feature at the south-east end of the north-east elevation (G1)

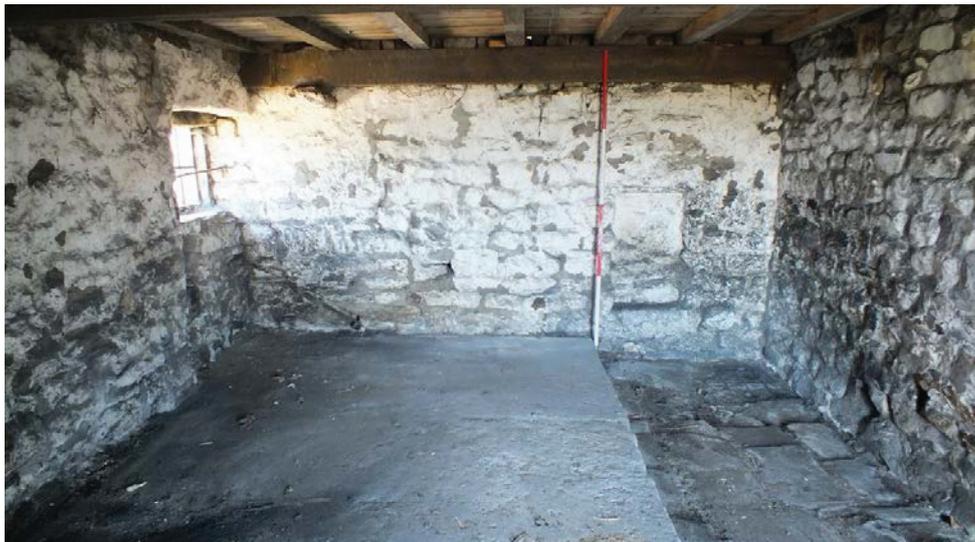
Plate 16: South-east elevation of G1

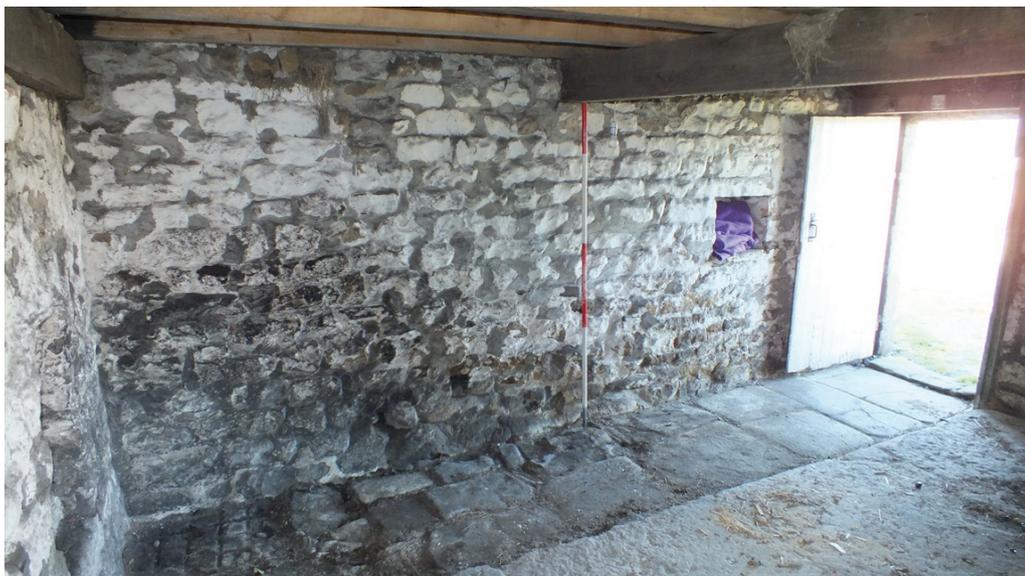
Plate 17: South-west elevation of G1

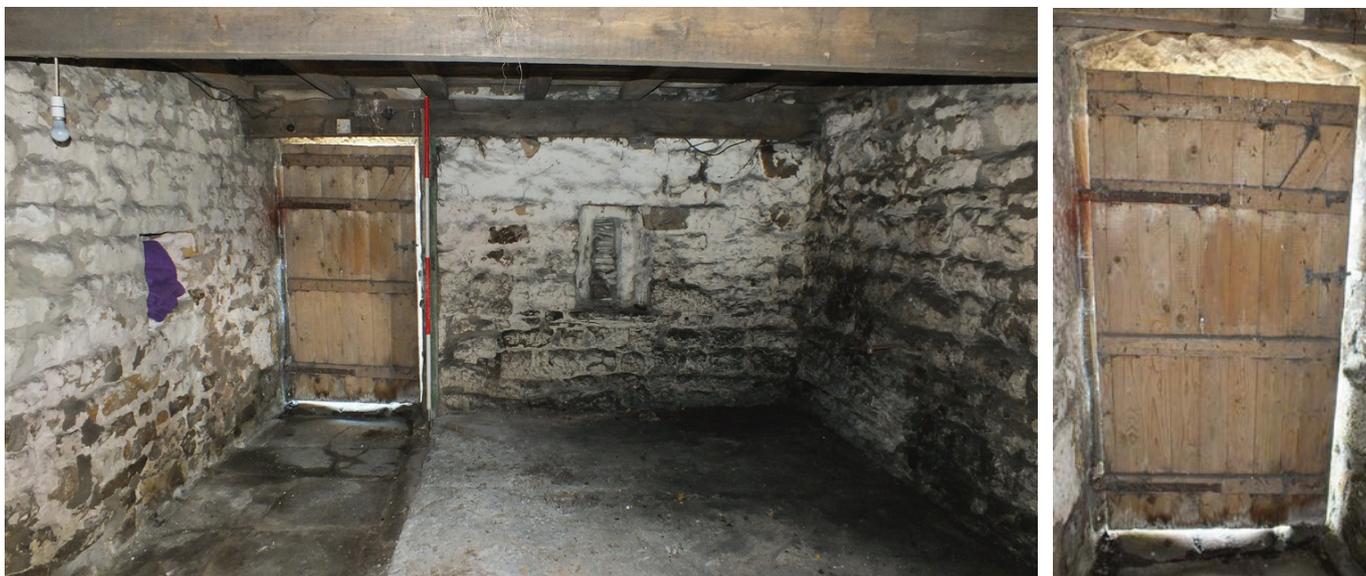
Plate 18 (left): North-west elevation of G1

Plate 19 (right): Plank door at the south-west side of the north-west elevation (G1)

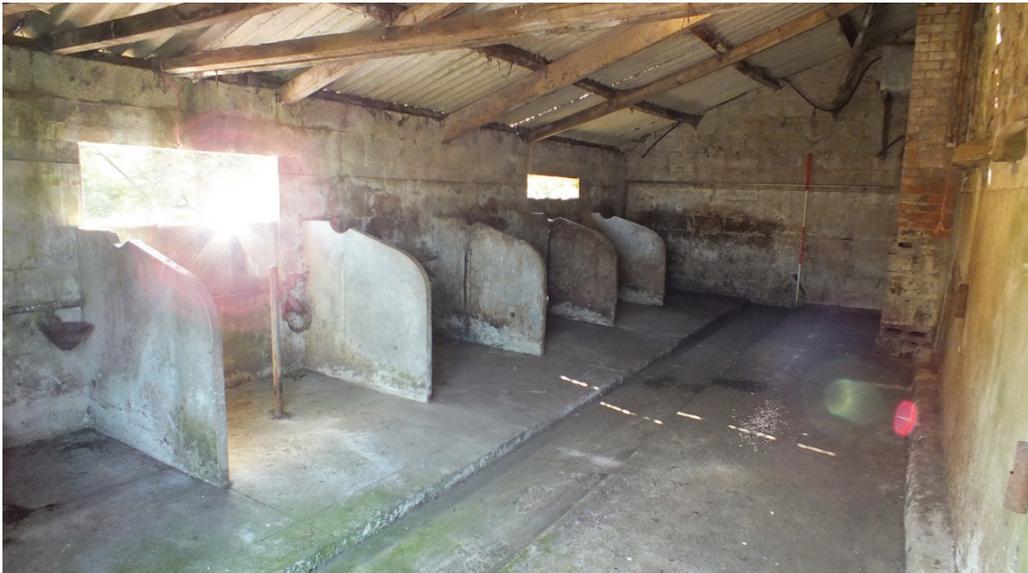
**Plate 20: Stalls along the south-east elevation of G2**

4.3.2 **Ground floor room 2 (G2)**: this was the shippon to the south-east side of the barn (Figure 4). It was open to the corrugated sheet roof, which had one 'light' panel. The floor was concrete with a channel to the north-west of centre aligned south-west/north-east. There were six concrete stalls with two drinking troughs and a central tethering post in each (some of which are now missing). The north-east, south-east and south-west elevations were all modern concrete block and all of the walls were concrete skimmed to c1.5m up. The north-east elevation was fitted for a large sliding door to the north-west side, now missing. The concrete stalls were equally spaced along the south-east elevation (Plate 20). There were two partially blocked windows on this side also; the openings at the top remained, the one to the south-west having been blocked with an additional course of blocks. The south-west elevation was plain apart from the water tank in the west corner (Plate 21). The north-west elevation was originally the external wall of the barn, with some throughstones (Plate 22). There were no obvious features visible, although there was a low plinth noted along most of the length of the wall at its base. To the south-west of centre on this side of the room was a large flue, the lower part was built of concrete block (to 1.12m) and above that it was red brick, sat on top of the plinth (Plate 23). At the south-west end, to the south-west side of the flue, was a possible roof scar from an earlier outshut or lean-to (Plate 24).

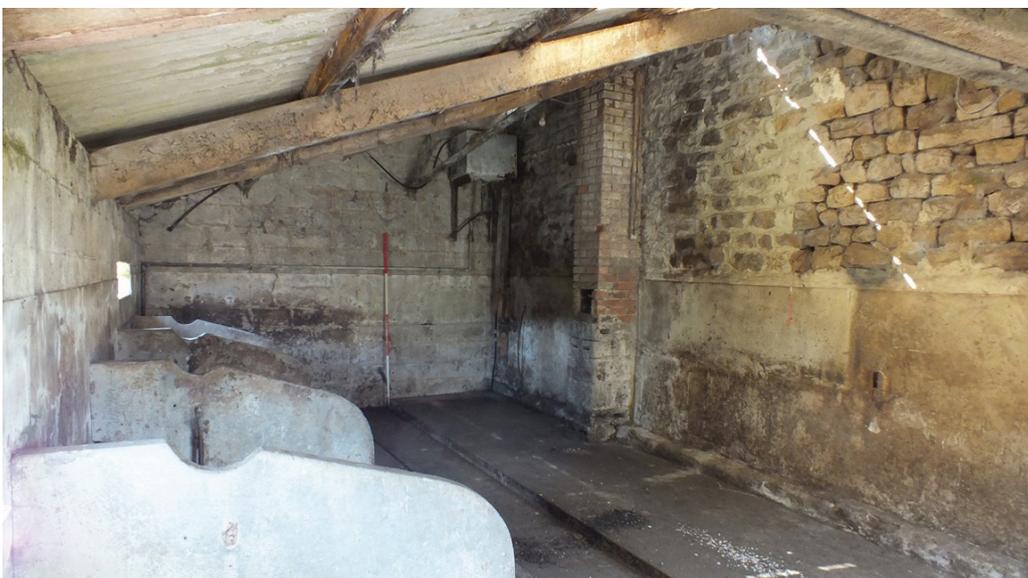
**Plate 21: West corner of G2**

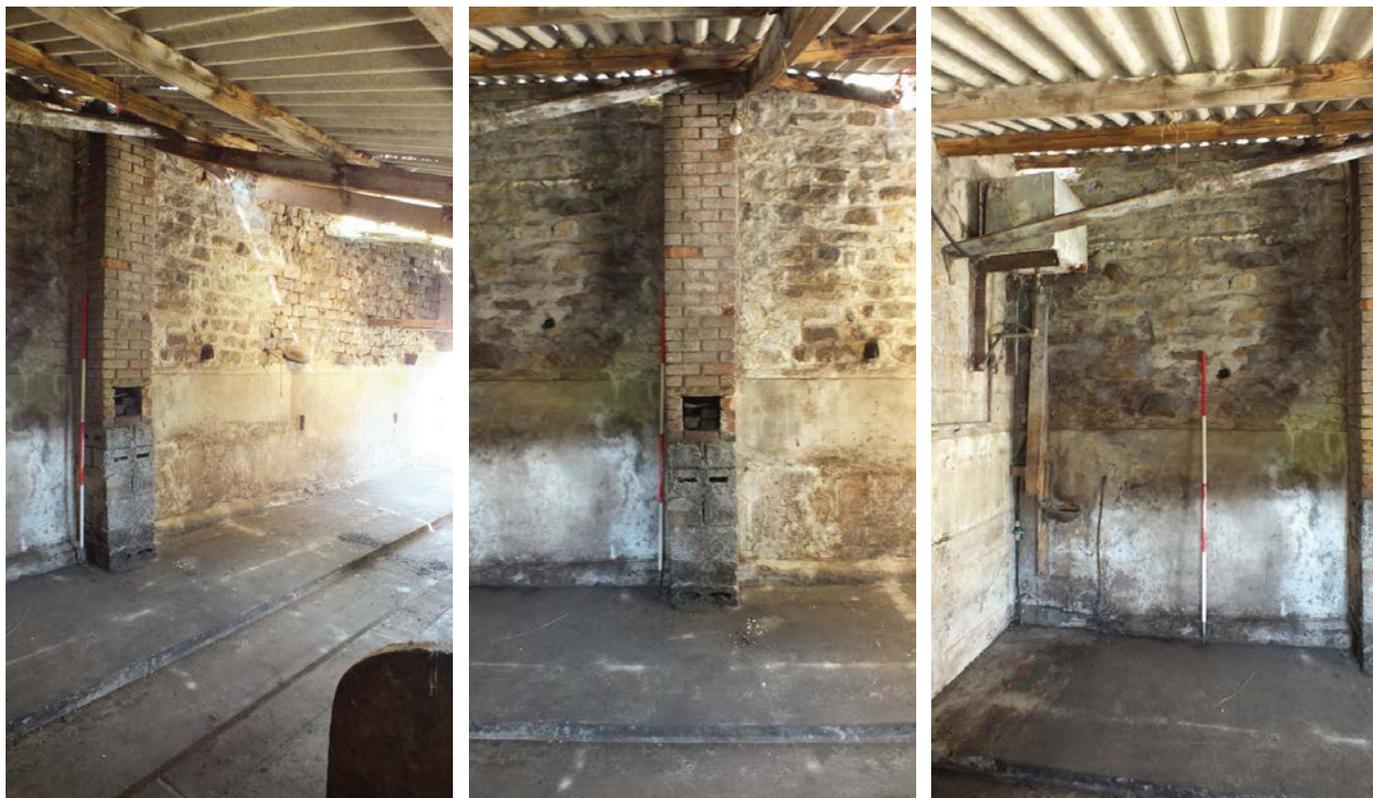
**Plate 22 (left): North-east end of the north-west elevation (G2)**

**Plate 23 (centre): Flue towards the south-west side of the north-west elevation (G2)**

**Plate 24 (right): South-west end of the north-west elevation (G2)**

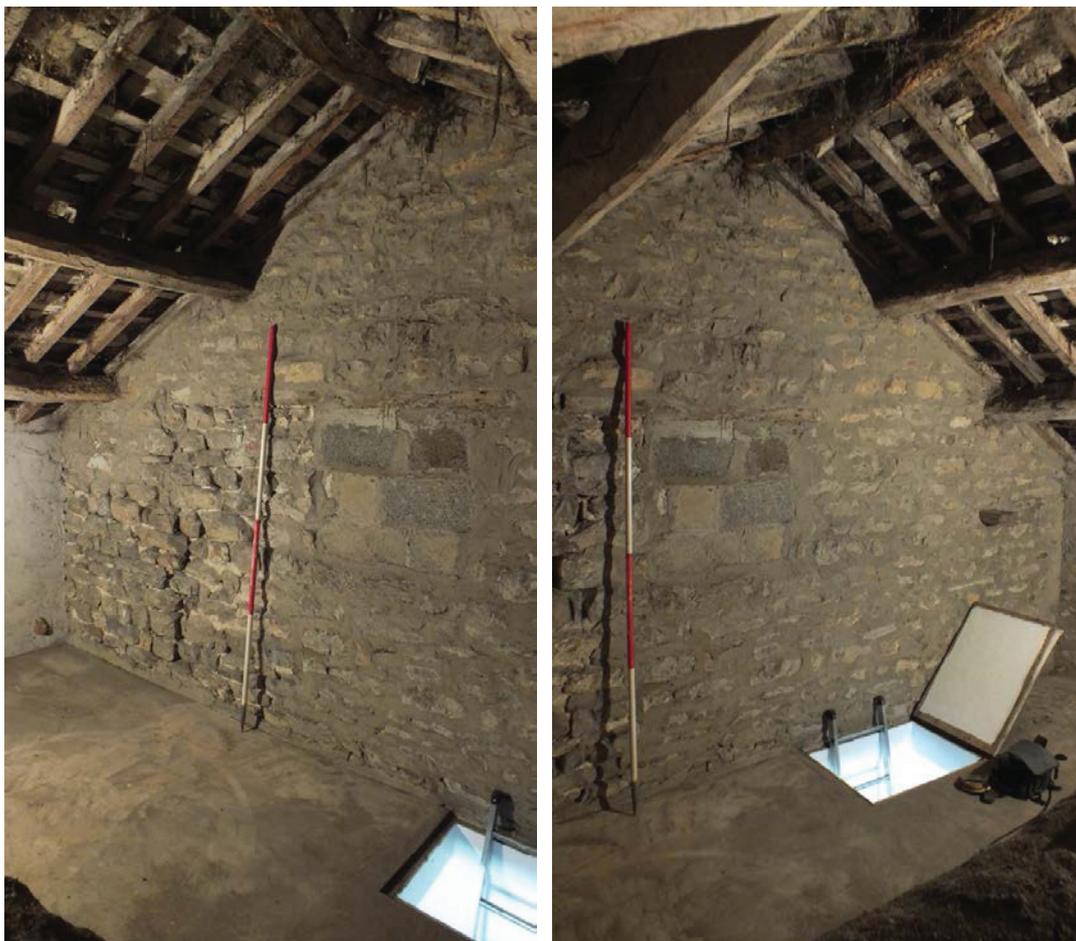
**Plate 25 (left): North-west end of the north-east elevation (F1)**

**Plate 26 (right): South-east end of the north-east elevation (F1)**

**4.3.3 First floor room 1 (F1):** this room, at the south-west end of the barn (above the kitchen), had been used recently for storage (Figure 5). There was a single north-west/south-east truss across the room, which was open to the slates of the roof. The beams were hand-cut and bowed, especially the purlins. There were two purlins per pitch and the rafters were machine-cut. The floor was modern hardboard with an access hatch to the kitchen below against the north-east wall. The north-east elevation was exposed stonework with some concrete re-pointing and some crumbly white mortar to the north-west end (Plate 25). There was a blocked window aperture towards the centre, with a timber lintel, which was blocked with modern block work and there was a projecting stone at the south-east end of the elevation, which was otherwise plain (Plate 26). The south-east elevation was similarly exposed stone with concrete re-pointing and was otherwise plain (Plate 27). The south-west elevation was the same as the south-east elevation but had a central, low-level beam slot (Plate 28, Plate 29 and Plate 30). The north-west elevation was exposed stone to the south-west of the truss, with a white crumbly mortar (Plate 31). To the north-east of the truss the wall was covered with white plaster, which was apparently unpainted. The tie-beam truss with curving collar was sat on projecting stones at the ends and was pegged at the joints, with two purlins per pitch and a ridge purlin (Plate 32 to Plate 36; Figure 6). The timbers of the truss are hand-finished and roughly chamfered and there was a carpenter's mark on the north-east side. The south-east end of the truss was marked 'II' on the north-east side (Plate 37).

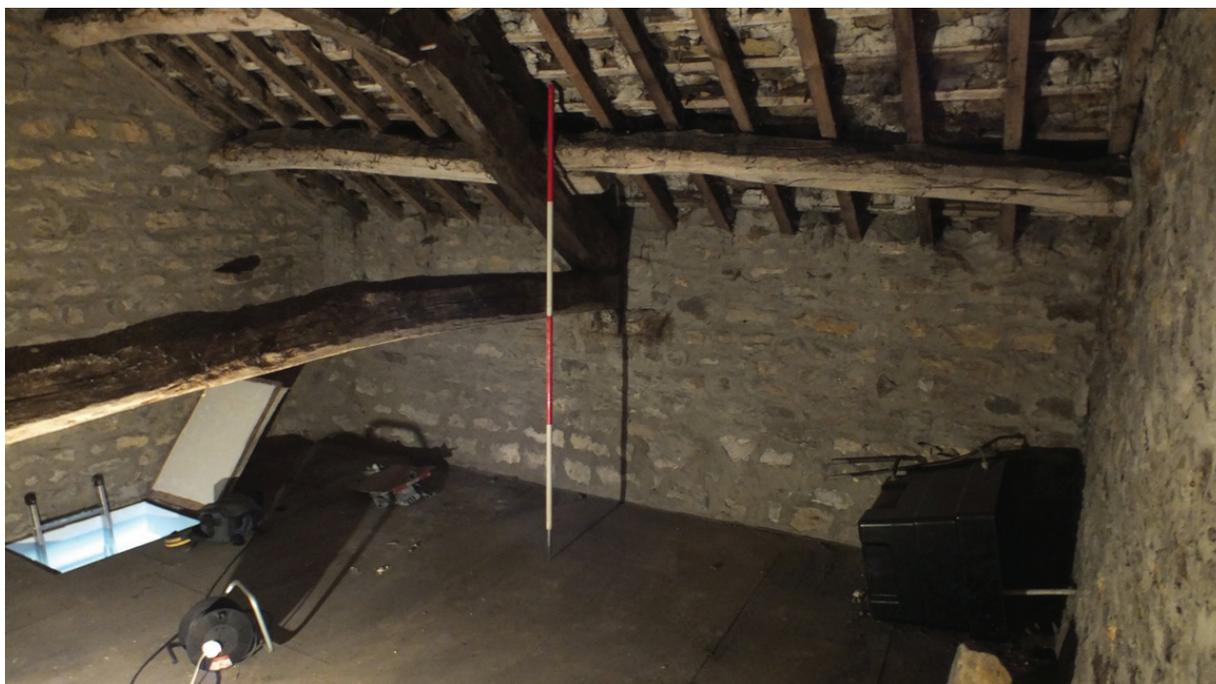
**Plate 27: South-east elevation (F1)**

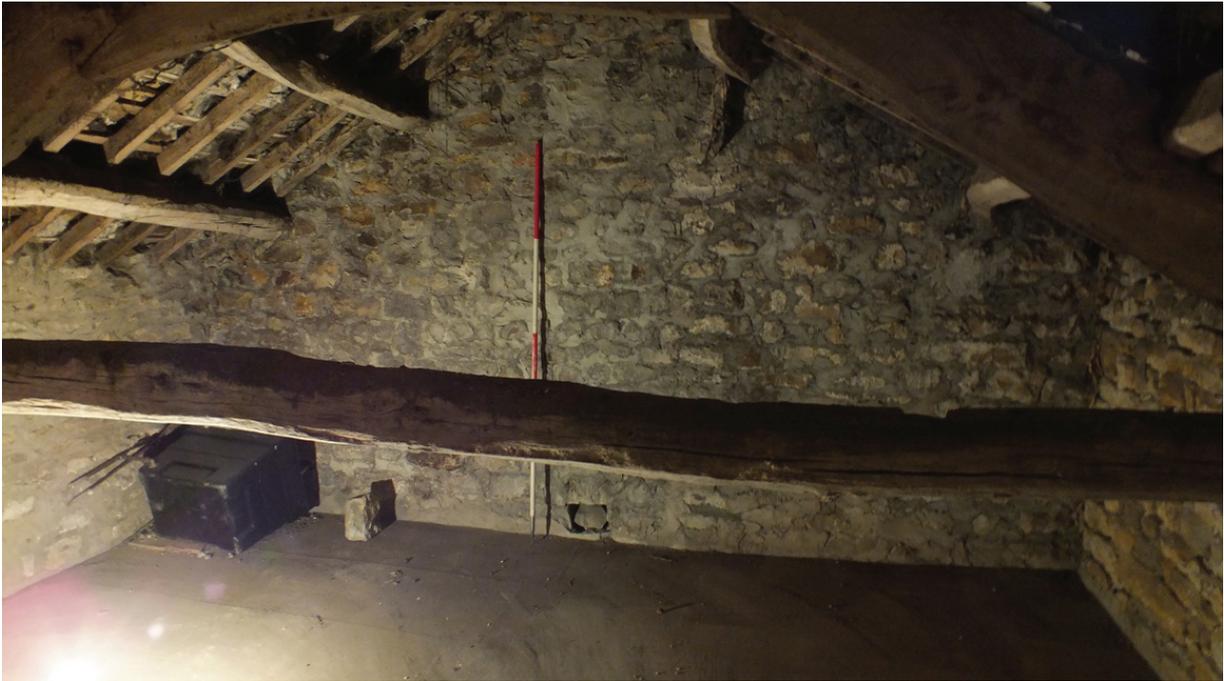
**Plate 28: South-west elevation (F1)**

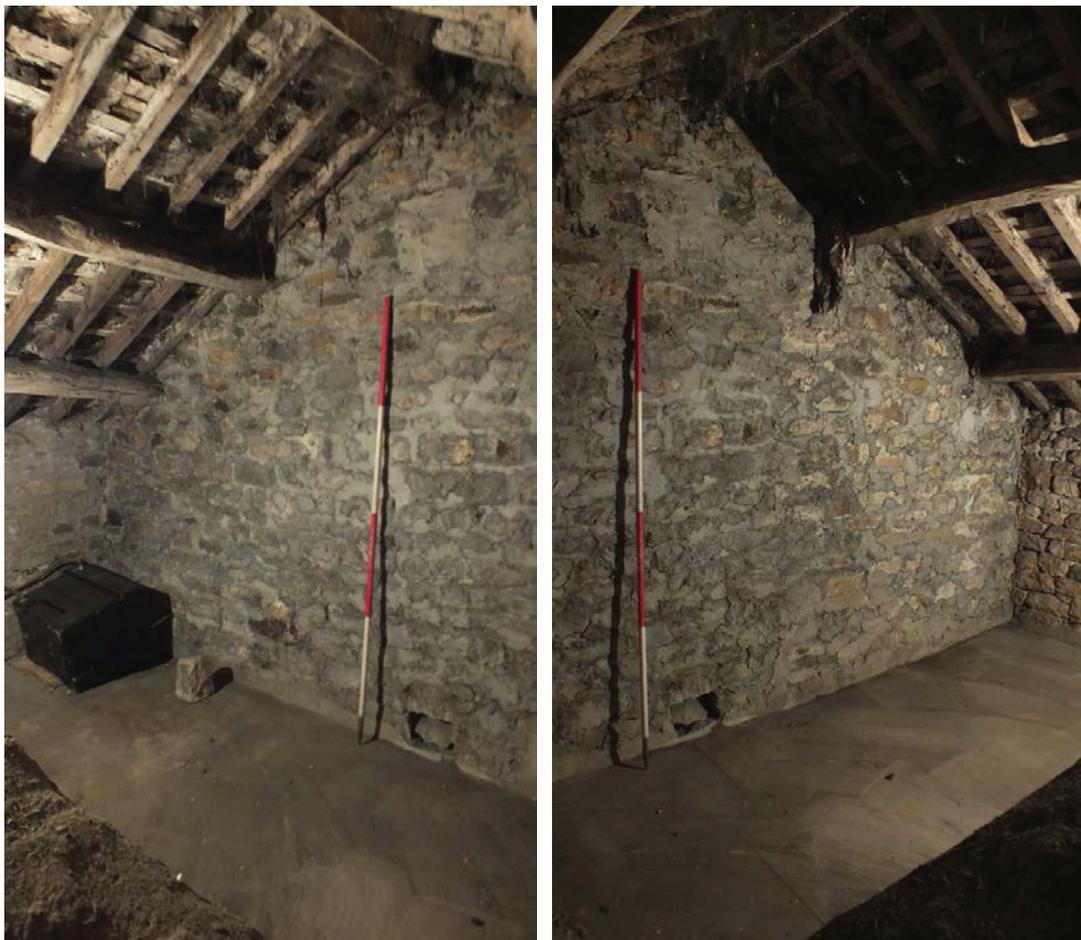
**Plate 29 (left): South-east end of the south-west elevation (F1)**

**Plate 30 (right): North-west end of the south-west elevation (F1)**

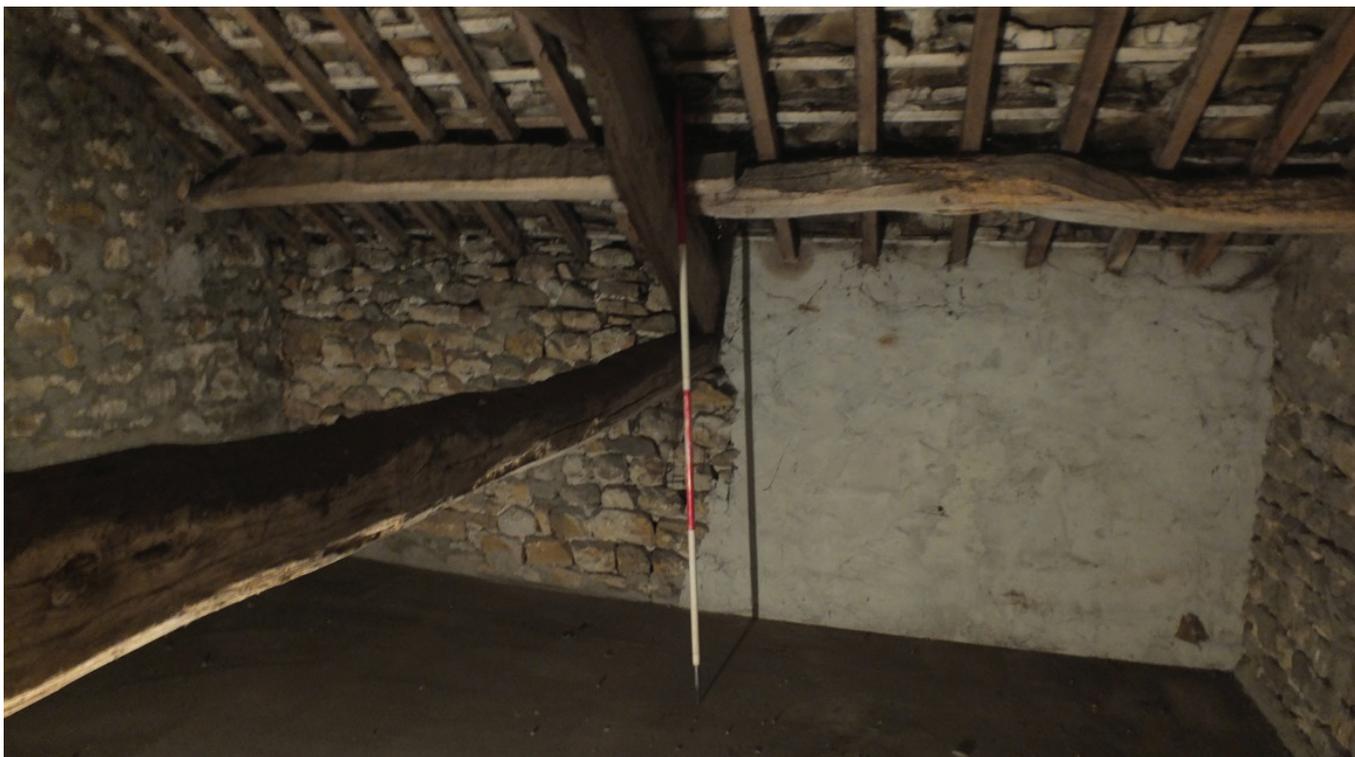
**Plate 31: North-west elevation (F1)**

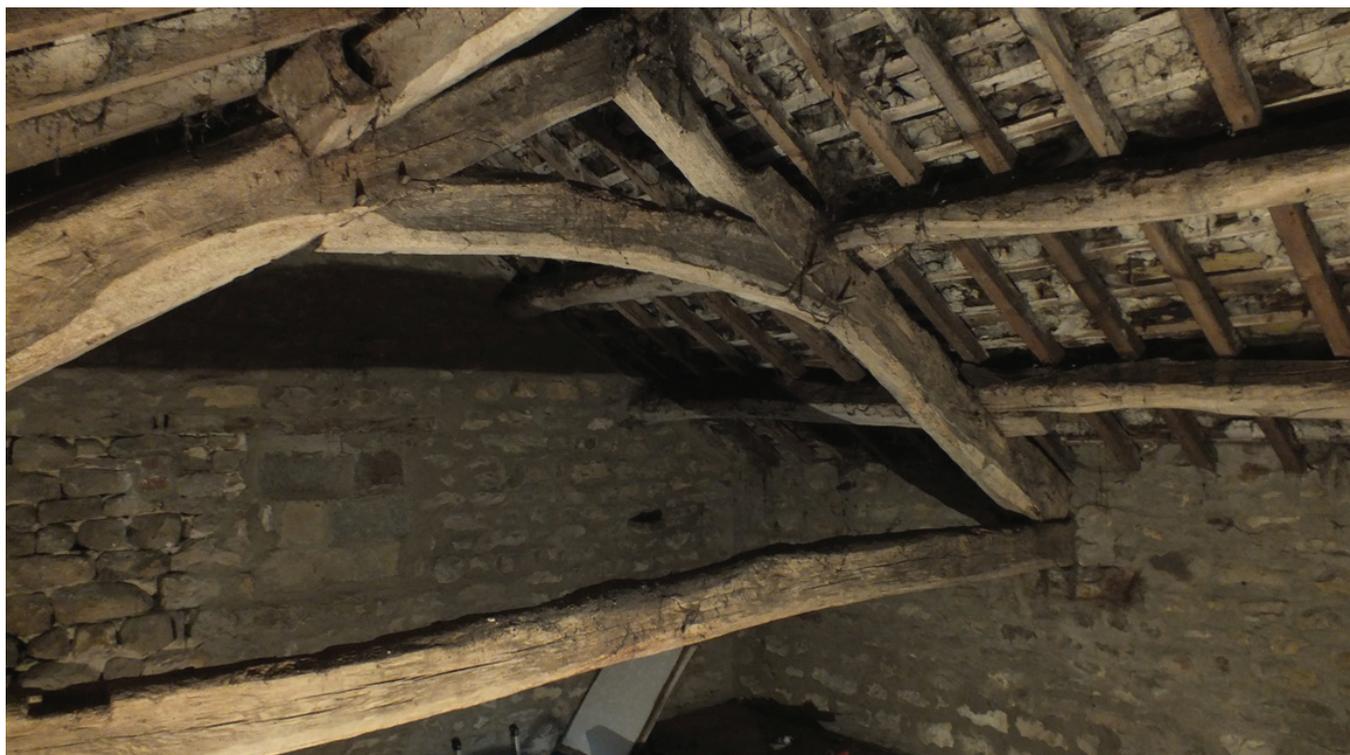
**Plate 32: South-west side of the truss (F1)**

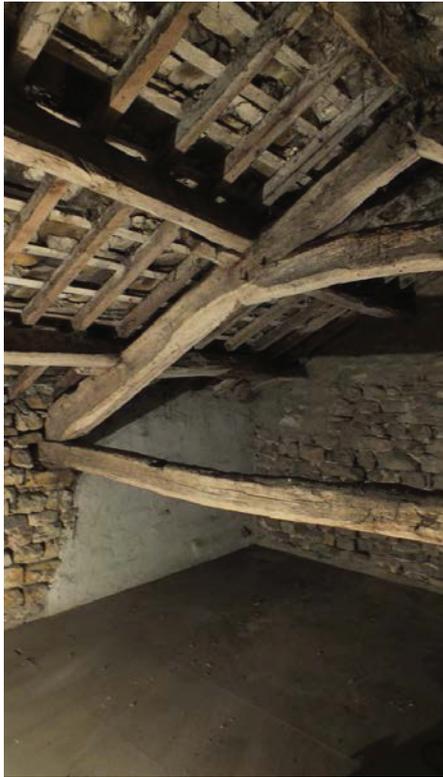
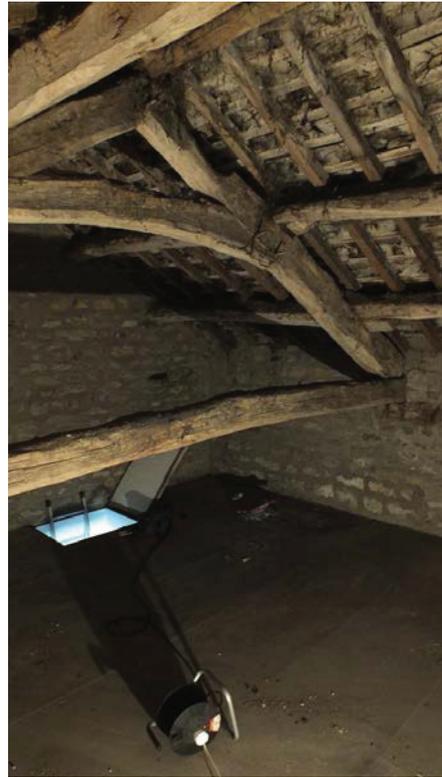
**Plate 33 (left): North-west end of the south-west side of the truss (F1)**

**Plate 34 (right): South-east end of the south-west side of the truss (F1)**
