# OAKHEAD FARM, MEWITH LANE, TATHAM, LANCASTER, LANCASHIRE

## Archaeological Building Recording

Planning Application Reference:  
1/15/00255/CU

September 2015

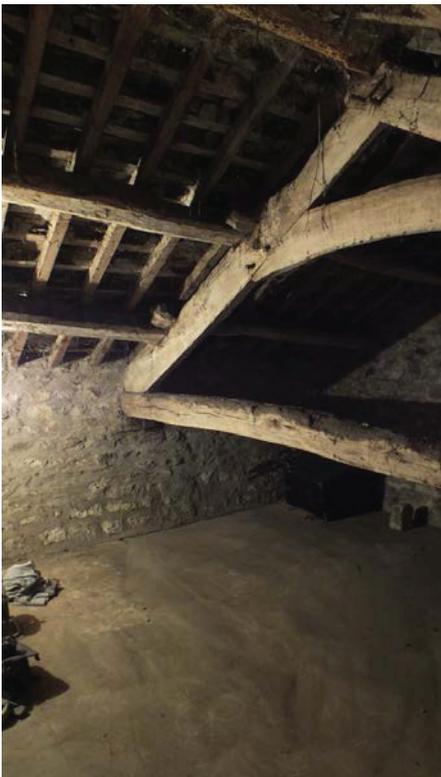
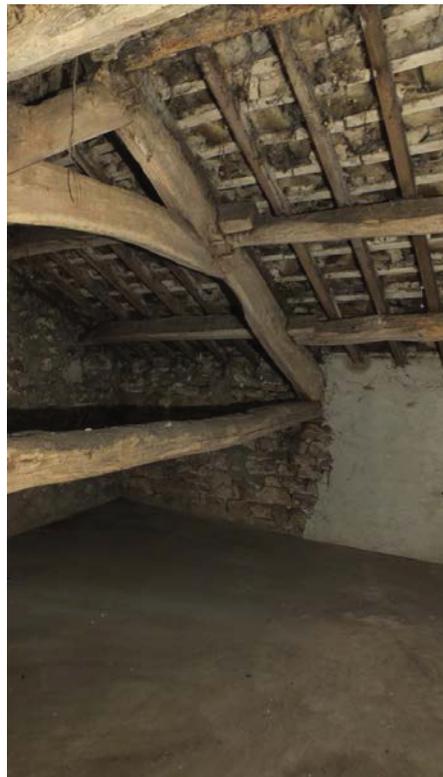
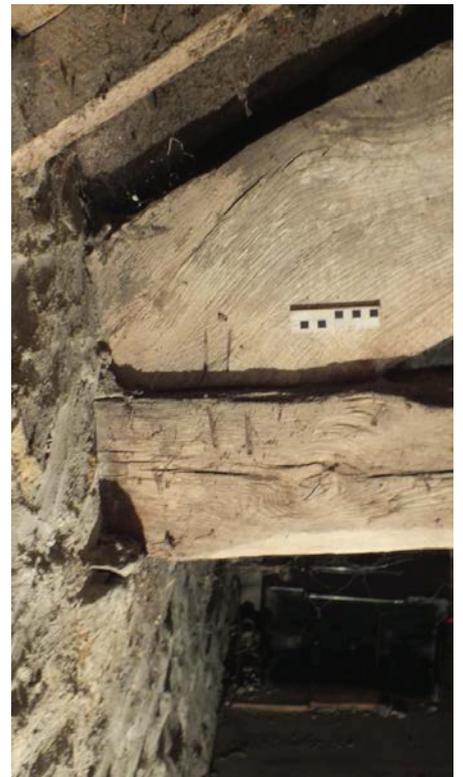
**Plate 35 (left): South-east end of the north-east side of the truss (F1)**

**Plate 36 (centre): North-west end of the north-east side of the truss (F1)**

**Plate 37 (right): Carpenter's mark at the south-east end on the north-east side of the truss (F1)**

**4.3.3 First floor room 1 (F1):** this room, at the south-west end of the barn (above the kitchen), had been used recently for storage (Figure 5). There was a single north-west/south-east truss across the room, which was open to the slates of the roof. The beams were hand-cut and bowed, especially the purlins. There were two purlins per pitch and the rafters were machine-cut. The floor was modern hardboard with an access hatch to the kitchen below against the north-east wall. The north-east elevation was exposed stonework with some concrete re-pointing and some crumbly white mortar to the north-west end (Plate 25). There was a blocked window aperture towards the centre, with a timber lintel, which was blocked with modern block work and there was a projecting stone at the south-east end of the elevation, which was otherwise plain (Plate 26). The south-east elevation was similarly exposed stone with concrete re-pointing and was otherwise plain (Plate 27). The south-west elevation was the same as the south-east elevation but had a central, low-level beam slot (Plate 28, Plate 29 and Plate 30). The north-west elevation was exposed stone to the south-west of the truss, with a white crumbly mortar (Plate 31). To the north-east of the truss the wall was covered with white plaster, which was apparently unpainted. The tie-beam truss with curving collar was sat on projecting stones at the ends and was pegged at the joints, with two purlins per pitch and a ridge purlin (Plate 32 to Plate 36; Figure 6). The timbers of the truss are hand-finished and roughly chamfered and there was a carpenter's mark on the north-east side. The south-east end of the truss was marked 'II' on the north-east side (Plate 37).

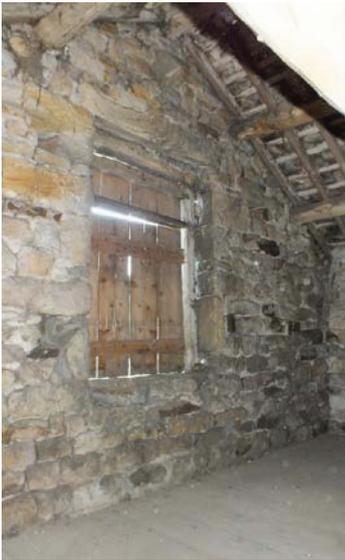
Plate 38 (left): North-east elevation (F2)

4.3.4 **First floor room 2 (F2):** this room was at the north-east end of the barn above G1 (Figure 5). It was open to the slate roof as was F1. Likewise there was a single north-west/south-east beam across the centre of the room. There was exposed stone with a white lime mortar throughout but there was no obvious concrete re-pointing as there had been in F1. The north-east elevation had a single large opening to the centre with a large timber panel door across it (Plate 38). The opening had quoins and a heavy timber lintel and stone sill. There were two blocked slots either side of this opening and a central owl hole above. There were two further vent slots at the top of the opening (one either side) in line with the ones below. The south-east elevation was plain apart from two rows of three blocked vent slots in line above one another (Plate 39). The south-west elevation had a central blocked window with modern block brick blocking it and there was a possible row of blocked vents below that (Plate 40). There were two blocked vent slots on the north-west elevation to the south south-west side and a low-level partially blocked window to the north-east (Plate 41). The stone lintel above showed its original extent and it had been blocked to the south-west and part boarded to the north-east with a single-light timber casement above. The tie-beam truss with curving collar was the same as in F1 (Plate 42 and Plate 43; Figure 7)

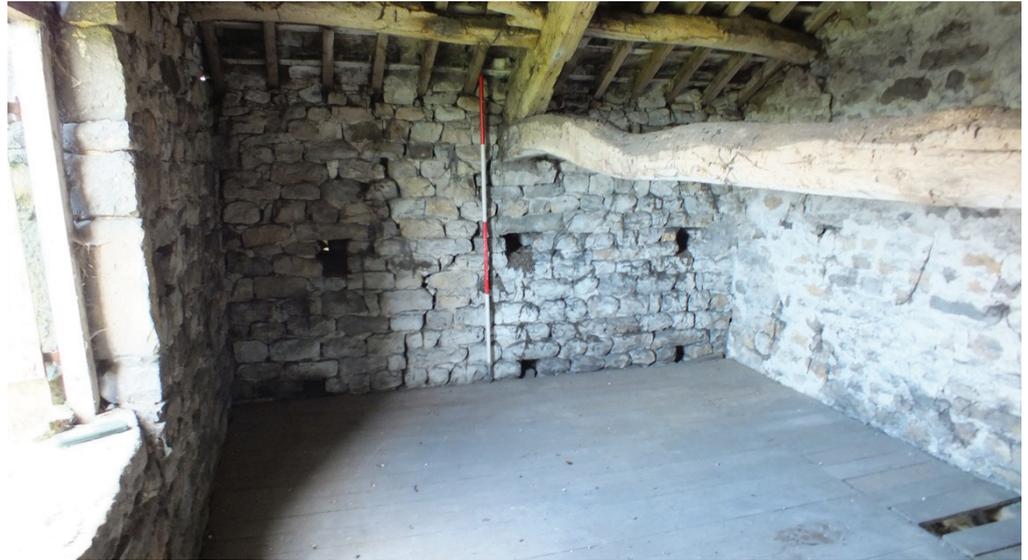
Plate 39 (right): South-east elevation (F2)

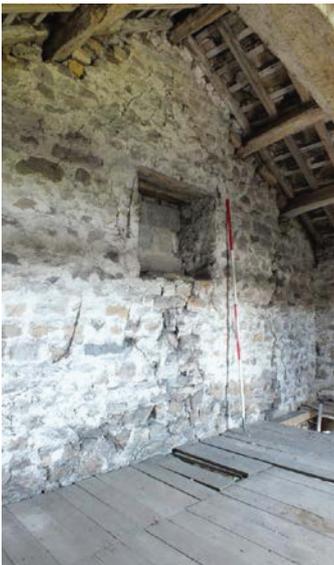
Plate 40 (left): South-west elevation (F2)

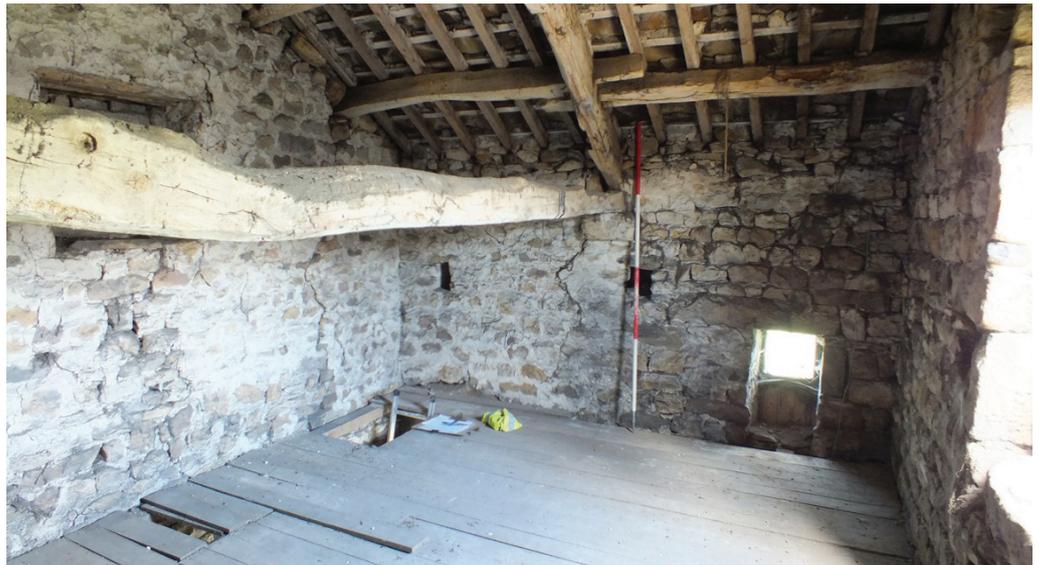
Plate 41 (right): North-west elevation (F2)

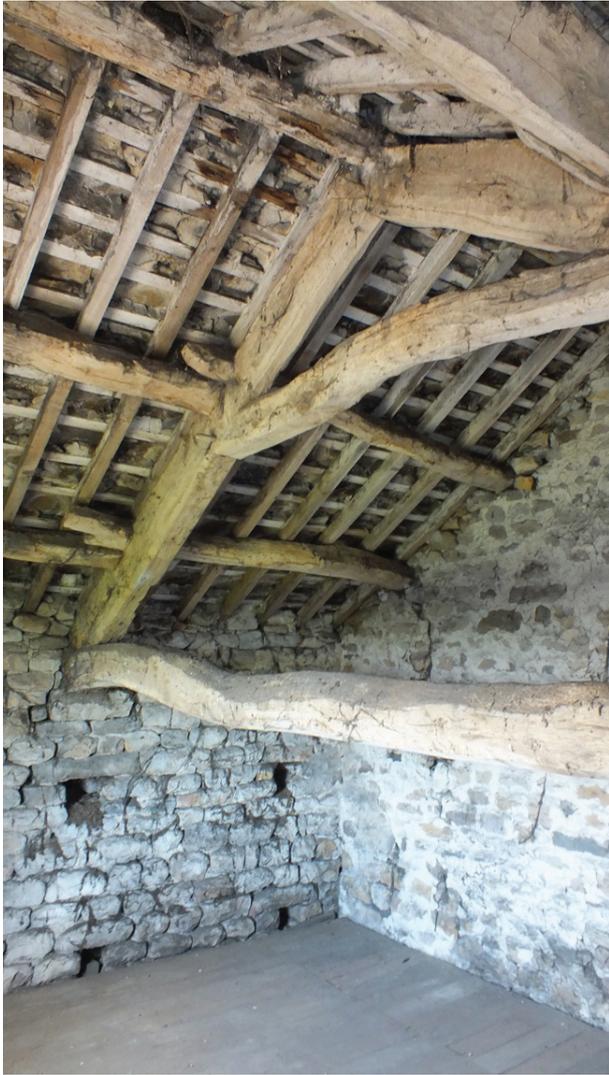
**Plate 42 (left): South-east end of the north-east side of the truss (F2)**

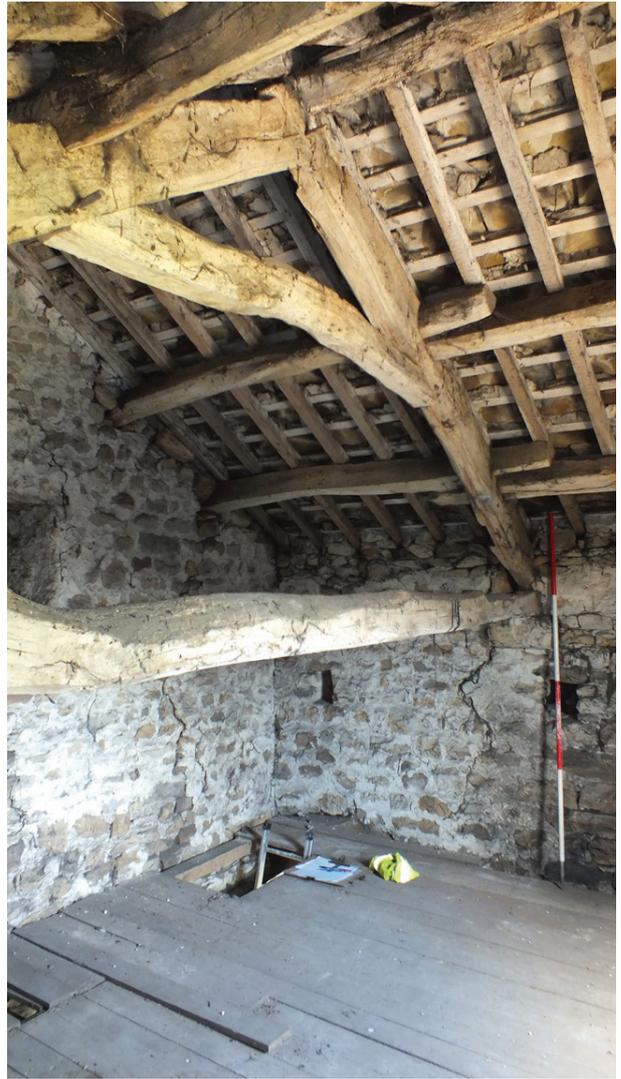
**Plate 43 (right): North-west end of the north-east side of the truss (F2)**
