# CHURCH OF THE GOOD SHEPHERD, GRIZEBECK, KIRKBY-IN-FURNESS, CUMBRIA

## Archaeological Building Recording

February 2016

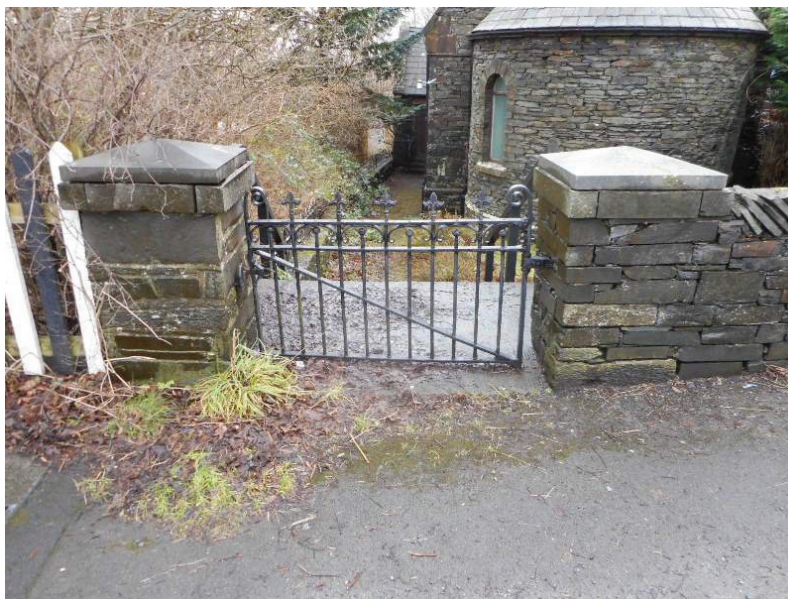
4.1.2 The associated boundary wall to the south is also of interest, which clearly butts the south-east corner of the porch and is constructed from slate, capped with concrete and a low wrought iron fence. It turns at the east end where it meets the concrete steps and there is a pair of slate gate piers with flat caps, between which is a cast iron gate (Plate 4). There are also timber hand rails along the steps. To the west of the church the boundary comprises an iron fence, while to the north it is a stone wall built into the slope.

Plate 4: Gate piers and iron gate at the top of the steps to the south-east of the church, viewed from the east

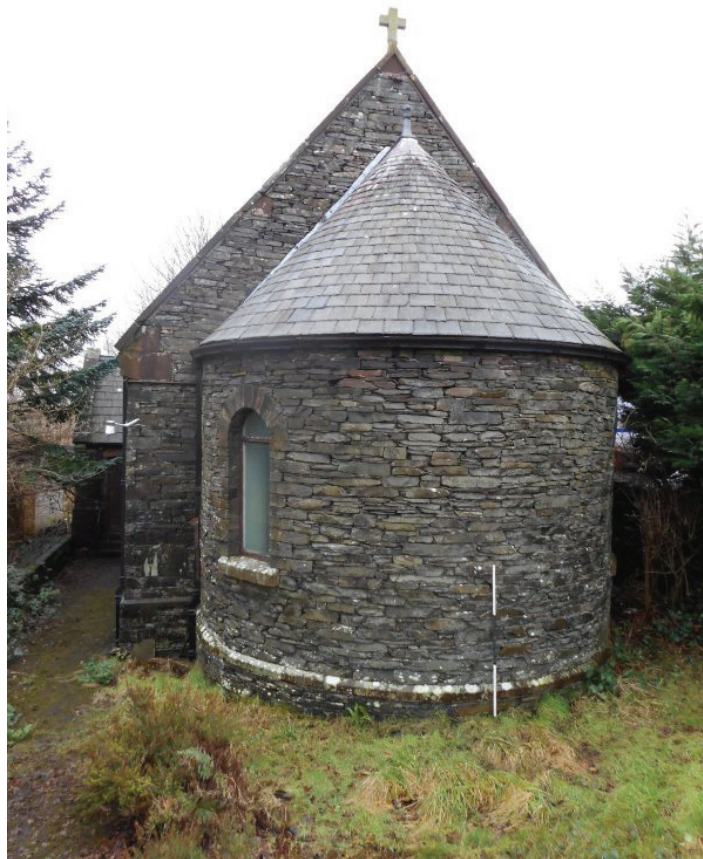
4.2.2 **East elevation:** the lower part comprises the end of the rounded apse, which has a chamfered sandstone plinth at the base and a conical roof topped with a ceramic finial (Plate 5). This section has a plainer iron gutter than is present elsewhere on the building. Behind and above this is the end gable of

**Plate 5: East external elevation, viewed from the east**

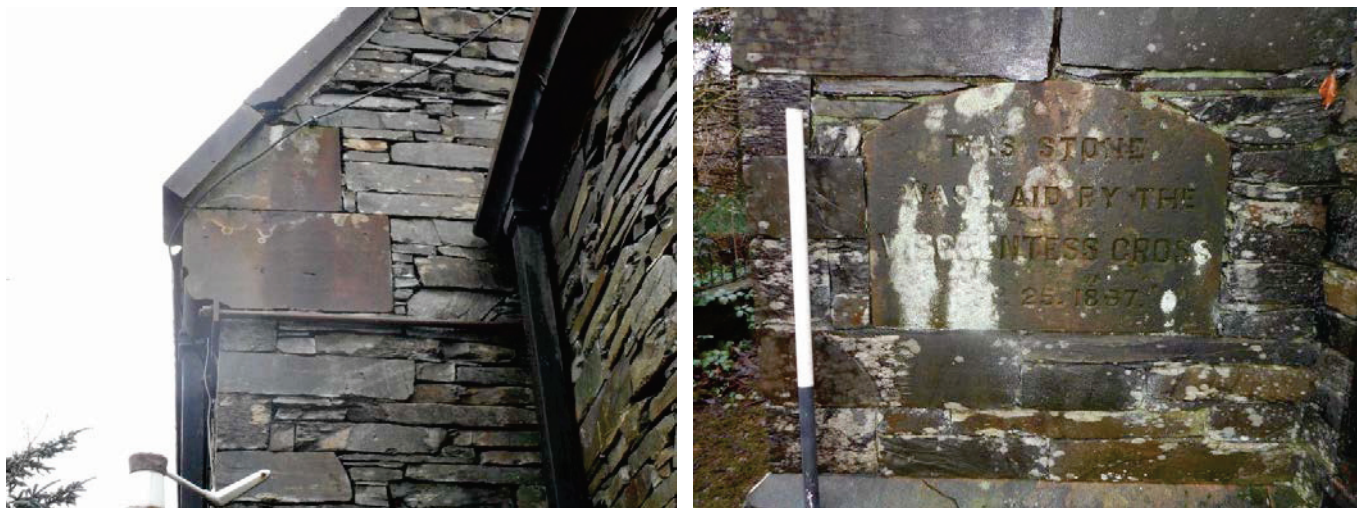
Plate 6 (left): Kneeler with tie rod running across, south side of east external elevation, viewed from the east

Plate 7 (right): Foundation stone, south side of east external elevation, viewed from the east

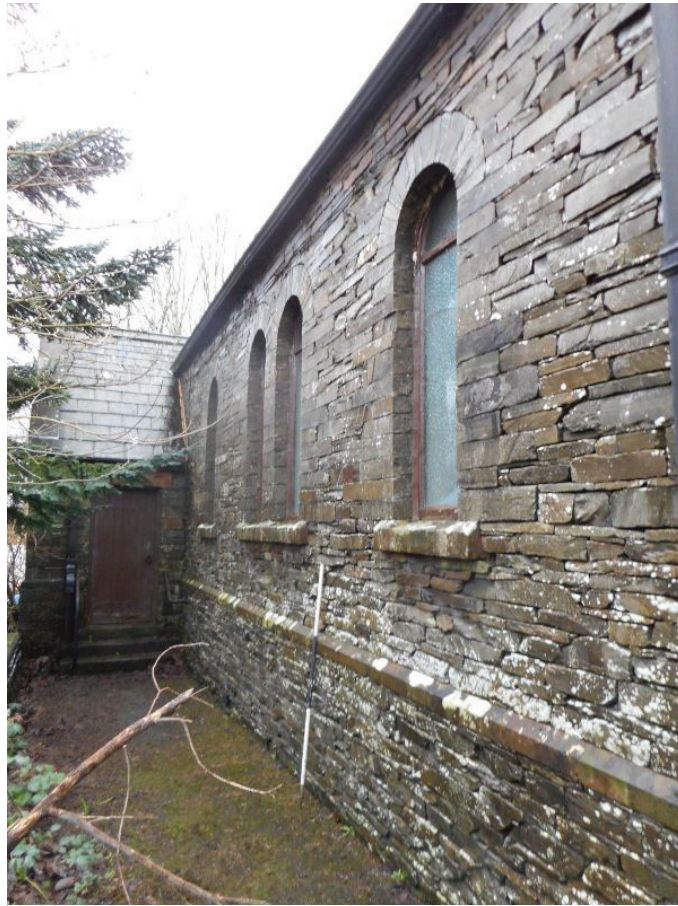
4.2.3 **South elevation:** this begins on the east side with the rounded wall of the apse, which has a single window with a round head as per that to the north and an attached timber notice board to the west. After a return to the west it continues as the main part of the building, which, like the north elevation, has four windows with rounded heads, although the central two are paired and share a single sill, and there is a chamfered sandstone plinth (Plate 11). West of the centre of the main part of the elevation there is a small rectangular hole at ground level, presumably for a vent below the floor. Following the return at the west end for the porch the elevation is continued by the gable end of the porch, which has three-quarter moulded sandstone kneelers, like the main part of the building, and a central window with a round head, two-light timber casement like those elsewhere, and sandstone sill and chamfered plinth below continuing the line of the main elevation.

**Plate 11: The main part of the south external elevation, viewed from the south-east**

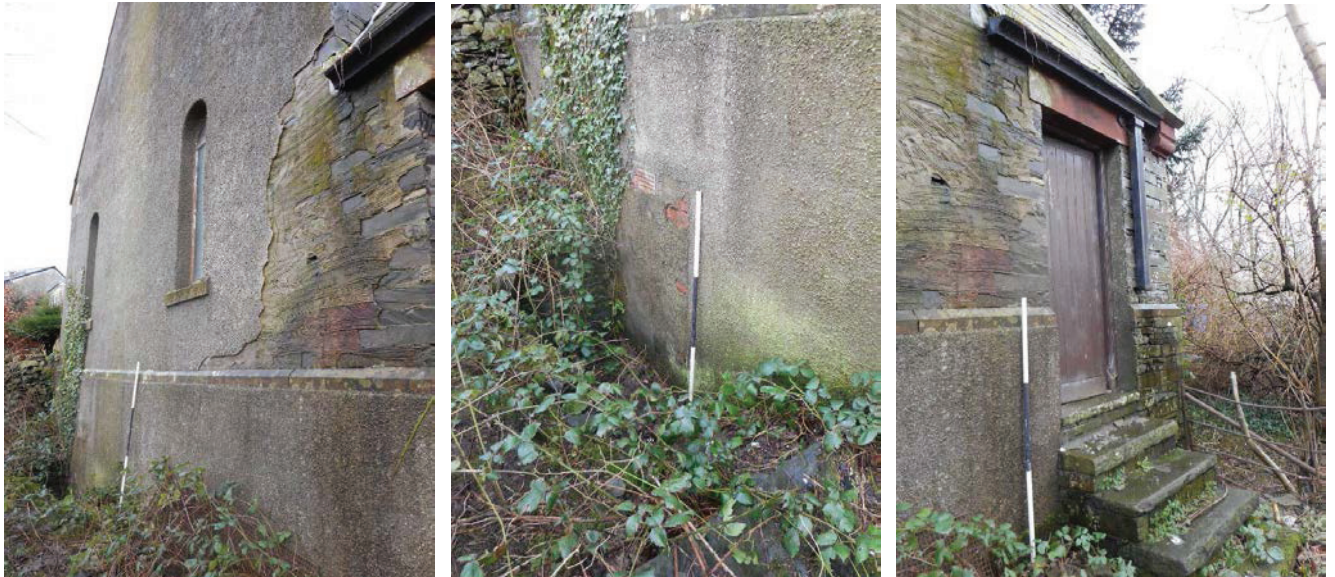
4.2.4 **West elevation:** this is mostly finished with roughcast concrete render, although the sandstone plinth, sills, and kneelers have been left exposed (Plate 12). Some of the render has come away from the wall on the main part of the elevation, while the porch on the south side does not appear to have ever been rendered. The construction behind the render is clearly coursed slate as per the rest of the building. On the north side there is a flight of slate steps running down to what was evidently originally a doorway into a basement, which is now blocked, seemingly with brick, and this has been finished with render, although a ceramic vent block has been left uncovered (Plate 13). To the south of this, at ground level, is a small rectangular hole, presumably for a vent. There are two windows in the main part of the elevation with round heads and two-light casements as per those in the rest of the building. Near the top of the gable is an attached gabled canopy forming a bell cote, supported by two upright posts on stone corbels with a slate roof and planks over the front. No bells appear to remain *in situ*. The stone coping on the gable proper above this has the remnants of a finial remaining. The south side of the elevation is extended by the side of the porch, which has a relatively simple beaded plank and batten door with a decorative Gothic-style escutcheon. There are five stone steps leading up to it and it has a plain sandstone lintel and chamfered plinth continuing the line of the plinth elsewhere on the building (Plate 14).

**Plate 12 (left): Lower part of the west external elevation, viewed from the south-west**

**Plate 13 (centre): Blocked basement doorway and steps in the west external elevation, viewed from the south-west**

**Plate 14 (right): Doorway into the porch on the south side of the west external elevation, viewed from the north-west**

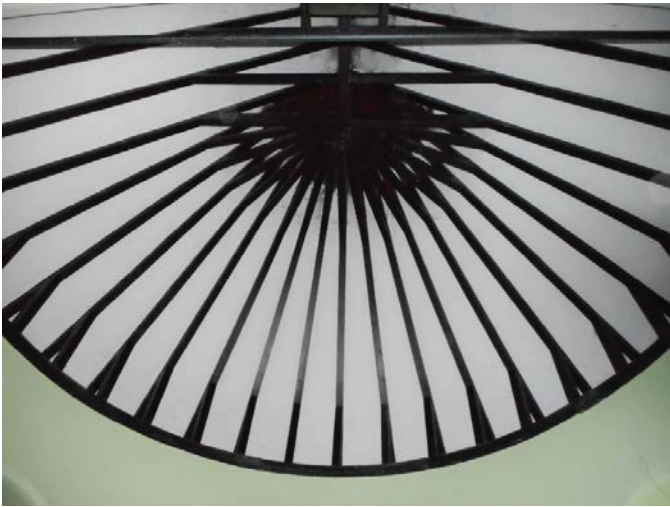
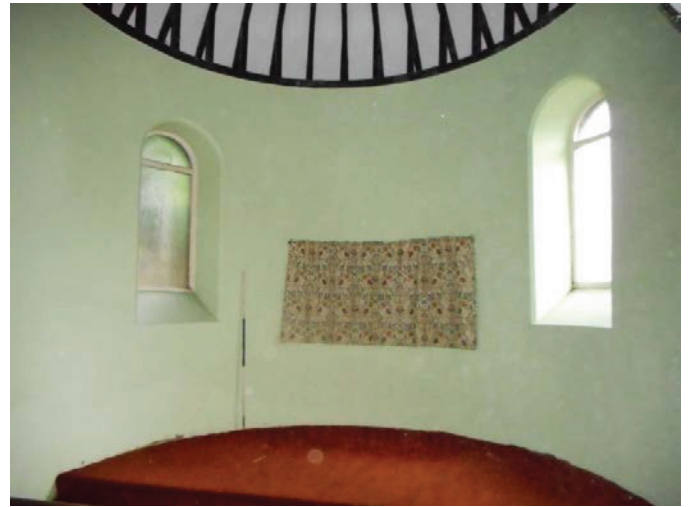
4.3.1 **Room 1:** this comprises the chancel at the east end of the building. It has a raised timber floor on two levels, finished with carpet. It is open to the roof, which is supported by a ring of narrow joists supported by upright posts sat on the top of the wall, as well as a fan of short collars at the top and further longer collars running north/south on the west side (Plate 15). The walls are all finished with plaster and paint and the north, east, and south walls essentially form a single curving wall, with a moulded rail along the top. This wall has two windows with rounded heads, chamfered jambs and sloping sills, housing two light fixed timber casements with frosted glass, which are slightly smaller than those in the nave (Room 2; Plate 16). The west elevation is dominated by the chancel arch, which has a moulded rail around the top of each side, but not around the arch, and a chamfered string course at the base. The communion rail fills the space below the arch (see *Section 4.3.4* below) and there is a tie rod running across near the base of the arch.

Plate 15 (left): Roof structure in Room 1

Plate 16 (right): General view of the Room 1 from the south-west showing the windows

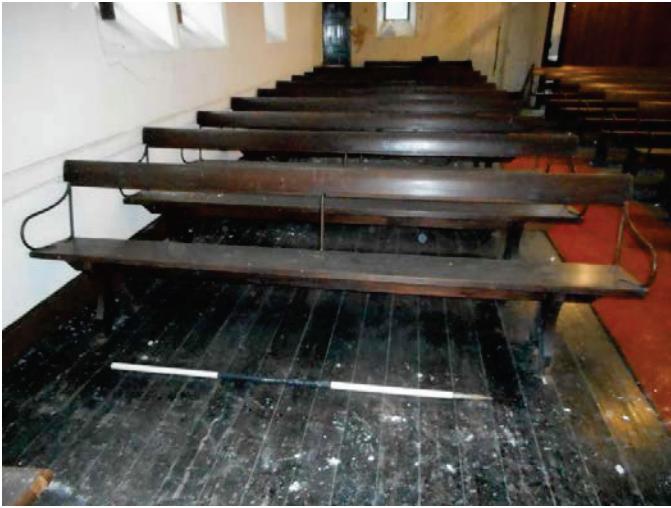
4.3.2 **Room 2:** this comprises the main body of the church (the nave). It is open to the roof and essentially open to the chancel at the east end (Room 1) via a large arch, with the porch accessed via a doorway on the west side of the south elevation. The floor is constructed from regular tongue and groove floorboards with a carpet over the central aisle and further patchy carpet at the west end. There are rows of pews along the north and south sides plus a further one at the west end, each comprising a relatively simple timber construction with iron bars supporting the back rest (Plate 17). The north-west corner is partitioned off with an L-shaped section of timber stud walling constructed from tongue and groove planks on the east side but plain boards to the south (Plate 18). The door in the south side is also constructed from tongue and groove planks, with a brass handle and escutcheon plate, set in a chamfered surround. Inside this space there are two shelves attached to the east side with curved iron brackets and a hinged timber bench at the base, as well as brass coat hooks throughout (Plate 19). It appears that the stud walling is later as it has been cut rather clumsily to fit round the dado rail on the wall (Plate 20). The lock on the door housed within the stud walling is also marked 'THE CROWN PATENT DOUBLE HANDLE N<sup>o</sup> 3576' on the internal face.

**Plate 17 (left): Pews along the south side of Room 2, viewed from the east**

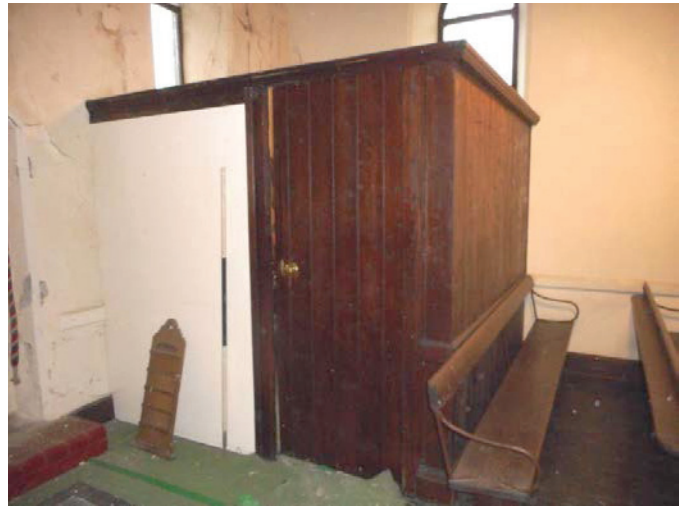
**Plate 18 (right): Stud walls in the north-west corner, viewed from the south-east**

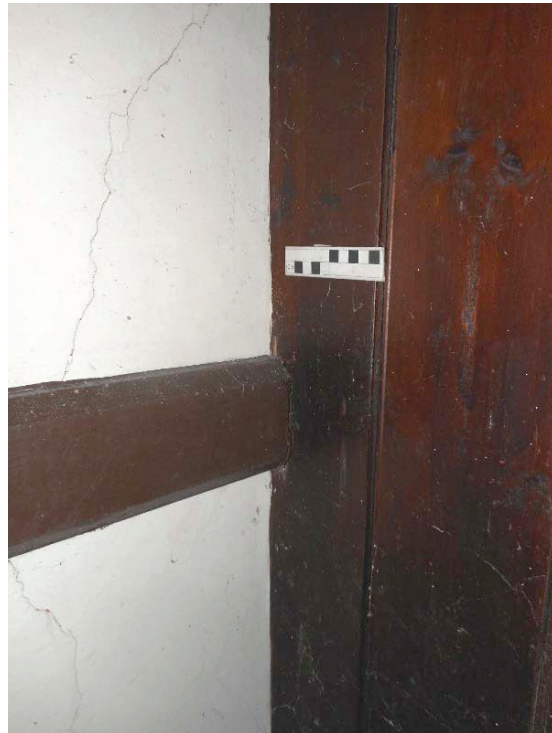
**Plate 20 (right): Junction between the stud wall and the rail attached to the north elevation, viewed from the south-west**

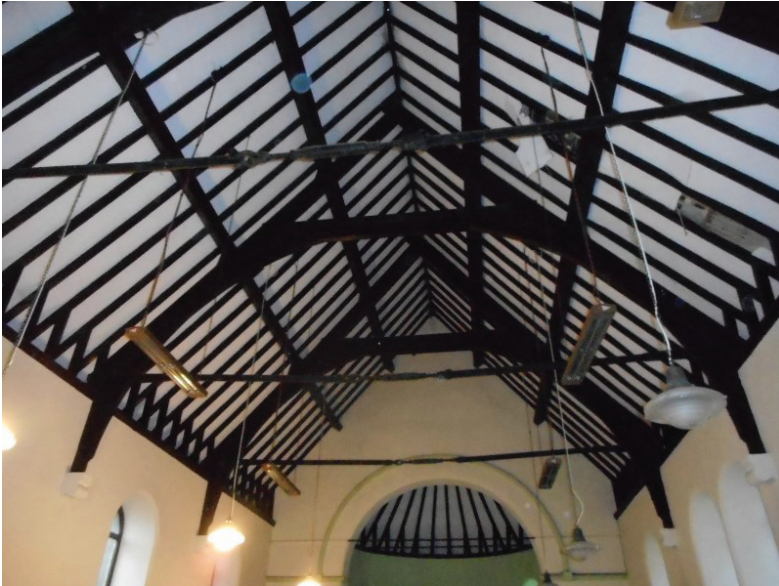
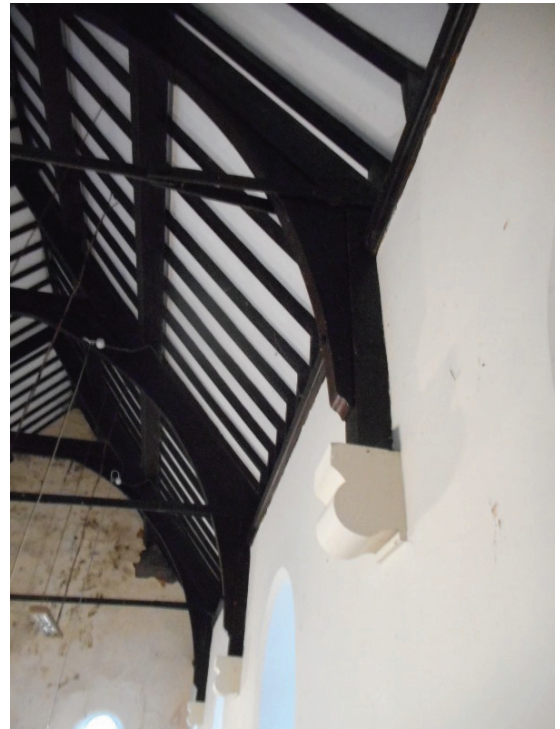
4.3.3 The roof of the nave is supported by three trusses each with a simple set of principal rafters, lap jointed south on top of north at the top, and a collar (Plate 21). This is, however, supported by a more elaborate structure comprising a post at either end sat on a scrolled stone corbel in the wall (Plate 22) and curving brackets against the lower part of the principal rafters and below the collar, constructed from several sections and fixed with bolts, forming a rounded arch. There is a further short post at either end sat on top of the wall but these are spread the full length of the building, each supporting a rafter. There is a tie rod running across each truss, strapped to it at either end and held with a threaded section in the centre between pieces of chain link. There are two purlins per pitch plus a ridge plank and a moulded rail along the top of the north and south walls.

**Plate 21 (left): Roof structure in Room 2, viewed from the west**

**Plate 22 (right): Detail of the base of the truss on the north side, Viewed from the east**

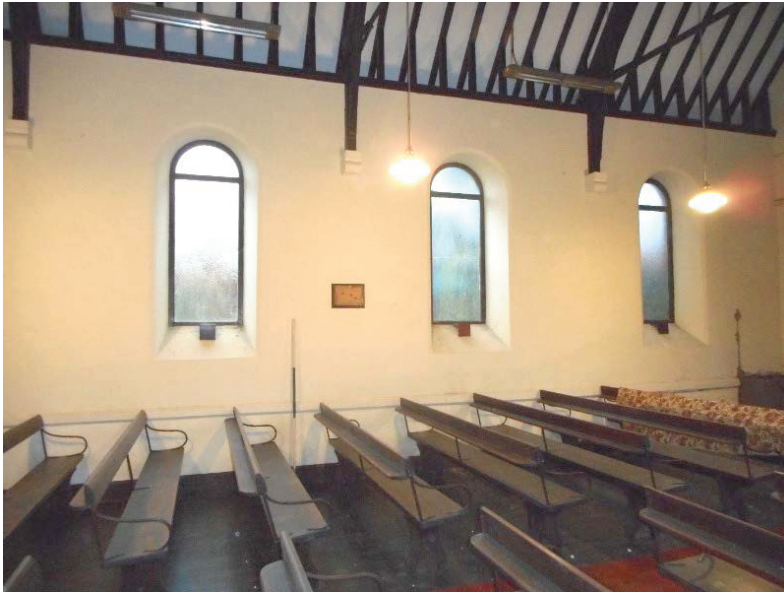
4.3.4 Throughout the room the walls are finished with plaster and paint with a chamfered low-level dado rail and a tall moulded skirting board. The north and south elevations each have a row of four windows, although in the north elevation the westernmost of these is contained within the stud walling and in the south elevation the central two are paired. Each window has a two-light fixed casement with frosted glass, sloping sills (with a small timber 'shelf' added), and chamfered jambs (Plate 23). In the centre of the north elevation there is a timber base for what was presumably a brass memorial plaque, now removed (Plate 23), and at the east end there is the scar of an attached structure, extending round to the east elevation, at which point the skirting board also stops (Plate 24). This corresponds with a scar in the floor, suggesting that this was the original position of the pulpit. The east elevation is dominated by the chancel arch, which is rounded and has a moulded band around the arch and extending to either side (Plate 25). At the bottom of the arch is a step up into the chancel with a communion rail either side comprising a polished timber rail supported on a single wrought iron bracket with twisted decoration and ivy leaves (Plate 26). Above, crossing the arch, is a single tie rod set against the wall matching that inside the chancel, while at the base on either side there is a chamfered sandstone string course, similar to that forming a plinth externally.

Plate 23 (left): North elevation, Room 2, viewed from the south-west

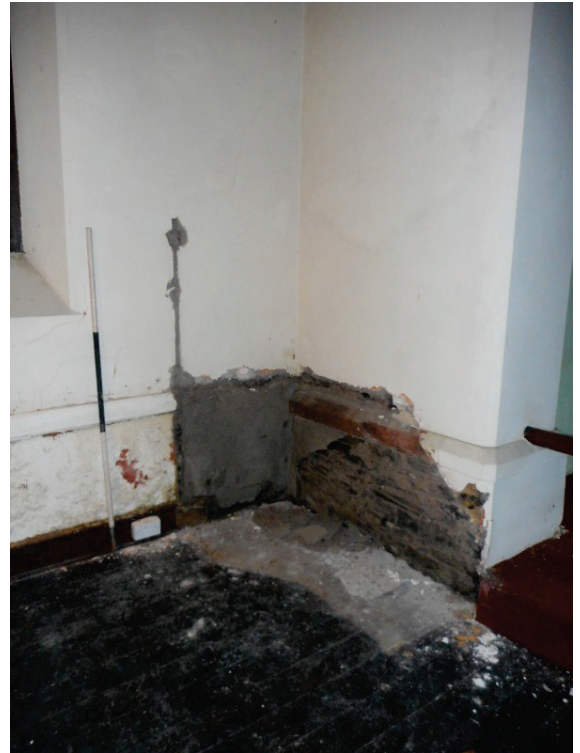
Plate 24 (right): Scar in the north-east corner of Room 2, viewed from the south-west

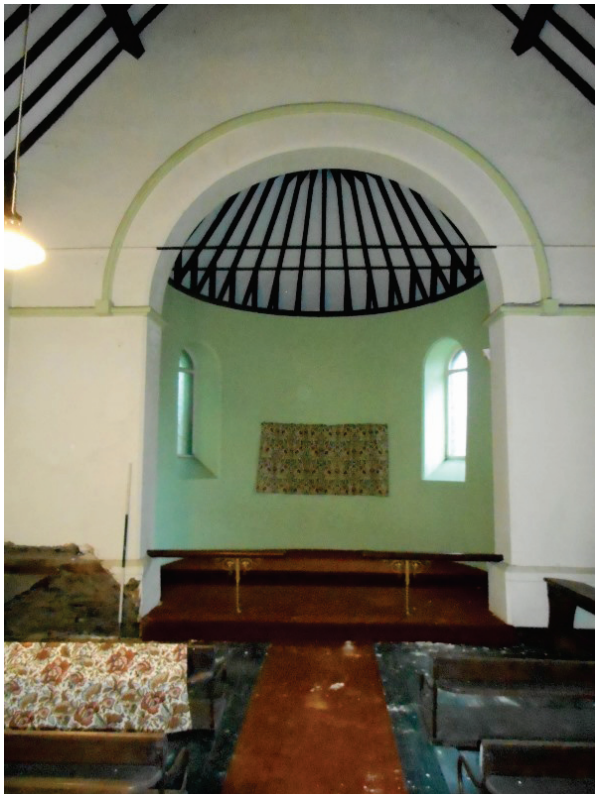
Plate 25 (left): Chancel arch in the east elevation of Room 2, viewed from the west

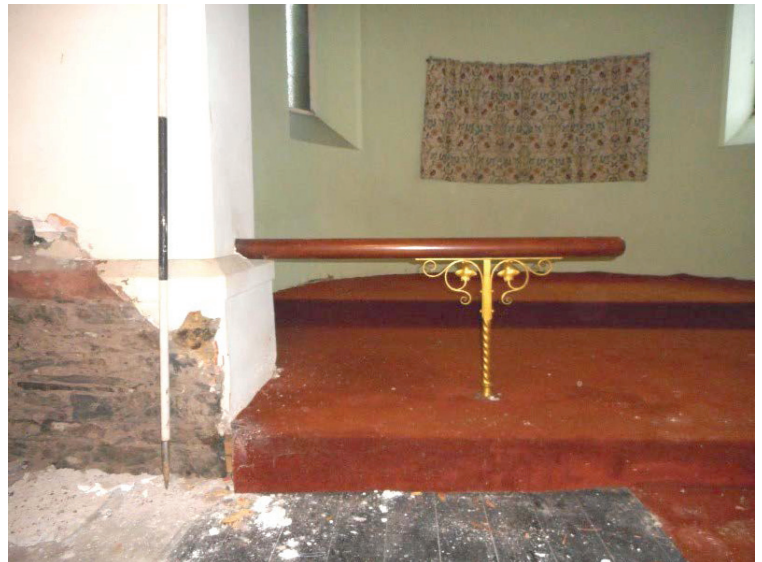
Plate 26 (right): Detail of the north side of the communion rail, east elevation of Room 2, viewed from the west

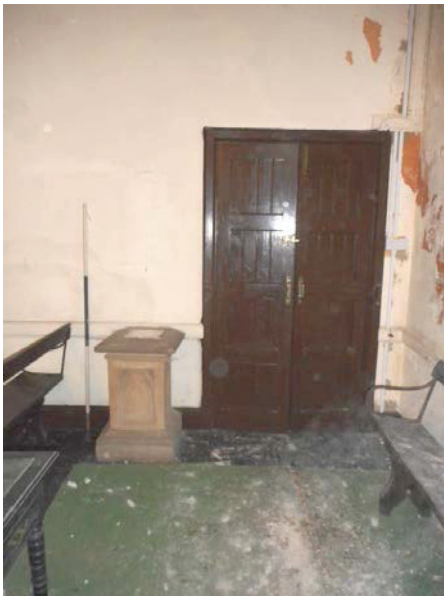
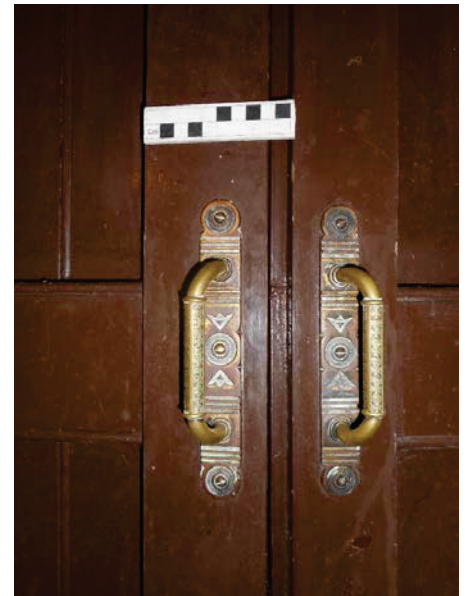
4.3.5 Apart from the row of windows the south elevation has a doorway at the west end with a double beaded plank and batten door (Plate 27) with an ornate brass latch and handles. The latch is decorated with concentric circles and parallel lines, seemingly in imitation of earlier, perhaps 17<sup>th</sup> century, versions (see Alcock and Hall 2002, 28; Plate 28) and the handles are decorated with more elaborate versions of the same design but also with Maltese crosses and possible Masonic symbols (Plate 29). A simple square font base carved in yellow sandstone, with a simple arch in the front panel and moulded plinth and coping, stands against the wall to the east of this doorway (Plate 27). The west elevation has two windows, one on either side, as per those to the north and south, the one to the north partially inside the room formed by the stud walling (Plate 30). In the centre of the elevation, at ground floor level is a narrow alcove formed by an opening with a rounded arch, the base of which steps up and out into the room and is apparently constructed from bricks with bull-nosed bricks forming the eastern edge. The bell rope hangs in front of this opening and is fixed to an iron lever projecting from the wall near the top. The plaster is in general in very poor condition across this elevation on account of extensive damp penetration.

**Plate 27 (left): The doorway and font base at the west end of the south elevation, Room 2, viewed from the north**

**Plate 28 (centre): Detail of the decorative latch on the door at the west end of the south elevation, Room 2, viewed from the north**

**Plate 29 (right): Detail of the decorative handles on the door at the west end of the south elevation, Room 2, viewed from the north**

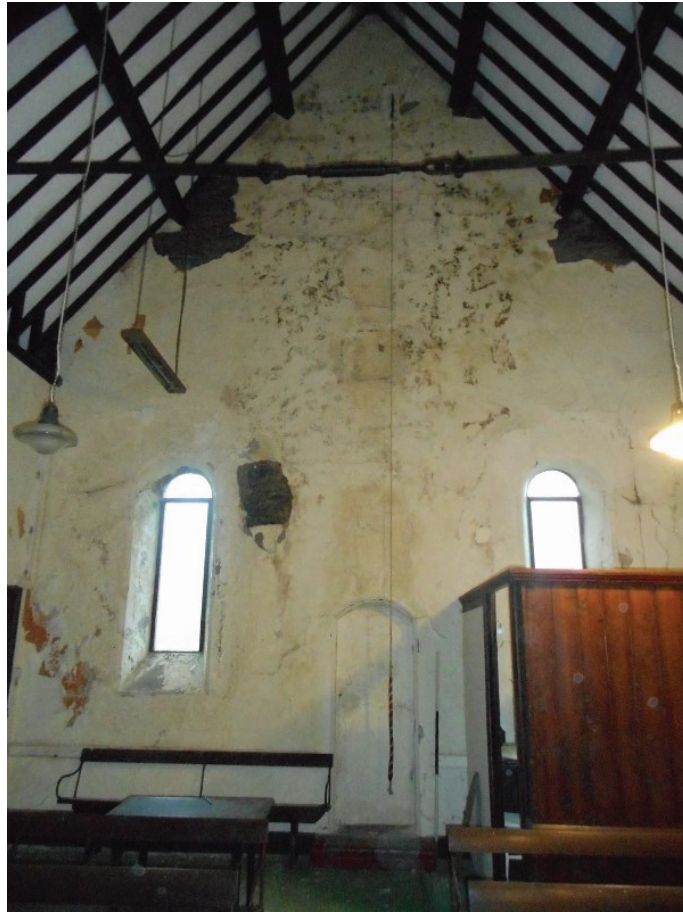
**Plate 30: The west elevation, Room 2, viewed from the east**

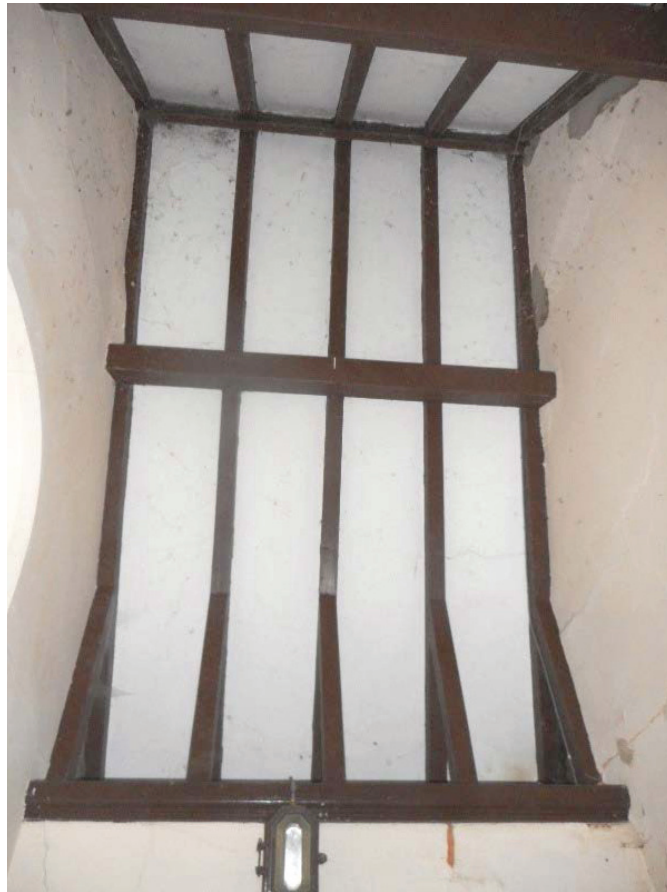
4.3.6 **Room 3:** this comprises the porch extending from the west end of the south elevation. It has a stone flag floor and is open to the roof, which is supported by rows of joists set on east/west walls above a moulded rail and there is a single purlin per pitch plus a ridge purlin (Plate 31). The walls are finished with plaster and paint with a moulded skirting board. The north elevation has a doorway with a double beaded plank and batten door (Plate 32) with decorative brass handles continuing the design used on the other side in Room 2 (see *Section 4.3.5* above; Plate 33). There are fuse boxes and associated electrical fixtures attached to the wall above and to the east plus a timber noticeboard. The east elevation has a moulded rail along the top but is otherwise dominated by a large doorway with a beaded plank and batten door (Plate 34) with large early timber lock bound with decorative Gothic style iron plates, with the remains of an iron latch below, also decorated in a similar style although partially broken (Plate 35). The south elevation has a single window, similar in style to those elsewhere in the building, with chamfered jambs, a sloping sill, and two-light fixed casement (Plate 36). The west elevation also has a doorway, although smaller than those to the north and east, with beaded plank and batten door (Plate 37), a pair of iron bolts, and the scar of a decorative latch like that to the east.

**Plate 31: Roof in Room 3**

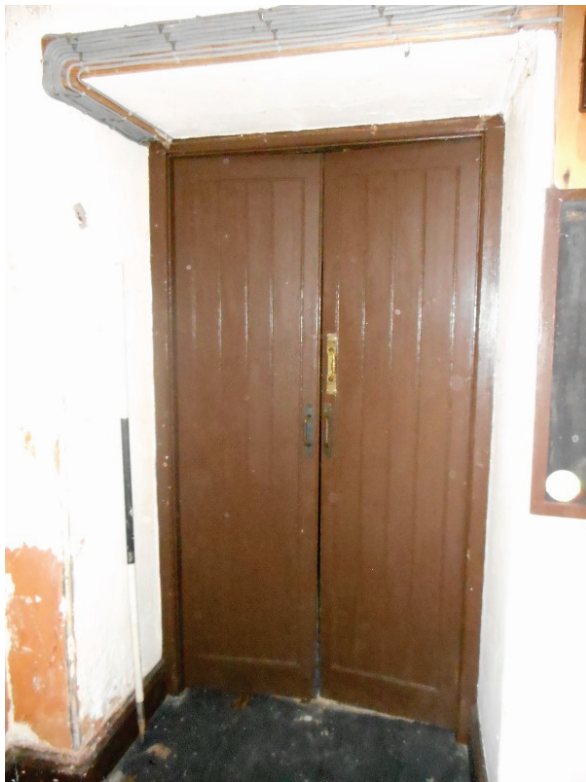
**Plate 32 (left): Doors in the north elevation, Room 3, viewed from the south**

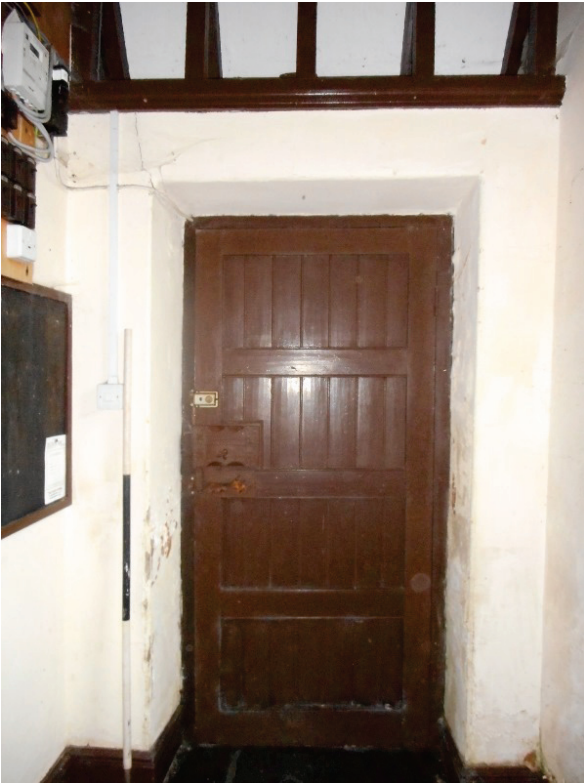
Plate 34 (left): Door in the east elevation, Room 3, viewed from the west

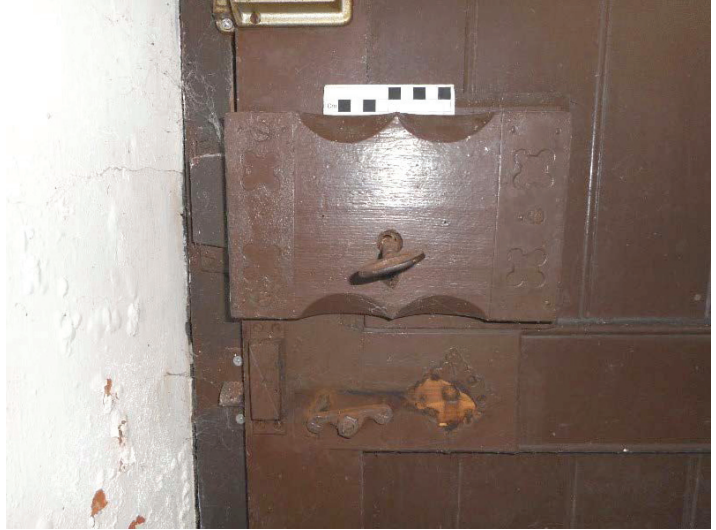
Plate 35 (right): Detail of the lock and latch on the door in the east elevation, Room 3, viewed from the west

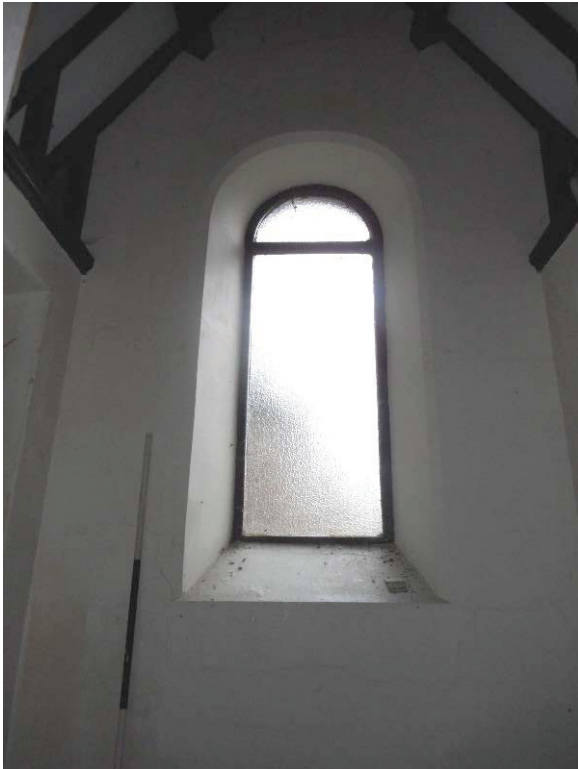
Plate 36 (left): Window in the south elevation, Room 3, viewed from the north

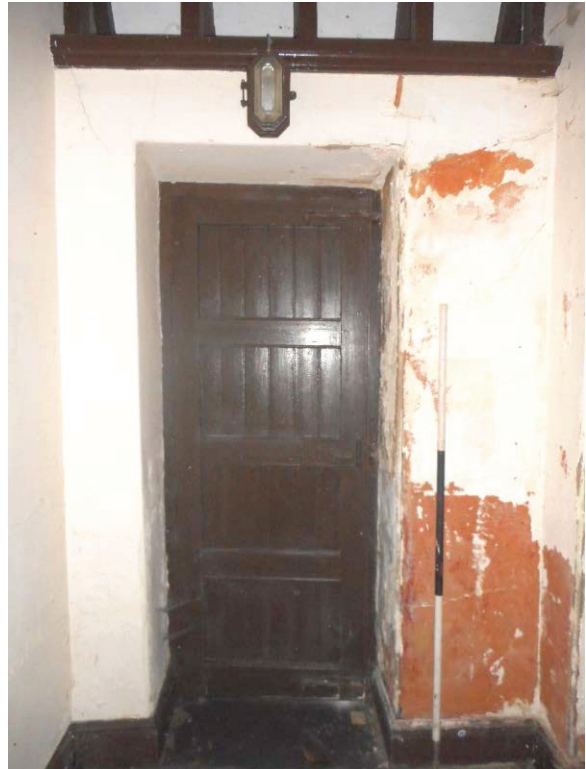
Plate 37 (right): Door in the west elevation, Room 3, viewed from the east
