23 UPPER BROOK STREET, ULVERSTON, CUMBRIA

Archaeological Building Recording

Client: Lanquest Properties Ltd
Planning Ap. Ref.: 5/06/0433
NGR: SD 28507 78445

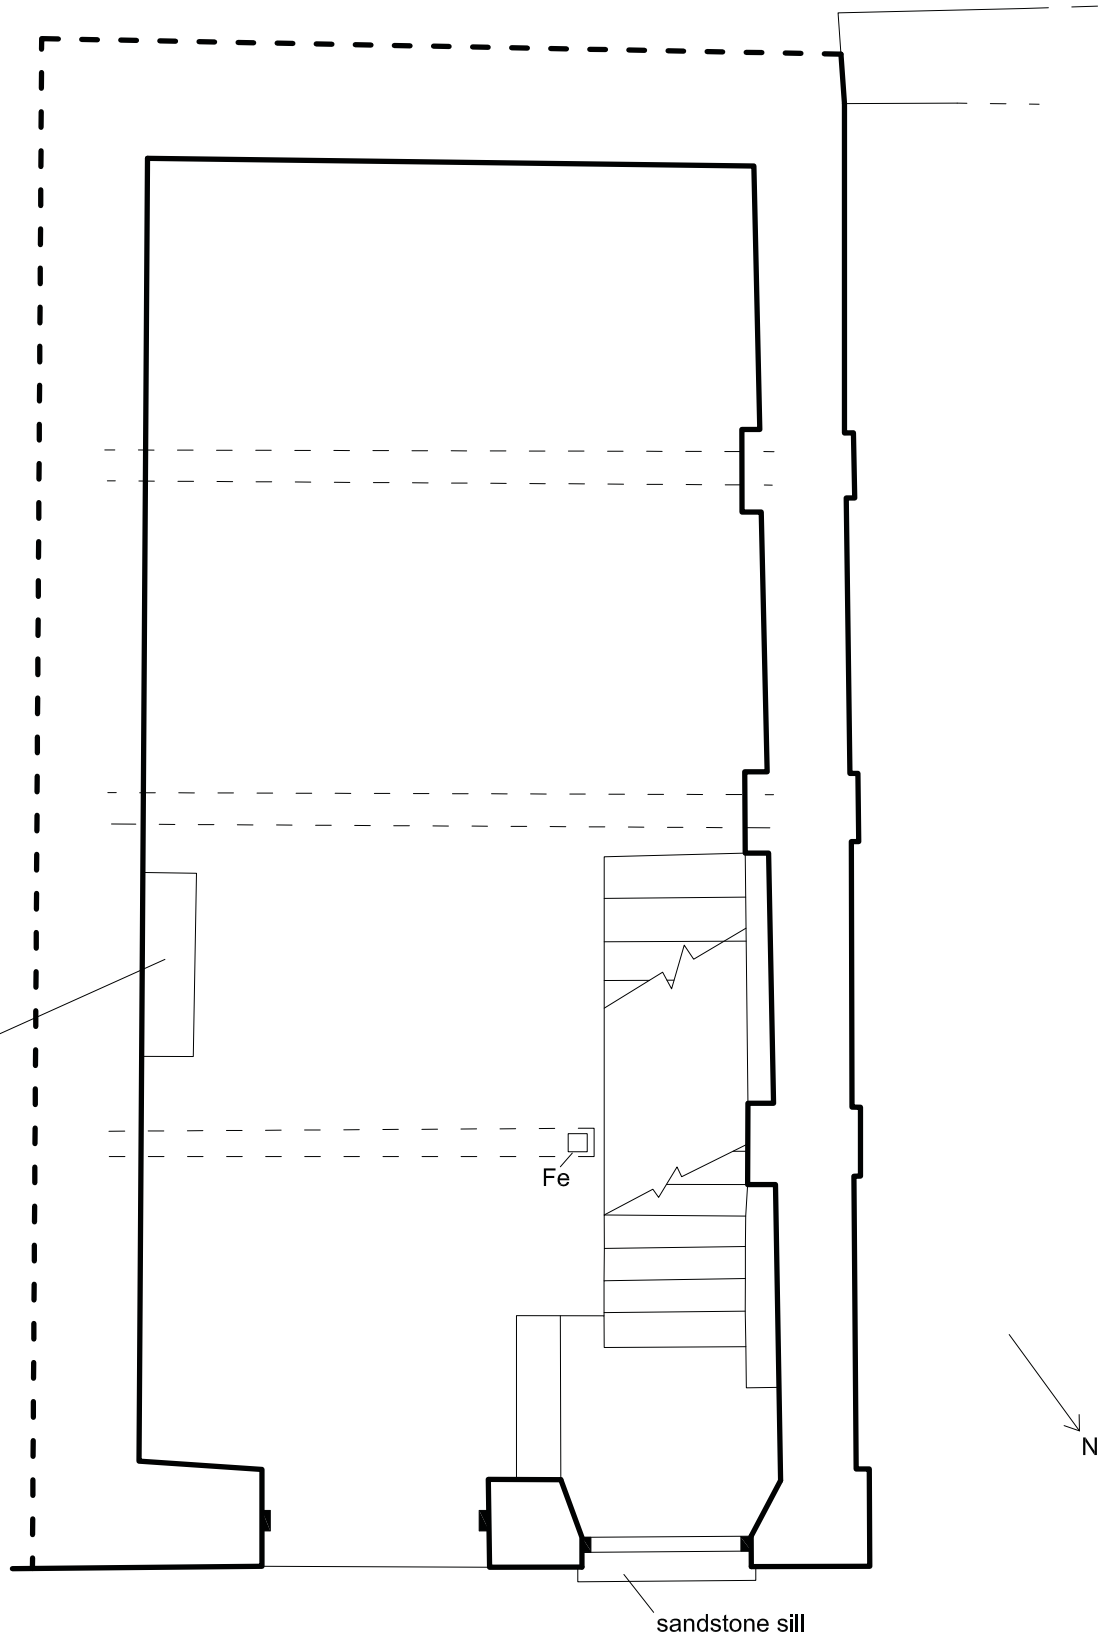
Figure 6: First floor plan

4.4.3 **First floor (Fig 6):** the stairway protrudes through the floorboards in the north corner of this room and is modern in construction. There are three ceiling beams all lightly chamfered which are orientated north-west/south-east; the rearmost (south-west) has a heavily chamfered south-west side. The floorboards are a mix of wide originals and later narrower tongue and groove boards. The underside of the hatch to the north-east of the building has beaded battens and beaded attachments around the opening and extra reinforcing. The walls are all concrete rendered. There is a window with splayed jambs on the north-west side of the north-east elevation. It has a modern plywood sill and plywood covering over the lintel, a beaded surround and a fixed four-light timber casement. The double loading doors on the south-east side of the north-east elevation each contain one light and are made from beaded tongue and groove planks. The doors have chamfered battens and long strap hinges and there are beaded boards over the lintel. The south-east and south-west elevations are plain. The buttresses on the north-west elevation continue into this floor although they are shallower and cut through at floor level for the insertion of an iron girder. There is a timber beam at ceiling level. The stairs are in the north side of the room

and once again the north-eastern-most beam has been cut away at its north-west end and supported on a post to facilitate them.

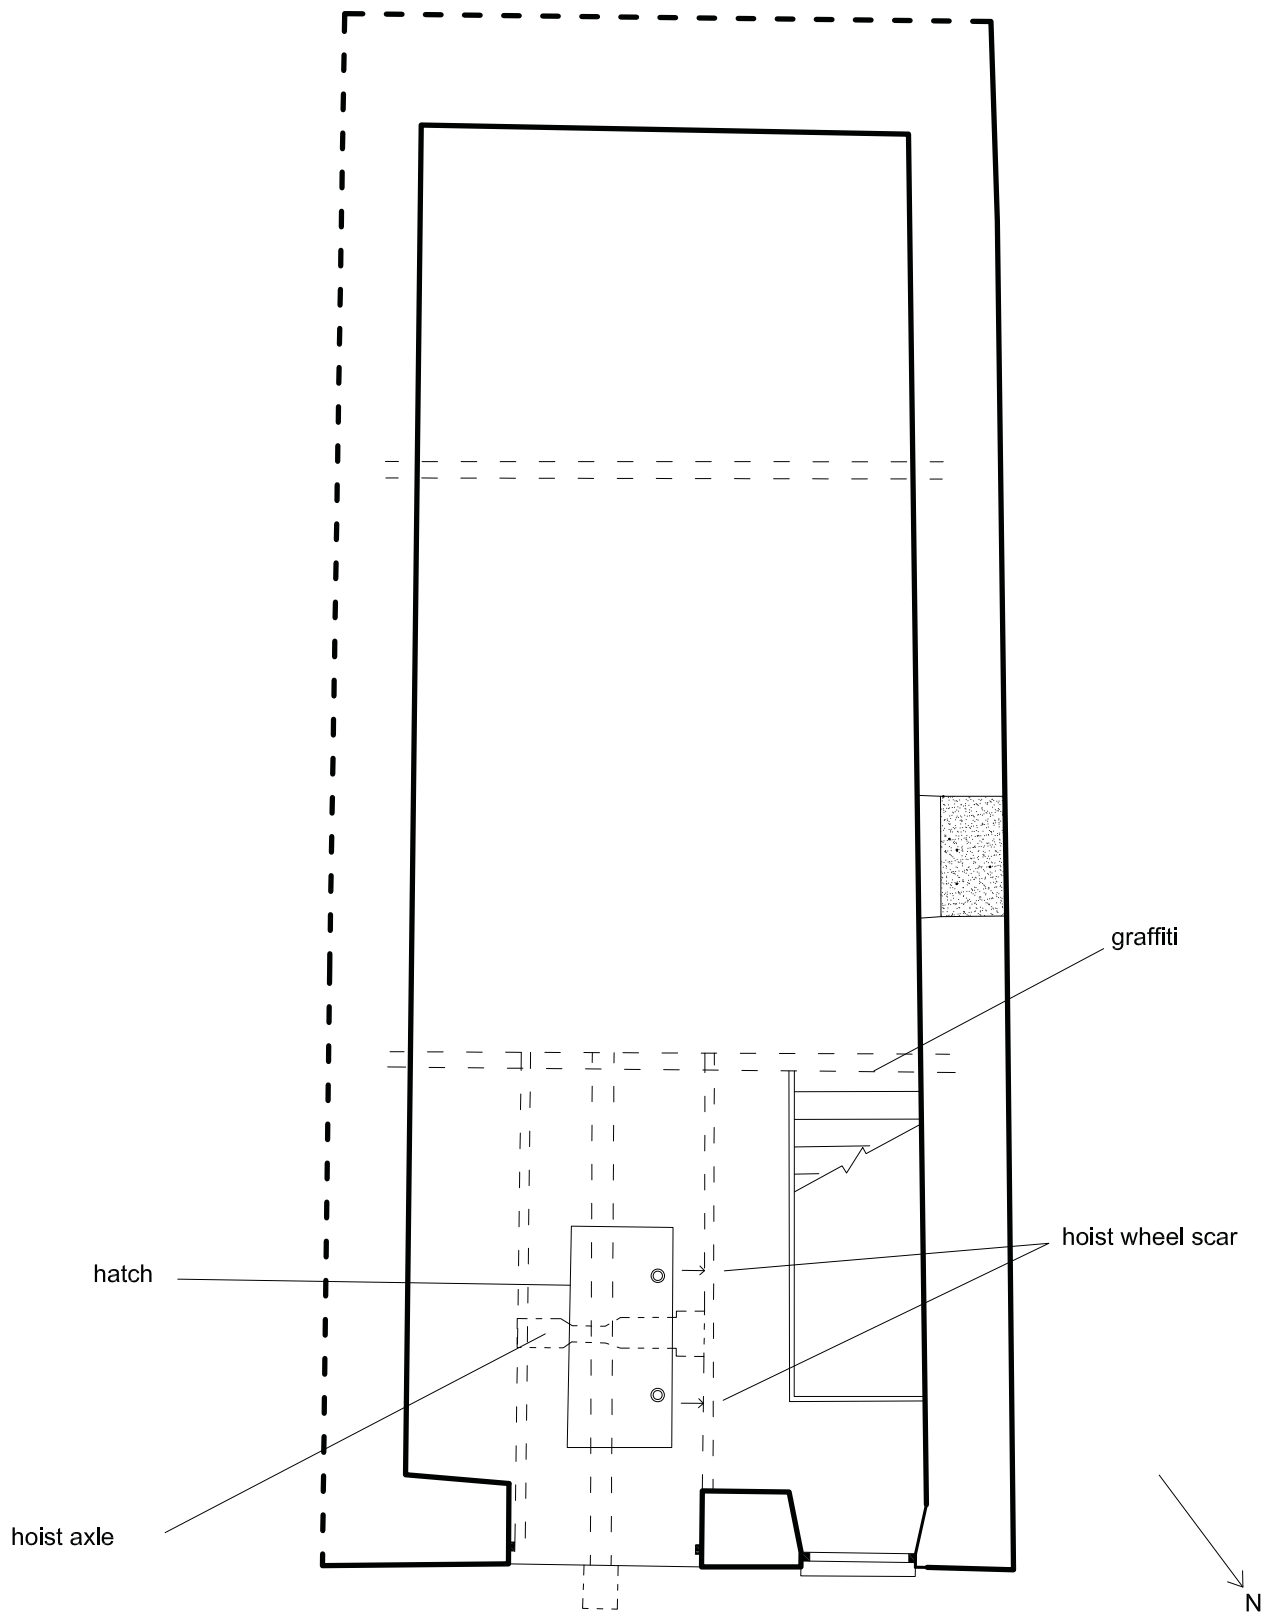
Figure 7: Second floor plan

4.4.4 **Second floor (Fig 7):** this has a board floor, with a mix of wide original boards (pitch pine?) and later narrow tongue and groove boards. There is a hatch in the north-east end of the floor with holes for two circular pull handles. The room extends to the rear beyond the footprint of the two lower floors and this area has a concrete floor. The roof is of corrugated concrete with three corrugated plastic skylights and is supported by two king post trusses (see Plate 8). Each truss has carpenters' marks and is very lightly stop chamfered (Fig 8). Graffiti on the north-east truss includes 'W. Woodburn' and 'A.E.S. May 16 1893' which is all in pencil. The south-west truss has an iron 'T'-shaped strap with a loop, which is attached to the base of the king post. There is a single purlin per pitch, overlapping at the north-east truss; both are lightly chamfered and show possible Baltic timber marks. The two angled ridge purlins are constructed from much later timbers.

4.4.5 The hoist mechanism at the north-east end of the room (see Plate 9 and Fig 7) consists of three parallel horizontal timbers running north-east/south-west. The outer two are laid on their edges while the central timber is flat and rests on the tie beam of the truss. This central timber is bolted to the underside of the two blocks of timber which form a wedge shaped run so the rope can exit a small opening in the wall some 0.20m above; graffiti on its north-west side reads 'SW'. The two outer beams support a cylindrical axle, the north-west end of which has spoke holes; the south-east end has been turned thinner to accommodate a rope or chain. An iron bar runs between the central beam and the north-west beam attached to their lower surfaces and on the inside of the north-west beam an iron plate is attached. Also on the inside of this beam scars are evident, indicating a wheel of between 0.60m and 0.80m in diameter was attached to the spoke holes in the cylindrical timber forming the hoist.

4.4.6 The north-west elevation contains a large loading door with two lights which is made from tongue and groove boards, chamfered battens, and long strap hinges. A small aperture in the roof above the door allows a chain or a rope to exit. The window to the south-east contains four lights and has a modern sill and lintel. The south-west and south-east elevations are plain. The north-west elevation contains a blocked window just north of the centre, leaving a slight recess. The stairs are in the north corner and there is modern repair to the floor in this area.

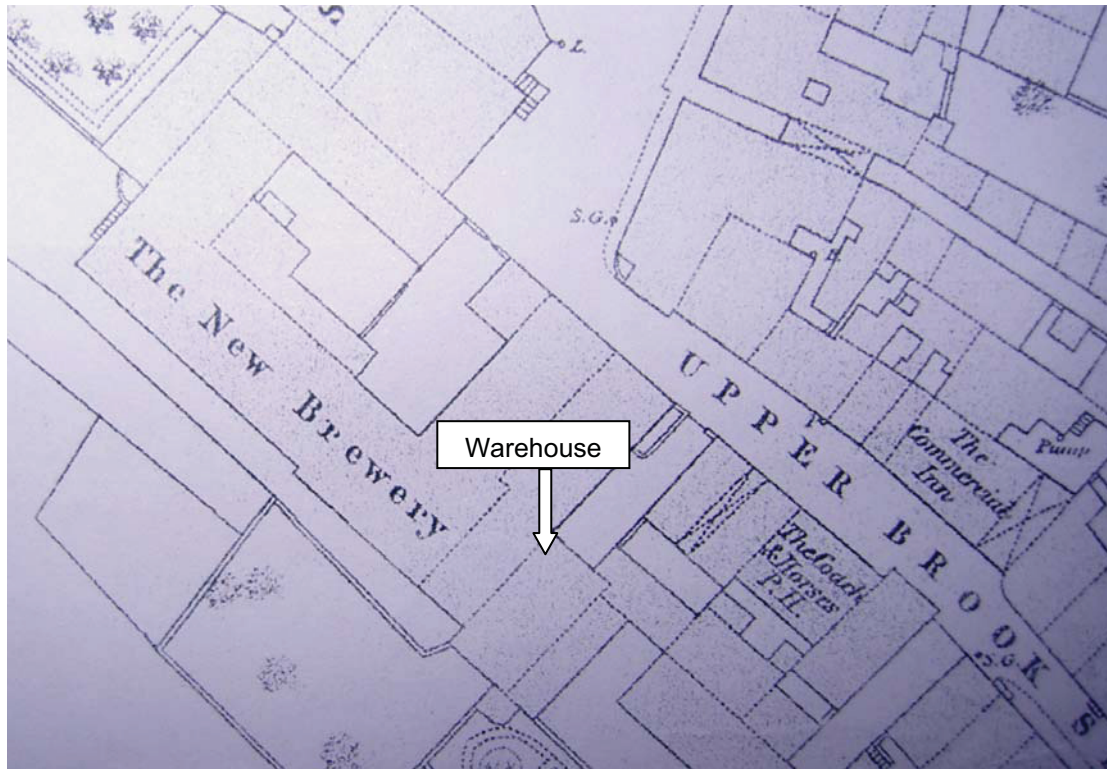
Plate 1: Extract from Ordnance Survey 1852 map

- **Ordnance Survey 1852 (Plate 1):** this is the first map to depict the warehouse and shows it butting the south-east side of the brewery building that pre-dates Wood's 1832 map. The warehouse also has a building butted on to its south-eastern side. It seems likely that the structure was a separate lean-to or shed in this yard area from where there has never been access into the warehouse. The lean-to utilised the already existing rear retaining wall and warehouse wall (see Plate 5);

5.2.1 **Phase 1:** the earliest phase involves the construction of the warehouse as seen on the 1852 Ordnance Survey map. The building butts the brewery building but there is no indication or suggestion that the two were ever linked. The detailed plan of the brewery c1854 (CRO(B) BD/KF 146/24 n.d.) shows that there was no doorway on the south-eastern side of the building, suggesting that access to the warehouse was gained from Upper Brook Street as is currently the case. The plan also shows the brewery was owned by the late Mr John Yarker with the warehouse plot being ascribed to the late G. Dodson.

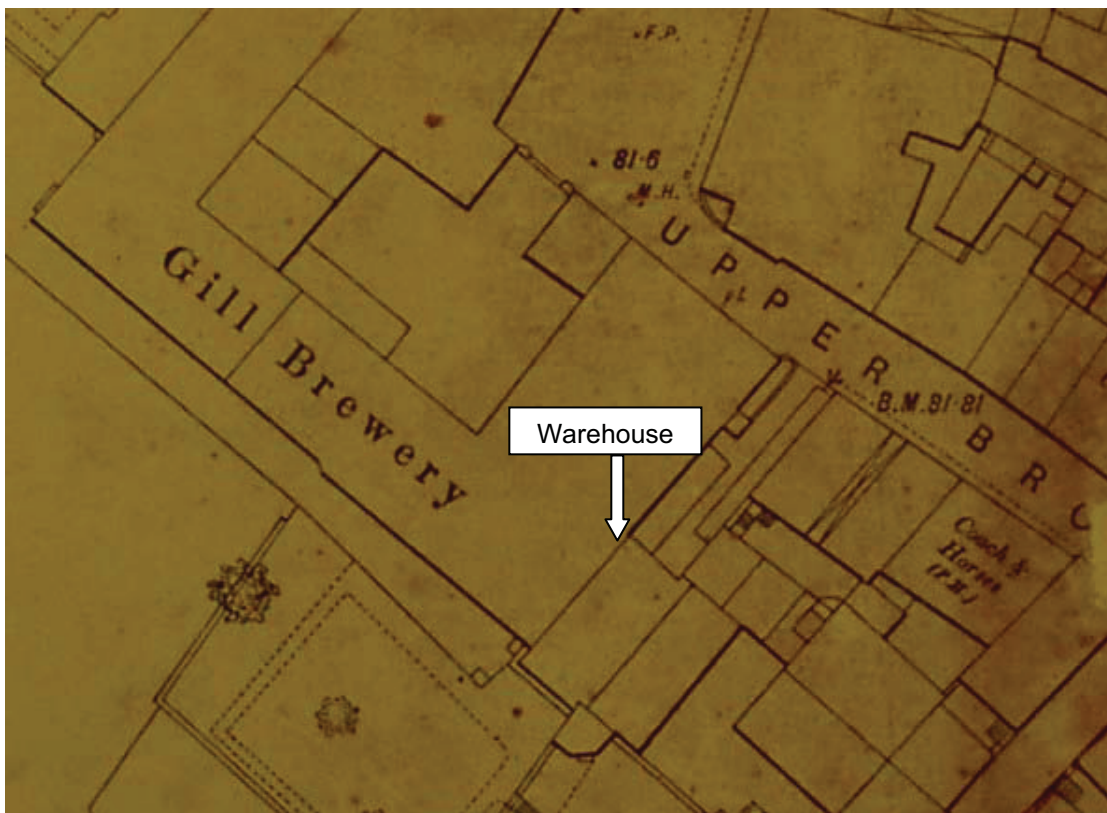
Plate 2: Extract from Ordnance Survey 1890 map

- **Ordnance Survey 1890 (Plate 2):** the warehouse remains largely unchanged from 1852 to 1890. The only slight changes occur in the driveway/access point to the building from Upper Brook Street. The main change is the addition of a long narrow building that butts the north-east elevation of the warehouse as well as the north-west side of the brewery. This building may be no more than a shed or covered outbuilding;

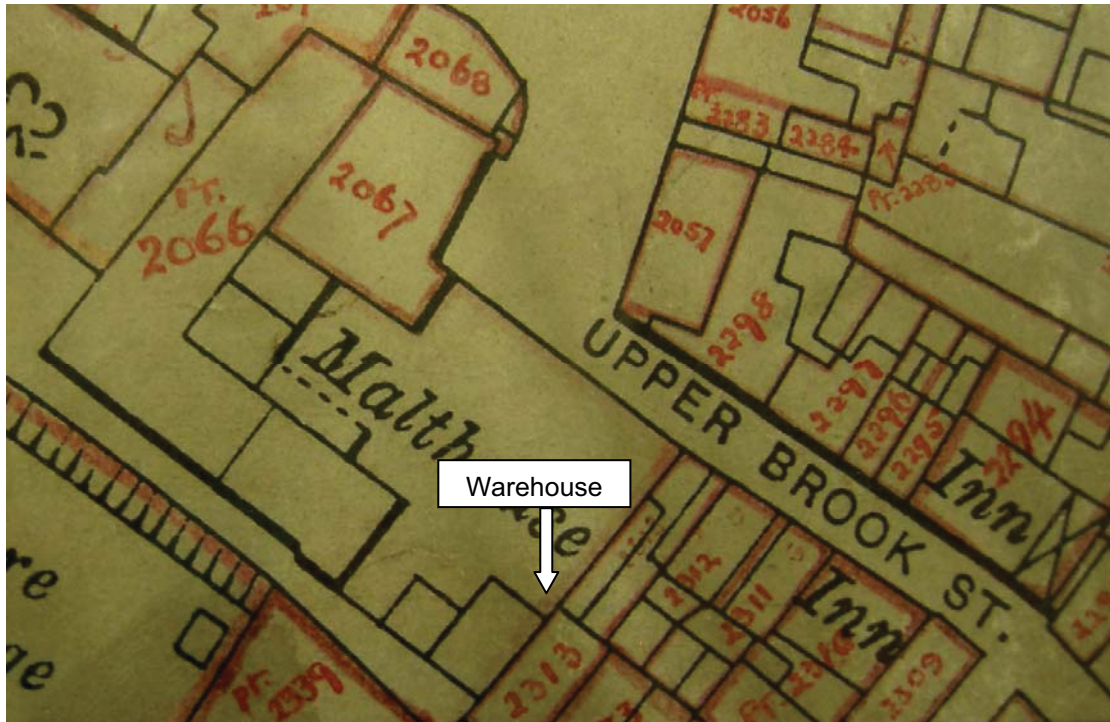
Plate 3: Extract from Ordnance Survey 1913 map

- **Ordnance Survey 1913 (Plate 3):** again the warehouse appears unchanged, the brewery building to the north-west has been demolished but its original south-eastern wall/boundary remains, running from the rear retaining wall to Upper Brook Street. Two small buildings have now been added on the brewery plot, adjacent to the north-west elevation of the warehouse;

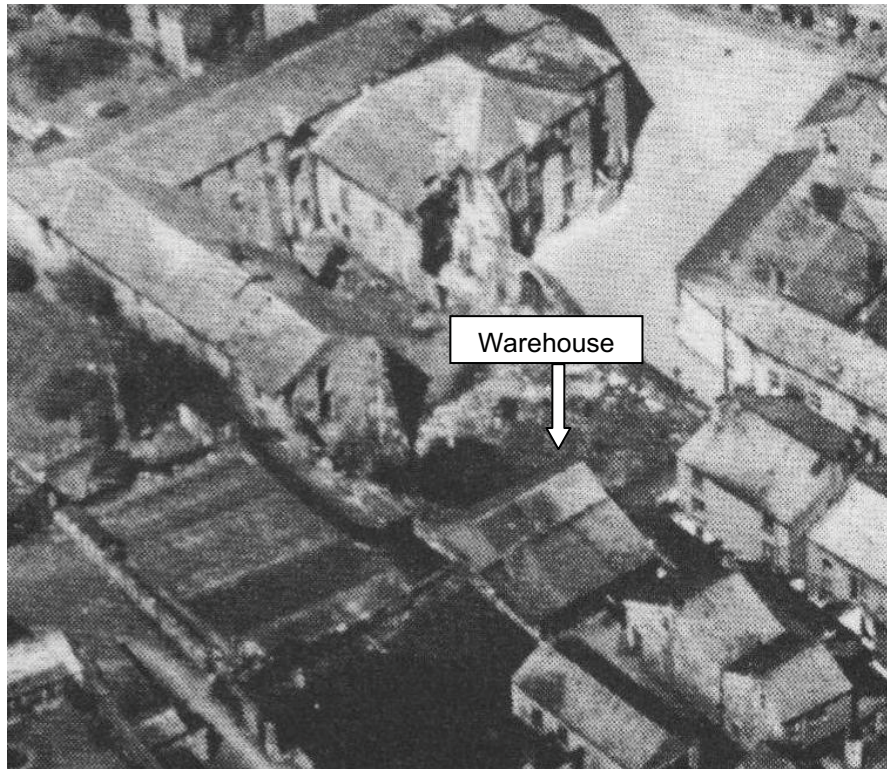
Plate 5: The warehouse in 1929 (Snell and Rushton 1979, 24)

3.1.3 An aerial photograph from 1929 shows the warehouse with its now vanished lean-to on the south-west side (Plate 5).

5.2.3 **Phase 2:** the next major development to the warehouse is the demolition of the adjacent brewery building to the north-west which occurred between 1890 and 1913. The blocked window on the second floor may well have come into being at this time; it would certainly have been of no use while the brewery still stood, given the fact the brewery buildings appear (from Plate 5) to be at least as high as the warehouse.

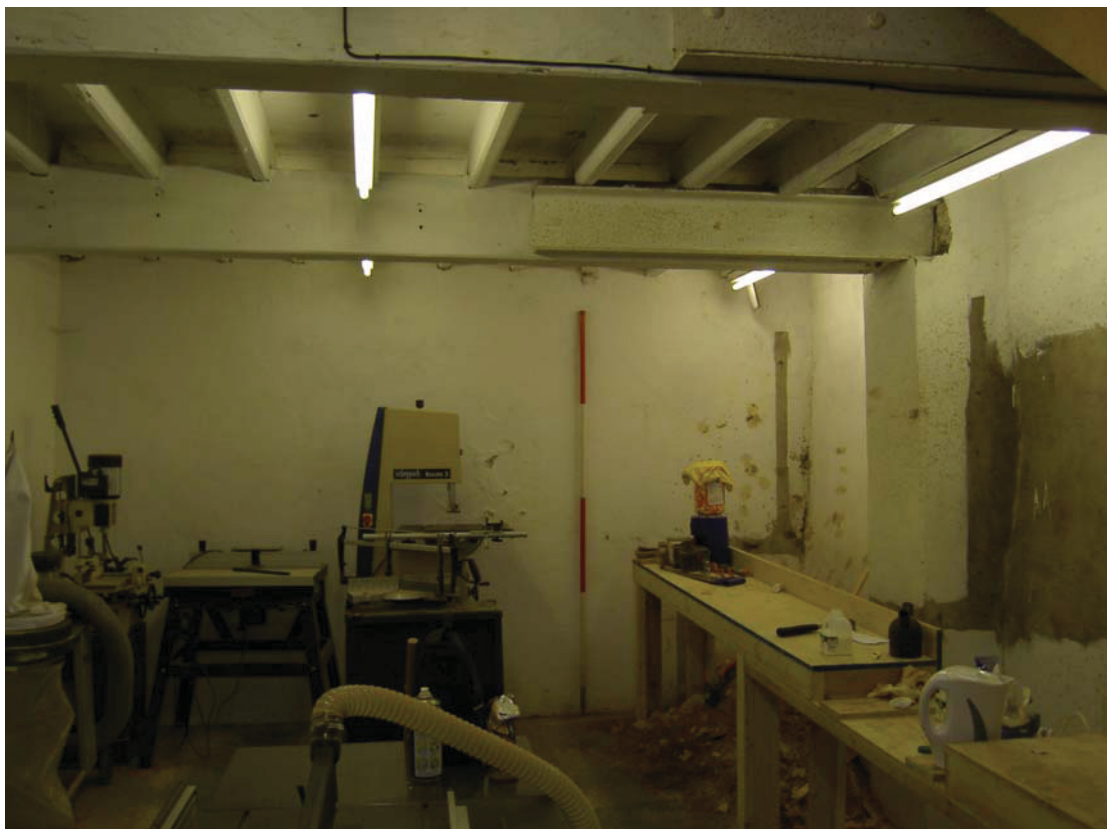
Plate 10: Detail of first floor beam repair

5.2.6 **Phase 4:** at some point the beams on the ground floor roof were repaired; this is evidenced by the addition of bolted-on iron girders to their north-west ends (see Plate 10). A large amount of the replaced floorboards are also on this side of the building and on this floor which suggests damp entered through the north-west wall. It seems likely that the new guttering arrangement (see *Section 5.2.5*) may well be responsible for moisture entering the wall of the warehouse at this level. The timbers in the roof were in very good condition and the flooring on the second floor was almost all original.

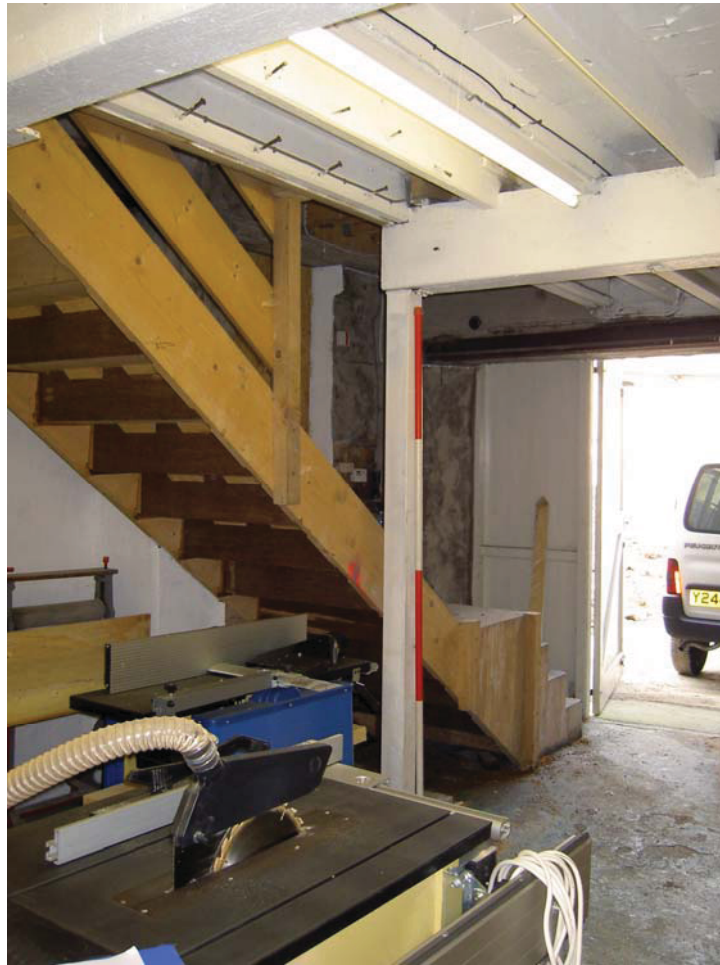
Plate 11: Cut beam and post support to accommodate modern stairway

5.2.7 **Phase 5:** at some point the window on the second floor was blocked and rendered over. In addition (probably very recently), the new stairway was introduced (see Plate 11) which involved the cutting of the north-eastern-most beam on the ground floor and first floor and supporting them on posts facilitating a wider stairway. At the time of the building recording the warehouse was being used as a joinery workshop where window frames were being produced; it is conceivable that the stairs were altered to allow the movement of frames between floors. The lean-to on the south-east side of the building has also been removed at some time since 1941.
