BARN AT SULLOM SIDE FARM, STRICKENS LANE, BARNACRE, PRESTON, LANCASHIRE

Archaeological Building Recording

July 2016

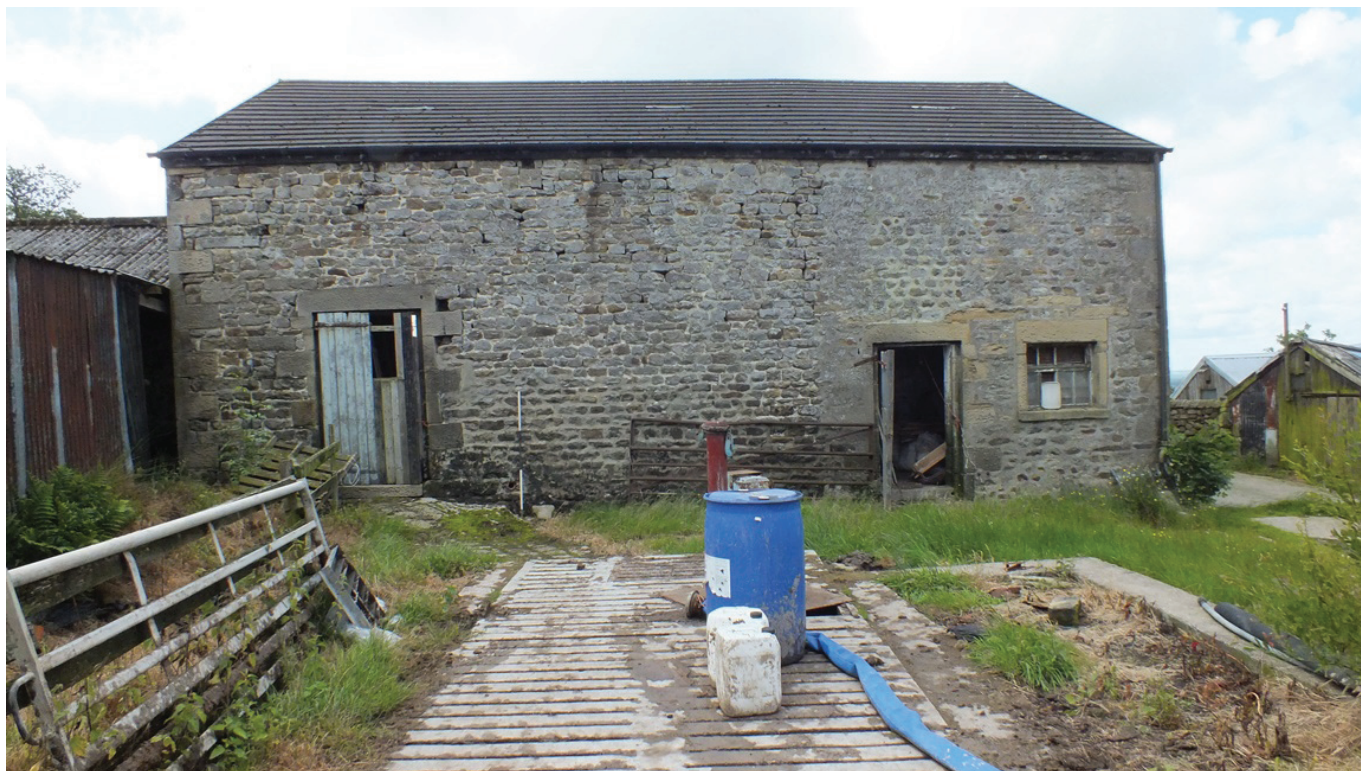
Plate 5: The north external elevation

4.2.1 **North elevation:** the east end of the north external elevation was finished with dressed quoins and there were quoins at the west end also, but these were not as neat as those to the east (Plate 5; Figure 2). There was a plain bargeboard along the top, supporting a plastic gutter. The doorway on the east side had dressed quoins and a lintel with rilled edges, rebated for a door, and housed a plain plank and batten type door with long hinges (Plate 6). There was a ceramic pipe in the wall to the west near its base. There was a further doorway to the west in a similar style, but the stonework was more eroded and the door was slightly smaller (Plate 7). Again the door was a plank and batten type on strap hinges with a concrete step and there was an eight-light timber casement window to the west of this, with a projecting sill, again with dressed surrounds, but the surrounds were heavily eroded. From just to the east of the west door the whole wall had been heavily repointed (and perhaps rebuilt) (Plate 7).

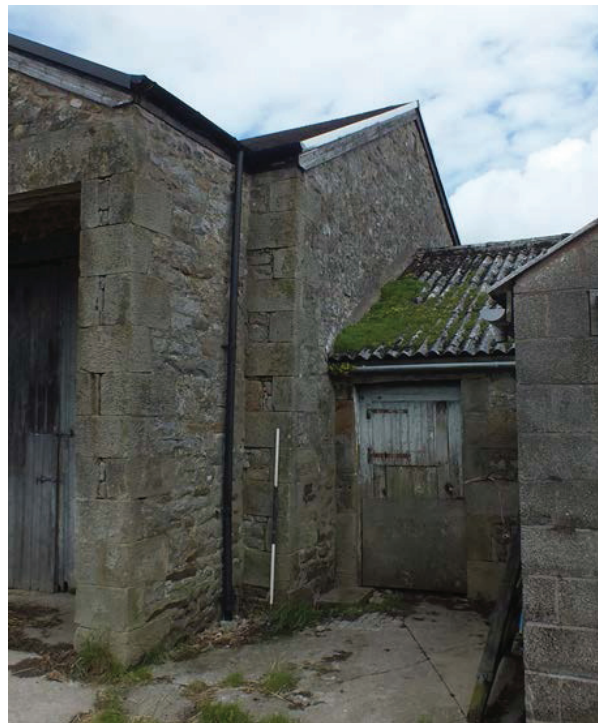
Plate 8: The east external elevation

4.2.2 **East elevation:** the east external elevation was mostly obscured by the attached building but the ends were finished with quoins (Plate 8) and there was a blocked small hole at the top, presumably an owl hole (Figure 2). The adjoining building looked to be butted against it, but they could have been a single build. Inside the building to the east the wall was whitewashed (Plate 9). It had two large projecting corbels and a doorway on the north side with a timber lintel and stone jambs including long upright pieces.

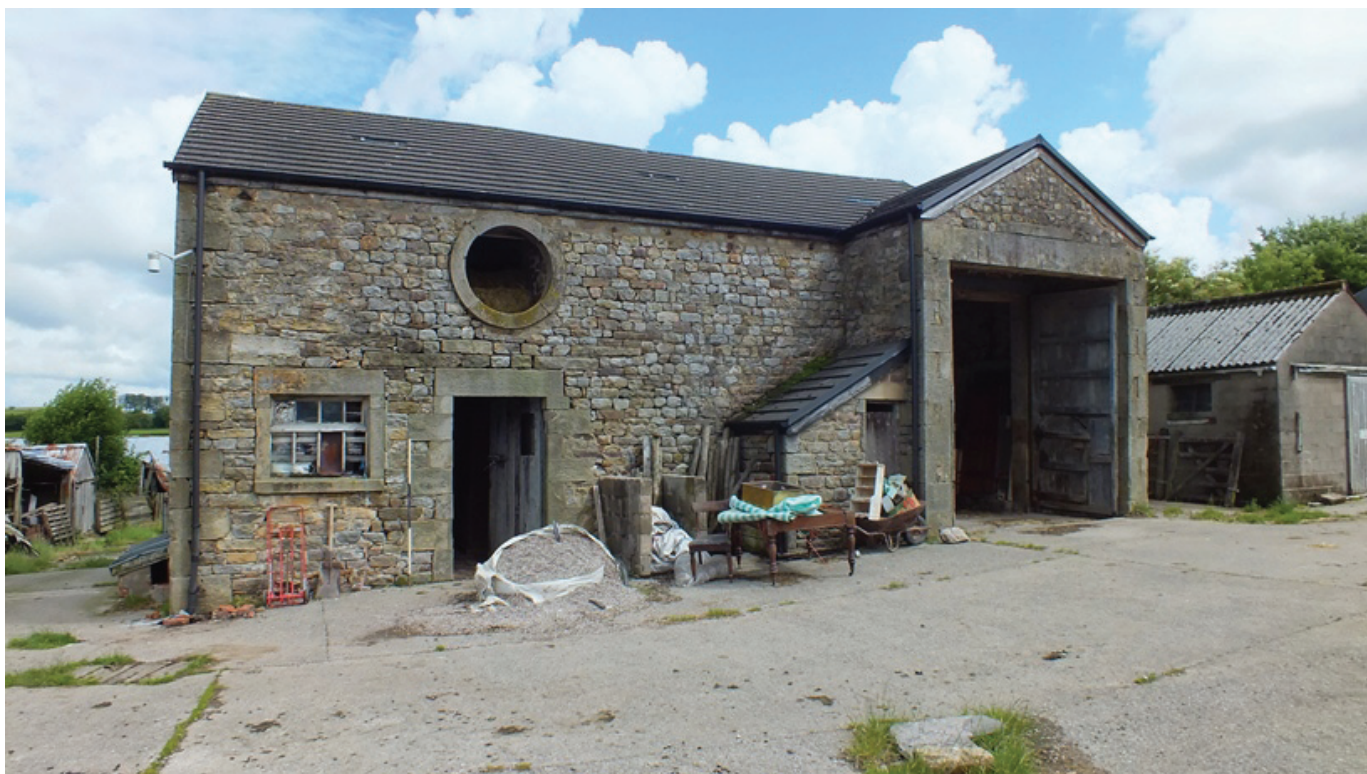
Plate 10: General view of the south external elevation

4.2.3 **South elevation:** there were dressed quoins around the apertures and at both ends of the south external elevation (Plate 10; Figure 3). There was a plain bargeboard along the top supporting rainwater goods. The window on the ground floor at the west end had dressed surrounds and a projecting sill and an eight-light timber casement. The doorway to the east was different to those to the north as it was not rebated and the lintel was a simple rectangular block (Plate 11). It had a tongue and groove plank and batten door with a window cut in. Two low concrete block walls to the east of it probably at one time formed a coal store (Plate 12) and the circular pitching window above it had a dressed surround and no casement. There was a large projecting porch at the east end of the elevation, with a gabled roof, a large stone lintel and quoins (Plate 13). It had a very tall double plank and batten door with a smaller door incorporated into it with a round head. On the west side of the porch there was a small mono-pitch lean-to with a narrow door on the east side with a plain stone lintel with a reused timber lintel behind. The west doorjamb was unusual because it incorporated a reused scrolled piece and long thin pieces of stone (Plate 14). The door was a tongue and groove, plank and batten type, in a plain surround, and it had quoins at the west end, rougher than the rest, and a machine-made red brick and concrete wall was added against the lower part of the west side.

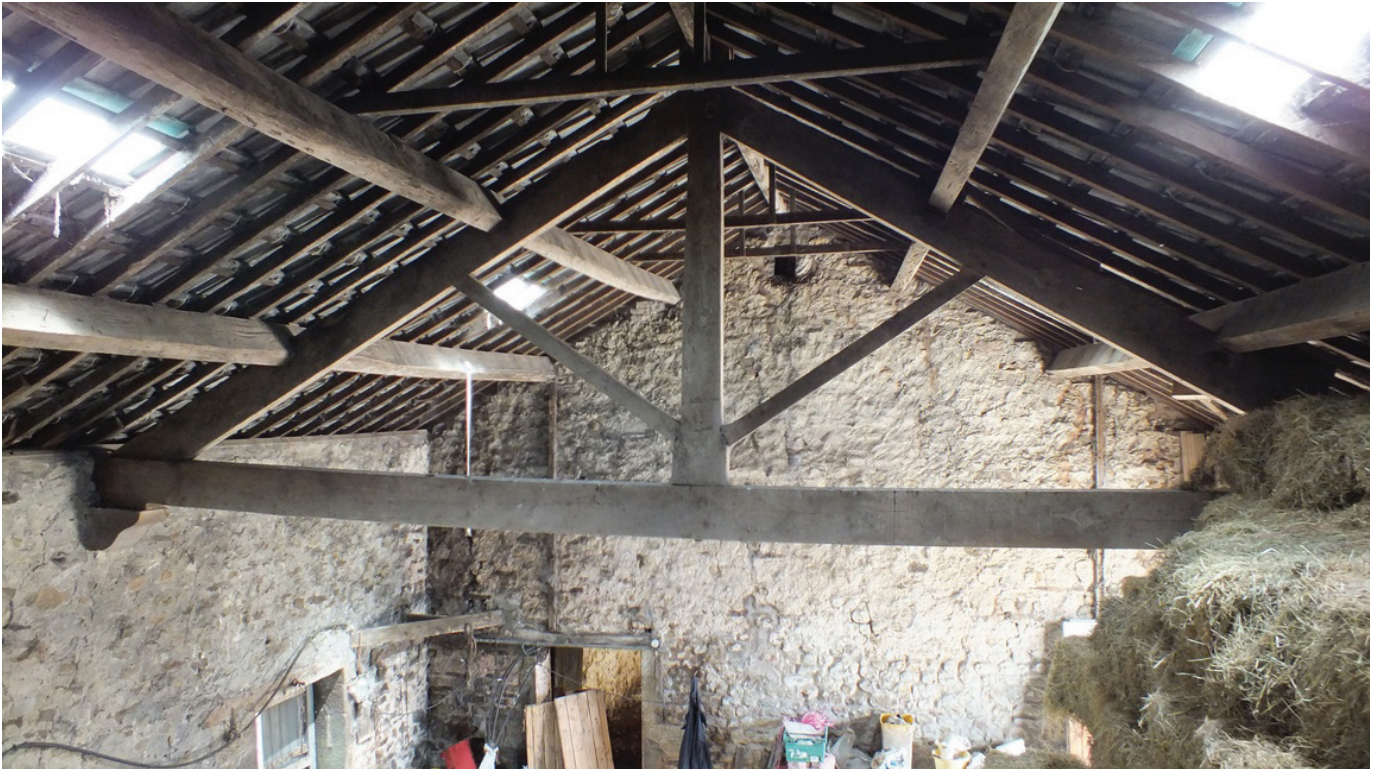
Plate 19: Truss in G1

4.3.1 **Ground floor room 1 (G1):** this room formed the main part of the building and it was open to the roof (Figure 4). It had an earth floor, which was covered with straw, apart from a stone threshold to the door to the south and a patchy brick area nearby. The roof comprised modern concrete tiles supported on a single north/south aligned, king post truss, angled to meet the principles, with angled braces, and bolted to the tie beam (Plate 19; Figure 6). The truss was set on top of the wall but it had slightly scrolled corbels below each end (Plate 20). There were two purlins per pitch and a ridge plank, chamfered to a point at the base, and two skylights in each pitch. The walls were all exposed stone with a rough, lime mortar pointing. The north elevation was mostly plain. It had a doorway on the east side, with a rough (possibly reused) timber lintel and dressed quoins, as per the exterior, and a plank and batten door (Plate 21). The batten was fixed in the north-east corner and there were bridging timbers across this corner. The east elevation formed the gable end and had an owl hole at the top (Plate 19). The lowest two metres had been repointed in concrete and there was a projecting concrete base against the doorway on the north side. The doorway had a reused timber lintel and dressed jambs, comprising three large blocks on each side, two upright and one horizontal (Plate 21). The south elevation had a large wagon door on the east side, with the gabled roof of the porch above (Plate 22). The doorway had quoins for the jambs and was rebated, housing a plank and batten double door incorporating a smaller door near its base. Machine-cut timber was used for the lintel in the main room but the timber in the porch had been reused behind the long stone lintel. There was a central pitching door on the upper level of the west elevation, with a (possibly reused) timber lintel and sill and rough quoins (Plate 23).

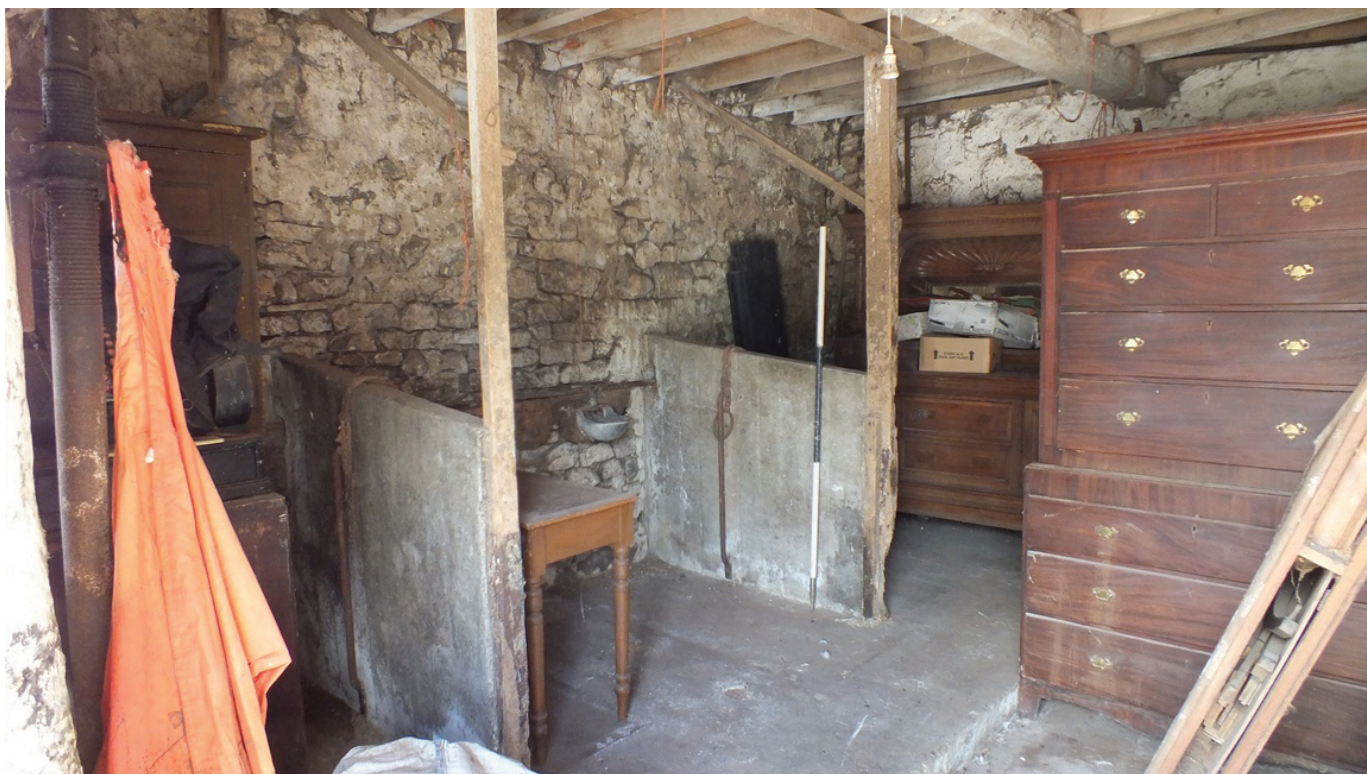
Plate 24: Stalls along the west side of G3

4.3.3 **Ground floor room 3 (G3):** this room occupied the south half of the west end of the building (Figure 4). It had a concrete floor, which was gridded on the east side and stepped up on the west, with two stall partitions comprising concrete sides and timber posts (Plate 24 and Plate 25). There was a single north/south beam across the ceiling (Plate 26), with chamfered sides and an empty slot for a post near the centre where the chamfering stopped (Plate 27). The joists on top were east/west and there was a pitching hole in the north-east corner with plywood sheets on top. The walls had remnants of whitewash over the stone. There was a small alcove in the east elevation (Plate 28). The door and window to the south had rough timber lintels and were otherwise as per the exterior. The west side had an iron pipe and water troughs for the stalls attached to the remains of a thick timber batten.

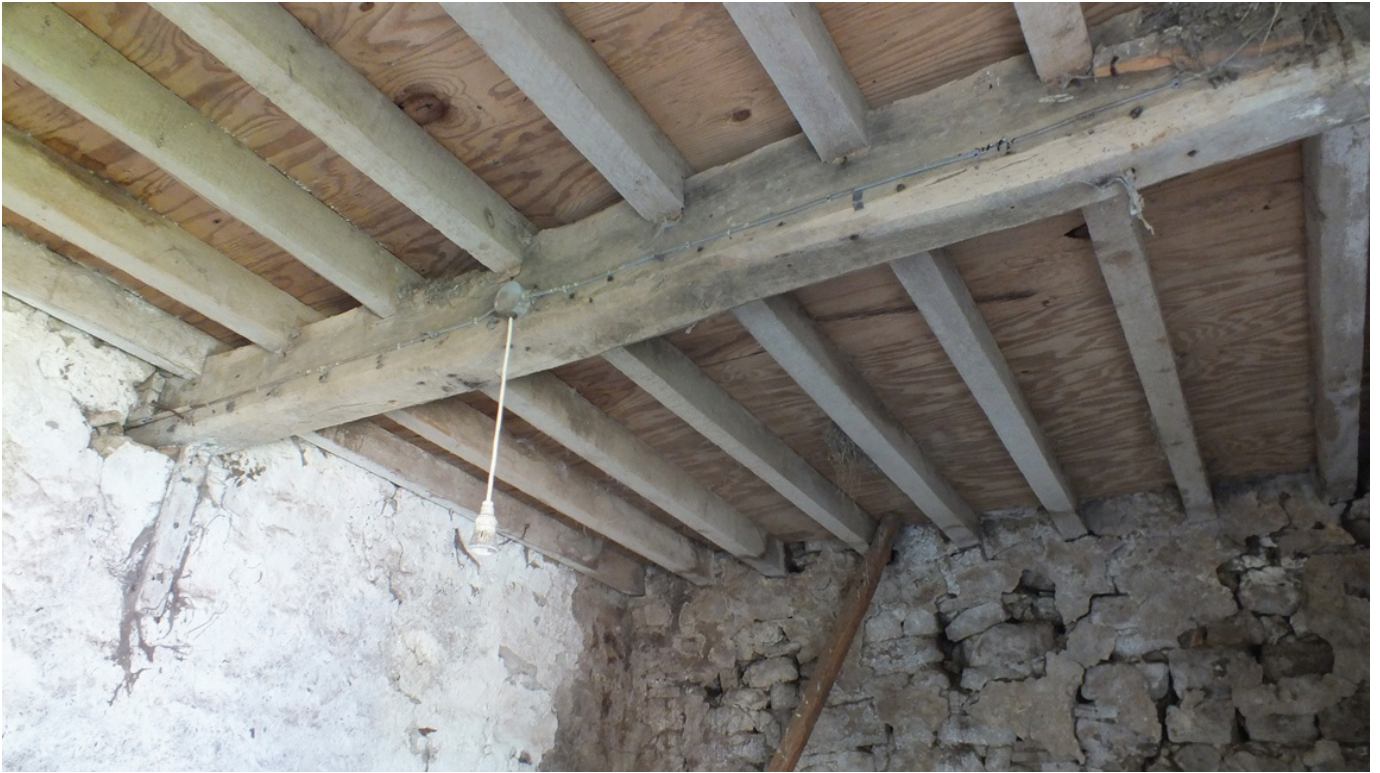
Plate 29: Beam in G4

4.3.4 **Ground floor room 4 (G4)**: this room, to the north of G3 (Figure 4), had a concrete floor with a step to the door to the north. There was a single roughly-chamfered beam, north/south across the ceiling, and joists with plywood on top (Plate 29). The walls were roughly whitewashed and were plain except for the west elevation, which had the remains of a timber manger attached, comprising pieces of round wood (Plate 30). The window and door to the north had rough timber lintels (Plate 31 and Plate 32 respectively).

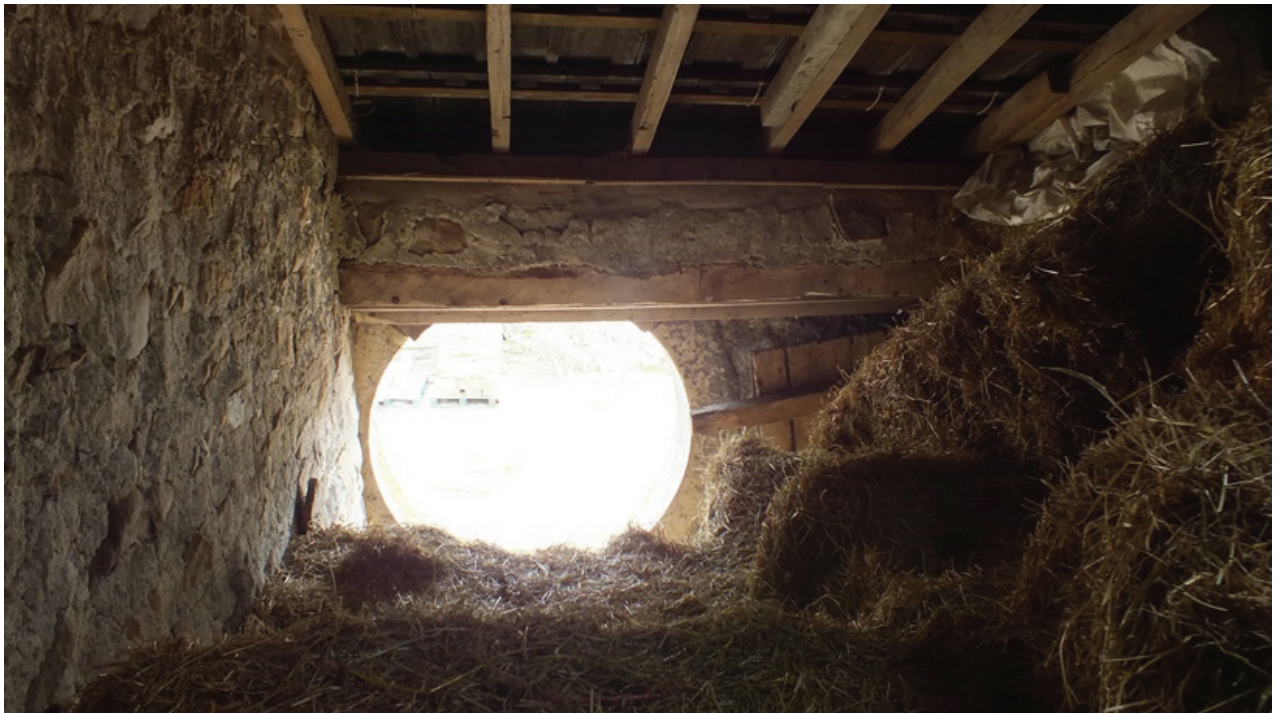
Plate 33: Pitching window in the south elevation of F1

4.3.5 **First floor room 1 (F1)**: this room formed a hayloft, with a timber board floor, over the west end of the barn. It was mostly full of straw bales. It was open to the roof. There were no trusses, just two purlins per pitch and a ridge purling, as per G1, and the backs of roof tiles were visible. These were marked 'REDLAND STONEWOLD REG. TRADE MARK 723043 BS 473/550'. The walls were stone with a rough lime mortar. Mostly plain throughout. The south elevation had a round window on the east side and stepped out and there was a timber rail built into the wall above that and to the west (Plate 33).
