# HIGH BARN, SNAB GREEN LANE, ARKHOLME, LANCASHIRE

## Archaeological Building Recording

Planning Application Reference:  
15/00275/PAA

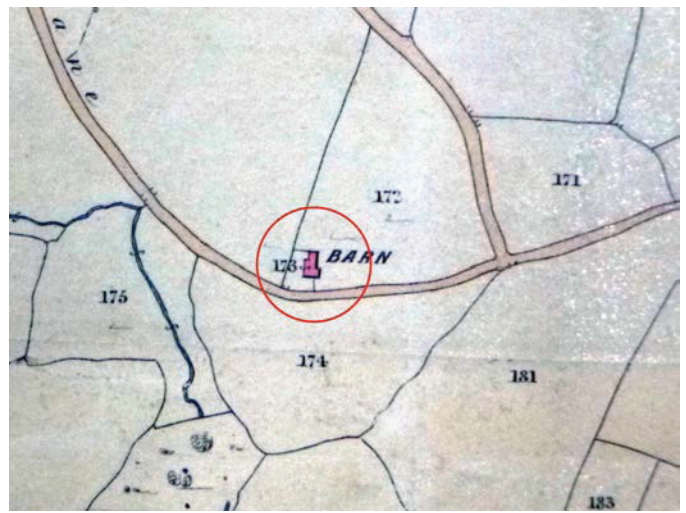
Plate 3 (right): Extract from the Tithe Map of 1849

3.1.3 **Tithe Map 1849:** this map (LRO(P) DRB 1/8 1849; Plate 3) shows a similarly rectangular-shaped barn to the earlier Ordnance Survey map (*cf.* Plate 2), possibly with additions to the east and west sides, but this is a little unclear due to the scales at which both maps were drawn. The site probably overlaps plots 172 and 173, parts of a field and a barn and yard. The accompanying schedule (see Table 1) records that both plots were owned by William Smith Cragg and occupied by William Hutton (LRO(P) DRB/1/8 1848). Hutton occupied a number of nearby plots either side of Snab Green Lane, to the north and west, as well as fields across the road to the north-east, all of which belonged to Cragg.

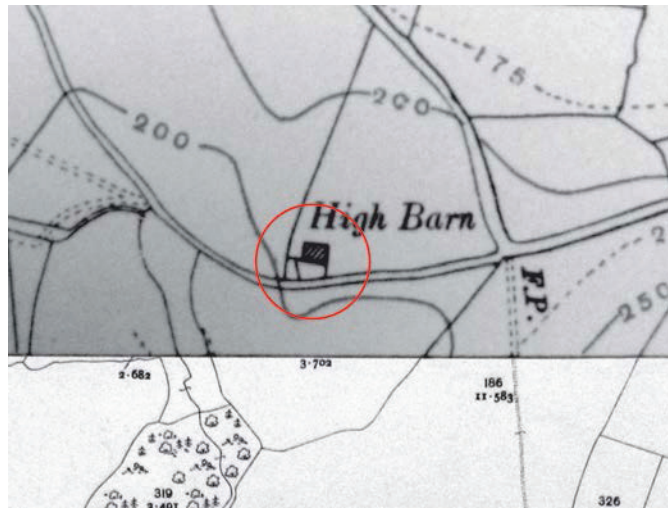
Plate 6: Extract from the Ordnance Survey maps of 1913 and 1919

3.1.5 **Ordnance Survey 1919:** although there was a 1913 edition of the Ordnance Survey map for the area to the south, no map sheet was available for consultation at the Lancashire Record Office in Preston for the area covering High Barn (*Lancashire Sheet XIX.15*). The next available map for the area dates to 1919, which is at a scale of 1:10,560, and it shows essentially the same information as the previous edition of the Ordnance Survey map (Plate 6; cf. Plate 5).

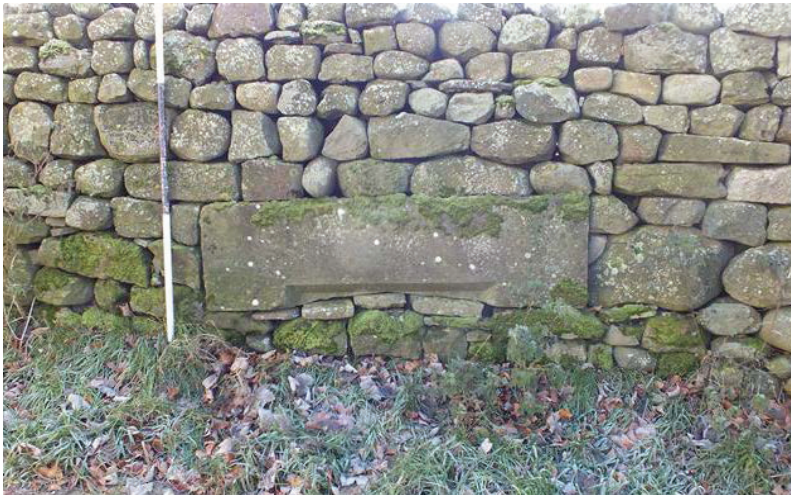
Plate 7 (left): Chamfered lintel re-used in the boundary wall to the south-east of the building, viewed from the west

4.1.1 The building is constructed primarily from the local buff or yellow gritstone, with the majority rock faced finished and laid in fairly random courses, while details such as lintels and quoins are more neatly dressed. The roof is grey slate with sandstone ridge tiles and is a relatively modern replacement. The timber is generally machine cut and well finished, although some rougher and re-used material is also present although only visible internally. There are areas of brick and concrete hard standing externally, although internally many of the original cobble and flag floors have been retained, although these too are augmented by concrete in places. Some sections of ceramic drain have been used to form vents in the east and west walls. Internally the stall partitions are constructed from large slabs of stone. There are the occasional pieces of stone evidently re-used from another building, with empty slots and sockets present, including a large lintel with chamfered decoration in the boundary wall to the south-east (Plate 7) and a loose block to the south-west with several sockets and a central slot (Plate 8).

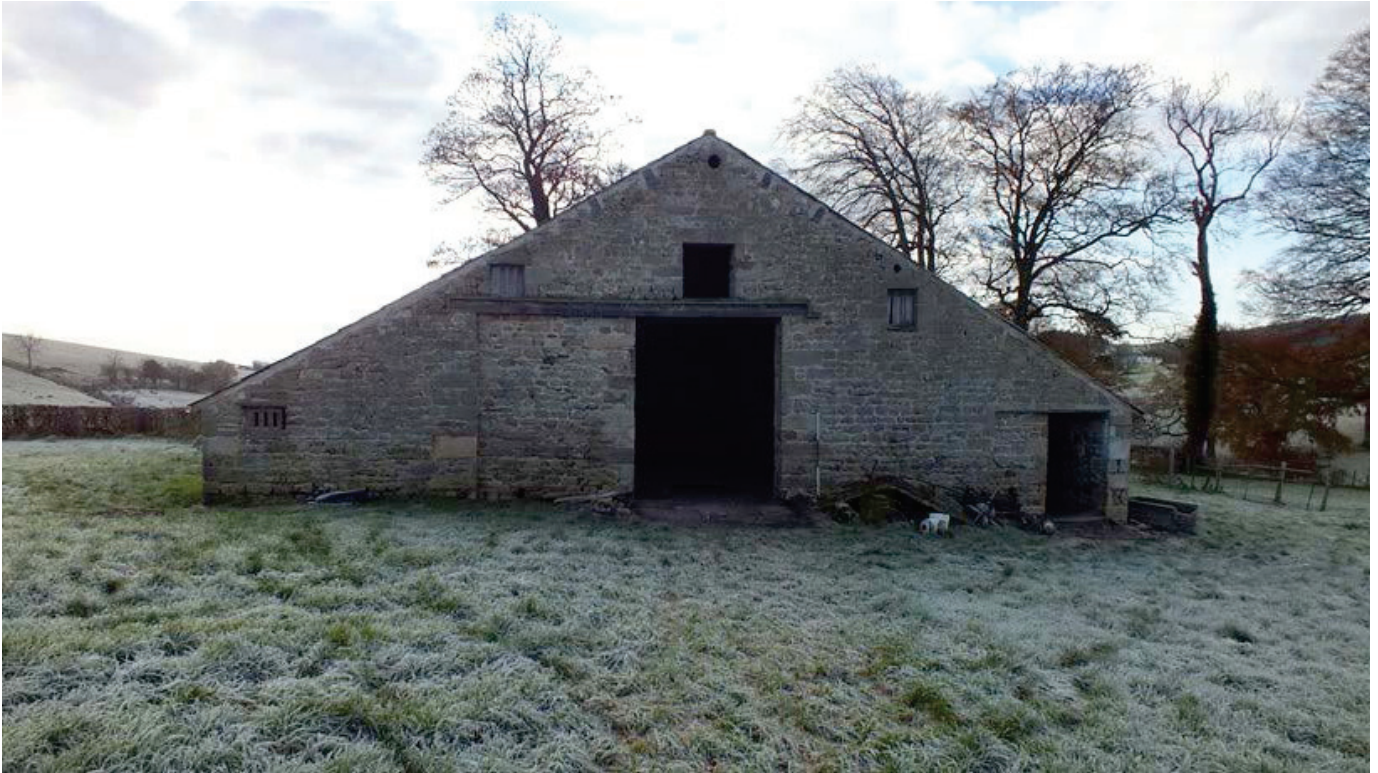
**Plate 9: The north external elevation, viewed from the north**

4.2.1 **North elevation:** this is the gable end and is very low at either end (Plate 9). The corners are finished with quoins and there is a small window on the east side with a thin stone sill and lintel and slatted timber infill. A re-used block with a slot cut into what is now the underside forms one of the quoins on the east side (Plate 10). There is a large central wagon doorway with quoined jambs and a heavy timber lintel below a simple hood mould. The east side is recessed but this is clearly part of the original design and the scar of an iron bar along the stone flag threshold suggests that this housed a sliding door (as per the surviving examples internally) (Plate 12). The stepped section is quoined too, and has a narrow slot vent or drain near the base and there are further stone flags running up to the threshold. Above the recessed section is a small aperture with quoins and a lintel and slatted infill, all squeezed into

the space below the roof. Above the actual doorway there is a further square opening with quoins and a lintel, above which is an owl hole constructed from two pieces of stone carved to form a circular opening. The west end of the elevation has a further round opening in the same style above another small aperture with a lintel, quoins and timber slatted infill. There is a doorway below these with quoined jambs, a lintel made from long narrow flags, and a flagged threshold, with a further external area of cobbles leading up to it. This too has a recessed section on the east side, which sits on top of the threshold flags, which also have an iron bar fixed to them (Plate 12), while the lintel has thin timber battens attached to its underside (Plate 13). Along the apex of the roof there is a line of repointing in concrete with corresponding slates fixed over the purlin ends. However, at the east and west ends it is apparent that there is also an earlier phase of concrete pointing with concrete covering the purlin ends.

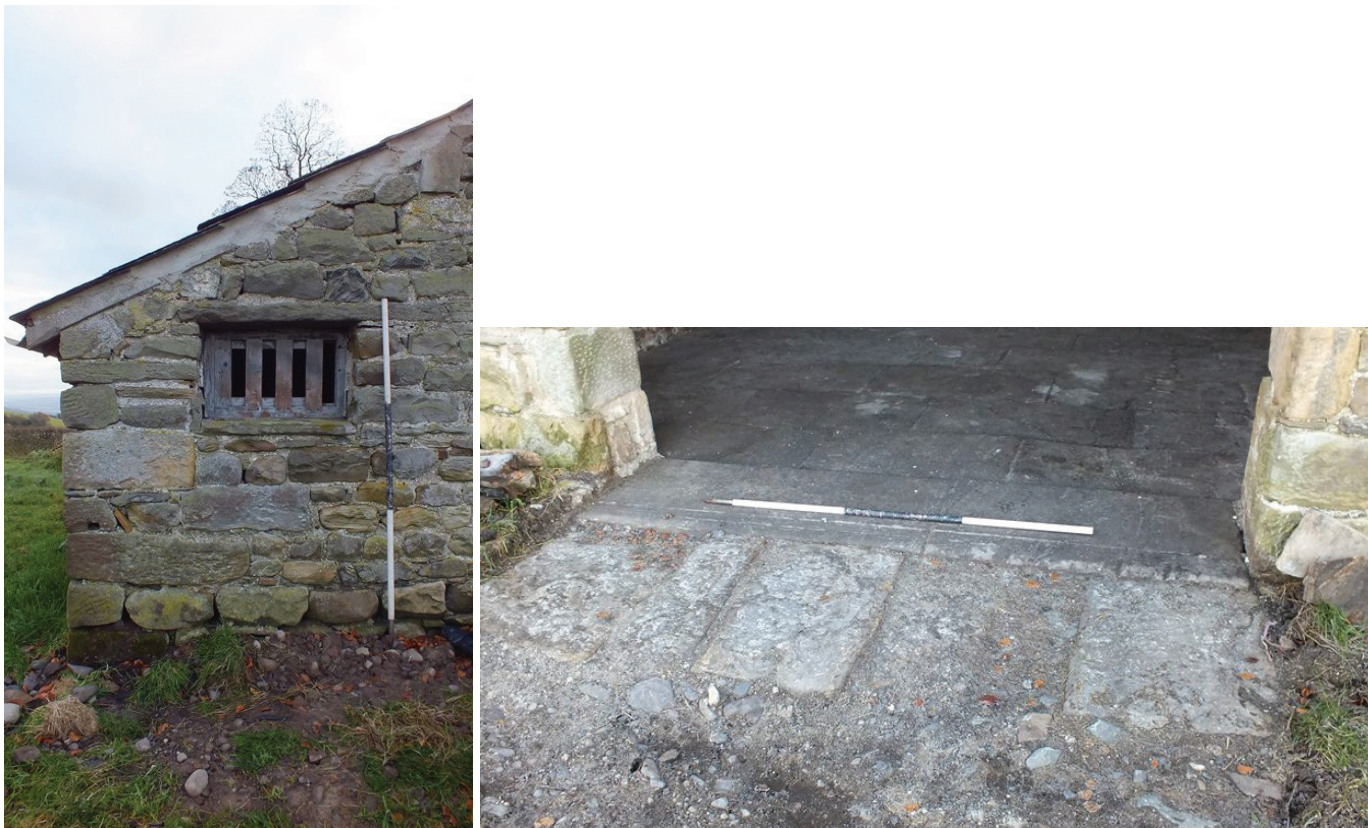
**Plate 10 (left):** The east side of the north external elevation, showing the re-used block, viewed from the north

**Plate 11 (right):** The threshold of the wagon doorway, viewed from the north-west

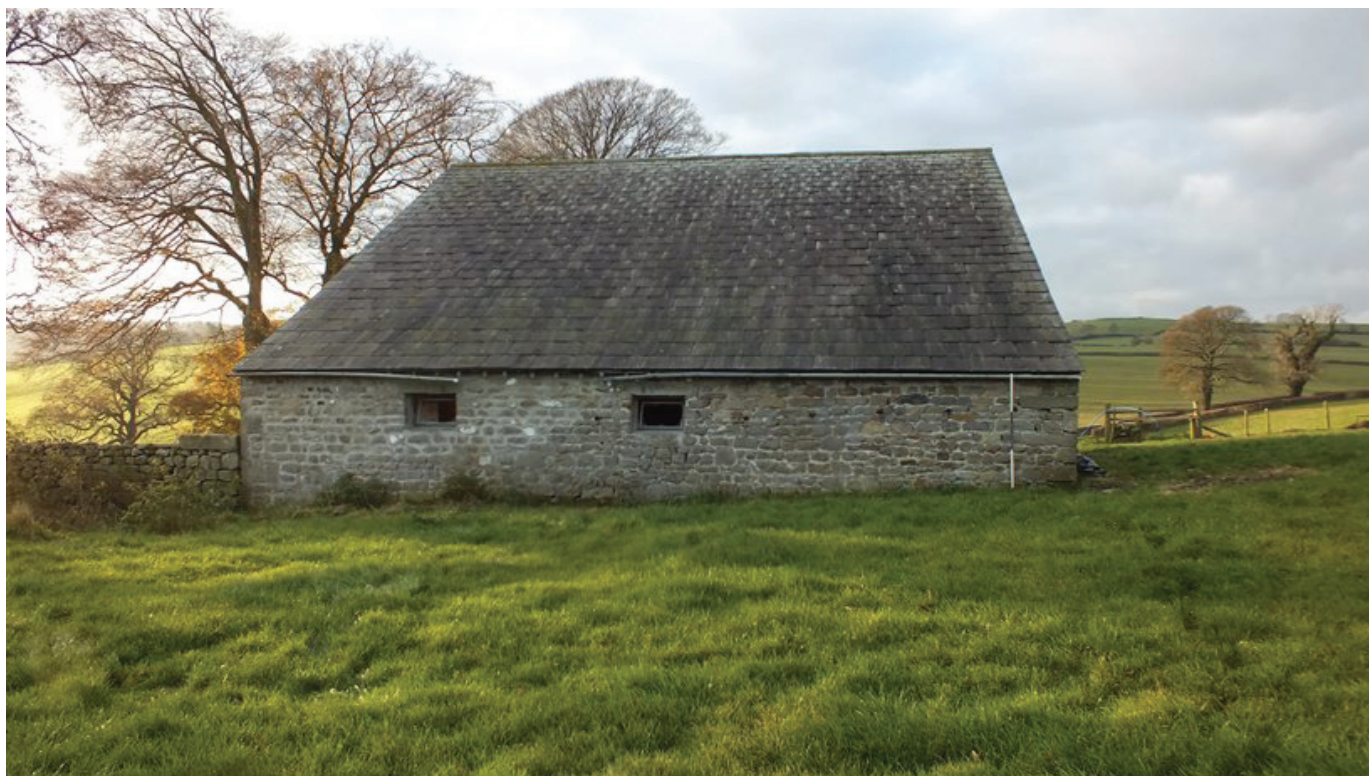
**Plate 14: The east external elevation, viewed from the east**

4.2.2 **East elevation:** this is relatively plain but has a row of six ceramic field drain pipe sections inserted into it to form vents from the centre to the north end (Plate 14). The south end has evidently been extensively repointed or even rebuilt. There are two windows, one in the centre and one to the north both with thick stone lintels but thin sills, or just concrete in the case of the south one, and no real quoins. There are dressed quoins at each end of the elevation.

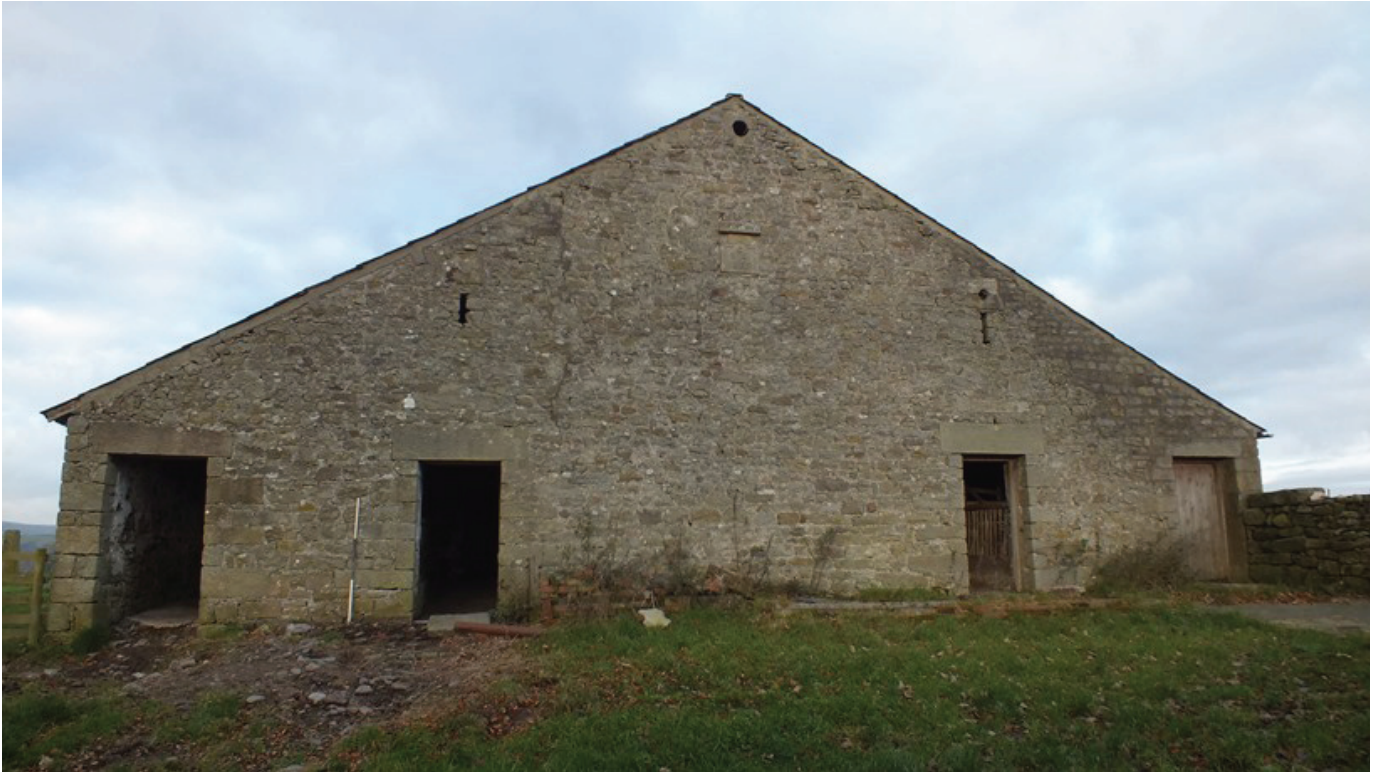
Plate 15: The south external elevation, viewed from the south

4.2.3 **South elevation:** this is the opposing gable end (Plate 15). There is a concrete and brick platform extending from it from the centre to the east end. Within the wall there are four doors, two at each side, all with heavy dressed stone lintels, the most central two the largest and also each with an iron fitting driven into the top and with further supporting lintels above. Both of the eastern doors have a relatively modern plank and batten door. At either end there is a slot vent with a further circular vent formed by two pieces of dressed stone above that (the west of which is blocked). The east end of the elevation has been heavily repointed or even rebuilt. In the centre of the elevation is a datestone with the inscription "W S C 1859" in relief within a dressed stone plaque with a simple drip mould above (Plate 16).

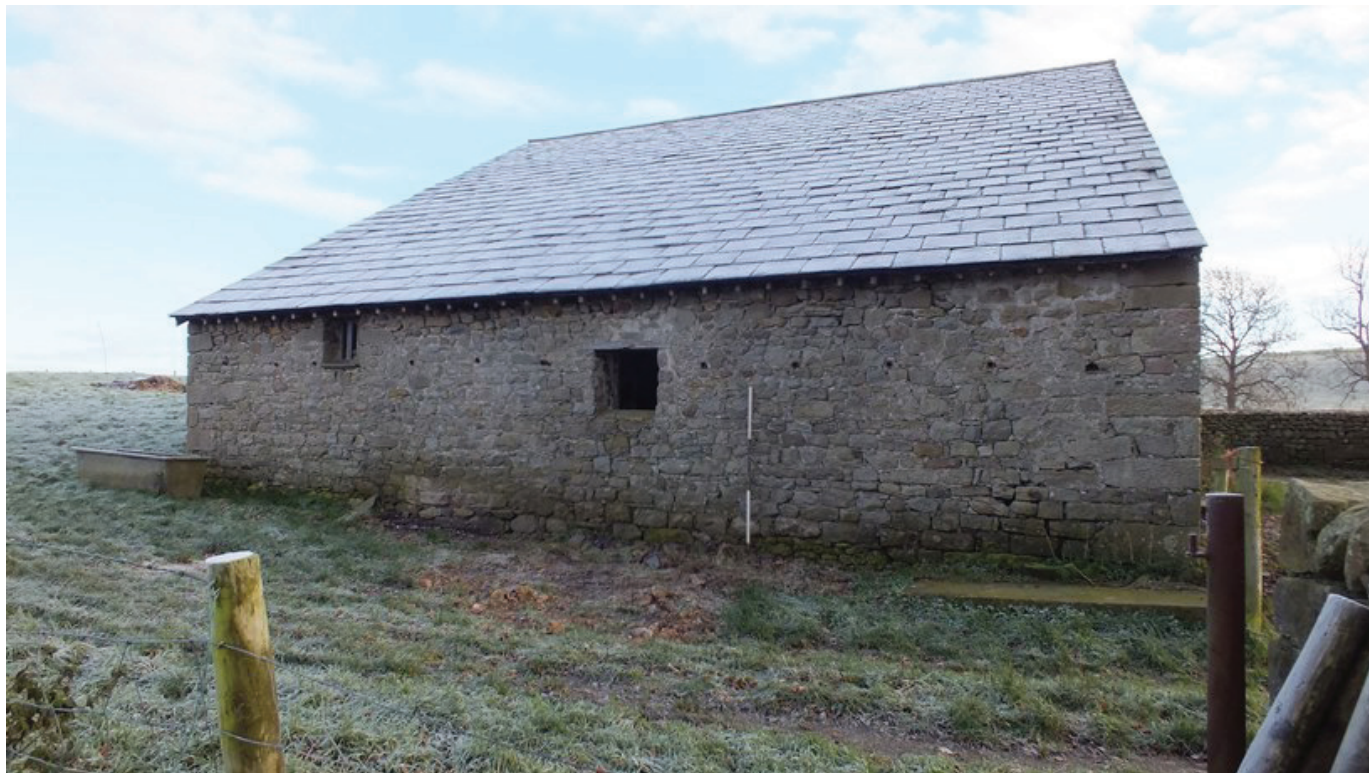
**Plate 17: The west external elevation, viewed from the south-west**

4.2.4 **West elevation:** there are quoins at each end and a re-used block at the south end with two slots in. There is a row of 11 ceramic field drain sections inserted as vents and a central window with a timber lintel, which has perhaps been inserted as there is lots of repointing around it and concrete over the sill. There is a further window at the north end, slightly higher than that to the south and has a thin stone sill and lintel, rough quoins and a slatted timber infill. A piece of re-used stone with two empty slots in it is present at the south end (Plate 18).

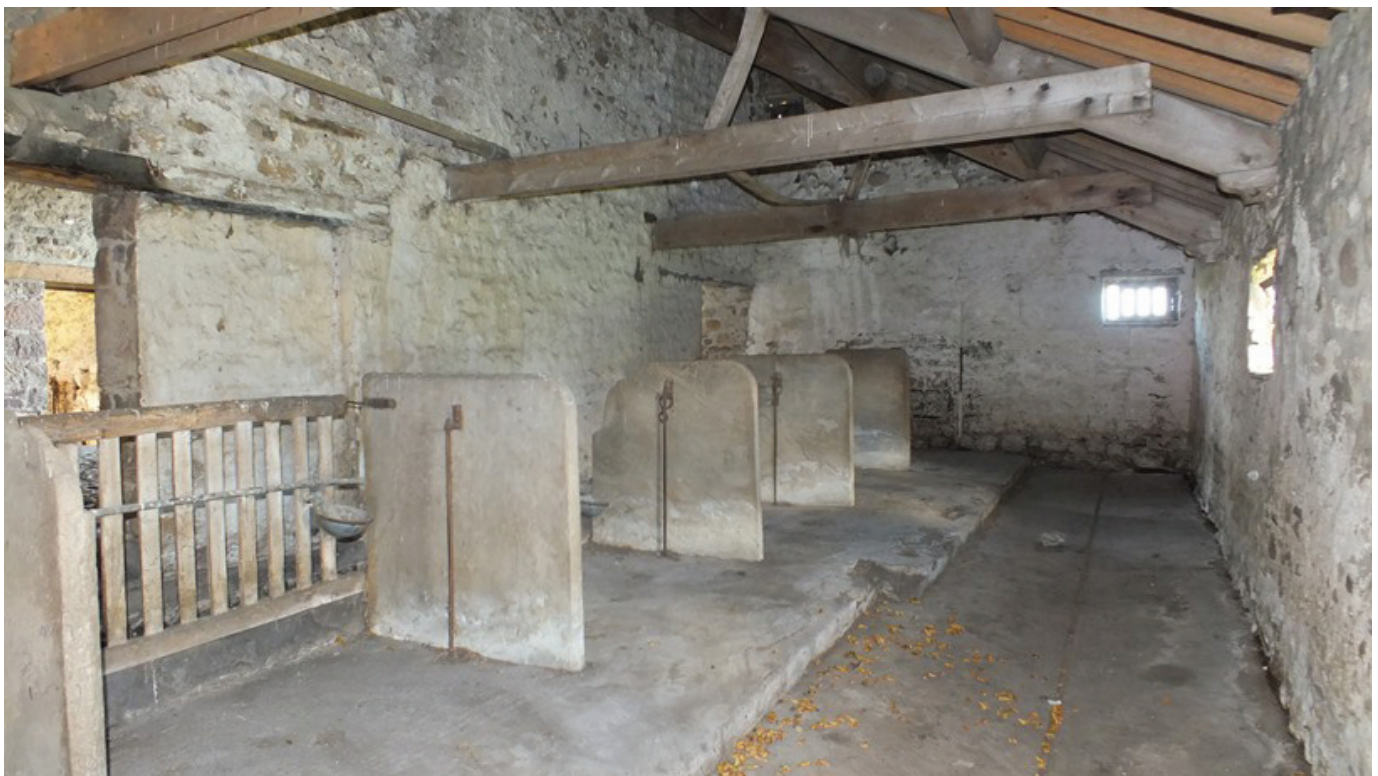
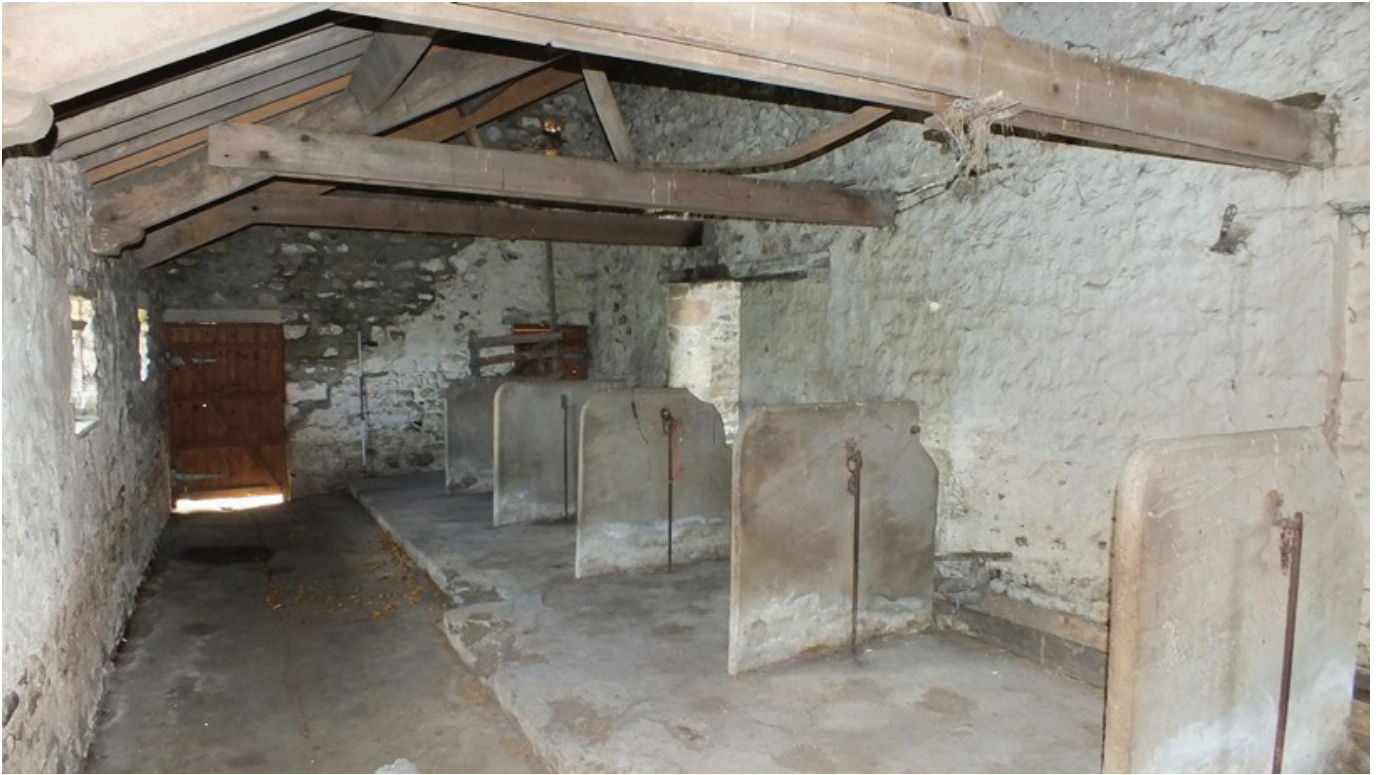
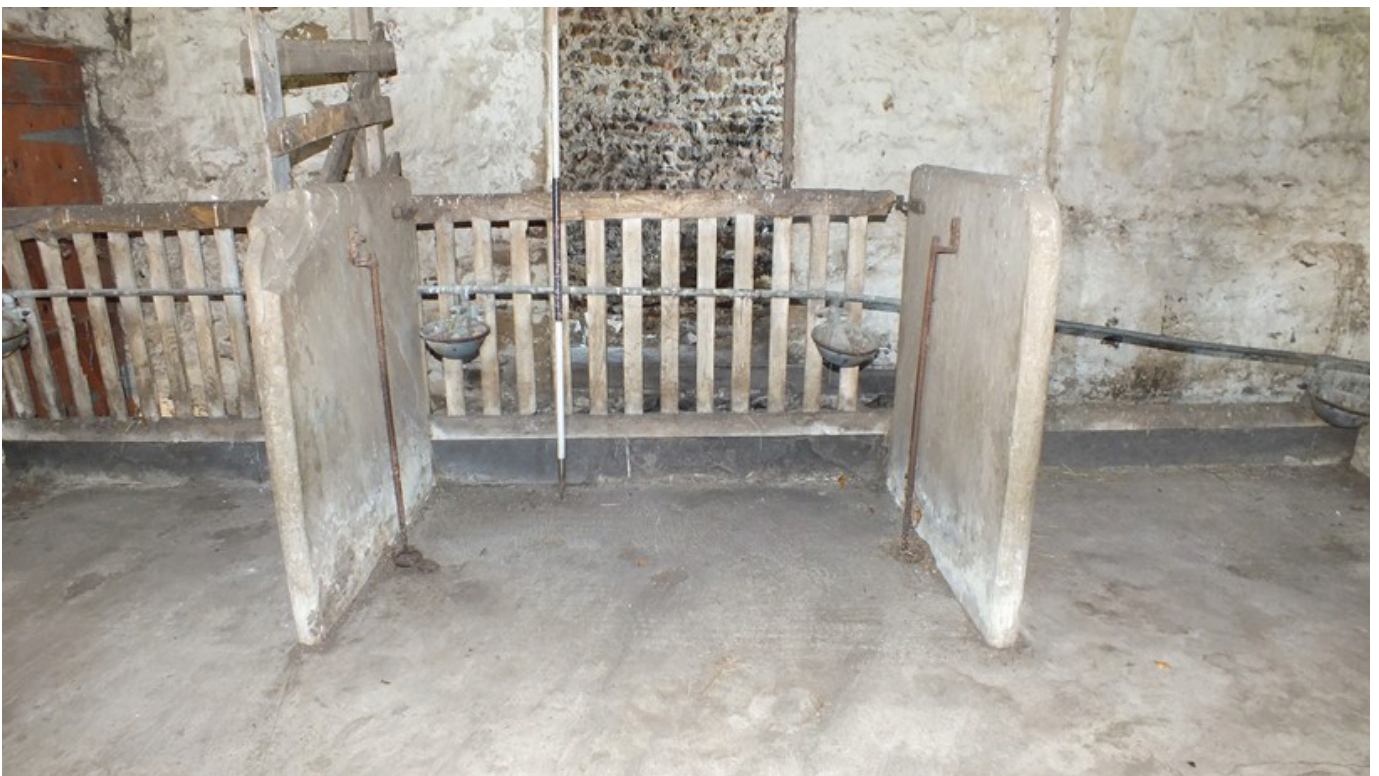
4.3.1 Ground floor Room 1 (G1): this comprises the eastern most section of the building. It has a concrete floor, stepped up from the east side to form a north/south orientated dung channel. The raised central section has a row of five stall partitions formed by upright stone slabs, each with an iron tether post attached to either side, forming six stalls (Plate 19 and Plate 20). The rear (west) edge of these is formed by shorter upright stone slabs with slots cut into the top for a timber panel, some of which survives at the south end (Plate 21). A water pipe runs along the back of the stalls, connecting to a number of metal troughs marked "PAT No 452755" and "Fordham". There is a rough timber partition at the south end attached to one of the stall partitions. The feed channel along the west side has a flagged floor (Plate 22). The roof is supported by three half trusses of basic tie-beam type, each comprising a pair of thick planks bolted to the tie beam at the east end and sat in the west wall with a single angled brace in the centre. All of the main pieces are machine sawn, although the brace appears hand-finished. There are three purlins per pitch, again all machine sawn while the rafters appear very recent and the roof is backed with modern roofing felt. The walls are finished with limewash. The north has an aperture at high level on the west side with a rough timber lintel. There is a lower window on the east side with a thinner rough timber lintel. There is also a roughly blocked vent or drain at ground level on the west side. The east elevation has a row of six square vents on the north side and two windows, one in the centre and one to the south, the north with a rough timber lintel and the south with a cast concrete one. Both have relatively late single light hinged timber casements and thin stone sills. The south end of the elevation has been heavily repointed or even rebuilt. The south elevation has a doorway on the east side, with a cast concrete lintel; this end has also been extensively repointed or even rebuilt (Plate 20). To the west there is another doorway with a timber lintel and both doorways have relatively modern plank and batten doors. Above the west doorway there are two small vents. The west elevation has a doorway on the south side with a long machine-cut timber lintel (Plate 22 and Plate 23), the centre of which has been scorched by fire (as is the end of the truss immediately above it; Plate 24). This doorway has a recessed section on the north side and an iron bar along the raised slab threshold with corresponding timber battens attached to the lintel above. There is a further doorway at the north end in a similar style, although with the recess on the south side (Plate 25). Part of the flag floor meeting it from the room to the west is missing.

**Plate 19: General view of Room G1, viewed from the south-east**

**Plate 20: General view of Room G1, viewed from the north-east**

**Plate 21: Detail of surviving stall in Room G1, viewed from the east**

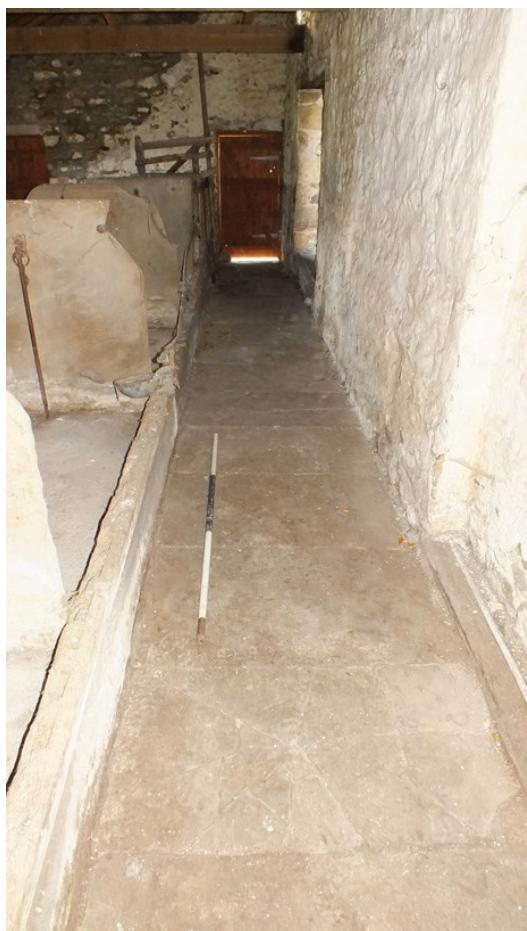
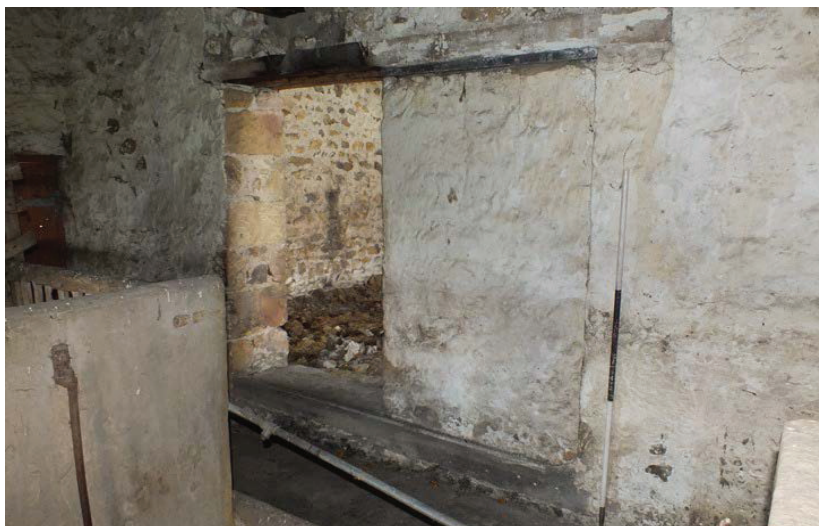
**Plate 22 (left):** Flag floor along the west side of Room G1, viewed from the north

**Plate 23 (right):** Doorway on the south side of the west internal elevation, viewed from the north-east

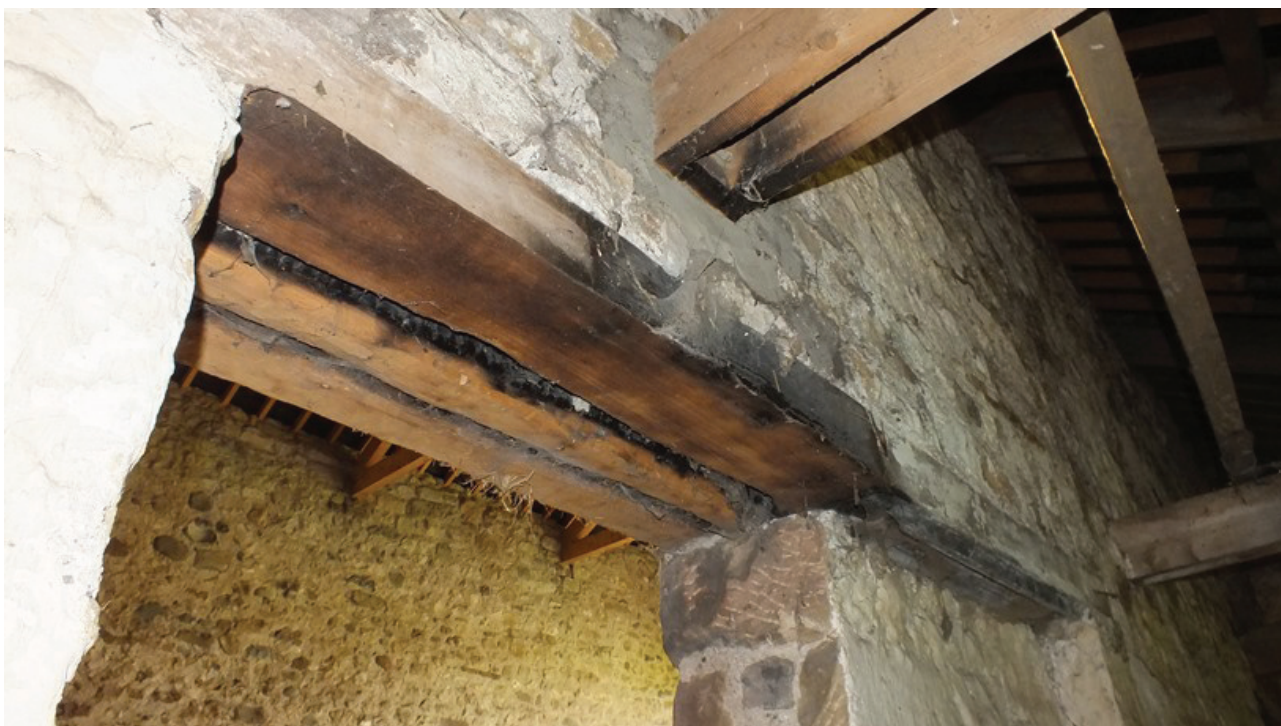
**Plate 24:** Detail of the lintel of the doorway on the south side of the west internal elevation showing the scorching, viewed from the south-east

5.1.5 **Phase 4 (late 20<sup>th</sup> century):** it is apparent from various pieces of evidence within the building (the scorching in Rooms G1 and G2) and anecdotally (Charles Fazackeley pers comm) that the building was badly damaged by fire relatively recently. This clearly resulted in the replacement of the roof structure over Room G2, albeit in a form that perhaps matched the original. It also led to repairs and perhaps fireproofing to the timber lintels of the doorways in the east and west elevations of G2. Elsewhere there has clearly been some loss of elements of the stalls, particularly in Room G3, where what was perhaps originally a window was also knocked through to form a doorway into Room G4.

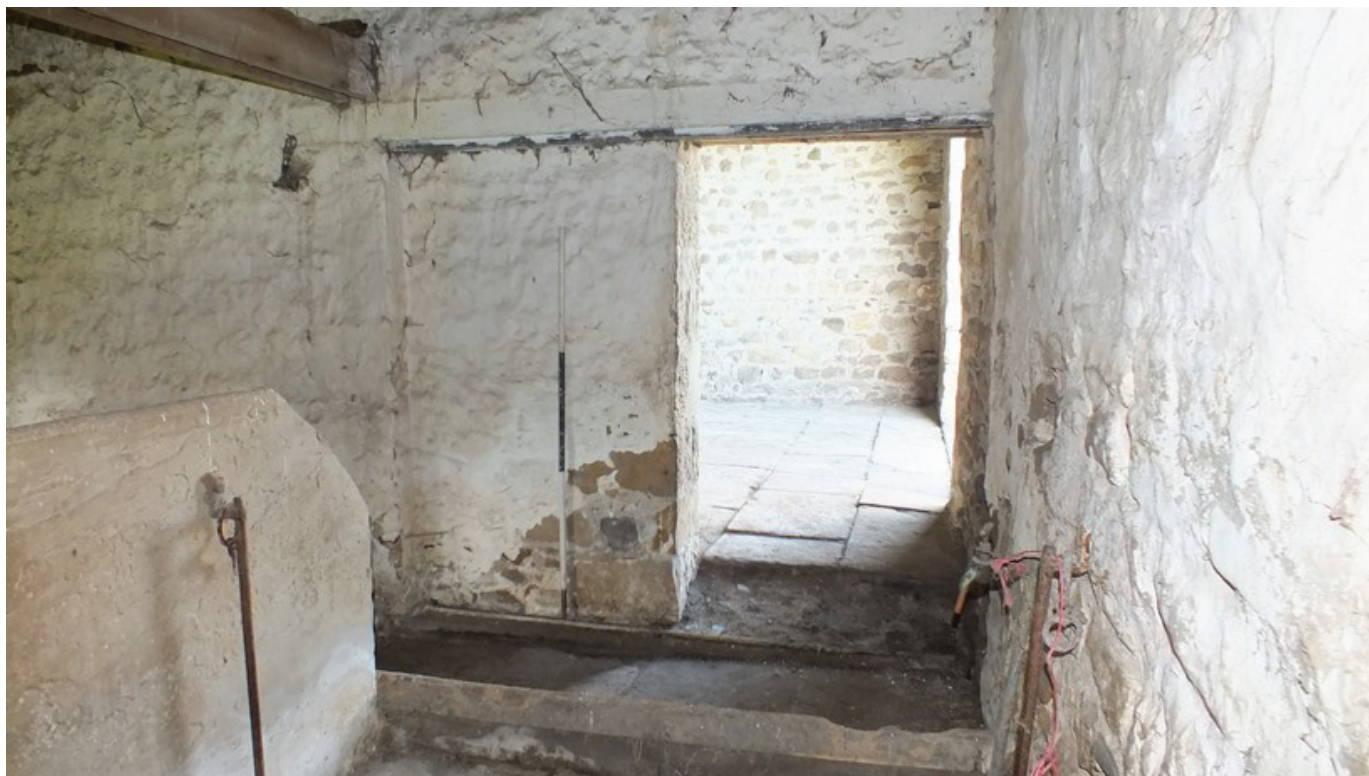
**Plate 25: Doorway at the north end of the west internal elevation of Room G1, viewed from the east**

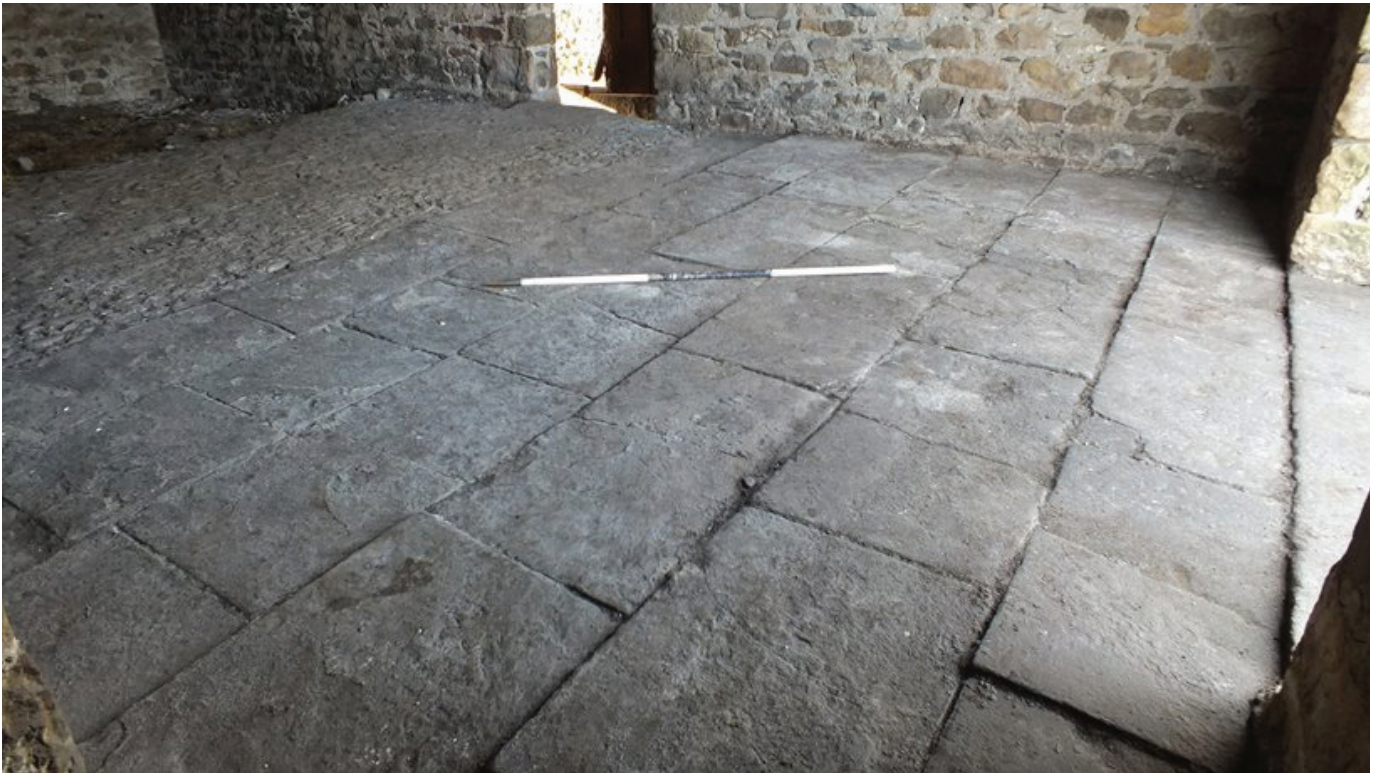
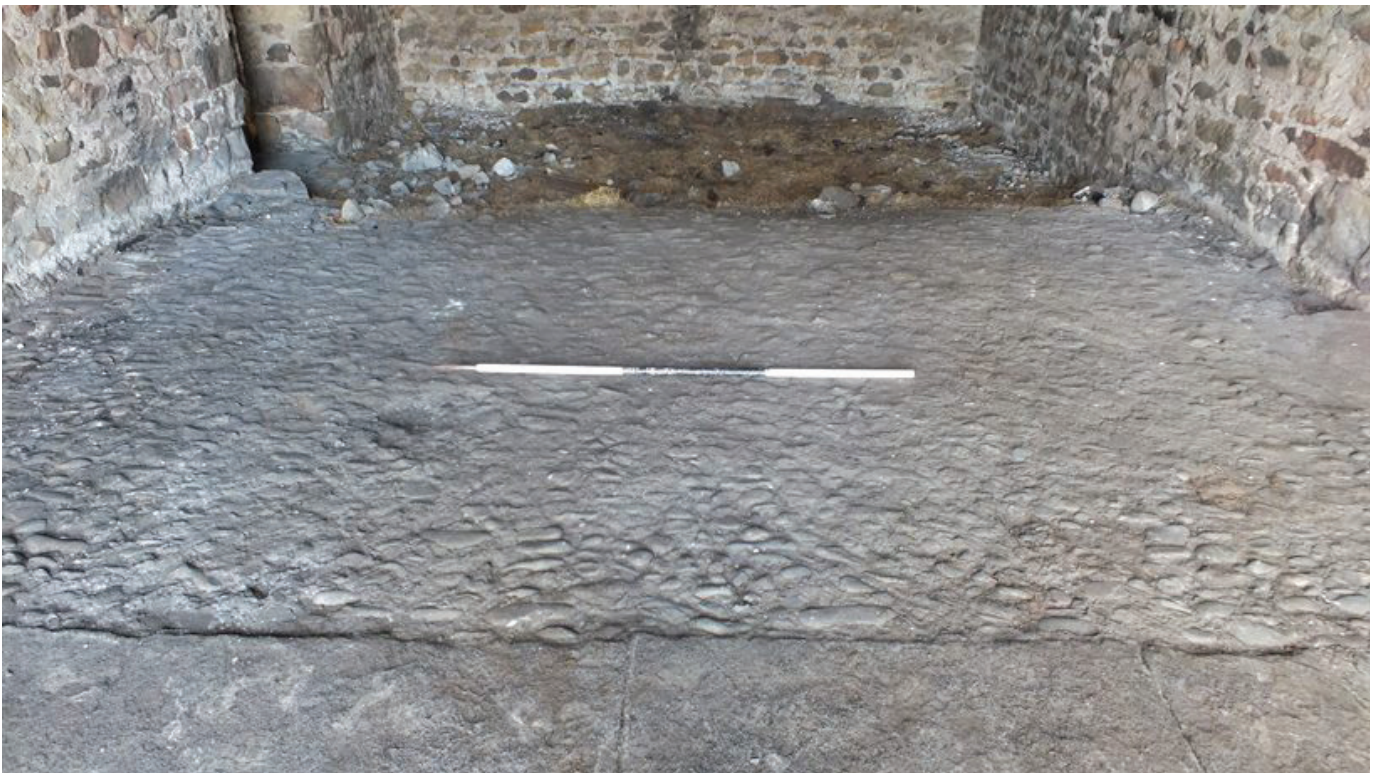
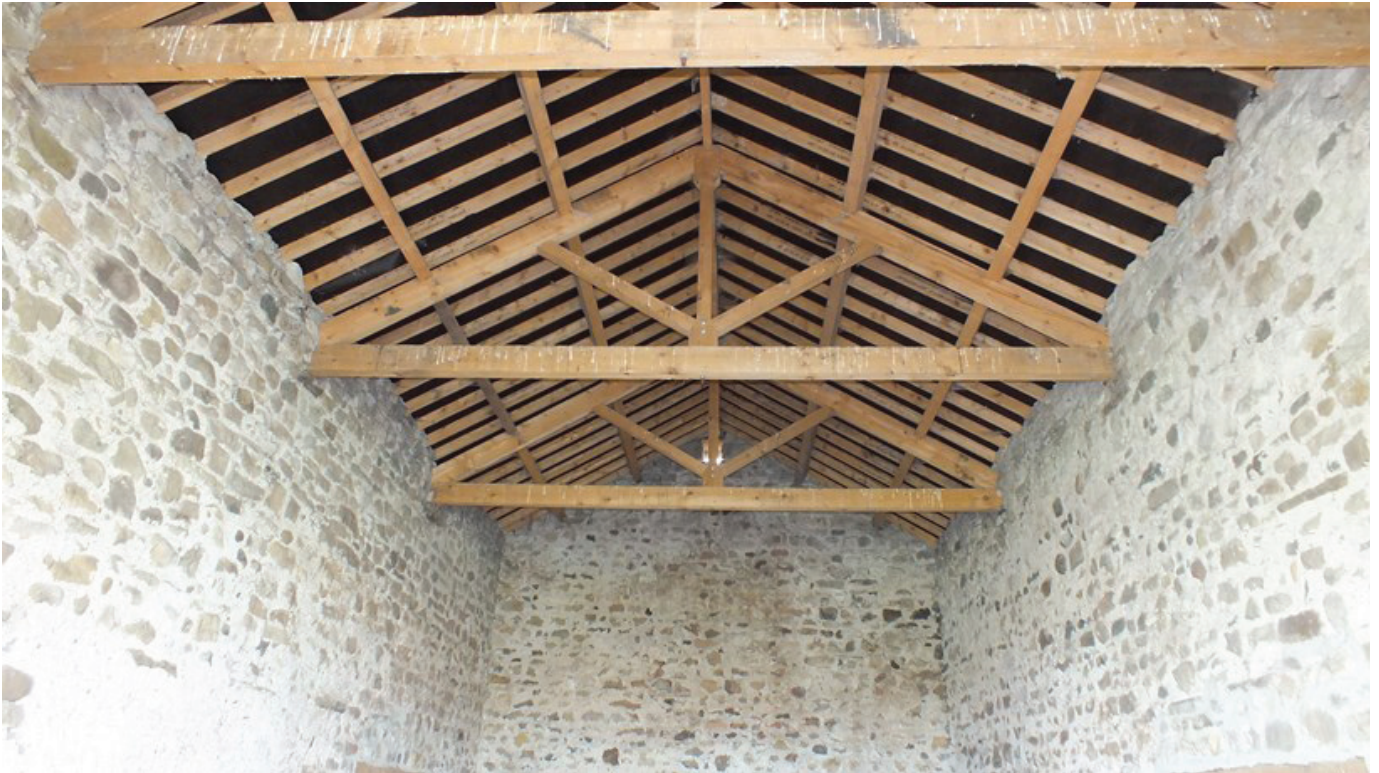
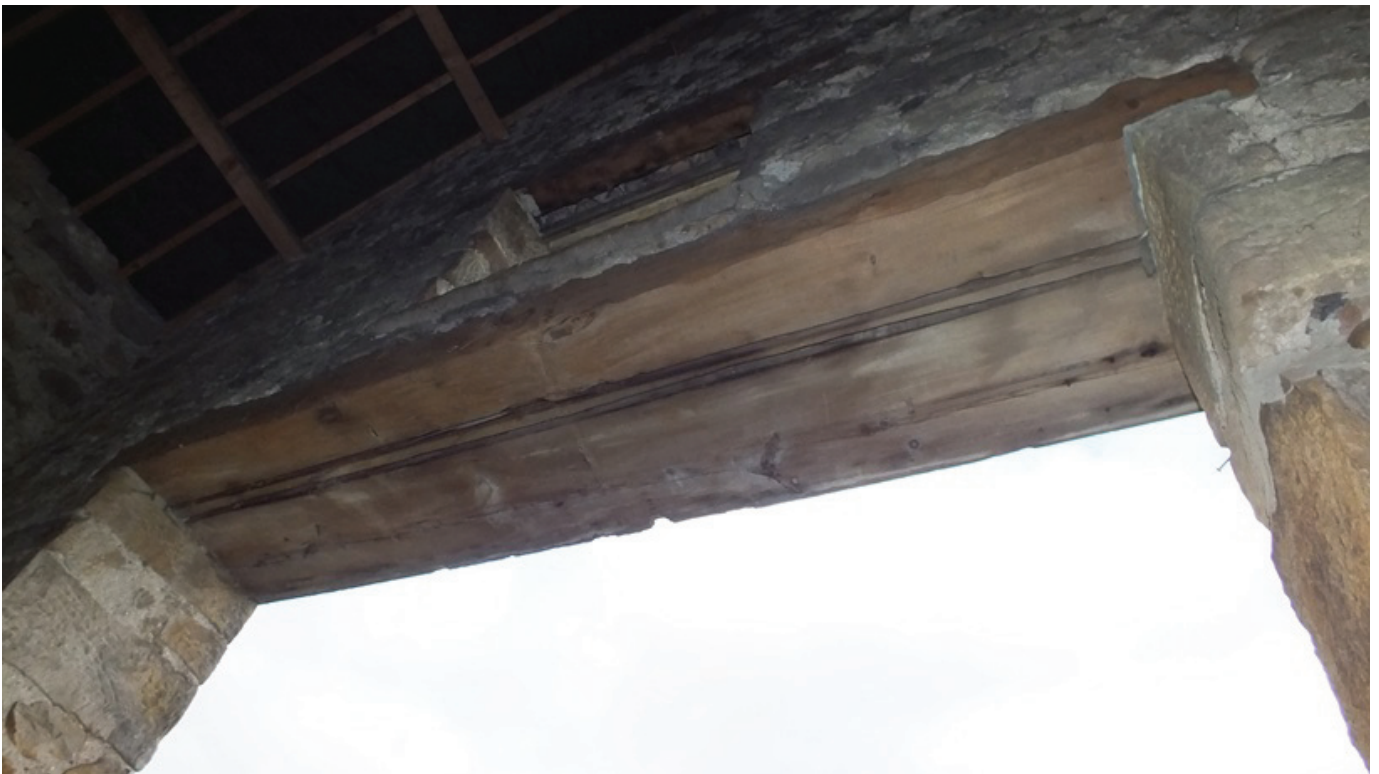
4.3.2 **Ground floor Room 2 (G2):** this comprises the central part of the building. The floor ranges from stone flags on the north side (Plate 26) to cobbles in the centre (Plate 27) but has apparently been removed at the south end leaving just earth at a lower level to the rest. The whole space is open to the roof, which is supported by three king post trusses that are evidently modern, and constructed from machine cut timber and bolted together, but were presumably made to match the originals (Plate 28). Each has a pair of angled braces and there are two purlins per pitch plus a ridge plank. All of the associated roof timbers are clearly quite modern and the slates are backed with modern roofing felt. The walls throughout are exposed stone finished with extruded lime mortar. The north elevation is dominated by a tall wagon doorway with quoined jambs and a heavy machine cut timber lintel with a pair of grooves apparently cut into the underside (Plate 29). Above there is a smaller aperture with a rougher timber lintel and there is a further small opening, presumably an owl hole, above this with a square lintel and quoins. The east elevation has a doorway at the north end with a rough timber lintel and quoined south jamb (the north side being formed by the north wall; Plate 30). At the south end there is a second doorway, which corresponds to the lower floor level at this end, again with a rough timber lintel, possibly treated with fire preventative and clearly a later insert as it has been rebuilt around it with concrete pointing, and quoined jambs. The south elevation is essentially plain although there is an owl hole at the top with a stone lintel and jambs and there is sooting across the centre of the wall. The west elevation also has sooting on the south side and has a near central doorway with a similar inserted lintel to the door to the east and quoined jambs and two stone flag steps leading down into the adjoining room (Plate 31).

**Plate 26: Flag floor on the north side of Room G2, viewed from the north-east**

**Plate 27: Cobbled floor in the centre of Room G2, viewed from the north**

**Plate 28: The roof trusses in Room G2, viewed from the north**

**Plate 29: Detail of the lintel over the wagon doorway in Room G2 showing the grooves, viewed from the south-east**

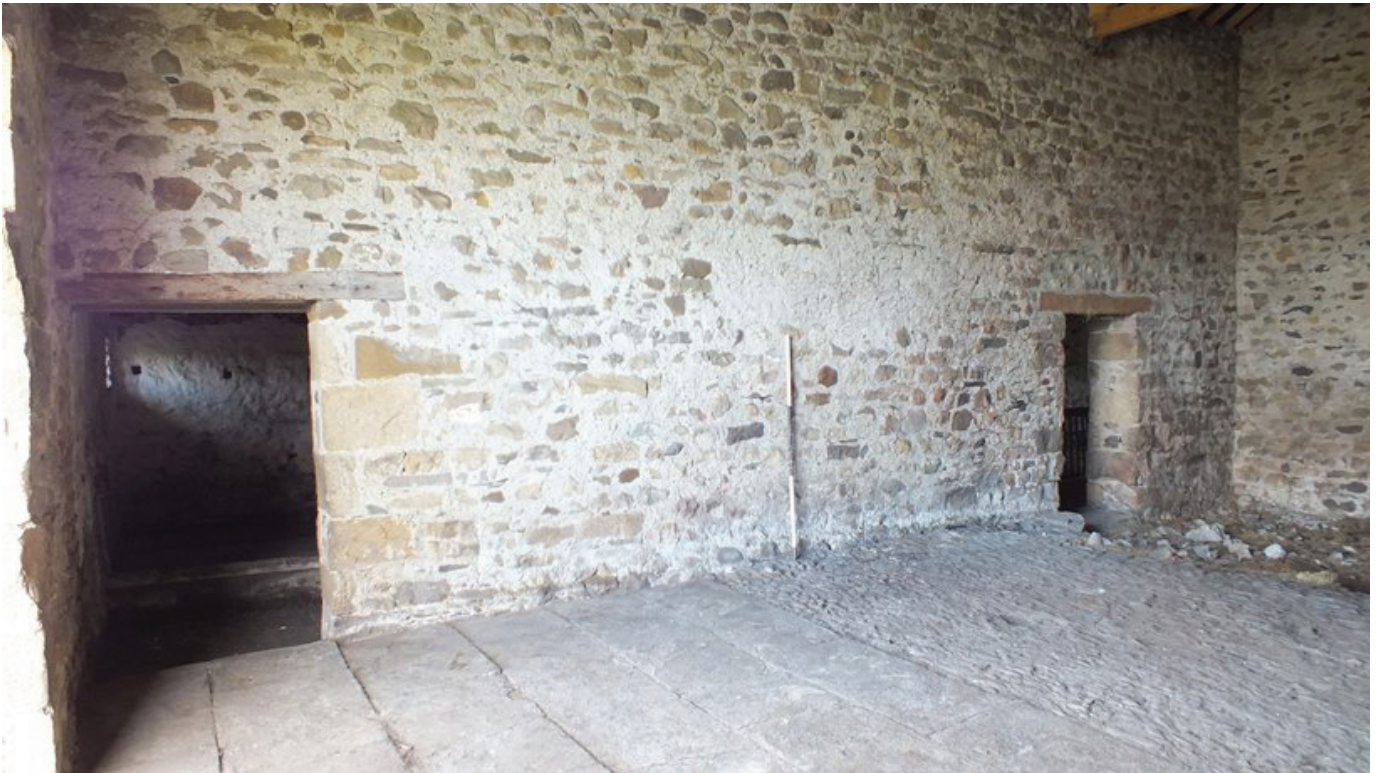
Plate 30: The east internal elevation, Room G2, viewed from the north-west
