# HIGH BARN, SNAB GREEN LANE, ARKHOLME, LANCASHIRE

## Archaeological Building Recording

Planning Application Reference:  
15/00275/PAA

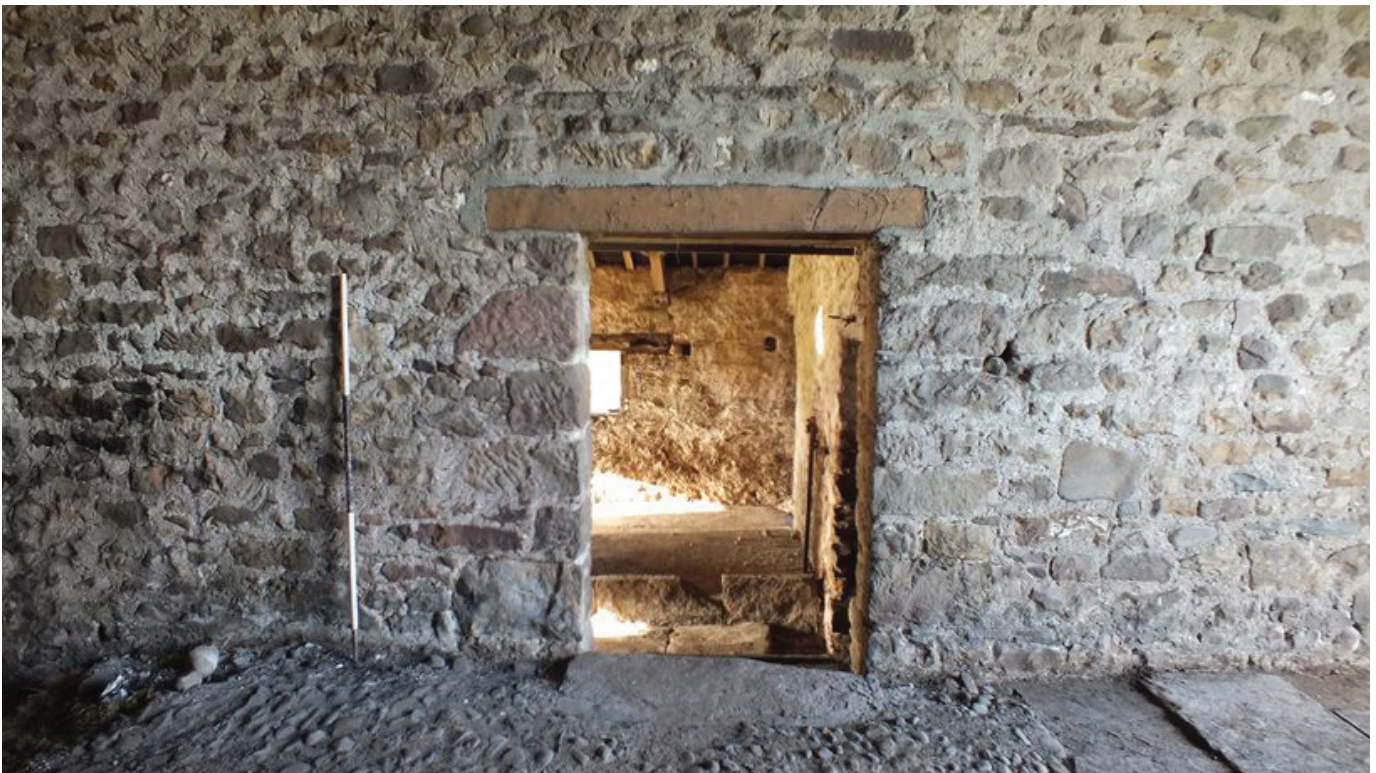
Plate 31: The doorway in the west internal elevation, Room G2, viewed from the east

4.3.2 **Ground floor Room 2 (G2):** this comprises the central part of the building. The floor ranges from stone flags on the north side (Plate 26) to cobbles in the centre (Plate 27) but has apparently been removed at the south end leaving just earth at a lower level to the rest. The whole space is open to the roof, which is supported by three king post trusses that are evidently modern, and constructed from machine cut timber and bolted together, but were presumably made to match the originals (Plate 28). Each has a pair of angled braces and there are two purlins per pitch plus a ridge plank. All of the associated roof timbers are clearly quite modern and the slates are backed with modern roofing felt. The walls throughout are exposed stone finished with extruded lime mortar. The north elevation is dominated by a tall wagon doorway with quoined jambs and a heavy machine cut timber lintel with a pair of grooves apparently cut into the underside (Plate 29). Above there is a smaller aperture with a rougher timber lintel and there is a further small opening, presumably an owl hole, above this with a square lintel and quoins. The east elevation has a doorway at the north end with a rough timber lintel and quoined south jamb (the north side being formed by the north wall; Plate 30). At the south end there is a second doorway, which corresponds to the lower floor level at this end, again with a rough timber lintel, possibly treated with fire preventative and clearly a later insert as it has been rebuilt around it with concrete pointing, and quoined jambs. The south elevation is essentially plain although there is an owl hole at the top with a stone lintel and jambs and there is sooting across the centre of the wall. The west elevation also has sooting on the south side and has a near central doorway with a similar inserted lintel to the door to the east and quoined jambs and two stone flag steps leading down into the adjoining room (Plate 31).

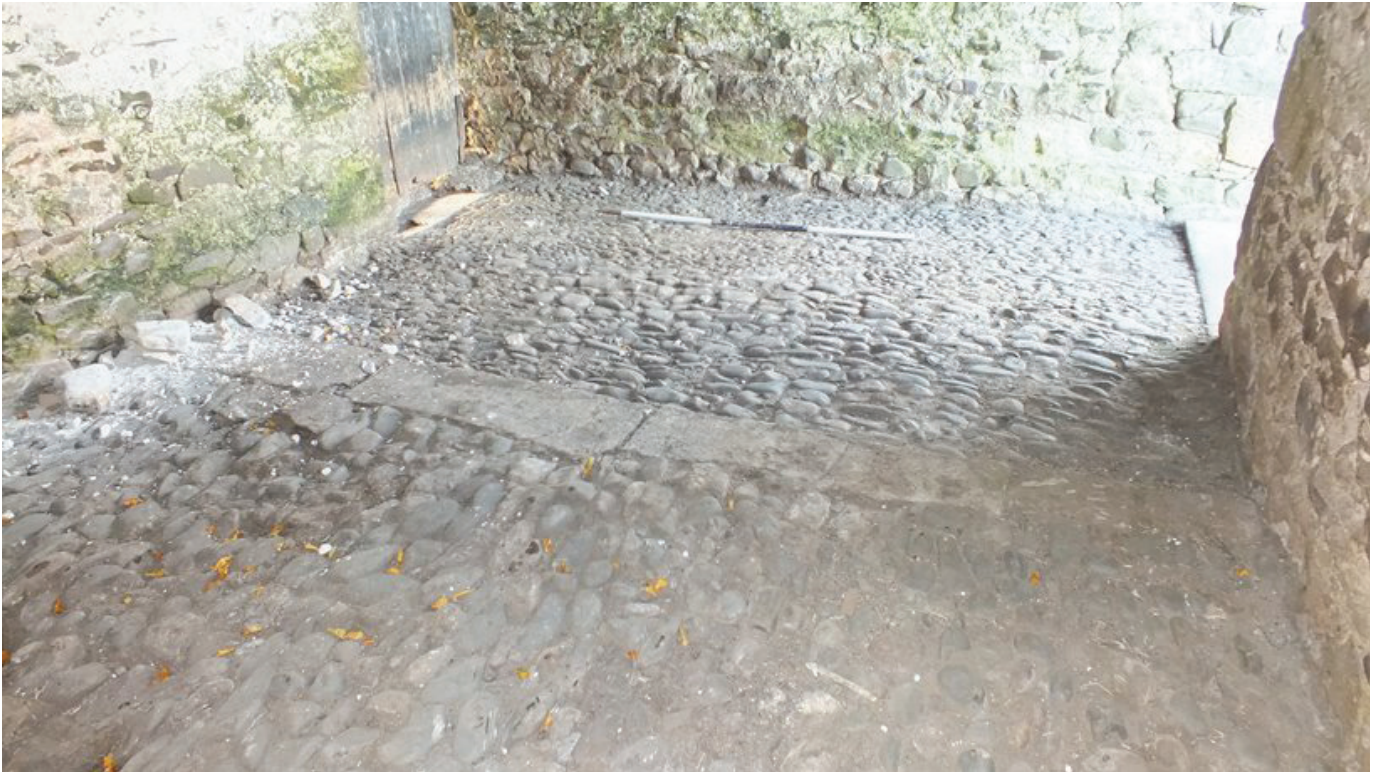
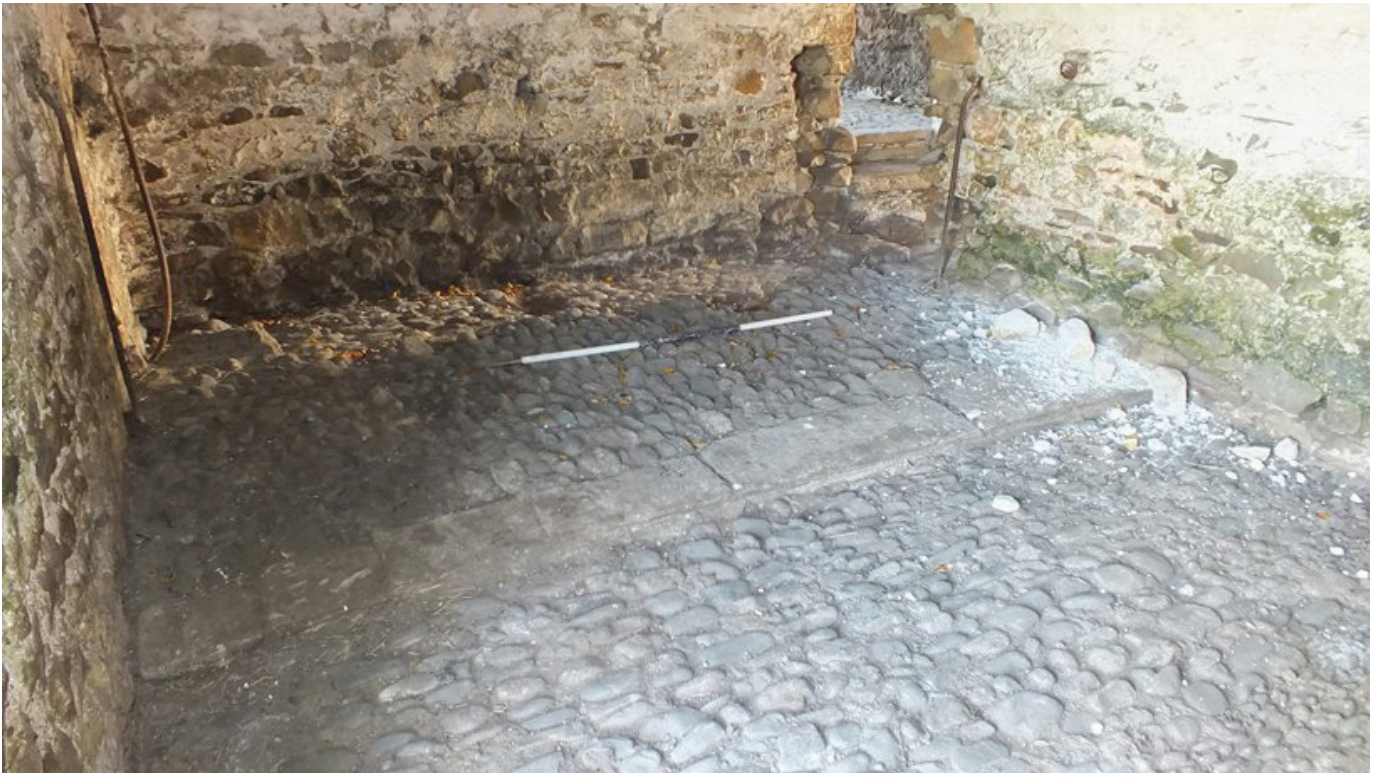
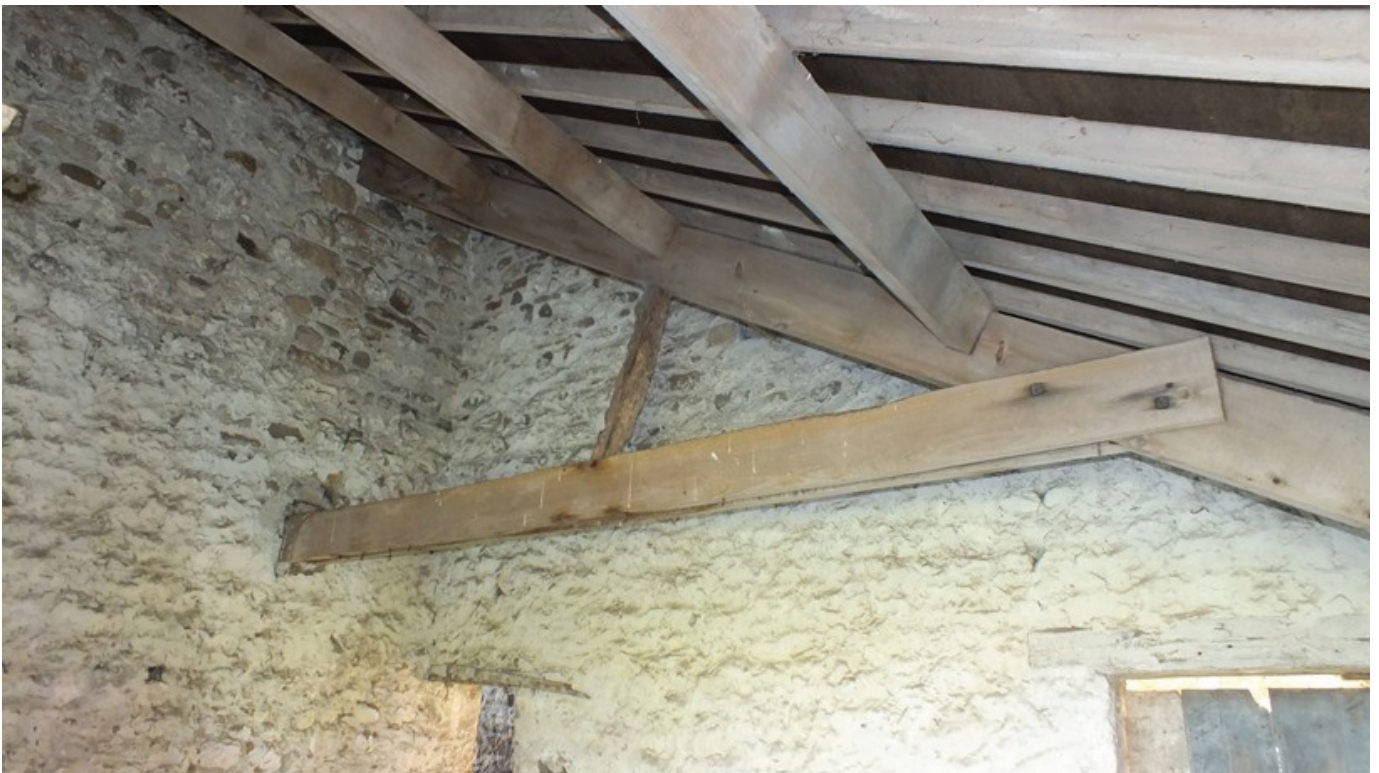
4.3.3 **Ground floor Room 3 (G3):** this comprises the north-east corner of the building. The floor is cobbled, with a section of particularly small cobbles forming a north/south passageway along the west side between the two doors (Plate 32), while the east side has a row of stone blocks forming a step up to a ragged broken edge with part of a raised edge remaining (Plate 33), evidently where there were timber stalls, with a lower cobbled floor forming a feed channel along the east wall. The roof is supported by a

single half truss matching that in Room 1 (see *Section 4.3.1* above; Plate 34) and supported by a scrolled timber corbel set into the west wall (Plate 39). There are three machine cut timber purlins and the rafters are also machine cut. The walls are finished throughout with limewash. The north elevation has a doorway on the west side with a timber lintel and quoined jambs. To the east there is an iron tether post attached to the wall and holes in the wall fabric denoting the position of timbers, presumably part of the stall as they are on the same line as the step in the floor, that have been removed (Plate 35). The east elevation is plain (Plate 36). The south elevation has a rough opening on the east side, the size of a doorway and with a thin timber lintel, but it is clearly been broken through the wall, perhaps from an earlier window (Plate 37). To the west of it an iron tether post is attached to the wall and at the west end there is a proper doorway with a timber lintel and plank and batten door on pivot hinges (Plate 38). The west elevation has a row of three small square holes, evidently vents and corresponding with the ceramic pipes visible externally (Plate 39). Just off centre is a window with a thin timber lintel and thin stone sill filled by timber slats.

**Plate 32: The floor on the west side of Room G3, viewed from the north-east**

**Plate 33: The floor on the east side of Room G3, viewed from the north-west**

**Plate 34: Truss in Room G3**

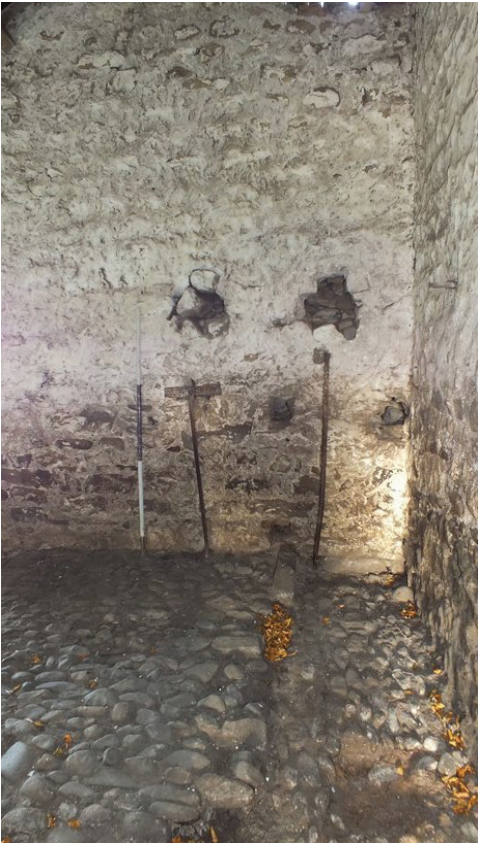
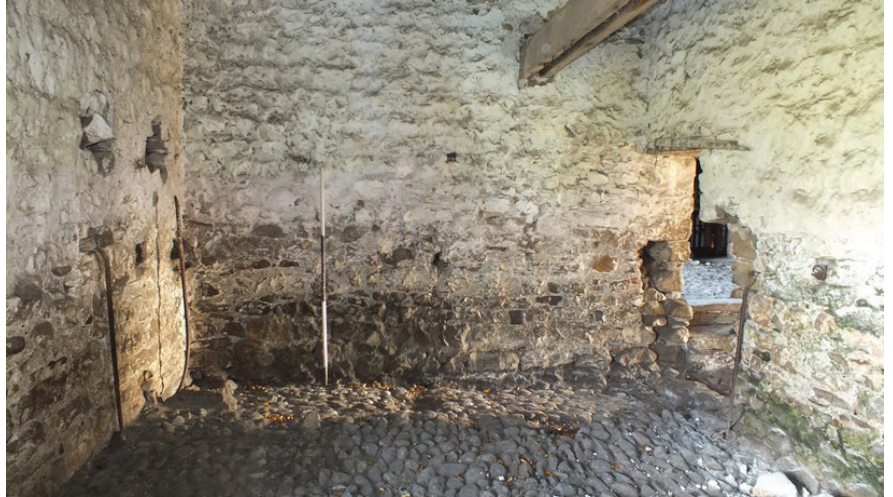
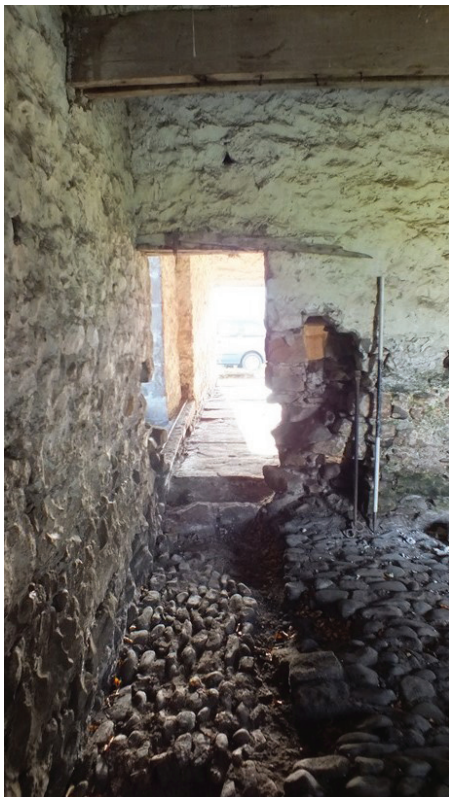
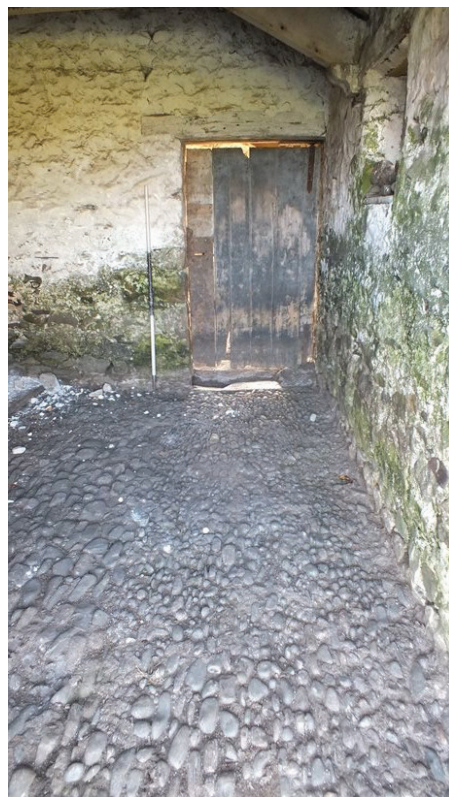
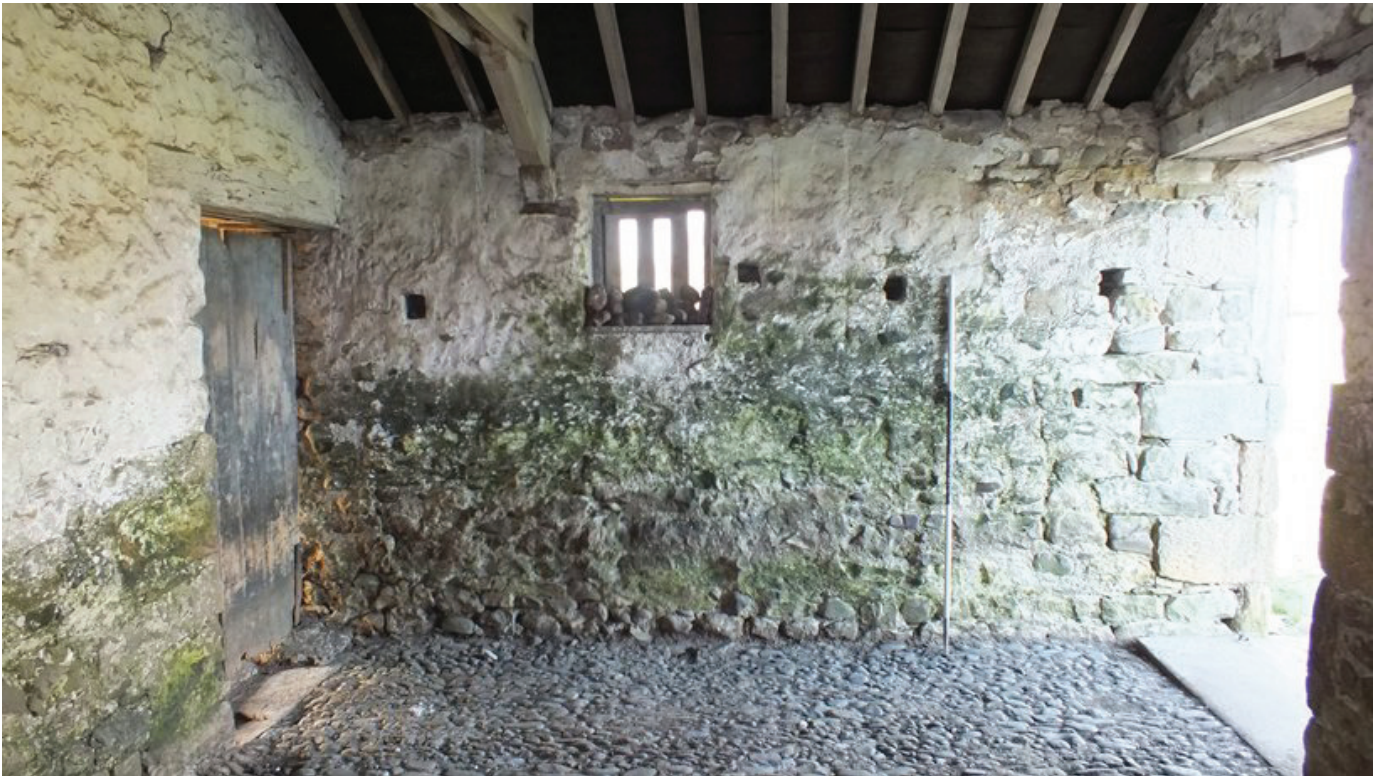
**Plate 35 (left): Holes in the east side of the north internal elevation, Room G3, viewed from the south**

**Plate 36 (right): The east internal elevation, Room G3, viewed from the east**

**Plate 37 (left): Doorway on the east side of the south internal elevation of Room G3, viewed from the north**

**Plate 38 (right): Doorway on the west side of the south internal elevation of Room G3, viewed from the north**

**Plate 39: The west internal elevation of Room G3, viewed from the east**

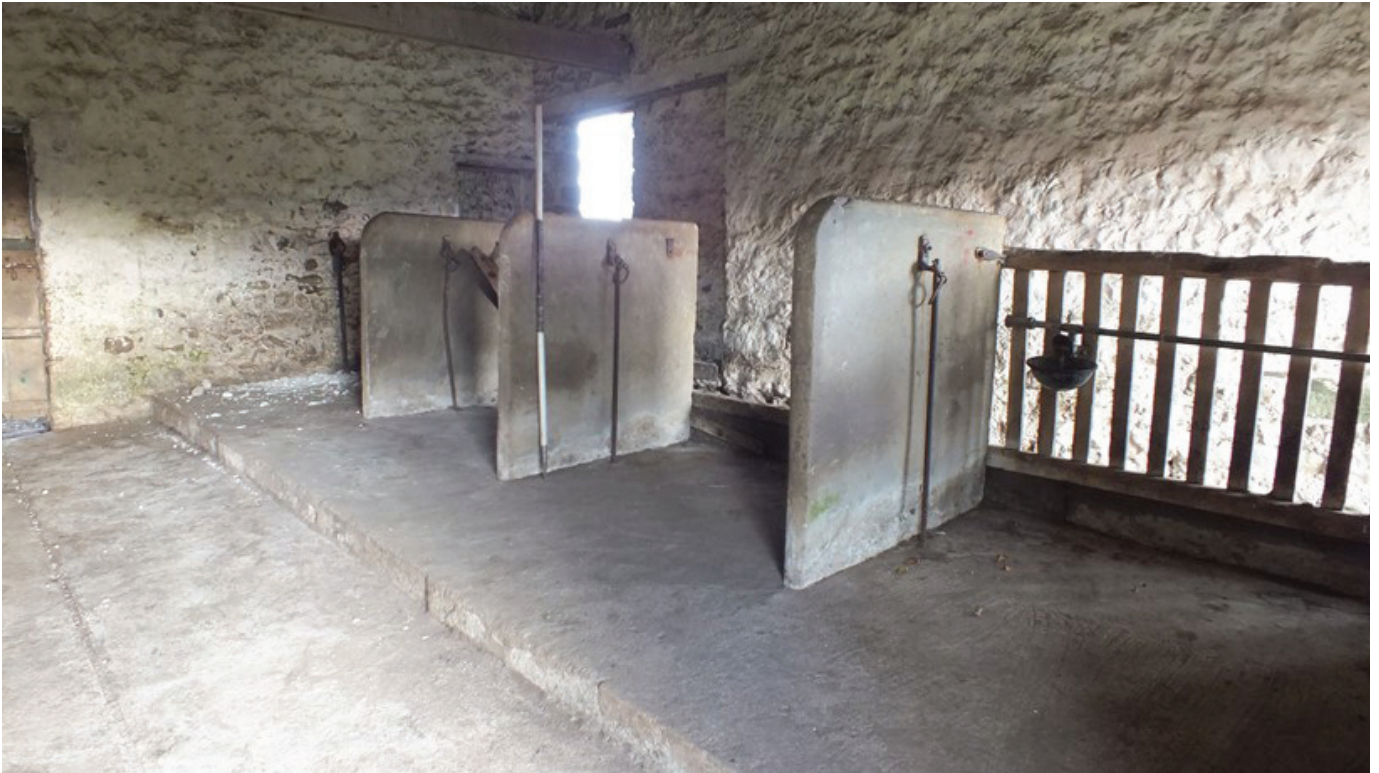
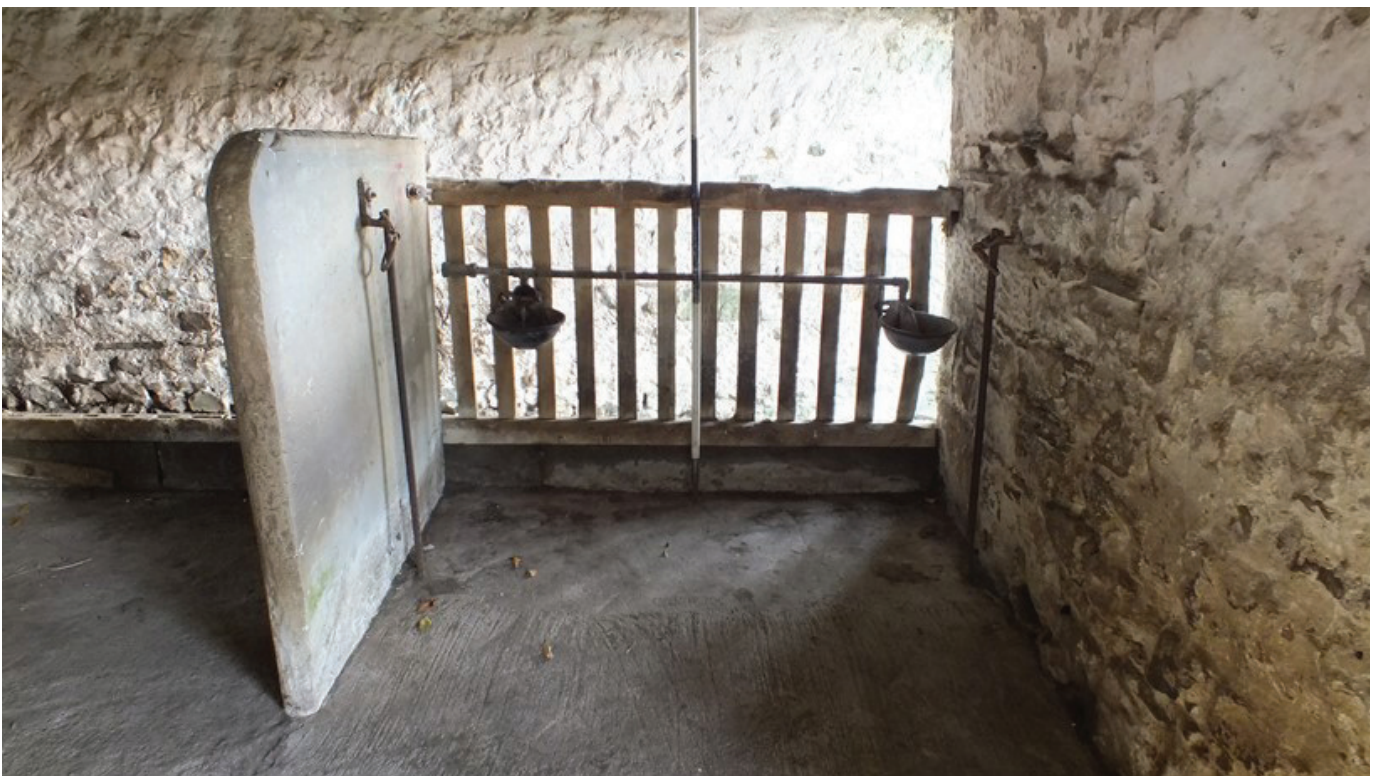
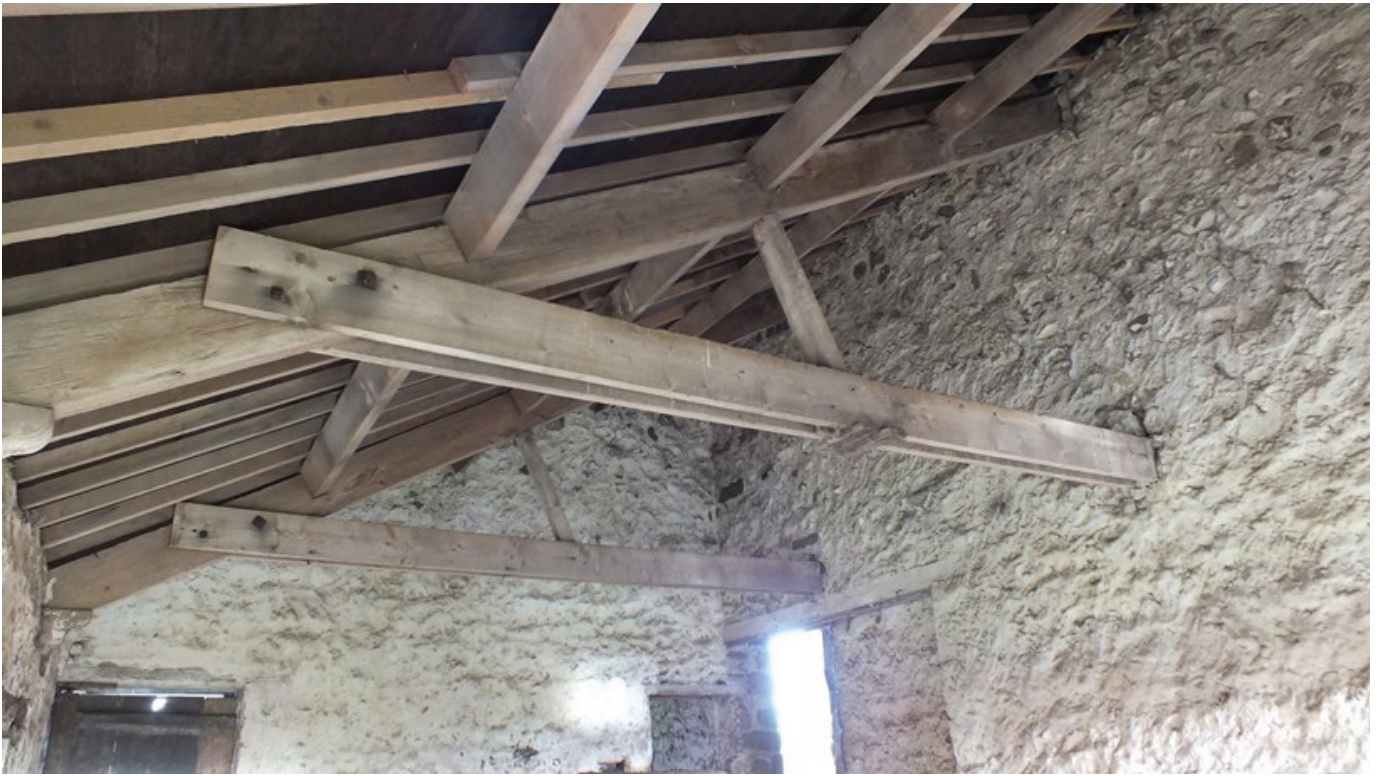
**4.3.4 Ground floor Room 4 (G4):** this forms the south-western corner of the building. It has a concrete floor on the west side, stepping up in the centre where it meets three stalls constructed from stone slabs, each with two iron tether posts attached, forming four stalls (Plate 40). There are also lower edge-set slabs forming the east edge with holes in the top to support a timber panel, part of which still remains at the south end as well as some of the water piping and metal troughs (Plate 41), which are the same as those in Room 1. Beyond this the floor of the associated feed passage is stone flags against the east side of the room. The roof is supported by two half trusses, as per those in Room 1 (Plate 42), again supported by scrolled timber corbels in the west elevation. There are also three purlins, all of which are machine cup timber, as are the rafters. The north elevation has a doorway on the west side with a beaded tongue and groove door with stop-chamfer decoration to the battens (Plate 43). To the east of this there is an iron tether post and an iron plate attached and at the east end is the inserted and very rough doorway, the lintel of which is thicker on this side, which clearly does not respect the floor levels of the two different rooms (Plate 46). Immediately to the west of this is a hole through the wall, perhaps where part of the timberwork of the stalls was attached. The east elevation has a doorway on the north side with thick stone slabs forming two steps up, one of which has an iron bar fixed to it (Plate 45). To the south of the opening there is a recessed section of wall and a machine cut timber lintel with paired smaller battens attached underneath. The south elevation has doorways on the east and west sides with fairly rough timber lintels and quoined jambs. On the east side there is a pair of small apertures above the doorway corresponding to the vents visible externally and a third above that is blocked, as well as a small hole in the wall, perhaps corresponding to the location of a beam forming part of the stalls (Plate 46). There are iron straps fixed below the central and west purlins and to the wall (Plate 47). The west elevation has a row of seven square vents, corresponding to the ceramic drains visible externally, and two scrolled timber corbels supporting the trusses (Plate 48). North of centre there is a window with a very rough timber lintel and thin stone sill, which has the remains of a hinged timber casement (Plate 48). There are also painted marks around the window, presumably tallies relating to the animals that were housed here.

**Plate 40: Stalls within Room G4, viewed from the west**

**Plate 41: Detail of the intact stall at the south end of Room G4, viewed from the west**

**Plate 42: Trusses in Room G4, viewed from the south-west**

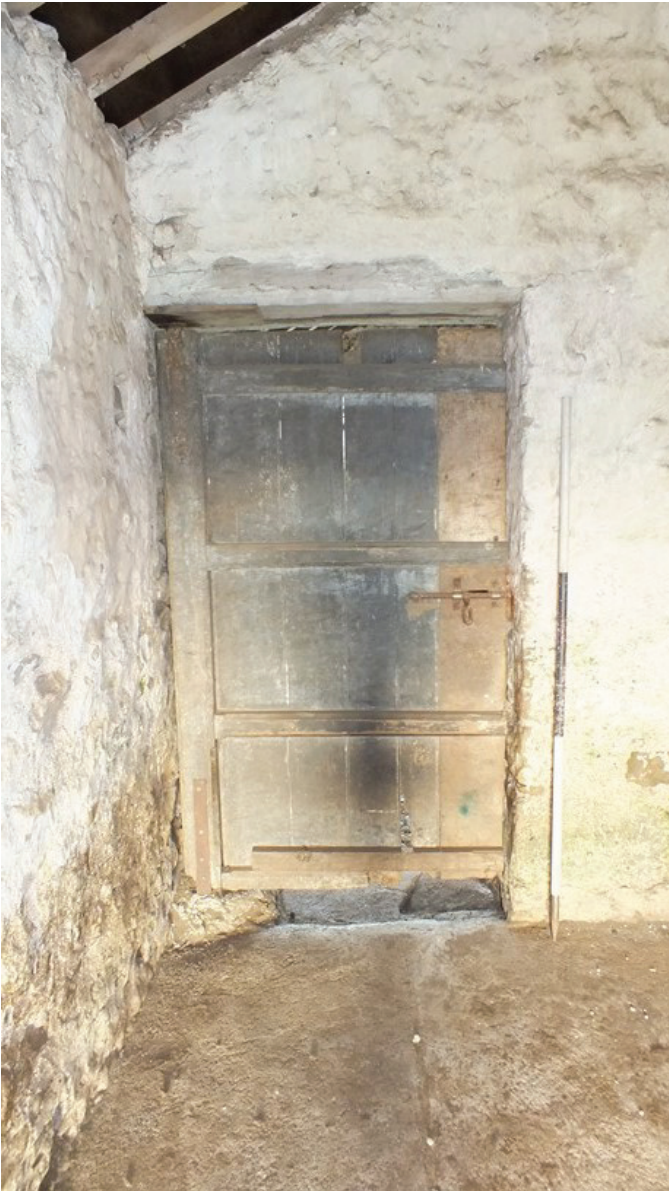
**Plate 43 (left):** Doorway on the west side of the north internal elevation of Room G4, viewed from the south  
**Plate 44 (right):** Doorway on the east side of the north internal elevation of Room G4, viewed from the south

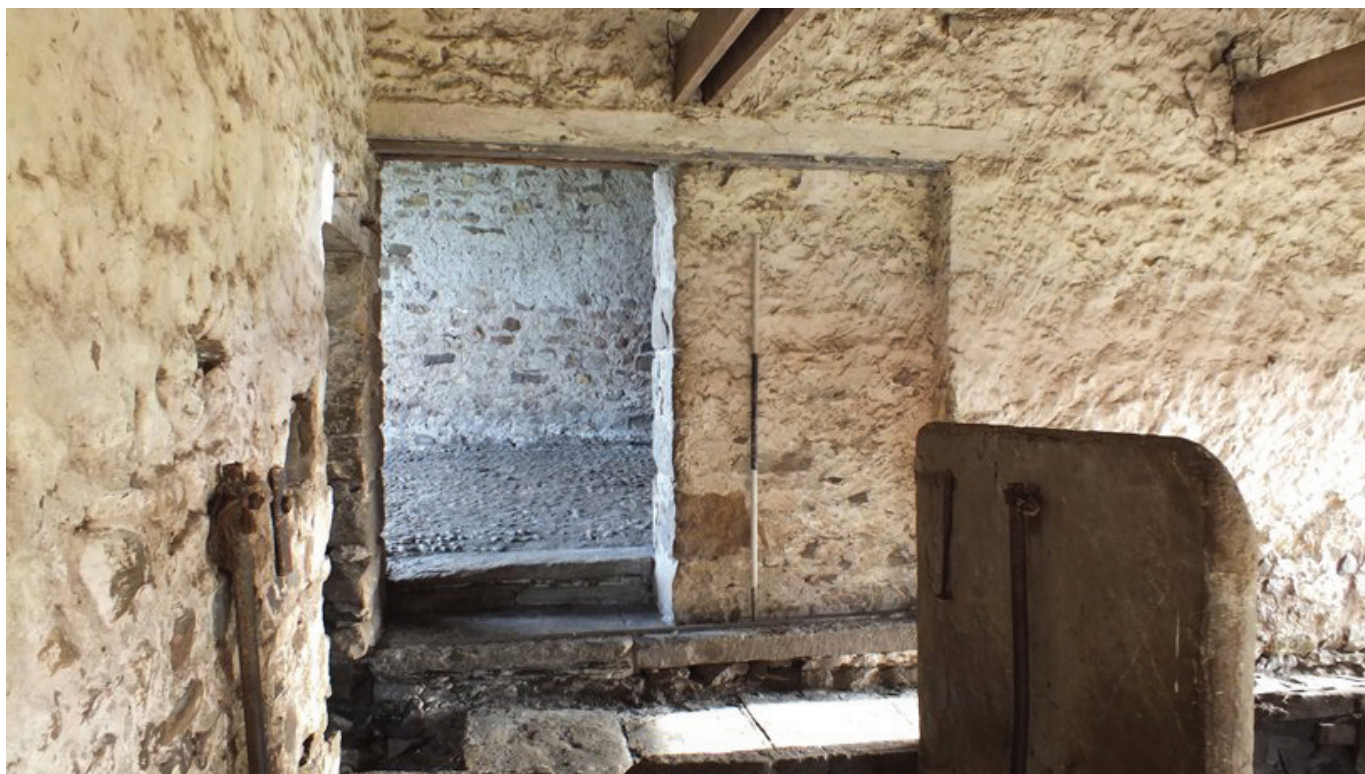
**Plate 45: Doorway on the north side of the east internal elevation of Room G4, viewed from the west**

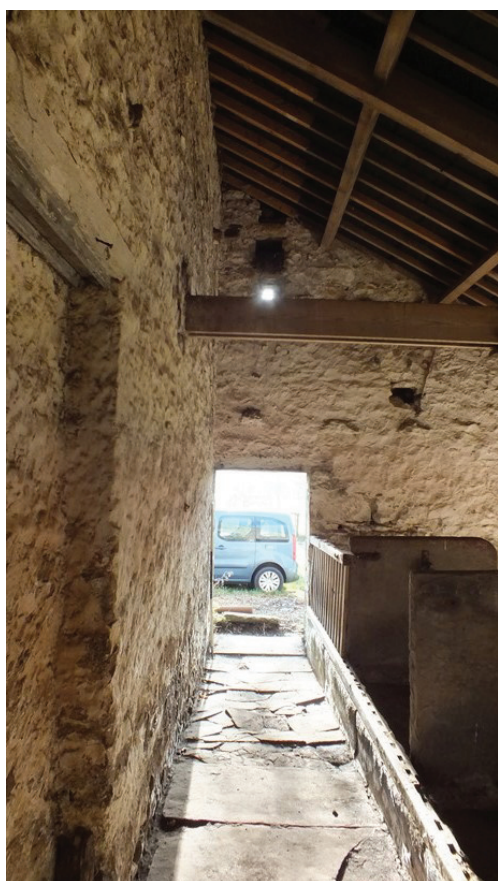
**Plate 46 (left): The doorway and vents on the east side of the south internal elevation of Room G4, viewed from the north**

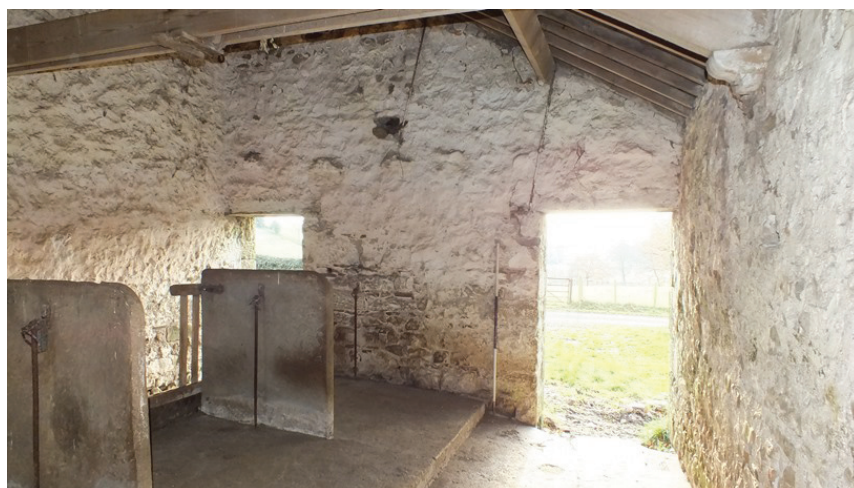
**Plate 47 (right): The west side of the south internal elevation of Room G4, viewed from the north-west**

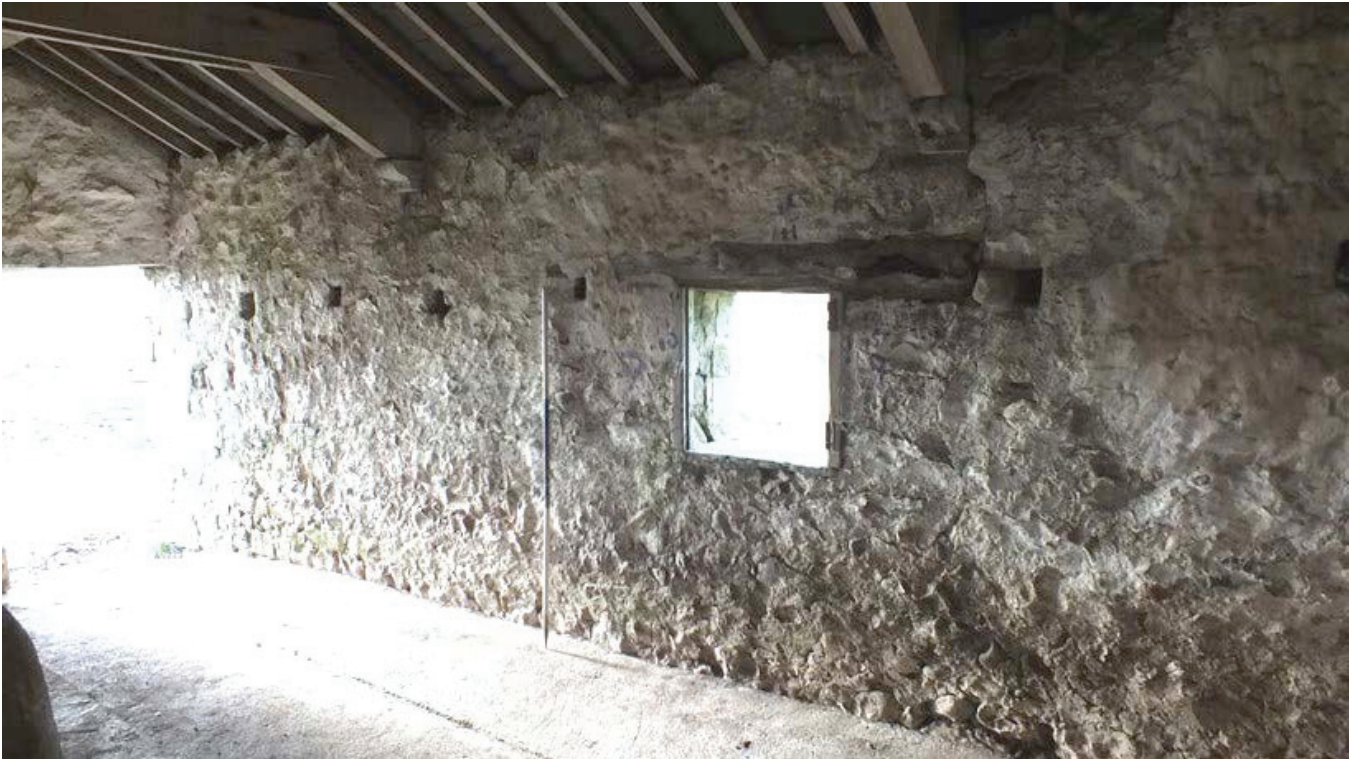
**Plate 48: The west internal elevation of Room G4, viewed from the north-east**
