# LEVENS HALL, KENDAL, CUMBRIA

## Archaeological Watching Brief

Client: Levens Heritage

February 2017

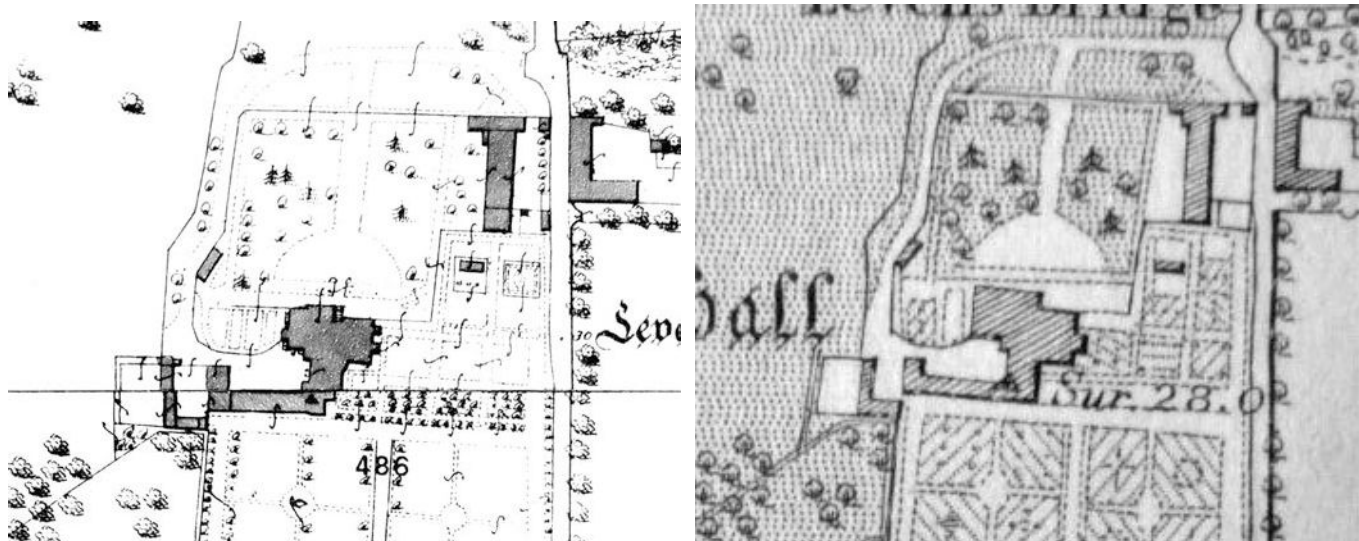
Plate 3 (left): Ordnance Survey map c1862

Plate 4 (right): Ordnance Survey map 1862

3.2.2 **Ordnance Survey map c1862**: the early editions of the Ordnance Survey mapping show open areas of the courtyard and between the courtyard and the potting sheds (see Plate 3 and Plate 4). The area to the west of the potting sheds (currently the site of the greenhouses) appears to be undeveloped.

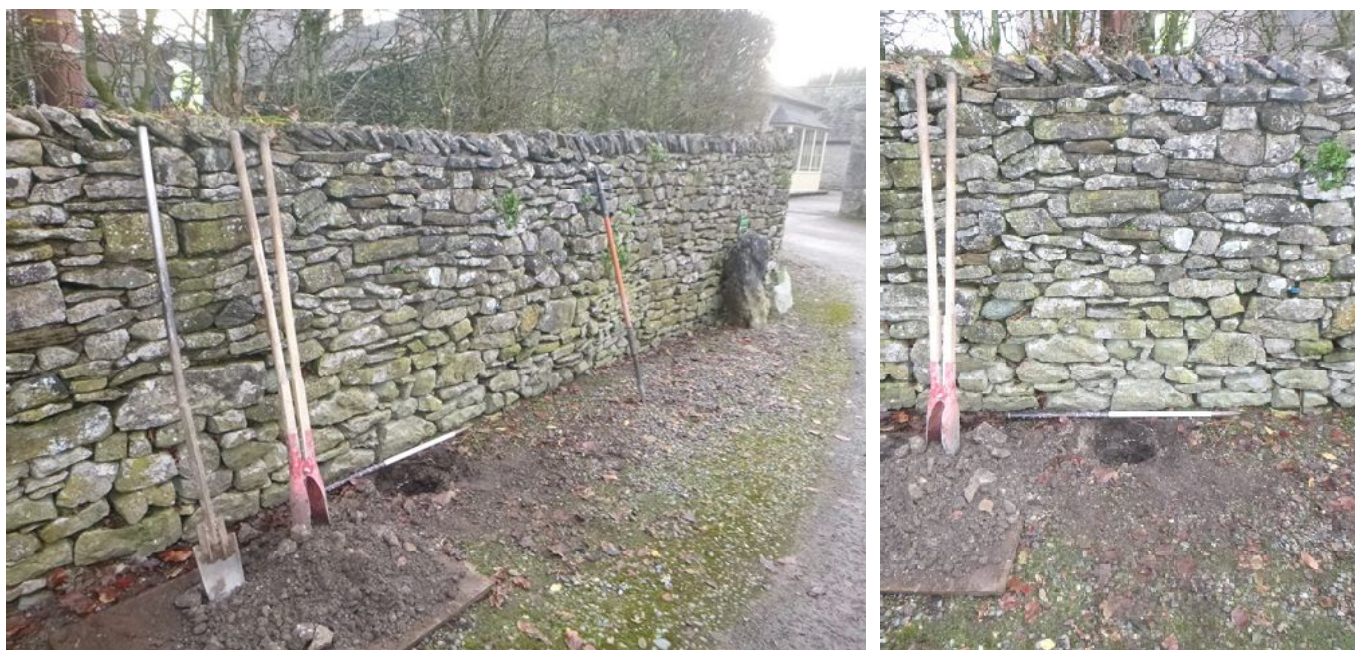
4.2.1 **TP01**: this test pit, which measured c0.3m by 0.4m, was located immediately to the west of the boundary wall of the garden (Plate 7 and Plate 8). The uppermost deposit comprised a loose pale gravelly material, 0.1m thick (**100**), over a very dark greyish brown sandy-silty-clay matrix, with 75% rounded gravel and 10% angular cobbles, 0.5m thick (**101**). There was a large boulder at the base on the east side, which possibly formed part of the footing for the extant wall, extending to a depth of c0.5m (Plate 9).

Plate 7 (left): Location of TP01 against the wall, viewed from the north-west

Plate 8 (right): TP01 and the wall, viewed from the west

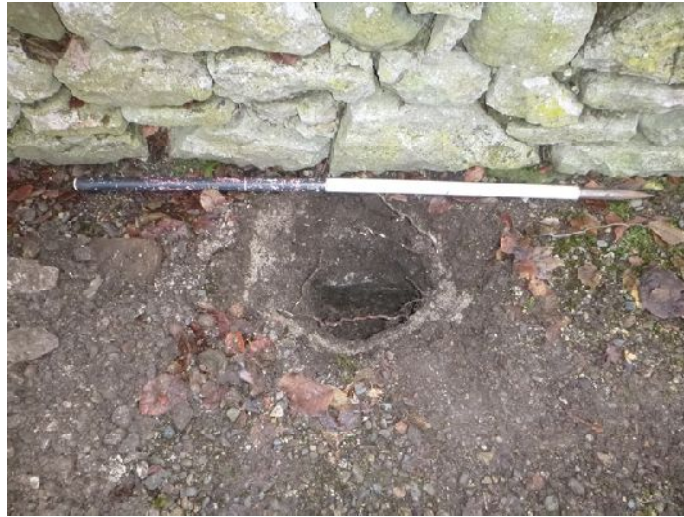
**Plate 9: TP01 excavated, viewed from the west**

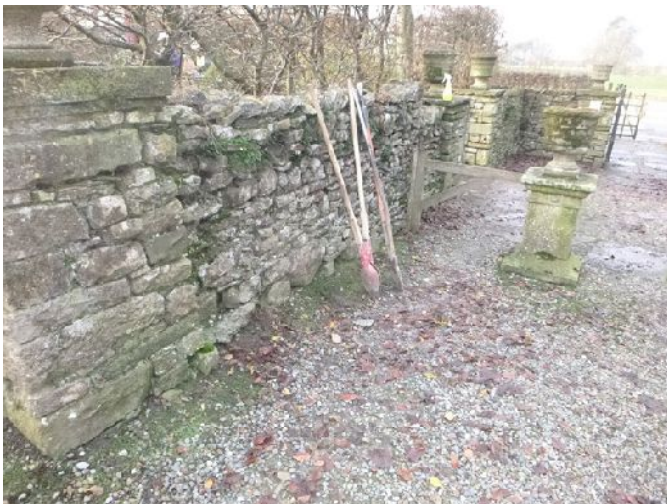
4.2.2 **TP02**: this test pit was located immediately north of the boundary wall (Plate 10). The initial deposit of loose, rounded gravel, mixed with lime mortar, 0.1m thick (**200**), became more rubble filled, with angular limestone cobbles in mid brown sandy-silt, but still contained lime mortar and some slate, to a depth of at least 0.5m (**201**). The south side had a well-built wall, six courses remaining, 0.6m deep (**202**). This earlier wall was below the current wall, 0.45m north/south 0.3m east/west, 0.25m to 0.3m out from the extant wall (Plate 11).

**Plate 10 (left): TP02 pre-excitation, viewed from north-east**

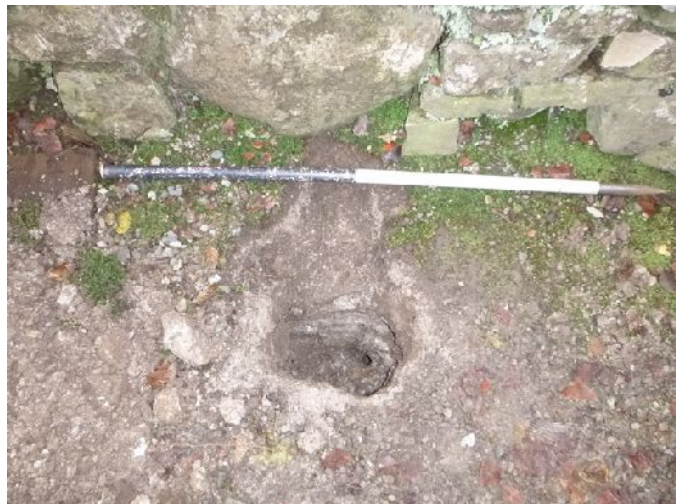
**Plate 11 (right): TP02 excavated, viewed from the north**

5.1.2 The only archaeological feature revealed during the watching brief was the wall exposed in TP02. The purpose and date of this is uncertain. No buildings are recorded in this location and so it is likely to represent the remains of an earlier boundary wall, pre-dating the one that now defines the north side of the garden.

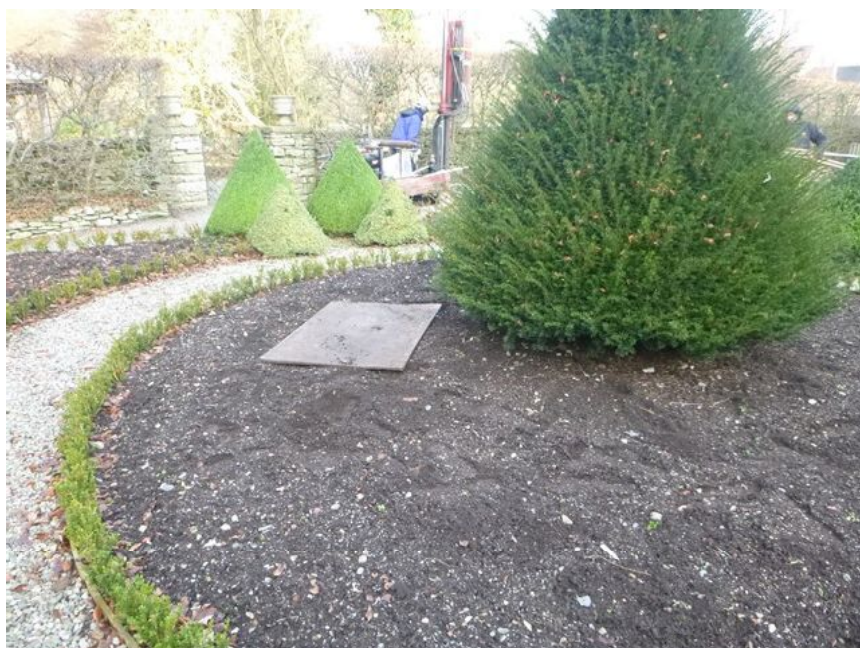
4.2.3 **TP03**: this test pit was located in the round flowerbed to the west (Plate 12 and Plate 13). The initial deposit comprised a very dark brownish grey garden soil, that was very loose and loamy and 0.35m thick (**300**), which lay over a firmer and more brown silty clay (**301**), with 25% angular limestone cobbles and lime mortar flecks over 0.7m thick (Plate 14).

Plate 12 (left): TP03 pre-excitation, viewed from the south-east

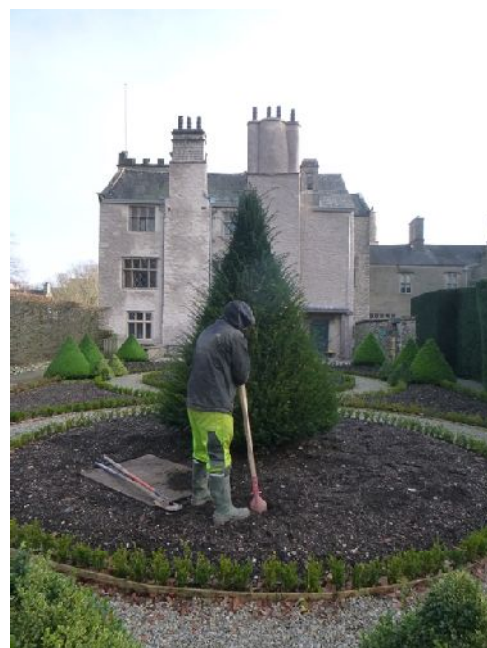
Plate 13 (right): TP03 working shot, viewed from the east

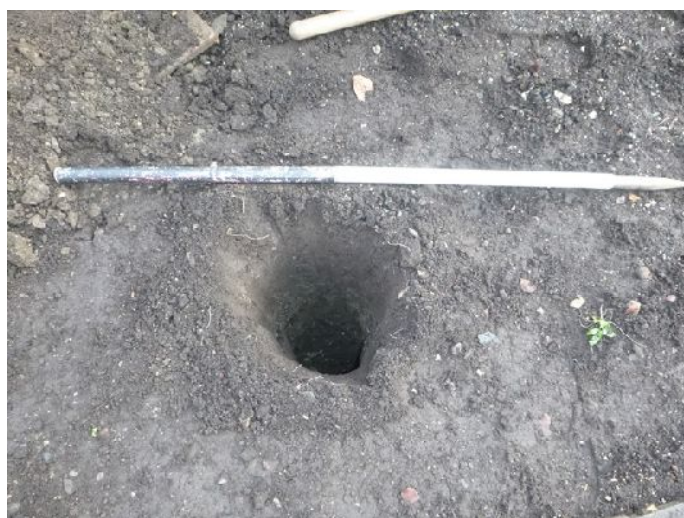
Plate 14: TP03 excavated, viewed from the east

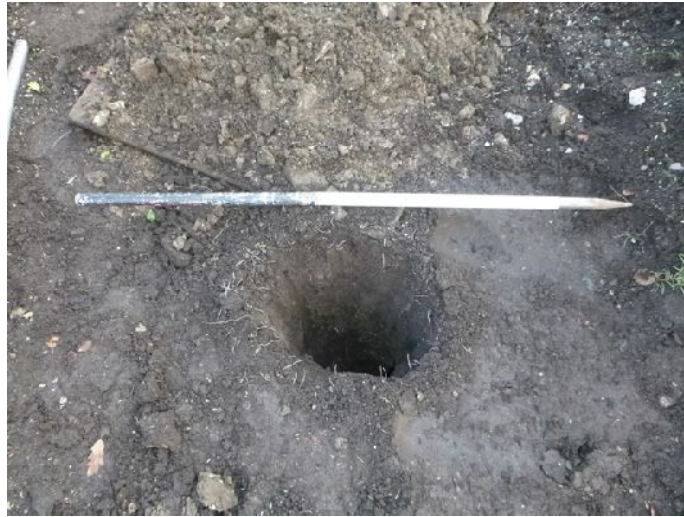
4.2.4 **TP04**: this test pit was in the round flowerbed to the east. The initial deposit comprised a loose dark brownish-grey loam, 0.3m thick (**400**), over a firmer mid-brownish-grey silty clay, with 25% angular limestone cobbles, lime mortar, bone, and shell, at least 0.7m thick and extending to the base of the pit (**401**) (Plate 15).

Plate 15: TP04 excavated, viewed from the north-east

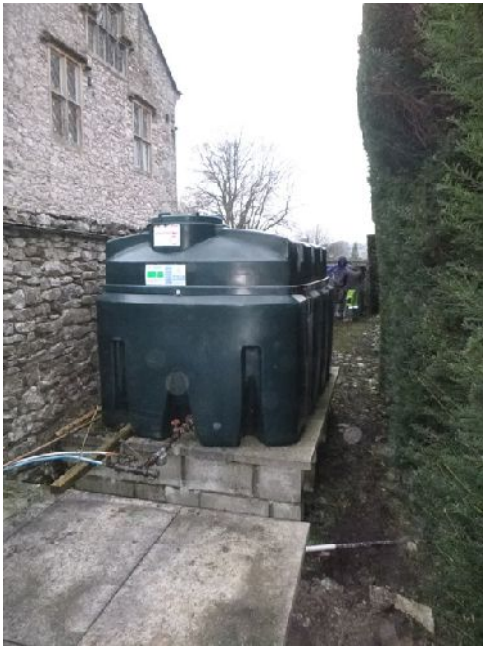
4.2.5 **TP05**: this test pit was located next to the tanks against the south side of the area, outside of the garden proper (Plate 16). The upper deposit of dark grey soft loam, 0.15m thick (**500**), overlay mid greyish-brown silty-clay with lime mortar and 10% angular cobbles, 0.25m thick (**501**), which in turn overlay a paler brown sandy clay with lime mortar and 10% angular cobbles (**502**), 0.6m thick (Plate 17).

Plate 16 (left): TP05 working shot, viewed from the west

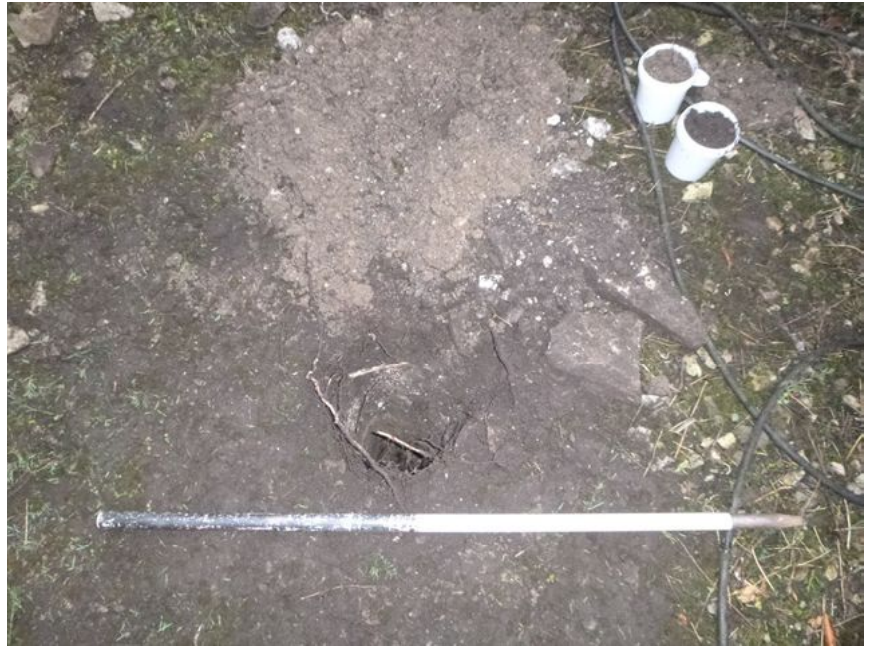
Plate 17 (right): TP05 excavated, viewed from the east

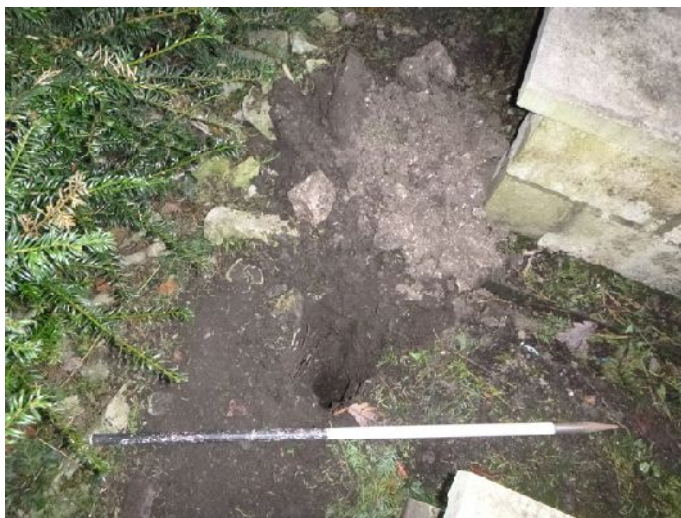
4.2.6 **TP06**: this test pit was also located on the south side of the area, to the east of TP05 and TP07. The upper deposit of soft dark grey silt, with 30% angular cobbles, was 0.35m thick (**600**), and lay over a paler grey silty-clay with lime mortar and 15% angular cobbles, 0.7m thick (**601**) (Plate 18).

**Plate 18: TP06 excavated, viewed from the south-east**

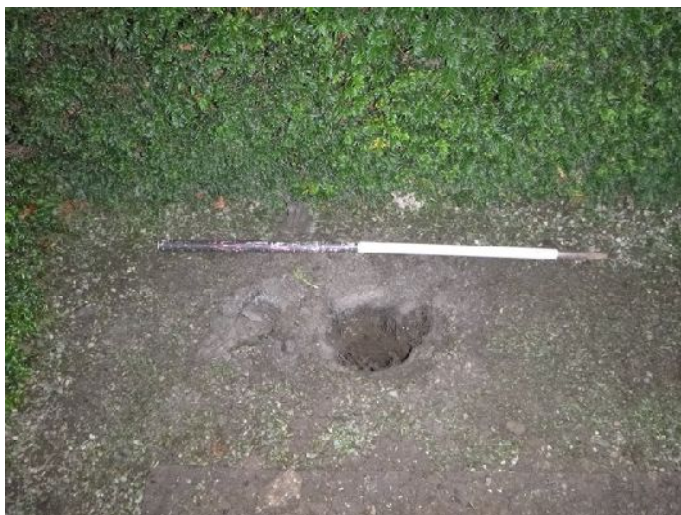
4.2.7 **TP07**: this test pit was located within the path on the south side of the gardens. The initial deposit of gravel forming the path, which was 0.1m thick, was on top of a textile membrane (**700**). Below this was a firmer mid greyish brown sandy clay, with 10% angular cobbles and lime mortar (**701**) and 1% slate, 0.9m thick (Plate 19).

**Plate 19: TP07 excavated, viewed from the north**

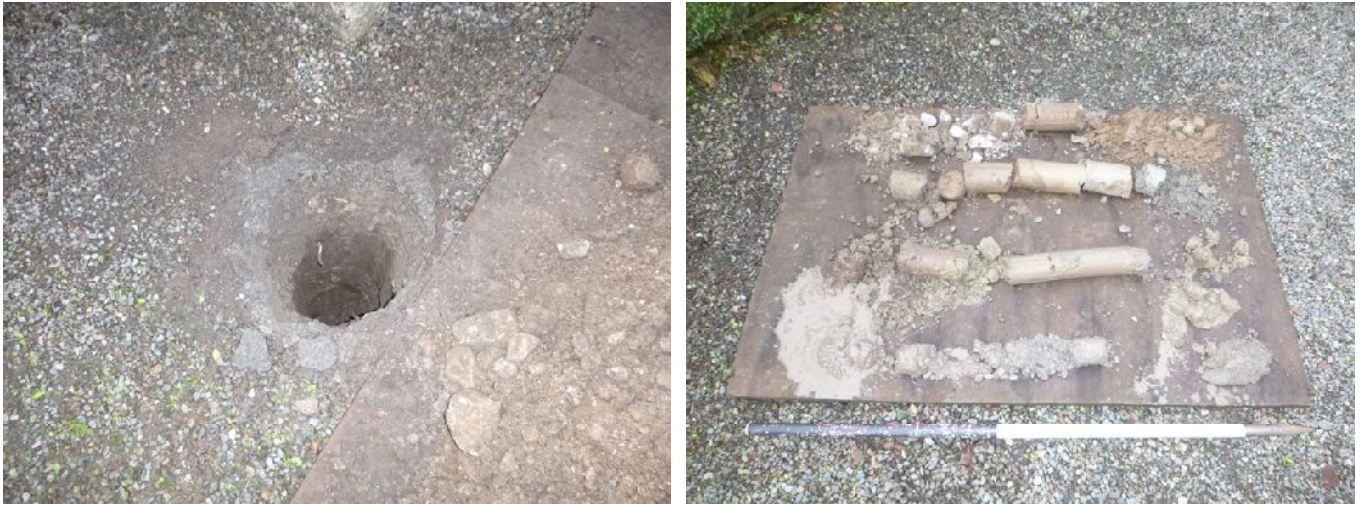
4.2.8 **WS01**: this borehole, to the west side of the area, c0.3m square, was initially dug with a post-holer and bar through loose grey gravel 0.1m thick forming the surface of the path (**1000**). This overlay a loose angular limestone rubble and some slate in a grey-brown silt matrix, 0.7m deep, also with lime mortar flecks (**1001**) (Plate 20). The rubble was observed to continue for c2-2.5m in the borehole before reaching a brown clay and pale grey silt, presumably of natural origin (Plate 21).

**Plate 20 (left): WS01 borehole top excavated, viewed from the north-east**

**Plate 21 (right): Material recovered from boring in WS01**

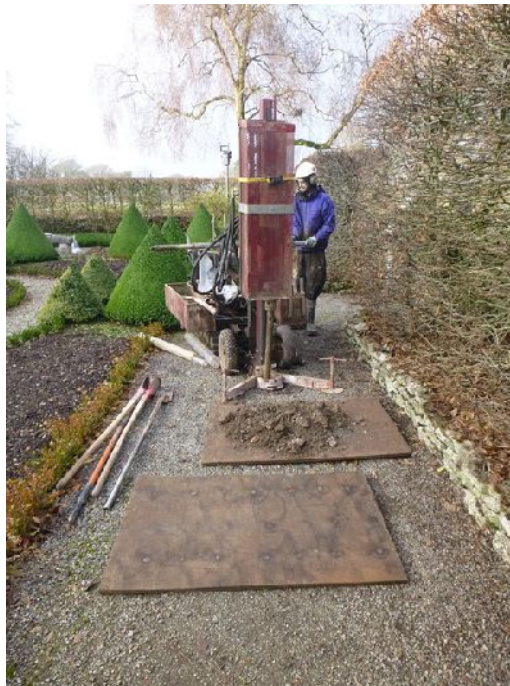
4.2.9 **WS02**: this borehole was fairly centrally located on the north side of the area. The initial deposit, a loose gravel 0.1m thick (**2000**), overlay mid brown silty clay, with 20% angular cobbles and lime mortar throughout, to a depth of 1m (**2001**) (Plate 22). Some bone fragments and brick were noted.

**Plate 22: WS02 working shot, viewed from the west**

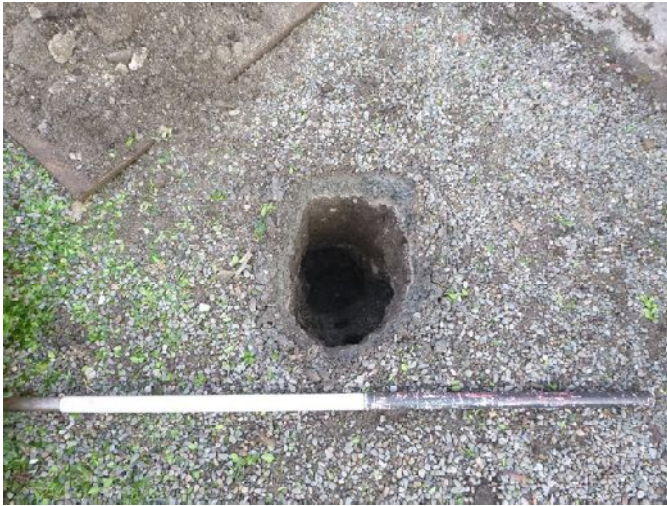
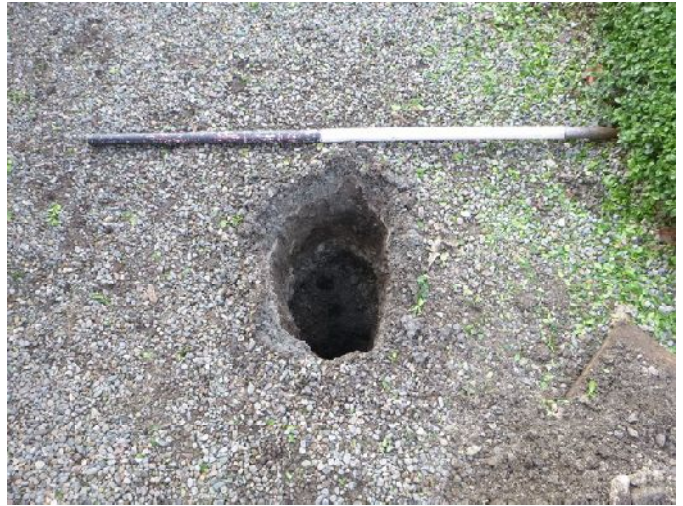
4.2.10 **WS03**: this borehole was on the east side of the area. The loose grey gravel forming the path, which was c0.05m thick (**3000**), overlay a firmer mid brown clay, 0.15m thick (**3001**). This in turn overlay a lime mortar rich deposit of angular cobbles in a mid-brown sandy clay matrix (**3002**), from which lots of bone and shell and medieval pottery were recovered, c0.5m thick, below which was a darker but similar deposit (**3003**) (Plate 23 and Plate 24).

**Plate 23 (left): WS03 excavated, viewed from the south-east**  
**Plate 24 (right): WS03 excavated, viewed from the north-west**
