FURNACE COTTAGE BARN, NEWLAND, ULVERSTON, CUMBRIA

Archaeological Building Recording

September 2017

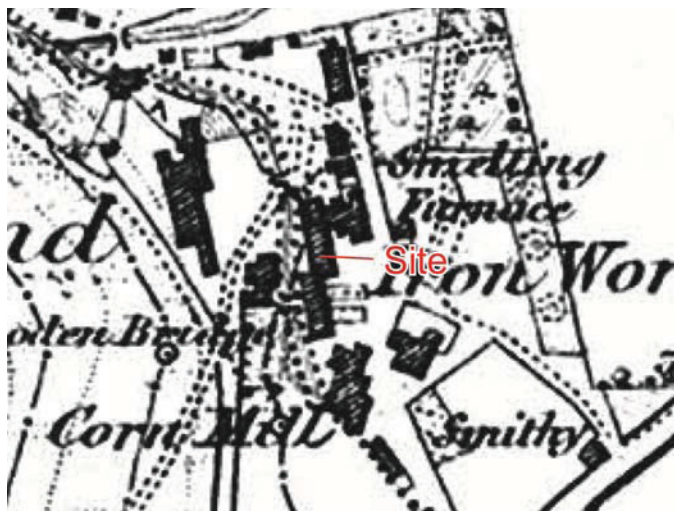
Plate 5 (left): Extract from 1851 Ordnance Survey, showing the location of the barn

3.1.6 **Ordnance Survey 1851**: this plan is broadly similar to the probably mid-19th century estate plan but no internal divisions are shown (Plate 5; cf. Plate 4).

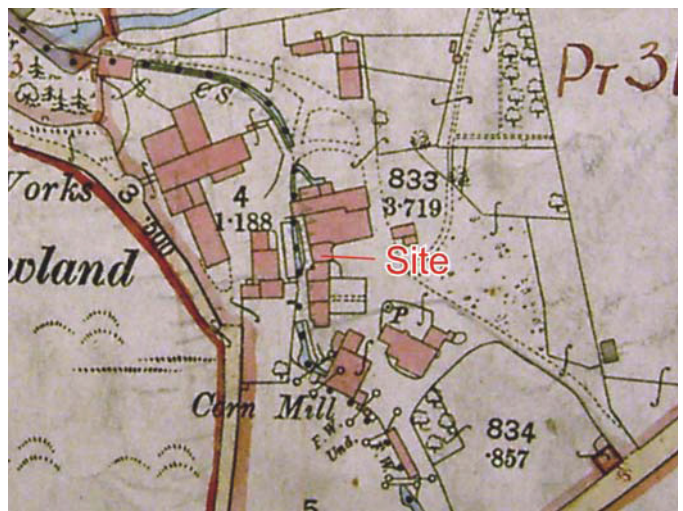
Plate 6 (right): Extract from 1890 Ordnance Survey, showing the location of the barn

3.1.7 **Ordnance Survey 1890**: this more detailed map shows the internal divisions within the furnace and terrace to the south (Plate 6).

3.1.8 **Plan 1904**: this plan (CAC(B) BDHJ/184/7/1 1904; Plate 7) has probably been hand drawn from the 1890 Ordnance Survey map (cf. Plate 6).

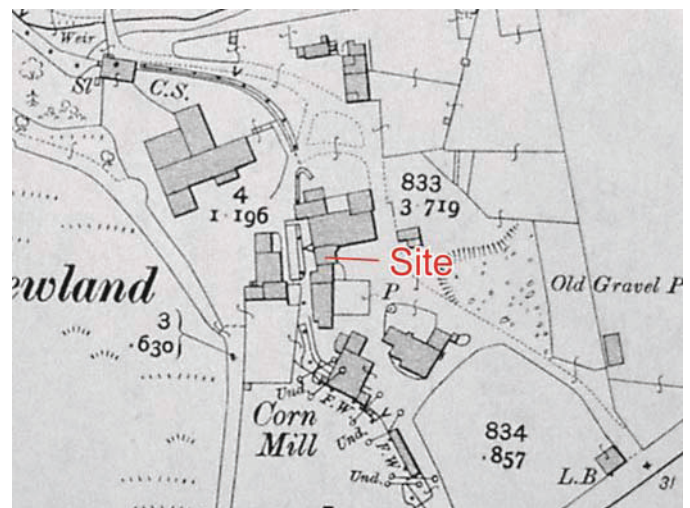
Plate 8 (right): Extract from 1913 Ordnance Survey, showing the location of the barn

3.1.9 **Ordnance Survey 1913**: the layout of the buildings is apparently unchanged (Plate 8).

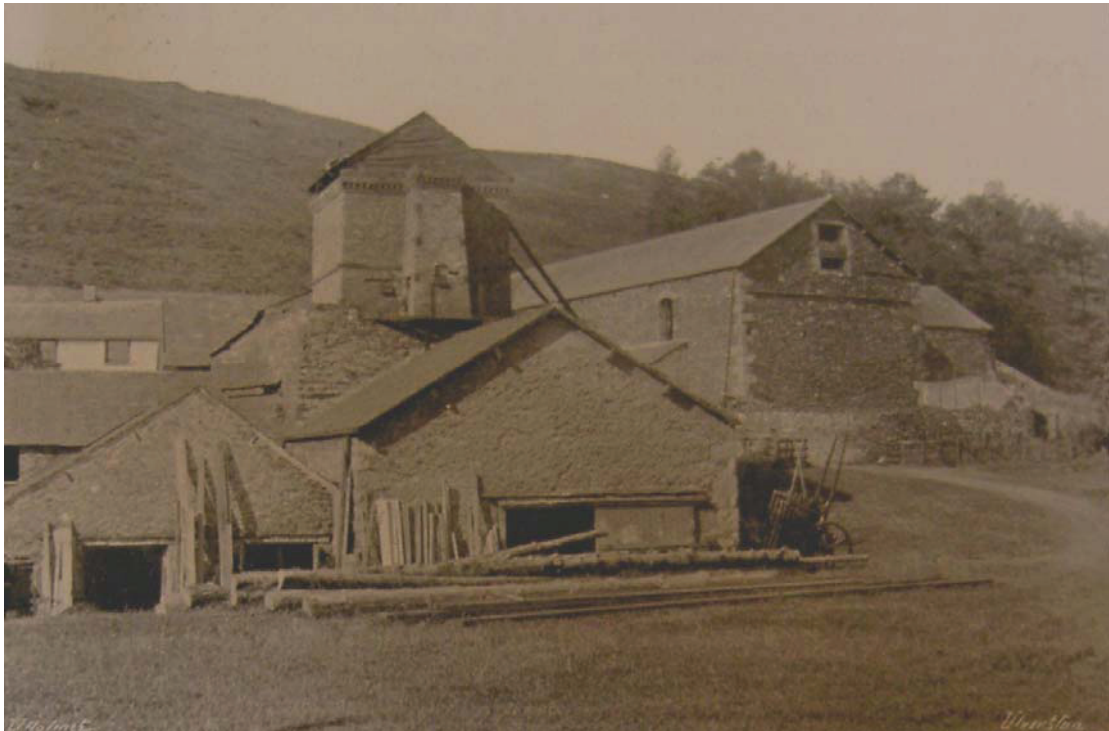
Plate 10: Newland Furnace c1897 shortly after its closure (Anon 1897)

3.2.6 The furnace was enlarged in the later 18th century with the addition of a forge in 1783 and a rolling mill in 1799; the latter subsequently became a blacking mill in the 19th century (Fell 1908, 218), while there is some evidence that the forge was contained within the old corn mill to the south of the furnace (Greenlane Archaeology 2009a). By 1818 Harrison, Ainslie and Co. seem to have been trading as the Newland Company (Goodall 2001, 4), and they continued to operate the furnace at Newland intermittently until 1891 (*op cit*, 7). According to Mannex's Directory of 1882 '*...from its commencement until 1874...considerable alterations and improvements were made, and coke and coal substituted for charcoal*' (Mannex and Co 1882, 249). These improvements are likely to have included the installation of a hot blast system whereby hot waste gases could be reused in the smelting process (Goodall 2001, 7). The brick chimney and raised throat evident in the only early photograph of the site (Plate 10) is likely to relate to this, as is the presence of the brick flue in the 'garage' (*ibid*).

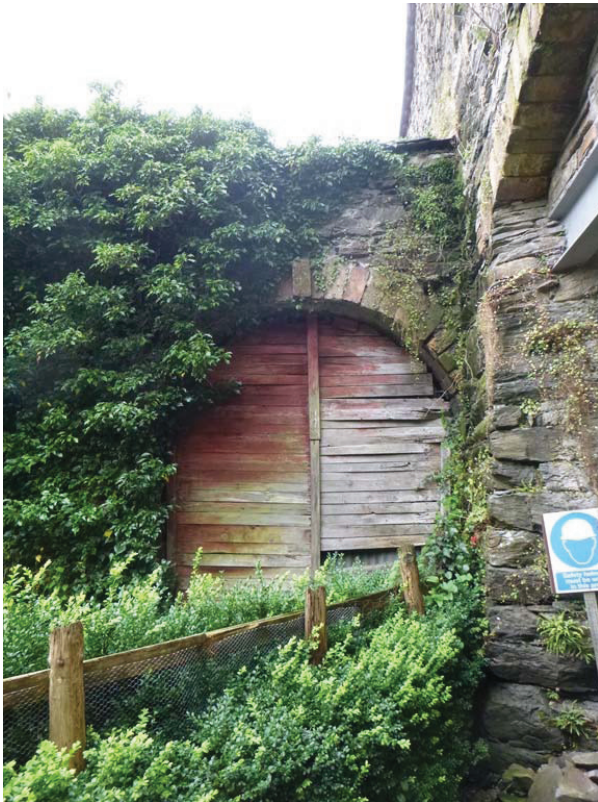
Plate 11 (left): Arched doorway at the north end of the east external elevation, viewed from the east

4.2.1 **East elevation:** at the north end is a large doorway with a semi-circular arched opening built of re-used furnace-lining bricks (Plate 11; Figure 2), in the centre of which is a keystone, also a brick, into which has been carved 'HAR & CO 1854' (Plate 12). The area within the doorway itself is filled with timber and corrugated sheet metal. Immediately to the south of this doorway a large block of red sandstone is incorporated into the base of the wall, and other blocks have been used in the south jamb, the north jamb being formed by the wall of the adjoining blast furnace. The central part of the elevation is mostly obscured with ivy (Plate 13), and the line of the elevation actually returns to the east and so forms part of the adjoining roofless structure. Beyond this return the elevation turns slightly to the west where the upper part meets the cottage. This angled section is supported by concrete lintel and within the section joining the cottage there is a wide doorway with a folding four-part plank and batten door, with a single light in each section, below two I-beam iron lintels (probably re-used rails) (Plate 14). Where the wall extends above the roof of the adjoining cottage it is finished with three dressed quoins and there are lots of bricks incorporated below the eaves.

5.2.5 **Phase 4 – 1854:** the dated keystone over the doorway at the north end of the east elevation is most probably indicative of the period at which a number of alterations were made; the doorway probably being made by the infilling of a wider opening at that end belonging to an earlier phase, perhaps essentially mirroring that on the opposite side of the casting house. This phase most probably also includes the raising of the roof to its current location and with its current structure, as evidenced by the additions to the east, south, and west elevations. The presence of Baltic timbers, something typically found in late 18th to early 19th century buildings (Greene 1995; 1996), does not preclude this as examples have been recorded locally in at least one industrial building built much later in the 19th century (Greenlane Archaeology 2007).

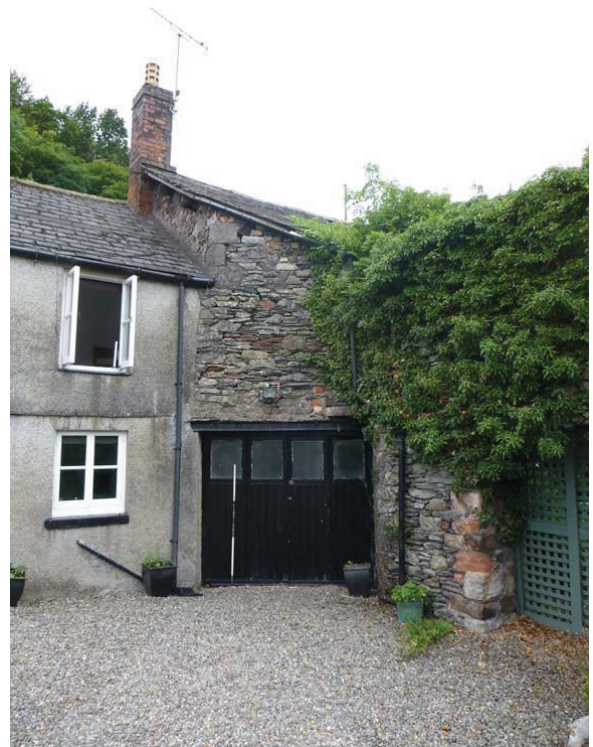
Plate 14 (right): The south end of the east external elevation showing the doorway, viewed from the south-east

4.2.2 **South elevation:** this only comprises a small section of gable above the roof line of the adjoining cottage (Plate 14). There is some patchy render remaining in places and the ends of two purlins project through the wall. The roof runs up to a square chimney built of red machine-made bricks, which serves the cottage, with a single ceramic pot. A lot of bricks, including furnace lining blocks, are incorporated into this elevation.

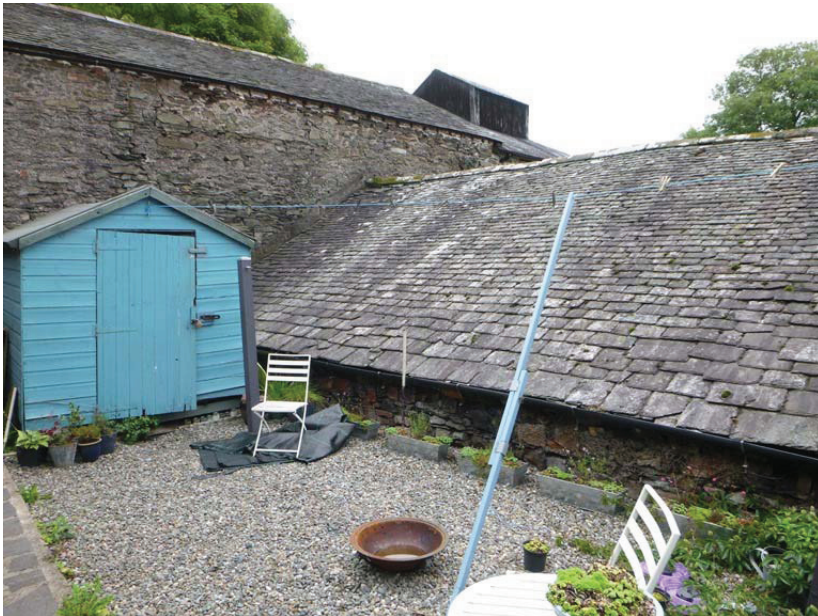
Plate 15 (left): The north end of the west external elevation, viewed from the south-west

4.2.3 **West elevation:** only a very small part of this is visible as the building is set into the slope and what there is comprises numerous re-used fire bricks (Plate 15; Figure 2). It adjoins the blast furnace at the north end and its wall has a large recessed section supported by a heavy timber beam further supported by a large cast iron column, perhaps a re-used pipe, with a slight collar at the top below a plank packing piece (Plate 16). The recessed area leads to a doorway leading into the upper floor of the furnace. At the south end the elevation meets the cottage, which it presumably butts against (Plate 17).

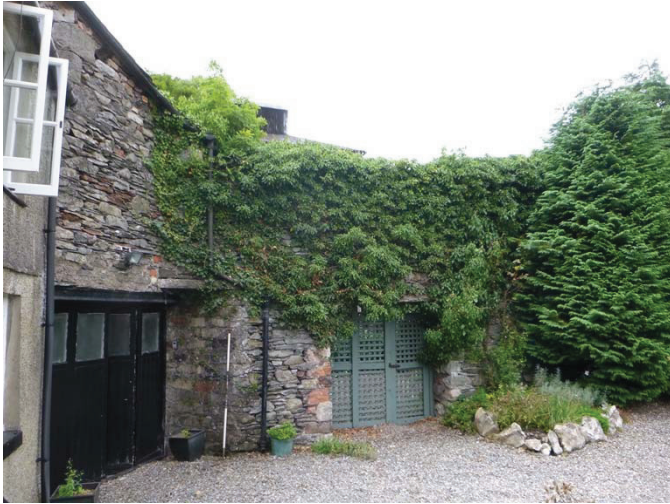
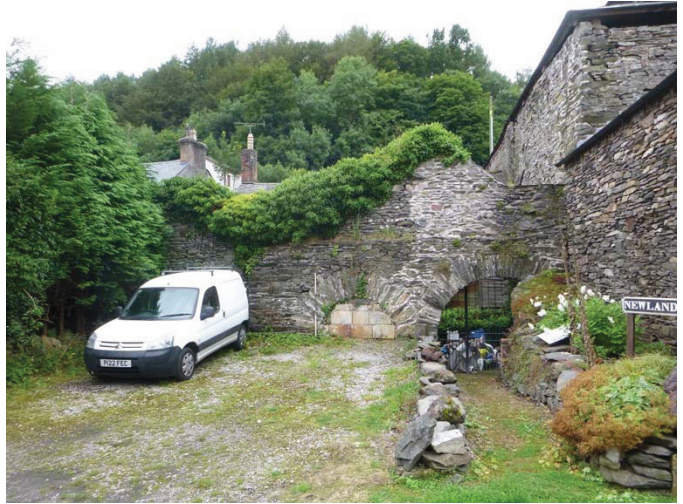
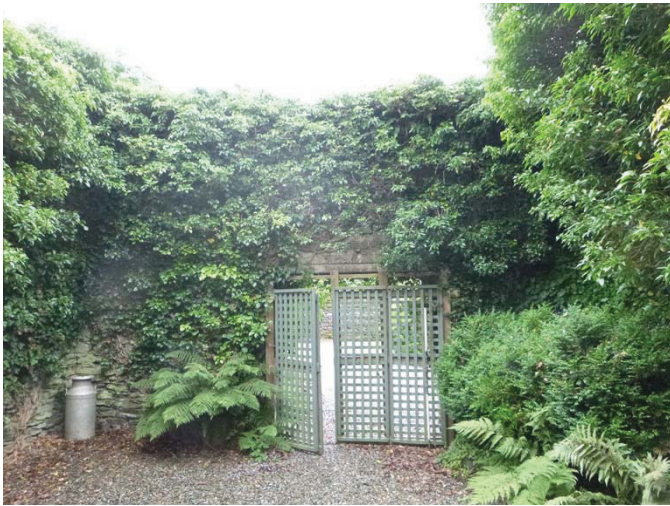
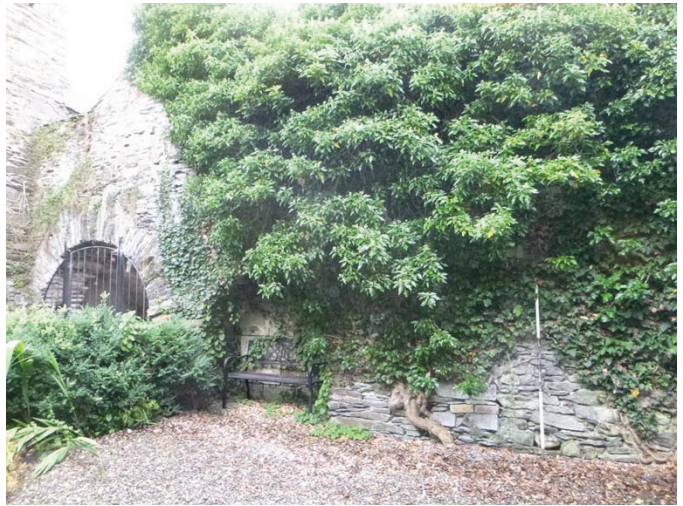
4.2.4 **Casting house:** while this does not strictly speaking form part of the barn as it now appears, it is evident that the barn is formed out of part of it, and so a brief examination was made. This structure is now a roofless ruin forming part of the curtilage of Furnace Cottage and running up to the south side of the furnace. Externally the south side is largely obscured by vegetation, but there is a large doorway on the west side with a very decayed timber lintel with a brick relieving arch above, the jambs of which incorporate a lot of furnace lining bricks, red sandstone, and dressed limestone blocks (Plate 18). The east elevation has dressed quoins on the south side, and a row of through stones in the wall immediately north of this, below which is a concrete skim for an attached outshut or lean to. The south end of the wall butts the north section, which projects slightly and incorporates two large openings with arched heads of voussoir edge-set slate, the smaller of which is blocked with furnace lining blocks (Plate 19). The top of this section is thinner than the lower part and finished with a gable. Internally the south elevation is largely obscured by ivy but the large opening on the west side has a concrete lintel (Plate 20). The east elevation is also largely covered by ivy but there is an evident butt joint on the south side and the smaller arch is only blocked externally leaving an alcove in the thick wall (Plate 21).

Plate 18 (left): The south external elevation of the ruined casting house to the east of the barn, viewed from the south

Plate 19 (right): The east external elevation of the ruined casting house to the east of the barn, viewed from the east

Plate 20 (left): The south internal elevation of the ruined casting house, viewed from the north

Plate 21 (right): The east internal elevation of the ruined casting house, viewed from the west

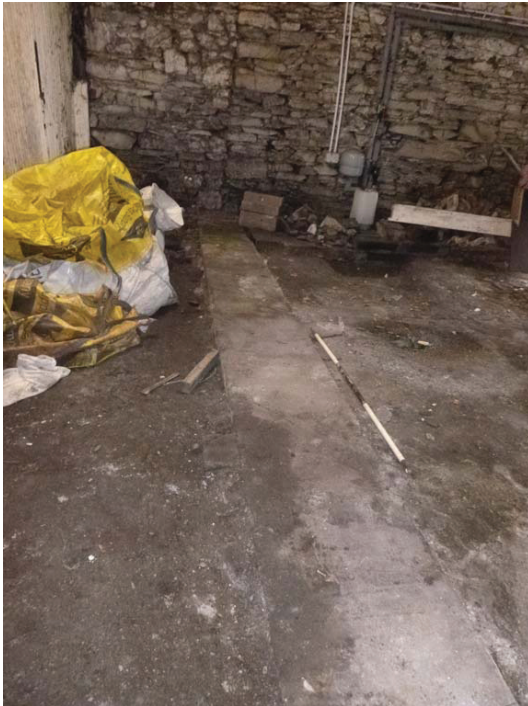
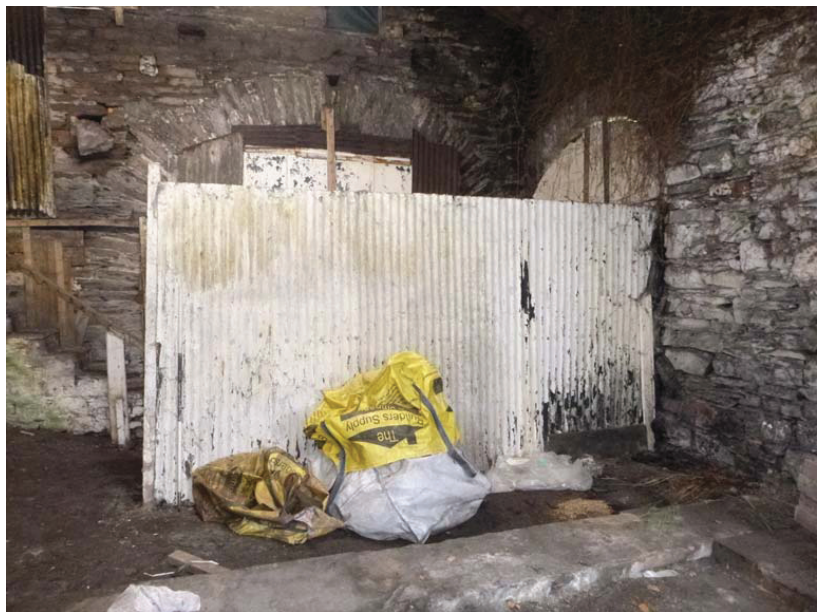
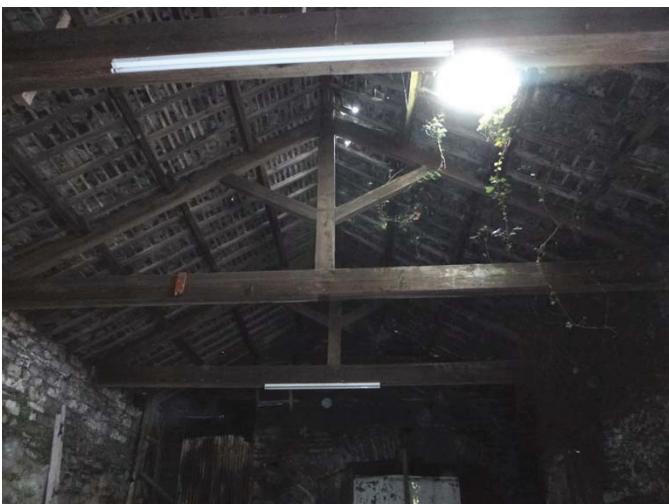
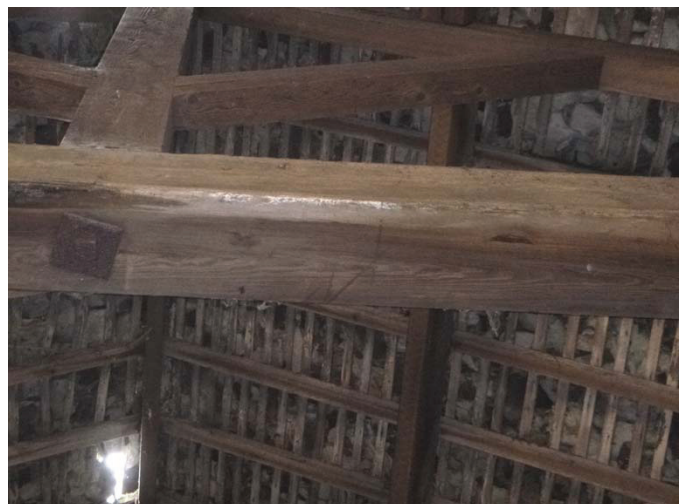
4.3.1 The floor is mostly finished with very rough and irregular concrete but the north end is separated from the rest by a more distinct and slightly raised band of concrete, perhaps originally a foundation for an internal wall or a structure of some form (Plate 22). Beyond this the north end has an earth floor, which is noticeably raised in the north-west corner. A rough partition constructed from corrugated roofing sheets supported by upright posts runs east/west part way across the room from the north end of the east elevation (Plate 23). The room is open to the roof, which is supported by three trusses, each of king post form, the king post fixed to the tie beam by an iron bolt, and with a pair of raised angled braces (Plate 24; Figure 3). There are Baltic timber marks on at least two of the tie beams; the central (Plate 26) and southern ones. There are three purlins per pitch and a ridge plank. The walls are generally finished with the remnants of whitewash, with the exception of the north elevation.

Plate 22 (left): The concrete strip dividing the earth floor at the north end from the concrete floor to the south, viewed from the west

Plate 23 (right): The partition wall on the north-east side of the room, viewed from the south

Plate 24 (left): The central truss, viewed from the south

Plate 25 (right): Baltic mark on the underside of the tie beam of the central truss, viewed from the north

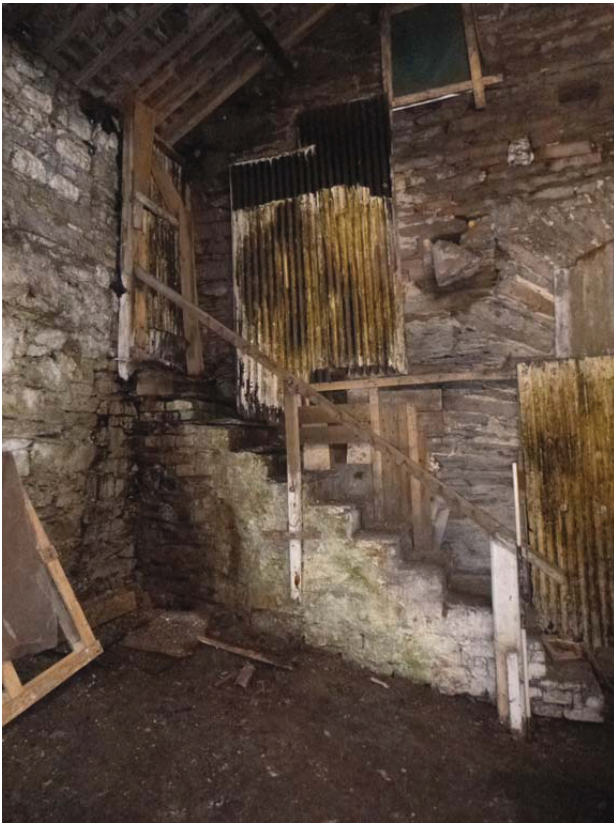
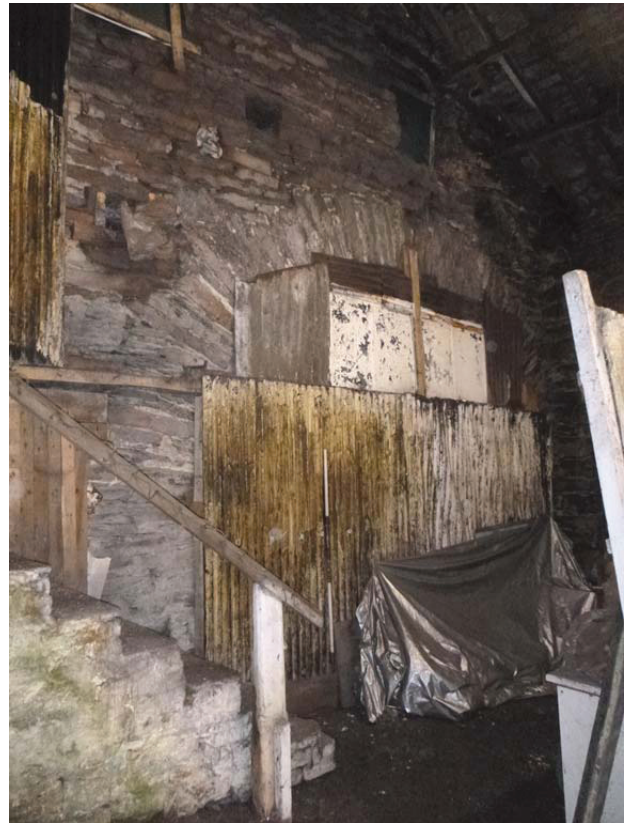
4.3.2 The north internal elevation has a flight of steps against it on the west side leading to what is presumably a doorway in the west elevation, although this is not visible externally (see *Section 4.2.3* above). The stairs are constructed from stone and brick – both fire brick and red brick, as well as at least one furnace-lining brick, and seem to butt the west elevation. They are topped with slate flags and there is a rough timber hand rail attached along the south side (Plate 26). Above the stairs there is an area of attached boarding and corrugated sheeting, presumably covering a doorway, with a smaller brick-lined aperture to the east of this (Plate 26). The elevation is dominated on the lower east side by a large opening with an arched top of voussoir slates, which is filled and partially covered by timber boards and corrugated sheeting (Plate 27). Above this are two small square alcoves or apertures, with a smaller possible one between and at the top of the elevation, which forms a gable, are presumably two small rectangular apertures covered by plastic sheeting held with timber battens. Running the full height of the north-east corner is a projecting 'buttress' that is actually the corner of the adjoining blast furnace stack.

Plate 26 (left): Steps on the west side of the north internal elevation, viewed from the south-east

Plate 27 (right): The large opening on the east side of the north internal elevation, viewed from the south-west

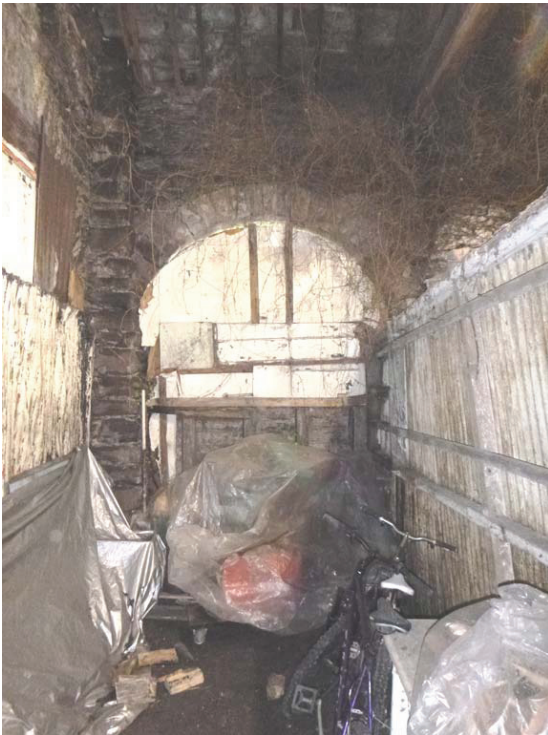
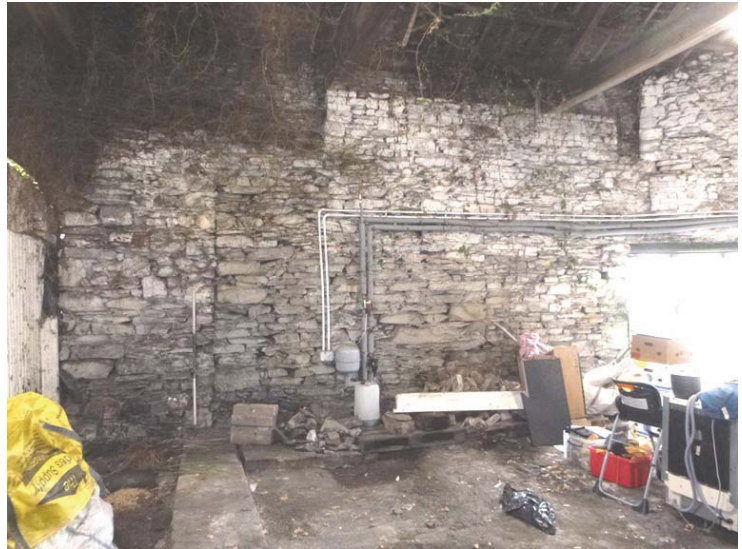
4.3.3 The east internal elevation is dominated on the north side by a large doorway with a round-headed arch constructed from re-used fire bricks and blocked with a random selection of pieces of timber including at least one complete door (Plate 28). The partition running part-way across the room springs from the south side of the doorway, and butts against the timber blocking. Beyond this there is a very evident butt joint in the wall with quoins, with a further butt joint to the south, although this slightly less visible and has less prominent quoins (Plate 29), all of which is indicative of the end of a building running east being incorporated into this wall. Above these joints the wall is stepped and thinner at the top. It also turns slightly to the west at the south end where it meets the doorway, which has possibly been enlarged or even inserted as its north jamb is evidently rebuilt. Above this there is an odd alcove in the wall, perhaps resulting from the butting of wall sections, and there is an apparent butt joint with the cottage to the south.

Plate 28 (left): Large doorway at the north end of the east internal elevation, viewed from the west

Plate 29 (right): Butt joints visible in the east internal elevation, viewed from the west

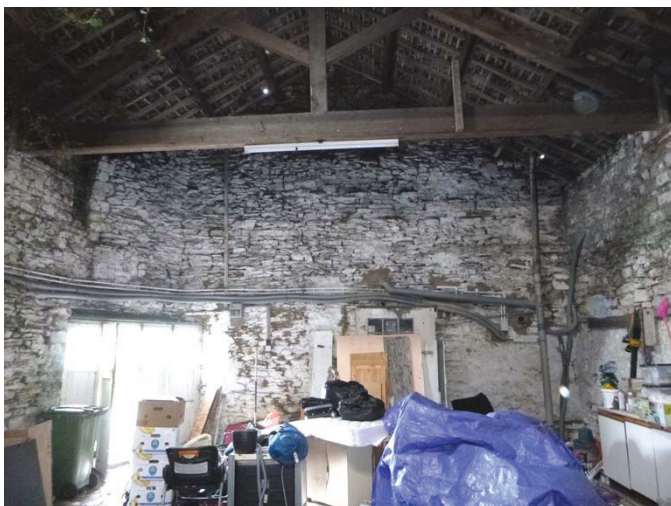
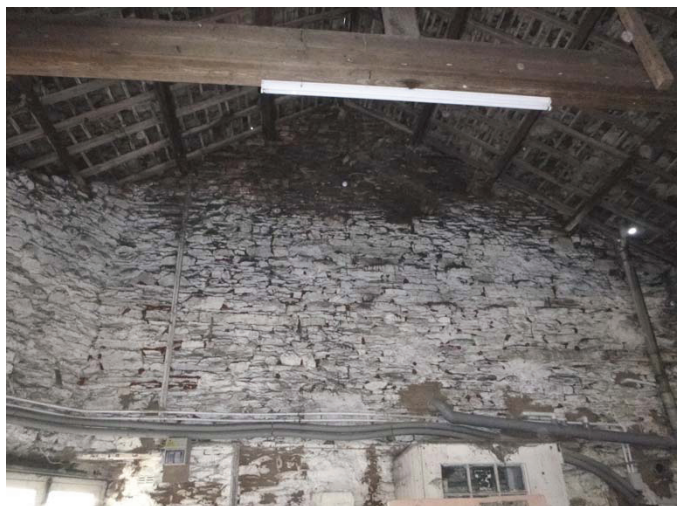
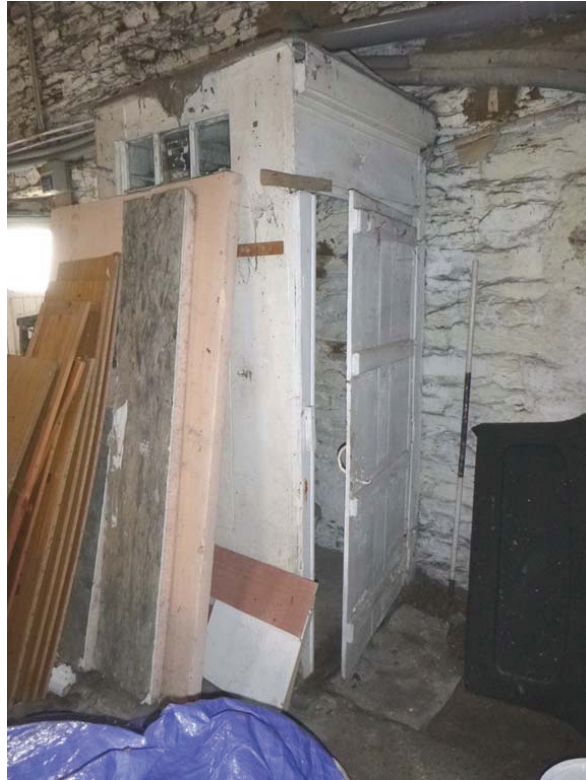
4.3.4 The south internal elevation comprises the opposing gable end and there are numerous projecting through-stones suggesting that it was once external (Plate 30). It has a slight angle at ground floor level, which forms the south jamb of the doorway and is supported by a timber lintel. Several further timbers are built into the main part of the south elevation, which has also evidently been raised on at least the west side as the ends of two purlins, presumably corresponding to the roof of the adjoining cottage, project through the wall (Plate 31). The base of the brick chimney serving the cottage is also visible at the top. There are lots of attached pipes and cables and in the centre at ground level a small room has been formed by timber partitions, constructed from a range of planks of different forms and incorporating a six-light fixed casement window on the north side and a door to the west, has been constructed to house a toilet (Plate 32).

Plate 30 (left): General view of the south internal elevation, viewed from the north

Plate 31 (right): Upper part of the south internal elevation, viewed from the north

Plate 32: The partition walls forming a toilet against the south internal elevation, viewed from the north-west

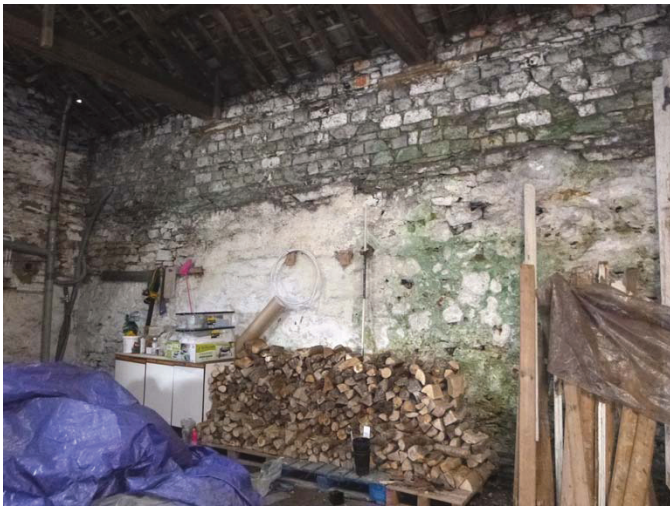
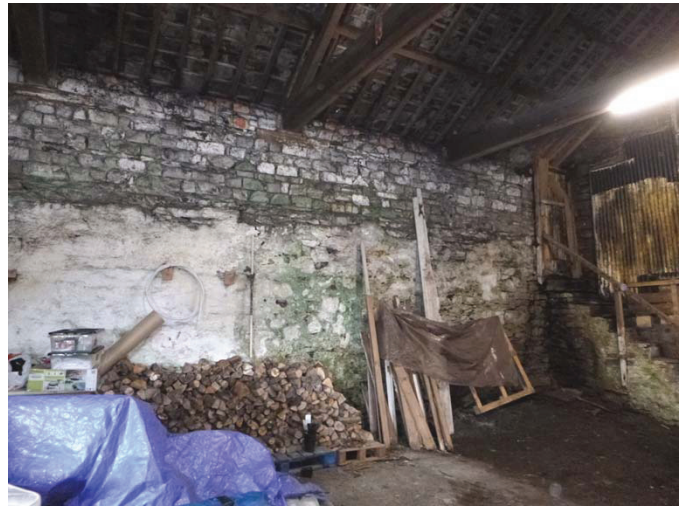
4.3.5 The west internal elevation is largely plain. The lower part is constructed from stone finished with a thick coat of whitewash, and this has evidently been raised by approximately 1m, the extension mostly comprising furnace lining bricks (Plate 33 and Plate 34). The upper part clearly butts the south elevation, although its relationship to the north is obscured by attached planks while the lower part appears earlier or contemporary with the south elevation, and is clearly earlier than the staircase.

Plate 33 (left): The south end of the west internal elevation, viewed from the north-east

Plate 34 (right): The north end of the west internal elevation, viewed from the south-east
