# BOWMANSTED, CONISTON, CUMBRIA

## Heritage Assessment

Client: Mr and Mrs Reeves

October 2017

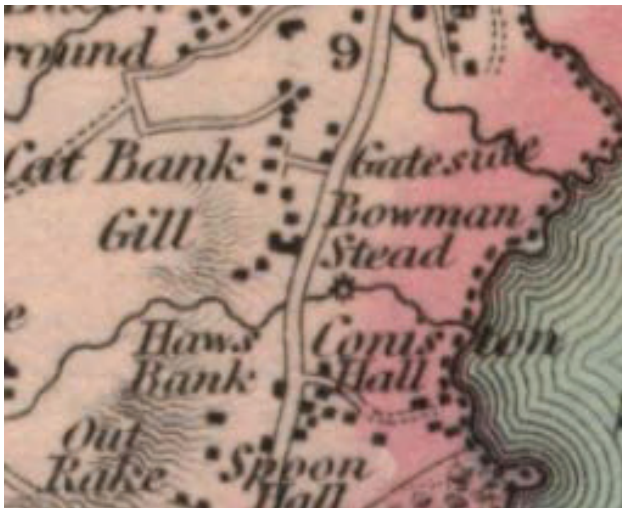
Plate 1: Extract from Hennet's map of 1830

3.1.1 **Introduction:** early maps of the area tend to be relatively lacking in detail and are not included in this section as they are not detailed enough to be useful in understanding the development of the property. Hennet's map of 1830 is one of the earliest to show the site in any detail and it actually names it, as 'Bowman Stead', and shows a C-shaped structure, although only schematically (Plate 1). There is no tithe map for Coniston, so the most useful maps for understanding the development of the site therefore date from the mid-19<sup>th</sup> century onwards.

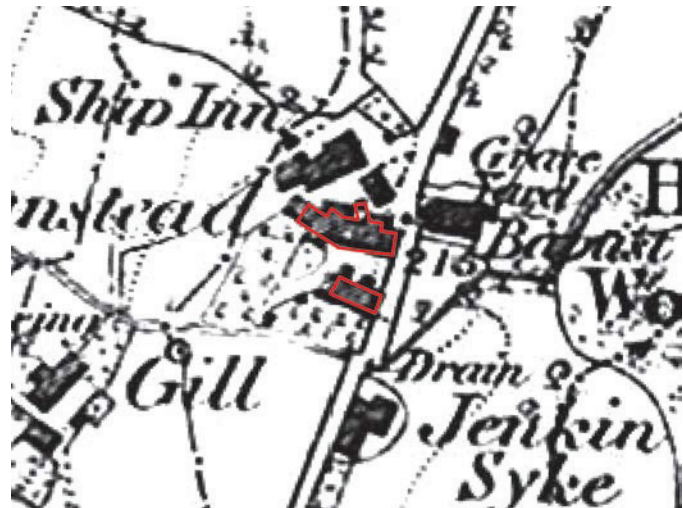
Plate 2: Extract from the Ordnance Survey map of 1851

3.1.2 **Ordnance Survey, 1851:** the general outline of the buildings comprising the site is apparent on the first edition 1: 10,560 scale Ordnance Survey, which was surveyed between 1846 and 1848 (Plate 2). The site of the main house and ancillary buildings comprised a separate block (**G10**) to the north side of the long east/west range (comprising **G1** to **G8** and **G11** and **G12**) at that time. There is apparently a structure against the west end of the south side (across **G2** and **G3**), which is no longer present. The detached barn also appears to have outshuts to the north and possibly west sides which are no longer extant.

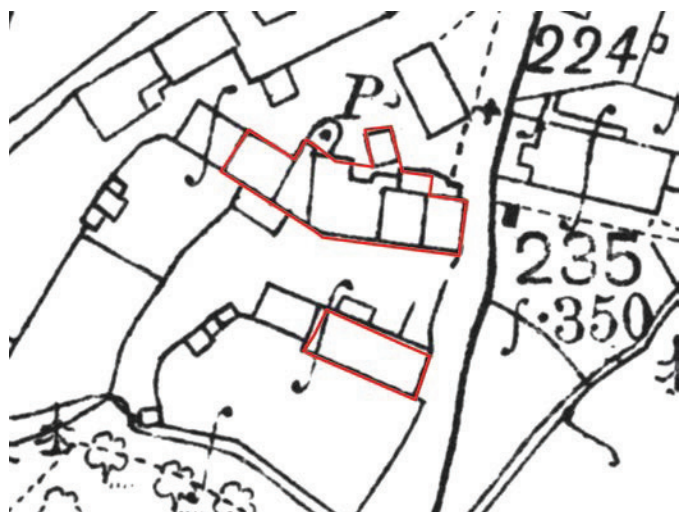
Plate 3: Extract from the Ordnance Survey map of 1890

Plate 4: Extract from the Ordnance Survey map of 1913

3.1.3 **Ordnance Survey, 1890:** this is the first available map produced by the Ordnance Survey at a scale of 1: 2,500 and as such shows much more detail (Plate 3). The detached block to the north side (**G10**) is still clearly separate from the range to the south (**G9** and **G9a** have clearly yet to be built) and there is still a structure against the south side (against **G2** and **G3**), which is no longer present. There is also clearly something built against the north side at the east end (north of **G12** and east of **G11**), which may also be shown on the 1851 edition, although this is a little unclear on the earlier edition. There is an interesting D-shaped building attached to the north side of the range (to the north of **G7** and possibly overlapping **G6**). This appears to enclose a pump, which is marked a 'P' but is not apparent on the 1851 edition (cf. Plate 2). There is only one possible outshut shown to the north side of the detached barn.

3.1.4 **Ordnance Survey, 1913:** this map shows a similar arrangement to the earlier edition (Plate 4; cf. Plate 3). The division along the north end of **G11** is no longer shown and the block to the north of **G12** is divided. The gap between the block to the north (**G10**) and the main house has been at least partially inbuilt by this point (relating to **G9**). The D-shaped block to the north side shown on the earlier edition is now simply shown as a rectangular enclosure. The building to the south side is still there (across **G2** and **G3**). The detached barn is unchanged from the earlier edition.

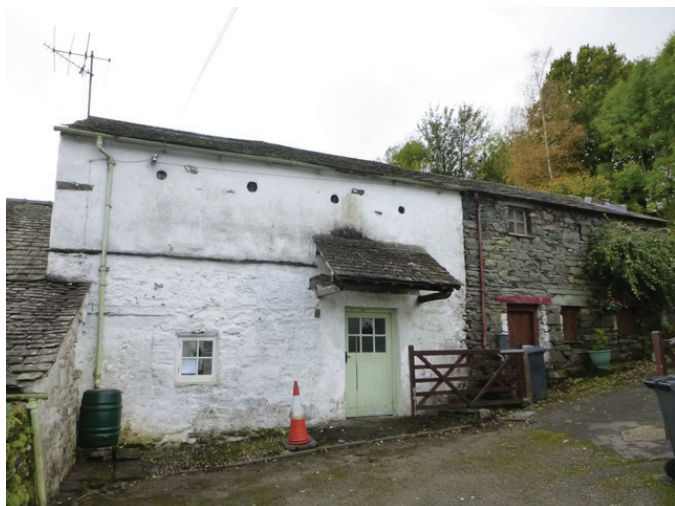
4.2.1 **House - north elevation:** the west end of the elevation, which is butted by an adjoining building to the, is two stories and taller than the rest, the lower level painted stone, the upper finished with smooth render above a slate drip course (Plate 9). There is a blocked doorway on the east side of the ground floor with a drip course, immediately to the east of which is a small window with a four-light hinged casement and there is a slight plinth at the base of the wall. To the west is another doorway clearly originally within a wider doorway that has been partially blocked, which now houses a plank door with six lights in the top. Above this is a projecting canopy supported on horizontal timbers and with a pitched slate roof. Along the top of the elevation is a row of three circular vents. The elevation returns to the north after this section where there is a small monopitch outshut, which has a small window with a six-light fixed timber casement (Plate 10).

**Plate 9 (left): the east end of the north external elevation, viewed from the north**

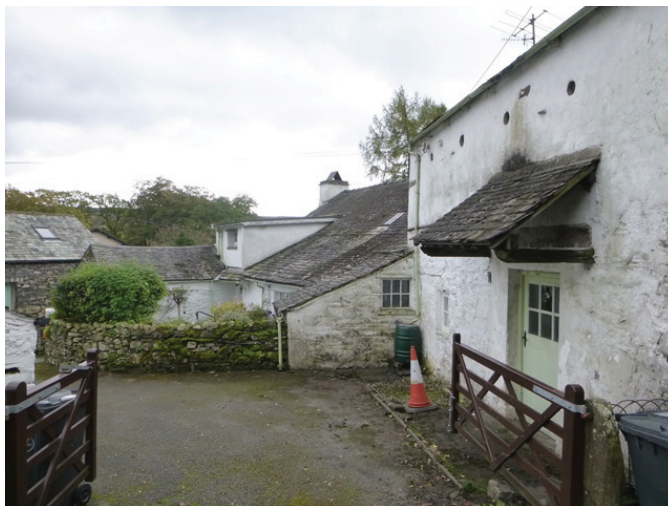
**Plate 10 (right): general view of the north external elevation, viewed from the west**

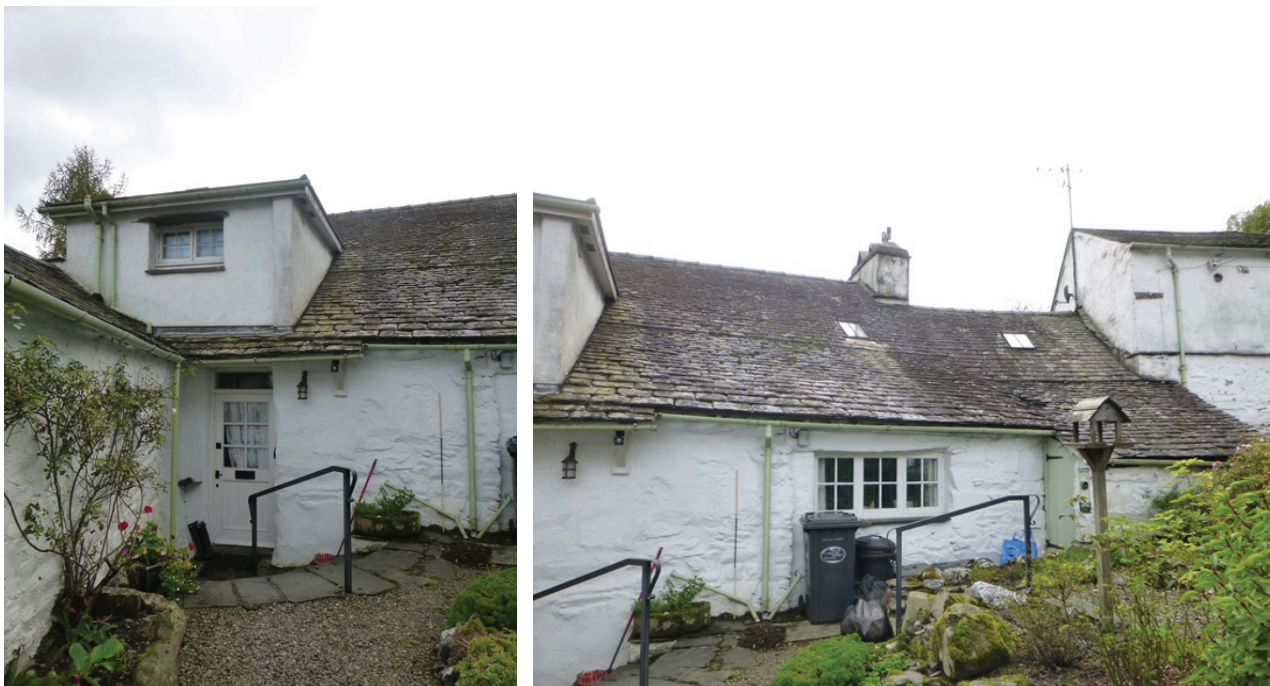
**Plate 11 (left): the dormer window on the west side of the central part of the north external elevation, viewed from the north-west**

**Plate 12 (right): the central part of the north external elevation, viewed from the north**

west side of this section is dominated by a long window with three four-light hinged timber casements, a long slate sill and a painted timber lintel, to the east of which is a step in the wall line at the jamb (Plate 12). To the west, the side of the monopitch outshut has a doorway with a plank and batten door.

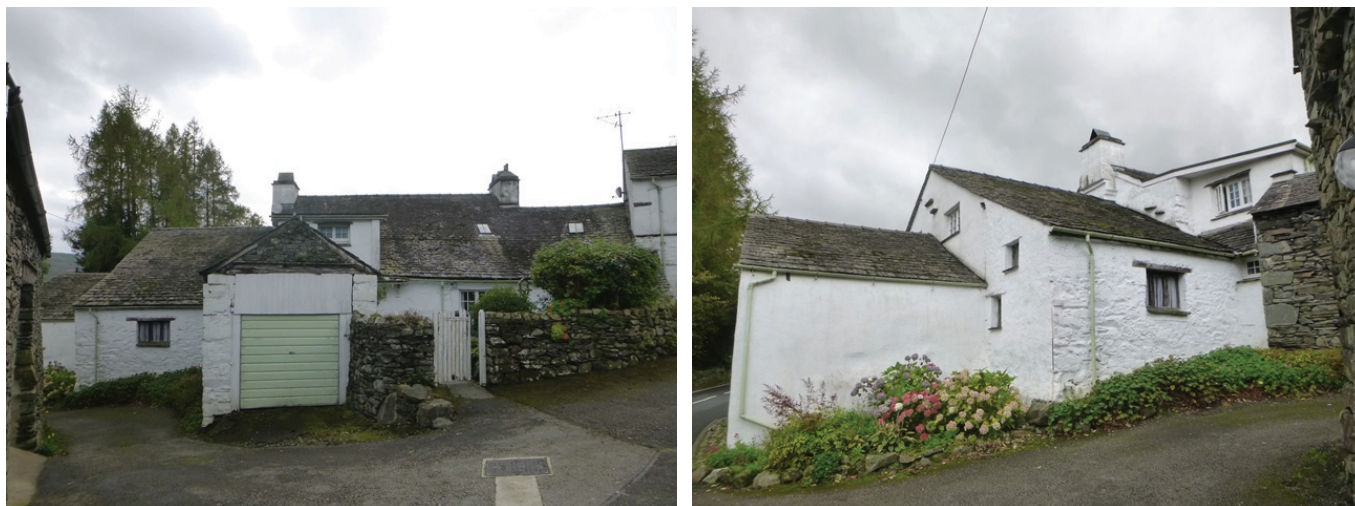
**Plate 13 (left): the projecting section on the east end of the north external elevation, viewed from the north**

4.2.3 To the east of the central section the wall returns where it meets the projecting garage, which has plain side walls and a large opening to the north with a modern retracting metal door and space above filled with timber planking (Plate 13). Beyond this a small window with a four-light timber casement with a slate sill in a small section where the return for the garage meets the main elevation, and beyond that is another window with a three light timber mullion (the mullions are very square) with a rough timber lintel and slate sill (Plate 14). The wall returns to the south where there are two further windows, again with timber mullions in the same style but only two lights, while the end of the elevation is otherwise plain.

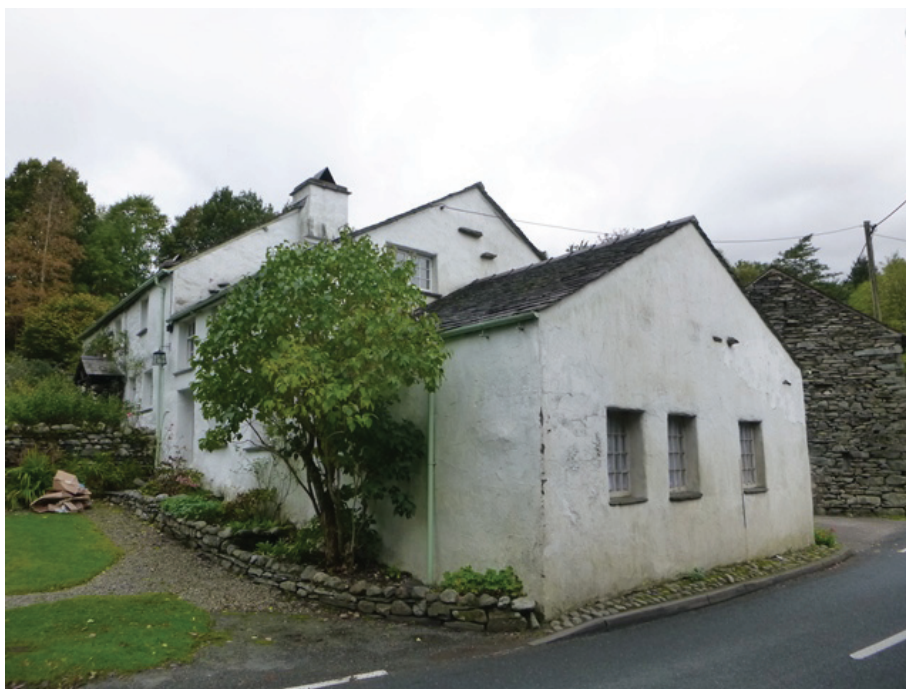
Plate 15: the east external elevation of the house, viewed from the south-east

4.2.4 **House - east elevation:** this is finished with smooth render, with a few through stones exposed, and forms a gable end (Plate 15). There is a row of three windows at ground floor level all with fixed 20-light casements with the odd single hinged light. Above this the gable of the taller section to the west continues and has a pair of windows each with six-light hinged casements and there are a further two large through stones to the north. Beyond this is the gable of the main house, which has a projecting chimney stack, slightly corbelled where it meets the lower adjoining roof.

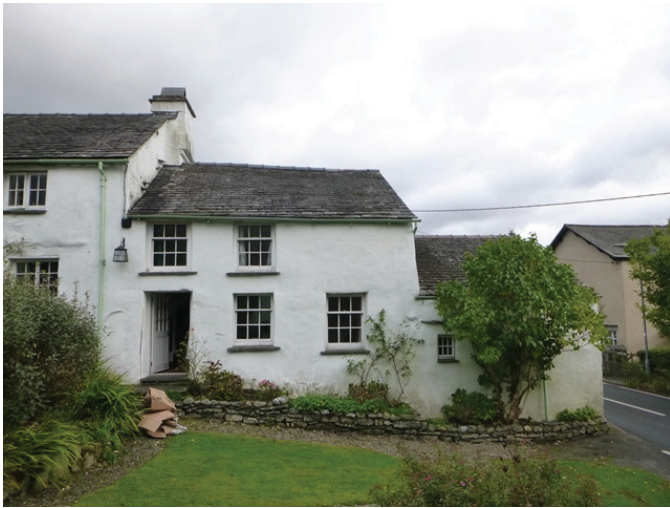
4.2.5 **House - south elevation:** the east end comprises two further sections, the larger of which, to the west, incorporates a large boulder in its footing (Plate 16). The east has two storeys but is lower than the main part of the house to the west and is finished with plain smooth render. There is a doorway on the west side with a relatively late plank door with nine lights up three slate steps. To the east are two windows each with nine-light sliding sash casements while the first floor has three further windows in the same style, and all have slate sills. The east end proper is a single storey or a storey and a half and lower again, with a small window with a six-light hinged timber casement with a thin slate sill and thin slate drip mould over. The main part of the house, to the west, has four ground floor windows with early six, eight, and nine-light casements, mostly fixed but the east hinged, all with slate sills (Plate 17). These are arranged two either side of a central doorway with a stone lintel and studded plank door with an early style latch and pair of six-lights in the top, all probably of early 20<sup>th</sup> century date. This doorway is covered by a fairly late timber porch with a gabled roof finished with slate and open trellis style sides. The floor of the porch is slate flags up two very low steps from the garden, with an early boot scraper set in the floor against the flags. At first floor level there are three windows, the west has a 16-light sideways-sliding sash casement, the central one is fixed and four lights, while the east is hinged and has eight lights. All have slate sills, the west very thin. The render becomes smoother at the east end where it meets the east end of the elevation.

**Plate 16 (left): the east end of the south external elevation of the house, viewed from the south**

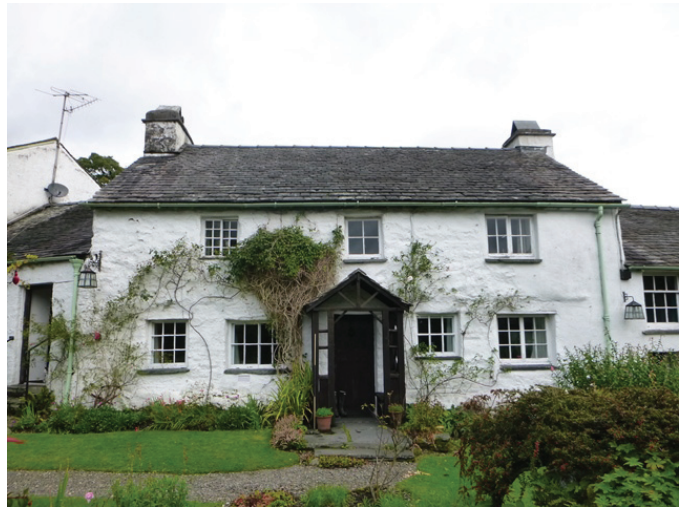
**Plate 17 (left): the main part of the south external elevation of the house, viewed from the south**

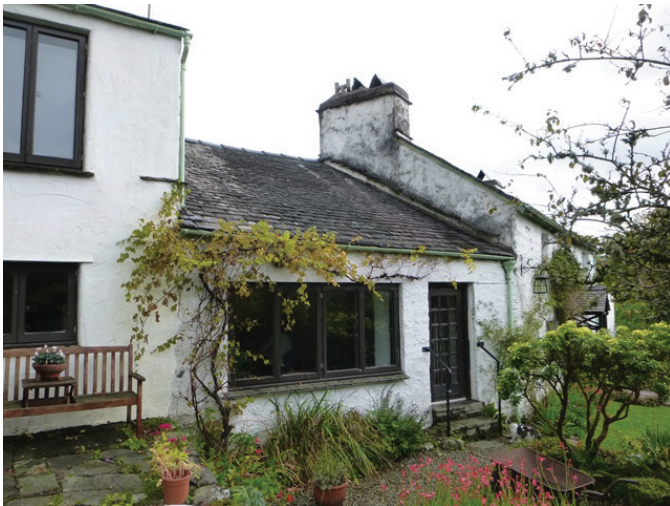
**Plate 18 (right): the in filled section between the west end and the main house, south external elevation, viewed from the south-west**

4.2.6 To the west is a single storey section of walling probably filling a gap between the west end and the main house to the east (Plate 18). It has a large window with a modern four light hinged casement and slate sills as per those to the east. There is a doorway on the west side up two slate steps with a modern timber door with 18-lights and attached metal hand rails. The west end is finished with relatively modern 'country cottage' style render and there are two large windows on the first floor with modern hinged timber casements of three or four lights and the sills are finished with roof slates (Plate 19). On the west side of the ground floor is a single small earlier window remains with a six-light casement (one hinged), a slate drip course over, and a slate lintel with an angled sill finished with roof slates. To the east of this is a long low window with four-light modern hinged casements and sills finished with slate as per the first floor. This section is clearly butted by the building to the west.

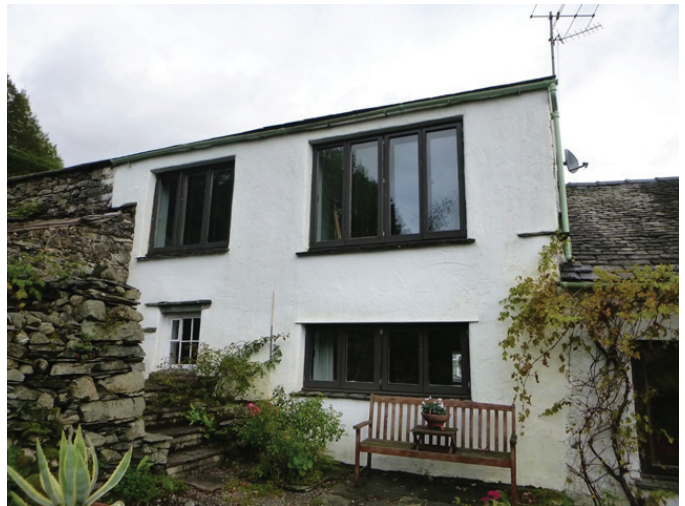
**Plate 19 (right): the west end of the south external elevation of the house, viewed from the south**

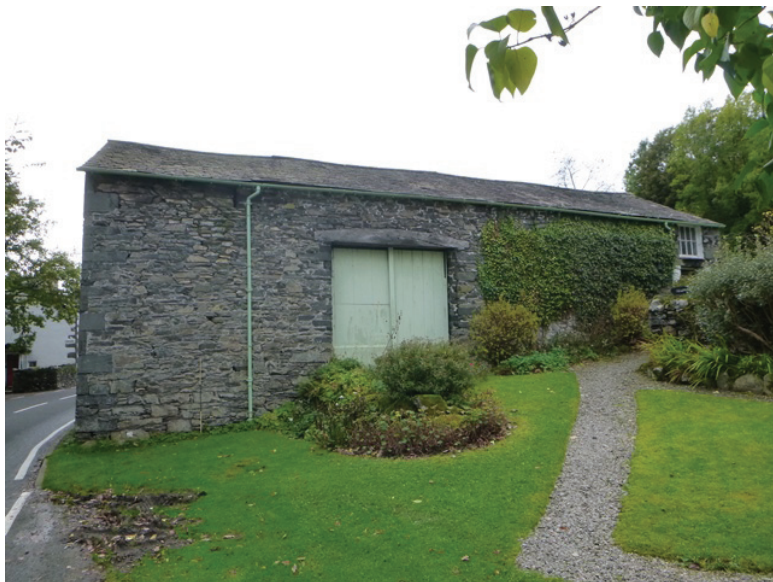
4.2.7 **Barn - north elevation:** the entire elevation is exposed stone bound with a gritty lime mortar and with large roughly dressed quoins at either end. There is a wagon doorway east of centre with a heavy timber lintel and a double door constructed from three wide beaded planks on the east side and five on the west, with additional planks attached over the lower part, both hung on long iron straps (Plate 20). There is a single narrow vent just below the roof line to the east of this door and another to the west, although this is obscured by ivy. The west end has a doorway with a reused door with four raised and

**Plate 20 (left): the east end of the north elevation of the barn, viewed from the north-east**

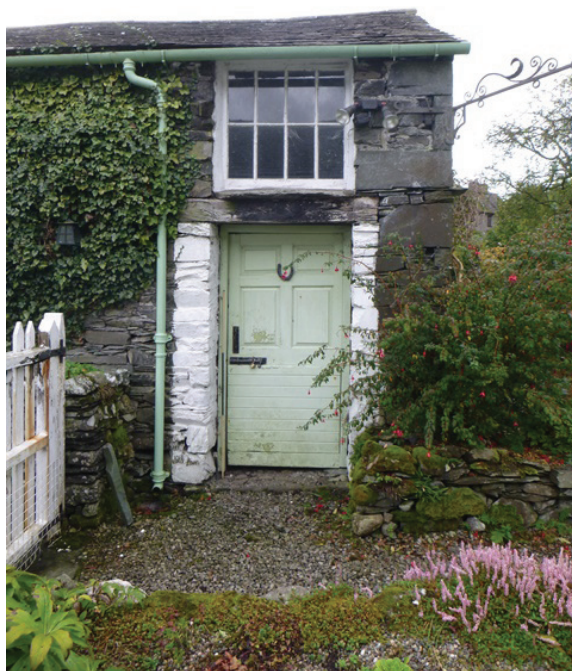
fielded panels visible and attached planks over the lower part, and above this there is a window with a fixed eight-light casement and slate sill, which forms the lintel of the doorway below (Plate 21).

**Plate 21 (right): the doorway and window in the west end of the north elevation of the barn, viewed from the north**

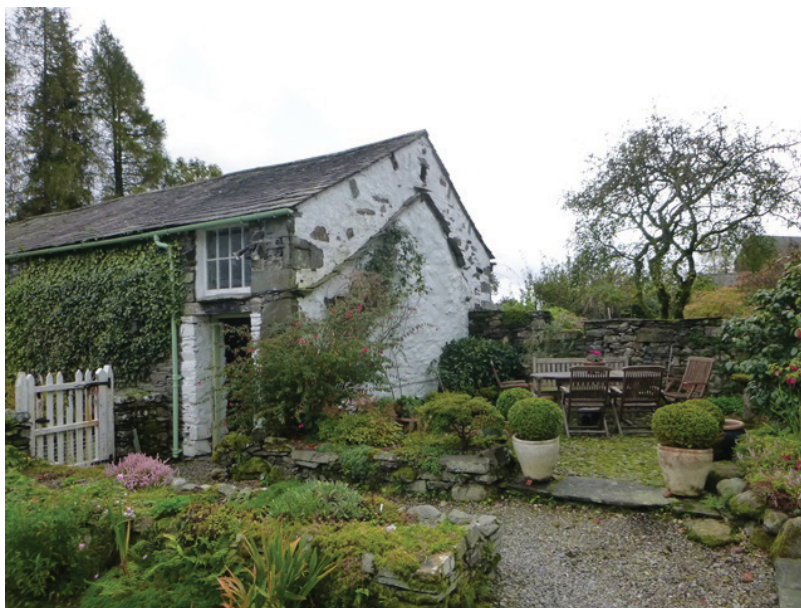
**Plate 22: the west external elevation of the barn, viewed from the north-west**

4.2.8 **Barn - west elevation:** this was evidently originally continued further to the east with a slightly lower section, part of which remains on the south side where it essentially now forms a garden feature. The line of the roof of this extension is evident as a row of projecting slates but the elevation (Plate 22) is otherwise fairly plain painted stone, with the exception of a window on the north side with an eight-light fixed casement, timber lintel and stone sill, which appears to be set within a former doorway.

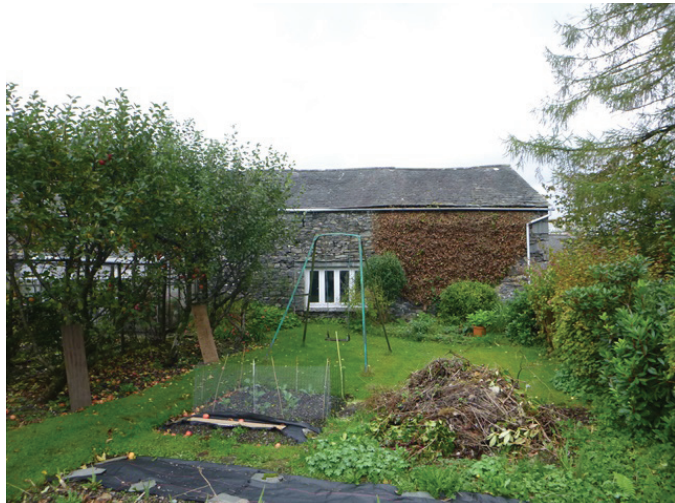
4.2.9 **Barn - south elevation:** this is largely plain, although partly obscured by an attached greenhouse on the west side, which has left a concrete skim across the otherwise exposed stone of the wall. There are three narrow vents below the roofline across the elevation, and on the east side there is a large window with a four-light hinged timber casement with a slate hung lintel and drip course, which is set within a former doorway (Plate 23). To the west is a pedestrian doorway with a plank door with three lights and a slate hung lintel. It continues at the west end by a low section of wall containing the lower part of two windows (Plate 24).

**Plate 23 (left):** the east end of the south external elevation of the barn, viewed from the south

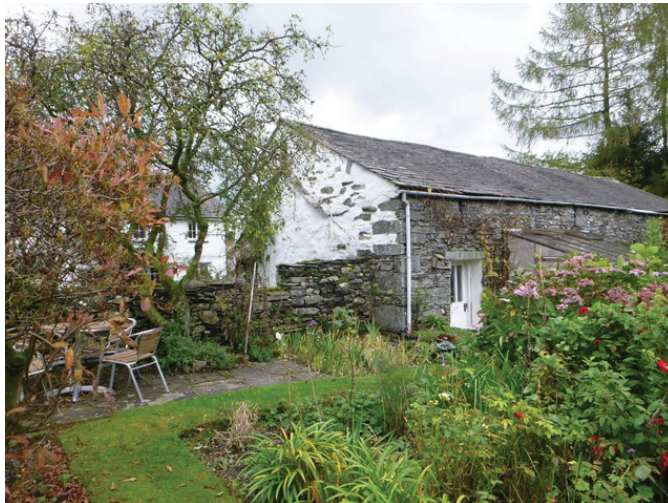
**Plate 24 (right):** the west end of the south external elevation of the barn, viewed from the south-west

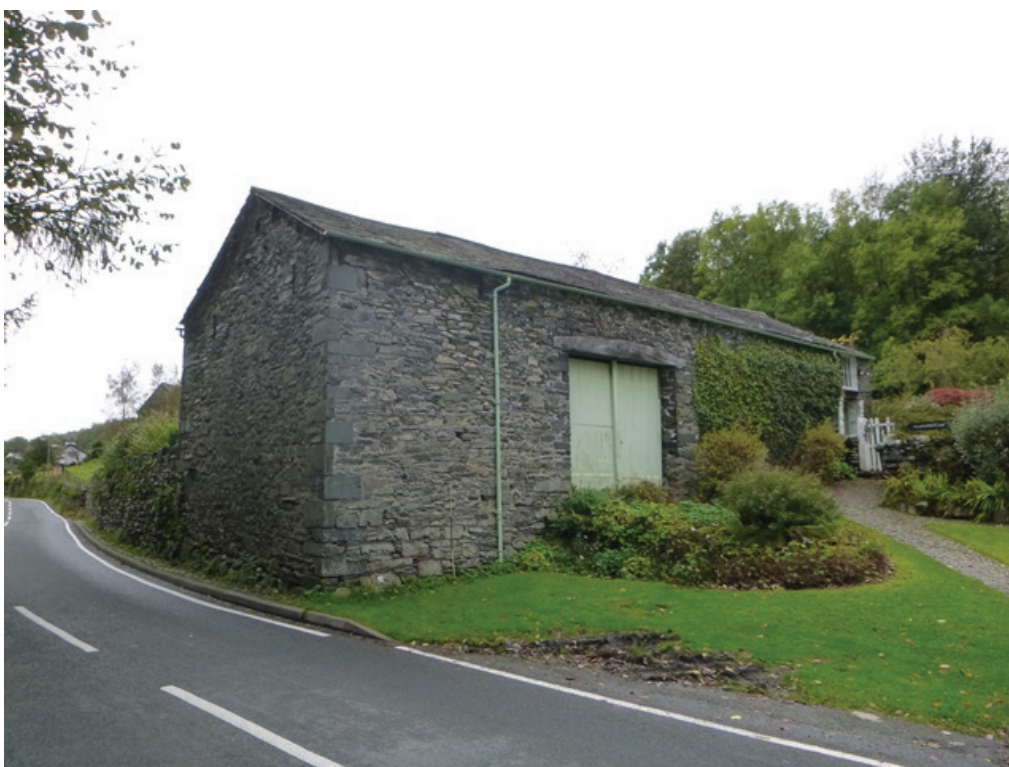
**Plate 25:** general view of the east and north external elevations of the barn, viewed from the north-east

4.2.10 **Barn – east elevation:** this is relatively plain, with two narrow vent slots near the top and an owl hole below the apex as well as slight plinth at the base (Plate 25).

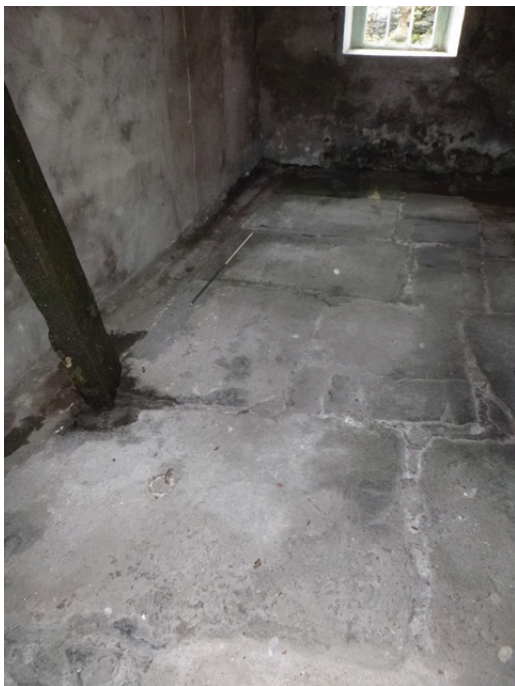
**Plate 26 (left): the flag floor and drainage channel along the west side of Room G1, viewed from the north-east**

4.3.1 **House ground floor Room 1 (G1):** this has a slate flag floor with a sandstone drainage gully along the west side running north/south (Plate 26), and there is a tether ring in the floor on the north-west side and a hole for what might be a second one to the north-east. The joists of ceiling and the boards are relatively modern machine cut timber with a plain staircase up leading to a large hinged hatch in the south-east corner. The walls are all finished with relatively modern plaster but to an unfinished state with just the scratch coat present and all of the elevations are relatively plain. There is a doorway to the north on the west side with a plank door with six lights and shelves on brackets on the east side. The south elevation has a small window on the south side with splayed jambs and a six-light fixed casement (Plate 27), and there is a single post against the west.

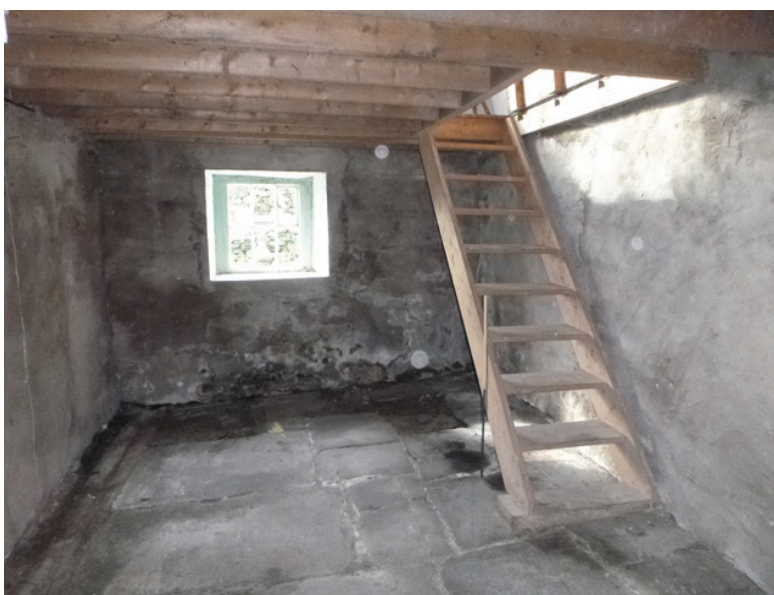
**Plate 27 (right): the south end of Room G1 and the staircase, viewed from the north**

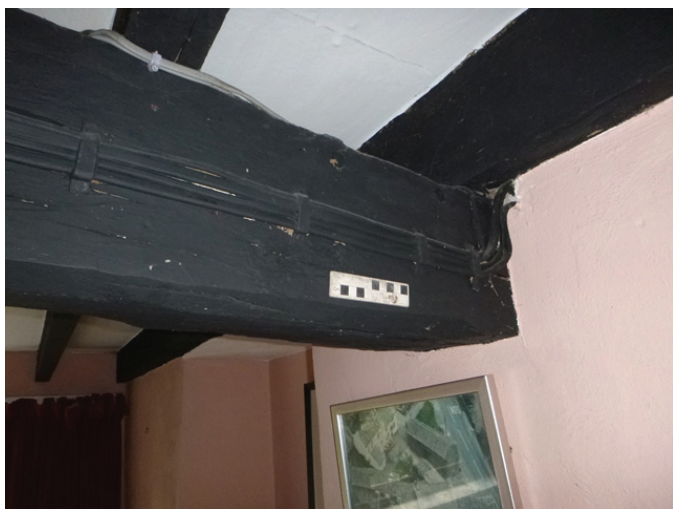
4.3.2 **House ground floor Room 2 (G2):** this has a timber laminate, almost parquet, floor and the ceiling is supported by a heavy beam running east/west supporting the joists. The beam has stop chamfer decoration at the east end (Plate 28) while the joists are sawn and at least one has very evident Baltic timber marks (Plate 29). The walls are finished with modern plaster and paint. There is a small window to the north with square jambs, a timber sill and secondary glazing (Plate 30), while the east elevation has a tall alcove on the south side, perhaps originally a doorway to Room **G1**. The south elevation has a long low window with a hinged casement and secondary glazing (Plate 30), while the west has a doorway south of the centre with a round head and a matching modern plank door and an open timber staircase against the wall to the north with a square newel post and hand rail (Plate 30).

Plate 28 (left): chamfered beam in Room G2, viewed from the north-west

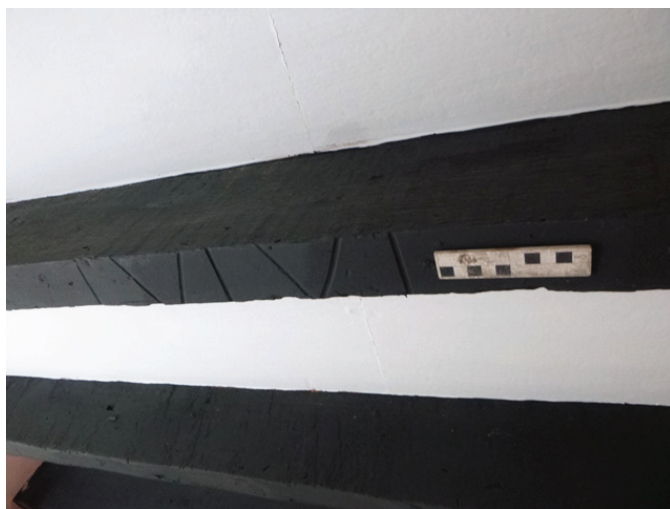
Plate 29 (right): Baltic timber marks on a joist in Room G2, viewed from the north-west

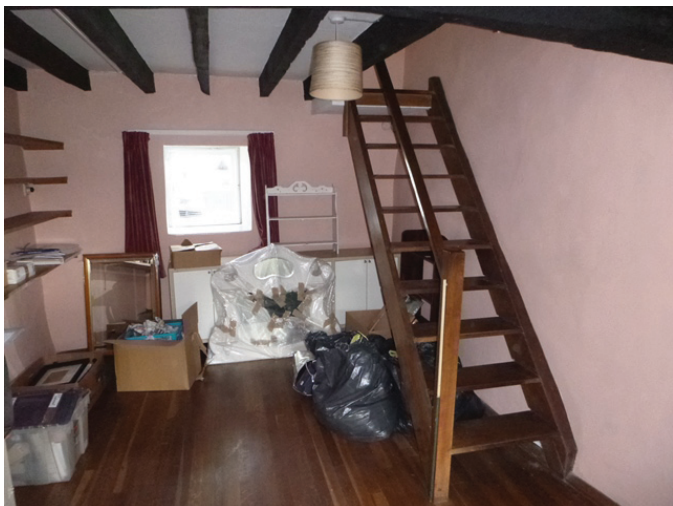
Plate 30 (left): the north end of Room G2, viewed from the south

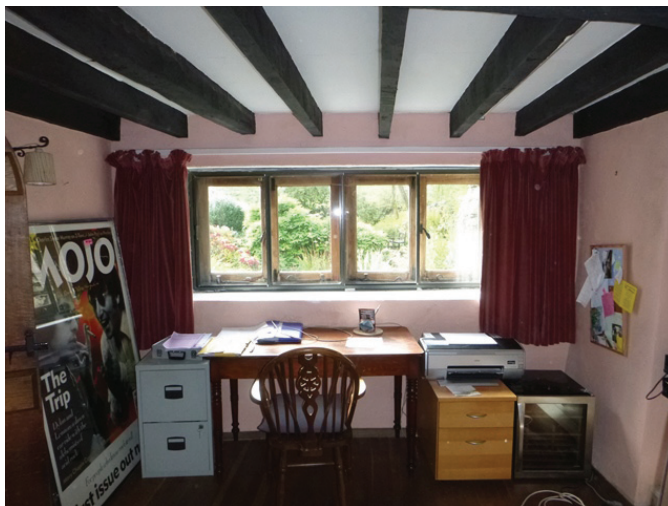
Plate 31 (right): the south end of Room G2, viewed from the north

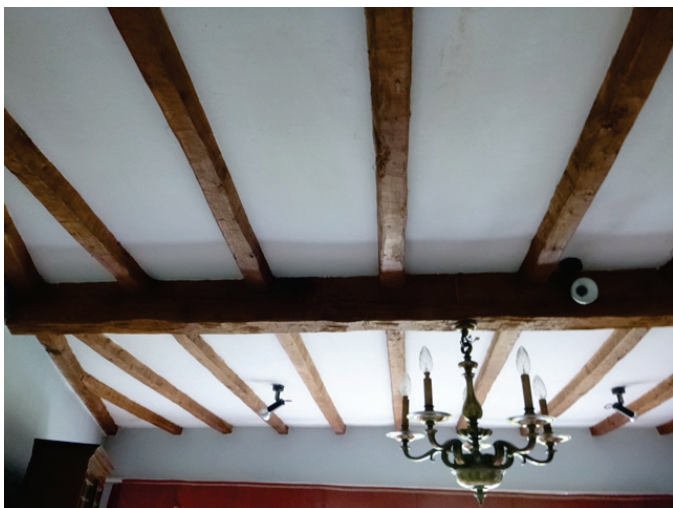
4.3.3 **House ground floor Room 3 (G3):** this has a timber floor and is open to the ceiling, which is supported by an exposed beam east/west and joists, all of which are hand-finished but very fresh and have either been cleaned, although not abrasively as the working is still evident, or are relatively recent (Plate 32). The walls are finished with modern plaster and paint. The north elevation has fitted shelves but is otherwise plain, there are doorways to the east and west up steps and both with rounded heads, and the south elevation has a long low window with secondary glazing and a doorway to the west (Plate 33).

Plate 32 (left): the ceiling in Room G3, viewed from the north

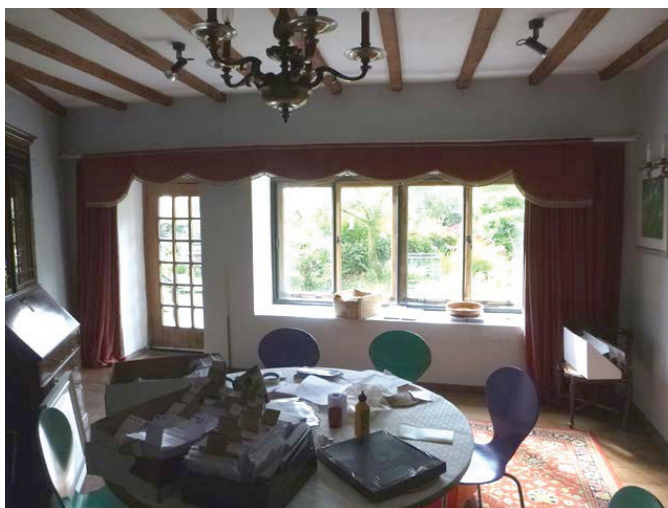
Plate 33 (right): the south end of Room G3, viewed from the north

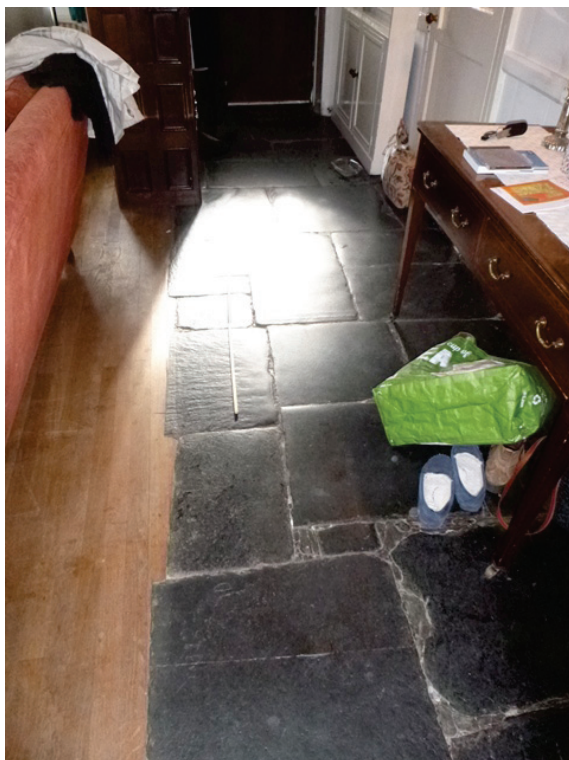
Plate 34 (left): the flag floor leading to the front door in Room G4, viewed from the north

4.3.4 **House ground floor Room 4 (G4):** this comprises an L-shaped corridor linking the front door, to the south, with the stairs to the first floor, to the east (Plate 35). The floor is a mixture of carpet finish and timber boards although the initial section running north/south from the front door is flagged (Plate 34). The ceiling has some early joists and the room is opened out into Room G8 on the west side where an original wall has clearly been removed. There are sections of muntin and plank wall along the east/west section of the corridor set below stud partition walls (Plate 35 and Plate 36), where it opens into the stairs, which are finished with a relatively plain hand rail (Plate 37). The walls are otherwise relatively plain with numerous doorways leading into other rooms, which are described in more detail elsewhere.

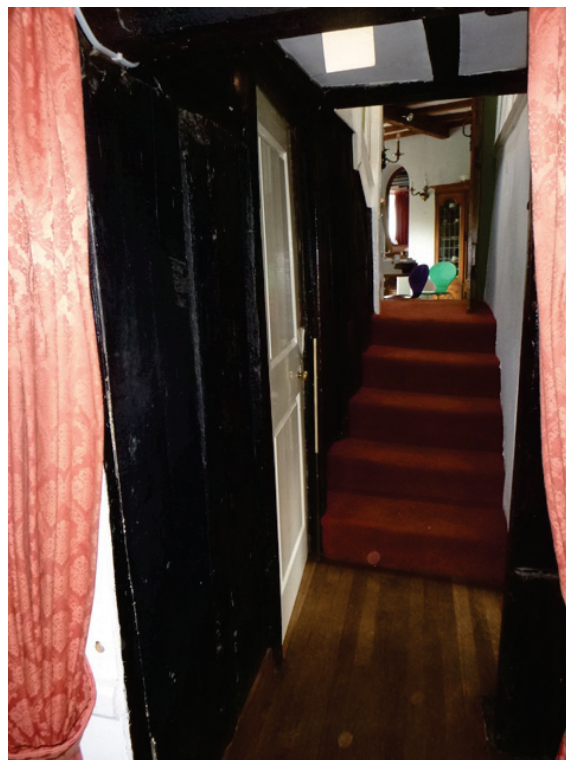
Plate 35 (right): Room G4 heading towards the stairs, viewed from the west

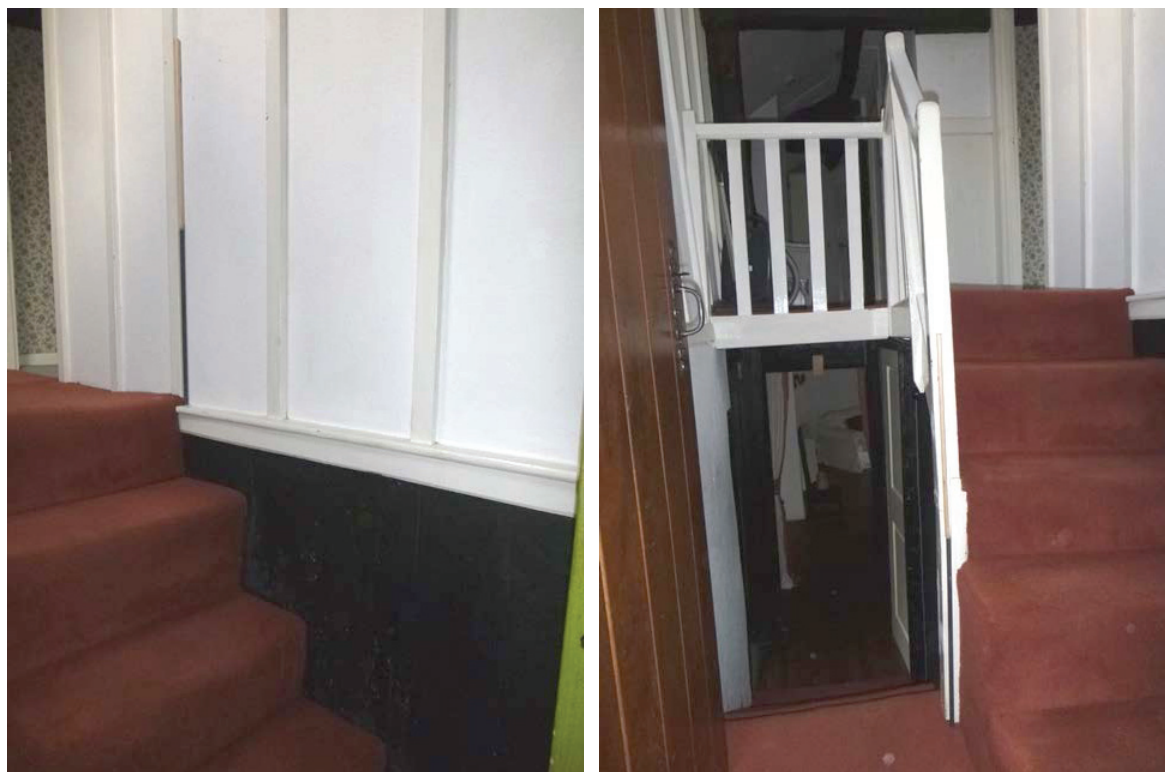
**Plate 36 (left): the plank and mutin wall on the south side of Room G4, viewed from the north-east**

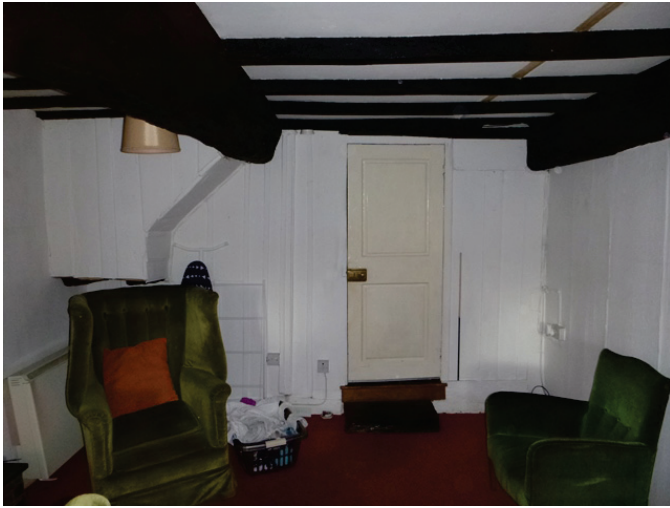
4.3.5 **House ground floor Room 5 (G5):** the floor is finished with carpet, presumably over flags, and the ceiling is supported by a heavy hand-finished beam orientated north/south, which is stop chamfered and has a square socket at its north end and possibly another at the south end now covered with a small piece of board. The walls are finished with plaster and paint. The north is of muntin and plank construction with stud walling on top and there is boxing in the north-east corner below the staircase and a central doorway with a two raised and fielded panel door (Plate 38). The west elevation is also a stud wall of some form, finished with wallpaper and with a central doorway with a two raised and fielded panel door in a beaded surround. A chamfered beam runs along it and this has a large slot in the underside at the north end. The south elevation has two windows both with secondary glazing, splayed jambs and timber sills with a step in the west (Plate 39). The east elevation has a 'spice cupboard' on the south side with a relatively late carved timber door in a plain surround (Plate 40) but what are probably the original timber shelves inside. To the north is a slightly projecting chimney breast with a relatively modern stone surround around the hearth (Plate 41).

Plate 38 (left): the north end of Room G5, viewed from the south

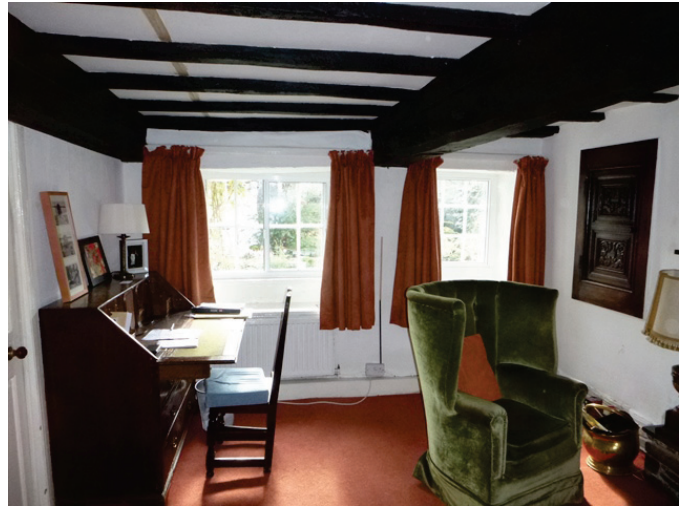
Plate 39 (right): the south end of Room G5, viewed from the north

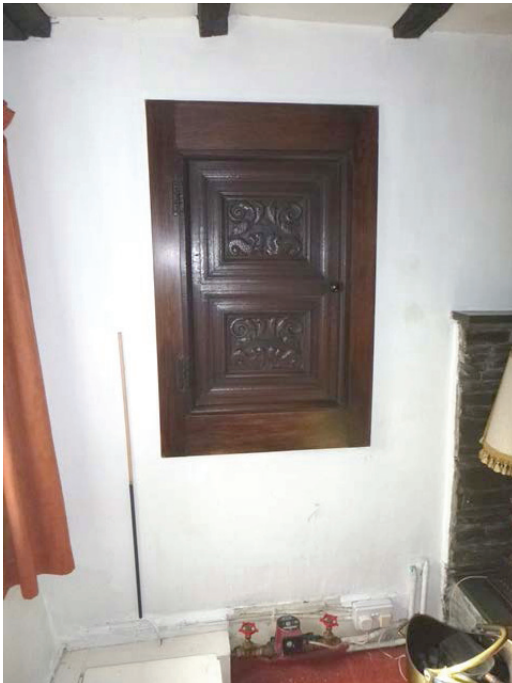
Plate 40 (left): the 'spice cupboard' in the east elevation of Room G5, viewed from the west

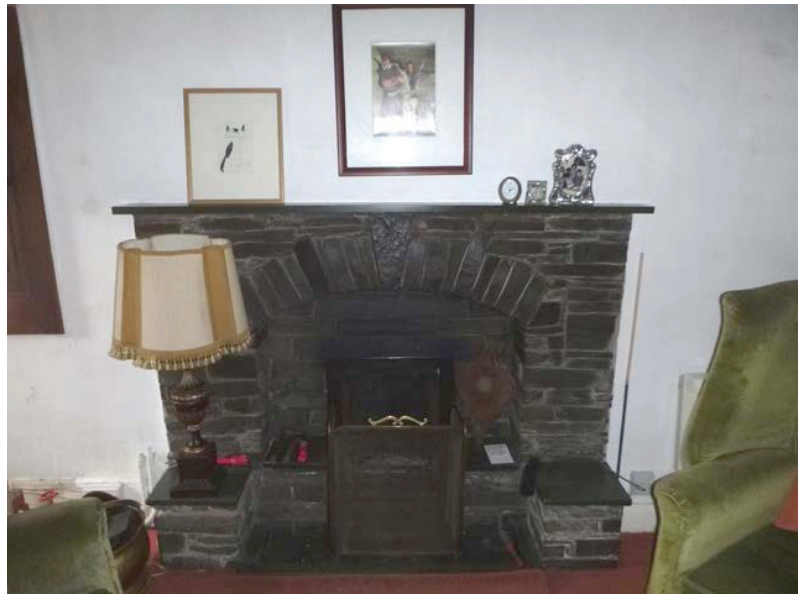
Plate 41 (right): the fireplace in the east elevation of Room G5, viewed from the west

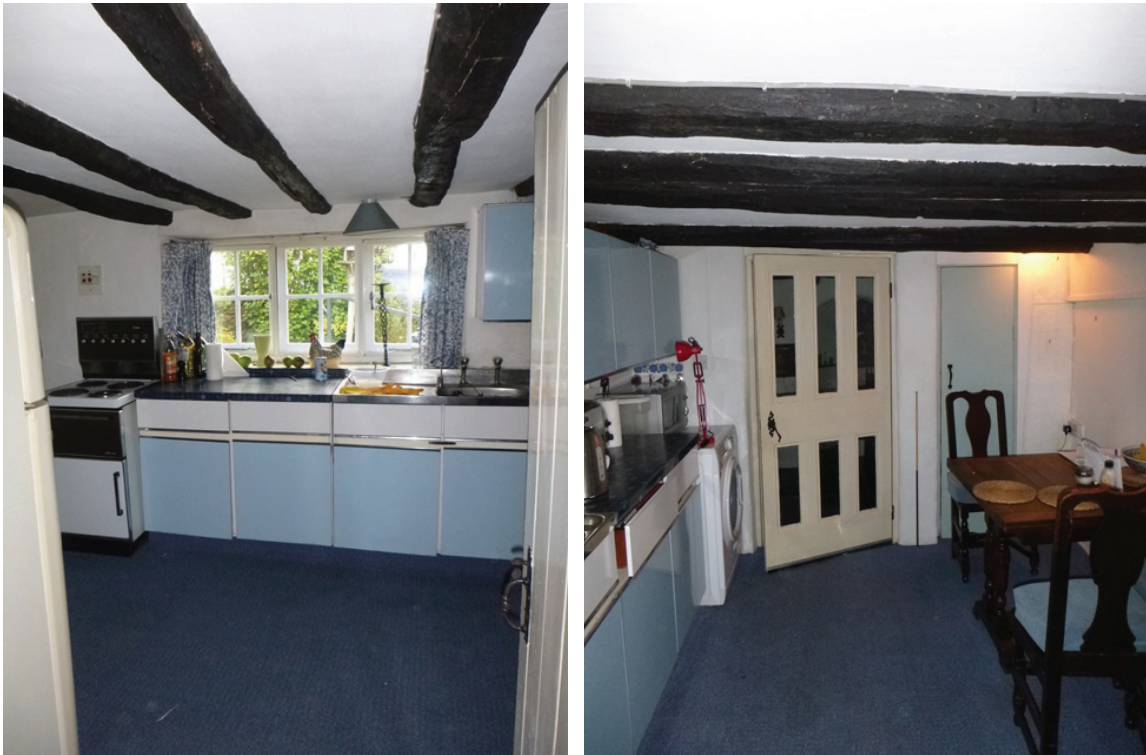
4.3.6 **House ground floor Room 6 (G6):** the floor is finished with carpet, over what are presumably flags, and the ceiling supported by hand finished joists. The walls are finished with plaster and paint. The north elevation has a long window with three four-light timber casements with chamfer decoration and secondary glazing (Plate 42). The west elevation has a doorway with a door with six lights and a tall alcove built into the wall to the south with a plain modern door (Plate 43). The south elevation is a stud wall, the east end of which is set below a hand-finished beam supported by two posts and there is a doorway in the centre with a plank and batten door of probably 19<sup>th</sup> century date. At the east end there is a small cupboard below the stairs in Room **G4** with a plank door. The east elevation has a slightly projecting chimney breast with a recessed hearth housing an oil stove (Plate 44).

Plate 42 (left): the north elevation of Room G6, viewed from the south

Plate 43 (right): the west end of Room G6, viewed from the east

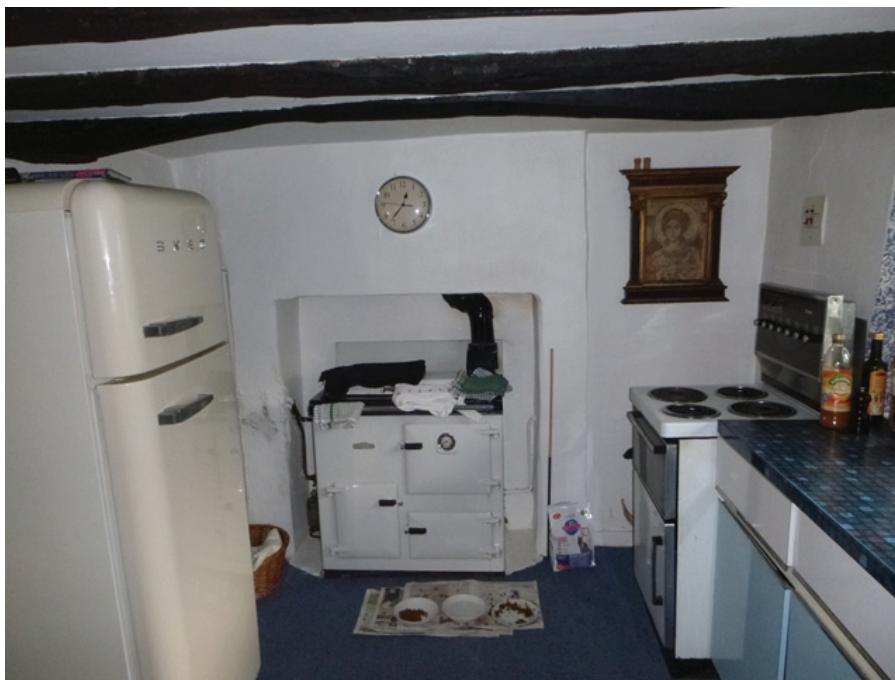
Plate 44: the east end of Room G6, viewed from the west

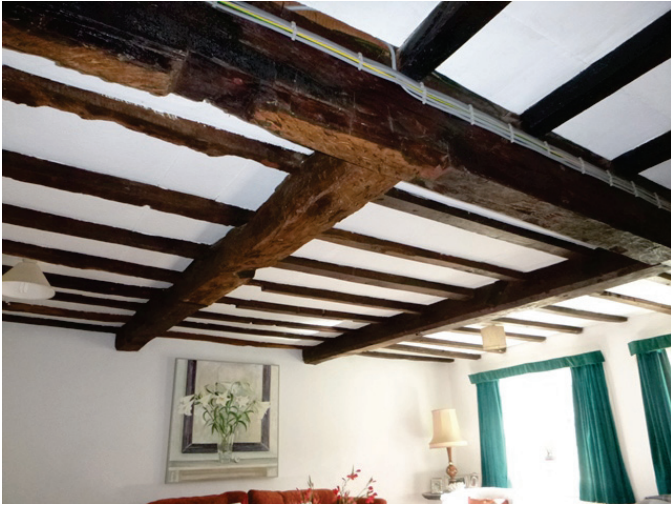
4.3.7 **House ground floor Room 8 (G8)**: this has a timber floor, although on the east side where it combines with Room G4 it has slate flags (see *Section 4.3.4* above). There are two heavy and hand-finished timber beams running east/west supporting joists (Plate 45), both with chamfer decoration and with empty angled sockets and peg holes suggesting they are re-used cruck blades (Plate 46). These meet and are jointed to a north/south beam at the east end, which originally denoted the position of the west wall of Room **G4**, which is much thicker and has several slots cut into it (Plate 47) and a boxed section below it at the south end forming a panelled cupboard (Plate 48). The walls are largely finished

Plate 45 (left): beams and joists in Room G8, viewed from the north-east

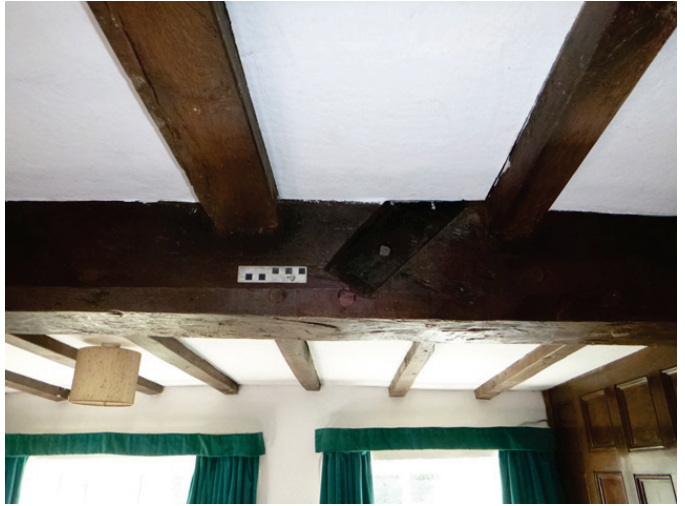
Plate 46 (right): slot in east/west beam in Room G8, viewed from the north

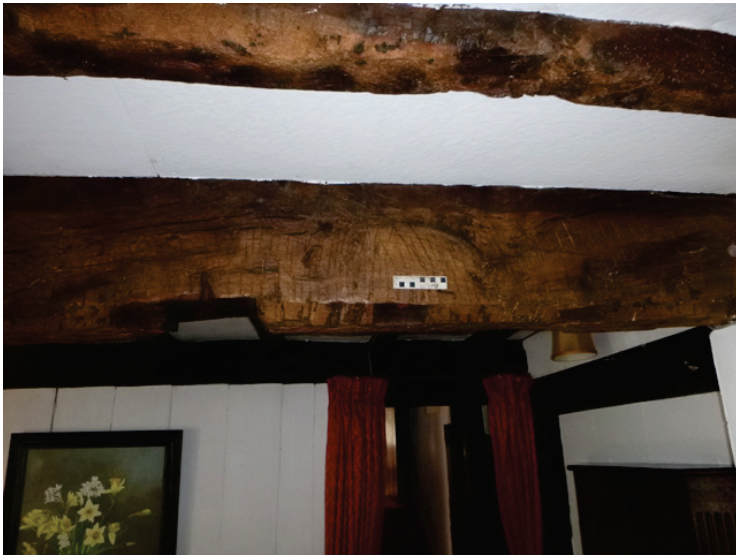
Plate 47 (left): slots in north/south beam in Room G8, viewed from the west
