# BOWMANSTED, CONISTON, CUMBRIA

## Heritage Assessment

Client: Mr and Mrs Reeves

October 2017

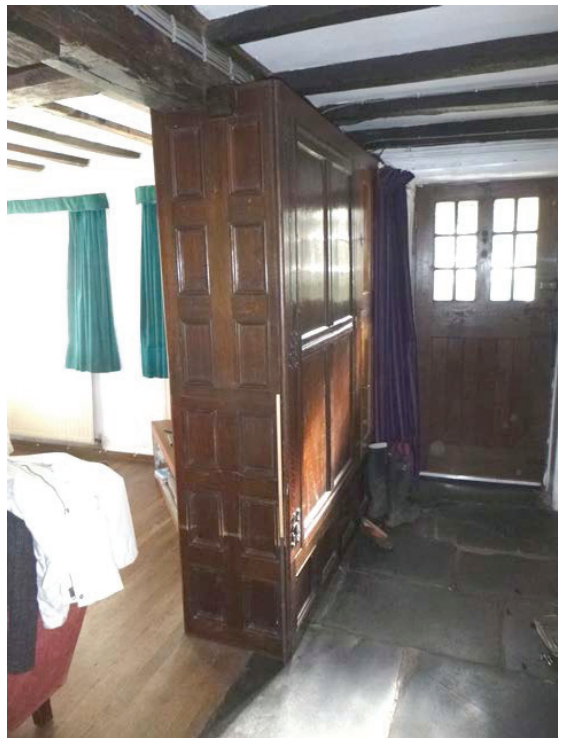
Plate 48 (right): boxed cupboard below the north/south beam in Room G8, viewed from the north-east

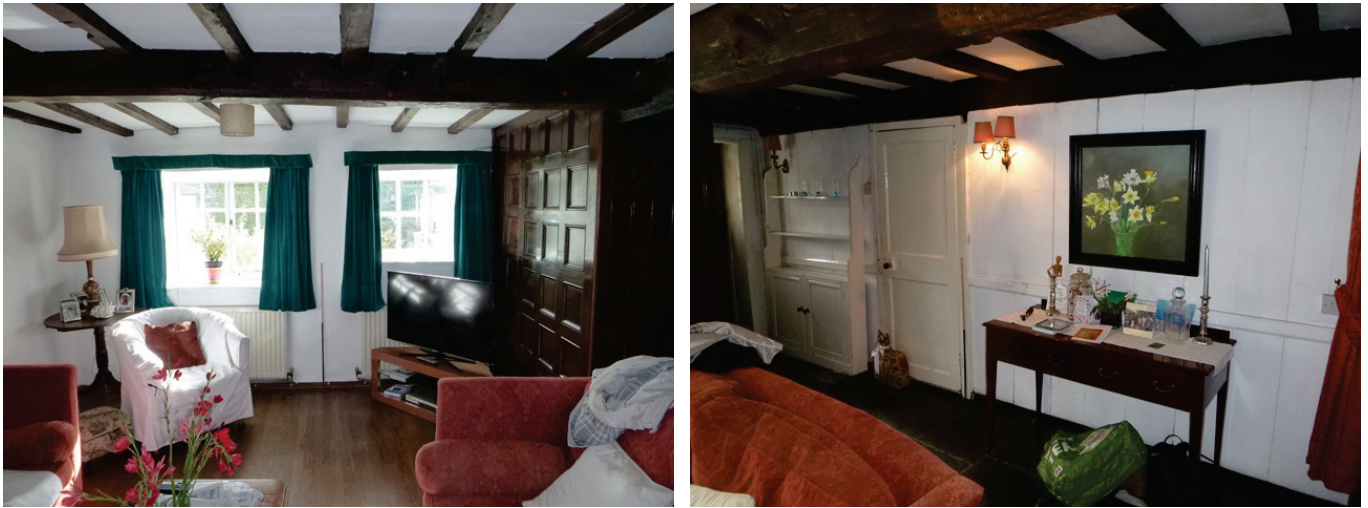
with plaster and paint. The north elevation steps out on the east side where it meets a step up into Room G4, after which there is a doorway with splayed jambs and a glazed door with 18 lights. The west elevation is plain. The south elevation has two windows with 12 and six-light sliding sash casements, splayed jambs and timber sills (Plate 49). The east elevation is open to Room G4, the east side of which is a timber stud wall constructed from planks and finished with wallpaper, with a central doorway with two beaded panels and a plain surround (Plate 50).

Plate 49 (left): the south elevation in Room G8, viewed from the north

Plate 50 (right): the east elevation in Room G4/8, viewed from the north-west

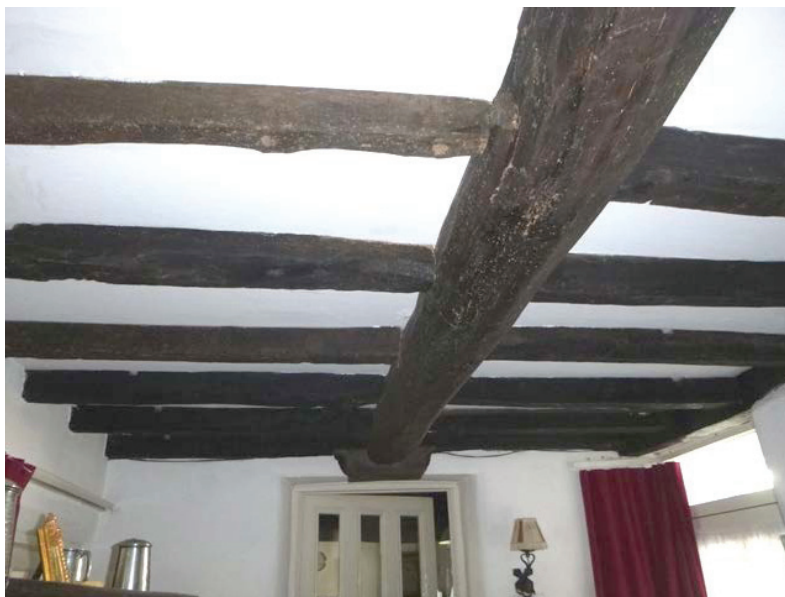
Plate 51: beam and joists in Room G9, viewed from the west

4.3.8 **House ground floor Room 9 (G9):** this has a flag floor, although the flags are noticeably very irregular sizes, and the ceiling is supported by a rough beam orientated east/west that is virtually round in section (Plate 51) that has a block at the east end made from thick planks attached around its end, the north and south faces of which form a curved scroll and are decorated with carved heads (Plate 52 and Plate 53). The walls are finished with plaster and paint. The north elevation has a doorway on the east side with a plank door with nine lights. (Plate 54) The west elevation has a doorway on the north side with a three panel relatively modern door. (This leads into a small toilet – Room **G9a** – with a lino floor and flat plaster ceiling and wallpapered walls, the only feature of note is a small window to the west with a four-light hinged casement). To the south of this doorway there is a large opening with a rounded head leading to a spiral staircase with thick timber steps (Plate 68), which are fixed with screws and topped by a relatively modern wrought iron handrail with twisted decoration. Mirroring this is a curving passageway connecting to Room **G10** that drops down a shallow flight of steps, finished with slate flags, forming a concentric staircase over all. The curving wall corresponding to this has a large timber shelf set into it and alcove above with a slate sill, perhaps originally a window. The south elevation is relatively plain, with a doorway on the east side up a single stone step, and the east elevation also has a doorway up two stone steps both of which have relatively modern glazed doors.

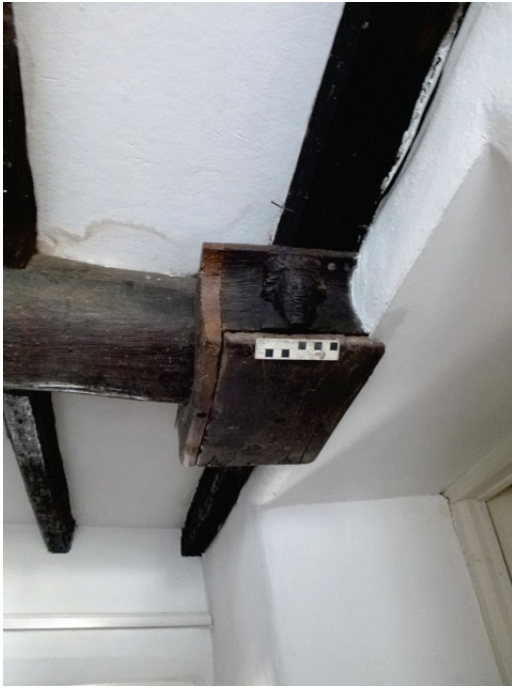
Plate 52 (left): decorated block covering the east end of the beam in Room G9m viewed from the north

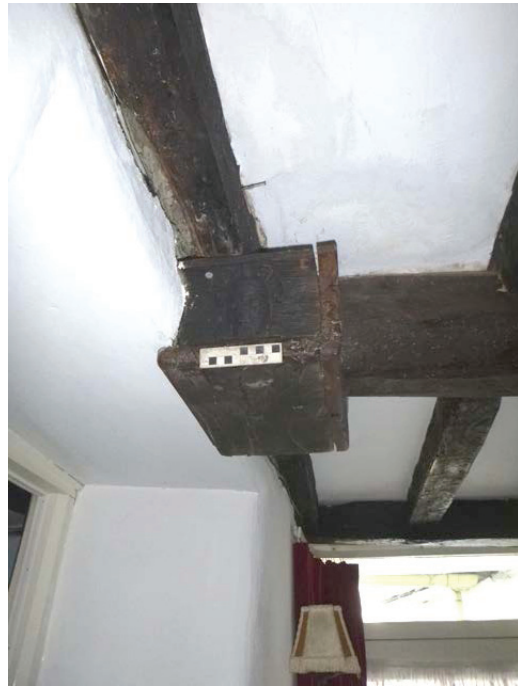
Plate 53 (right): decorated block covering the east end of the beam in Room G9, viewed from the south

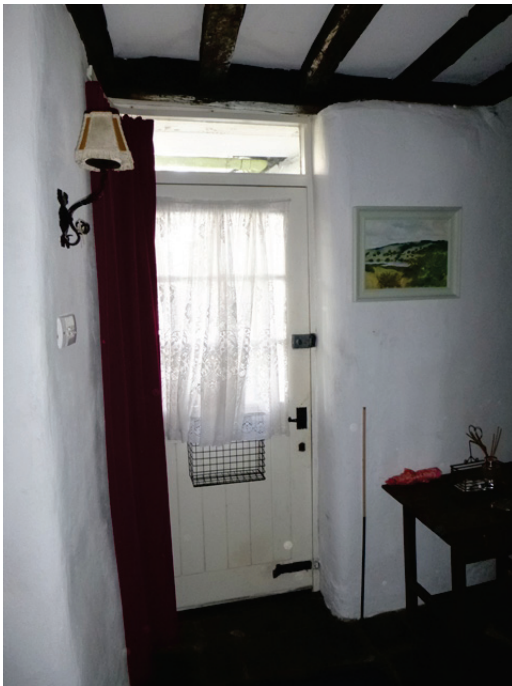
Plate 54 (left): the doorway in the north elevation of Room G9, viewed from the south

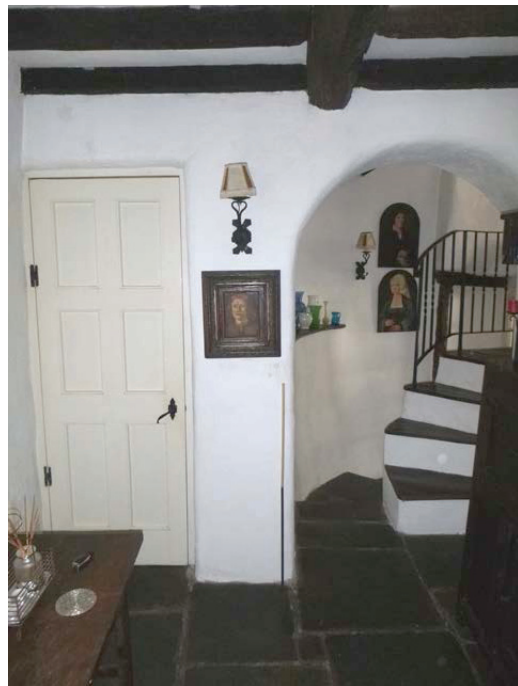
Plate 55 (right): the west end of Room G9, viewed from the east

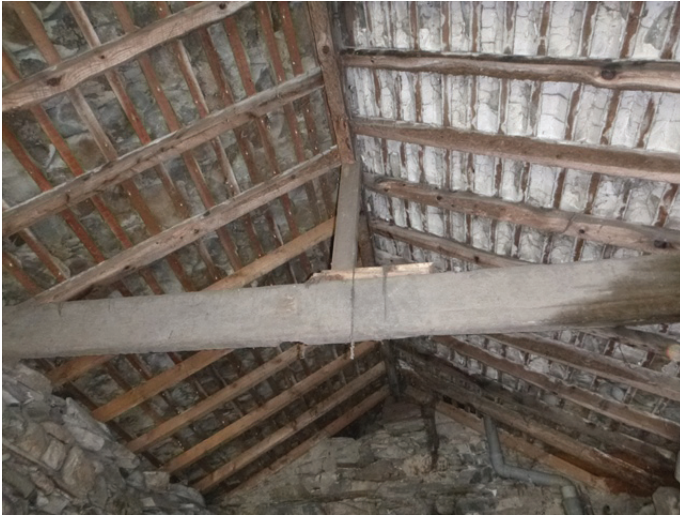
**Plate 56 (left): the truss in Room G10, viewed from the north**

4.3.9 **House ground floor Room 10 (G10)**: this has tarmac floor and is open to the roof, which is supported on a single very basic king post truss constructed from machine cut timber, little more than a thick plank (Plate 56). The walls are all exposed stone. The north elevation has a wide doorway with a heavy timber lintel and timber infill above, and there are alcoves to the west and south, the larger of which to the south is probably a blocked window and has a stone sill and lintel (Plate 57).

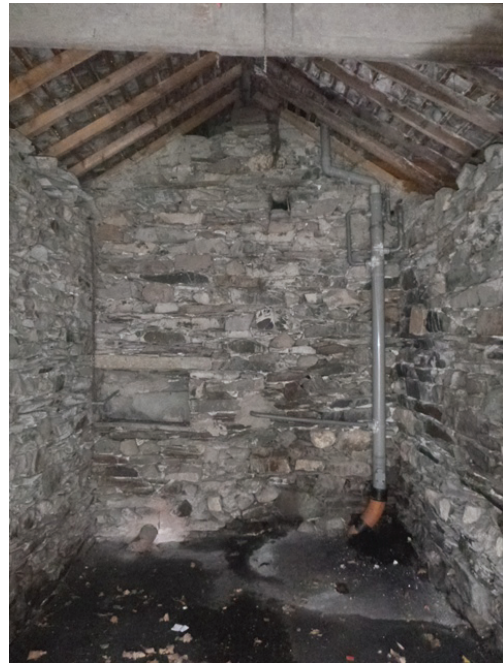
**Plate 57 (right): the south end of Room G10, viewed from the north**

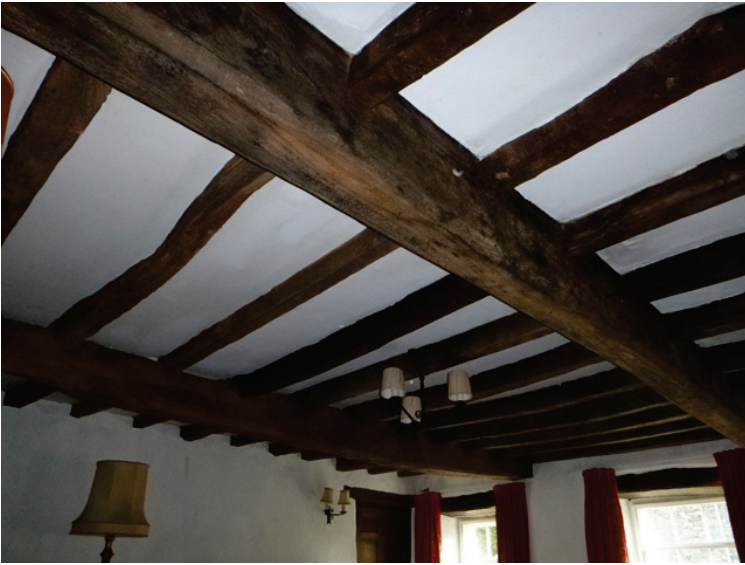
Plate 58 (left): beams in Room G11, viewed from the north-east

4.3.10 **House ground floor Room 11 (G11):** this has a timber floor as per the other rooms on this floor and a plaster ceiling supported by two beams orientated north/south and joists, all of which are hand finished and chamfered. There are some empty slots in the west face of the western beam and the walls are finished with plaster and paint. The north-west corner steps back and the wide opening into this is spanned by a further heavy beam running east/west, which in turn supports one of the north/south beams. The north elevation has a doorway on the east side with a relatively late door in the same style as those in Room **G9**, with 10 lights and a canted top. Rough timbers have been attached around it to form a surround, step, and lintel but these are clearly late additions and a decorative carved timber frieze, clearly reused from elsewhere, has been attached to the 'lintel' (Plate 59). To the west of this door the wall returns to the north where this is an alcove with a timber lintel and timber shelf and sill (Plate 60). In the north elevation proper, within the extension there is a window with a heavy timber lintel, thick timber sill, and three-light very square mullion casement with twisted iron bars between. To the west is another small alcove with a slate sill. In the north end of the west elevation there are two windows and irregular heights both with thick timber sills, rough timber lintels, and two-light mullion casements, which are again very square (Plate 61). At the south end of the elevation there is a doorway with a relatively early six-panel door incorporating a decorated frieze but this is supported by relatively late hinges (Plate 62). The south elevation has two windows with timber sills, exposed rough timber lintels, and secondary glazing. There is a doorway at the east end with a plank door with nine lights. The east elevation is dominated by a large central fireplace in a projecting chimney breast that slopes inward at the top and has chamfered stone corbels on either side (Plate 63). The front has an elaborately decorated carved timber surround dated 1665 around a very plain opening. The hearth itself is raised and comprises a large slate slab with timber on either side. There are alcoves set into both sides of the chimney breast, the south has an early timber door, although this has clearly been reused as the lock is on the opposite side to the handle and it is fixed with relatively modern screws, and houses pipes for a back boiler, while the north is plain but much deeper and both have slightly projecting slate lintel and a slate sill. At the north end of the east elevation there is also some panelled timber boxing below the stairs running from Room **G9**, which appears relatively late (Plate 59).

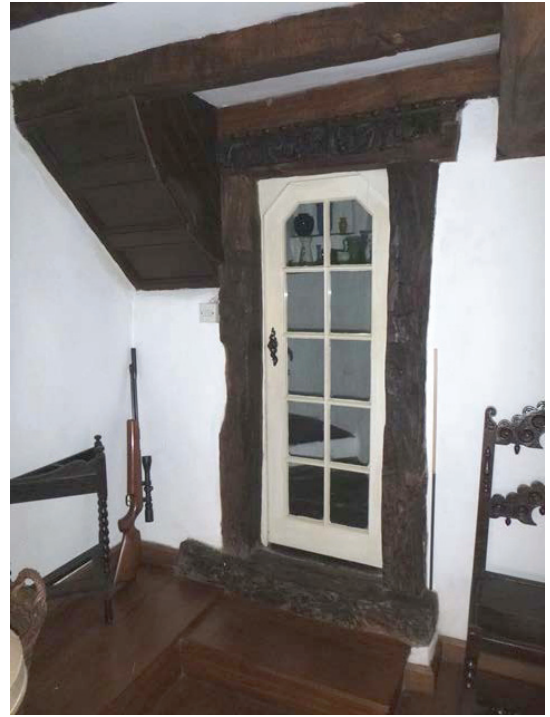
Plate 59 (right): doorway in the north elevation of Room G11 and boxing below the stairs, viewed from the south-west

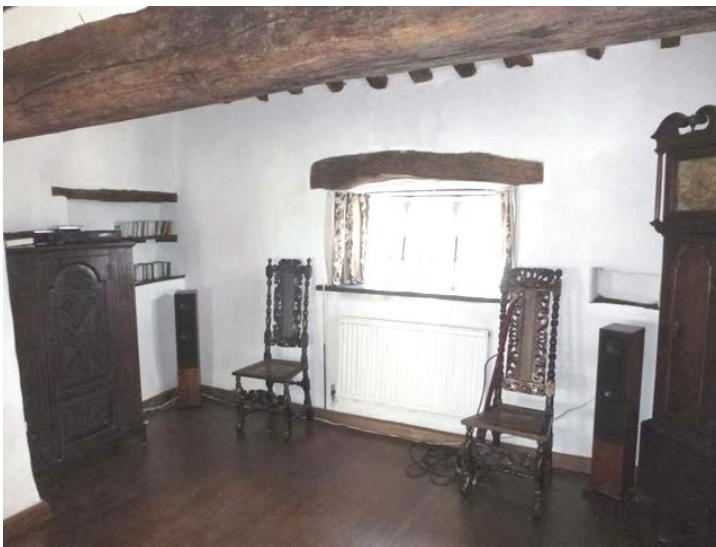
Plate 60 (left): the west end of the north elevation of Room G11, within the extension, viewed from the south-west

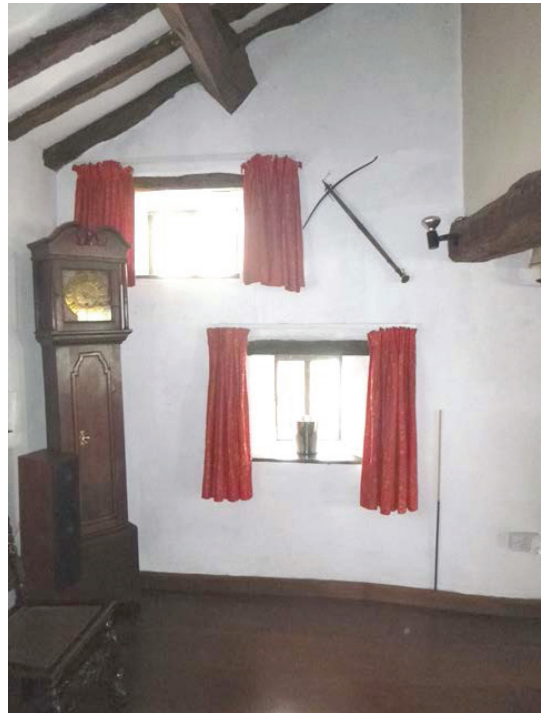
Plate 61 (right): the windows at the north end of the west elevation of Room G11, viewed from the east

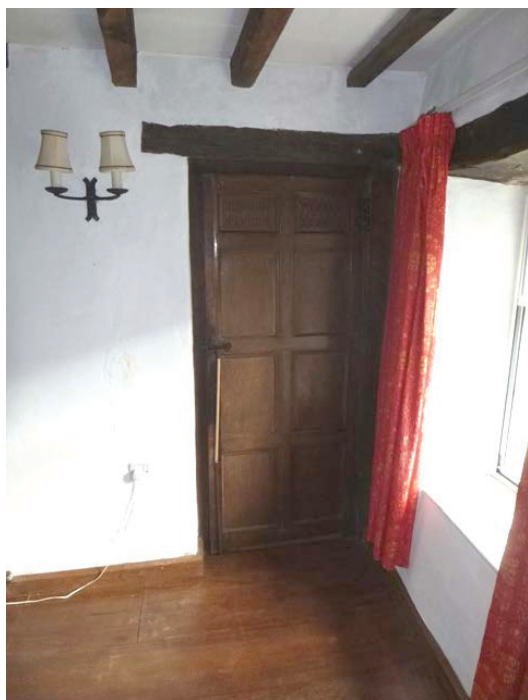
Plate 62 (left): the doorway on the south side of the west elevation of Room G11, viewed from the east

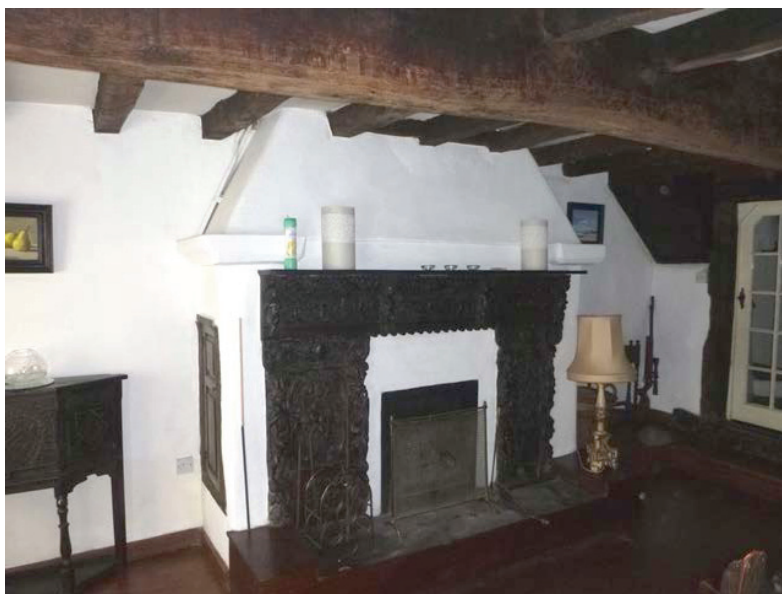
Plate 63 (right): the fireplace on the east elevation of Room G11, viewed from the south-west

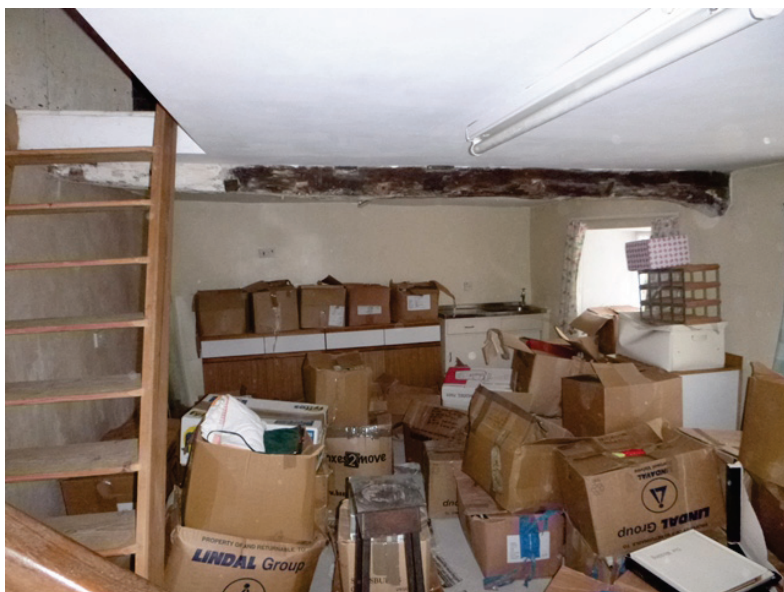
4.3.11 *House ground floor Room 12 (G12)*: this has a concrete floor and a flat plaster ceiling supported by a single beam orientated east/west with is slightly curved at the west end (Plate 64). The walls are all finished with modern plaster, and the north elevation is plain, and there are relatively modern timber stairs up to the first floor on the east side (Plate 64) and a shorter staircase up to Room **G11** in the south-east corner. There are three windows in the west elevation with timber sills and a small window on the east side of the south elevation overlooking the stairs, which also has a timber sill. The doorway at the top of the stairs to the east is a relatively early essentially six panel type, but has clearly been rehung in its current position (Plate 65).

Plate 64 (left): general view of Room G12, from the south

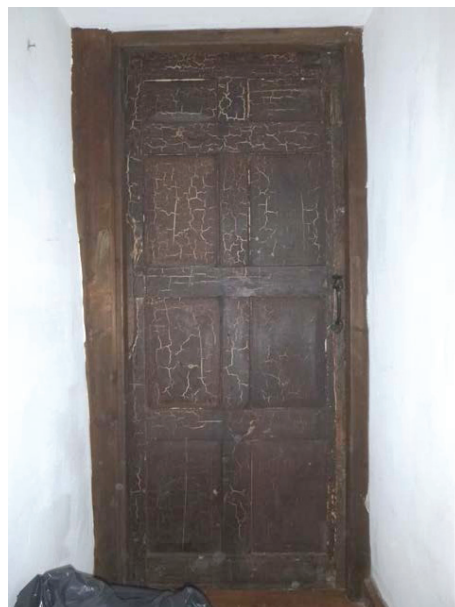
Plate 65 (right): the doorway in the east elevation of Room G12, viewed from the west

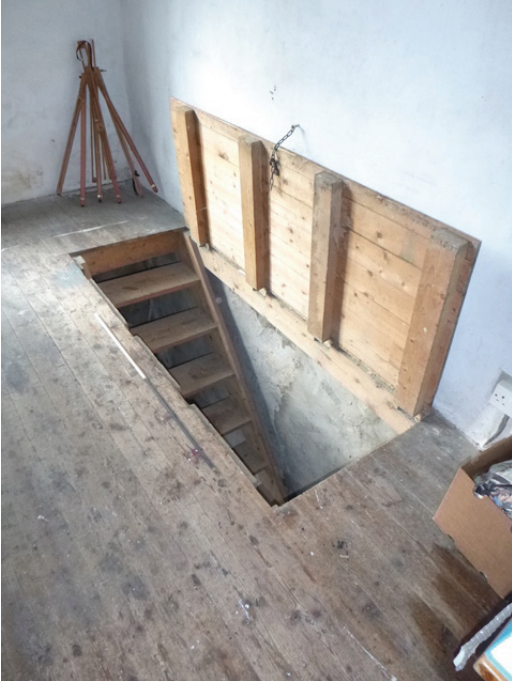
Plate 66 (left): the hatch in the south-east corner of Room F1, viewed from the north-west

4.3.11 **House first floor Room 1 (F1)**: this has tongue and groove floorboards that incorporate a large hatch in the south-east corner, leading to the stairs to Room **G1** below (Plate 66). It is open to the roof, which has two purlins per pitch and a ridge plank with plaster board or similar between (Plate 67). The walls are finished with modern plaster and paint, the north and east are plain, while the south has a wide window with aluminium secondary glazing (Plate 68). The west elevation has a doorway on the north side, which is very plain and has no door, with Bakelite light switches to the south. There are modern shelves attached to the north elevation.

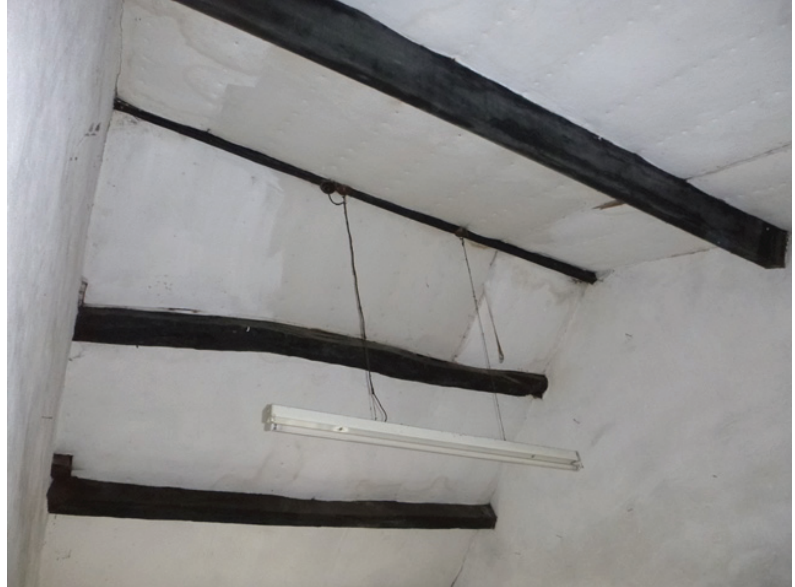
Plate 67 (right): the roof in Room F1, viewed from the south-east

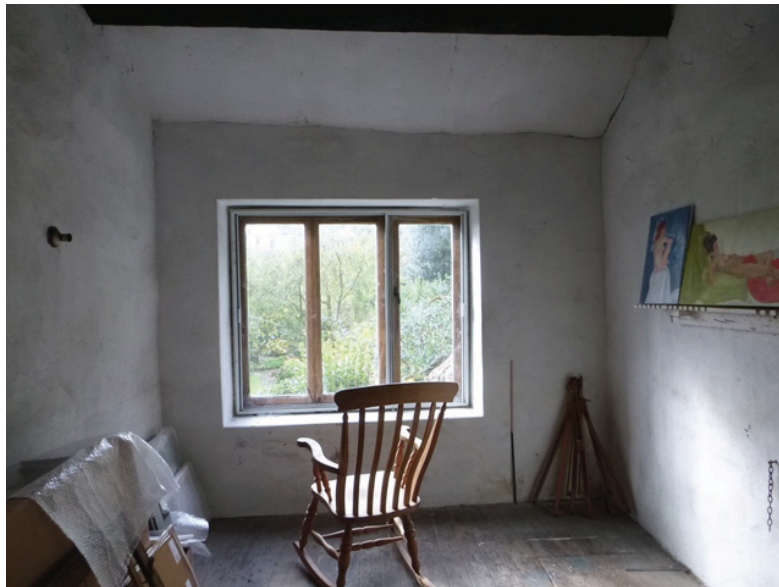
Plate 68: the south end of Room F1, viewed from the north

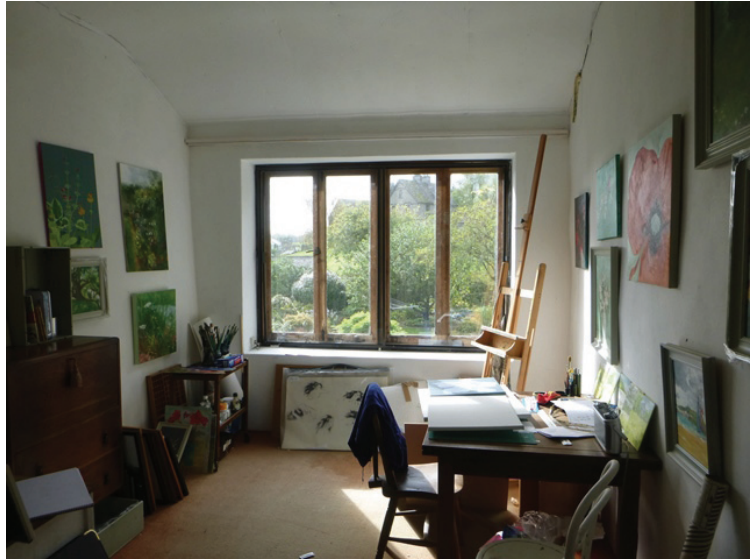
**Plate 69 (left): the boxing around the doorway in the north-west corner of Room F2, viewed from the south-east**

4.3.12 **House first floor Room 2 (F2)**: the floor is finished with carpet, over boards, and the roof is hidden by a suspended ceiling of boards with a hatch on the west side. The walls are finished with plaster and paint and mostly plain, with the exception of the west elevation, which has timber boxing around a doorway and associated stairs down to the room below with a plank and batten door (Plate 69).

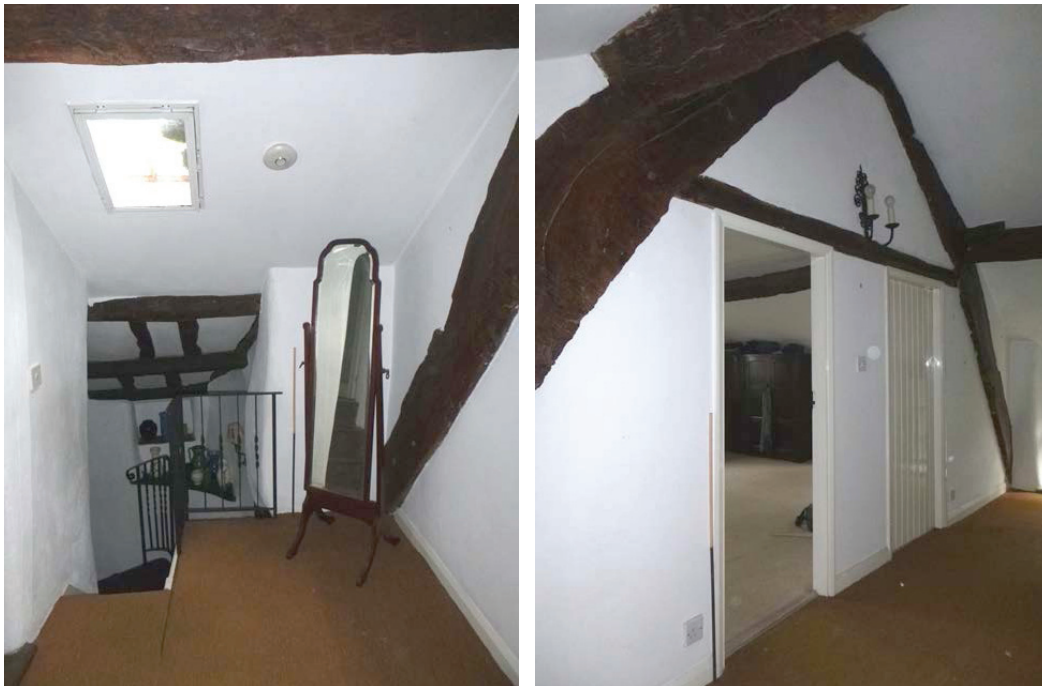
Plate 75 (left): the north end of Room F8, viewed from the south

Plate 76 (right): the cruck truss to the west of Room F8, viewed from the north-east

4.3.18 **House first floor Room 8 (F8)**: this comprises a very narrow space, little more than a corridor connecting the spiral stairs to the north with the corridor (Room **G4**). The floor is finished with carpet and the walls and ceiling with plaster, with a skylight on the north side. The north elevation is essentially open to the spiral stairs, which have a late wrought iron hand rail on the top (Plate 75). The west elevation incorporates a raised cruck truss with substantial cruck blades (Plate 76 and Plate 77) and a small and simple collar at the top (Plate 78) plus a tie beam, all of which are hand finished and pegged. There is a single purlin in each pitch in the same style but empty slots for lower purlins, indicating that the roof has been raised. Two doorways are incorporated into the stud wall below the truss both with tongue and groove plank and batten doors. The south elevation has a window, the sill of which is virtually at floor level, with a nine-light sliding sash casement and timber sill.

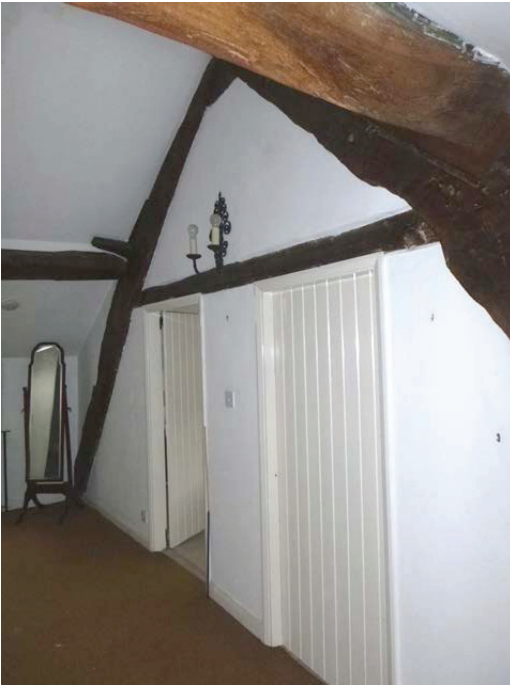
**Plate 77 (left): the cruck truss to the west of Room F8, viewed from the south-east**

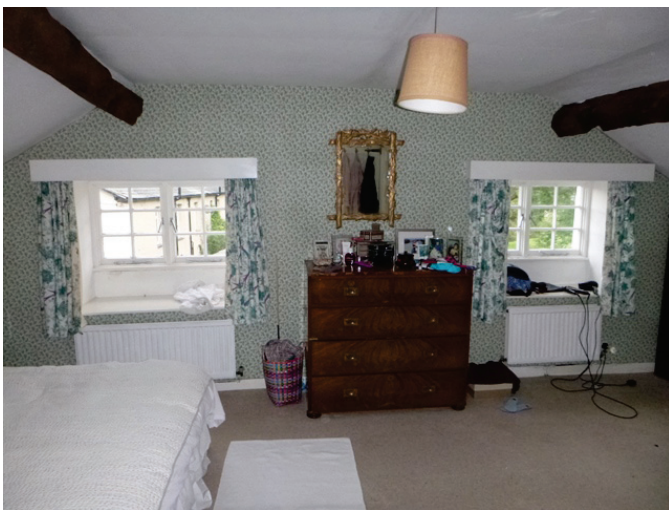
**Plate 79 (left): the west elevation of Room F10, viewed from the east**

4.3.20 **House first floor Room 10 (F10)**: the floor is finished with carpet and the ceiling and walls with plaster and paint. The north elevation is plain, while the west has two windows with timber window seats (Plate 79). The south elevation also has a window with its timber sill at floor level (Plate 80), while the east incorporates the raised cruck truss (Plate 81). This is as per Room F8, although the jointing for the tie beam is visible, while the collar is not as it is hidden behind the lowered ceiling. On this side the truss has a number of additional spurs visible (Plate 82 and Plate 84) as well as a group of three taper marks on the southern cruck blade (Plate 83).

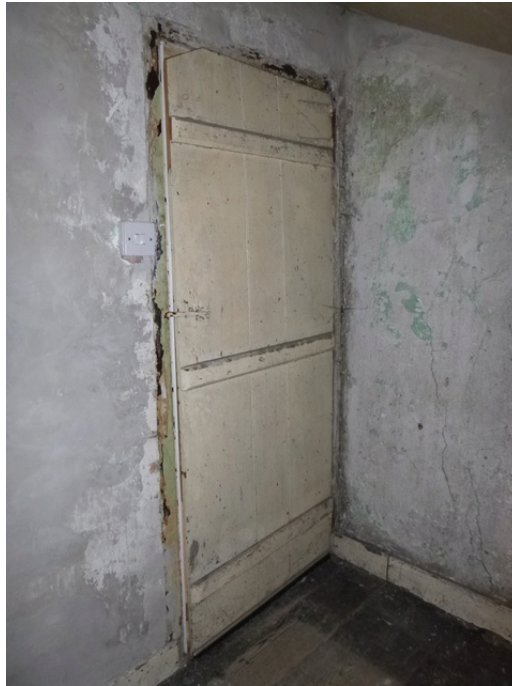
**Plate 85: the doorway on the east side of Room F11, viewed from the north-west**

4.3.21 **House first floor Room 11 (F11)**: this is very plain and divided by a modern stud wall into two separate rooms. The floor comprises wide timber boards, it is open to the roof, which is finished with plasterboard, and the walls are finished with plaster. The walls are all plain but there is a doorway on the east side of the stud wall with a tongue and groove plank and batten door on long 19<sup>th</sup> strap hinges and with a matching latch (Plate 85).

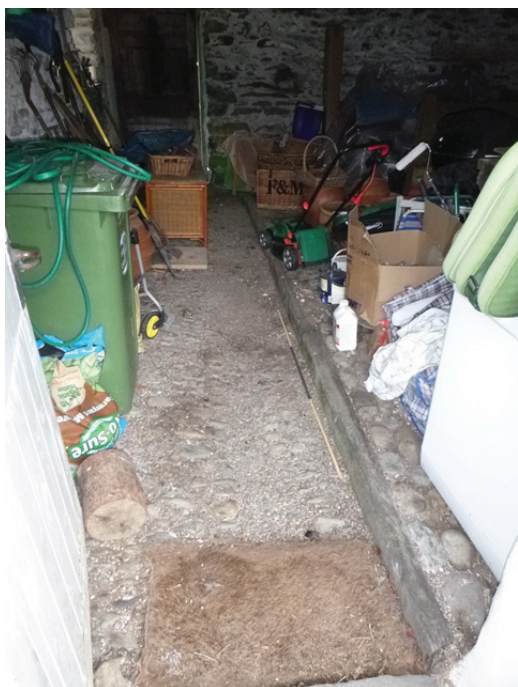
**Plate 86 (left): cobbled passageway on the east side of the barn, viewed from the south**

4.3.22 **Barn:** the floor is mostly earth but with some cobbling on the east side including a passageway between the doorways (Plate 86) and a raised cobbled area bounded by edge-set flags to the west of this, as well as an area of roughly stepped flags to the north. The roof is supported by three trusses of simple tie beam type, with the tie beams forming an overlapping joint, with two purlins per pitch and a ridge plank (Plate 87). The walls are exposed stone with lime pointing. The north elevation has a doorway on the east side with a rough timber lintel and a panel door on L-shaped hinges with a window above (Plate 88). To the west are a row of three joist holes, demonstrating that there must have originally be a hay loft at this end. Below these is a small alcove with a timber lintel and rough slate sill. To the west is a wagon doorway with a rough and re-used timber lintel and pair of large plank doors (Plate 89). There are two high-level slot vents with splayed jambs in this elevation and two further small alcoves at the west end with timber lintels. The west elevation is fairly plain but has a central 'scar' perhaps denoting the line of an earlier built but more likely relating to where things have been stacked against the wall, and there are two slot vents at high level with splayed jambs plus an owl hole at the top and a further small alcove in the centre (Plate 90). The south elevation has a window on the west side, which is clearly set within a partially blocked doorway (Plate 91), which has a stop chamfered lintel with holes either side that presumably relate to supporting timbers for a canopy like that present externally to the north. There are four slot vents along the top of the wall with splayed jambs and stone lintels and three joist holes at the east end matching those to the north. At the far east end is a doorway with a concrete lintel and a plank and batten door. The east elevation has a small alcove on the south side with a thin timber lintel and a slate sill and an owl hole below the apex. To the north is a window with a reused timber lintel that is clearly set within a blocked doorway.

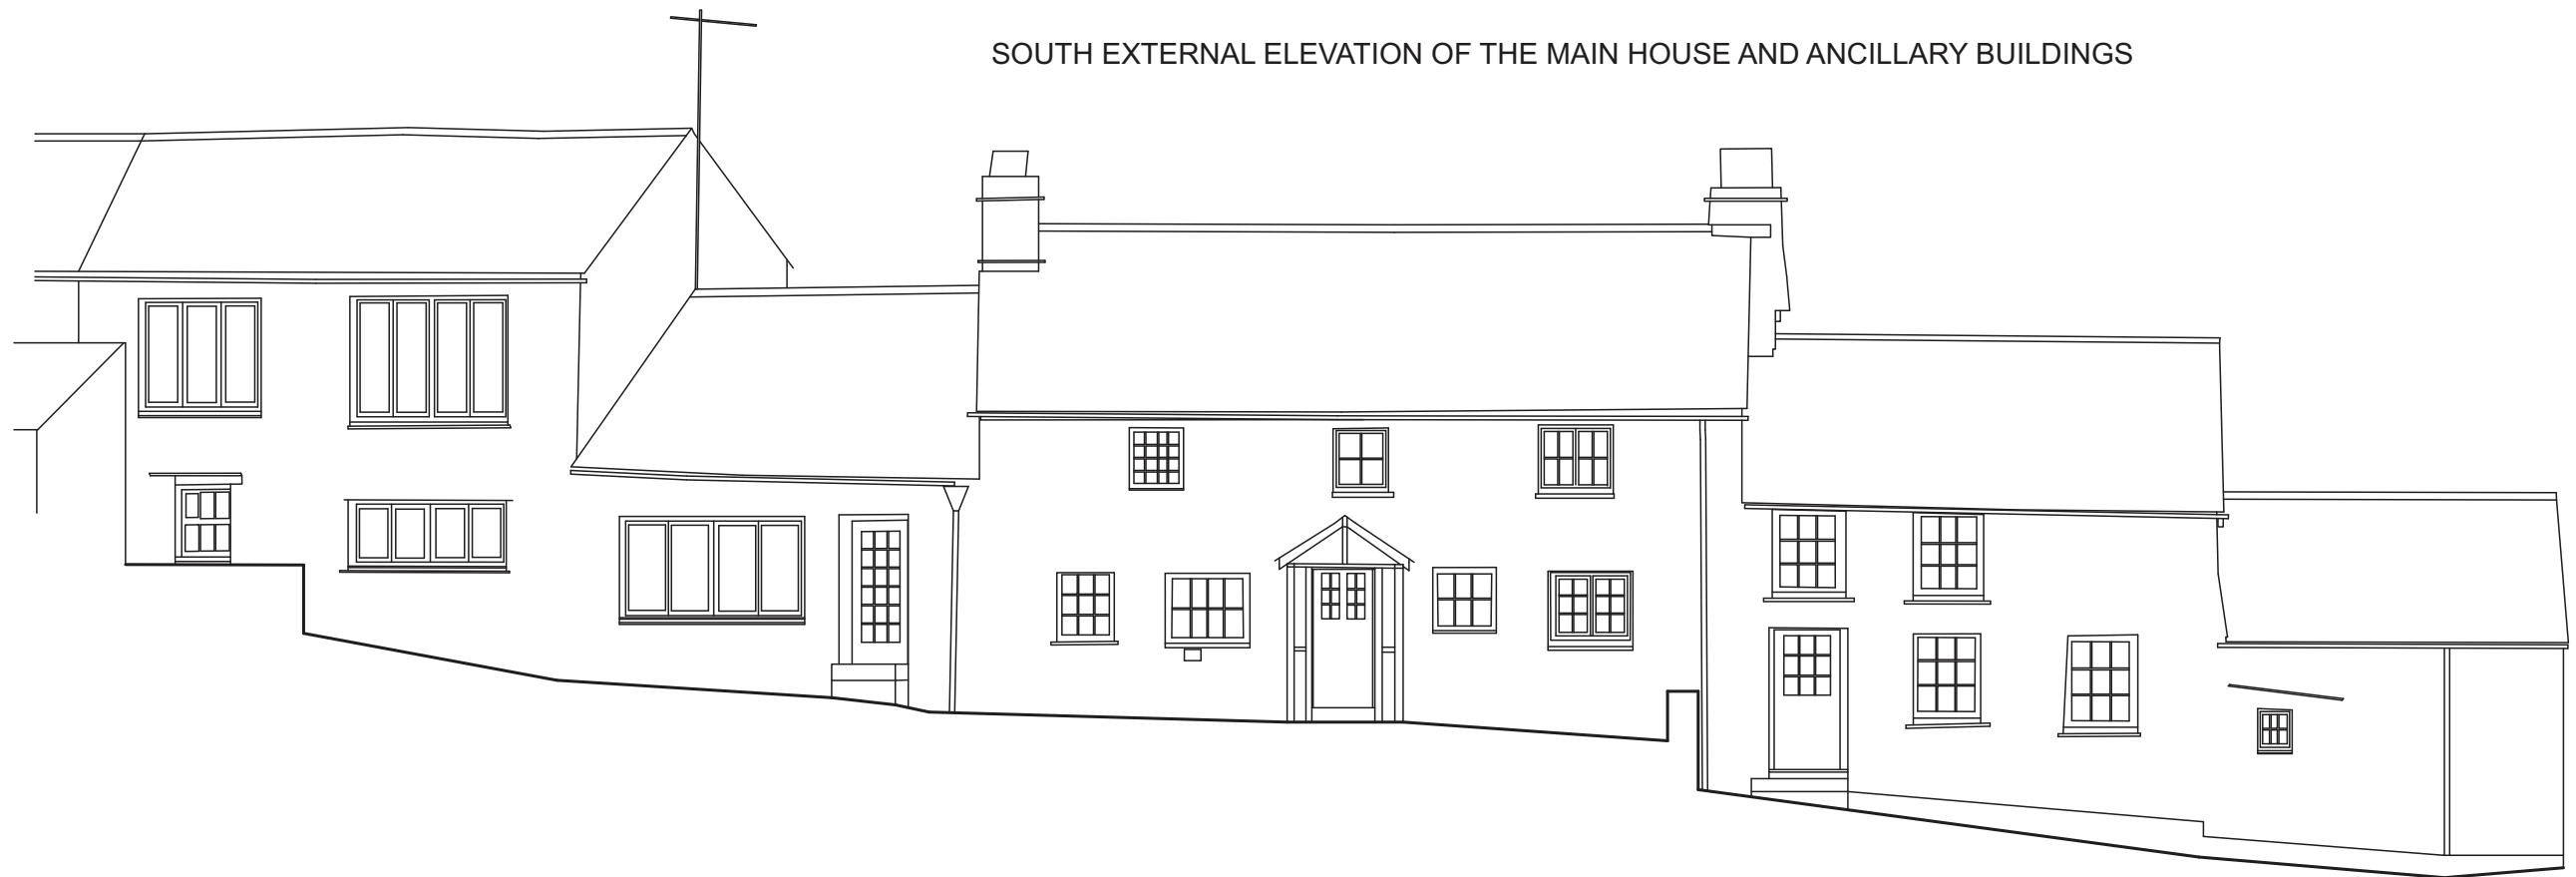
Figure 2: North and south external elevations of the main house and ancillary buildings

NORTH EXTERNAL ELEVATION OF THE MAIN HOUSE AND ANCILLARY BUILDINGS

SOUTH EXTERNAL ELEVATION OF THE MAIN HOUSE AND ANCILLARY BUILDINGS

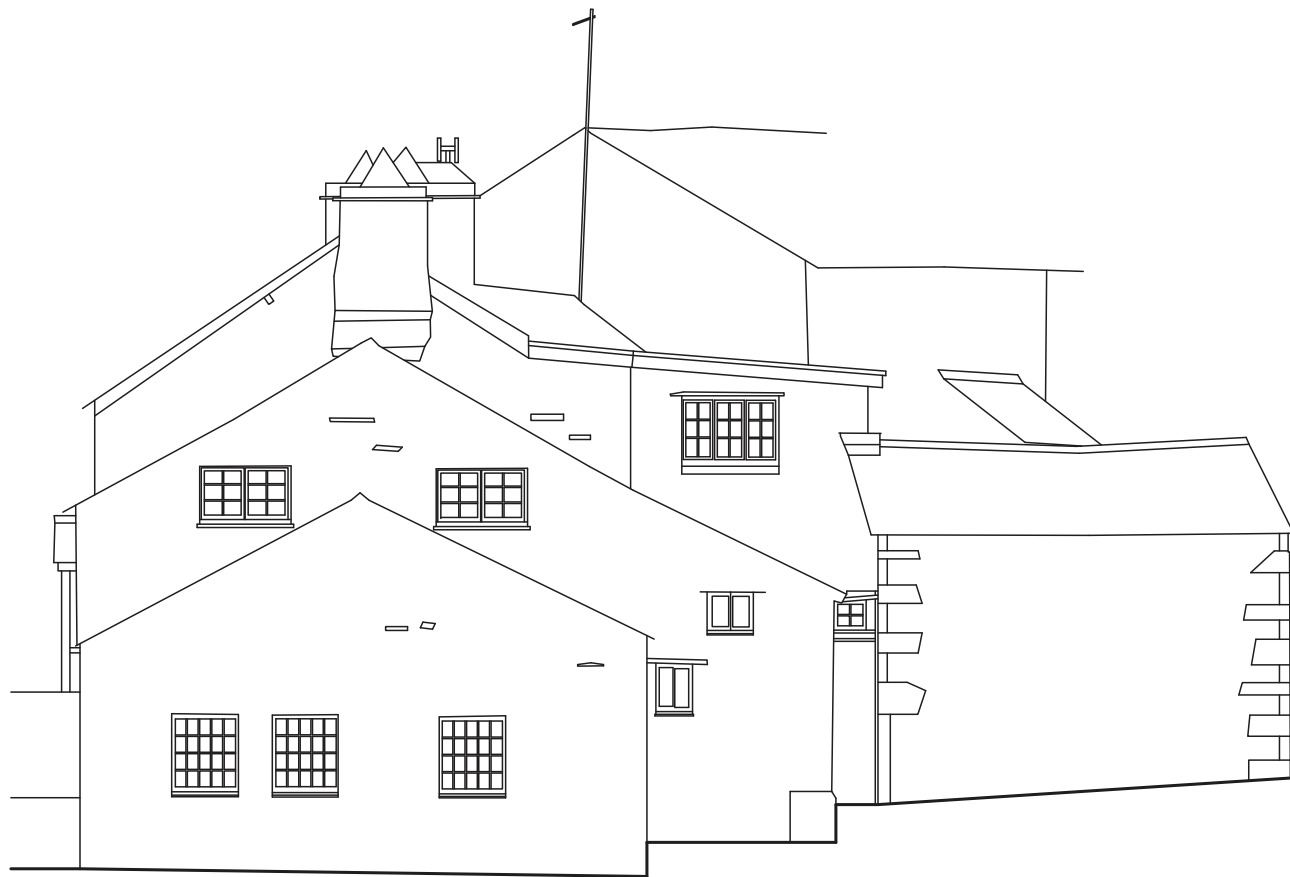
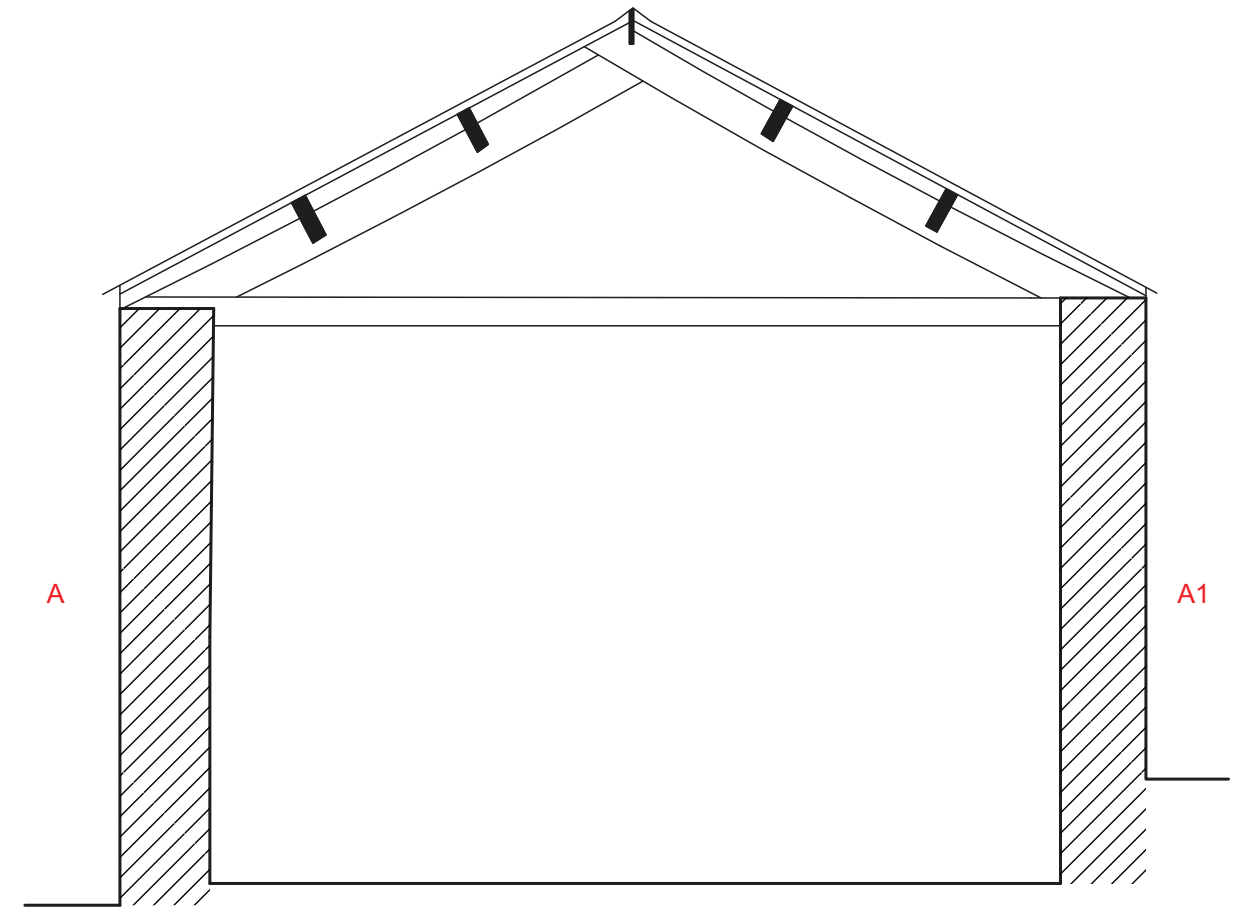
Figure 3: East external elevation of the main house and ancillary buildings and west-facing cross-section through the detached barn

EAST EXTERNAL ELEVATION OF THE MAIN HOUSE AND ANCILLARY BUILDINGS

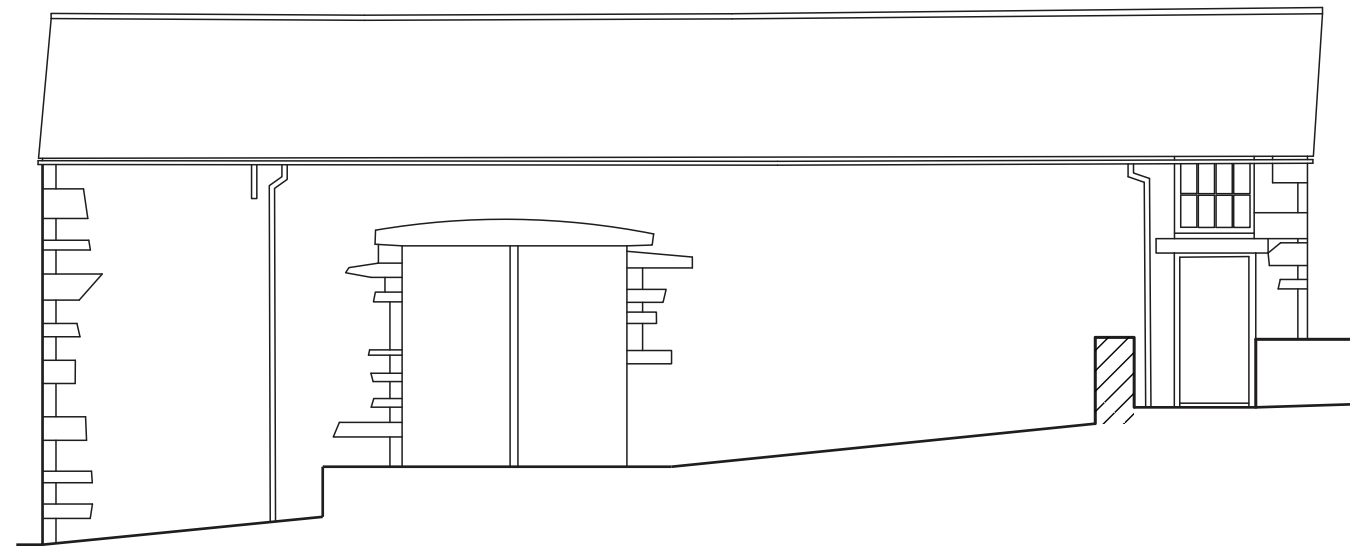
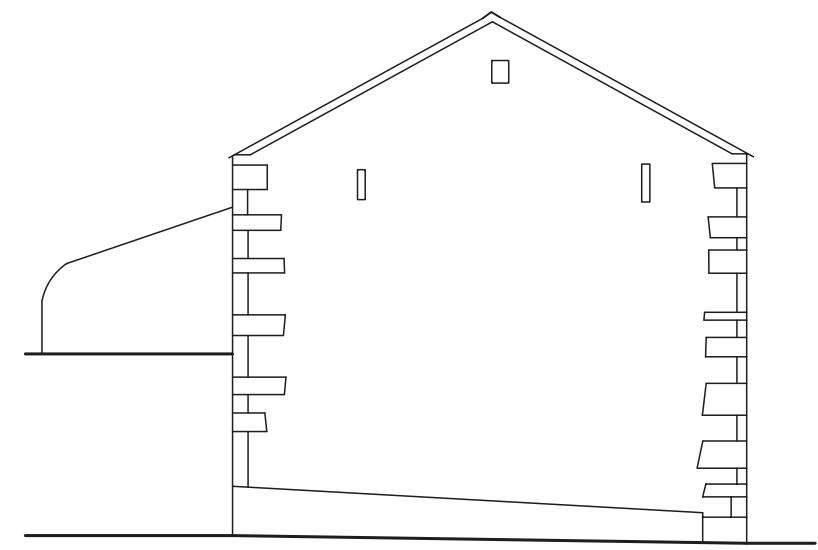
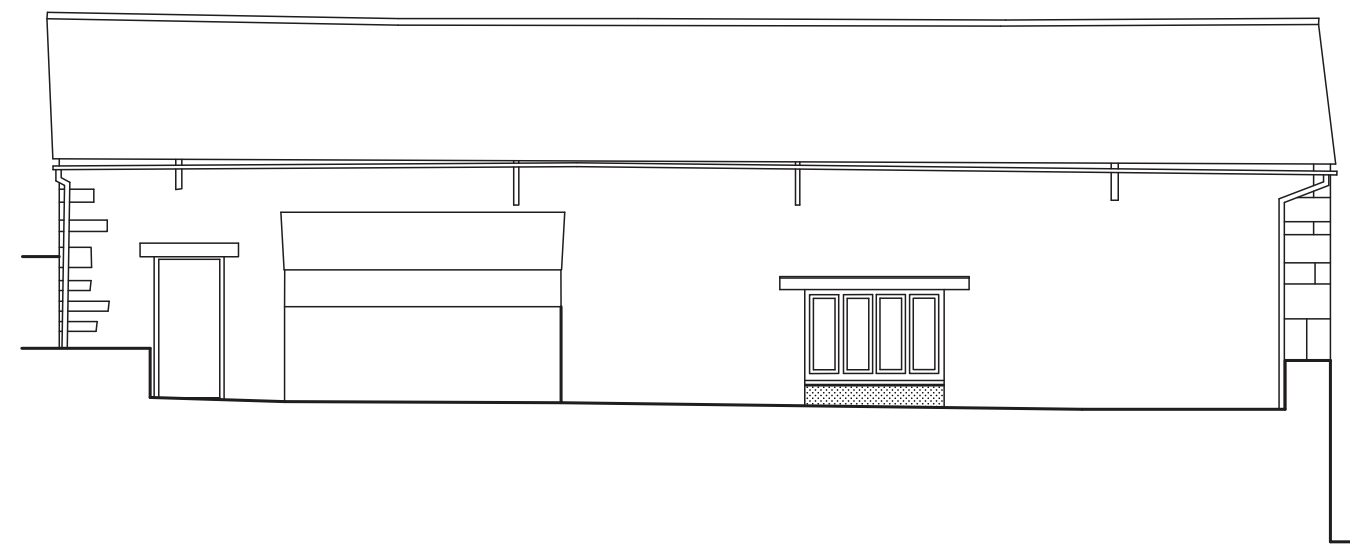
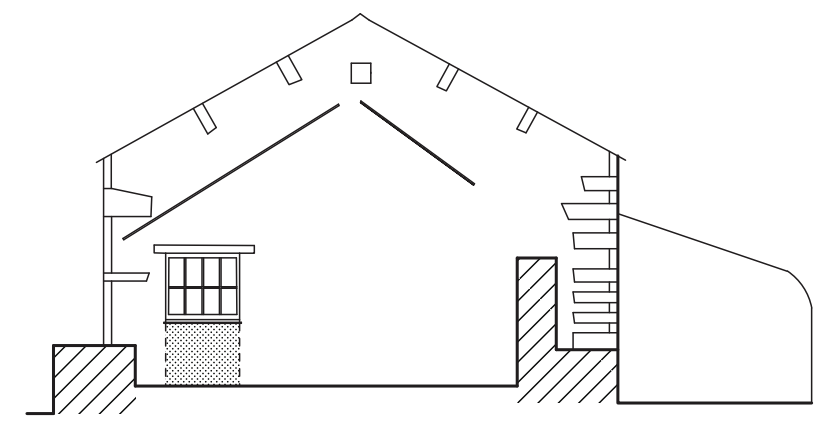
Figure 4: External elevations of the detached barn

NORTH EXTERNAL ELEVATION

EAST EXTERNAL ELEVATION

SOUTH EXTERNAL ELEVATION

WEST EXTERNAL ELEVATION
