LAND TO THE REAR OF 41 MITCHELGATE, KIRKBY LONSDALE, CUMBRIA

Archaeological Building Recording and Watching Brief

May 2018

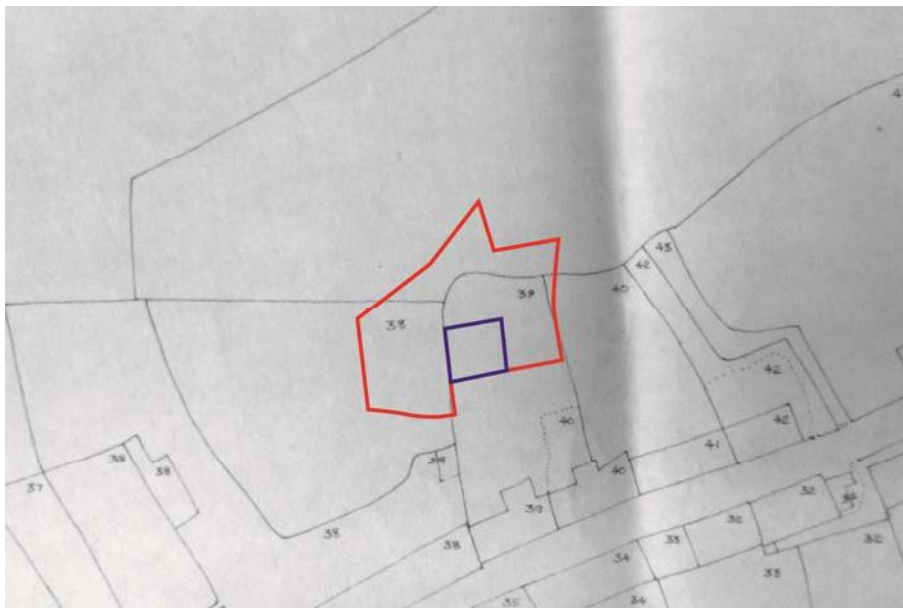
Plate 1: Extract from the plan of c1790

3.1.2 **Map of c1790:** this is the earliest detailed plan of the town (CAC(K) WDY/183 c1790). The site occupies part of at least three or possibly four large fields to the north side of what would become Mitchelgate, but it is otherwise undeveloped (Plate 1). The plots are labelled 38, 39, 40 and 44, which presumably relate to a schedule of some kind but it was not available with the plan.

3.1.9 **Summary:** the site occupied parts of open fields on the earliest available map of the area, dated c1790 (Plate 1). The road to the south, which would later be known as Mitchelgate, was already established with some properties shown along it. A beck is shown to cut across the north end of the site on the tithe map (Plate 2), dated 1849, but the square building near the centre of the site was not built until between 1849 and 1857, which is when the first 1:2,500 edition Ordnance Survey map was surveyed (see Plate 4). The beck was covered or infilled to the east after that and before c1910 and a small building was added to the north side of the older square one (Plate 5). The site then remained unchanged until at least 1938, which is the date of revisions shown on the 1945 edition (Plate 7). The small building to the north has evidently been removed since and the square building has become ruinous (Plate 7; cf. Figure 1).

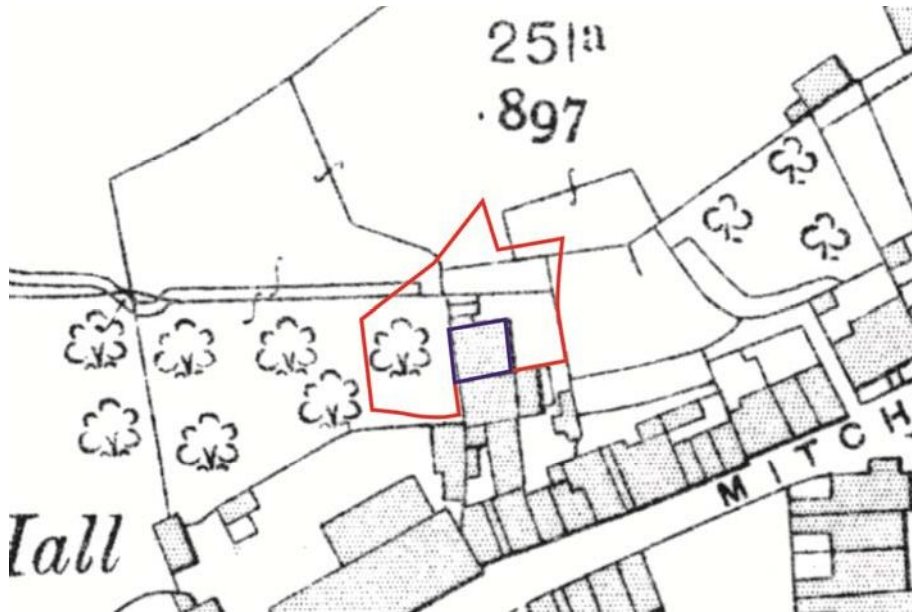
Plate 6: Extract from the Ordnance Survey map of 1914

3.1.7 **Ordnance Survey, 1914:** the same information is shown on Westmorland sheet XLVII.8, printed in 1914, as the earlier Lancashire map for the area (Plate 6; cf. Plate 5); both the 1913 and 1914 maps of the area show revisions from 1910.

3.1.8 **Ordnance Survey, 1945:** the site is relatively unchanged between 1914 and 1945 (Plate 7; cf. Plate 6).

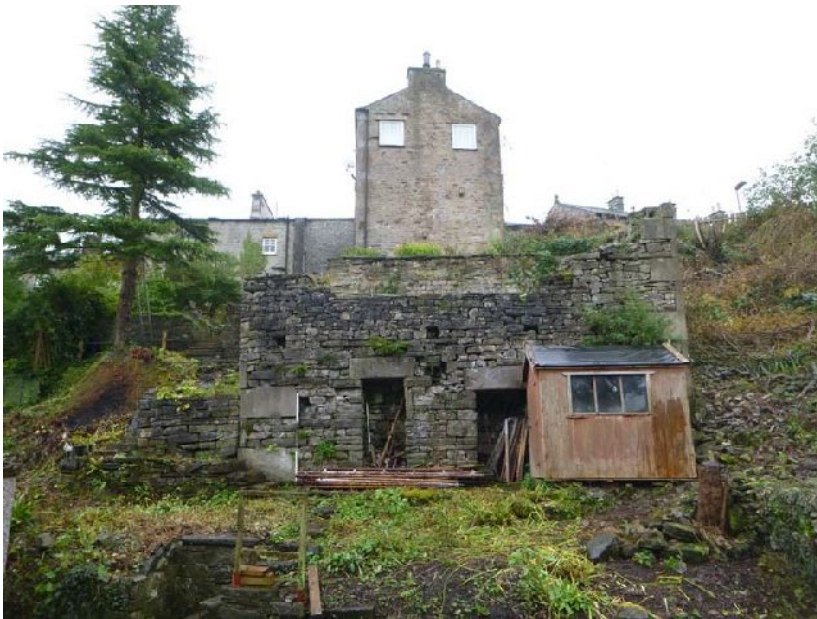
Plate 8 (left): General view of the site showing the position of the building relative to the slope and building to the south, viewed from the north

4.1.1 At the time of the building recording the structure comprised only a complete single storey but clearly originally extended to at least two storeys (Plate 8; Figure 2). It is square in plan and built into the slope with the south side essentially a retaining wall, but with a further retaining wall behind this, set below a four storey building at the top of the slope to the south (Plate 9). The former mill race runs essentially east/west a short distance to the north of the building close to the edge of the development site (Plate 10). The whole structure is constructed from the local dark yellow gritstone laid in rough courses with large quoins at the corners. At first floor level, which was accessible via a flight of more recent steps up the east side, the floor is finished with stone flags and there was an iron swage block lying loose on the ground (Plate 11) and a carved stone water tank or trough (Plate 12).

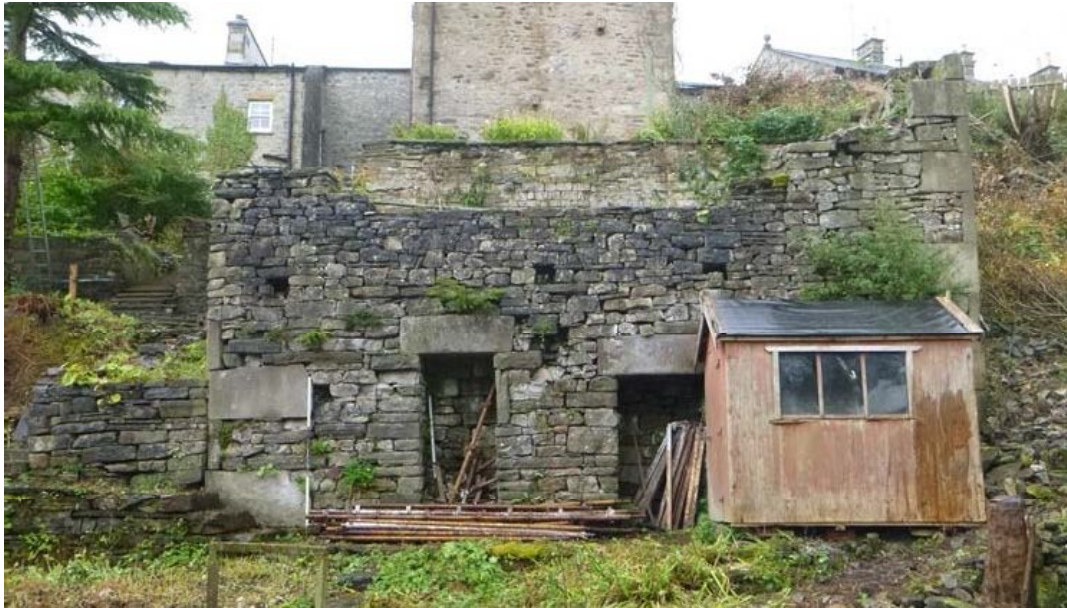
Plate 13: North external elevation

4.2.1 **North elevation:** there is a pair of doorways at ground floor level with heavy stone lintels, which are blocked internally, and a row of three putlog holes above. There are modern retaining walls to the east and in front to the north.

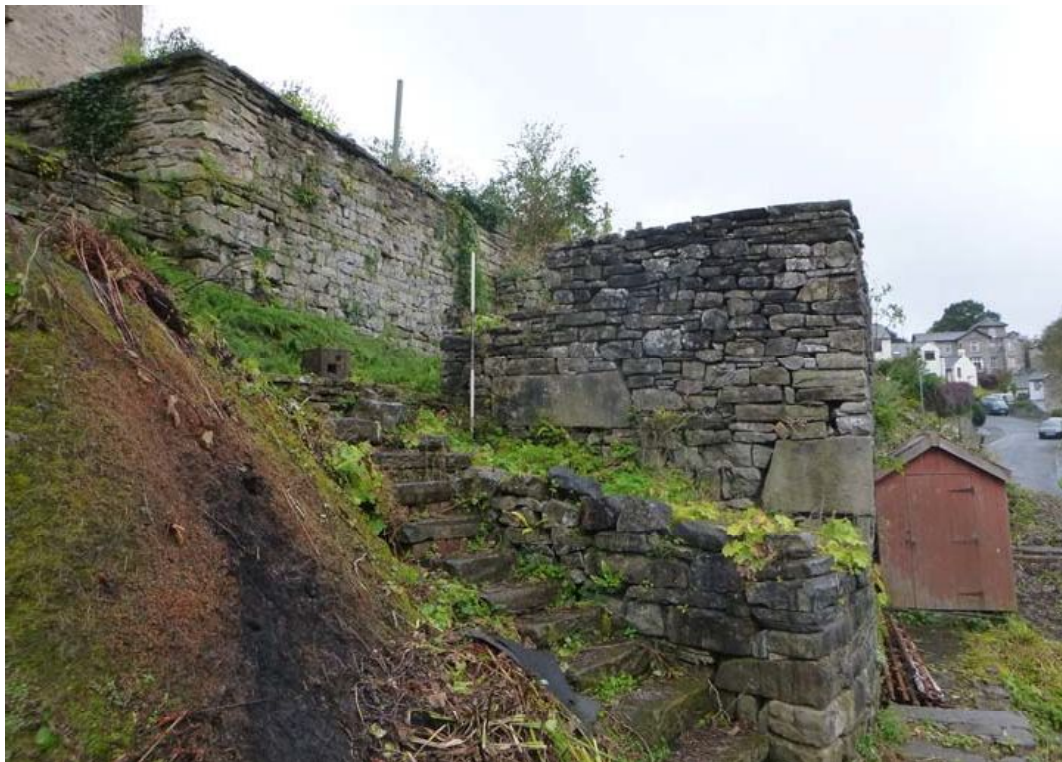
Plate 14: East external elevation

4.2.2 **East elevation:** the east elevation has collapsed much more than the north side of the building. There is an opening visible with a large lintel but this is mostly now covered by the retaining wall to the east. At the south end there is part of a jamb for a doorway before a large gap extending to the south to the rear wall.

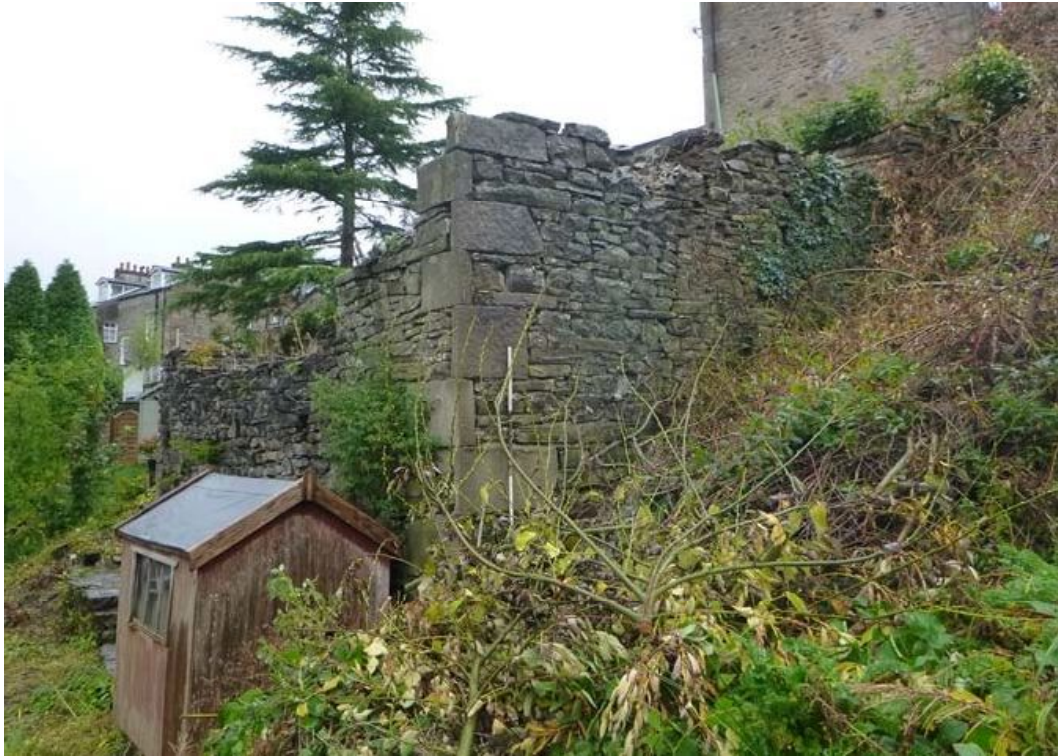
Plate 15: West external elevation

4.2.3 **West elevation:** the west elevation is plain, apart from some possible blocked putlog holes and the quoins are visible at the north end.

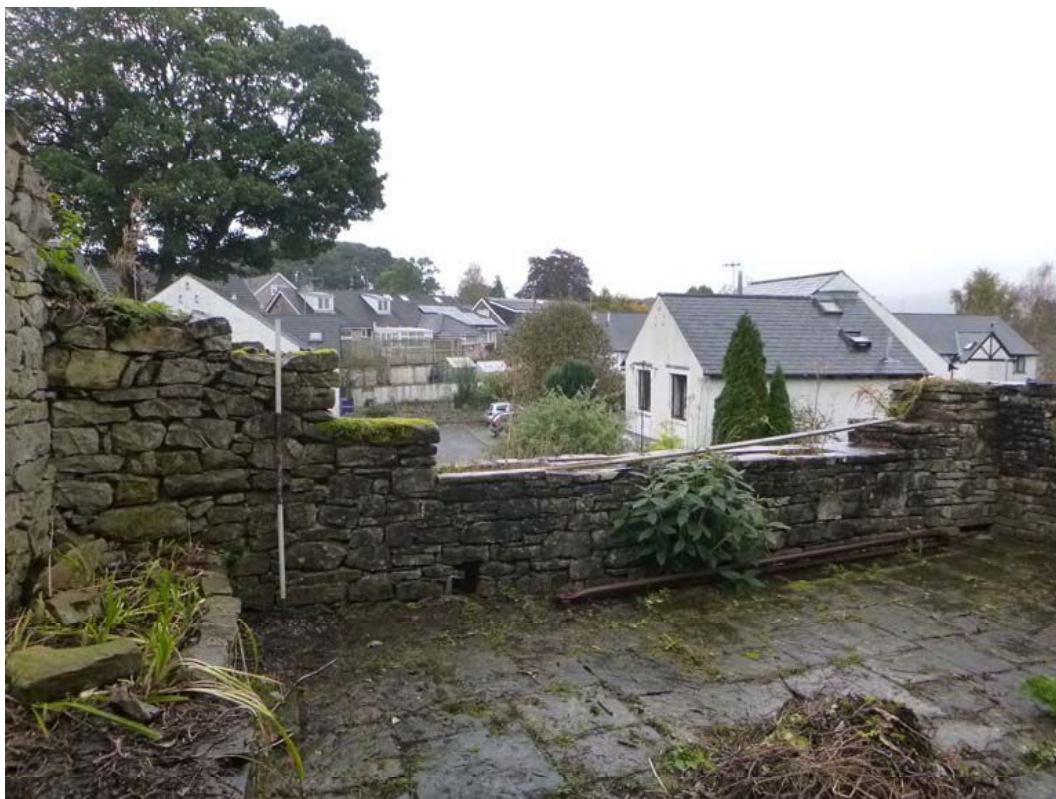
Plate 16: North internal elevation of the room on the first floor

4.3.1 **First floor:** there are low walls inserted around each of the north, south and west walls of the room at first floor level, forming flower beds, although with a wider block on the east side that perhaps represents the base of a hearth and is butted by the other walls. There are also recesses created on the top of the north wall acting as flowerbeds (Plate 16). The wall tops have also been tidied up with flags to the north and south and along part of the east wall (Plate 17 and Plate 18). There are small apertures at ground level along the north elevation, perhaps matching the 'putlog holes' seen externally. The west wall is rougher but more survives and there is as a central aperture with a dressed lintel above and a projecting hearth (Plate 19). There are two pairs of projecting corbels above that presumably supported some form of canopy over the hearth below, one (the lower one to the north) with an L-shaped iron bar above and possible opening between. The west elevation clearly butts the south wall, which is otherwise plain. The east elevation is mostly missing but presumably comprised a large doorway on the south side between the remains of the jamb to the north and the south elevation.

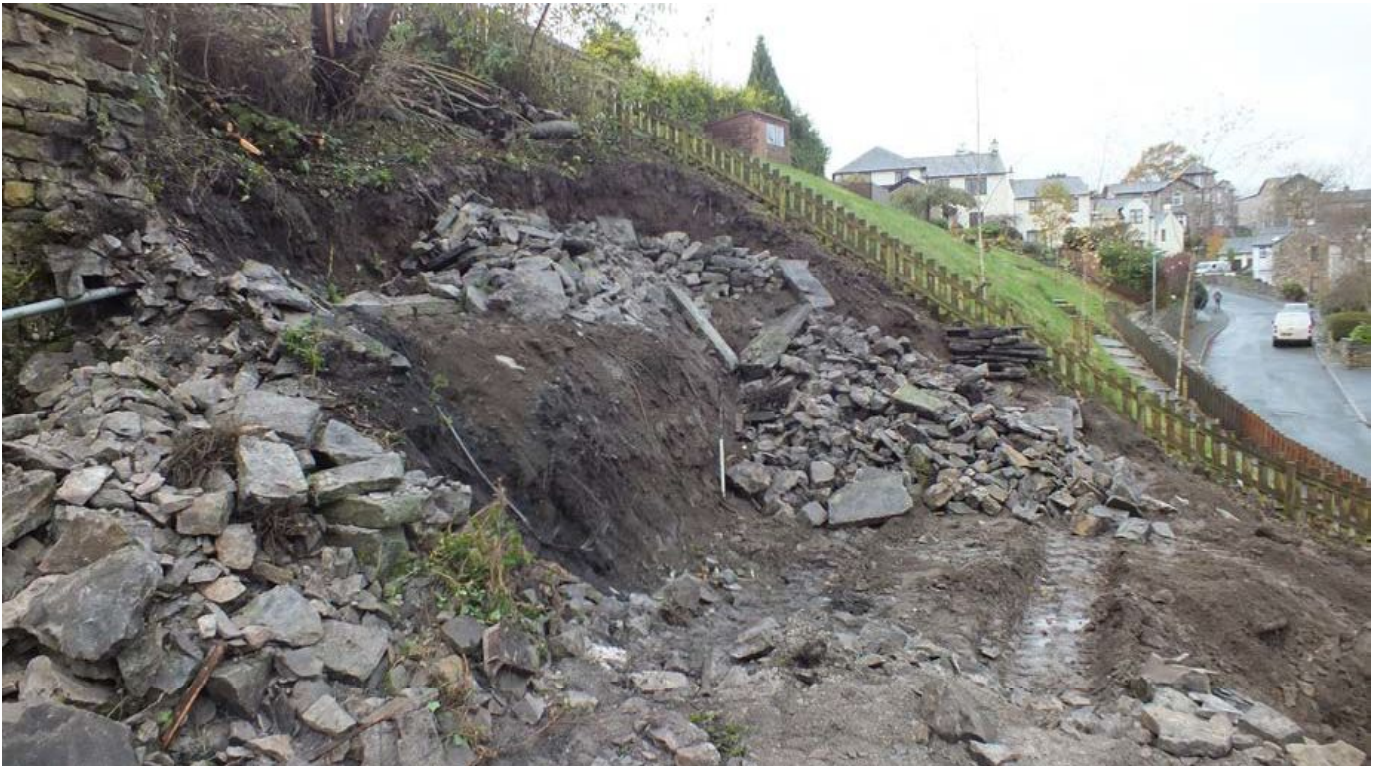
Plate 20: Terraced area to the west of the site, viewed from the east

5.1.1 The site to the north side of No. 41 Mitchelgate is extremely steep. To the west side of the area the hillside drops approximately 5m in height from the south side of the existing building to the top of the boundary wall along Lower Abbotsgate, which equates to approximately 10m from south to north as the crow flies, and a similar drop is noted over the east side (Figure 3 and Figure 4). Preparation of the site for the excavation of footings for the new build was logistically complex and it was necessary to excavate an area to the west to form terraces to facilitate the storage of material during demolition of the standing building. The terraced area cut into a grey-brown silt (**100**; Plate 20 and Plate 21; Figure 3), which was fairly soft and contained loose rubble and pipework, including plastic pipes.

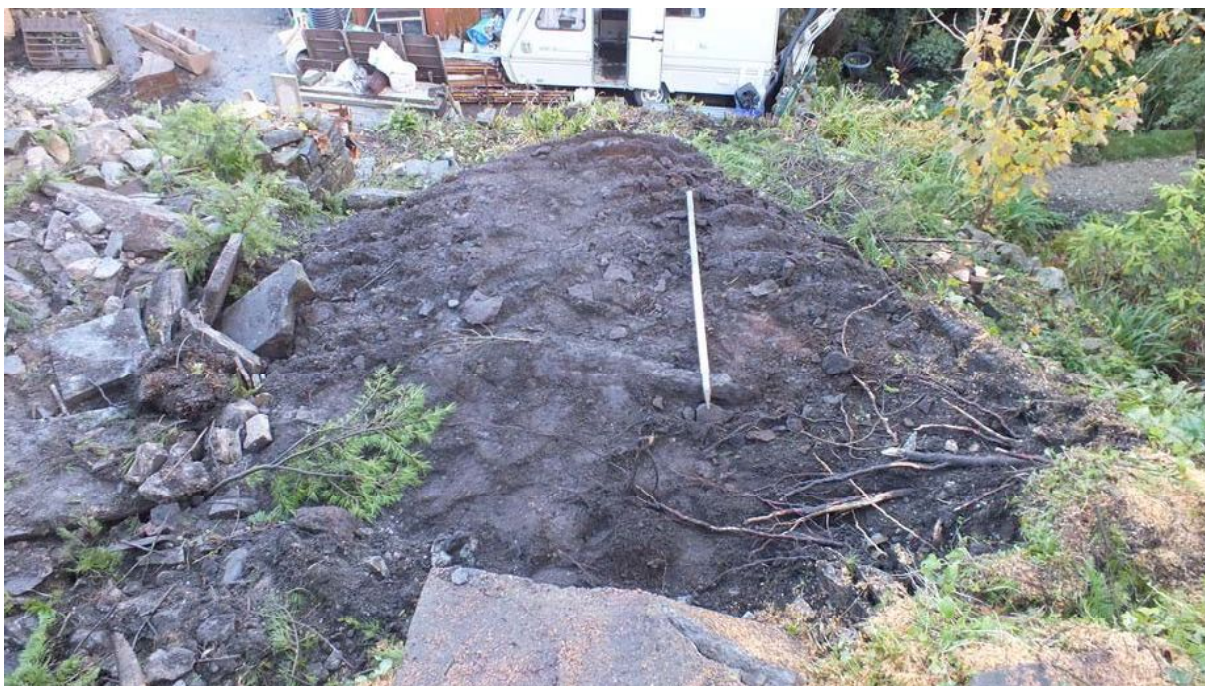
Plate 22: Slag heap at the east side of the site, viewed from on top

5.1.2 Immediately to the east of the standing structure, at the base of the steps to the back of No. 41, was a slag heap (**101**) (Figure 2; Plate 22). The slag, presumably the waste by-product derived from a furnace or foundry, was iron-rich, and had compacted and set to be very firm. It was at least 0.4m to 0.5m thick and had tipped downhill and spread over a wide area. It was spread over a height of at least 1m from below the steps to the south to its base (Plate 23) and required 'peckering out' by machine. The slag heap was striated with impurities and had fairly clear 'tip lines'. It was clearly above a ceramic drain in the south-east corner (Plate 24) and some post-medieval pot was noted and 'tap slag' was recovered from immediately below it (see *Section 5.2* below).

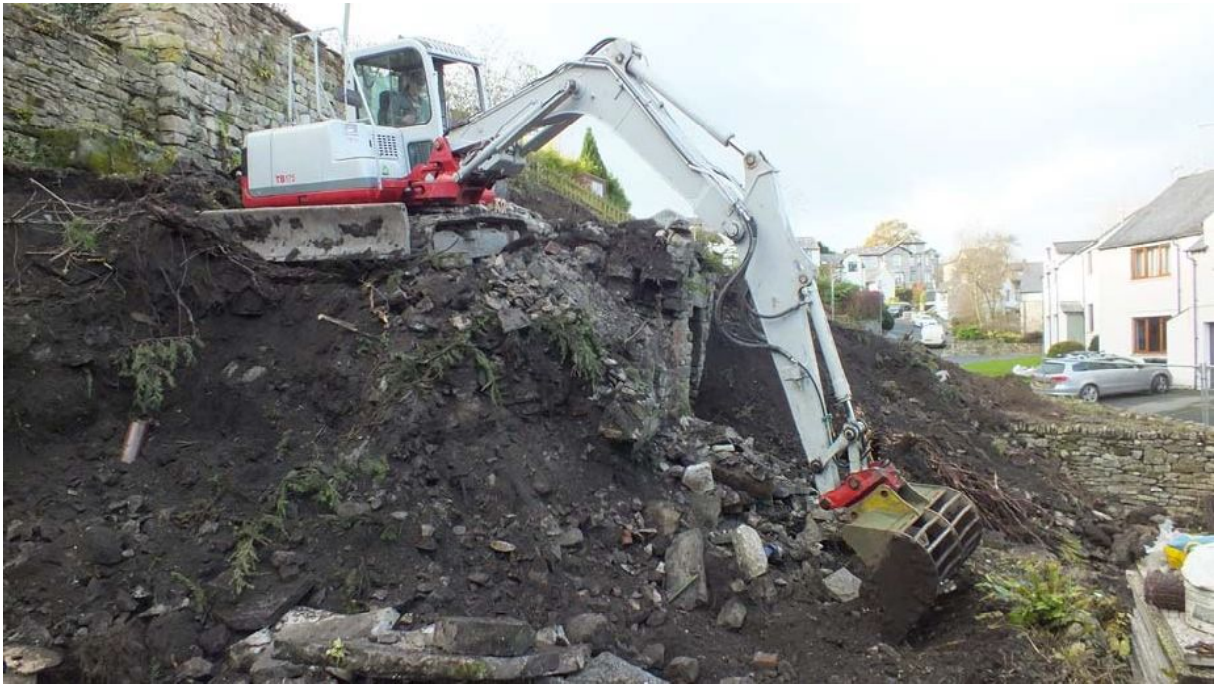
Plate 27: Demolition of the standing building underway

5.1.5 As noted in the methodology, the standing structure was dug out from east to west with the machine sat on top (Plate 27 and Plate 28). Health and safety considerations prevented close examination of the structure as it was demolished and it was not possible to examine in detail the north wall of the structure fronting onto Lower Abbotsgate. A small quantity of 'Claughton' frogged brick was noted, perhaps incorporated into the structure for repairs, and there were some heavy timber beams, possibly joists and/or lintels, noted within the backfill of the structure (Plate 28 and Plate 29), the back wall of which was partially exposed whilst demolition was underway. The wall of the structure at the east side was 0.68m thick where it was cut through in section (Plate 30 and Plate 31). The inside of the back wall was c1.4m to 1.6m to the north of the tall wall behind (to the north of No. 41; Figure 4; Plate 31),

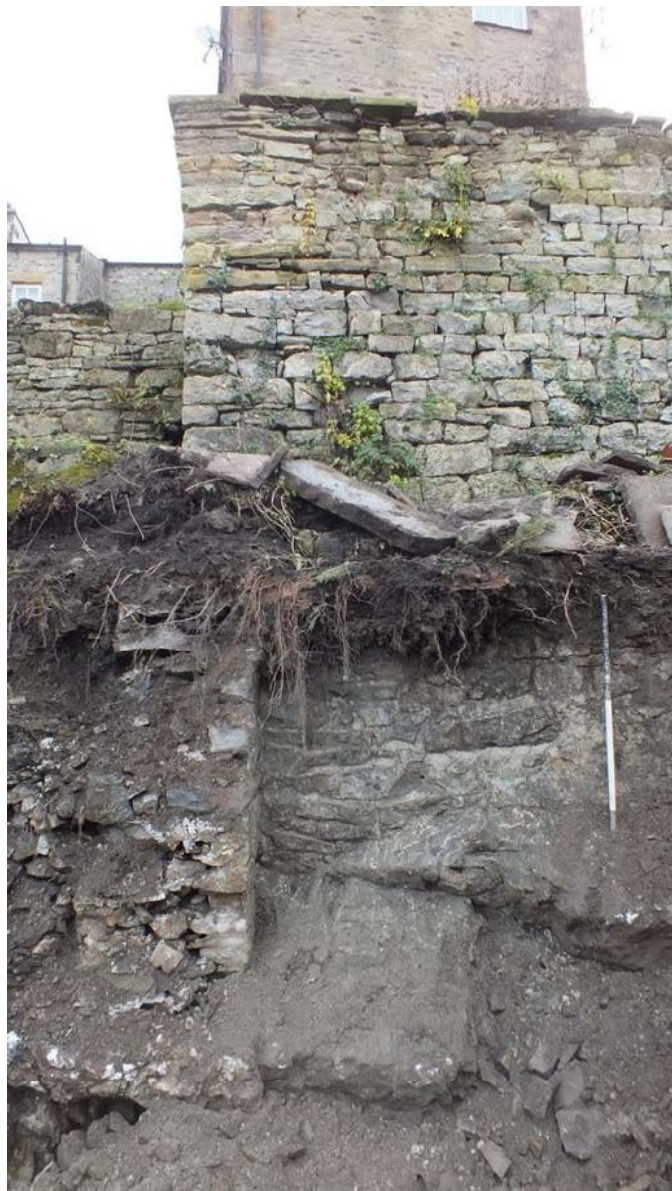
Plate 31 (right): The east side and back wall of the standing building following excavation

although it was difficult to accurately measure the distance of the back wall from the tall wall behind due to the difference in heights between the two at this point. The back wall comprised large angular stones within a white lime mortar and was built directly on top of the bedrock (Plate 32), which seemed to form an east/west band across the site.

6.2.1 Clearance of the buildings on site revealed that the back wall of the standing structure to the rear of 41 Mitchelgate was built directly on top of the limestone bedrock. The bedrock formed an east/west band across much of the south side of the site and a blackish silt deposit (**103**) had built up against the bedrock and come to engulf the sides of the standing structure. Much of this material had presumably been dumped over the ridge from the late 18th to early 20th century date as post-medieval finds, including a clay tobacco pipe stem, were retrieved from right up against the bedrock even at the lowest level of excavation. It is unclear whether some of this material was cleared before the ruinous building on site was constructed. Some of the later material which comprised a fairly coherent 19th to 20th century group accumulated behind the low garden wall where it would have gathered as the dumped deposit progressively formed a slope down to the north away from Mitchelgate. The drain to the east side of the site cut through some of this material (**103**), but its edges could not be discerned, and finds, which were thought at the time of excavation to have come from within a possible cut for it, had a similar date to the material from elsewhere in **103**. The drain was perhaps originally of late 18th/19th century date (although it had clearly been modified, certainly towards the north end, by the insertion of modern plastic piping). The slag heap (**101**) to the east side of the standing structure at the south side of the site had clearly built up over **103** and above the drain, so the slag deposit must have formed later. The slag tipped down to the south and east following the lie of the underlying silt deposit (**103**) and was noted to be striated, presumably indicating impurities within it and probably 'tip lines'. It had clearly been added to on a number of occasions over an unknown period of time and spread over a wide downslope area.
