# THE FARMERS, MARKET PLACE, ULVERSTON, CUMBRIA

## Archaeological Watching Brief

Client: Chattaway Inns

March 2018

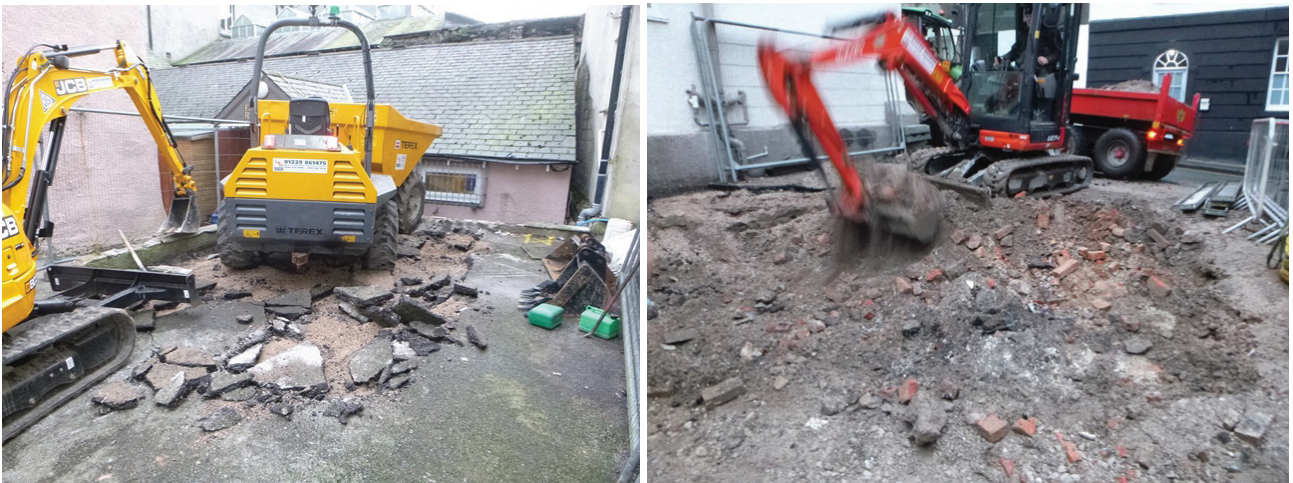
Plate 1 (left): Breaking up the tarmac at the start of the watching brief, facing the kitchen on the south of the site

Plate 2: Loading rubble into the trailer

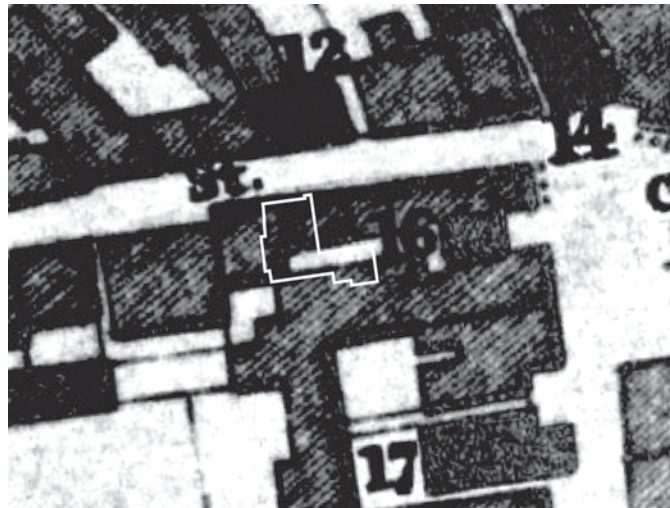
3.1.2 **Wood's plan of Ulverston, 1832:** this is the first detailed map of the town and it shows that the site was built on at the time (Plate 3). Daltongate was at that time known as Duke Street.

Plate 3: Extract from Wood's plan of Ulverston, 1832

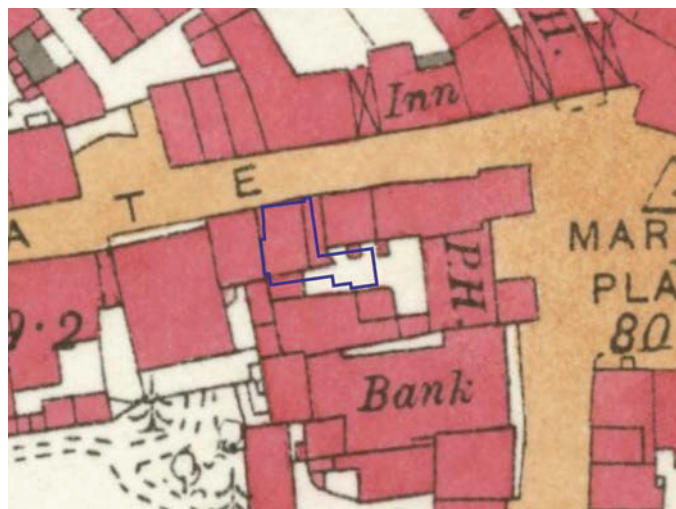
3.1.4 **Ordnance Survey, 1891:** this map is the first edition 1:2,500 scale map of Ulverston, and is not as detailed as the town plan of 1852, so does not include steps or pavements, for instance. It shows the same arrangement of buildings and yards as the previous map, with a couple of differences (Plate 5). Firstly, a boundary is shown between the rear of the building fronting onto Daltongate and the small building adjoining it to the south. Secondly, what was previously shown as a covered passage is now shown simply as a narrow building.

Plate 5 (right): Extract from Ordnance Survey map of 1891

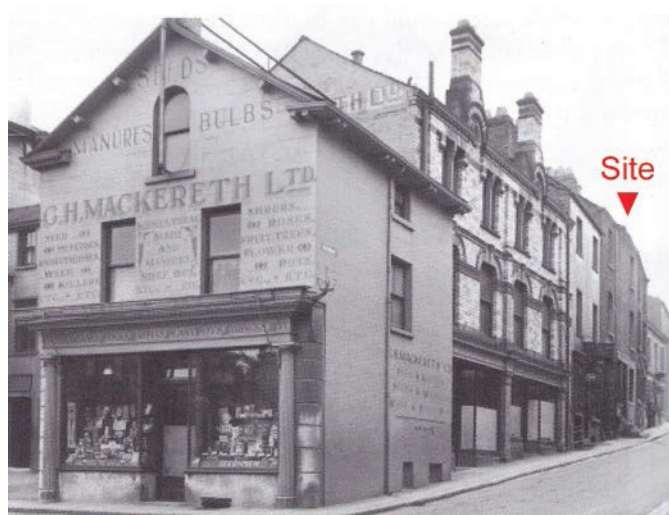
3.1.5 **Photo, c1900:** this undated photograph of the lower (east) end of Daltongate (Plate 6), probably from around 1900, includes a view of the frontage of the building previously on the site (Plate 7). The building in the location of the covered passageway is three stories high, with the first and second floor windows being visible, together with a downpipe to the west. The roof then apparently increases in height for the main building to the west, which has a decorative frontage encompassing the front door and adjacent windows to the east and west. The front door is accessed via three steps up from the pavement. Windows are visible for the first and second floors above.

Plate 6 (left): Daltongate from Market Place (Snell and Snell 2008, 70)

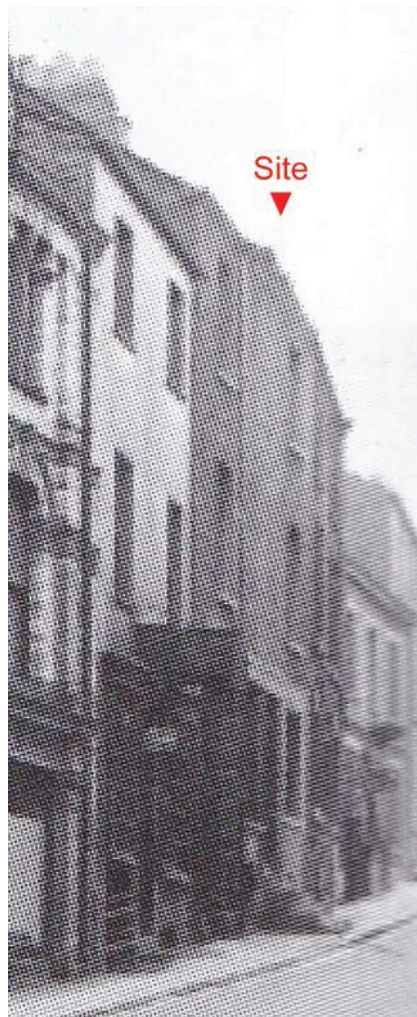
Plate 7 (right): Zoomed in portion of Plate 6 showing the front elevation of the building previously standing on the site (with darker render in the centre of the photo)

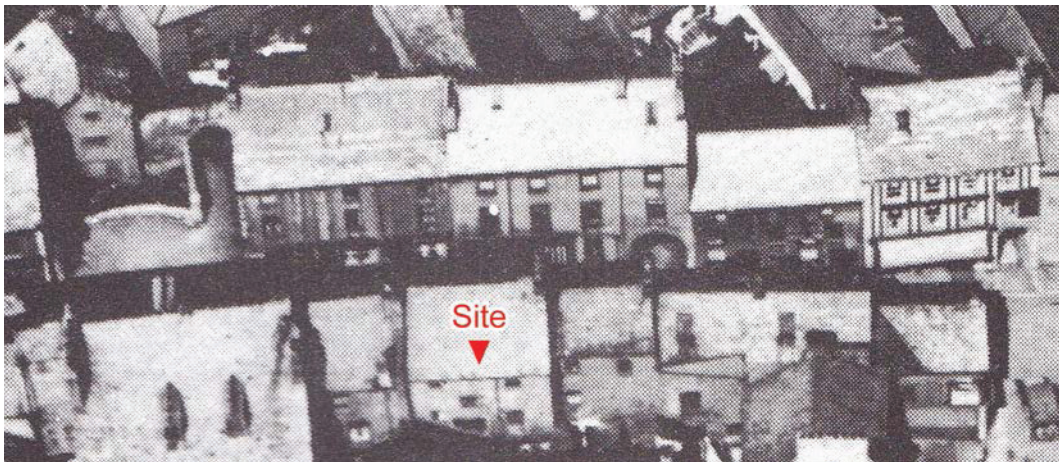
3.1.7 **Aerial photograph, 1929:** this aerial photograph of Ulverston shows the roof and rear elevation of the building on the site at the time (Plate 9). It shows what appears to be a single building in the area of the main building and what was previously shown as a covered passage. The chimney stack is on the east side, and windows are shown in the rear (south) elevation. The building shown on the maps to the south-west may be what is shown with a dark pitched roof running north/south, with the top of the ridge possibly around first floor level on the main building.

Plate 9: Aerial photograph showing the lower part of Daltongate in 1929, showing the rear elevation of the building previously standing on the site (Aerofilms Ltd 1929, reproduced in Snell and Rushton 1979, 24)

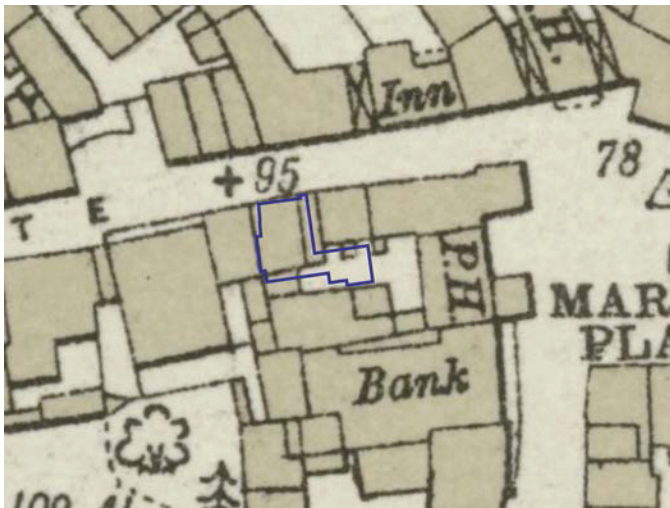
3.1.8 **Ordnance Survey, 1933:** this map, revised in 1931 and 1932, shows the same arrangement of buildings as the previous map (Plate 10).

Plate 10 (left): Extract from Ordnance Survey map of 1933

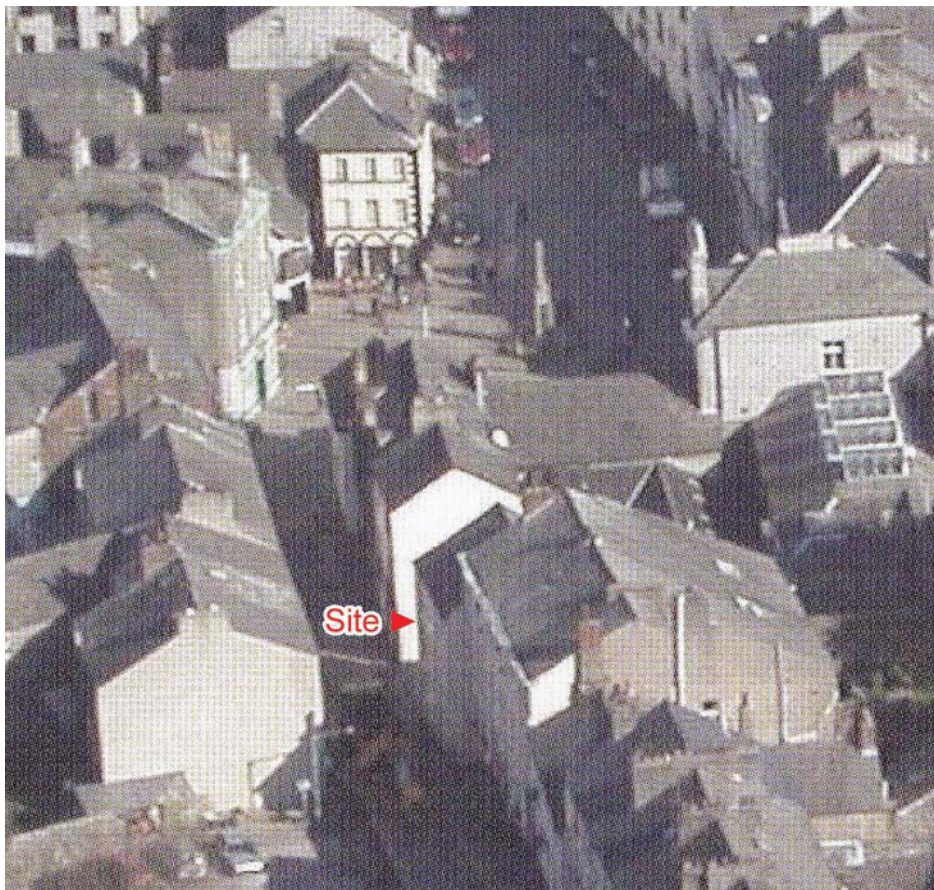
3.1.10 **Aerial photograph, 2003:** this aerial photograph shows the site with the previous building having been demolished for the first time (Plate 12). No further details are visible due to the angle of the photograph.

Plate 12: Aerial photograph showing lower part of Daltongate in 2003, with the building on site no longer present (McKeever 2010, 55) (taken from the west)

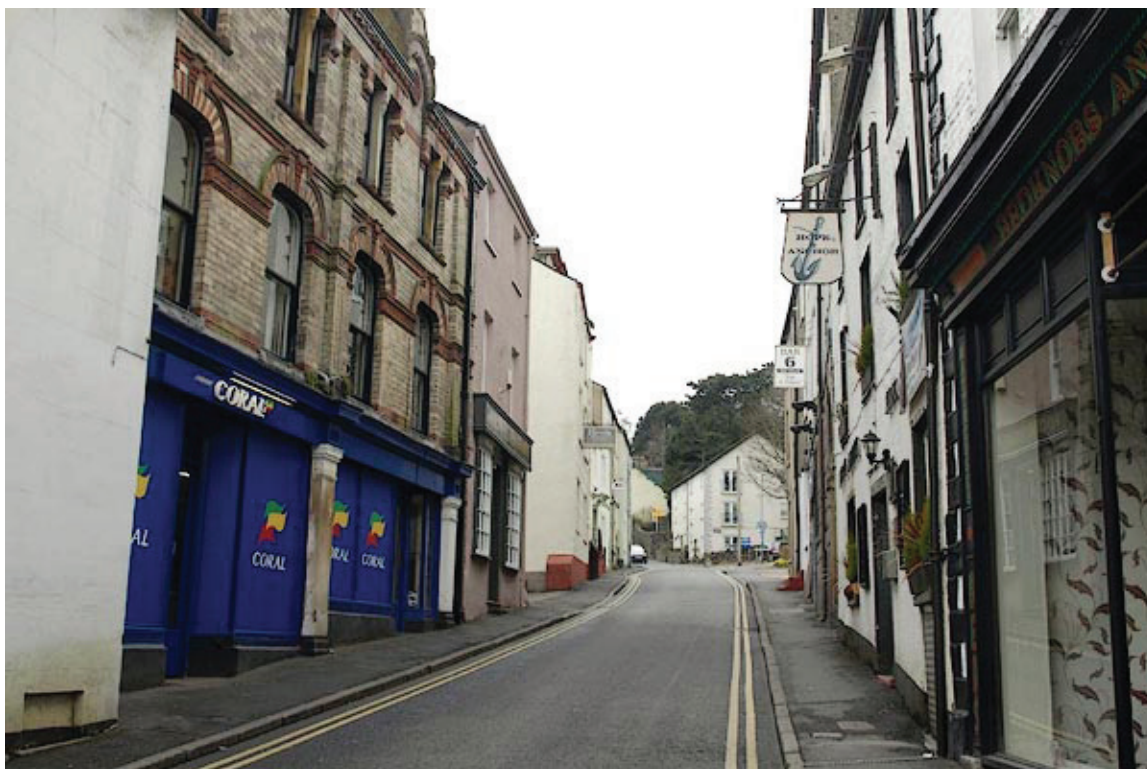
3.1.11 **Photograph, 2013:** this street level photograph shows the site largely as it was in the previous photograph, but from ground level rather than from above, and from the opposite direction (Plate 13).

**Plate 13: The site viewed from lower on Daltongate in 2013 (Norgate 2013) (taken from the east)**

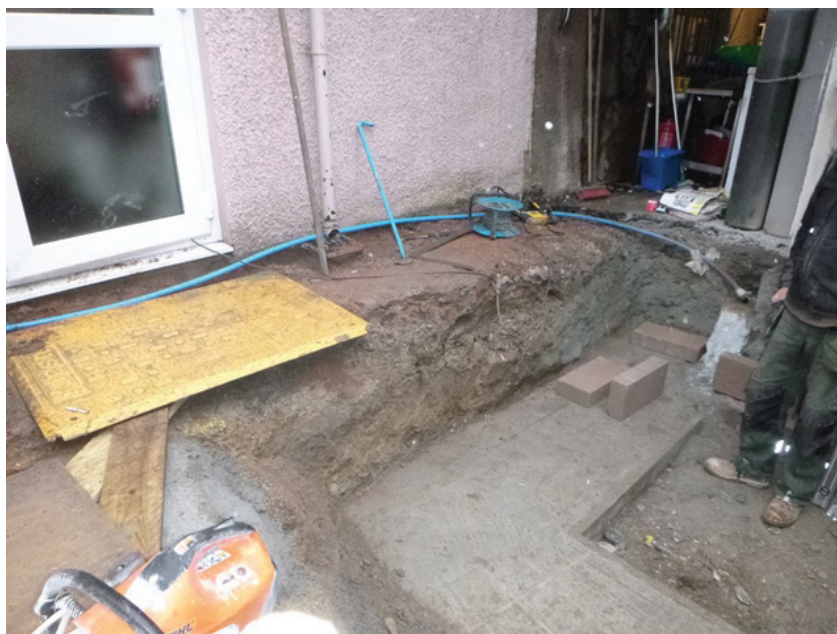
Plate 14: South-facing section in the south-east area of the site

4.1.1 **South-east area:** this area was dug without an archaeologist on site, while the builders were waiting for party wall consent to dig the main part of the site. It was apparent from observations made during the watching brief that the area had seen considerable disturbance and the only deposits consistent with the natural geology (**115**) were present (Plate 14).

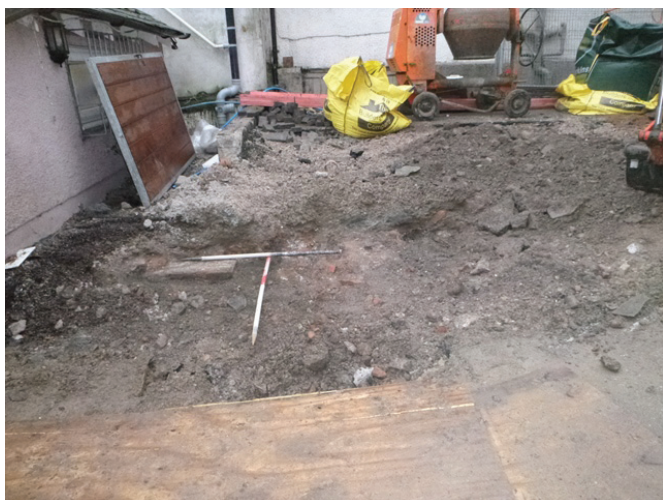
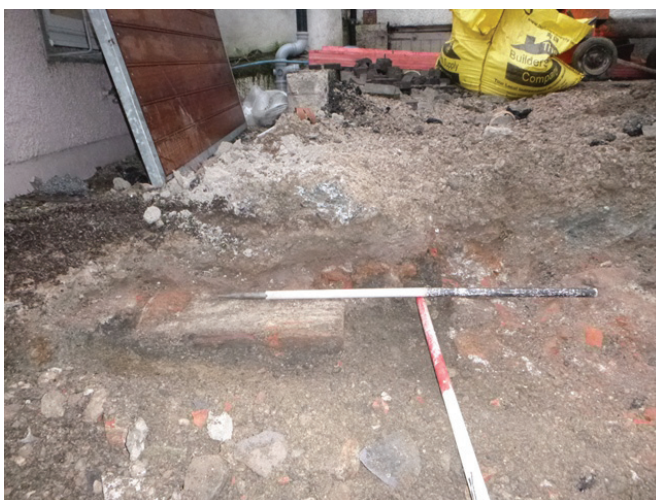
4.1.3 **Wall 104:** a short section of brick wall one brick width thick was present at the south-east of the site (**104**) (Plate 15 and Plate 16), and the foundation cut for the wall (**103**) had been cut through the subsoil (**105**), and backfilled with deposit **102** (Plate 17) The foundation cut **103** was visible along the east side of wall **104**. It was at least 0.6m long (it continued into the unexcavated deposits to the south), and was approximately 0.14m to the east of wall **104**. It was half-sectioned, and revealed to be 0.33m deep from the top as revealed by the watching brief to the slate bedding (**110**) for wall **104** below (Plate 18). The sides were vertical, and the base of the cut was not visible beneath the slate bedding (**110**). Backfill **102** was a fairly loose black sandy silt, with 40% pebbles and brick fragment inclusions, and it filled foundation cut **103** down to the slate bedding for wall **104**. The top of wall **104** was high in the south, and lowest in the north, but white mortar was present on the tops of the bricks, so it was not clear what or where the top surface had originally been. Four courses of bricks were present above the slate bedding. Wall **104** was rectangular in plan, and orientated north/south. It was constructed from handmade bricks, each of which measured 0.24m long by 0.11m wide and 0.07m thick. The bricks were bonded with soft white mortar, and the small amount revealed was a mixture of pairs of bricks laid as stretchers and headers.

**Plate 15 (left): Wall 104 (centre left), taken from the east**

**Plate 16 (right): Close up of wall 104**

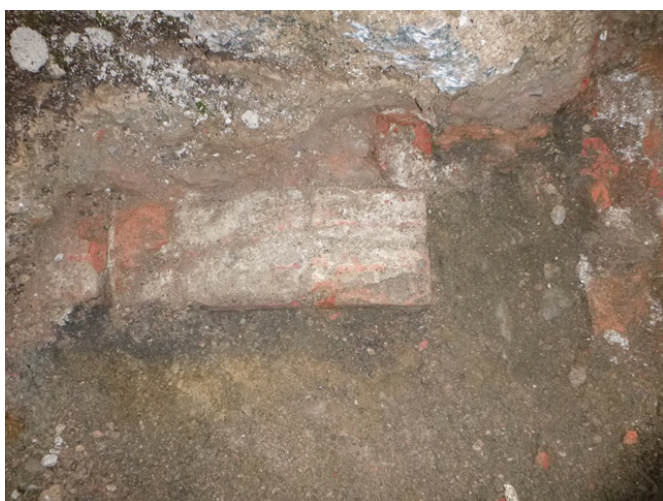
**Plate 17 (left): Wall 104 from above, showing foundation cut 103 and black backfill 102**

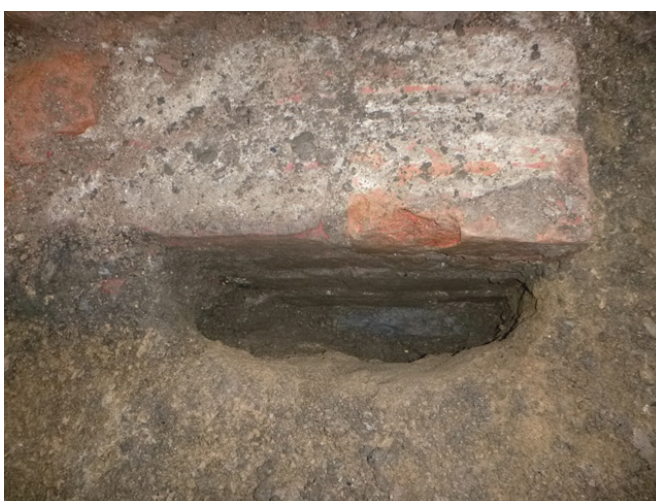
**Plate 18 (right): Half section of backfill 102 with slate bedding 110 for wall 104 visible at base**

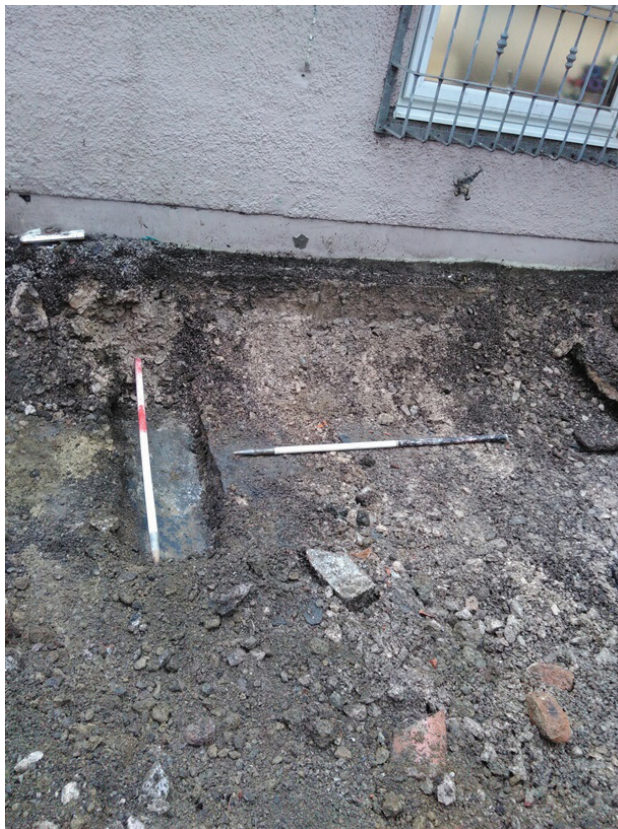
Plate 19: Slate bedding 110 after removal of wall 104, prior to cleaning of flag surface 109, taken from the north

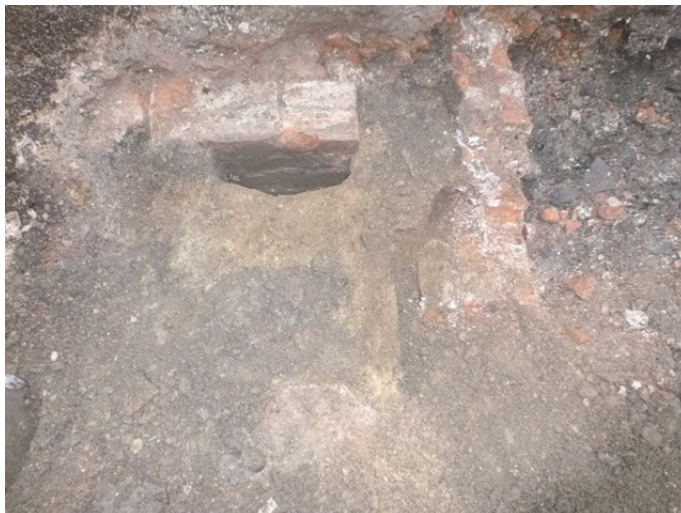
4.1.4 **Wall 107:** part of another wall (107), comprising a single lump of cemented sandstone, was revealed to the east of wall 104, surrounded by pebbly black deposit 106, which lay on top of subsoil 105. It was on the line of wall 108 north/south, beyond the south-east corner. It was strongly bounded, and had to be removed with a breaker.

Plate 20: Wall 107 (centre front of shot) with pebbly black deposit 106, subsoil 105, and wall 104, in that order to the west, and east/west section of wall 108 to the north, taken from the east

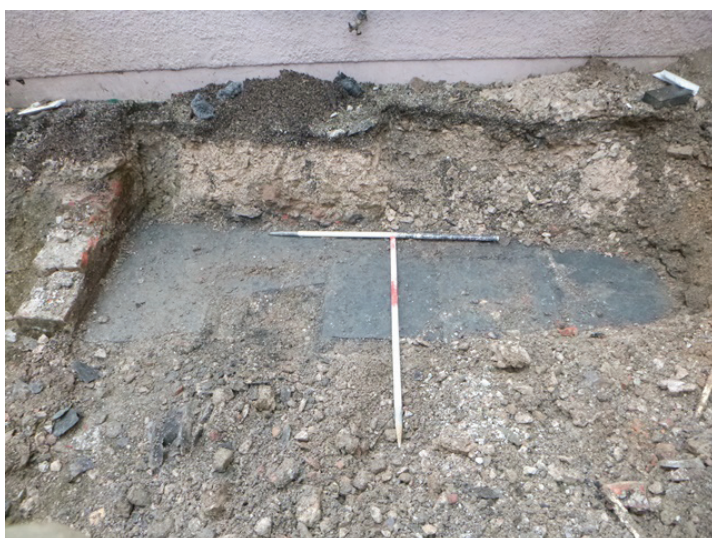
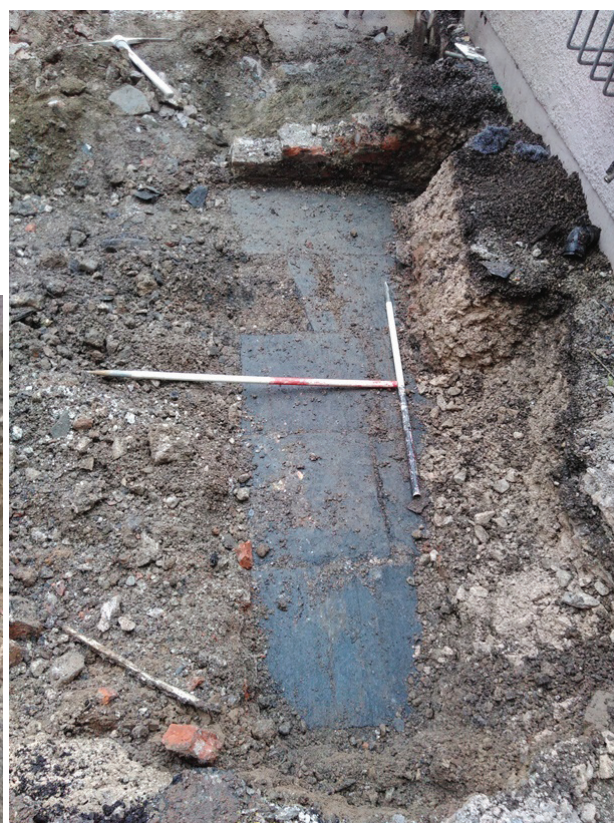
4.1.5 **Flag surface 109:** following further ground reduction in the same area, flag surface 109 was revealed, abutting wall 104 and running east/west from the west side of the wall (Plate 21 and Plate 22), as far as the west boundary of the site (Plate 23). Flag surface 109 was made of unmortared rectangular slate flags laid onto a dark grey-black loose gritty deposit (112) including coal debris, which also included a large smooth flagstone and the contents of a rat burrow. In one area there was degraded linoleum on

**Plate 21 (left): Wall 104 along east side of flag surface 109, taken from the north**  
**Plate 22 (right): Wall 104 along east side of flag surface 109, taken from the west**

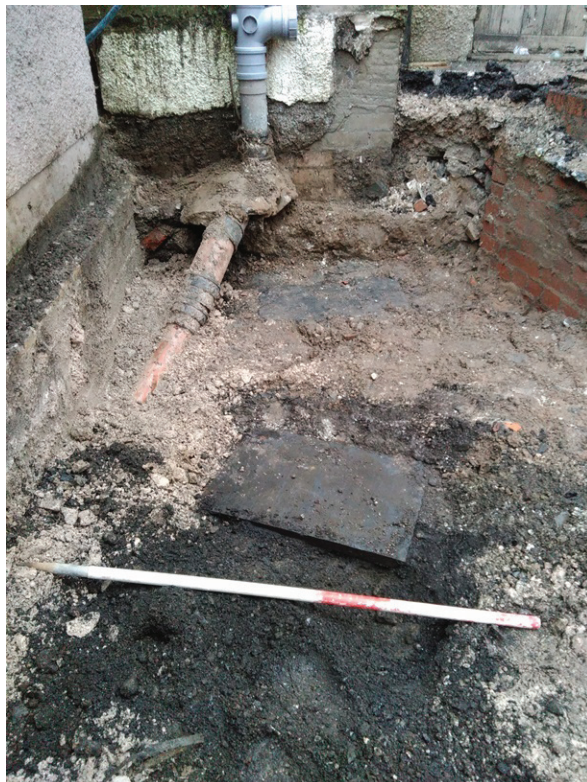
**Plate 23:** The furthest extent west of flag surface 109 (centre rear, with pipe to left), and polished stone flag within black bedding layer 112, taken from the east

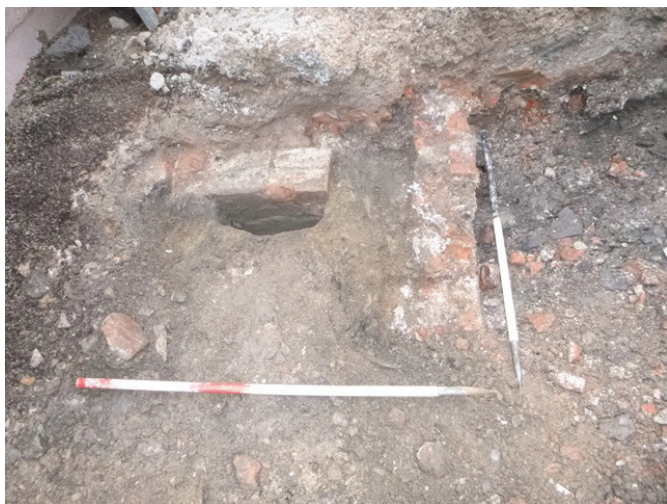
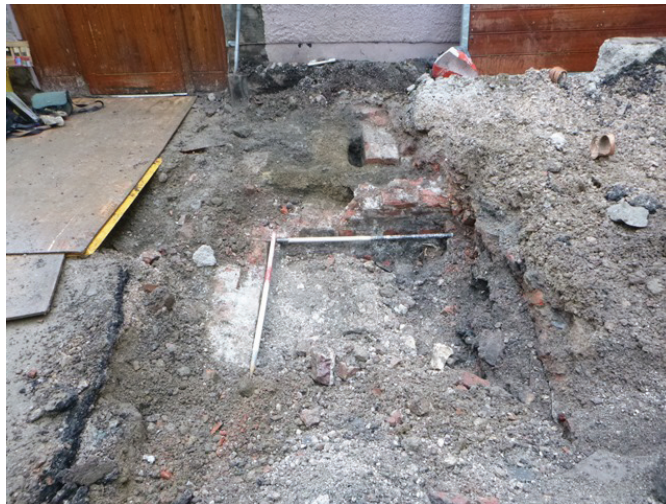
4.1.6 **Wall 108:** to the north of wall 104 was an L-shaped wall (108) in the south-east of the main site, which survived as five courses of bricks (of which the top three courses leaned slightly towards the north) laid in stretcher bond onto a stone boulder foundation along the east/west section, and two courses of bricks laid onto a chamfered (brick?) footing along the north/south section. The courses were bonded with a hard grey cement, and both faces were whitewashed.

**Plate 24 (left):** Wall 104 (in the south, left of shot) and east/west section of wall 108, taken from the east

**Plate 25 (right):** Wall 108 running east/west (surviving as five courses) and north/south (surviving as two courses), taken from the north

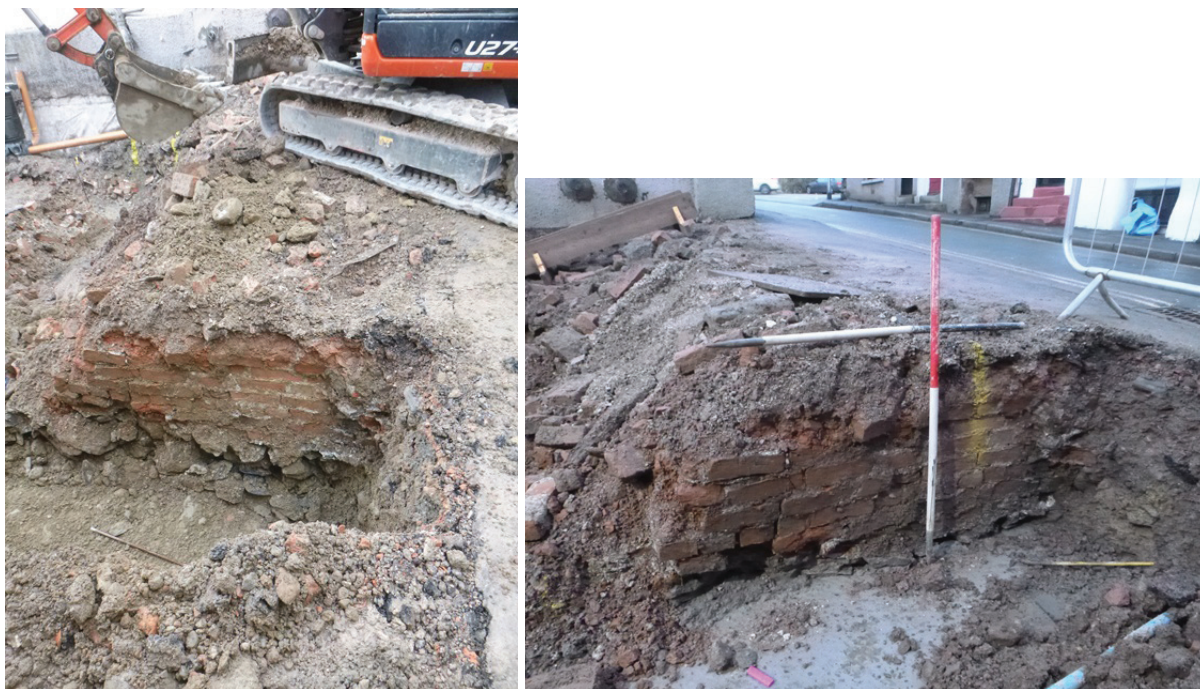
4.1.7 Wall 108 continued from the corner described previously towards the north, and it was revealed to be seven courses high in the east-facing section of the north end of the east foundation trench (Plate 26 and Plate 27).

**Plate 26 (left): East-facing elevation of wall 108 along the east-facing section of the north end of the east foundation trench, immediately prior to concrete being poured, taken from the east**

**Plate 27 (right): East-facing elevation of wall 108 after concrete foundation had set, taken from the east-south-east**

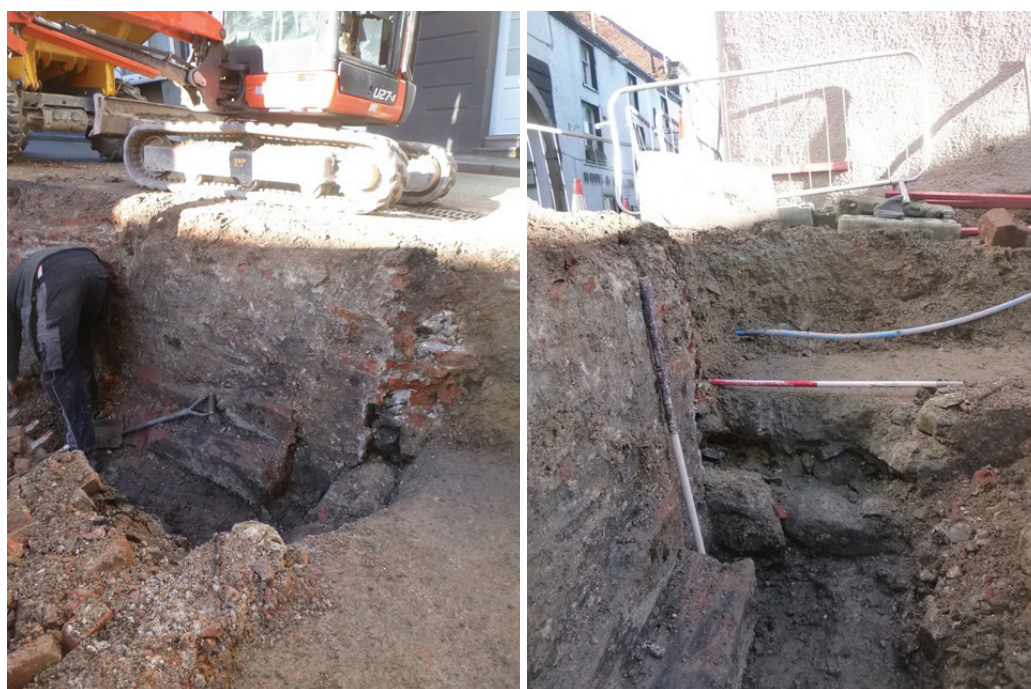
**Plate 28 (left): Section of wall 108 following removal of the wall, showing rubble and large foundation boulders, taken from the south**

**Plate 29 (right): Foundation of wall 108 at the north end, following removal of brick portion of wall, taken from the west**

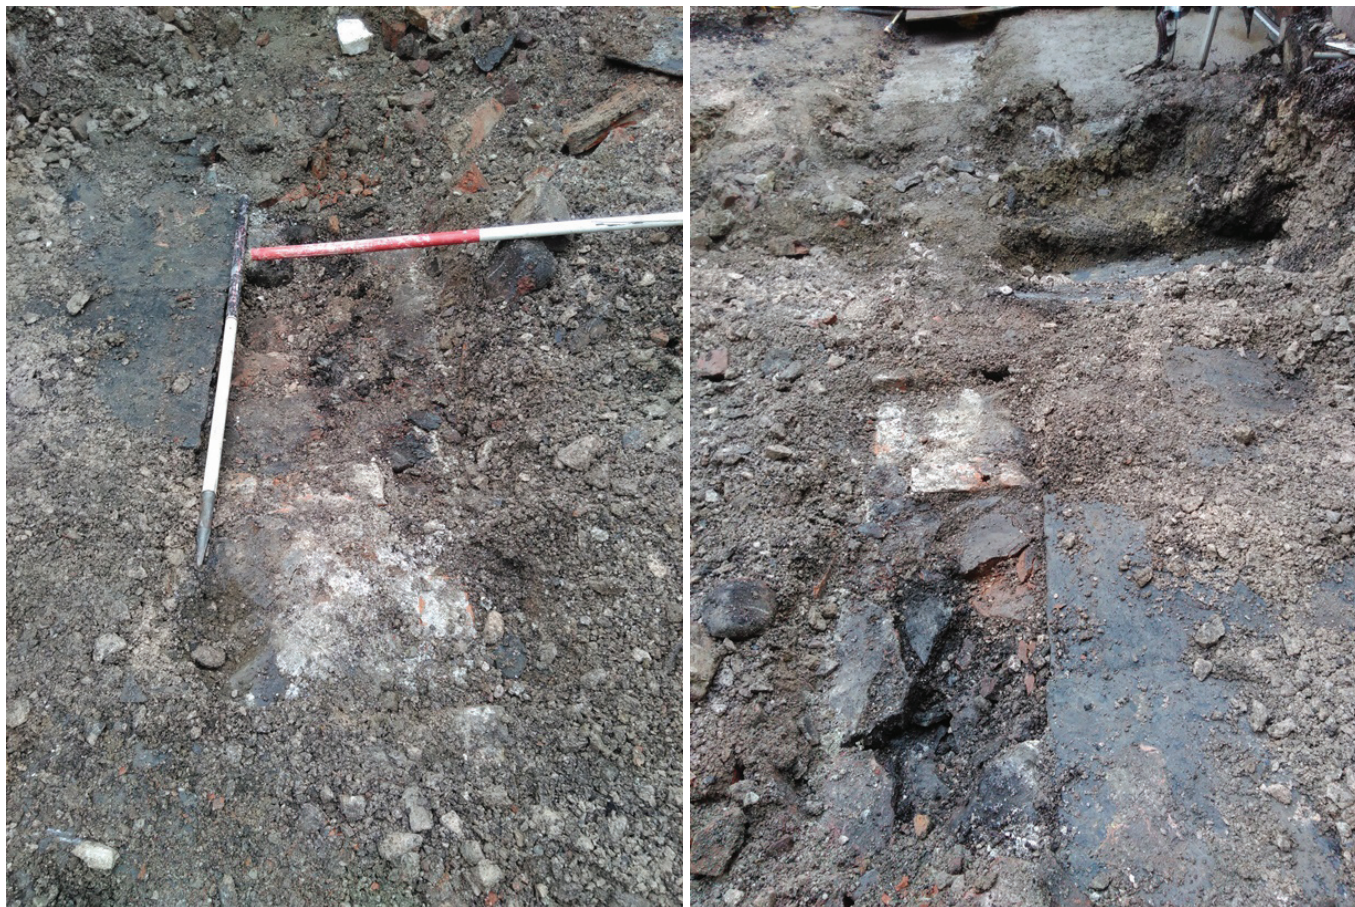
**Plate 30 (left): Flag surface 109 butted by wall 111, taken from the east**

**Plate 31 (right): Flag surface 109 butted by wall 111, with slate bedding 110 visible beyond the flag surface, taken from the west**

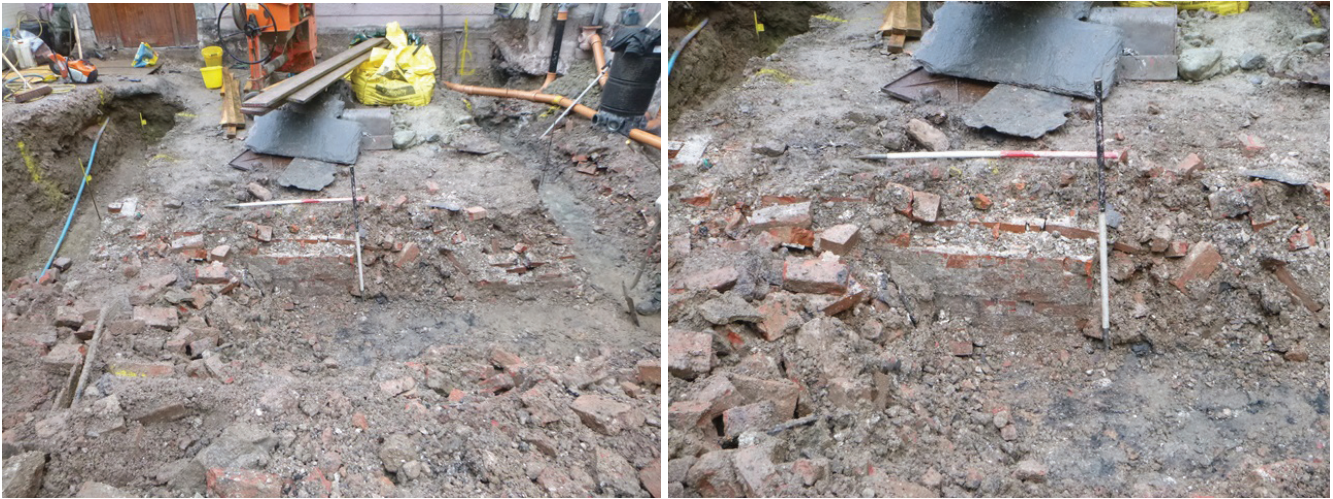
4.1.10 **Wall 117:** wall **117** ran westwards from wall **108**. It was at least eight courses high along the south side of the north foundation trench, where it was whitewashed on the north-facing elevation (Plate 32 and Plate 33). The wall was cut by the west foundation trench where nine courses survived in the west-facing section, in English garden wall bond (five rows of stretchers to one row of headers) (Plate 34). The bricks were 0.23m long by 0.10m wide and 0.06m thick.

**Plate 32 (left): Wall 117 north-facing elevation along the south side of the north foundation trench, taken from the north**

**Plate 33 (right): Close up of best-preserved portion of wall 117**

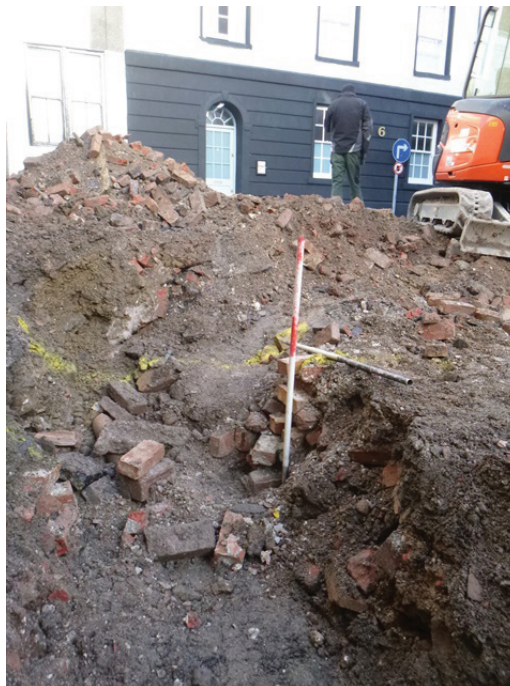
**Plate 34: Wall 117 west-facing section, cut by west foundation trench, taken from the south-south-west**

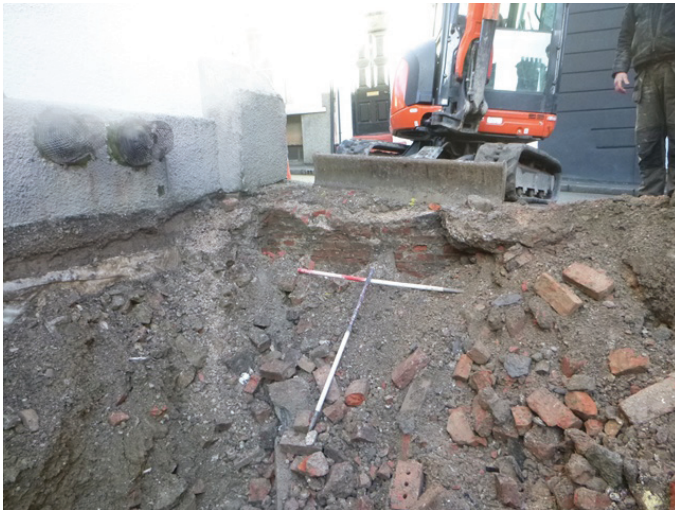
4.1.11 **Wall 119:** wall **119** was revealed along the north edge of the site, next to the pavement on Daltongate, running between wall **116** in the west and wall **108** in the east (Plate 35 and Plate 36). It was four brick widths thick (Plate 37), and it appeared to butt against wall **116**. This was particularly clear where the top few courses of wall **119** were leaning southwards, and wall **116** was unaffected (Plate 38, Plate 39, and Plate 40). The south-facing elevation of wall **119** was covered in blackened whitewash, particularly lower down. It contained a blocked opening which ran as far as wall **108** in the east (Plate 41), so it was not possible to examine the junction of the main part of wall **119** with wall **108** as they did not join. The blocked opening partially covered the upper of two red sandstone steps that led down to the natural on the south side of the wall (Plate 41, Plate 42, and Plate 43). Both steps were very worn down on the west side, and at the base of the flight the natural was covered in black rubber mats. Between the east side of the steps and the foundations of wall **108**, there was a very wet, black patch in the natural which contained a concentration of fragments of pottery and perhaps represents a small pit.

**Plate 35 (left): Wall 119 at the west end of the north side of the site, prior to removal of bricks, taken from the south-south-east**

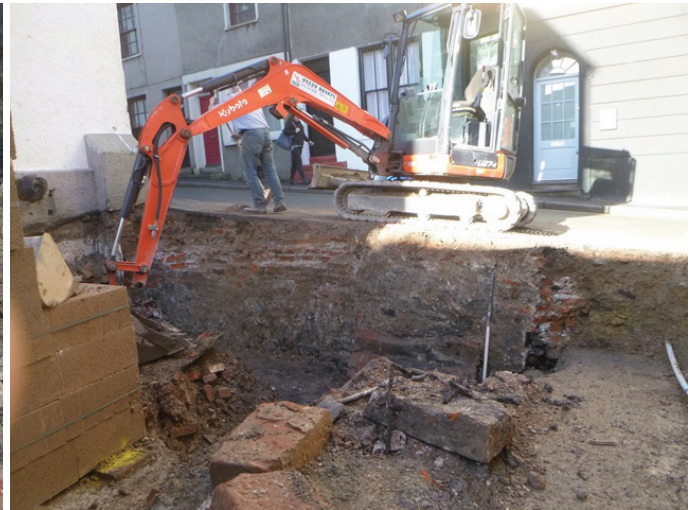
**Plate 36 (right): Wall 119 running from the west end of the north side of the site to the corner with 108 (removed, and visible in section), showing blocked opening within wall, with sandstone steps below, taken from the south**

5.1.4 **Phase 3 (19<sup>th</sup>/early 20<sup>th</sup> century):** at some point during the lifetime of the building fronting onto Daltongate, opening for the door to the cellar was blocked. In addition, broken pottery dated to the 19<sup>th</sup> century was dumped in a possible pit to the east of the foot of the sandstone cellar steps. It is possible that wall **107** also relates to this phase.

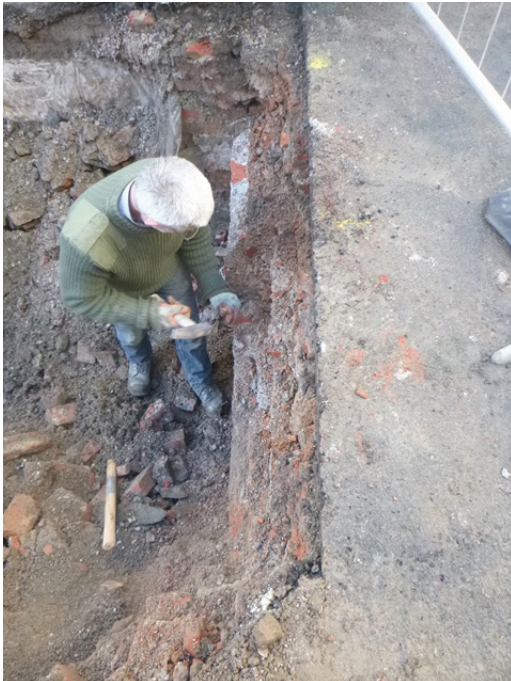
**Plate 37 (left): Working shot of wall 119 during brick removal, showing four courses thick**

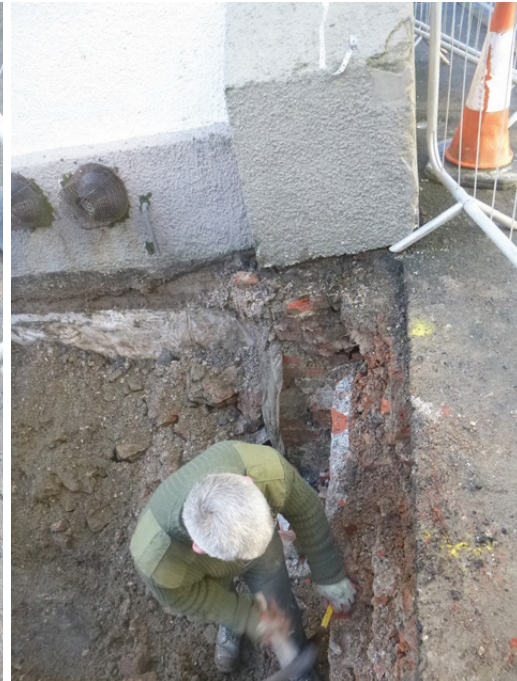
**Plate 38 (right): Working shot of wall 119 showing junction with remaining pillar of wall 116 below buttress, taken from the east**

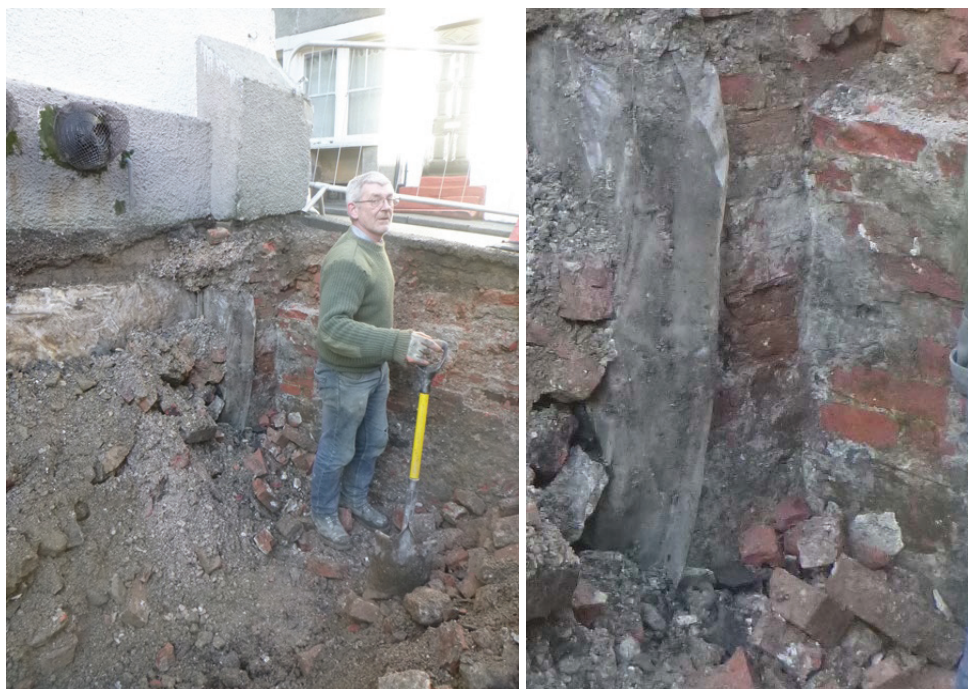
**Plate 39 (left): Working shot showing the junction of wall 116 and wall 119, taken from the south-east**  
**Plate 40 (right): Close up of junction of wall 116 and wall 119, showing wall 119 butting against wall 116, following removal of top few courses of bricks from wall 119**

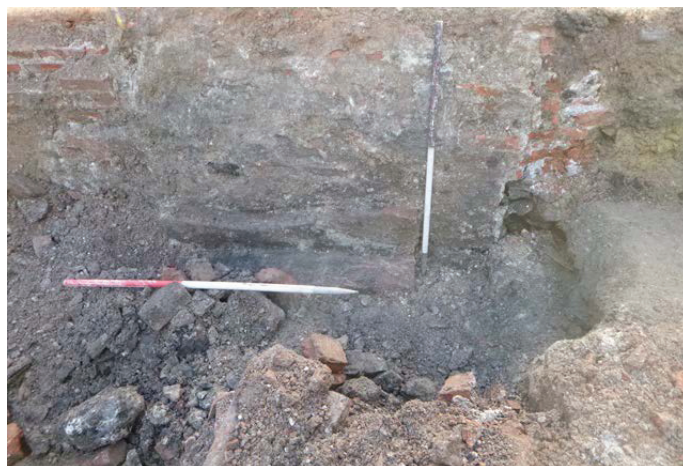
**Plate 41: Blocked opening in wall 119 with red sandstone steps below, showing wear on left-hand side (west), taken from the south**

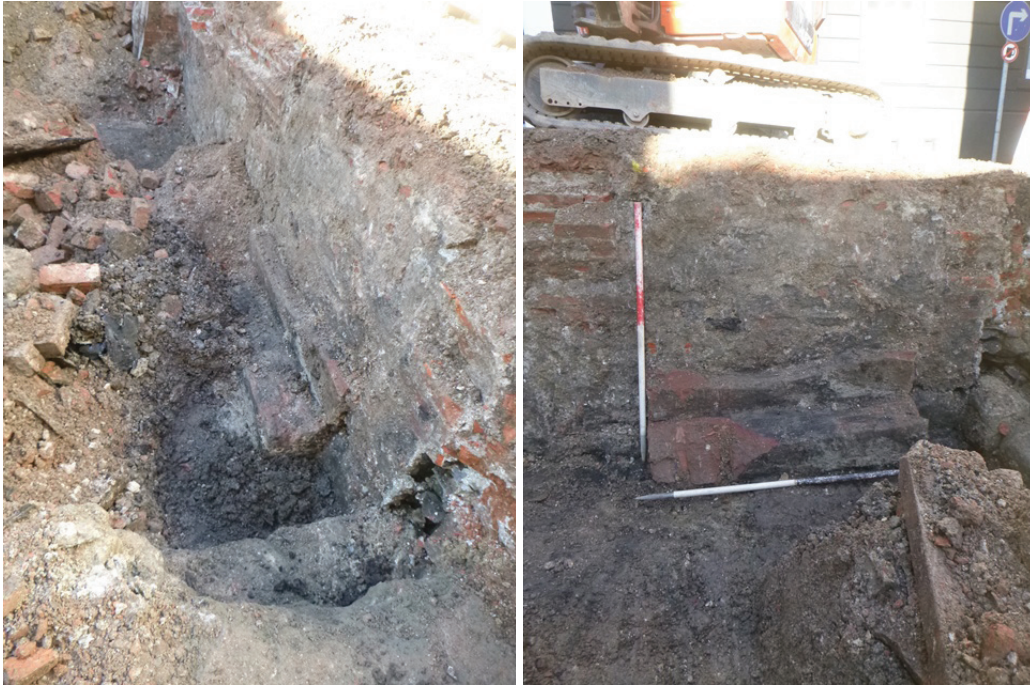
**Plate 42 (left): Red sandstone steps below blocked opening in wall 119, showing profile on east face, taken from the east**

**Plate 43 (right): Red sandstone steps with part of west side removed during cleaning with toothed ditching bucket, below blocked opening in wall 119, taken from the south**

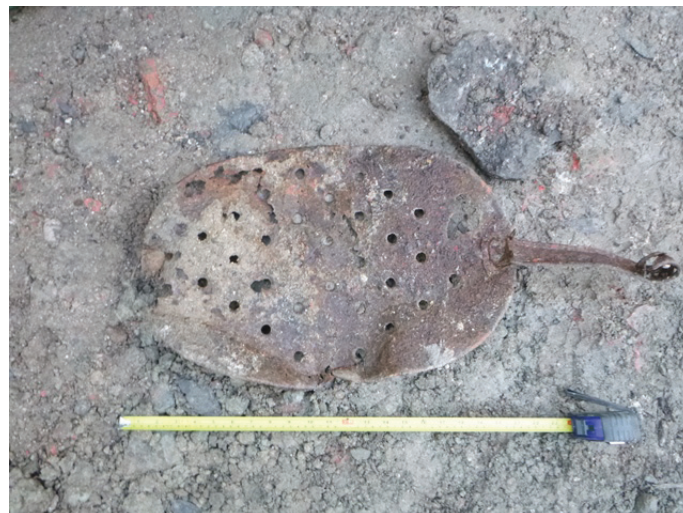
4.2.12 **Rubble backfill 114:** context 114 was loose pale brown gritty clay rubble with 20% handmade brick and patches of mortar, up to approximately 1m thick, and it covered the area bounded by walls 108, 119, and 116, but also extending to the south over wall 111 and flags 109. Within it were iron objects including three sash weights, a pierced object (Plate 44), and from the area close to the sandstone steps there were window bars of the type commonly used over cellar lights, and a large strap hinge. In addition, there were many pieces of red sandstone, including a large pecked rectangular piece with a moulding along the edge (Plate 45), a quoin with chamfered edges (Plate 46), and a block with several holes (Plate 47). Complete glass bottles were also recovered (see *Appendix 3*), and there were plastic objects such as Fairy liquid bottles.

**Plate 44: Pierced iron object from rubble backfill 114**

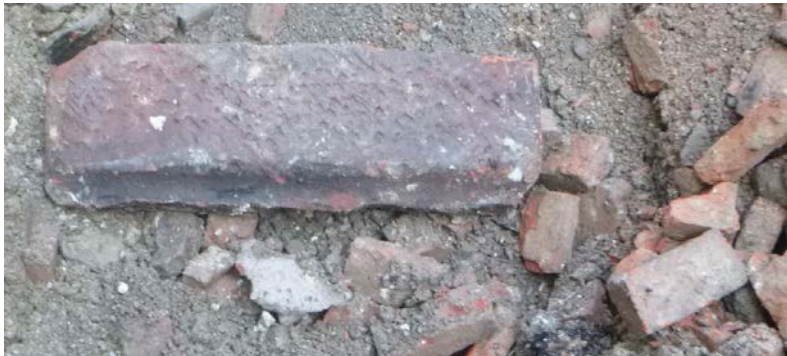
**Plate 45: Pecked red sandstone with moulded edge from rubble backfill 114**

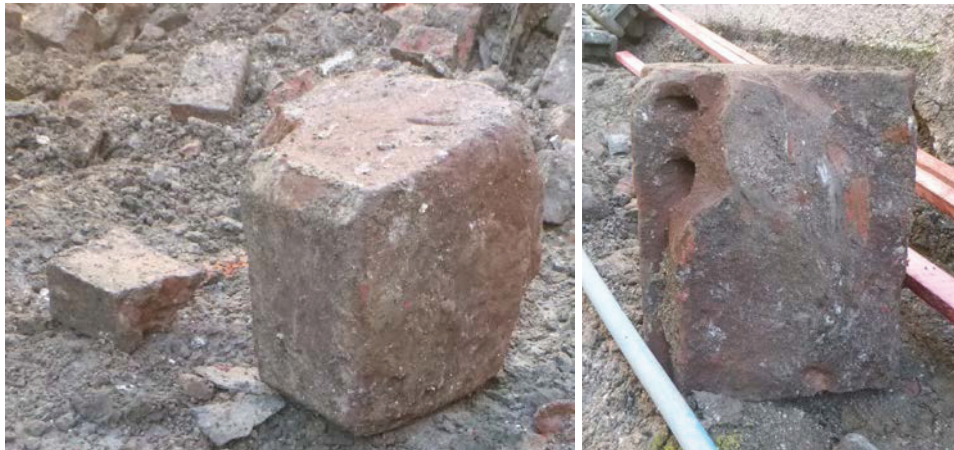
**Plate 46 (left): Red sandstone quoin with chamfered edges from rubble backfill 114**

**Plate 47 (right): Red sandstone block with several holes from rubble backfill 114**
