HALL FARM BARN, KELLET ROAD, OVER KELLET, LANCASHIRE

Archaeological Building Recording

February 2018

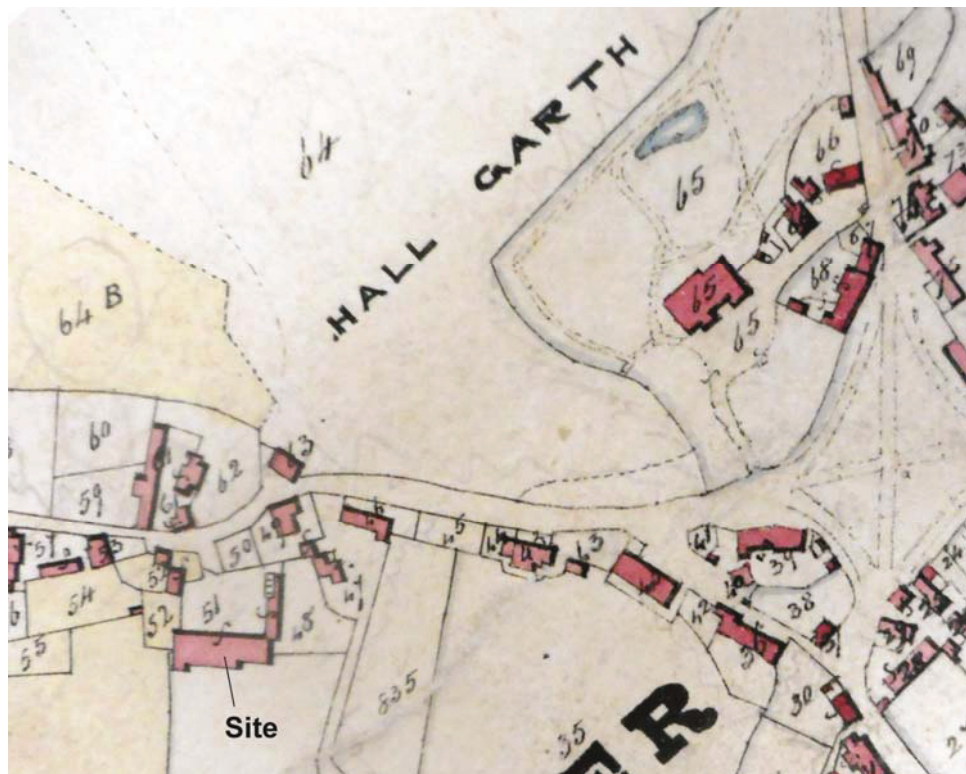
Plate 1: Extract from the tithe map for the parish of Over Kellet (LRO(P) DRB 1/118 1840)

3.1.2 **Tithe Map 1840:** this map shows the two ranges of farm buildings on the site – a larger one running east/west, with two protruding sections along the south side, and the smaller buildings running north/south, with the northern end narrower than the southern portion, and four unroofed structures along the north-west (Plate 1). The schedule number for the courtyard and the ranges of buildings is 51, and is described as 'Barns & fold' in the accompanying award (LRO(P) DRB 1/118 1847), with associated land given schedule number 50 to the north, and the farmhouse given schedule number 49 to the north-east (see Table 1, below).

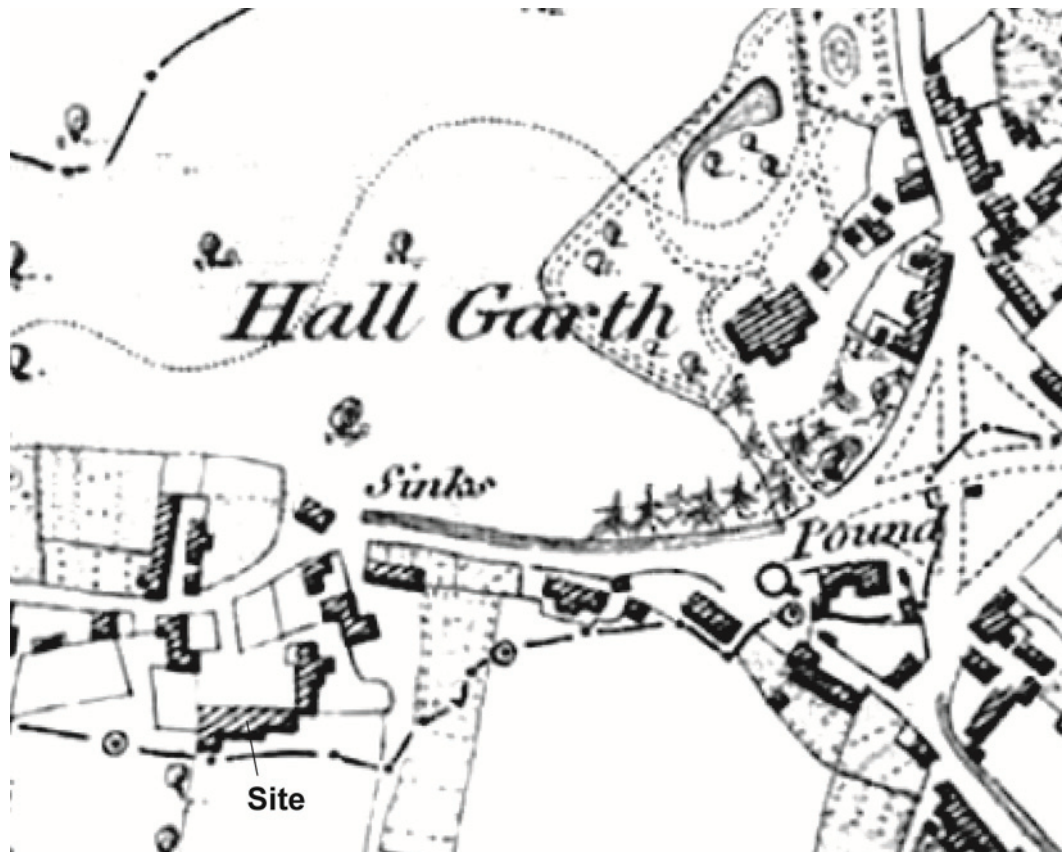
Plate 2: Extract from the Ordnance Survey map of 1847

3.1.3 **Ordnance Survey 1847:** this map, surveyed in 1845-6, shows the main east/west range very similar to that shown on the tithe map of 1840 (Plate 2). The south-west projecting section, however,

seems to extend further south. The north/south range has two additional projecting sections on the east side towards the north end.

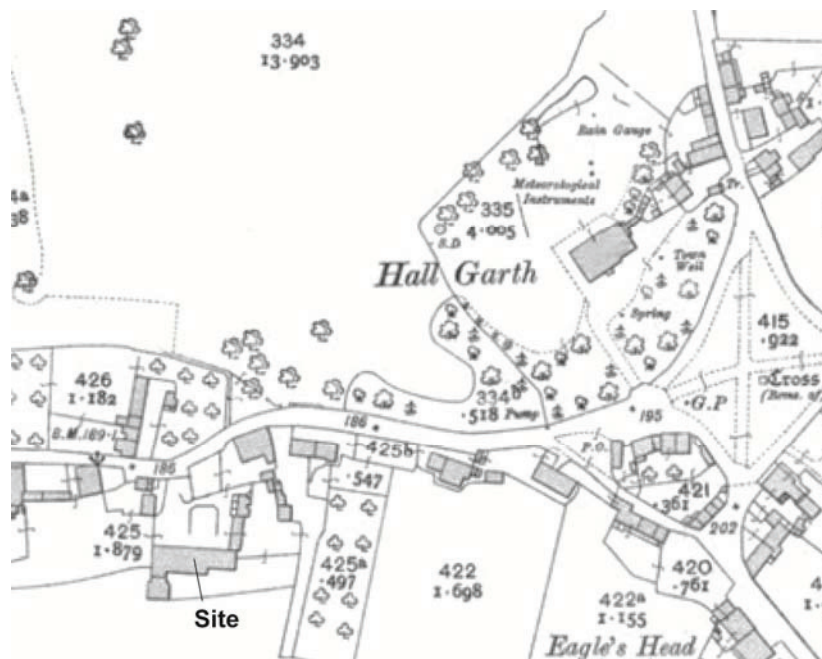
Plate 5: Extract from the Ordnance Survey map of 1913

3.1.6 **Ordnance Survey 1913:** this map is the first to name Hall Farm, and interestingly it is shown in larger text than Hall Garth, and not next to the site which is the subject of this report, but further to the west (Plate 5). This might indicate that the farm to the west has by this time been incorporated into Hall Farm. The rating valuation of 1910 had clearly shown them to be separate landholdings, with the occupier of plot 13 not Adam Platt. The pump is no longer shown, and there is a horseshoe-shaped wall

in the courtyard, and another curved wall coming off the corner of what was listed as the garden on the tithe map. The farm buildings under investigation generally do not appear to have changed a great deal, since the previous maps were produced.

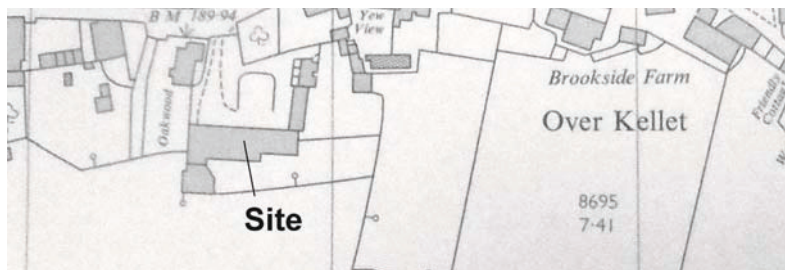
Plate 6: Extract from Ordnance Survey map of 1969

3.1.8 **Ordnance Survey 1969:** this map again names Hall Farm in a position that indicates it includes the farm to the west (Plate 6). The buildings are unchanged from the previous map, with only two track lines shown near the horseshoe-shaped wall in the courtyard, and a tree shown in the garden.

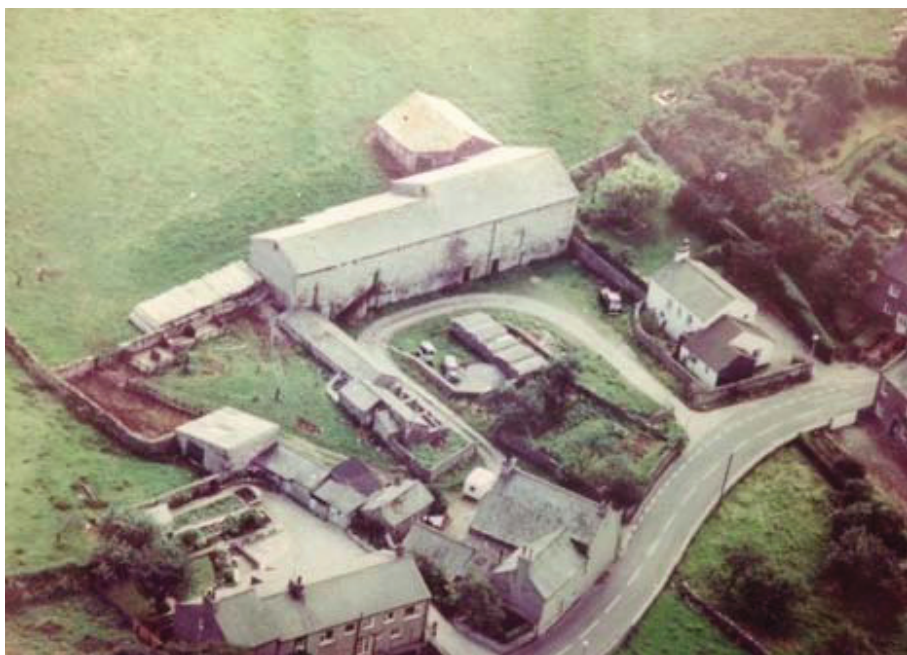
Plate 7: Aerial photograph from 1972 (after Studio Hills Ltd 2014, 4)

3.1.9 **Aerial photograph 1972:** an aerial photograph from 1972 shows the buildings in three dimensions for the first time (Plate 7). This demonstrates that the buildings were in considerably better condition at this time and all still roofed and that the late extension to the west side of the south elevation was still standing. It appears from the photograph to have been constructed from a different material to the rest of the building, perhaps brick or red sandstone.

5.1.6 **Phase 5 (late 20th century)**: it is clear from the photograph dated 1972 (Plate 7) that at that time the building was still in reasonable condition with an intact roof throughout and with the extension to the south-west still standing. Between that date and the present day the building has clearly decayed very rapidly, with the collapse of much of the roof and the demolition of the extension to the south-west. It is tempting to suggest in the case of the latter that this was carried out in order to allow the horse engine mechanism to be removed, presumably for the scrap value of any iron components by that time. Much of this damage seems to have occurred once the buildings fell out of use in the 1990s (Studio Hills Ltd 2014, 21).

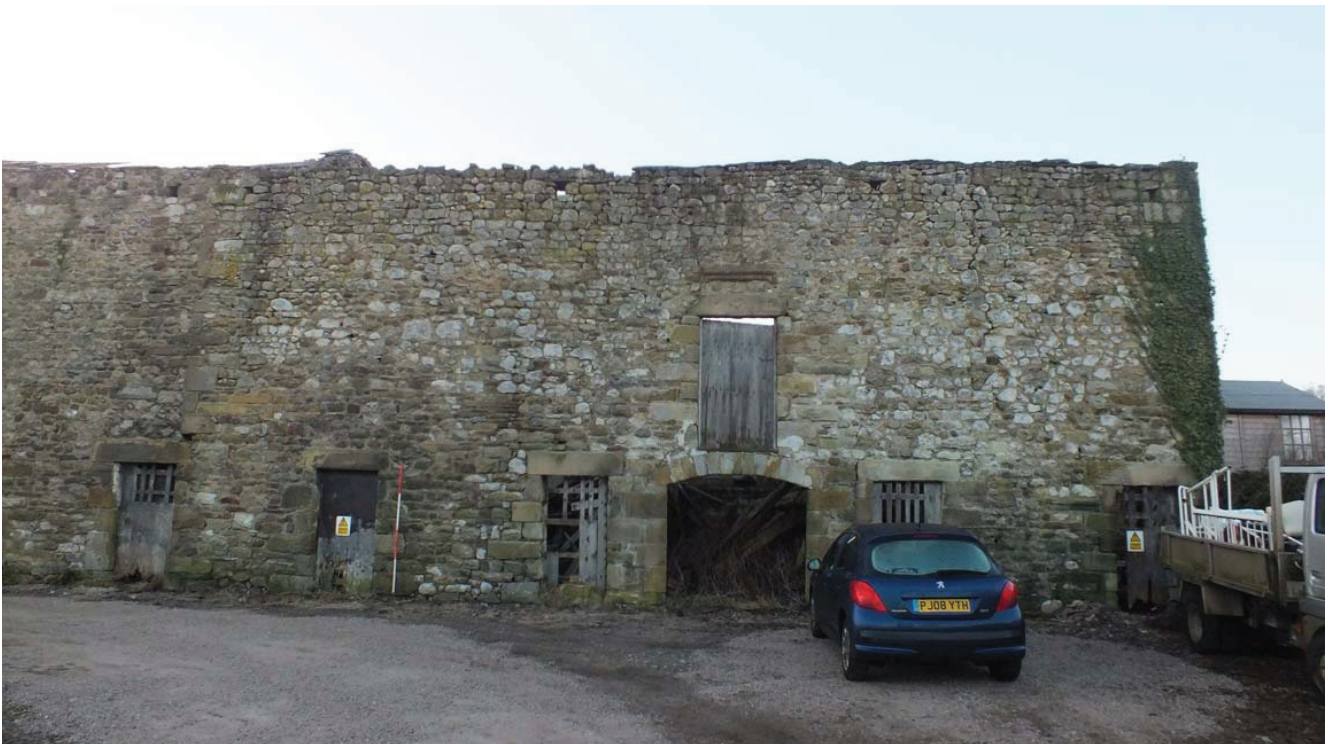
Plate 8: West end of north external elevation of main block

4.2.1 **North elevation, Main Block** (Figure 2): there is a row of four square vents along the top (Plate 8). The west end has two doorways on the ground floor both with plank and batten doors with slots. The western doorway has neatly dressed and V-jointed quoins but a plainer dressed lintel (Plate 9). The doorway to the east of this has slightly chamfered quoins and a stop chamfered lintel (Plate 10). There is a reused piece of stone with a slot next to the western door. To the east is a large wagon door with flat voussoir arch and quoined jambs on the ground floor (Plate 11), above which is a winnowing door with rougher quoins and a plank and batten door in a plain surround, above which is a reused moulded piece of stone, possibly a lintel (Plate 12). To the east are two further ground floor doorways with slightly irregular quoins and plank doors. To the east of these is a row of quoins extending to full height, all varying in form, with a lintel for the doorway to the east cut in and utilising them for its west jamb (Plate 13). The east jamb is chamfered quoins, and the lintel has a pecked finish with neat bands round. There is a further reused piece of stone to the east with a square hole.

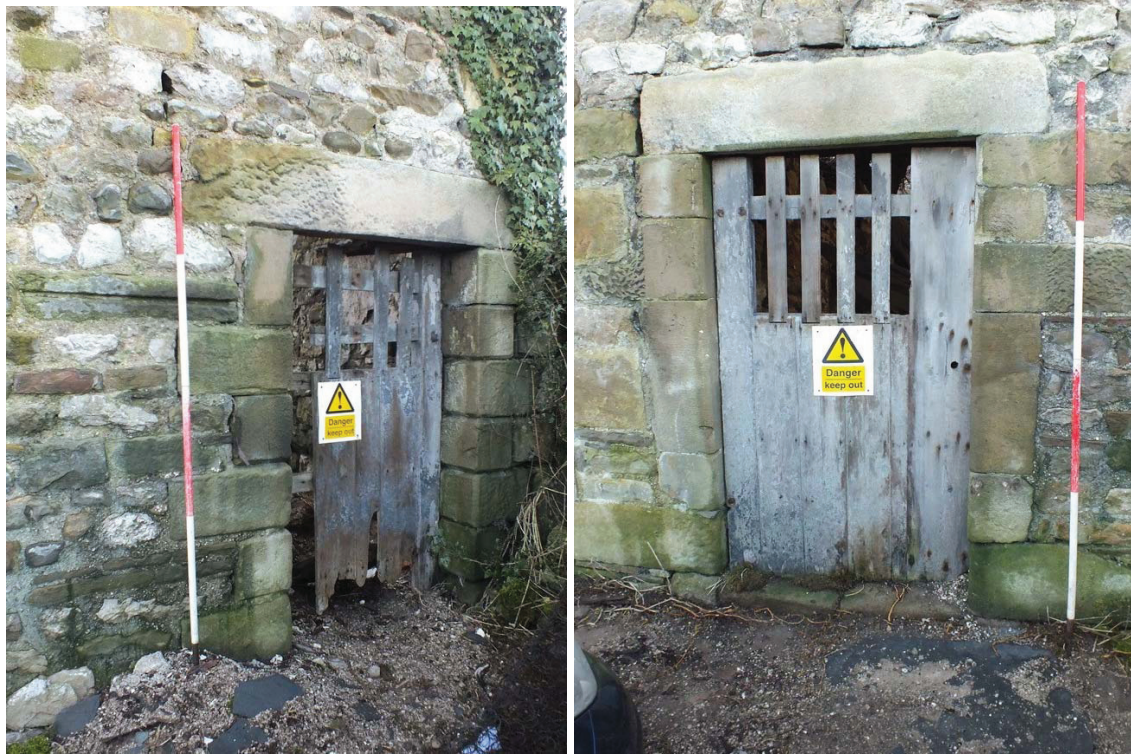
Plate 9 (left): The westernmost door in north external elevation of main block

Plate 10 (right): Second door from the west end of the north external elevation of the main block

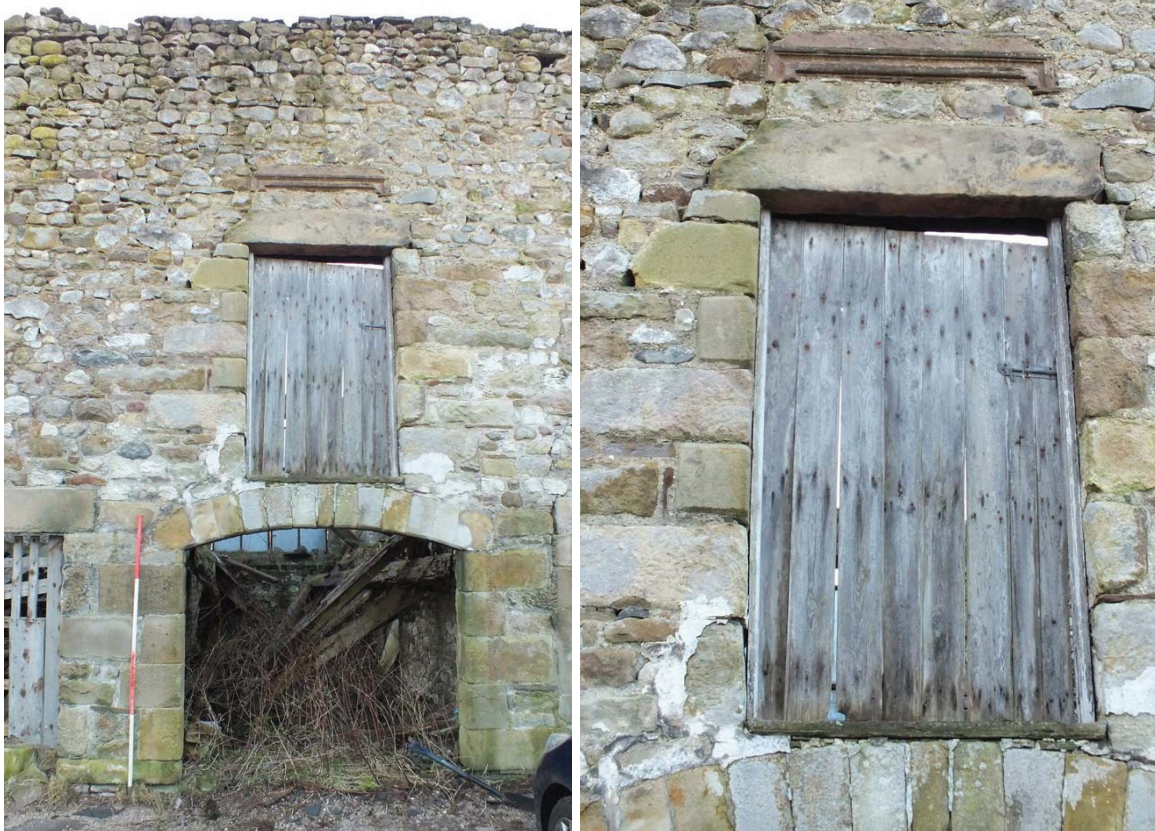
Plate 11: Wagon doorway at west end of north external elevation of main block, with pitching door above

Plate 12: Detail of winnowing door with reused moulded piece above in the north external elevation of the main block

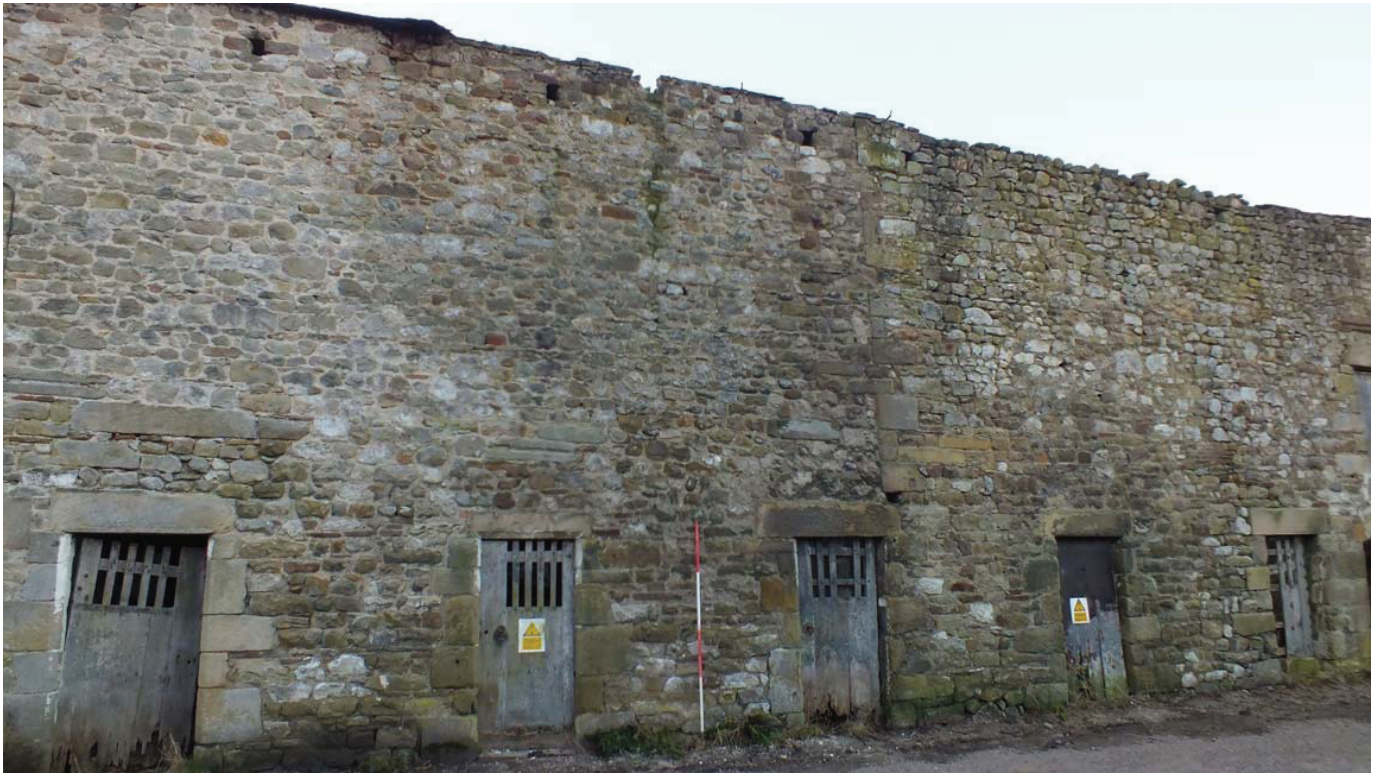
Plate 13: Central part of north external elevation of the main block

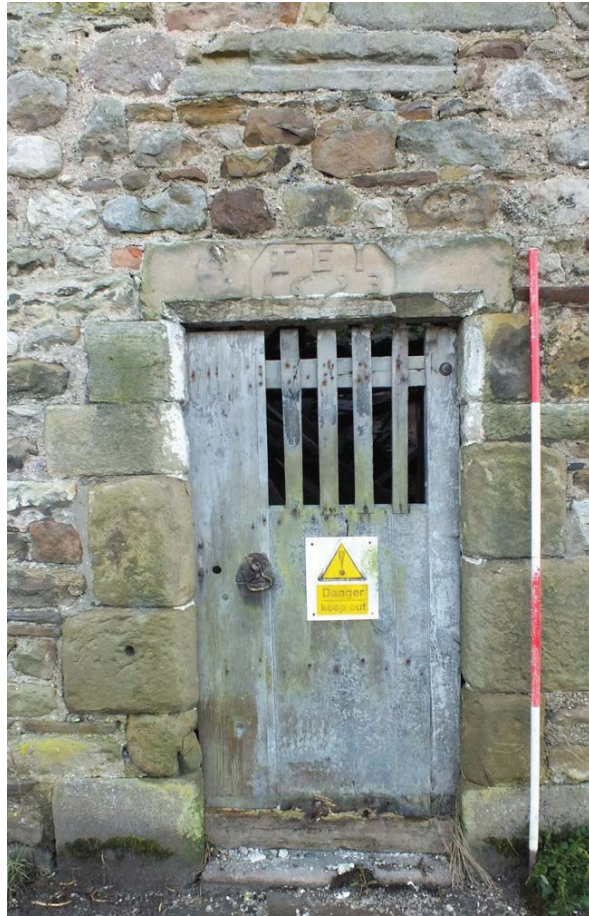
Plate 14: Doorway in the north external elevation of the main block with the datestone 'TEI 1693' and reused stone above

4.2.2 To the east is a doorway with chamfered quoined jambs and a lintel with the date 'TEI 1693' (Plate 14). Above is a reused piece with a slot and hole for timber stud. To the east is a further doorway with chamfered jambs and a plain lintel, which has a plank and batten door with slots in the door. There is a large lintel-like piece above too and another reused slab with slots for timber above that to the east. There is a wagon doorway to the east with a chamfered flat voussoir arch and chamfered jambs, with a double plank and batten door (Plate 15 and Plate 16). There is a first floor doorway over the wagon doorway with a chamfered lintel, which is presumably reused as it is unnecessarily long, and there are also two small holes above wagon door, which were presumably for joists supporting a timber access to the upper door. Immediately east of the wagon doorway is a flight of stone steps (Plate 16), and beyond these, to the east, is a small window filled with slatted timber with a large dressed lintel and quoins and doorway (Plate 17). To the east of this is a doorway with chamfered jambs and a plain timber lintel and double plank and batten door above which is a further reused piece, possibly from a mullion window. The door has graffiti carved into it in the form of initials such as 'MPW', 'MW', 'TP', and 'TC' (Plate 18). To the east is a small window as per that to the west. The east end is covered by north/south block there is a row of six square vents along the top of the east end.

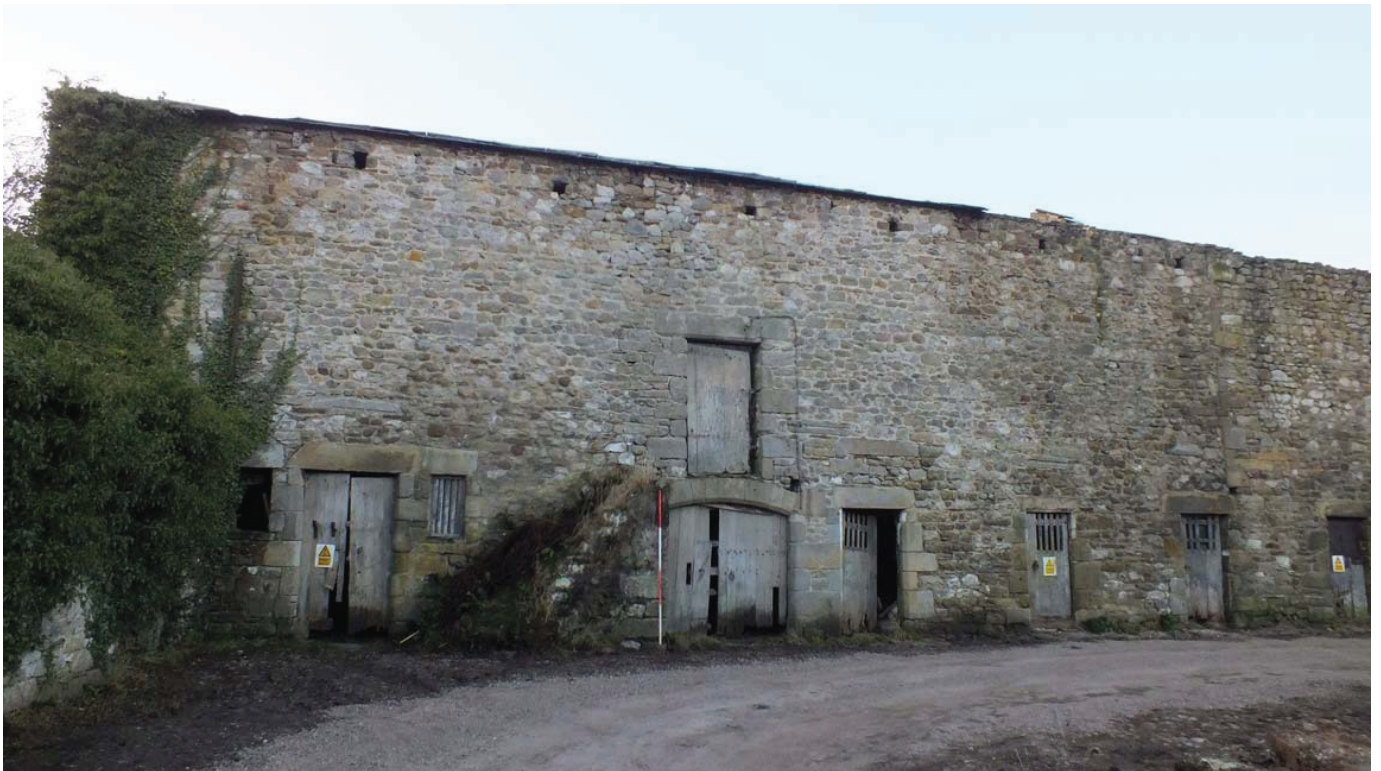
Plate 15: East end of north external elevation of main block

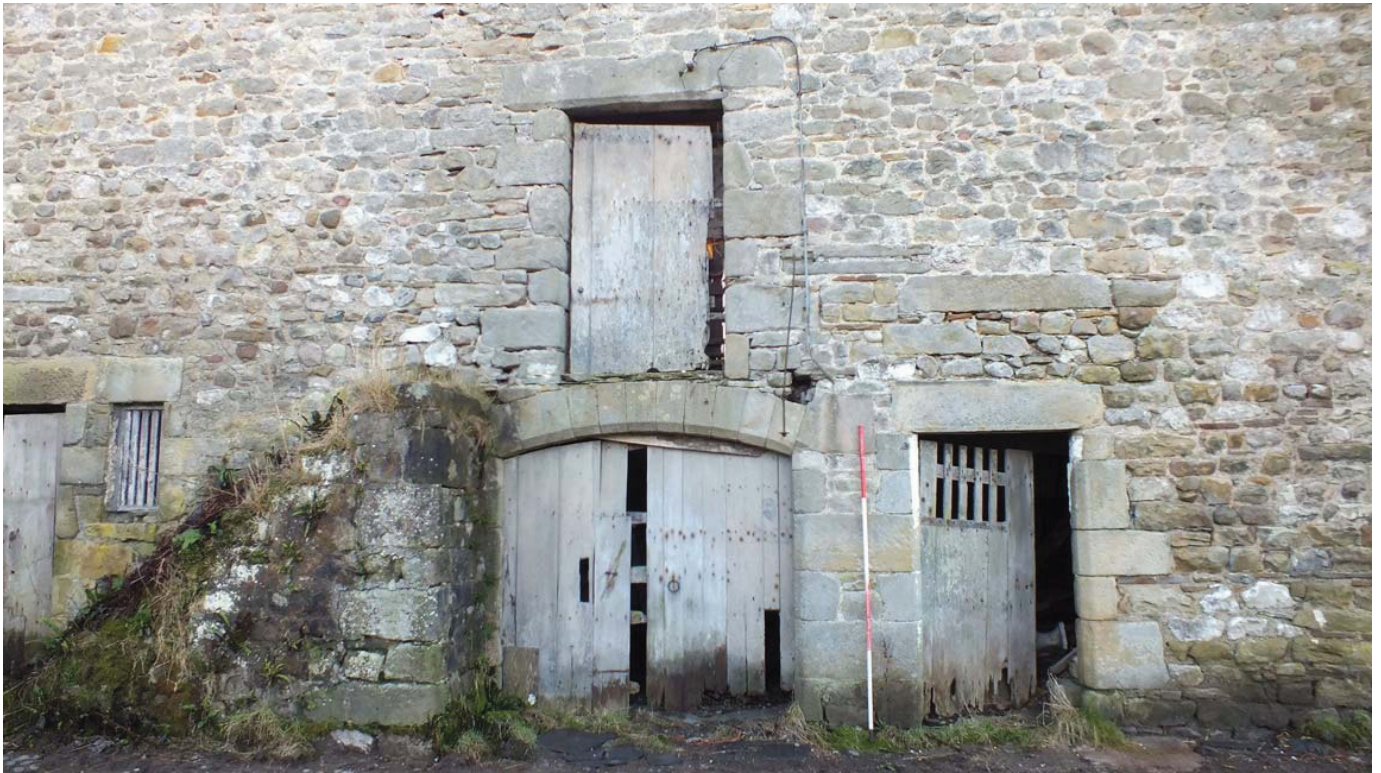
Plate 16: Detail of the wagon doorway and stairs at the east end of the north external elevation of the main block

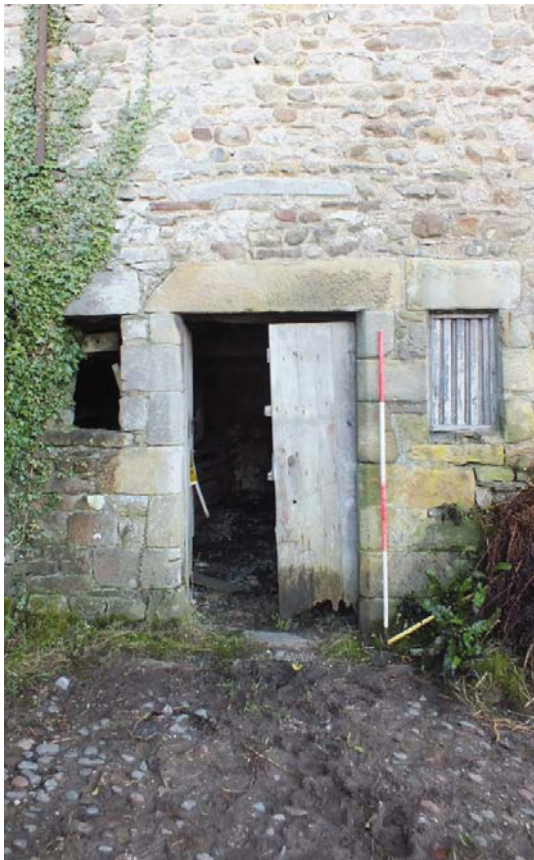
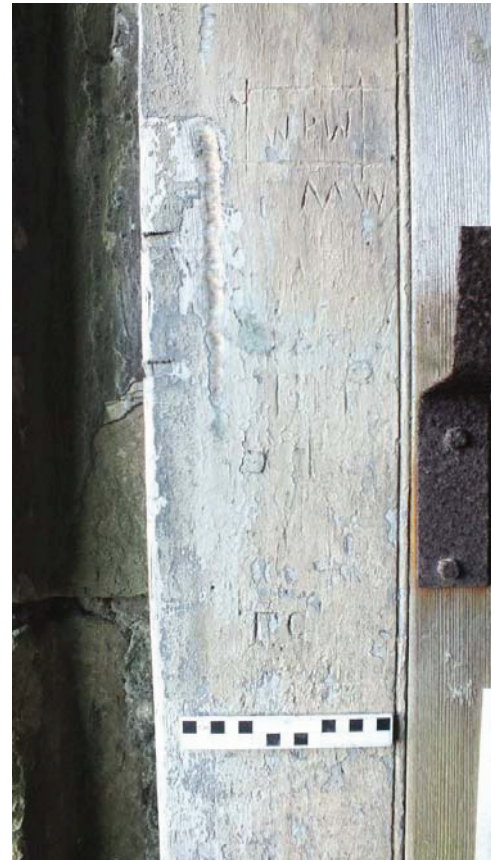
Plate 17 (left): Easternmost door in the east end of north external elevation

Plate 18 (right): Graffiti carved into the door at the east end of the north external elevation

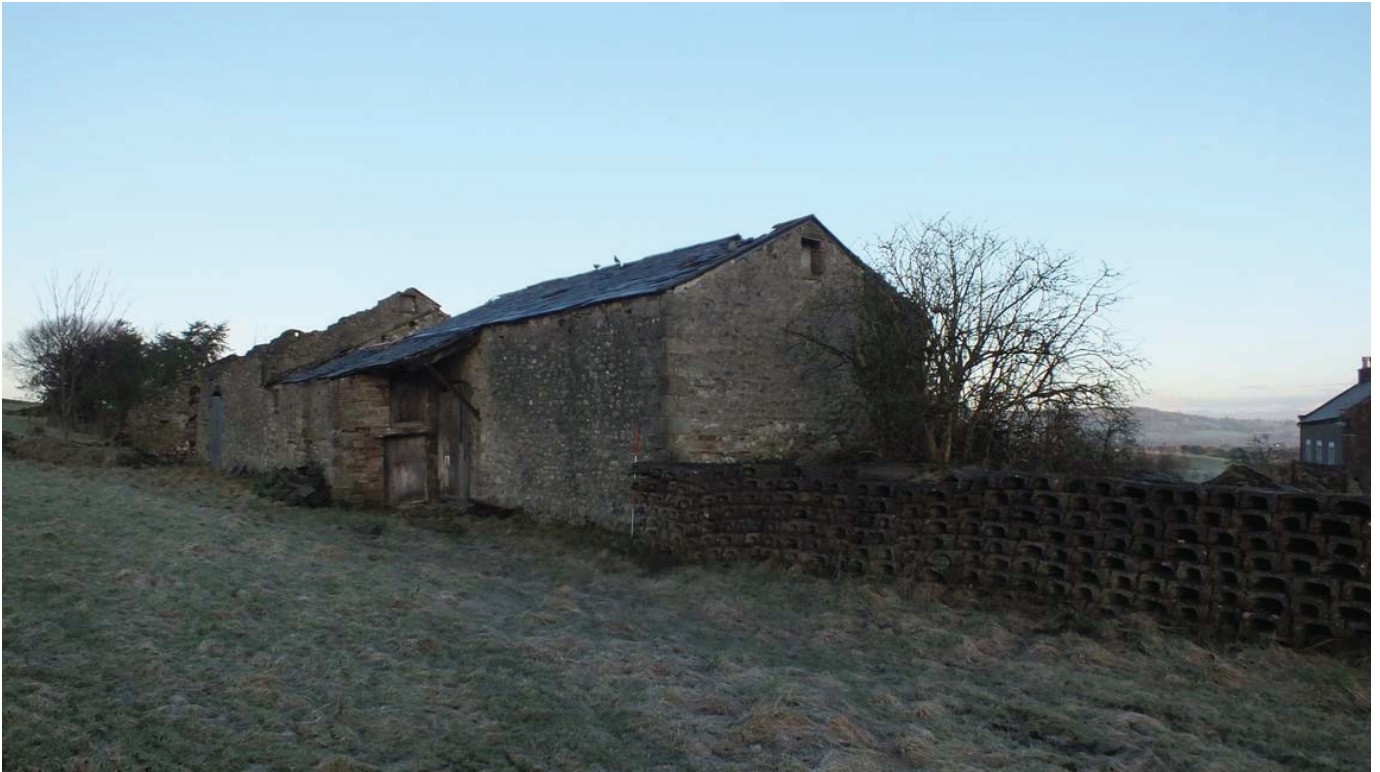
Plate 19: The east external elevation of the main block

4.2.3 **East elevation, Main Block** (Figure 2): this is a gable end, partly obscured by a tree and material piled against it beyond a field boundary, which butts it south of centre. There are quoins at the ends made of dressed stone, and it is otherwise fairly plain apart from a square opening below the apex, presumably an owl hole, with thin sill and lintel. The ends of internal beams project through the wall near the base.

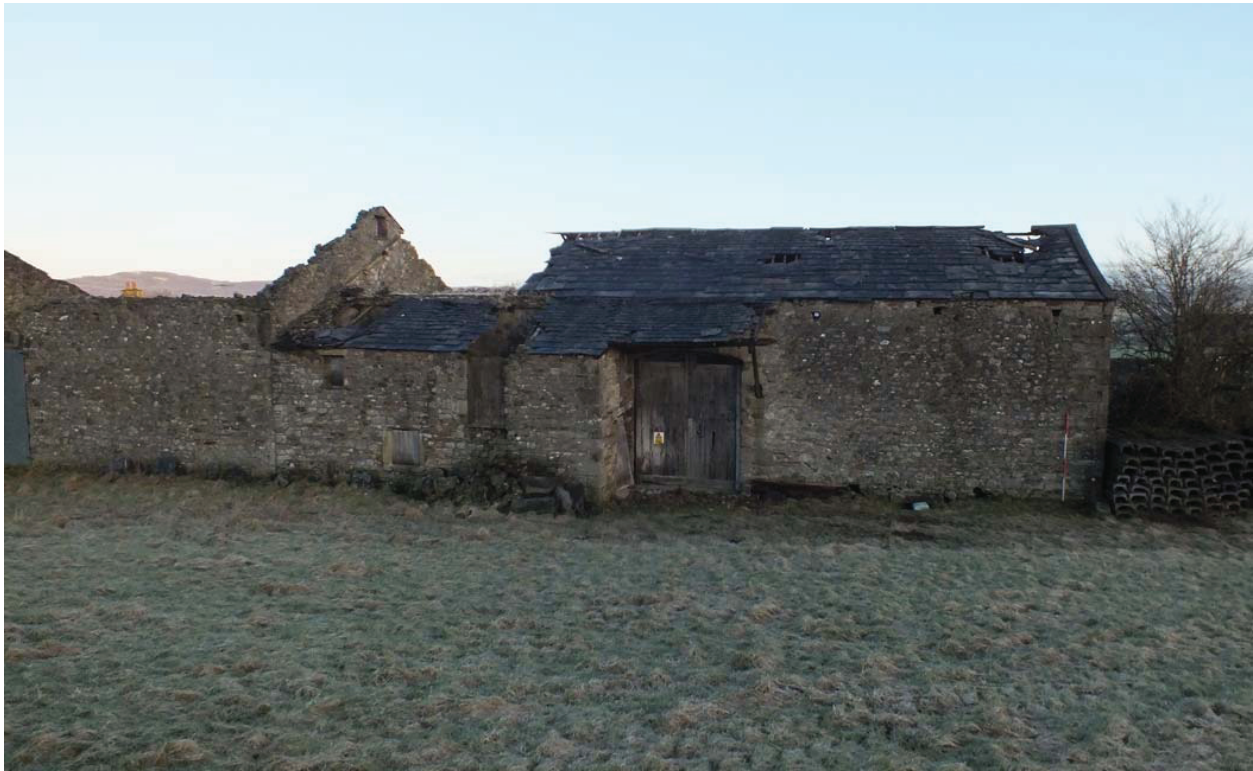
Plate 20: The east end of the south external elevation of the main block

4.2.4 **South elevation, Main Block** (Figure 3): the east end of the south elevation has plain quoins and a row of threw square vents at the top (Plate 20). To the west is a wagon doorway with chamfered flat voussoir arch and quoined jambs and a canopy over the surround on the east side supported by a bracket and on the west side on the return. The wagon doorway has a double plank and batten door with graffiti sketch of a boat (Plate 21) and initials 'ICR', 'W', etc. There is a return to the west, which butts the main wall and includes an upper level pitching door, with a plank and batten door, thin stone sill and timber lintel, below which is a wider doorway on the ground floor with thin machine cut timber lintel (Plate 22), and graffiti 'JP' carved into one of the south quoins (Plate 23). After the return of the elevation proper there is a high level doorway on the east side blocked with board and with a thin sill and no lintel, a low window near the centre with a dressed stone surround with moulding that not quite fitting the lintel correctly (Plate 24), and a further small window high up to the west with a rough stone lintel. The west end of this section butts the main part of the elevation to the west.

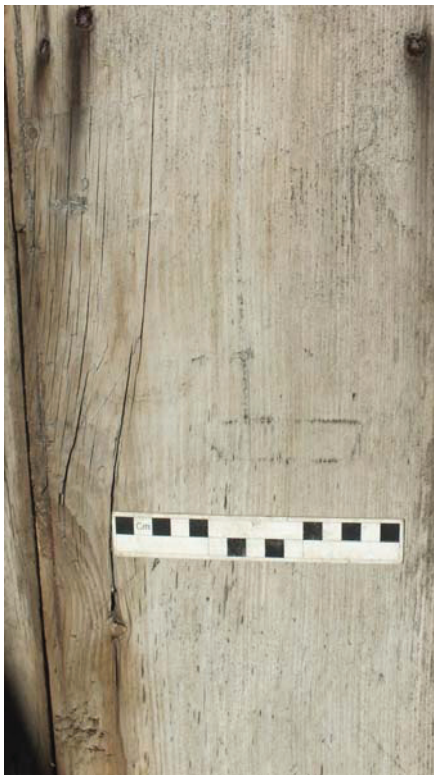
Plate 21 (left): Graffiti boat scratched into the surround of the eastern wagon door in the south external elevation of the main block

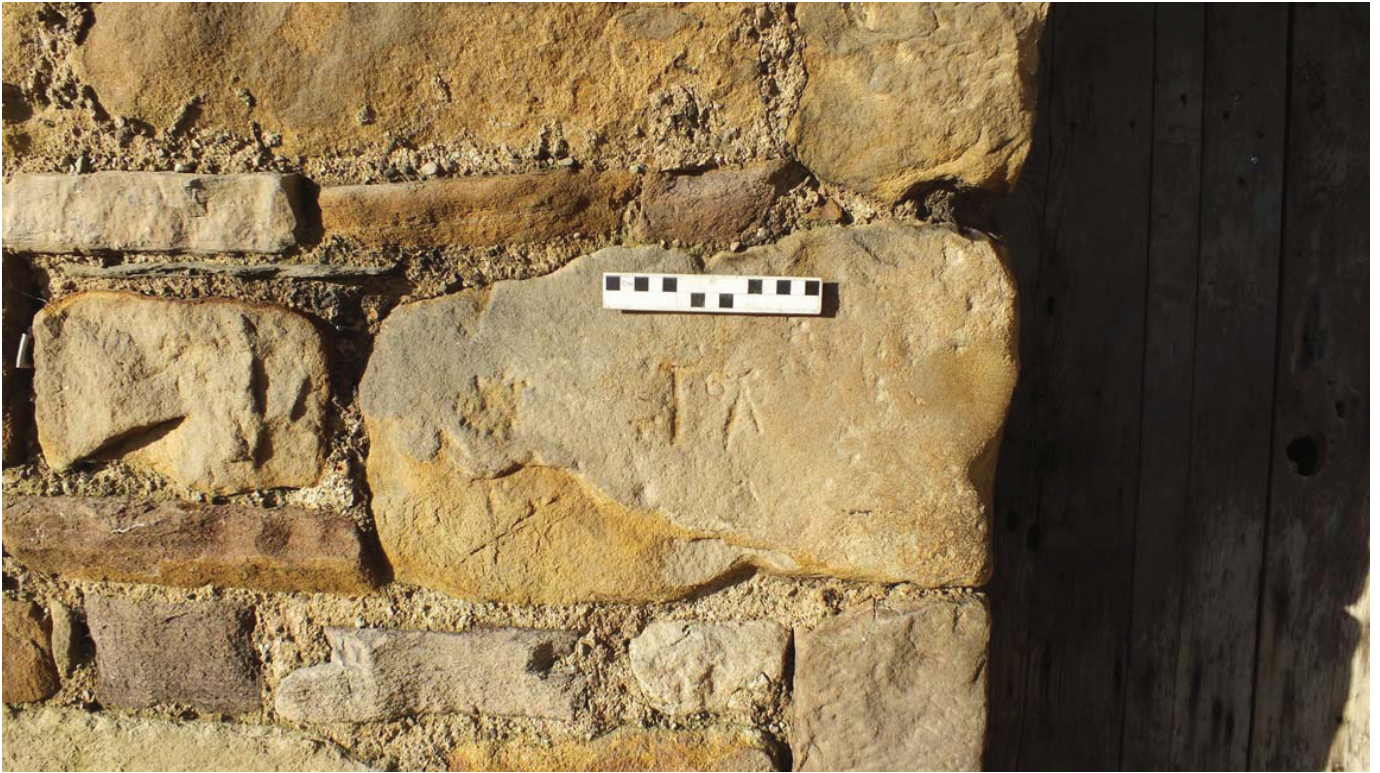
Plate 23: Graffiti 'JA' carved into a quoin in the return at the east end of the south external elevation of the main block

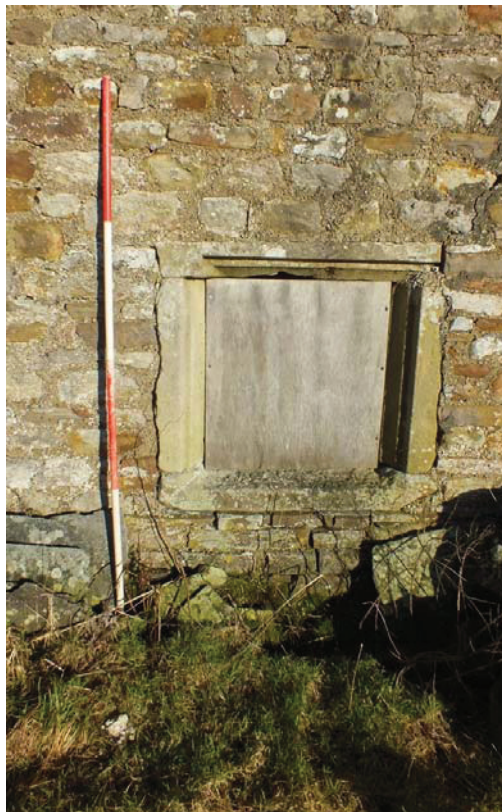
Plate 24: Window with moulded surround on the east side of the south external elevation of the main block

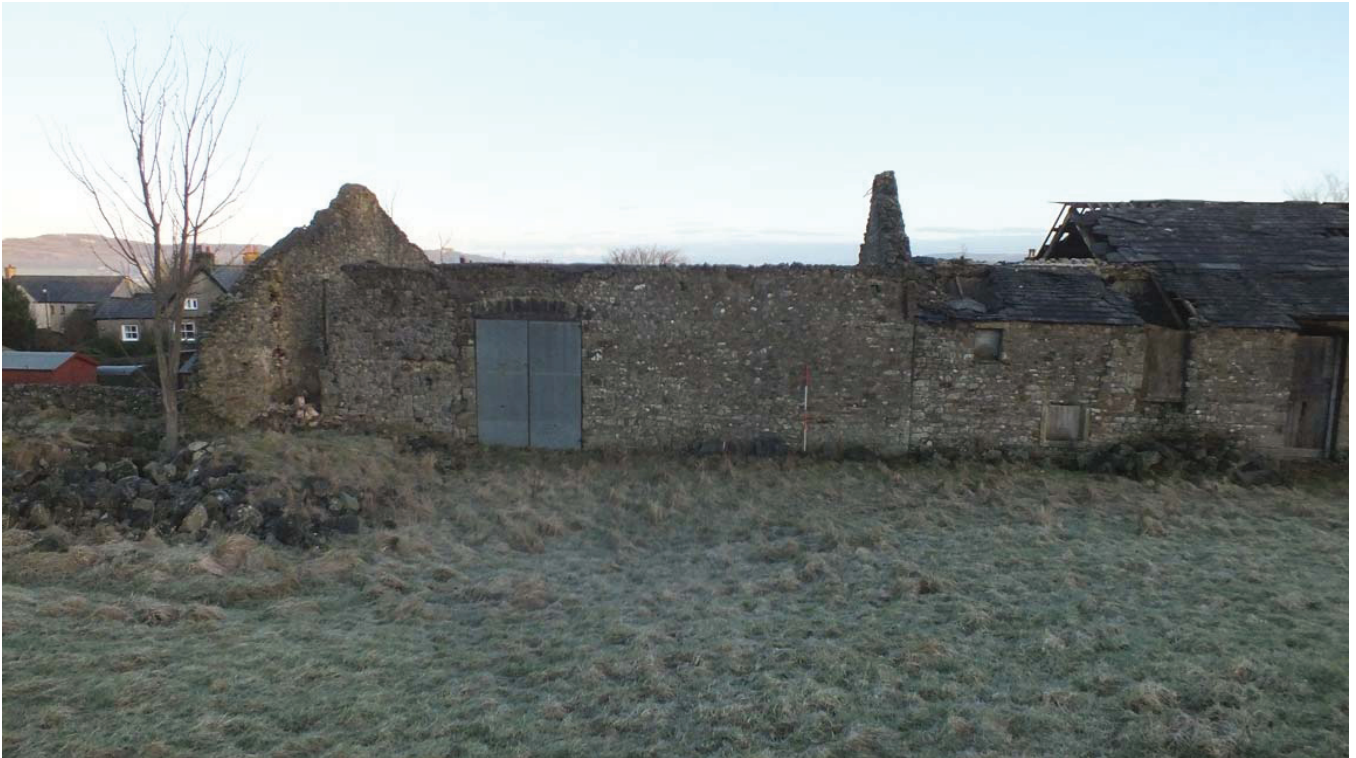
4.2.5 The west end of the south elevation is generally fairly plain, with two square ventilation holes at high level and a wagon doorway to the west with a flat voussoir arch and metal double doors (Plate 25). There is a blocked doorway immediately to the west of this with no lintel and stones projecting from its

Plate 25: The west end of the south external elevation of the main block

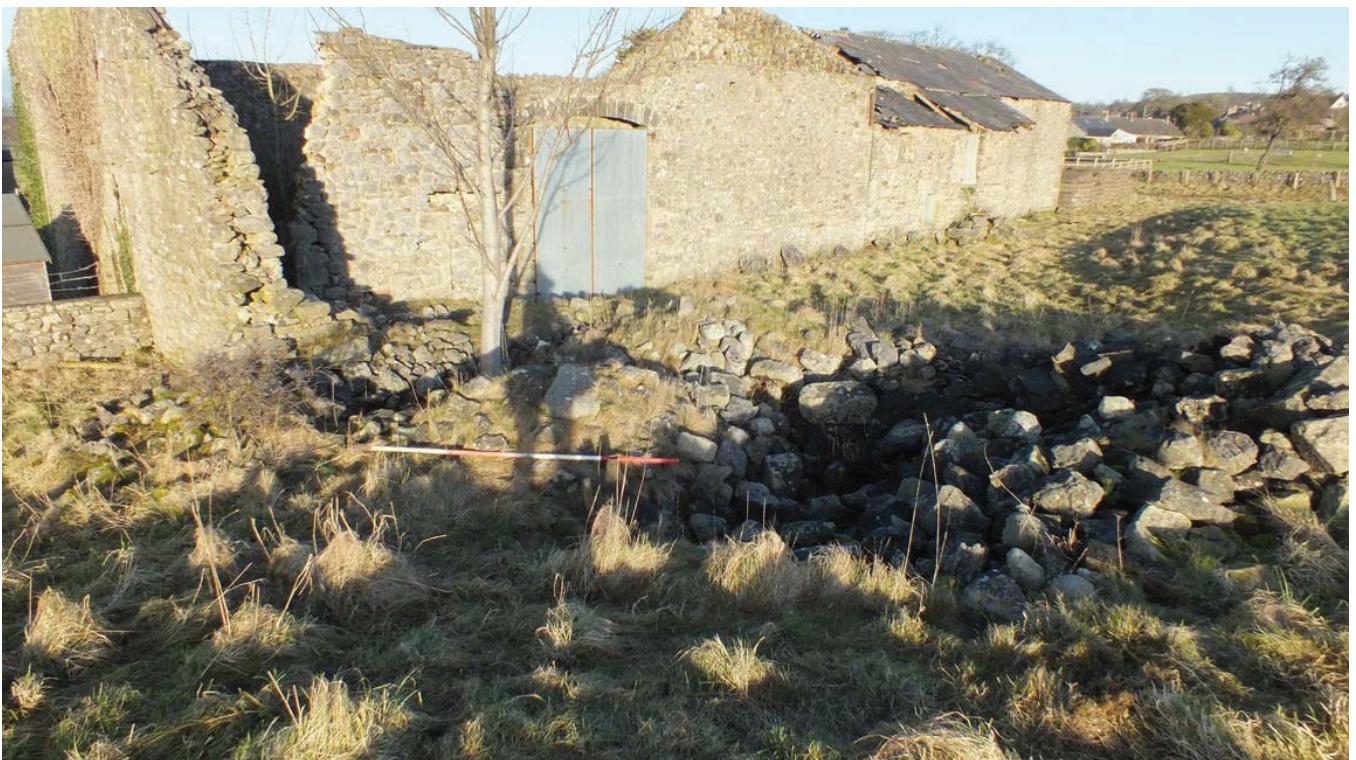
east jamb for a further wall running to the south, and the top part of the wall above this has clearly been rebuilt or even extended. This now corresponds to a large amount of rubble with some discernable walls forming an approximately square structure (Plate 26). The west end of the elevation is largely ruinous with the remains of an opening at this end evident as a row of quoins.

Plate 26: The ruined structure to the south of the west end of the south external elevation of the main block

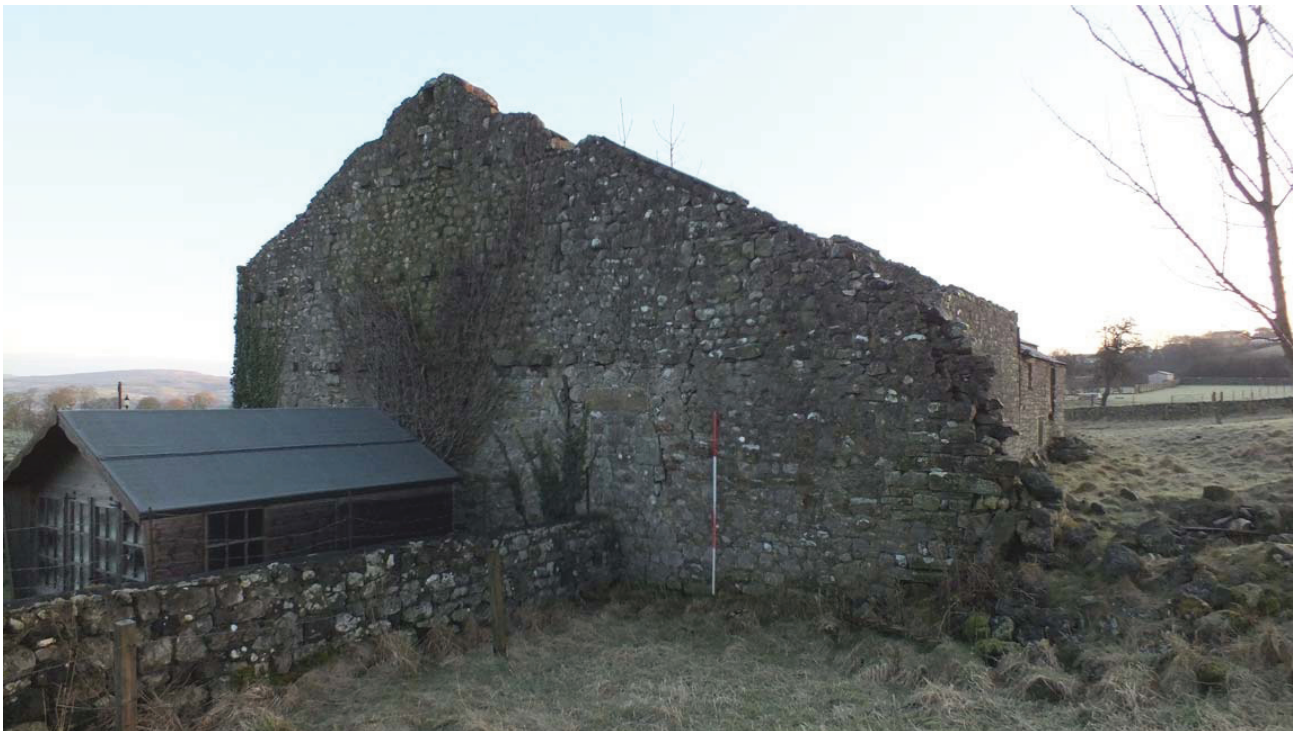
Plate 27: The south side of the west external elevation of the main block

4.2.6 **West elevation, Main Block** (Figure 3): this comprises a gable end and is partially collapsed, especially on the south side (Plate 27). There are three rows of throughstones, some of which, on the south side, comprise reused pieces of moulded stone, perhaps fragments of mullion or window surround (Plate 28). There is a possible small opening low on the south side but this is obscured by rubble and the gable evidently originally extended a lot further to the south into what is now a ruined structure comprising little more than a pile of rubble. There is a blocked opening south of the centre with a dressed lintel and quoins and a small owl hole near the apex. The north end was not accessible during the building recording and is obscured by vegetation.

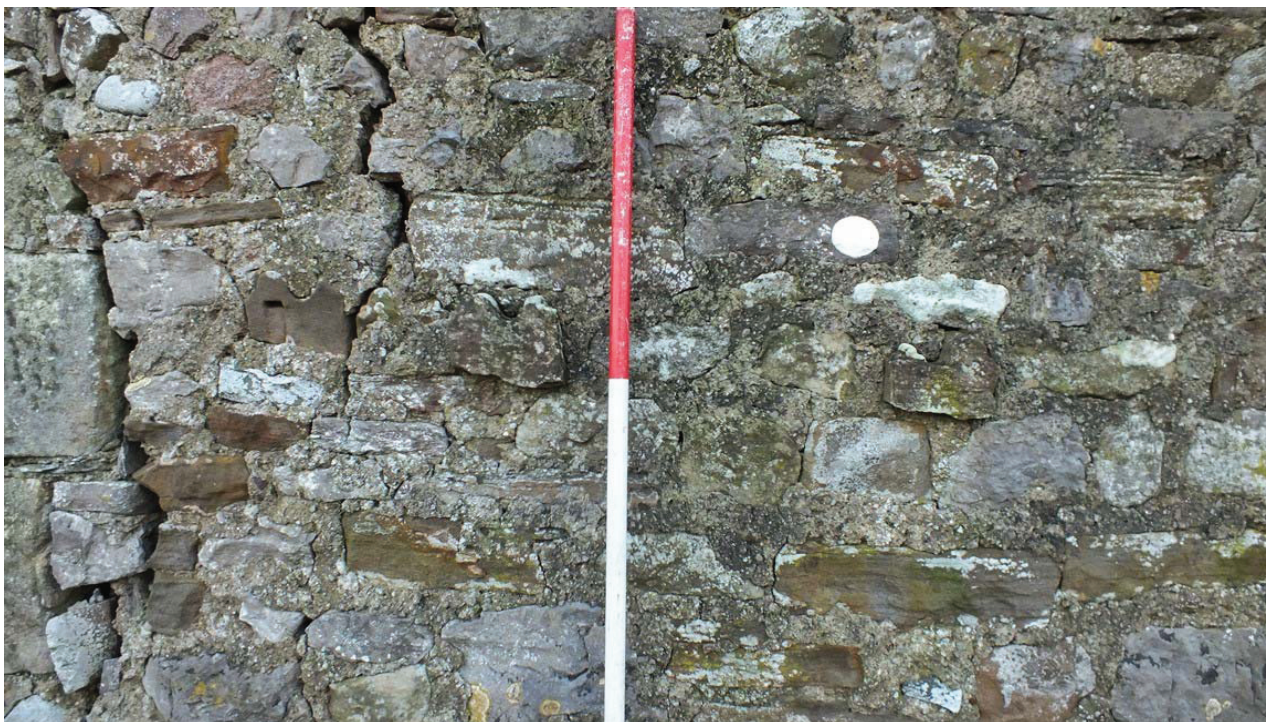
Plate 28: Detail of reused stone in the west external elevation of the main block

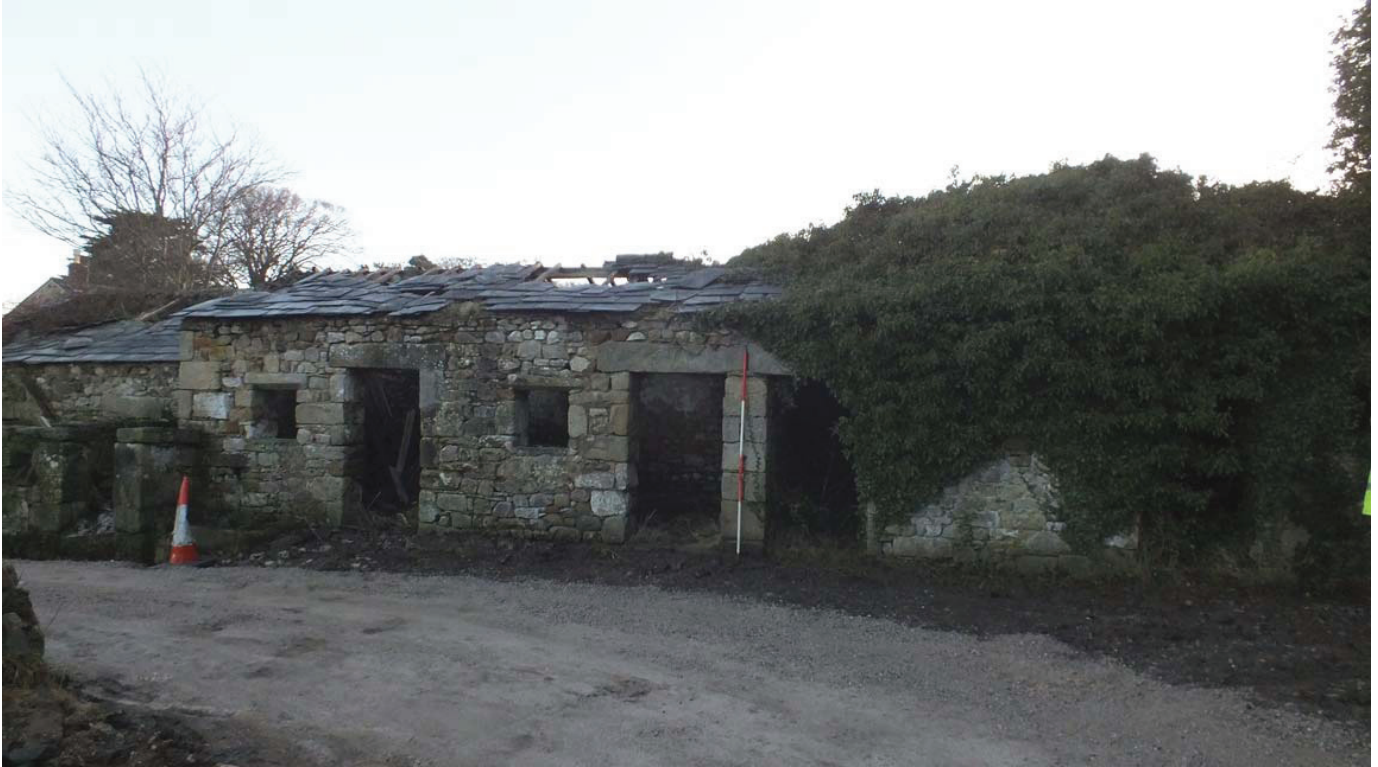
Plate 29: The south end of west external elevation of the north/south block

4.2.7 **West elevation, north/south block** (Figure 3): the south end is obscured by ivy but there is a window just visible with a rebated lintel (reused?), and a doorway with a stone lintel with no door, but with strap hinges (Plate 29). There are two further doorways to the north, both with rough quoins and large lintels. There is a further window to the north with a chamfered lintel, with concrete over the sill. There is another window to the north also with a chamfered lintel but evidently reused and concrete over the sill. There is a door between these two windows with rough quoins and lintel. The quoins at the north end where it meets the pig sties must be part of the same build as they are keyed into each other.
