HALL FARM BARN, KELLET ROAD, OVER KELLET, LANCASHIRE

Archaeological Building Recording

February 2018

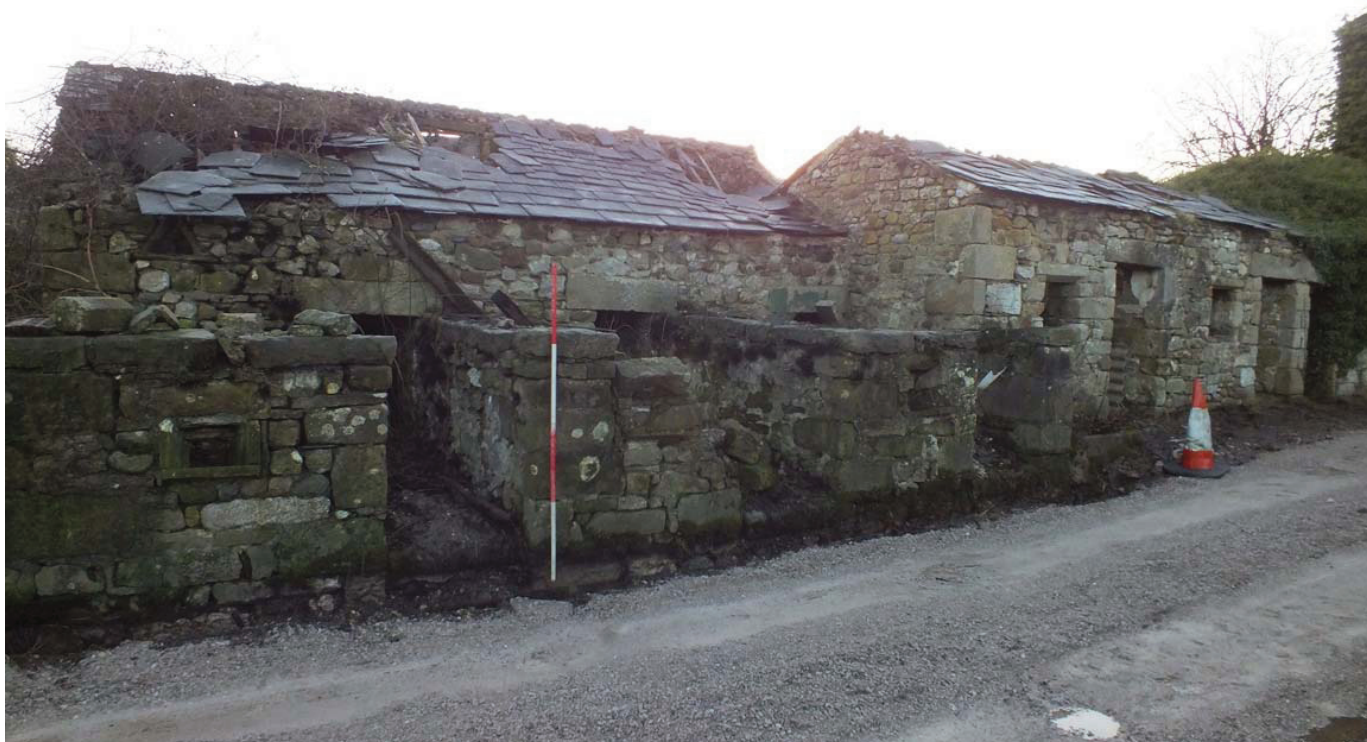
Plate 30: The north end of the west external elevation of the north/south block, showing its relationship to the south end

4.2.8 At the north end there are three sties each with an outer L-shaped wall with a stone feed chute and a small doorway on the south side (Plate 30). The wall proper beyond has a low doorway in each sty with small quoins and a large lintel. There is a triangular vent high on the north end and the outer walls are topped with rough flat blocks (Plate 31).

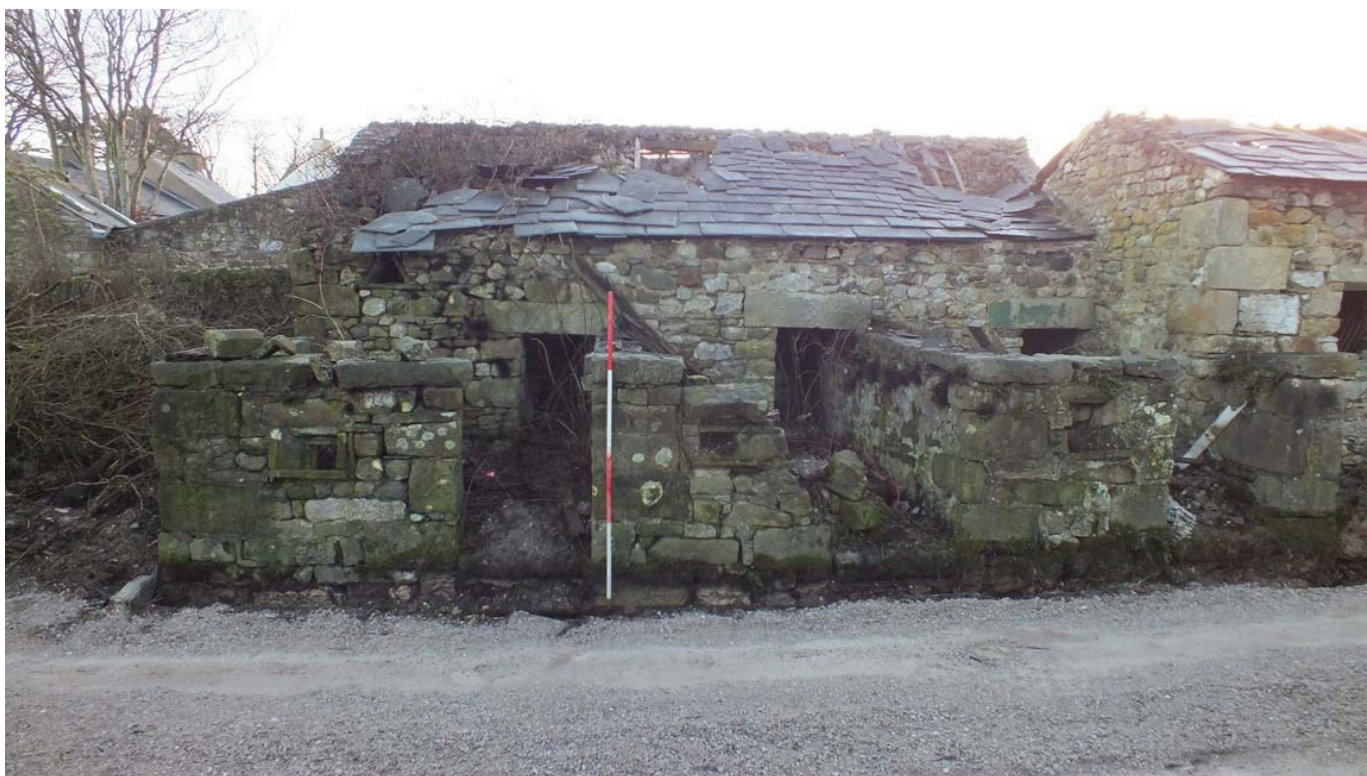
Plate 31: The north end of the west external elevation of the north/south block

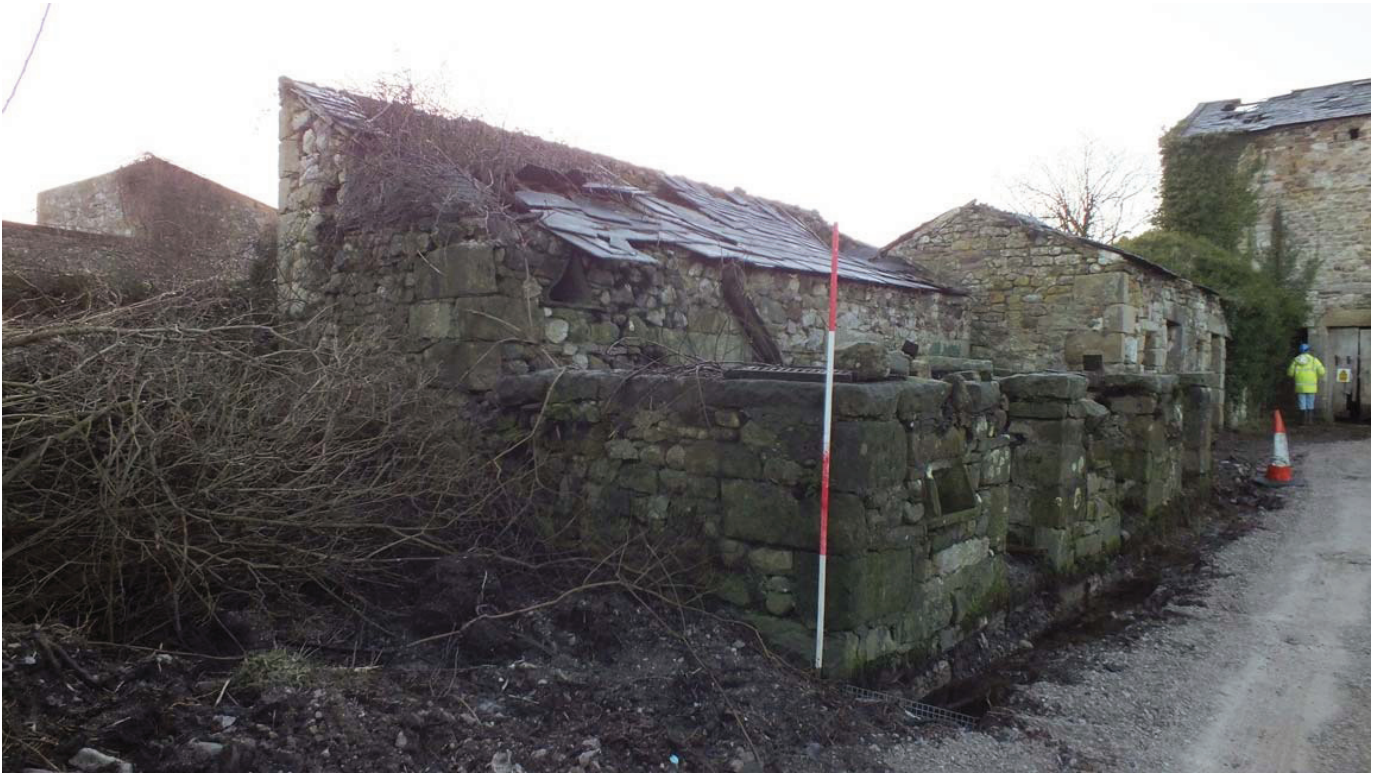
Plate 32: The north external elevation of the north/south block

4.2.3 **North elevation, north/south block:** this comprises a plain monopitch gable with quoins and a collapsed hole east of centre (Plate 32). There is a gable of the stable beyond to the south, which is also plain with quoins and extended by the outer wall of the pig sty, which is finished with large quoins.

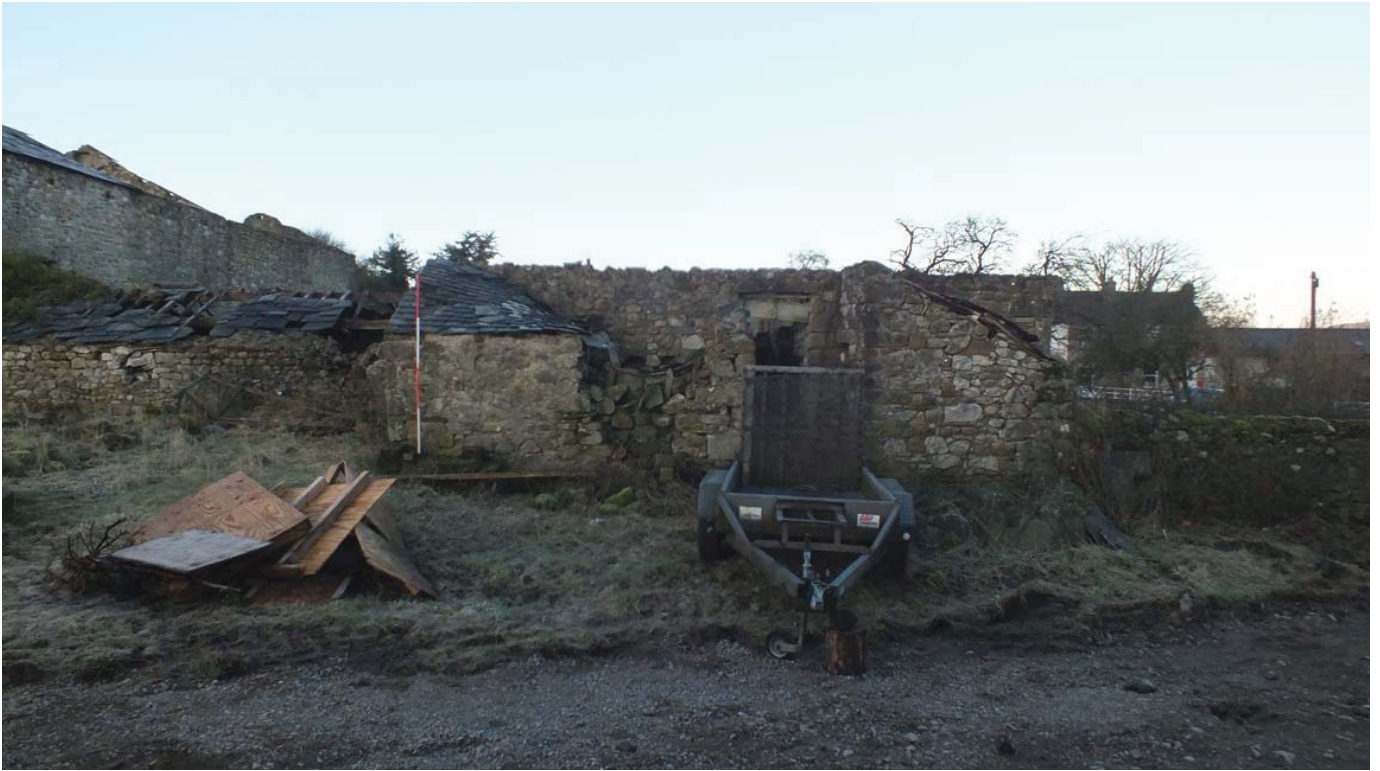
4.2.4 **East external elevation of the north/south block** (Figure 2): the north end is continued by the boundary wall and is partially covered by another monopitch outshut (Plate 33). The return to the west has a doorway with rough quoins and lintel. To the south of the outshut is a raised doorway with rough quoins and lintel and still and the remains of a plain timber surround. There is a further return to the east for another larger outshut with the remains of a window on the west side, just jambs and a rough sill (the roof is gone) and a doorway to the east which is very low, with a rough lintel and quoins. The larger outshut's east wall is plain and partially collapsed, with quoins (Plate 34). The return to the west has a low doorway with a stone lintel and west jamb side of pig sty. There is a small opening above the door too. The rest of the elevation, to the rear of the stables, is plain and turns at the south end to meet the corner of the main block.

Plate 33: The north end of the east external elevation of the north/south block

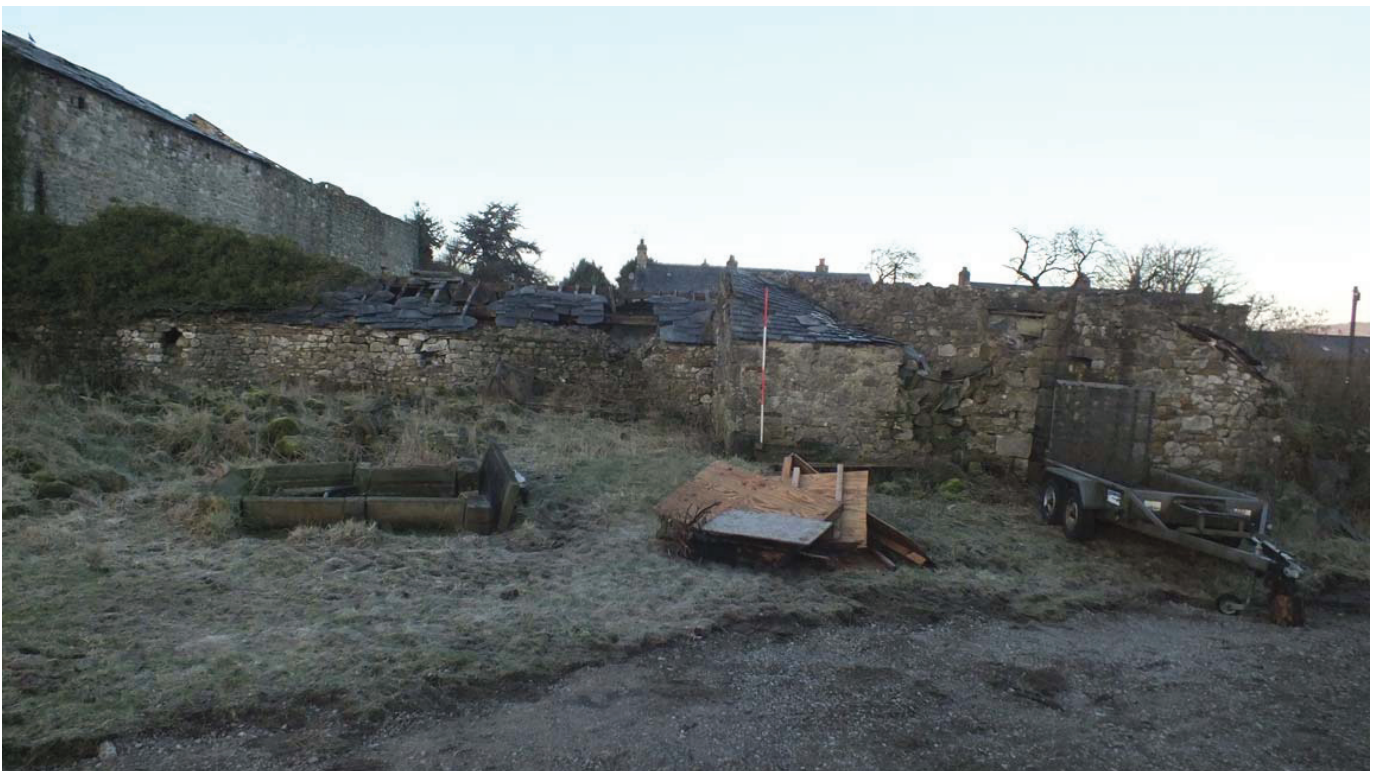
Plate 34: The south end of the east external elevation of the north/south block

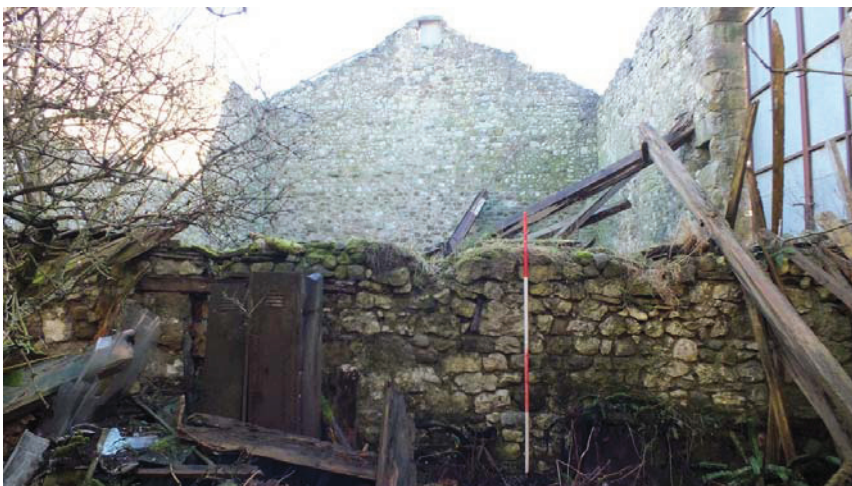
4.3.1 **Ground floor Room 1 (G1)**: the floor is obscured by rubble and debris from the collapse of the roof, the ceiling is gone, and the walls are finished with the remnants of limewash. The north elevation has two doorways with timber lintels and plank and batten doors and a row of joist holes for the first floor. The east elevation is mostly plain, with a central doorway with a timber lintel, but it noteworthy that this wall is built mainly of limestone (Plate 35). The south elevation is mostly plain with machine made brick with frogs used to edge some of the joist holes and to block an opening west of the centre. There is a possible opening on the west side blocked with stone (Plate 36). The west elevation has a splayed vent on the south side that has been blocked externally. In the centre there is a large alcove with a stone lintel and thin stone sill (Plate 37) and at the north end there is a further tall, shallow alcove that evidently acts as a rebate for the door (Plate 38). There are two holes at first floor level that perhaps represent the position of beams.

Plate 35 (left): The east internal elevation, Room G1

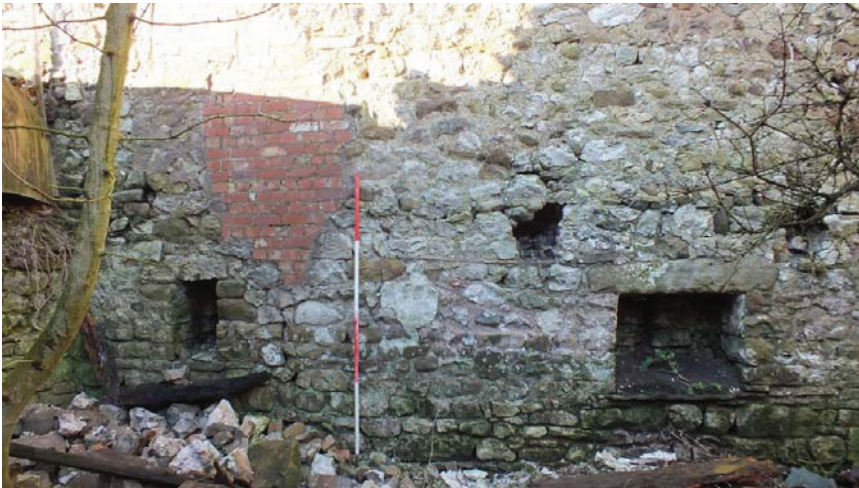
Plate 37 (left): The west internal elevation, Room G1

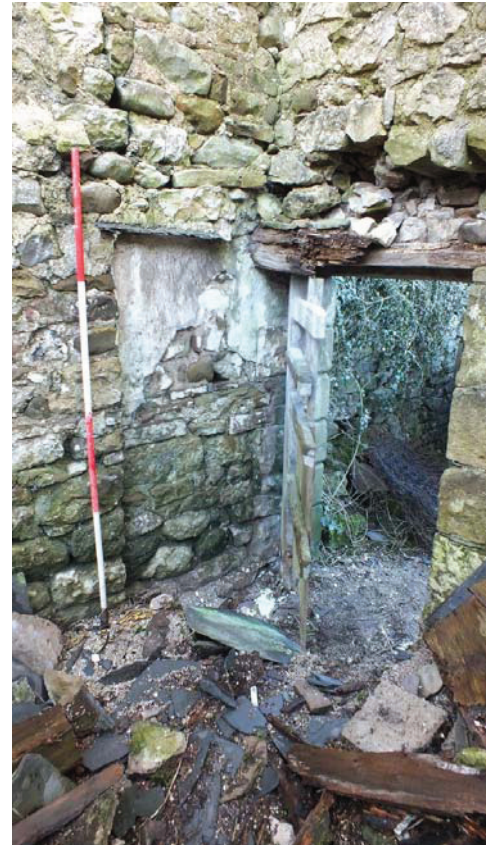
Plate 38 (right): The north-west corner of Room G1 showing the doorway and alcove

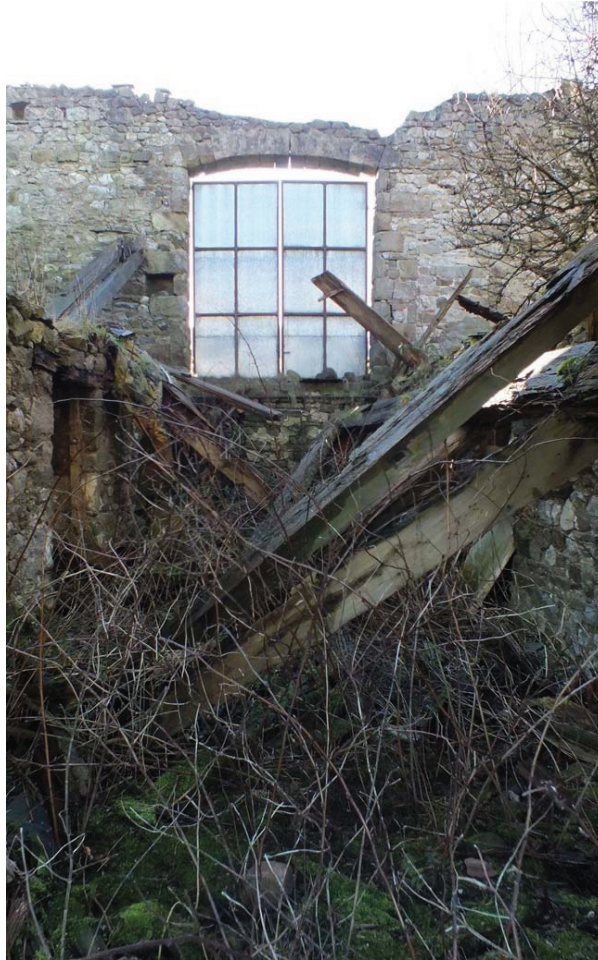
Plate 39: General view of Room G2

4.3.2 **Ground floor Room 2 (G2):** the floor is obscured by rubble and debris from the collapsed roof and first floor (Plate 39) and it is therefore open to what remains of the roof. The walls have the remnants of whitewash. The north elevation is dominated by a wagon doorway with a flat voussoir arch and timber lintel internally and strap hinges on pintels but no surviving door. The east and west elevations are only extend to first floor level and each has a central doorway with a timber lintel. The south elevation is plain, with an iron pipe along the top.

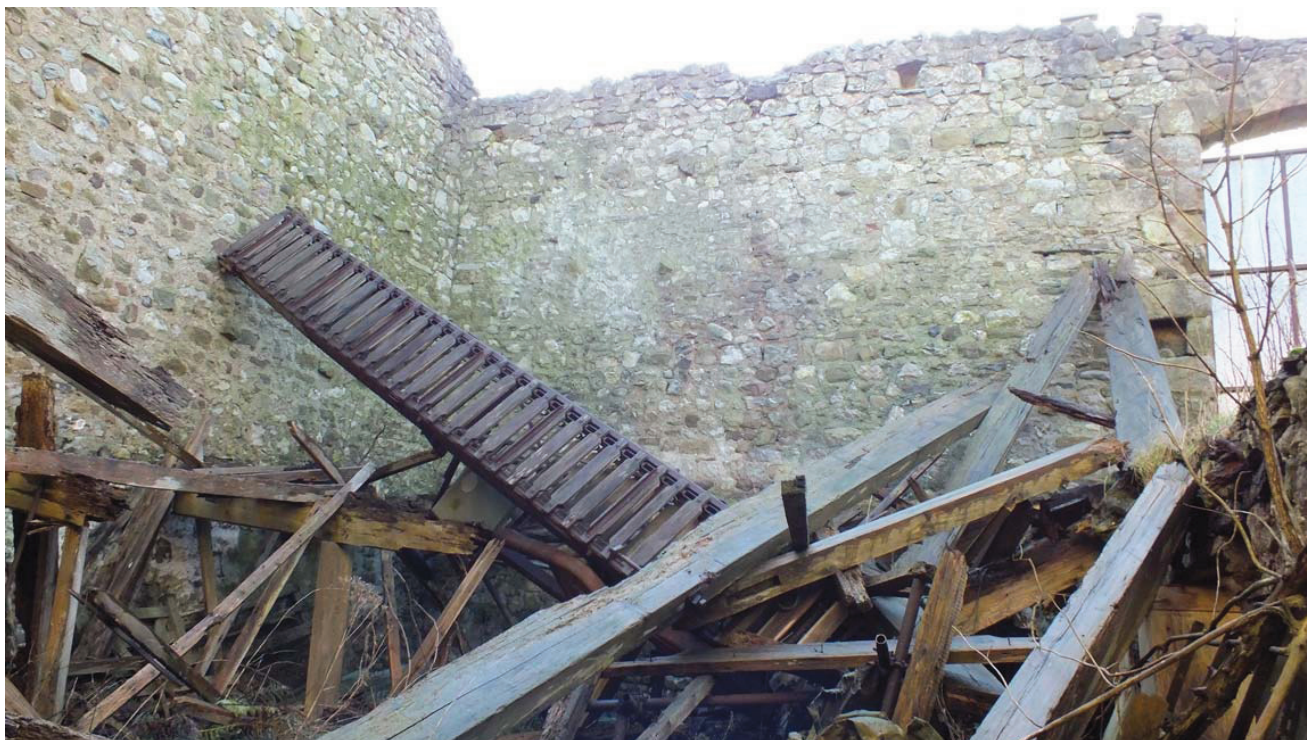
Plate 40: General view of Room G3

4.3.3 **Ground floor Room 3 (G3):** this room was not accessible and the floor is again obscured by rubble and debris from the collapsed roof and floor and is open to the roof (Plate 40). The walls have no obvious finish. The north elevation has two doorways with timber lintels, the west reused. The west elevation has a central doorway, while the south and east elevations are plain.

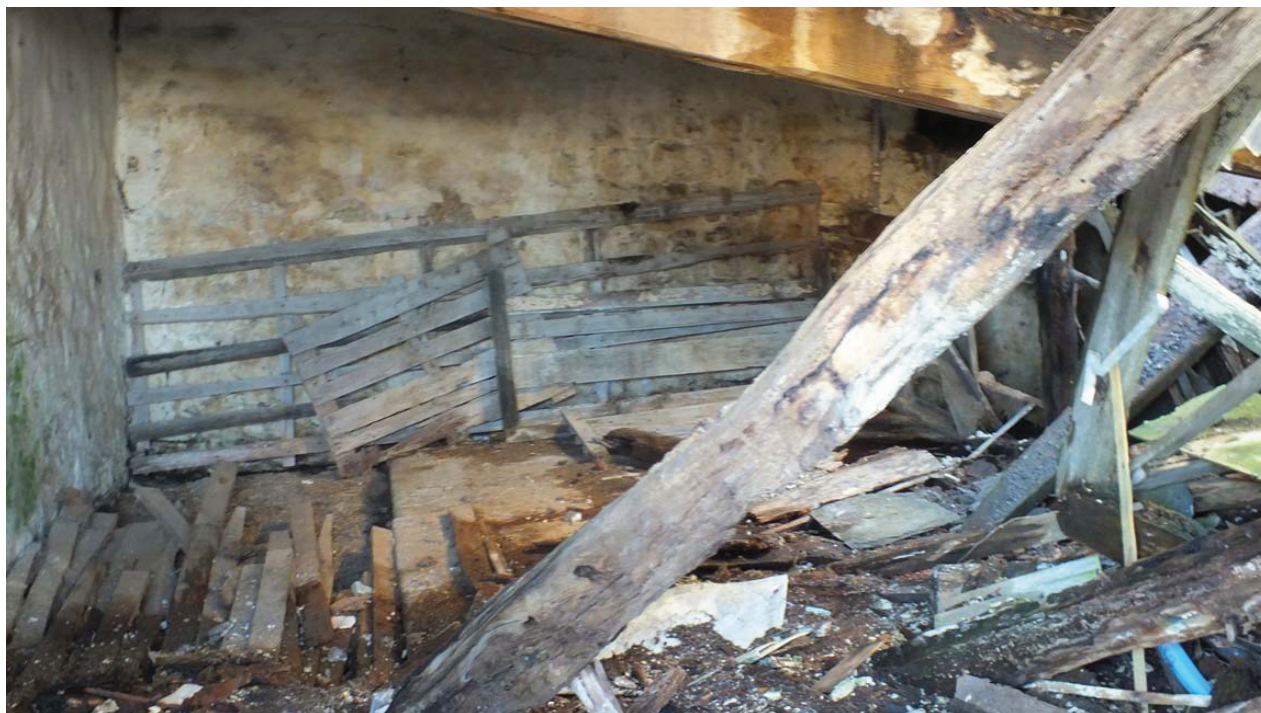
Plate 41: The dung channel on the east side of Room G4

4.3.4 **Ground floor Room 4 (G4):** this is also inaccessible and the floor due to an unsafe ceiling and the floor is largely obscured by debris, although there is a dung channel visible as a step in the floor on the east side. The ceiling is supported by three beams orientated east/west, which support joists and all of the timbers are sawn. The walls are finished with limewash and there are three doorways to the north with timber lintels, which are evidently reused, probably former cruck blades, the eastern one with carpenter's mark 'IIII' chiselled into it next to an empty joint hole. The east and west elevations are plain, while the south elevation is mostly obscured but there is an alcove on the west side with a timber lintel.

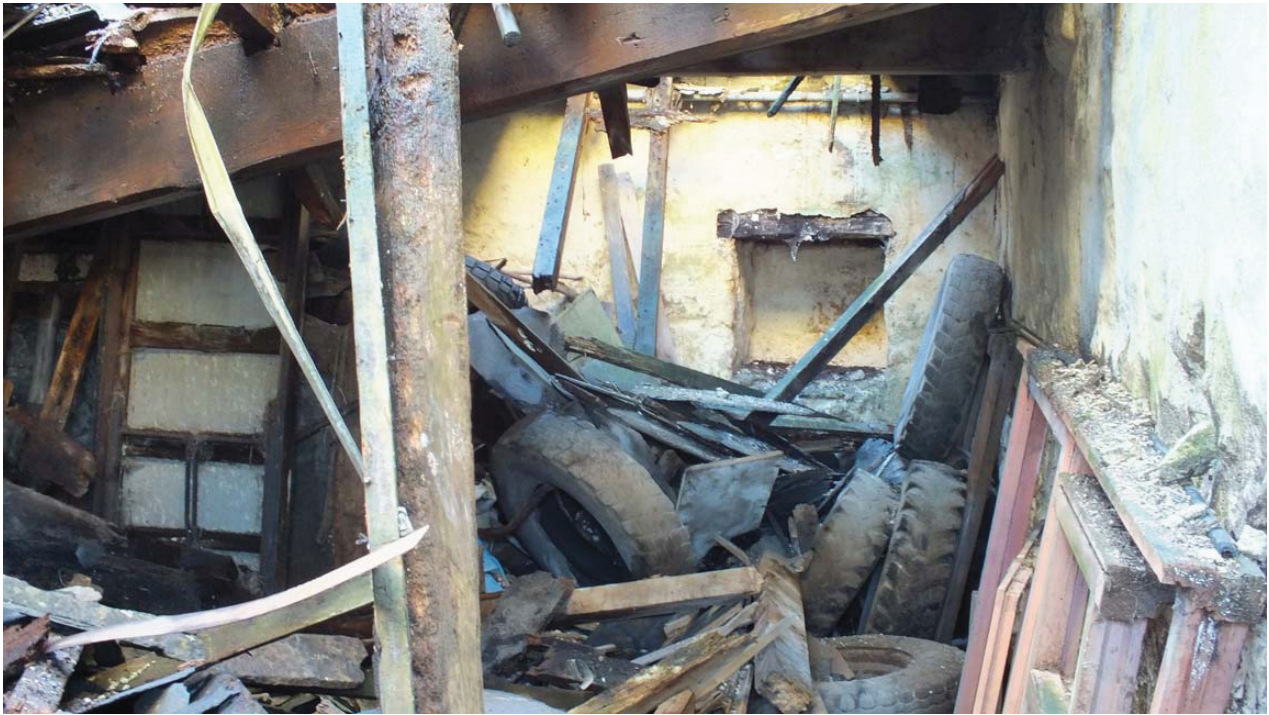
Plate 42: The alcove on the west side of the south elevation in Room G4

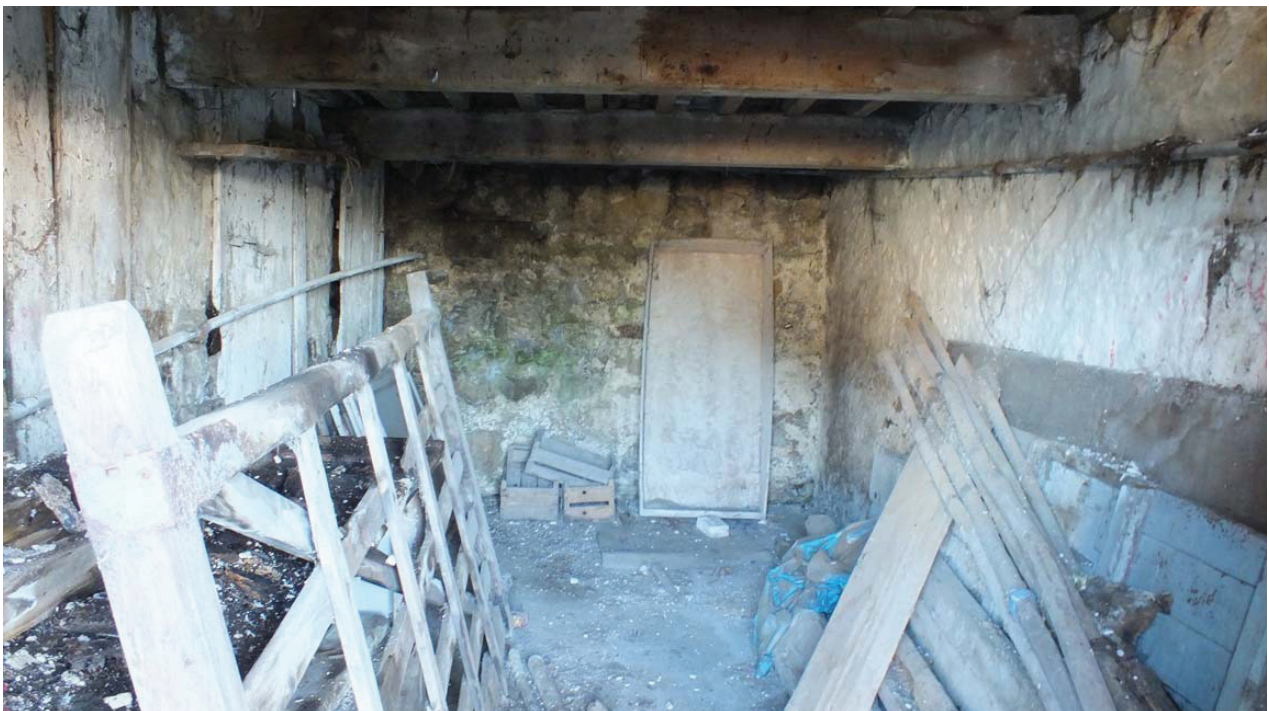
Plate 43: General view of Room G5

4.3.5 **Ground floor Room 5 (G5):** this has concrete floor and timber ceiling comprised of beams running east/west supporting joists and floor boards, all of which are sawn. The walls are finished with limewash and the east is partially clad with planks, although these are in part blocking openings on this side. The north elevation has a wagon door with a timber lintel, which is chamfered but this doesn't match the opening and so has evidently been reused. The west and south elevations are plain.

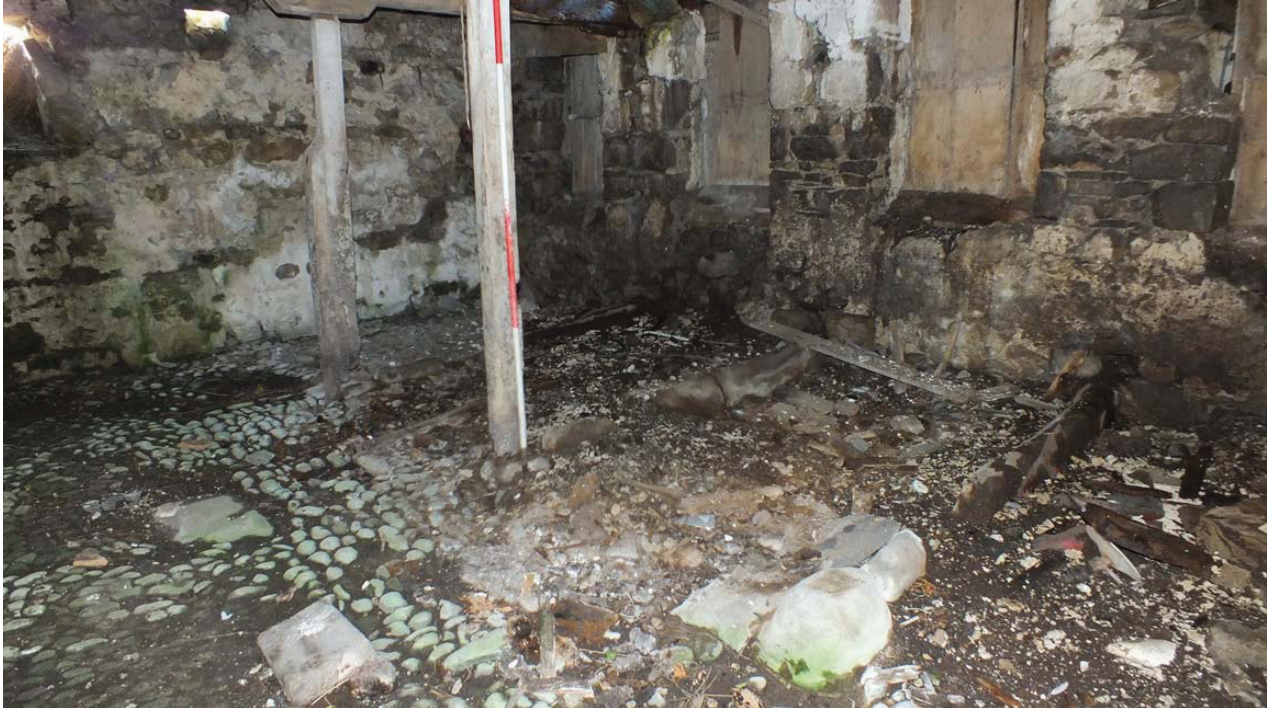
Plate 44: Stall partition bases and cobbled floor on the west side of Room G6

posts still present (Plate 44). The walls are finished with limewash. The north elevation has central doorway with splayed jambs and a double plank and batten door supported by strap hinges on pintels (Plate 45). There are small windows either side and these and the doorway share a single timber lintel that is roughly chamfered. There is a further attached bracket to the east with a timber peg. The east elevation has four chutes built into the wall extending to the floor above, all of which have timber lintels (Plate 46). The south elevation has a central aperture extending to the external ground level with a rough timber lintel and stone sill. The west elevation has four openings all of which extend to the ceiling level and are blocked with planks on the opposite side, one of which has the initials 'T.P.' painted on it (Plate 47).

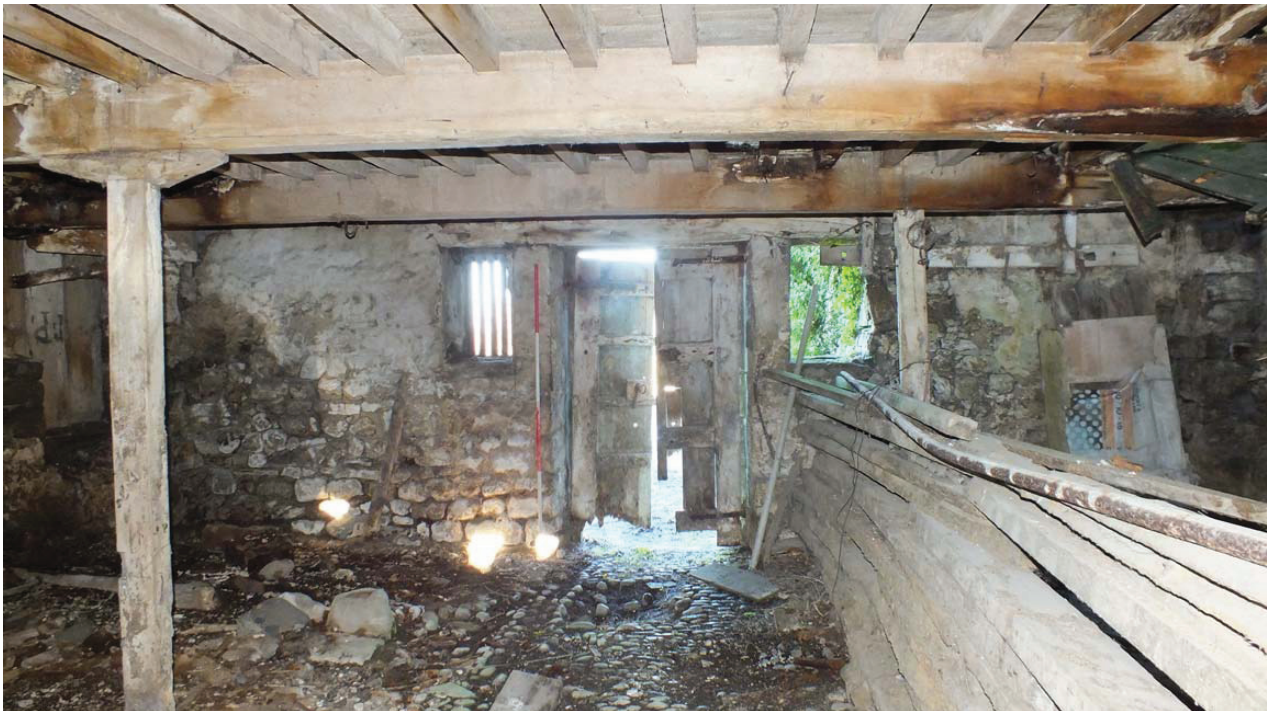
Plate 45: The north elevation of Room G6

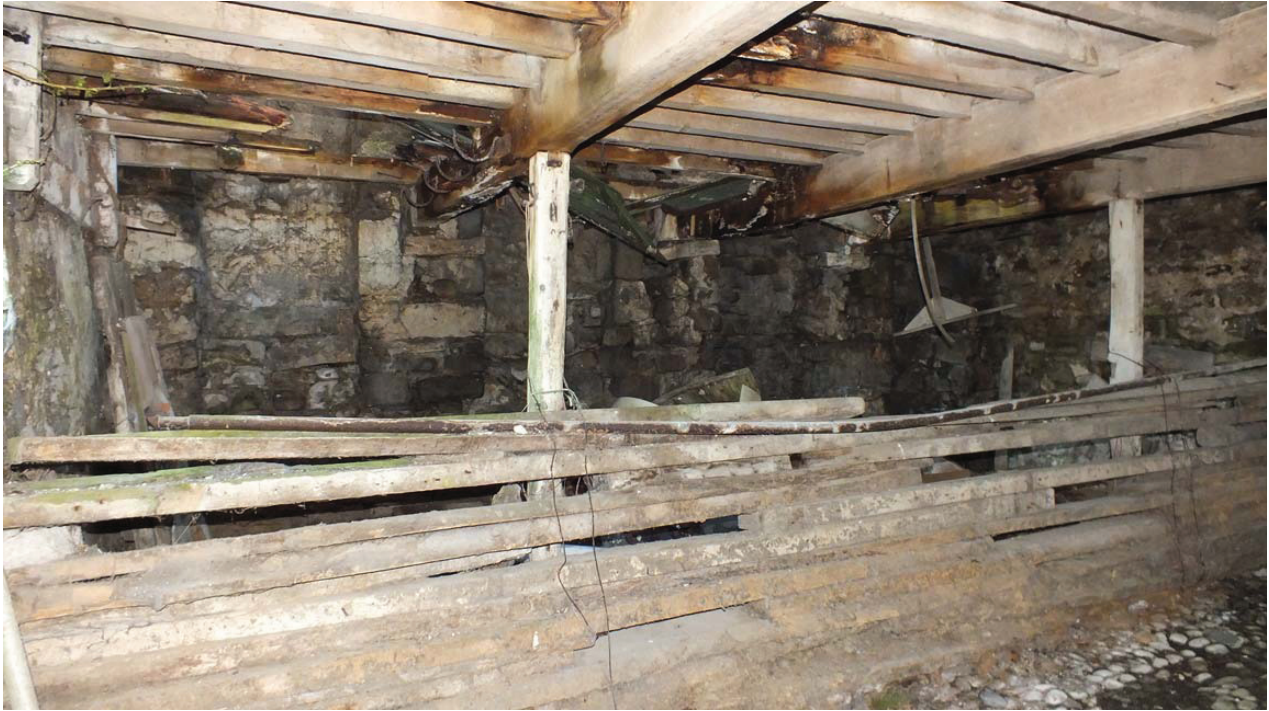
Plate 46: The east elevation of Room G6

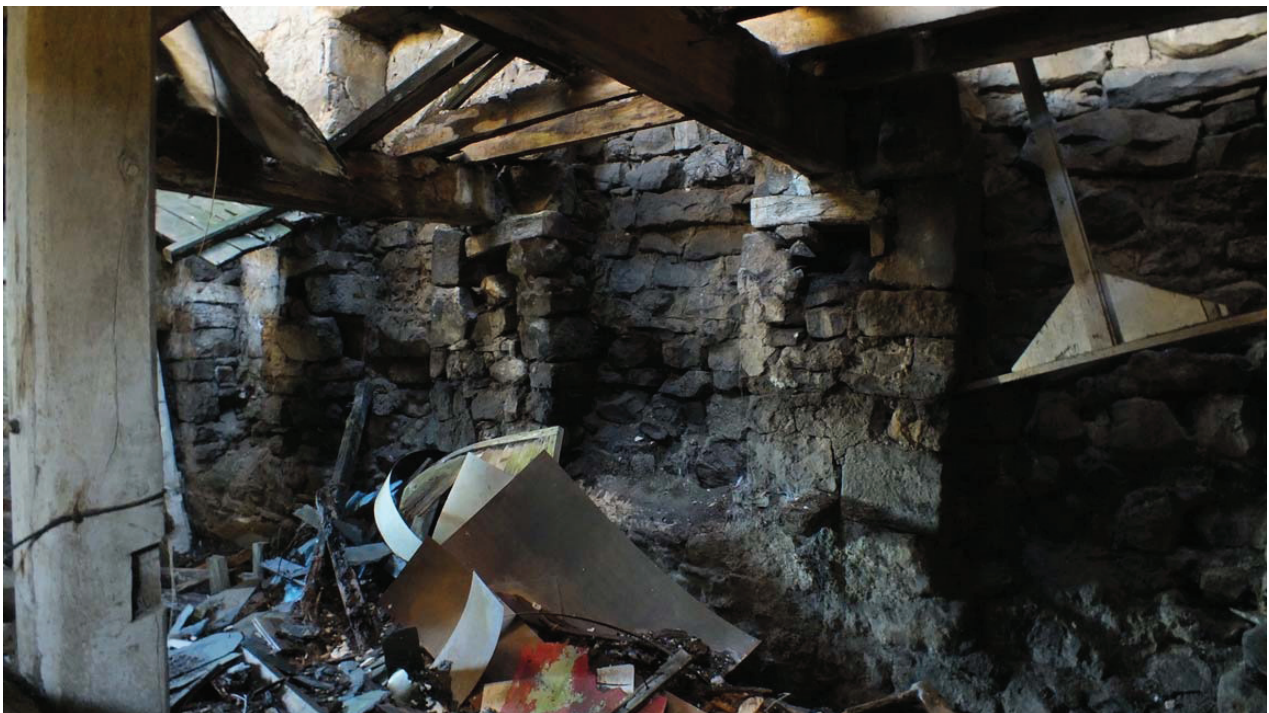
Plate 47: The west elevation of Room G6

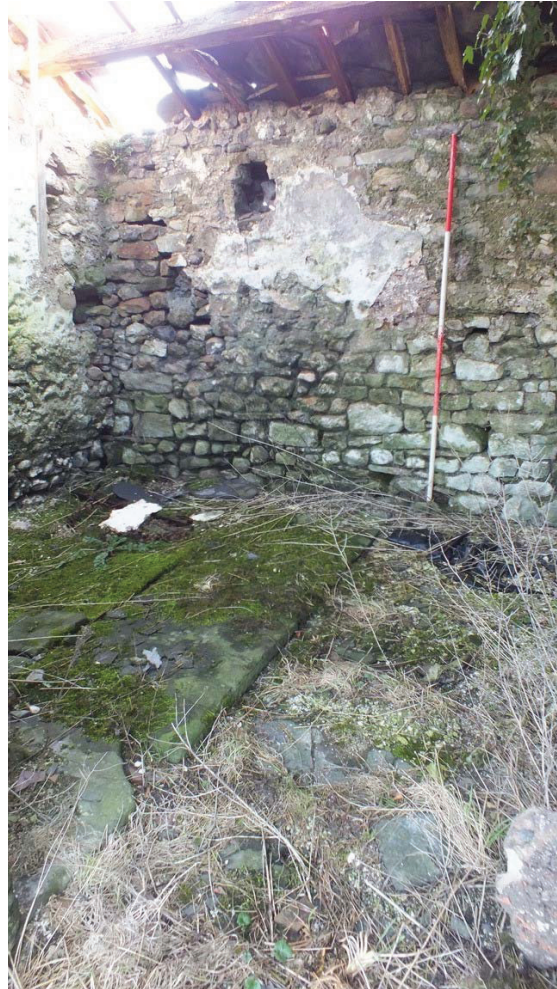
Plate 48: The floor of Room G9 showing the raised floor and channel

4.3.9 **Ground floor Room 9 (G9):** this has a stone flag floor, which steps up on the north side leaving a channel along the south side. The roof is mostly collapsed with just a single purlin, the ridge and some of the rafters remaining. The walls are finished with limewash, and the north, east, and south are plain. There is a window and doorway to the west both with reused timber lintels.

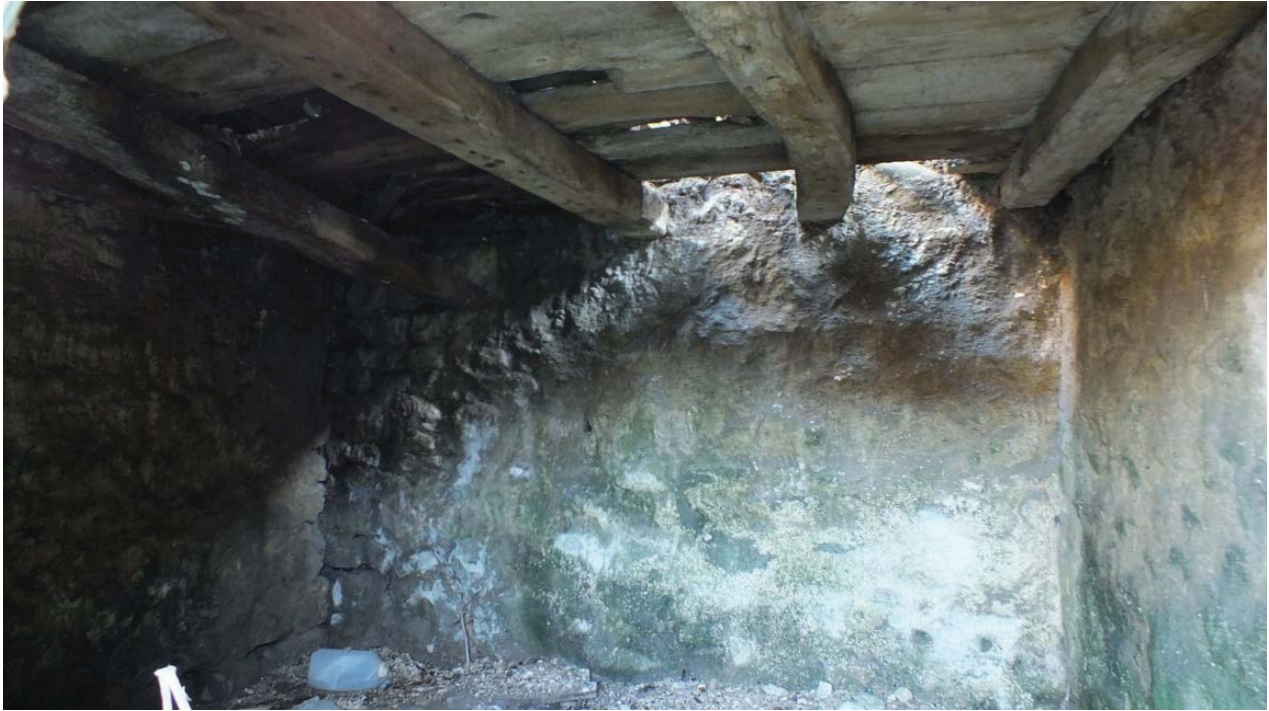
Plate 49: General view of Room G12

4.3.12 **Ground floor Room 12 (G12):** again the floor is obscured by debris and the ceiling comprises joists orientated east/west most of which are relatively rough and some reused and support boards (Plate 49). The walls are finished with limewash and there is a doorway to the west with a timber lintel, which is also probably reused.

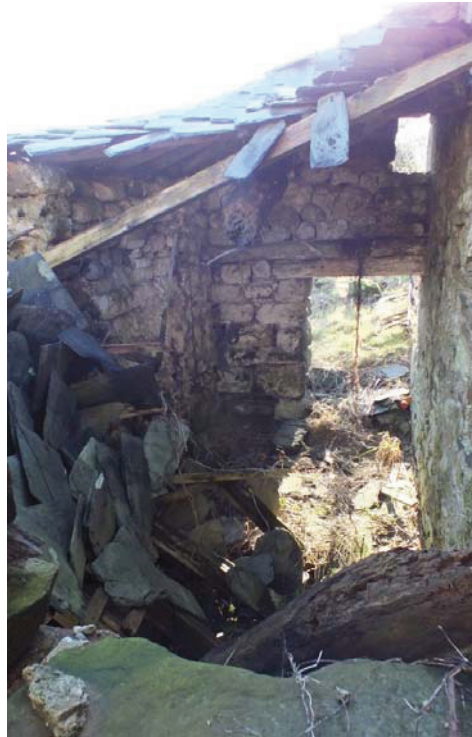
Plate 50: General view of Room G15

4.3.15 **Ground floor Room 15 (G15)**: again the floor is largely obscured by debris from the collapsed roof. The walls are limewash and largely plain but there are doorways to the north and south with rough timber lintels, plus the remains of a window formed against the building to the west with a stone sill, there is also a small opening above the doorway to the south (Plate 50).

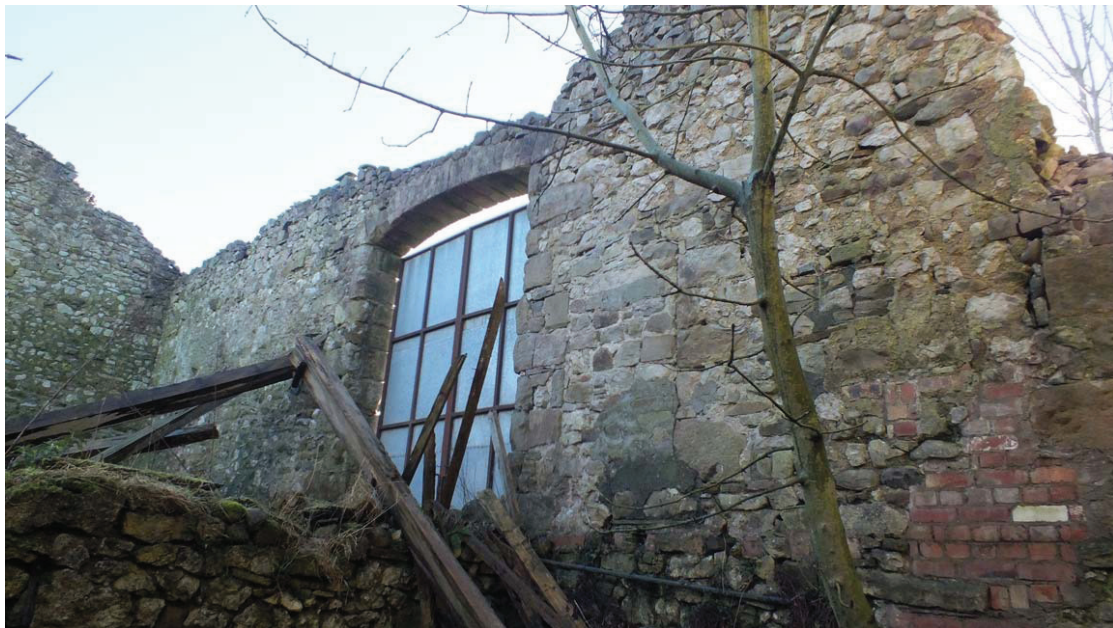
Plate 51: The south internal elevation of Room F1

4.3.16 **First floor Room 1 (F1)**: this extends over Rooms G1-G3. The floor and roof have collapsed and the walls are exposed stone. The north elevation has square vents along the top and a central winnowing door with a timber lintel, quoins and a plank and batten door. The east elevation is gable end with a square owl hole at the top with a thin stone lintel (Plate 35). The south elevation has row of square vents at the top and a central wagon doorway with a voussoir arch and quoined jambs, and there is a further opening to the west with quoins plus another to the west where the wall has mostly collapsed, although there is some rebuild or blocking at this point in machine made brick (Plate 51). The west elevation is a gable end, extending beyond the line of the room to the south where the wall has collapsed. There is an opening on the south side with a timber lintel blocked with machine made brick with a further patch of rebuild in the same brick below. The south-west corner incorporates lots of limestone and the west elevation also uses lots of red sandstone.

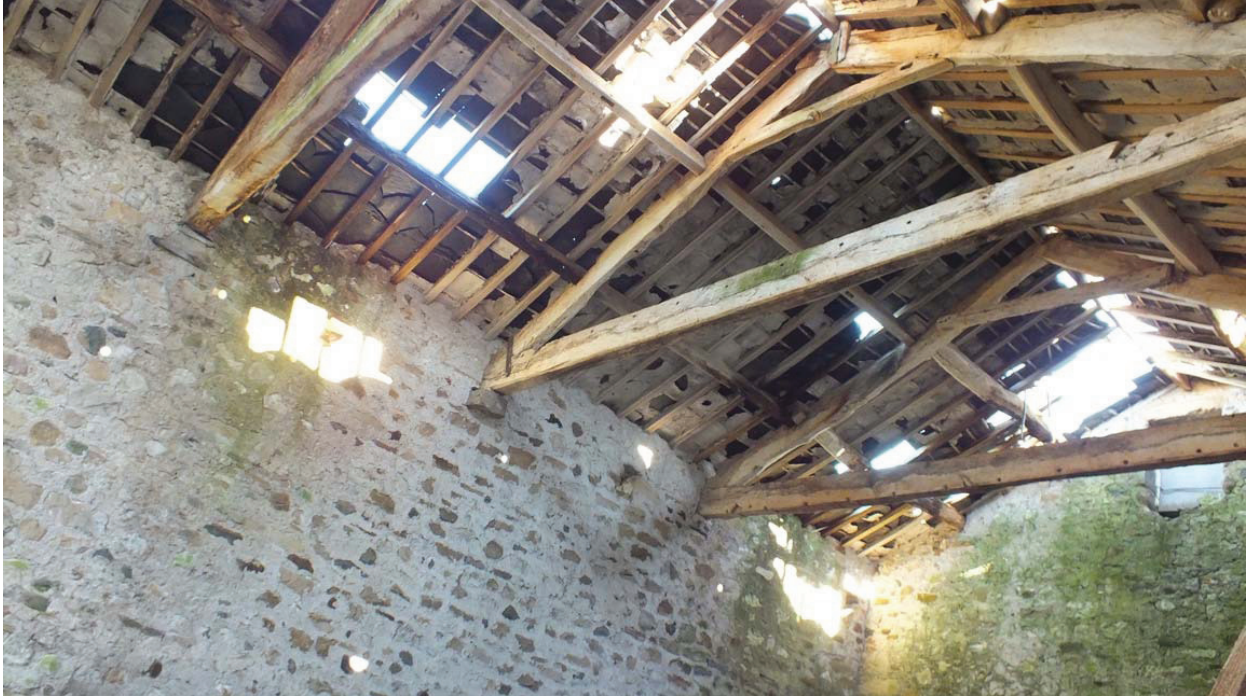
4.3.17 **First floor Room 2 (F2)**: this extends over Room G4 and could not be fully accessed. It has a timber board floor although this has mostly collapsed on the west side and is raised on the east side, and a large part of the roof still remains, with five trusses still present. These are of basic tie beam type with a collar, and there are two purlins per pitch plus a ridge plank and all of the timber is hand finished (Plate 52; Figure 7). The north elevation has a winnowing door with a timber lintel internally and a double plank and batten door (Plate 53). There is a wagon doorway to the south with a rough reused timber lintel and double plank and batten doors. There are owl holes at the top of the east and west elevations.

Plate 52: Trusses in Room F2

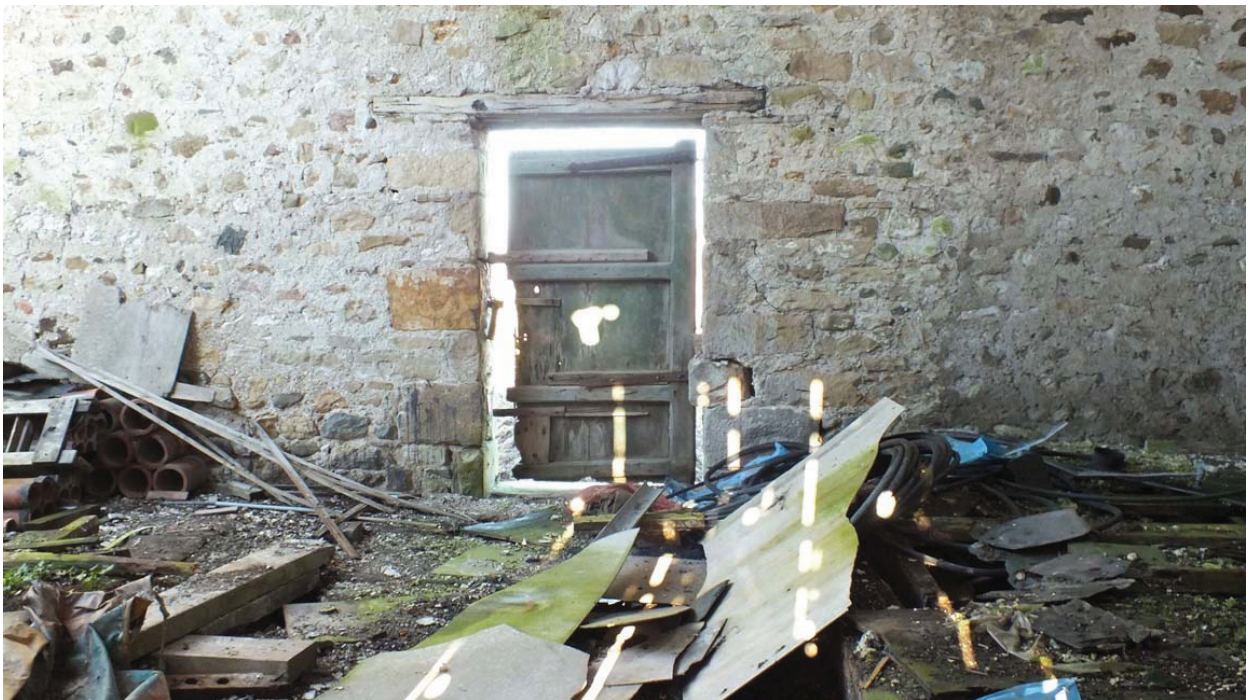
Plate 53: The winnowing door in the north elevation of Room F2

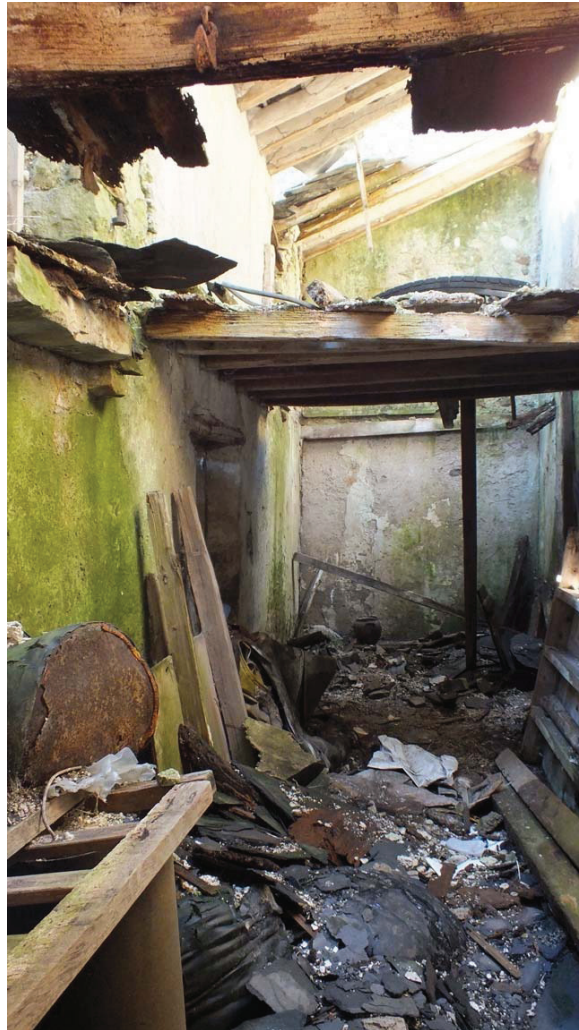
4.3.18 **First floor Room 3 (F3)**: the room could not be fully accessed. The floor is obscured by debris and the upper floor has collapsed leaving just joists and the room open to the monopitch roof, which is

supported by just rafters sat on the north and south walls (Plate 54). All of the timber is sawn, the roof has plaster sarking against the slates, and the walls are finished with rough plaster and limewash. The north elevation is plain with joist holes. The east elevation has doorways on the ground and upper floors with timber lintels. The south elevation has a lower level window with splayed jambs, and two upper level openings with timber lintels, the stone sill of the east one projects from the wall line.

Plate 54: General view of Room F3
