HALL FARM BARN, KELLET ROAD, OVER KELLET, LANCASHIRE

Archaeological Building Recording

February 2018

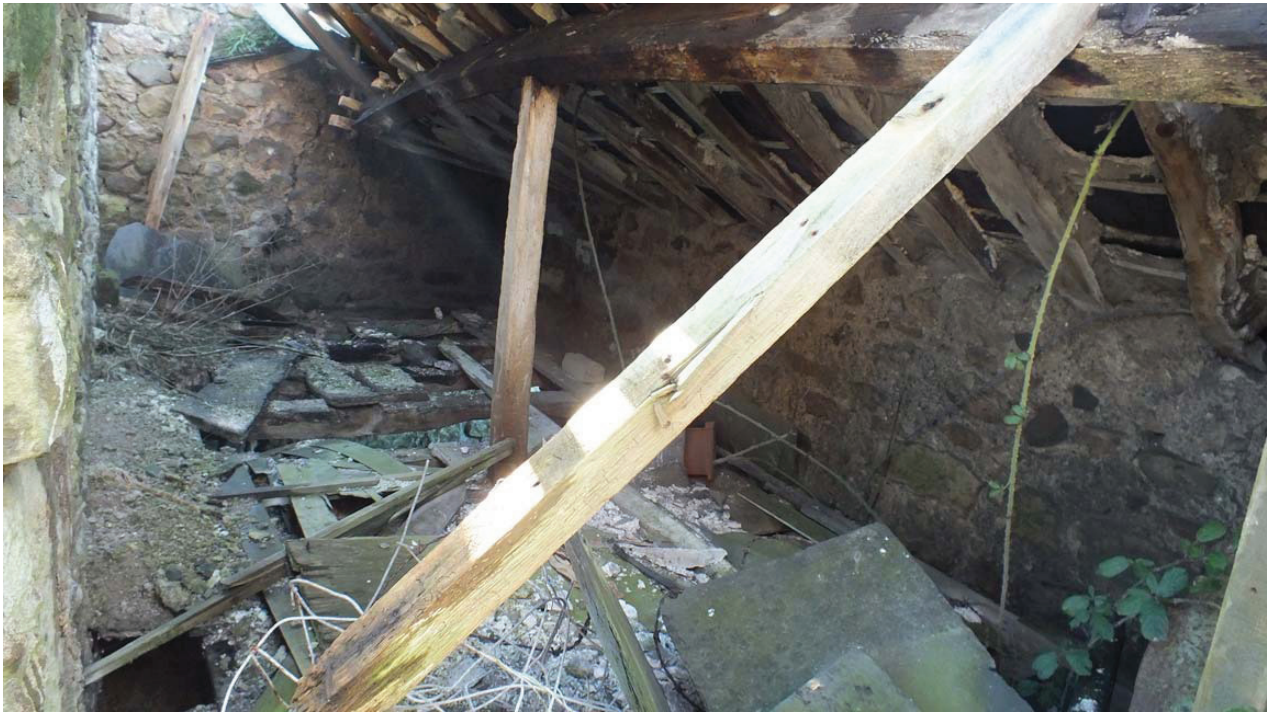
4.3.19 **First floor Room 4 (F4)**: this is above Rooms G11-G12 and has a partially collapsed timber board floor supported by joists running east/west. The monopitch has also mostly collapsed and is supported by a single sawn purlin, which is supported by a post midway along (Plate 55). The walls are unfinished; there is an opening to the east, the lintel of which has gone, and an opening to the north with a sawn timber lintel and plain timber surround.

Plate 55: General view of Room F4

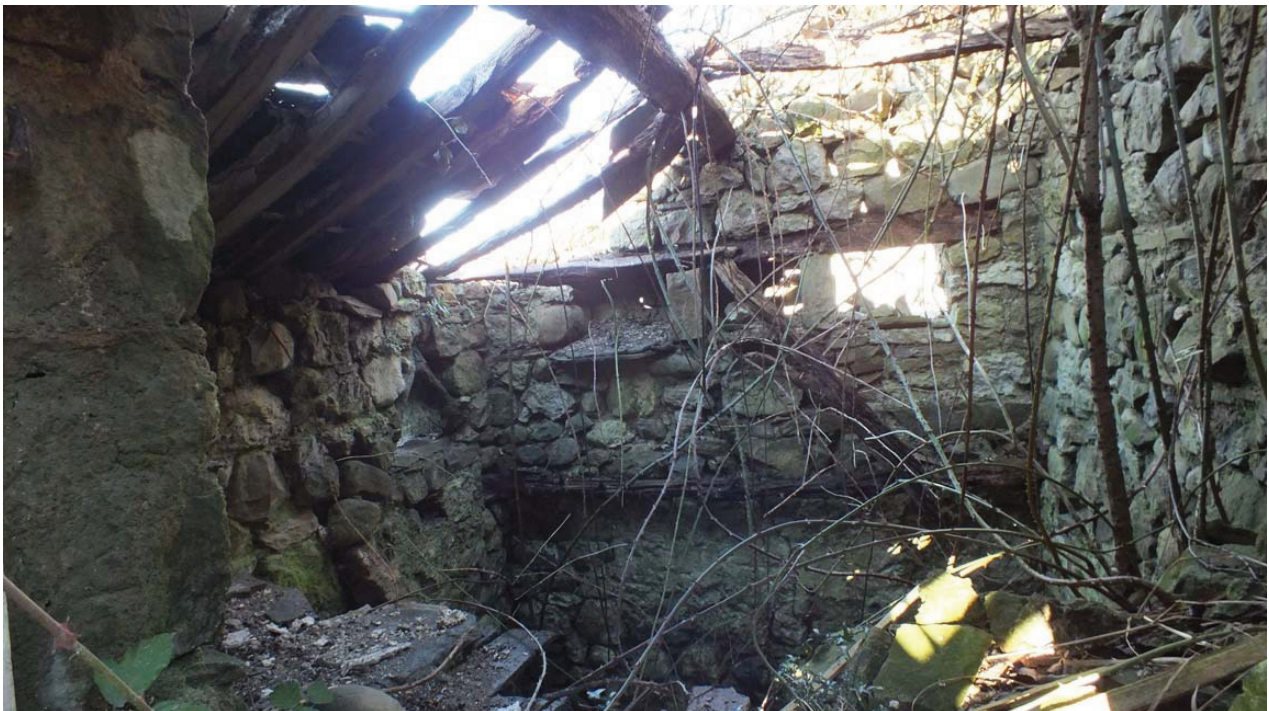
4.3.20 **First floor Room 5 (F5):** this is located above Room G13. It has a timber board floor, which is largely collapsed and a monopitch roof with a single purlin. The walls are unfinished and in the north elevation there are three alcoves sharing a single timber lintel and slate sills (Plate 56). The west elevation has a triangular vent on the north side constructed from stone.

Plate 56: General view of Room F5
