# NEWTON MANOR, GOSFORTH, SEASCALE, CUMBRIA

## Archaeological Building Recording

Client: John Coward Architects

February 2018

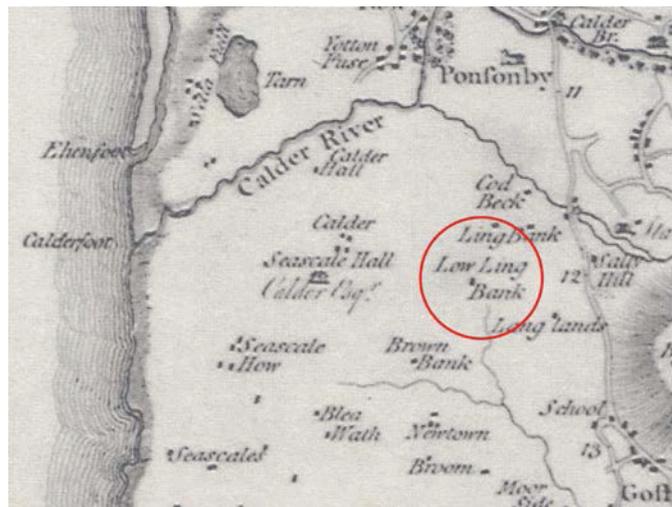
Plate 1: Extract from Donald's map of 1774

3.1.2 **Donald's Map of Cumberland, 1774:** this map shows that there were buildings at the site, formerly known as Low Ling Bank (Plate 1); however, it lacks sufficient detail to further aid our understanding of their development.

3.1.8 **Summary:** it is evident from the cartographic sources that the site was formerly known as Low Ling Bank or Low Lingbank and that there were buildings on the site at least as early as 1774 (Plate 1). Low Lingbank is depicted in detail on the Ordnance Survey maps from the 1860s (Plate 2 and Plate 3), however, the current building, known as Newton Manor, replaced these early buildings either in whole or in part by 1899 (Plate 4). The building was substantially enlarged with the addition of a two storey extension to the north-east c1907 (Plate 5).

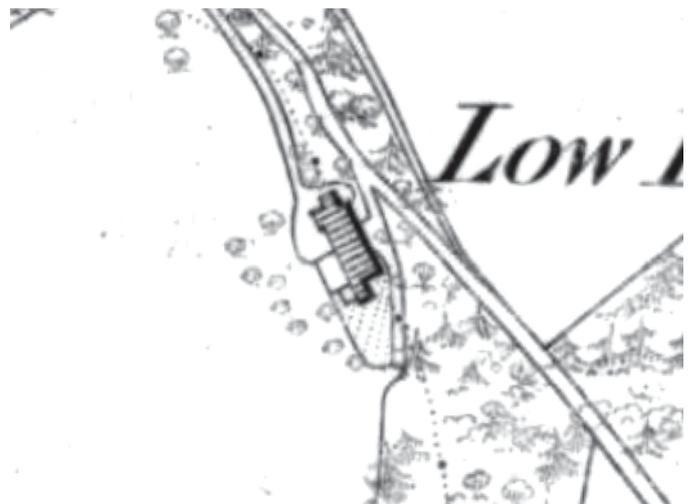
Plate 3 (right): Extract from the 1:10,560 scale Ordnance Survey map of 1867

3.1.3 **Ordnance Survey 1867:** the 1:10,560 and 1:2,500 maps for the area were probably surveyed and published at approximately the same time, although the 1:2,500 map did not have any date information. Both name it 'Low Lingbank' and show a long rectangular block of buildings aligned north-west/south-east with numerous projecting outshuts, while the more detailed shows that the main building was divided into two sections (Plate 2 and Plate 3).

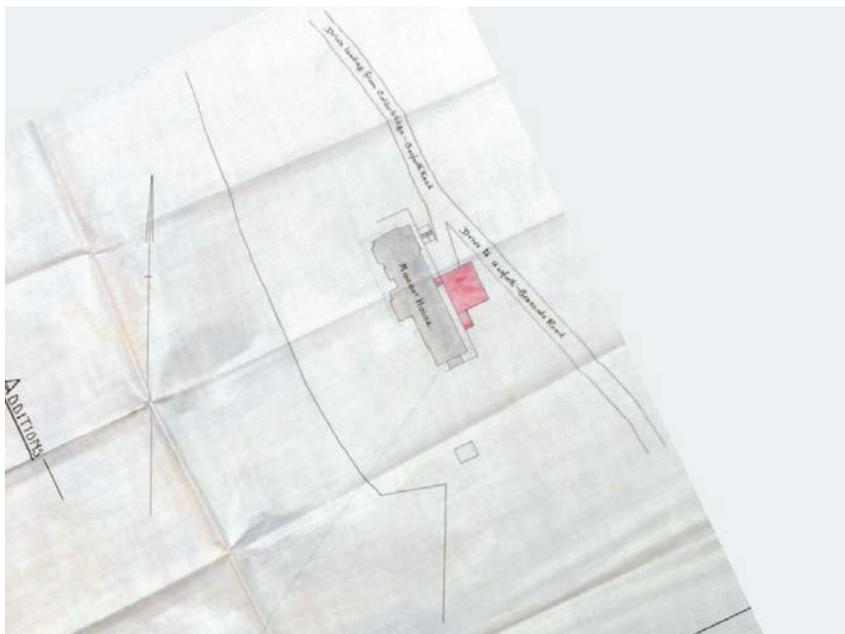
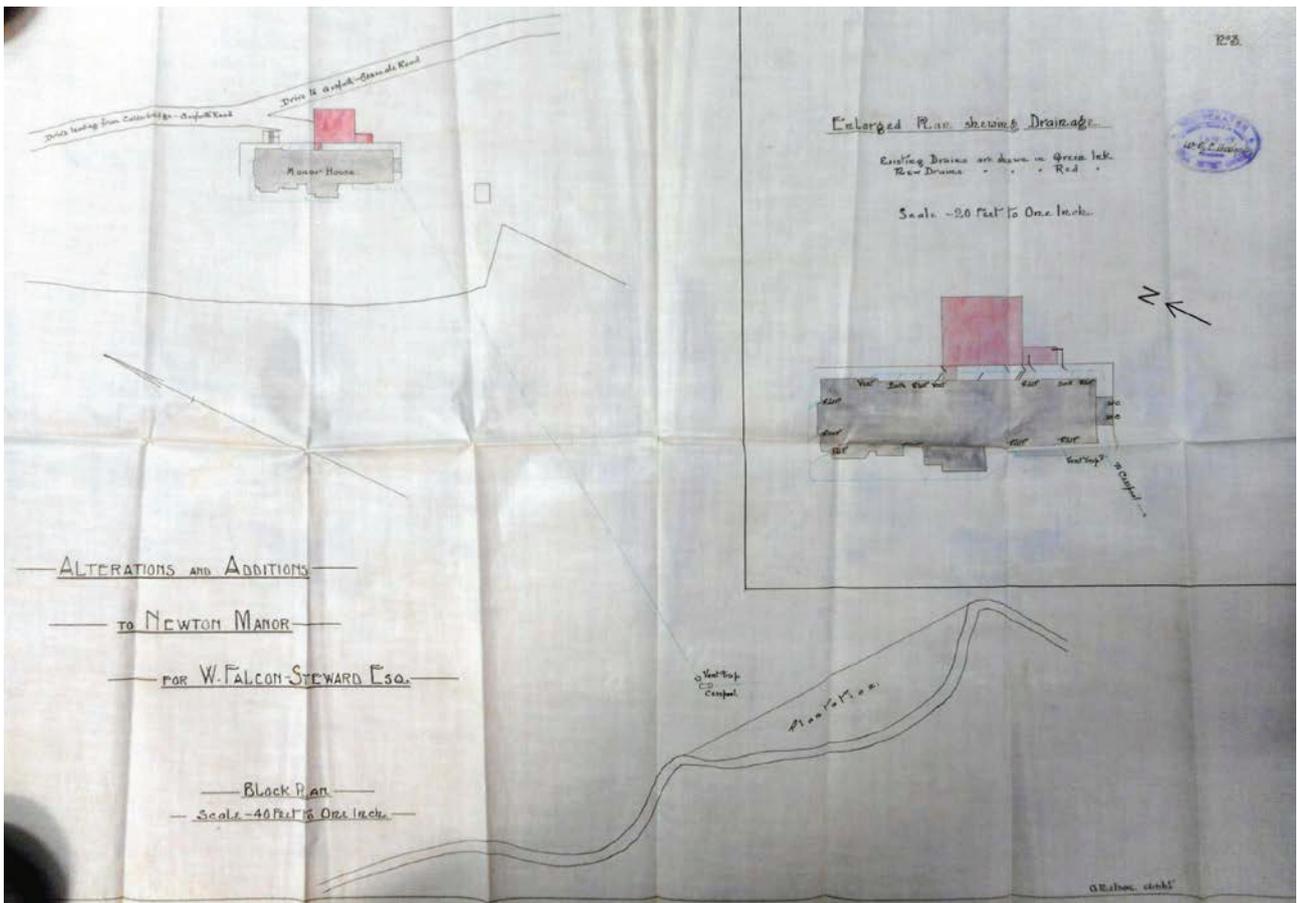
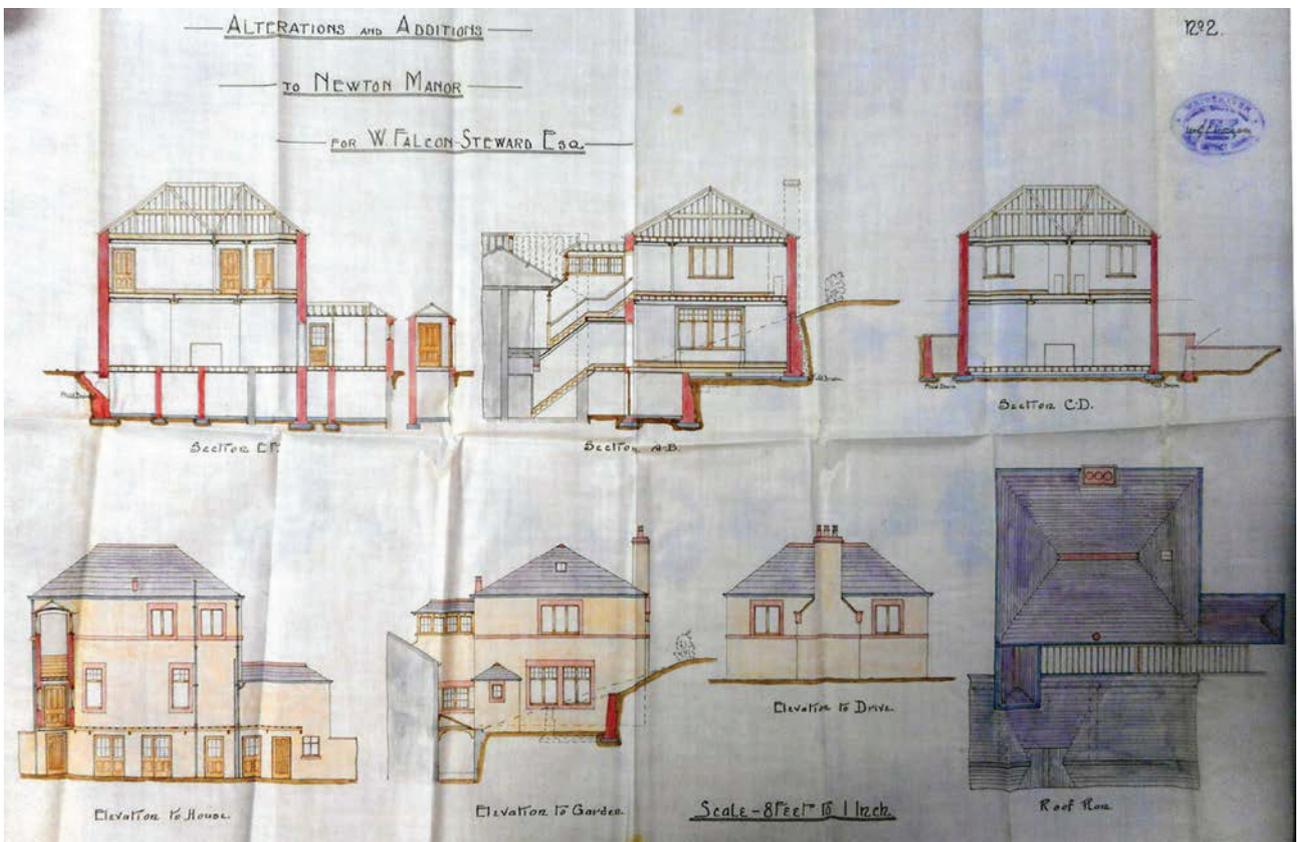
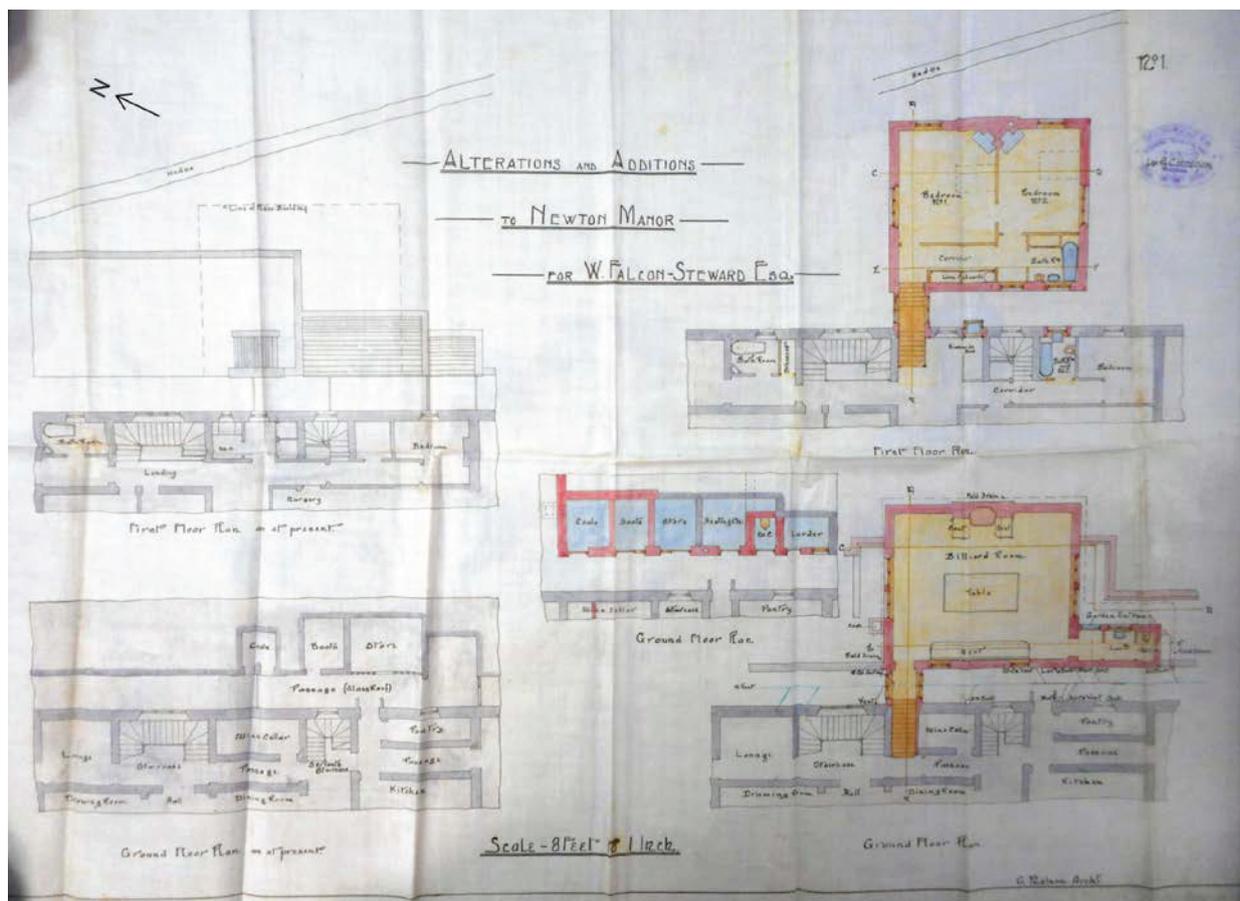
3.1.5 **Additions, 1907:** plans were produced in 1907 for W Falcon-Steward by the Whitehaven architect G Nelson to extend the Manor with the addition of a two storey extension to the north-east side, comprising a billiard room on the ground floor and two bedrooms and a bathroom on the first floor (Plate 5 to Plate 8; CAC(W) SRDED/3/1/534 1907).

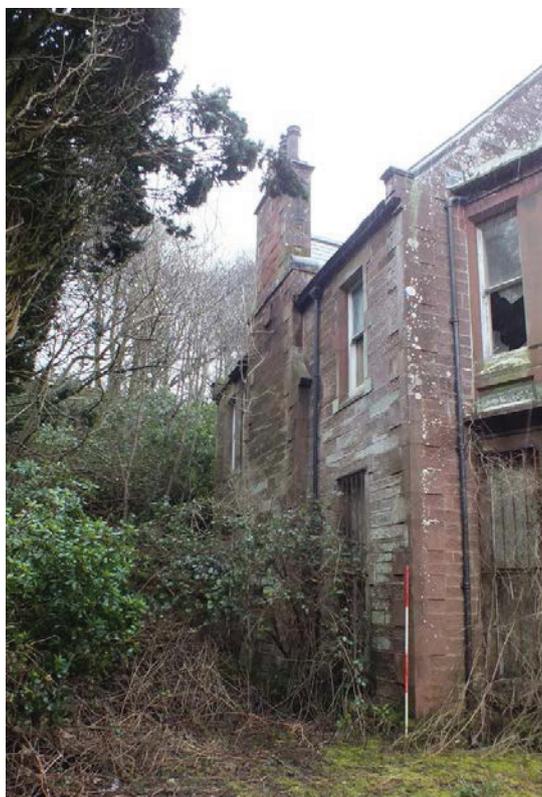
Plate 11: The north-west external elevation, viewed from the west

4.2.1 **Main block – north-west external elevation:** this comprises a large gable at the end of the building (Plate 11). It has a central projecting chimney breast with four octagonal ceramic pots on top of a moulded coping, two angled steps on the sides, and a blank heraldic shield in the centre. There are two windows on either side on both ground and first floor, the first floor ones with surviving two-light sliding sash casements, the ground floor ones covered by boards and metal bars, and all in dressed stone surrounds. There is also an angled plinth at the base and dressed quoins at the corners.

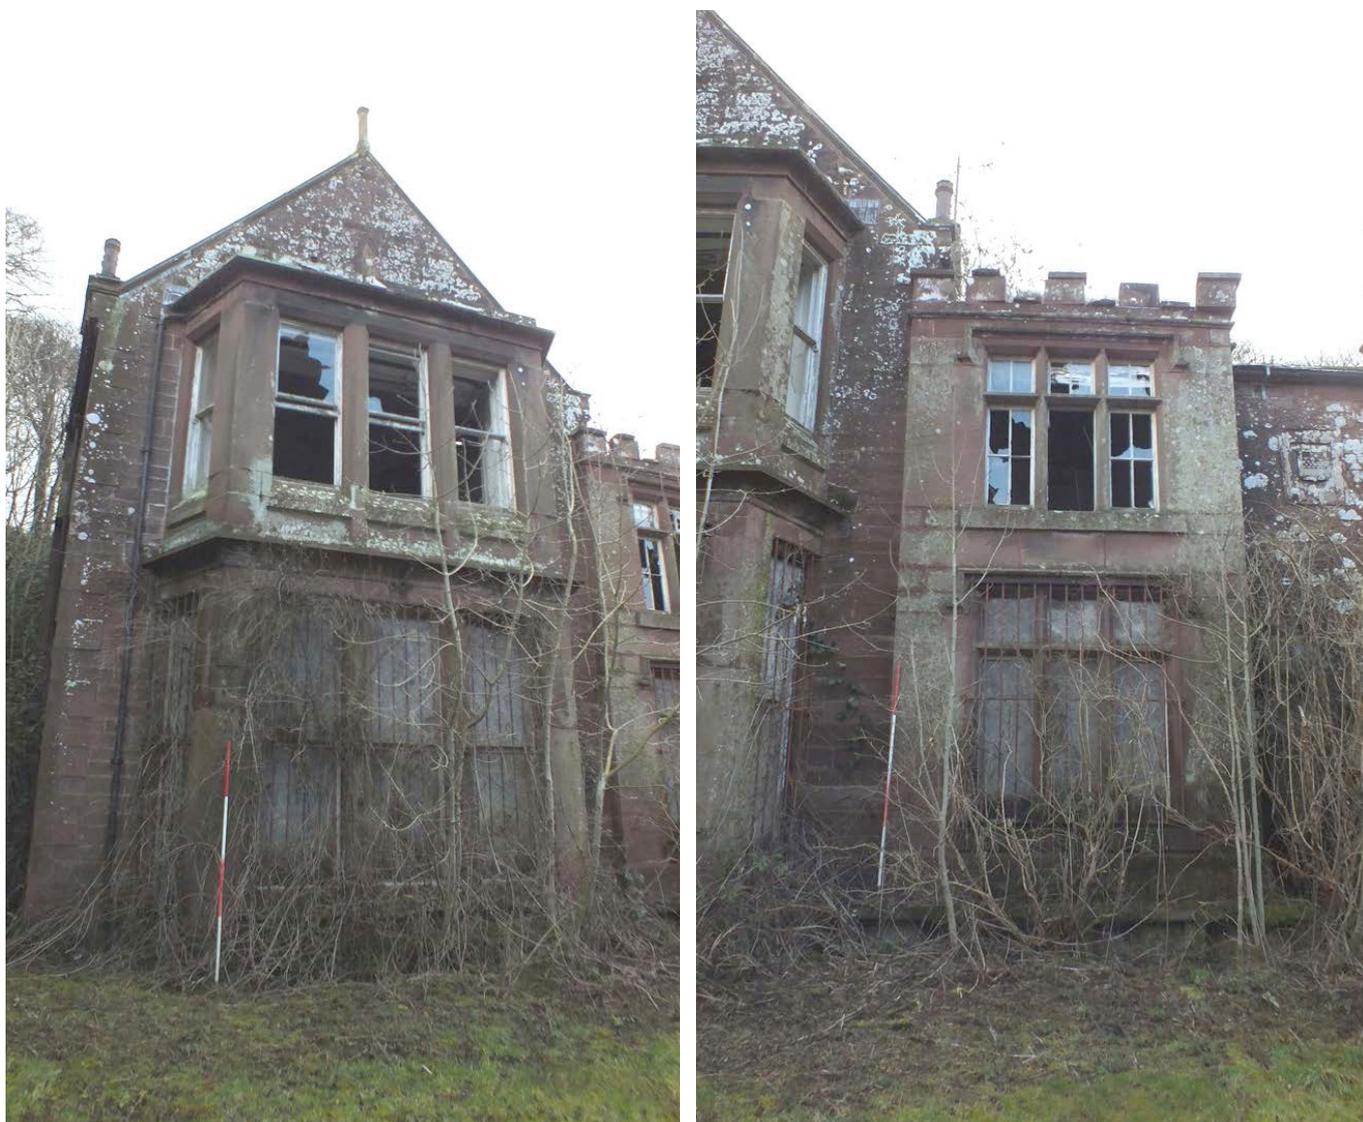
**4.2.2 Main block – south-west external elevation:** this comprises the front of the building and formed a single long elevation punctuated by several returns. The north-west end formed a gabled topped with an octagonal finial and with a moulded coping (Plate 12). At the top was a small pointed arched opening in a dressed surround, now blocked but presumably designed as such. The bulk of the rest of the elevation is filled by a large projecting bay window extending over two floors with a cavetto moulded entablature. Each floor has three central windows divided by stone mullions and a window in each side, on the first floor these have two-light sliding sash casements with horns but on the ground floor they are covered by boards and metal bars. Below each row of windows are open recessed panels. To the south-east of the bay window is a square projecting section forming a sham turret, topped with a dressed battlement on top with a moulded band below (Plate 13). This too has a window on ground and first floor, both of mullion and transom form with a moulded hood mould over. The first floor glazing within this comprises fixed two and four-light casements, while the ground floor is covered by boards and metal bars. This also a projecting stone ‘bench’ along the base, supported on short square pillars. The return on the south-east side has a window on the first floor with a transom housing two four-light casements with a drip mould over. There is a further drip mould below but this does not apparently correspond to another window.

**Plate 12 (left):** The north-west end of the south-west external elevation, viewed from the south-west

**Plate 13 (right):** The ‘turret’ on the north-west end of the south-west external elevation, viewed from the south-west

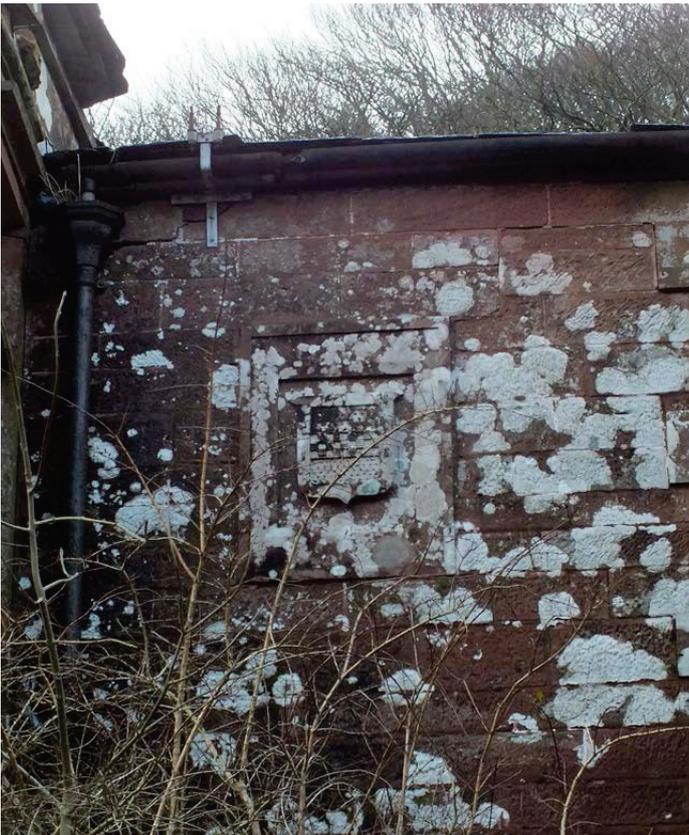
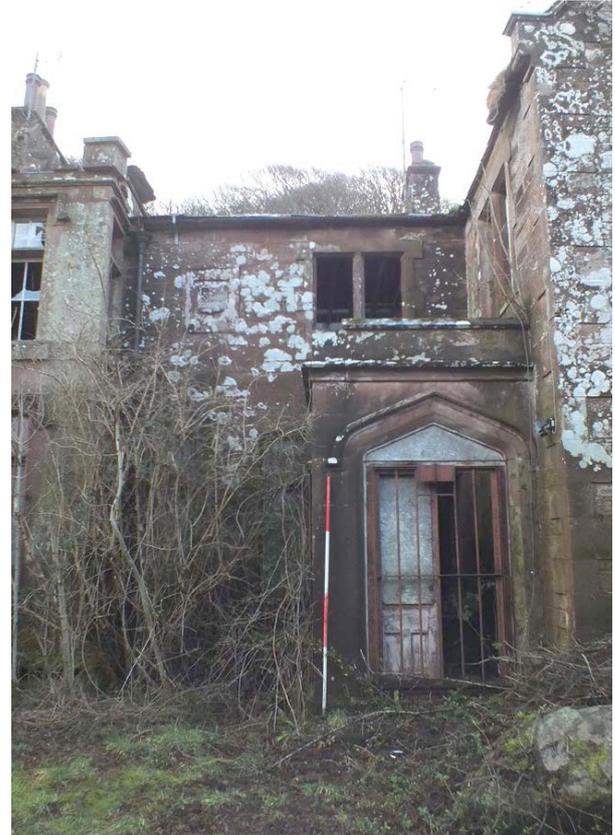
4.2.3 To the south-east of the 'turret' there are a further two windows divided by a stone mullion and covered with boards and bars. Above is a coat of arms carved in relief and set within a rectangular panel (Plate 14). To the south-east of this, at first floor level, is a further window of two parts divided by a stone mullion, now missing its casements, with slightly projecting dressed jambs and in the return to the south-west at the same level there is another window of the same type with two-light sliding sash casements with horns remaining. Below is a single storey porch with a flat roof (now missing) with moulded coping along the top including a deep entablature (Plate 15). There are two openings in the north-west side with moulded arched tops and divided by a stone mullion and sat on a rail with a perforated stone balustrade below. There is a doorway in the south-west side with a similar moulded arched top and the remains of a panelled door. Beyond the porch the elevation forms another large gable topped with a moulded cornice and octagonal finial (Plate 16). At first floor level there is a mullion and transom window housing three two-light sliding sash casements with a drip mould over. At ground floor level there is a similar, but larger, window with a drip mould, but it is covered by boards and metal bars.

**Plate 14 (left): The coat of arms in the south-west external elevation, viewed from the south-west**

**Plate 15 (right): The porch near the centre of the south-west external elevation, viewed from the south-west**

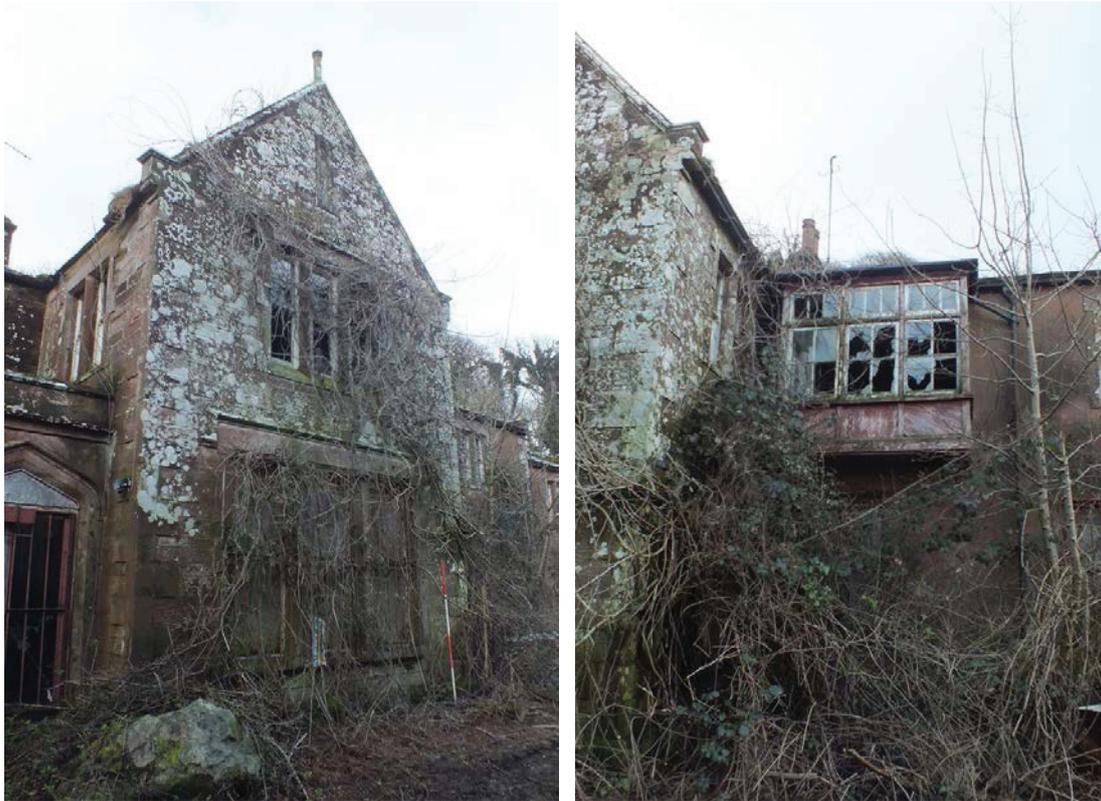
**Plate 16 (left): The projecting gable at the centre of the south-west external elevation, viewed from the west**

**Plate 17 (right): The gallery forming part of the south-west external elevation, viewed from the south-west**

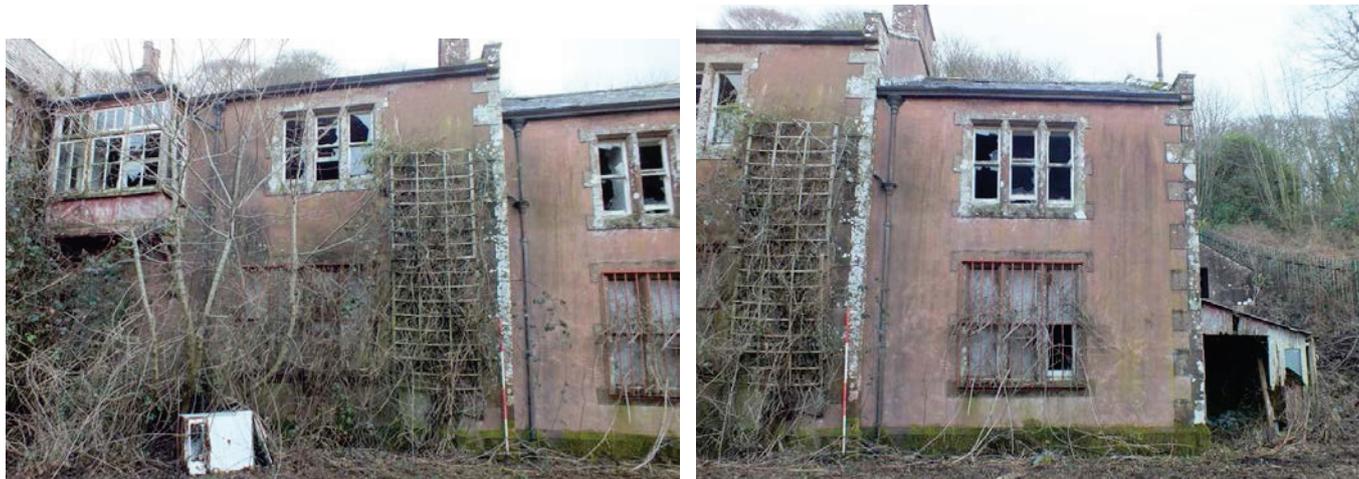
4.2.4 The return beyond this gable has another first floor window comprising two two-light sliding sash casements with horns divided by a stone mullion. There is another, taller, window on the ground floor too divided by a transom into two parts but obscured by boards and metal bars. Beyond this the rest of the elevation is essentially on a single line, although there is a slight step back toward the south-east end and it all has a slight chamfered plinth at the base. Just beyond the return to the north-west there is a window on the ground floor divided by a central mullion but otherwise covered by boards and bars. Above it is a projecting timber gallery supported by brackets set on stone corbels (Plate 17). It is constructed from tongue and groove planks set diagonally between stop chamfered posts and rails with the top part comprising a long timber mullion and transom window of three and four fixed lights, extending around the north-west and south-east sides. South-east of this is a ground floor window with three mullions, covered by boards and metal bars, above which is a similar but slightly smaller window divided by three mullions and housing three two-light sliding sash casements with horns (Plate 18). The step in the wall line to the south-east of these is finished with quoins, with a kneeler at the top at the end of the coping of the gable. Beyond this there are two further windows, one on each floor, both with the mullions and the first floor one with surviving two-light sliding sash casements with horns (Plate 19). The south corner is finished with dressed quoins topped with a kneeler supporting the end of the coping of the south-east gable and extended by a low attached monopitch outshut constructed from timber planks and with a simple door and single-light window.

**Plate 18 (left):** The south-east end of the south-west external elevation, viewed from the south-west

**Plate 19 (right):** The far south-west end of the south-west external elevation, viewed from the south-west

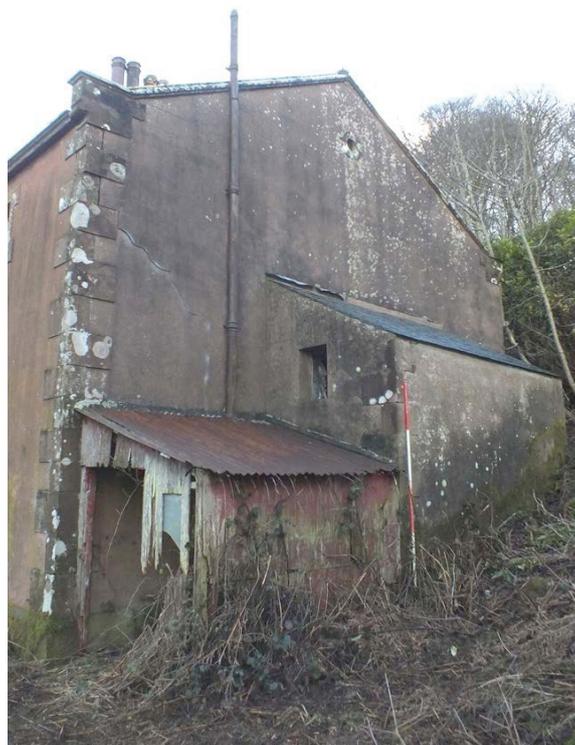
4.2.5 **Main block – south-east external elevation:** this forms a gable end, with a slightly taller gable projecting above it to the north-west, both of which are finished with render scored to give the appearance of ashlar blocks (Plate 20). The lower part is obscured by an attached timber monopitch outshut on the south-west side with a corrugated metal roof, although within this the original wall comes to a plinth as per the south-west elevation. To the north-east is a taller monopitch outshut with a slate roof, finished with smooth render but with dressed quoins at the corners. It has a small window in the south-west return. The main elevation is essentially plain but with a moulded coping extending into kneelers at either end with scrolled details and quoins below on the south-west side only. In the centre of the gable is a circular opening with a dressed stone surround. The gable projecting above it has similar kneelers and a moulded coping and is topped by a chimney of ashlar stone supporting six ceramic octagonal-section chimneys, four of which are in the same style.

**Plate 20:** The south-east external elevation, viewed from the west

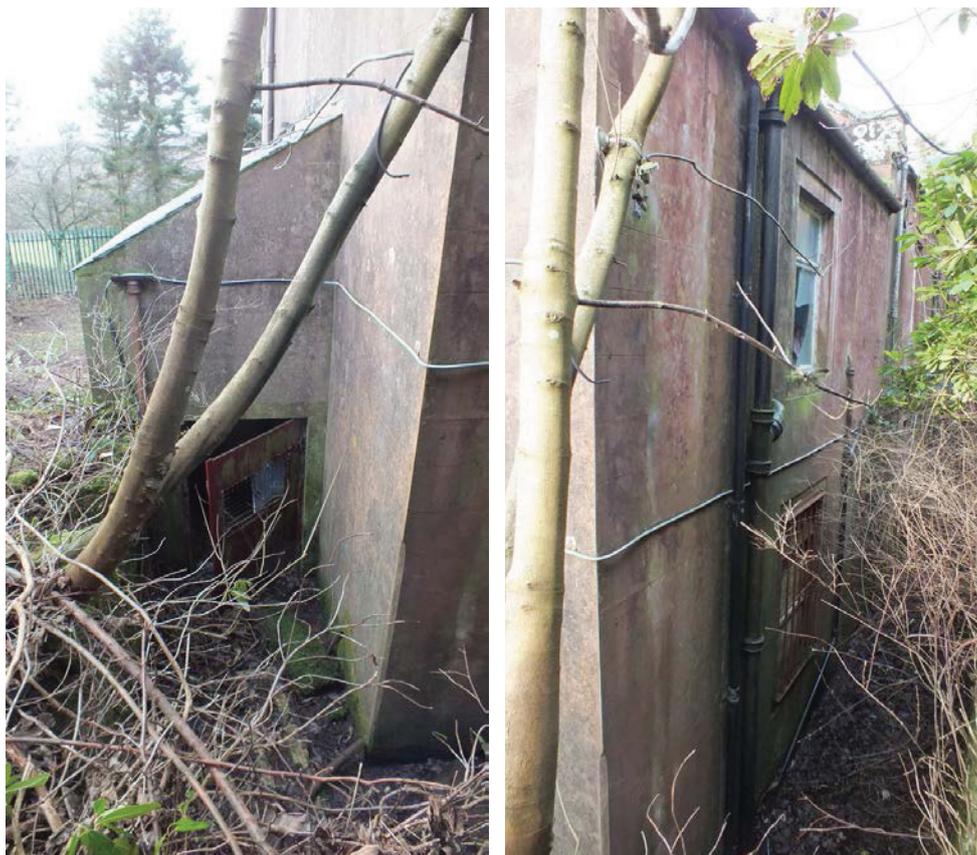
**4.2.6 Main block – north-east external elevation:** this was difficult to fully access, especially the central part. The south-east end is rendered and scored to make an ashlar block effect and extended by the rendered monopitch outshut on the, which has a single doorway with square dressed stone surrounds and a plank and batten door with strap hinges with a single light covered by mesh (Plate 21). To the north-west the main part of the elevation has a window on the ground and first floors, the former covered by boards and metal bars, the latter with two-light fixed casements and both in rebated plain dressed stone square surrounds (Plate 22). To the north-west are two further ground floor and three further first floor windows, the first floor ones with six-light sliding sash casements. Between the ground floor windows is a doorway with a projecting porch constructed from solid stone slabs and with a flat canopy with some moulding. North-west of the centre, at first floor level, is a projecting timber gallery, similar in style to that to the south-west but smaller. North-east of this is a return at first floor level forming a walkway connecting to the detached building to the north-east. This has a long window at first floor level with two nine-light casements and a roof light above with four six-light casements below a hipped roof. Below this walkway is a doorway and the remains of associated timber infilling. Beyond the walkway is a first floor mullion and transom window with six openings housing two and three light casements. North-west of this are a further two windows, one on each floor. The ground floor example with two lights in a plain stone surround covered by boards and metal bars, the first floor a 12-light sliding sash casement with no horns (Plate 23). Low to the north-west is a lead hopper built into a hole in the wall (Plate 24), immediately before a step in the wall where it forms a large gable. This has two first floor windows, one on either side, both with two-light sliding sash casements with horns in dressed stone surrounds (Plate 25). At the top in the centre of the gable is a raised cross-shaped decoration in the form of blank arrow slots or gun loops and the top is finished with an octagonal finial and moulded coping, with quoins at the north-west end proper.

**Plate 21 (left):** The outshut at the south-east end of the north-east external elevation, viewed from the north-east

**Plate 22 (right):** The south-east end of the north-east external elevation, viewed from the east

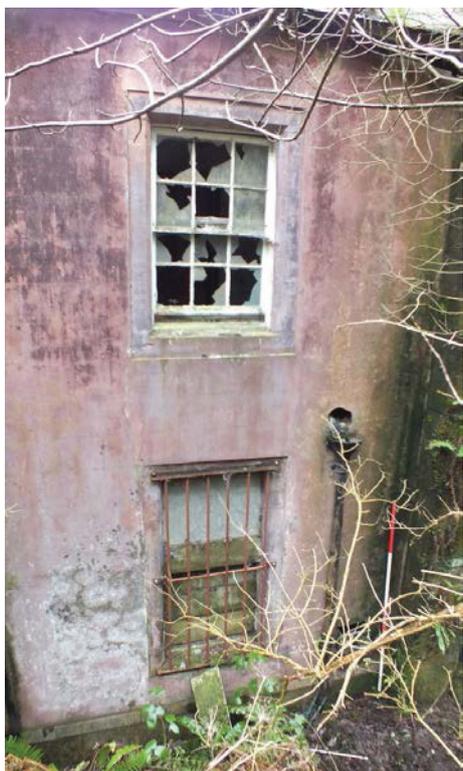
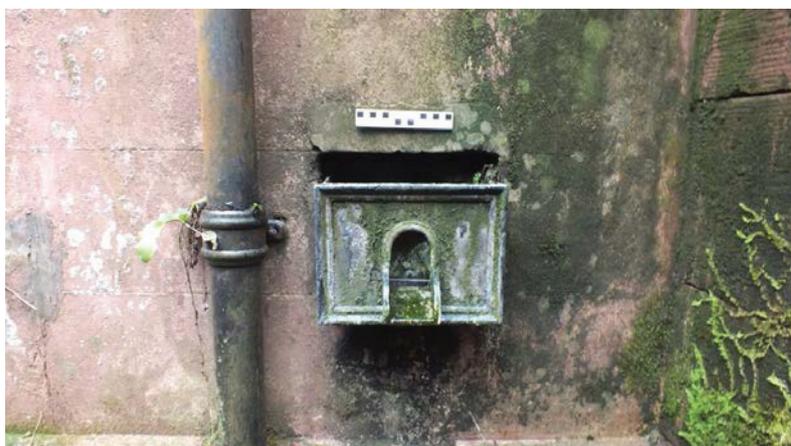
**Plate 23 (left): Windows in the north-east external elevation north-west of the return connecting to the detached building, viewed from the north-east**

**Plate 24 (right): Lead hopper at the north-west end of the north-east external elevation, viewed from the north-east**

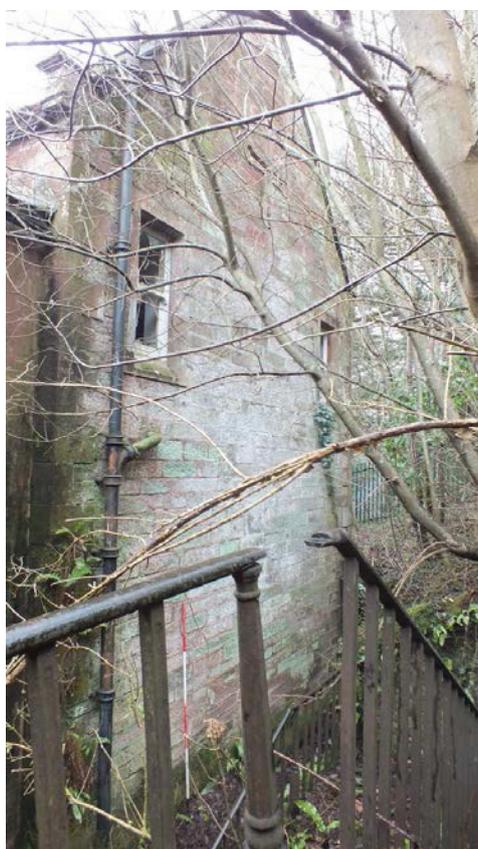
**Plate 25: The north-west end of the north-east external elevation, viewed from the east**

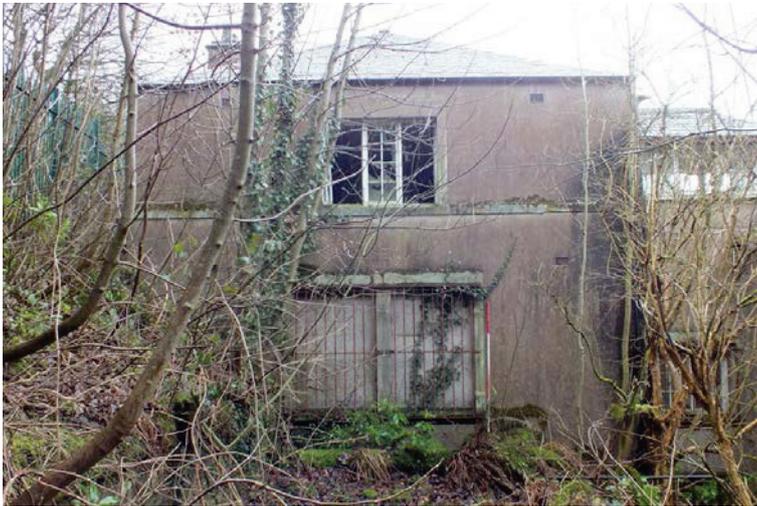
**4.2.7 Detached block – north-west external elevation:** this is finished with render as per the rest of this block, scored to give the appearance of ashlar blocks and with a square stone string course midway along. There is a large window on the lower floor with a central square stone mullion and square surround but the window is blocked with boards and bars (Plate 26). On the upper floor there is a further window also with square surrounds and utilising the string course for its sill and with three eight-light hinged timber casements. The whole elevation is extended to the south-west into a first floor walkway bridging over the passage running along the north-east side of the main building and connecting to it at first floor level. This contains a further window in the lower floor with a pair of nine-light casements and a raised rooflight above comprised of four six-light casements (Plate 27). There are numerous ceramic vents across the main part of the elevation.

**Plate 26 (left):** The main part of the north-west external elevation of the detached block, viewed from the north-west

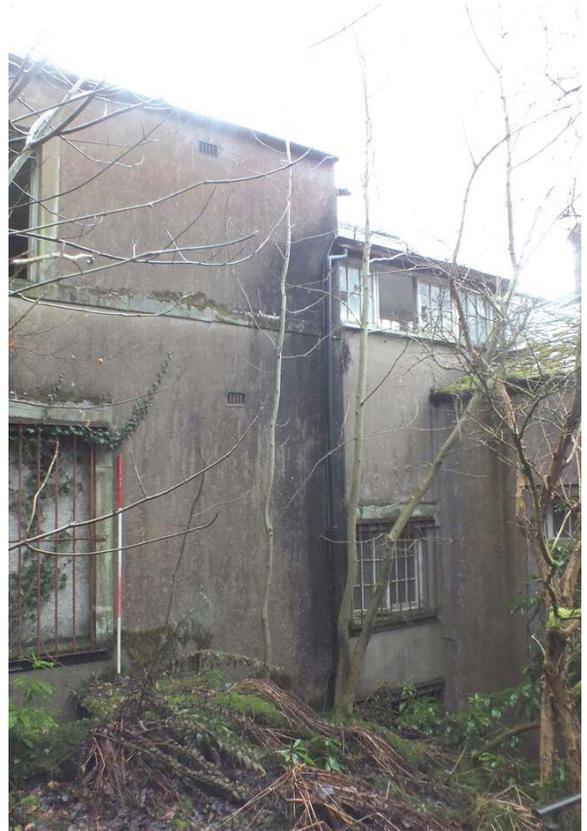
**Plate 27 (right):** The extension of the north-west external elevation of the detached block joining the main building, viewed from the north

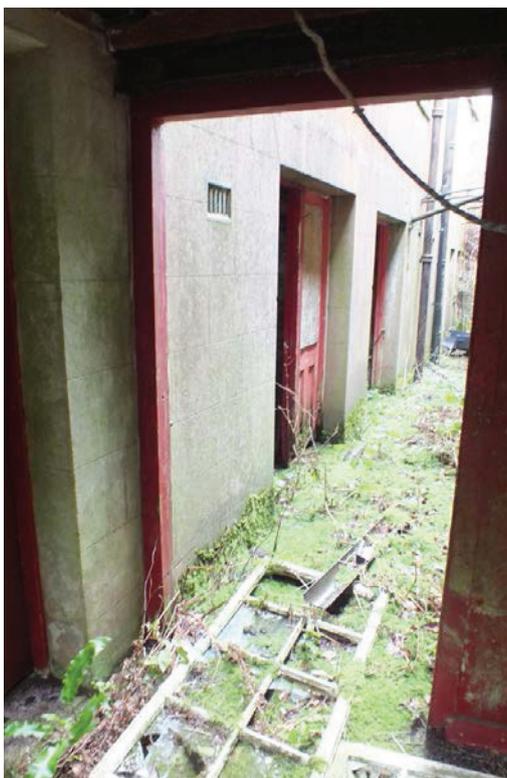
**4.2.8 Detached block – south-west external elevation:** this was difficult to view due to access to the passageway being obstructed. The upper two floors each had two windows. The lower part, where it was built into the slope, had a row of six doorways all with panel doors and plain door surrounds and there were numerous ceramic vents (Plate 28).

**Plate 28: Doorways in the lower part of the south-west external elevation of the detached block, viewed from the north-west**

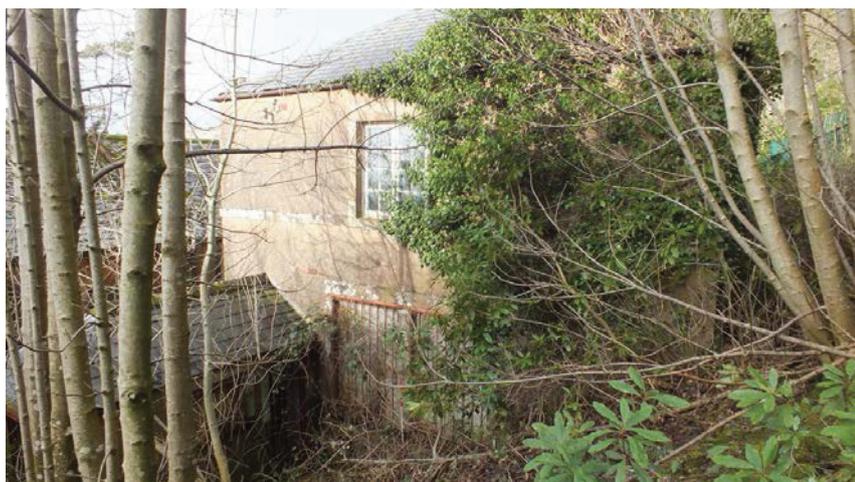
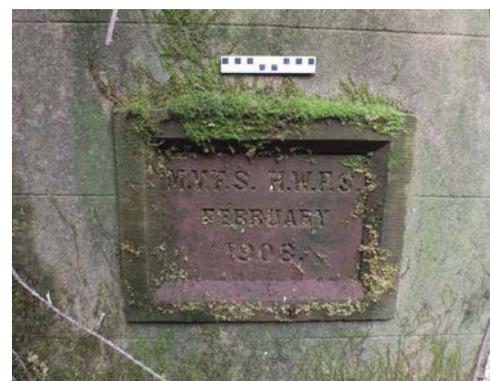
4.2.9 **Detached block – south-east external elevation:** the south corner of this is covered by the end of a small outshut, which is plain render with single small window covered by boards and a hipped roof (Plate 29). The main elevation beyond this also has a hipped roof and is finished with render with a square stone string course across the centre. There is a large window at what is ground floor level in this building with a central square stone mullion and surround, the casement covered by boards and bars. On the floor above is a further slightly narrower window, the sill of which is formed from the string course and which also has a square stone surround and houses a pair of hinged timber eight-light casements. At the base of the elevation is a datestone inscribed ‘M.V.F.S. H.W.F.S. FEBRUARY 1908’ (Plate 30), and there are also two ceramic vents to the north-east with pointed Gothic openings.

**Plate 29 (left): The south-east external elevation of the detached block, viewed from the south-east**

**Plate 30 (right): The datestone in the south-east external elevation of the detached block, viewed from the south-east**

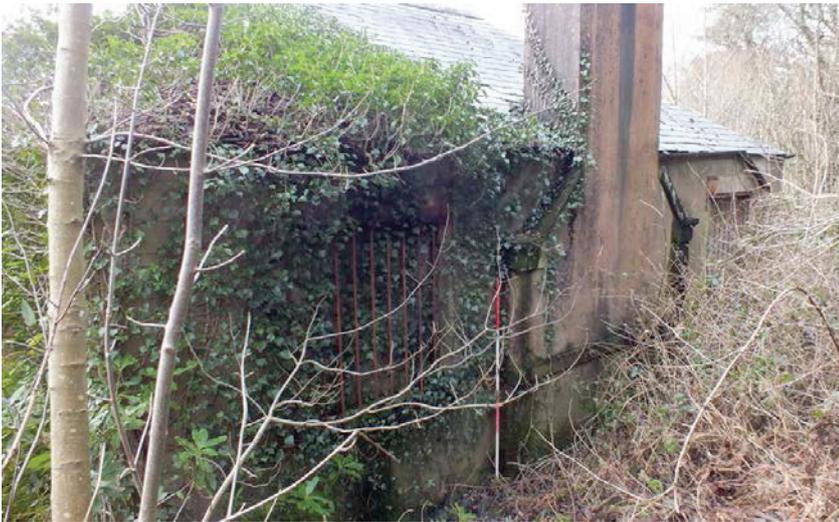
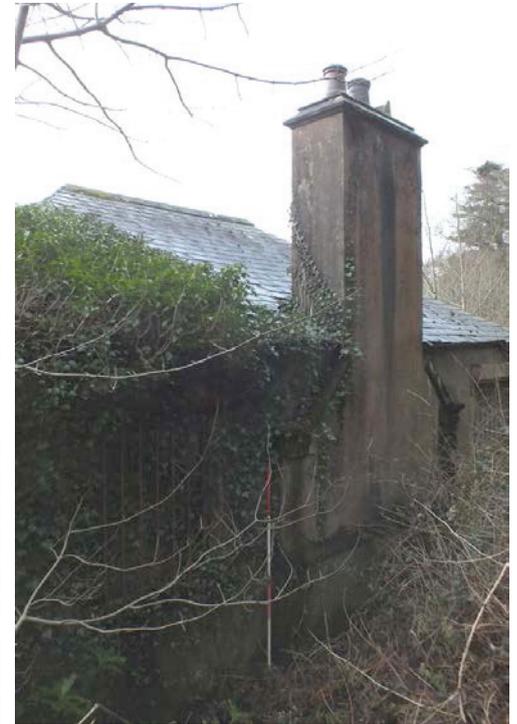
4.2.10 **Detached block – north-east external elevation:** the south-east end of this is extended by the lower outshut, which has a small window on the south-east side with square surrounds that is covered by boards and bars, with a doorway to the north-west also similarly covered although the door is panelled. There is also a ceramic vent like that in the south-east elevation. The main elevation, to the north-west, has a window on either end, with the same string course forming the sill and with plain stone surrounds and covered by boards and bars (Plate 31). In the centre is a projecting chimney stack, the string course continuing round it and with moulded copings with kneelers on the angled base tier (Plate 32). The top of the stack has further moulded copings and supports three round ceramic pots.

**Plate 31 (left):** The north-east external elevation of the detached building, viewed from the south-east

**Plate 32 (right):** The chimney forming part of the north-east external elevation of the detached building, viewed from the south-east

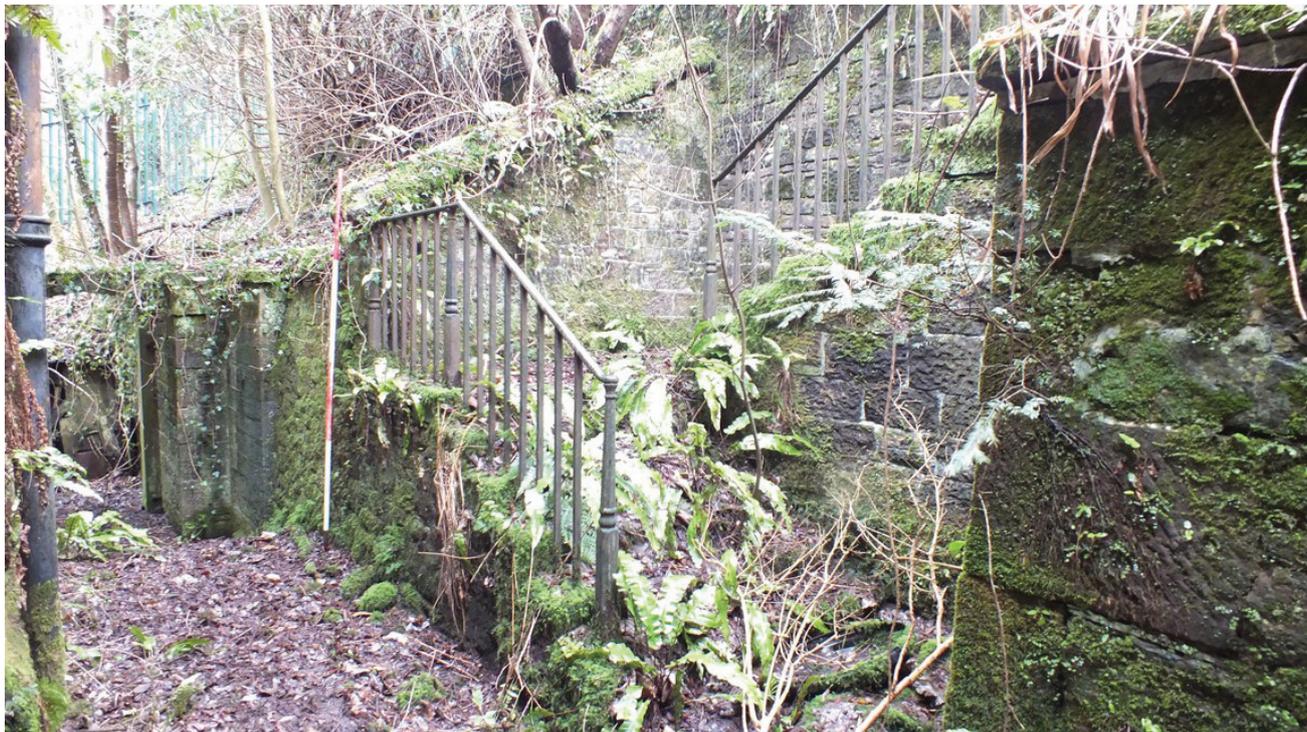
4.2.11 **Other external detail:** where the main part of the building is built into the slope on the north-east side there is a passageway built alongside, and this is also the case along the south-east side of the detached block and there is also a lowered section along the north-west side of the detached block (Plate 26). There is also a staircase connecting the main building, via the passageway along the north-east side, to the detached building. This effectively forms part of the walls of the passageway and comprises a single section returning on itself topped with iron railings (Plate 33).

Plate 33: Staircase connecting the two buildings, viewed from the south

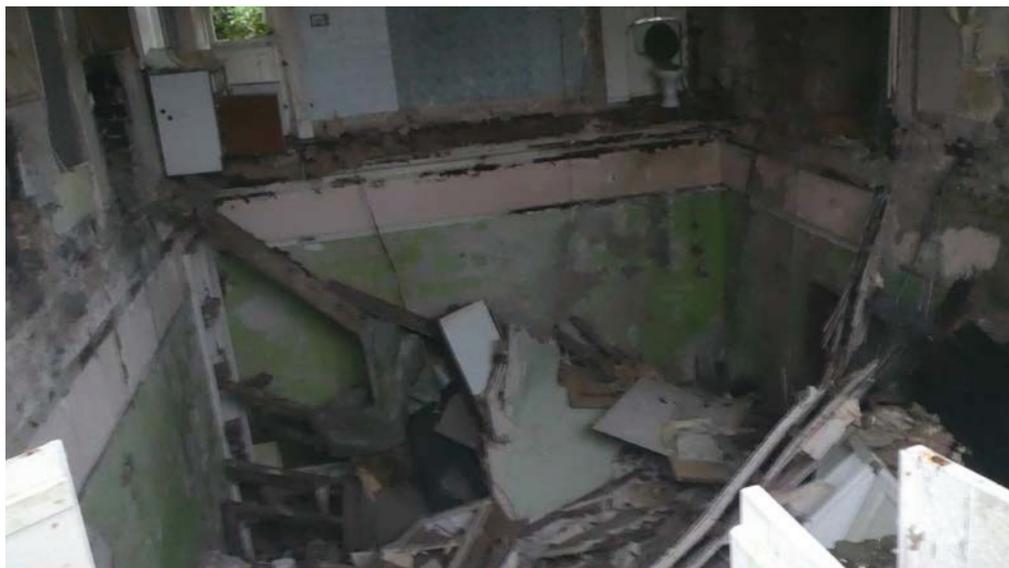
4.3.2 **Ground floor, Room 1 (G1):** the floor is entirely covered in debris and the ceiling collapsed. The walls are finished with plaster and paint and with traces of a cornice (Plate 34). The north-west elevation has an evident alcove with shelves incorporated into what was a window externally but there was no evidence for a fireplace on this floor. There is a doorway in the south-east elevation and window to the south-west.

Plate 34: The interior of Room G1, viewed from the south-west

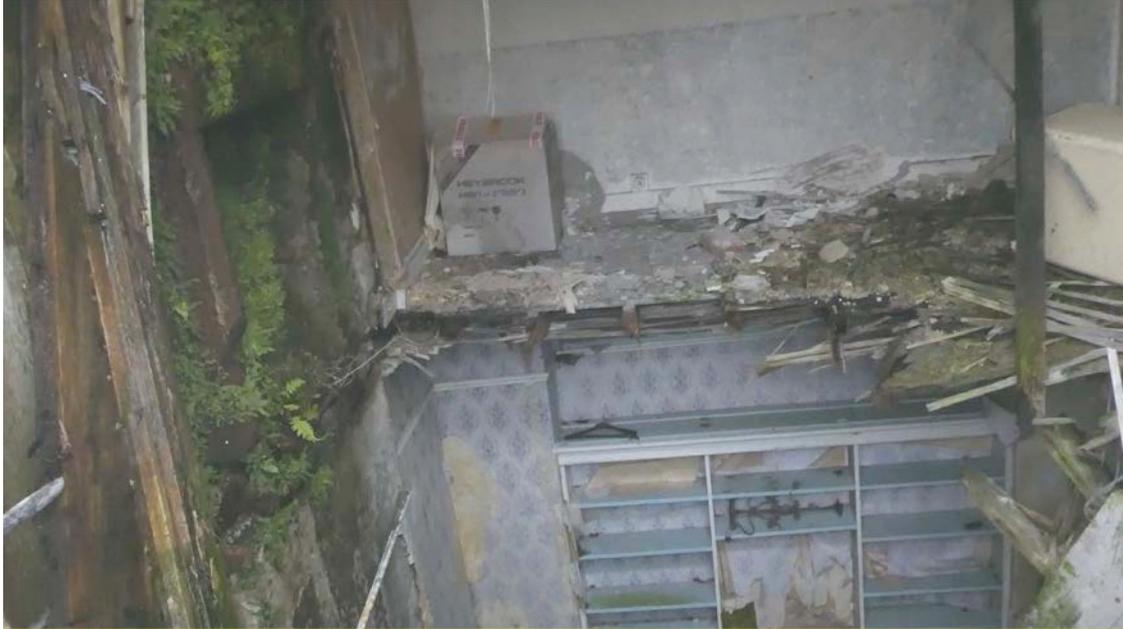
4.3.5 **Ground floor, Room 6:** this was difficult to view and largely obscured by rubble. The walls are finished with plaster and wall paper with a moulded dado rail. There is a possible fireplace to the north-west and a large fitted cupboard to the north-east set within a wide alcove (Plate 35).

**Plate 35: The interior of Room G6, viewed from the south-west**

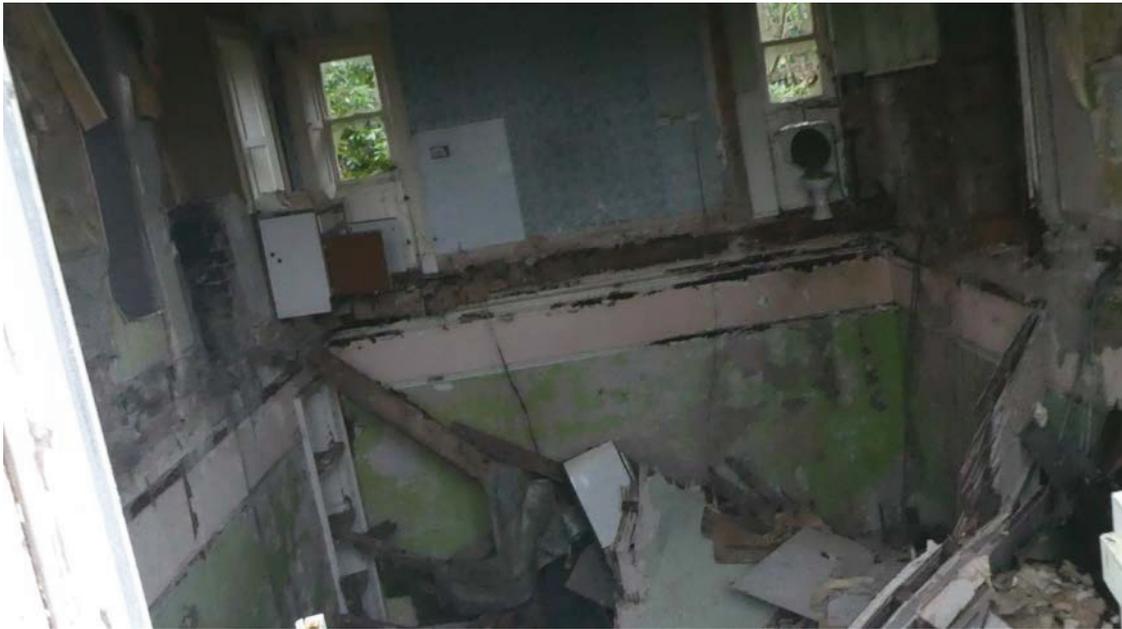
4.3.7 **First floor Room 1:** this was clearly originally several rooms but the internal partitions have now collapsed with the floor. The ceiling is plaster but not apparently with any surviving cornice. The walls are finished with plaster and wall paper and there are windows to the north-west and north-east with two-light sliding sash casements and an opening for a fireplace to the north-west, although the fireplace itself has been removed (Plate 36).

**Plate 36: The interior of Room F1, viewed from the south-west**
