# NEWTON MANOR, GOSFORTH, SEASCALE, CUMBRIA

## Archaeological Building Recording

Client: John Coward Architects

February 2018

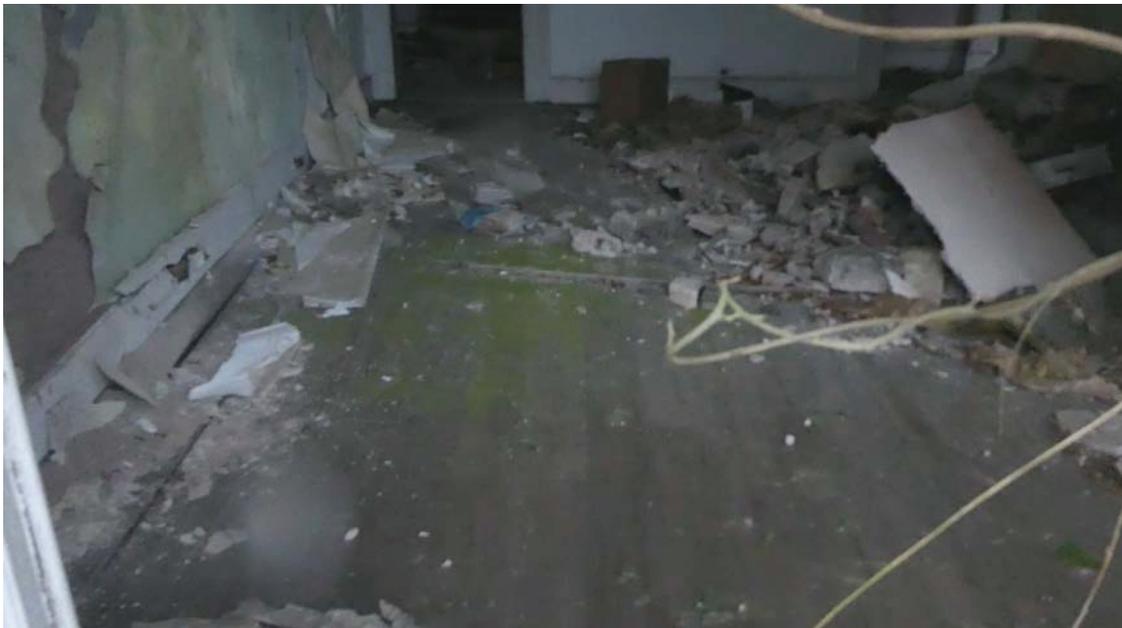
4.3.10 **First Floor, Room 5:** this has a timber board floor still intact and the walls were finished with plaster and paint and a tall skirting board (Plate 37).

**Plate 37: The interior of Room F5, viewed from the south-west**

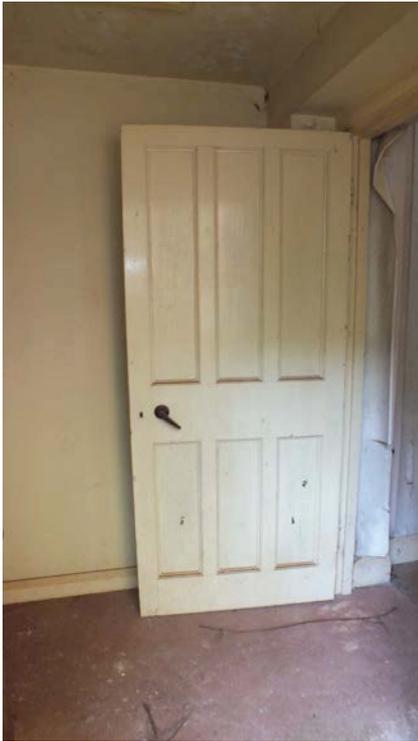
4.3.11 **First Floor, Room 13:** this has a painted concrete floor and plaster ceiling, with a small hatch into the roof space. The walls are finished with plaster and paint and there is a doorway to the north-west with a six-panel door (Plate 38).

**Plate 38 (left): Doorway in Room F13, viewed from the north-east**

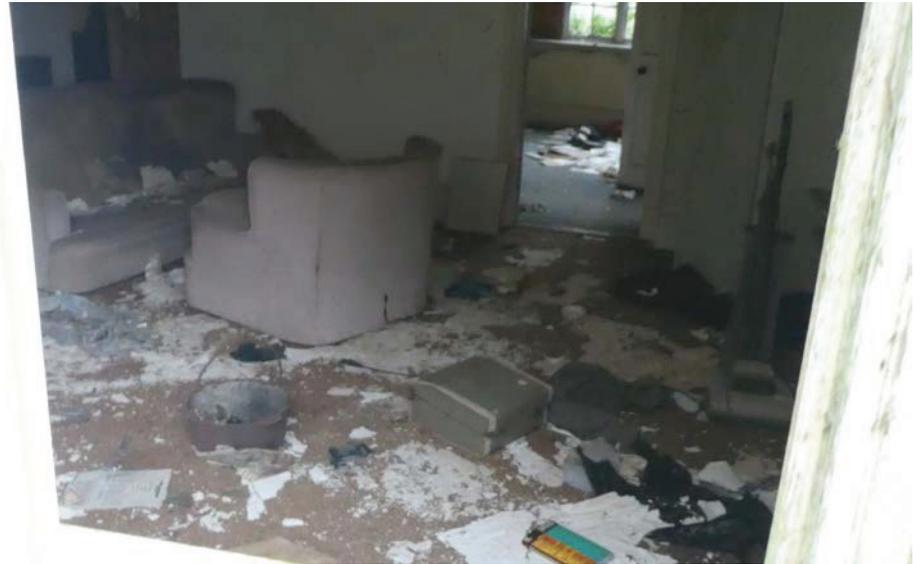
**Plate 39 (right): Interior of Room S2, viewed from the north-west**

4.3.12 **Second Floor, Room 1:** this has a timber board floor and the walls are finished with plaster and paint. The doorways have relatively plain surrounds (Plate 39).
