THE GATEHOUSE, CALDER BRIDGE, GOSFORTH, CUMBRIA

Archaeological Building Recording

April 2018

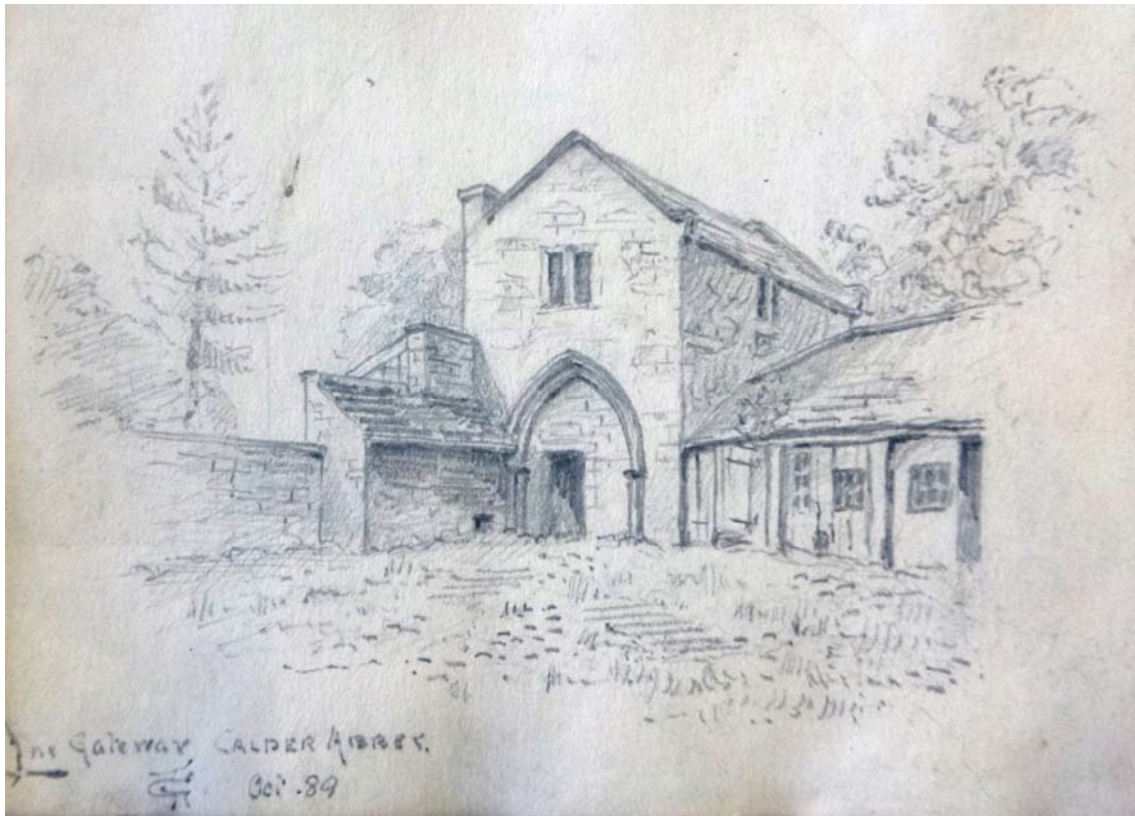
Plate 5: Sketch of the gatehouse dated 1889 (CAC(C) DX 2114/1 c1892-1894)

3.1.7 **Sketch, 1889:** a pencil sketch by an unknown artist dated October 1889 is present in the archives in Carlisle (CAC(C) DX 2114/1 c1892-1894). Again there are some inaccuracies in the drawing, which has made the building appear taller and thinner than it actually is, but this drawing otherwise shows a number of features of interest. While it is apparent that the building has changed relatively little since the previous sketch was produced it does show that the original arched gateway on the east side

was still mostly blocked leaving a smaller doorway (Plate 5). In addition, the slope of an outshut on the south side of the gatehouse is just visible, confirming the presence of an adjoining building, as shown on the early plans.

3.1.6 **Sketch, 1886:** a sketch of the gatehouse, apparently signed 'JRL' accompanies Loftie's second account of the remains of Calder Abbey (Loftie 1886) (Plate 4). There are clearly some discrepancies in terms of the dimensions of the building compared to later views (see Plate 5 and Plate 8) but some important details are apparent. Firstly, the arched opening on the east side has clearly been largely blocked by this date leaving a smaller doorway. Secondly, the chimney on the south-east corner is shorter than it is now and as it is depicted in later images, while the building attached to the north side was clearly a stable or animal housing. The building otherwise appears much as it does today.

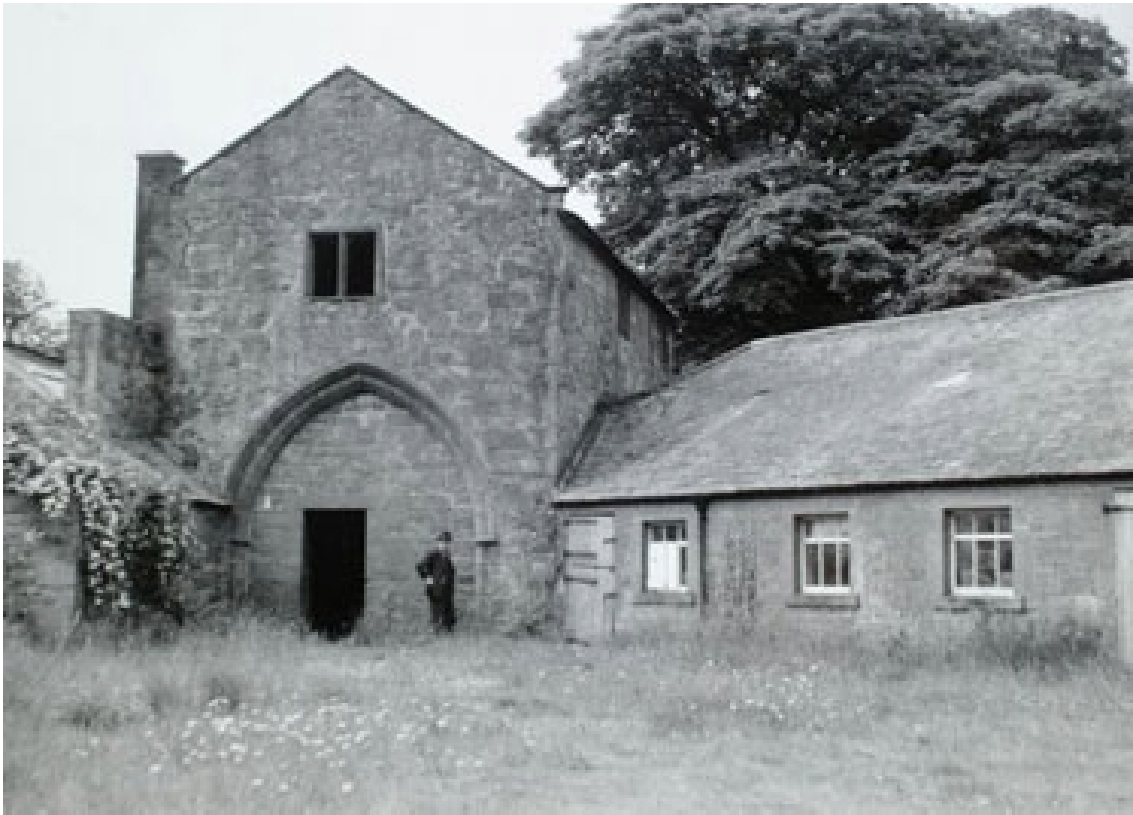
Plate 8: Photograph of the gatehouse from the 1920s (Cumbria Image Bank 2018)

3.1.10 **Photograph, c1920s:** a photograph held in the Cumbria Image Bank shows the gatehouse from the east in what is thought to be the 1920s (Cumbria Image Bank 2018; ref ct12356). It is remarkable how little the building has apparently changed since the production of the earlier sketch (Plate 8; cf. Plate 5), although it is apparent that the site was somewhat neglected by this date as the adjoining yard is very overgrown.

Plate 8). By the late 20th century it had been converted into a garage, with the arched opening to the east unblocked and the current door inserted and the Phase 3 floor removed and replaced with the current mezzanine. It is not clear exactly when this took place; the Listing states that it was in use as a garage by 1984 but the graffiti on the north internal elevation suggests that the Phase 3 floor was still in place as late as 1987 (see *Section 4.3.2*). The floor was most likely replaced during this period and following the conversion of the former outbuildings attached to the north elevation an additional extension was added to the west side of the north external elevation, leaving much of this side obscured.

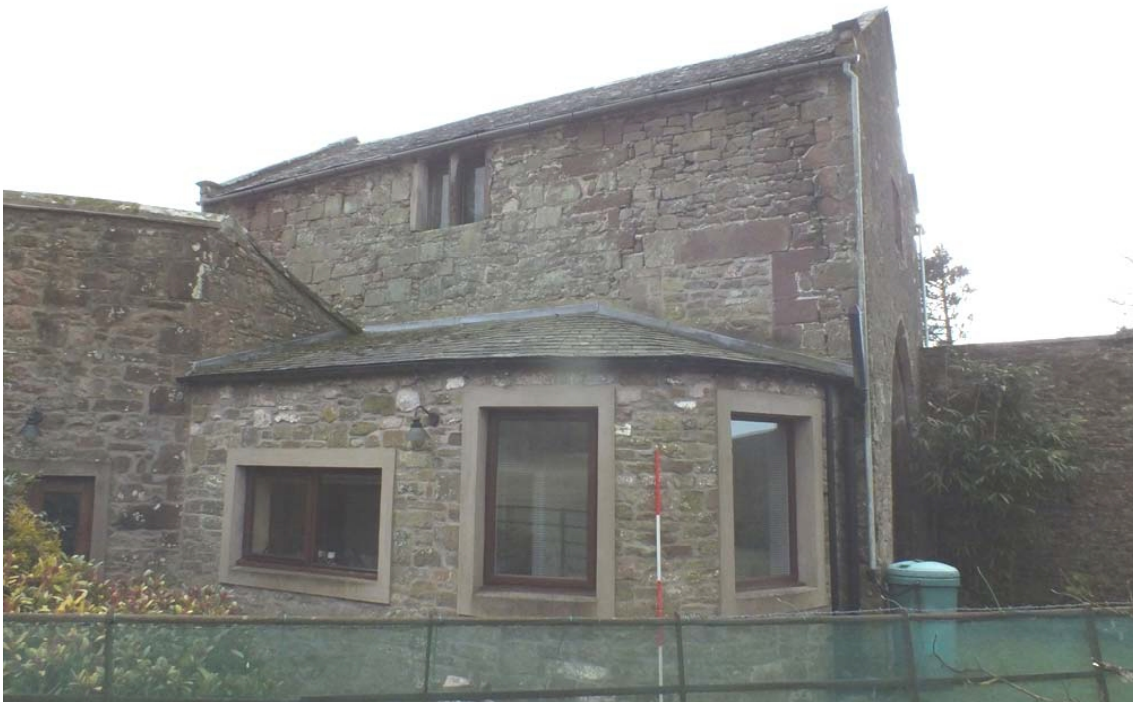
Plate 9: General view of the north external elevation, viewed from the north-west

4.2.1 **North external elevation:** the lower part of the elevation is obscured by the attached former outbuilding and a later extension (Plate 9). The west side has clearly been substantially rebuilt and incorporates a first floor doorway with a dressed sandstone lintel and quoins, which has been subsequently blocked with stone. In the centre is a window that extends to the eaves and has a two-light mullion of chamfered red sandstone. The east side is relatively plain and constructed from roughly dressed blocks laid in rough courses and both ends are finished with quoins.

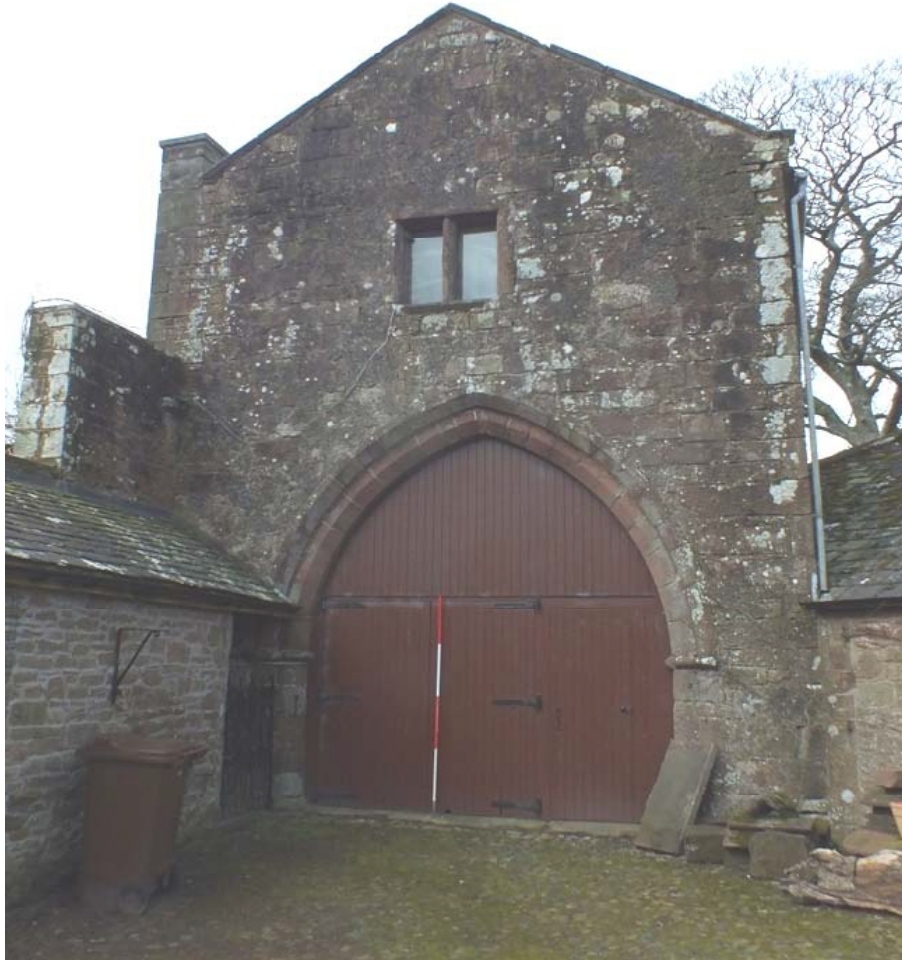
Plate 10: General view of the east external elevation, viewed from the east

4.2.2 **East external elevation:** this forms the gable end, and is topped with a dressed coping with kneelers, although the south side is extended above this by a square chimney with a flat top. It is constructed from roughly dressed blocks laid in fairly random courses, although there are some patches of surviving render (Plate 10). The elevation is dominated by a central large pointed arch with dressed double chamfered jambs. This has been infilled with a modern timber stud wall constructed from planks and housing a double garage door hung on large hinges and a pedestrian door. Above the arch is a

single window with a two-light chamfered stone mullion. The south side is also partially obscured by an attached monopitch outshut above which is a tall section of the boundary wall extending from the east elevation.

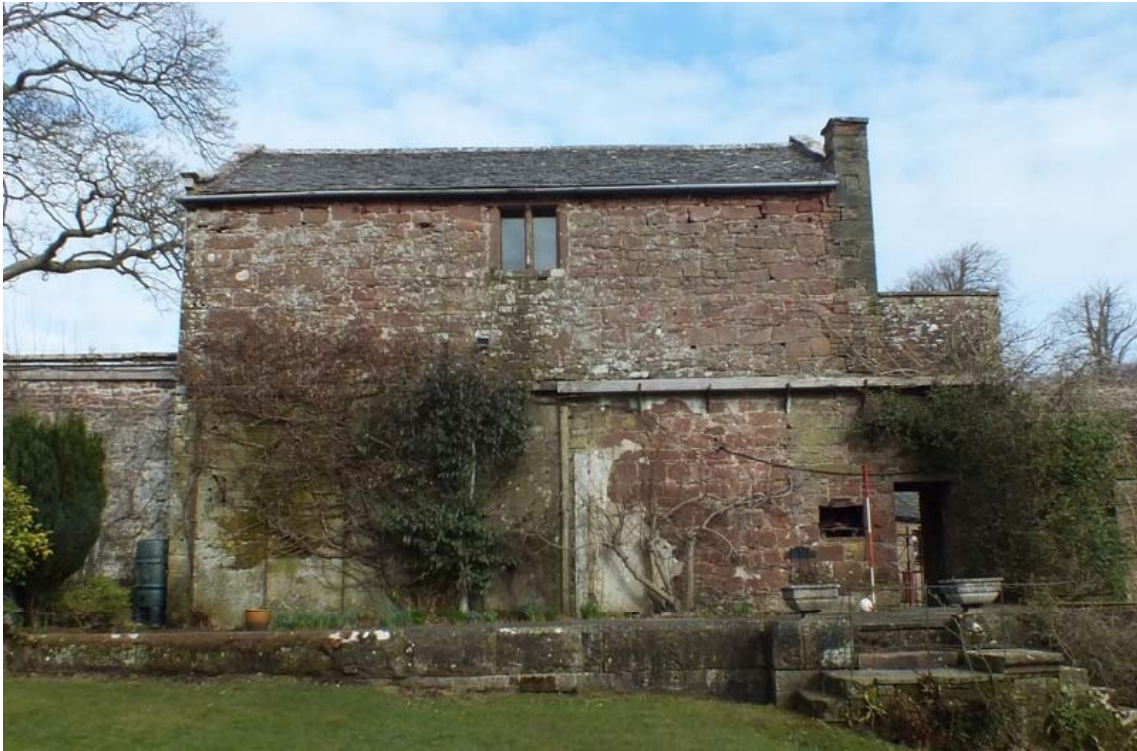
Plate 11: General view of the south external elevation, viewed from the south

4.2.3 South external elevation: this is also constructed from roughly dressed red sandstone blocks, although these are obscured over large parts of the ground floor by a later concrete skim and vegetation on the west side and there are various small patches of brick at first floor level on the east side (Plate 11). There are also various notches in some of the stonework, presumably relating to fixtures that have been removed. On the east side a small alcove has apparently been knocked into the wall to provide a fireplace (Plate 12) and this links into a flue in the wall, which extends into a square chimney raised above the eaves. A timber gutter supported by iron brackets runs along at first floor level on the east side, and the elevation continues into the adjoining boundary wall, suggesting it is perhaps contemporary. At second floor level there is a central window with a two-light central window with chamfered stone mullions.

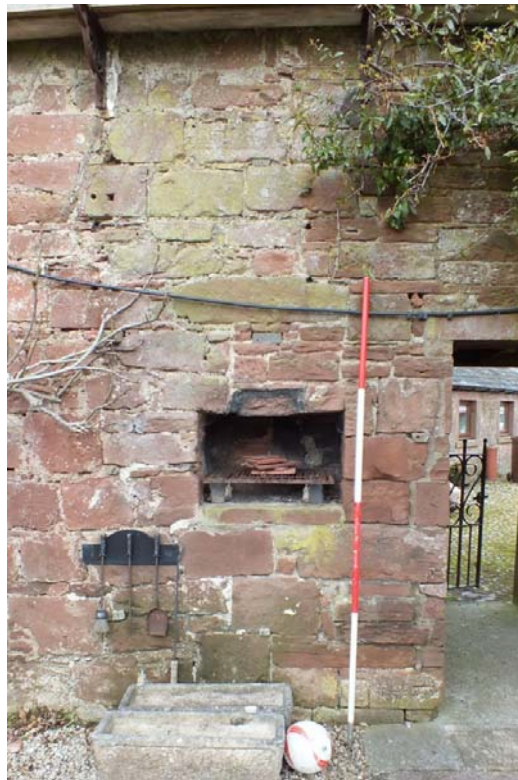
Plate 12: Fireplace built into the east end of the south external elevation, viewed from the south

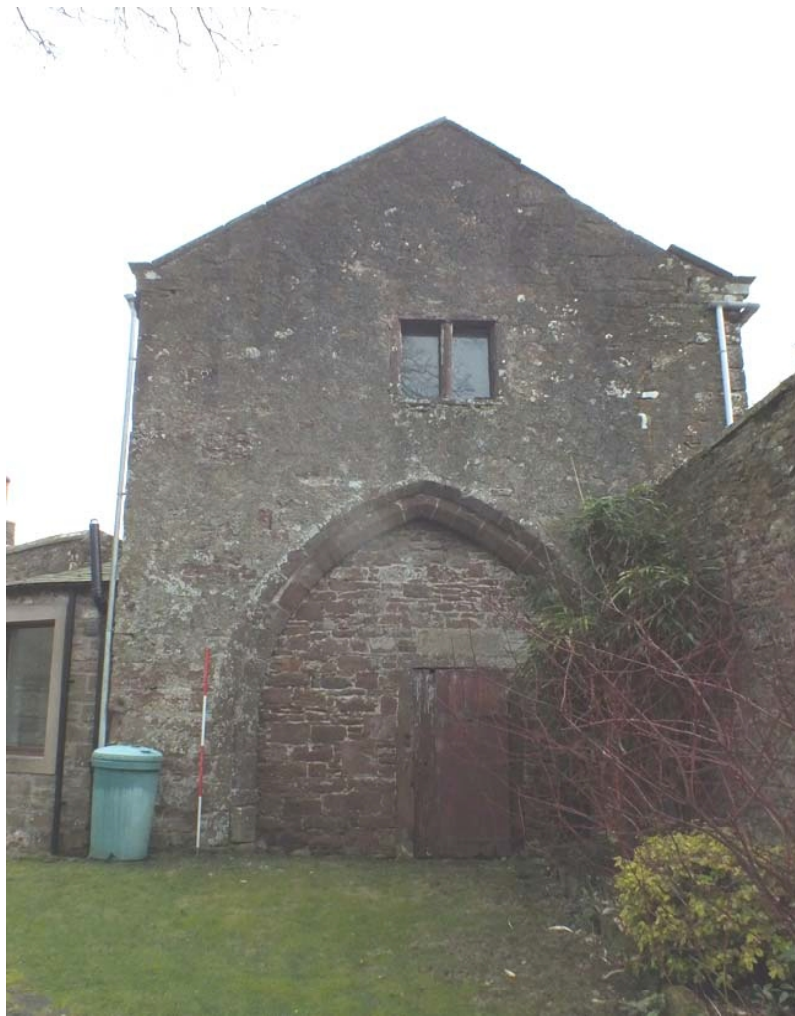
Plate 13: General view of the west external elevation, viewed from the west

4.2.4 **West external elevation:** this too is constructed from roughly dressed red sandstone blocks, although exact arrangement of most of these is obscured by the remains of roughcast render (Plate 13). The centre is dominated by a large arched opening with dressed double chamfered jambs, which has been blocked with stone leaving a smaller pedestrian doorway on the south side, which has a square stone surround and an additional larger stone lintel. Above the arch is a central window with a two-light chamfered mullion, which is apparently at least partly reused as the sill has the returns for a further

three-light or larger window. The eaves are finished with the remains of a dressed stone coping with a slight moulding coming to kneelers. The south side is butted by a tall boundary wall, and a line in the stonework above this may be an extension of this line.

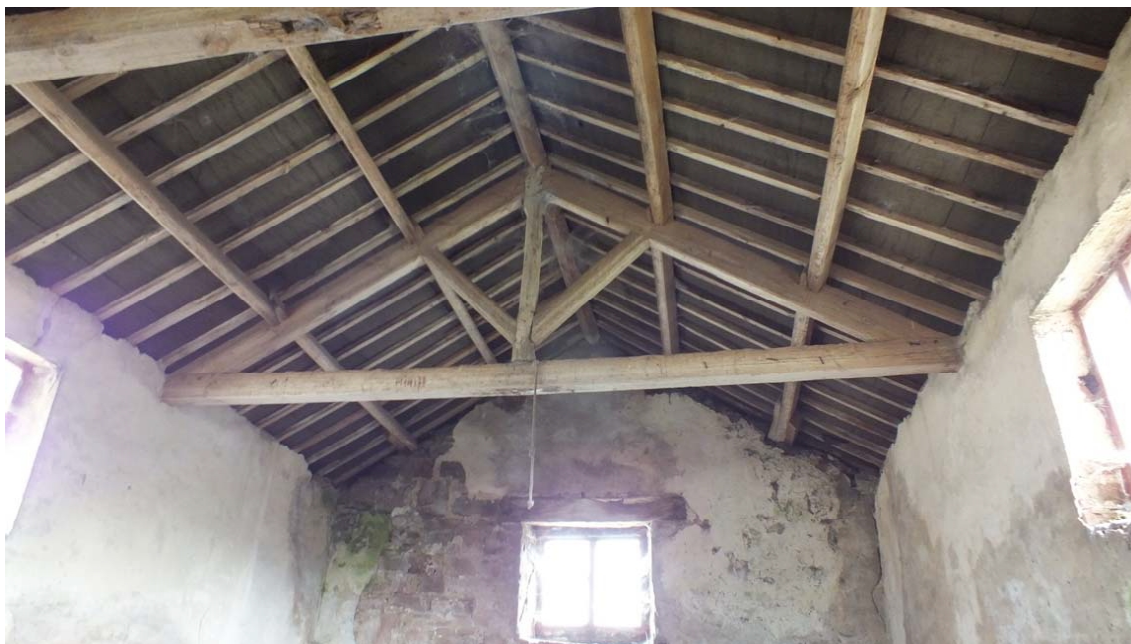
4.3.1 This now extends to the roof although it has clearly had internal floors at different heights belonging to different periods and still has a modern mezzanine floor against the west end. The floor is finished with modern cobbles set in concrete. The roof is supported by two suspended king post trusses with a splayed head and angled braces running from sloping joggles (Campbell 2000) (Plate 14). The interior is largely exposed stone laid primarily in fairly rough courses, but traces of lime wash are present throughout and at the top, beyond a step in the wall that originally supported a first floor, is finished with plaster, which clearly originally extended below this level.

Plate 14: Eastern truss, viewed from the west

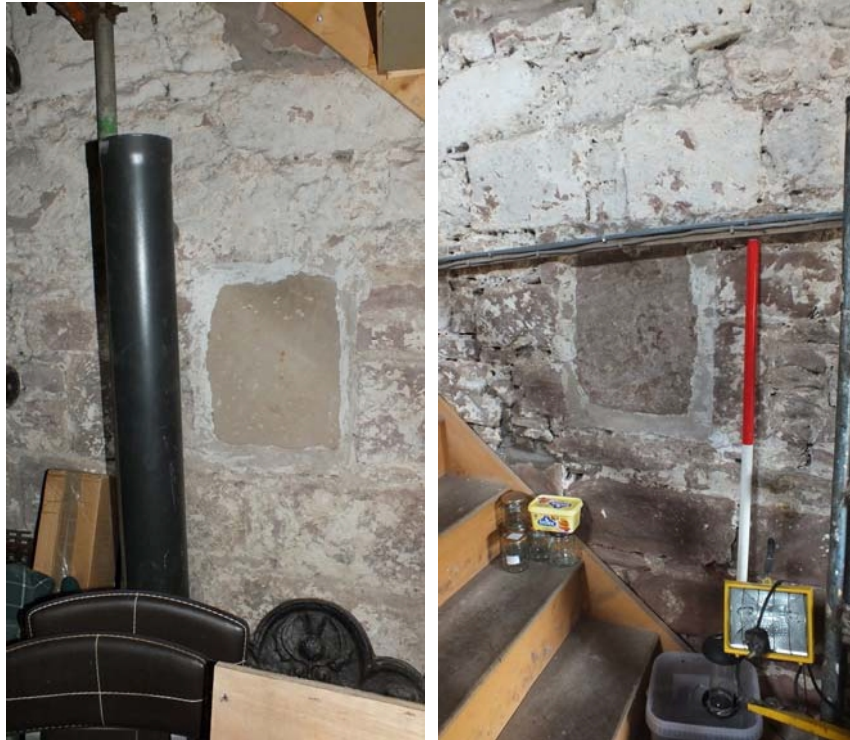
4.3.2 The north internal elevation has modern timber staircase attached west of the centre and a row of three blocked openings at ground floor level, two of which are filled with a single slab, while the third, at the east end (Plate 15 and Plate 16), is filled with smaller stones. The ends of two timber beams project from the wall, and the same height as the current mezzanine floor but clearly pre-dating it (Plate 17). At first floor level there is a doorway on the west side in an area that has clearly been substantially rebuilt, with a rough timber lintel into which has been inserted a modern set of shelves (Plate 18). To the east are four patches of plaster (Plate 19), the western two of which have circles scored into them (Plate 20), perhaps 'witch marks', while those to the east have scored and pencil graffiti: 'Matt. E. Thompson', 'Joan Burton June 3rd 1945', 'JVB 1958', '1968 Cooper', 'bewsh 1987', 'O. Bell 1968' and 'J Tyson 1862' (Plate 21). At second floor level the walls is entirely finished with plaster, except for the west end above the doorway, with a window in the centre with a modern two-light timber casement.

Plate 15 (left): Aperture blocked with a single slab on the west side of the ground floor of the north internal elevation, viewed from the south

Plate 16 (right): Aperture blocked with a single slab in the centre of the ground floor of the north internal elevation, viewed from the south

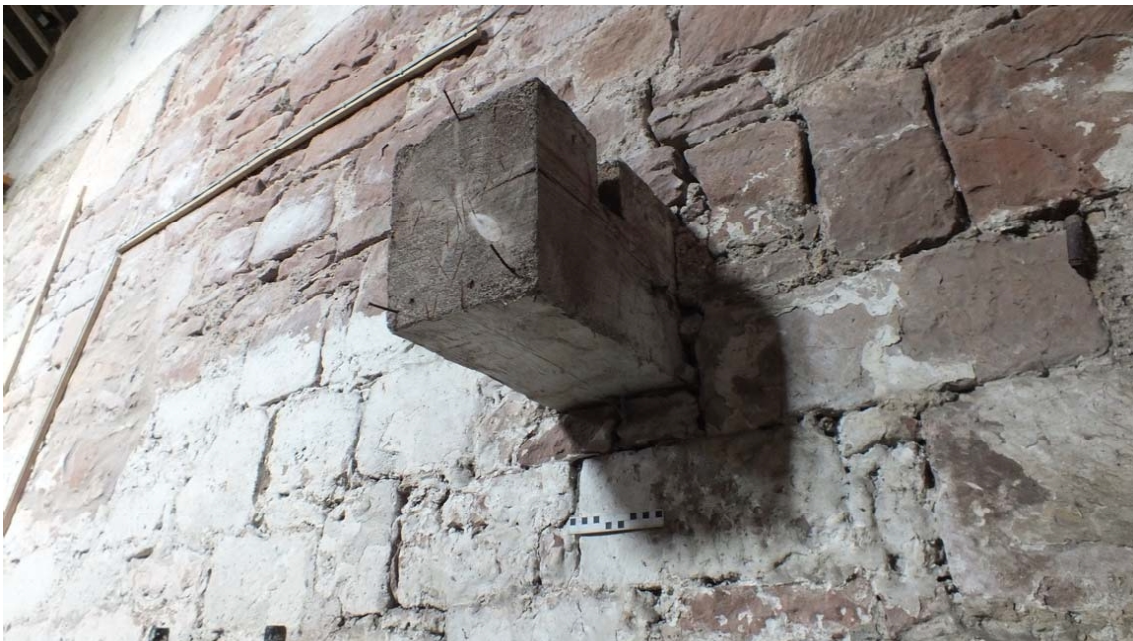
Plate 17: Remains of early beam projecting from the north internal elevation, viewed from the south-east

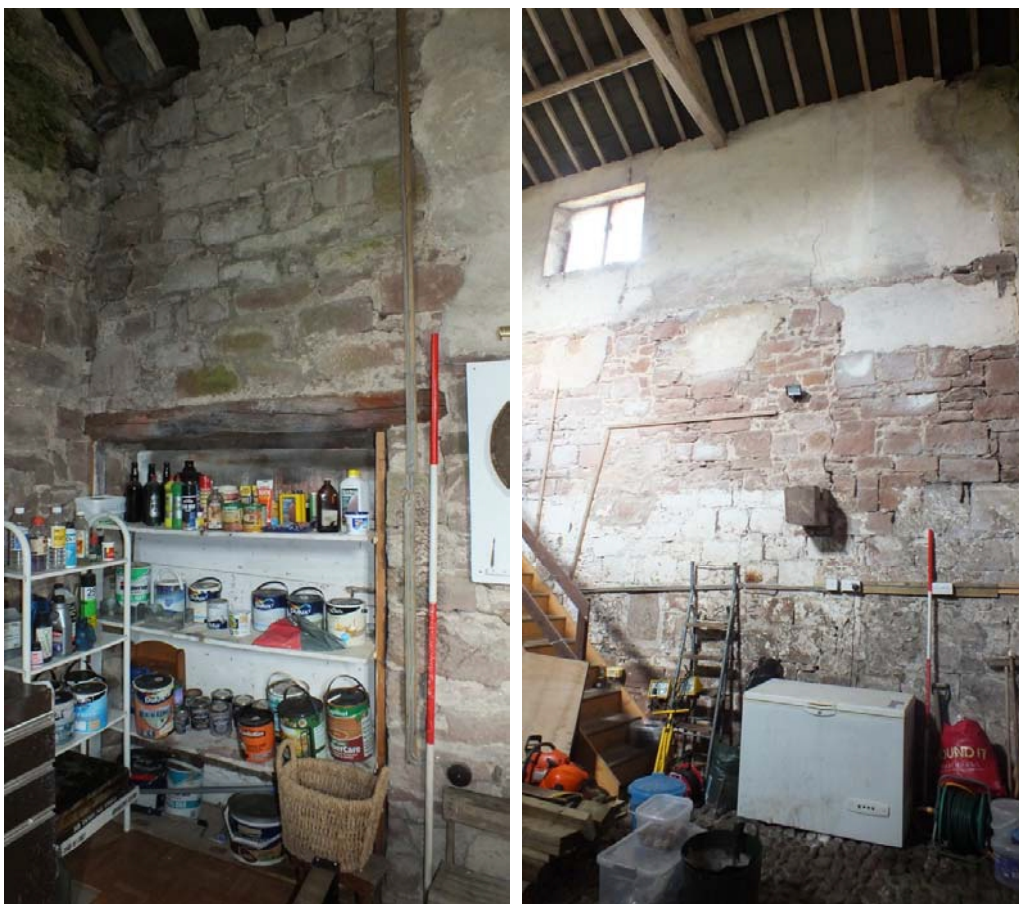
Plate 18 (left): Doorway at the west end of the first floor of the north internal elevation, viewed from the south-east

Plate 19 (right): General view of the east end of the north internal elevation, viewed from the south

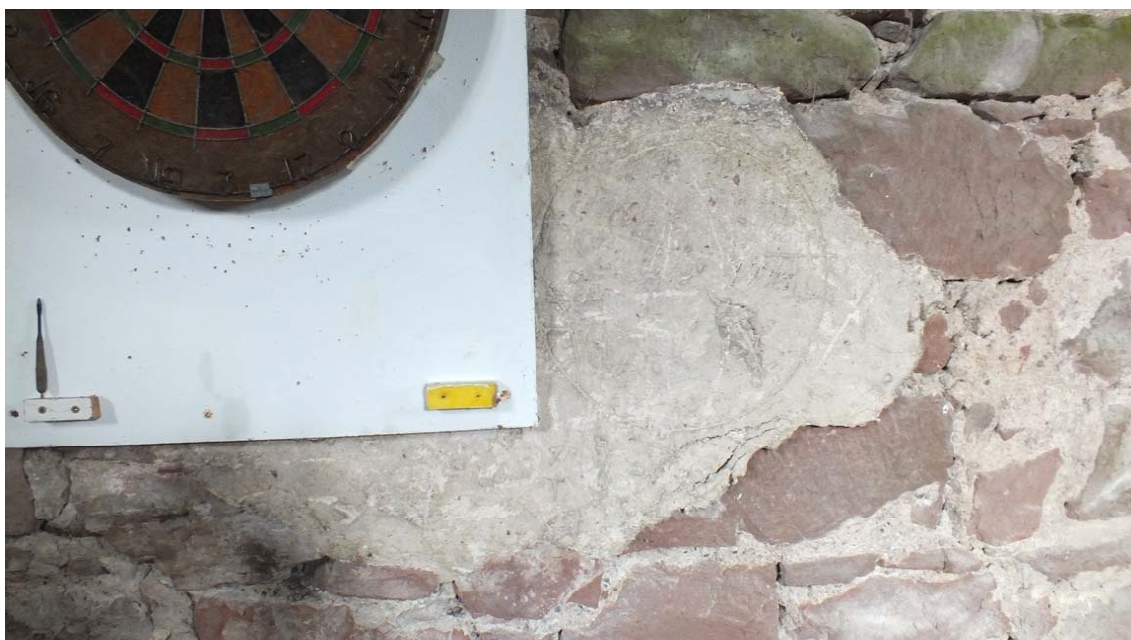
Plate 20: Graffiti circle on the west side of the first floor of the north internal elevation, viewed from the south

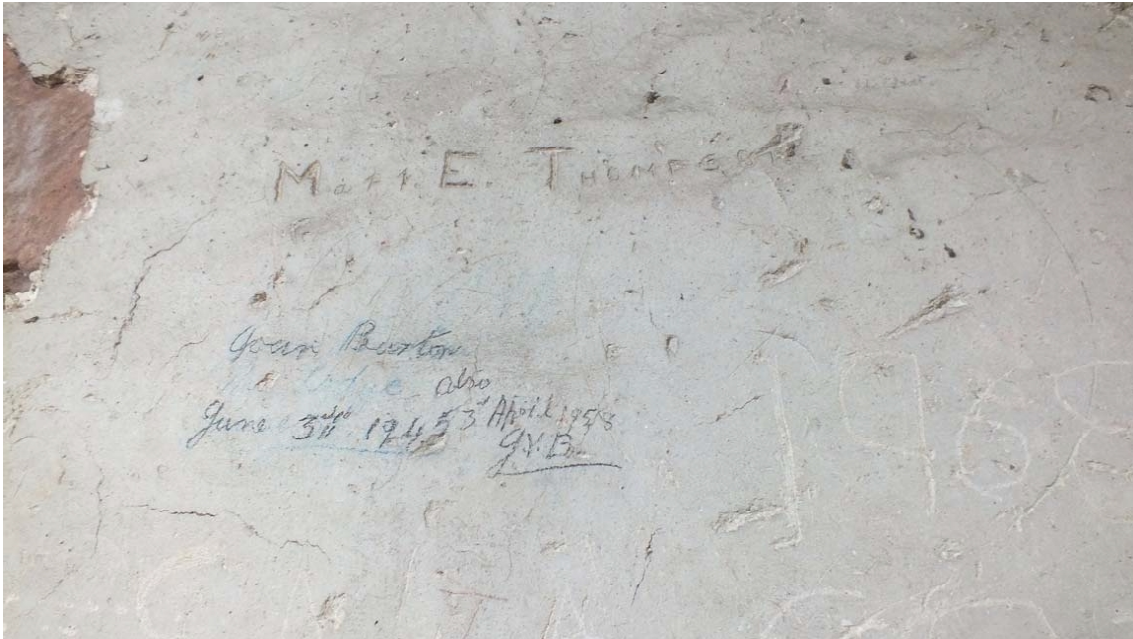
Plate 21: Example of graffiti on the east side of the first floor of the north internal elevation, viewed from the south

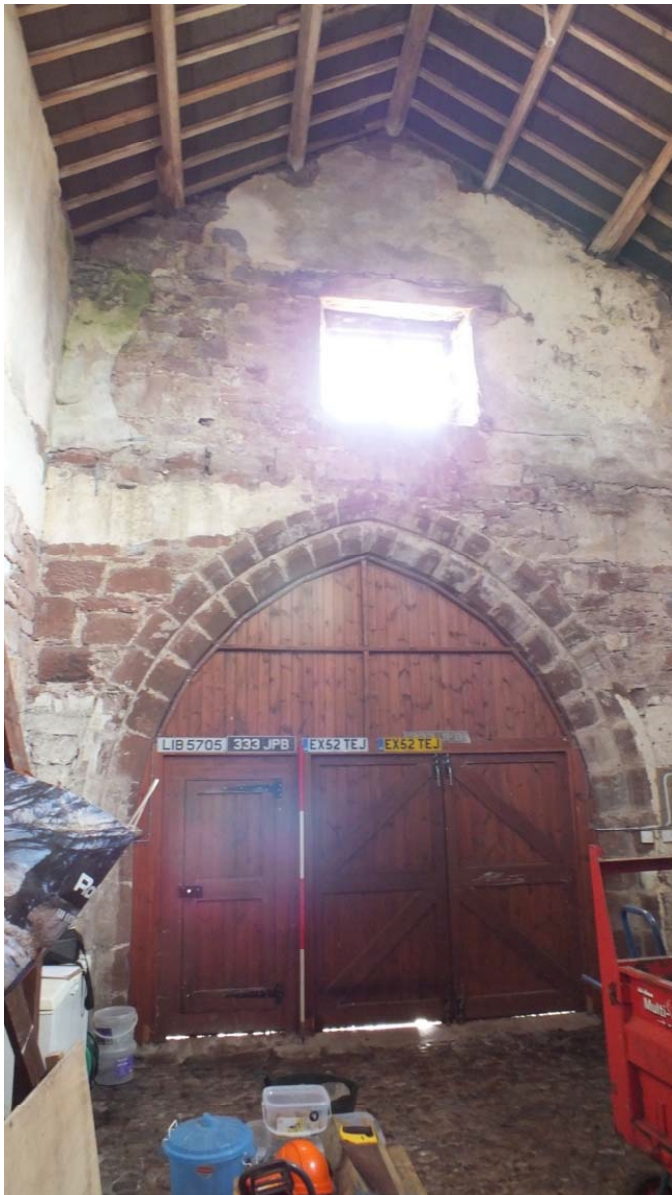
4.3.3 The east internal elevation is dominated by the large arched opening, which extends to first floor level and is finished with neatly dressed stones and has a slight plinth (Plate 22). There are various attached timber battens supporting electrical wiring and a large patch of plaster on the south side. The arched opening is filled with a modern stud wall of timber plank construction, housing a double plank and batten door, with diagonal battens, and a pedestrian plan and batten door. At first floor level there are three shallow voids on the south side cut into the stonework (Plate 23) and another cut into the north side of the arch, which evidently formed the housing for joists. At first floor level much of the wall is finished with plaster and there is a central window with a large rough timber lintel and modern two-light timber casement.

Plate 22 (left): General view of the east internal elevation, viewed from the west

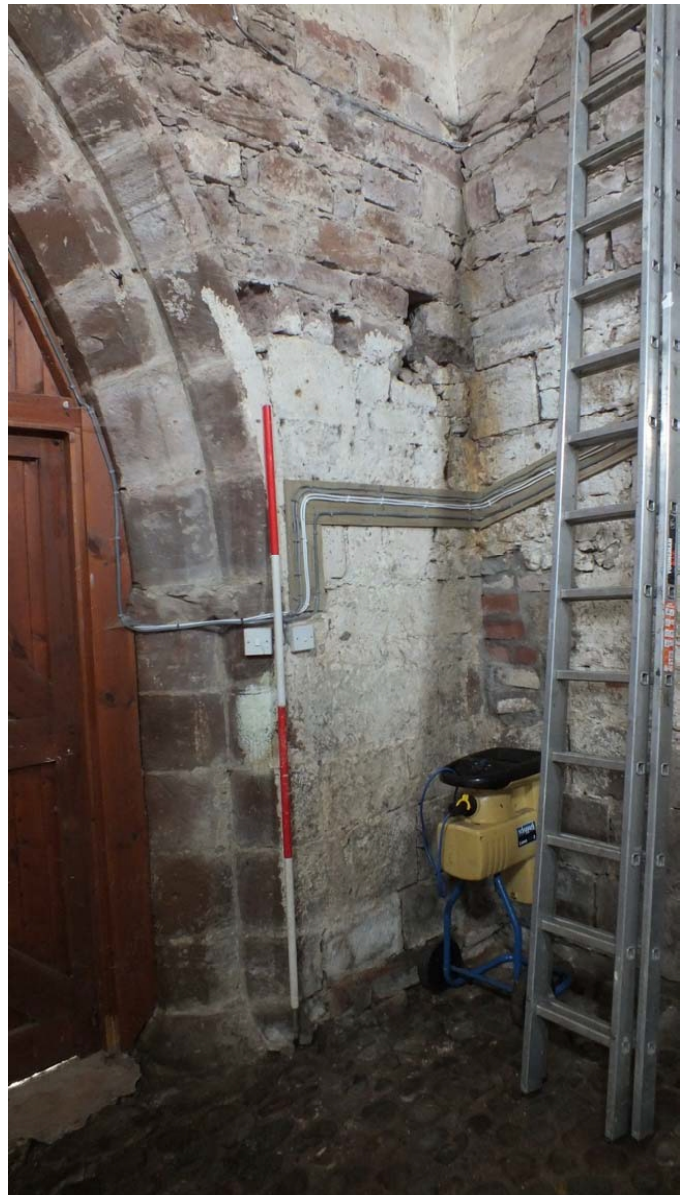
Plate 23 (right): Joist slots cut into the south side of the east internal elevation, viewed from the north-west

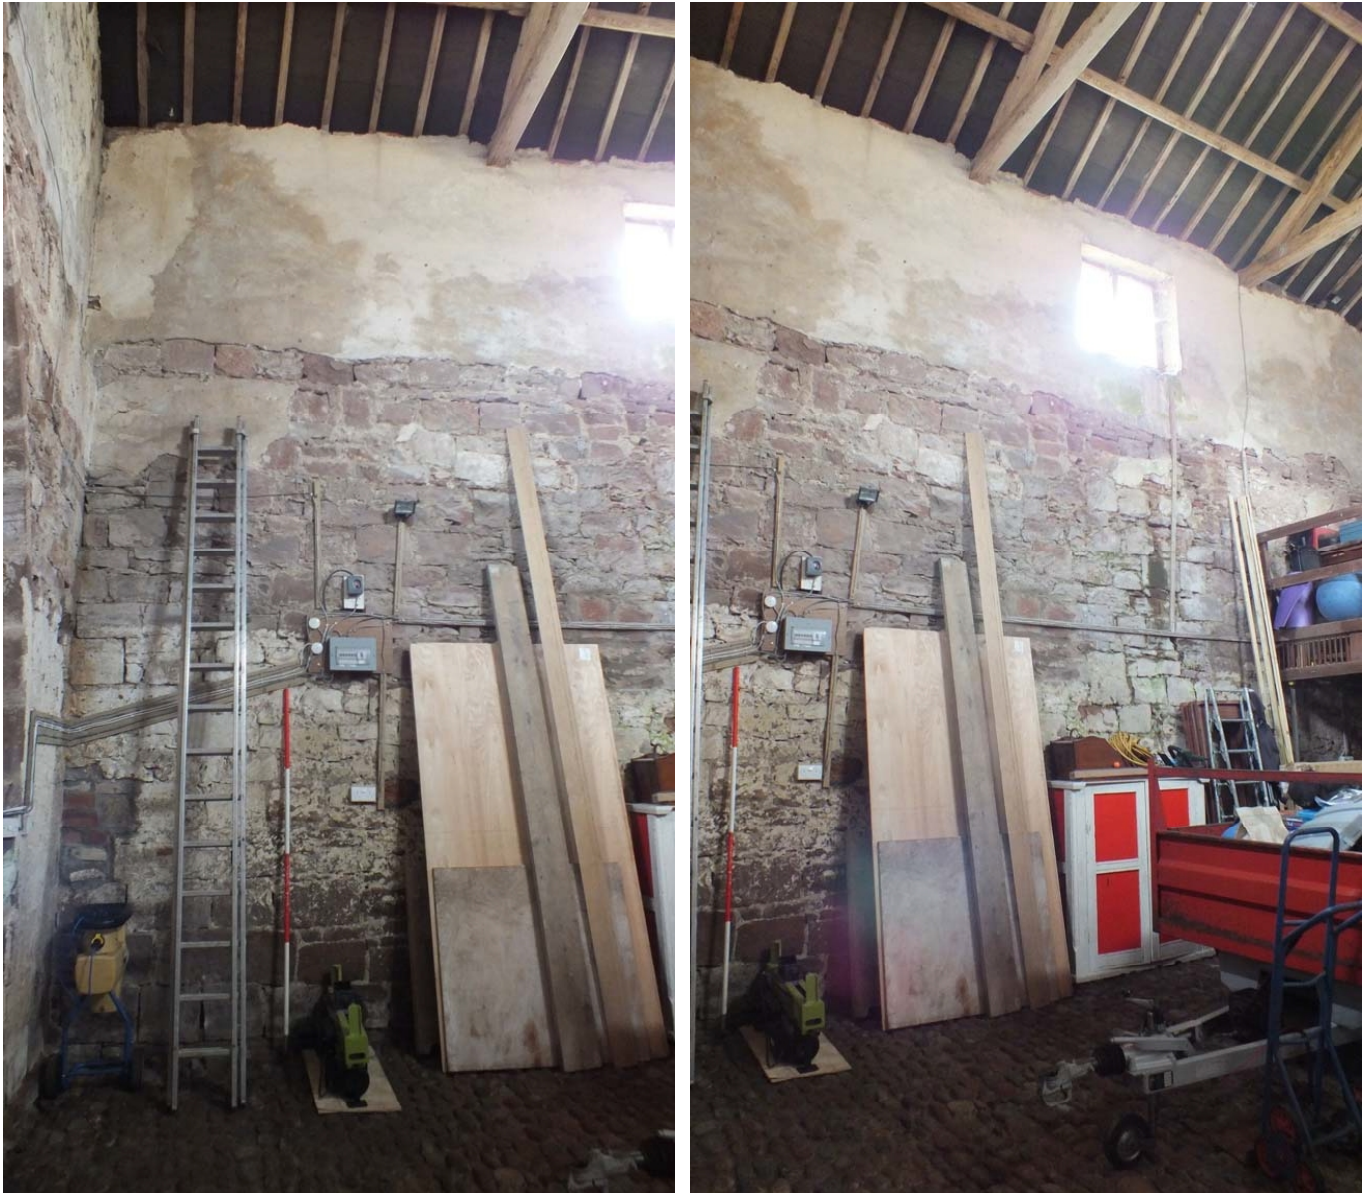
4.3.4 The lower part of the south internal elevation is relatively unremarkable, although some of the blocks have dressed notches within them but these do not appear to correspond to any obvious use. A small part of the east end has been partially rebuilt and this section incorporates red brick (Plate 24) and there are numerous attached timber battens with electrical wiring and other fixtures attached. A cupboard sat against the wall obscures a small section near the centre and there is a large void below the modern first floor that presumably houses an earlier beams. First floor level is very similar, with the modern floor and associated handrail and a fixed work bench obscuring some areas of the west end. In addition, there are three narrow openings blocked with stone just below the step for the second floor (Plate 25). The second floor is finished with plaster and has a central window with a modern two-light timber casement.

Plate 24 (left): The east side of the south internal elevation showing the brick rebuild, viewed from the north

Plate 25 (right): General view of the south internal elevation showing the blocked slots, viewed from the north-east

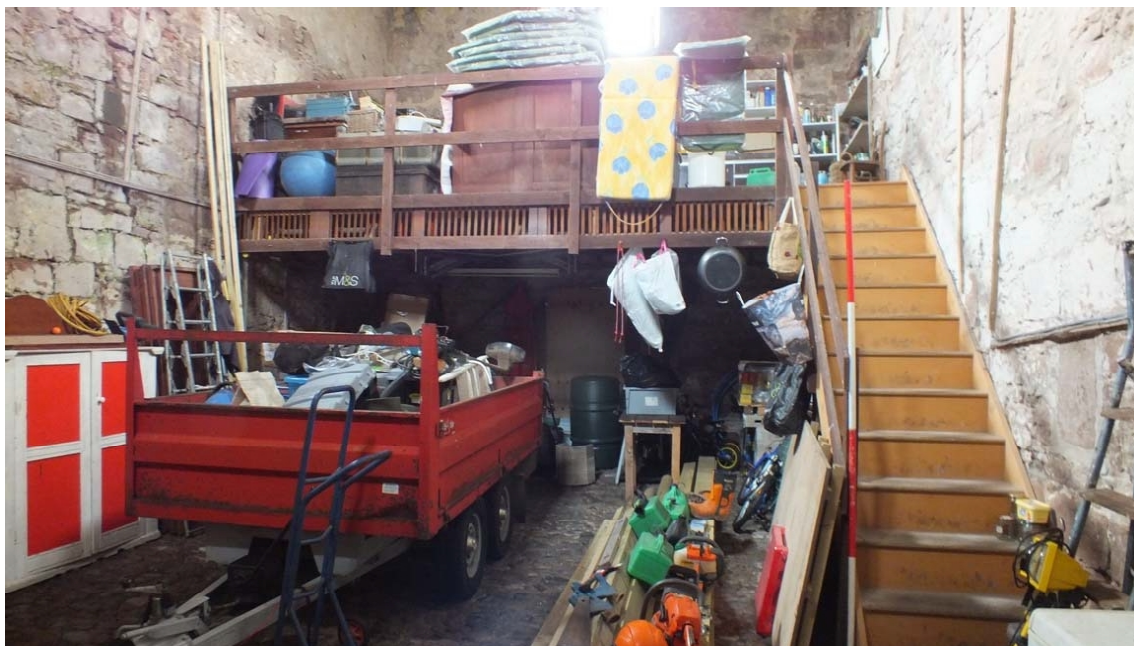
4.3.5 Much of the west internal elevation is obscured by lime wash and attached fixtures (Plate 26), but the lower level has the outer edge of the large arched opening visible, which has been blocked with fairly random courses and incorporates a smaller pedestrian doorway. This has a piece of plywood fixed over it but clearly has dressed square surrounds (Plate 27). At first floor level there is further attached furniture obscuring much of the wall, and above this the second floor level is largely finished with plaster and has a central window with a large timber lintel and modern two-light timber casement.

Plate 26: General view of the west internal elevation, viewed from the east

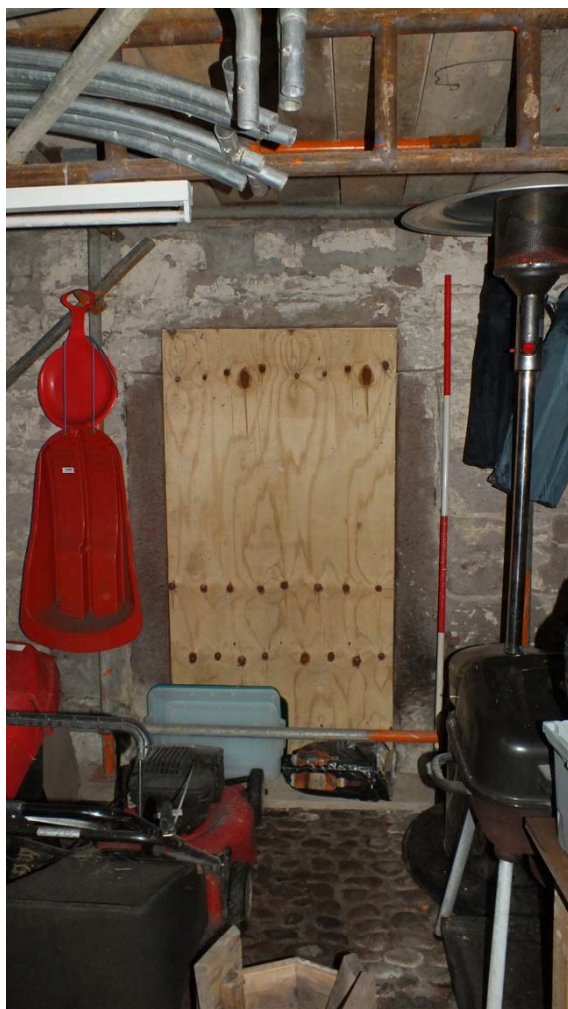
Plate 27: the pedestrian doorway in the centre of the west internal elevation, viewed from the east

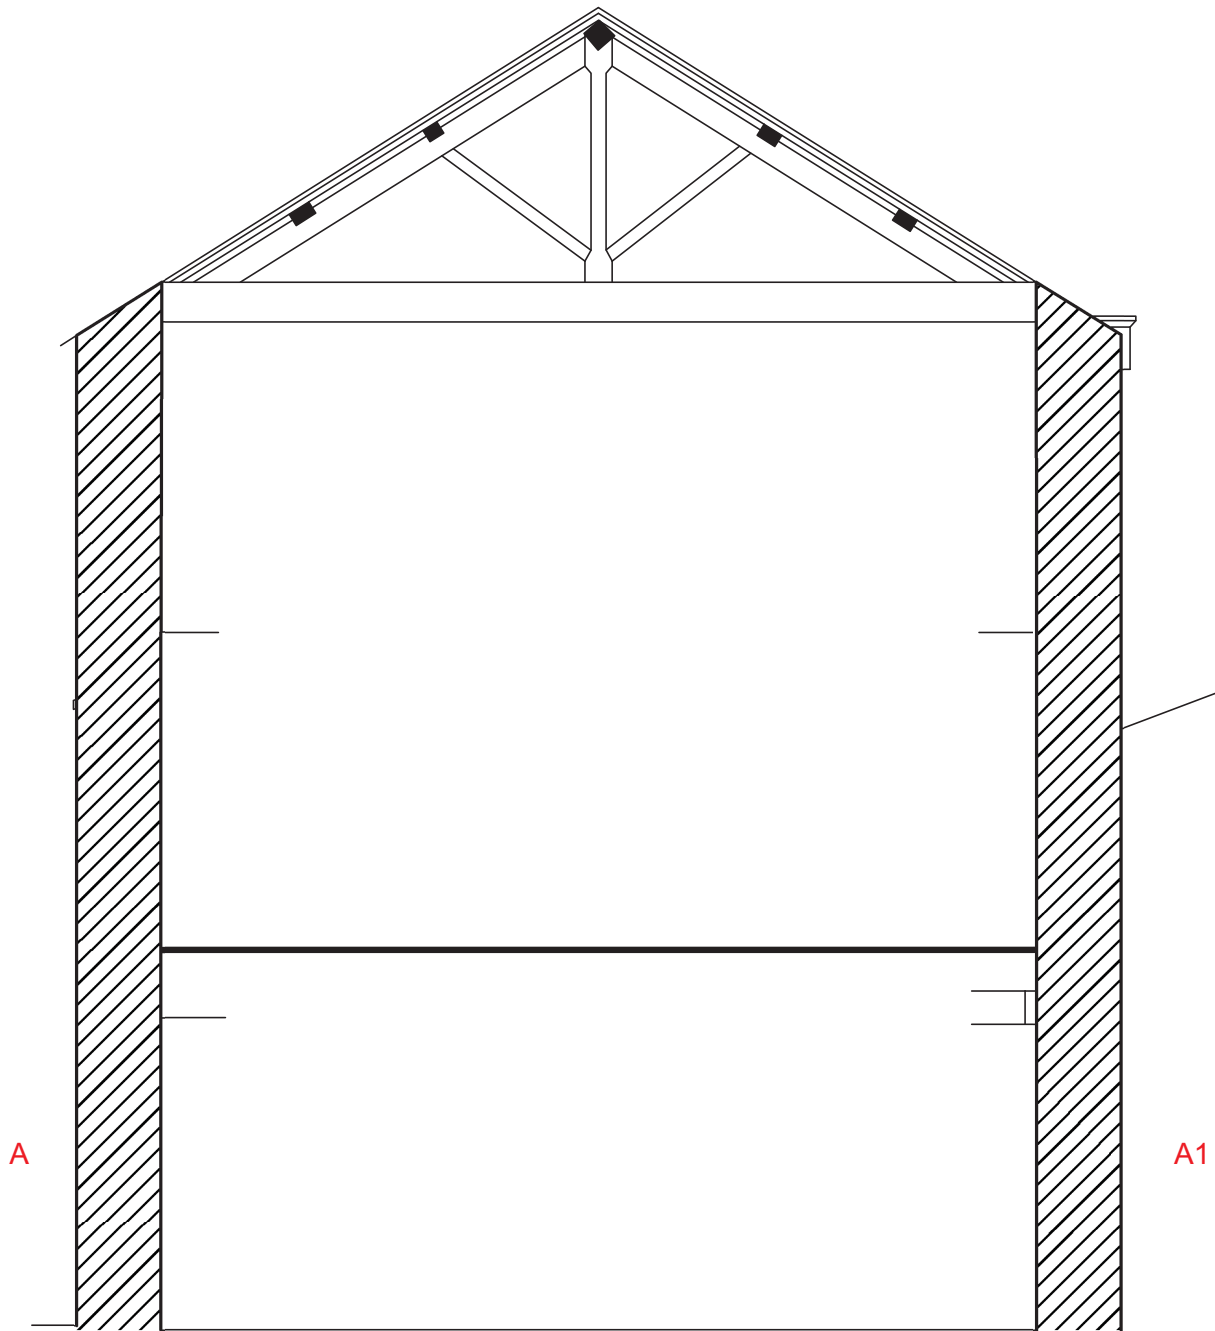
Figure 7: Cross-section A-A1

- iv. internal elevations at 1: 100 (Figure 5 and Figure 6);
 - v. a cross-section showing the detail of the truss at 1:50 (Figure 7).
