BARN AT WHITTINGTON FARM, MAIN STREET, WHITTINGTON, LANCASHIRE

Archaeological Building Recording

Client: Mr and Mrs Mackereth

March 2019

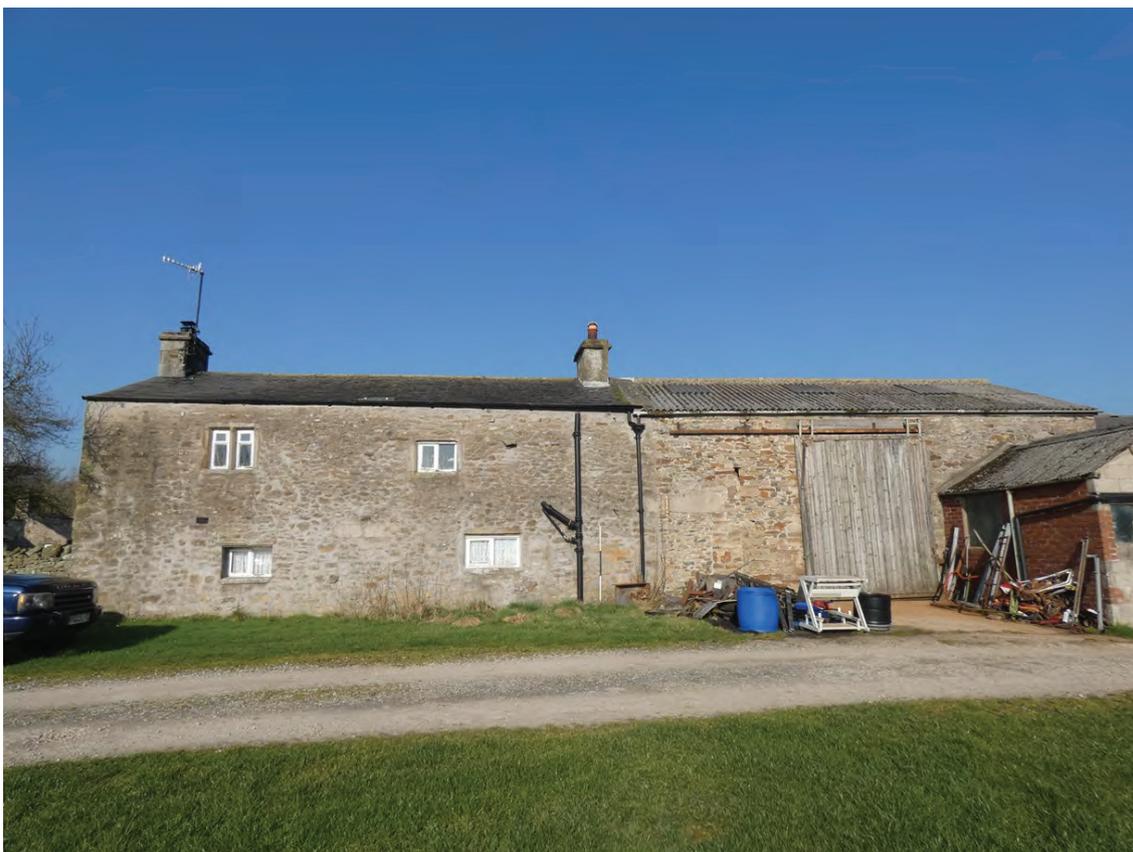
1.2.1 The barn at Whittington Farm is located on the east side of the centre of Whittington, at a height of approximately 40m AOD. It is attached to a cottage at its south-west end called Wayside, which is now a separate property to Whittington Farm. Both Wayside and Whittington Farm at Grade II Listed Buildings (see *Appendix 1*).

Plate 1: The barn in relation to the cottage to the south-west, viewed from the south-east

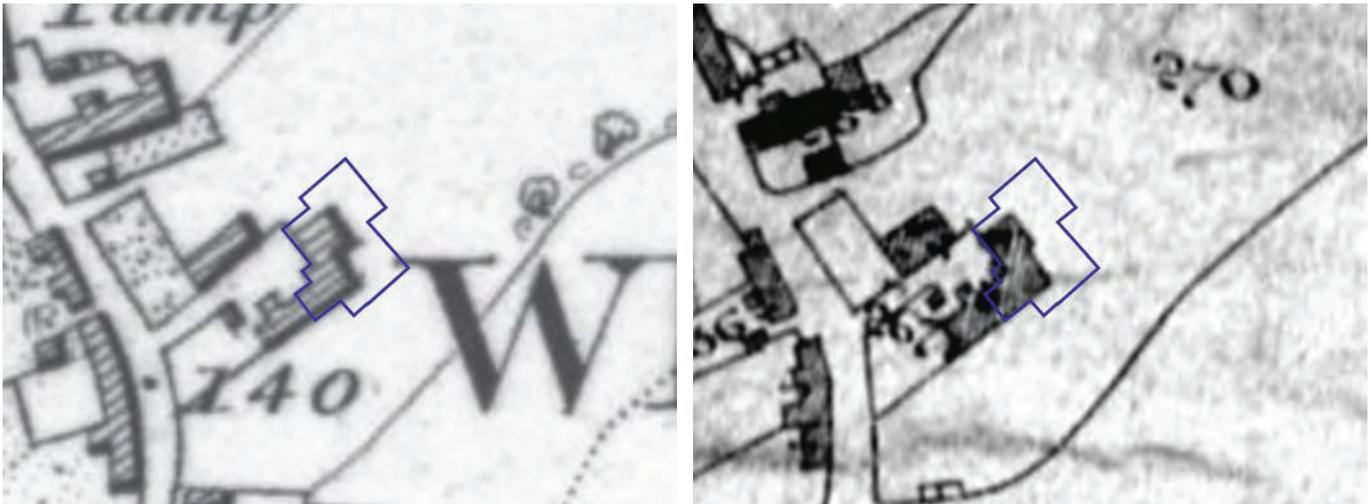
3.1.2 **Ordnance Survey 1847:** somewhat unusually, the first detailed map of the site is the first edition six inch Ordnance Survey map of 1847, which was surveyed in 1844-5. This appears to show a courtyard arrangement with the southeast range of buildings having a small extension to the northwest, and two extensions to the north (or possibly an extension linking an existing building further north). There is a simple rectangular building along the northwest side of the courtyard, and a small building to the west of the southeast range.

3.1.3 **Tithe map 1849:** the tithe map is at a larger scale than the Ordnance Survey map that immediately preceded it. The tithe map appears to show a very similar courtyard arrangement to that shown on the Ordnance Survey six inch map, although the northwest building appears to have doubled in size with an extension to the north. For the courtyard arrangement from the tithe map and associated apportionment, the landowner is Butler Thornton, and the occupier is Edward Birkett (PRO IR 29/18/335 1848, 14). Edward Birkett is evidently a farmer who occupies 15 fields and two collections of buildings. His main residence is Whittington Farm (although the farm name is not given) - plot number 266 of the tithe map, which is described in the apportionment as *House, Outbuildings, Garden, Fold, &c.* The second group of buildings that he occupies as part of the farm is plot 267 (Wayside, although again the building name is not given), which is described as *Cottages, Fold, &c.*

Plate 2 (left): Extract from the 1st edition 6 inch Ordnance Survey map of 1847

Plate 3 (right): Extract from Whittington tithe map of 1849, showing the site (plot 267) and Whittington Farm to the south (plot 266) (PRO IR 30/18/335 1849)

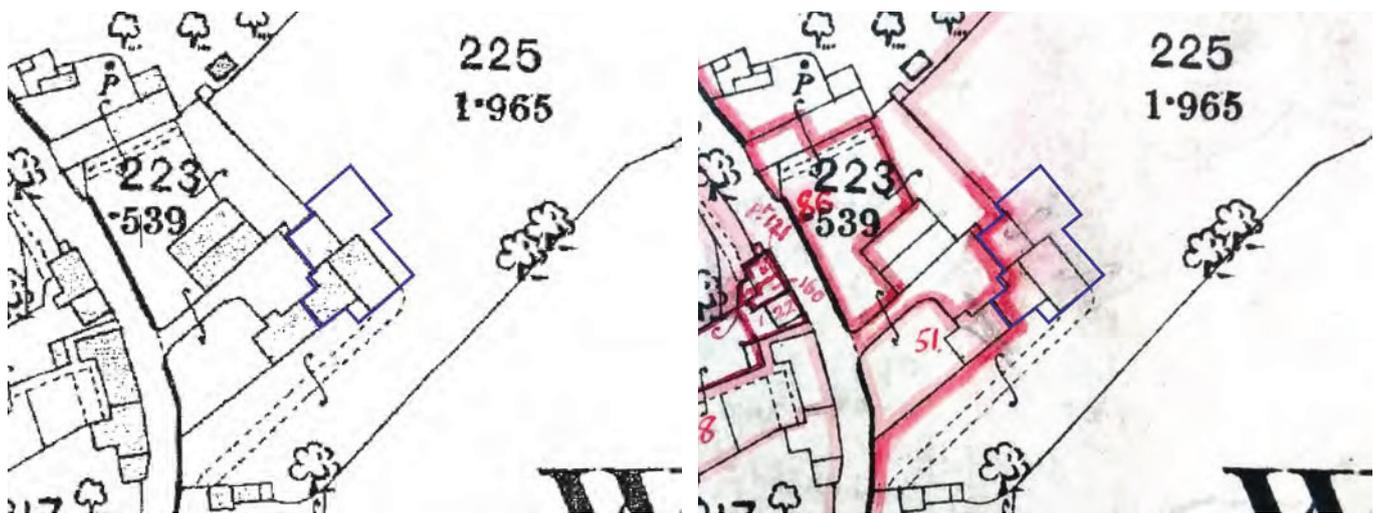
3.1.4 **Ordnance Survey 1891:** this is the first edition 25 inch Ordnance Survey map, and there are some definite changes that can be seen to the farm buildings around the Wayside courtyard when compared with the earlier tithe map. The main change is an extension to the southeast range of buildings by the addition of a northwest/southeast orientated building to the northeast end of the range, with a track added linking this new building to the courtyard of Whittington Farm, to the south. The small building on its own to the west of the Wayside range has now been demolished. The land divisions to the north Wayside courtyard have changed significantly.

3.1.5 **Land Valuation 1910:** this map shows what is now called Wayside as part of Plot 51, and what is now Whittington Farm and the barn attached to Wayside part of Plot 85. Both plots are owned by H. Dawson-Greene, and Wayside is described as a cottage and land, occupied by Thomas Tallon, whilst Whittington Farm is described as a house and agricultural land, occupied by William Lund (LRO DVLA 1/7/11 1910).

Plate 4 (left): Extract from the 1st edition 25 inch Ordnance Survey map of 1891

Plate 5 (right): Extract from the same map as Plate 3, but with 1910 valuation annotations (LRO DVLA 2/1 XIX.8 1910)

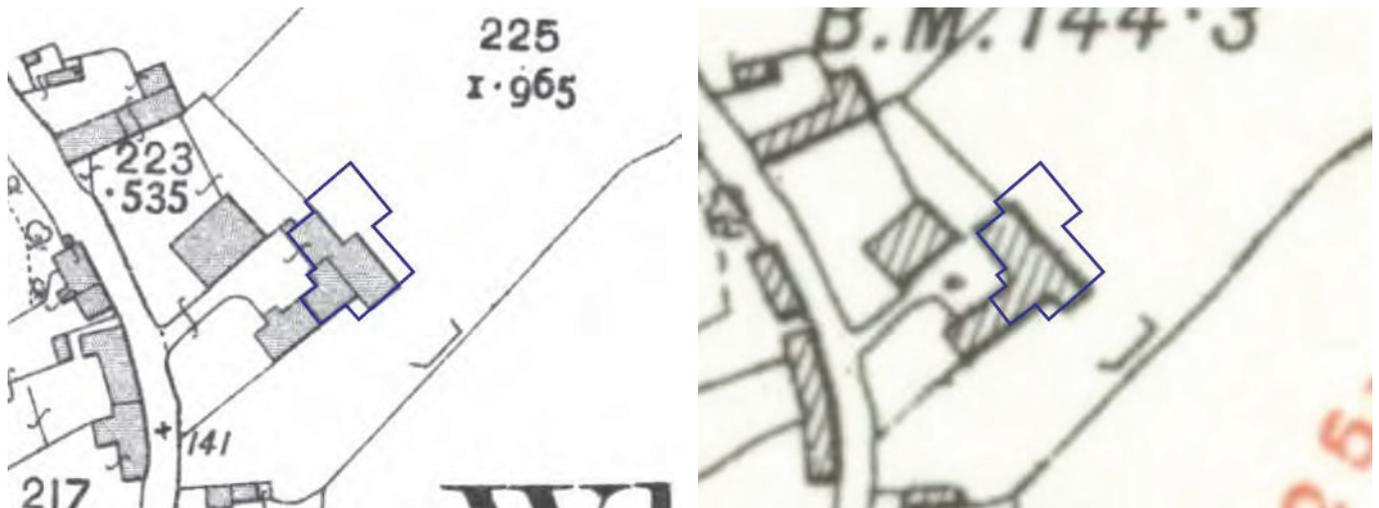
3.1.6 **Ordnance Survey 1913:** this map does not show any major changes compared with the previous Ordnance Survey map.

3.1.7 **Ordnance Survey 1919:** this is a six inch map, and therefore much less detailed than the previous three maps. It does not show any major changes.

Plate 6 (left): Extract from the 2nd edition 25 inch Ordnance Survey map of 1913

Plate 7 (right): Extract from the 4th edition 6 inch Ordnance Survey map of 1919

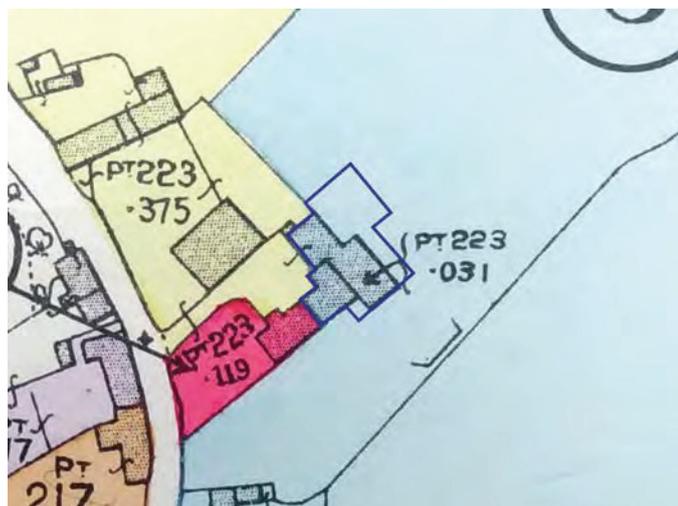
3.1.8 **Sales particulars 1924:** there are three lots in the sale of the Whittington Hall Estate that are very close to the site (LRO DDGR Est 1924 and LRO DDHH 1/963 1924). Lot 3 (in blue), Whittington Farm, includes the site barn, and that part of Ordnance Survey number 223 within Lot 3 is described as 'Barn and Shippon'; Lot 7 (in yellow), Harrisons Farm, is the farm immediately to the north, and includes the barn that appeared from the maps to form the north-western range of buildings on the courtyard; and Lot 8 (in red) is Wayside. The Heritage Statement records that when the estate was sold in 1924, Whittington Farm was not bought by the buyers of the main estate (JWRC 2015, 7).

Plate 8 (left): Detailed map from the 1924 Whittington Hall Estate sales particulars (LRO DDGR Est 1924)

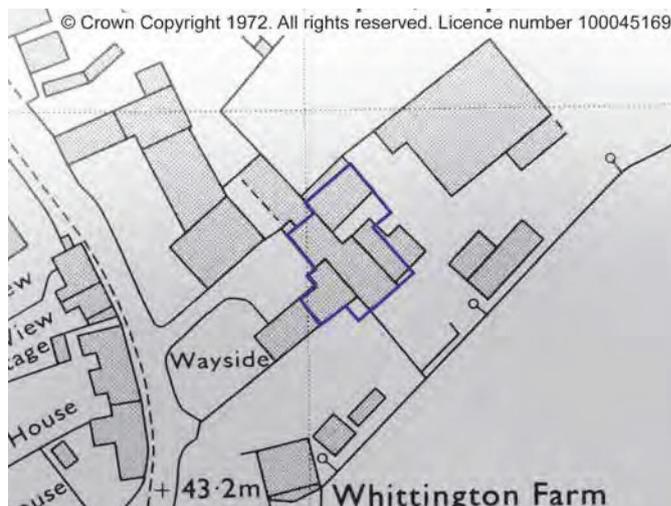
3.1.9 **Ordnance Survey 1972:** this is the first map to name all the buildings – Whittington Farm, Wayside, and Harrison Farm to the north. It can be seen that lots of buildings have been added to the northeast of the barn site.

Plate 9 (right): Extract from the Ordnance Survey map of 1972

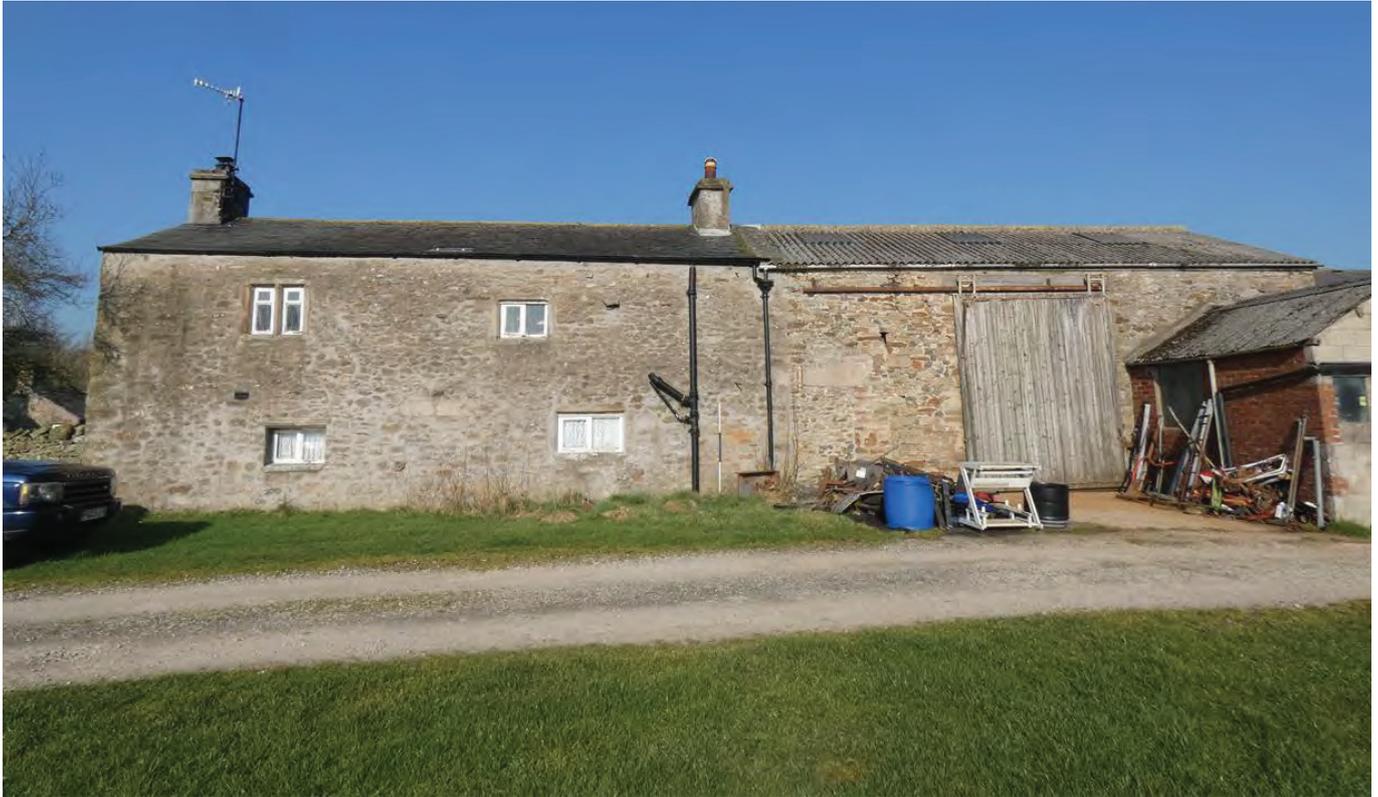
4.1.1 **Arrangement:** the building comprises an essentially L-shaped range, the main part orientated north-east/south-west, butting against an earlier cottage (Wayside) at the south-west end (Plate 10) and considerably wider at the north-east end, where it has been further extended to the north-west by a modern concrete block and corrugated sheet shed. It is on the opposite side of an open yard to the main farmhouse at Whittington Farm, which is to the south-east. Further modern farm buildings have been constructed to the north-east and north-west of the barn.

Plate 10: The south-east external elevation of the barn showing the relationship to the adjoining cottage, viewed from the south-east

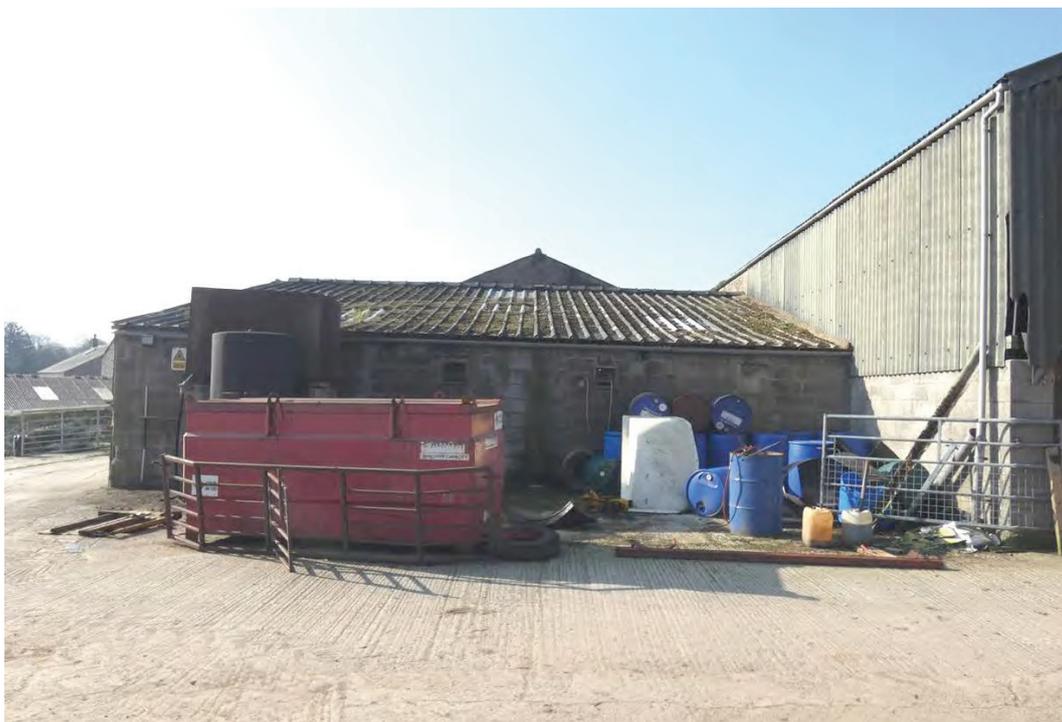
4.2.1 **North-east external elevation:** this is partly covered on the south-east side by a concrete structure supporting a fuel tank. The bulk of the elevation proper comprises the concrete block extension and the steel frame shed to the north-west (Plate 11). The concrete block section has a row of four square vents (one of which is obscured by the fuel tank), all of which have iron surrounds; those at either end are blocked with concrete while the other two have timber slats inside. Above this section the gable of the earlier barn is visible; it is finished with concrete render. The elevation is continued to the north-west by a range of modern sheds constructed from corrugated sheeting on a low concrete block wall; this has a wide doorway on the south-west side and is further continued to the north-west by an open-fronted shed of similar style (Plate 12).

Plate 11: The south-east end of the north-east external elevation, viewed from the north-east

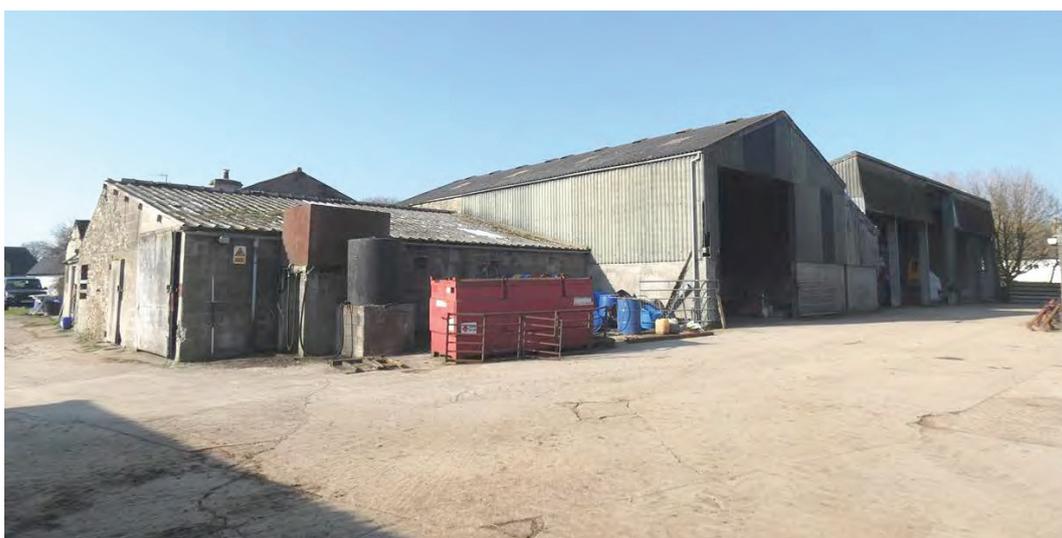
Plate 12: The north-east external elevation viewed from the east showing the modern extension to the north-west

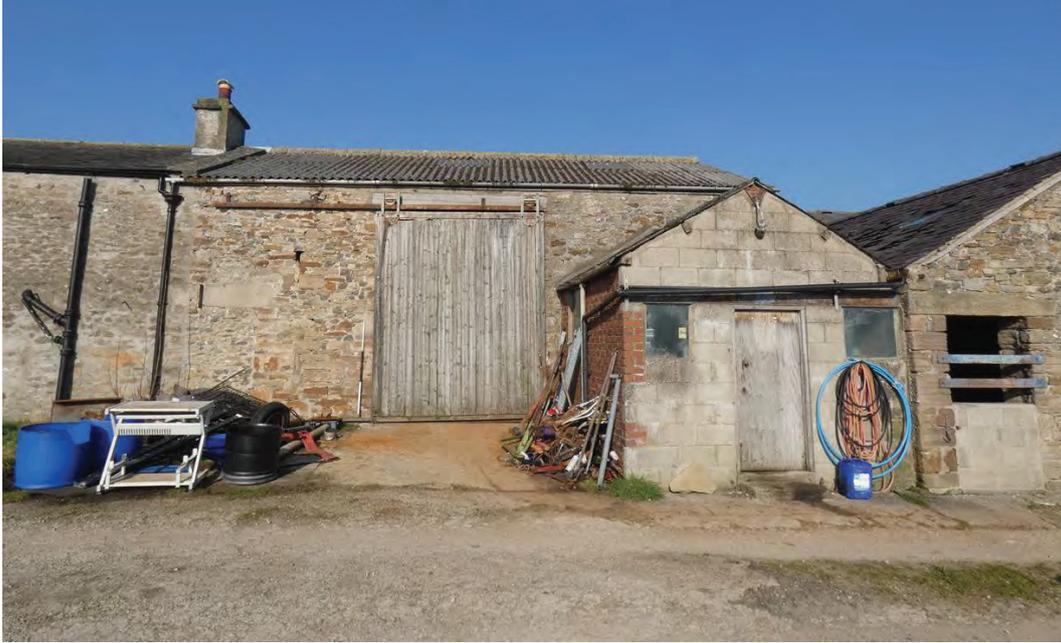
4.2.2 South-east external elevation: the south-west end is clearly butting against the neighbouring cottage and is constructed from rough course of gritstone with a doorway on the south-west side that has a large stone lintel and is blocked with stone (Plate 13). To the north-east of this there is a ventilation slot, also blocked with stone, and possibly another below, beyond which is a large wagon doorway with a tongue and groove plank and batten sliding door on an iron rail and with a machine cut timber lintel. To the north-east of this the wall returns with the side of a small outshut built of machine made red brick, although with quoins in concrete block at the south-east end, and with a window with a single light fixed casement (Plate 14). After the return again to the north-east this end of the elevation is formed by two low gables (Plate 15), the south-east constructed from concrete blocks with red brick 'quoins' on the south-west side and two windows with single-light fixed casements either side of a central doorway with a very plain single panel door. All of the openings share a single iron I-beam lintel. The gable to the north-east projects slightly and has large dressed stones forming quoins on its south-west side, which continue into the jamb of a doorway with a heavy stone lintel, the lower part of which is blocked with

concrete blocks and there are two iron bands across the upper part. To the north-east there is another doorway the jambs of which are finished with concrete and which has a thin stone lintel and modern timber sheet door. In the apex of this gable there is a small owl hole with timber surround and thin stone sill. What was presumably the original end of the building has been extended to the north-east with a section built of concrete blocks. This has a further much wider doorway with an iron I-beam lintel and modern timber sheet door. The elevation is further extended at the north-east end by the addition of a concrete block structure supporting a fuel tank.

Plate 13 (left): The south-west end of the south-east external elevation, viewed from the south-east

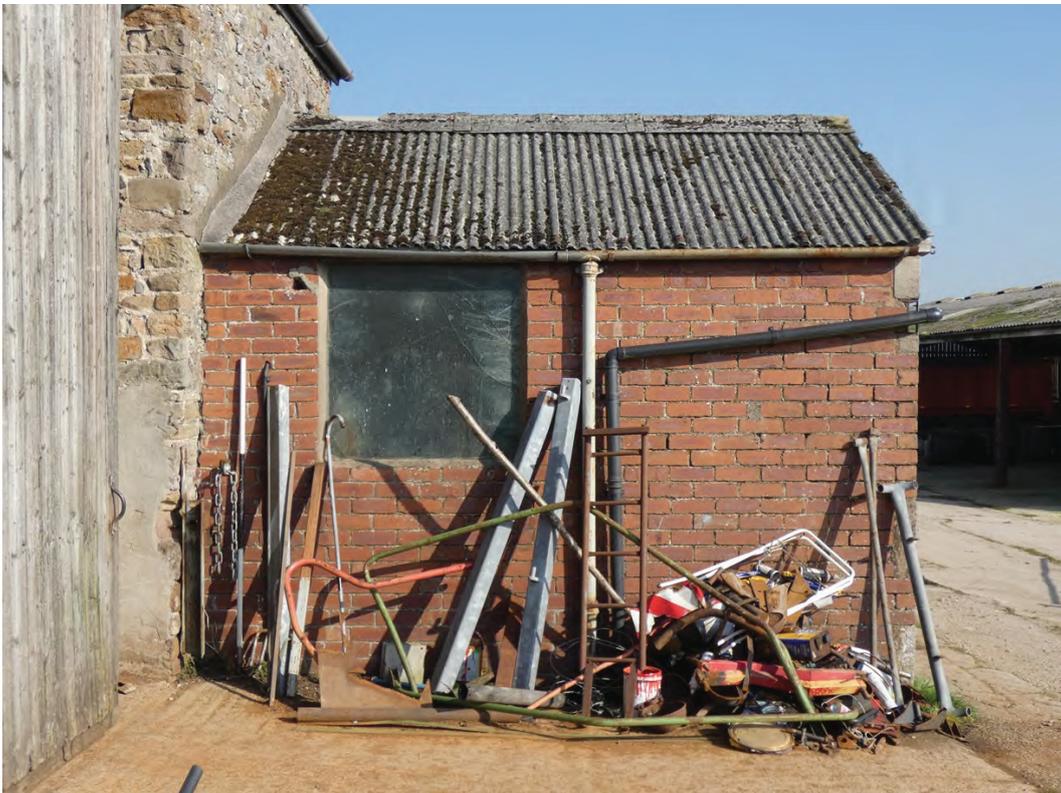
Plate 14 (right): The return to the south-east of the south-east external elevation, viewed from the south-west

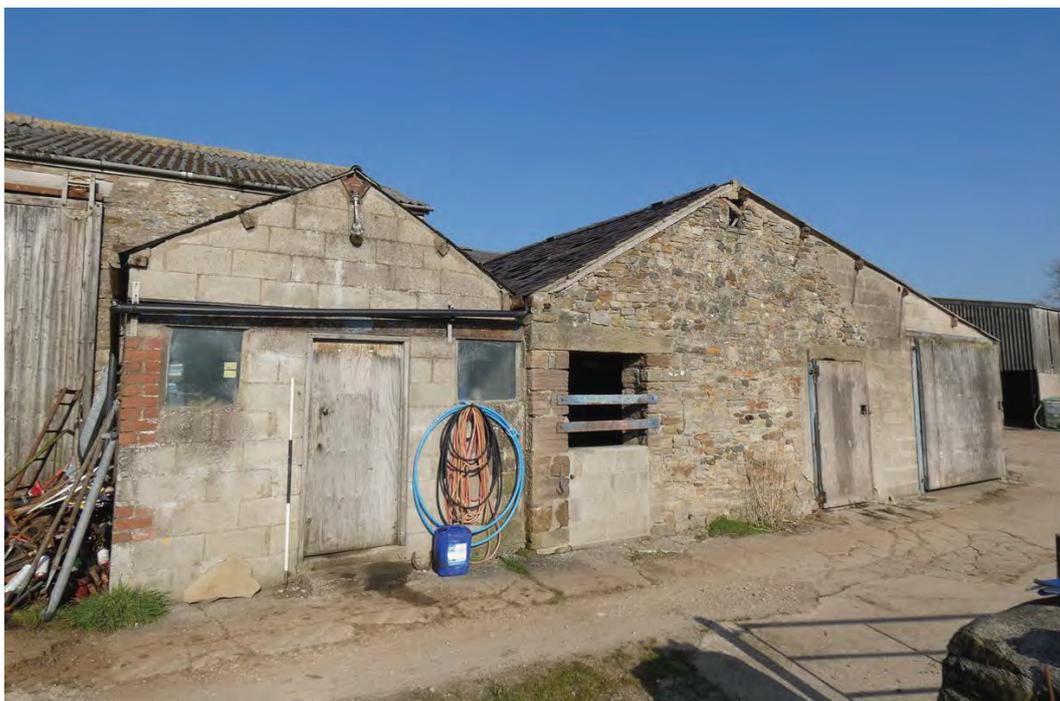
Plate 15: The north-east end of the south-east external elevation, viewed from the east

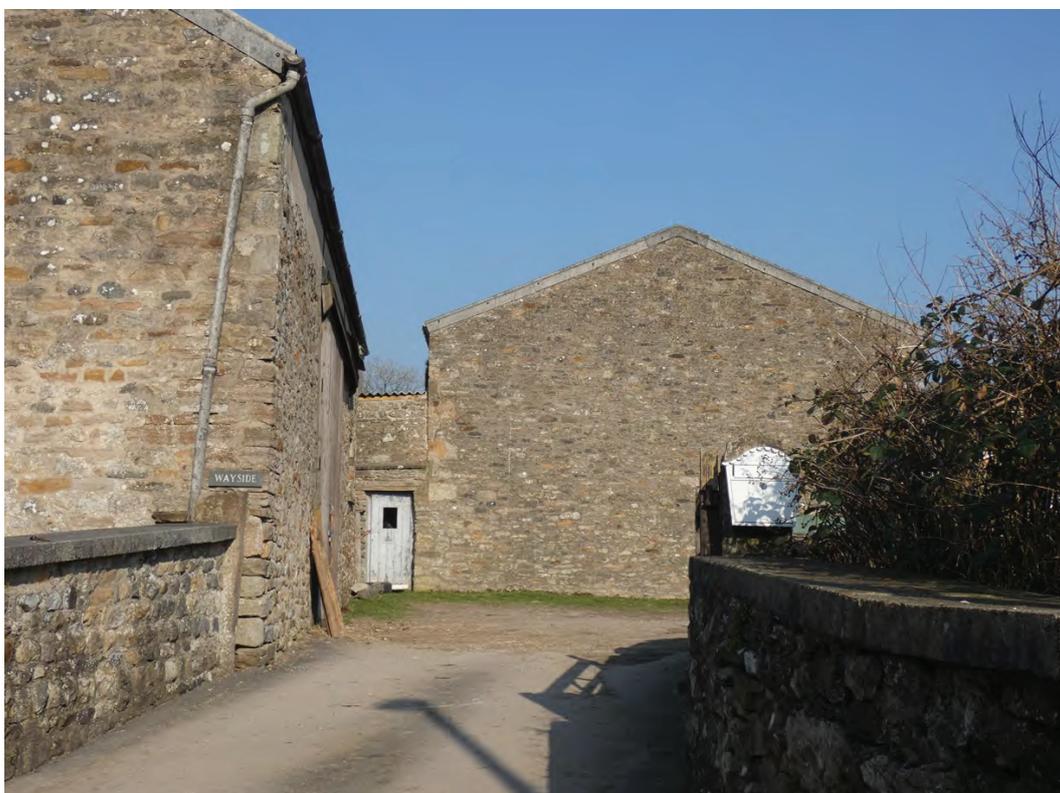
4.2.3 **South-west external elevation:** this could not be fully accessed but part of it could be viewed from the entrance drive to the adjoining property. This showed that the north-west side of the elevation comprised a large gable constructed in stone with dressed quoins (Plate 16). This was extended on the north-west side by a flat roofed addition, the south-east end of which was constructed from stone and had a doorway, although the rest was open fronted and not otherwise accessible.

Plate 16: The north-west end of the south-west external elevation, viewed from the south-west

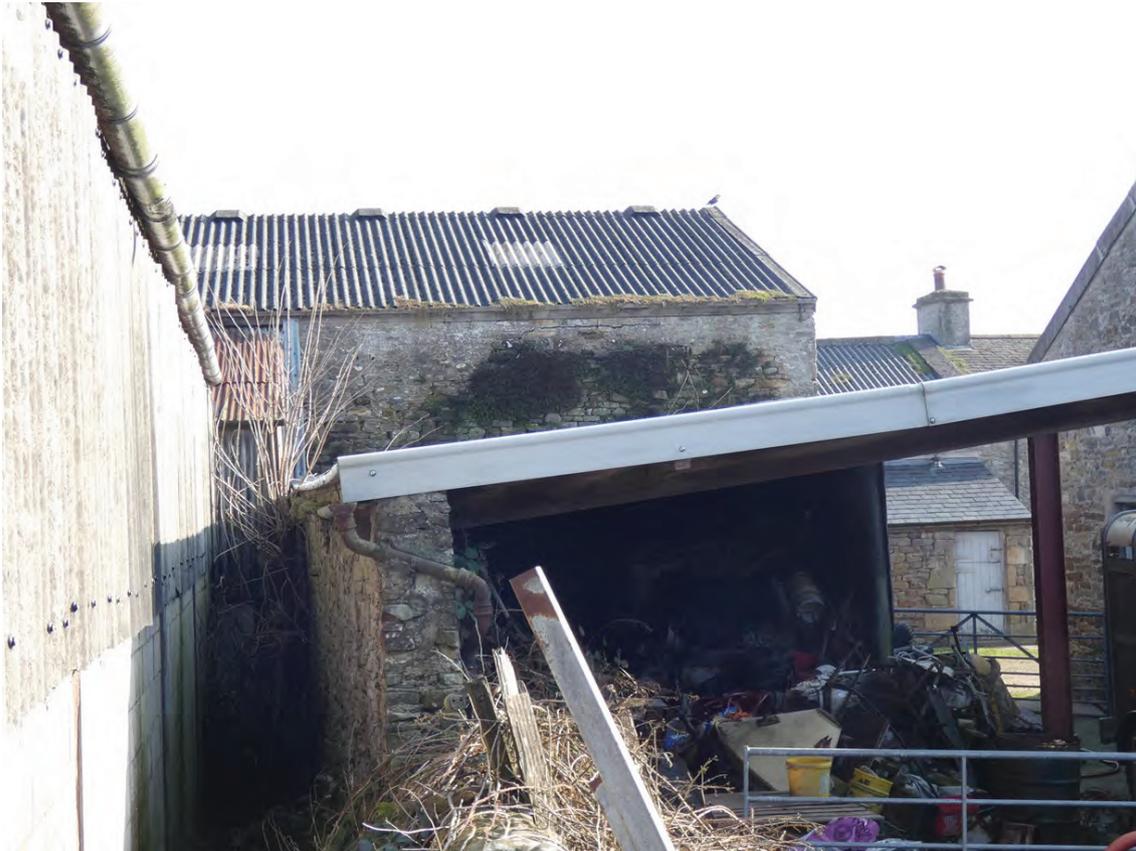
4.2.4 **North-west external elevation:** this also could not be fully accessed and was largely obscured by an adjoining open-fronted shed but it was evident that the return on the north-east side was constructed from stone and essentially plain (Plate 17).

Plate 17: The north-east end of the north-west external elevation

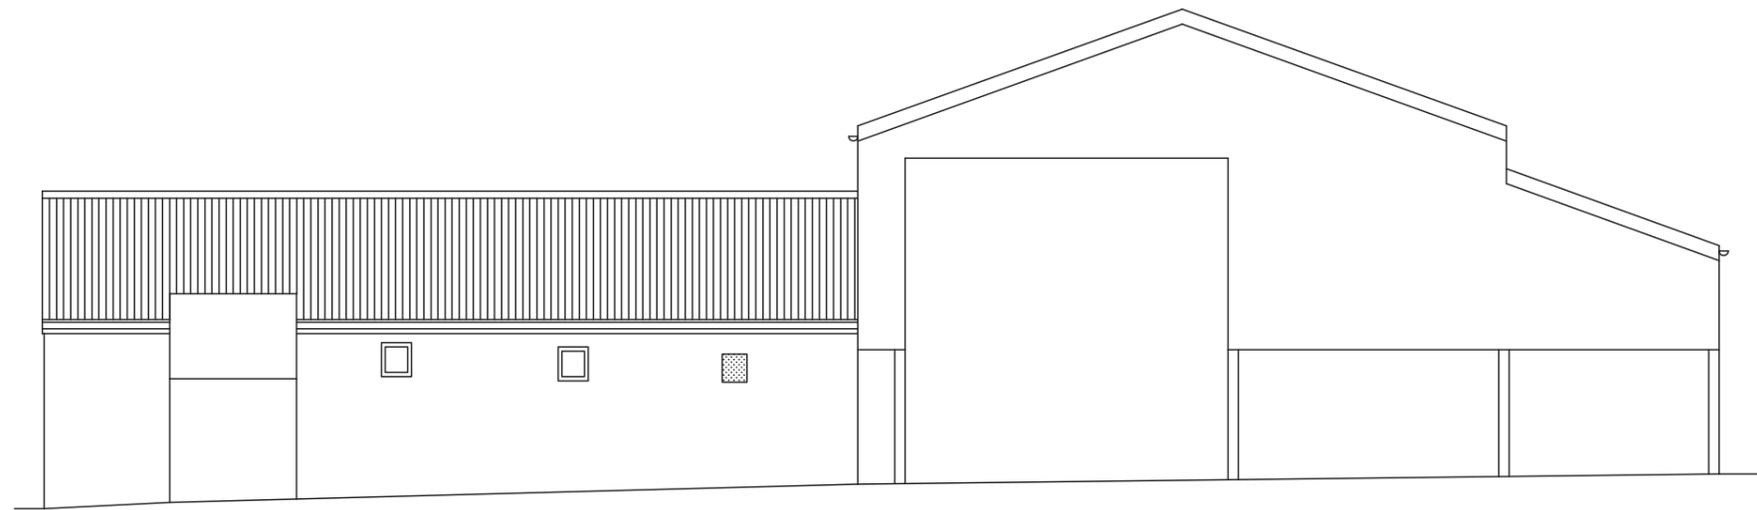
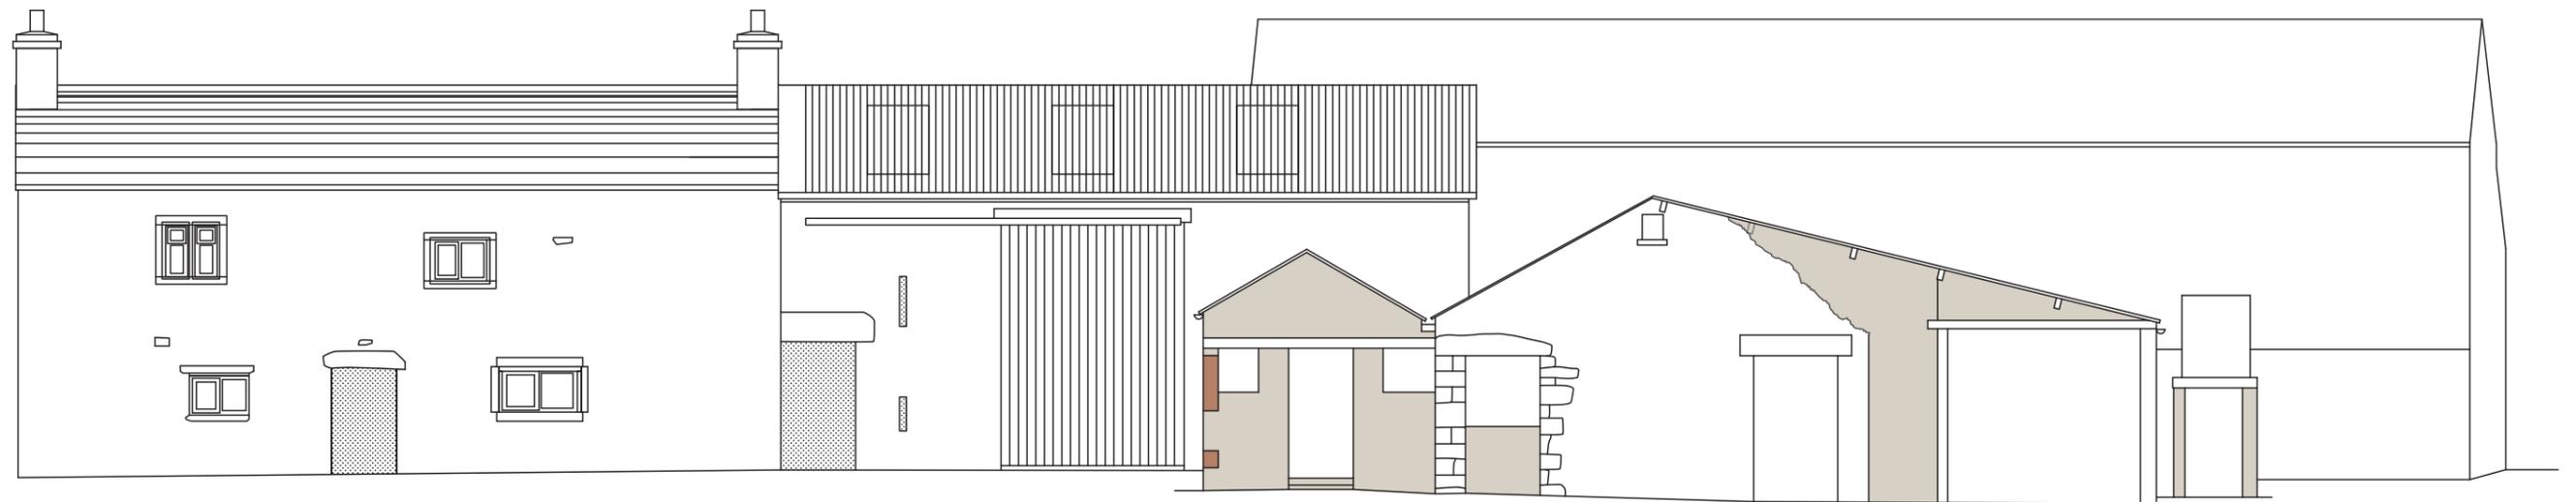
Figure 2: North-east and south-east external elevations

NORTH-EAST EXTERNAL ELEVATION

SOUTH-EAST EXTERNAL ELEVATION

house - not surveyed in detail

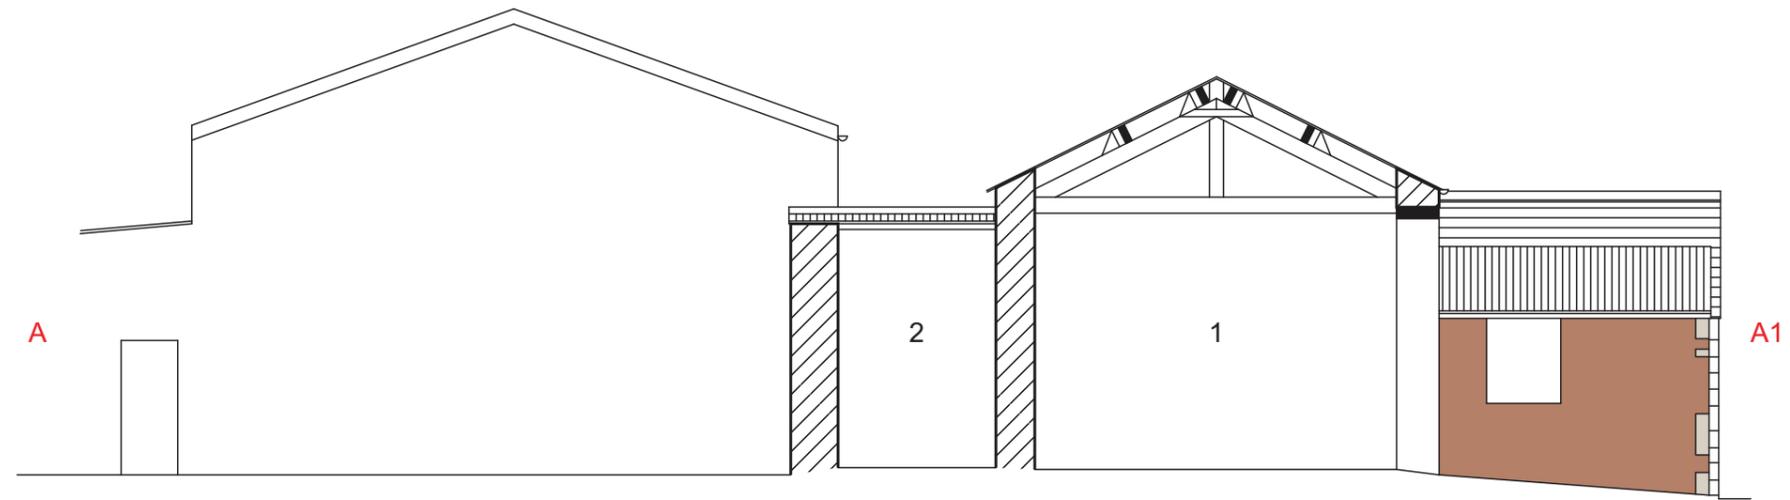
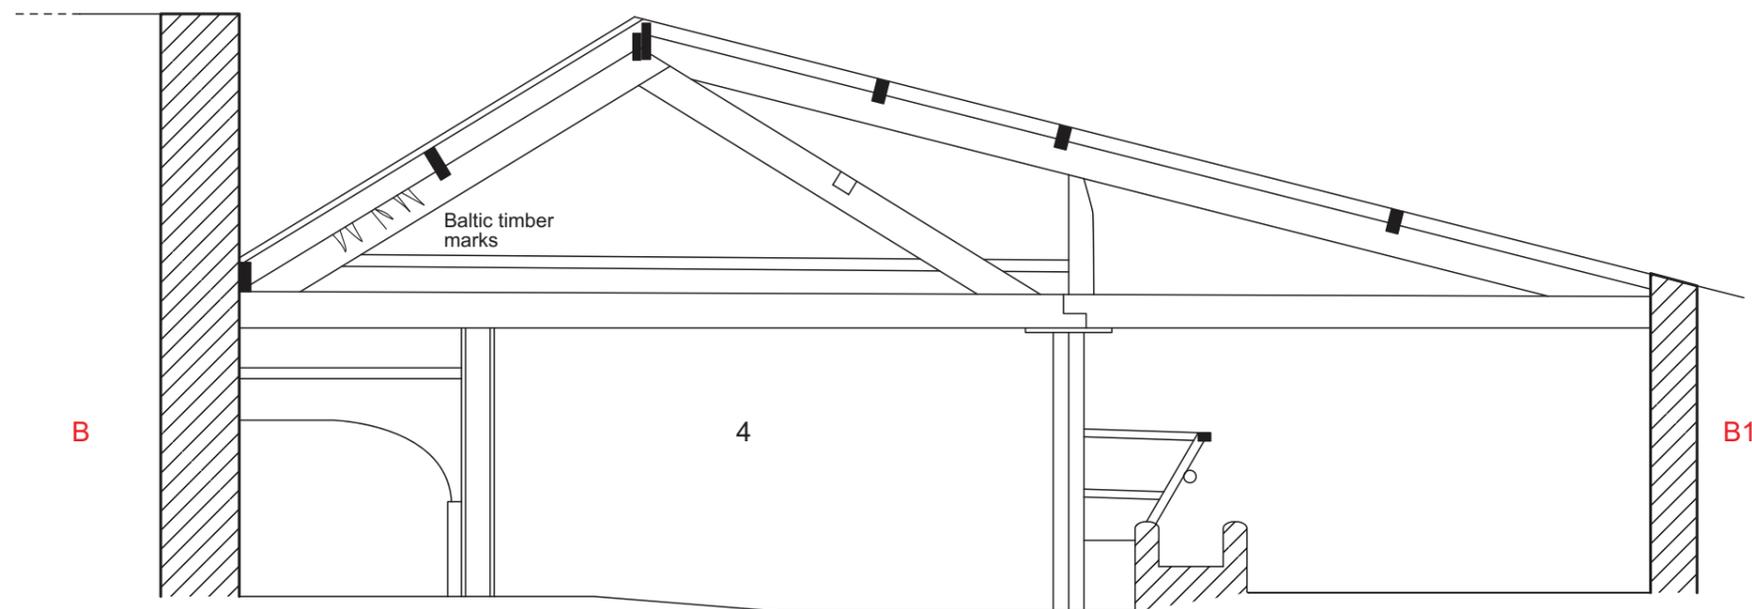
Figure 3: Sections A-A1 and B-B1

Key: concrete block brick cross-sectional timber cross-sectional wall 2 room number

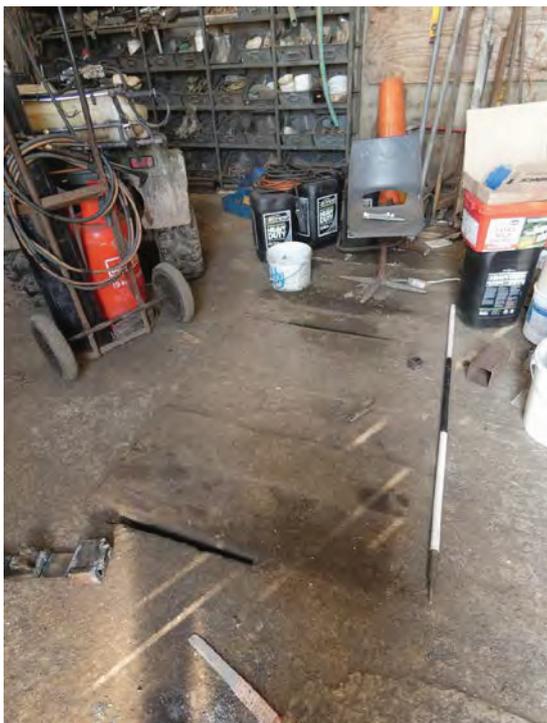
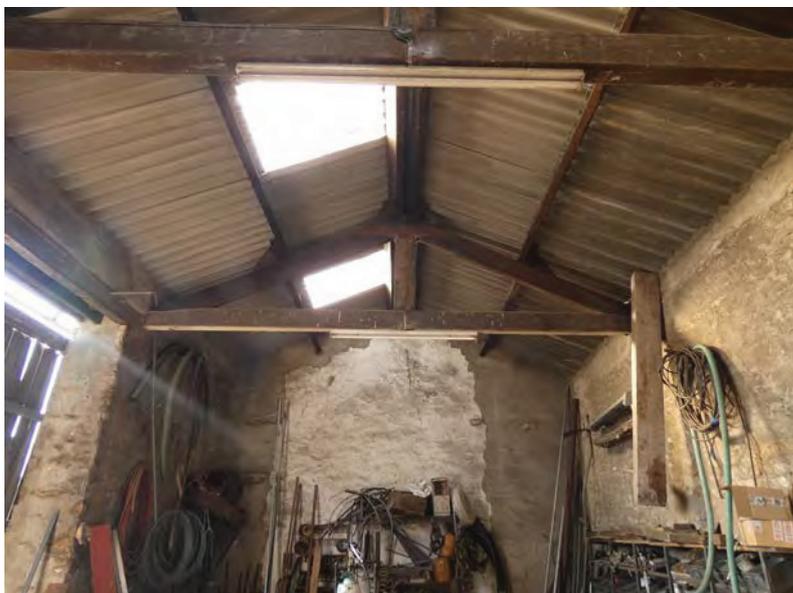
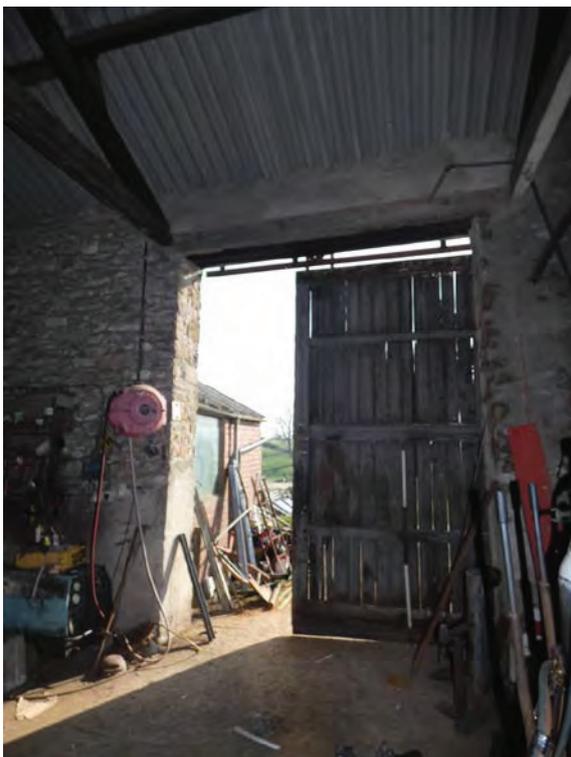
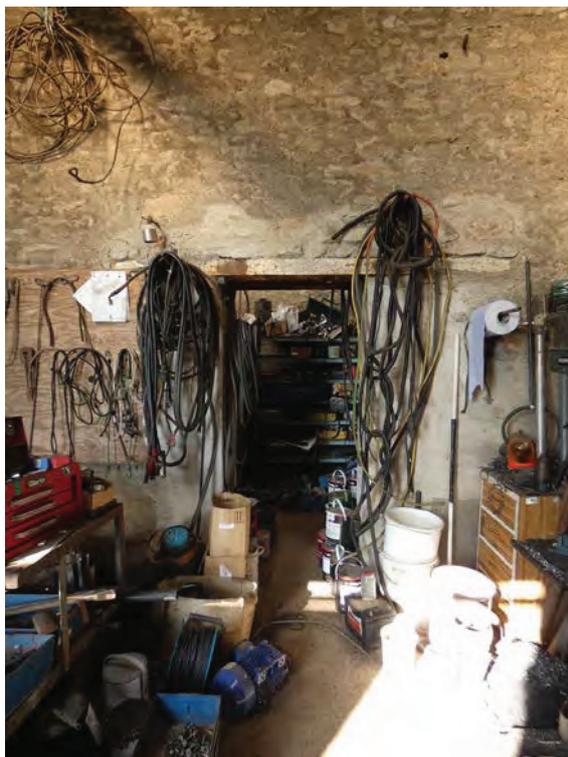
4.3.1 **Ground floor Room 1:** this is the main barn at the south-west end of the range. It has a concrete floor with a vehicle inspection pit aligned north-west/south-east near the centre covered by large timber sleepers (Plate 18). It is open to the roof, which is corrugated concrete/asbestos supported by two trusses. The trusses are king post-type of machine-cut timber, with a metal plate across the top on both faces. There is a single purlin per pitch and a pair at the ridge support by wedges on principals (Plate 19). There are three corrugated plastic roof lights on the south-east side. The walls are rough stone, mostly with rough pointing. The **north-east elevation** is plain apart from a course of through stones. The **south-east elevation** is plain apart from a wagon door at the centre, with a very tall (raised?) machine-cut timber lintel (Plate 20). The **south-west elevation** has the remains of earlier render in the centre and numerous through stones. The **north-west elevation** is mostly plain, with a small doorway on the north-east side, with an iron I-beam lintel and concrete block in the jambs showing that it is inserted (Plate 21).

Plate 18 (left): Inspection hatch in the floor of Room G1, viewed from the south-east

Plate 19 (right): South-west truss in Room G1, viewed from the north-east

Plate 20 (left): Wagon doorway in the south-west elevation of Room G1, viewed from the west

Plate 21 (right): Doorway in the north-west elevation of Room G1, viewed from the south-east

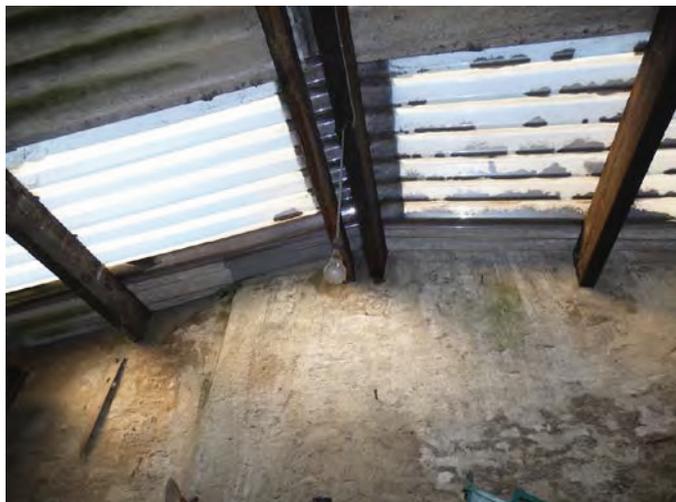
4.3.2 **Ground floor Room 2:** this has a concrete floor continuing from Room 1. It is open to the roof, which is supported by just a pair of purlins at the apex and one per pitch (Plate 22). It has corrugated concrete asbestos sheeting with a single plastic roof light per pitch. The walls are stone with rough mortar cover, and are all basically plain although mostly obscured by shelving. The **north-west elevation** is stepped on the south-west side (Plate 22). The **south-east elevation** has a doorway with an iron I-beam lintel and concrete block in the jambs and is clearly inserted.

Plate 22 (left): Roof and stepped section in the north-west elevation in Room G2, viewed from the south-east

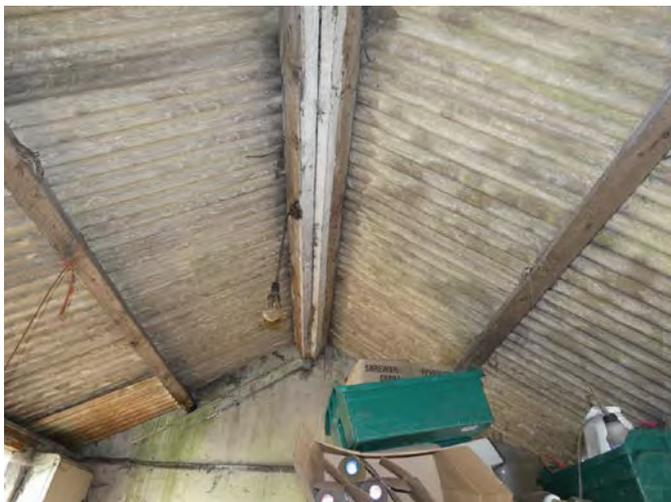
Plate 23 (right): Roof in Room G3, viewed from the south-east

4.3.3 **Ground floor Room 3:** this has a concrete floor, with two steps up from the south-east end, which are also concrete. It is open to the roof, which is a simple corrugated asbestos concrete sheeting supported by paired machine-cut purlins at the apex and a single purlin per pitch (Plate 23). There is a

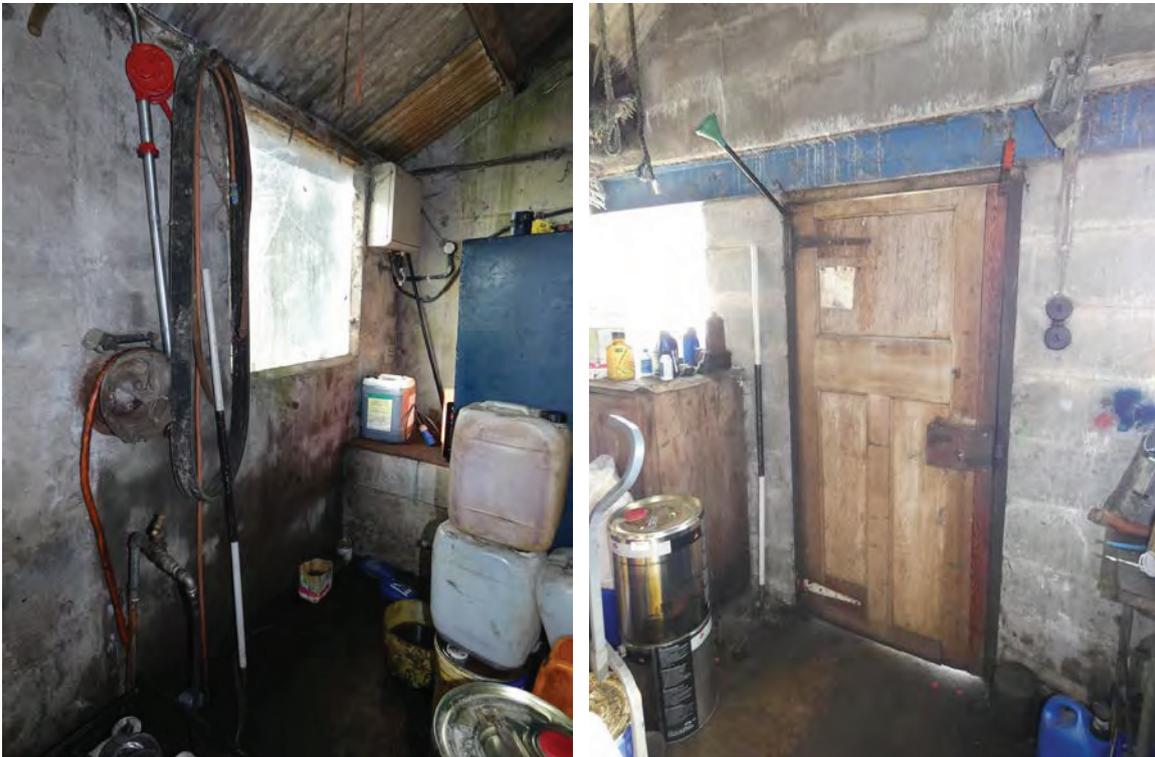
further beam on the north-east side where the roof flattens out. The walls are finished with concrete. The **north-east** and **north-west elevations** are plain, with a built-up 'box' of concrete blocks topped with plywood in the south corner (Plate 24). The **south-east elevation** has a doorway with a single-light window either side, all of which share an iron I-beam lintel. The doorway has a reused three-panel door with a large lock (Plate 25). The **south-west elevation** has a single light window on the north-west side, with a machine-cut timber lintel which forms the wall plate.

Plate 24 (right): Window in the south-west elevation of Room G3, viewed from the east

Plate 25 (left): Doorway in the south-east elevation of Room G3, viewed from the west
