BARN AT WHITTINGTON FARM, MAIN STREET, WHITTINGTON, LANCASHIRE

Archaeological Building Recording

Client: Mr and Mrs Mackereth

March 2019

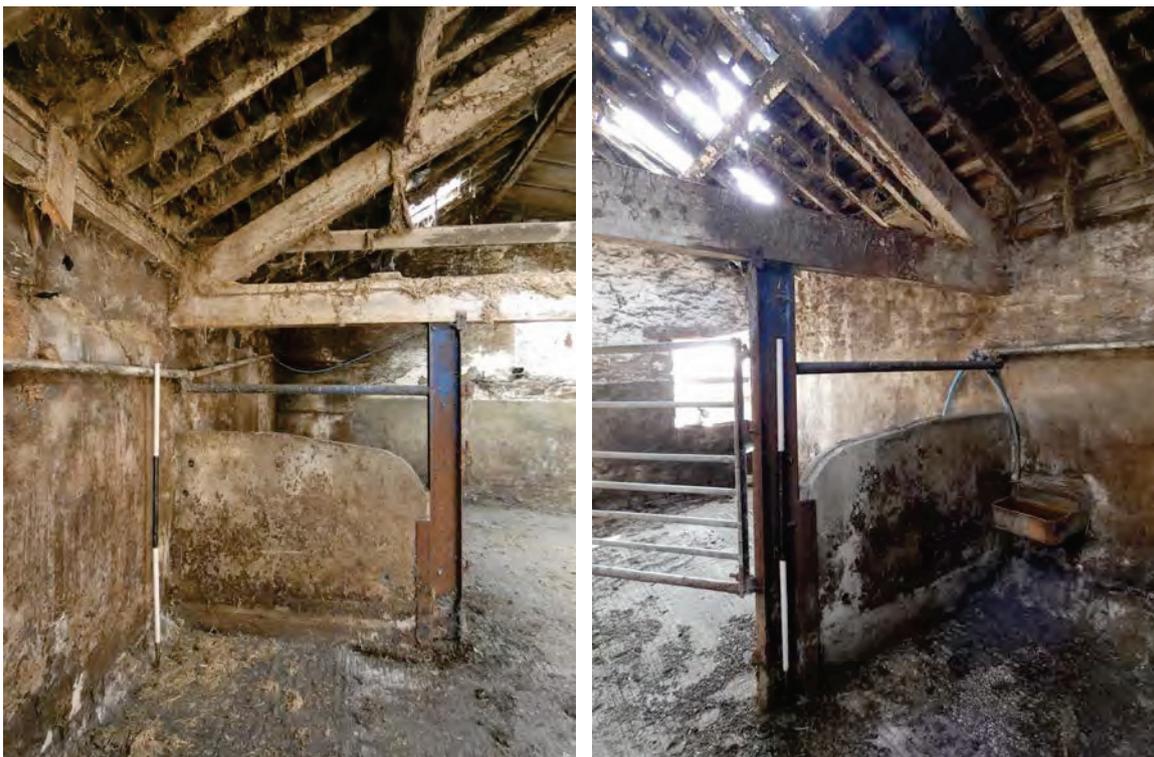
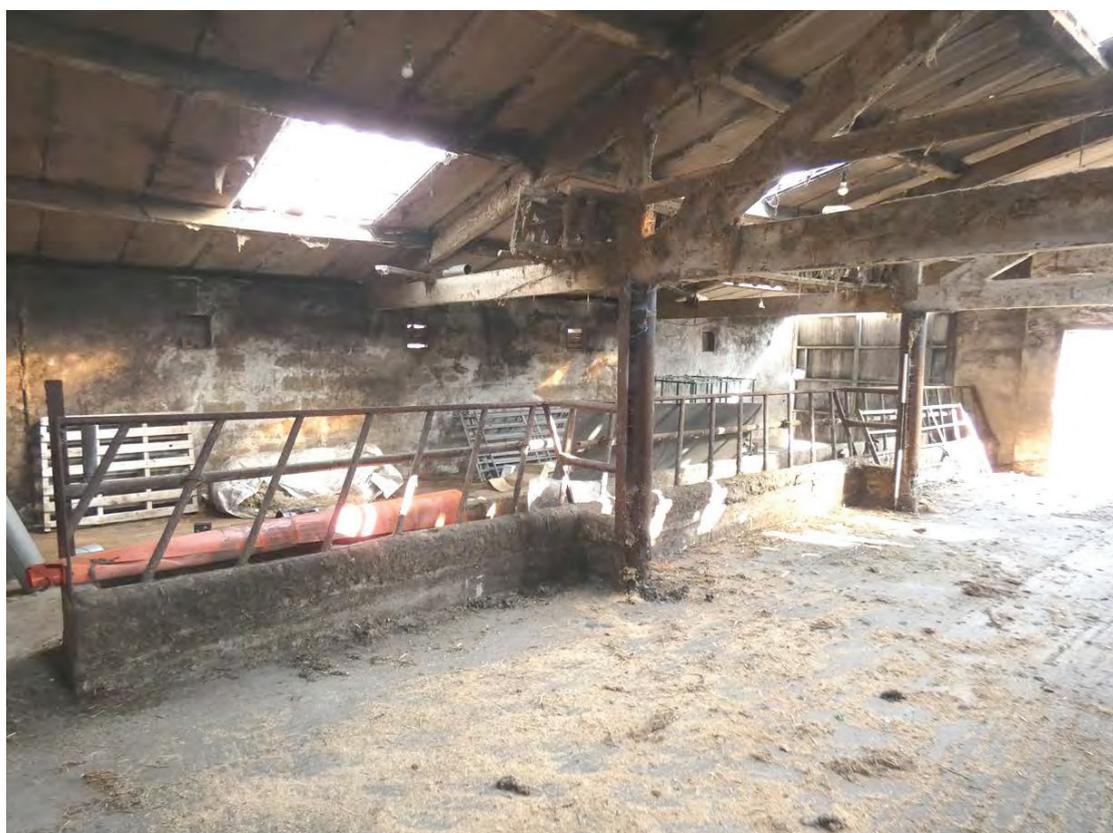
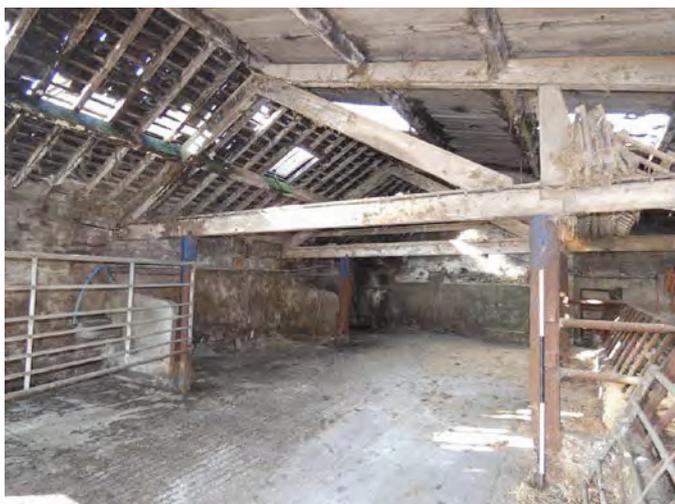
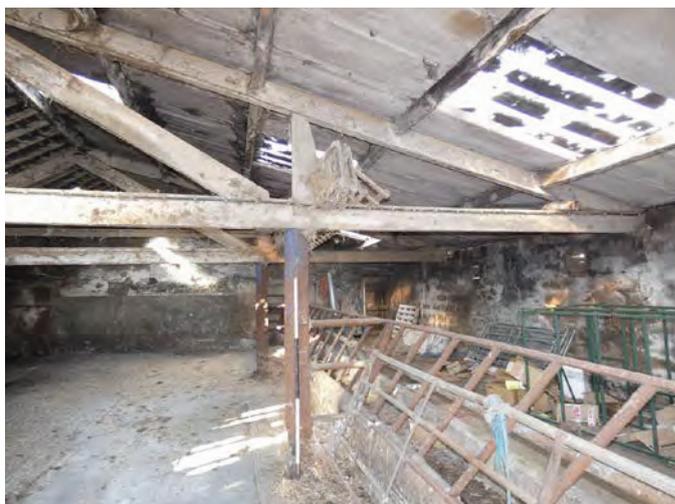
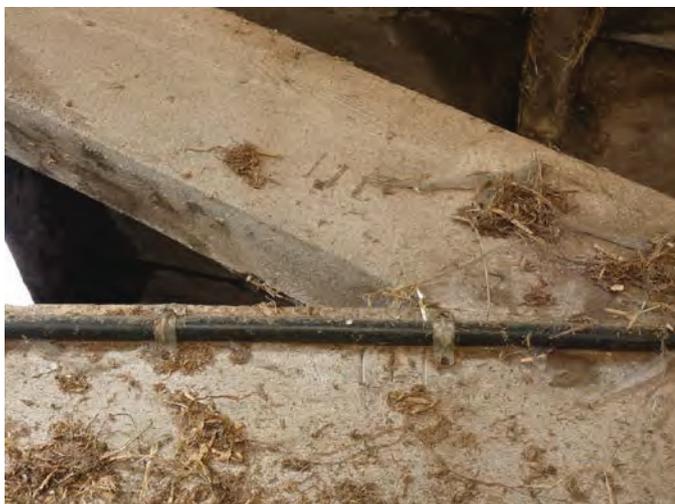
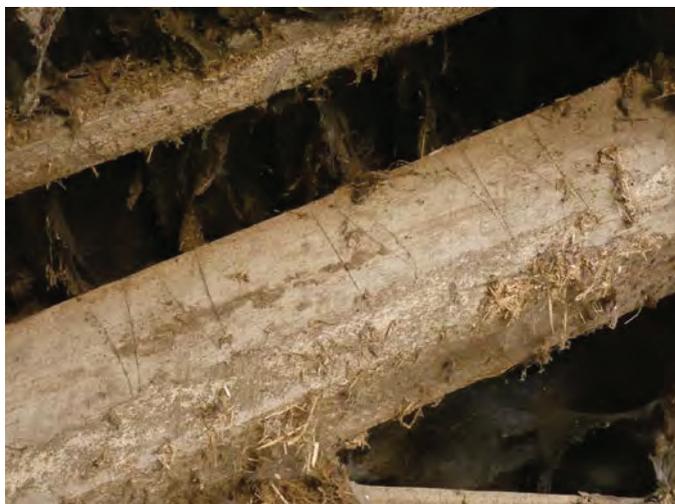
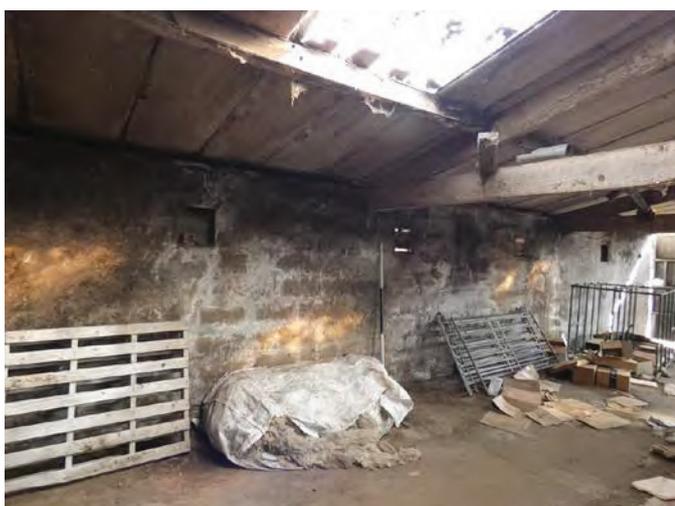
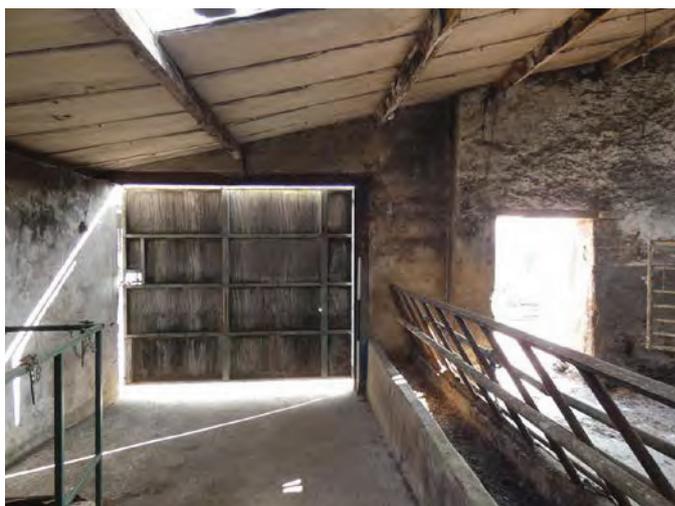
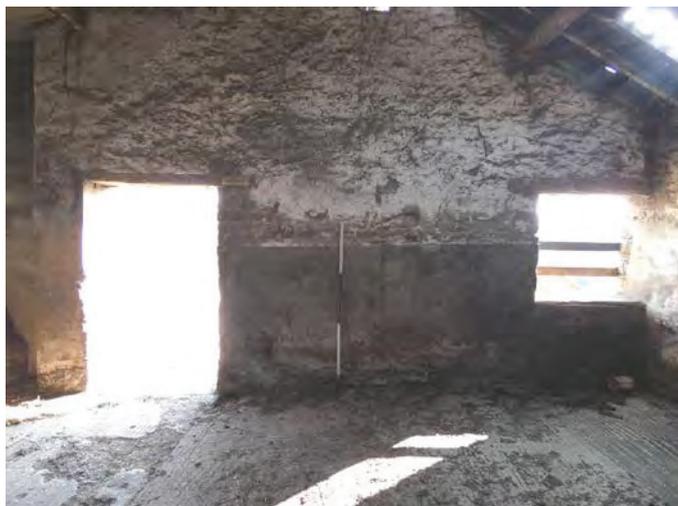
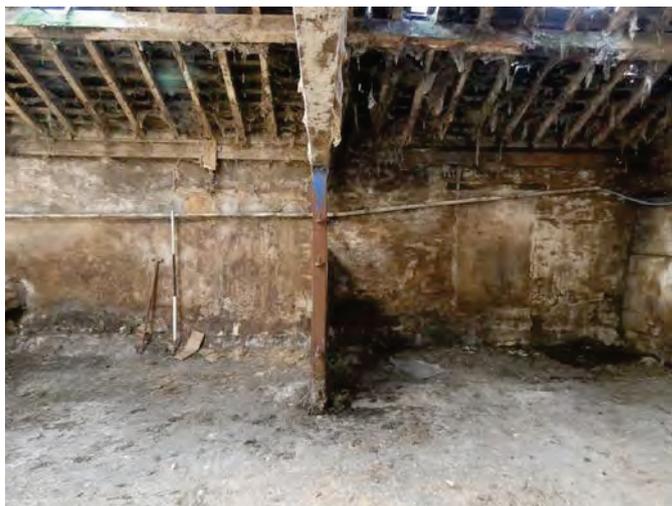
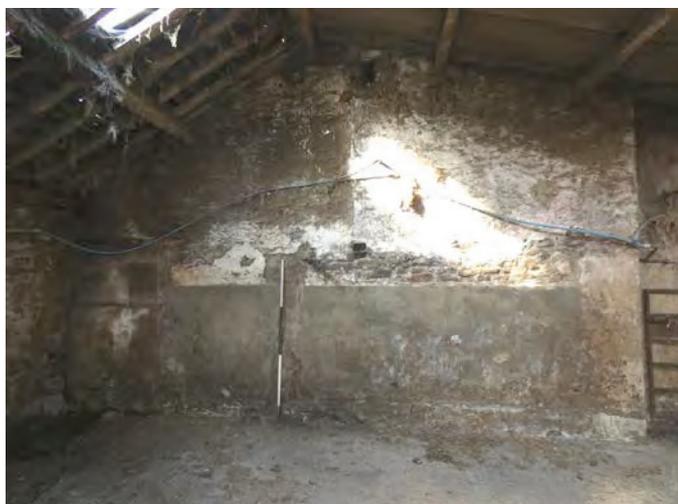
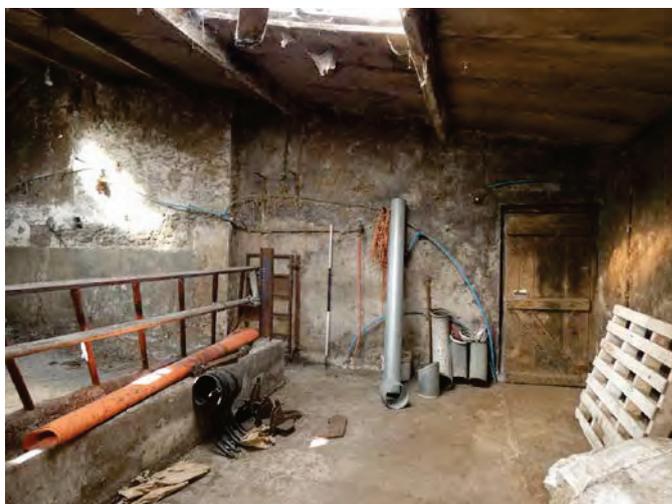
4.3.4 **Ground floor Room 4:** this has a concrete floor, which is gridded and sloping down to a shallow channel on the south-west side. It is plain on the north-east side but sloping down to the door. There are two stalls on the south-west side, against I-beams supporting roof trusses, which have concrete stalls with an iron tether pole above (Plate 26 and Plate 27). There is a long feed trough aligned north-west/south-east on the north-east side of the centre of the room, with iron manger bars over it and further bars connecting to I-beams supporting the roof. The roof is Welsh slate on the south-west side with an early iron skylight. It is concrete asbestos sheeting to the north-east with plastic skylights, supported by two tie beam trusses that have been extended to the north-east to accommodate an extension to the building (Plate 29 and Plate 30). There is an extra principal and tie beam section and a short king post. The trusses have carpenter's marks 'II' and 'III' (Plate 31) on the south-east face of the south-east truss and Baltic timber marks on the south-east face of the north-west truss (Plate 32). The trusses are supported by an iron I-beam and round iron column with a flat plate on top. The walls are finished with limewash but with a concrete skim over the lower part and the north-east is all concrete. The **north-east elevation** has four small openings with those at either end blocked leaving a 0.1m deep alcove and the rest filled with slatted timber (Plate 33). The **south-east elevation** has a wide doorway in the extended section on the north-east side, with an I-beam lintel and a south-west jamb (Plate 34). There are two smaller doorways to the south-west, with timber internal lintels which are rough and reused (the north-east lintel is chamfered) and the lower part of the south-west doorway is blocked with concrete blocks (Plate 35). The **south-west elevation** has a blocked doorway on the north-west side (Plate 36) and a possible second doorway to the south-east, both with timber lintels. The **north-west elevation** has a blocked doorway on the south-west side filled with concrete blocks and with a timber lintel. There is a butt joint and a small hole high up (Plate 37) then a step in the wall on the north-east

side at the extension, beyond which is a further doorway with a plank and batten door and a plain surround (Plate 38).

Plate 26 (left): Stall against the south-west elevation of Room G4, viewed from the south-east

Plate 27 (right): Stall against the south-west elevation of Room G4, viewed from the west

Plate 28: Stall across the centre of Room G4, viewed from the south

Plate 29 (left): South-west end of south-east truss in Room G4, viewed from the south-east

Plate 30 (right): North-east end of south-east truss in Room G4, viewed from the south-east

Plate 31 (left): Carpenter's mark 'III' on south-east truss in Room G4, viewed from the south-east

Plate 32 (right): Baltic timber marks on the north-west truss in Room G4, viewed from the south-east

Plate 33 (left): North-east elevation, Room G4, viewed from the south

Plate 34 (right): North-east end of the south-east elevation, Room G4, viewed from the north-west

Plate 35 (left): South-west end of the south-east elevation, Room G4, viewed from the north-west

Plate 36 (right): South-west elevation showing blocked doorways, Room G4, viewed from the north-east

Plate 37 (left): South-west side of north-west elevation, Room G4, viewed from the south-east

Plate 38 (right): North-east side of the north-west elevation, Room G4, viewed from the south-east

5.2.4 **Phase 3 (early 19th century):** the early maps show that further additions had been made by the middle of the 19th century but the evidence from within the building shows that they were slightly later than Phase 2; it is not possible to be certain exactly what order they occurred in but it seems likely that they are broadly contemporary although some were replaced by later alterations. An addition was made to the north-east end of the Phase 1 barn continuing its line but not apparently corresponding to the present structure, with the possible exception of the north-east end of the north-west elevation of Room G4. This probably comprised additional cow housing, but perhaps as a lean-to, and evidently represented yet more expansion at Whittington Farm. A further addition was also made by filling in the space between the Phase 1 barn and the Phase 2 extension (corresponding with Room G2), presumably to form a small loose box or calf pen, which was evidently originally only accessible from the north-east.

5.2.5 **Phase 4 (late 19th century):** between 1847 and 1890 the building was further enlarged with the creation of a new extension at the north-east end, which went beyond the original line of the Phase 1 barn. This corresponds with the approximately the south-western two thirds of Room G4 and clearly formed a much larger cow house or shippon, with the access to the probable loose box formed in Phase 2 (Room G2) retained.

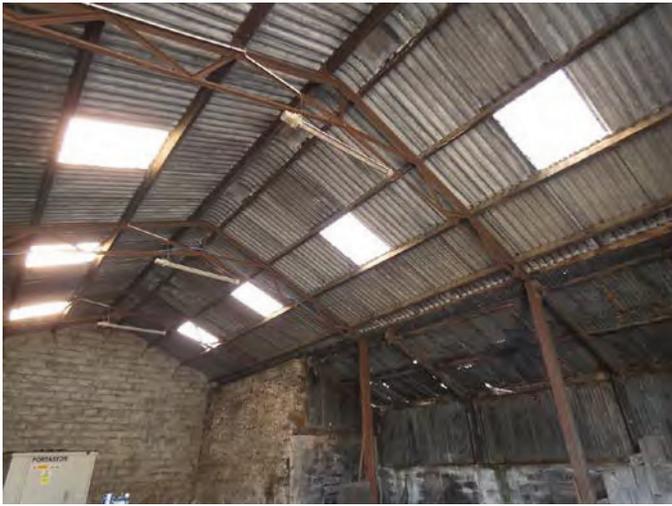
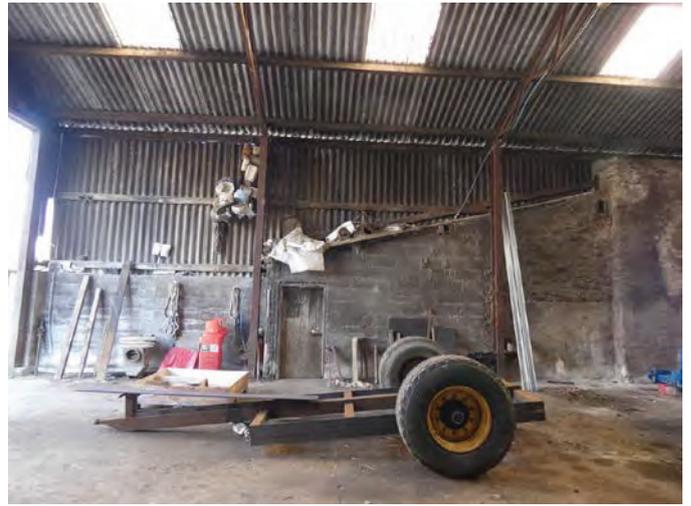
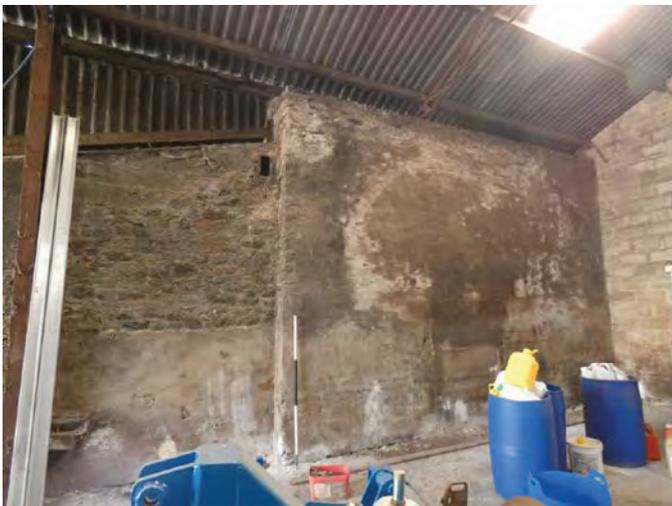
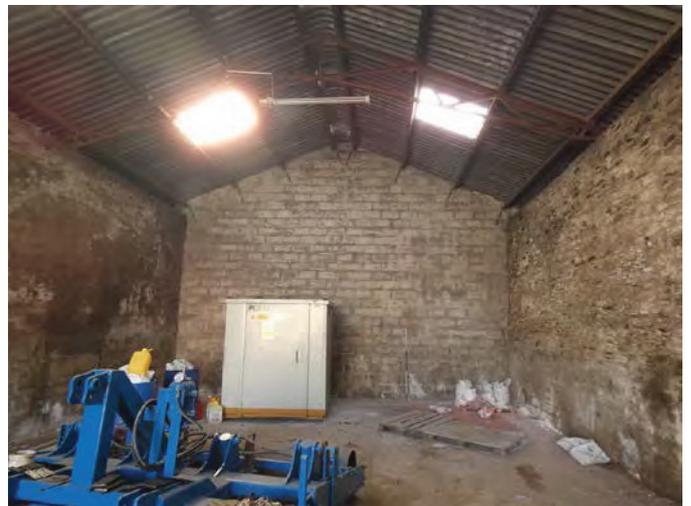
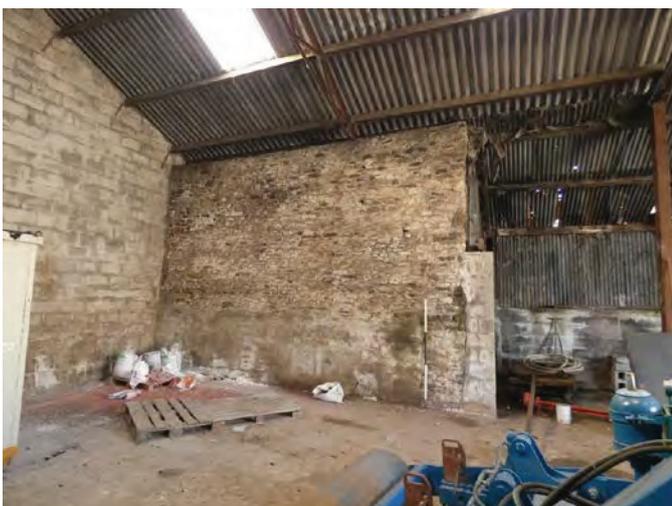
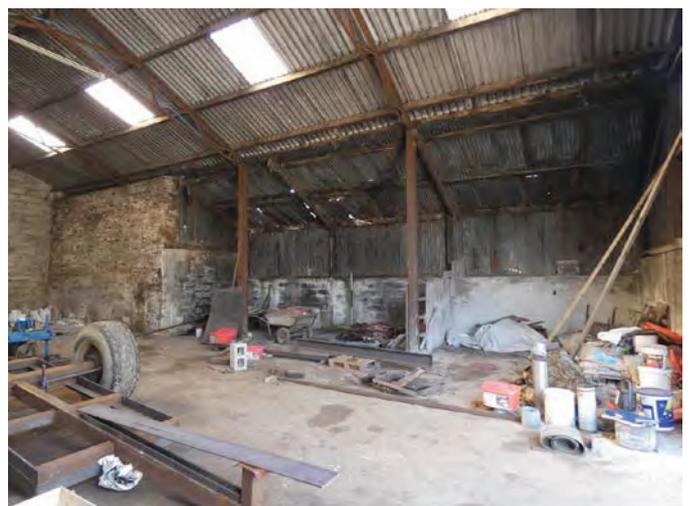
4.3.5 **Ground floor Room 5:** this is a modern shed added to earlier walls. It has a concrete floor, and is open to the modern corrugated asbestos concrete sheet roof, which is supported by machine-cut timber purlins and three steel L-section trusses, which are supported by iron-square section posts at either end (Plate 39). The walls are a mixture of concrete block supporting a modern iron frame covered by corrugated sheeting or earlier stone. The **north-east elevation** comprises modern sheeting with a large doorway on the south-east side. The **south-east elevation** is concrete block and sheeting at the north-east end, which butts an earlier section built in concrete block comprising the side of a monopitch wall containing a doorway with a plank and batten door (Plate 40). This in turn butts a stone wall, perhaps also the side of a monopitch section, possibly with quoins at the north-east end. After this there is a further step to a tall section of stone wall finished with a concrete skim, which has a doorway blocked with stone on the south-west side (Plate 41). The **south-west elevation** is a plain and constructed from concrete blocks, with the walls to the north-west and south-east butting against this (Plate 42). The **north-west elevation** comprises a tall stone section on the south-west side, the lower part of which is skimmed with concrete (Plate 43). This is butted at the north-east end by a concrete block wall, which returns to the north-west before turning back to the north-east. From this return it is entirely modern and constructed from concrete blocks with corrugated sheeting above (Plate 44).

Plate 39 (left): Trusses in Room G5, viewed from the north

Plate 40 (right): North-east end of the south-east elevation, Room G5, viewed from the north-west

Plate 41 (left): South-west end of the south-east elevation, Room G5, viewed from the north-west

Plate 42 (right): South-west elevation of Room G5, viewed from the north-east

Plate 43 (left): South-west end of the north-west elevation, Room G5, viewed from the east

Plate 44 (right): North-east end of the north-west elevation, Room G5, viewed from the east

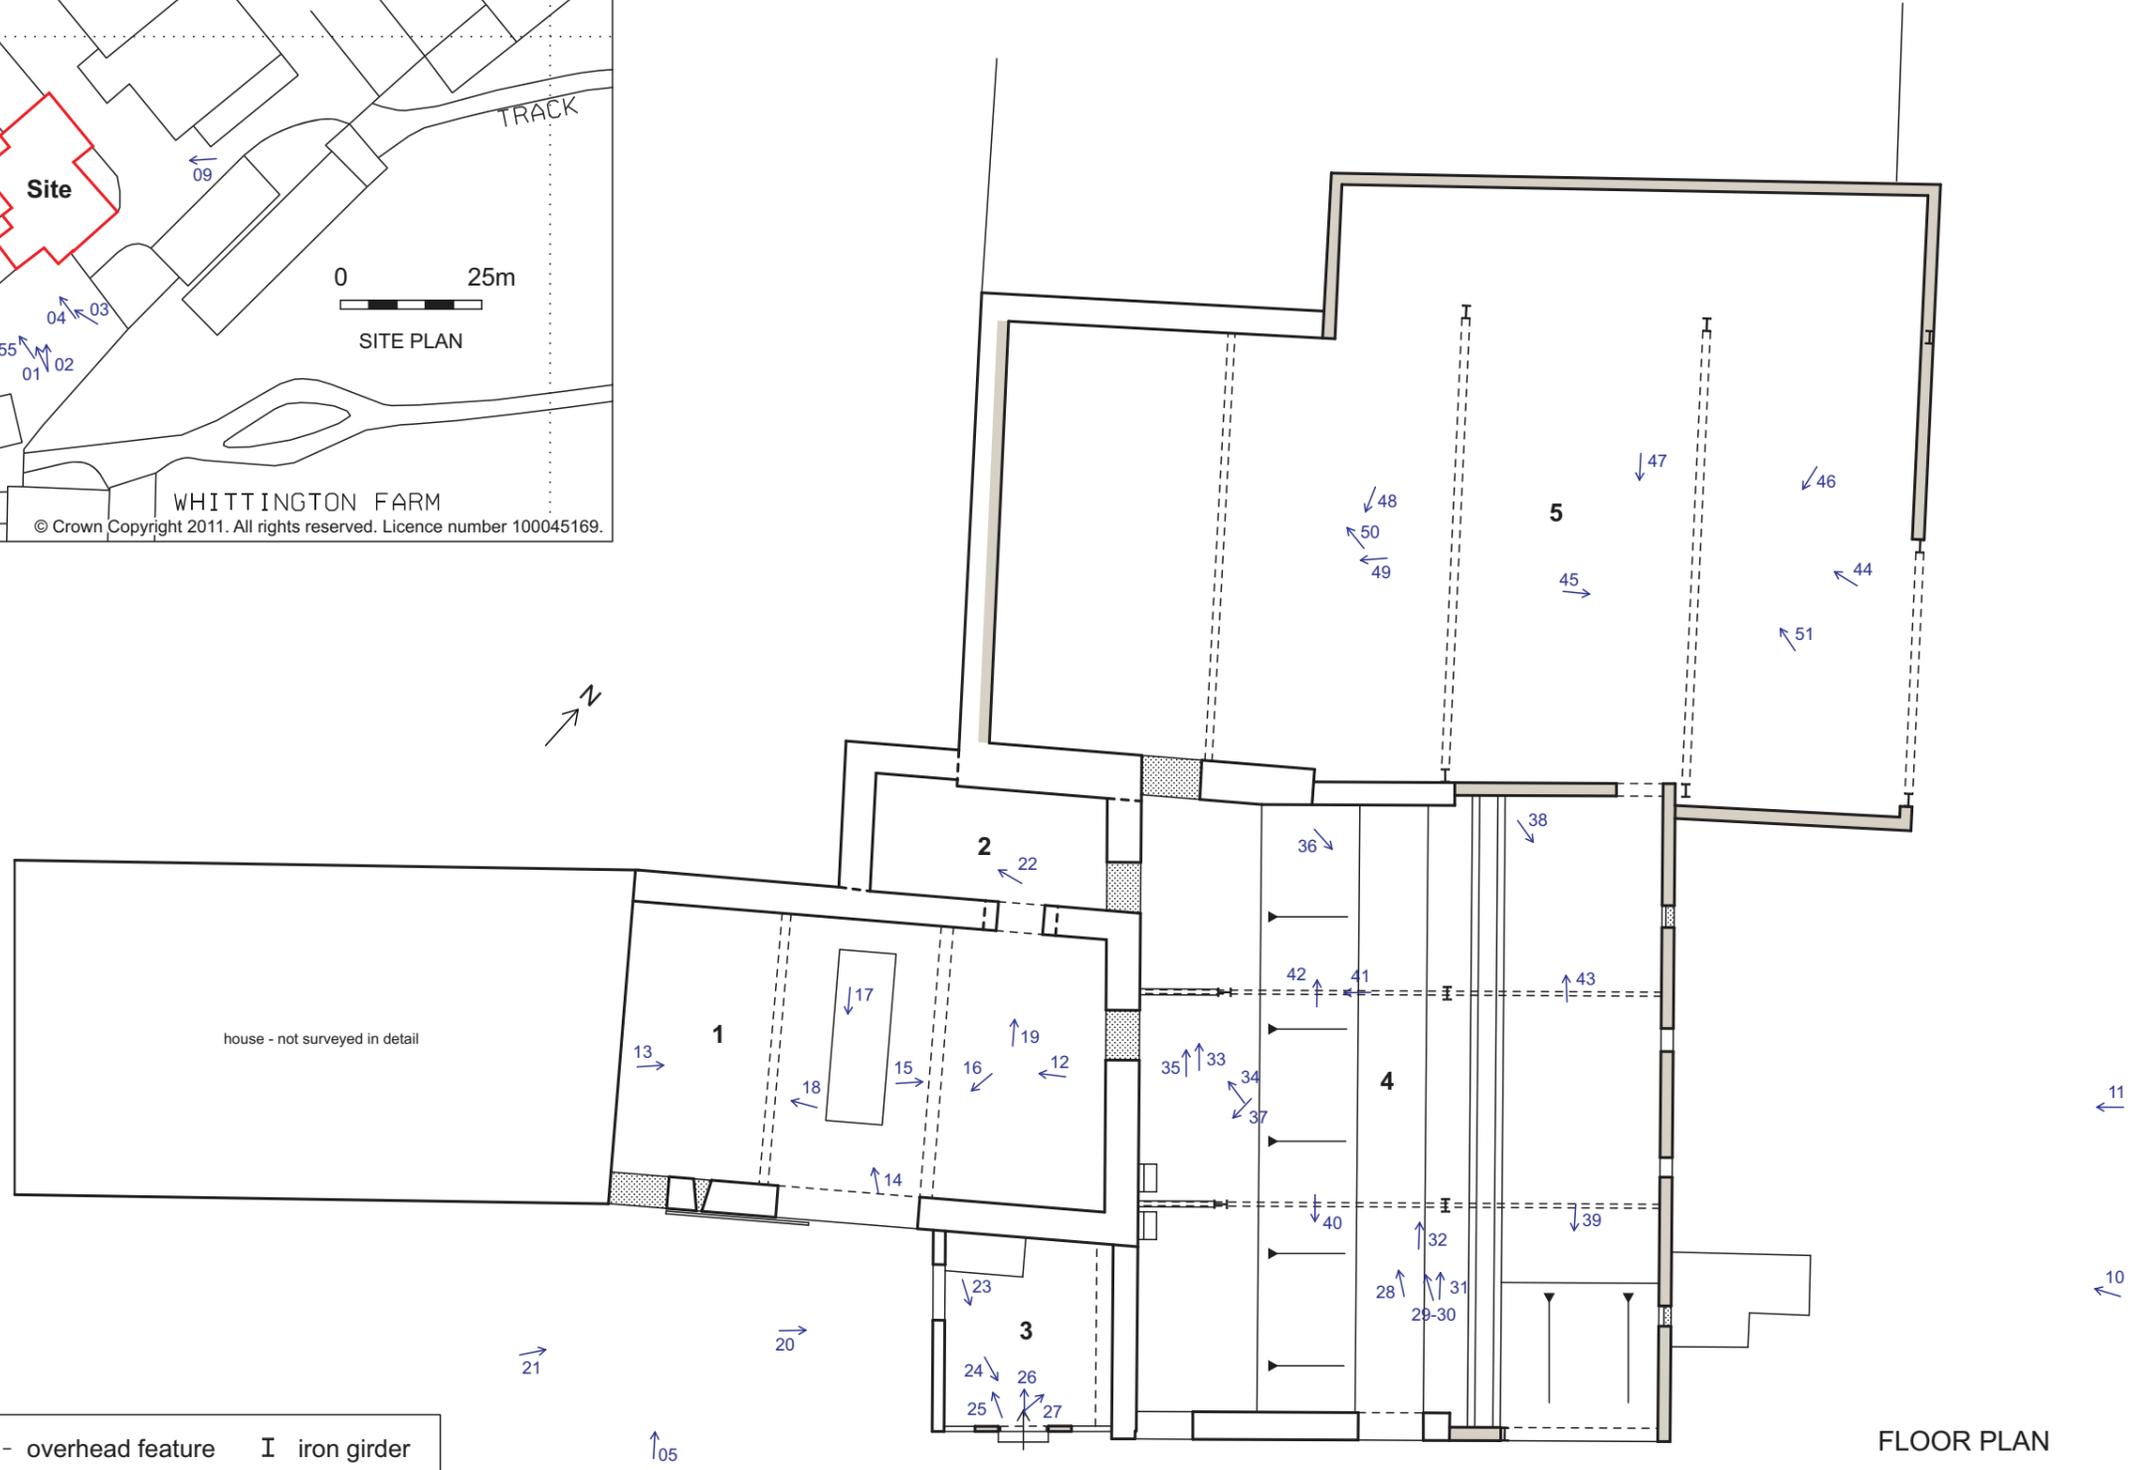
FLOOR PLAN

Key: blocked feature overhead feature iron girder
4 room number drawn section photo I.D. and direction
 step up (in direction of arrow) concrete block
 slope down (in direction of arrow) cross-sectional timber
