FURNESS ABBEY COTTAGE, ABBEY APPROACH, BARROW-IN-FURNESS, CUMBRIA

Archaeological Watching Brief

Client: Mr and Mrs Gilmour
Scheduled Monument Consent
Ref.: HSD 9/2/8945
NGR: SD 21778 72039

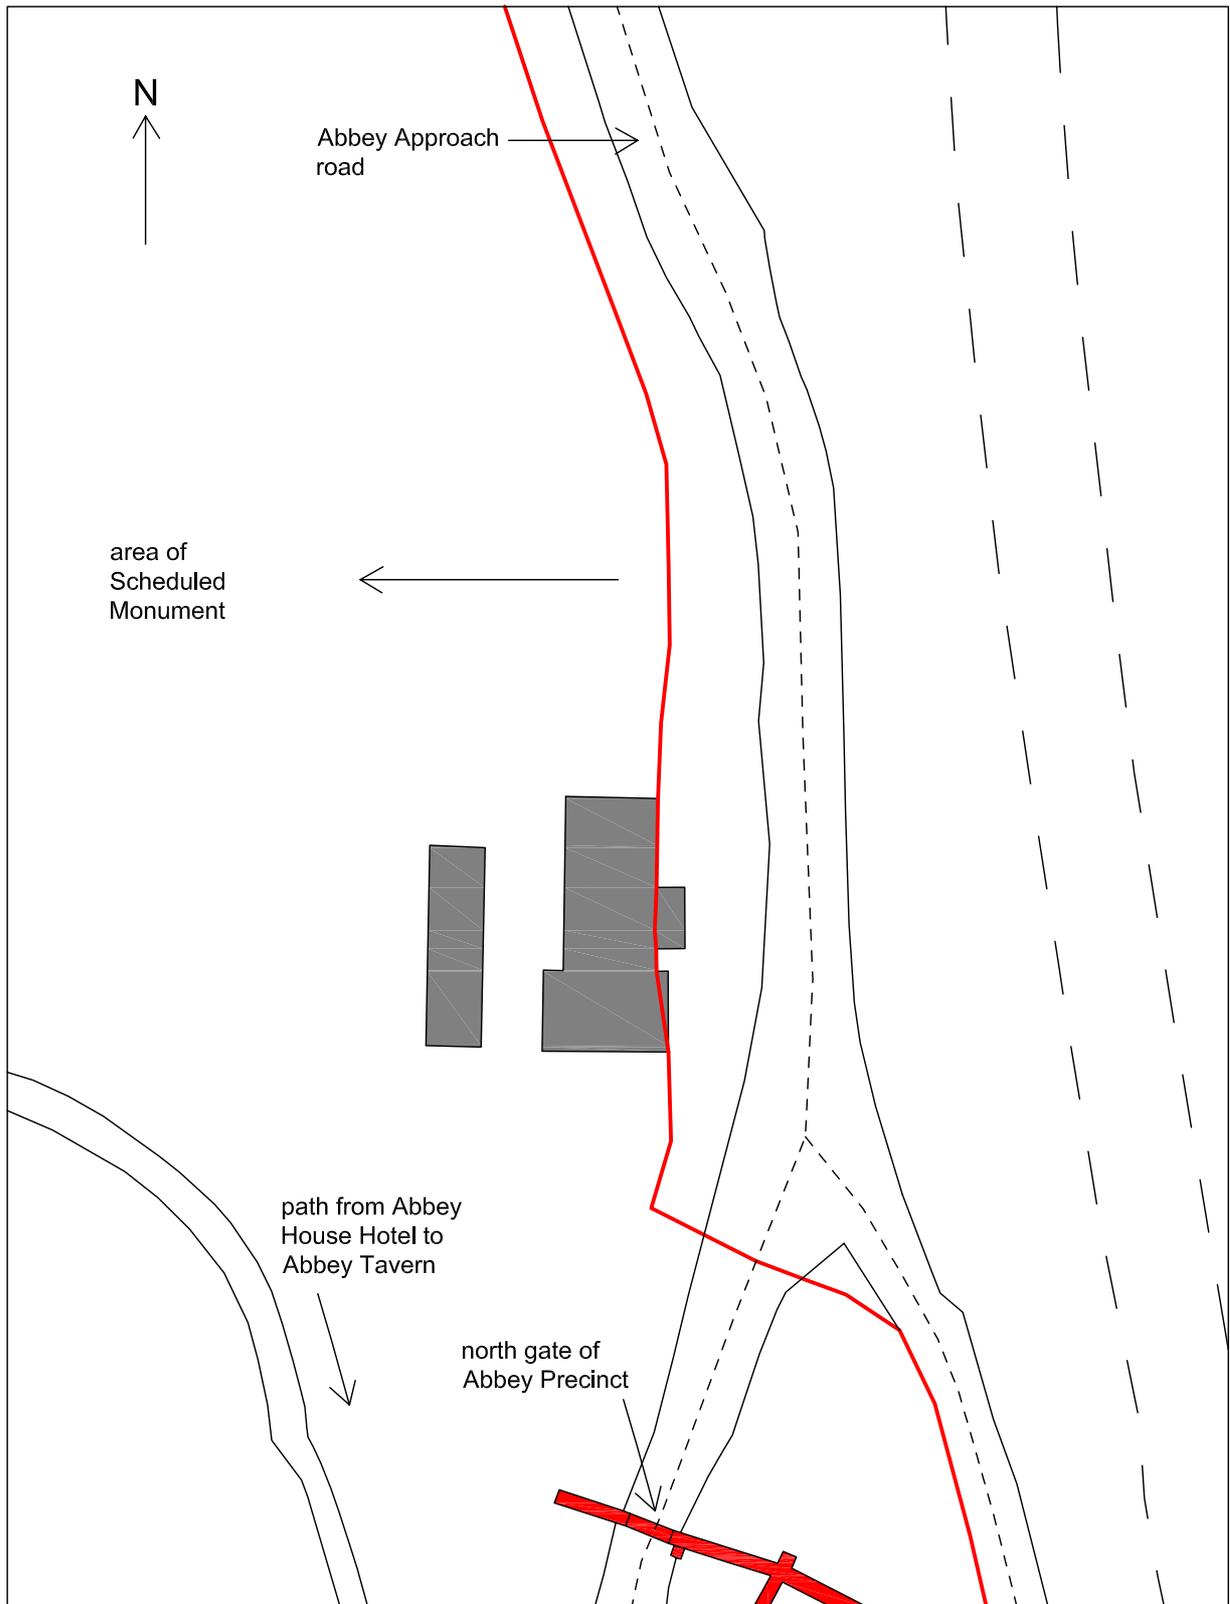
Figure 2: Immediate site location

3.2.8 **English Heritage Plan** (see Fig 2): this modern plan of the site shows that the northern half of the stable block and the coach housing have both been demolished. This must have occurred sometime after the 1956 OS map was produced, and prior to the listing of the property in 1983. A porch has also been added to the eastern elevation, its construction would also fall into the same date range.

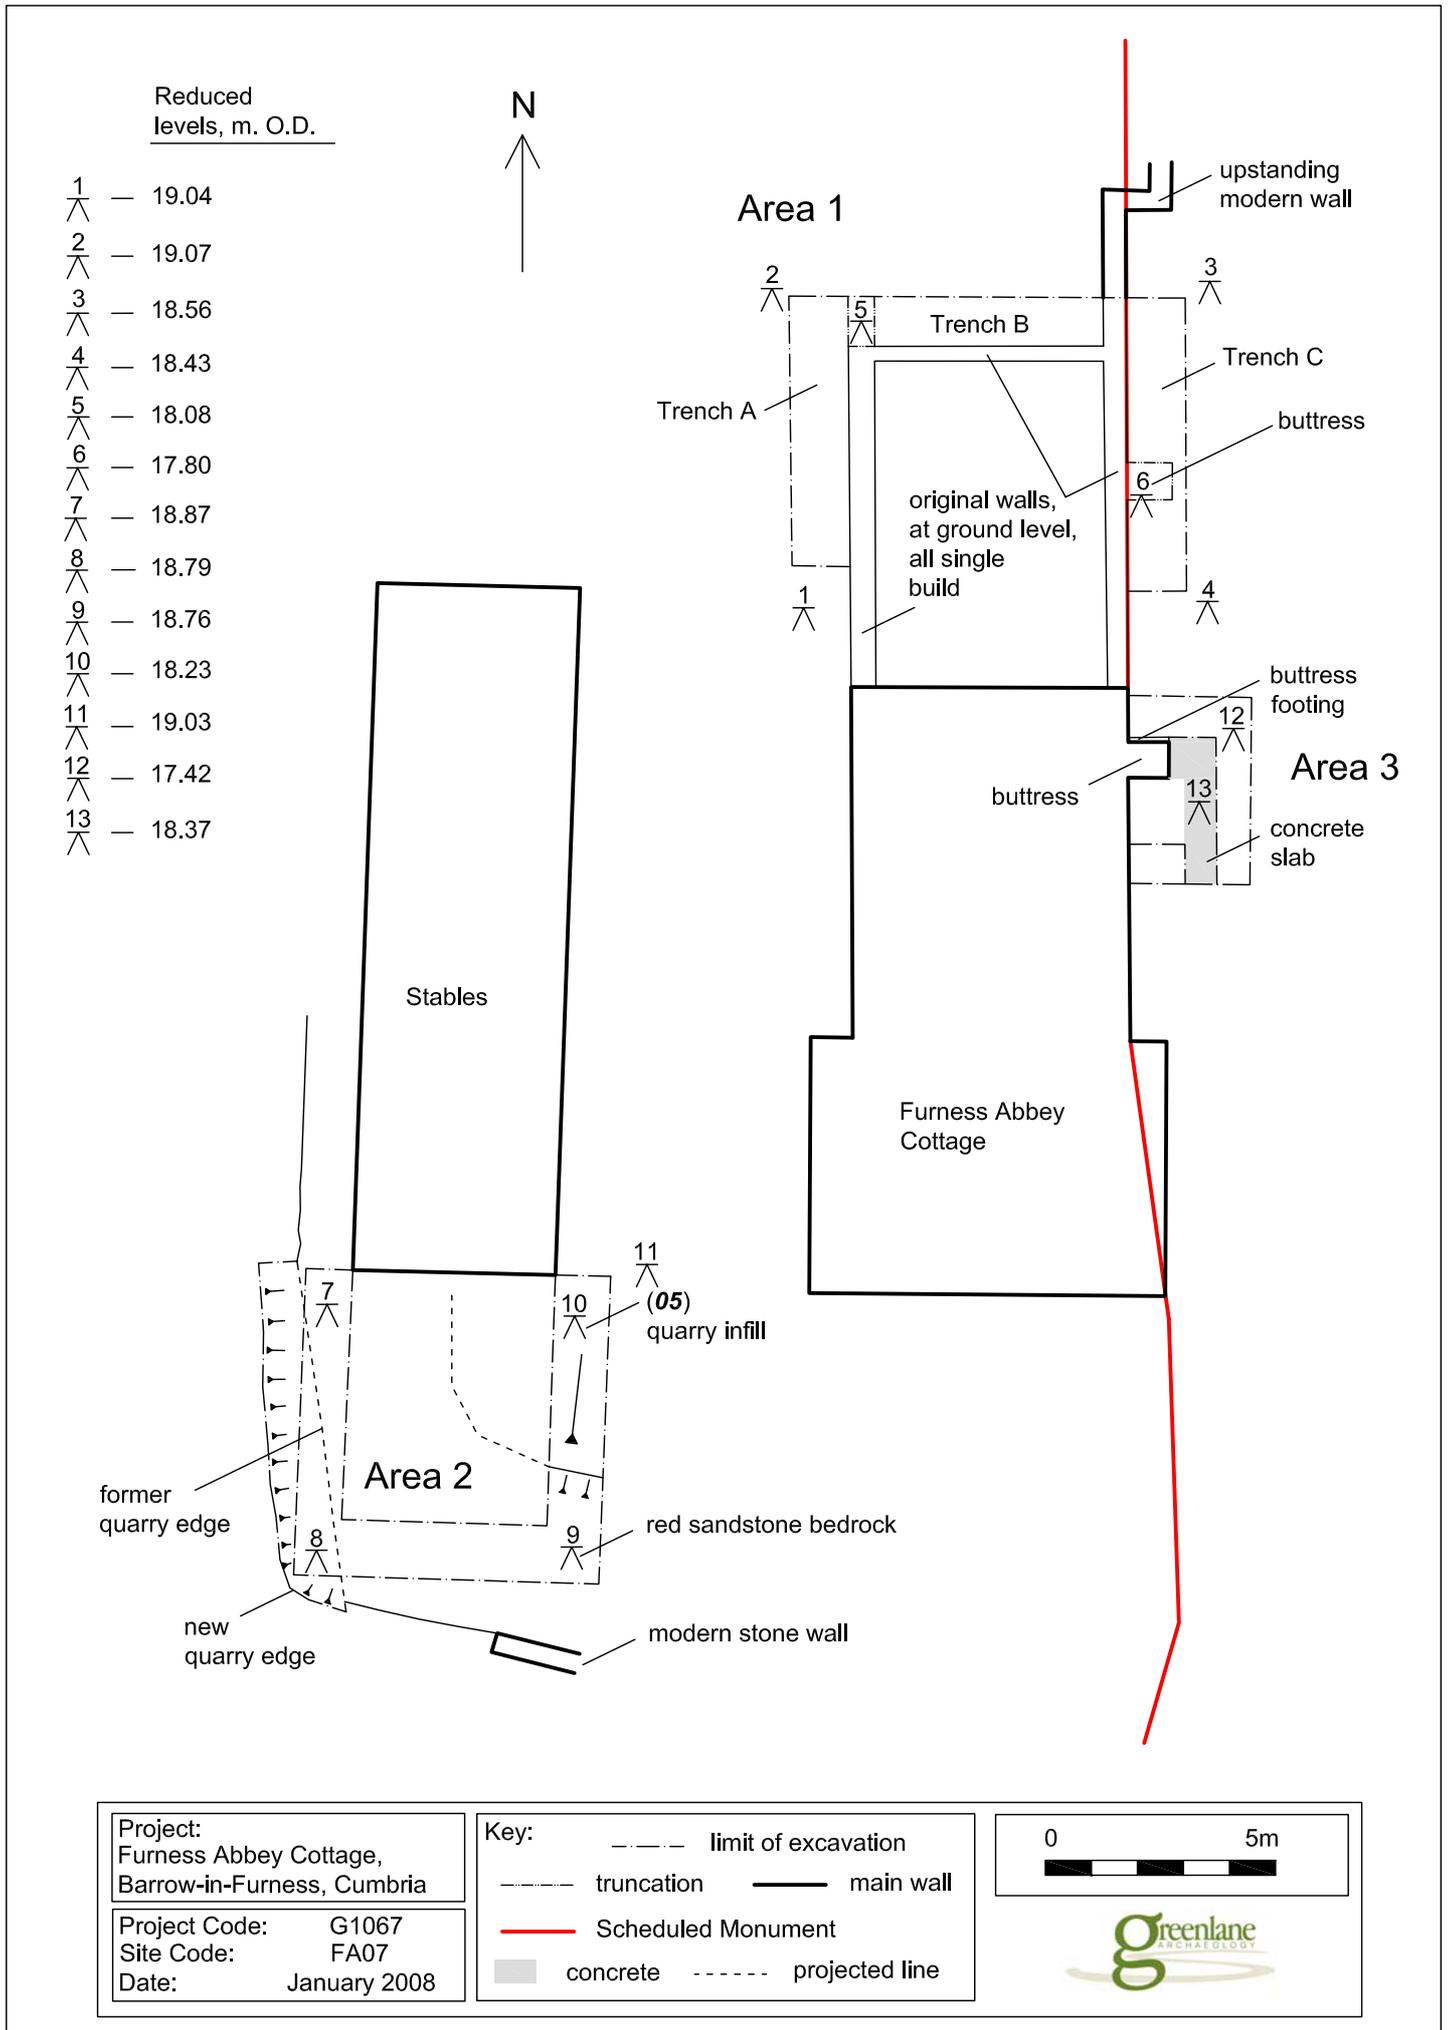
Figure 3: Trench plans

4.1.2 **Area 1:** a large U-shaped trench marked the footings of the two storey extension to butt the north of the existing house. Due to the logistics of its excavation the trench was recorded in three separate parts, A, B, and C (Plates 8-10). The footings excavated followed the outer edges of existing below ground red sandstone foundation walls that relate to the original plan of the cottage and its associated coach house (see Fig 3). The material excavated, (**01**), was a loose pinkish-orange sandy, silty-clay with moderate quantities of angular gravels, the clay content rose imperceptibly with depth. This deposit was interpreted as the natural glacial tills of the area that had been at least partly disturbed by the earlier footings. At a depth of 1m a more solid clayey layer was found which also corresponded with the depth of the earlier wall foundations, at this level the building inspector was satisfied with the integrity of the ground and excavation ceased. There was no evidence for the original construction cuts of the earlier walls in the homogenous natural deposits and no finds were recovered. Trenches A and B which were within the Scheduled Monument boundary were overlain with deposit (**02**), this was a 0.20m thick deposit of moderately firm, mid to dark greyish-brown silty-clay with occasional gravels. This deposit lacked the organic content of a garden soil and seemed more likely to have developed in a yard area, as with deposit (**01**) it was devoid of artefacts. Trench C to the east of the garden wall was overlain by garden soil (**03**) which was a greyish dark-brown slightly clayey-silt with occasional gravels and charcoal inclusions. This deposit was within the current garden and again was free from finds. The buttress that was known to exist in this area extended into the trench (see Plate 8; Fig 3) and was keyed in to the main wall and contemporary with it.

4.1.4 **Area 3:** this small U-shaped foundation trench for the new porch was excavated adjacent to the eastern elevation of the house (Plate 12). The garden soil (**03**) overlay the natural glacial tills (**01**) exactly as with Trench C in Area 1. No finds were recovered and as with Area 1 it is assumed that this ground was disturbed by the original construction of the house in c1873, as well as the previous porch of which a concrete pad still remains in the ground (see Fig 3).

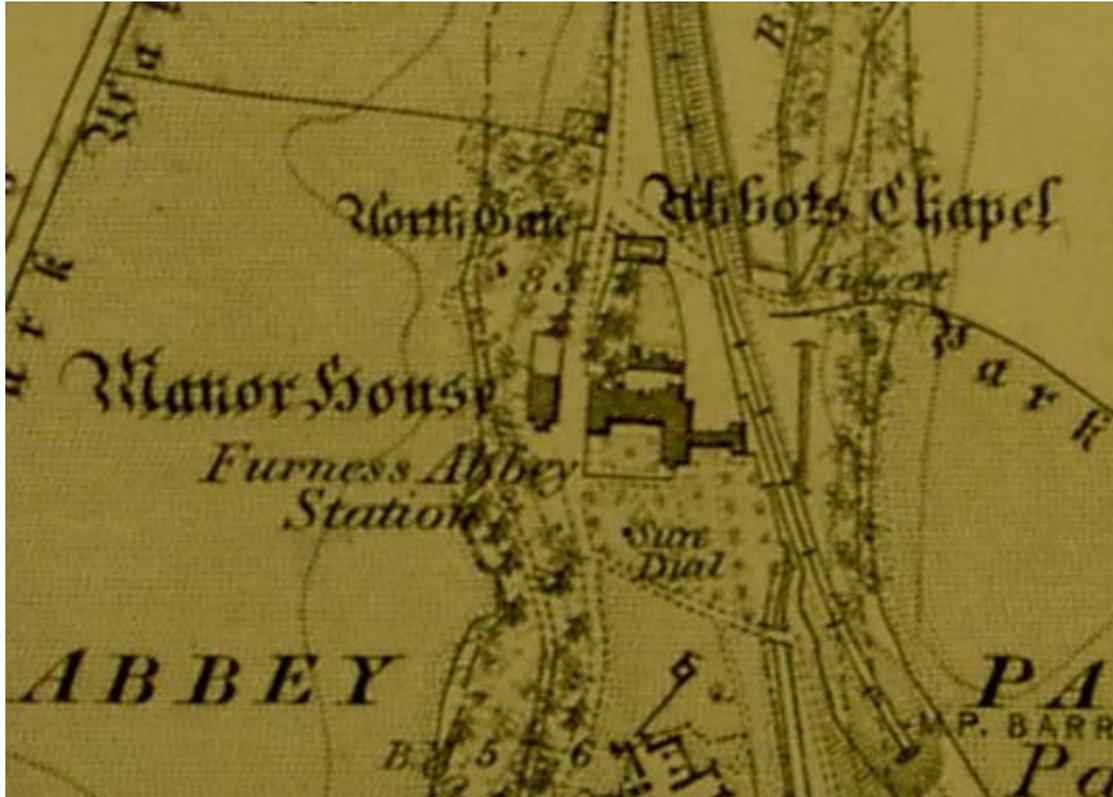
3.2.3 **Ordnance Survey 1851** (Plate 3): the first accurate map of the site shows that Furness Abbey Cottage was not built by this date. It does appear that there is a small standing building at the site at this time; this building also appears on an enlarged plan of the Furness Abbey site dated 1843 (from the original survey carried out for the Furness Railway). This plan is reproduced by Dickinson (1967, 73) but the original could not be located in the Record Office.

Plate 3: Extract from the 1850 Ordnance Survey map, there appears to be a building on the site at this date, north of the east-west wall in the top centre

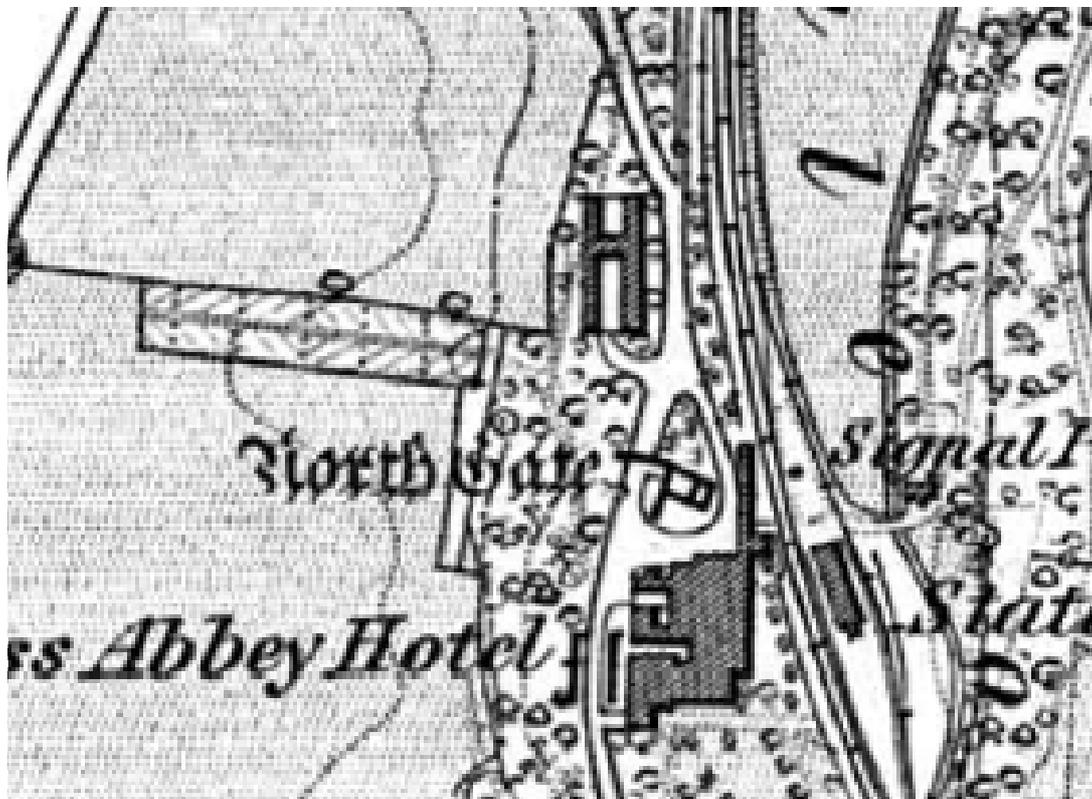
3.2.4 **Ordnance Survey 1873** (Plate 4): this is the first map to show Furness Abbey Cottage. The stabling to the west and the coach house to the north is clearly visible and the main house is represented by the lower right hand leg of the 'H' shape.

Plate 4: Extract from the 1873 Ordnance Survey map (the H-shaped building is Furness Abbey Cottage in its earliest form)

5.1.2 The foundations of the coach house were discovered to the north of the cottage, in Area 1. These foundations appeared to closely resemble the plan of the buildings as shown on the 1873 Ordnance Survey map (Plate 4), however the western north-south orientated wall (Trench B) continues past the southern wall of the east-west building (Trench B). This may indicate that the layout of the mapped buildings is wrong, or that the foundations laid did not reflect the end build.

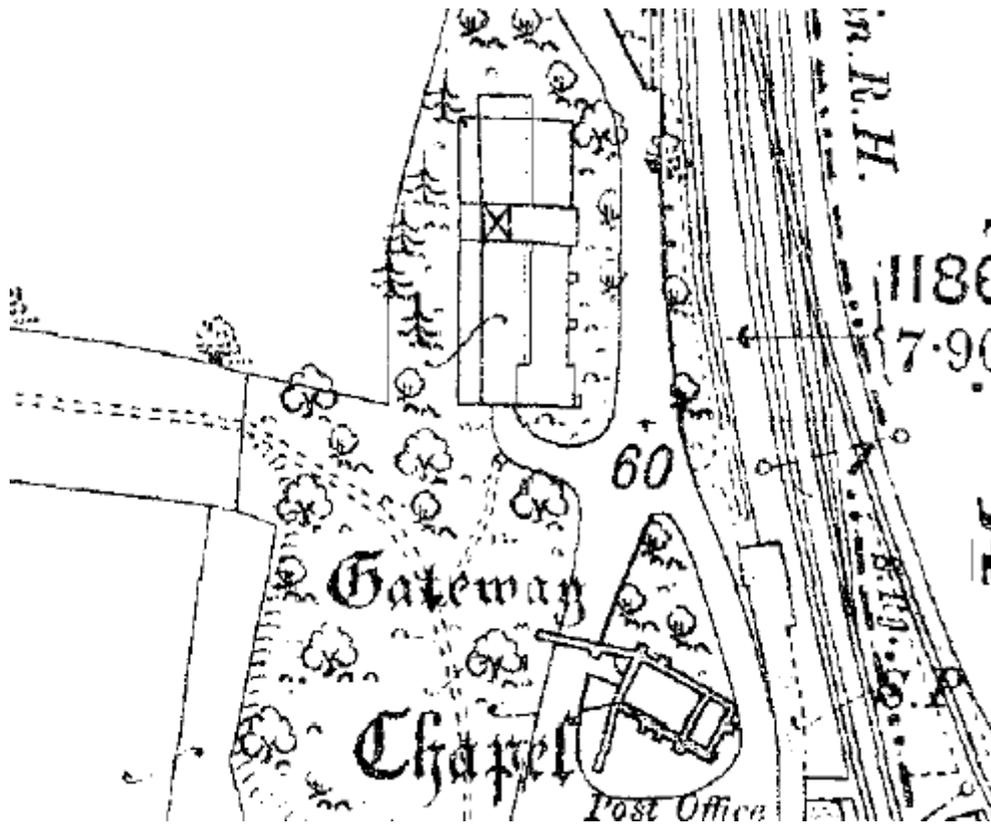
3.2.5 **Ordnance Survey 1891** (Plate 5): this map shows a very similar plan to the 1873 map, the main difference being the apparent addition of an outbuilding at the north end of the 'H' shape. The detail is also greater on this map and shows the covered walkway between the drive of the main house through to the yard of the stables and coach house area. It is clear from this plan that access to the coach house could only be gained from the south side of the property at this date.

Plate 5: Extract from the 1891 Ordnance Survey, note the eastern buttresses

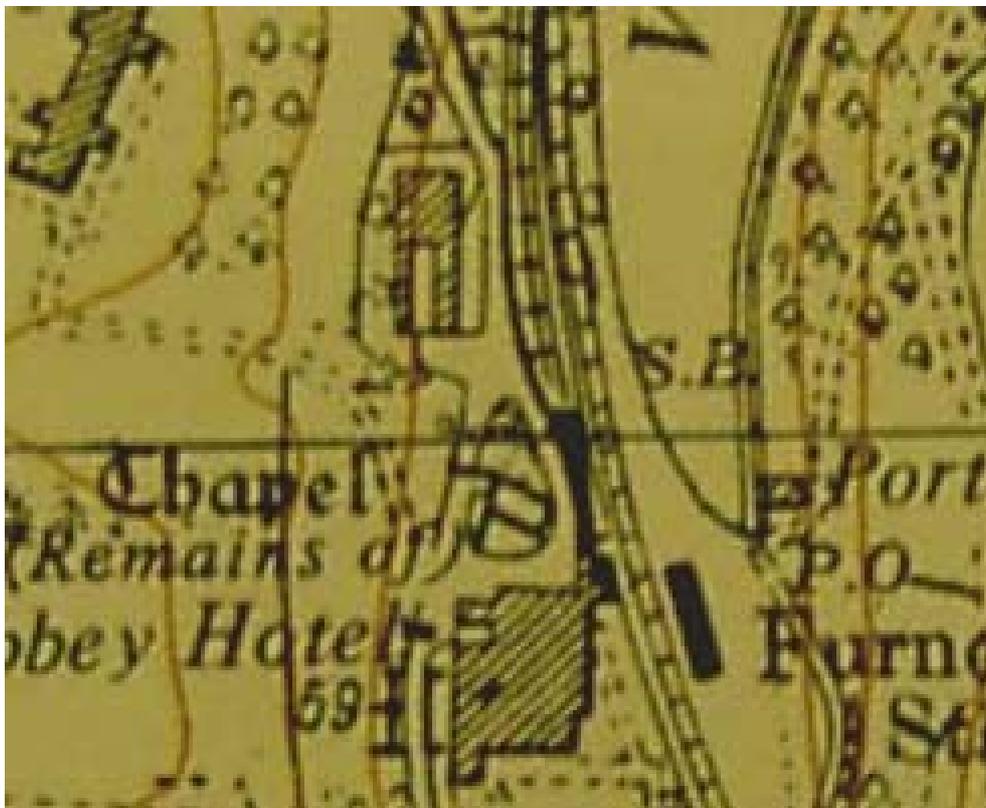
3.2.6 **Ordnance Survey 1956** (Plate 6): this map apparently shows that the entire yard area was covered by this date and the layout of the buildings remains the same. It is also noticeable that the boundary to the south of the cottage has disappeared by this date.

Plate 6: Extract from the 1956 Ordnance Survey, which appears to show covered yard

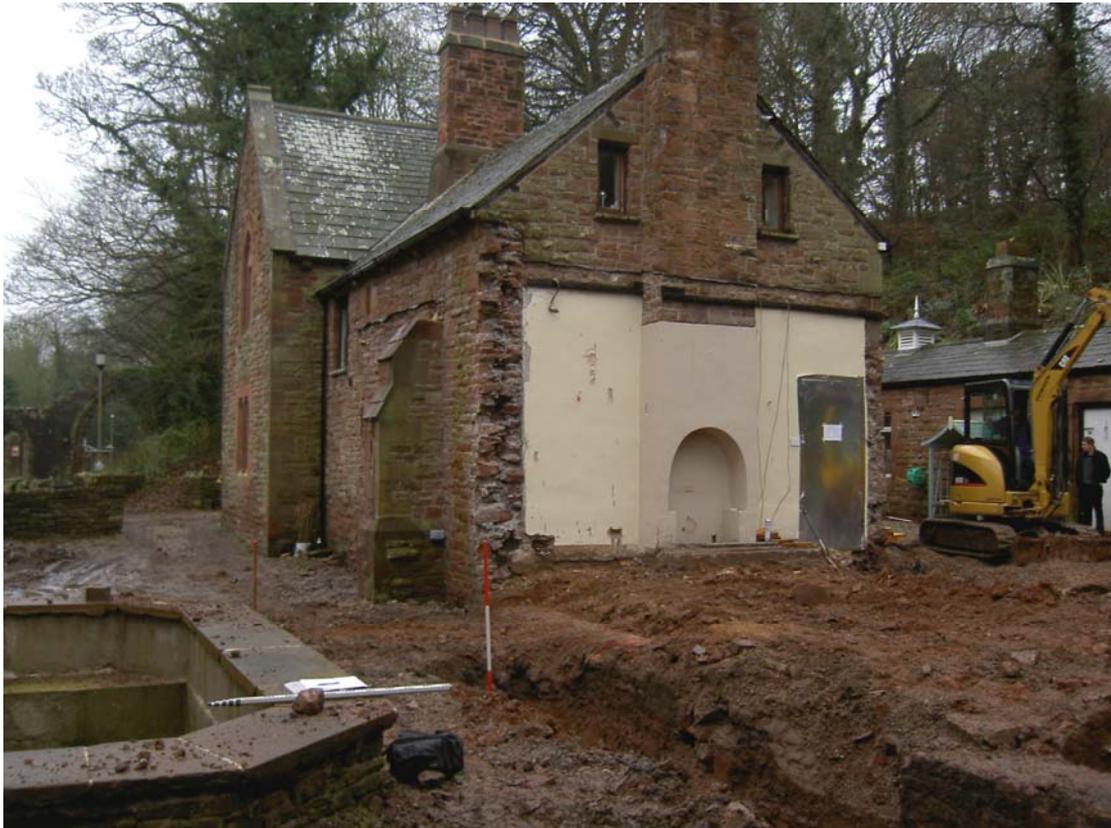
2.3.1 Three separate areas of foundation trenching were monitored; Area 1 adjacent to the north end of the current property marks the location of the proposed extension (Plate 7), Area 2 to the south-west of the house marks the location of the proposed garage, and Area 3 adjacent to the eastern elevation of the property the location of a new porch. The trenches were then recorded in the following manner:

Plate 7: Furness Abbey Cottage from the north, showing Area 1

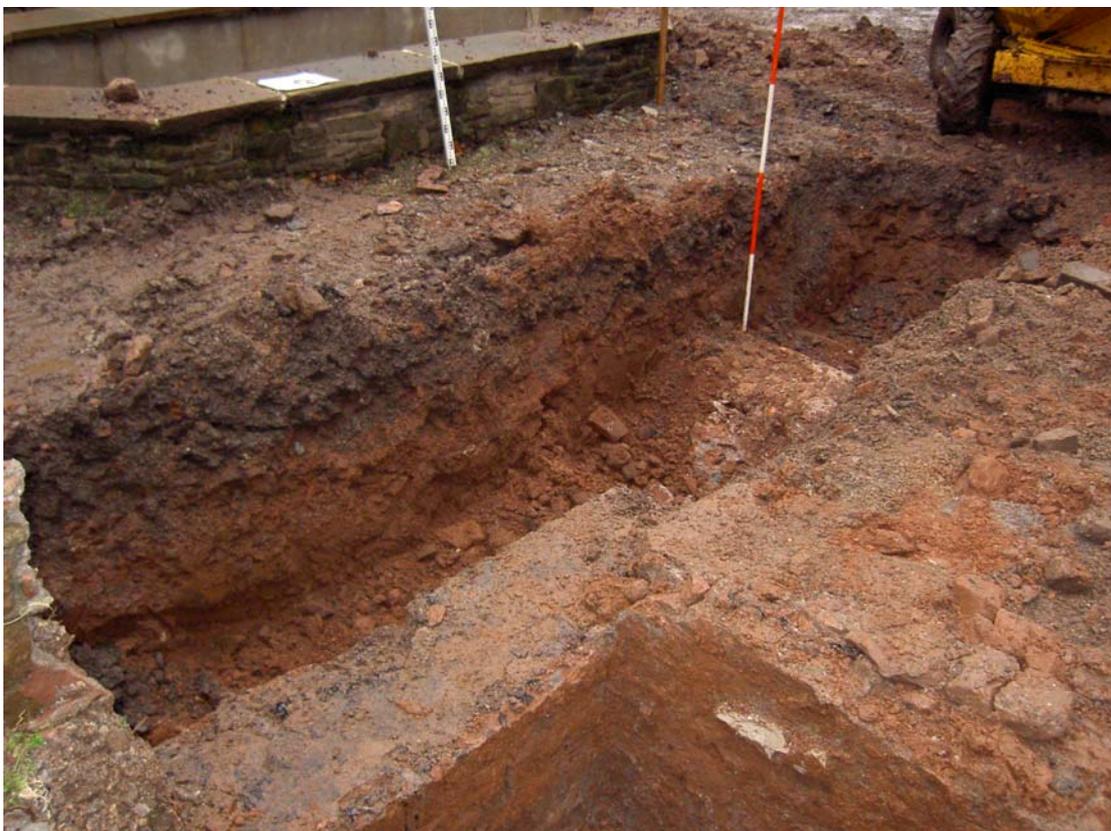
Plate 8: Area 1, Trench C, from north-west, note buttress near ranging rod

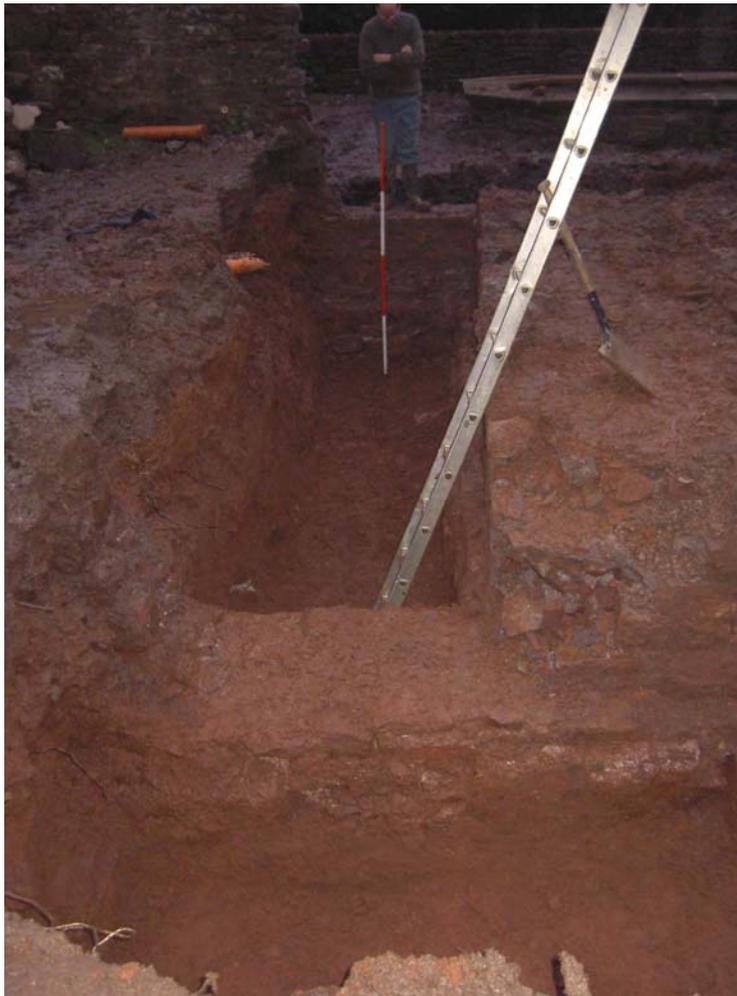
Plate 9: Area 1, Trench B, from west

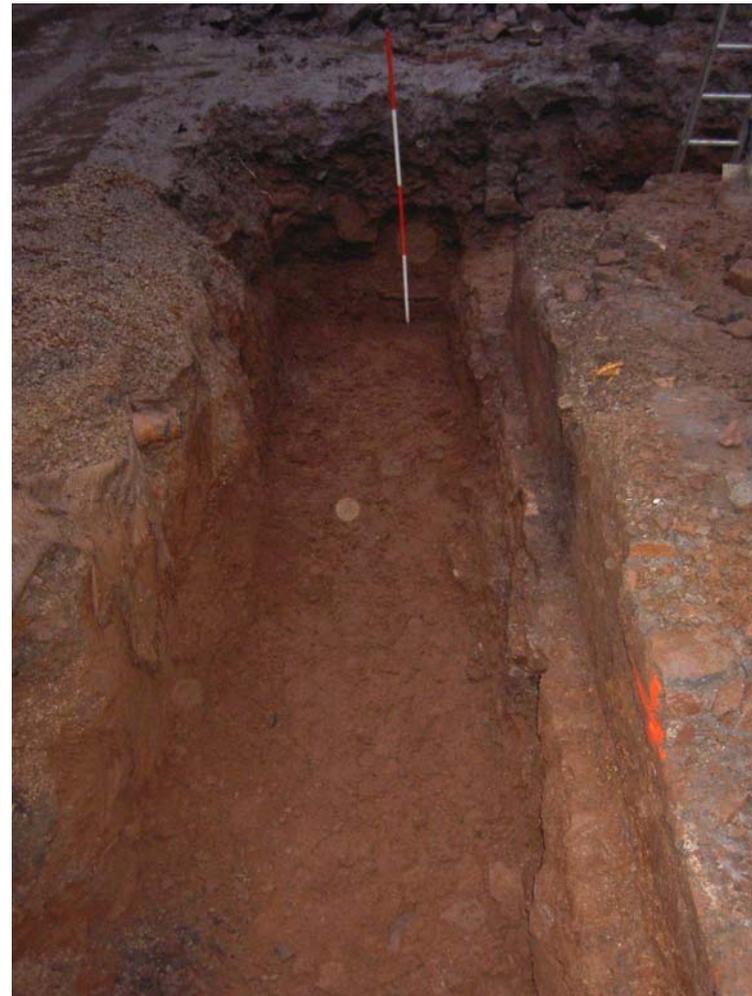
Plate 10: Area 1, Trench A, from the south

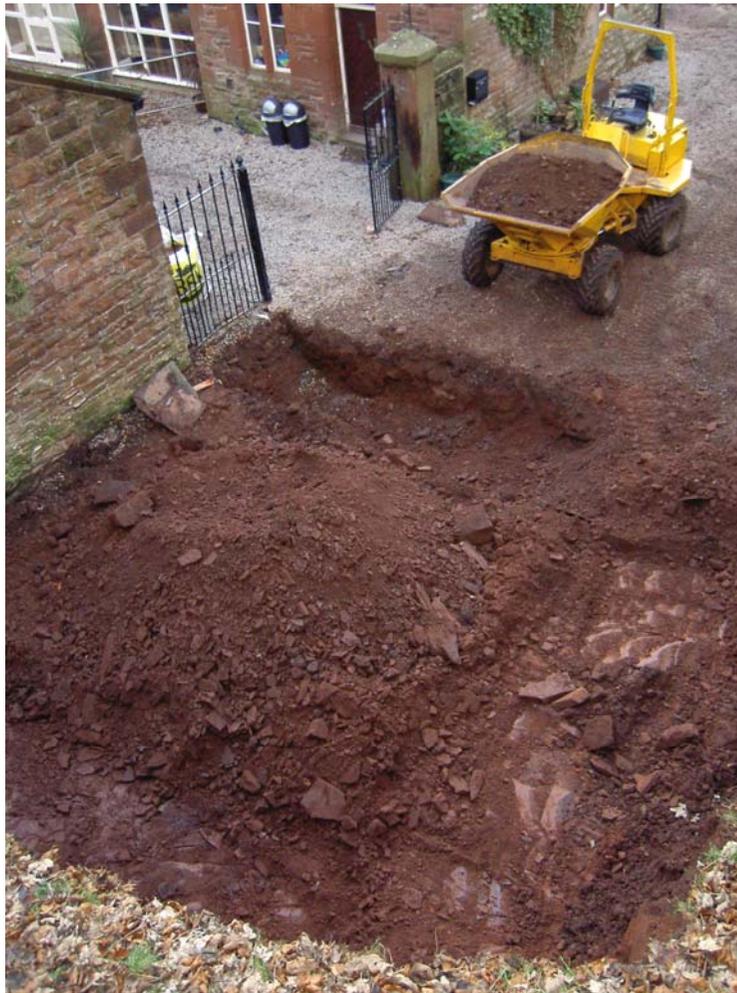
4.1.3 **Area 2:** a U-shaped trench was excavated to house the foundations for the garage, which was to utilise the existing southern elevation of the stable block to the west of the house (Plate 11). In addition to the trench, part of the steep quarry wall immediately west of the stable block was removed, and loose material including some driveway gravel was removed from within the footprint of the proposed garage building. The removal of part of the quarry face revealed thin and fractured layers of highly weathered red sandstone that would only be suitable for rubble courses. During the levelling of the garage footprint, prior to the excavation of the trench, a layer of pinkish mid-brown silty-sand was observed beneath the driveway gravels, this contained frequent broken angular red sandstone pieces which were typically 0.05m – 0.25m in length. This 0.20m thick layer, (**04**), appeared to be derived from the weathering of the exposed rock face possibly combined with relict quarrying debris. From this deposit a broken stoneware bottle was recovered (see Section 4.2, below). It would seem likely that this artefact post-dates the quarrying activity and has probably found its way into this deposit at the time of the cottage's construction (c1873) or later, when landscaping of the site would have occurred. At the west and south sides of the garage this layer sat on top of sandstone bedrock; in the north-east corner of this area it overlay context **05**, a less homogenous layer suggestive of

Plate 11: Area 2, from the south-west

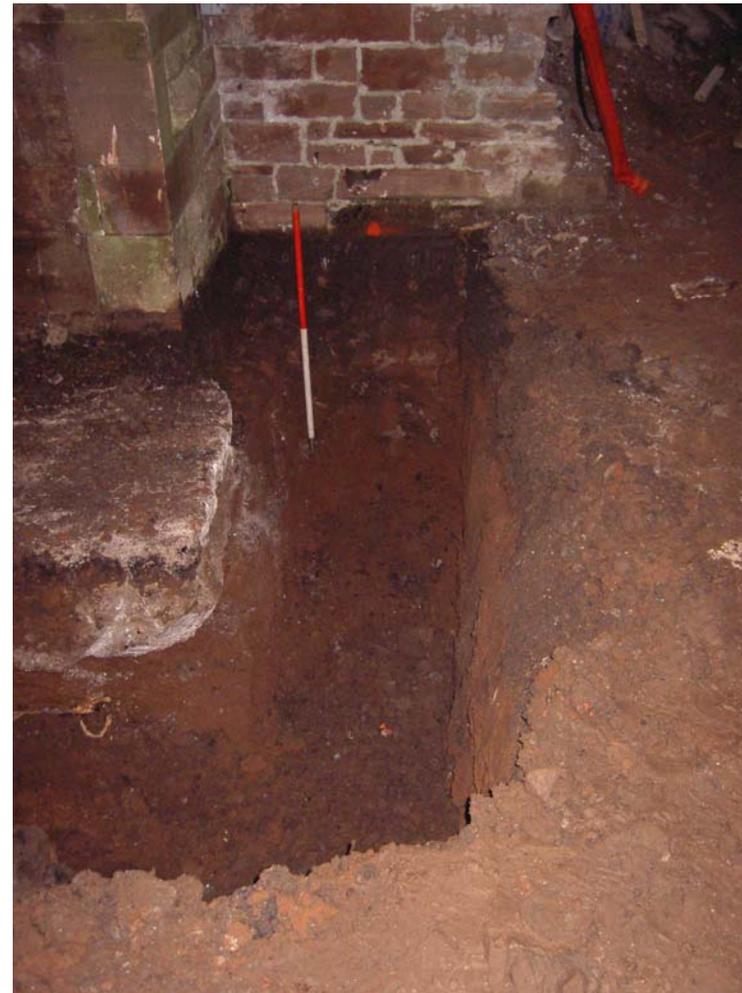
Plate 12: Area 3, from the west

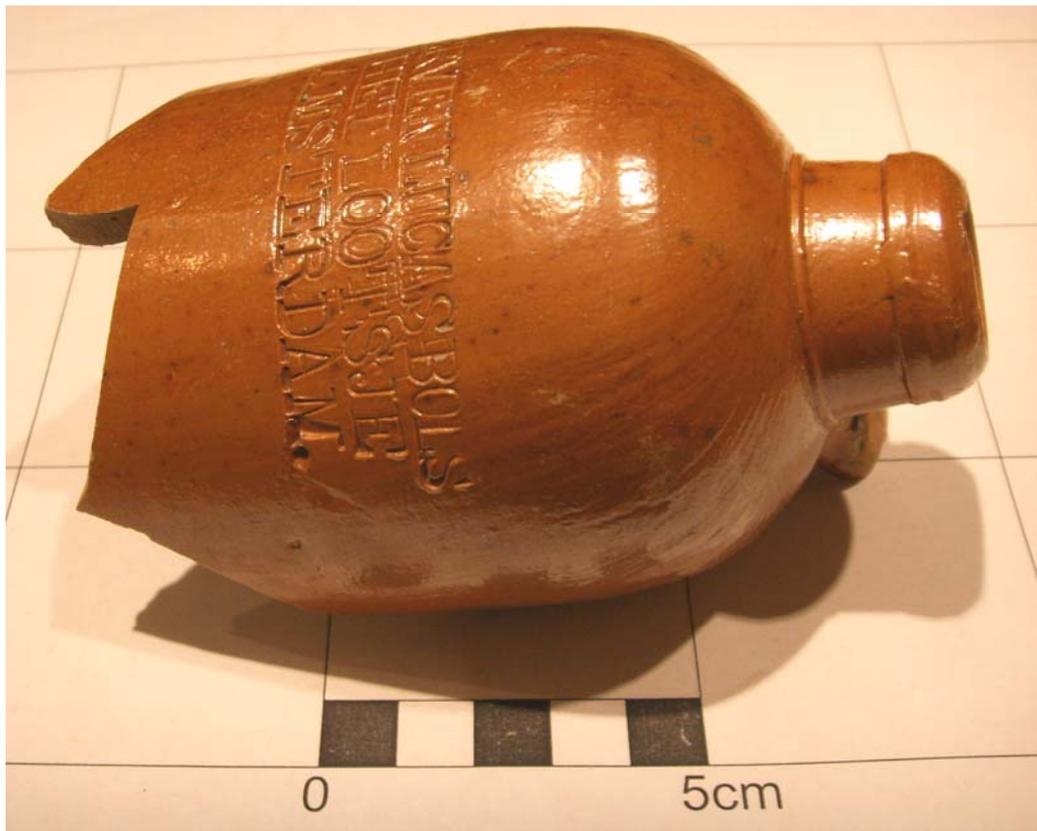
4.2.1 A single find was recovered, part of a stoneware gin or liqueur bottle from Amsterdam (Plate 13). This find was not from a sealed context and its presence in deposit **04** is probably the result tipping and landscaping.

4.2.2 The bottle bore the impressed mark 'ERVEN LUCAS BOLS / HET LOOTSJE / AMSTERDAM' (this translates as 'Heirs of Lucas Bols, The Little Shed, Amsterdam'). This company was in existence by the 17th century, but there was only a need to produce their own marked bottles from around 1850 onwards (Vermeulen 1997). Prior to this date local customers were bringing their containers to the factory, which were mainly German mineral water jugs (*ibid*). For selling outside Amsterdam the company purchased German stoneware jugs from German traders who were travelling through Holland with horse-drawn wagons carrying empty containers (*ibid*). From 1854 the company ordered their stoneware jugs directly from Germany, and they were still ordering them from the same pottery at the end of the 20th century (*ibid*).

4.2.3 The presence of a handle on the bottle recovered from context **04** suggests a latest possible date for the find. During the First World War it was not possible for the company to import bottles from Germany, and when imports resumed after the war they could only be produced without the handle (*ibid*). The date of the bottle is therefore c1850 to c1914.

Plate 13: Stoneware bottle from context **04**

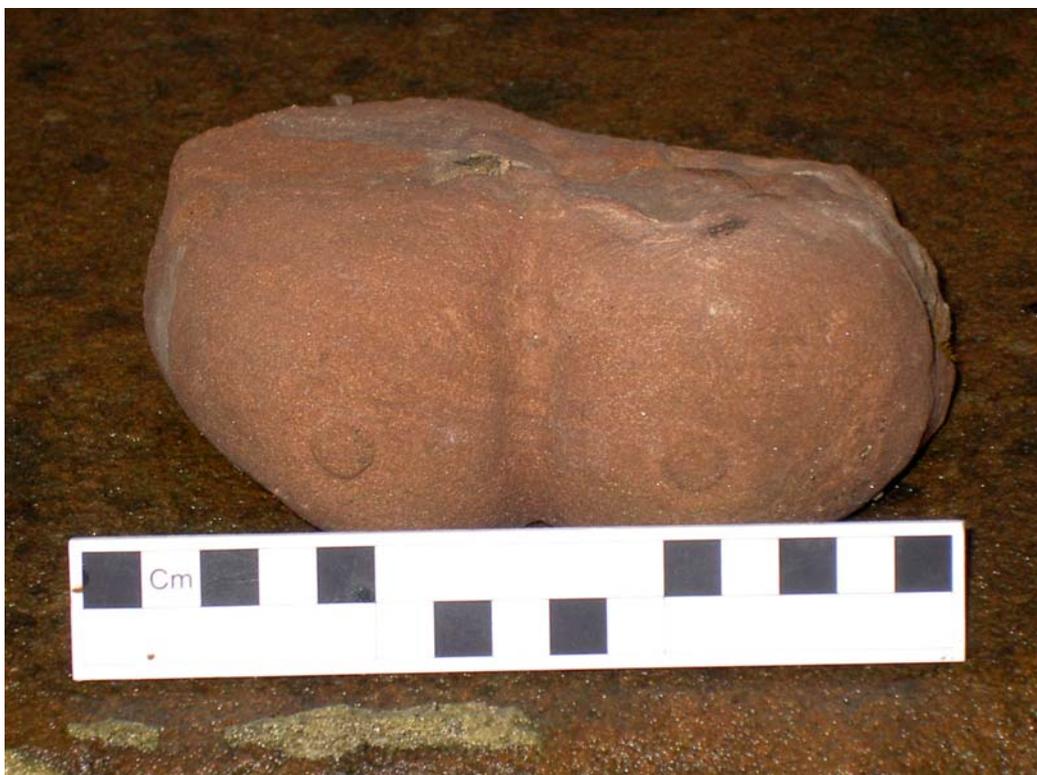
4.1.1 **Introduction:** three separate areas of foundation trenching were monitored; Area 1 adjacent to the north end of the current property marks the location of the proposed extension, Area 2 to the south-west of the house marks the location of the proposed garage, and Area 3 adjacent to the eastern elevation of the property the location of a new porch. General observations were also made, and a brief photographic record was made of a carved stone that had been built into the west wall of a lean-to against the north wall of the cottage (Plate 14), which was demolished prior to the start of the watching brief.

Plate 14: Carved stone apparently from demolished outbuilding to north of Furness
Abbey Cottage
