# MILL ROAD, GLEASTON, CUMBRIA

## Archaeological Watching Brief

Client: Stephen Morrison  
Planning Ap. Ref.: 5/06/0353  
NGR: SD 25790 70825

© Greenlane Archaeology Ltd  
January 2008

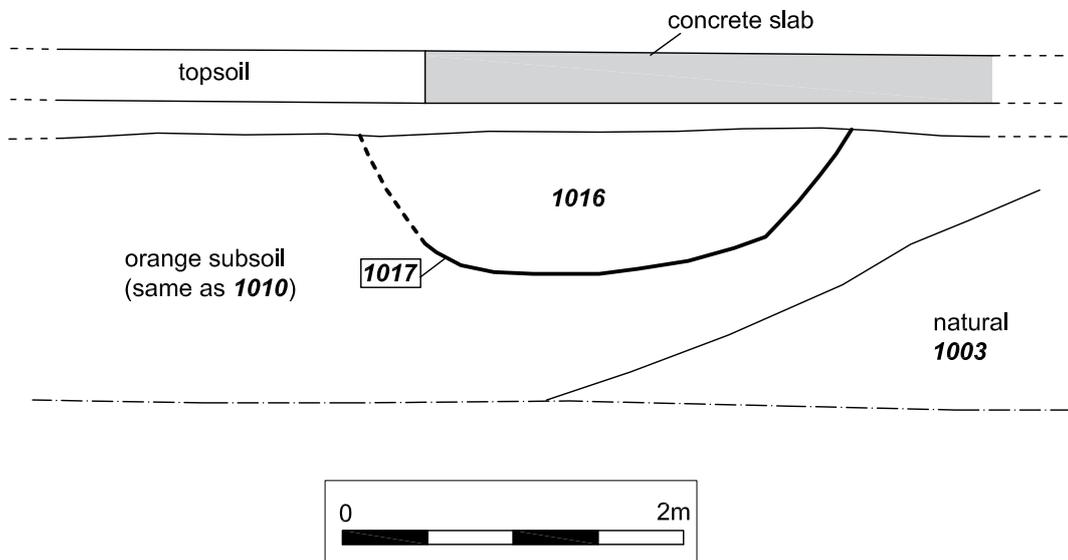
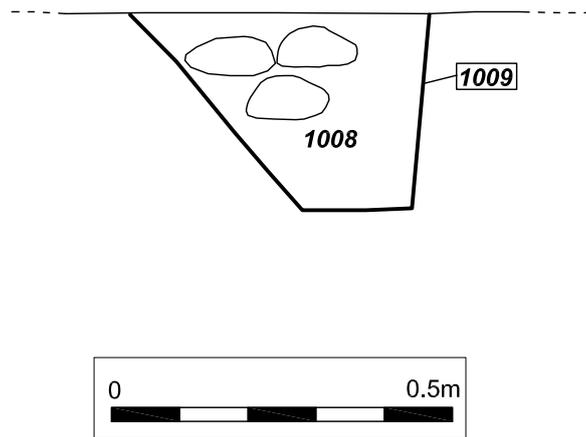
Figure 5: Measured sketch sections through **1009** and **1017**

East-facing section through **1017** and deposits beneath the west property boundary

East-facing section through **1009**

3.4.2 Prior to the excavation of the foundation trenches part of the boundary between the site and the property to the west was demolished as it was considered unsafe and liable to be undermined. Where the site was cleared against this wall a large pit feature was revealed beneath the line of the property boundary. This was evident only as a U-shaped negative feature, 2m long north/south and 0.5m deep (**1017**) and filled with a mid grey silty clay and 10% sub-angular cobbles (**1016**; Plate 8). The position of this feature meant that it could not be properly investigated, and was only visible in section (Fig 5); if it originally extended to the west it is likely to have been substantially truncated by the construction of a garage on that side of the boundary. The clearance of the area against the boundary also revealed the nature of the natural deposits and showed that beneath the topsoil was a layer of subsoil (the same as **1010**, perhaps hillwash?) that had been truncated on the north side of the site as buildings were constructed.

4.2.4 The subsoil (**1010**) also contained some early finds, and had evidently been truncated leaving only a small area south of **1009** and its line visible in section against the western boundary of the site (Fig 5). This perhaps indicates that this deposit represents the original ground surface, prior to the construction of the earlier house in the 17<sup>th</sup> or 18<sup>th</sup> century, which was largely removed during the initial and subsequent periods of building; it is notable that the majority of medieval pottery found during the evaluation came from this deposit. It perhaps partially represents hillwash collected on top of a sterile layer (suggested as resulting from a flooding episode based on the results of the evaluation) hence it was able to bury the small pit revealed on the southern edge of the site.

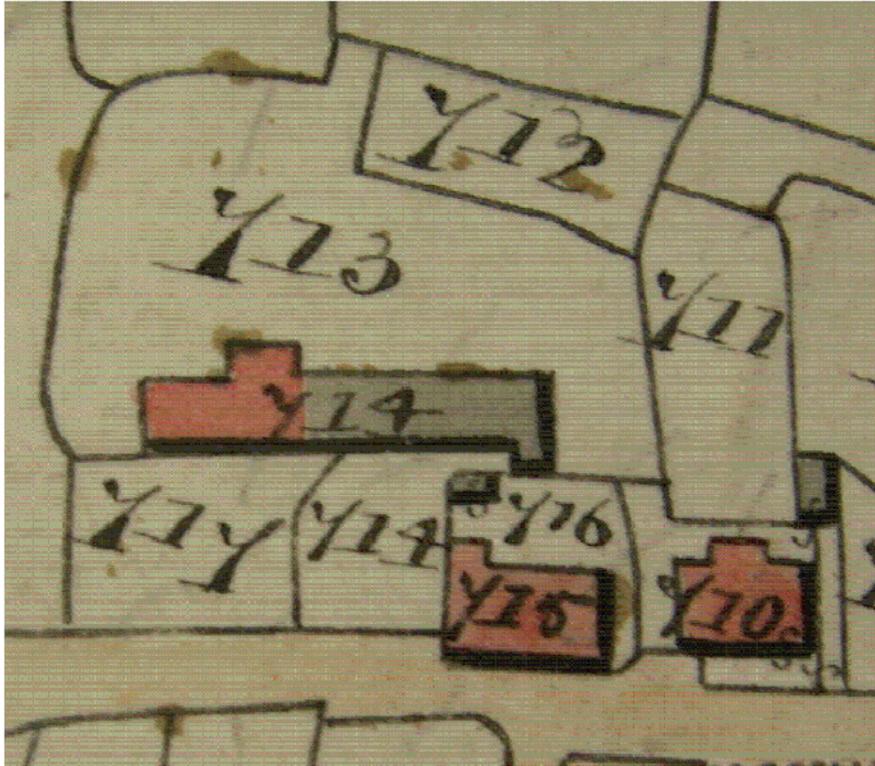
Plate 1: Part of the Tithe Map showing the plot and the earliest building recorded on the site (714) and stackyards (713) (CRO(B) BPR 21 1848)

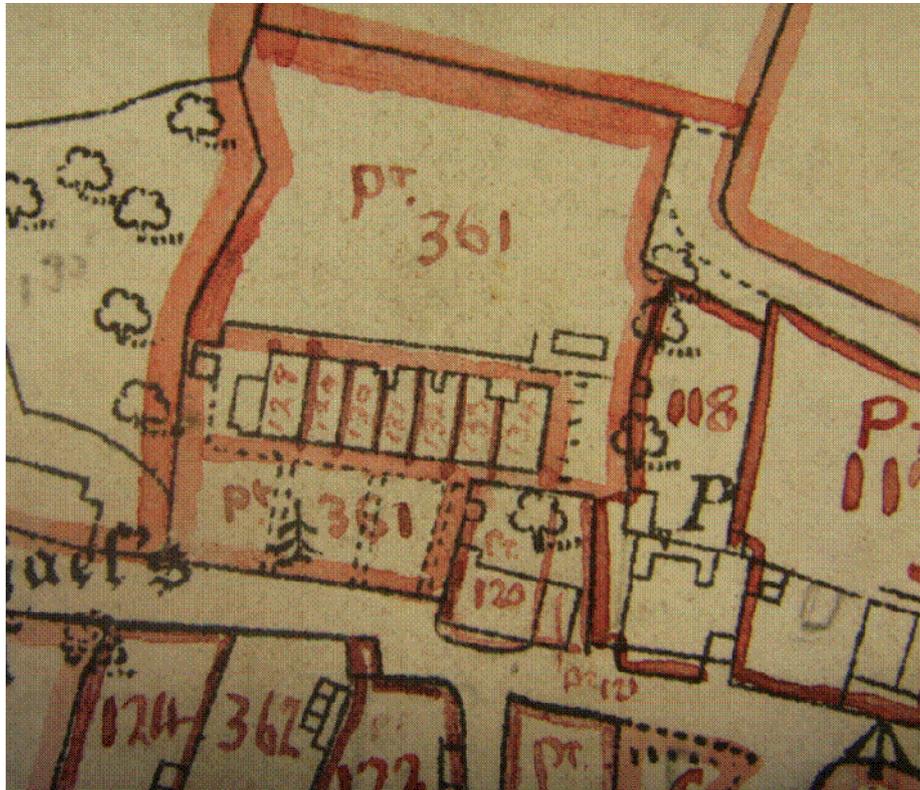
Plate 2: Part of the Ordnance Survey map of 1890 showing the row of cottages built on the plot replacing the earlier building

1.3.8 The map evidence shows that by 1890 the original house had been demolished and replaced with a row of cottages, so these are likely to have been built between 1881 and this date (see below). The Inland Revenue valuation of 1910 (CRO(B) BT/IR 1 1910, page 13, Plots 128-134) gives details of the majority of the occupiers, although not all of the properties seem to have been used at the time (see Table 1 above), and states that the entire block was owned by John Frankland (see Table 2 above). Curiously, three of the cottages (132-134) are occupied by someone called Lawson, and an Eliza Lawson, perhaps the same person, also owned the adjoining Fernleigh House at this time (*ibid*).

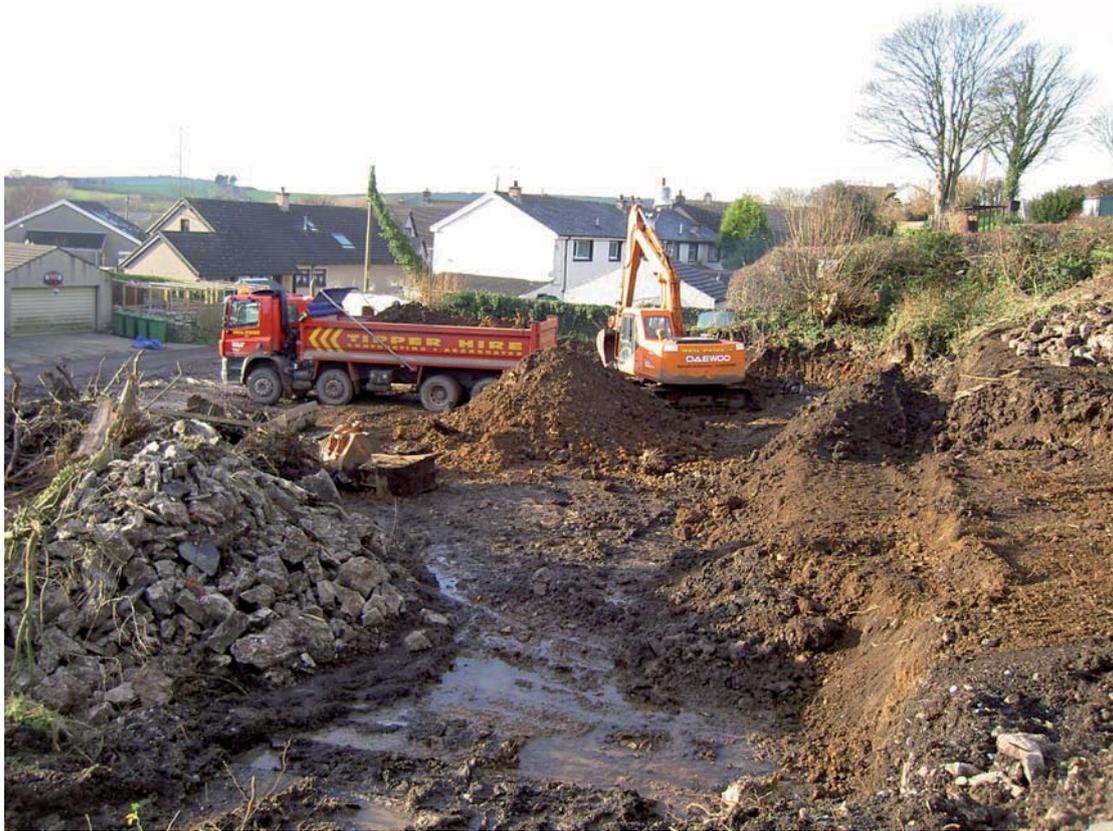
Plate 3: General view of the site during the removal of topsoil

3.2.1 Prior to the excavation of foundation trenches and the preparation of the site for this, the entire area was stripped of any overburden, topsoil, and the remains of vegetation. Prior to the watching brief beginning a section of the topsoil had already been removed alongside the road to the south and replaced with rubble hardcore in order to provide hard standing for vehicles; this was therefore not observed. At the same time that the topsoil was being removed the steep area on the north side of the site was being terraced; the retaining wall had already been largely removed and considerable amounts of soil were being taken away from the north side of the site (Plate 3). Although this area of the site was not monitored the removal of the retaining wall revealed large amounts of 19<sup>th</sup> century pottery and food waste, including bone (many showing butchery marks) and marine shell such as cockle, mussel, and oyster, were evident in the area behind the retaining wall. This had evidently either been dumped there during the construction of the retaining wall or accumulated following its construction, although the depth, quantity and un-abraded condition would suggest the former. A vertical-sided feature 1m wide and 0.65m deep and filled with a firm mid grey-brown silty clay with 20% sub-angular and rounded cobbles was also evident cut into the natural behind the retaining wall. This probably represents the position of a toilet associated with the row of cottages that formerly stood on the site, and another, slightly shallower cut containing a ceramic pipe was evident some distance to the west behind the retaining wall.

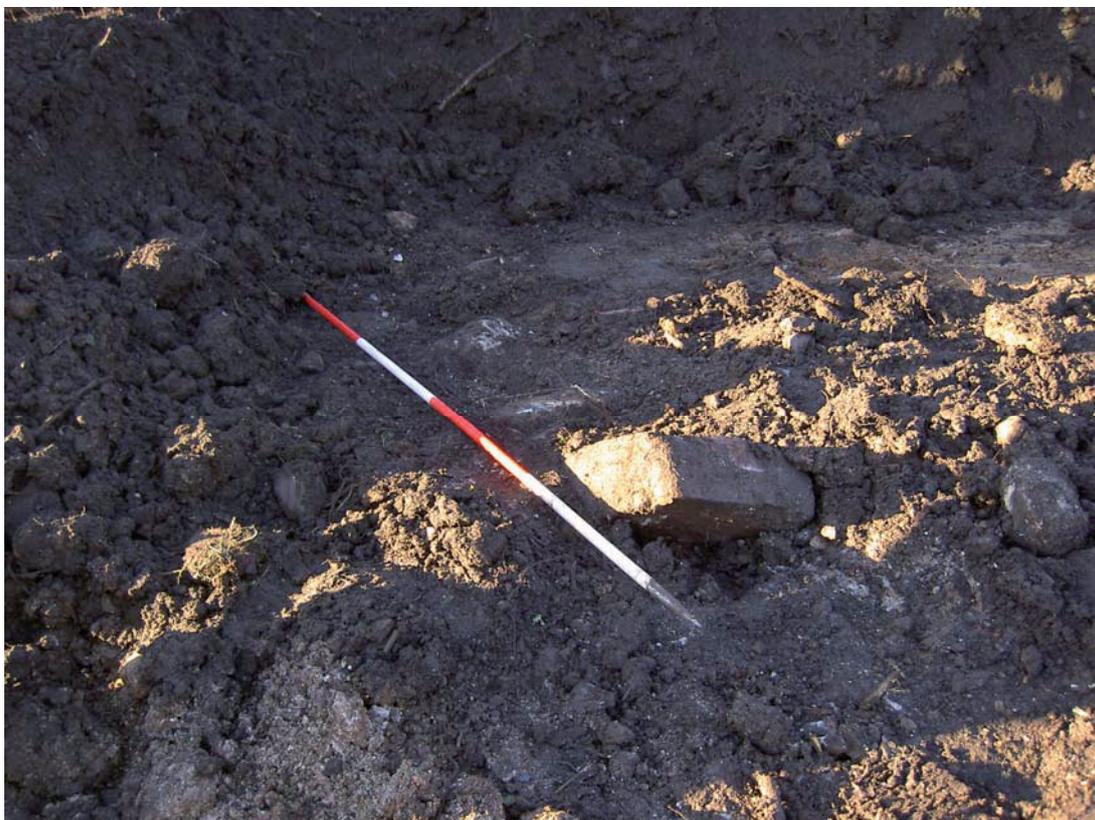
Plate 4: Large boulders making up part of wall **1005**

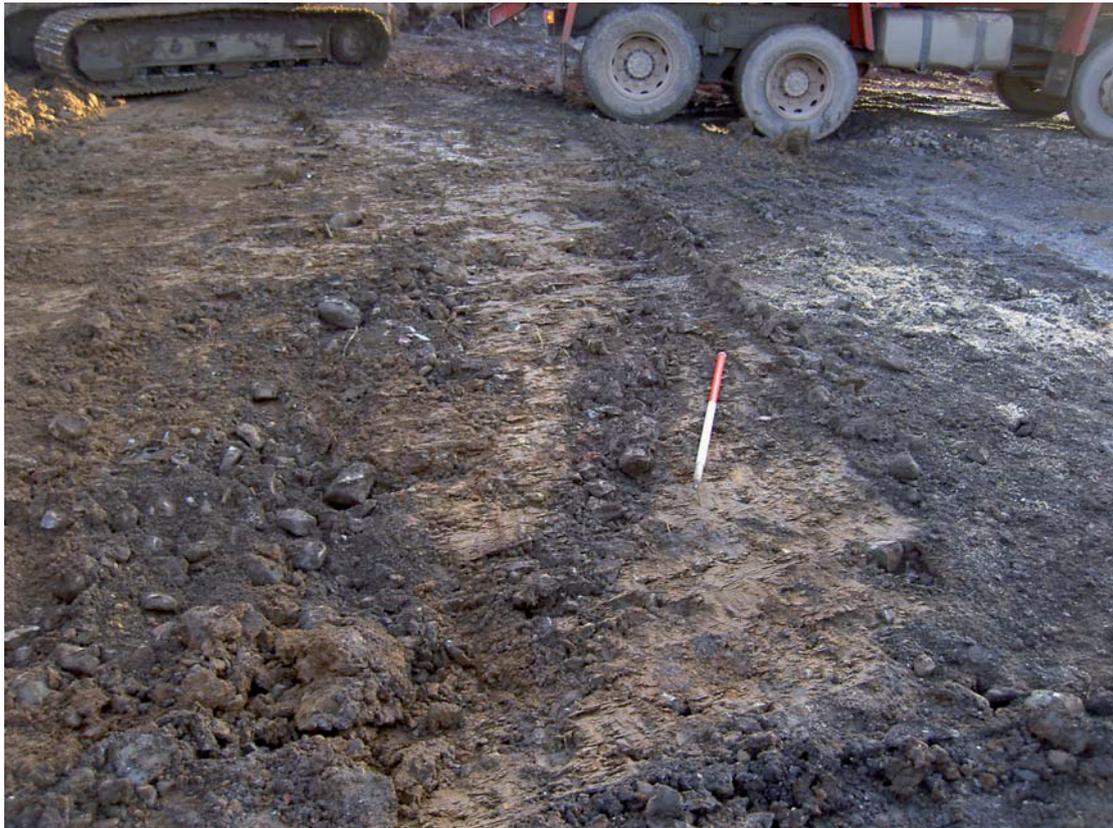
Plate 5: Linear feature **1009** as revealed during the watching brief

features previously identified were easily identifiable, the majority having already been substantially truncated. The position of linear feature **1009** was generally discernable, and was in some cases fairly obvious in section; in one area it contained a considerable quantity of charcoal flecking.

4.2.3 The stone filled hollows (**1012** and **1015**) and ditch (**1009**) are also evidently post-medieval in date and, although the finds do not easily allow close dating, it is evident that a 17<sup>th</sup> - 18<sup>th</sup> century date is common throughout, although the fill of **1012** (**1011**) has 19<sup>th</sup> - 20<sup>th</sup> century finds suggesting it was filled later or that these are intrusive. The medieval pottery recovered from **1008** during the watching brief is clearly residual, although pottery of this type made at Silverdale regularly occurs in 17<sup>th</sup> century contexts (White 2000, 290). These features are likely, therefore, to relate to the construction of the early house, or immediately thereafter, and were probably connected to attempts to improve and drain the ground; it is notable that this area is described as a 'stackyard' on the Tithe Map of 1848 (plot 713; Plate 1), which would indicate an area that it was desirable to keep dry.

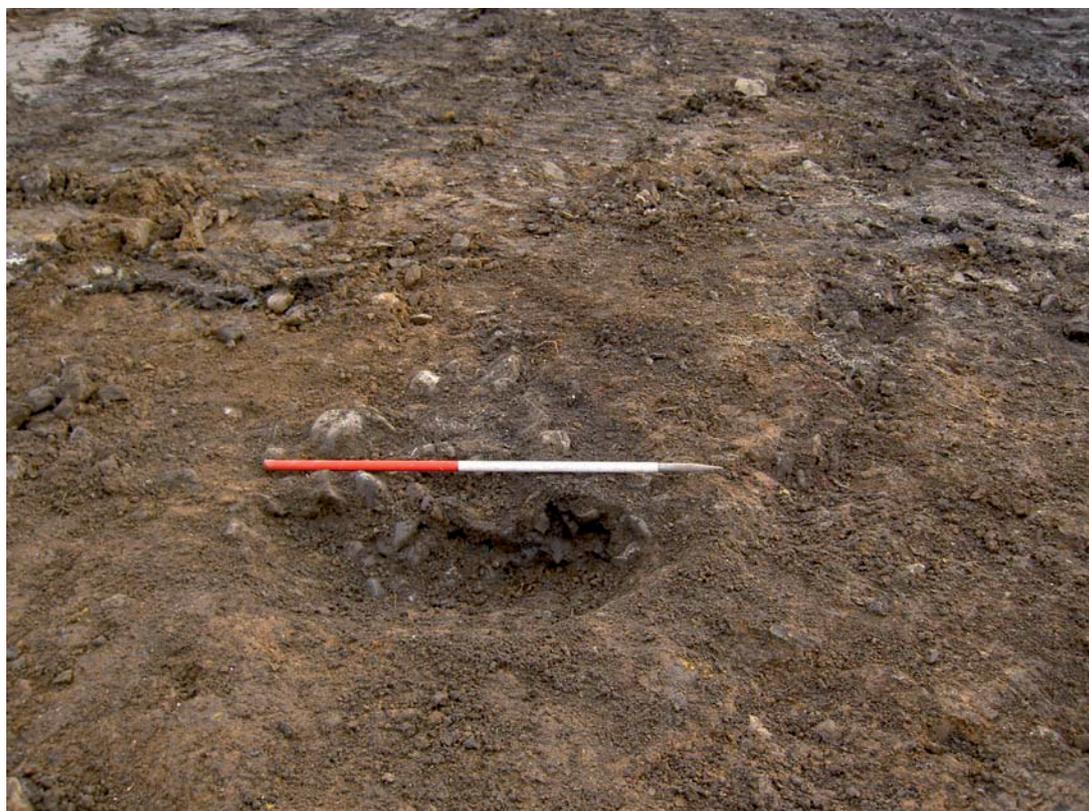
Plate 6: Pit **1015** and the adjacent end of **1009** (to the right) as revealed during the watching brief

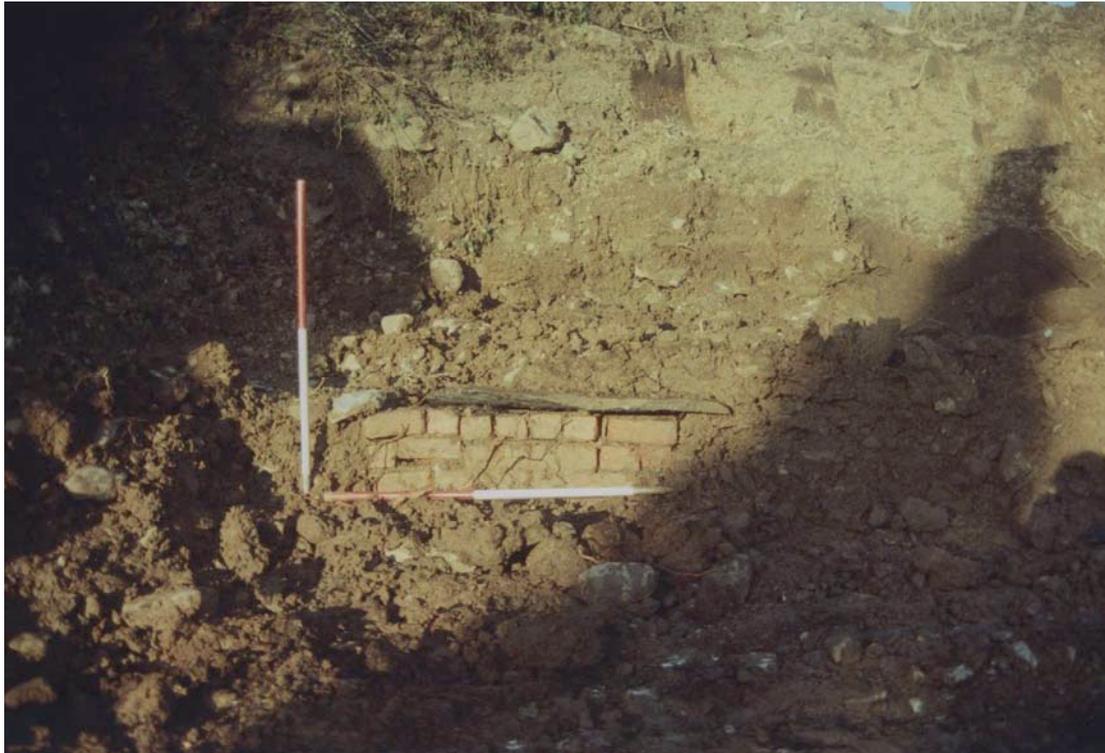
Plate 7: Brick drain junction capped with slate revealed behind the retaining wall during the watching brief

4.2.2 The pipes, ceramic drains, and brick drain junction, although not easily dateable in themselves, clearly relate to the row of late 19<sup>th</sup> century cottages. The iron pipe evidently cuts through cobbles **1002** and so must be later. These features also closely correspond with the position of the retaining wall, which the map evidence shows was clearly constructed at the same time as the cottages. The copious amounts of late 19<sup>th</sup> century finds (which were not retained) from the area behind this wall and the cuts, probably for water pipes and toilets, also confirm this.

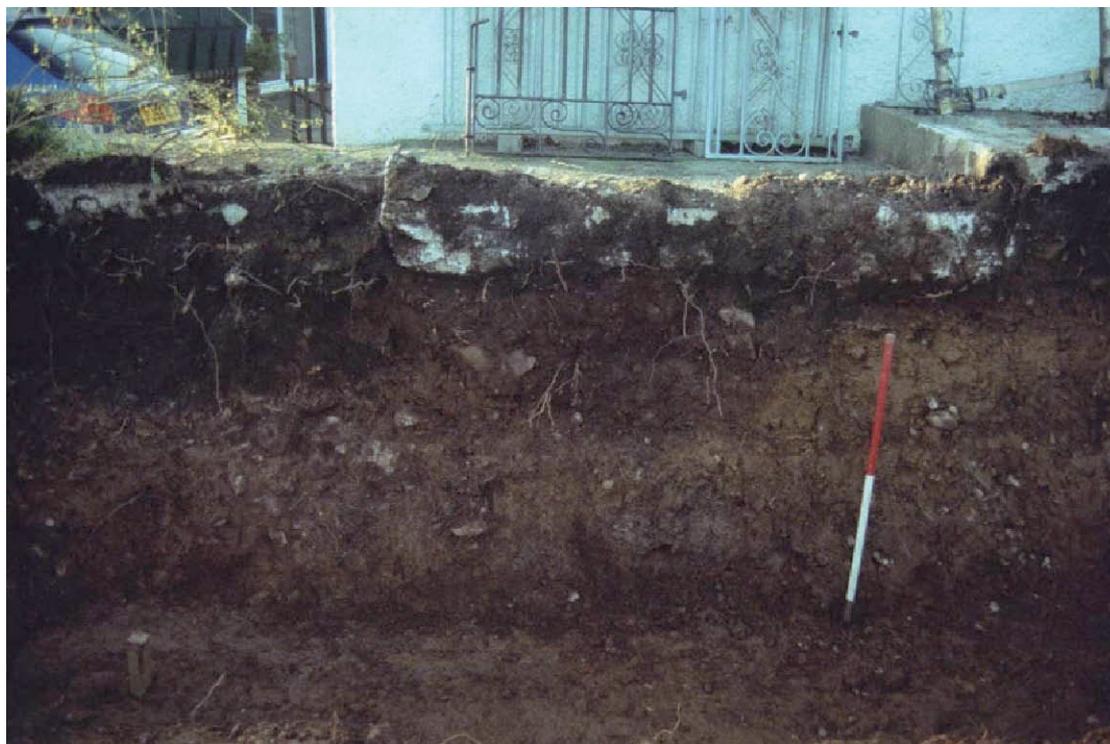
Plate 8: Large pit **1017** as revealed beneath the property boundary during the watching brief showing the slope of the natural and subsoil deposits beneath
