MIDDLE BROWS FARM, CARR LANE, MIDDLETON, LANCASHIRE

Archaeological Building Recording

Client: Tom Hargreaves
Planning Ap. Refs.: 07/00045/CU,
07/00051/LB, 07/00050/FUL,
07/00054/LB, 07/00048/FUL,
07/00049/FUL

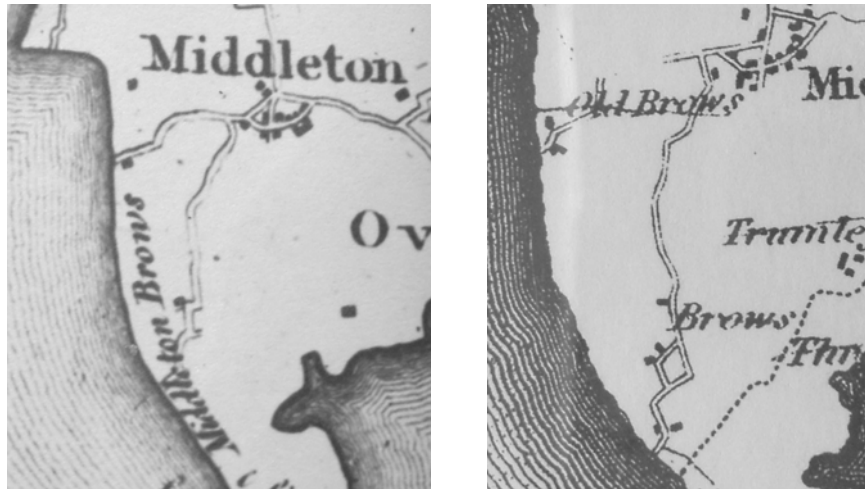
Plate 2: Yates' map of 1786

3.3.2 **Yates 1786:** although not detailed it is evident that there were buildings present on the site of Middle Brows at this time (Plate 2). The entire group of farms in the area is referred to only as 'Middleton Brows' however, and no further information is available.

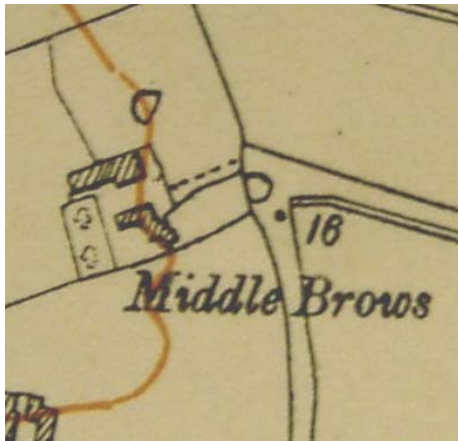
Plate 10: Ordnance Survey map of 1955

3.3.9 **Ordnance Survey 1955:** although not detailed it would appear from this map that at least one of the small additions made to the buildings by 1891, the porch on the south side of the house, had been removed (Plate 10). Other than that the site is essentially unchanged.

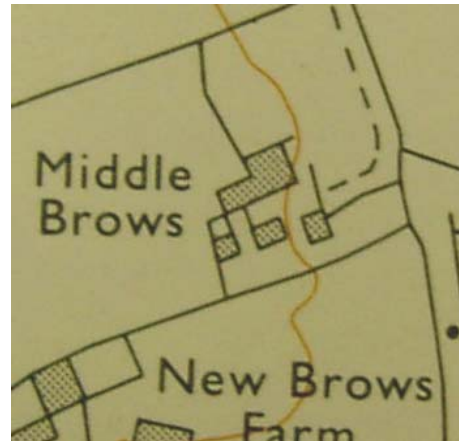
Plate 11: Ordnance Survey map of 1975

3.3.10 **Ordnance Survey 1975:** this is again not detailed, and the only apparent alteration is to the range of buildings opposing the farmhouse and barn, which have been replaced or converted into three small detached structures (Plate 11). One of these, at the west end, is clearly the present farmhouse. The following map from 1994 is essentially exactly the same, and was apparently not a full revision so shows no evident changes on the site.

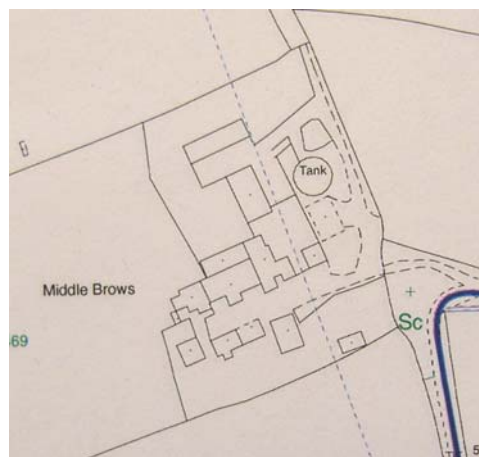
Plate 12: Map from the deeds dated 2000

3.3.11 **Deeds 2000:** this is a detailed map, presumably produced by the Ordnance Survey, which reveals a number of things about the site. A large number of additional buildings have been added to the north and east side of the barn, but it appears that the porch is still present on the south side of the house (Plate 12). In addition, the mounting block situated against the south side of the house also appears to be shown.

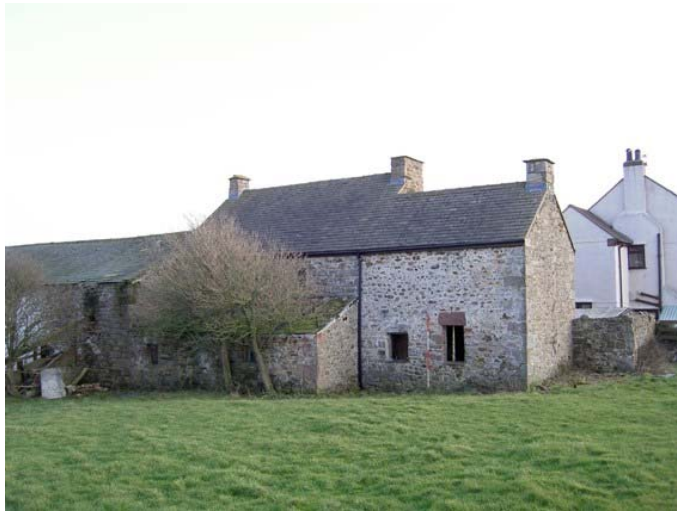
4.2.1 **North elevation:** the west end is formed by the western extension to the house, and there is an evident butt-joint with the main house (Plate 13). There are two windows on the ground floor, both with heavy stone lintels and thin stone sills, with the remains of elements of the casements surviving. To the east, attached to the original house, there is a single-storey monopitch outshut. The west end of this is plain, except for two ceramic pipes inserted to act as vents just below the roof. The north elevation has two windows, the westernmost is plain with a heavy lintel, while the east has a similar lintel but the jambs and sill are made of re-used pieces of one or more mullion windows (Plate 14). The outshut butts the barn the east end. The first floor, of the house proper, has two small windows with chamfered stone surrounds either side of a tall central stair window, also with chamfered jambs; the upper part has been blocked with stone and the lower part is covered by the monopitch outshut. To the east the north elevation of the barn has been finished with limewash as a result of having a later shippon attached to it, which has obscured a considerable amount of detail and left numerous scars corresponding to pipes and other fittings (Plate 15). There is a small window on the west side in an area of collapsing wall with a modern two-light casement. To the east of this is another small window, with a heavy lintel evidently made out of a re-used broken and chamfered lintel, with a small recessed rectangular panel on the west side (perhaps the position of a date, although obscured by repeated layers of limewash; Plate 16). In the eastern jamb another piece of re-used stone is present with a rectangular slot and circular hole cut into it, perhaps the socket for a post from a shippon stall and/or door pivot. Beneath this window a large container formed from riveted sheets of iron with a hinged lid on the north side and no base on the south has been inserted through the

Plate 13: North elevation of the west extension to the house

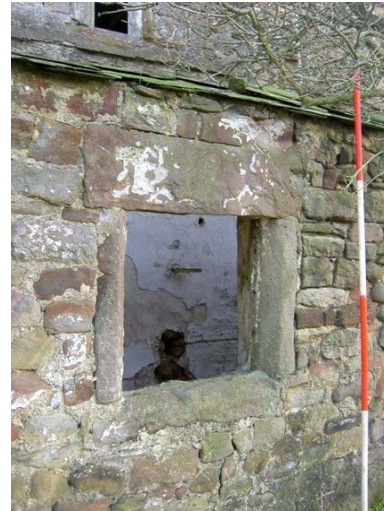
Plate 14: Window incorporating re-used mullions

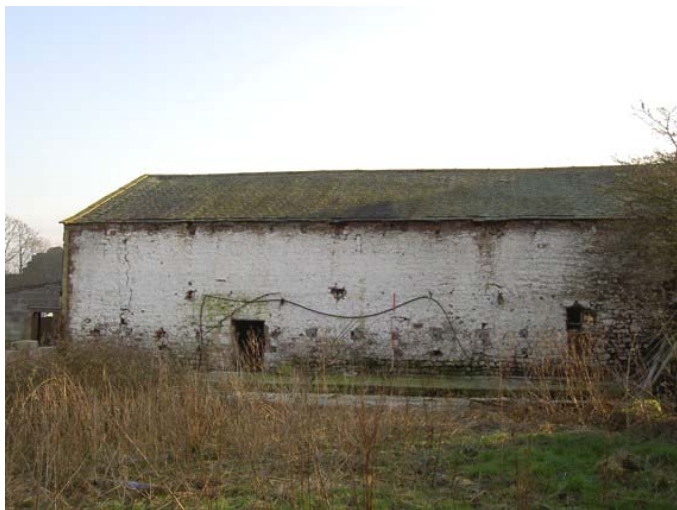
wall forming a chute. To the east there is a doorway with a dressed stone lintel and quoined jambs. At first floor level three winnowing slots blocked with bricks are visible, and at the north-east corner the remains of a concrete block wall butt the building.

Plate 15: North elevation of the barn

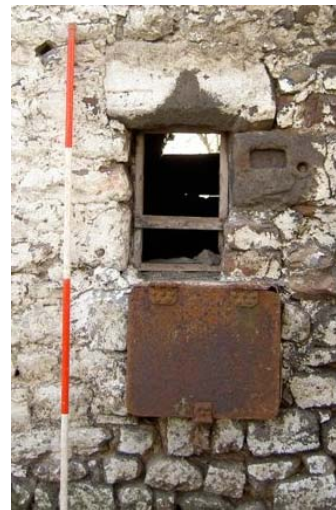
Plate 16: Re-used stone and iron container with lid forming a chute incorporated into a window in the west end of the north elevation of the barn

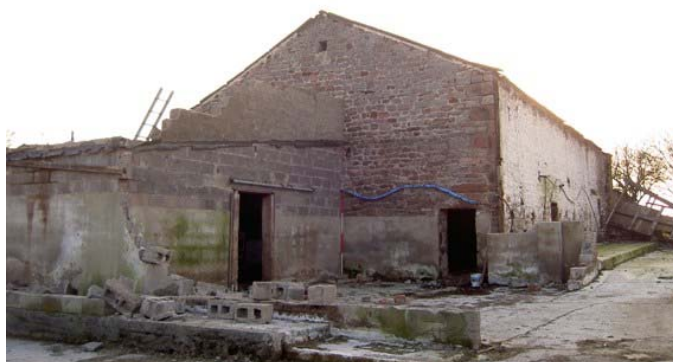
4.2.2 East elevation: this is the gable end of the barn; the north side is exposed due to the demolition of attached modern buildings, while the south side is largely obscured by their presence and the lower part is finished with a skim of concrete (Plate 17). The elevation is generally plain; there is a doorway on the north side with a heavy stone lintel, coping slabs have been placed on top of the slates on the roof itself, and there is an owl hole in the centre below the apex. Despite being obscured, a blocked doorway is evident on the south side, within the attached modern buildings, and there is an alcove within the interior of the attached building formed in the external wall of the barn. Several joists have been inserted into the wall to support the first floor within the attached building.

Plate 17: East gable and the remains of attached modern buildings

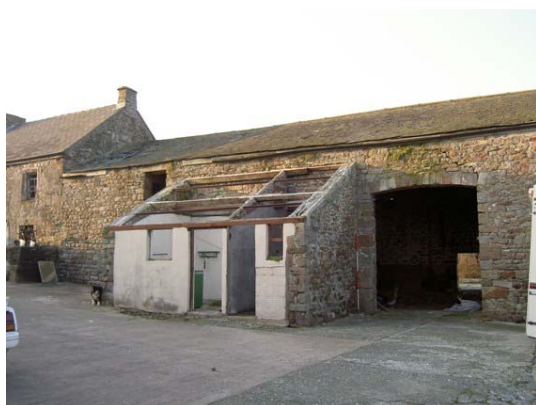
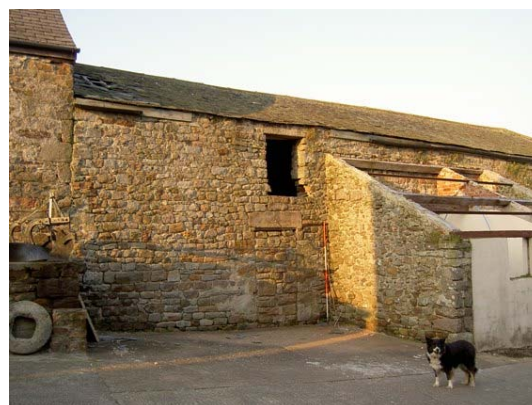
4.2.3 **South elevation:** the eastern half is formed by the barn, at the east end of which is a large wagon doorway with a flat arch made up of dressed blocks (Plate 18). Immediately west of this is an attached monopitch outshut, with stone flanking walls to the east and west and originally with an open front to the south (Plate 18). The roof covering has been removed, exposing the fabric of the roof structure, which is constructed from two timber beams and two iron rails, probably from a narrow gauge railway. The infilled south side has two doorways and two small windows, the one to the east with a modern two-light timber casement, and all of these openings share a single machine-cut timber lintel. To the west of the outshut there is a ground floor doorway blocked with stone, with a heavy stone lintel, which is neatly dressed and has a chamfered edge (Plate 19). The chamfer turns at the corners into the jambs, which are quoined and do not continue the decoration, perhaps suggesting that the lintel is re-used, although there is evidence for rebuilding around the doorway maybe indicating that it has been remodelled. Above this doorway, slightly to the east, is a pitching doorway with a stone lintel, the sill of which appears to have been removed. To the west of these doorways it is evident that the barn butts the house.

Plate 18: South elevation of the barn, with the attached outshut

Plate 19: South elevation of the barn showing blocked doorway

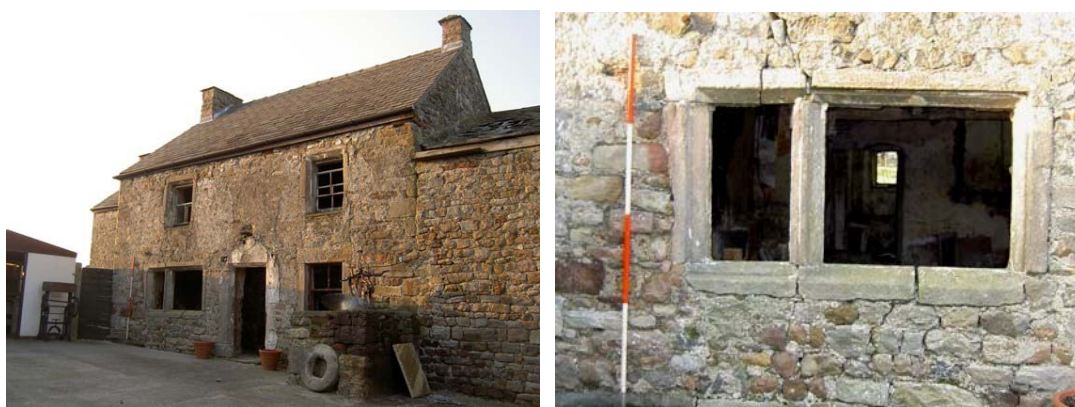
4.2.4 The house is two storeys high with a large stone built mounting block butting the east side of the ground floor and partially obscuring a window. There are two windows per floor; on the ground floor the east window has dressed square surrounds, is evidently inserted, and has the remains of a four-light sliding sash window *in situ* (Plate 20). To the west is a wide mullion window with a single mullion surviving on the east side and the scar of the bases of another to the east. The

mullion has a plain chamfer on its inner side but a deep square rebate on the outer and the surround matches this design, with a deep rebate on the lintel and a plain chamfer on the sill (Plate 21). However, in the western third this arrangement is reversed, perhaps indicating some remodelling or that it was originally constructed with the sill and lintel reversed. The widened east side also has the paint scar for a timber frame, suggesting it was remodelled to accommodate a sliding sash window. Between the two ground floor windows is a central doorway, which has a heavy lintel decorated with cyma-moulding, which extends into the quined jambs, although it is heavily eroded in the central area (Plate 22). It has a tongue and groove plank door and the scar of a porch is evident above the lintel and around the upper part of the jambs. The first floor has two windows, each of which originally comprised a two-light mullion; the chamfered jambs and lintels are still present, but the mullion has been removed as has the original sill. A new thin sill has been added at a lower level, to form a taller window, and the remains of a timber four-light sliding sash casement are present in each case.

Plate 20: The south elevation of the house

Plate 21: Detail of the mullion window within the south elevation

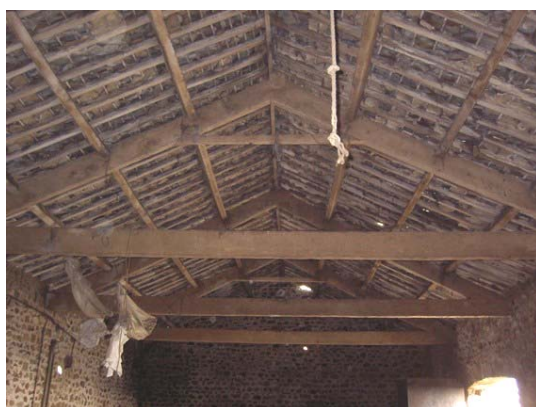
4.3.1 **Floor, roof, and dividing wall:** the floor is obscured by a layer of straw and dung, except for a small area of flags on the south side corresponding to the position of the wagon doorway and forming the remains of an original threshing floor. The roof is supported by four tie beam trusses constructed from sawn timber. The principal rafters are notch-jointed together and there is a thin collar between them (Plate 24). There are three purlins per pitch, probably scarf jointed where they meet at the purlins, and a thin ridge board. The trusses have carpenters' marks irregularly positioned, although some are possibly hidden by layers of dust, at the junctions between the collar and principal rafter, the tie beam and the principal rafter, and the two principal rafters. These are numbered 'II', 'III', 'IIII', and 'V' from west to east (Fig 4). Truss IIII has the initials 'OJ' scratched into the east face of the tie beam, and Truss V has the initials 'JG' scratched into the underside of the tie beam and some possible Baltic timber marks, in the form of two or three simple lines scratched into the east face of the tie beam crossing the entire surface, but these were very indistinct. The east end of the building is sub-divided by a low stone wall supporting a floor forming a half loft with a low shippon beneath (Plate 25). The wall appears to be original, although it butts the north and south walls of the barn. It has a central doorway, although this has evidently been raised in height, as has the entire wall, in a mix of concrete blocks and Claughton bricks. The wall supports a number of telegraph poles, which in turn support the floor boards for the half loft.

Plate 24: West faces of the trusses within the barn

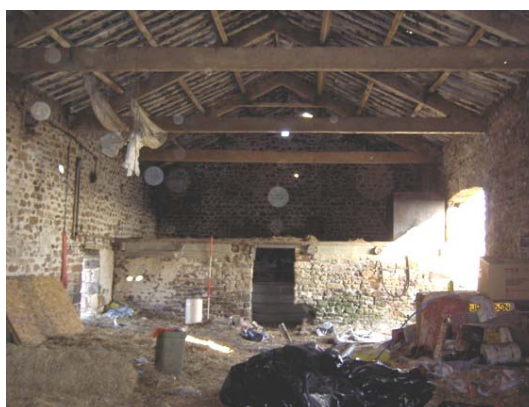
Plate 25: Dividing wall at the east end of the barn

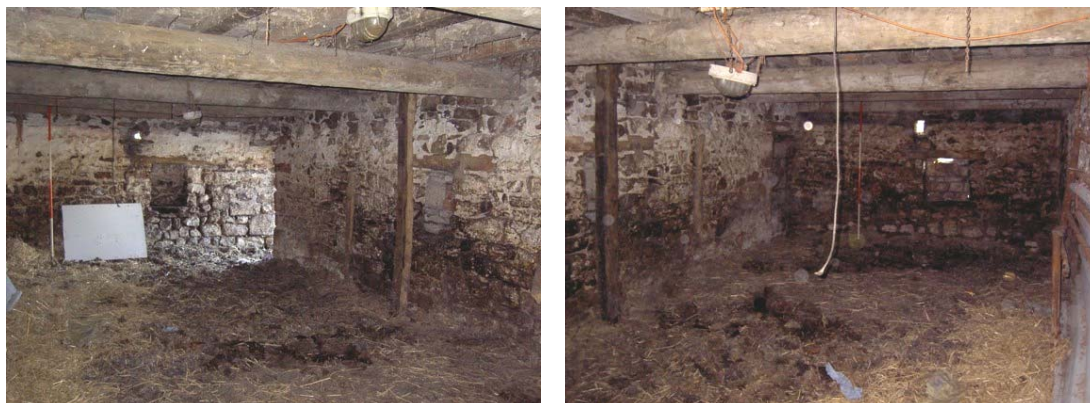
4.3.2 **North elevation:** there are three winnowing slots present, effectively at first floor level, all of which are blocked from the outside with brick and have splayed jambs and stone lintels. There are two more on the ground floor, also blocked, and two small apertures at the west end. These both have very simple modern casements surviving; the area above the westernmost is partially collapsed while the easternmost has a timber lintel and an inserted iron container beneath it forming a chute (see *Section 4.2.1*). In the vicinity of these windows the scars of joist or beam holes for a half loft and a dividing wall, which probably originally had a similar arrangement to that at the east end, are evident. To the east, adjacent to the extant dividing wall is a doorway with a rough hand-finished timber lintel with numerous relict peg holes. Within the shippon, at the west end, there is a small alcove built into the north elevation with a timber lintel and wide stone sill (Plate 26).

Plate 26: North-east corner of the shippon at the east end of the barn, showing the alcove in the north wall

Plate 27: South side of the shippon, showing opposing alcove

4.3.3 **South elevation:** the lower part of the east end, within the shippon, has an alcove built into the wall with a timber lintel and a stone sill (Plate 27). Immediately above and slightly to the east is a small square vent. Above the floor of the half loft the wall is plain. To the west is the large wagon doorway with a flat arch, and west of this on the ground floor there are two winnowing slots similar to those in the north elevation. Further west there is the stub of a dividing wall, matching the position of that to the north. Immediately adjacent to this is a blocked doorway on the ground floor, above which is a pitching doorway, to the west of which is a row of joist holes denoting the position of the half loft.

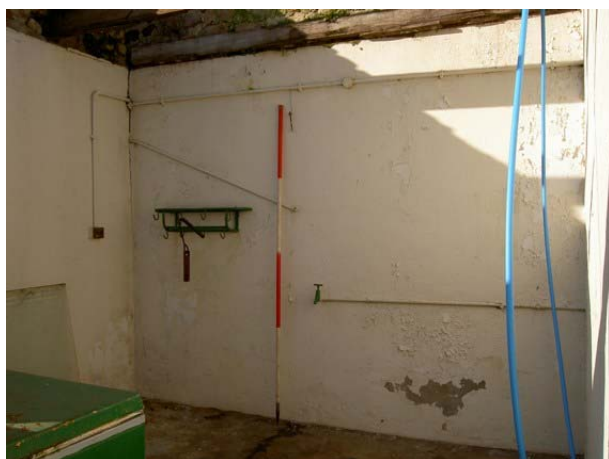
monopitch roof, and there is an additional beam orientated east/west. All of the walls are finished with a skim of concrete with attached ducting for electrical cables and water pipes on the north and south sides. The west elevation is brick, with scars for attached fittings. The south elevation has a small two-light window to the east and a doorway to the west. The western room also has a concrete floor and an additional beam in the roof. Again, all of the walls are finished with a skim of concrete and painted, with pipes and electrical ducting attached to the north and west walls. There is a metal bracket with hooks attached to the north elevation (used for hanging buckets used in milking; Tom Hargreaves pers comm.; Plate 28). The south elevation has a window and a doorway.

Plate 28: Internal view of south outshut, western room

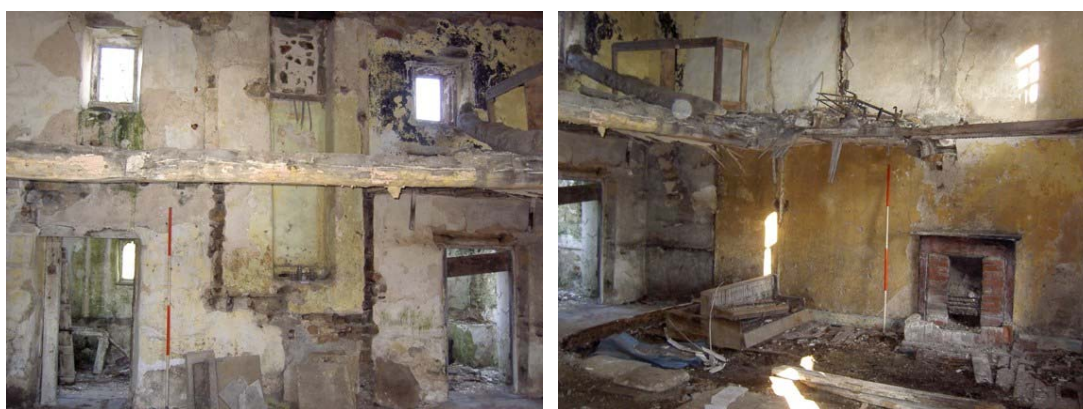
4.4.3 The north elevation has a blocked central stair window extending through both floors, with stone transoms still *in situ* (Plate 29). It is flanked by a pair of small single-light windows on the first floor, both of which have timber lintels. The ground floor has a doorway on either side, both of which have plain jambs, although the western has a rebate housing part of the frame. Both have re-used timber lintels and the western one is also possibly part of a former cruck blade. In the centre of the ground floor the scar of the former staircase is evident in the plaster. The upper part of the east elevation is mainly unremarkable, although the joist holes for the upper floor and a loft are evident, as is the position of a possible partition wall. On the ground floor there are scars for a partition wall and shelving on the north side; there is a beaded skirting board on the south side, corresponding to the area with floorboards (Plate 30). There is a fireplace within this section of the wall, with a square stone surround with a beaded inner edge and plain timber mantle. The opening has been partially filled with brick to make it narrower, and this supports an iron grate. Similar bricks, some of which are evidently marked 'Claughton', are laid on edge on a stone hearth forming an outer fender.

Plate 29: North internal elevation of the house

Plate 30: East internal elevation

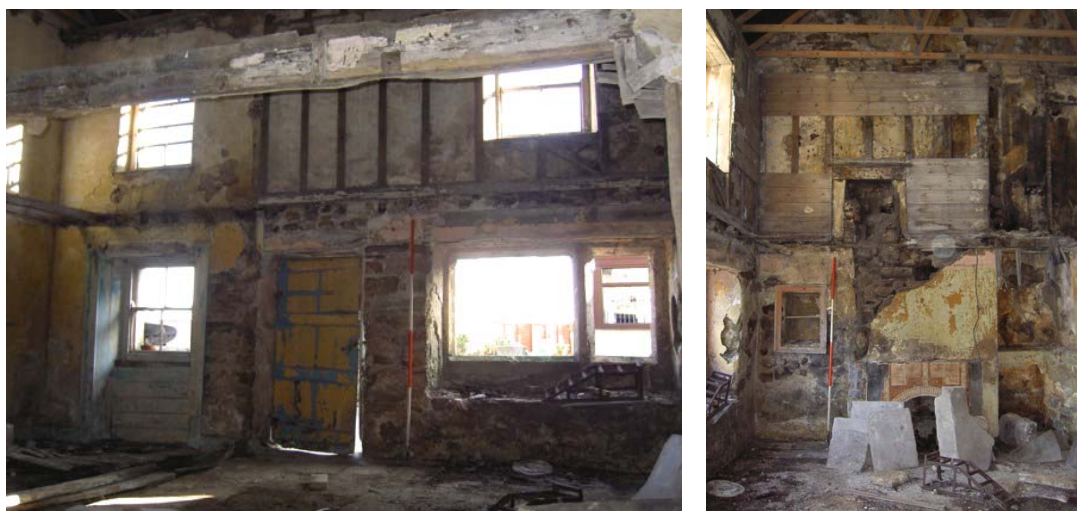
4.4.4 The south elevation has a window on the east side of the ground floor with splayed jambs finished with tongue and groove board panelling, and there is more of the same below (Plate 31). It has a re-used timber lintel. To the west the central doorway has a plank door (perhaps original) held by chamfered battens, with strap hinges and a bolt and latch remaining. It also has a re-used timber lintel, which appears to extend over the window to the west. The west window has deep jambs and houses a window seat; the stone mullions and surround are more simply finished. On the first floor there are two windows, each with thin timber sills. The one to the west has tongue and groove panelling attached to battens around it. The west elevation has a small alcove on the south side of the ground floor, with its original moulded surround and a single shelf remaining *in situ*. There is a slightly off-centre chimney breast to the north, which has been modified with the addition of Claughton bricks on the south side and a tiled front (c1940s) to the east forming an arched opening with a ceramic fireback (Plate 32). To the north of the fireplace a shelved area has been formed between the chimney breast and the stub wall below the remaining beam. At the far north end there is an inserted doorway with a thin timber lintel.

Plate 31: South internal elevation of house

Plate 32: South side of the west internal elevation of house, showing fireplaces

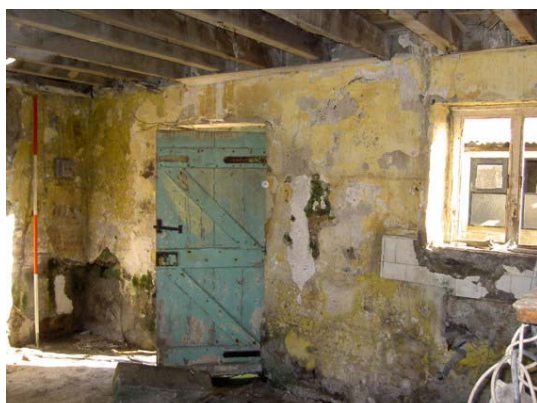
4.4.5 **West extension:** on the ground floor the remains of a stone flag floor are present throughout and the ceiling, which survives almost completely, comprises machine-cut joists and regular tongue and groove floor boards. The first floor, which was not accessible but was visible through holes in the floor below, is open to the roof, which is modern and supported by multiple tie beam trusses. All of the walls have the remnants of a plaster and paint finish surviving. On the ground floor the north elevation has two windows, both with rough timber lintels (perhaps re-used); the west window has a timber sill, the east is stone. The east elevation has a doorway on the north side with a beaded tongue and groove plank door held by chamfered battens and with strap hinges (Plate 33). There are electrical fittings attached to the wall to the south. The south elevation has a doorway on the east side with a timber lintel, with a plank door held by chamfered battens and with strap hinges and a lock surviving. To the west is a window with splayed jambs, a modern casement, and a timber lintel. It is tiled beneath and there is a water pipe projecting through the wall beneath the sill. The west elevation has an off-centre chimney breast, with a large iron range remaining (Plate 34). It has a door finished with ceramic tiles, and the hearth is finished with a moulded iron fender and sits on a large flag stone. To the north there is a small alcove in the wall, with a plain timber surround. On the first floor there is a plain doorway, probably inserted, in the north-east corner, and a narrow chimney breast in the centre of the west elevation. There is a single window in the south elevation with splayed jambs.

Plate 33: South-east corner of west extension

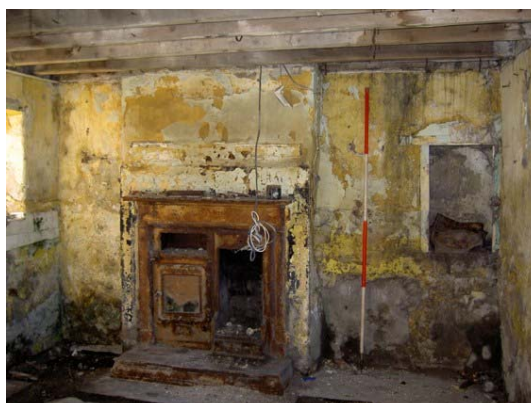
Plate 34: West internal elevation of west extension

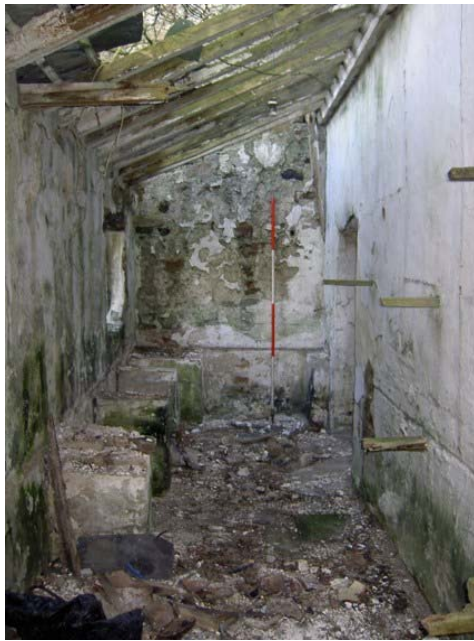
4.4.6 **North outshut:** this has a stone flag floor, much obscured by rubble and debris, and a monopitch roof with machine-cut timber joists and supported by a beam against the south wall. All of the walls have the remnants of whitewash remaining. The north elevation is relatively plain, and has two windows; one to the west with a timber lintel and one to the east with no lintel. Low columns built of brick and/or stone, which formerly supported a bench or shelf, are positioned against the east side of this elevation (Plate 35). The east and west elevations are unremarkable. The south elevation contains two doorways, both with plain surrounds. The one to the east has a hand-finished timber lintel, the one to the west a machine-cut one. The west door also has a slightly rebated jamb, with the remains of the door frame on the west side. There are timber brackets that presumably held shelves projecting horizontally across the elevation and a further low stone/brick base on the east side.

Plate 35: East end of north outshut
