# 130-136 STRICKLANDGATE, KENDAL, CUMBRIA

## Archaeological Desk-Based Assessment

Client: Lake District Estates Co Ltd  
Planning Ap. Ref.: 5/08/0070  
NGR: SD 5145 9305

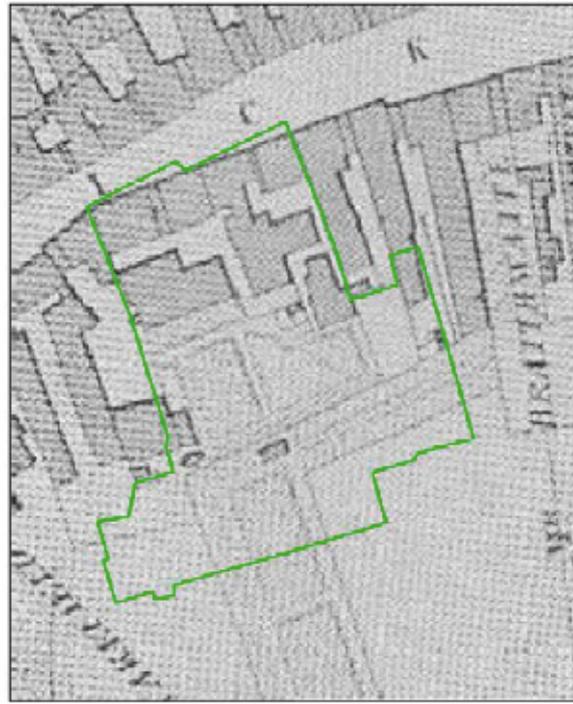
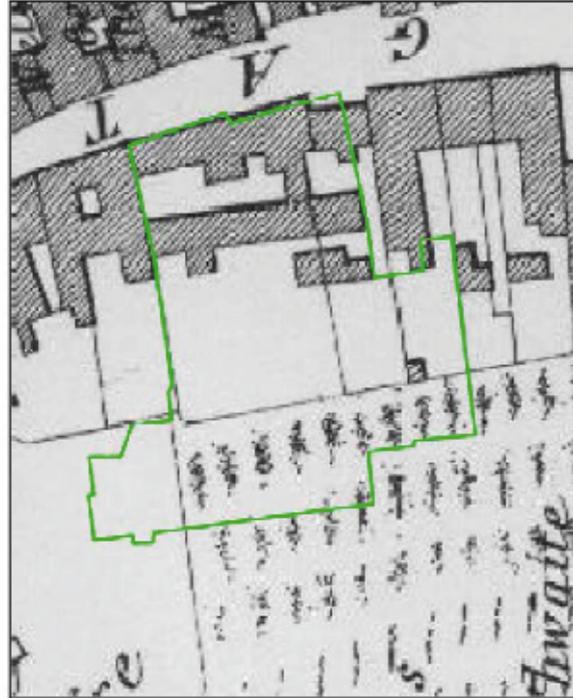
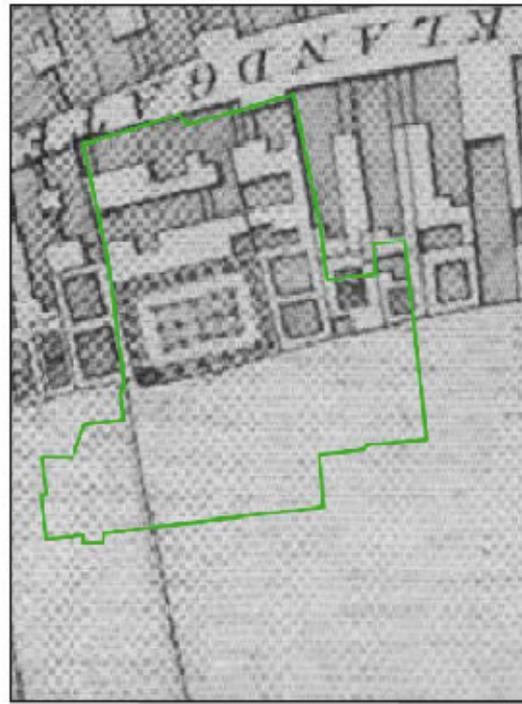
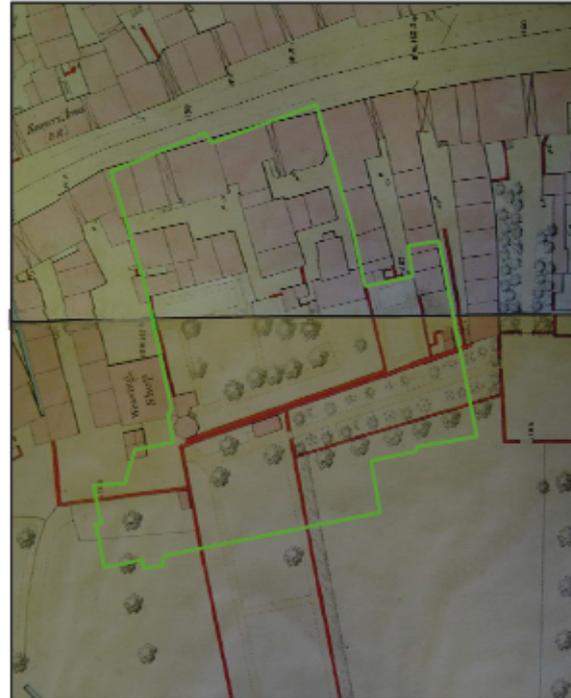
Figure 2: Map regression 1787-c1859

3.2.1 **Todd 1787:** this map shows there are properties on the site with frontages to Stricklandgate and buildings to the rear. Behind these buildings are rectangular areas which were possibly allotments or gardens. There is property running along the south boundary with access via a passageway through property on Stricklandgate; more detail of this arrangement can be seen on the subsequent Ordnance Survey maps.

3.2.2 **Wood 1833:** this appears to be a more simplified or schematic map than Todd's, and shows that there are established properties on the site with frontages onto Stricklandgate, with buildings running parallel to the rear. On the west side of the property boundaries there is a field which is marked as belonging to a Mrs Braithwaite.

3.2.3 **Hoggarth 1853:** this map shows the same properties and boundaries as Wood's map, but with slightly more detail. There is now what may be an established garden to the rear of the largest plot and several smaller buildings to the south of it.

3.2.4 **Ordnance Survey c1859 and 1859:** these maps (of different scales but essentially the same date) are extremely detailed, and show the divisions within the buildings and the design of the large garden to the rear, which includes a small octagonal building in the north-west corner, probably a summerhouse. The field to the west has now been divided into smaller plots, and a weaving shop is shown just outside the north boundary of the site. It is striking that the layout of the buildings is closer to that shown by Todd in 1787 than to that shown by Wood or Hoggarth in the intervening period.

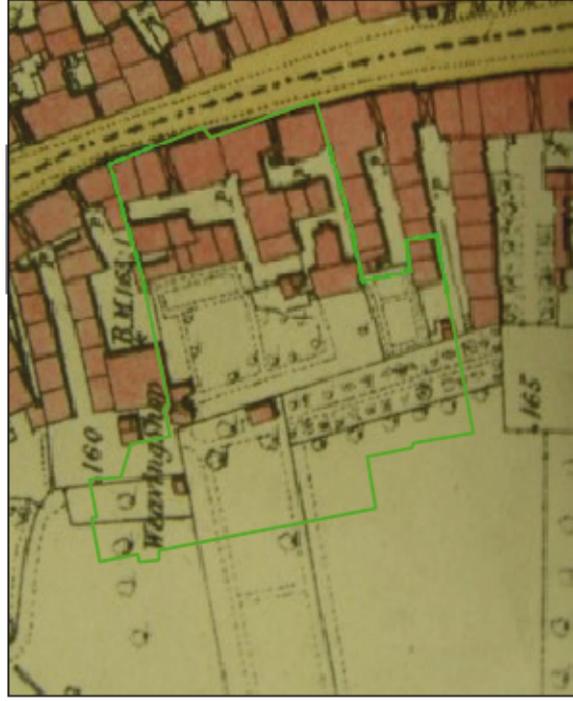
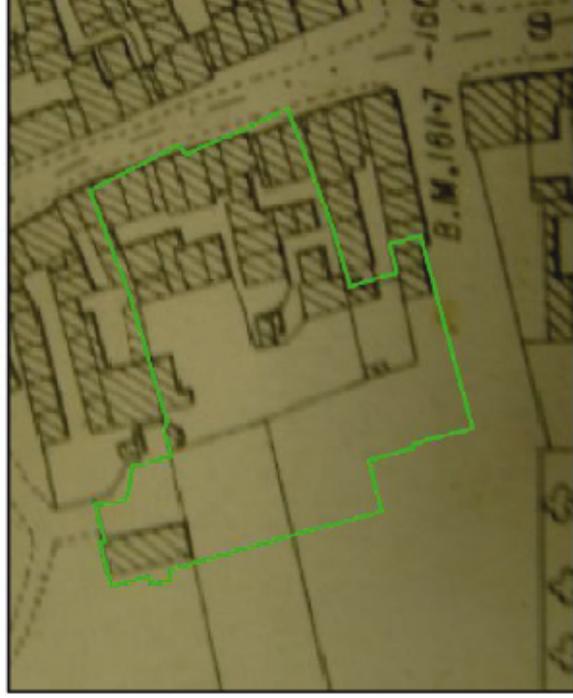
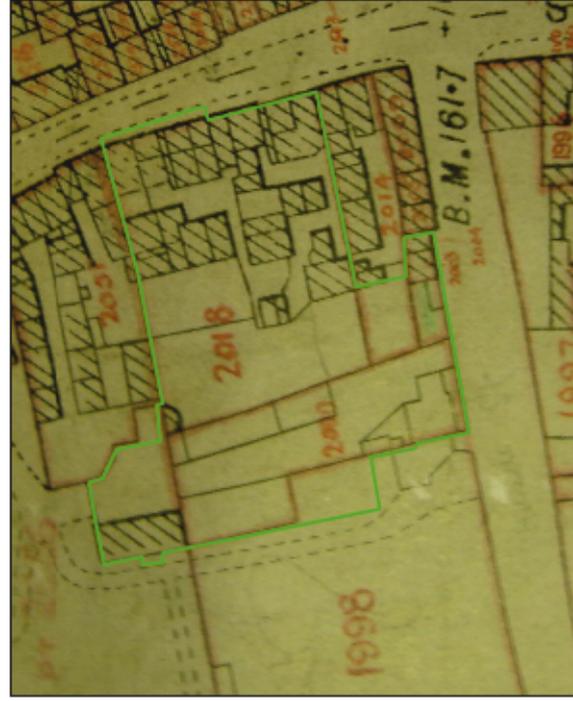
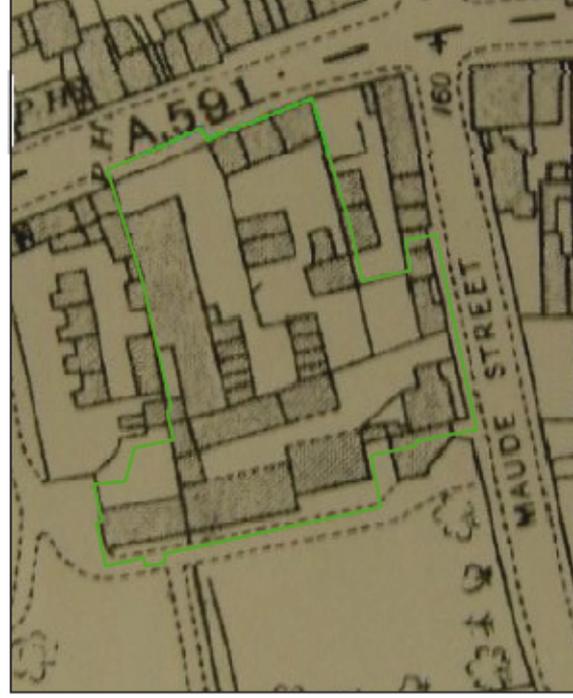
Figure 3: Map regression 1859-1938

3.2.5 **Ordnance Survey 1898:** this map shows that there has been little change to the properties with the site area and the boundaries are unchanged, but due to changes in the Ordnance Survey's mapping conventions the detail of the garden has not been shown. In the top north-west corner of the site there is now a detached property. To the south of the site, three properties on the west side of Stricklandgate and a row of seven properties running east/west have been demolished allowing greater access to the field to the west. The row of buildings on the south boundary of the site is still extant.

3.2.6 **Ordnance Survey 1912:** to the south of the site boundary opposite Sandes Avenue the access shown on the Ordnance Survey 1898 is now Maude Street. This street continues along the south boundary of what was Mrs Braithwaite's field, terminating at the west end. A strip of land running north/south on the east side of the field appears to have been given over to buildings, which are accessed from Maude Street. The Rating Valuation (CRO(K) WT/DV/2/27 1910) shows that the two cottages within the proposed development area on Maude Street belonged to a Reverend Maude, another on Maude Street belonged to George Burrow (now Maudlands), and the properties on Stricklandgate (now numbers 130-136) belonging to a Thomas Leighton (although they are described as a single cottage).

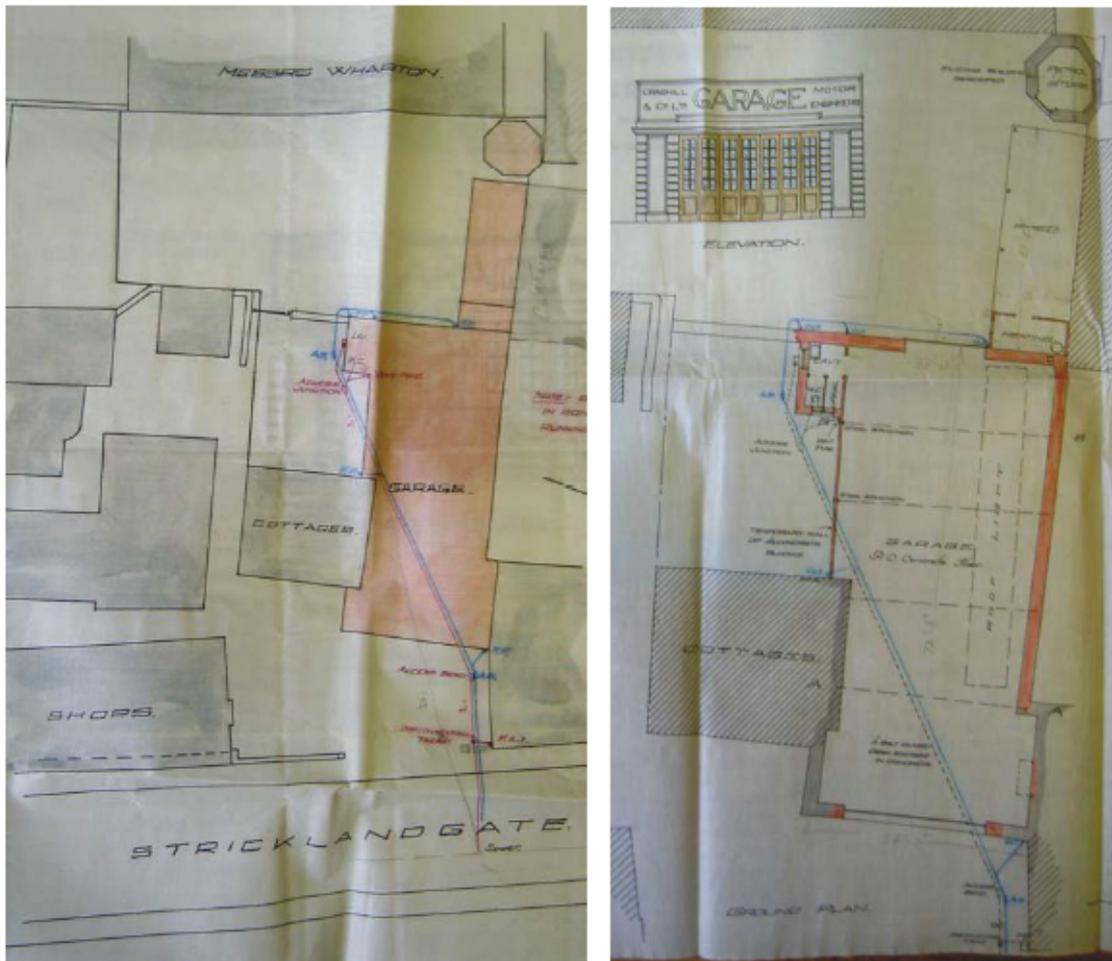
3.2.7 **Deposited plans 1920-1930:** a large number of plans relating to properties built on the proposed development area in the early 20<sup>th</sup> century are present in the Cumbria Record Office in Kendal. These show that in 1920 plans were submitted for the construction of a new garage for Messrs Craghill and Co (CRO(K) WSMB/K11/S150 1920). This comprised an approximately rectangular building orientated approximately east/west situated on the north side of the site, and also incorporated the former octagonal summerhouse at its west end (Plate 1). The garage was situated in a small gap amongst buildings to the south labelled 'cottages' and a large building to the west labelled 'Messrs Wharton'. Additional drawings also show the position of water pipes leading to Stricklandgate, a heating chamber and

shed to the west, and indicate that the octagonal building was to be converted into a petrol store (Plate 2).

Plate 1: (left) Plan of proposed garage for Messrs Craghill and Co (CRO(K) WSMB/K11/S150 1920)

Plate 2: (right) Detailed plan of proposed garage for Messrs Craghill and Co (CRO(K) WSMB/K11/S150 1920)

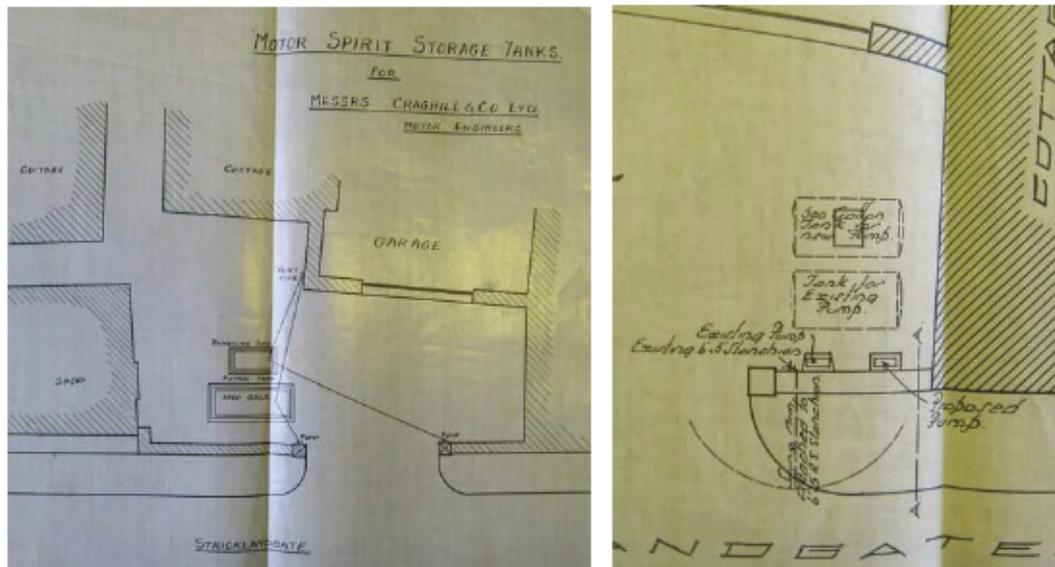
3.2.8 A subsequent plan from 1921 shows the location of two fuel tanks and a petrol pump that were added to the garage alongside the entrance to Stricklandgate, on the south side (Plate 3). In 1925 plans were submitted for five garages (CRO(K) WSMB/K11/M21 1925), and in 1926 further plans were submitted for the construction of an additional workshop to the west of the main garage, adjoining the converted summerhouse/petrol store and heating chamber (CRO(K) WSMB/K11/S223 1926). In 1928 an additional pair of fuel tanks were positioned on the north side of the entrance from Stricklandgate (CRO(K) WSMB/K11/S238 1928), again associated with a new petrol pump, although there is apparently a pump and tank already shown in this general location (Plate 4). In 1930 an additional group of lock-up garages were added on the west side of the site, to the south of the workshop constructed in 1926 (CRO(K) WSMB/K11/S276 1930).

**Plate 3: (left) Position of fuel tanks added in 1921 (CRO(K) WSMB/K11/S155 1921)**

**Plate 4: (right) Position of fuel tanks added in 1928 (CRO(K) WSMB/K11/S238 1928)**

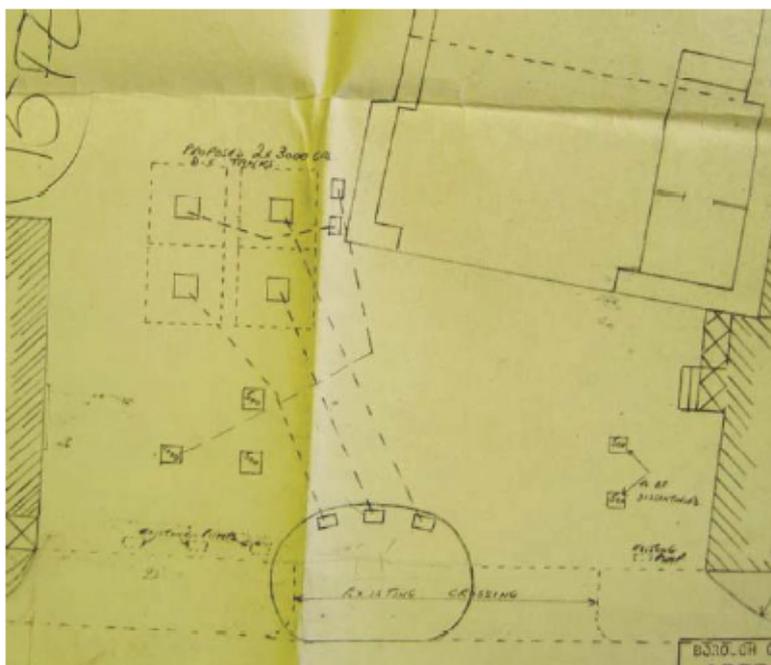
**3.2.9 Deposited plans 1961:** further plans relating to the garage are also deposited in the record office in Kendal regarding alterations made in 1961. These specifically deal with the addition of a new set of three petrol pumps at the Stricklandgate entrance and the creation of two 3000 gallon tanks, a short distance to the west. The original plans (CRO(K) WSMB/K11/S957 1961) were refused and a request was made that the tank was moved closer to the garage buildings and the swing arms removed to facilitate access. New plans were therefore submitted shortly afterwards with these alterations made (CRO(K) WSMB/K11/S959 1961; Plate 5). The position of the original pumps is also shown on this plan, although there are five marked rather than four. These are shown as two 500 gallon tanks on the north side (labelled 'to be discontinued') and two 500 and one 1000 gallon tanks on the south side.

**Plate 5: Plan showing the proposed new 3000 gallon tanks and associated pumps in 1961 (CRO(K) WSMB/K11/S959 1961)**

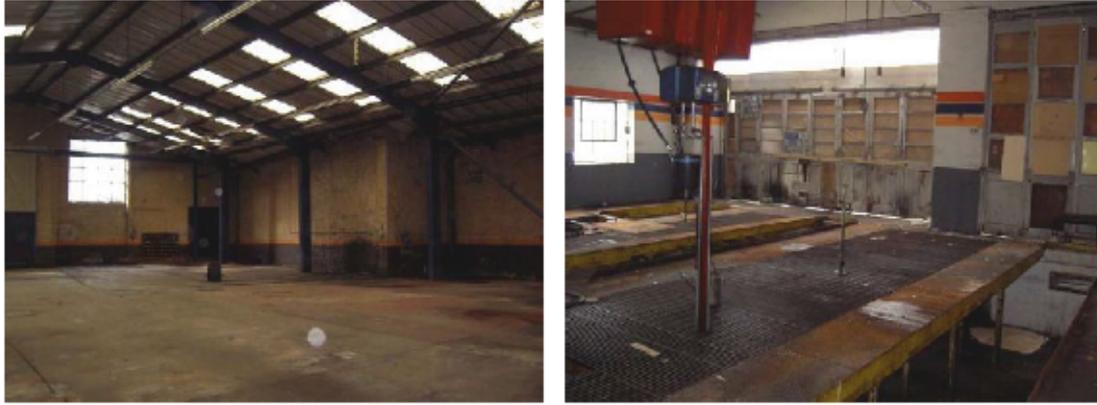
3.3.6 **Garage buildings to west:** this forms a large steel framed structure, on concrete bases, with stone external walls and concrete floors (Plate 6). The walls probably contain elements from earlier buildings belonging to the garage, but the majority of the structure is evidently quite modern, perhaps no more than 40 years old. It is to be demolished as part of the proposed development.

3.3.6 **Garage buildings to east:** these form two parts; a square block on the south side, again with a steel framed structure but containing a series of vehicle inspection pits filling almost its entire extent (Plate 7), and an L-shaped block to the north and north-west, which is also constructed on a steel frame but with timber and glass and is on a raised concrete base. The former building is perhaps no more than 40 years old, while the latter is quite modern, and both are to be demolished as part of the proposed development.

**Plate 6: (left) Interior of the western garage buildings showing steel frame structure and concrete floor**

**Plate 7: (right) Interior of the eastern garage buildings showing the large vehicle inspection pit**

4.3.2 **Standing structures:** the standing buildings on site belonging to the garage are of little archaeological interest, and so their demolition is of no significance.

4.5.1 **Standing buildings:** it is not recommended that any further recording of the standing buildings on site be undertaken.

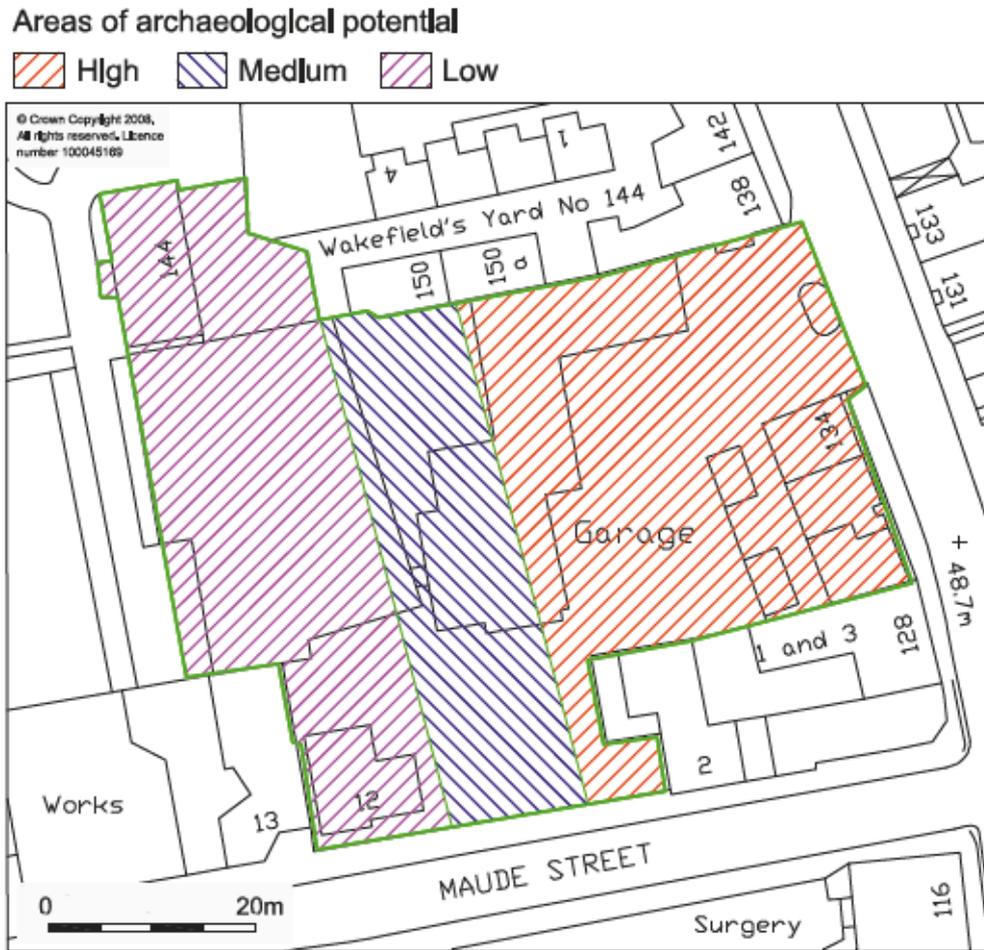
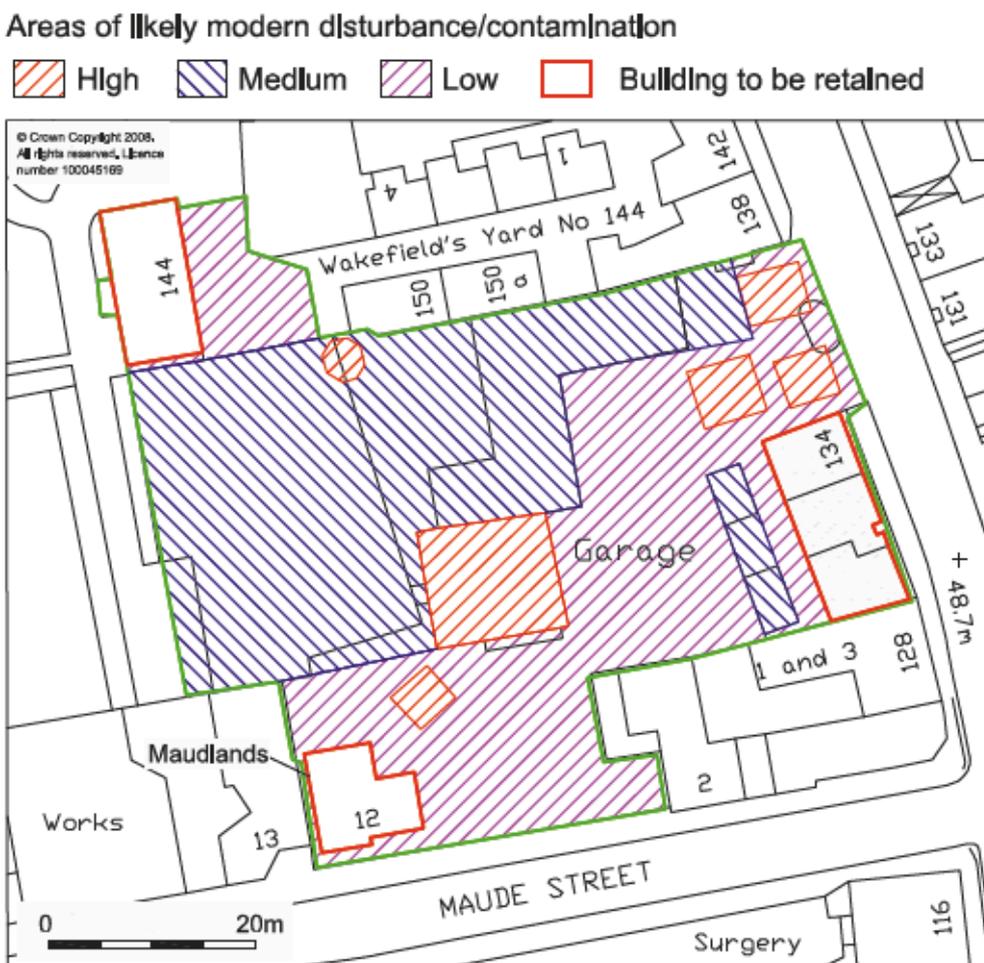
**Figure 4: Areas of archaeological potential and likely disturbance**

4.2.2 **Area type A – high archaeological potential:** areas that are likely to contain remains of medieval activity based on the known location of such features revealed during excavation on similar sites along Stricklandgate. In the case of the proposed development area this specifically includes the area fronting directly onto Stricklandgate, as these have seen limited amounts of archaeological investigation.

4.2.3 **Area type B – medium archaeological potential:** areas that may contain peripheral remains of medieval activity or where more extensive remains of post-medieval activity are likely.

4.2.4 **Area type C – low archaeological potential:** areas that are likely to have seen little development in either the medieval or post-medieval period, in this case particularly those that the map evidence suggests were originally open fields rather than part of plots running off Stricklandgate.

4.2.5 **Area type 1 – low level of disturbance:** areas that have, for example, remained gardens over long periods of time and seen very little development at any time.

4.2.6 **Area type 2 – medium level of disturbance:** areas that have only seen development recently, or have only ever had relatively light-weight structures built on them, or only been developed in the post-medieval period, rather than more recently.

**4.2.7 Area type 3 – high level of disturbance:** areas that have seen extensive development, particularly recently, or that have been subject to very intrusive structures or are likely to be contaminated with hazardous material. This specifically includes cellars and deep structures, and in the case of the site also includes petrol tanks and vehicle inspection pits.

4.5.2 **Below ground remains:** it is recommended that a programme of evaluation trenching be undertaken across the entire area in order to more accurately assess the nature of any below ground remains. This can be undertaken prior to the demolition of the garage buildings, in order to fit with the anticipated schedule, and will in particular enable the extent of disturbance to be ascertained. Evaluation trenches can even be excavated within some of the larger buildings if this is considered safe and practical. It is anticipated that those areas shown as having high archaeological potential (Fig 4), will need to be subject to further excavation where new buildings are to be erected, but the identification of any extensive disturbance is a priority in order to establish exactly where this will be necessary, if at all.
