LEWTHWAITE AND TOWNLEY'S YARD, CROSS LANE, KENDAL, CUMBRIA

Archaeological Desk-Based
Assessment

Client: Lewthwaite and Townley
Planning Ap. Ref.: 5/06/1276
NGR: SD 5151 9209

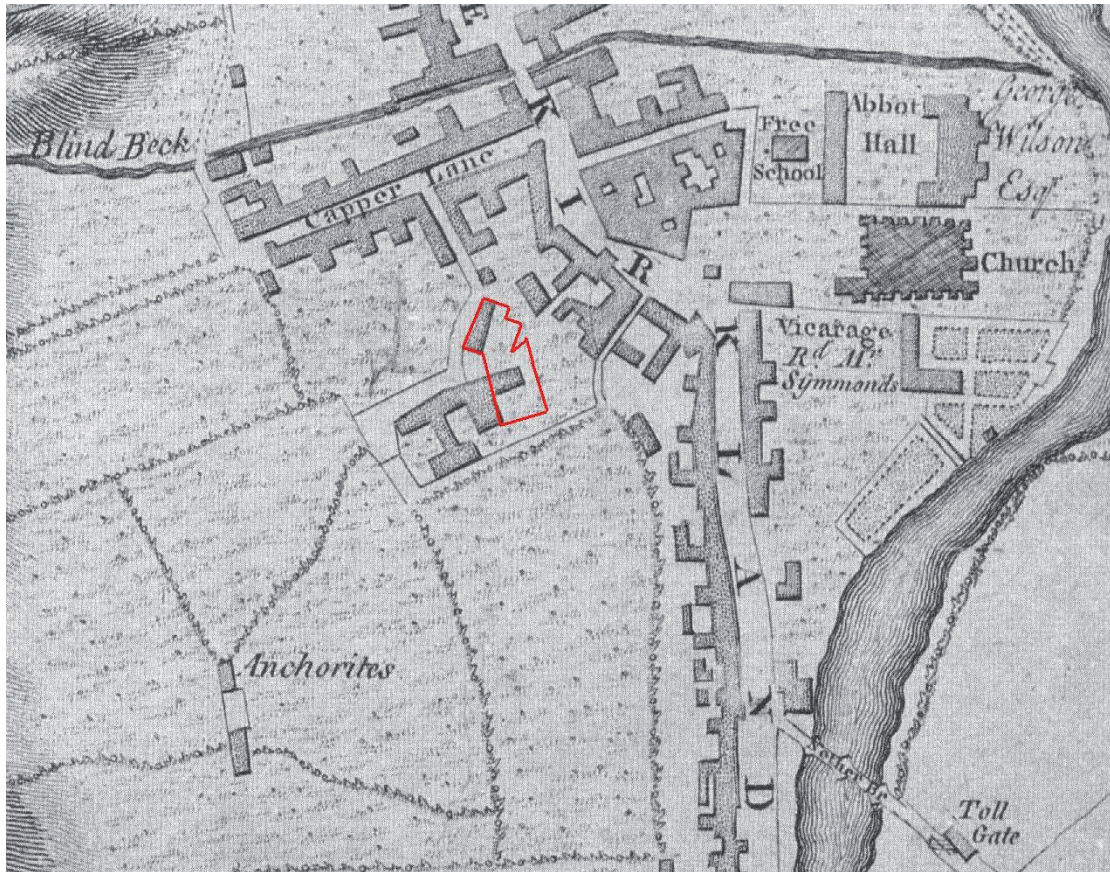
Plate 1: Extract from Jefferys' map of 1770

3.1.1 **Jefferys 1770 (Plate 1):** this map clearly shows the building that is currently Lewthwaite and Townley's workshop, to the north, as well as buildings to the south in the location of the current garages. The buildings in the location of the garages are on the eastern end of what is later known as Brockbeck Cottages, which are themselves apparently attached to Kirkbarrow House, which is not named but is situated to the south. It is assumed that the change in alignment part way along the north-south part of Cross Lane is incorrect, and the map is clearly far more schematic than those that followed.

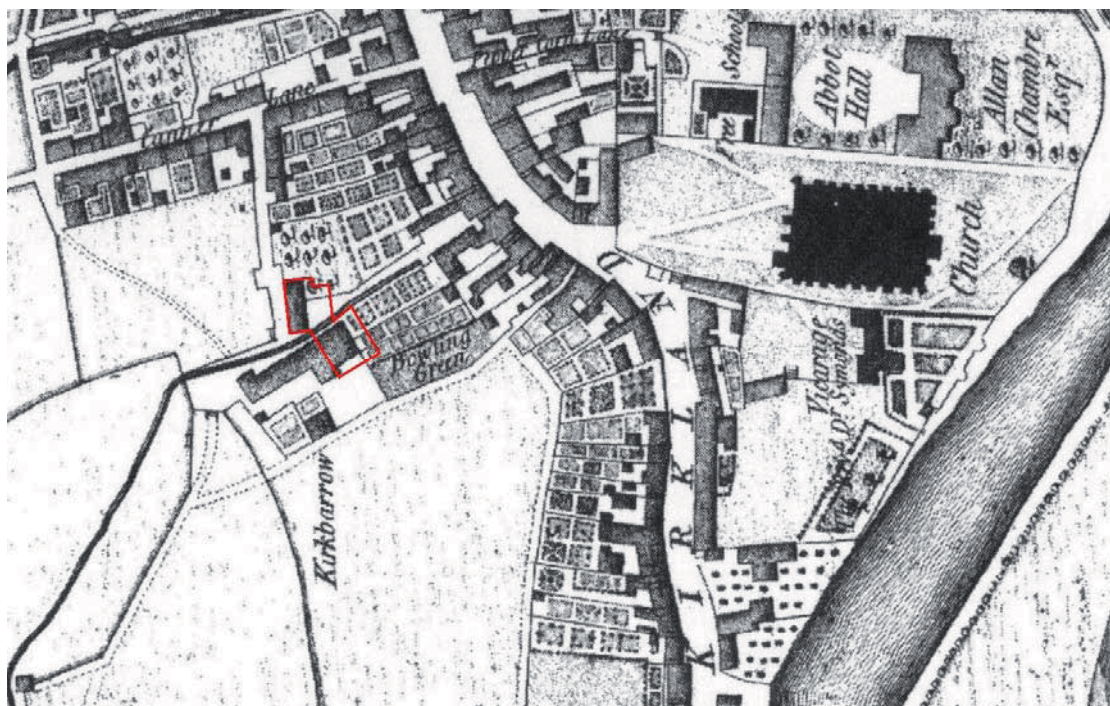
Plate 2: Extract from Todd's map of 1787

3.1.2 **Todd 1787 (Plate 2):** this map shows the building that is currently Lewthwaite and Townley's workshop next to Cock Beck, which runs immediately to the south. The buildings to the east of Brockbeck Cottages, beneath the current garages, are also still present. It can be seen that Brockbeck Cottages and Kirkbarrow House, which is labelled 'Kirkbarrow', are not joined together by buildings.

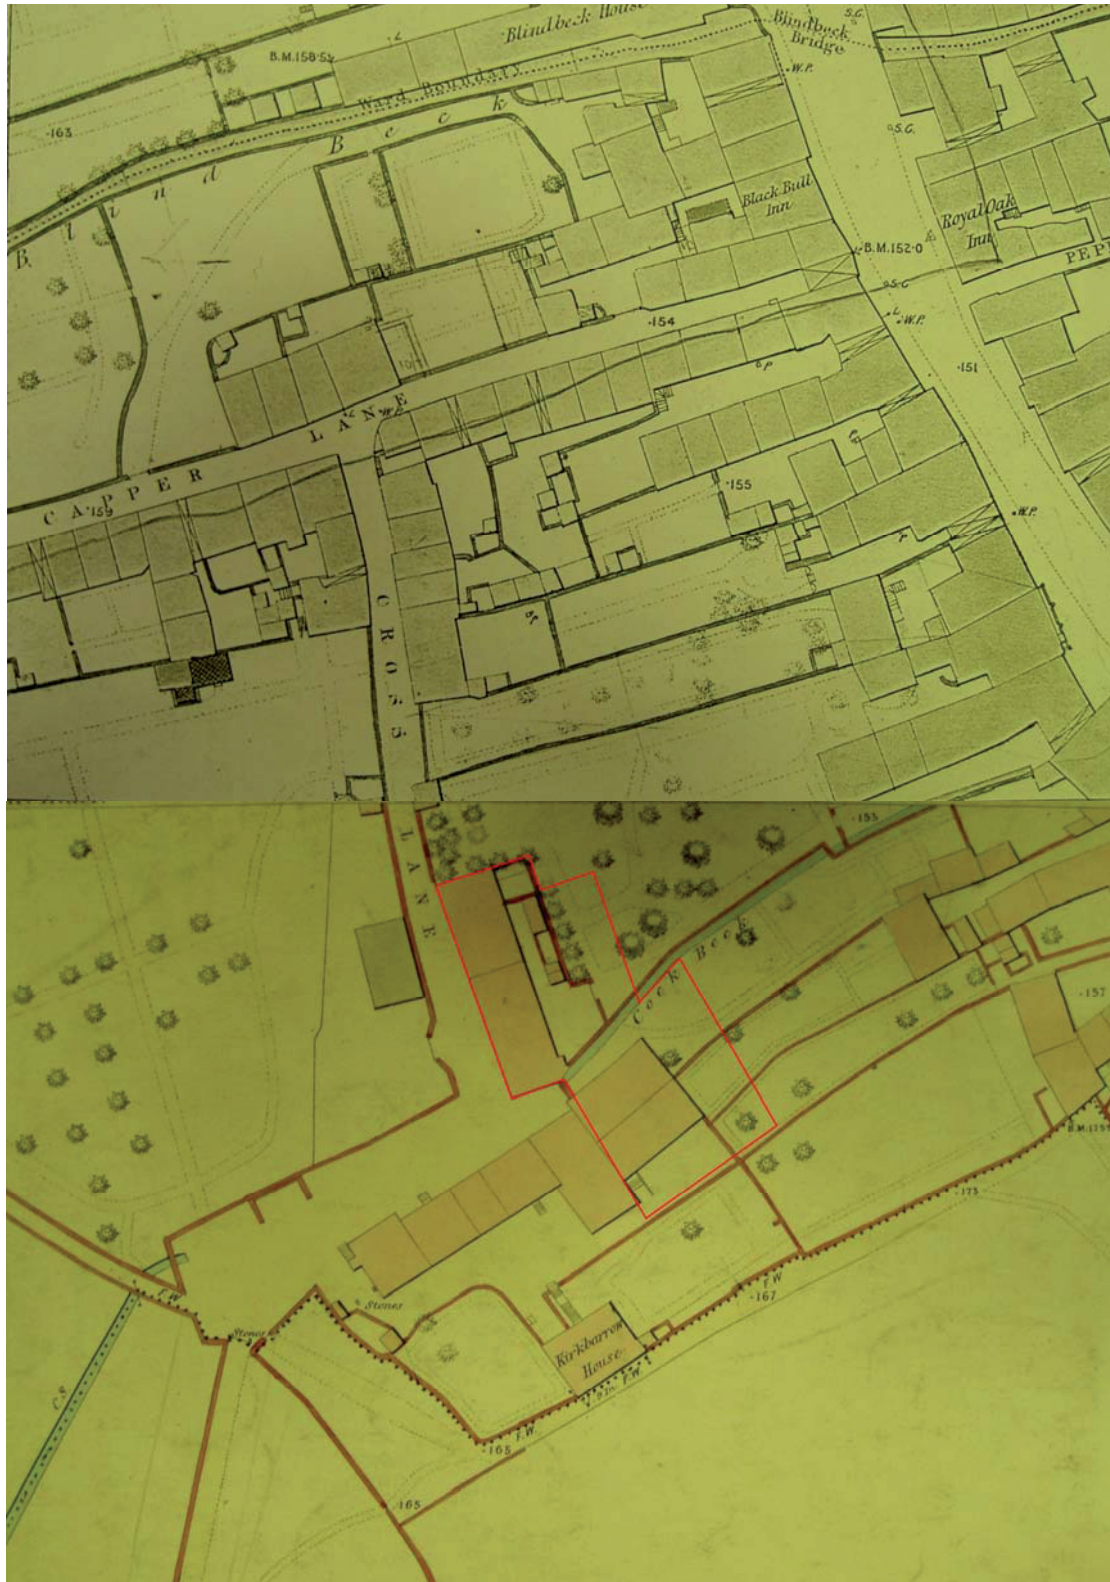
Plate 5: Extract from Ordnance Survey maps c1858, 1:500

3.1.5 **Ordnance Survey c1858 (Plate 5):** this map is extremely detailed, and shows the divisions within the building that is currently Lewthwaite and Townley's workshop, as well as within the outbuildings to the east, and the buildings to the east of Brockbeck Cottages.

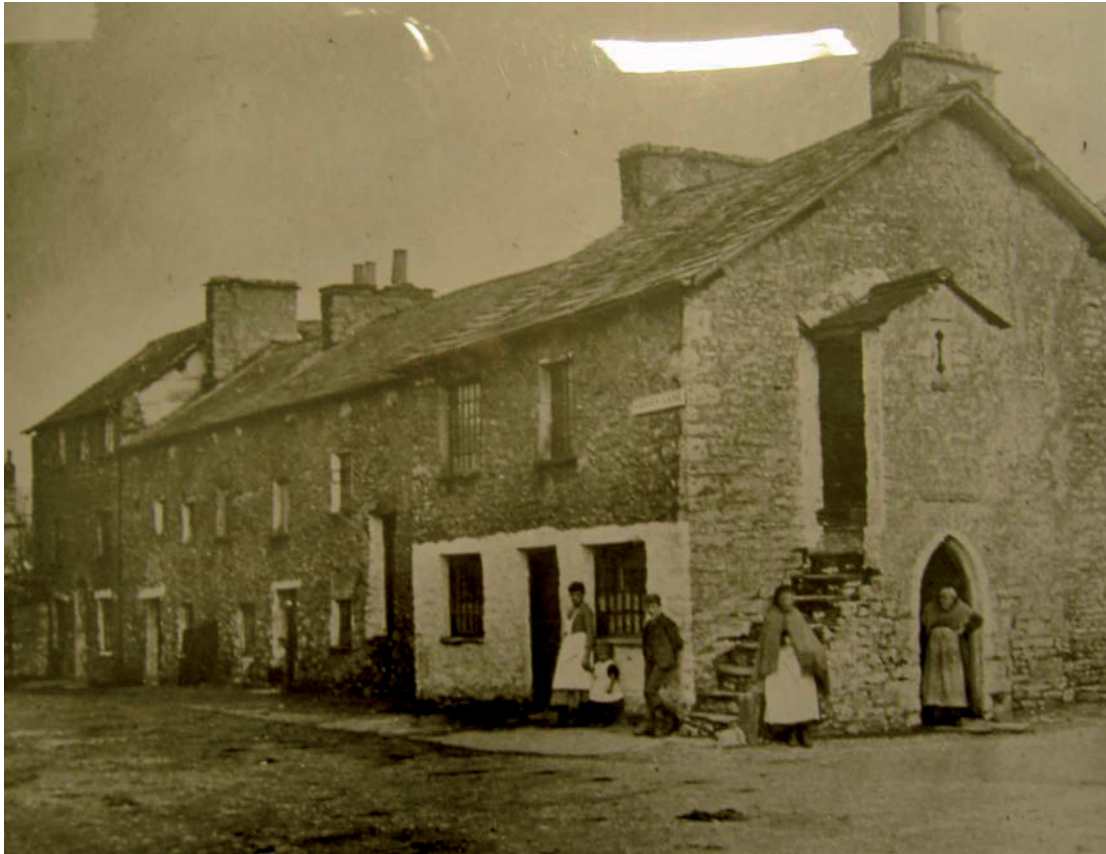
3.1.6 **Undated photograph, pre 1900 (Plate 6):** this photograph appears to have been taken following the demolition of the buildings to the east of Brockbeck Cottages (KLSL image number 004546 pre 1900). It shows Brockbeck Cottages with the rather unusual Gothic-style porch on the west end. Various people are posing for the photograph, some of whom are shown in the same poses and the same clothes in a sketch of the porch published in 1900 (Curwen 1900, 157), which must have been based on this photograph, and it is on this basis that it has been given a pre 1900 date.

Plate 6: Brockbeck Cottages on Cross Lane, pre 1900 (Kendal Local Studies Library, image number 004546)

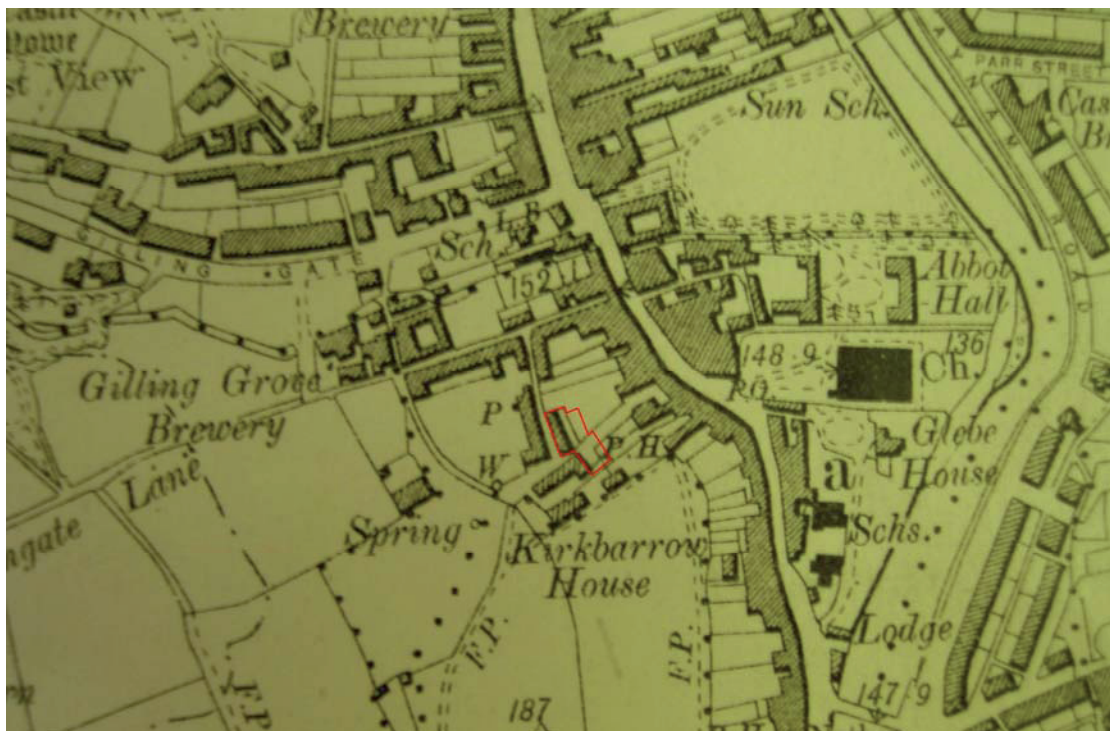
Plate 7: Extract from Ordnance Survey map of 1899

3.1.7 **Ordnance Survey 1899 (Plate 7):** unfortunately this was the largest scale map available for this date at the Record Office, as they apparently do not hold the second edition 1:2500 map. Although lacking in detail, it is the first map to show what is currently The Mint Cake Works building on the west side of Cross Lane, opposite Lewthwaite and Townley's workshop. It also shows Brockbeck Cottages following the demolition of the buildings to the east.

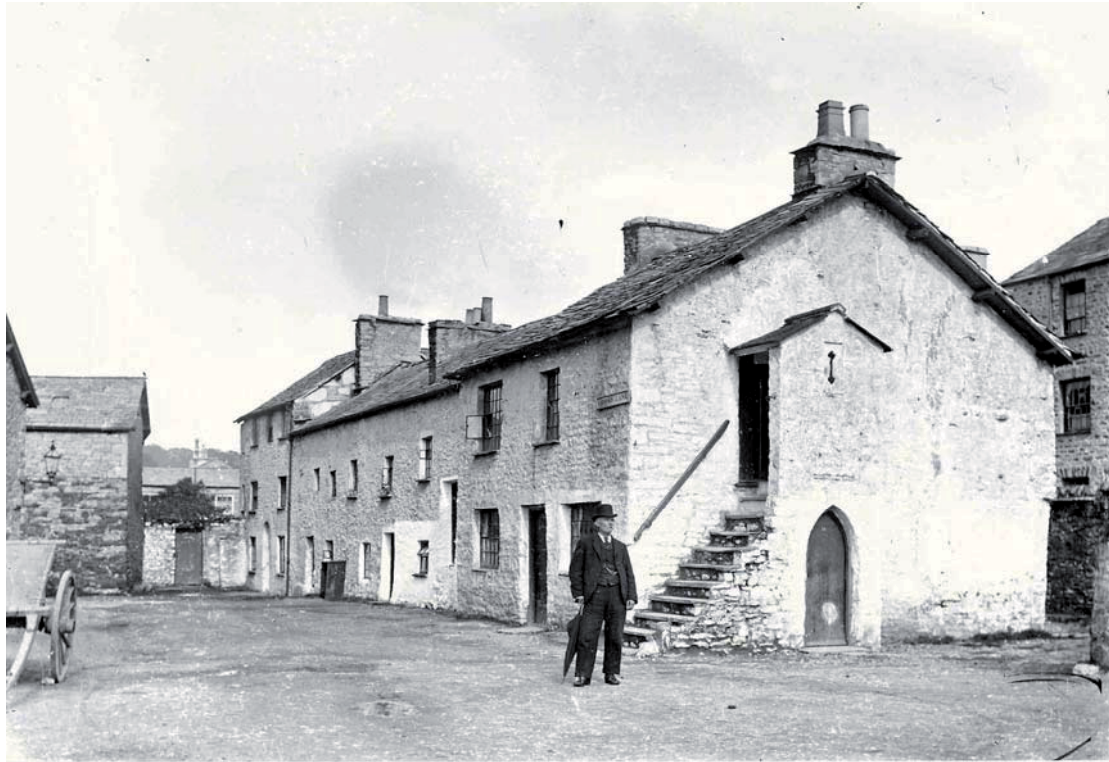
3.1.8 **Undated photograph, c1900-1920 (Plate 8):** this photograph is very similar to the pre 1900 photograph (KLSL image number 002312 c1900-1920). However, it shows the ends of buildings on the opposite side of Cross Lane from Brockbeck Cottages, in addition to Brockbeck Cottages themselves. It shows the west elevation

of the south end of the building that is currently Lewthwaite and Townley's workshop. It has a slate roof, and the four limestone quoins are clearly shown at the top of the wall as they appear today. The sliding workshop door is not yet present, as it is a later insertion. Part of the south end of The Mint Cake Works building is also shown, with a gas lamp attached and a cart in the foreground.

Plate 8: Brockbeck Cottages on Cross Lane, c1900-1920, with the south end of the building that is currently Lewthwaite and Townley's workshop on the left hand side (KLSL image number 002312 c1900-1920)

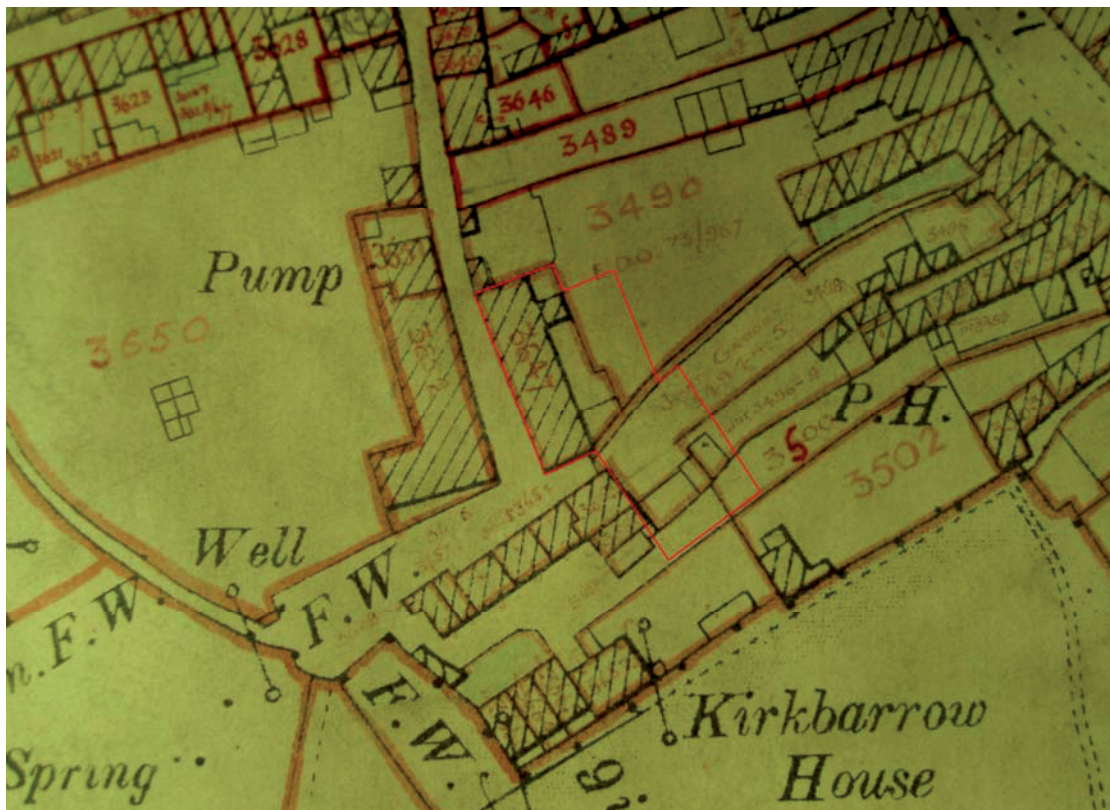
3.1.9 **Ordnance Survey 1913 (Plate 9):** this map was enlarged from the 1897 revision of the 1:2500 scale map, for the purposes of allowing enough room to annotate property numbers relating to the 1910 valuation. It can be seen that the previous outbuildings along the east side of the building that is currently Lewthwaite and Townley's workshop are no longer present. However, a small extension is shown to the east, and another small building butts onto it to the north. Various divisions are shown within the garden in the south of the site.

Plate 9: Extract from Ordnance Survey map of 1913 showing numbers corresponding to properties on 1910 Valuation

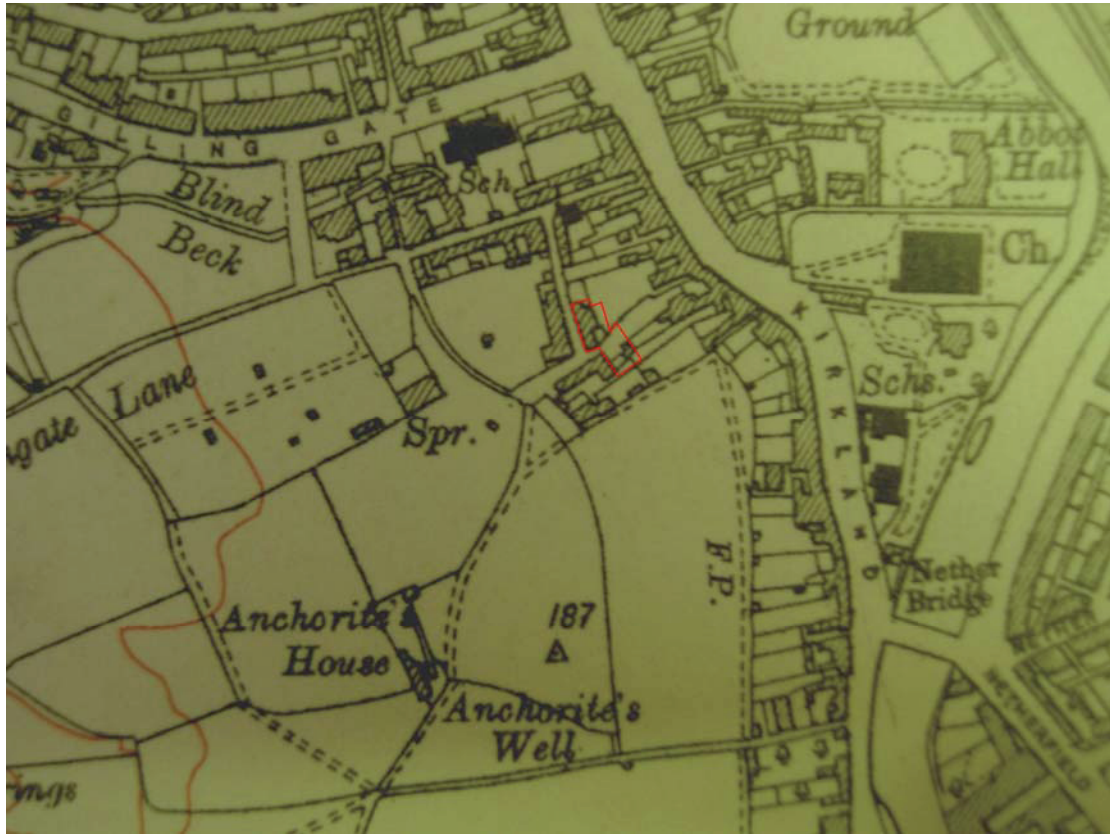
Plate 10: Extract from Ordnance Survey map of 1920

3.1.10 **Ordnance Survey 1920 (Plate 10):** once again, this was the largest scale map available around this date, as the third edition 1:2500 scale map for this area was missing from the Record Office. Although the map is lacking in detail, it can be seen that a longer extension has been built along the east side of the building that is currently Lewthwaite and Townley's workshop.

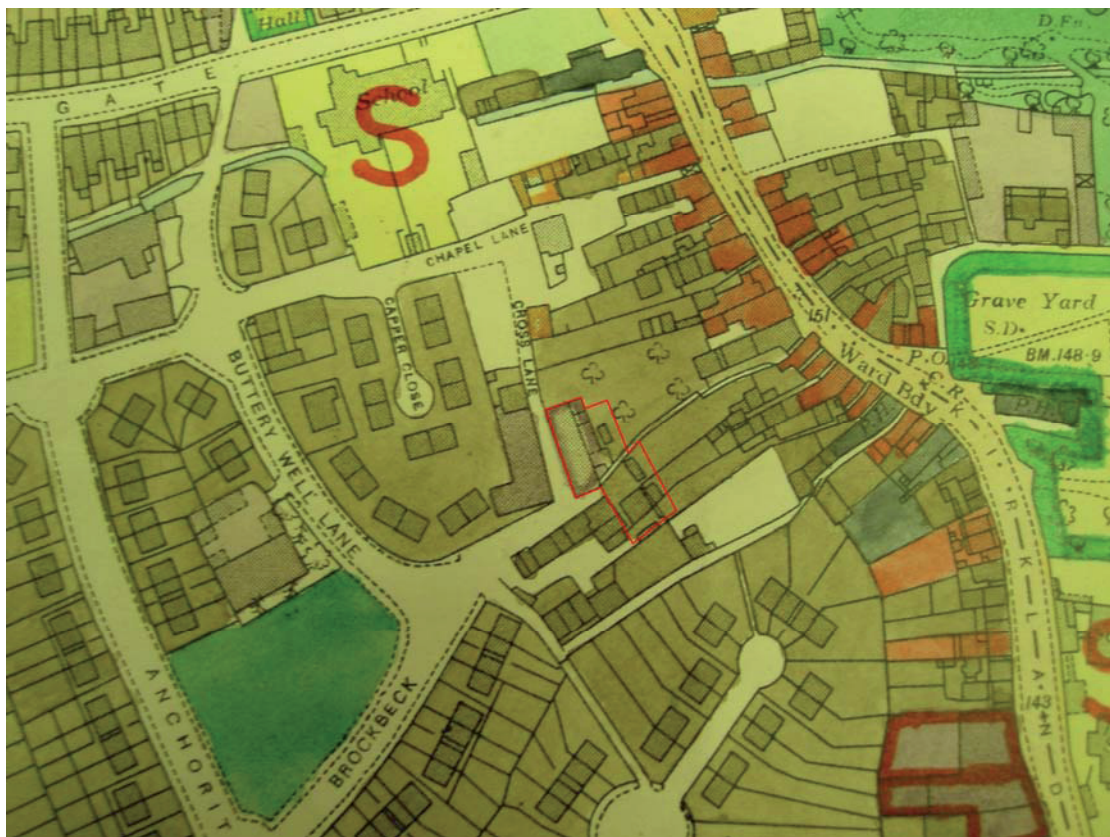
Plate 11: Extract from Ordnance Survey map of 1938

3.1.11 **Ordnance Survey 1938 (Plate 11):** this map is more detailed than the previous one, and shows the divisions within the eastern extension. Several roofed buildings appear to lie within the southern half of the site.

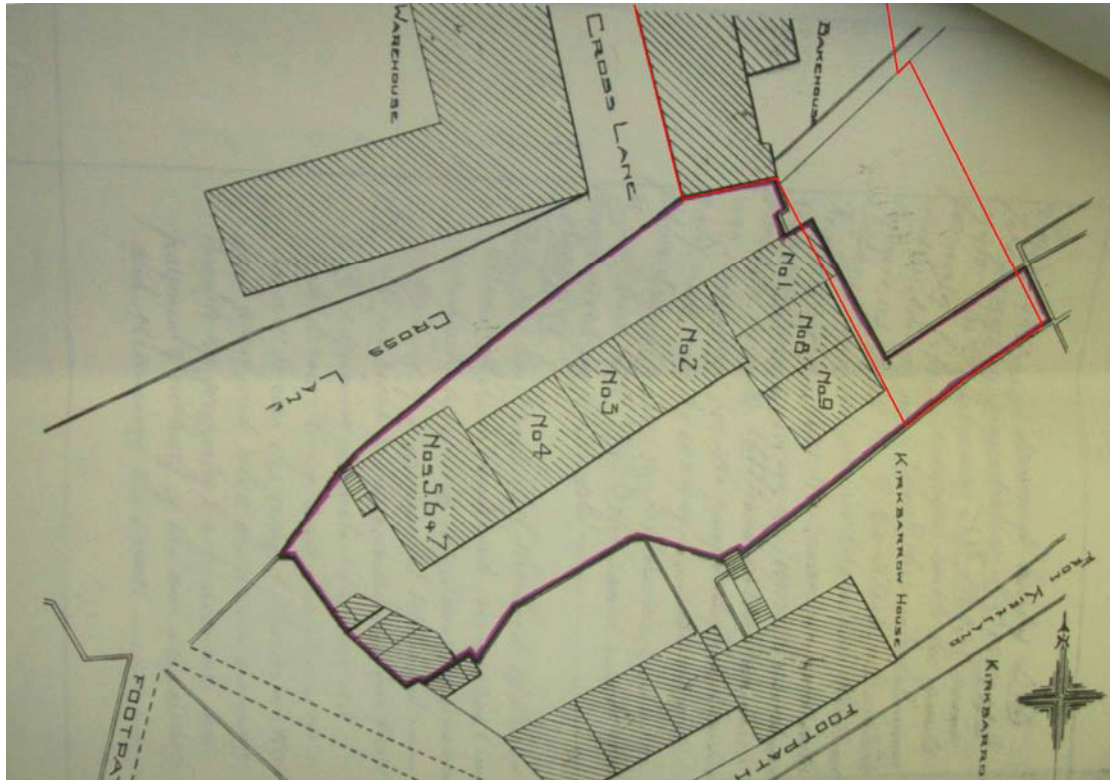
3.1.12 **Plan from deeds, 1930s (Plate 12):** this shows the southern end of the building that is currently Lewthwaite and Townley's workshop, which is described as a bakehouse.

Plate 12: Plan from deeds, 1930s, showing bakehouse (top right)

3.2.5 *Bakehouse:* when Don Lewthwaite's father purchased the building it was being used as a bakehouse (D Lewthwaite pers comm.; see also the plan from the deeds from the 1930s; Plate 12). When the baker moved out, Don Lewthwaite's father built the baker a new bakehouse behind the building purchased, closer to Kirkland (D Lewthwaite pers comm.). It was not possible to establish with certainty which bakeries were connected to, or located in, the building, but the information that was found is presented here.

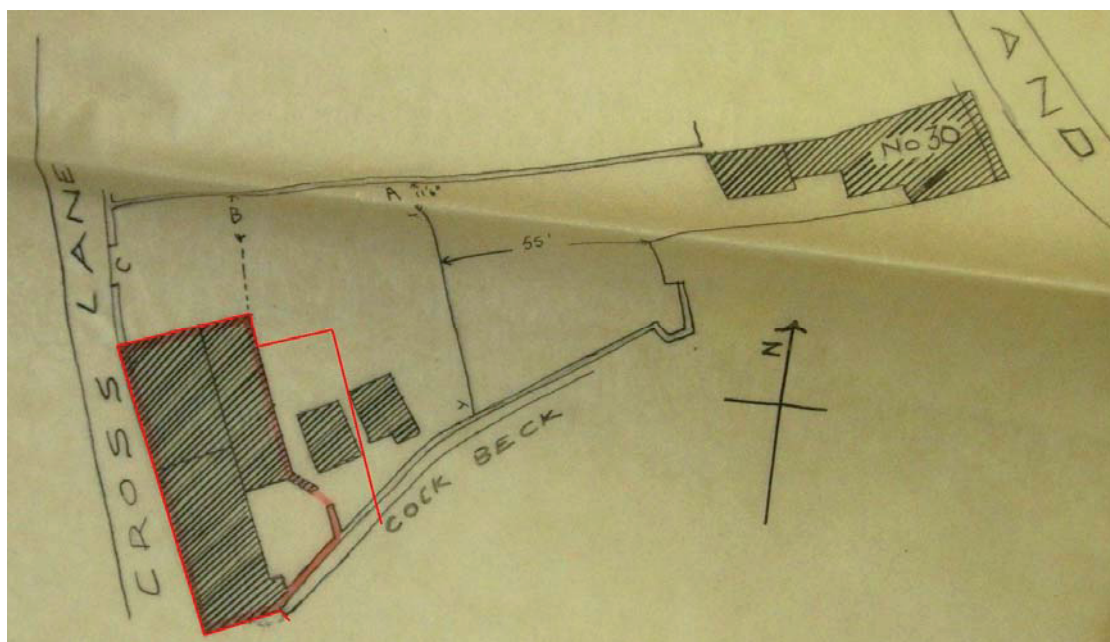
Plate 13: Plan from deeds, 1955

3.1.13 **Plan from deeds, 1955 (Plate 13):** this shows the building that is currently Lewthwaite and Townley's workshop, together with the yard, a small building to the east, and Cock Beck to the south.

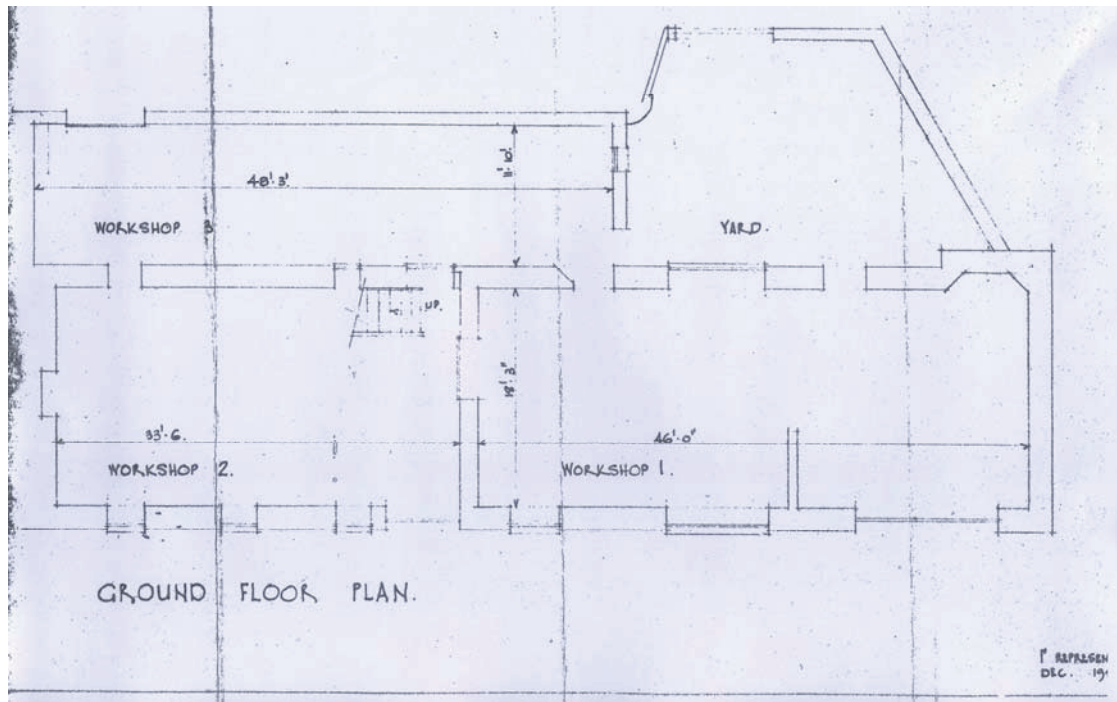
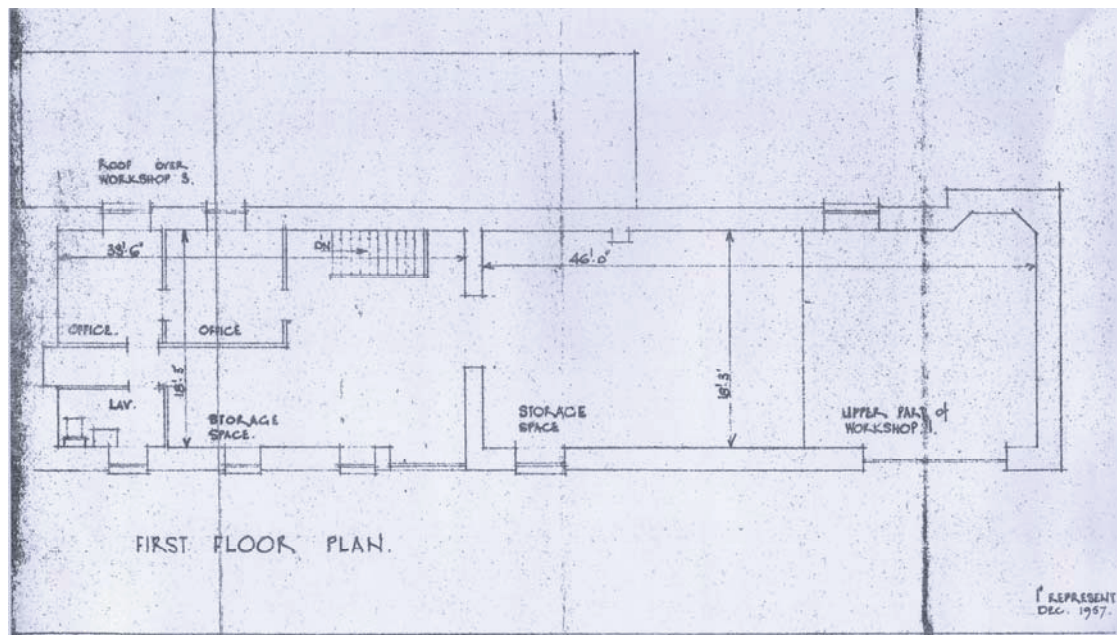
3.1.14 **Floor plans, 1957 (Plates 14 and 15):** these show the layout of Lewthwaite and Townley's workshop, apparently shortly after they took over the buildings.

Plate 14: Ground floor plan, 1957

Plate 15: First floor plan, 1957

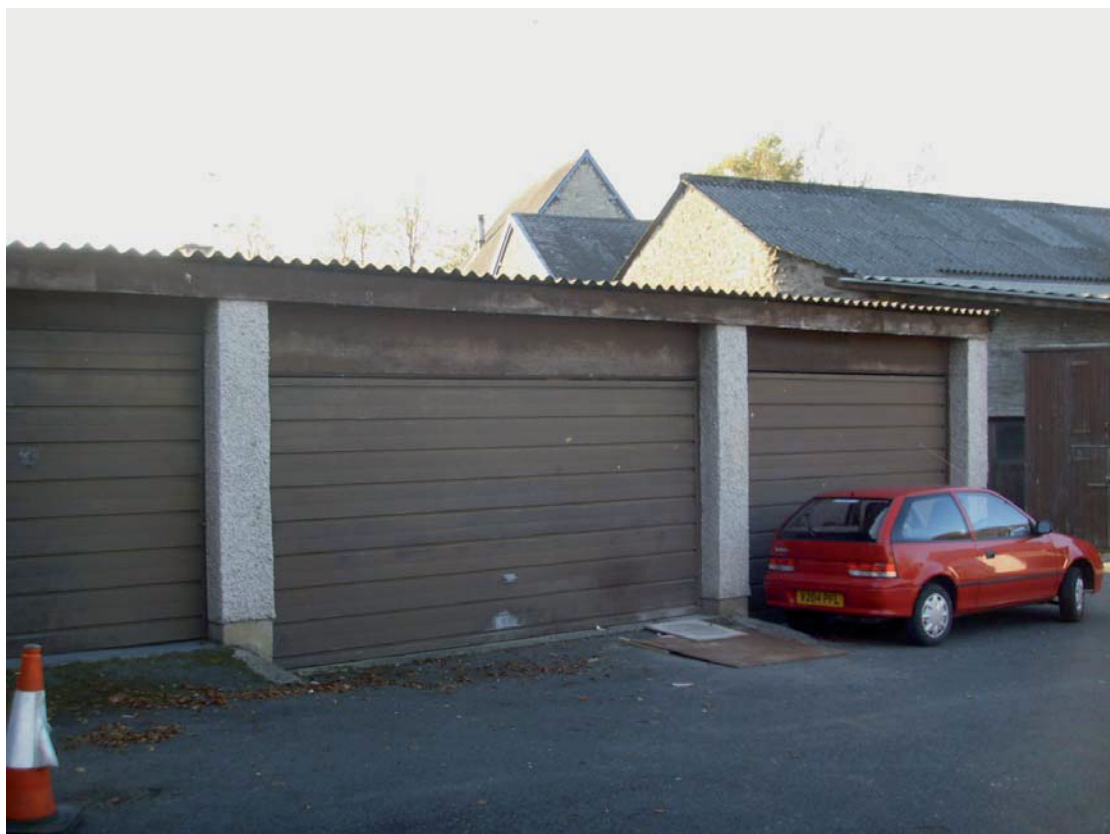
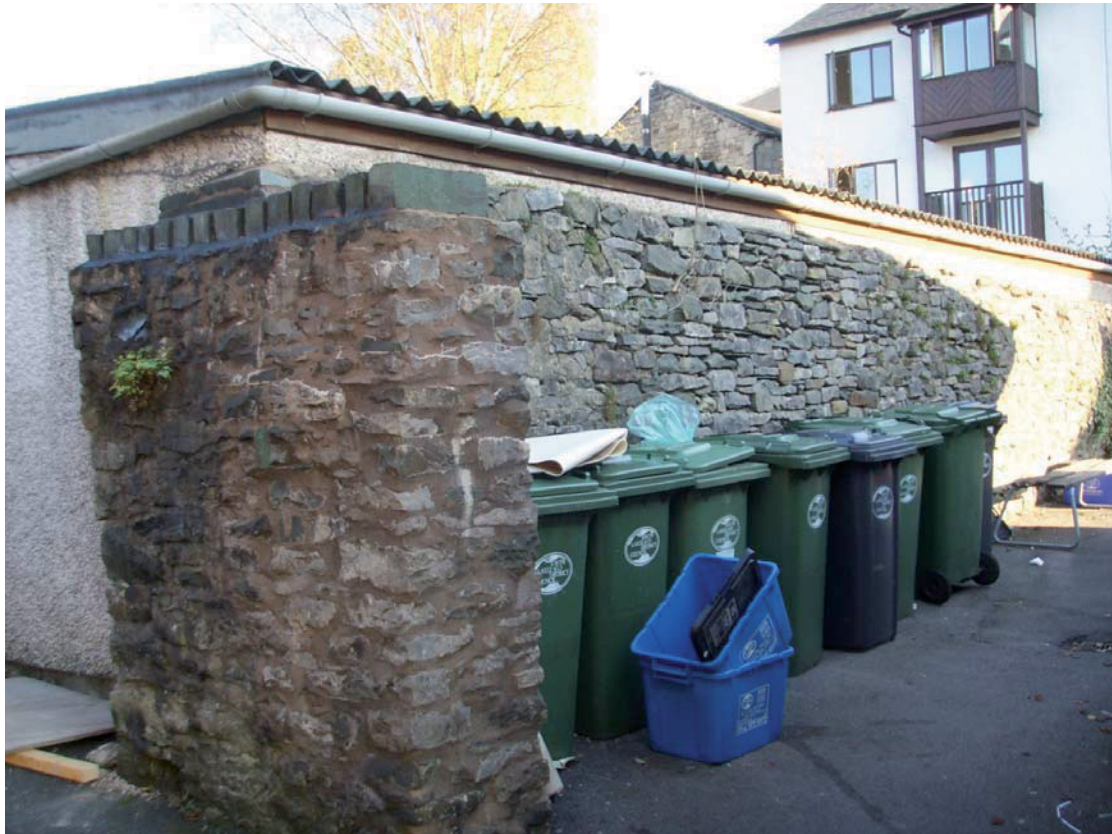
3.3.7 **Garages:** these are modern, with the front of each being taken up by a single metal door, and they have corrugated roofs (Plate 19). They do not incorporate parts of any earlier structures. However, the wall to their rear (south-west) may have formed part of the north-east end of, or been situated at the very end of, Brockbeck Cottages, following their demolition in the 1960s (Plate 20).

Plate 19: Front view of the garages to be demolished, facing west

Plate 20: Rear view of the garages to be demolished, facing east

4.4.3 **Garages:** following the demolition of the garages, it is recommended that the area be monitored by an archaeological watching brief in order to assess the survival of remains pre-dating the construction of the garages. Should any significant remains be encountered these should be recorded as appropriate, most likely through more detailed excavation.

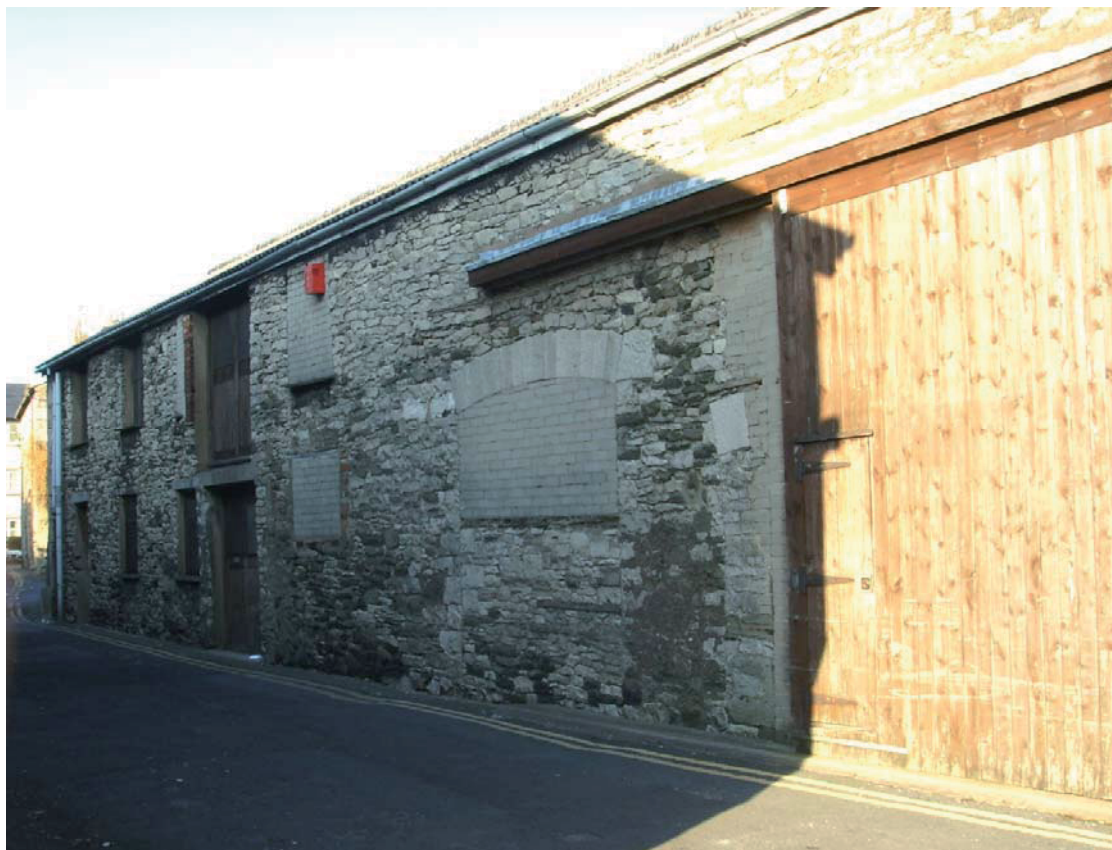
3.3.1 During the site visit the buildings occupied by Lewthwaite and Townley were examined (for example Plates 21, 22, 24, and 27), with a view to establishing the condition, structure, and past uses of the buildings. The buildings will be described according to the annotation on the 1957 floor plans.

Plate 21: View of the main standing building on Cross Lane, facing north

4.4.1 **Standing buildings:** as a condition of any future planning consent, the buildings should be recorded to English Heritage Level 2. It is then recommended that they be converted, retaining as much of the original fabric as possible. The eastern extension could be demolished, as it is of late 20th century date, and has little architectural or historical merit.

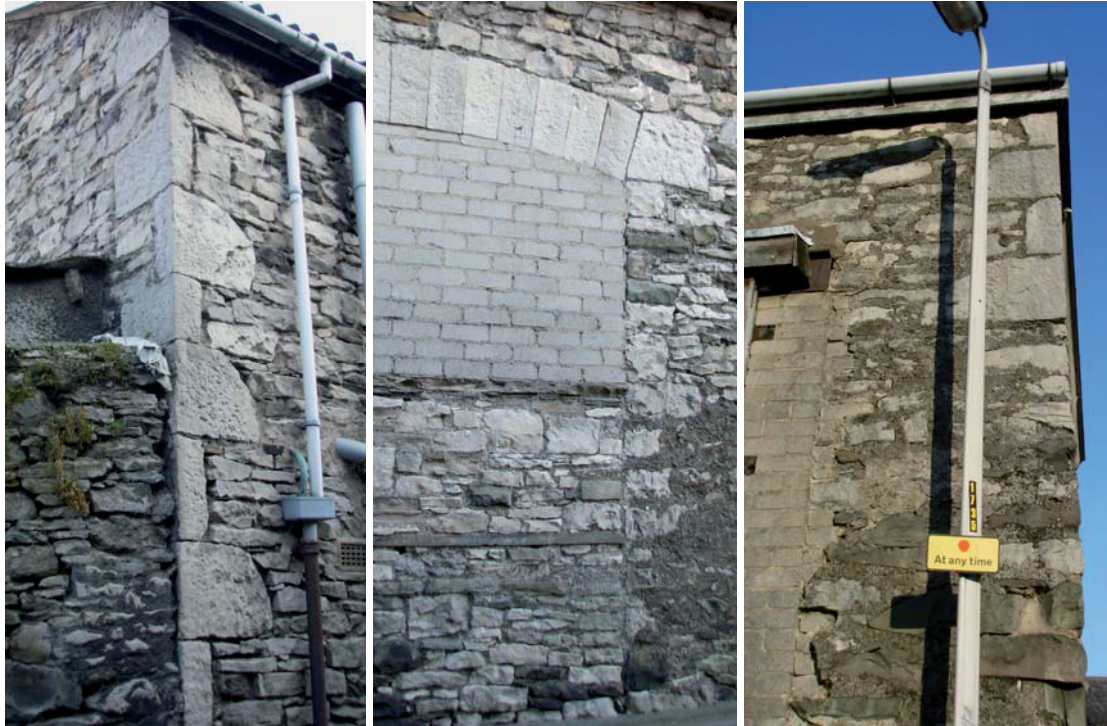
3.3.2 ***Building containing Workshop 1***: this building has two wagon doorways with rounded arched tops, opposite each other on the east and west sides of the building. On the west exterior elevation it can be seen that the arch comprises dressed limestone blocks (Plate 23). These are also partly visible on the interior of both doorways, although they have been whitewashed and partly rendered over. A large sliding workshop door has been inserted in the south-west of the building, and on the exterior it can be seen that this appears to have cut through a previous arched doorway (Plate 21). The timber roof structure appears to be the original 18th century trusses, although the earlier slate roof has been replaced with corrugated concrete/asbestos and plastic, which allows far more light into the workshop (Plate 28). Although on the 1957 plans this building appears to have had a first floor, this is not currently present, except at the very north end. The use for which this building was constructed is unclear, but it may have been a barn. It has an unusual projecting section, extending through both floor levels, at its south-east corner, where it previously met Cock Beck (Plates 25-26). This may possibly indicate that it drew water or possibly power from the beck, but there is no real evidence for this.

Plates 22-24: Details of the limestone quoin and doorway arches on Cross Lane

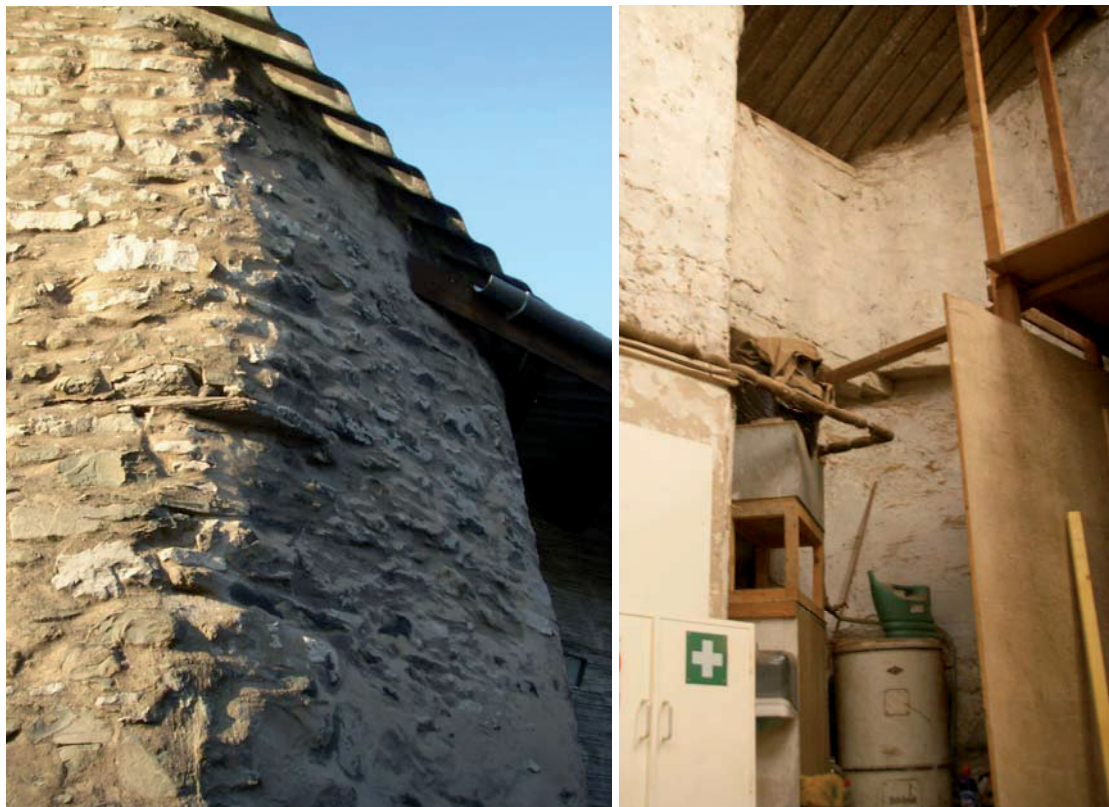
Plates 25-26: The exterior of the unusual building corner (with a timber board protruding), and the interior of the same part of the building

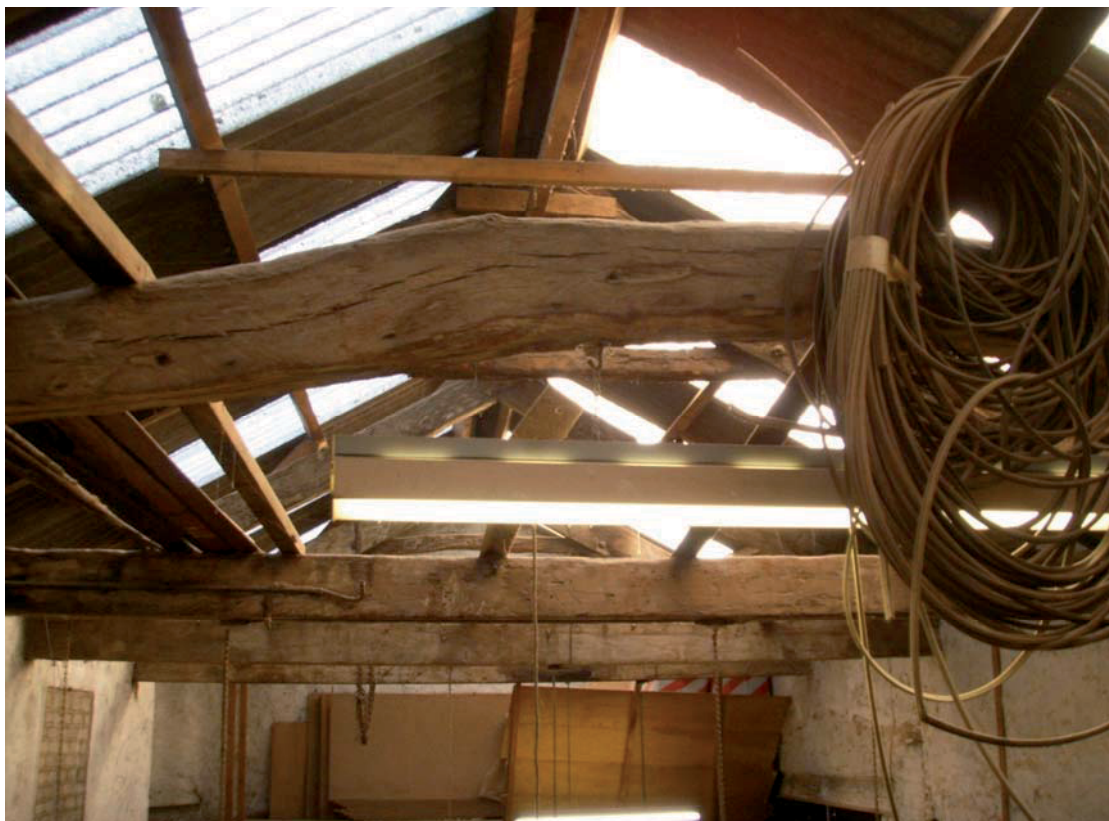
Plate 28: Possible original 18th century roof trusses in Workshop 1

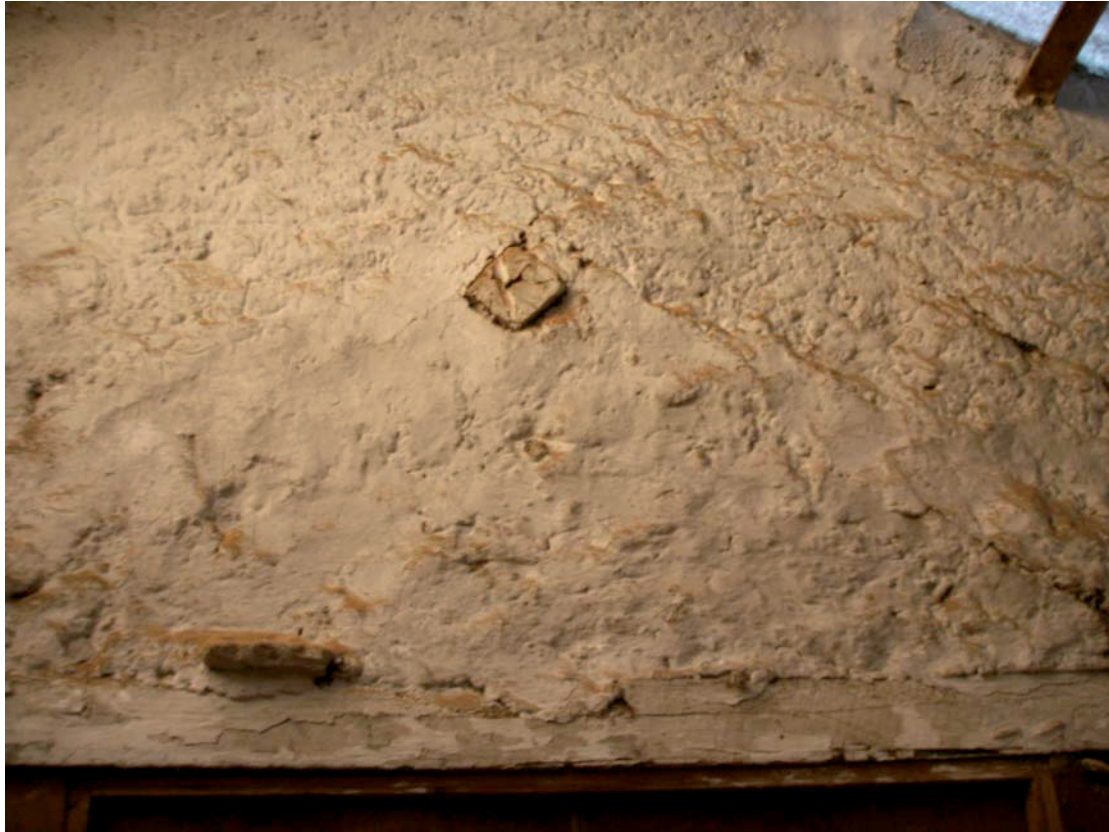
3.3.3 **Building containing Workshop 2:** this building has retained a first floor, with timber joists visible from the ground floor in the eastern half. It seems this building previously had a slightly lower roof than the building containing Workshop 1, and the previous roof line can be seen on the north-facing wall between the two buildings (Plate 29). The wall height of this building has been increased by at least three courses of bricks. The panelled offices shown on the 1957 plan are still partially present, although the partition walls within the main space of the building have been removed. The remains of some posters, probably of 20th century date, are also present. Timber roof trusses, possibly of 19th century date, are present, although the slots that previously held the purlins are empty, since the slate roof has been replaced by a corrugated asbestos/concrete roof punctuated with areas of corrugated plastic. The ground floor has been divided in two along the north-south axis, with the western half currently being used as office space.

Plate 29: First floor of Workshop 2, above doorway into Workshop 1, showing roof scar
