104 ABBEY ROAD, BARROW-IN-FURNESS, CUMBRIA

Archaeological Building Recording

Client: Barrow Borough Council
NGR: SD 19960 69680

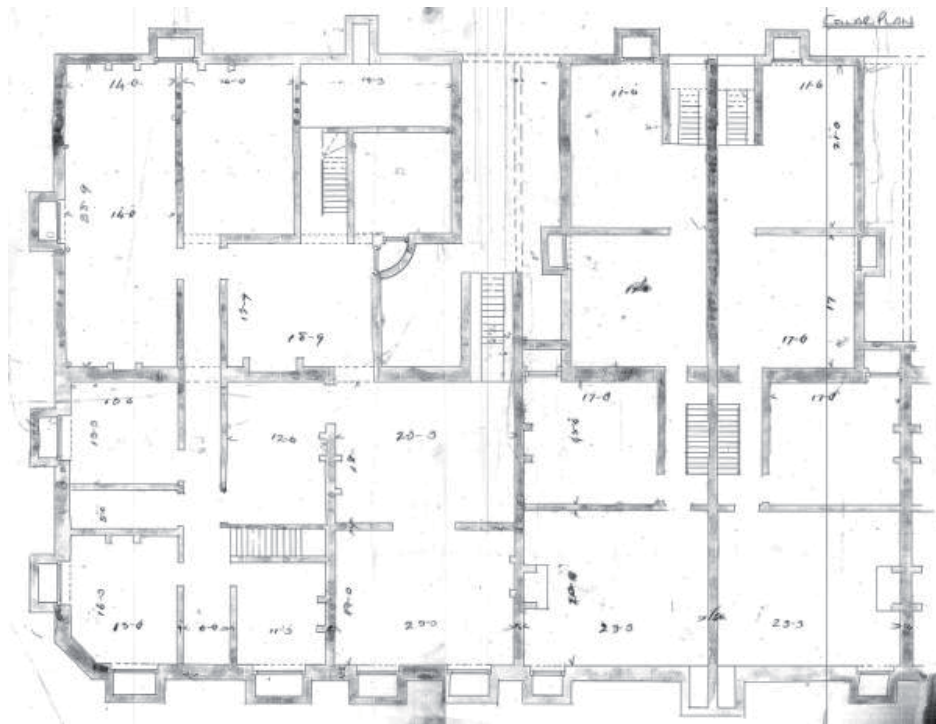
Plate 1: Proposed plan of the cellar, 1874. The Duke of Edinburgh Hotel is on the left, 104 on the right

3.3.3 The main interior wall of the building, shown here orientated vertically (Plate 1), is the main feature which is present both in the proposed plans and in the present building. In the cellar the east main staircase at the rear of the building is in the correct place. However, the south stairs have either been moved or were not placed according to the plan. Also, there is no present sign of there having been any centrally located staircases into the cellar. The overall layout of the interior walls of the cellar appears to have changed considerably, although this largely due to modern alterations. It does appear that the rear of the cellar was originally planned to be much narrower than its present-day state.

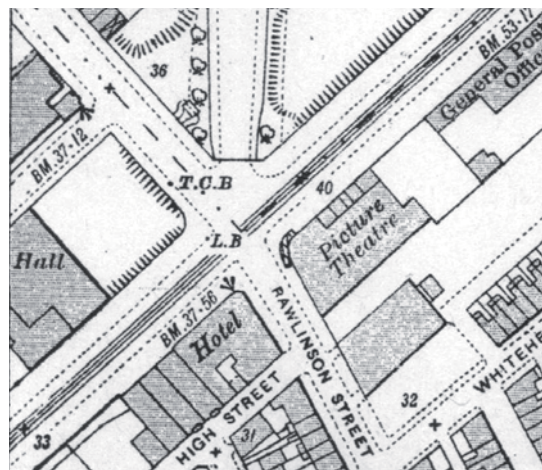
Plate 9: Ordnance Survey map, 1938

3.3.11 **Ordnance Survey, 1938:** in this map the footprint of No. 104 remains the same but a small extension has been added to the south corner of No. 102 (Plate 9). This is more likely to be the construction of a new building adjacent to the shops rather than extension to the building itself.

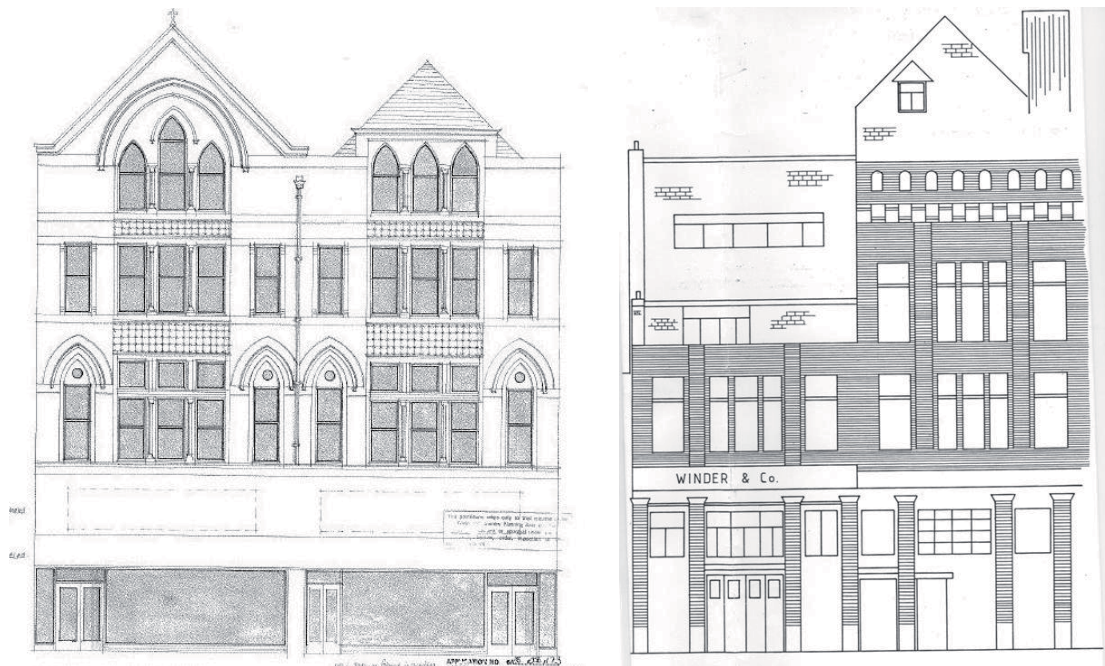
Plate 14: (left) The front elevation in 1986

Plate 15: (right) Part of the rear elevation in 1986

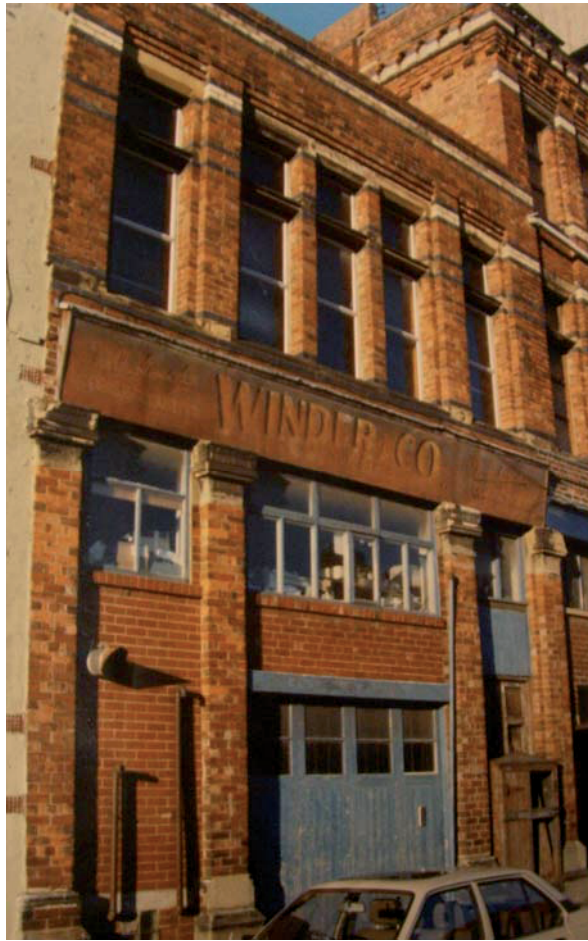
information the views of the rear (south-east) elevation show that it originally had decorative crenellated brickwork along the top of the wall, continuing that still present on the south-west and north-east elevations, which has since been removed.

Plate 16: A view of the rear of 102 Abbey Road in 1991, just showing the original crenellated brickwork extending round No. 104 in the top right corner

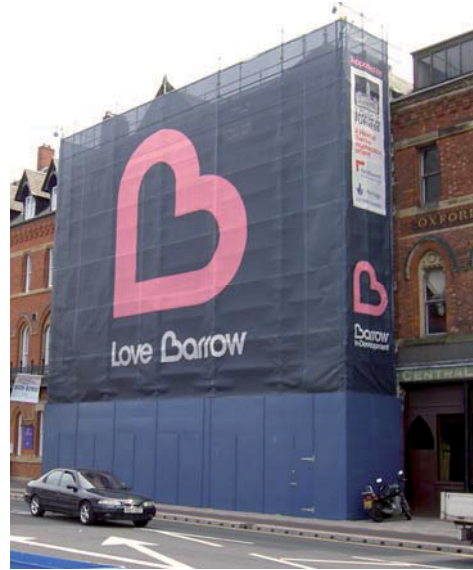
Plate 18: (right) The front elevation in 2008

4.1.1 The property is located near the corner of Abbey Road and Rawlinson Street, Barrow-in-Furness, between the Duke of Edinburgh Hotel to the north-east and No. 102 (also known as 'Oxford Chambers') to the south-west. It is orientated north-west/south-east, with the north-west elevation facing onto Abbey Road and the south-east onto High Street at the rear. Little of either the front or rear elevations can currently be seen from the street due to the presence of scaffolding and a hoarding, although photographs from the 1990s show both elevations much more clearly (compare Plate 17 and Plate 18).

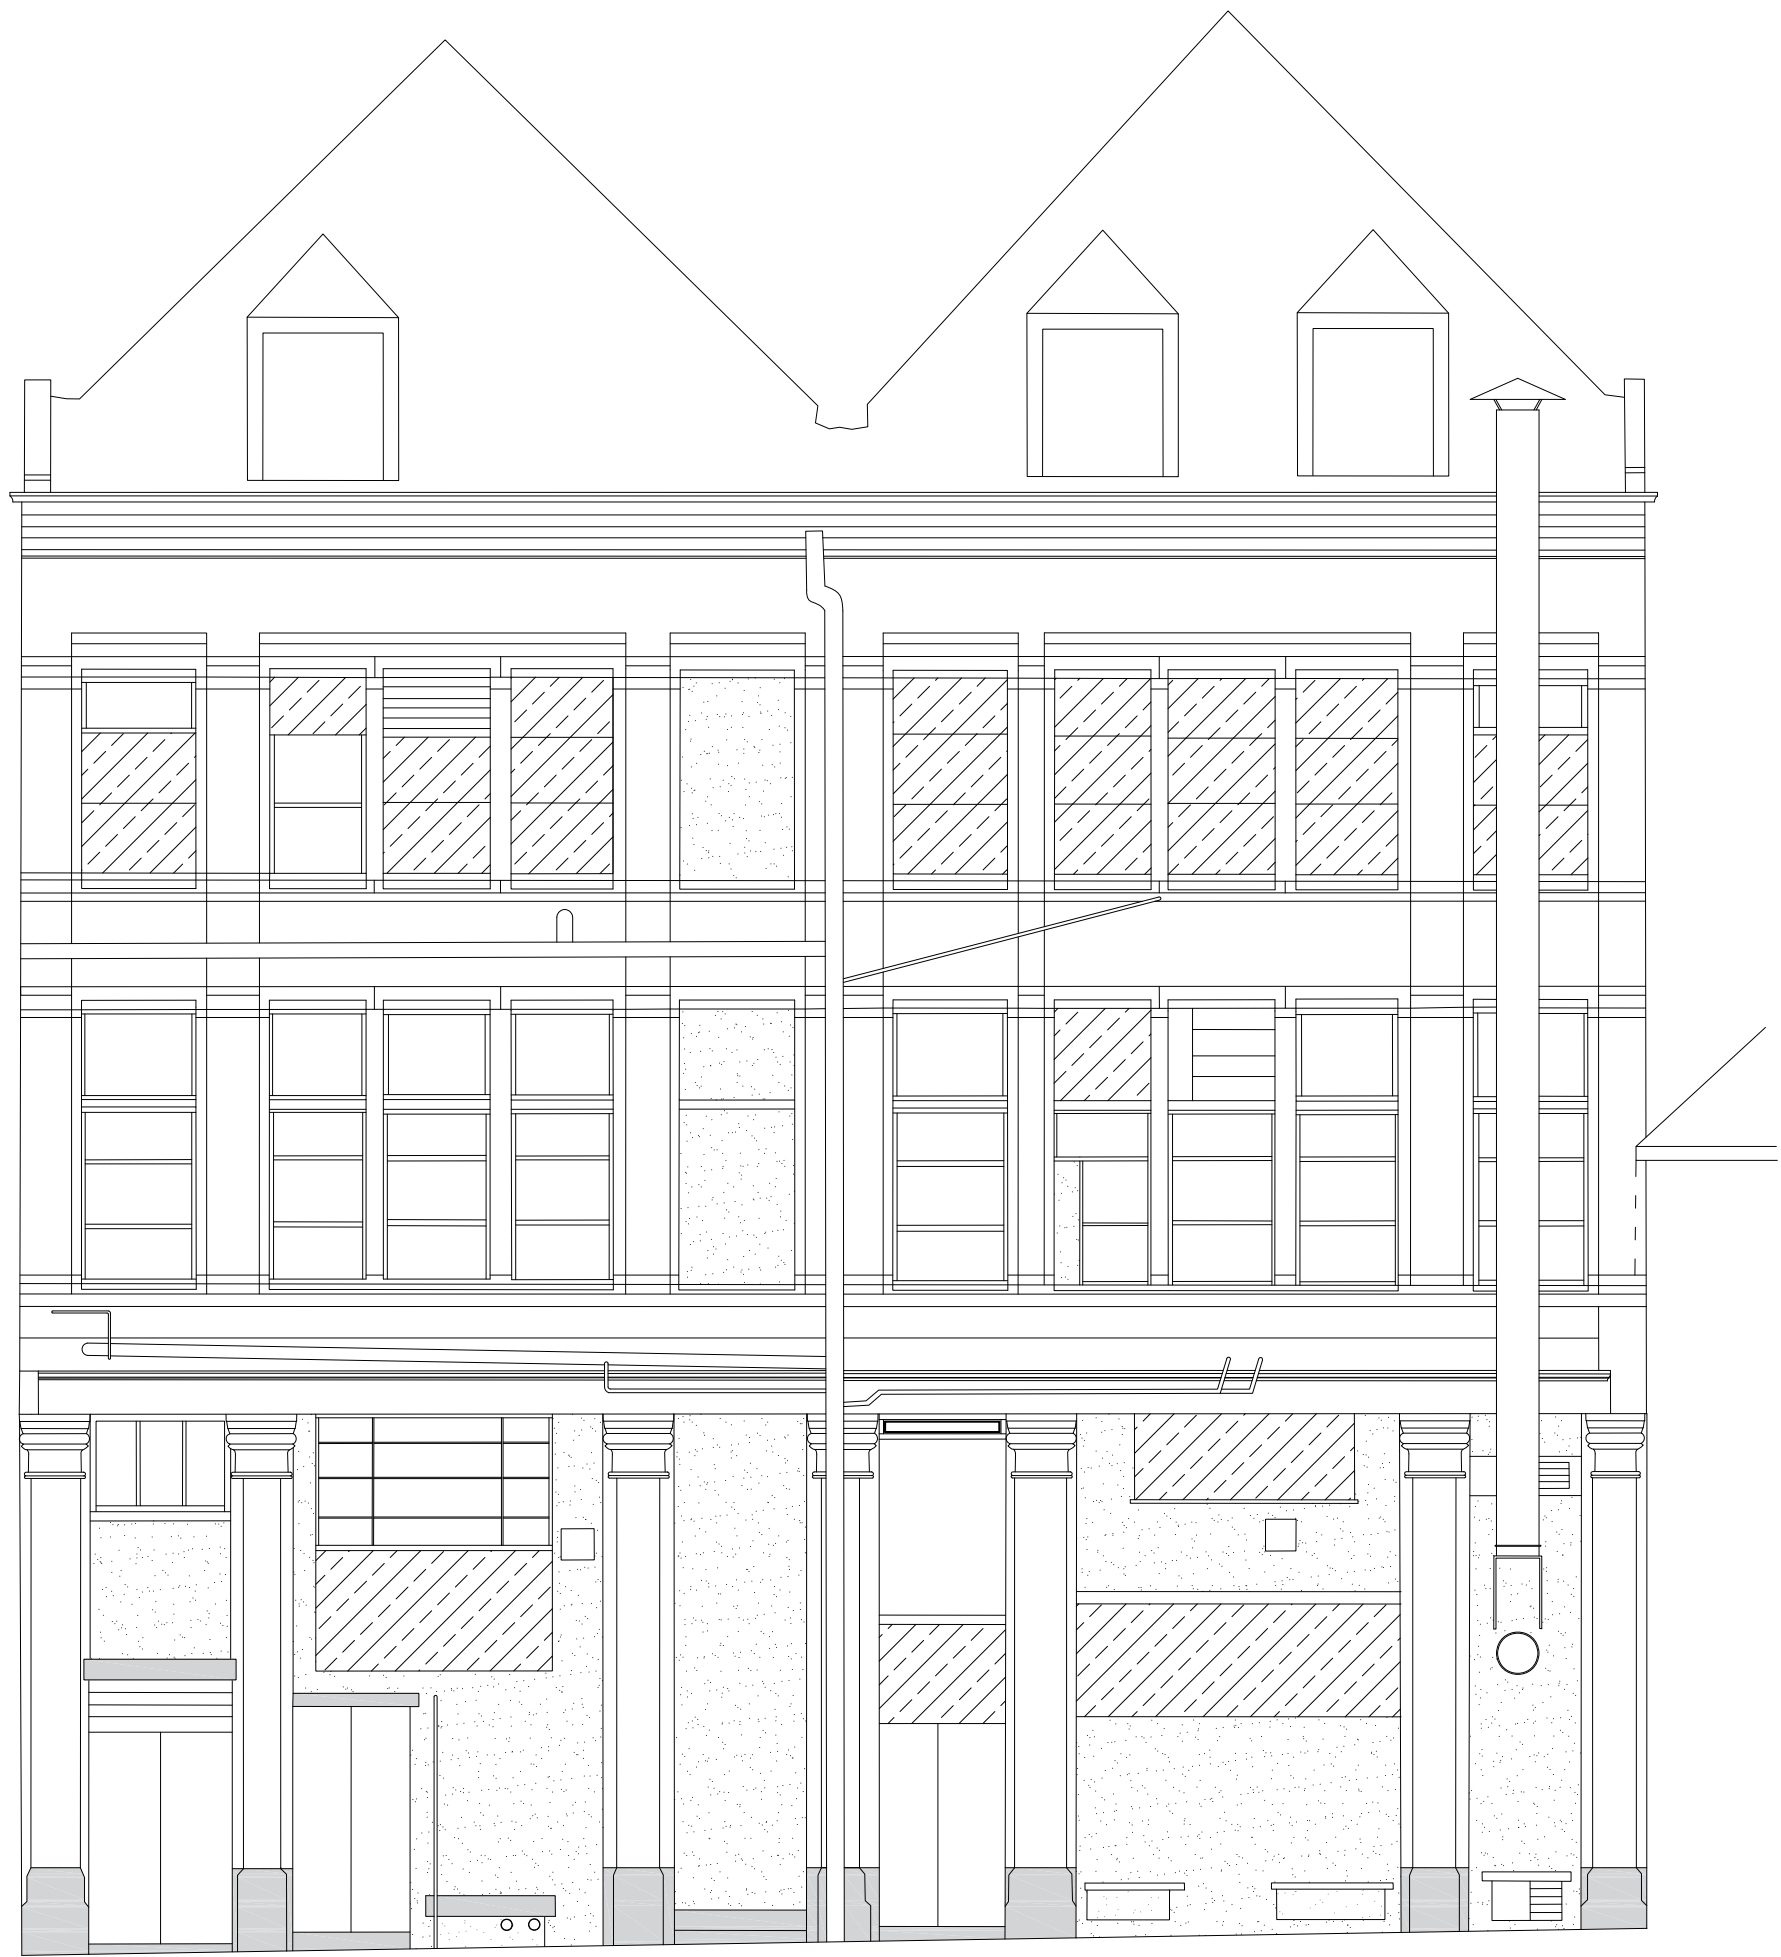
4.2.2 **South-east elevation:** the rear elevation of the building appears to be integrated with the Duke of Edinburgh to the north-east and the rear of Oxford Chamber to the south-west (Fig 3). The former is unsurprising given that the plans show that the buildings were constructed at the same time, but this suggests that Oxford Chambers was built shortly afterwards or also at the same time. Along the elevation, at regular intervals, are seven original brick columns, which extend upwards to the height of the bottom of the first floor. These have sandstone bases, most of which are covered with a skim of concrete, and are topped with moulded sandstone capitals (Plate 20). At ground floor level these support a painted timber hoarding. At the south-west end is a double doorway recessed into the wall, with a chamfered concrete lintel and modern timber doors (Plate 21). Above this, at the level of the mezzanine floor, is a timber-framed six-light window with sandstone sill. To the north-east is another double doorway, again in a recess, with a sandstone lintel and timber doors. Low down to the north-east of this is a blocked window with sandstone lintel, into which two round metal vents have been inserted. Above the door is a timber-framed 12-light window. No sill or lintel is visible, and below this is a large board, which may cover the lower part of the window and any sill. These features are situated in a bay between the second and third brick columns from the south-west and the brickwork appears much newer than on the rest of the elevation. To the north-east of this, in the next bay, there are no features, although there is a sandstone step similar to those up to the doors in other bays along this elevation, suggesting that a doorway has been blocked. In the next bay north-east is another timber door within a recess, with an overlight blocked with board. Above this is an area of painted timber hoarding. At street level in the next bay north-east are two windows with sandstone lintels, both blocked with modern bricks (Plate 22). Above this is a long window with sandstone lintel, also blocked with boards, and above this is another window, blocked with a board and with no visible lintel or sill. In the bay at the north-east end of the elevation is a window with timber louvres and chamfered sandstone lintel. Above this is a large steel ventilation tube projecting from the wall. Above the window there is four-light timber-framed window, the bottom right light of which has been blocked with a board and replaced with a vent. This window appears to have been altered with a lower brick infill

5.4.3 The rear elevation has already been subject to several poor quality and inappropriate alterations, particularly on the lower floors, and any general improvement would probably be to its benefit. Ideally replacing later brick repairs and blocking with more matching brick would be advisable, but this would likely prove prohibitively expensive, difficult and unnecessary. Removing the large metal duct would certainly be recommended but it would otherwise probably be unnecessary to attempt to return the elevation to its 'original' form as the details of this are largely unknown. Some of the more decorative timberwork, the moulded rail running the full width of the elevation across the top of the ground floor and panelled section above the central door in particular, are worth retaining, and if at all possible replacing the decorative brickwork that was present along the top of the elevation (which should, in any case, not have been removed) would be beneficial. Perhaps the most interesting features in the rear elevation are the projecting columns with moulded stone capitals, and these should certainly be restored and retained, removing the concrete from the bases if possible.

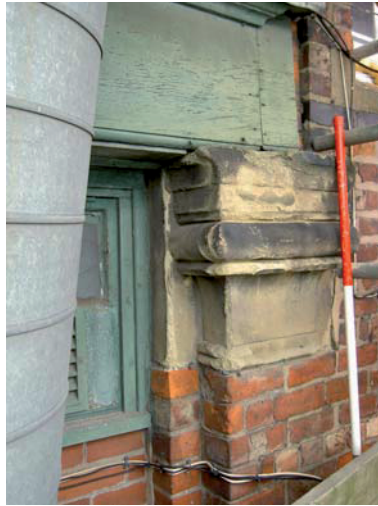
Plate 20: Detail of sandstone capital at north-east end of the rear elevation

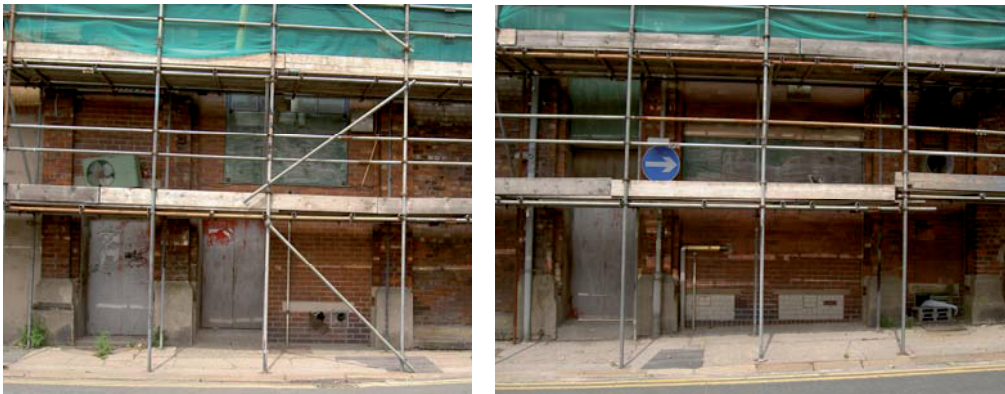
Plate 21: (left) Rear (south-east) elevation ground floor, south-west half

Plate 22: (right) Rear (south-east) elevation ground floor, north-east half

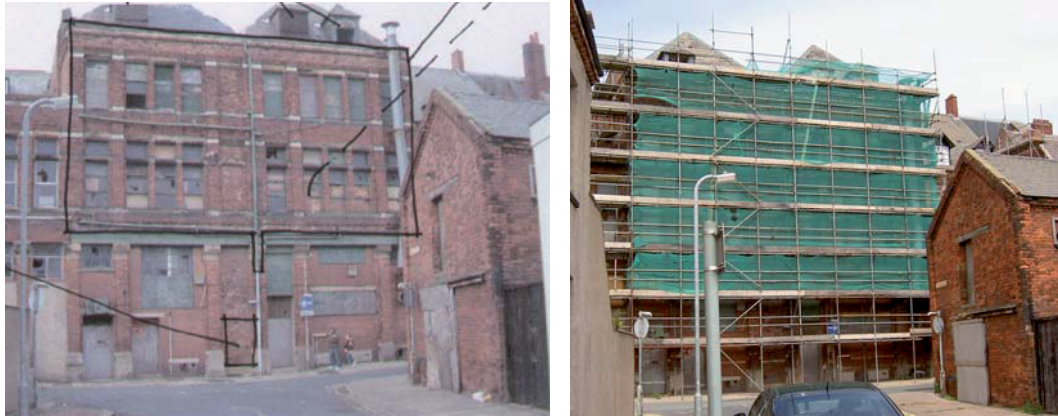
Plate 23: (left) Rear (south-east) elevation, as it appeared prior to the erection of scaffolding

Plate 24: (right) Rear elevation in 2008

4.2.3 The first and second floors of the elevation are almost identical, with sandstone sills and lintels, and nine three-light, timber-framed square-headed windows, those on the first floor each with a single transom forming an additional light above (see Plate 23 and Plate 24). The sills and lintels form a single band, which chamfered sections at the position of each window, and there are additional bands of decorative black and yellow bricks. There is a single window in each end bay between the projecting brick columns, and three in each of the wider bays. Many of the lights of these windows have been blocked with boards, and in the fourth window from the north-east on the first floor a narrow column of bricks has been inserted on the south-west side in front of the window. The remaining window is situated in the narrow bay north-east of centre, while the bay to the south-west of the centre is block with brick and displays no features other than the sandstone bands. Above the sandstone lintel band of the second floor windows are overhanging decorative bricks, which close the bays, bringing the wall flush with the brick columns. Above this is a sandstone stringcourse, and above this is a band of decorative bricks (two courses of yellow bricks framed above with a single course of black bricks and below by another such course), topped by another sandstone stringcourse as a coping. This band extends around to the north and south elevations of the building, although on the rear elevation the parapet appears to have been altered and lowered. At attic level there are two gable-end dormer windows projecting from the north-east half of the roof, and single gable end dormer window projecting from the south-west half. Across the elevation the windows are generally fixed timber casements, though mainly blocked with boards, and the dormers themselves are

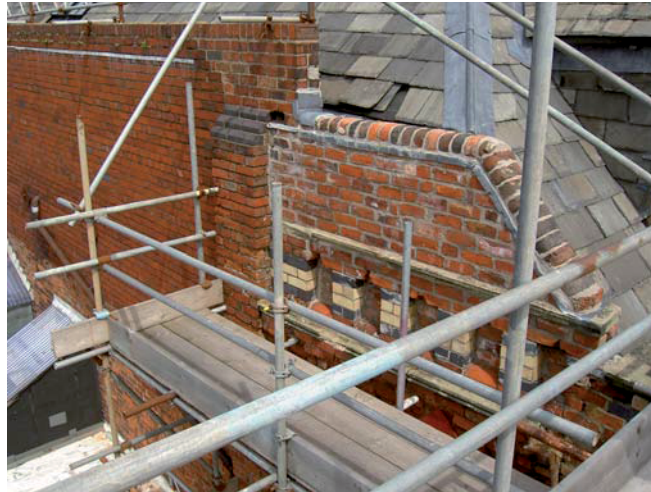
Plate 25: Detail of the south-east corner of the south-west elevation, showing decorative brickwork and repairs

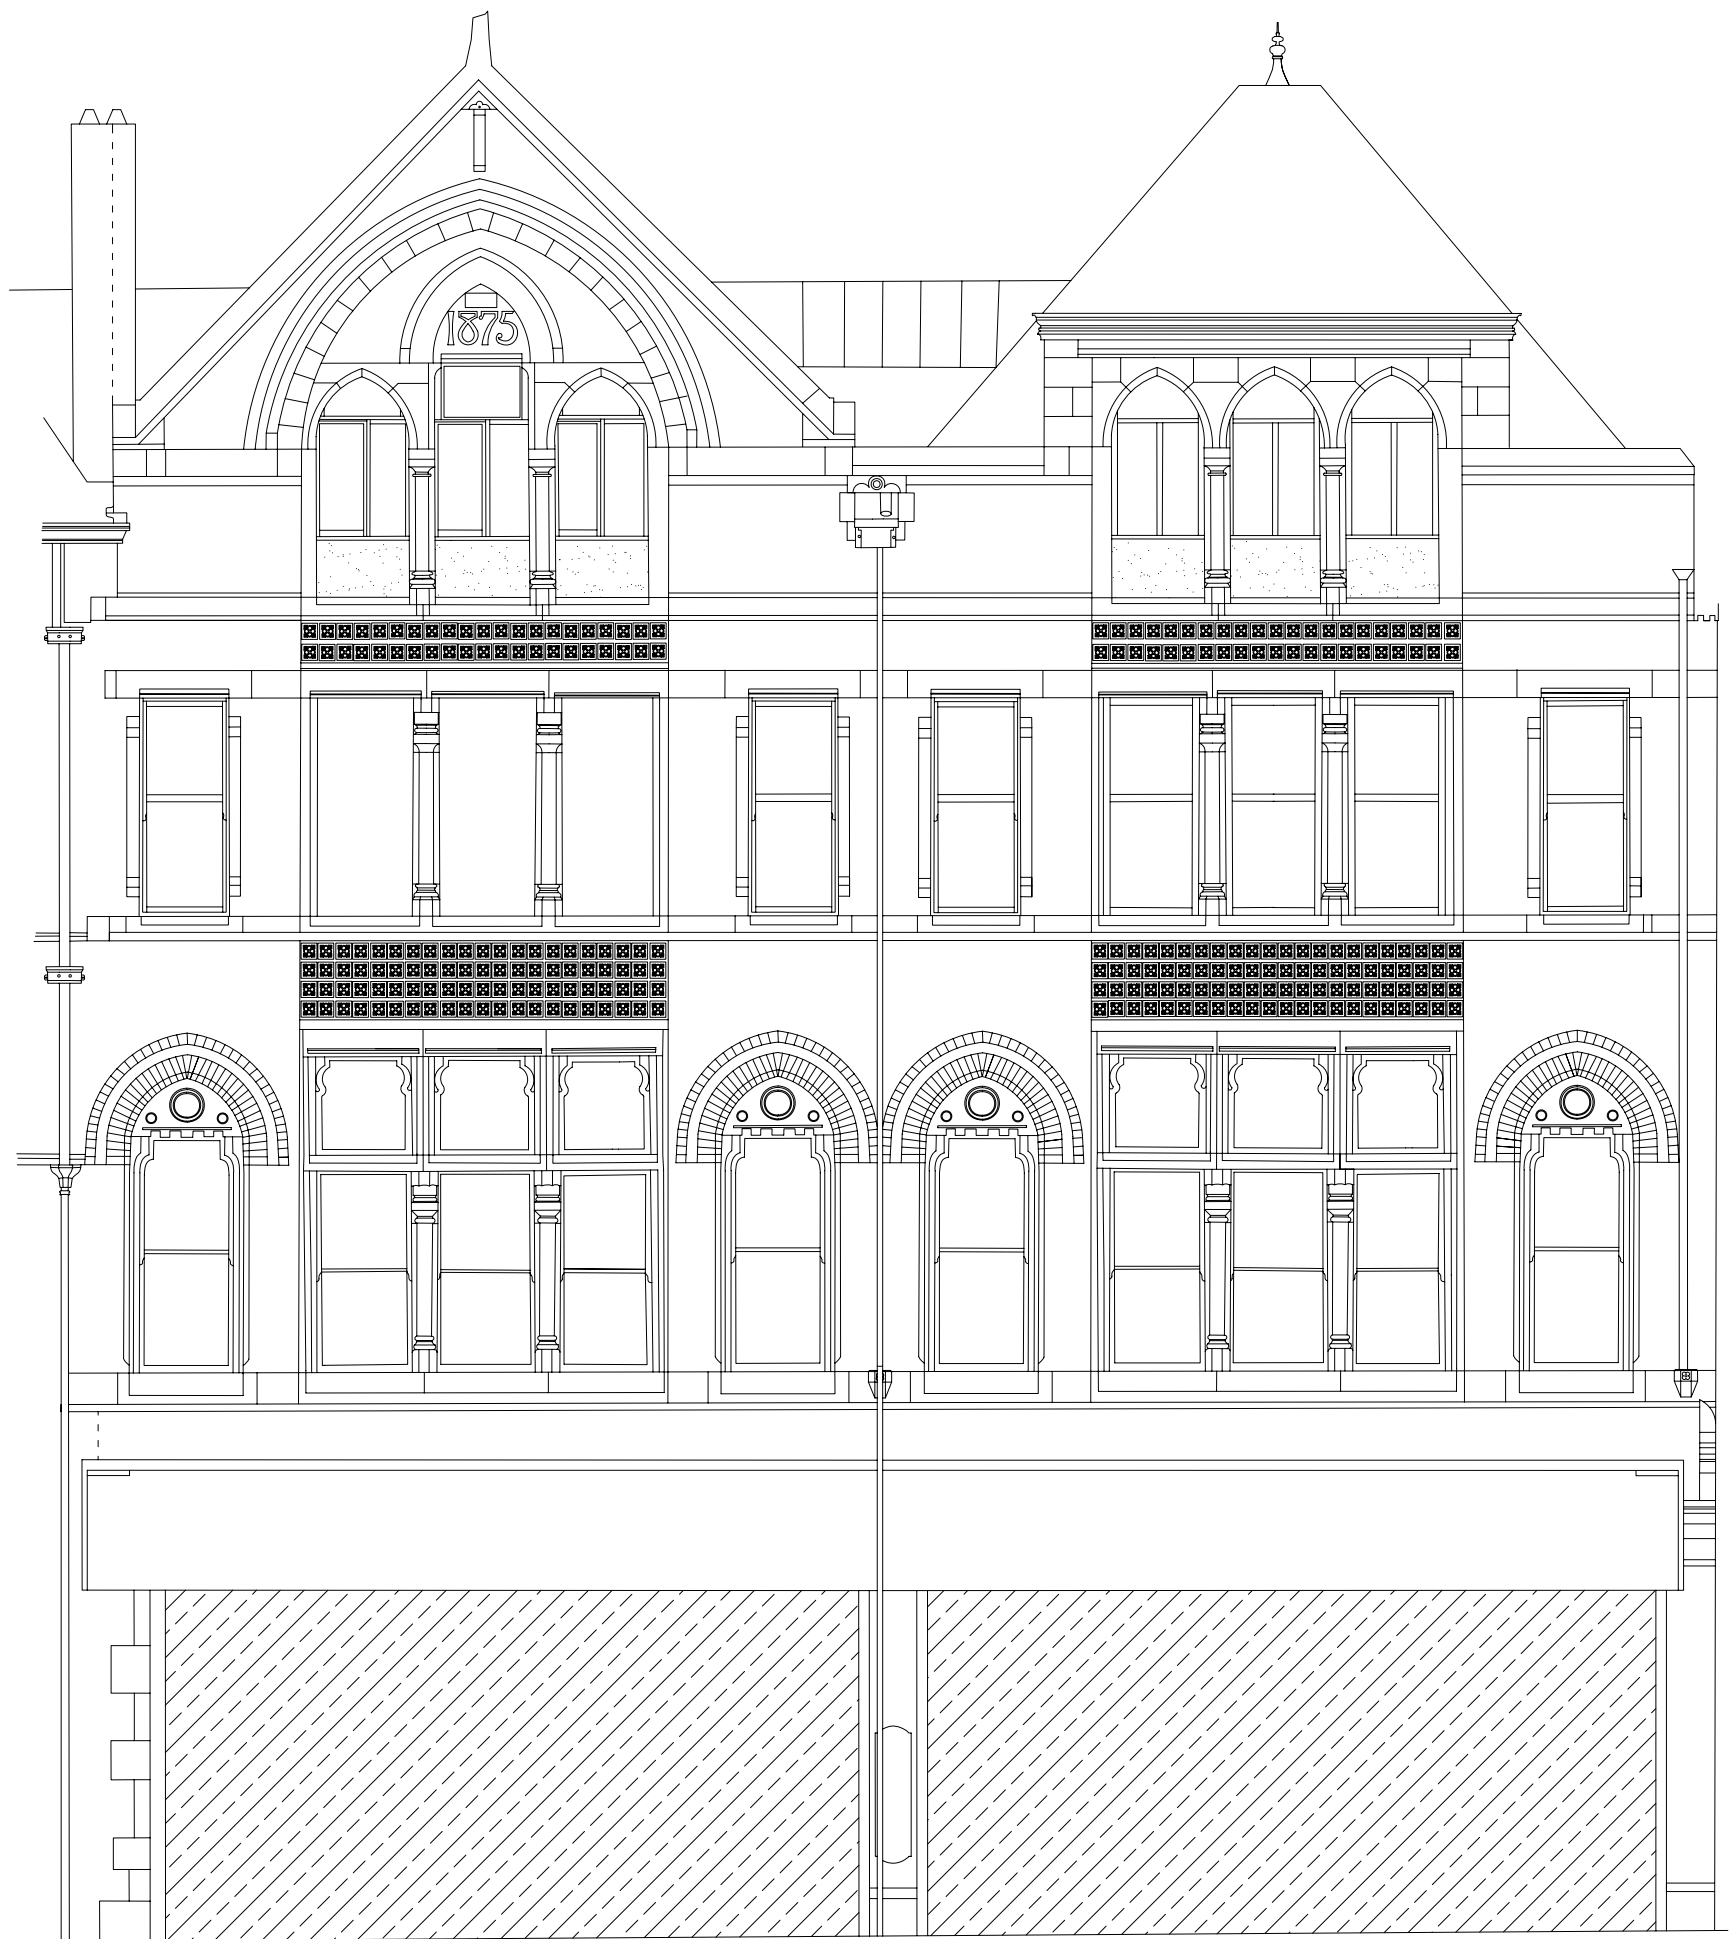
Figure 5: Front (north-west) external elevation

4.2.5 North-west elevation: the front elevation of No.104 Abbey Road appears to butt both the Duke of Edinburgh to the north-east and Oxford Chambers to the south-west but the decorative scheme and general arrangement are consistent with them all being broadly contemporary (Fig 5). The ground floor has been altered substantially and now has modern shop fronts. These include two large timber-framed single-light shop windows, each flanked by timber-framed double doorways, each with a long single-light window. Above these is timber hoarding, on which the faint outlines of letters can be made out, presumably the remains of shop signs. The first floor has a moulded sill band of sandstone, with three two-light plain sash windows set in recesses with colonette sandstone mullions, above the centre of each shop front. Each sash window has a shouldered transom light. Above these are mid-floor decorative terracotta tiles, laid out in a rectangle in four rows of 21 or 22 tiles (Plate 26). Flanking each set of sash windows are two-light sash windows in sandstone ashlar surrounds with decorative lintels set behind brick pointed arches with cut back hoodmoulds, over which is an arch of dark grey bricks (Plate 27). The second floor is of a similar layout, except all the windows are square-headed, and the sets of three two-light sash windows do not possess transom lights. There is also a lintel band of sandstone, and more decorative terracotta tiles, these laid in two rows of 21. The attic level has a sandstone sill band. The north-east bay has a stepped window with three three-light windows. The arch of the central window is taller than those either side in order to accommodate and frame a datestone inscribed '1875'. There is a banded panel under the pointed hoodmould, and above the hoodmould a course of dark-grey bricks follows the curve of the arch. The roof is gable ended with moulded copings and a sandstone finial, now broken. The bay to the south-west has a similar set of three three-light arched windows, although these are all of the same height, within a large dormer beneath a hipped roof with pointed metal finial. There is a section of coped parapet to either side of this dormer. All attic windows are modern casements above a brick infill. At the top of the south-west side of the elevation, in the immediately adjoining section of wall belonging to Oxford Chambers, there is a row of bricks marked 'W.G.'

5.3.3 The most significant element of the remaining fabric is the front elevation, which has survived in a reasonable condition, although badly affected by erosion,

5.4.2 Retaining and repairing the front elevation is perhaps the most important improvement that can be made to the building, although this would need to include retaining the original sliding sash windows where possible. The shop front is a particularly difficult area as it is difficult to know how much, if any original fabric remains, and it was not possible to identify any images depicting it before the 1980s. It is likely, however that the central timber panel is close to the original and that the form given in 1986 is not totally inappropriate; it appears from the original plans that it had a pair of large glazed windows with a central doorway in each (Plate 2), and the drawings from 1986 are not too different (Plate 14). The details of the hoarding or area for signage are not clear however, as they are not evident on the original drawings. It is possible that they remain *in situ* beneath the present structure and may take a similar form to that now exposed on No. 102.

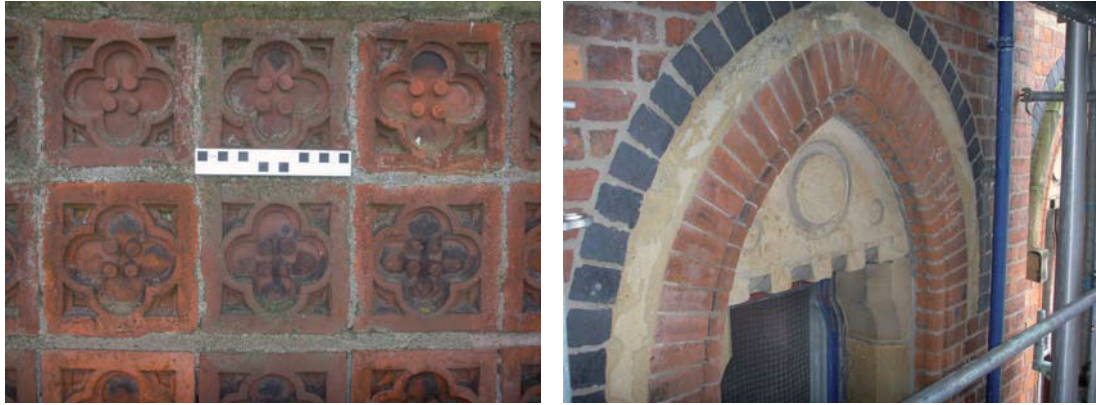
Plate 26: (right) Detail of terracotta tiles

Plate 27: (left) Arched window showing decorative brickwork and stone

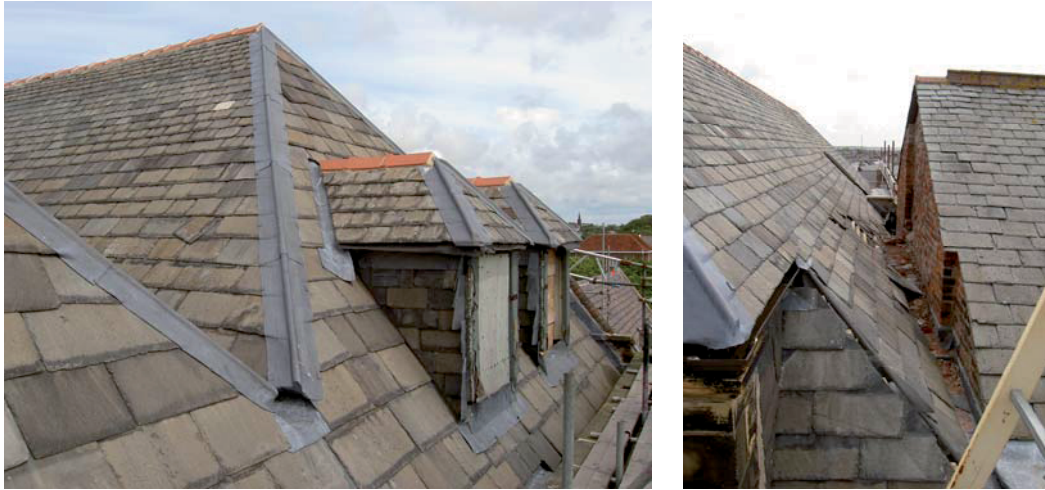
Plate 28: (right) South-east roof elevation from the south

Plate 29: (right) South-west roof elevation, from the north-west showing the partially collapsed and since repaired section of the adjoining Oxford Chambers

4.2.6 **Roof:** the roof is divided into two separate halves, both pitched and orientated north-west/south-east, covering the north-east and south-west attic rooms. The north-west end of the north-east roof is gable ended, and the south-east end is hipped, with two pitched, gabled dormers (Plate 28). Both ends of the south-west roof are hipped, with a single gabled dormer at the south-east end, just south-west of the centre-line. The north-west end has coped mouldings and a coped parapet, and the south-east end has a parapet topped with a sandstone coping. This parapet has been altered, possibly due to recent damage caused by the partial collapse of part of the neighbouring No. 102 (Plate 29; some of the bricks within the collapsed material are also marked 'W.G.'), and is lower than its original height. The north-east and south-west elevations have brick parapet walls, sloped at the south-east ends, extending to slightly over half the length of the building. Between the two roofs, at the north-west end, is a pitched north-east/south-west roof, above the connecting attic corridor, with a modern, timber-framed, 10-light skylight (Plate 30). At the south-east end of the north-west parapet wall is a brick chimney stack, with concrete flaunching and a single remaining ceramic chimney pot. To the north-west of this is another chimney stack with concrete flaunching, but no chimney pots. North-west of centre is another pitched roof orientated north-east/south-west, butting the hipped roof of the Duke of Edinburgh at its north-east end. To the north-west of this is a tall chimney stack with concrete flaunching and six chimney pots in two rows. This chimney stack appears to have been built in two parts, the south-west being slightly thinner (Plate 31). The roofs are covered with local grey slate, with the tiles gradually decreasing in size towards the ridge of the roof, and a number are loose and in need of repair. There is also with lead flashing on the hips, valleys and gutters, and ceramic angular ridge tiles.

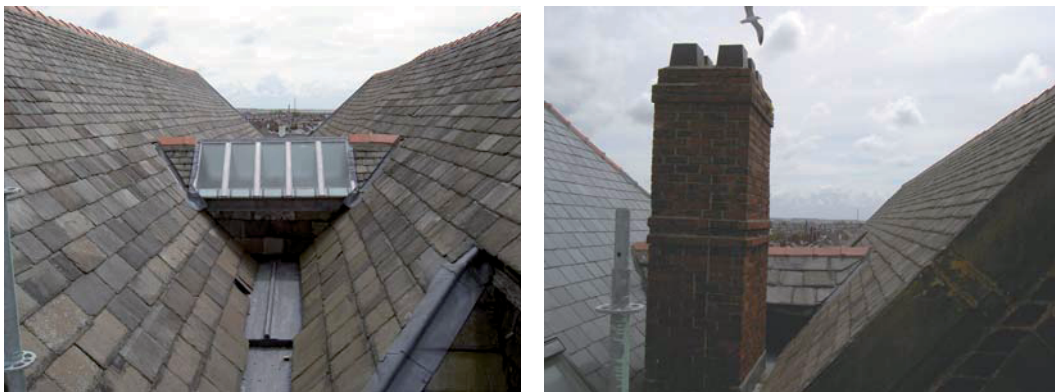
Plate 30: (left) Roof of connecting corridor between attic floor Rooms 1a and 2a, viewed from the north-west

Plate 31: (right) North-east roof elevation from the north-west, showing chimney stack and pitched roof running from 104 Abbey Road to the roof of the Duke of Edinburgh on the left

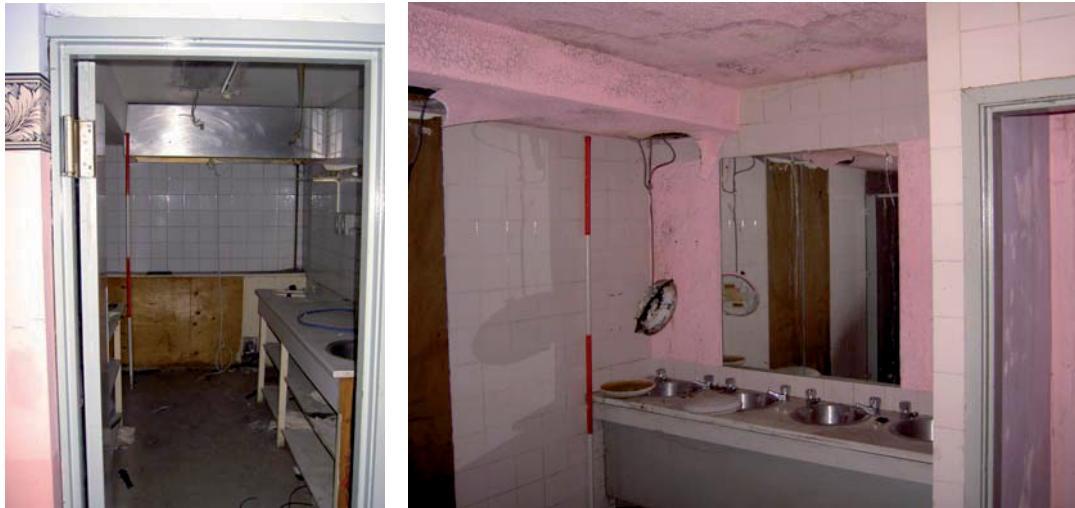
Plate 32: (left) Basement Room 2c, south-west elevation

Plate 33: (right) Basement Room 2e, south corner

the elevation, a hardboard bench projects into the room. Immediately to the north-east of this is the doorway from behind the bar in Room 2. All elevations are finished with paint and wallpaper. Room 2c is a kitchen area (Plate 32). The floor is of concrete and the ceiling is finished with plaster, with a large modern metal extractor fan at the north-east end. All the elevations are covered with modern white ceramic tiles. The north-east elevation has a small ledge formed by timber panelling just forward of the wall itself, up to the mid height of the wall. The south-east elevation has a timber shelf part-way up, and a timber bench with wooden shelves and a ceramic sink against it. The south-west elevation has a timber framed door in the centre, with a modern plywood door, leading to Room 2. The north-west elevation has a wooden shelf part way up, and a timber bench against it. There is a timber-framed doorway from Room 2b at the north-east end.

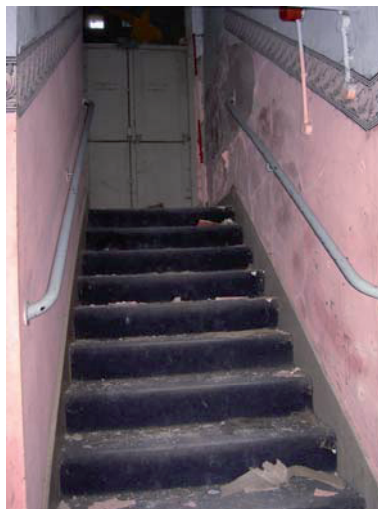
Plate 34: Basement, stairs, looking south-east up to the basement/ground floor landing

4.3.10 **Basement-ground floor, main stairs:** the stairs themselves are covered with carpet, running upwards from north-west to south-east to a small landing, also carpeted. The walls are finished with wallpaper and paint, with metal handrails on either side of the stairs. There is a large double doorway with timber doors exiting onto High Street at the south-west end of the south-east elevation at landing level, and a wooden cupboard in a timber framed alcove to the north-east of this. The north-east and south-west elevations are finished with wallpaper and paint, but are otherwise plain. The north-west elevation has the stairs down on the south-west side. On the north-east side is a timber-framed doorway with a wood door, leading to the stairs to the ground floor (Plate 34).

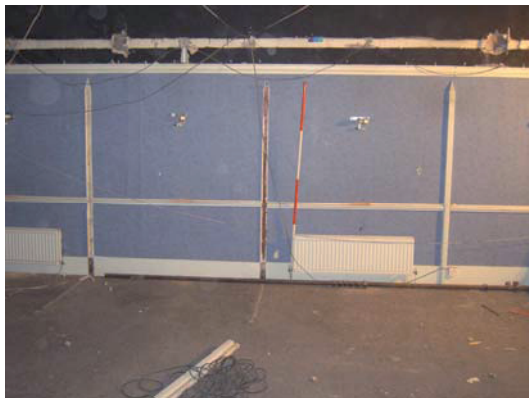
wallpaper up to a height of c2.25m, above which the elevation is painted black (Plate 35). A white painted timber skirting board runs the length of the elevation. A timber, white painted dado rail runs the length of the elevation approximately 0.75m above the floor, and another at c2.10m. There are timber uprights, or scars of such, attached to the wall at regular intervals. At a height of c2.50m are regular holes in the wall for supporting beams, possibly for a now missing mezzanine floor or false ceiling. The south-east elevation is finished with wallpaper, with a timber, white-painted skirting board. There is a wide, timber-framed doorway in the centre, with timber double doors, with a small rectangular single-light window in each. The ceiling at the north-east end overhangs the lower south-east elevation, and is supported by two timber uprights (Plate 36). To the south-west of the double door, the wall returns to the north-west, coming just short of the upper elevation, before returning again to the south-west. To the south-west of this return is a timber-framed doorway with a timber door. From this point onwards there is a timber white-painted dado rail running along the elevation. The south-west elevation is similar in appearance and style to the north-east elevation, except for two details. There is a large aperture just south-east of centre, which is the large hole knocked through the wall from Room 1, and a large doorway from Room 1, now with its frame missing, is in the centre. The north-west elevation has been largely formed by the addition of a false partition wall. At the south-west end is a wide timber framed doorway with timber, single-light double doors, leading to a small vestibule, at the north-west end of which is a similar double doorway with similar doors, exiting onto Abbey Road. To the north-east of the inner double door is the partition wall, formed of modern concrete blocks, with plaster and wallpaper over a timber frame. Just north-east of centre the wall returns to the south-east, and then to the north-east to meet the north-east elevation. Against the south-west part of this wall is a bar area, while the rest of the wall is decorated and finished in a similar fashion to the north-east and south-west elevations. It should be noted that on the other side of this partition wall are the former nightclub ticket booth and stairs to the basement below, although they are inaccessible from this room.

Plate 35: (left) Ground floor Room 2, north-east elevation

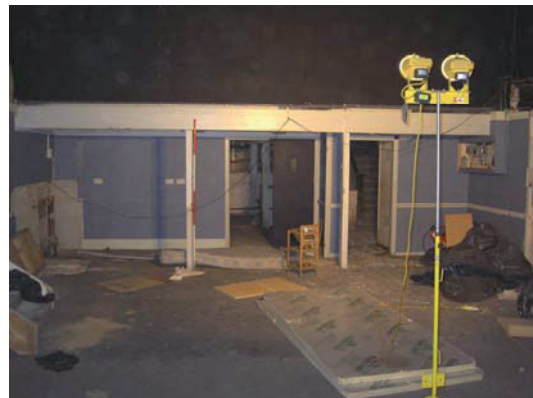
Plate 36: (right) Ground floor Room 2, south-east elevation

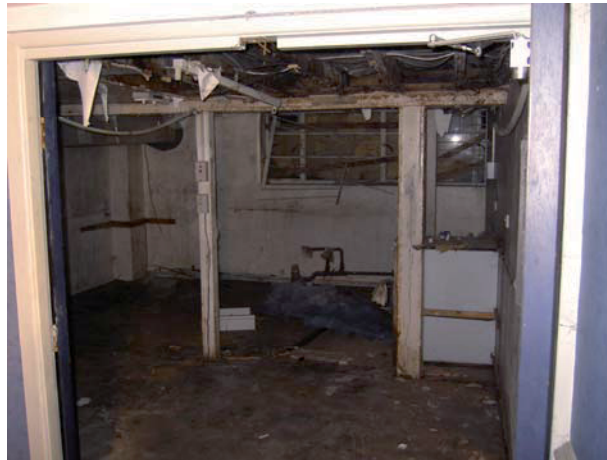
Plate 37: Ground floor Room 2a, south-east elevation

4.3.14 **Ground floor, Room 2a:** the floor is covered by floor tiles, the ceiling is hardboard attached to a timber framework centred on an iron beam orientated north-east/south-west across the centre. This beam is supported by three timber posts, one in the centre, and another slightly larger one to the south (Plate 37). The third supporting pillar in the south corner of the room. The walls are all finished with plaster and paint. The north-east elevation has a chimney breast covering the north-west half and an upright in the east corner. There are shelves mounted on the wall just west of centre. The south-east elevation has a timber-framed, 12-light window, extending south-east from the centre of the elevation, which is blocked with boards on the outside. The south-west elevation has a small plinth with attached timber

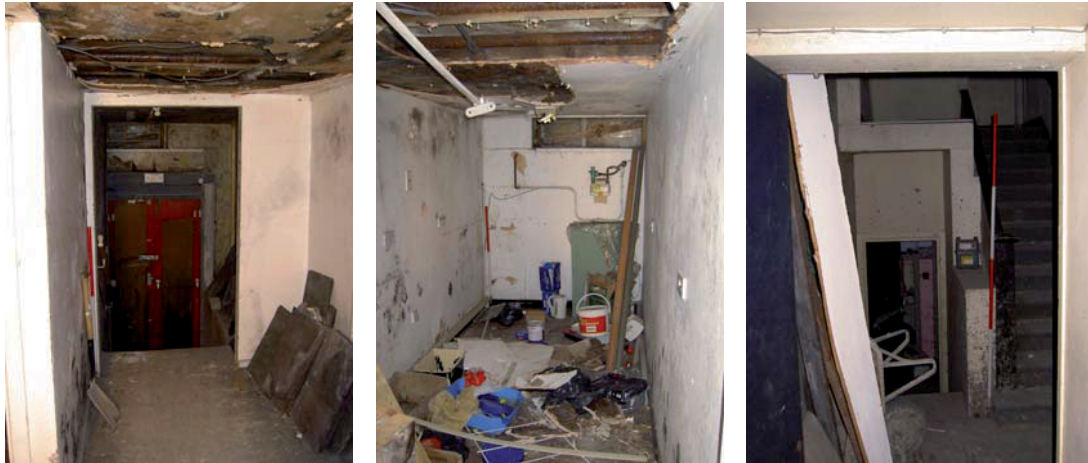
Plate 38: (left) Area S1, centre of the south-east elevation, showing door to High Street (left)

Plate 39: (centre) Area S2, south-east elevation

Plate 40: (right) Area S3, looking south-east towards stairs to basement and first floor

4.3.15 Ground floor, stairs Area S1-S3: Area S1 (the south rear stairs) has a board floor and a ceiling comprised of a framework of metal pipes covered with hardboard and finished with paint. The north-east elevation is finished with plaster and paint. At the north-west end is a timber-framed doorway leading to Area S3. Immediately to the south-east of this is a return to the south-west, followed by a return to the south-east, around Area S2. The remainder of the elevation is plain. The south-east elevation is primarily finished with plaster and paint. There is a timber-framed doorway with a timber door north-east of centre leading to Area S2. To the south-west of this the wall returns to the south-east to butt the rear exterior wall of the building. In the centre of the elevation is a large timber framed doorway (Plate 38), with double doors, exiting onto High Street at ground level (this doorway is down a small flight of steps, at the top of which is an empty doorway, through which the double doors can be seen). To the south-west of the double doorway, the wall returns to the north-west to form the north-east wall of the south stairs. At the south-west end of the elevation are the south stairs. These are timber with metal edging, with a timber, varnished banister. The south-west elevation is finished in plaster and paint. At the south-east end, the small set of stairs to street level doors are set forward of the wall, resulting in a small plinth, which has been topped with timber. There are a series of small returns in the wall starting in the centre (north-east, north-west, south-west, north-west, south-west, north-west then south-west again), behind which are the south stairs. At the north-west end of the elevation is a large aperture giving access to the stairs. The north-west elevation is largely plain, although there is a large timber doorway with double fire-doors in the centre, leading to Room 1.

4.3.16 Area S2 is an enclosed room, possibly most recently used for storage, although marked on the 1980s plans as a kitchen. The floor comprises large boards, and the ceiling is of the same construction as Area S1. All the elevations are stud walls constructed from plasterboard finished with plaster and paint, except for south-east elevation, which is the rear exterior wall of the building. The north-east and south-west elevations are plain. The south-east elevation has the bottom left corner of a large timber framed window high in the centre and continuing beyond the room to the south-west (Plate 39), partially obscured by the room's south-west elevation and the ceiling. Four lights of this window can be seen from this room. The north-west elevation has a timber framed doorway at the south-west end leading to Area S1.

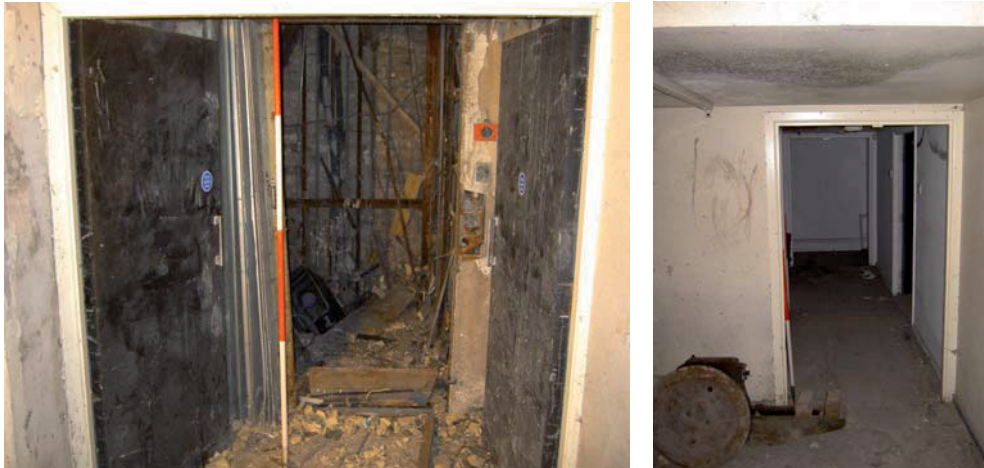
Plate 41: (left) Room S3, elevator shaft, looking south-east

Plate 42: (right) Room S3, looking south-west towards Area S1

4.3.17 Area S3 is divided north-west/south-east by the main interior wall. The floor is concrete, the high ceiling appears to be plastered and painted, and in the east corner comprises of the underneath of the east rear stairs, which is wood panelled. The ceiling in the south-west half of the room (i.e. south-west of the main interior wall) is much lower and constructed in a similar fashion to the ceiling in Area S1. The north-east elevation is concrete and painted and there are stairs down to the basement landing on the south-east side. The south-east elevation is taken up on its north-east half by the east stairs. At the north-east end the concrete stairs lead down to a timber-framed doorway with a timber fire-door which leads to the basement landing. On the south-west side of these stairs is a concrete projection into the room, which is topped with timber. On the south-west side of this are the stairs leading to the floor above (Plate 40). The stairs are timber, covered with carpet, with a timber painted banister on the north-east side, and a varnished handrail on the south-west side. At the top of the stairs is a short landing. On the south-west side of the stairs is the main interior wall, which is orientated north-west/south-east and has a large aperture at its north-west end, allowing access between the two halves of the area. At the south-west end of the elevation is a wide timber doorframe, with large double fire-doors. Behind these is the elevator shaft, which has bare brick walls, although the remains of lift machinery can be seen. The rear wall of the elevator shaft is the rear exterior wall of the building (Plate 41). The south-west elevation is of brick at the south-east end (the elevator shaft), and constructed of plasterboard finished with paint for its remainder. There is a wide timber-framed doorway at the north-west end, leading to Area S1 (Plate 42). The north-west elevation is plasterboard finished with paint. There is a timber-framed doorway with a plywood door in the centre, giving access to a large, built-in cupboard room of plasterboard construction with wooden slatted floor-to-ceiling shelves on all elevations. To the north-east of the cupboard door is a timber-framed doorway with a fire-door, which leads to Room 2.

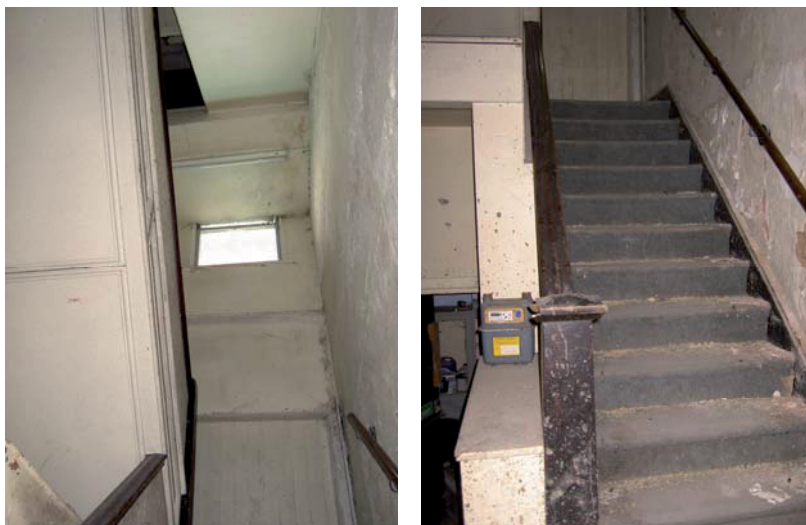
Plate 43: (left) East main stairs south-east elevation

Plate 44: (right) East main stairs, looking south-east to ground floor/first floor landing

4.3.18 Ground to first floor, east main stairs and east mezzanine: the landing of the east main stairs is carpeted and the ceiling, formed by the underneath of the stairs to the second floor, is finished with plaster and paint. All elevations are finished with wallpaper and paint. The north-east elevation of the landing itself is taken up by a timber-framed doorway to the inserted mezzanine floor in the east corner of the building, above Ground floor Room 2a. Beyond the doorway is a short corridor running south-east/north-west, with a blocked timber-framed four-light window on the south-east elevation, leading to further rooms to the north-east and north-west. The rooms in this area appear to have been male and female toilets as indicated by wall-signs. However, this area was not accessible due to unsafe floors. The south-east elevation of the landing has a timber-framed single-light window high in the centre. Beneath this and to the south-west is a wide aperture which appears to have been blocked with planks, which have been finished with paint to match the walls and given the addition of a skirting board (Plate 43). The elevation also has a moulded wooden dado rail. The south-west elevation is plain. The north-west elevation is taken up by the stairs down to ground level on the south-west side and the stairs up to the first floor on the north-east side. These stairs are carpeted and have a timber, varnished handrail on either side. An early newel post remains on the landing, which is square in section with a flattened pyramidal top (Plate 44).
