104 ABBEY ROAD, BARROW-IN-FURNESS, CUMBRIA

Archaeological Building Recording

Client: Barrow Borough Council
NGR: SD 19960 69680

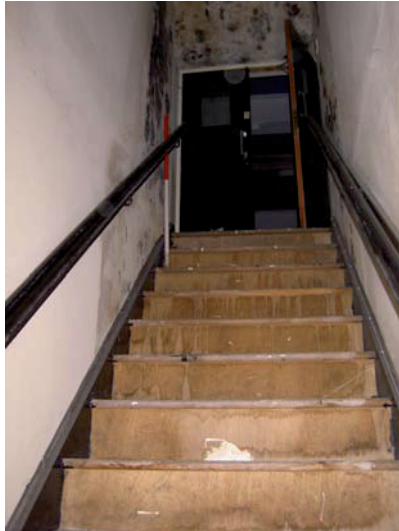
Plate 45: (right) South main stairs, looking north-west towards First floor Room 1

4.3.19 **Ground to first floor, south main stairs:** the landing of the south main stairs is covered by linoleum. The ceiling appears to be finished with plaster and paint, as are all elevations in this stairs area. The north-east elevation of the landing itself is a plain plasterboard partition wall, on the other side of which is mezzanine Room M3. The south-east elevation has a window blocked by boards on the north-east side, which extends beyond the north-east partition wall. There is another similar window to the south-west of this. The south-west elevation is plain. The north-west elevation is taken up by the stairs down to the ground floor on the south-west side, and the stairs up to the first floor in the centre. The latter stairs are of timber construction, with painted timber handrails on either side (Plate 45). To the north-east of these stairs is a timber-framed doorway leading to the mezzanine floor.

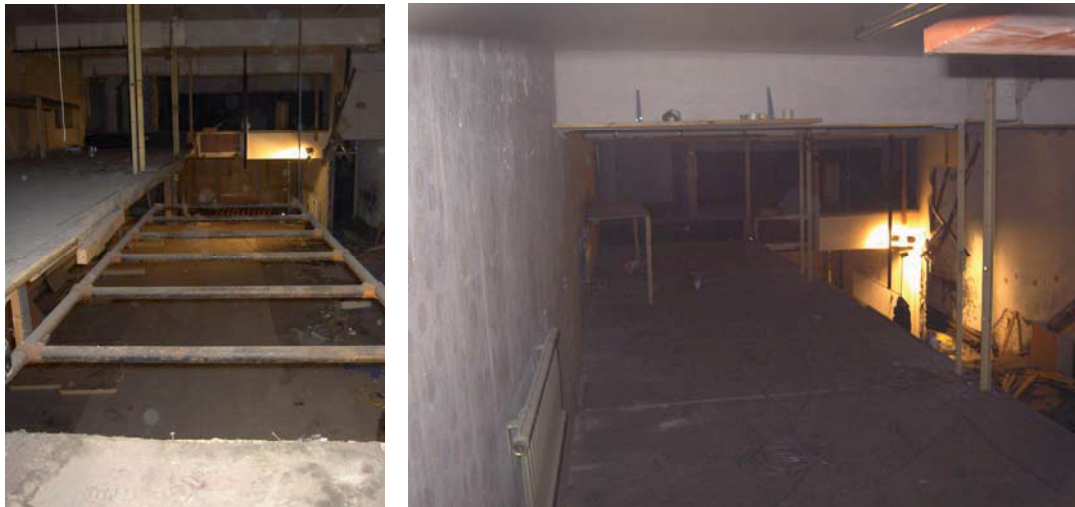
Plate 46: (right) Mezzanine floor, looking north-west

Plate 47: (left) View of mezzanine floor extending above the south-west side of ground floor Room 1, looking towards the space above the shop fronts to the north-west

4.3.20 **Mezzanine floor, general:** the floor of this area is constructed of large boards over a steel tubular framework, which in turn is supported by steel I-beams running from the south-west external wall to the original interior partition wall, and steel pillars from the ceiling above (Plate 46; Fig 11). The majority of the mezzanine floor, the area that was most accessible, is situated above Areas S1-S3, although there were further areas above the shop front to the north-west and over ground floor Room 2a, but these could not be fully accessed. The mezzanine corridor runs south-east/north-west from the south-east external wall (Fig 7). The floor is covered with linoleum, except for its south-east end, which, after a small step up just south-east of centre, is covered with carpet. The ceiling is comprised of boards, finished with plaster and paint, as are all the elevations. The north-east elevation has a timber-framed doorway, with a timber door with a single-light window, in the centre, leading to Room M3. The south-east elevation is taken up by a timber-framed doorway with a timber fire-door. The south-west elevation has a timber doorframe just north-west of centre, with a timber door, which gives access to Room M1. To the north-west of this the elevation is constructed of plywood, with a timber-framed four-light window running the length of the wall. The north-west elevation is taken up by a large aperture which formerly gave access to the rest of the mezzanine floor, but now leads to empty space above ground floor Room 1. The steel- and timber-constructed floor is supported along the south-west exterior wall above the south-west side of ground floor Room 1. This floor is c2.0m below the original ceiling and wooden shelves have been attached to the original main beams. A false floor can be seen at the north-west end of the floor above the ground floor shop front (Plate 47). The construction of this appears to be from timber and boards and a timber partition wall projects from the

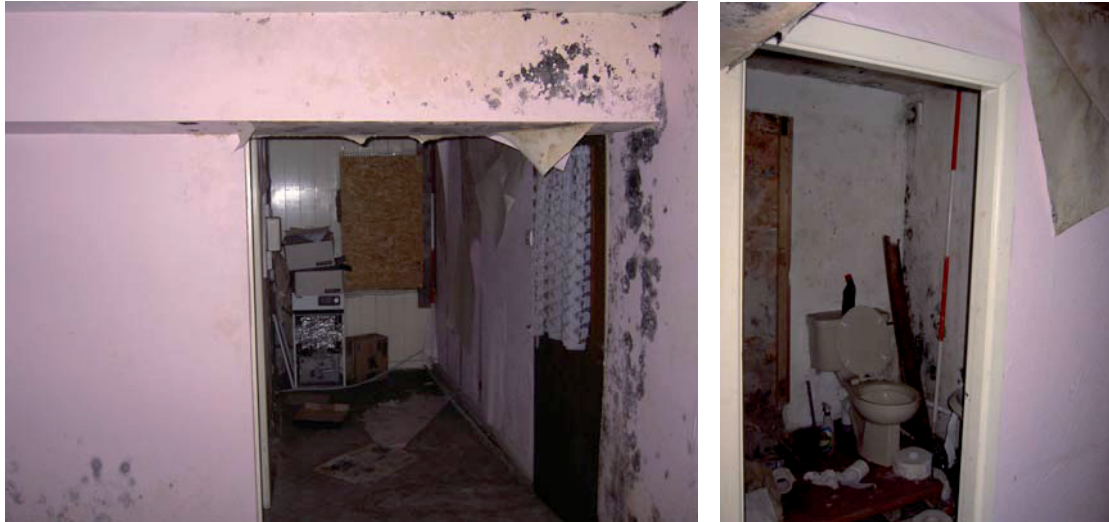
Plate 48: (left) Mezzanine room M3, south-east elevation

Plate 49: (right) Mezzanine room M4, looking from room M3

4.3.23 Mezzanine floor, Room M3: the floor is covered with linoleum and the ceiling finished with plaster and paint. The north-east elevation is finished with wallpaper and paint and there is a timber-framed doorway with timber door leading to Room M4 at the north-west end. The south-east elevation has painted wood panelling and there is a timber-framed window blocked with boards on the south-west side. This window continues from the landing area to the south-west. The south-west elevation is finished with wallpaper and paint. There is a timber-framed doorway with a timber door with a single-light window at the north-west end, leading to the mezzanine corridor (Plate 48). The north-west elevation is finished with wallpaper and paint, and is mostly taken up by the large aperture through to Room M2.

4.3.24 Mezzanine floor, Room M4: this small room is a former toilet/shower room (Plate 49). The floor is covered with linoleum on the south-west half, while the north-east half is raised up with a wood plinth. The ceiling is finished with plaster and paint. The north-east elevation is plasterboard finished with plaster and whitewash. The north-west half shows the scar of what was probably a shower cubicle, and the south-east half has a toilet bowl attached. The south-east elevation is again finished with plaster and whitewash, and there is a ceramic standing sink attached to the wall at the south-west end. The south-west elevation has a timber-framed doorway with a timber door at the north-west end, which leads to Room M3. The north-west elevation is mostly plain, although the scar of the shower cubicle can be seen in the centre immediately above the step of the floor.

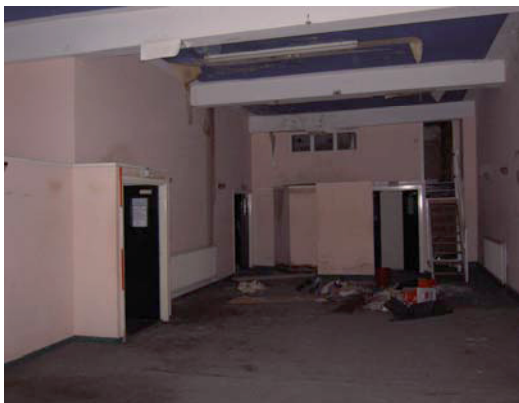
Plate 50: (left) First floor Room 1, south-east elevation

4.3.27 The south-east elevation comprises of a plasterboard partition wall, finished with plaster and paint (Plate 50). At the north-east end the elevation returns diagonally to the west before returning again to the south-west. In the centre is a return to north-west, followed by another return to the south-west and then again to the south-east, around the entrance to Room 1b, followed again by a return to the south-west. Just south-west of centre is a timber-framed doorway with wood double doors, each with a single-light window, leading to the south main stairs, which terminate on this floor. High in the centre is a timber-framed three-light window from the mezzanine room above. South-west of this door the elevation returns briefly to the south-east before returning to the south-west to butt the south-west elevation. At the south-west end is a timber-framed doorway to a small storage cupboard. Directly in front of this doorway is a set of timber steps, painted and varnished, with a wood handrail on the south-west side. At the top of these steps is a timber-framed doorway with a modern plywood door to the mezzanine room above. The south-west elevation is finished with wallpaper and paint and is mostly plain apart from a timber skirting board which runs the length of the elevation as far as the partition wall at the north-west end. To the north-west of this partition is a chimney breast (Plate 51). The north-west elevation has a two-light sash window in a timber frame at the south-west end. In the centre is a large timber casement with three two-light sash windows, each with a single-light window above. To the north-east of this is another timber-framed, two-light sash window (Plate 52). All windows are covered with modern wire mesh.

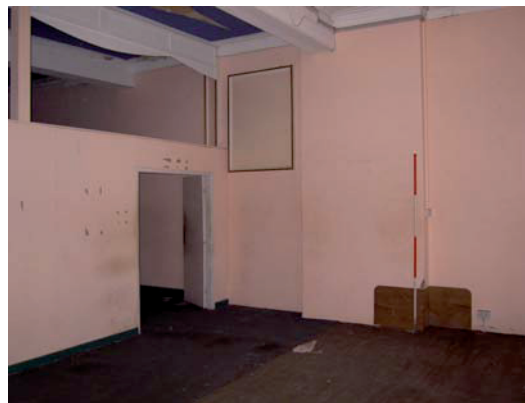
Plate 51: (right) First floor Room 1, north-west end, looking south

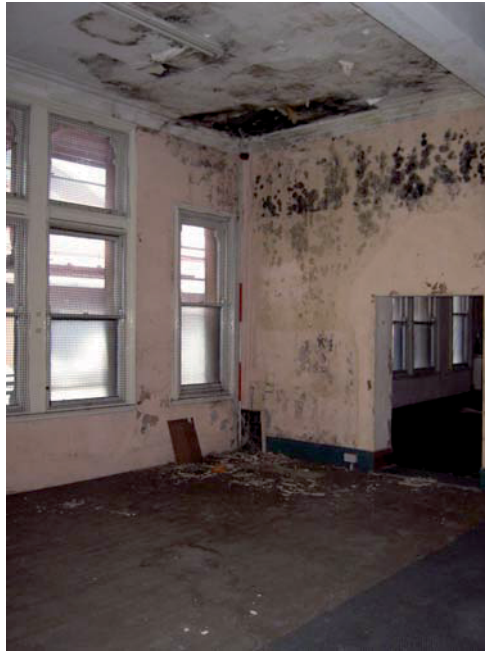
Plate 52: (left) First floor Room 1, north corner showing part of the window

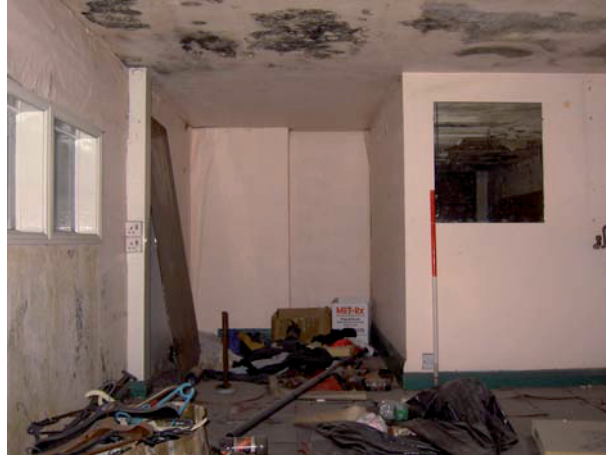
Plate 53: First floor mezzanine room, north-east elevation

apart from the timber shelves against most of its length. The north-west elevation is also finished with wallpaper and paint, with a painted timber skirting board. There is a timber-framed doorway with a single plywood door at the south-west end, which opens out onto the timber steps into Room 1. In the centre of the elevation are three single-light timber-framed windows, and to the north-east of these is a timber upright (Plate 53).

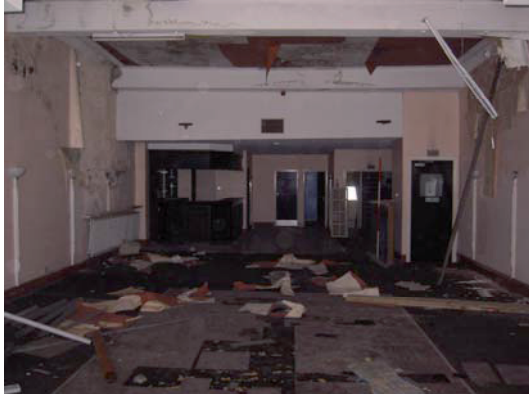
Plate 54: (left) First floor Room 2, south-east elevation

4.3.30 **First floor, Room 2:** this room takes up the majority of the north-east half of the building, separated from Room 1 by the original interior wall (Plate 54). The floor is mostly covered with carpet, although the east corner is finished with linoleum and there is a large rectangular area in the centre of the room, which is framed with metal and covered with floor tiles. The ceiling has been finished with wallpaper and paint and is supported by large beams orientated north-east/south-west, which have also been painted. The ceiling is much lower at the south-east end of the room than at the north-west end due to the construction of a false ceiling, obscuring the beams at that end of the room. The beam at the north-west end of the room has also been fitted with false crenelated ornamentation constructed from timber (Plate 55). All elevations are finished with wallpaper and paint and have a painted wood skirting board. Plasterboard partition walls have been constructed at the south-east end of the room to create further rooms. The north-east elevation has a chimney breast at the north-west end (Plate 55). There are upright light fixtures against the wall at regular intervals, and there is a timber shelf attached to the wall south-east of centre. To the south-east of this is a bar area, with a timber constructed bar, and timber shelves and mirrors attached to the walls. At the south-east end of the bar the elevation returns to the south-west for c3m, before returning again to the south-east. At the south-east end of the elevation is a timber-framed doorway with a modern plywood door, leading to Room 2a. The south-east elevation comprises of a plasterboard partition wall, finished with wallpaper and paint. There a timber-framed doorway with modern plywood door at the north-east end, within the bar area, leading to Room 2a. There is a timber-framed doorway with modern plywood door in the centre of the elevation. To the south-west of this is another similar door. Both of these doors give access to Room 2b. Immediately to the south-west of this second door is a return to the north-west for c3m, followed by a return to the south-west. At the south-west end of the elevation is a timber-framed doorway with a set of timber double doors, each with a single-light window. The south-west elevation has plasterboard at the south-east end, mounted in front of the original interior wall. This extends north-west as far as a plasterboard partition wall, just south-east of centre, which has been constructed around the area of the central stairs, forming a c1.5m square which extends into the room, with a timber-framed door leading to the central stairs on the north-west side. The elevation from this point north-west comprises of

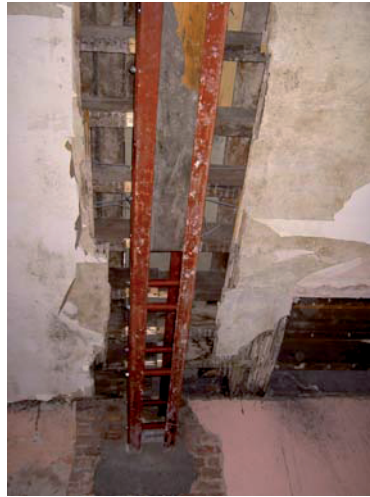
Plate 60: Detail of beam repair in Second floor Room 1

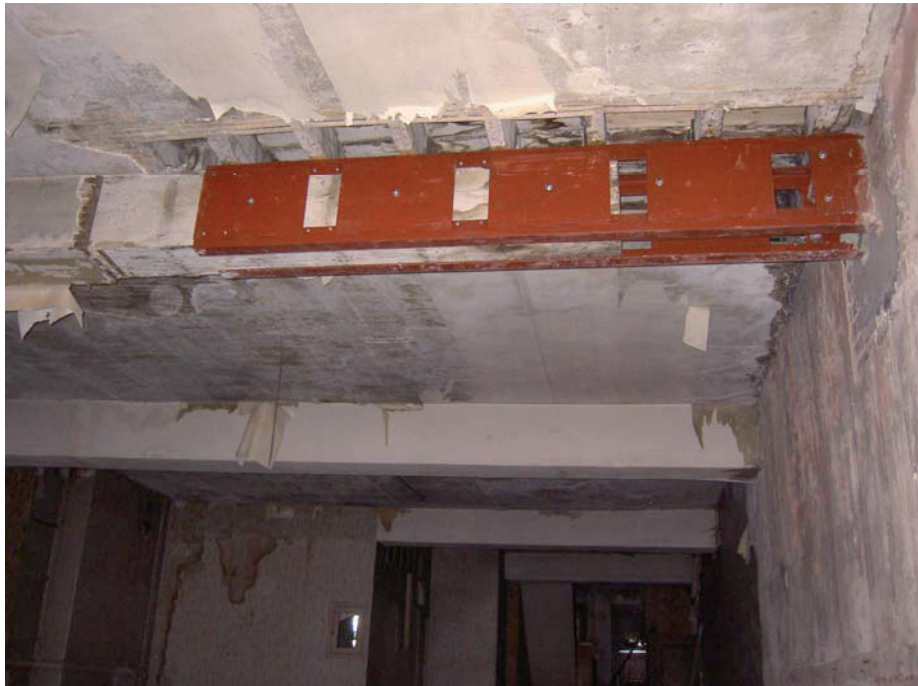
Plate 64: Detail of beam repair, Second floor Room 2

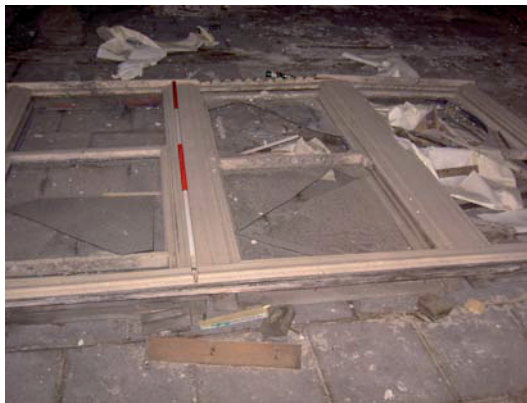
Plate 67: (left) Second floor Room 2, removed window casement

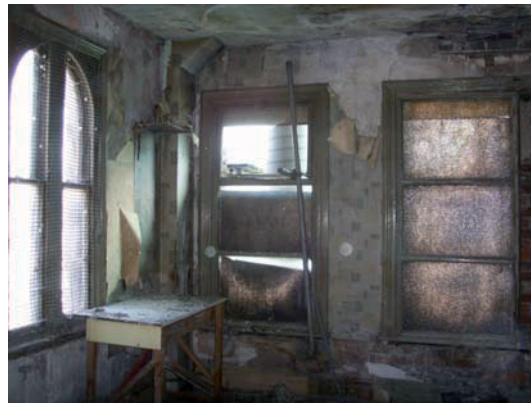
Plate 68: (right) South-east elevation of Room 2b

to the south-east of this is a window with a rectangular moulded surround and four-light sliding sash casement with a round-headed top. The south-east elevation has two more windows with moulded surrounds and fixed three-light casements (Plate 68). The south-west and north-west elevations could not easily be examined, although the south-west was evidently plain and the north-west had a single doorway to Room 2a.

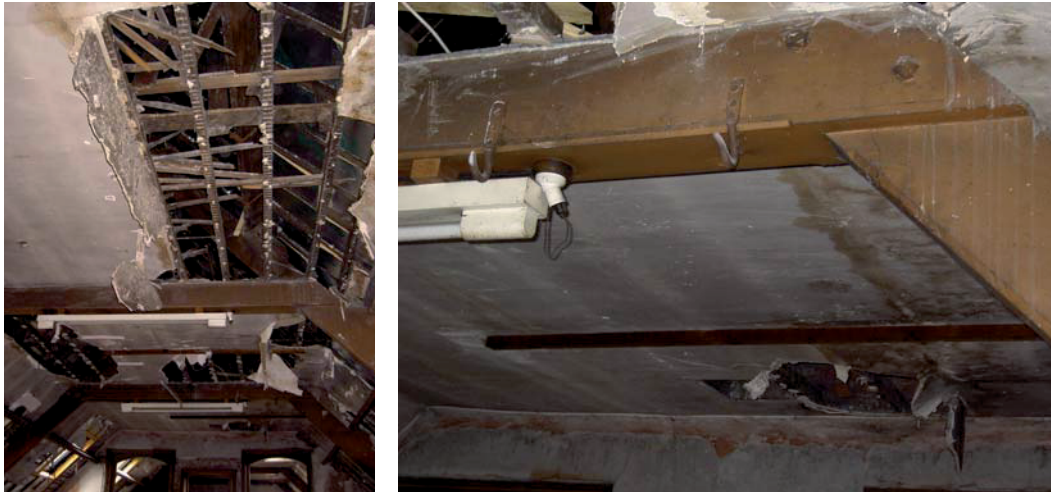
Plate 72: (left) View of ceiling structure in attic Room 1a

Plate 73: (right) Attic Room 1a, metal (brass?) hooks attached to truss

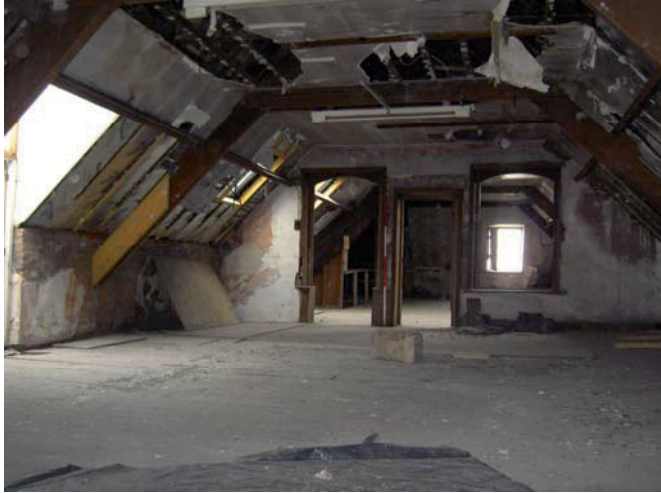
4.3.44 **Attic floor, Room 1a:** the north-east and south-west elevations have painted timber skirting boards along their entire lengths. The south-east elevation has a skirting board on its south half only (Plate 74). The north-east elevation has a timber framed door in the centre, with plywood double doors, each with a single-light window (Plate 75). There is space for an overlight, but this does not seem to have been included. The door is situated within an aperture in the main interior wall and is located at the halfway point of a short corridor formed by a small pitched roof adjoining both the north-east and south-west roofs between Rooms 1a and 2a, with a modern 10-light timber-framed skylight. Immediately to the north-west of this door is the north-east end of the north-west truss of this room. To the south-east of the door is the north-east end of the south-east truss of this room, which has a modern softwood repair attached with bolts. At the south-east end of the elevation is a modern two-light hinged opening skylight. The south-east elevation has a timber-framed doorway in the centre (Plate 76). This doorway has a flat arch and an ogee moulded surround. To the south-west is a window with a timber casement with flat arch, and an ogee moulded surround with a timber sill, the panes of which are no longer extant (Plate 77). To the north-east of the door is a similar window, although the sill and the wall below have been removed to form a door, and the bare walls clad with timber planks. Above the door, in the ceiling, is a small timber-lined aperture. The south-west elevation has a chimney breast south-east of centre with a blocked fireplace, although the hearth stone in front is still visible. To the immediate north-west of this is the south-west end of the south-east truss. In the centre the wall is slightly recessed, and it is noteworthy that this recess is directly opposite the adjoining corridor to Room 2a, although no such corridor appears to be in evidence here. To the north-west of this recess is the south-west end of the north-west truss of this room. Immediately to the north-west of this is another chimney breast, this with an iron fireplace still extant, with a hearth stone in front (Plate 78). The north-west elevation has a row of three timber-framed three-light windows, one in the centre and another to either side (Plate 79). At the north-east and south-west ends the ceiling slopes down to the north-west elevation.

Plate 74: (left) Attic Room 1a, south-east elevation

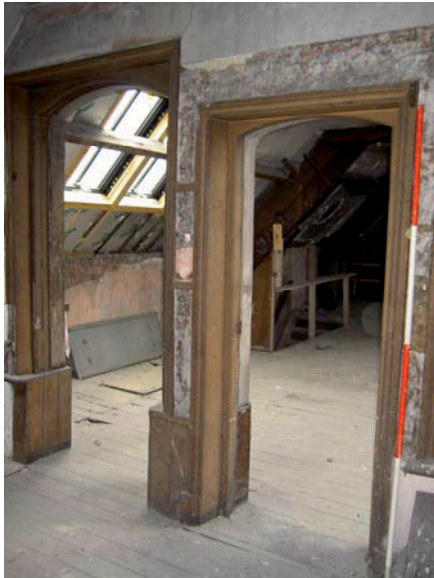
Plate 76: (left) Detail of door and converted window in south-east elevation of attic Room 1a

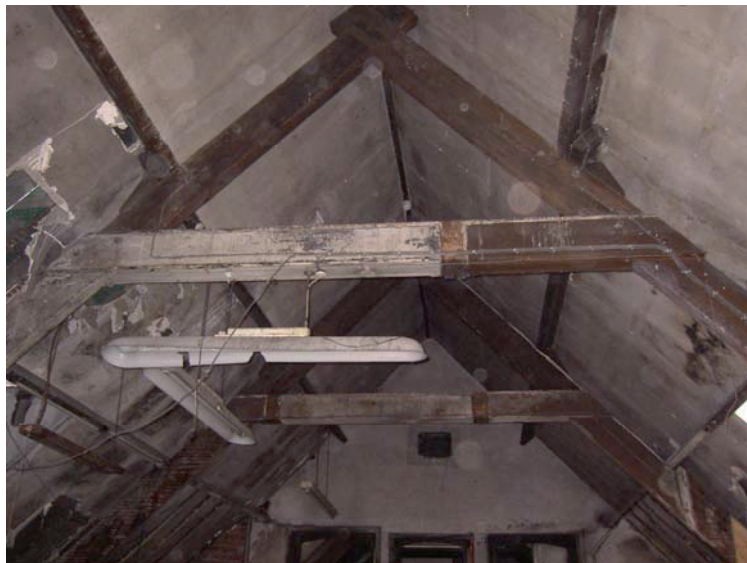
4.3.46 **Attic floor, Room 2a:** this room comprises of the north-west half of the north-east attic space. The ceiling here has not been lowered by the insertion of a plasterboard ceiling between the collars, but rather, plasterboard has been attached to the rafters (Plate 84). This has been finished with plaster and paint. The floor is of bare floorboards as throughout the attic, but a long timber beam orientated south-east/north-west in the floor immediately north-west of the partition wall suggests that the south corner of this room may have been partitioned off at some point. Alternatively this beam may be all that remains of a central staircase on the north-east side of the main interior wall that. The north-east elevation has a chimney breast with blocked fireplace north-west of centre, in front of which is a concrete plinth (Plate 85). There is a small round aperture in the upper south-east part of the front of the chimney breast. These two features suggest that after blocking, the chimney breast may have been converted to accommodate a boiler. To the north-west of this chimney breast the wall has been adorned with graffiti reading "...SK ...EORGE". Immediately to the south-east of the chimney breast is the north-east end of the north-west truss of this room. To the south-east of the truss is a sloped alcove above the wall. This south-west/north-east upward slope is covered with boards and the wall below appears to be a blocked aperture. Above the sloping boards is a vertical painted timber wall, and covering the entire alcove from this rear wall to the sloping roof is a pitched timber-framed eight-light skylight similar to that above the connecting corridor between Rooms 1a and 2a. The timber of this skylight appears to be very recent and is covered with clear plastic sheeting. Above this, however, the structure is covered by the slates of the roof. These features, and the fact that this alcove is also directly opposite the connecting corridor, implies that Room 2a may have had a similar connecting corridor to an attic room of the Duke of Edinburgh Hotel to the north-east (Plate 85). To the south-east of this is the north-east end of the south-east truss of this room. The south-east elevation comprises a brick partition wall dividing Rooms 2a and 2b. In the centre is a timber-framed doorway, with an ogee moulded surround and flat arch (Plate 86). The door is of timber with two lower panels and two one-light windows above, now blocked with boards. The door also has a timber handle, orientated at approximately 45° from vertical. To either side of this door is a four-light sash window within a timber casement with ogee-moulded surround, with a timber sill. The north-east window has only one pane remaining, whilst the south-west has two, with a third blocked with hardboard. High above the door, in the centre, is a square aperture, covered with modern wire mesh, which does not extend through the wall. North-east of the north-east window the wall projects

Plate 84: (above) Attic Room 2a, roof structure detail, looking south-east

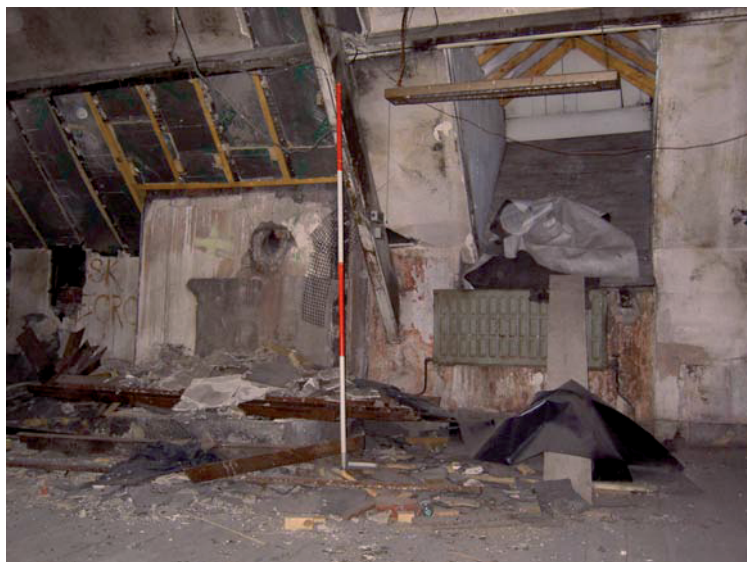
Plate 85: (below) Attic Room 2a, north-west half of the north-east elevation. What may have once been a connecting corridor to the Duke of Edinburgh Hotel can be seen to the right of the chimney breast

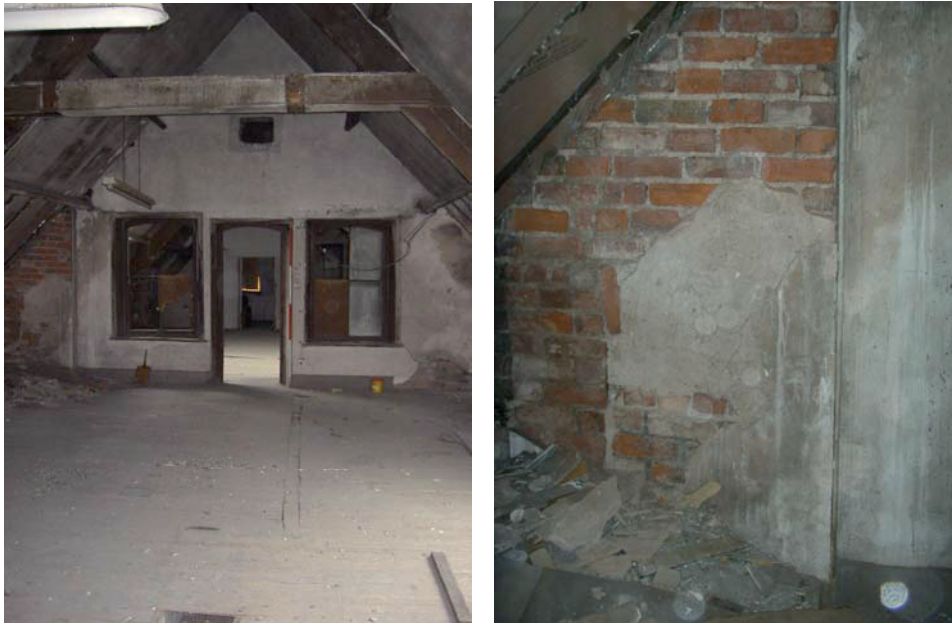
slightly, making it thicker than elsewhere, and a small window close to the ground, with a flattened brick arch and blocked with brick is partially visible beneath the plaster (Plate 87). The south-west elevation has a chimney breast in the south-east corner, with a blocked fireplace and a hearth stone still visible. To the north-west of this is the south-west end of the south-east truss, which has been repaired with a modern softwood support, attached with bolts (Plate 88). In the centre of the elevation is the adjoining door to Room 1a and to the north-west of this is the south-west end of the north-west truss. The north-west elevation has a similar layout to the north-west elevation of Room 1a, with a timber-framed three-light window in the centre and another such window to either side (Plate 89). On this elevation, however, the centre window is taller than the others, the plaster below the windows has been removed (or was perhaps never present), and the elevation itself is entirely vertical, formed by the gable end of the roof.

Plate 86: (left) Attic Room 2a, south-east elevation

Plate 87: (right) Attic Room 2a, blocked window on the north-east side of the south-east elevation

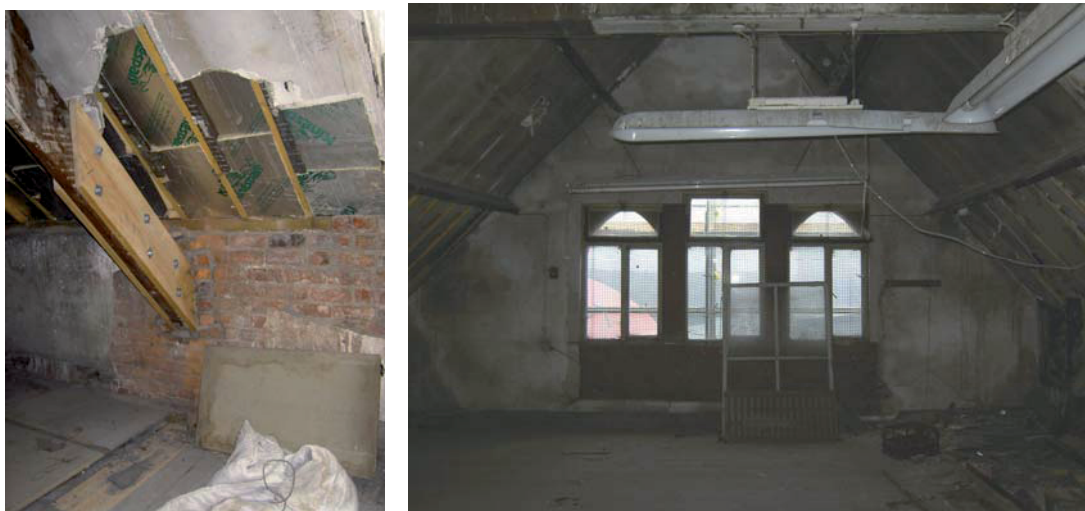
Plate 88: (left) Attic Room 2a, detail of repair to south-west end of south-east truss

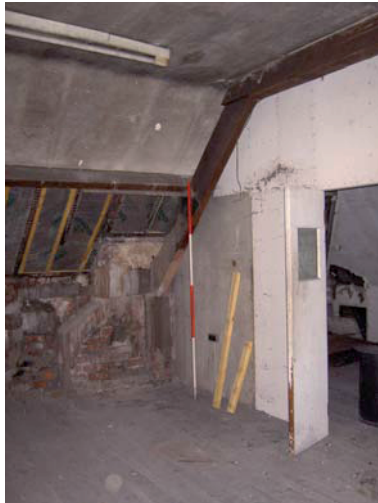
extends into the chimney breast itself (Plate 90). Immediately to the south-east of this, obscuring the south-east part of the chimney breast, the partition wall of Room 2c returns to the south-west. In the centre of the room this wall then returns to the south-east to continue to the south-east elevation. The partition wall is of hardboard and is whitewashed but is otherwise plain on this elevation. The south-east elevation is taken up on the north-east half by the partition wall (Plate 91). There is a timber double-door inserted into this wall just north-east of centre of the entire elevation. Each door has a single-light window. Immediately to the south-east of this door the elevation returns to the south-east. The south-west half of the elevation is taken up by the interior of the rear elevation of the building. There is a timber-framed four-light dormer window south-west of centre, which has been blocked with boards. To the north-east and south-west of this window the ceiling slopes downwards to meet the south-east elevation. The south-west elevation has a short timber double-door to Room 1b at its south-east end. To the immediate north-west of this is the south-west end of the south-east truss of this room. North-west of centre is the south-west end of the north-west truss. At the north-west end of the elevation is another modern timber casement with two two-light skylights. The north-west elevation has the timber door through to Room 2a in the centre, with the sash windows on either side (Plate 92). Neither the door nor either window has a surround on this side, and the sills of the windows are sloped.

Plate 90: (left) Attic Room 2b, chimney breast in east corner

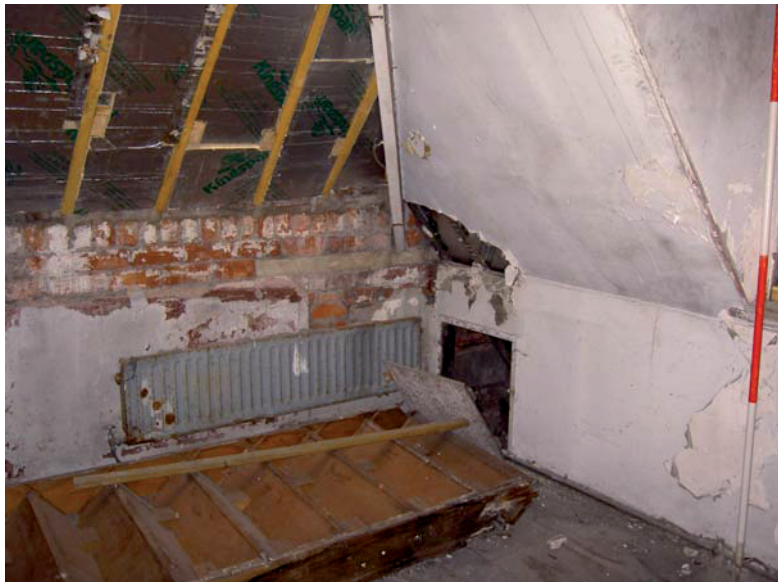
Plate 93: (below) Attic Room 2c, east corner, showing hatch to crawlspace
