ULVERSTON PARISH CHURCH, ULVERSTON, CUMBRIA

Archaeological Watching Brief

Client: Ulverston Parish Church
Renewal Committee
NGR 328876 478731

© Greenlane Archaeology Ltd
October 2008

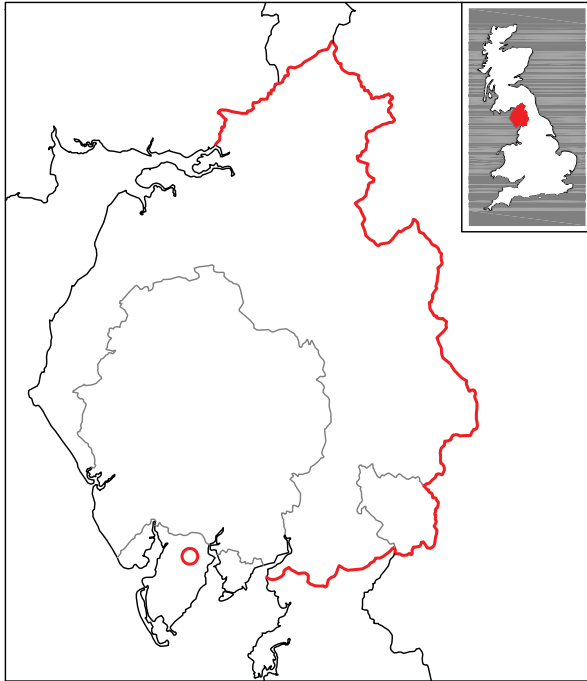
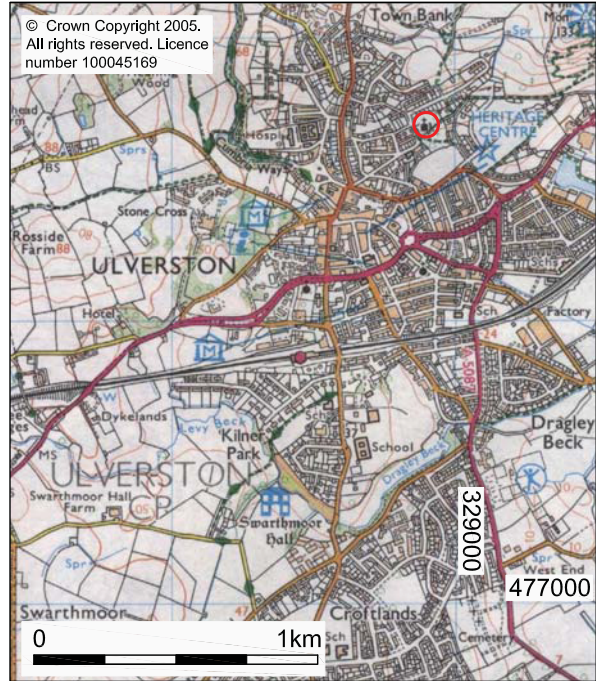
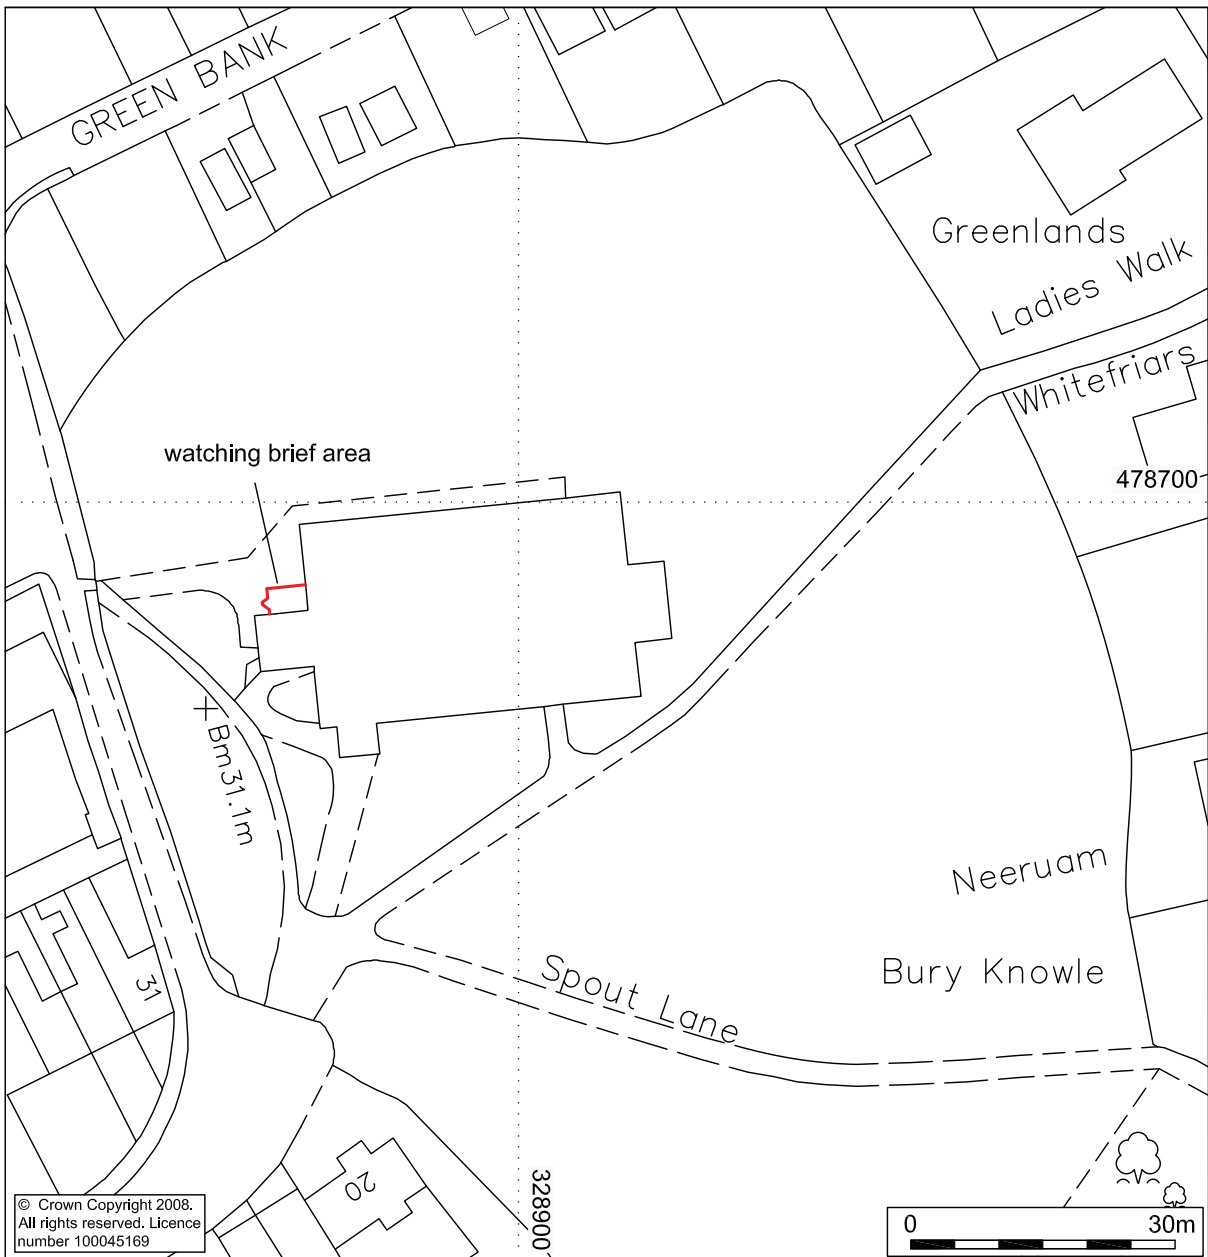
Figure 1: Site location

1.2.1 Ulverston Parish Church is located in a quiet residential area on the north-east side of Ulverston, a short distance from the foot of the hill of Hoad and approximately 31m above sea level (Fig 1).

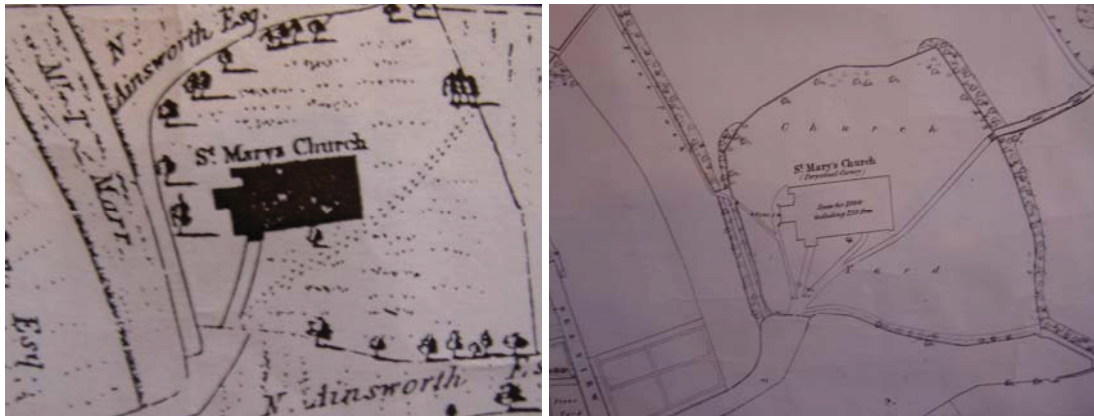
Plate 1: (left) Wood's map of 1832

3.4.2 **Wood's map of 1832:** this map shows there is little development around the church grounds and the church is clearly slightly smaller than it is at present (Plate 1). Both aisles have evidently been constructed by this point, however, and there appears to be a small extension at the west end of the north aisle.

3.4.3 **Ordnance Survey, 1852:** this map shows that little has changed since 1832, although it does provide considerably more detail regarding the arrangement of the paths around the church, and states that it has seats for 1,400 people (Plate 2).

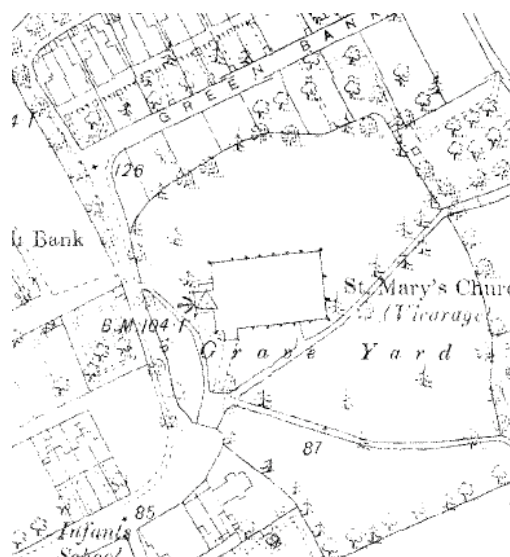
Plate 3: Ordnance Survey map of 1891

3.4.4 **Ordnance Survey, 1891:** this map shows development of the land to the west and north of the churchyard since 1852 (Plate 3). The church is now wider, due to the enlargement of the north aisle in 1864, and the extension on the north-west corner of the church was also apparently removed at this time. A small outbuilding is also visible on the north side of the tower, having evidently been built since 1852.

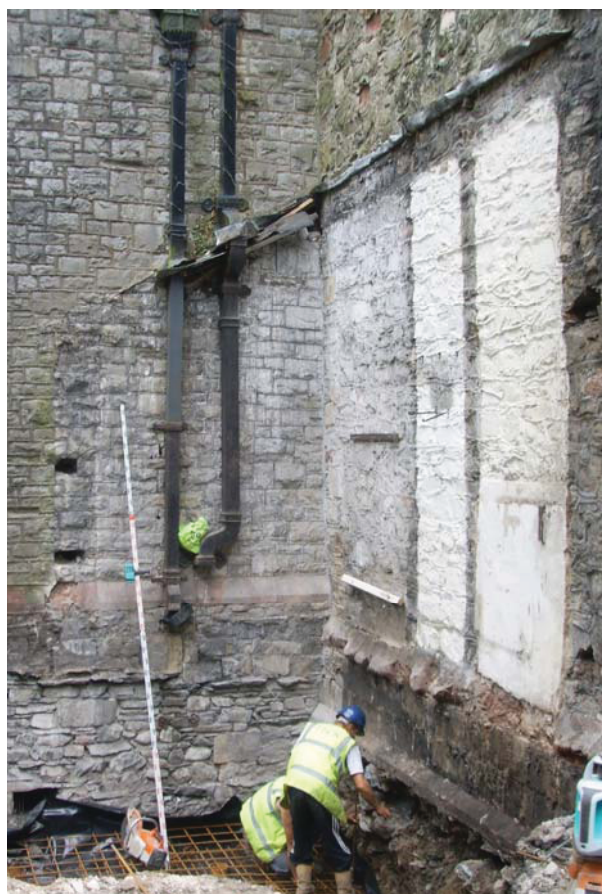
Plate 4: Working shot showing outline of demolished outbuilding

4.2.1 The watching brief covered a small area of excavation at the west end of the building, on the north side of the tower (Fig 2). The outbuilding that was situated here had already been demolished in preparation for the work (Plate 4).

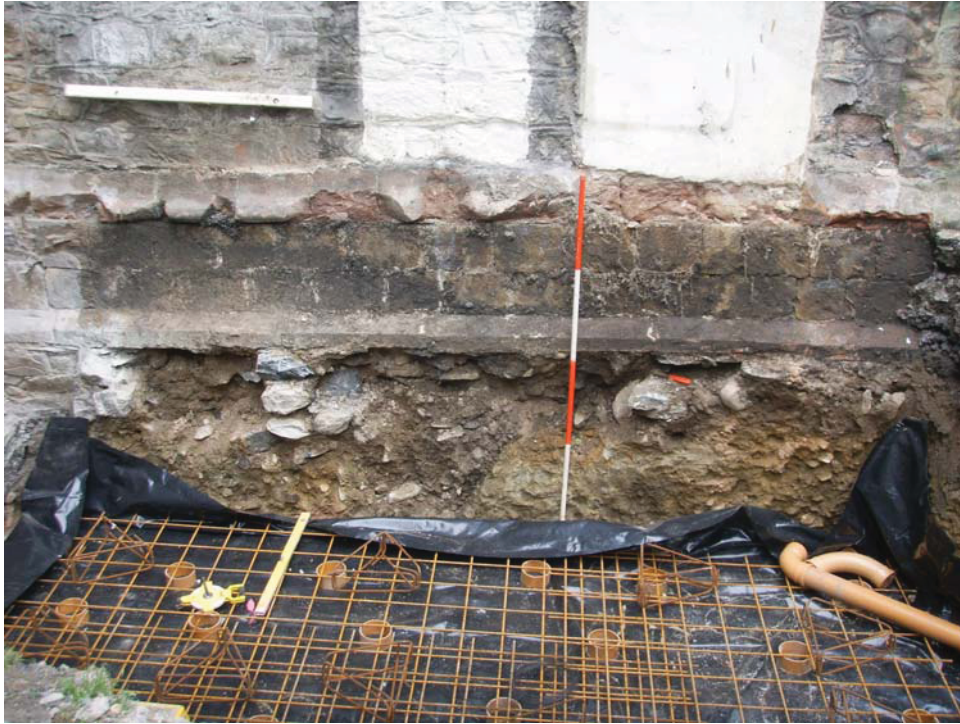
Plate 5: General shot showing the features in Section 1

4.2.3 The north facing section (Fig 3; Plate 5), revealed the foundation of the tower which had a depth of 1.1m. The tower footings of dressed stone (Plate 3), reached a depth of 0.8m below which was a 0.5m deep layer of sub-angular boulders (**104**) which had been bedded into **102**. A small area of these appeared more consolidated than the rest and appeared to form a truncated wall (Fig 3), but this was perhaps due stones elsewhere having fallen from the section or been removed during the excavation of the foundations. Below this foundation was a 'V' shaped cut (**105**) 1.06m wide at the top, the base of which extended below the level of the excavation. The fill of this feature (**106**) was a loose dark brown sandy clay with inclusions of rounded gravels (1%) and occasional human bone. The north section revealed evidence of a stone lined channel running parallel along the west wall of the north aisle (**107**). The channel was 0.45m in width and 0.5m in depth. The lining of the channel is 0.4m high and 0.36m wide, constructed of loosely mortared stone. On the west elevation of the north aisle the channel went to a depth of 1m and was also capped with slate (Plate 6).

5.1.1 The watching brief revealed that the foundation of the tower appear remarkably shallow considering the weight they have to support. The 'V' shaped feature below the footings is interesting and would appear stratigraphically to be quite early: it seems to pre-date the tower, in which case it would be earlier than 1540. However, the limited nature of the investigation make this difficult to confirm and it is perhaps more likely that it is relatively recent feature that probably formed service trench accessing the basement, which housed a boiler, that has gone out of use and been backfilled. In this case it would be likely to be contemporary with the late 19th century outshut that formerly stood on this side of the tower. The human bones found in the topsoil (**101**) and back fill of **106** are probably from disturbed graves, probably left by the construction of the outbuilding in the late 19th century. The channel (**107**), which runs along the west elevation of the north aisle, protects the footings from moisture ingress from the surrounding soil, and was probably constructed the north aisle took its present form in the 1860s.

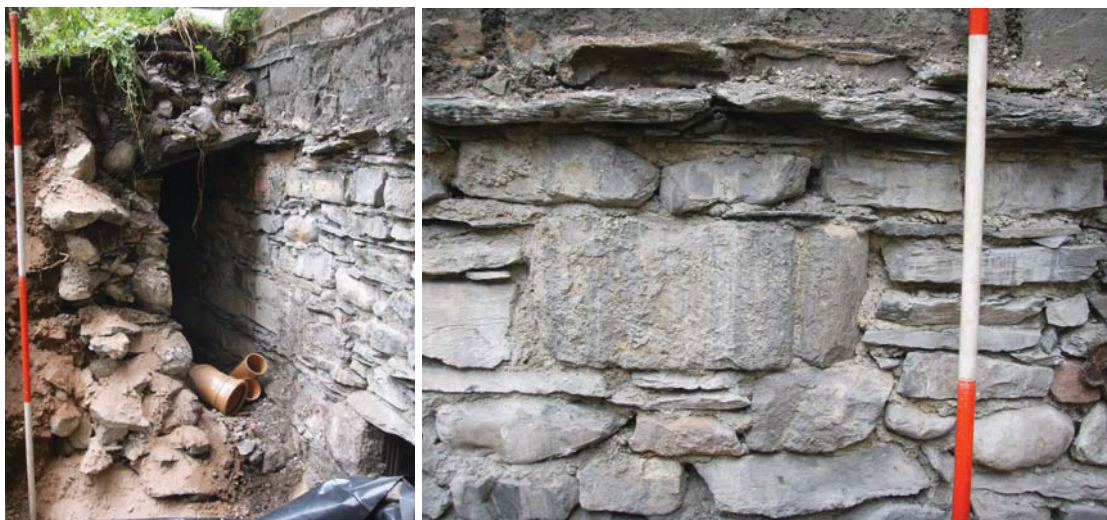
Plate 6: (left) Walled channel (107) against the west elevation of the north aisle**Plate 7: (right) Detail of re-used stone including part of a column in the west elevation of the north aisle**

4.2.4 A number of observations were also made of the extant walls of both the tower and the north aisle. The lower part of the tower is finished with a chamfered plinth of neatly dressed sandstone, above which is a band of neatly dressed sandstone blocks, and above these is a moulded string course. Much of this stone is likely to be re-used, being a mix of yellow and red sandstone, which is not found in the immediate locality. Above this the wall of the tower is a more random mix of local slate and both types of sandstone. There was also evident re-used sandstone in the north aisle, including some neatly worked blocks; one with a chamfered edge (perhaps a sill?) was evident within the area of the walled channel (**107**), and another was evidently a piece of a cylindrical column (Plate 7).

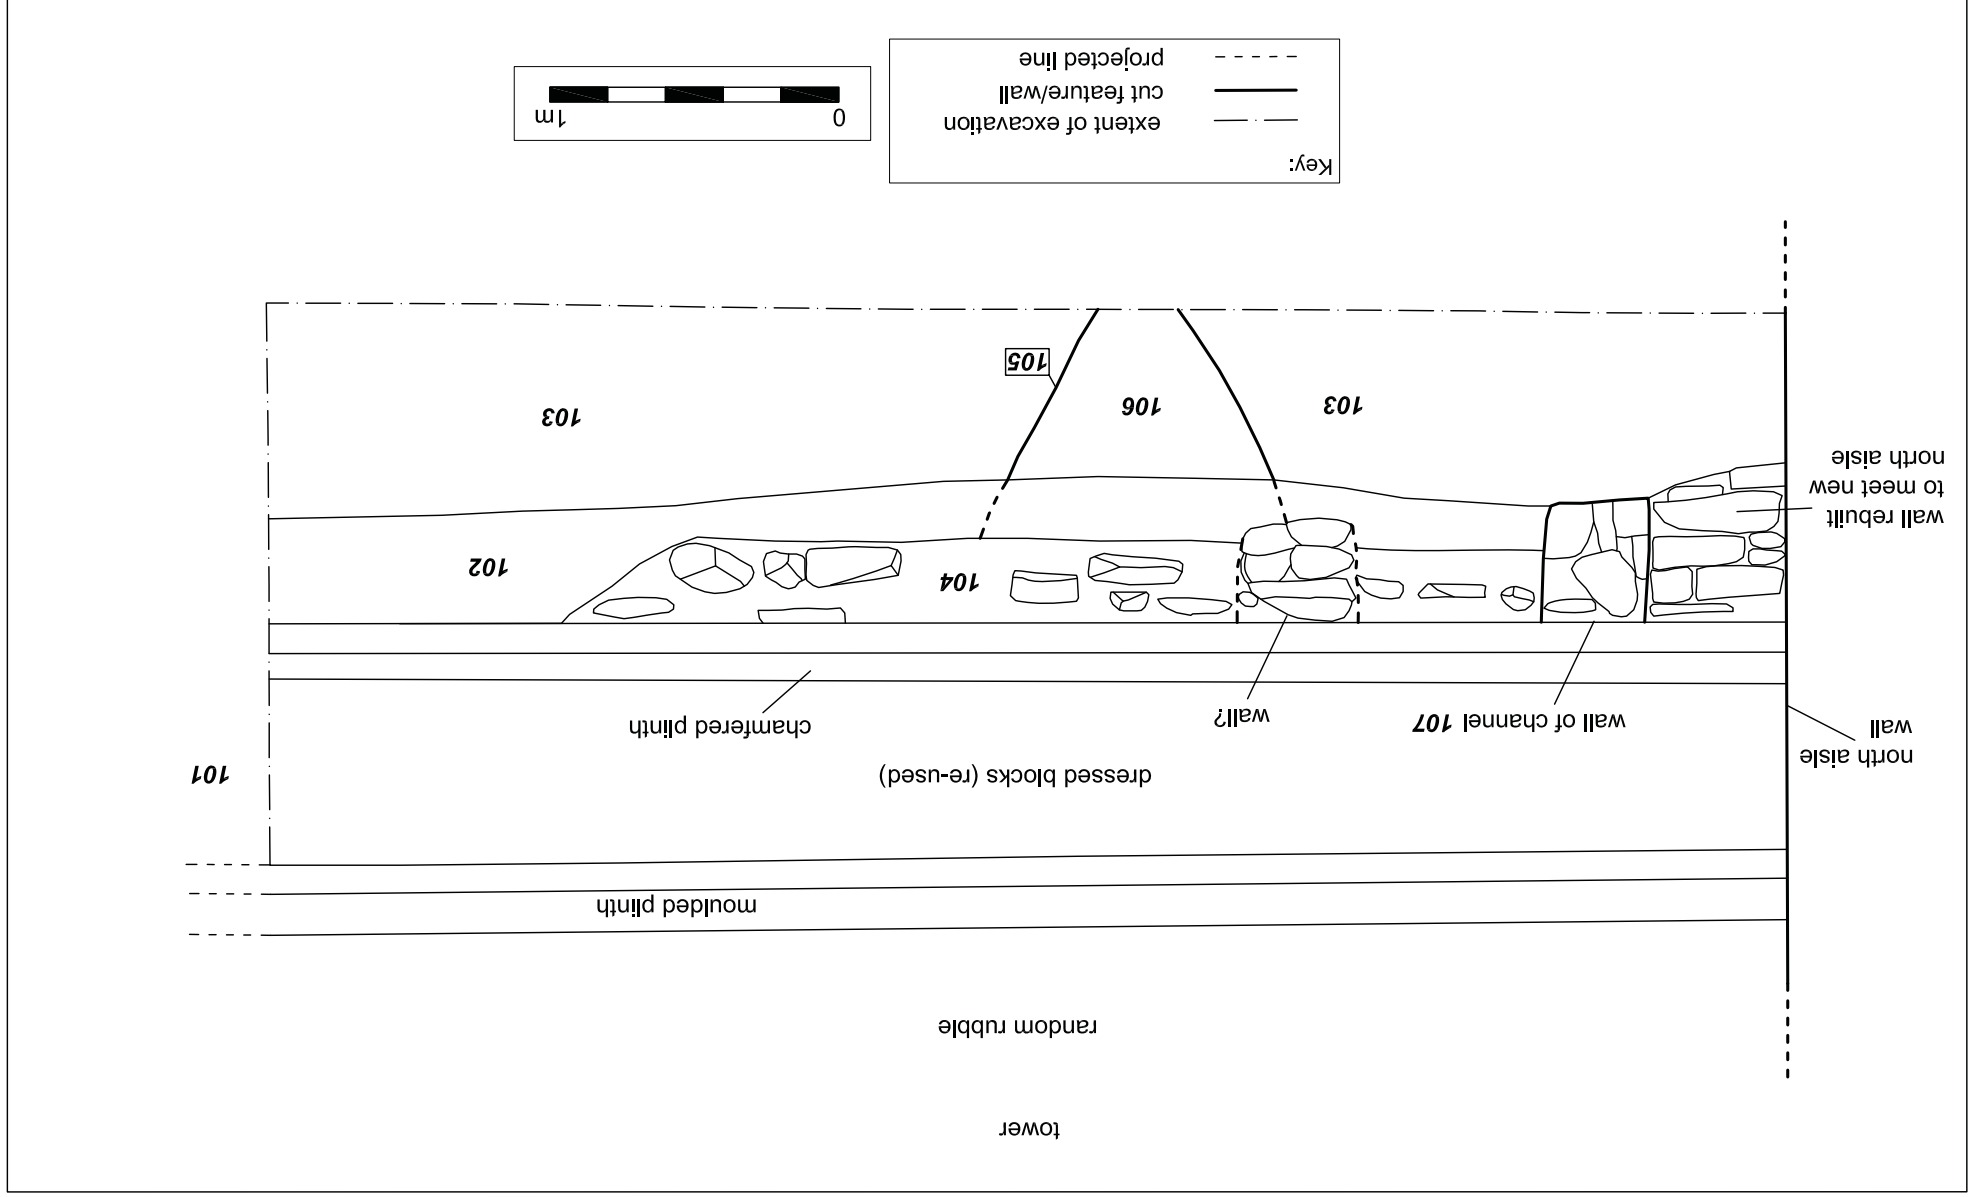
Figure 3: North-facing section

4.2.2 The area of excavation was 5.3m by 3.5m with a maximum depth of 2.1m. The upper deposit, **101**, was a dark greyish brown loose sandy clay topsoil with well sorted rounded gravels (5%). Inclusions consisted of brick (1%) and a moderate amount of human bone (2%). This layer of soil had a maximum depth of 0.8m and was heavily disturbed by service pipes on the west side. The layer below, **102**, was a mid-brown soft silty clay with inclusions of small rounded pebbles (1%). Below this layer was the natural glacial till, **103**; a firm clay varying in colour from orange to pale greyish yellow with 20% sub-angular cobbles.
