# BARN AT MANOR HOUSE, HOWGILL LANE, RIMINGTON, LANCASHIRE

## Archaeological Watching Brief

Planning Application Reference:  
3/2018/0036

November 2021

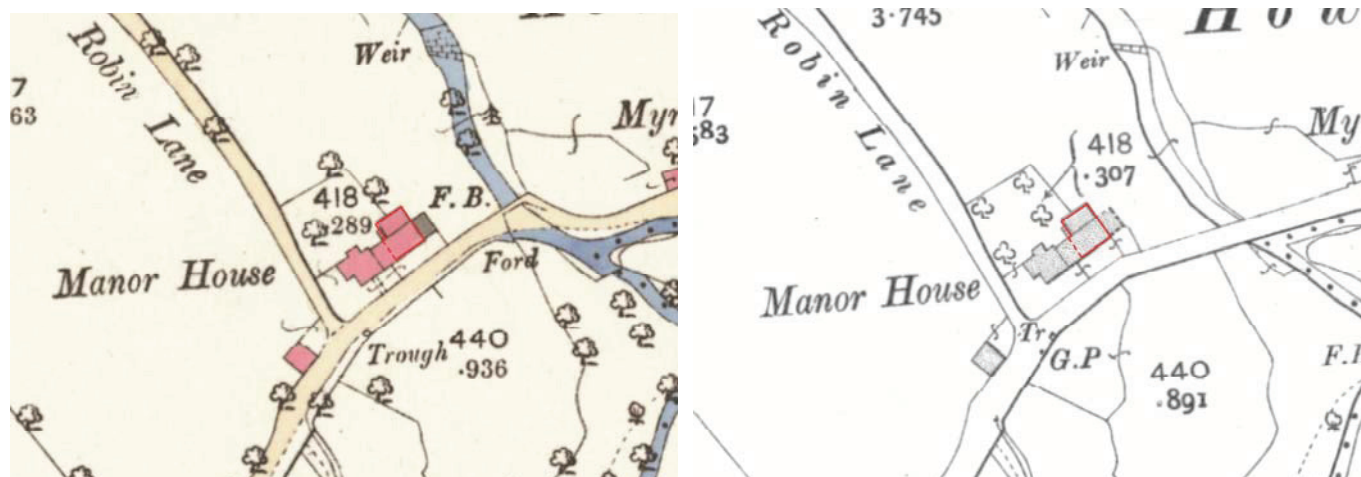
Plate 3 (left): Extract from the Ordnance Survey map of 1894

Plate 4 (right): Extract from the Ordnance Survey map of 1909

3.1.4 **Ordnance Survey, 1894:** this is the first 1:2,500 scale map of the area produced by the Ordnance Survey (surveyed in 1893) and is therefore much more detailed than the previous map, which was produced at a scale of 1:10,560 (Plate 3; cf. Plate 2). The footprint of the building, which is labelled 'Manor House' (coloured in pink) is the same as it appears today. The site occupies the north-east end of the long rectangular block and the shorter rectangular block to the north-west side at the north-east end of that, and a dividing line is shown between the two blocks. Steps are shown to the south-west side of the shorter block to the rear and a block coloured grey is shown to the north-east end of the buildings at the front.

3.1.5 **Ordnance Survey, 1909:** this map shows much the same information as the previous edition of the Ordnance Survey mapping (Plate 4; cf. Plate 3).

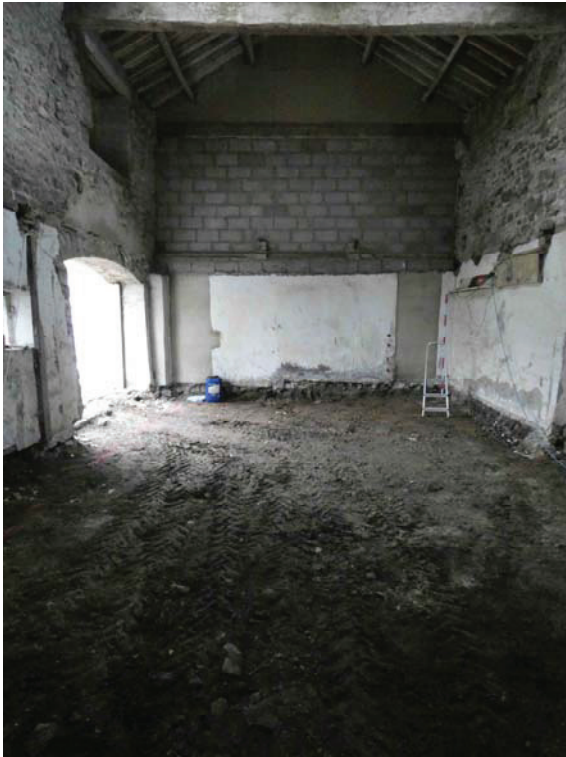
**Plate 5 (left): General view of the south-west end of G1/G2 following the removal of the concrete floor and dividing wall**

4.1.2 Trenches c0.7m to 0.8m wide were excavated around the inside edge of room G1/G2 along the south-west, north-east and south-east sides. A small section of the area of the footings could not be monitored in the south corner of the room due to a requirement for access. The internal space had also been reduced slightly and made level with the removal of the concrete floor prior to the excavation of the trenches. However, a further reduction in the depth of the internal area was monitored when the trenches around the outside edge of the room were completed as far as practicable.

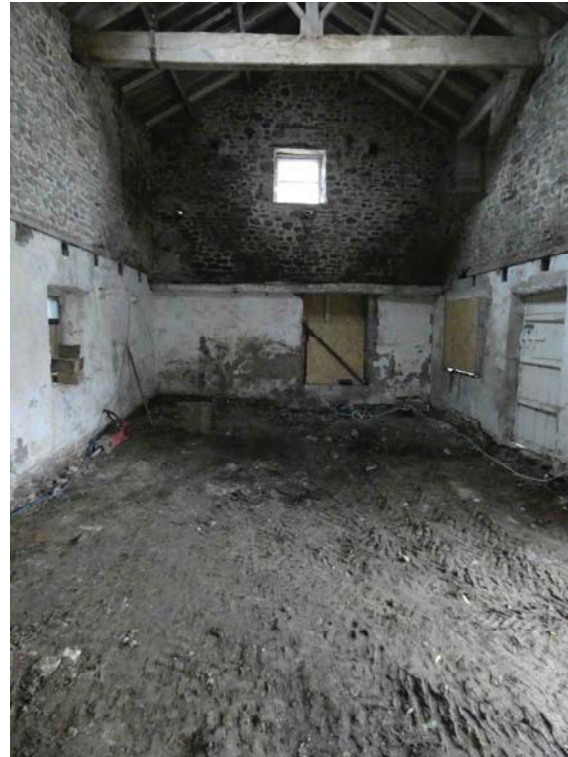
**Plate 6 (right): General view of the north-east end of G1/G2 following the removal of the concrete floor and dividing wall**

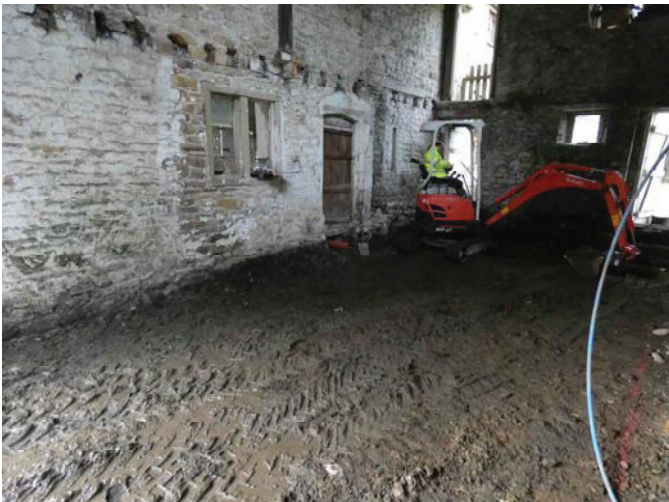
**Plate 7 (left): General view of the south-east side of G3/G4 following the removal of the floors and dividing wall**

4.1.3 In room G3/G4, the trenches were excavated along the south-west and north-west sides. It was not practical to monitor the area in front of the large arched opening to the north-east side of the room because of the requirement for access and because of the risk of water entering the trench once opened at this point. The tracks of the dumper had already churned this area, which, based on observations in the far end of the trench which could be observed, was probably straight onto the underlying clay natural (see below). Removal of the floors in this room and making the surface level had already overcut the natural across most of the area.

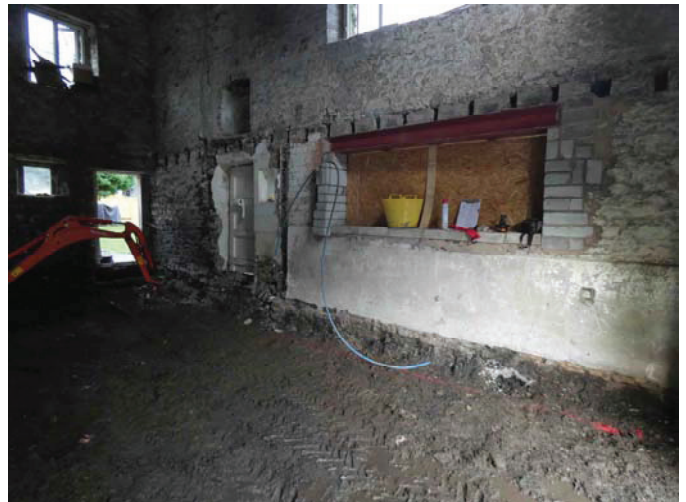
**Plate 8 (right): General view of the north-west side of G3/G4 following the removal of the floors and dividing wall**

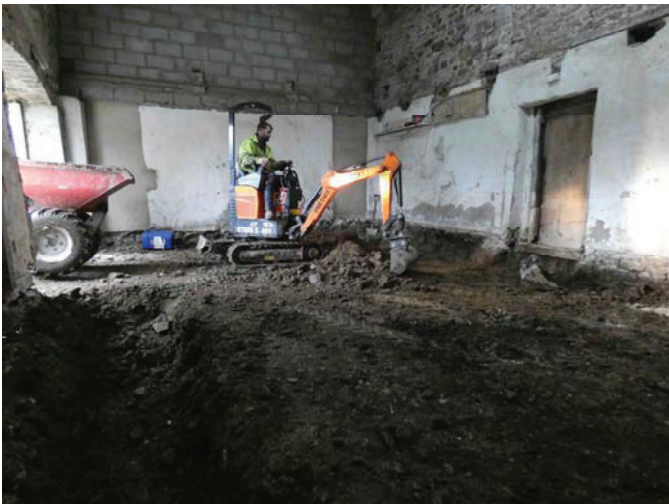
**Plate 9 (left): Working shot in G1/G2**

4.1.4 The conditions under which the excavation was conducted were not ideal from an archaeological standpoint and some compromise was necessary in order that the required construction work could go ahead. Monitoring the groundworks was hampered by a lack of lighting inside the building, especially with regard to colour changes within the underlying deposits (see Plate 9 and Plate 10). Pinches of the deposits revealed during the course of digging the trenches were taken to the nearest open door or window to be examined in the daylight; however, it is possible that subtler variations within them will have been missed. In addition, a toothed bucket was used, which can churn deposits, leaving an uneven finish within the base of each trench and making it more difficult to detect changes within deposits. To counteract this, trench sections were examined frequently, but at times it often became merely an exercise in finds retrieval.

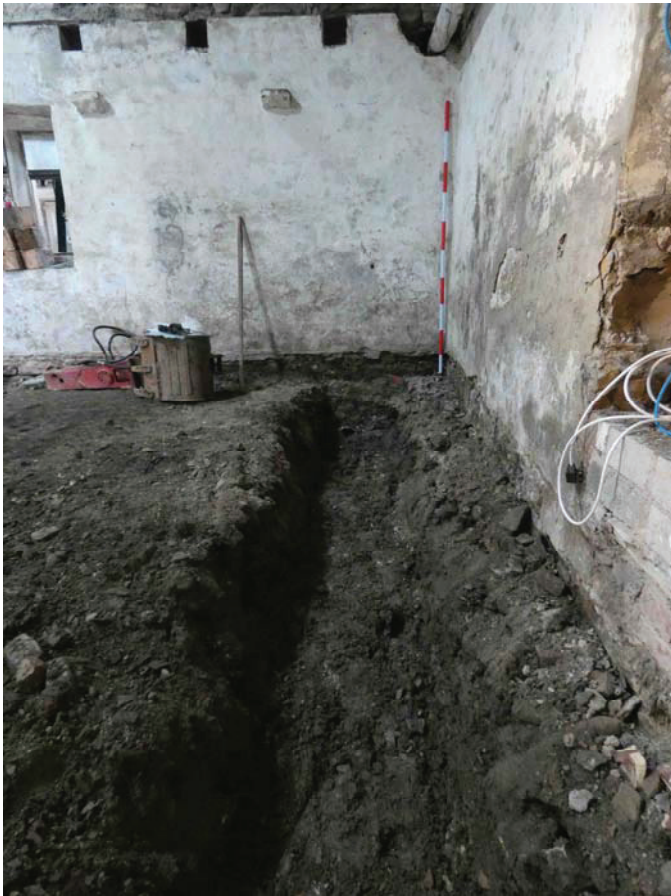
4.2.2 Removal of the concrete had exposed a thin layer of dusty grey sandy material (**100**) in the north-east corner (Plate 11), up to 0.1m thick, which appeared to peter out to the south-east, which contained some whitish grey flecks of crumbly mortar. Below that was a dark, brownish-grey silty clay with frequent sub-rounded cobble-size and larger stones (**102**). This became less silty and lighter brown to the south-west side, appearing to be simply a variation of the same deposit, and was excavated to 0.5m to 0.6m thick and continued beyond the depth of the trench (Plate 12). This deposit, including variations within it, is considered to probably be the underlying 'natural' boulder clay.

Plate 11 (left): Trench along the north-east side of G1/G2

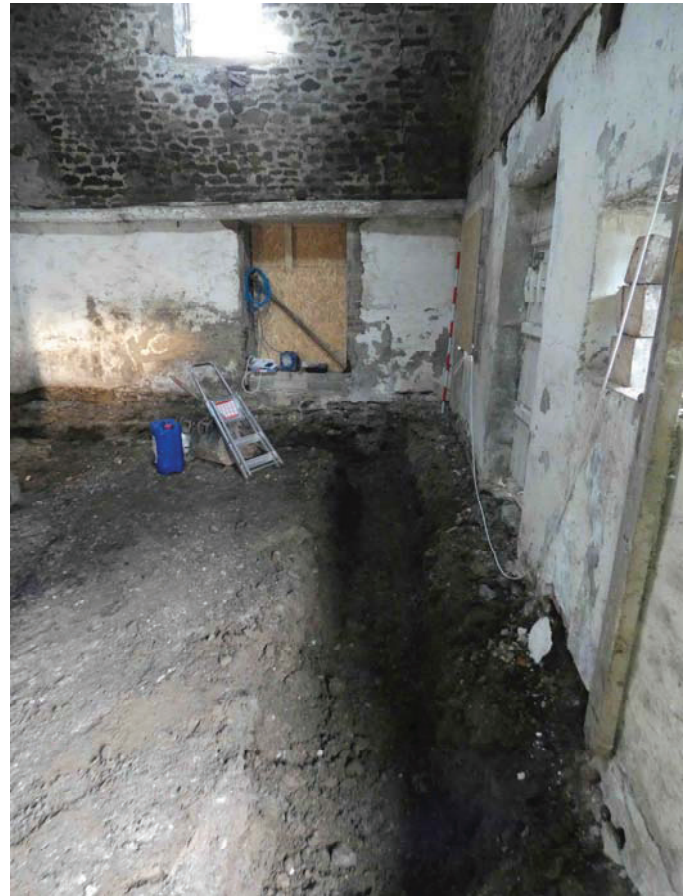
Plate 12 (right): Trench along the south-east side of G1/G2

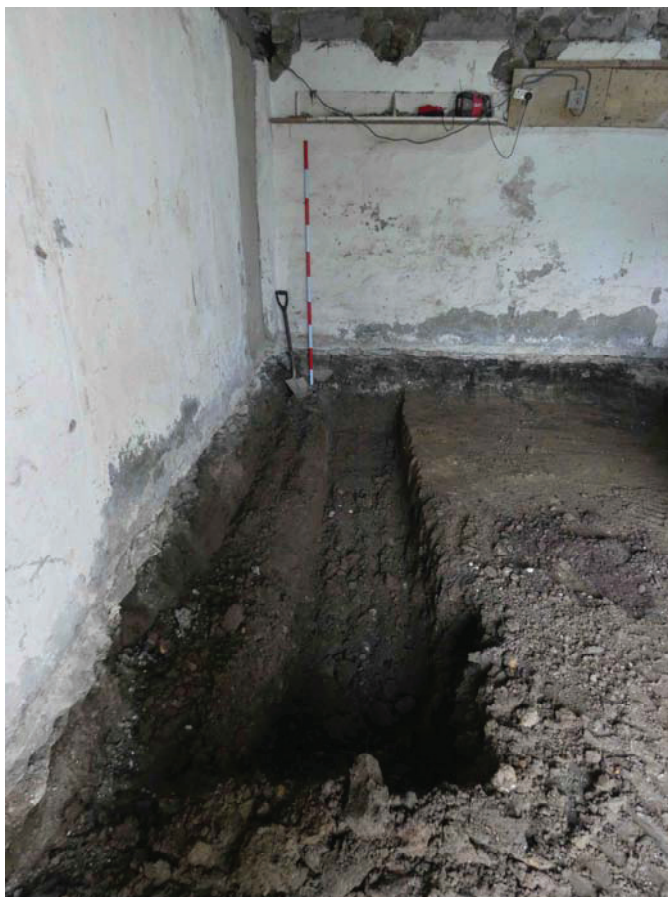
4.2.3 Immediately below the concrete in the west corner of the room, in the trench to the south-west side of the room, was a sandier clay (**103**). It was mid-to-light greyish-brown (Plate 13), with fewer inclusions than noted in the 'natural' to the north-east end of the room. Some cattle-size bone was removed from the upper extent of this deposit; however, these finds are considered likely to be intrusive to this deposit, either from an overlying deposit or from the fill of a cut which was not detected during the course of the groundworks. It is possible that this deposit was simply a variation of **102**.

**Plate 13: Trench along the south-west side of G1/G2**

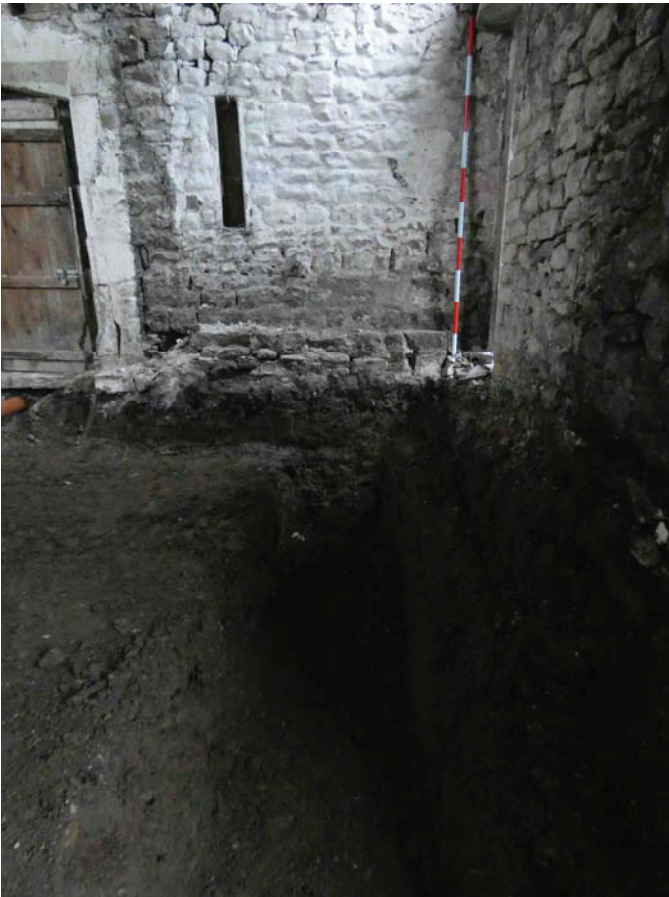
**Plate 14 (left): Trench section below the south-east elevation of G3/G4**

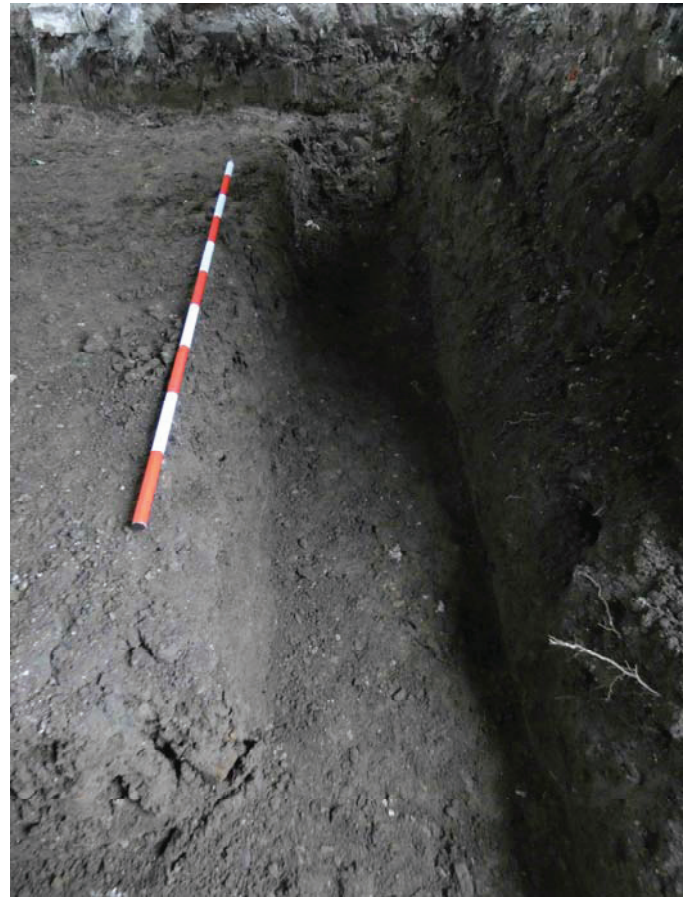
**Plate 15 (right): Trench along the south-west side of G3/G4**

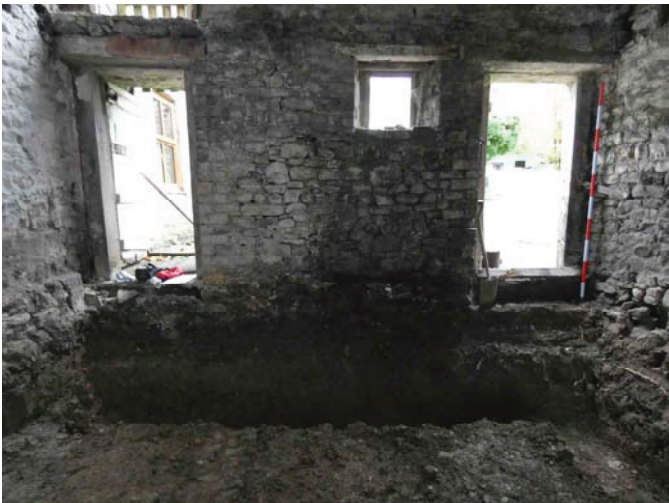
4.2.6 To the south-west end of the room there was a slightly darker, grey silty-clay (**104**) above **103** (see Plate 16). It was up to 0.15m thick, at its nearest point to the south-west wall, and petered out within perhaps 1.5m to 2.0m to the north-east. Some animal bone that was recovered from here probably came from this context. It may have been what was left of the old floor in G4 from the building recording, although the concrete floor of G3 seems to have been laid straight on to the boulder clay at the north-east end of G3/G4. G4 was previously a calf pen and then used as a coal store and storage, so the spread of a darker silty deposit could easily relate to the area's former use for either of these two

**Plate 16 (left): Trench along the south-west side of G3/G4**

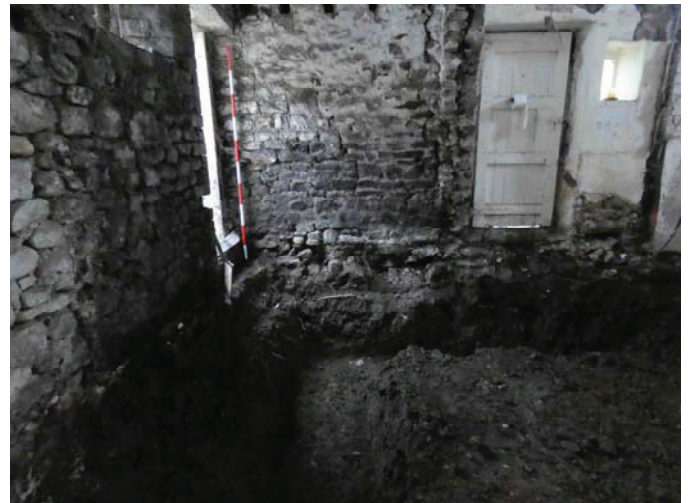
**Plate 17 (right): Trench excavated in the west corner of G3/G4**

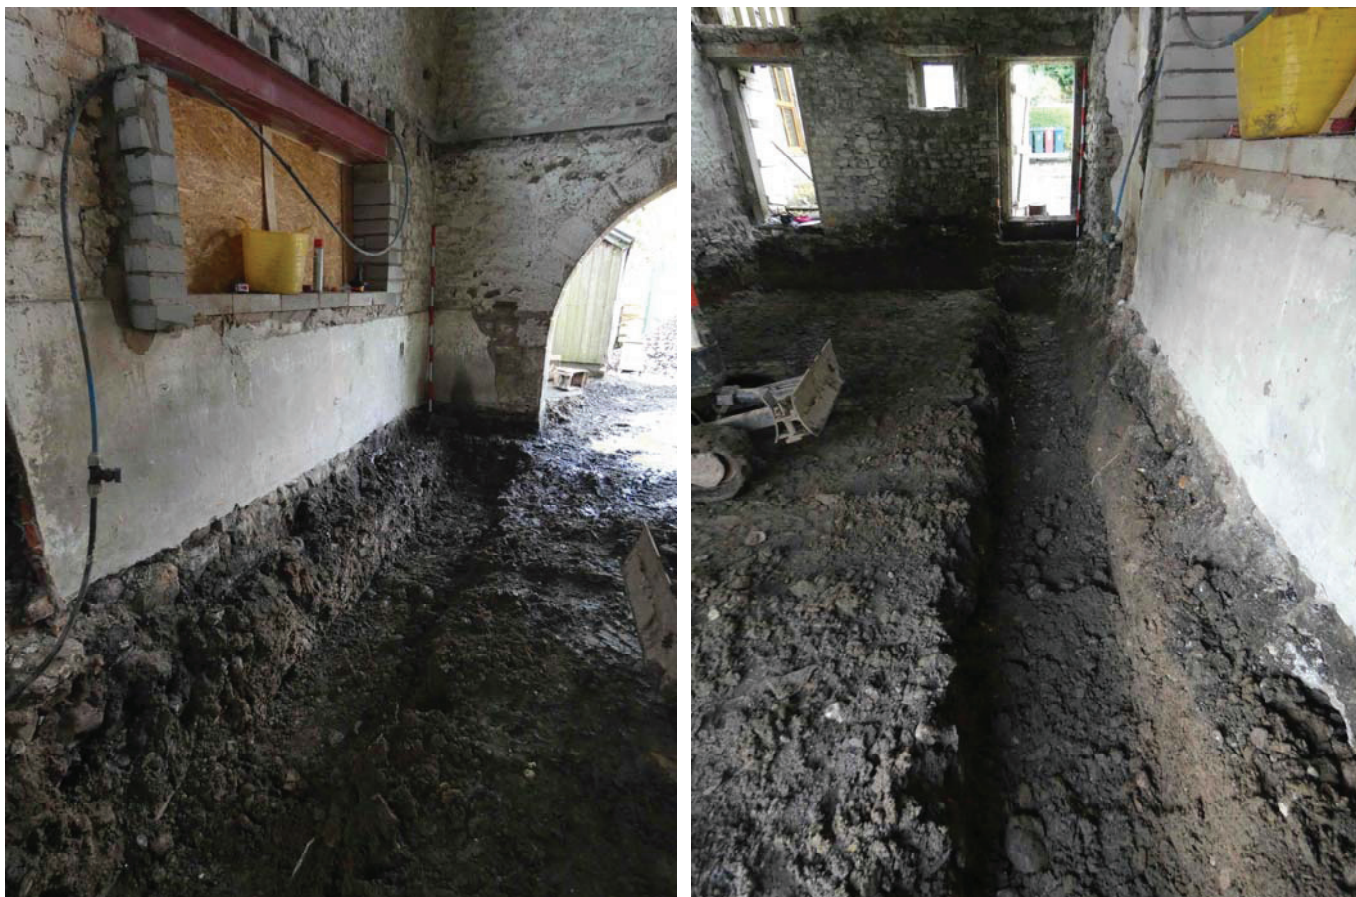
Plate 18 (left): Oblique view of the trench along the north-west side of G3/G4

Plate 19 (right): Trench along the north-west side of G3/G4
