COACH HOUSE AT MANSERGH HOUSE, BORWICK, LANCASHIRE

Heritage Statement

June 2020

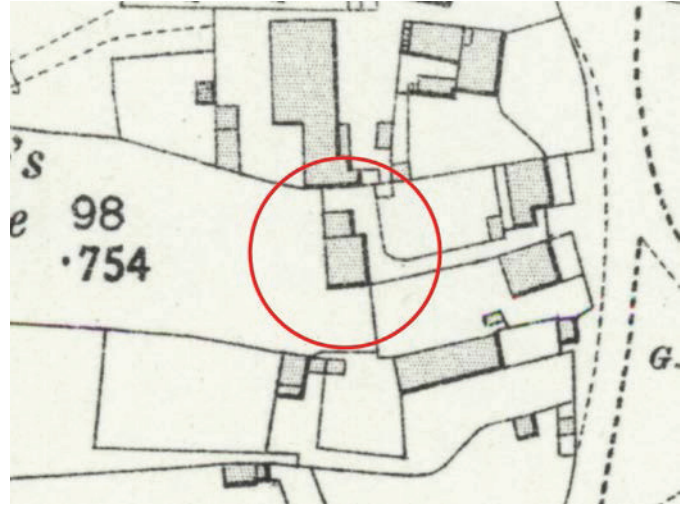
Plate 4 (right): Extract from the Ordnance Survey map of 1913

3.2.4 **Ordnance Survey, 1913:** the building is shown in the same form as on the previous map, but this time a division is marked between the main part and the smaller northern section (Plate 4). This clearly shows that the current arrangement was in place by at least the early 20th century.

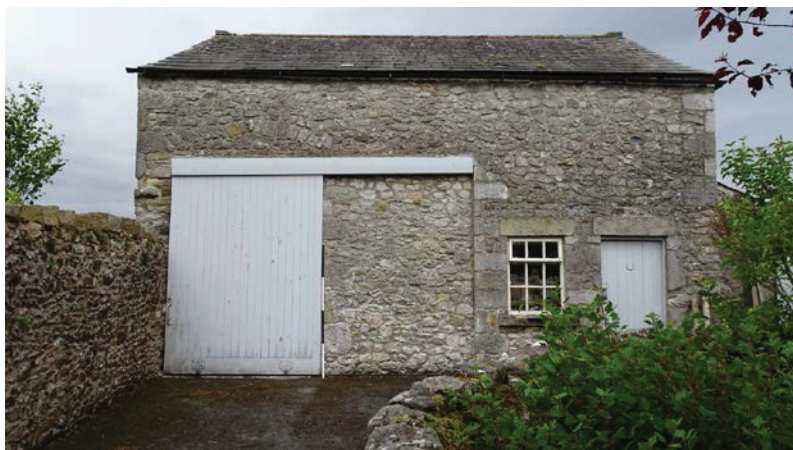
3.4.1 The building comprises a single structure orientated north/south; the north end smaller than the main part (Plate 5 to Plate 8). Both sections are the same height, although the northern end of the main section has an upper floor, and there is a further lower extension at the north end with a monopitch roof. It is largely constructed from rough limestone in random courses with dressed blocks used for details such as quoins and lintels, although brick has been used for an internal dividing wall. Internally the walls are generally finished with limewash to varying degrees of fineness, although the building was used for storage at the time of the site visit meaning the interior was quite cluttered. It was apparent that there was a fireplace against the west internal wall of the main part of the building. The main part of the structure also still houses stall partitions and feed troughs for animals. Stylistically the most readily dateable part of the building is the roof trusses, which are a simple tie beam type of probably late 18th to early 19th century date (Plate 9; Brunskill 2002, 153).

Plate 5 (left): The west external elevation, viewed from the west

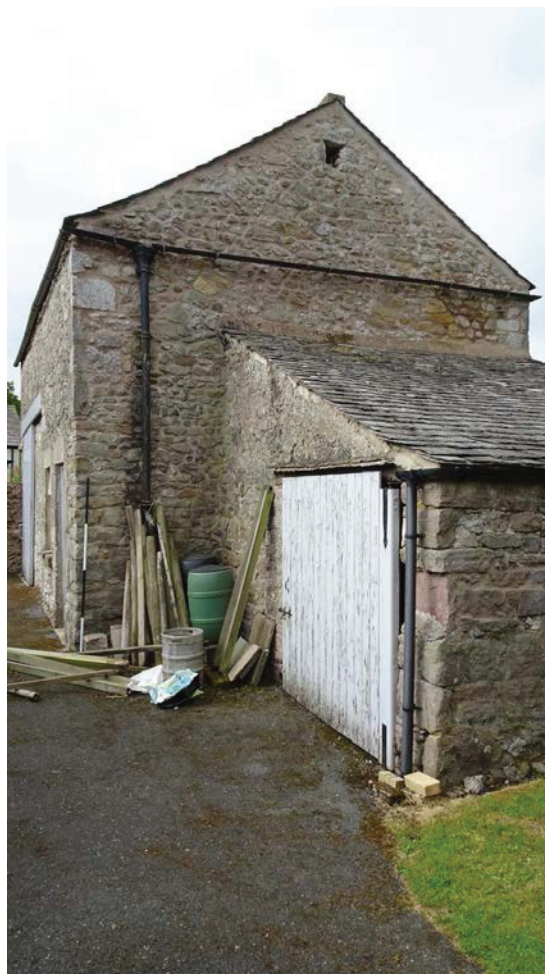
Plate 6 (right): The north external elevation, viewed from the north-west

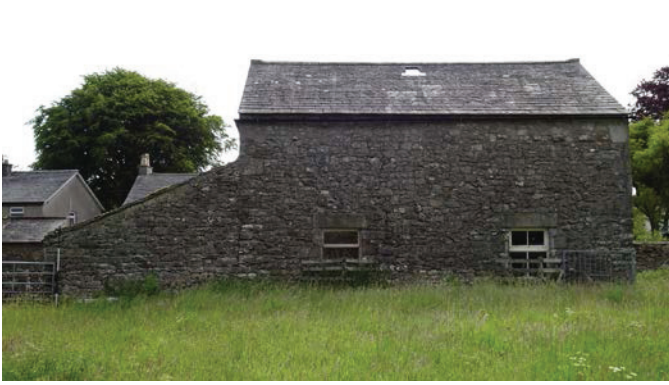
Plate 7 (left): The east external elevation, viewed from the east

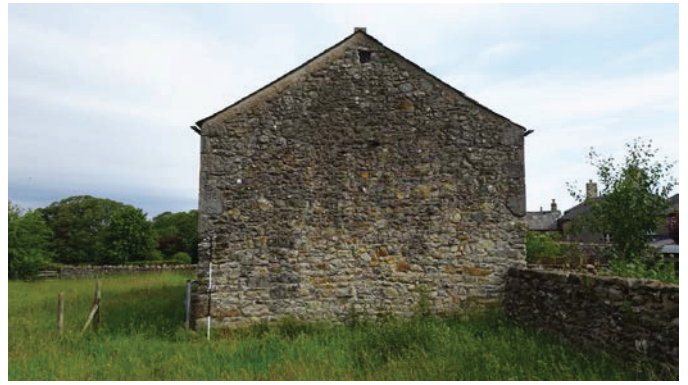
Plate 8 (right): The south external elevation, viewed from the south

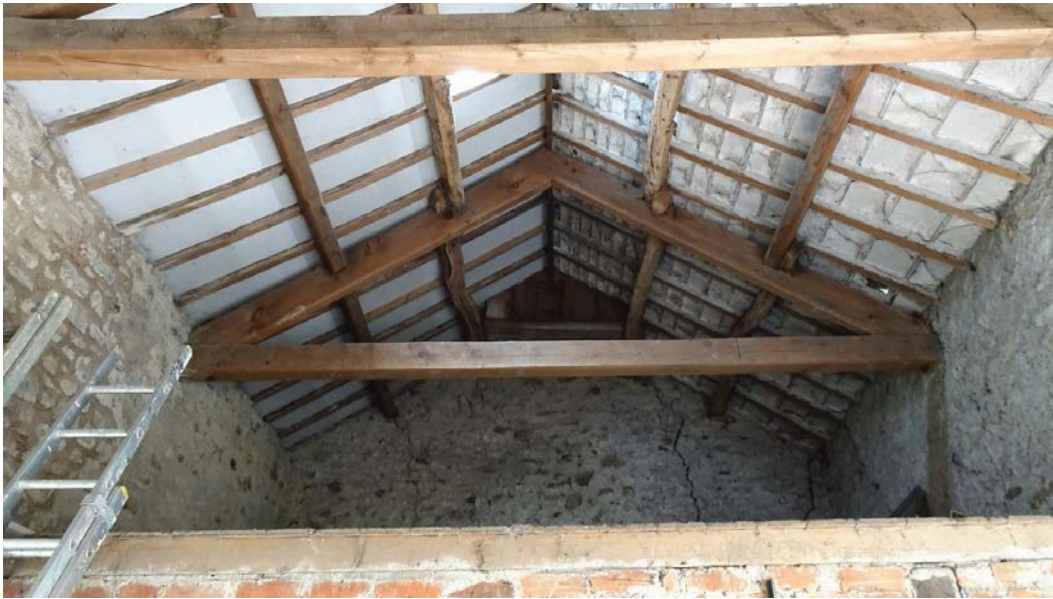
Plate 9: Tie beam truss at the north end of the main section of the building, viewed from the south
