TOWN HEAD, NEWBY BRIDGE, CUMBRIA

Archaeological Building Recording

July 2020

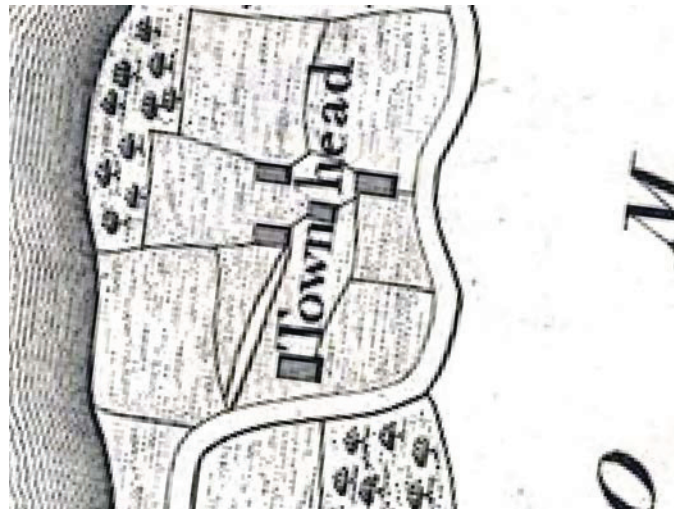
Plate 2: Extract from Clark's map of 1787 (Clarke 1787), rotated to put north at the top

3.1.3 **Clarke, 1787:** this map, entitled 'A Map of the Southern Part of Lake Winandermere and its Environs' was published in a collection of plans produced by James Clarke (Clarke 1787). The current site occupies the fields around Town Head; the bulk of the area to the east of the road to the east of Town Head is common land at this point (Plate 2). Five buildings are shown at Town Head, all of them aligned broadly east/west, but it is unclear which, if any, relate to the current buildings on the site.

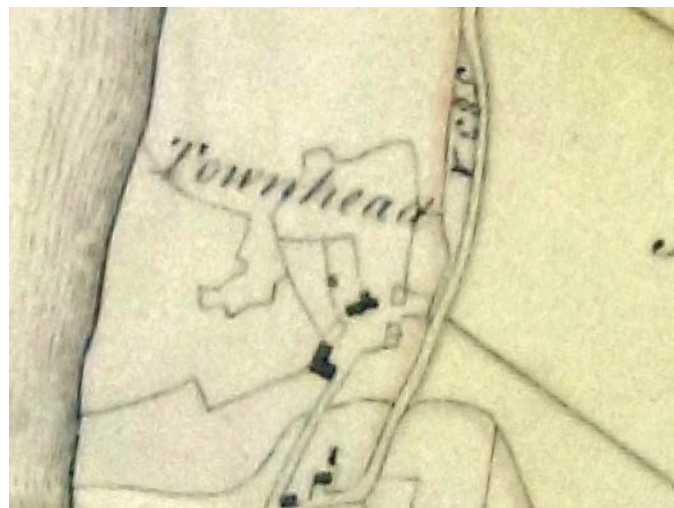
Plate 3: Extract from the enclosure map of 1807 (CAC(K) WPR 89 Z3 1807)

3.1.4 **Enclosure Map, 1807:** the enclosure map for the division of Staveley in Cartmel is included with the enclosure award for Cartmel (CAC(K) WPR 89 Z3 1807). The site occupies the fields around Town Head and parts of plots 582 and 583 to the east. There are six buildings shown at Town Head and while, as with earlier maps of the area, it is unclear which, if any, relate to the current buildings on the site, the large L-shaped block appears to correspond to the main house as depicted on later maps.

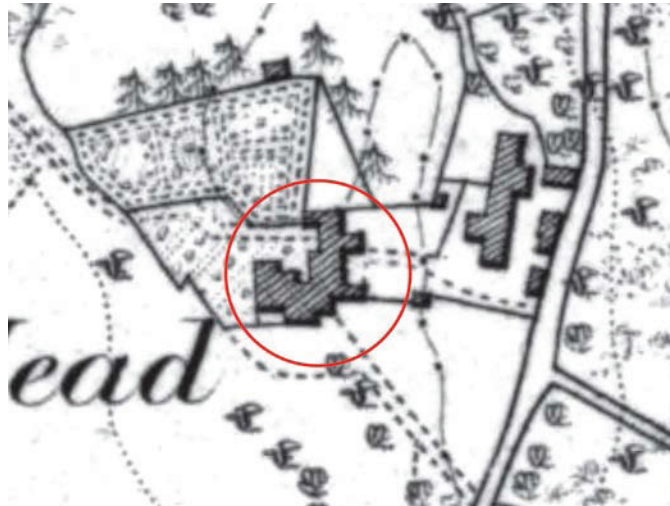
Plate 4: Extract from the Ordnance Survey map of 1851

3.1.5 **Ordnance Survey, 1851:** this is the first Ordnance Survey map for the area produced at a useful scale (1:10,560). It shows the main blocks of buildings at Town Head in much more detail than the earlier maps, including 'Old Dog Kennel' to the north and 'Boat House' to the north-west, as well as various springs and culverts, wooded areas, gardens and tracks across the area (Plate 4). The route of the road as it approached Town Head from the south has been moved some distance to the east, bypassing the buildings at Town Head.

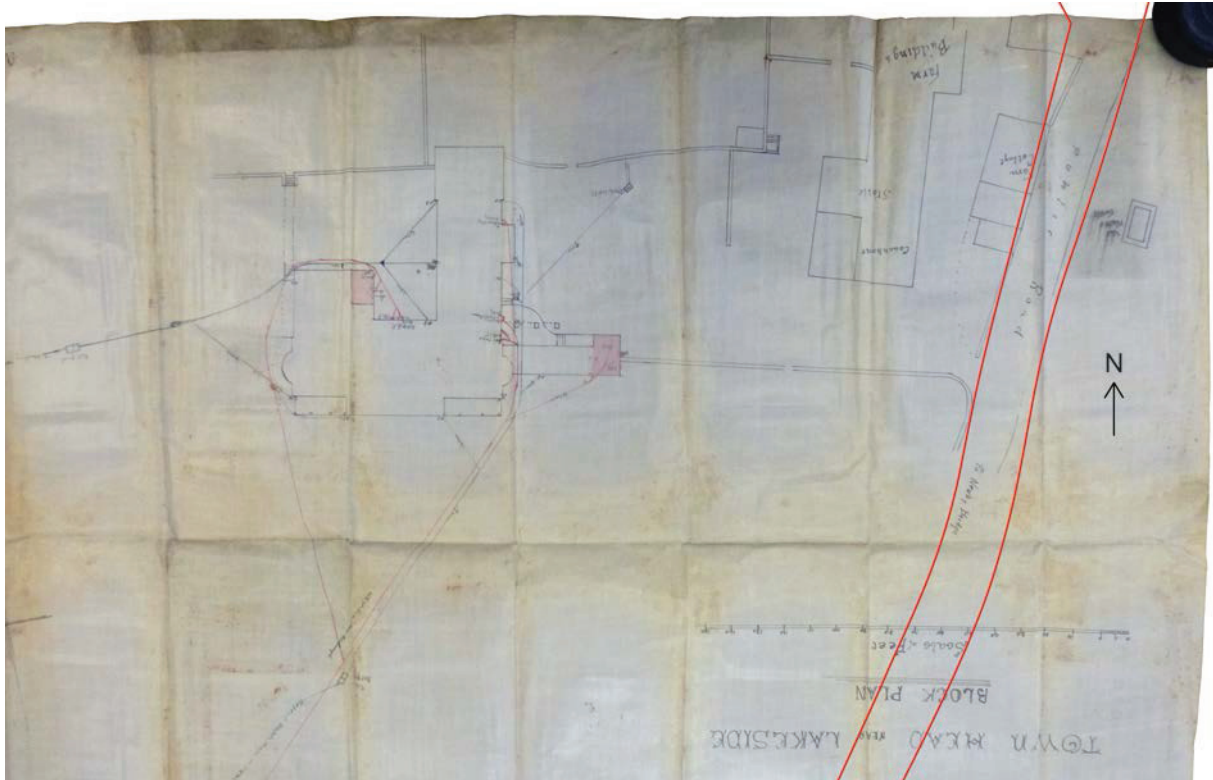
Plate 6: Block plan of the proposed new privy and ash pit, 1896

3.1.7 **New Privy and Ash Pit, 1896:** this is primarily a plan, produced by a 'J Fleming Ambleside', of a proposed new toilet and ash pit, but it includes a relatively detailed plan of the immediate environs of the house and associated drainage (CAC(B) BSRDNL/1/611 1896). While it is possible to discern some detail about the house such as the projecting south front with flanking verandas and rounded bay windows to the east and west, the most useful aspect is perhaps that the detached buildings to the north-east are labelled 'Farm Buildings' with an attached 'Stable' and 'Coach house' at the south end and a separate 'Farm Cottage' to the east. It also has separate detailed drawings of the proposed privy and ash pit, produced by 'Jas Dacre Builder Finsthwaite' for 'CG Townley Esq'.

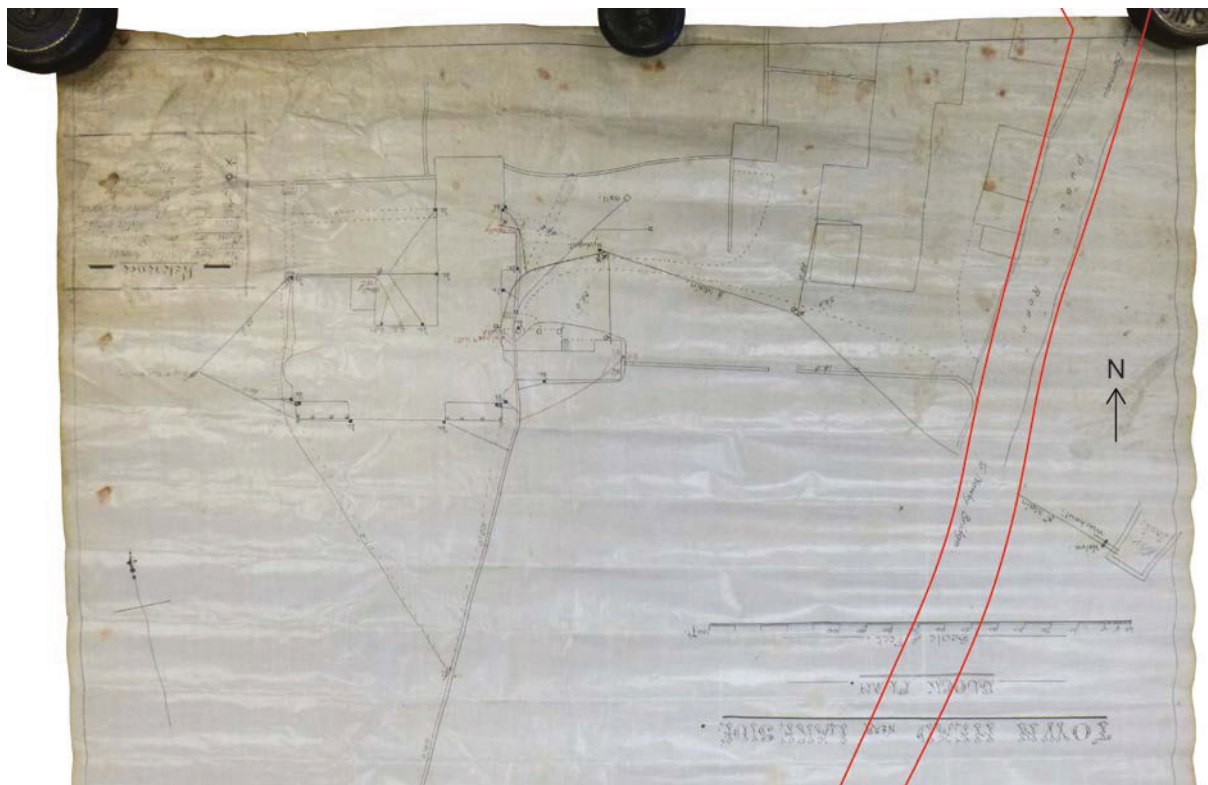
Plate 8: Drainage plan, 1897

3.1.8 **Drainage Plan, 1897:** this is essentially an identical plan of the site also produced by J Fleming (CAC(B) BDHJ/Plans/50 1897). It shows the house and farm buildings in the same detail, but without any of the specific labelling on the farm buildings, with the drains shown in more detail.

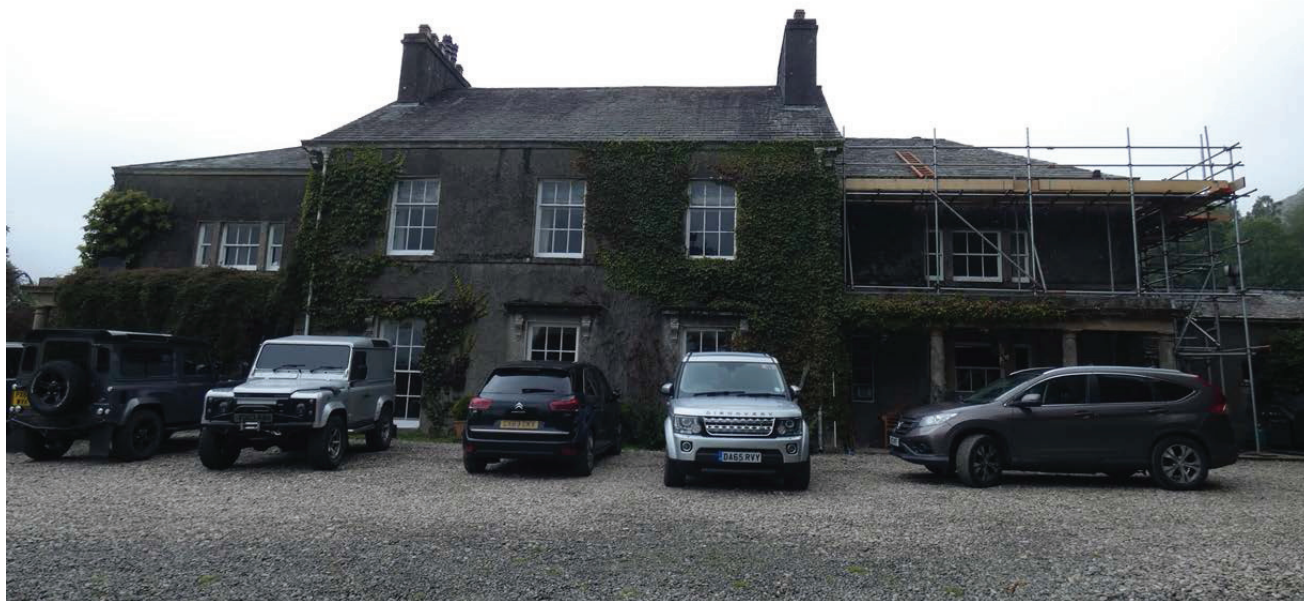
Plate 12: The south external elevation, viewed from the south

4.2.1 **South external elevation:** this comprises the front elevation, overlooking lawns and with an open aspect over fields and down to Lake Windermere. The main part of the house comprises a symmetrical central block with flanking wings that are slightly lower and have hipped roofs, and are further extended by semi-circular bays in the west and east elevations (Plate 12). Each wing also has an attached veranda comprising five Doric columns (one engaged at each end) supporting a moulded entablature. Within the lower part of the west wing there is a single window with a three over six light sliding sash (Plate 13). At first floor level in the west wing there is a long low three-part window with a pair of one over one light sash casements flanking a central three over three light sash. There is a moulded entablature across the top. The central part of the elevation has a symmetrical row of three full height windows with six over six light sash casements with very narrow stone surrounds and moulded hoods supported on scrolled brackets with floral modillions (Plate 14 and Plate 15). A square string course above forms the sill of a matching row of three windows with three over six light casements and thin surrounds, with a moulded entablature along the top of the wall. The east wing has a similar first floor window to that at the west end, while the ground floor has a similar form of window but with fixed casements forming the flanking side lights and another small two-light window to the west of this (Plate 16). The elevation is extended to the east by the low range of outbuildings, which butt against a rounded section projecting from the east wing. The outbuildings also have a hipped roof at the east end but the elevation is relatively plain, with two small windows with hinged two-light fixed casements and plain dressed stone sills and a doorway at the east end with a tongue and groove plank door in a beaded surround.

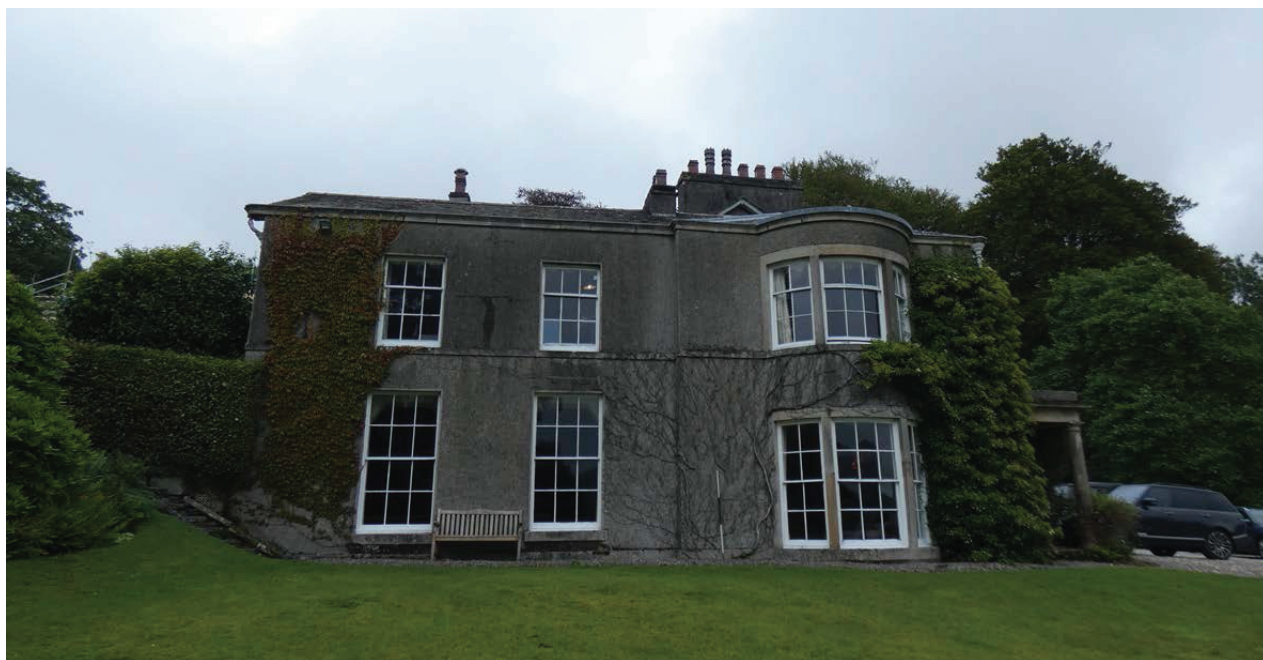
Plate 17: The west external elevation, viewed from the west

4.2.2 **West external elevation:** the veranda projects on the south side (Plate 17) and within this is a doorway with an original door with six raised and fielded panels with mouldings. The south end of the elevation is otherwise dominated by a semi-circular bay window extending over two floors with a pair of four over four light sash windows flanking a central six over six light window on the ground floor and a pair of two over four light sash windows flanking a central three over six light window on the first floor (Plate 18). These all have square dressed surrounds and a square string course forming the first-floor sills and moulded entablature above. The string course extends to the north and this section steps back from the main part and has two windows per floor comprising six over six light sashes on the ground floor and three over six light sashes on the first floor all with thin stone surrounds and with the same entablature along the top of the wall (Plate 19). The west elevation of the north wing, within the rear courtyard, has a series of irregular windows comprising two six over six light sash casements with dressed stone sills, a tall six over 18 light sash casement (presumably a stair window), and a single two light window at low level (Plate 20). There is also a blocked doorway visible as a shallow alcove to the north of the windows. The north end steps out beyond the blocked doorway and there are two three over three light sash windows with horns and a small outshut with a flat roof with a glazed section at the south end (Plate 21).

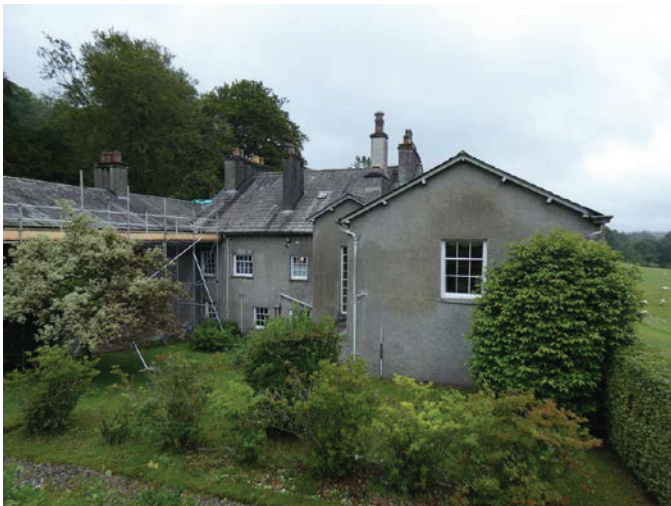
Plate 22 (left): The west side of the north external elevation, viewed from the north

4.2.3 North external elevation: the west side of this comprises a large projecting gable with two purlins visible per pitch plus the ridge, a central window with a three over six light sash casement and a thicker sill than to the south and west and a tall chimney stack on top (Plate 22). A small monopitch outshut extends from the east side of this and continues below a projecting tall narrow gable end containing a long 24-light stair window. The main elevation to the east of this has an irregular collection of windows, two with four over eight light sashes, two with three over six light sashes, and two with six over six light sashes. There is an additional tall chimney behind the front (south) elevation at this point (Plate 23). The east end of the elevation comprises just a plain gable with two purlins per pitch exposed plus a ridge and a lower window extending below the ground level on this side with a two over two light sash casement with horns. At the east end the elevation is continued by the low range of outbuildings extending from the south side of the building. These are largely open fronted, with a column built of slate on the east side and a small window with a three over three light casement with iron bars over to the east (Plate 24).

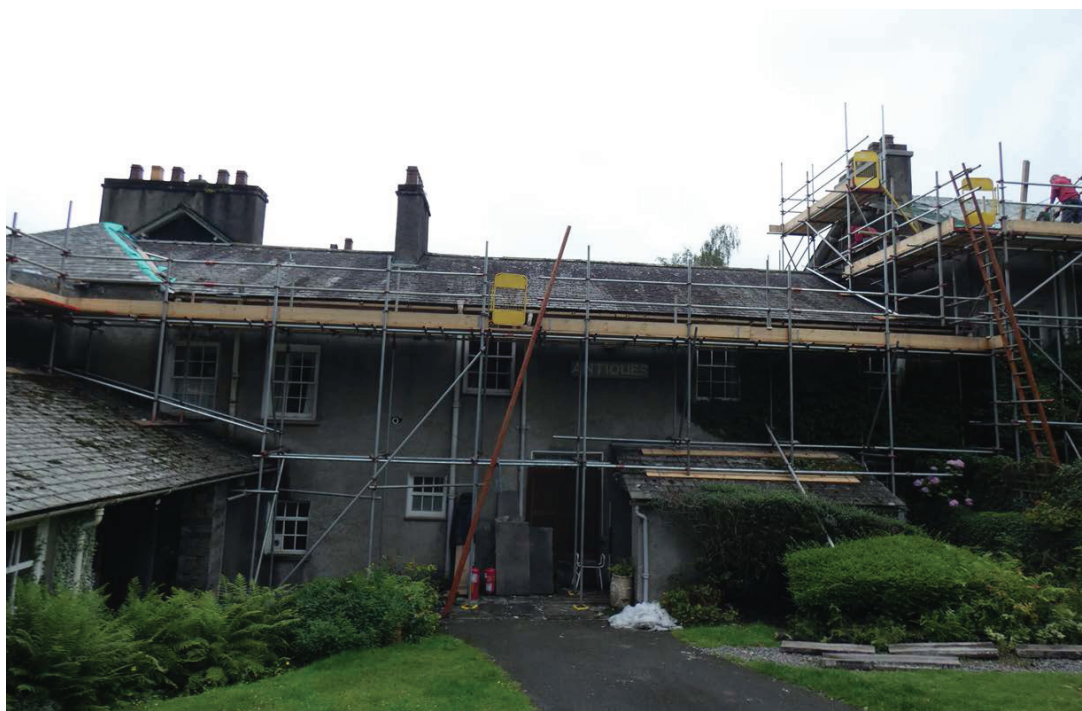
Plate 25: The east external elevation, viewed from the east

4.2.4 **East external elevation:** the north side has a small monopitch outshut attached, which has a small window in the with a hinged six-light casement, and a doorway in the south side with a moulded four panel door in a stop chamfered surround. Immediately to the south of which is a large eight over eight light sash window at first floor level with large dressed stone lintel and a much smaller light to the south of this with a two over four light hinged casement. At the lower floor level there is a 10 over 10 light sash window. The main part of the elevation, to the south (Plate 25), has a long low monopitch outshut over the ground floor with a doorway in its south end with no door. There are large windows to the north and south of this outshut at ground level each with a 10 over 10 light sash casement. There are two further windows to the south at ground level with hinged three over three and three over six light casements. At first floor level there is a row of three six over six light casement windows and two more close together at the south end, one of which has a thicker sill. The low outshut range extending to the east at the south end is butted against a semi-circular projection from the main part of the building, which has a window at first floor level with a six over six light sash casement. There is a doorway with a plank and batten door effectively within the area covered by the outshut range, and beyond this, at the south end of the elevation is another door with 12-lights.

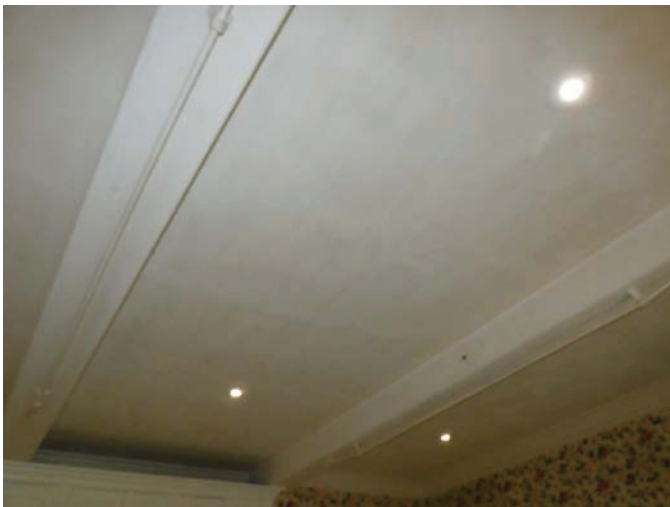
Plate 26 (left): Beams and iron bars in Room G1, viewed from the south-west

4.3.1 **Ground Floor Room 1:** this has a tiled floor and plaster ceiling with two plastered beams with beaded edges and iron bars attached, presumably for hanging items from rather than tie rods (Plate 26) and there is a moulded cornice (Plate 27). The north elevation is dominated by a large alcove filled with a cupboard that has panelled doors and moulded drawers (Plate 28). There is a doorway to the east of this with a moulded surround and six-panel moulded door. The east elevation has a central doorway with six moulded panels, the top two of which are glazed (Plate 29), and leads into a semi-circular pantry with relatively modern shelves attached to the walls and a stone flag floor. There is another doorway to the south in the east elevation proper up a single step, which has a single raised and fielded panel and 12 lights over (Plate 29). The south elevation is dominated by a wide three-part window with splayed jambs, with a smaller window to the west with square jambs (Plate 30). The west elevation has a deep cupboard built into the south-east corner with panelled doors but also incorporating an electric cooker (Plate 31). To the north is a large fireplace, now incorporating an Aga but with an original stone surround around the fireplace opening. To the north is a doorway with a six-panel door; the wall is evidently extremely thick.

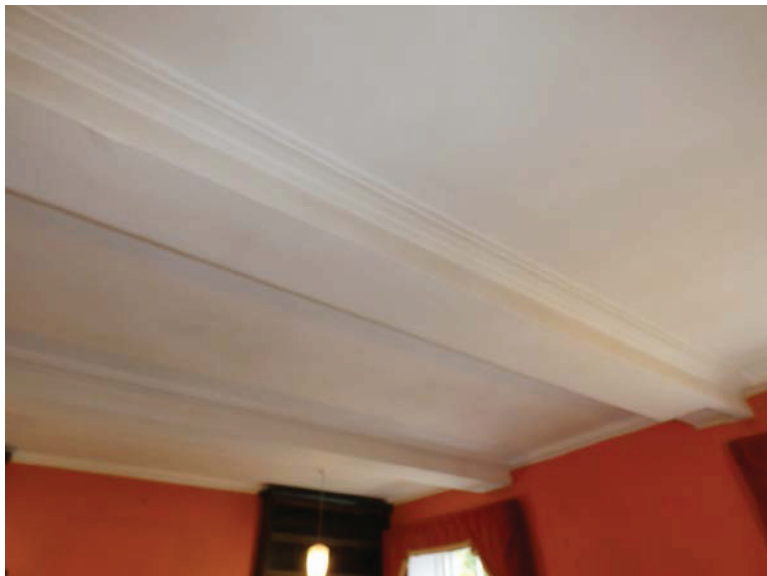
Plate 32 (left): The ceiling in Room G2, viewed from the north-west

4.3.2 **Ground Floor Room 2:** the floor is finished with carpet and the ceiling plaster, supported by three beams orientated north/south and there is a relatively simple cornice (Plate 32). The north elevation has an alcove housing a built-in cupboard with a moulded surround and doors in the lower part (Plate 33). The east elevation has a central fireplace with a polished stone and iron insert and a hob grate with floral decoration (Plate 34). There are fixed timber bookshelves either side with some simple moulded decoration; these are evidently not original as they have been fairly crudely attached around the cornice. The south elevation has two full-height windows with splayed jambs and panelled shutters (Plate 35). The west elevation has a tall fixed bookshelf on the south side, similar in style to those to the east (Plate 36). To the north is a doorway with a dark polished hardwood finish and six moulded panels (Plate 36).

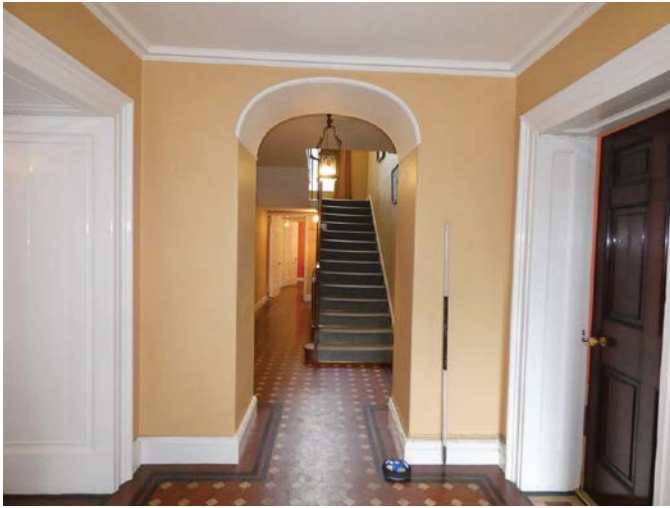
Plate 37 (left): The north elevation, Room G3, viewed from the south

4.3.3 **Ground Floor Room 3:** this has a tiled floor and plaster ceiling with a shallow cornice. The north elevation has a round-headed opening leading to Room G4 (Plate 37). The east elevation has a doorway on the north side with a moulded surround and dark polished hardwood door with six moulded panels (Plate 38). The south elevation has a full height window with square jambs and panelled shutters (Plate 39). The west elevation has a doorway on the south side with four moulded panels, panelled jambs and a moulded surround (Plate 40) and there is a second doorway to the north with moulded surrounds, deep panelled jambs and a dark polished hardwood door with six moulded panels.

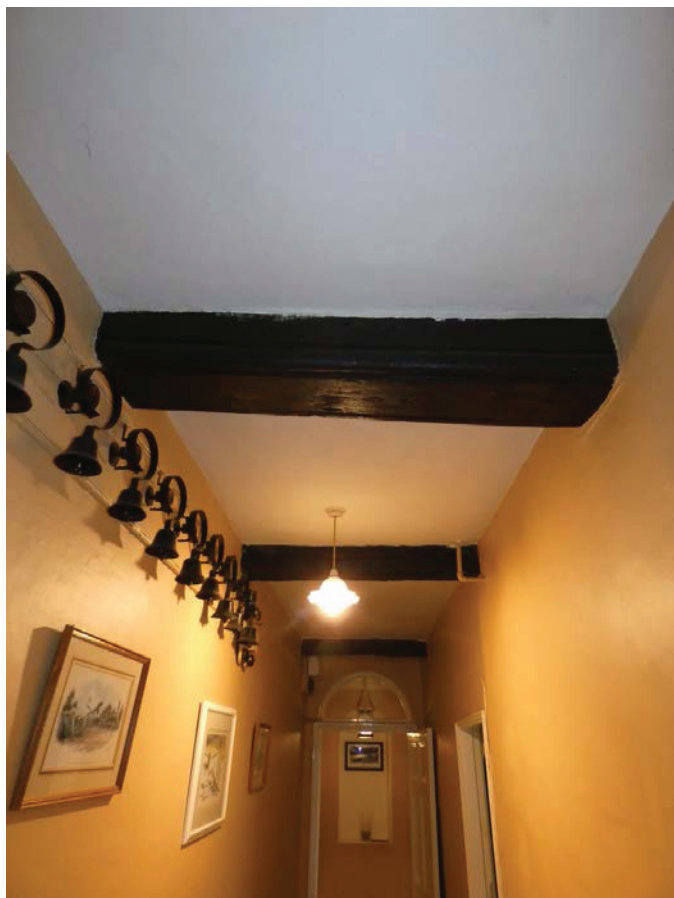
Plate 41 (left): Beams in the ceiling of Room G4, showing the beading, viewed from the east

4.3.4 **Ground Floor Room 4:** this comprises an L-shaped corridor linking the east end of the main part of the building with the main staircase, with a short arm also connecting to a corridor that links to the back staircase. The floor is finished with tiles, of relatively modern type to the east and quarry tiles to the west. The east/west arm is relatively plain while the north/south has a cornice and there are four beams running across the east/west section all hand finished timber painted black, one of which has a heavy beading (Plate 41). The east/west arm has a doorway in the north elevation with a six-panel moulded door and moulded surround and the short arm to the north has window at the north end and a similar doorway to the west. The east elevation has further two doorways with similar style (Plate 42). The south elevation is largely plain, with the exception of a row of servants' bells attached high on the east side (Plate 43) and there is doorway in at the point where the east/west and north/south arms meet with a six

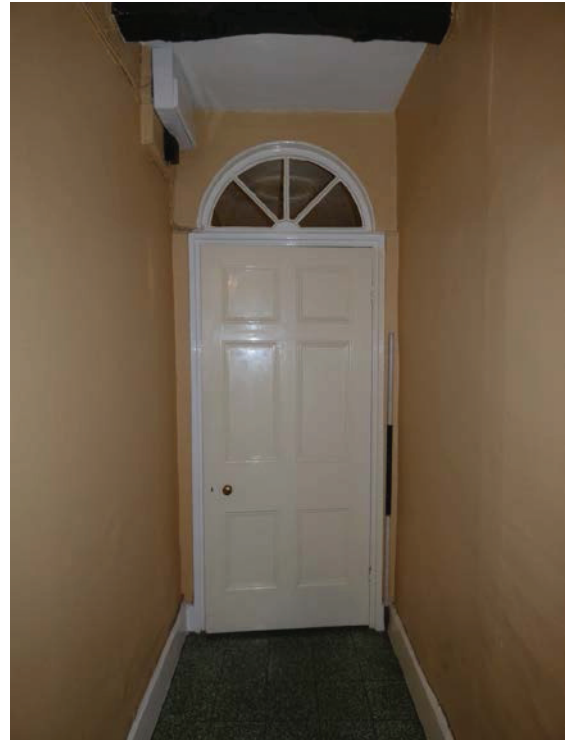
Plate 44 (right): Doorway dividing Room G4, viewed from the east

moulded panel door and four-light semi-circular fan light over (Plate 44). The north/south section is dominated by the staircase, which is set against the east wall and has relatively plain turned newel posts and square balusters (Plate 45). The west elevation has a round-headed alcove on the south side (Plate 46) and a doorway to the north with a dark polished hardwood door with six-panels and deep panelled jambs. The north end has a doorway with a six-panel door and moulded surround.

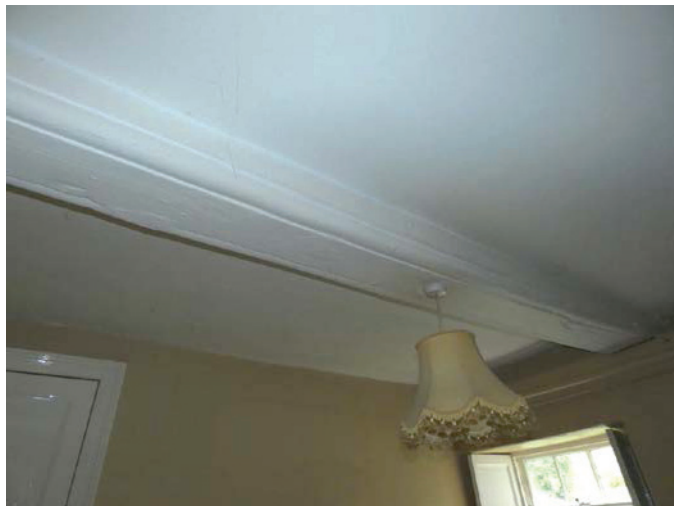
Plate 47 (left): Beam in Room G5, viewed from the south-east

4.3.5 **Ground Floor Room 5:** this has a timber floor, with relatively narrow boards running north/south and a plaster ceiling with a single beam with a wide chamfer, also north/south, continuing from Room G4. The walls are largely plain. The north elevation has a window on the west side with splayed jambs with shutters and there is boxed piping along the wall top. The east elevation has a doorway on the south side with a moulded surround and the door has six moulded panels. The south elevation is plain, while the west has a cupboard on the south side with panelled doors.

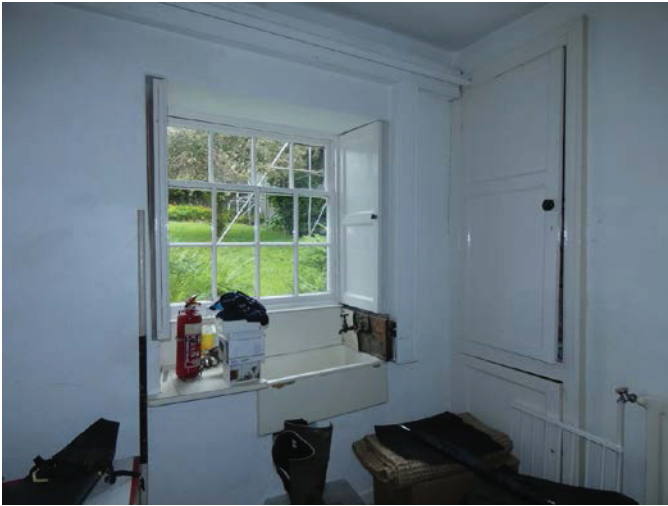
Plate 49 (left): The north-east corner of Room G6, showing the window and cupboard, viewed from the south-west

4.3.6 **Ground Floor Room 6:** this has a linoleum floor over boards and is raised relative to Room G4. The plaster ceiling has a beam orientated north/south on the west side (Plate 50), continuing from Room G4. The north elevation has a window in the centre with square jambs with shutters and an inset sink below (Plate 49). The east elevation has a cupboard built in on the north side with two panelled doors (Plate 49). The south elevation has a single doorway on the east side with a six moulded panel door, and the wall steps out to a thicker section on the west side. The west elevation is covered by an early fitted cupboard, although it has evidently been added at a later date (Plate 50).

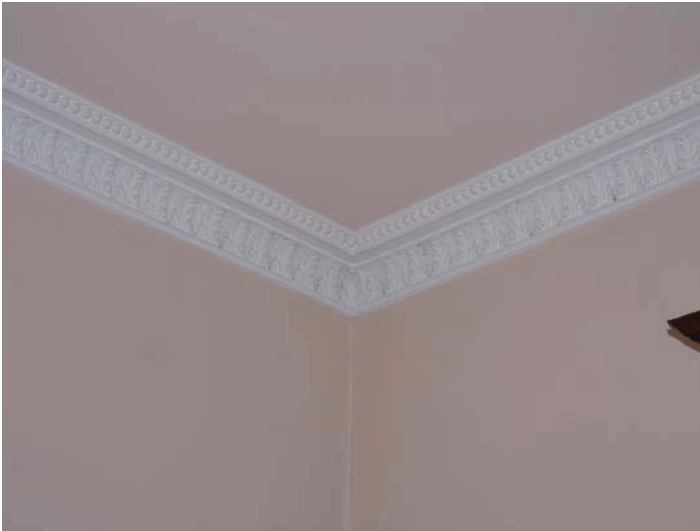
Plate 51 (left): Cornice detail in Room G7, viewed from the north-west

4.3.7 **Ground Floor Room 7:** this has a timber floor with relatively narrow boards running north/south and the plaster ceiling has an acanthus leaf cornice. The north elevation has a large fireplace with a polished stone chimney piece with floral decoration. The east elevation has a doorway on the south side, while the south has a tall window with square jambs and no shutters. The west elevation is largely formed by the curving semi-circular bay window, which has fluted details and floral modillions.

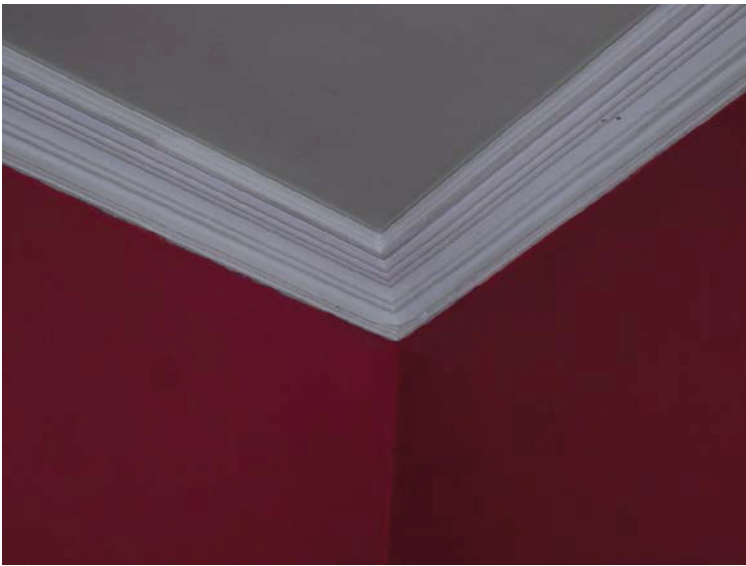
Plate 55 (left): Detail of the cornice in Room G8, viewed from the north-west

4.3.8 **Ground Floor Room 8:** this also has a timber floor, with the relatively narrow boards running north/south and a plaster ceiling. There is a fluted and moulded dado rail running around the walls and a relatively plain cornice (Plate 55). The north and south elevations are plain, while the east elevation has a fireplace with a polished black marble surround (Plate 56). The original insert has been removed and the back has been either stripped to the original stone or had new stone added. There is a doorway to the south with a dark polished hardwood door and moulded surround. The west elevation has two tall windows with splayed jambs with panelled shutters and moulded surrounds (Plate 57).

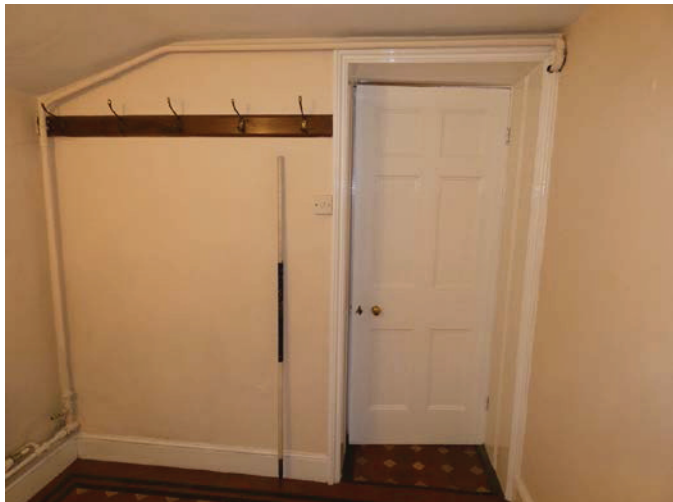
Plate 58 (left): Doorway to the south in Room G9, viewed from the north

4.3.9 **Ground Floor Room 9:** this comprises a small bathroom, divided into two parts. It has a tiled floor with two two over two light windows to the east and a doorway with a six-panel door to the south (Plate 58), with beaded panels in the jambs, as well as one in the dividing wall. The plaster ceiling slopes down with the roof line to the east and there is an early 20th century toilet and sink (Plate 59).

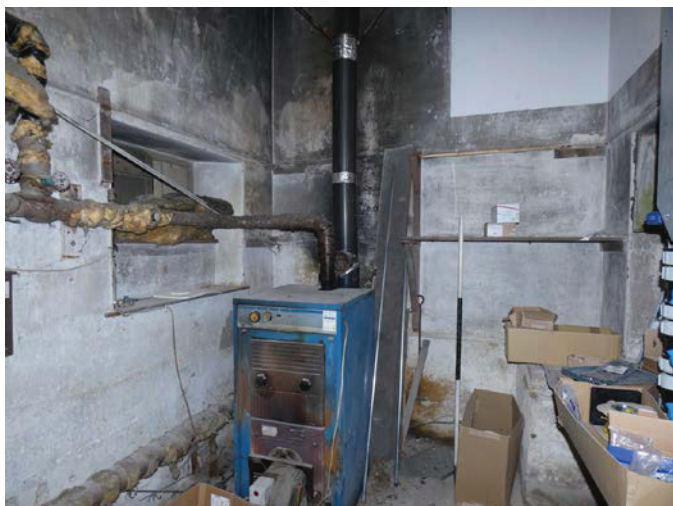
Plate 60 (left): The north and east elevation of Room G10, viewed from the south-west

4.3.10 **Ground Floor Room 10:** this comprises a boiler and/or plant room and has a concrete floor, with a hole cut into the south side for electricity cables. The walls are finished with plaster and mostly plain. The north elevation has a small window on the east side in a tall alcove with a timber shutter (Plate 60) and there is a doorway to the west with a plank and batten door. The east elevation has shelves on angled brackets attached and scars where there were originally more (Plate 60). There is a stone bench against the south elevation and the scar for where this originally ran further to the west below a pair of windows, each set in a tall alcove a covered by timber shuttering (Plate 61). The west elevation is partly curved following the curving projection from the main building (Plate 62).

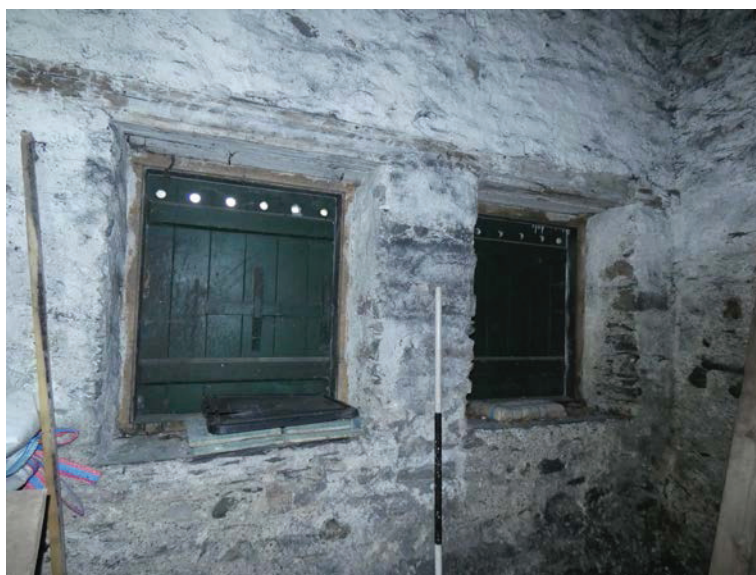
Plate 64: Pair of apertures on the east side of the north elevation of Room G11, viewed from the south

4.3.11 **Ground Floor Room 11:** this has a stone flag floor and is open to the roof, which is constructed from machine cut purlins. The walls are rough stone finished with limewash and are all plain, apart from the north, which has a doorway on the west side with a tongue and groove plant door with long strap hinges and an original lock with decorative plates (Plate 63). To the east there are two apertures, which share a single chamfered lintel and have tongue and groove plank and batten shutters with sliding timber bolts and ventilation holes along the top.

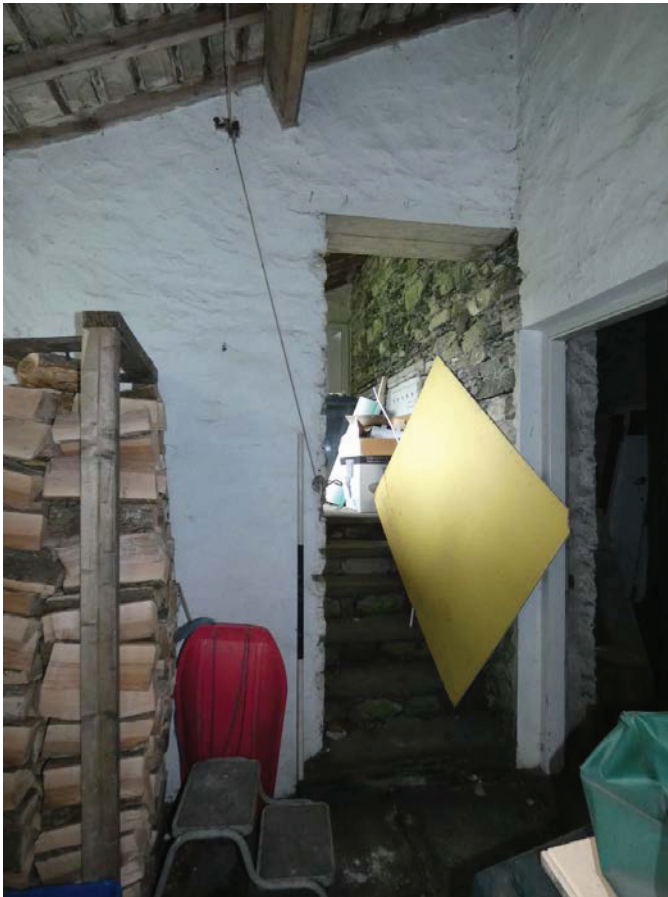
Plate 65 (left): Stairs between the two sections of Room G12, viewed from the west

4.3.12 **Ground Floor Room 12:** this essentially comprises an open space along the north side of the outshuts, with a flag floor on the west side raised via a flight of steps to the east (Plate 65). There is a half truss at the west end supporting the roof, with a joggled joint between the tie beam and the principal, which is supported by a square block of masonry (Plate 66). The walls within this room are largely open on the north side but are limewashed stone elsewhere. There is a hinged three over three light window in the one continuous section of the north elevation. The south elevation has two apertures at the east end, two doorways and a two-light window. There are doorways to the east and west with tongue and groove plank doors.

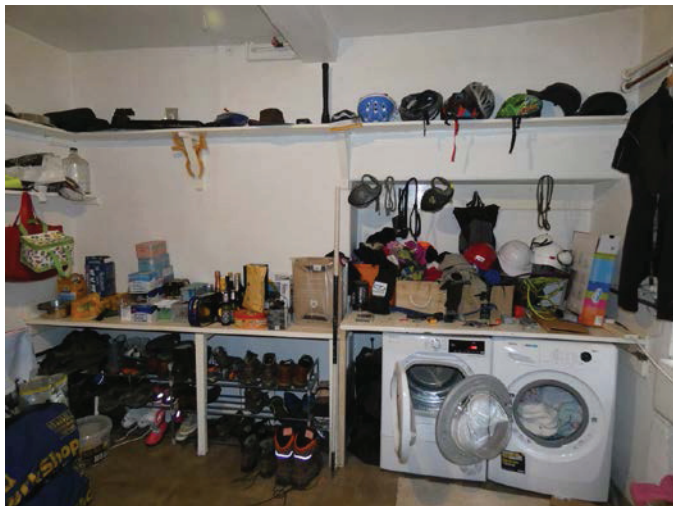
Plate 67 (left): The north elevation of Room G15, viewed from the south

4.3.15 **Ground Floor Room 15:** this has a concrete floor, stepped up from G1 to the south, and a flat plaster ceiling with a single beam north/south with meat hooks on the west side. There are shelves on brackets along the north, west and south walls and a wide and low alcove on the east side of the north elevation (Plate 67). There is a doorway in the south elevation with six plain panels and a doorway in the east elevation with a tongue and groove door plus a window to the north of this with a six-light casement, the top three hinged, below which is an inset sink with tiles around (Plate 68).

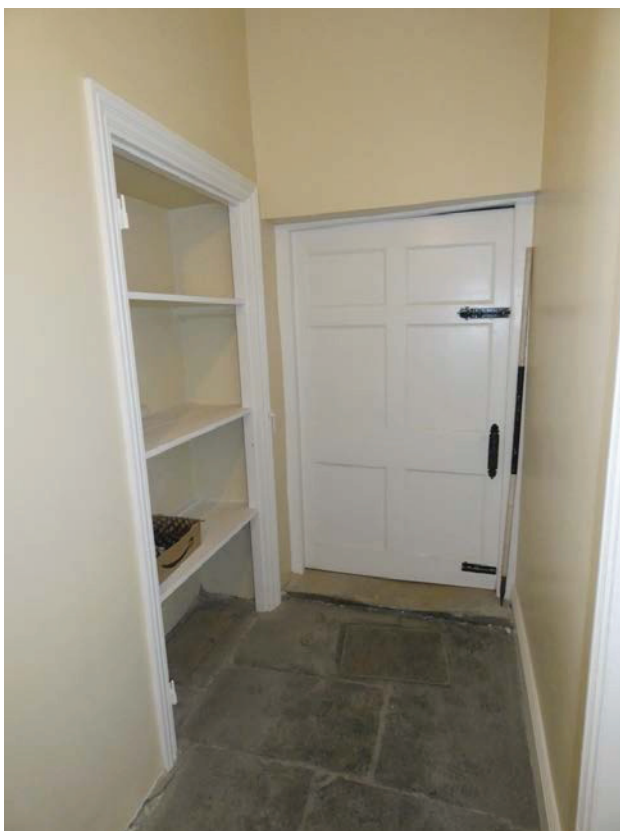
Plate 69 (left): Alcove in the west elevation and doorway to the north in Room G16, viewed from the south-east

4.3.16 **Ground Floor Room 16:** this comprises a short corridor linking the main house to the north wing and the back stairs and includes a small toilet running off the east side. It has a stone flag floor, although the toilet has a modern stone floor and it has all be extensively modernised. There are a pair of windows to the west, one with a six over six light sash and the other the lower part of a tall stair window, that extends into the floor above. There is also an alcove in the north end of the west elevation, with a moulded surround and three timber shelves, but the door has been removed. The north elevation has a wide six-panel door with a decorated bolt while the door to the east is plank and batten, with an opening on the south side to the stairs finished with tongue and groove planks on the south side.

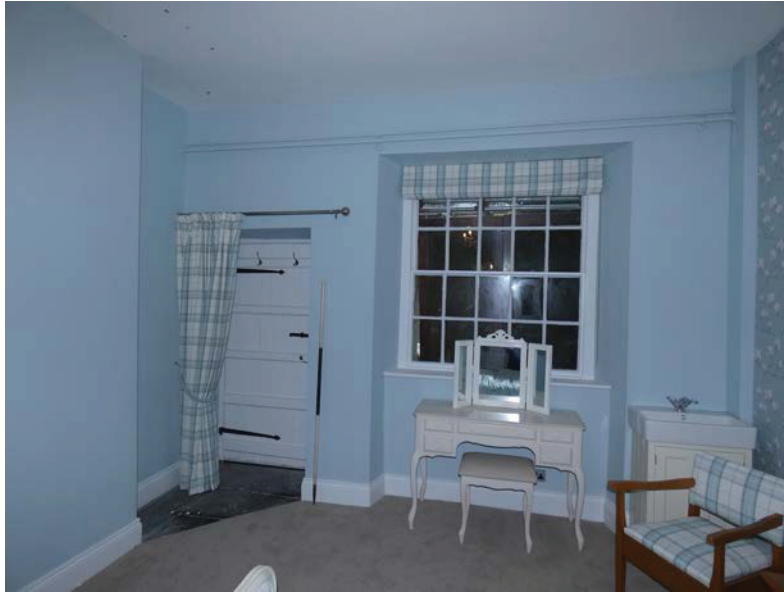
Plate 71: The east elevation of Room G17, viewed from the west

4.3.17 **Ground Floor Room 17:** this has been totally modernised but possibly has a stone flag floor finished with carpet and has two hand-finished timber beams orientated north/south supporting the ceiling. There is a door to the east with long strap hinges and a 10 over 10 light window (Plate 71).

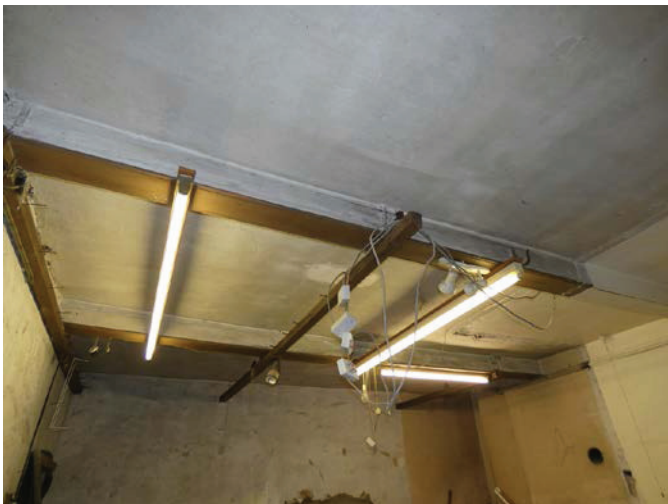
Plate 72 (left): Beams and attached timbers in the Room of Room G18, viewed from the east

4.3.18 **Ground Floor Room 18:** this has had the floor removed to the earth and some internal walls removed. The ceiling is supported by two beams orientated north/south, with three additional timbers added on the south side across these, orientated east/west (Plate 72). The walls have been stripped to the original plaster. The north elevation has a concrete staircase forming a dog-leg to a doorway at high level, which has a door with six moulded panels (Plate 73). There is a slight step in the wall to the east of this and a large pipe inserted (presumably for a stove flue). Beyond this is an airing cupboard built into the wall, with two panelled doors backed with hardboard and there is a further tall alcove to the east. The east elevation has a large window with relatively recent bars on the inside (Plate 74) and a beaded tongue and groove door to the south on long strap hinges and with some red baize still in place (Plate 75). The south elevation is essentially plain, but with a doorway on the west side obscured by plastic sheeting. The west elevation is also plain, but with upright slates set against its base, presumably as some form of water proofing.

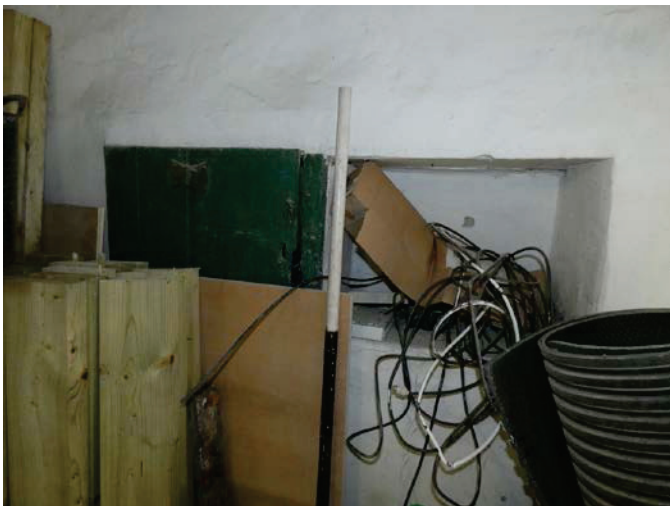
Plate 76 (left): Alcove in the east elevation of Room G18a, viewed from the south-west

4.3.19 To the east of Room 18 is a small porch split into two rooms (Room G18a and G18b) neither of which have any features of great interest. The southern of these (Room G18a) is larger and has an alcove on the east side with a plank door covering the north side with early 'butterfly' hinges (Plate 76). There are two doorways to the west with beaded plank and batten doors, the south with elaborate hinges. The door to the north into Room G18b is a plank and batten also. The roof of G18b is supported by a single rough timber, which has what appears to be a timber pulley block on top (Plate 77). The walls are finished with limewash over stone and there is a single corbel in the west elevation.

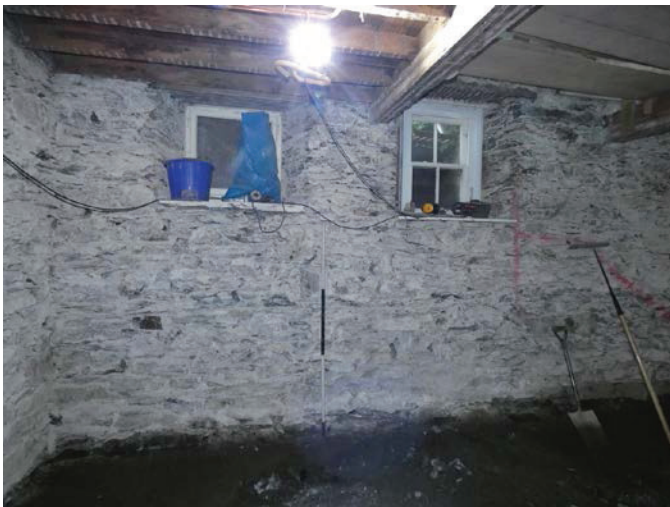
Plate 78 (left): The north elevation of Room G19, viewed from the south

4.3.19 Ground Floor Room 19: this has also had the floor removed and the bedrock is exposed in places. The plaster has also been removed from most of the walls, revealing the slate construction. The ceiling has also had the plaster removed exposing two machine cut timber beams orientated north/south and similar joists. The north elevation has a window near the centre with a four light sash casement with horns. There is a further aperture to the west covered with mesh (Plate 78). The east elevation has a doorway on the north side; the door has been removed, but there is a three light over light (Plate 79). Through this is a small porch, which has a six-panel door to the south and exposed bedrock up to c1m tall in the north elevation (Plate 80). To the south is a large window with a 10 over 10 sash casement in splayed jambs and with a timber sill (Plate 79). The south elevation has a fireplace on the east side, with a fairly simple timber surround and floral iron insert, which is flanked by cupboards with moulded surrounds, modern glass shelving, and a single panel door in the base of each (Plate 81). The fireplace and cupboards are all part of a timber stud construction projecting from the main wall. There is also a doorway to the west with a six-panel door. The west elevation has a window with a three over three light casement with horns and a machine cut timber lintel, and below the sill a large square section has been filled with modern concrete blocks.

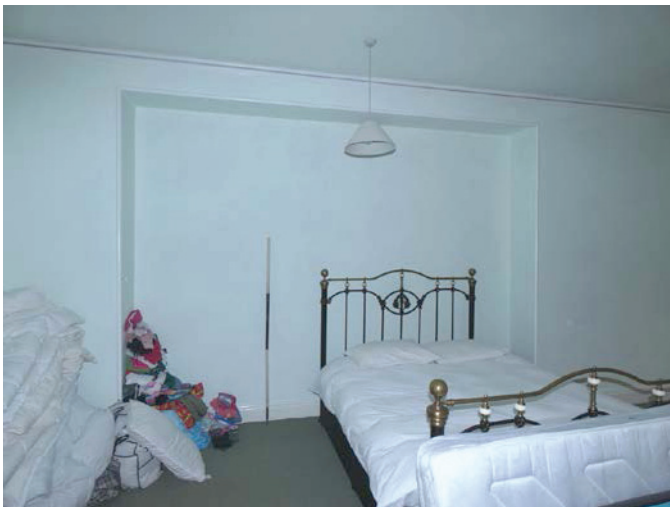
Plate 82 (left): Alcove in the north elevation of Room F1, viewed from the south

4.3.20 **First Floor Room 1:** the floor is finished with carpet over timber boards and the ceiling is flat plaster with a simple cornice. The north elevation has a wide alcove with roll moulded edges coming to octagonal bases (Plate 82). The east elevation is dominated by a semi-circular bay with a single window with a six over six light casement. Again, the roll moulded surround of the opening has octagonal bases (Plate 83). The south elevation has a wide three-part window with a pair of one over one light casements flanking a central three over three light sash, and an inserted timber sill has been added below (Plate 84). The west elevation is plain apart from a vent for a flue – the hearthstone is present below the carpet, and a doorway on the north side with a six-panel door (Plate 85).

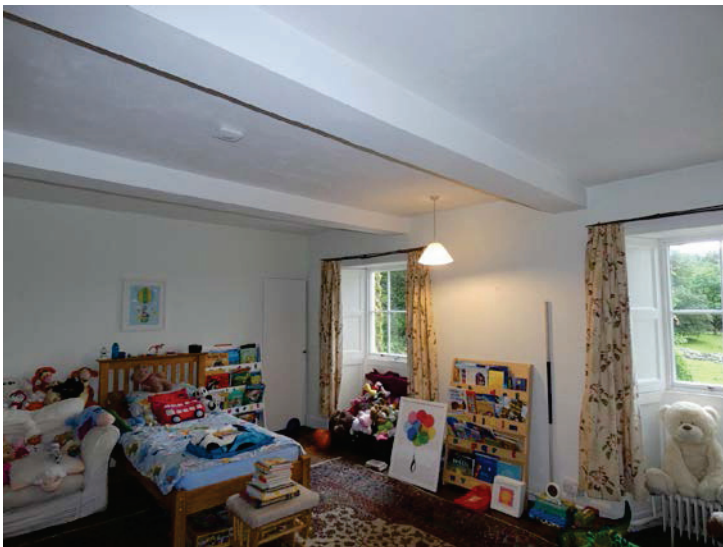
Plate 86 (left): Beams supporting the ceiling in Room F2, viewed from the north-west

4.3.21 **First Floor Room 2:** this is divided into two parts by a stud partition wall and has a timber board floor, orientated north/south and relatively wide. The ceiling is supported by four beams finished with plaster orientated north/south divided between the two spaces (Plate 86). The walls are relatively plain; there is a doorway with a six-panel door in the north elevation of the eastern room and the east elevation has a hearth stone south of the centre and in the south-east corner there is a small cupboard with an early door with two very rough raised panels (Plate 87). There are three windows to the south with splayed jambs with panelled shutters. The western room has a second hearth stone against the west elevation and a cupboard on the west side of the north elevation with a six-panel door.

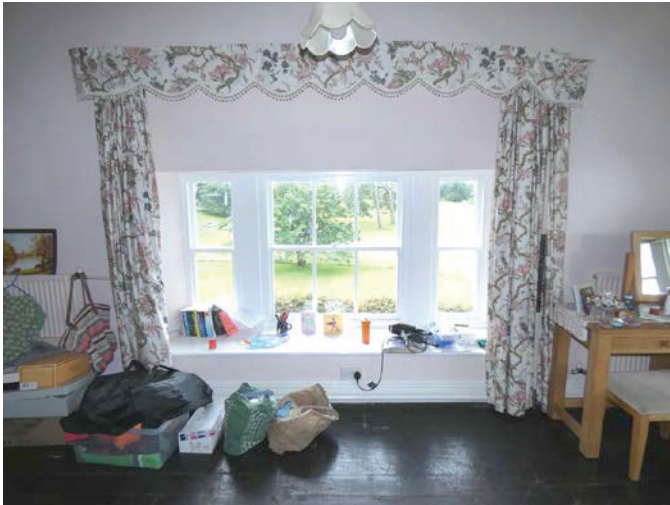
Plate 88 (left): The window in the south elevation of Room F3, viewed from the north

4.3.22 **First Floor Room 3:** this has a timber floor, the boards, which are relatively narrow and orientated east/west. The flat plaster ceiling has a simple cornice and the north elevation is plain, apart from a tiled hearth. The east elevation has a doorway with a six-panel door and steps down into Room F5. The south elevation has a long window with splayed jambs and a timber sill (Plate 88). The west elevation is filled by a semi-circular bay window, which has panelling below (Plate 89).
